Report No. UT-14.09

## **SEISMIC EVALUATION OF GROUTED SPLICE SLEEVE CONNECTIONS FOR PRECAST RC BRIDGE PIERS IN ABC**

Utah Department of Transportation  
Research Division

**Final Report  
October 2014**

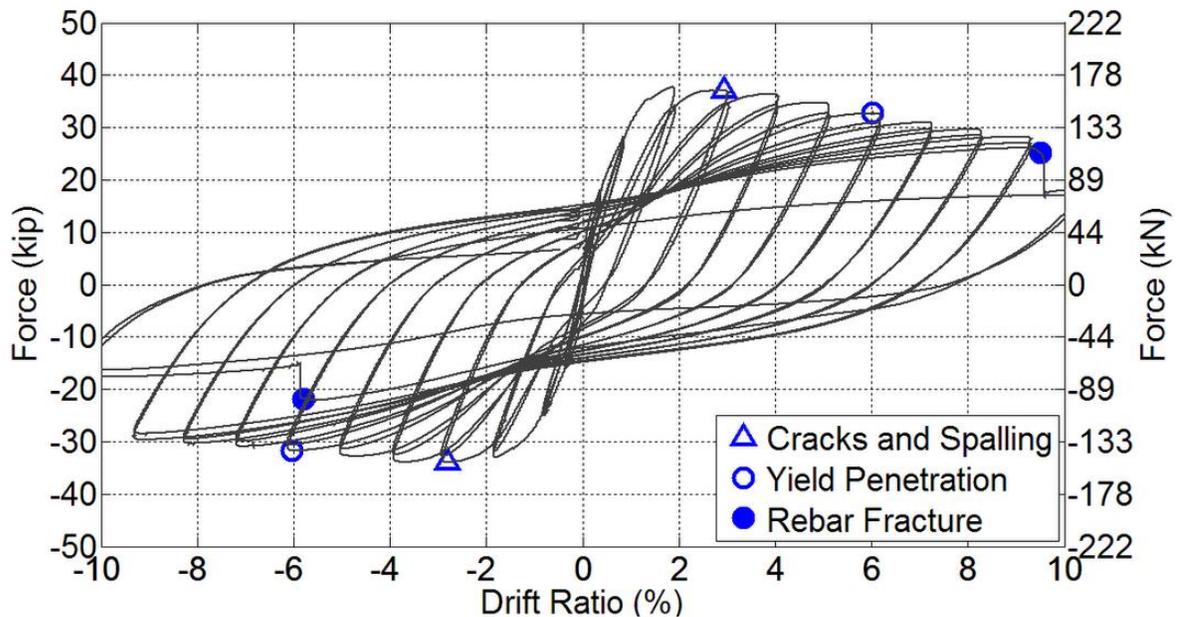
Figure 4-53. Hysteresis response of FGSS-CIP with damage states.

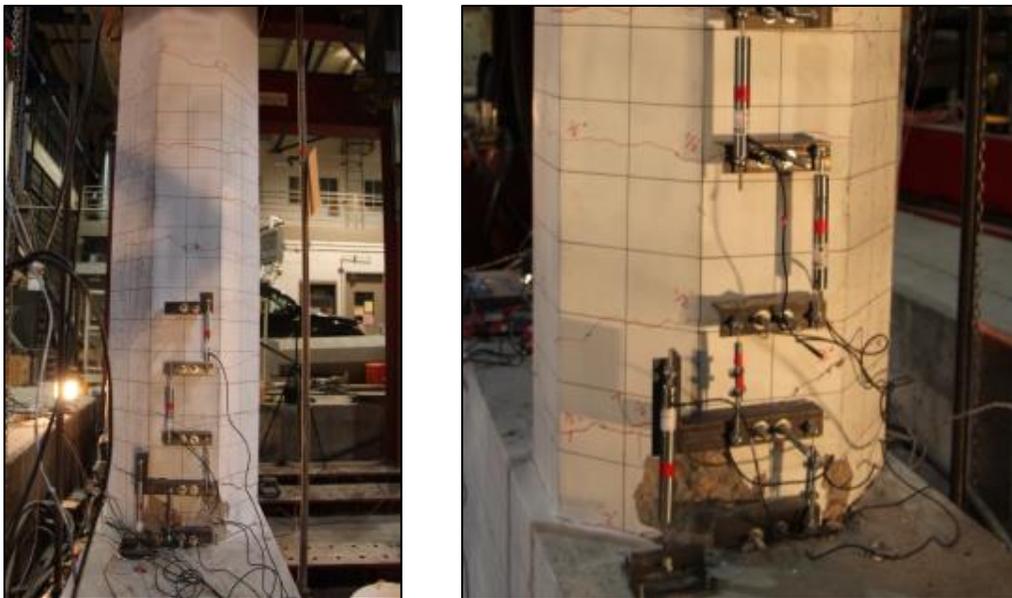
Figure 4-54. Damage state for FGSS-CIP at 3% drift ratio.

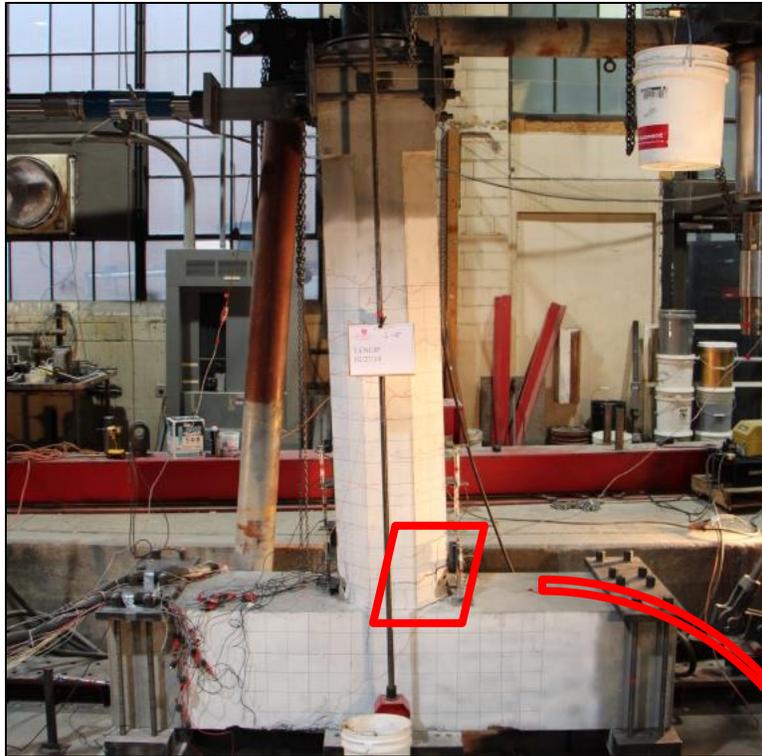
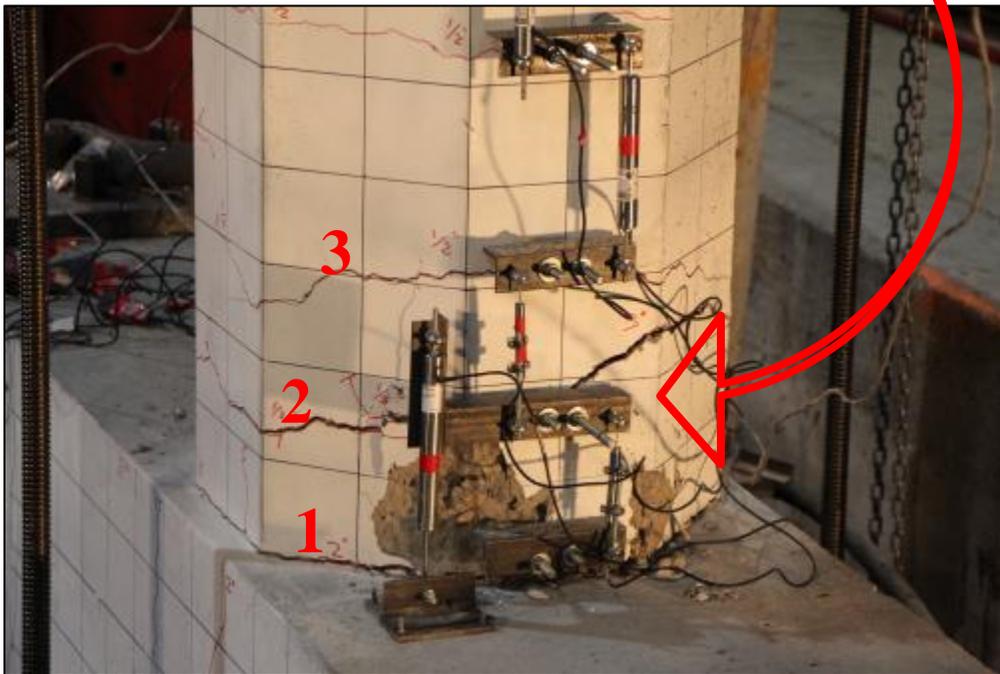
Figure 4-55. FGSS-CIP at peak displacement during 4% drift ratio; largest three cracks.

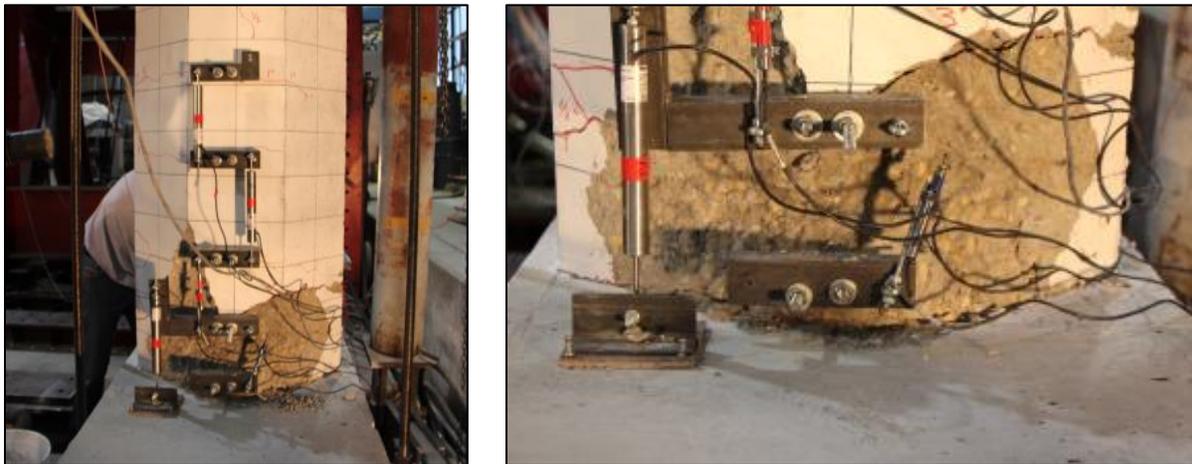
Figure 4-56. Damage state for FGSS-CIP at 6% drift ratio: cracks and spalling, yield penetration.

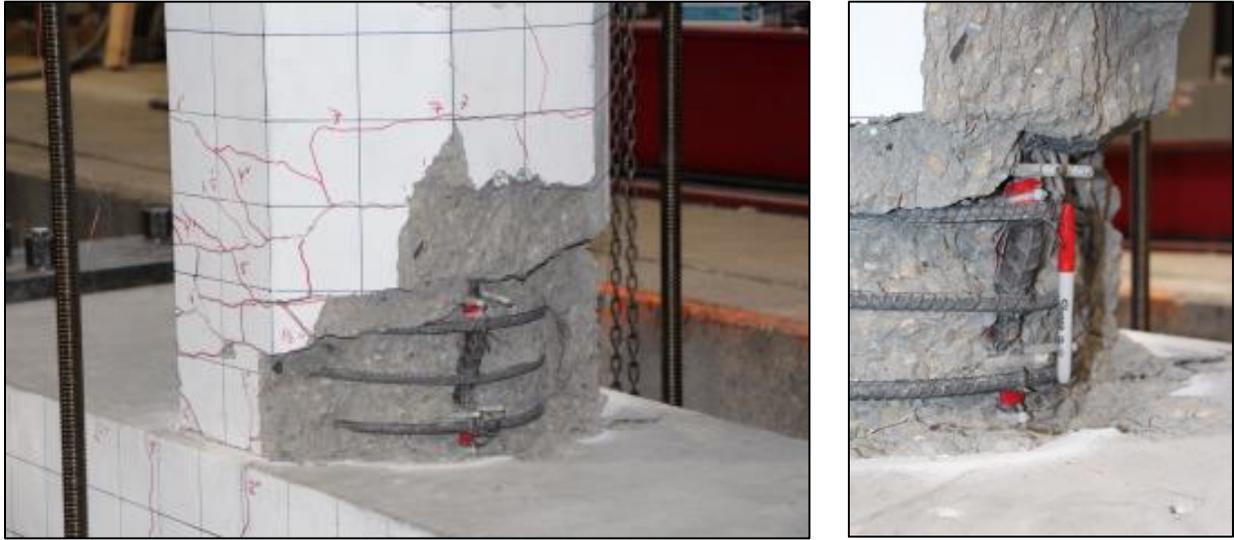
Figure 4-57. Damage state for FGSS-CIP at end of test: cracks and spalling, rebar buckling and fracture.

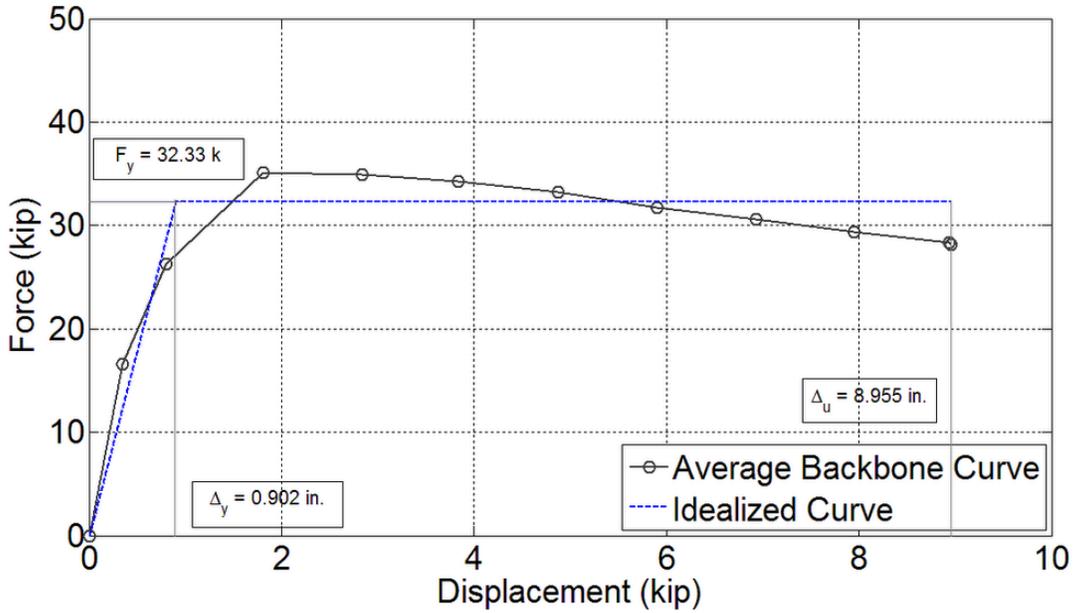
Figure 4-58. Average backbone curve and displacement ductility of FGSS-CIP.

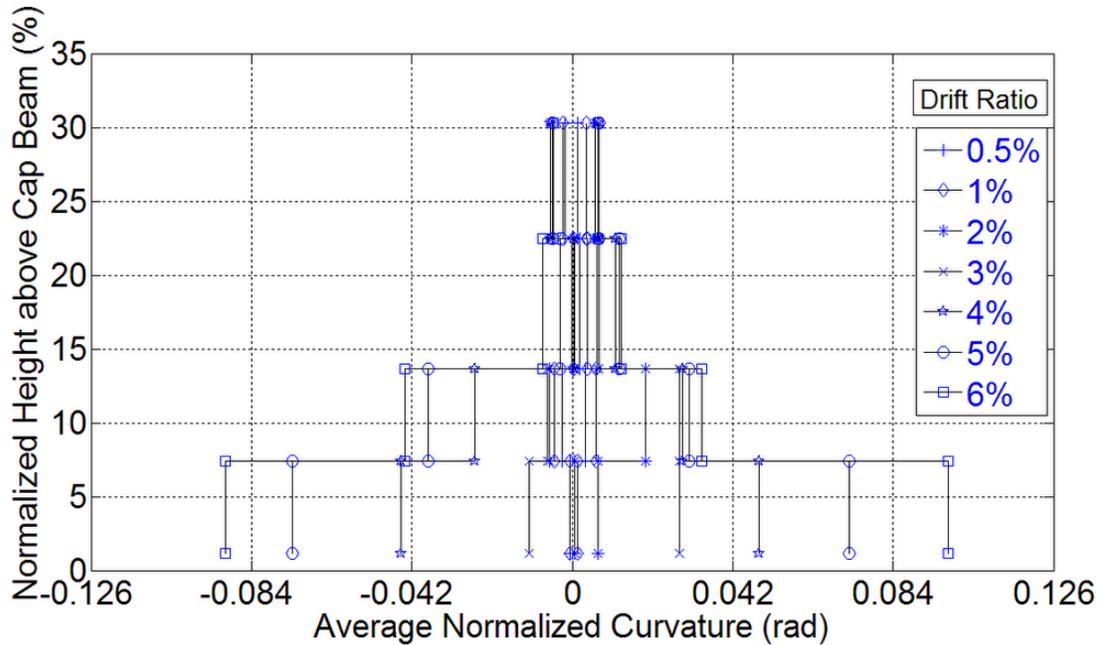
Figure 4-61. Normalized curvature distribution for FGSS-CIP.

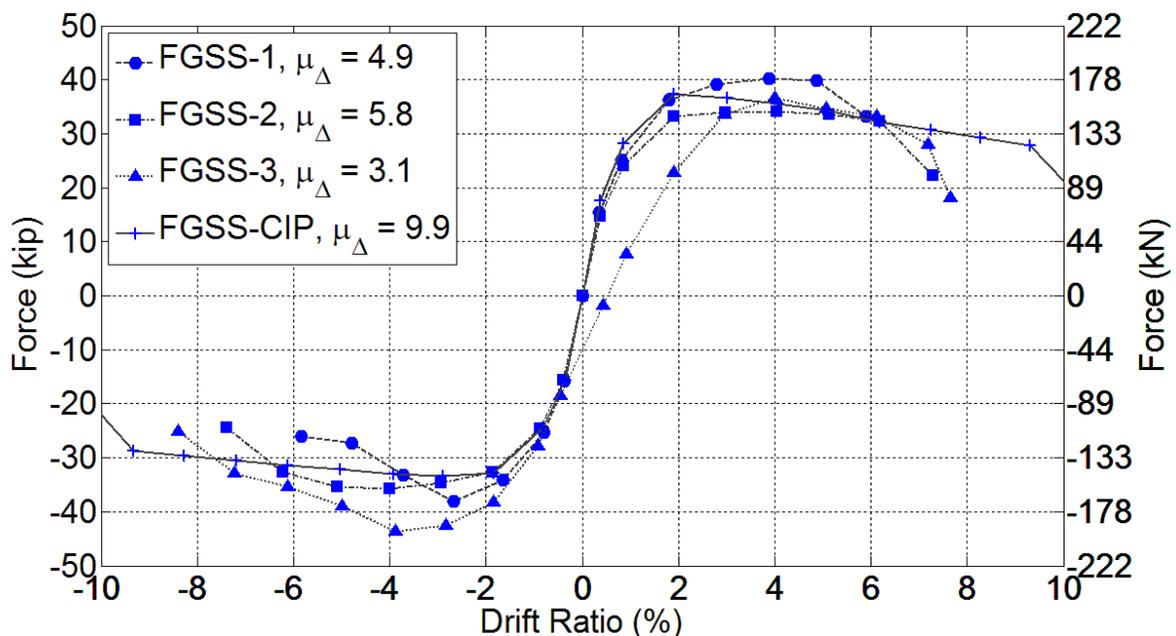
Figure 4-62. Force-displacement response of column-to-cap beam test specimens.

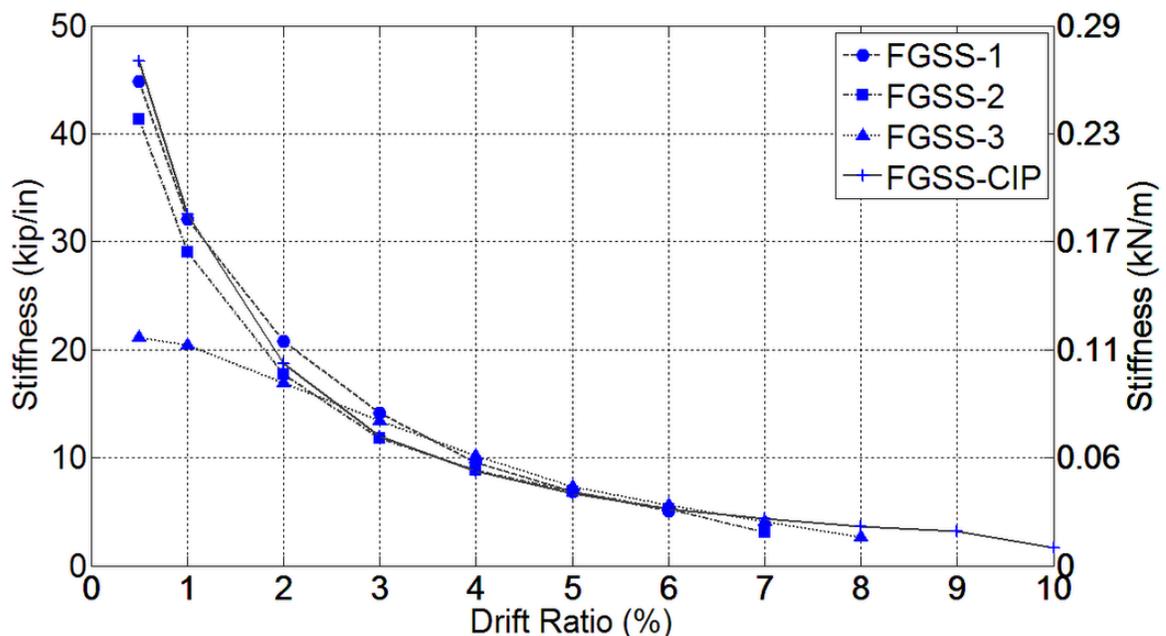
Figure 4-63. Stiffness degradation for column-to-cap beam test specimens.

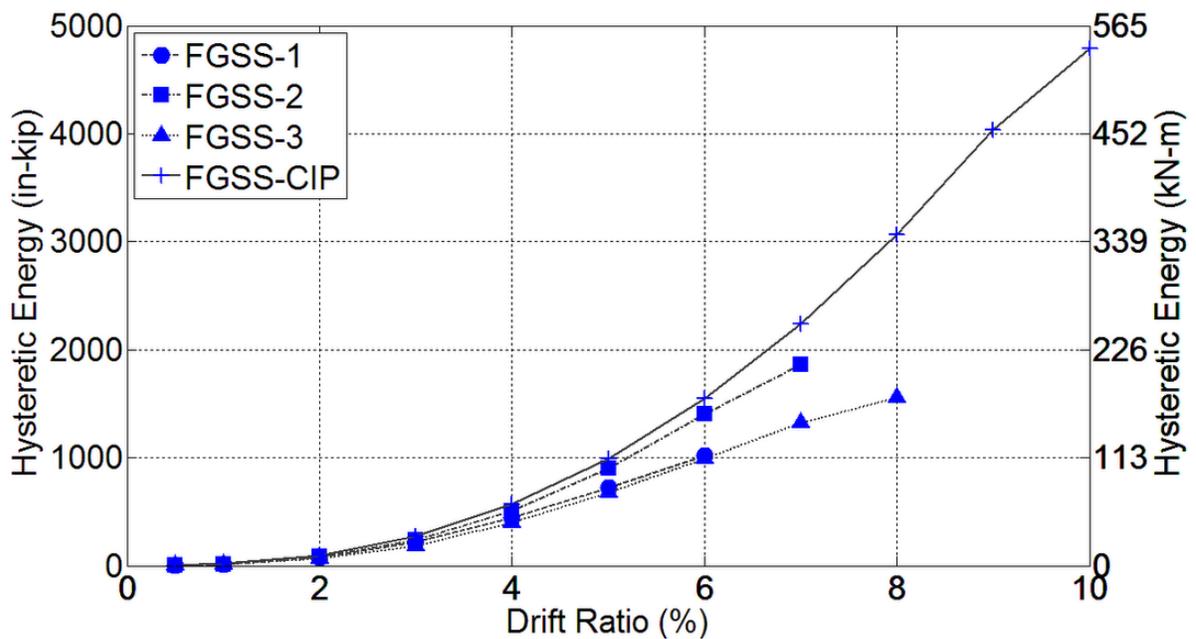
Figure 4-64. Cumulative hysteretic energy for column-to-cap beam test specimens.
