Update on TPF-5(281)
“Steel Bridge Research, Inspection, Training,
and Engineering Center”
(S-BRITE)

Prepared by

Robert J. Connor

Purdue University

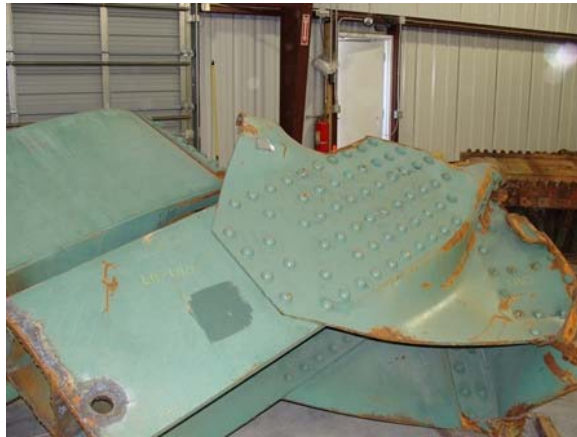
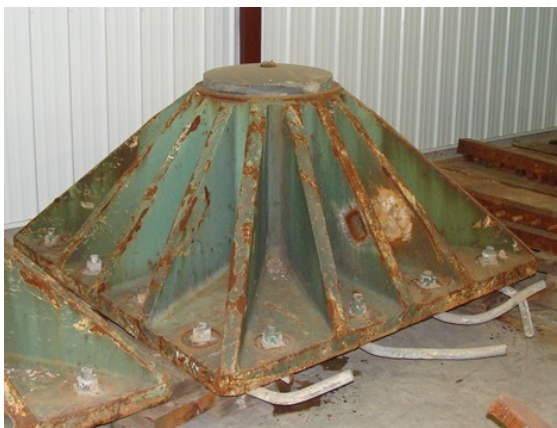
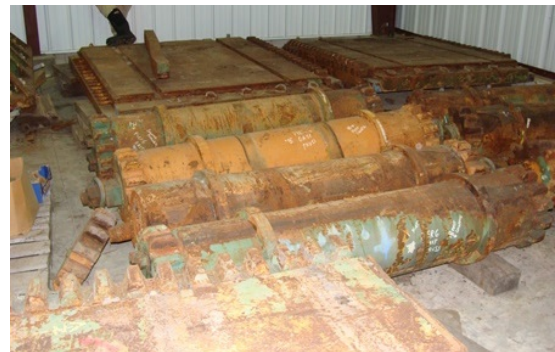
- Selected components from the I-35W Bridge, including a U10 and L11 joint (key joints in the failure of the bridge), large bearings, various joints, and members were provided by Minnesota DOT. The gusset plate joints are currently housed at the Bowen Laboratory to protect them from the weather. Long-term plans include the construction of a pole barn that can be used to keep these important components out of the weather. Other components, such as joints and miscellaneous members will be permitted to weather naturally outdoors.

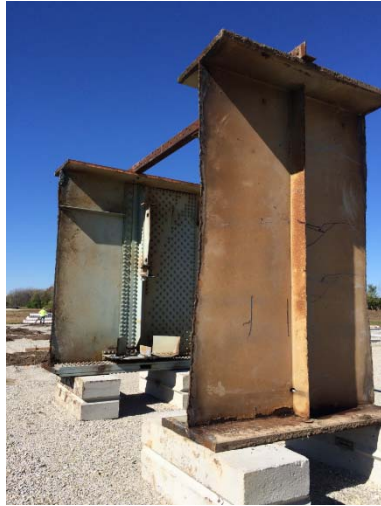
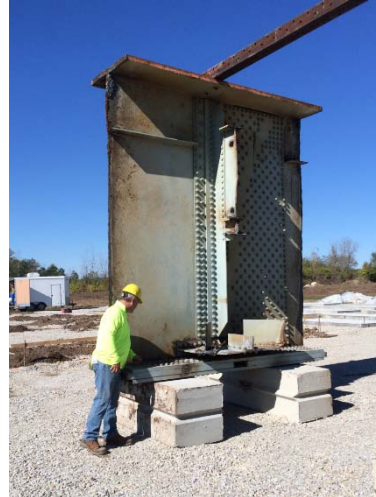
- Two sections of 12 foot deep plate girder from the Lafayette Bridge in Minnesota have been erected. One of these girders contained a full depth fracture that occurred in the 1970s and is a “famous” fracture so to speak to fatigue and fracture researchers. In addition, a corresponding girder was also obtained that did not fracture, but was retrofit to prevent future fractures. These sections are extremely valuable for the short courses and for steel design courses.

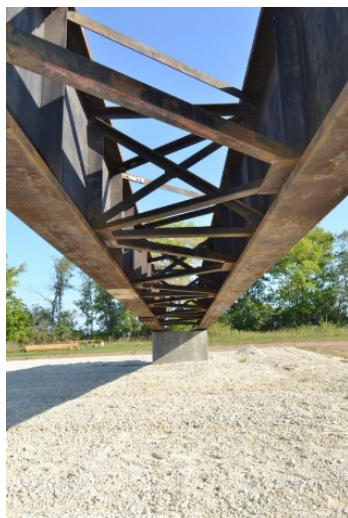
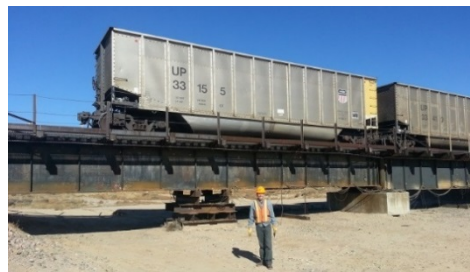
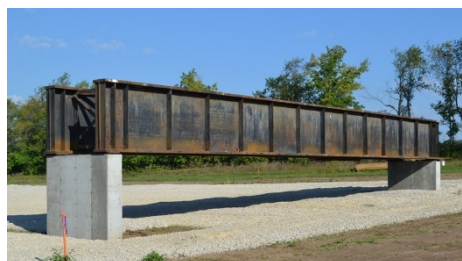
- An entire 65 foot span welded two-girder railroad bridge fabricated in the late 1950s was erected at S-BRITE in the fall of 2014. The bridge spent most of its life on the Pennsylvania railroad in New Jersey, but was retired and sent to the Transportation Technology Center Inc. in Pueblo to be placed on their test track. While in Pueblo, the bridge was subjected millions of tons of train loading. The bridge possesses details susceptible to Constraint Induced Fracture (CIF). While in Pueblo, two such fracture occurred; one was repaired while the other remains in the bridge. When TTCI was finished with the bridge, it was donated to S-BRITE and shipped to Lafayette via BNSF and CSX at no charge.

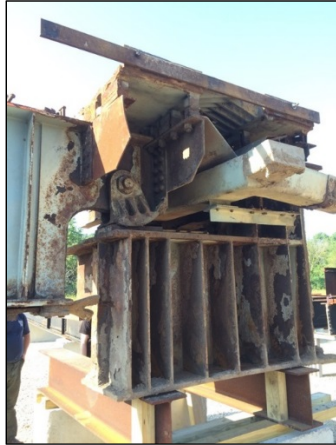
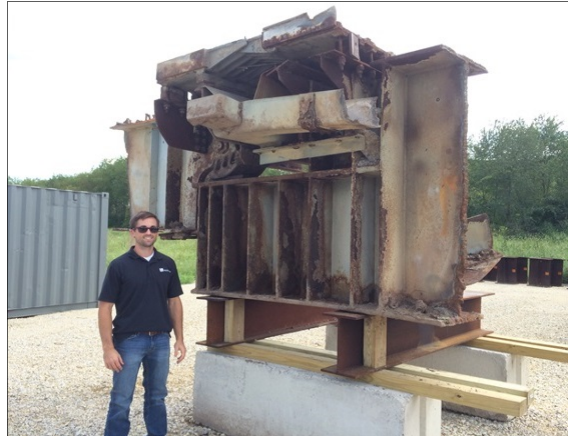
- A section of a ship-lap joint and tooth dam has been acquired. A ship-lap joint is one where one smaller girder is supported on a larger, deeper girder. The leaking joint caused considerable corrosion to the girders below as can be seen in the photographs below. The specimen was provided by the Minnesota DOT and is an excellent example of corrosion damage at a leaking joint that is useful in short courses and bridge design courses.

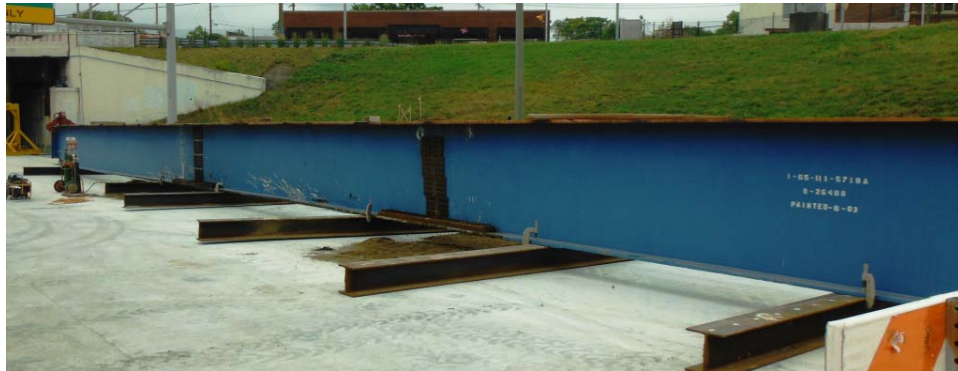
- Selected portions (about 200 feet in total) of large plate girders from the Virginia Avenue over I-65 were donated to S-BRITE by INDOT. The girders are six feet deep. These girders have been repeatedly struck by over-height vehicles. There is significant damage to the girders, including brittle fractures with bolted splices. Various nicks, gouges, and broken stiffener connections are also apparent. The girders will be erected at S-BRITE in the Spring/summer of 2015. It is anticipated a concrete deck may be added as part of other research on long-term concrete deck performance and inspection.

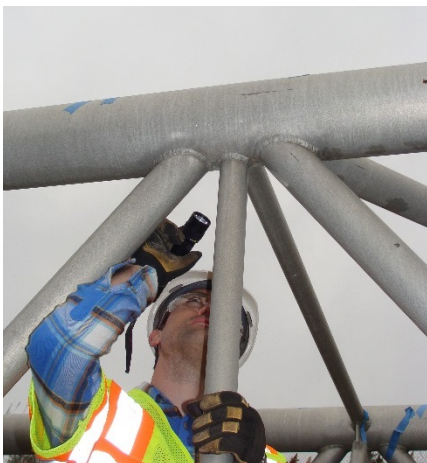
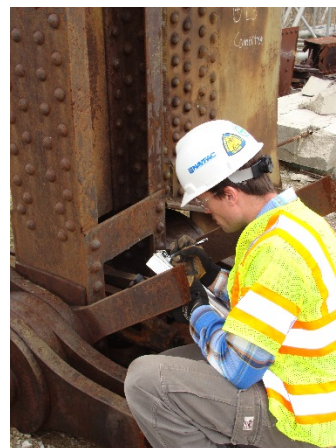
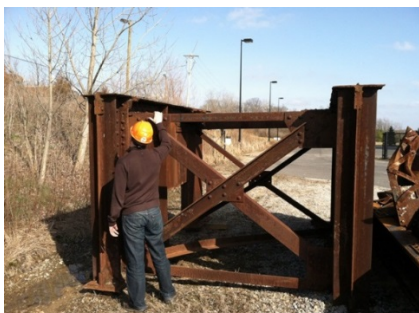
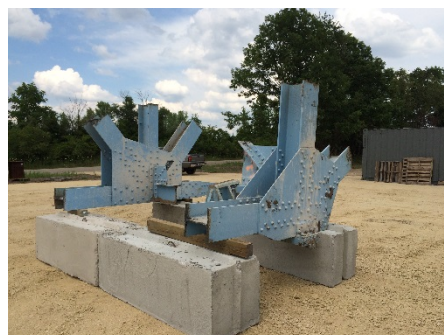
- Miscellaneous components from various bridges continue to be obtained. The specimens included those with corrosion, cracks, and other damage. Some specimens however have no damage and are useful for illustration of basic steel detailing. A few photographs of these specimens are below.

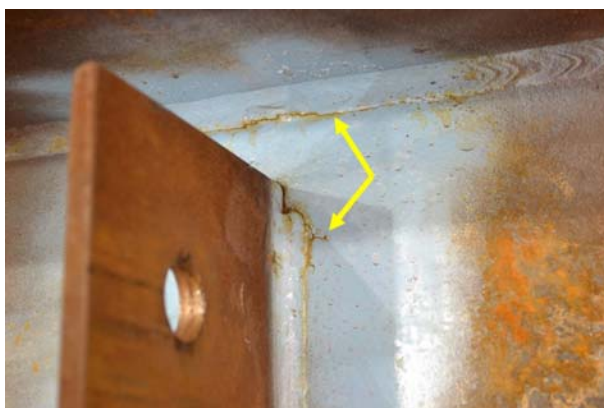
By far, one of the most common types of cracking that has been observed on highway bridges throughout the US is out of plane distortion cracking. A typical crack is shown in Figure 1. Various retrofit strategies have been developed for these details, including hold drilling, rigidly attaching the stiffener to the flange via welding or bolting, cutting back the stiffener, and combinations thereof. In addition, cracking is also observed at gusset plate/stiffener intersections. However, incorrectly selecting or implementing any one of these types of retrofits has also been observed to be ineffective, for example a common mistake is drilling holes that are too small. Further, challenges exist when the cracking is adjacent to a top flange that is embedded in concrete due to limited access if a bolted retrofit is selected.

Figure 1 – Photograph of typical out-of-plane crack at transverse connection plate
