PAVEMENT SUBGRADE PERFORMANCE STUDY

Test Section 712

Subgrade AASHTO soil type A-7-5 at 20 percent gravimetric moisture content

Edel R. Cortez⁽¹⁾

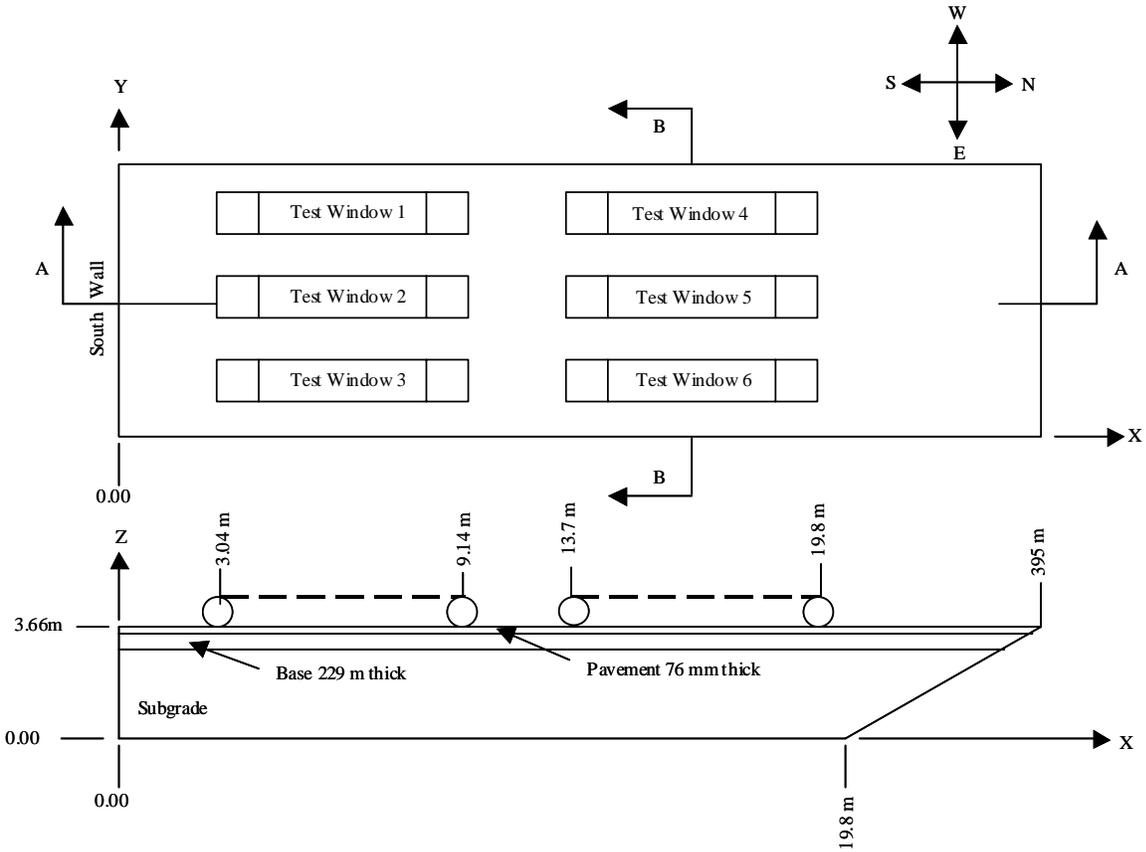
Figure 1 a. Plan view and longitudinal cross section of test section.

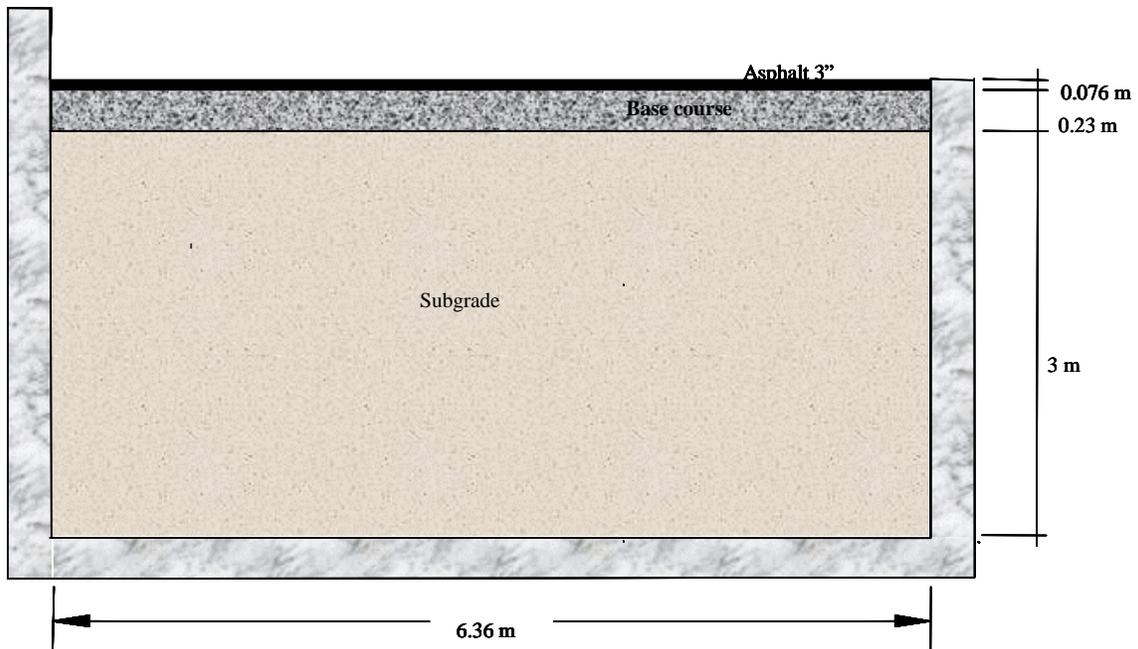
Figure 1 b. Transversal cross section.

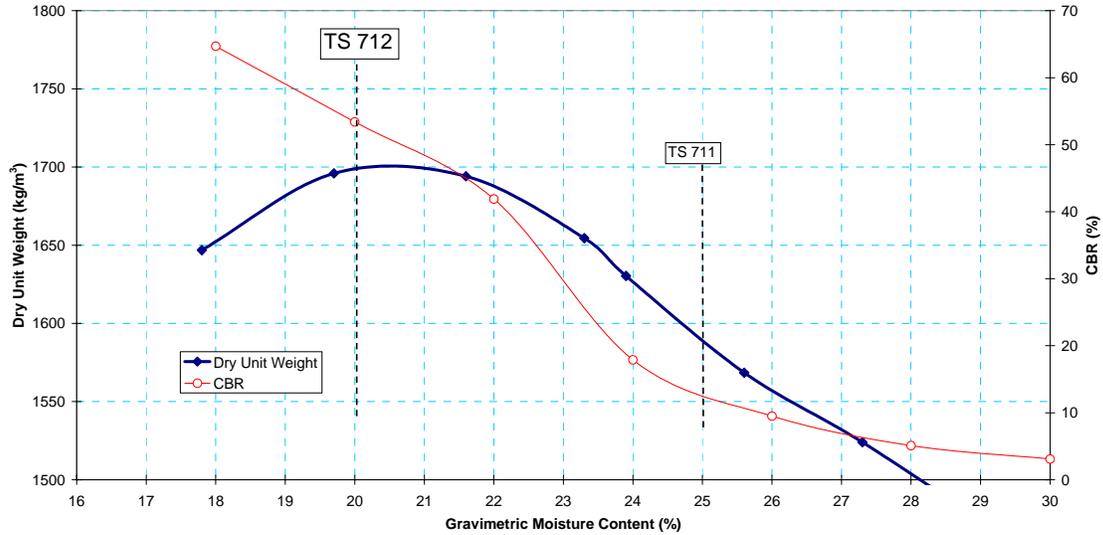
The maximum density and optimum gravimetric moisture content for the subgrade soil were 1700 kg/m^3 (106.1 pcf) and 20.5 percent respectively. The average as-built subgrade moisture content was 20 percent. The laboratory CBR for this moisture content was approximately 53 percent.

Figure 3. Subgrade modified Proctor and laboratory CBR test results.

Figure 3 shows that, for this subgrade soil at 20 percent moisture content, the laboratory CBR value is approximately 53 percent. Figure 17 shows that this is equivalent to a resilient modulus (M_r) of 220.6 MPa (32 ksi).

The as-built gravimetric moisture content of the subgrade soil in Test Section 712 was 20 percent. The modified Proctor optimum moisture content was 20.5 percent. Laboratory test results presented in Figure 3 show that this subgrade soil at 20 percent moisture content has a CBR of 53 percent that indicates a relatively strong soil. Producing the target rut depth of 12.7 mm (0.5 inch) became time and cost prohibitive. For example, Test Window 712c5 was tested with the standard axial load of 80 kN (18 kips). After 500,000 traffic repetitions, the rut depth was only 3.6 mm. The axial load was increased for the remaining test windows, but even with the higher load intensities, for each test window, the number of traffic repetitions needed to produce 12.7 mm of rut depth had to be estimated by projecting the experimental rutting curve. For Test Window 712c5 with the standard axial load, failure was estimated to occur at approximately 60 million traffic repetitions.

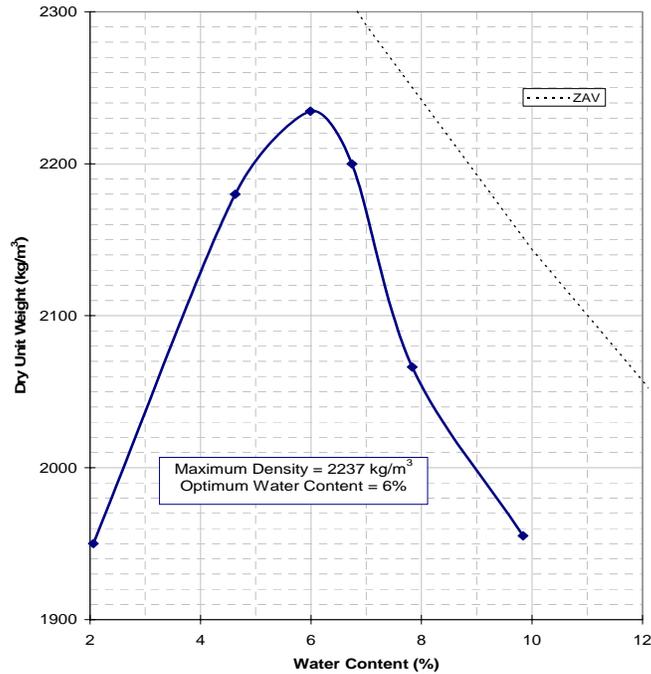
Figure 4. Base course modified Proctor test results.

The modified Proctor test results shown in Figure 4 indicate that the optimum gravimetric moisture content of the base course material was 6 percent and the maximum density was 2237 kg/m^3 (139.5 pcf). In practice, with high hydraulic conductivity

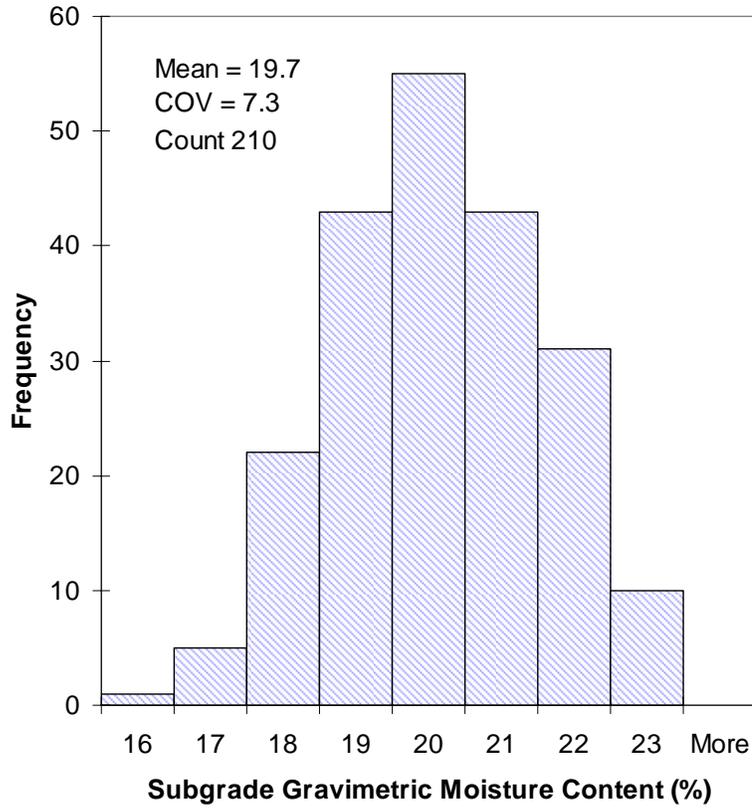
Figure 5. Subgrade moisture content.

The mean moisture content of the subgrade was 20 percent. The average moisture content of the base course during construction was 5.9 percent.

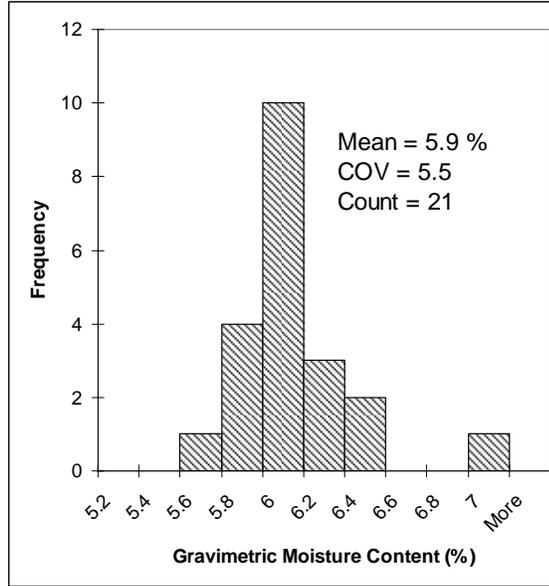
Figure 6. Base course gravimetric moisture content.

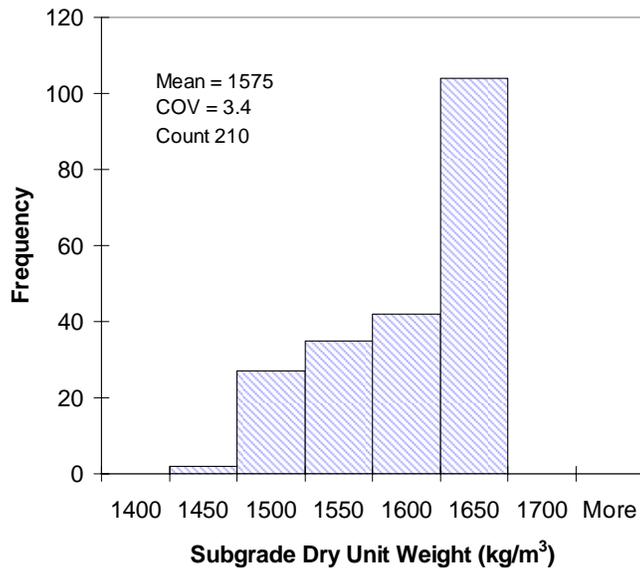
Figure 7. Subgrade dry unit weight.

The mean dry density of the subgrade was 1575 kg/m^3 (98.3 pcf). The mean dry density of the base course was 2350 kg/m^3 (146.7 pcf). The mean density of the AC was 2300 kg/m^3 (143.6 pcf).

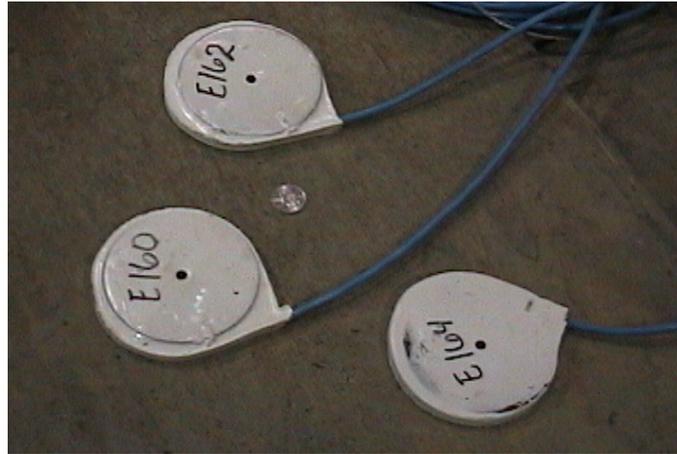
Displacement measurements were made in the base and subgrade by means of ϵ mu coils. Strain can be deduced from displacement measurements between coil pairs in either coaxial or co-planar arrangements. The sensors were placed 150 mm center to center. Displacements were measured in the longitudinal (x), transverse (y), and vertical (z) direction of loading. Displacements in the vertical direction were measured to a depth of 1.52 m.

Figure 9. Emu coils in a co-planar arrangement to measure longitudinal and transverse displacements. A US 25-cent coin is included for scale reference.

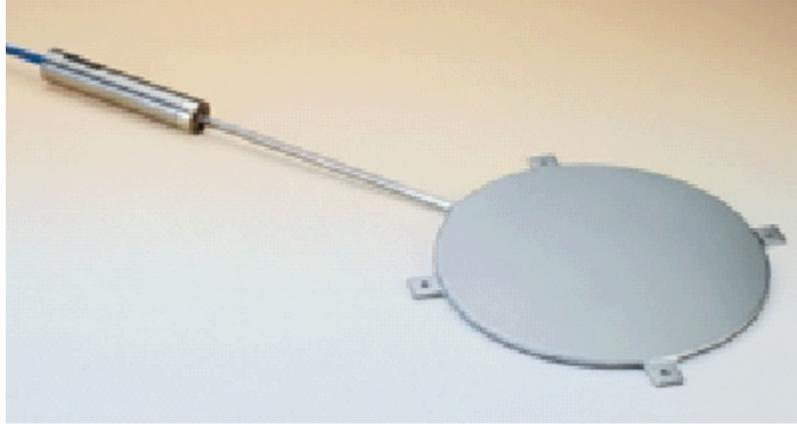
Figure 11. Large Geokon® stress cell used in the base course.

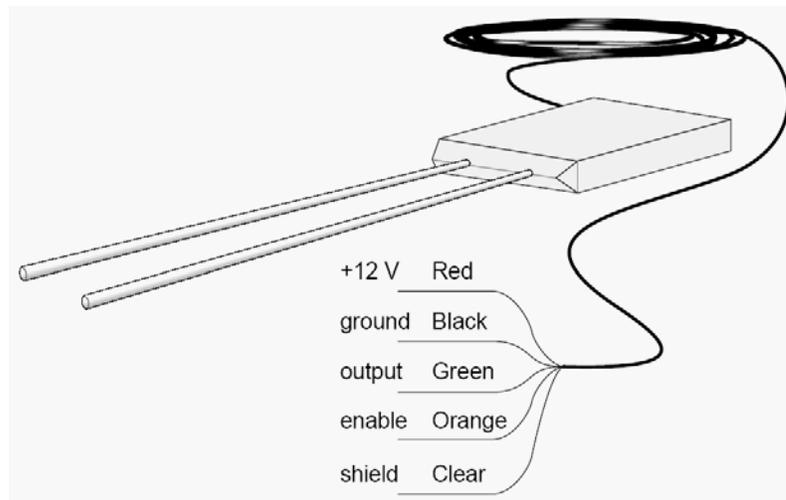
Campbell Scientific® reflectometer soil moisture probes model CS615 were used to measure the moisture content in the base and subgrade during the traffic tests. These sensors measure the oscillation frequency between two rods embedded in the moist soil. The oscillation frequency is related to the dielectric constant that changes with moisture content, and to a lesser degree with temperature. The sensor readings are also affected by salinity, mineralogy and presence of organic materials. Volumetric moisture content is converted to gravimetric moisture content through weight-volume relationships and soil specific gravity. These sensors alone are not accurate enough for the purpose of this study, but this deficiency was corrected by calibrating them with oven dry measurements taken during construction.

Figure 12. Campbell Scientific® reflectometer soil moisture probes model CS615.

Moisture sensors were located at three depths at each of three horizontal locations. There were moisture sensors in the middle of the base course, and in the subgrade at 15 cm (6 in.) and 61 cm (2 ft.) below the top of the subgrade.

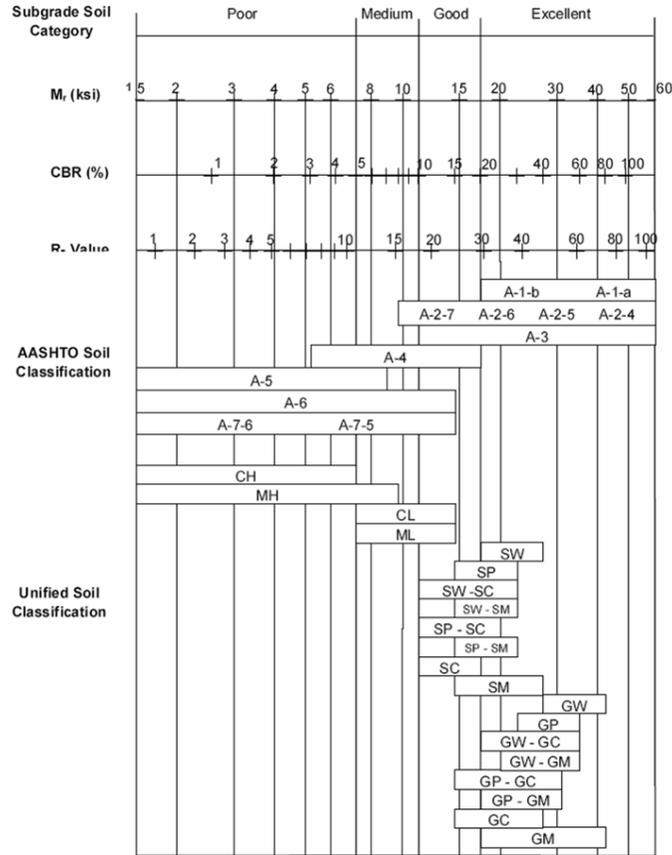
Figure 17. Relationships between CBR and resilient modulus for various soil types. (Proposed AASHTO M-E Guide, 2004).

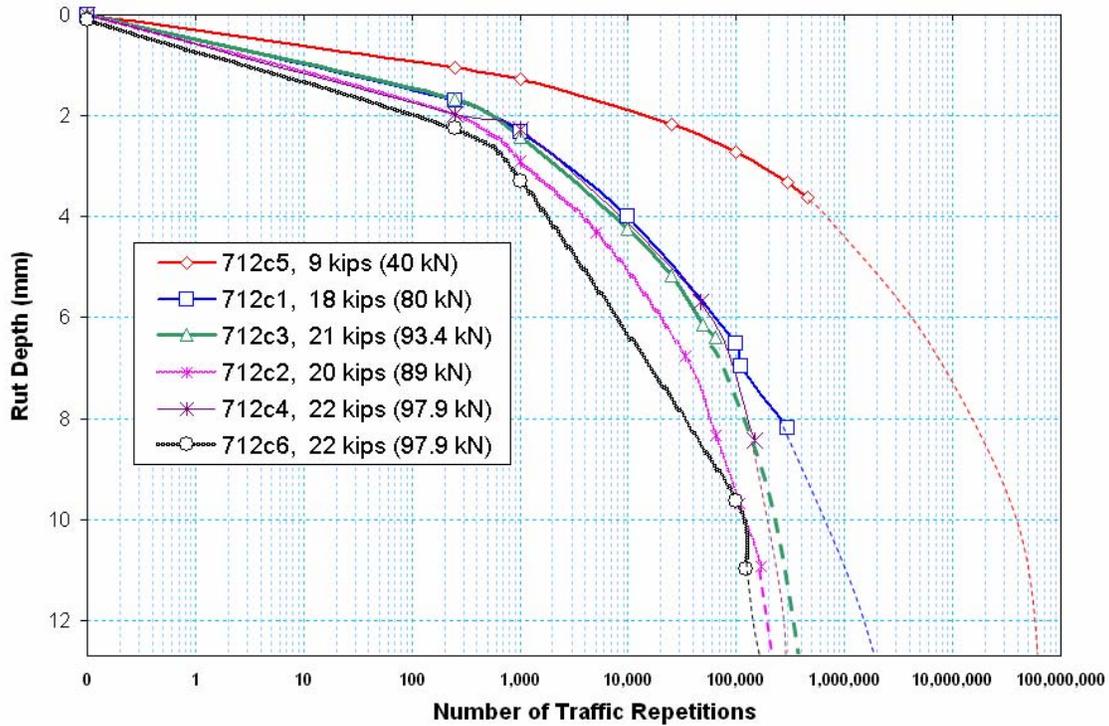
Transverse surface profile measurements were taken before HVS testing, at several intermediate numbers of traffic passes, and at the end of testing. Rut depth was calculated as the difference between the profile measurements taken at the given pass level and the profile measurements taken prior to testing (pass level zero). Cross sectional profile measurements were taken at 305-mm (1-ft.) intervals along the effective test window for a total of 20 locations. A laser profilometer scanning at 5-mm intervals was used to make the measurements. For each test window, the maximum rut depth at each cross section was used to assemble a longitudinal profile. Using the average rut depth of the 20 cross sections for each test window, Figure 18 shows the progression of rut depths as a function of traffic repetitions for test windows subjected to various load intensities. Figure 18 also shows the axial load intensity applied to each test window. As expected, test windows tested with heavier loads deformed faster than those tested with lighter loads.

Figure 18. Average rut depth as function of traffic load repetitions and semi-axial load intensity.

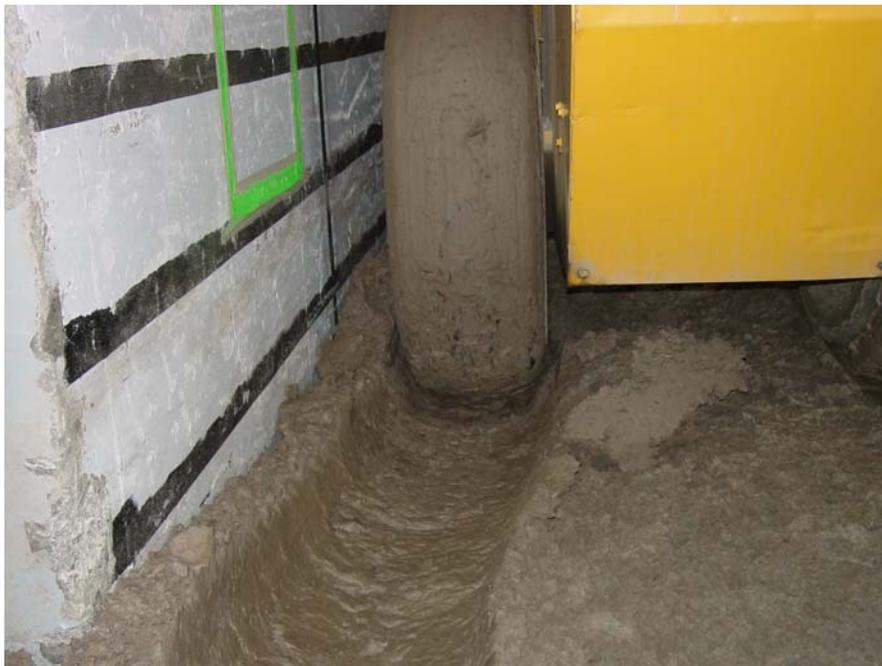
No cracking was observed in any of the test windows of Test Section 712. This was probably due to the relatively strong subgrade. The subgrade gravimetric soil moisture content was 20.5 percent that approximately corresponds to its optimum moisture content. Test Section 711 was similar to Test Section 712 except that its subgrade soil moisture content was 25 percent. During the construction of that test section, a layer of soil was moistened more than intended, and the soil became very sticky and unworkable. Figure 19 shows a large rut caused by a rubber tire of our steel roller, and much muddy soil sticking to the tire. Moisture measurements on this layer of soil indicated values of gravimetric moisture content ranging from 27 to 35 percent. This subgrade soil tends to form lumps whereby the center of the lumps is dryer than the surrounding surface layer. This may explain why the workability and stability of this soil deteriorates rapidly past a threshold of strong and stable behavior. A similar soil behavior was observed in a test section from a previous study (Perkins and Cortez, 2005) that was built with this subgrade soil at 29 percent gravimetric moisture content. Also during the construction of the test section, the soil became unworkably sticky and unstable at some locations where minor increments of moisture content existed. Although this subgrade soil is relatively strong for a wide range of moisture contents, there appears to be a threshold beyond which even small increments of moisture content may render the soil unworkable. Figure 2 shows that the soil contains 33 percent of soil particles within the clay particle size range. The large clay content appears to govern the behavior of the soil mass.

Figure 19. Unstable soil behavior with gravimetric moisture contents between 27 and 35 percent..

Accelerated pavement testing (APT) was conducted on a test section with a subgrade soil that was classified as AASHTO type A-7-5 (USCS type MH). The as-built gravimetric moisture content of the subgrade soil in Test Section 712 was 20 percent. The modified Proctor optimum moisture content was 20.5 percent. Laboratory test results presented in Figure 3 show that this subgrade soil at 20 percent moisture content has a CBR of 53 percent. Figure 17 shows that resilient modulus (M_r) for a CBR value of 53 percent is 220.6 MPa (32 ksi). This value is consistent with the DCP measurements conducted in the subgrade during the forensic evaluation. Therefore, at this moisture condition, this is a relatively strong subgrade soil. However, during the construction of the test section, it was observed that, for this soil, past a threshold, even small increases of moisture can render the soil weak, unstable and unworkable as shown in Figure 19.

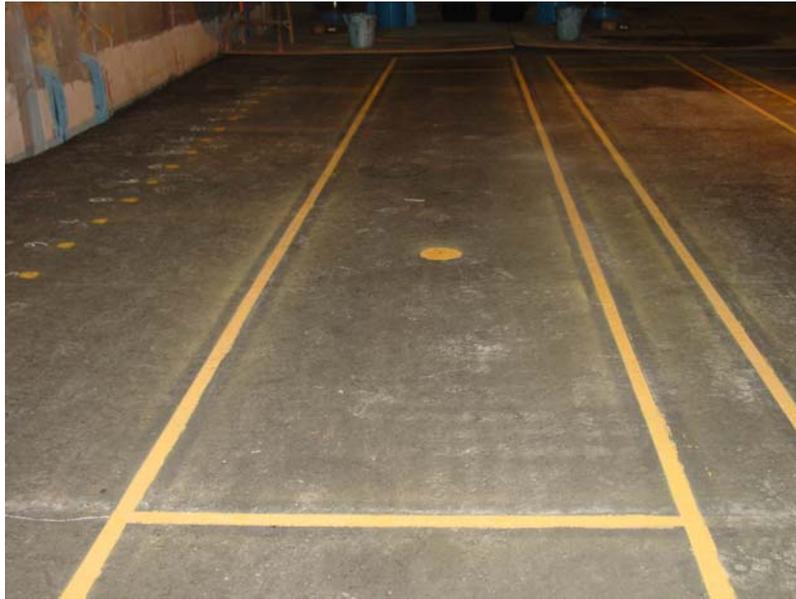
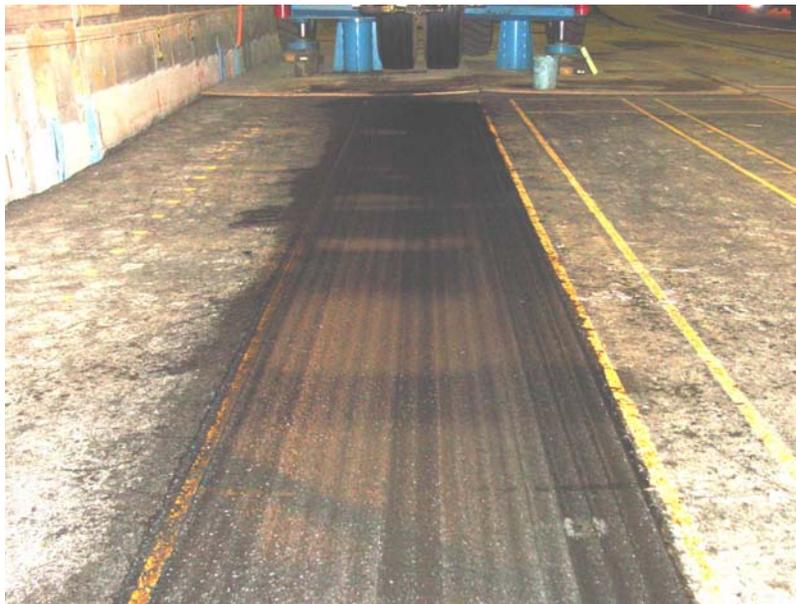
Figure 20a. Test Window 712c1 before HVS traffic.

Figure 20b. Test Window 712c1 at the end of HVS traffic.

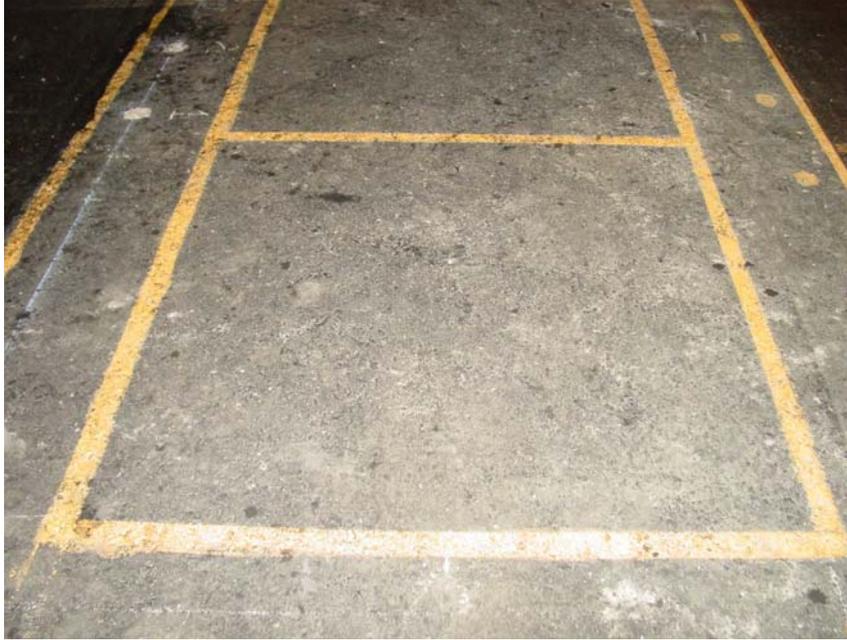
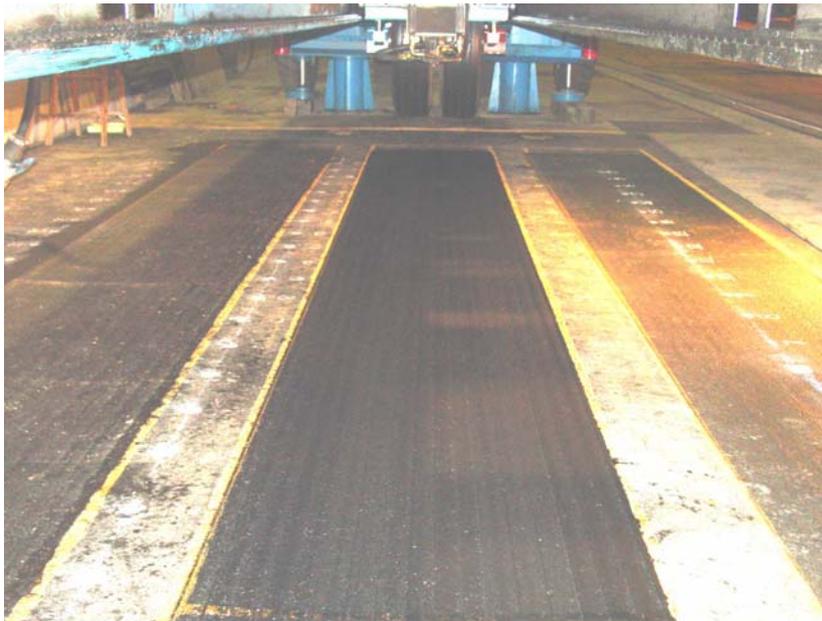
Figure 21a. Test Window 712c2 before HVS traffic.

Figure 21b. Test Window 712c2 at the end of HVS traffic.

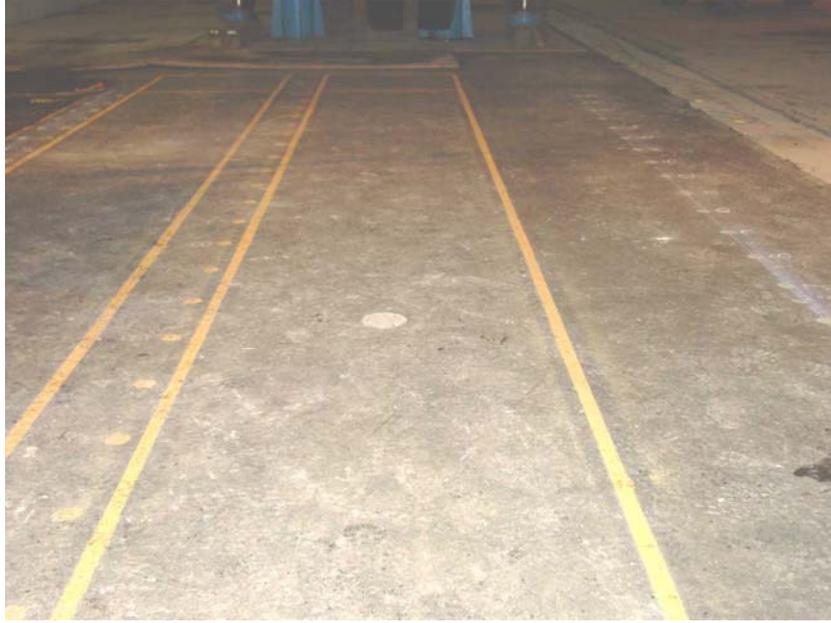
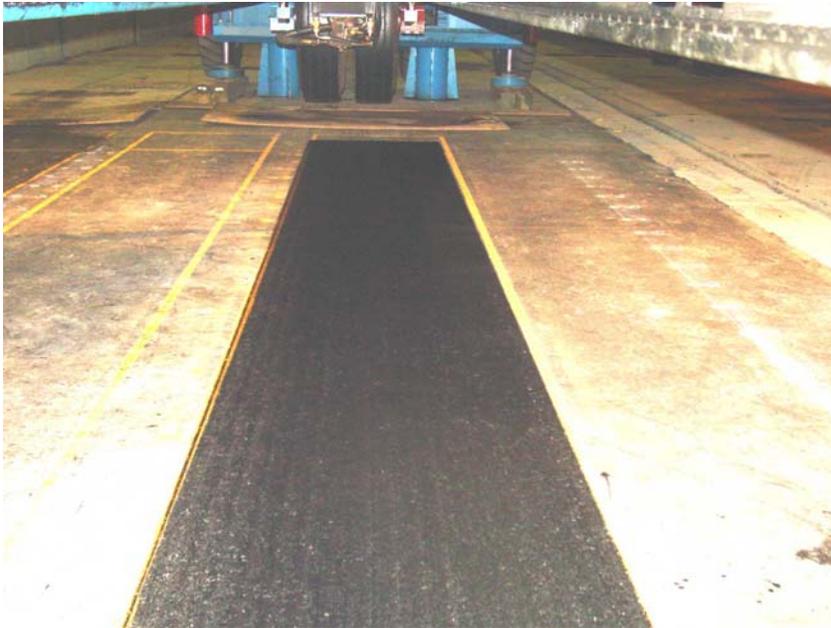
Figure 22a. Test Window 712c3 before HVS traffic.

Figure 22b. Test Window 712c3 at the end of HVS traffic.

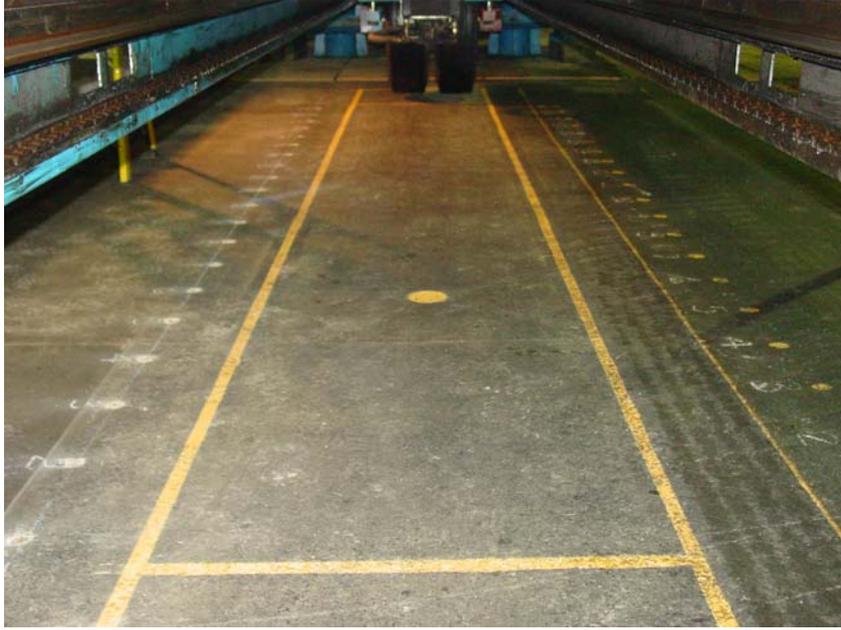
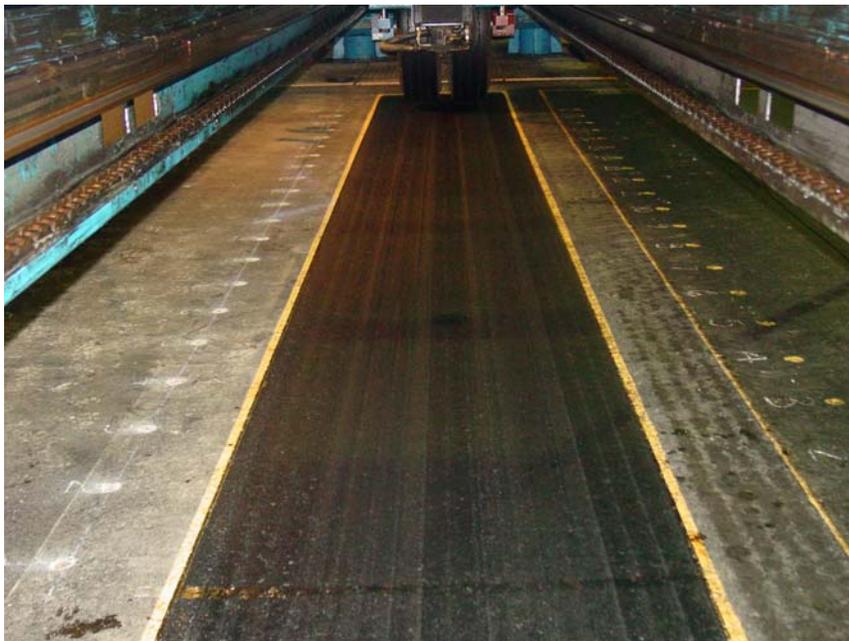
Figure 23a. Test Window 712c4 before HVS traffic.

Figure 23. Test Window 712c4 at the end of HVS traffic.

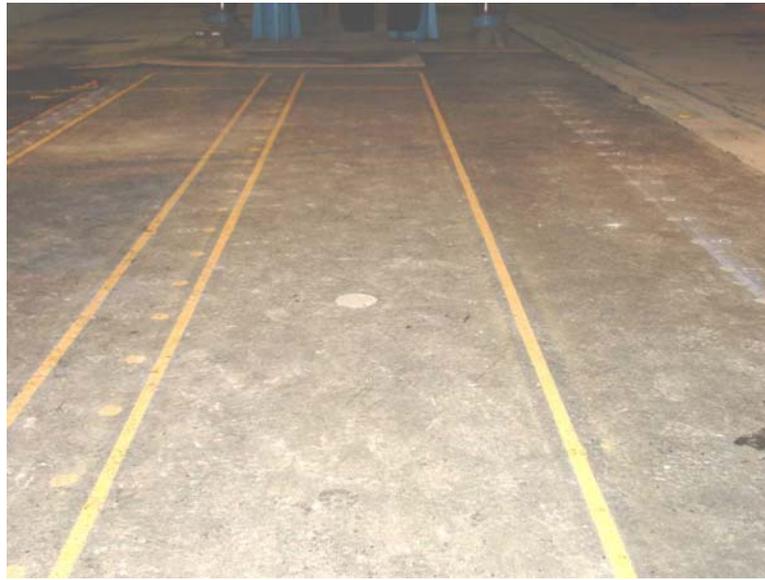
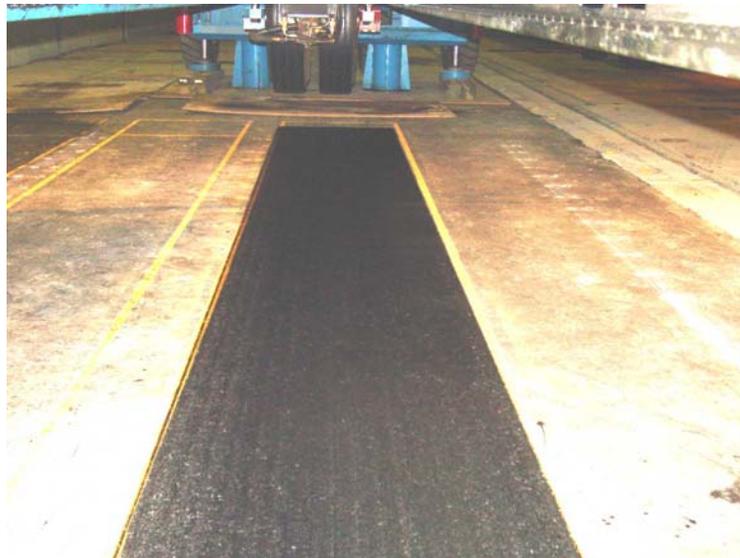
Figure 24a. Test Window 712c5 before HVS traffic.

Figure 24b. Test Window 712c5 at the end of HVS traffic

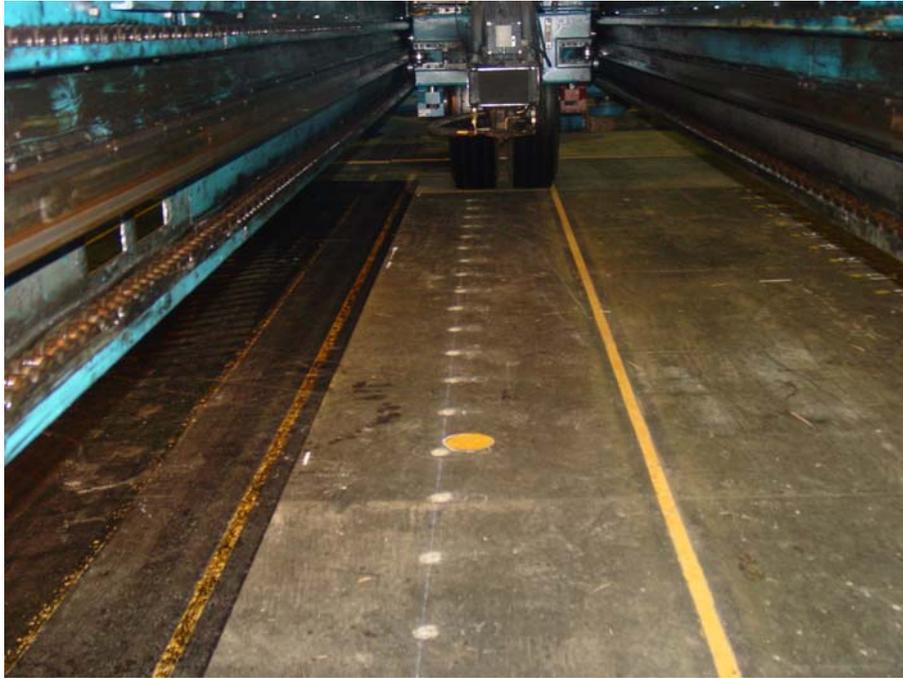
Figure 25a. Test Window 712c6 before HVS traffic.

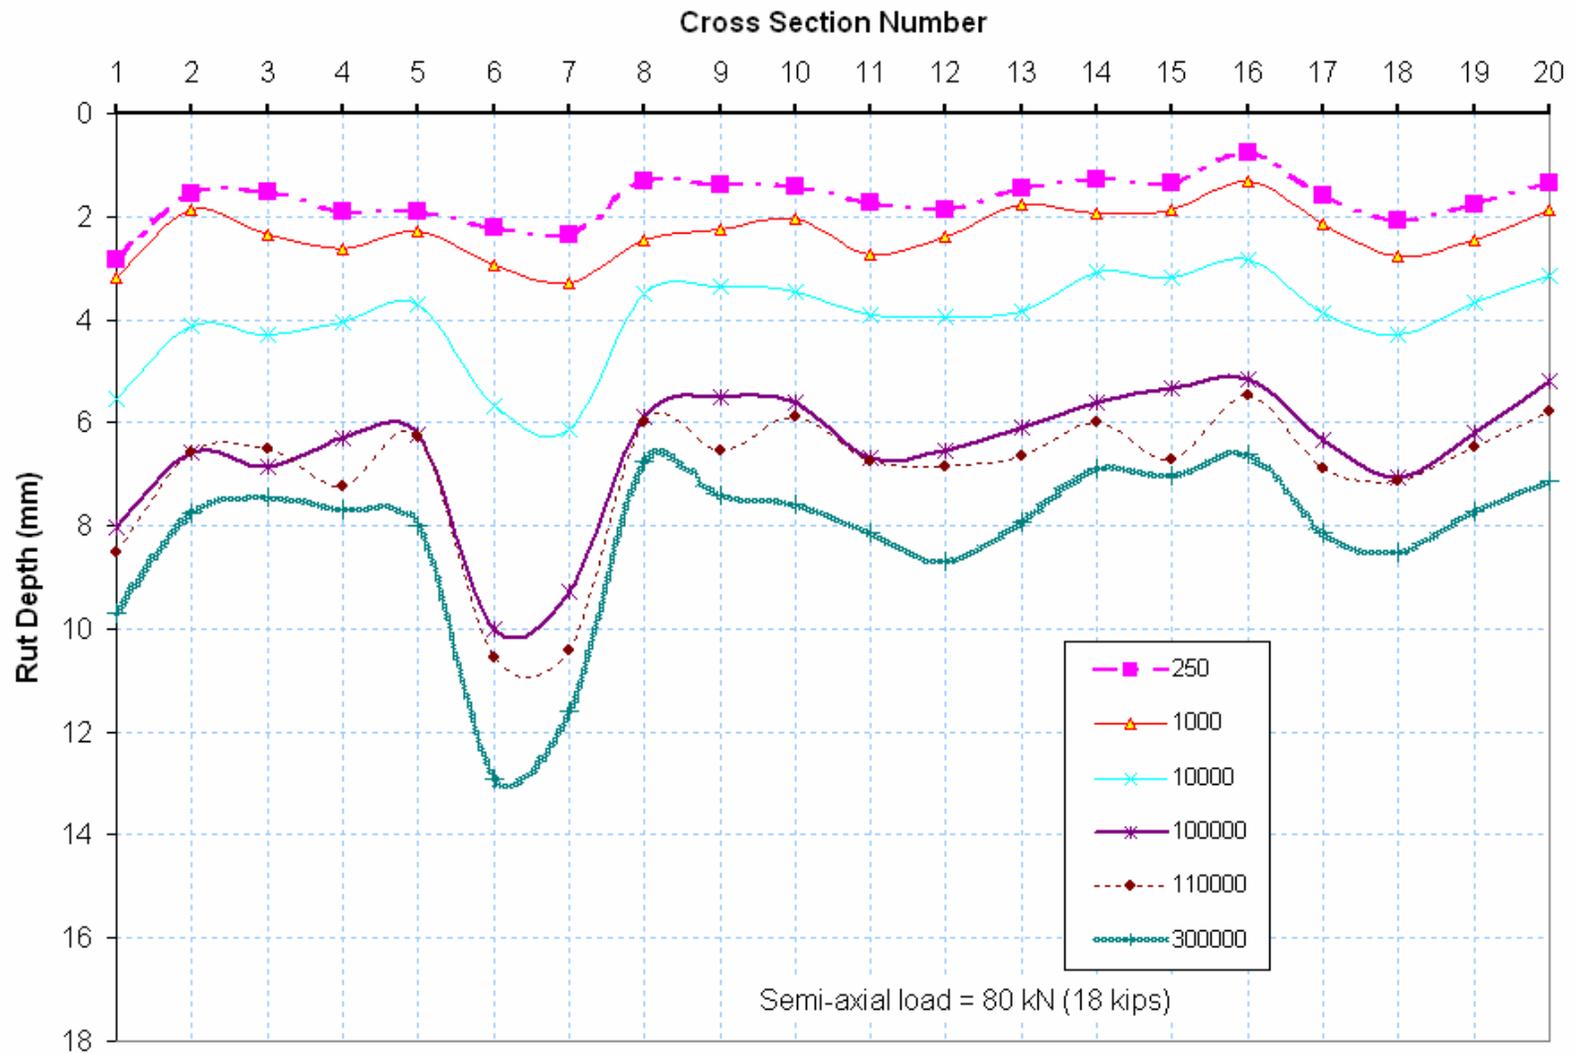
Figure 26. Progression of surface rutting along the center of the tire path in Test Window 712c1.

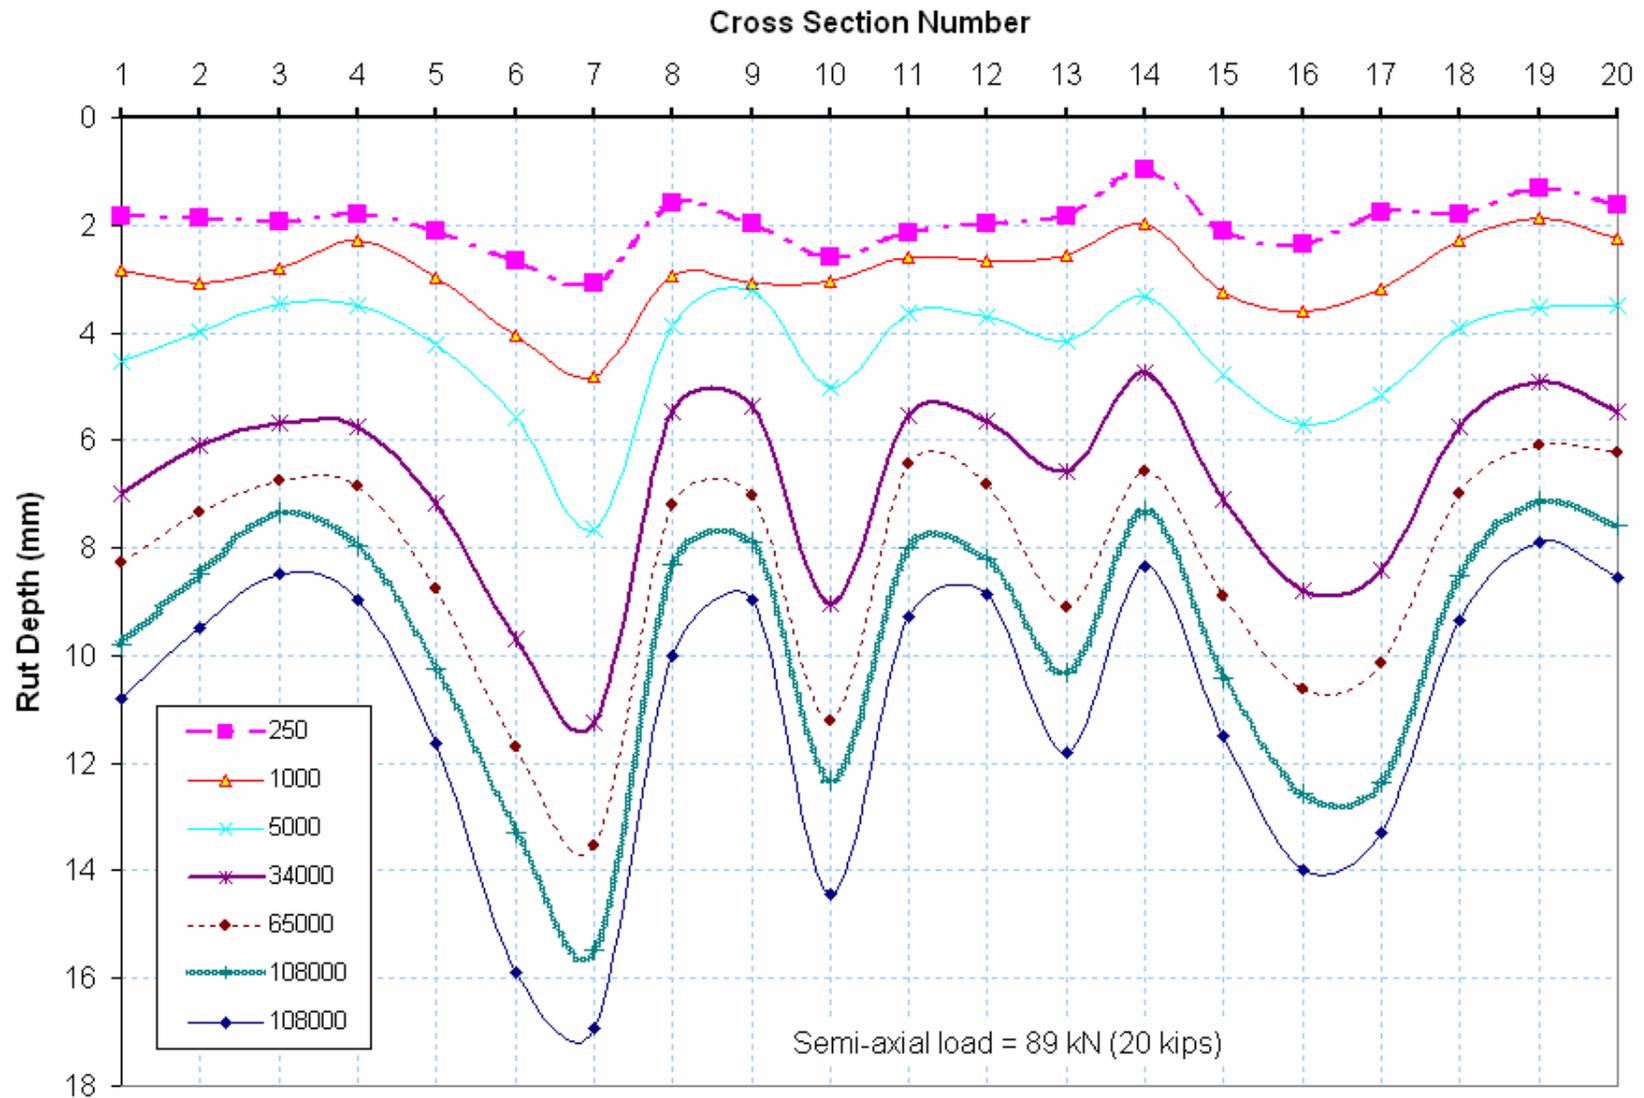
Figure 27. Progression of surface rutting along the center of the tire path in Test Window 712c2.

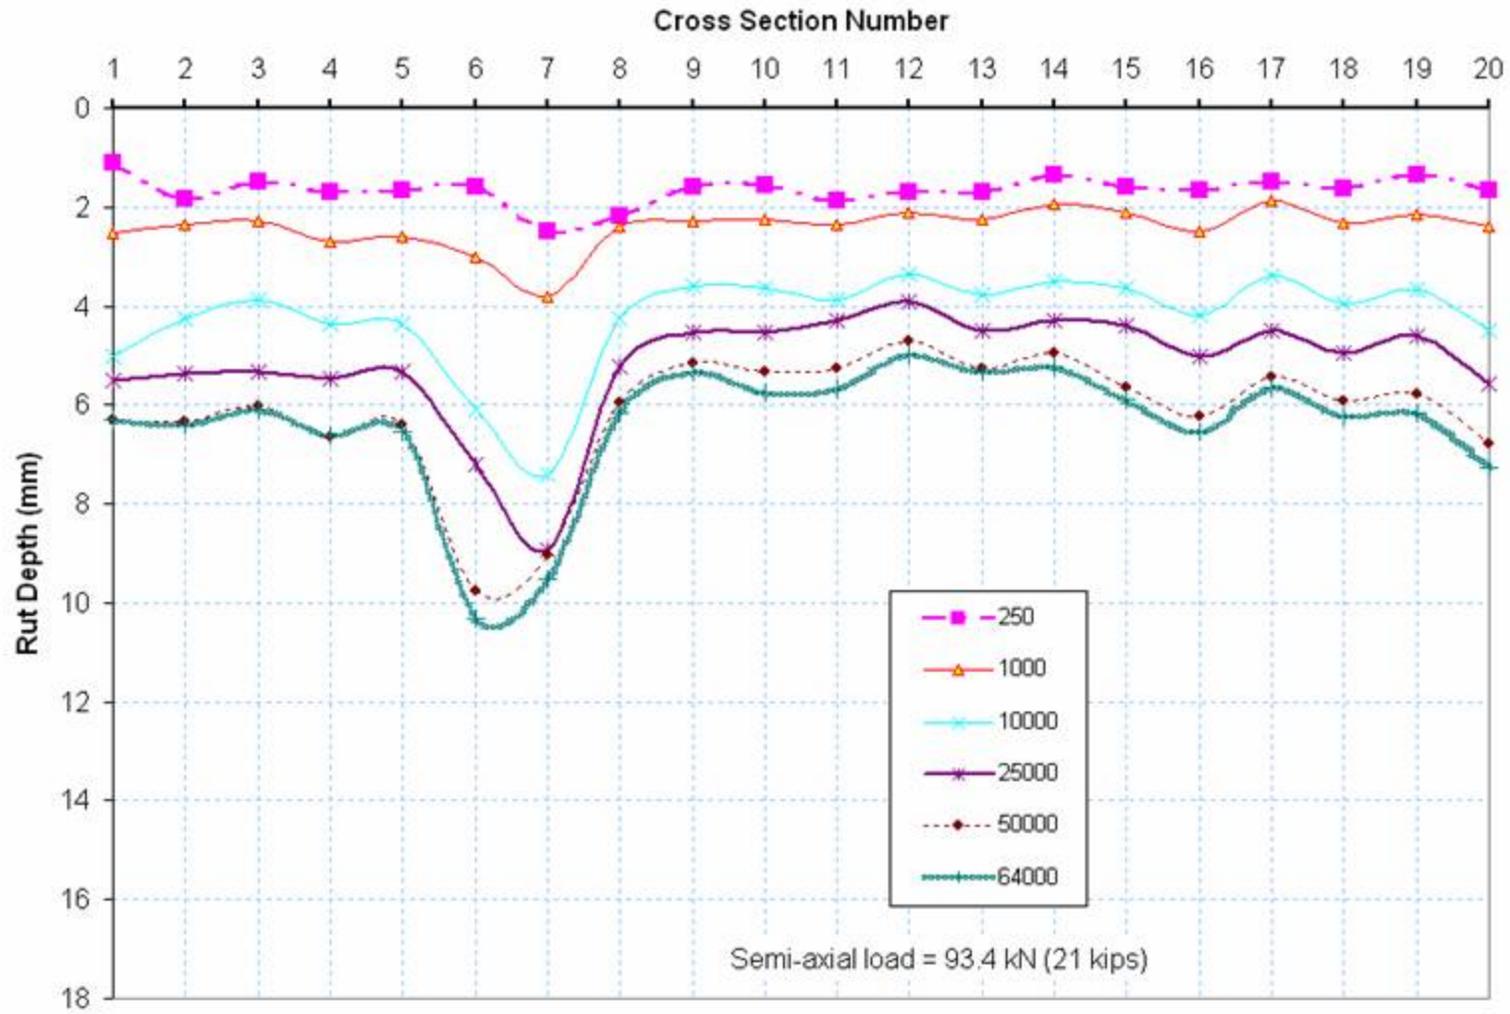
Figure 28. Progression of surface rutting along the center of the tire path in Test Window 712c3.

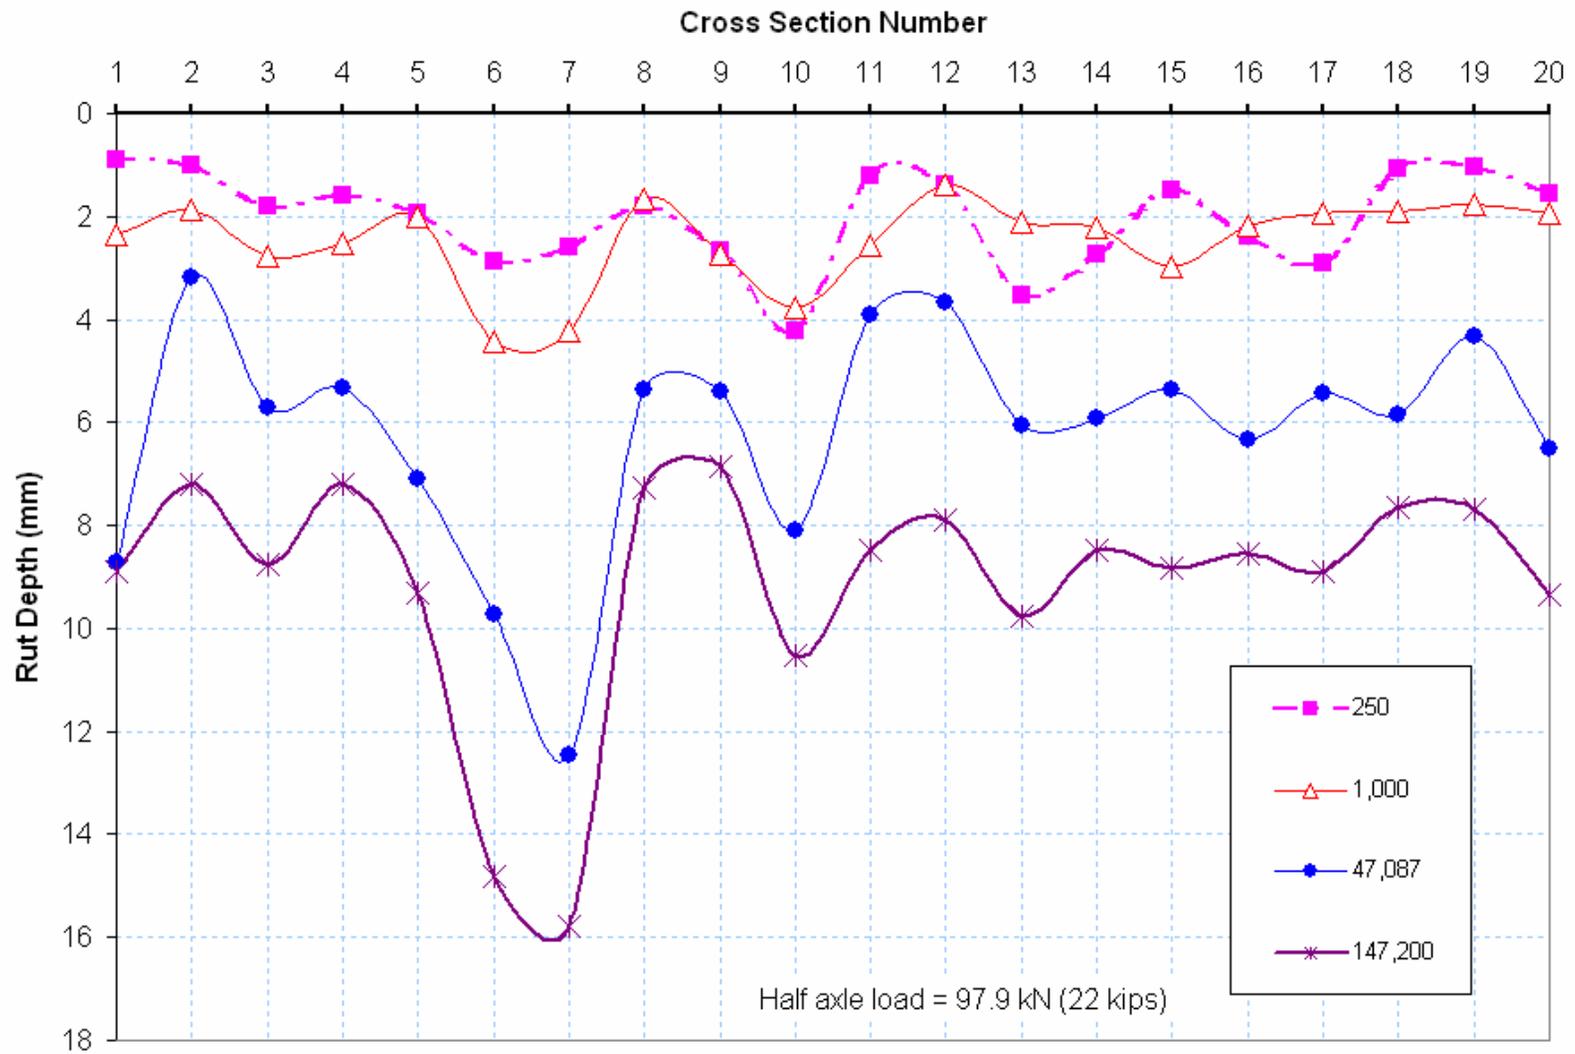
Figure 29. Progression of surface rutting along the center of the tire path in Test Window 712c4.
