PAVEMENT SUBGRADE PERFORMANCE STUDY

Test Section 712

Subgrade AASHTO soil type A-7-5 at 20 percent gravimetric moisture content

Edel R. Cortez⁽¹⁾

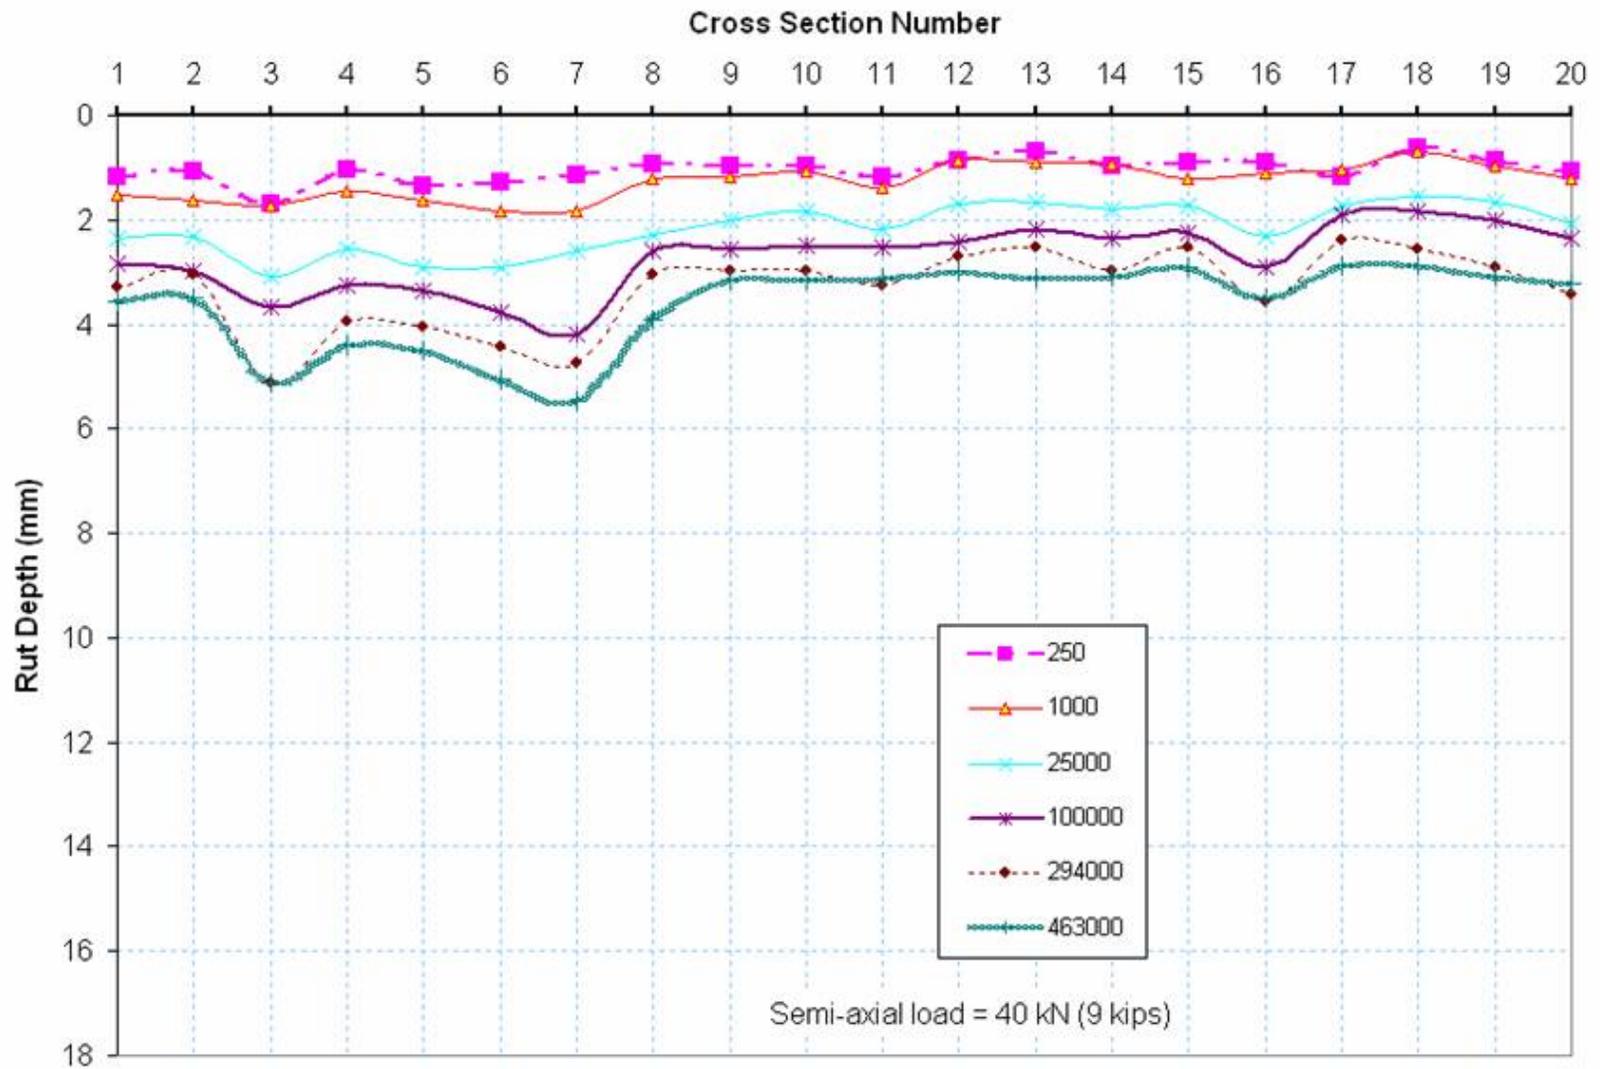
Figure 30. Progression of surface rutting along the center of the tire path in Test Window C5

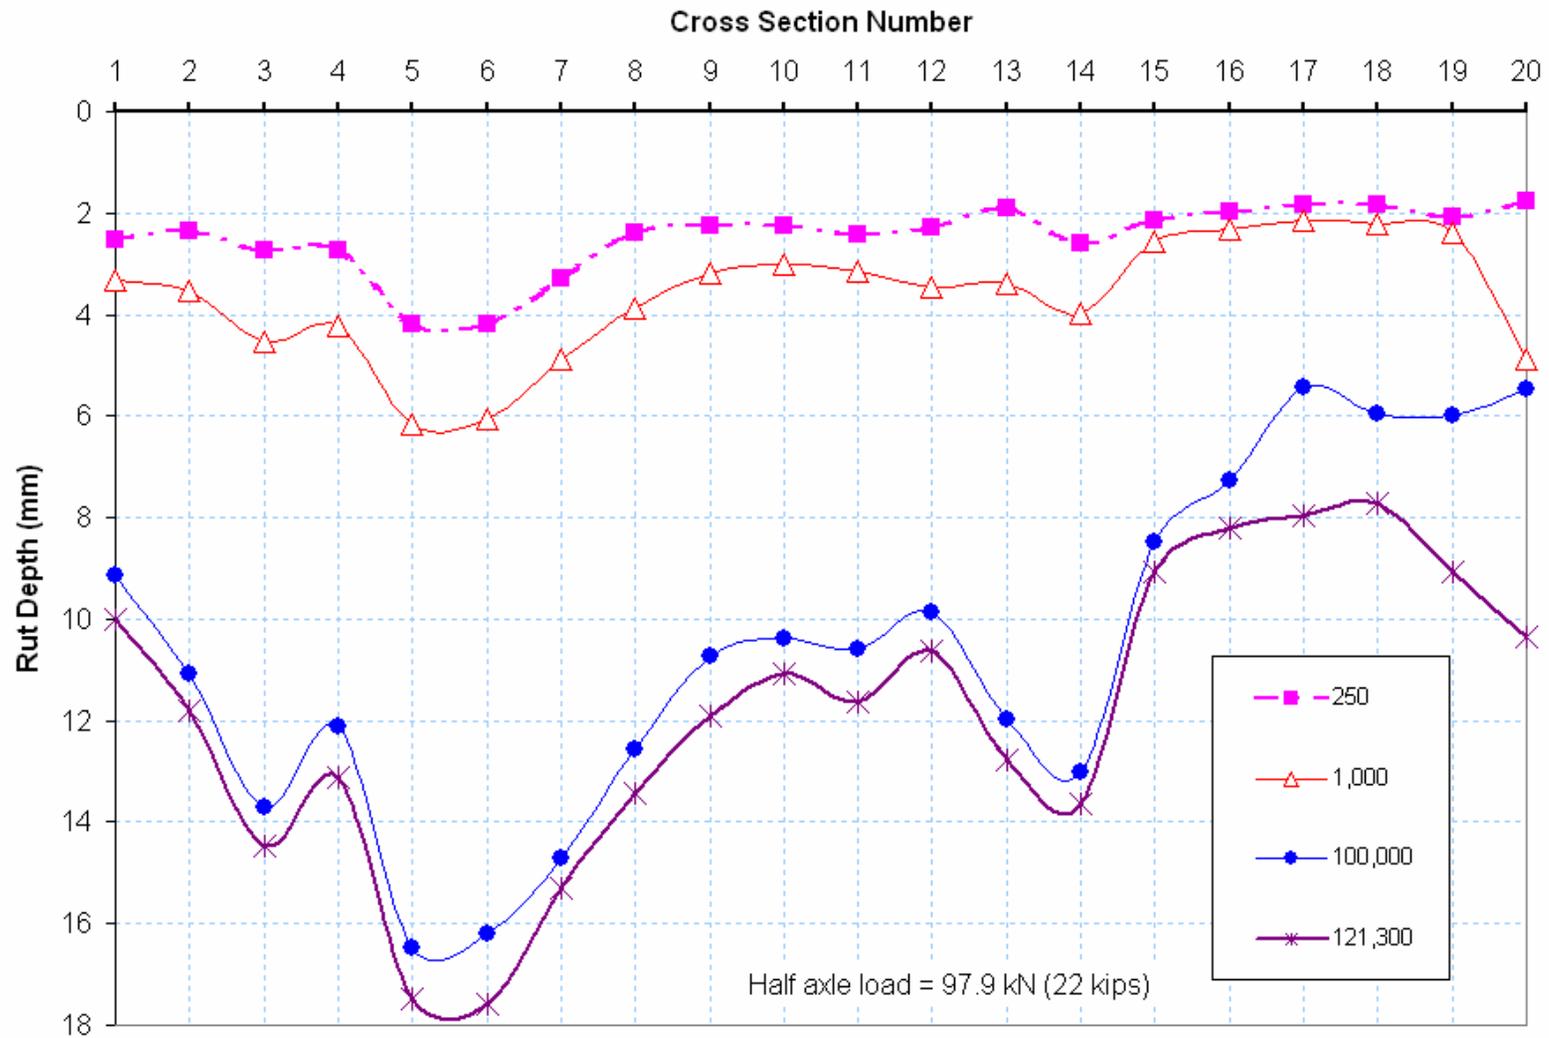
Figure 31. Progression of surface rutting along the center of the tire path in Test Window 712c6.

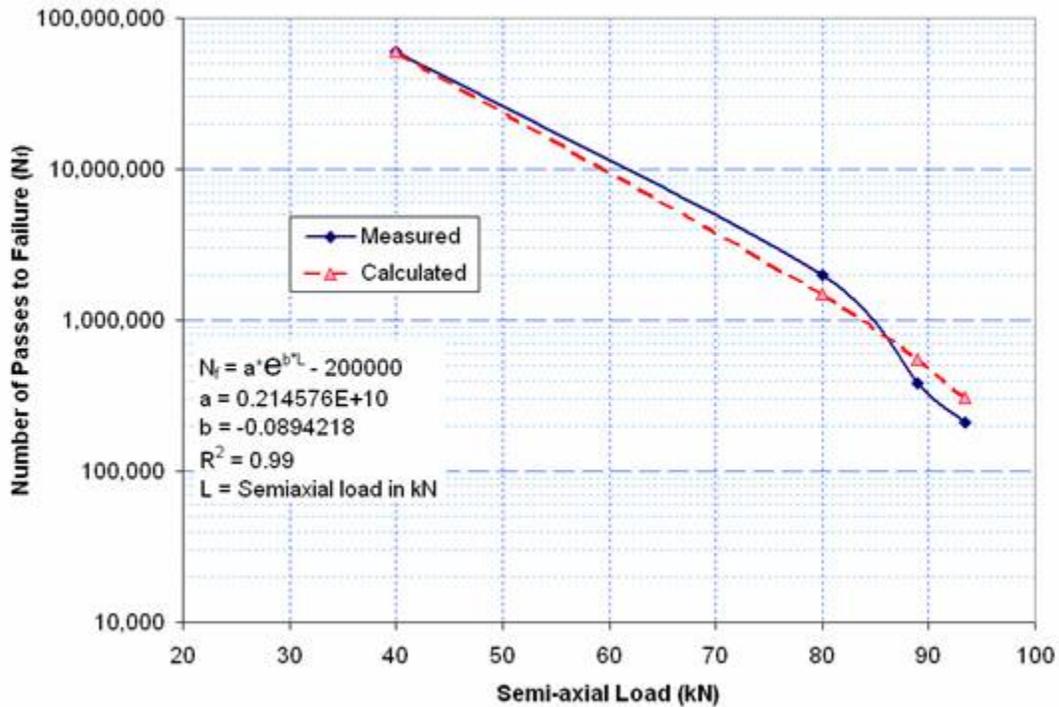
Table 8 shows the number of traffic passes required to cause a rut depth of 12.7 mm (0.5 in) estimated from the projections of the experimental data. Figure 32 graphically shows the relationship between load intensity and number of traffic passes to failure, and also a power function that fits the experimental data with an R^2 value of 0.996.

Figure 32 Load repetitions to failure as a function of load intensity.

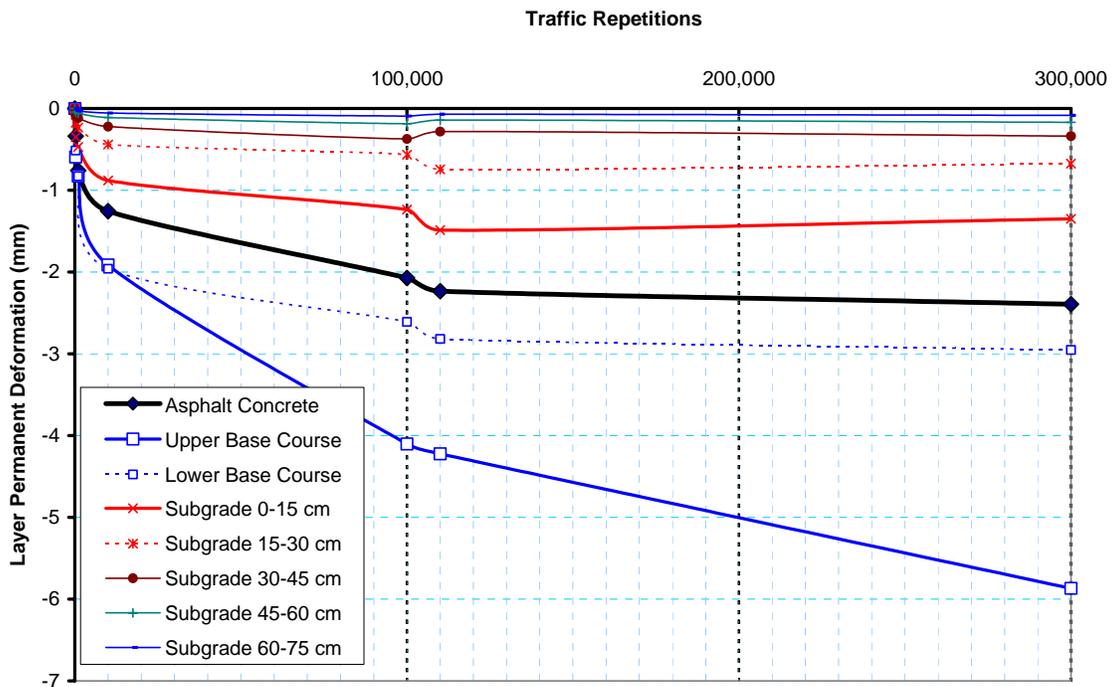
Figure 33a. Layer by layer vertical permanent deformation in Test Window 712c1 with 80 kN semi-axial load.

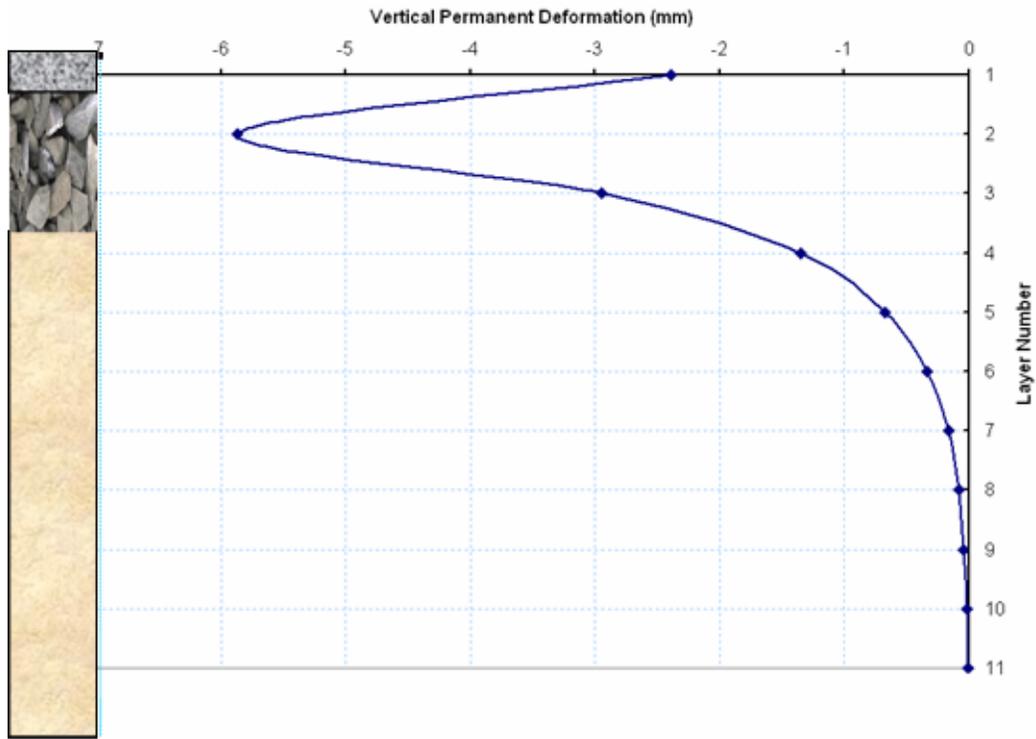
Figure 33b. Layer by layer vertical permanent deformation at failure in Test Window 712c1 with 80-kN semi-axial load.

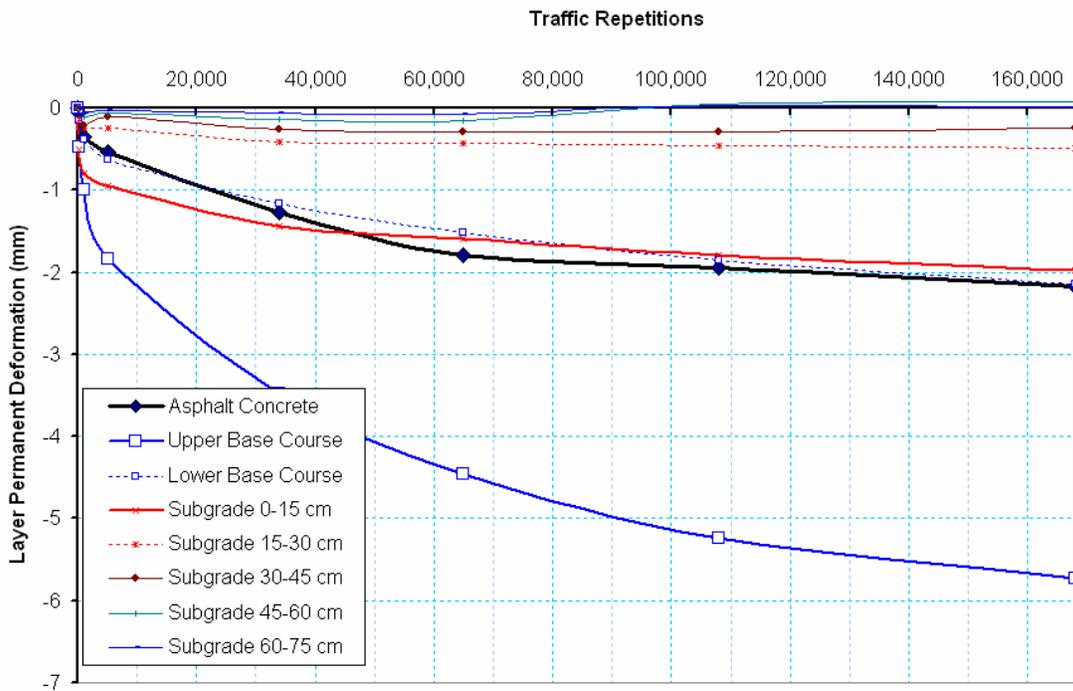
Figure 34a. Layer by layer vertical permanent deformation in Test Window 712c2 with 89-kN semi-axial load.

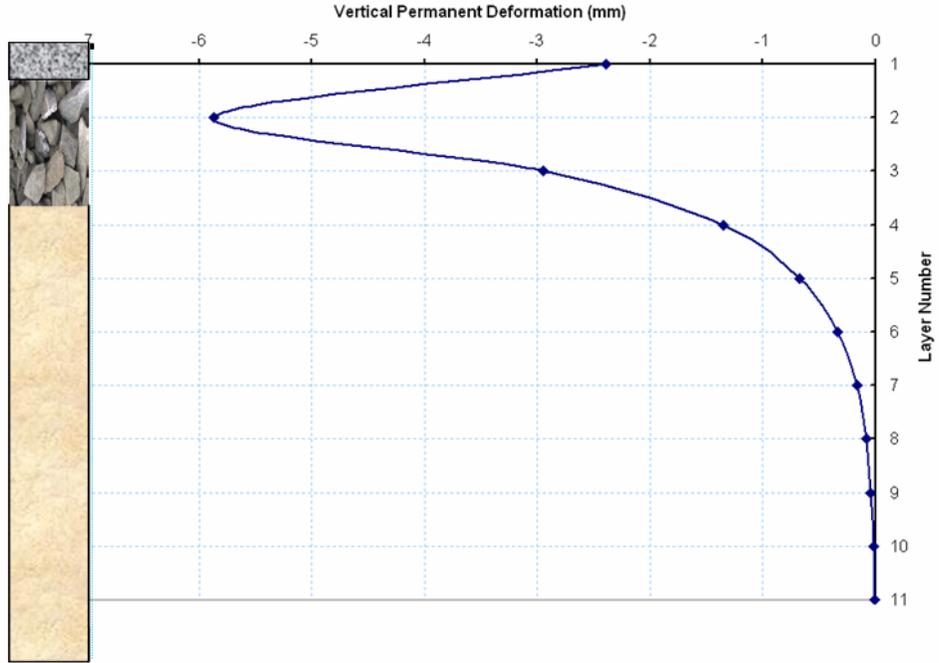
Figure 34b. Layer by layer vertical permanent deformation at failure in Test Window 712c2 with 89-kN semi-axial load.

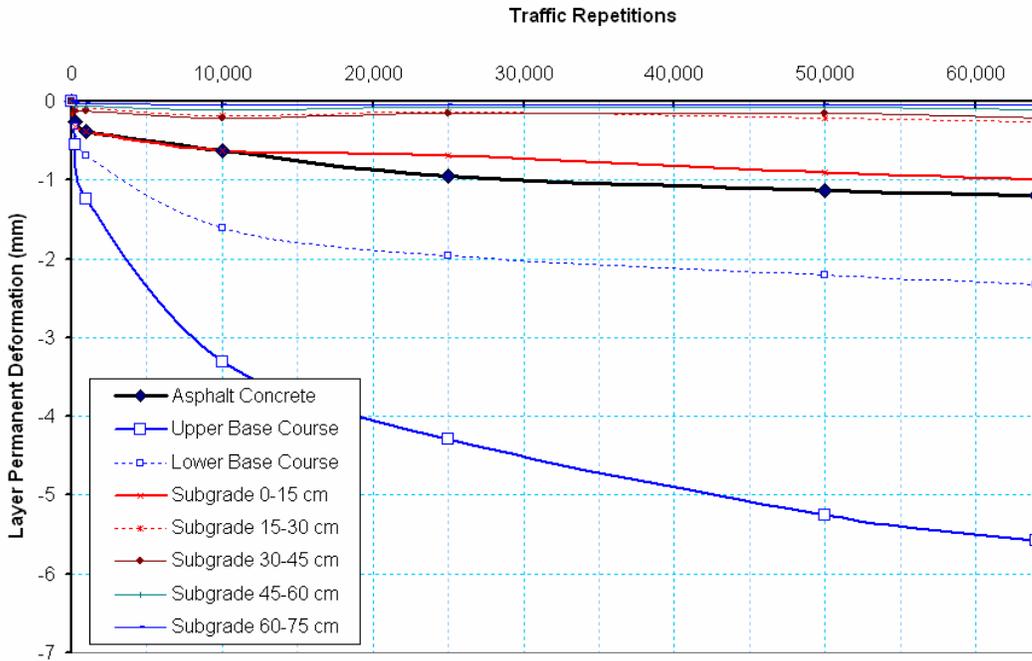
Figure 35a. Layer by layer vertical permanent deformation in Test Window 712c3 with 93.4-kN semi-axial load.

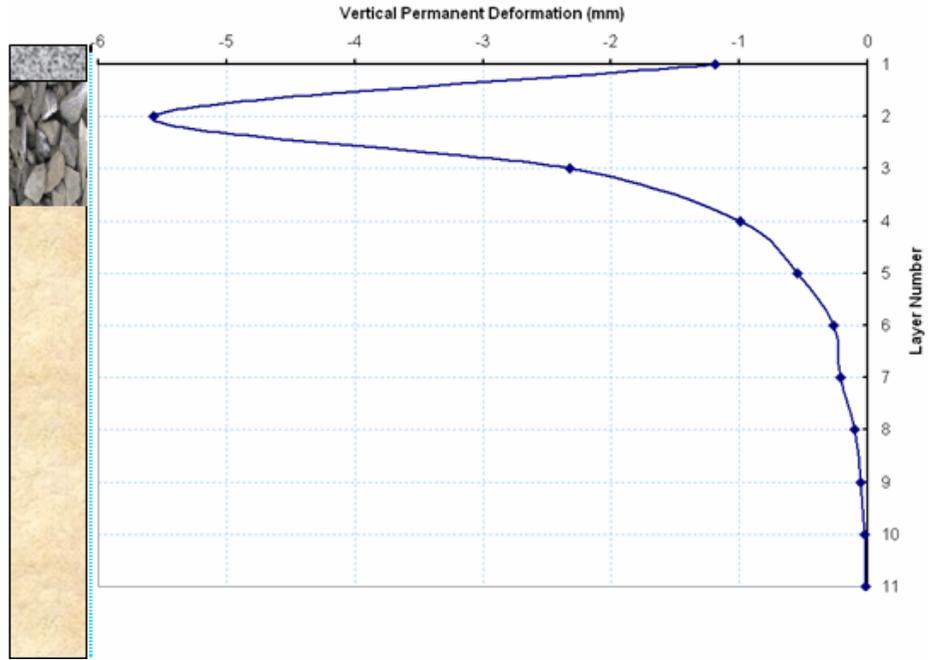
Figure 35b. Layer by layer vertical permanent deformation at failure in Test Window 713c3 with 93.4-kN semi-axial load.

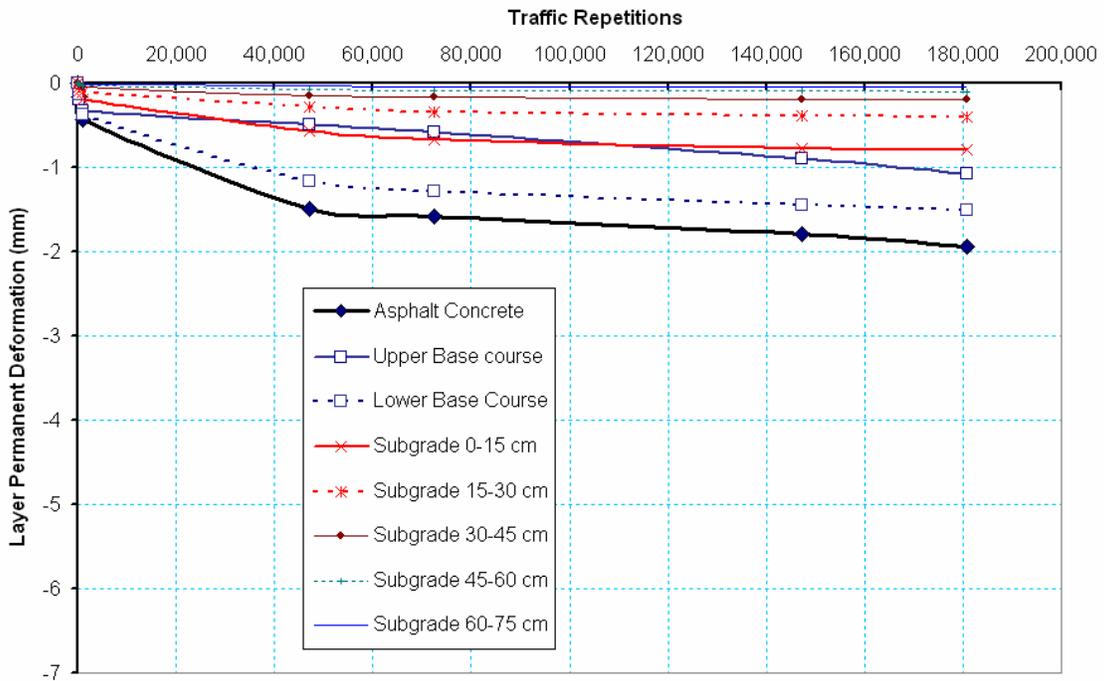
Figure 36a. Layer by layer vertical permanent deformation in Test Window 712c4 with 97.9-kN semi-axial load.

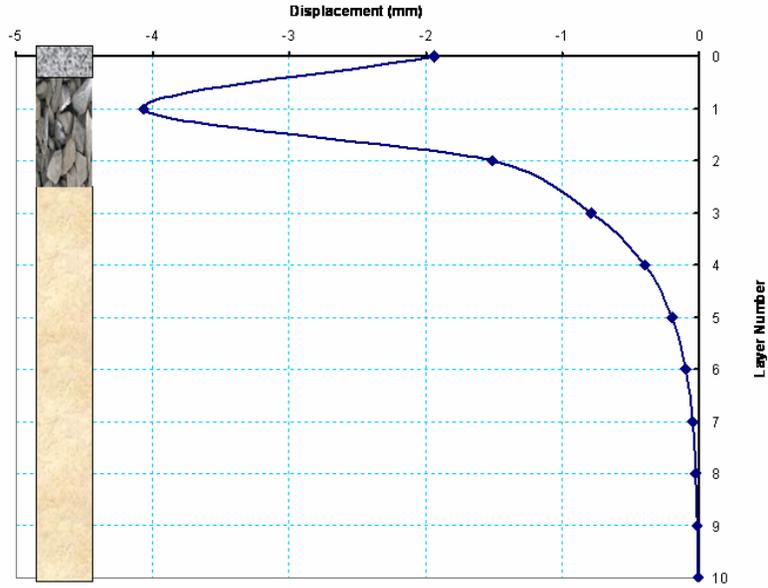
Figure 36b. Layer by layer vertical permanent deformation at failure in Test Window 713c4 with 97.9-kN semi-axial load.

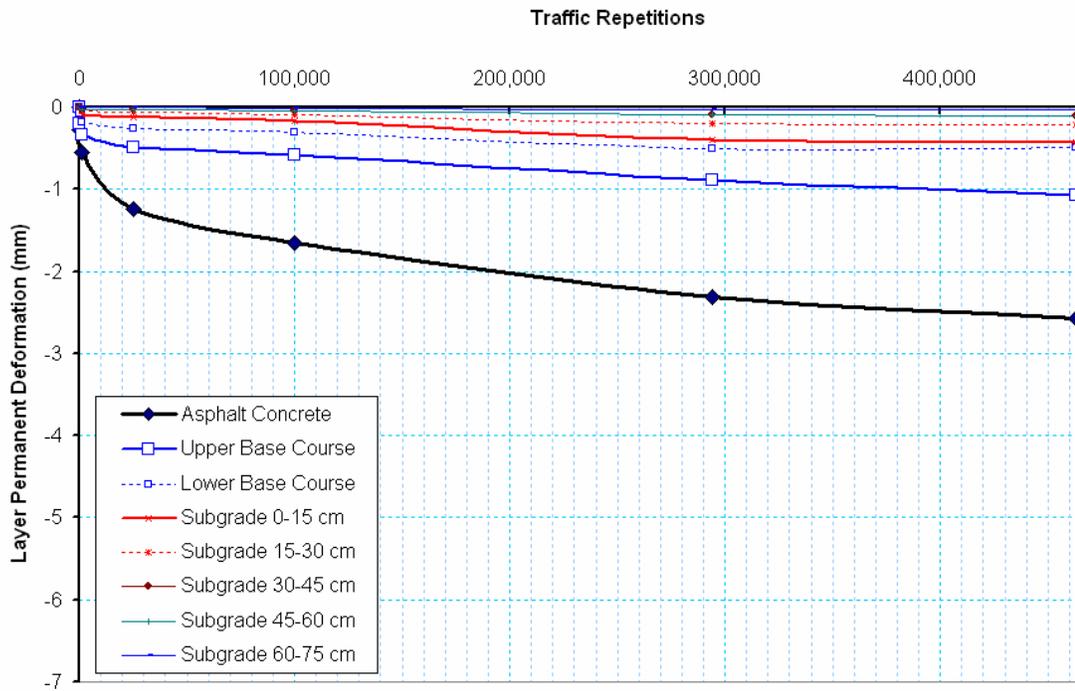
Figure 37a. Layer by layer vertical permanent deformation in Test Window 712c5 with 40 kN semi-axial load.

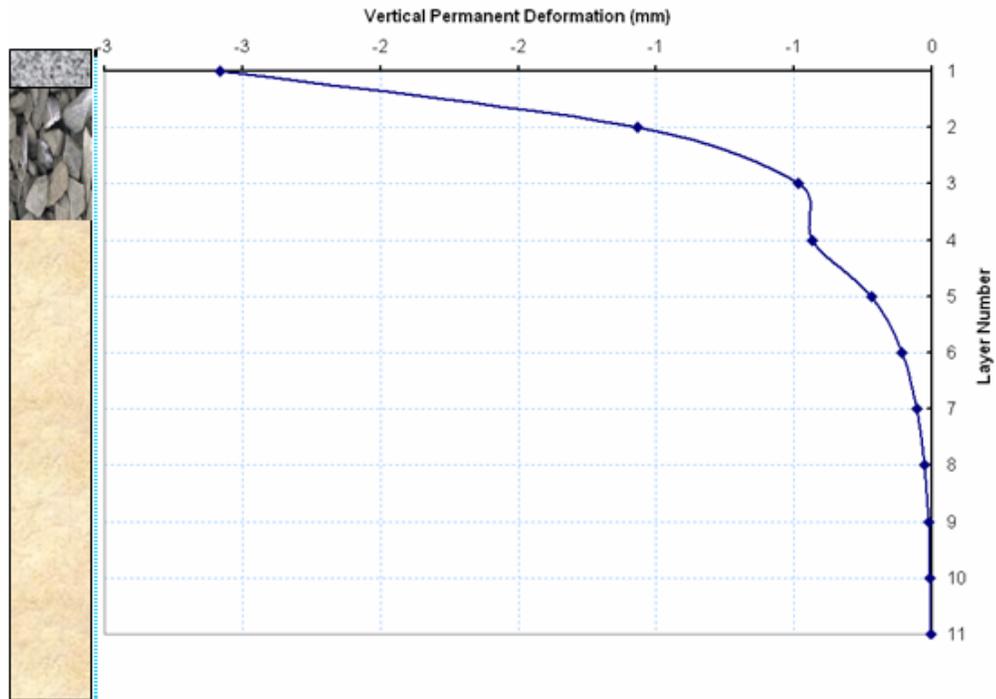
Figure 37b. Layer by layer vertical permanent deformation at end of traffic in Test Window 712c5 with 40-kN half axle load.

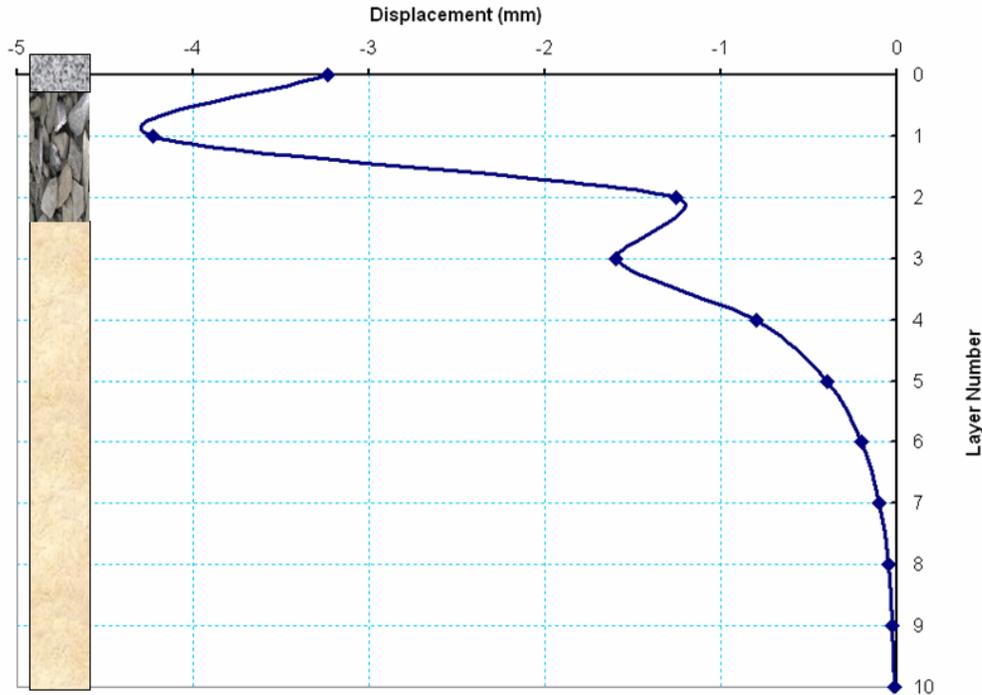
Figure 38b. Layer by layer vertical permanent deformation at end of traffic in Test Window 712c6 with 97.9-kN half axle load.

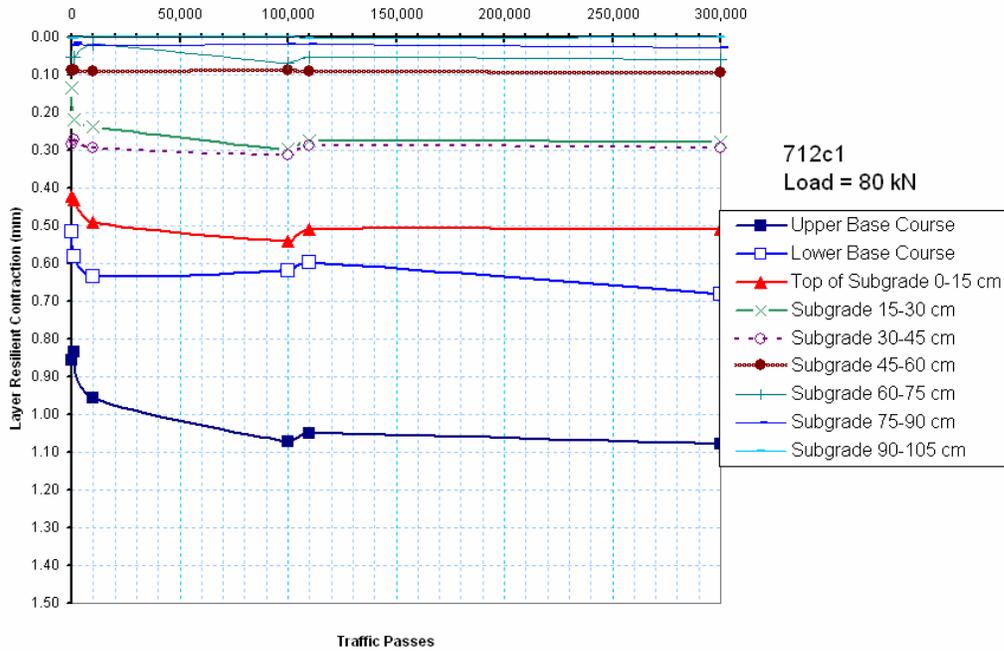
Figure 39. Resilient vertical deformations at various layers in Test Window 712c1.

In general, resilient deformation and strain increased in proportion to the traffic load intensity. Resilient strains as a function of load repetitions are presented in Figure 45 for a location 76 mm (3 in.) below the top of the subgrade. It can be seen that, in this test section, the resilient strains remained nearly constant throughout the traffic tests.

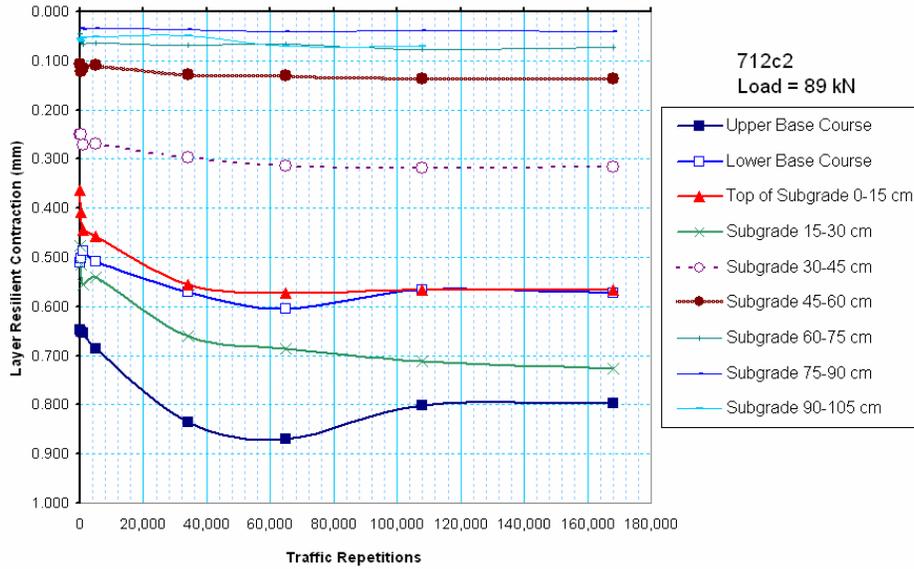
Figure 40. Resilient vertical deformations at various layers in Test Window 712c2.

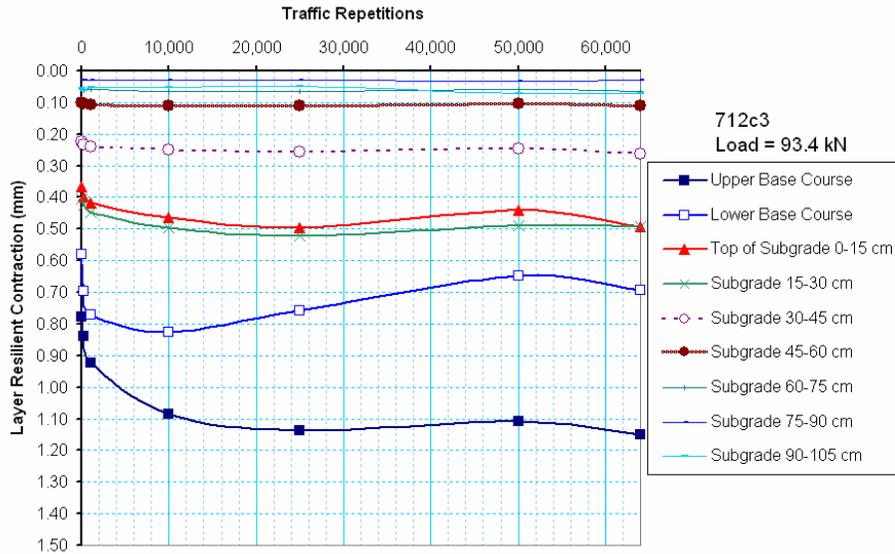
Figure 41. Resilient vertical deformations at various layers in Test Window 712c3.

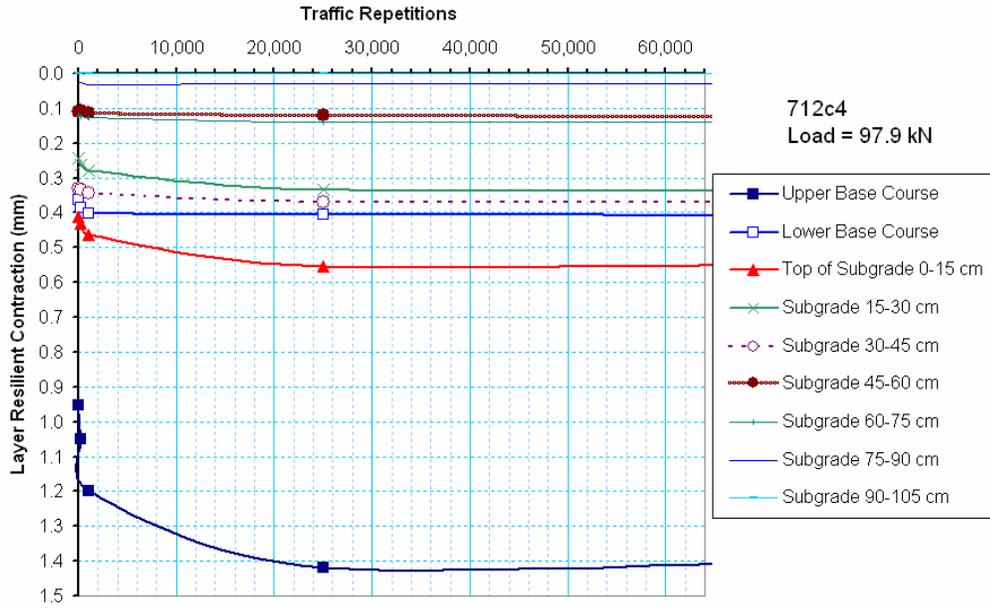
Figure 42. Resilient vertical deformations at various layers in Test Window 712c4.

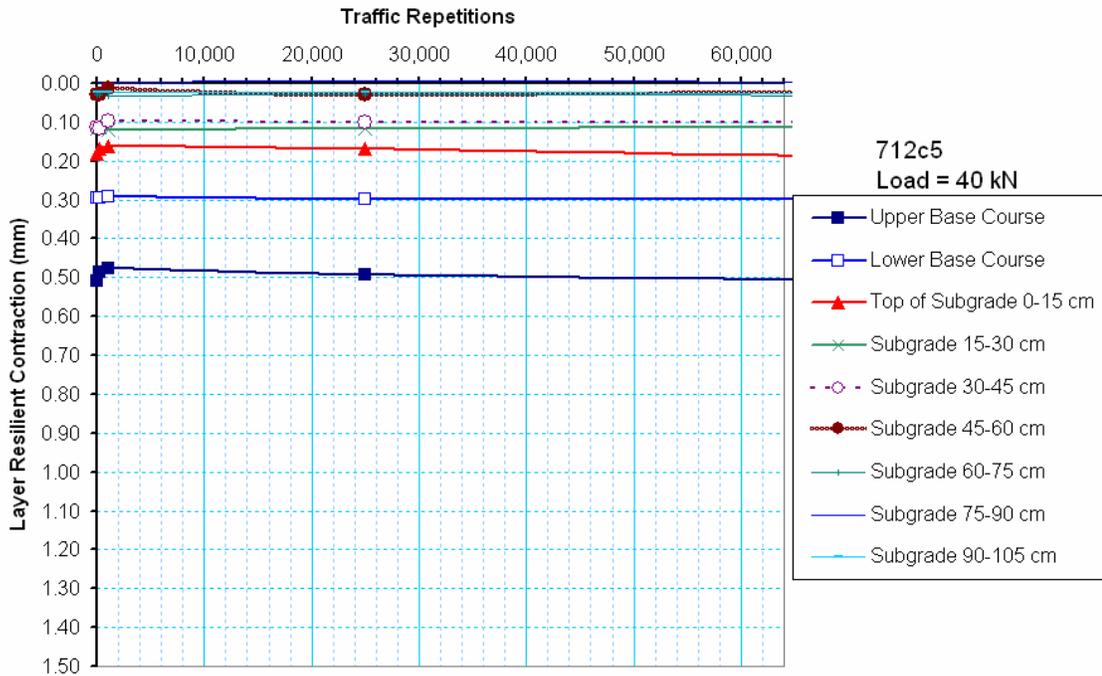
Figure 43. Resilient vertical deformations at various layers in Test Window 712c5.

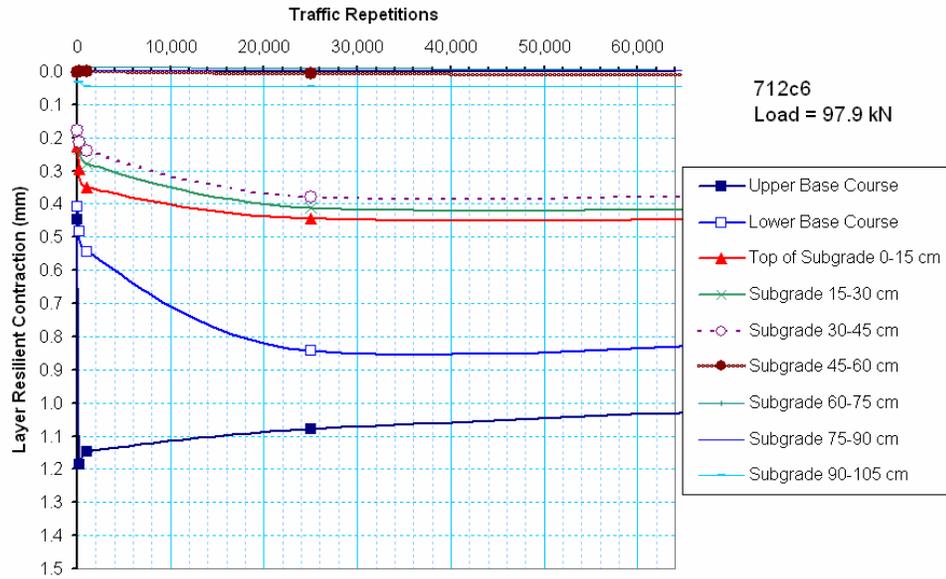
Figure 44. Resilient vertical deformations at various layers in Test Window 712c6.

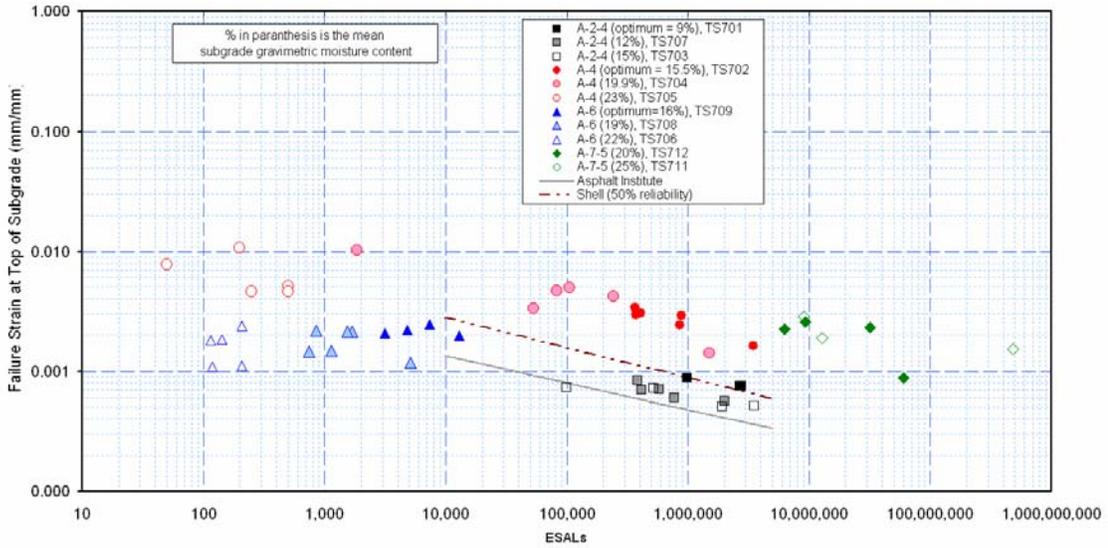
Figure 46. Effect of soil type and moisture content on subgrade failure criteria.

Figure 46 shows the resilient strain at the top of the subgrade at failure for all the subgrade soils included in this study. The existing subgrade failure criteria established by the Asphalt Institute and the Shell corporation are also graphed for comparison. It can be seen that the resilient behavior of the subgrade soil A-2-4 is consistent with the two established criteria, but significant differences occur for other soils. The data suggests that subgrade resilient strain criteria must be tailored to soil type.

Figure 46 shows the resilient strain at the top of the subgrade at failure for all the subgrade soils included in this study. The existing subgrade failure criteria established by the Asphalt Institute and the Shell corporation are also graphed for comparison. It can be seen that the resilient behavior of the subgrade soil A-2-4 is consistent with the two established criteria, but significant differences occur for other soils. The data suggests that subgrade resilient strain criteria must be tailored to soil type. Figure 46 also shows that the AASHTO type A-2-4 soil is significantly less susceptible to moisture content than the other soil types. Subgrade soil AASHTO type A-4 is most susceptible to moisture variations. This is a silty soil, and therefore, it is also most susceptible to frost heaving and spring thaw weakening. Unfortunately, this is also the most abundant subgrade soil type found in the United States and in the world (Rollings, R., 2004).

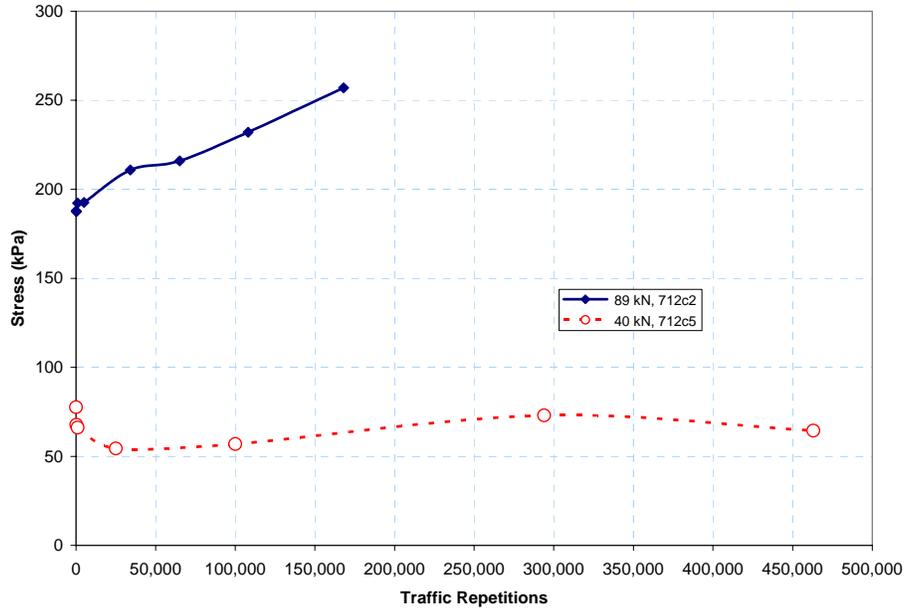
Figure 47. Stress measurements in the middle of the base course in Test Windows 712c2 and 712c5.

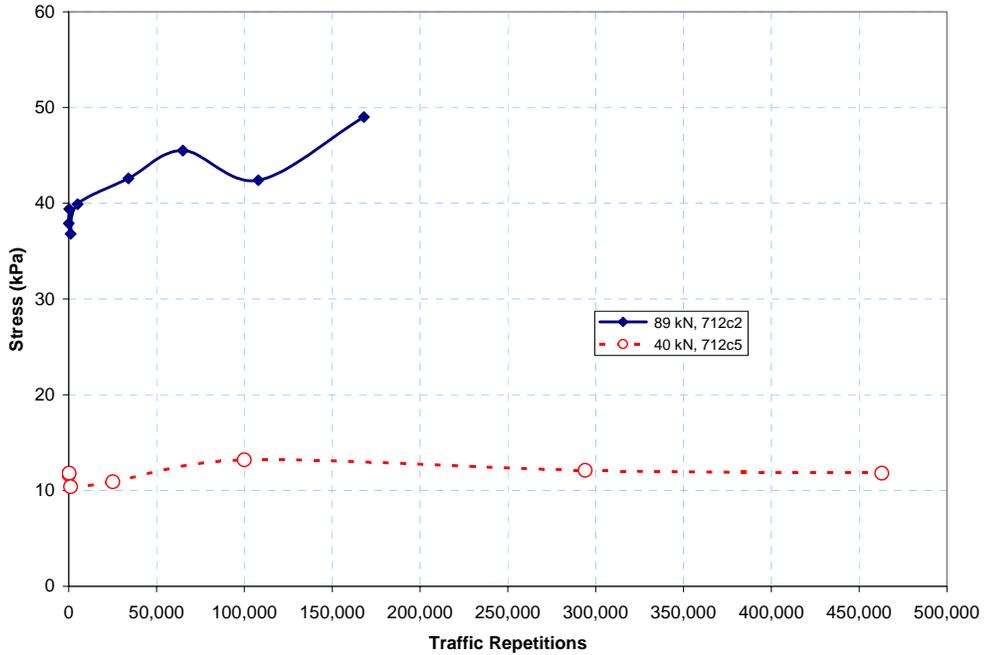
Figure 49. Stress measurements at a depth of 686 mm (27 in.) below the top of the asphalt concrete for semi-axial loads of 40 kN (9 kips) 89 kN (20 kips).

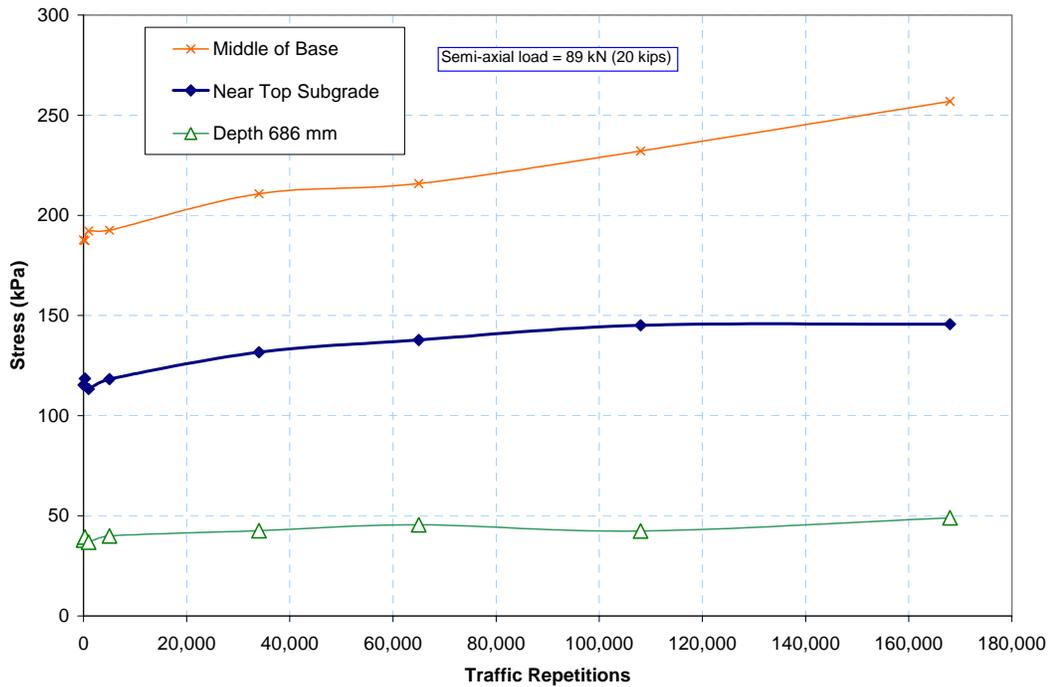
Figure 50. Stress measurements at various depths in Test Window 712c2 with a semi-axial load of 89 kN (20 kips).

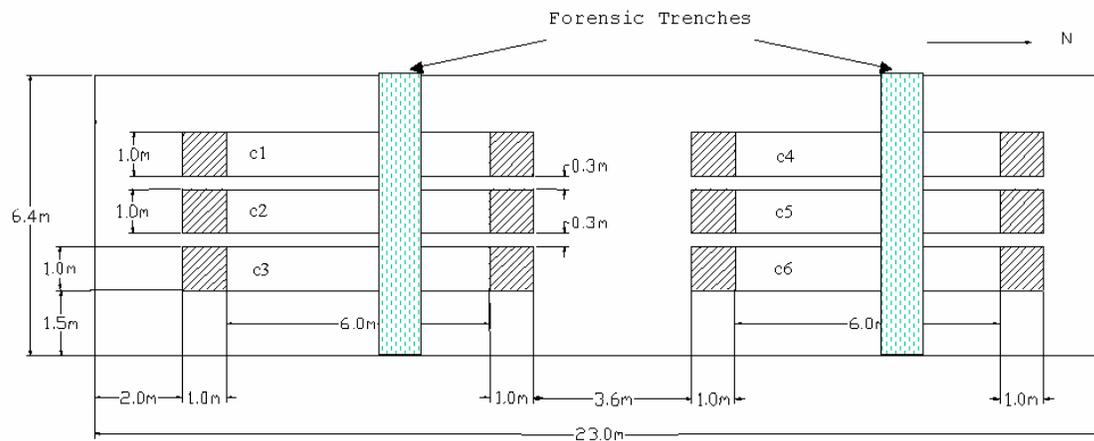
A forensic evaluation was conducted to establish the condition of the pavement structure at the end of the traffic tests. Two trenches were cut across the test windows. One trench was excavated across test windows 1, 2, and 3 on the south region of the test section. This trench will be referred to as the “South Trench”. Another trench was excavated in the north region of the test section. This trench cut across test windows 4, 5, and 6. The boundaries of the trenches were carefully located and marked to avoid damaging the embedded sensors and wires. Dry saw cutting was used to avoid disturbing the base and subgrade moisture contents. Base course and subgrade soil samples were taken immediately after exposure to determine their moisture contents by the oven-dry method. The side surfaces were carefully scrapped and dusted off to be able to measure asphalt and base layer thickness.

Figure 51. Location of the forensic trenches in Test Section 712

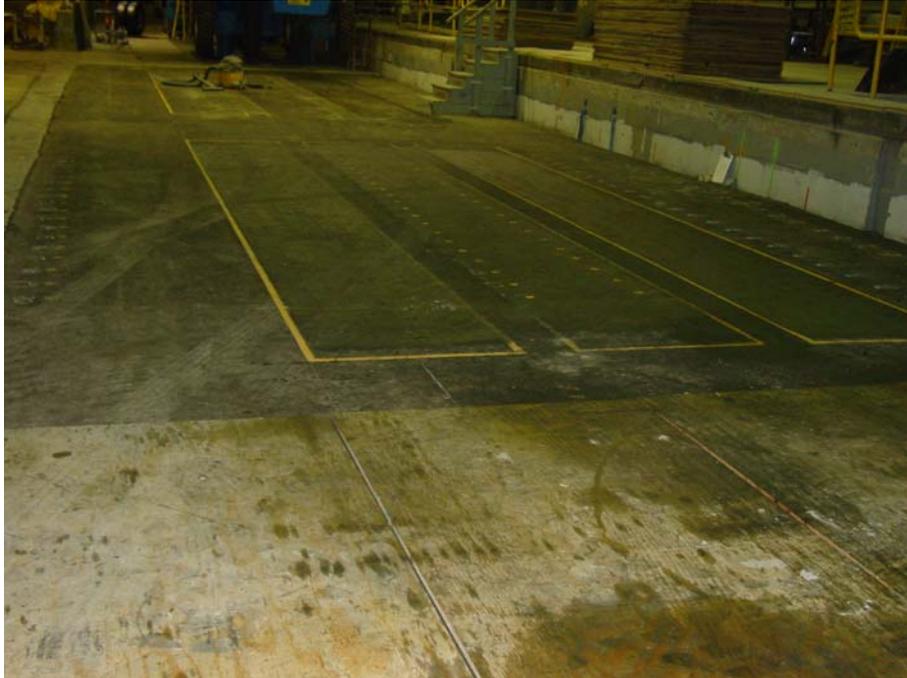
Figure 52 shows a view of the test section at the end of traffic. The distress mode in all the test windows in this test section were limited to smooth rutting. No other form of distress (cracking, delamination, shoving, etc.) was observed. Test window 712c4 was traffic tested first.

Figure 52. View of test section at the end of traffic tests.

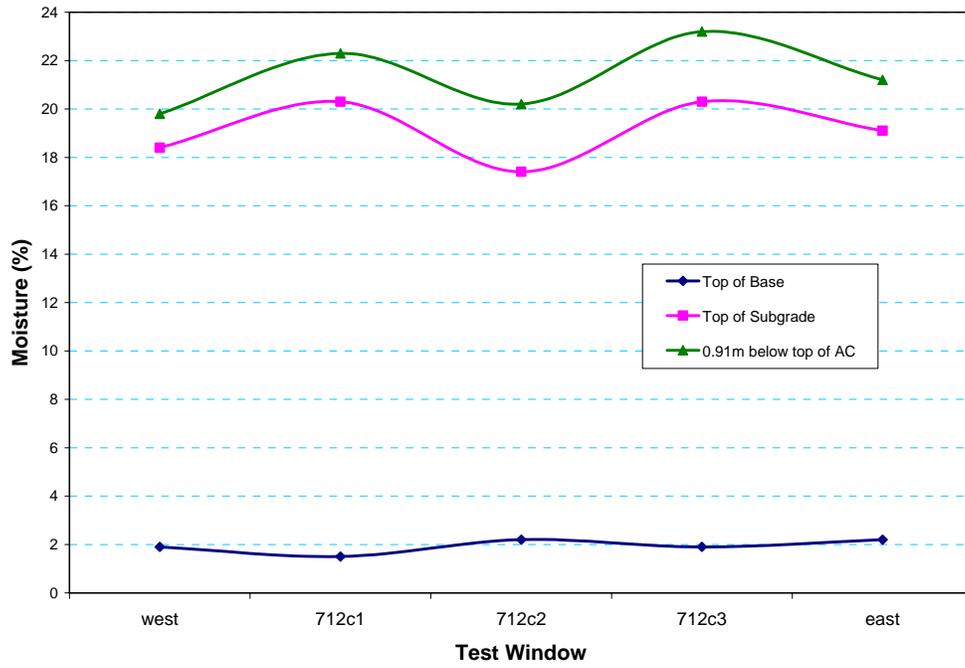
Moisture and density measurements were conducted inside the trenches in the base course and in the upper subgrade down to a depth of 0.91 m (3 ft.) below the top of the asphalt concrete. Figure 53 and 56 show the gravimetric moisture contents in the south and north trenches respectively. The measured values are consistent with those obtained during the construction. Figures 57 and 60 show density measurements for the south and north trenches at each test window and also at locations outside the traffic areas at the east and west sides of the test windows. Most measured values are above 90 percent of modified Proctor density.

Figure 53. Moisture content in the base and upper subgrade in the south trench.

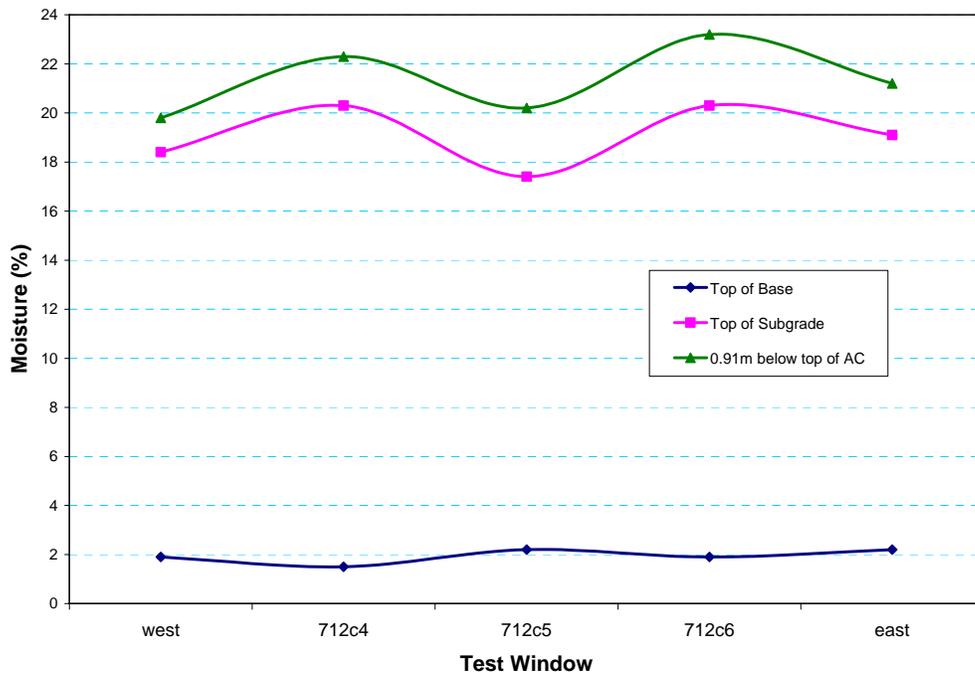
Figure 54. Moisture content in the base and upper subgrade in the north trench.

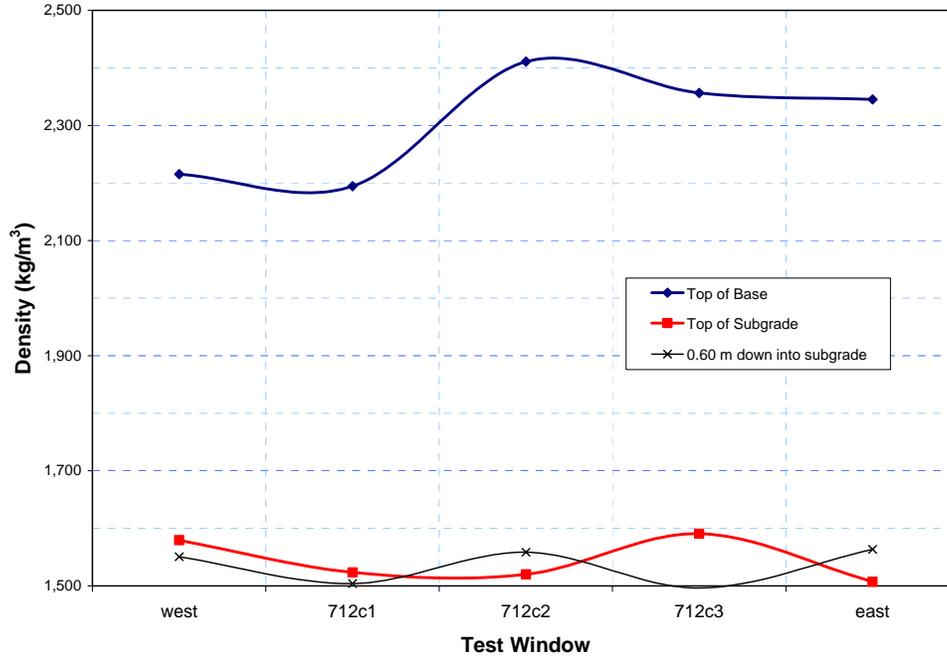
Figure 55. Density measurements in the base and upper subgrade in the south trench.
