PAVEMENT SUBGRADE PERFORMANCE STUDY

Test Section 712

Subgrade AASHTO soil type A-7-5 at 20 percent gravimetric moisture content

Edel R. Cortez⁽¹⁾

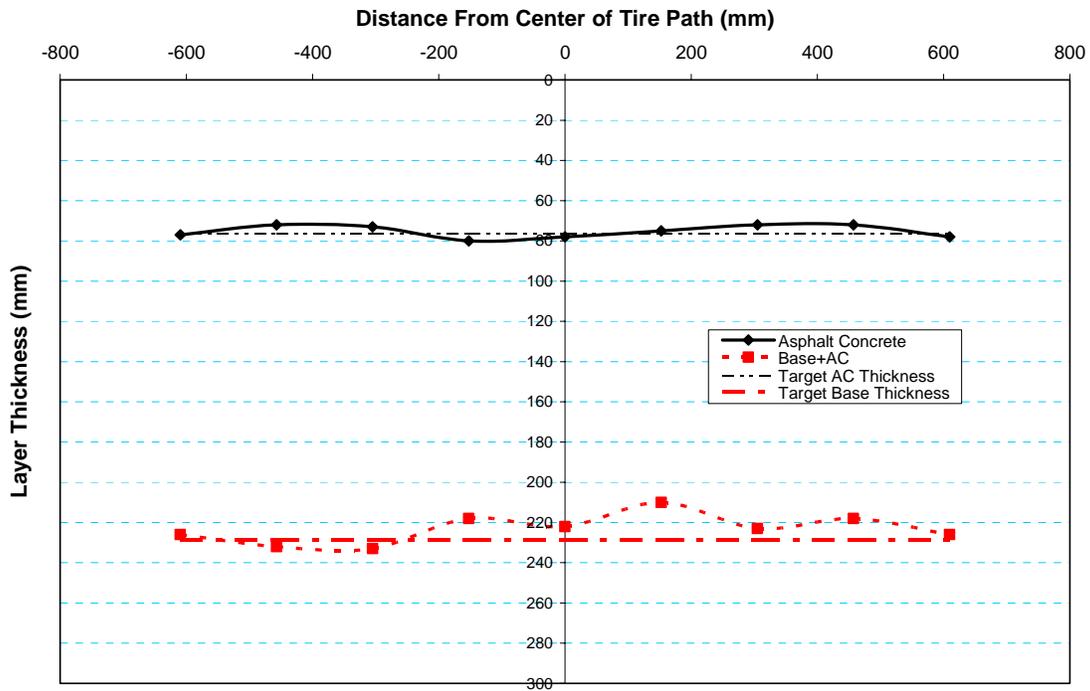
Figure 57. Layer thickness measurements across Test Window C1.

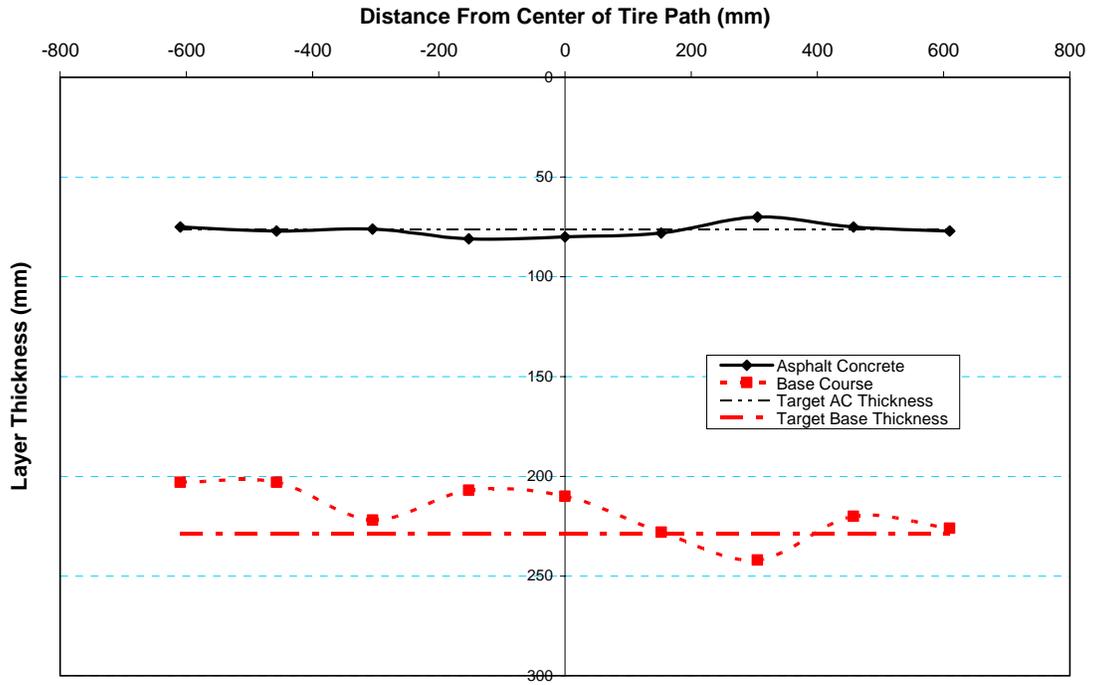
Figure 58. Layer thickness measurements across Test Window C2.

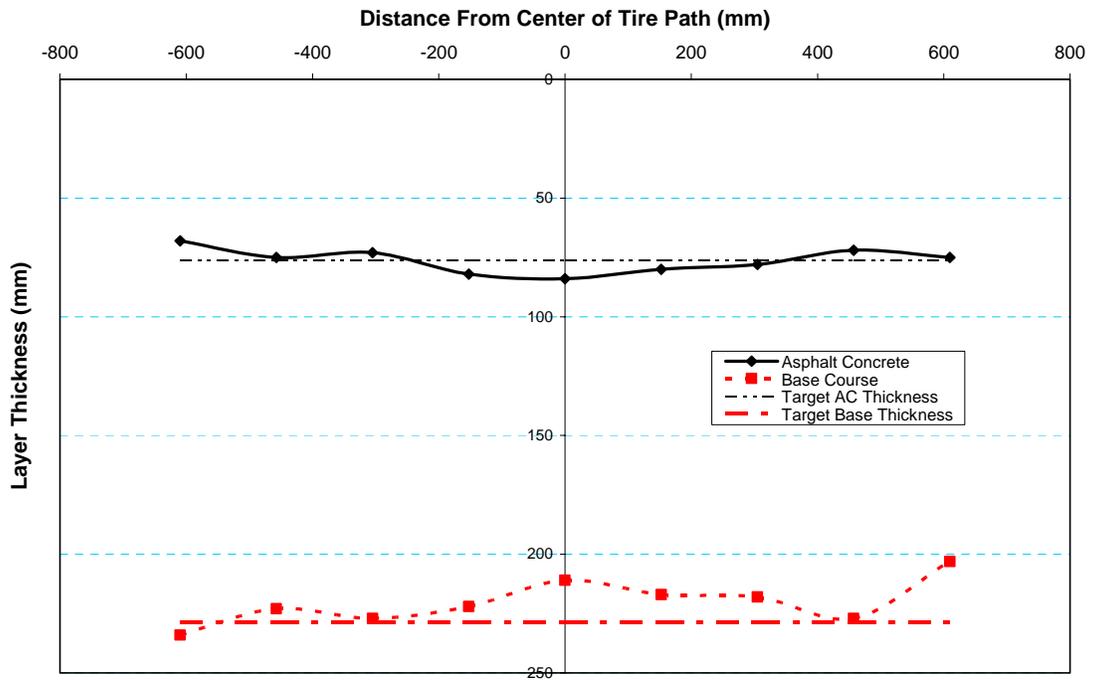
Figure 59. Layer thickness measurements across Test Window C3.

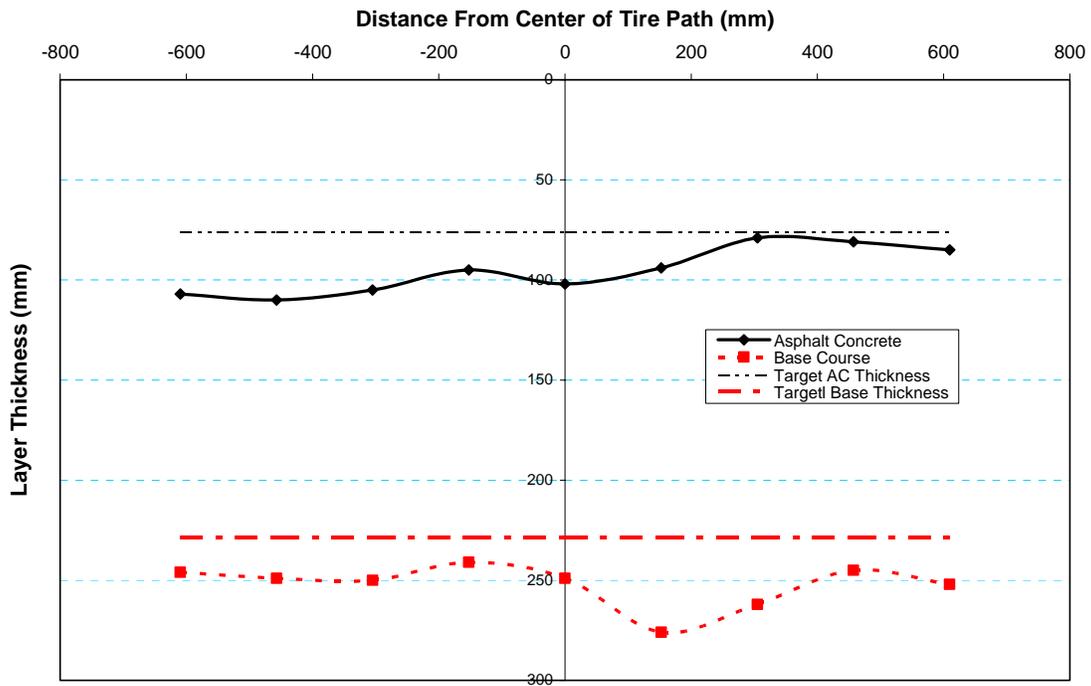
Figure 60. Layer thickness measurements across Test Window C4.

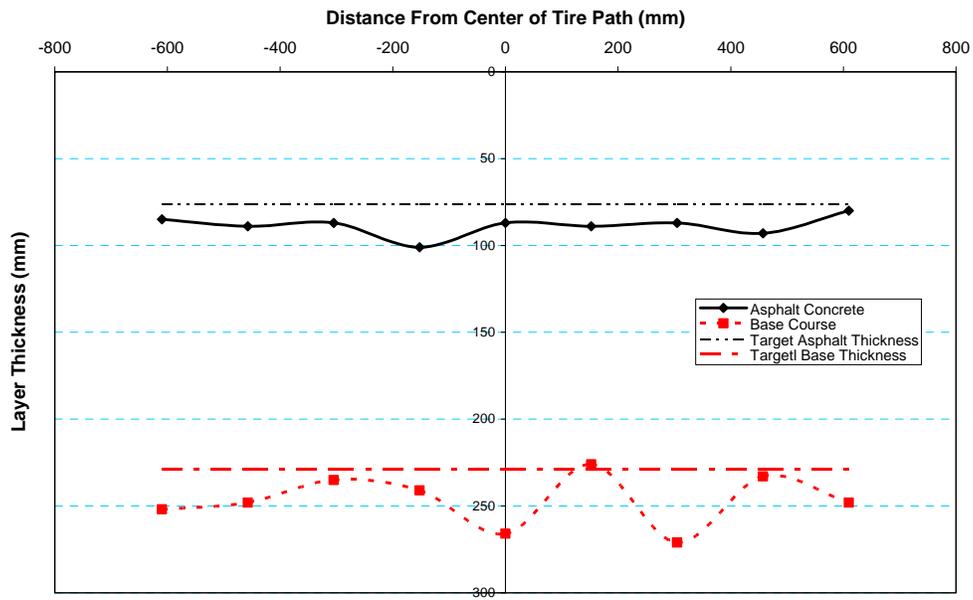
Figure 61. Layer thickness measurements across Test Window C5.

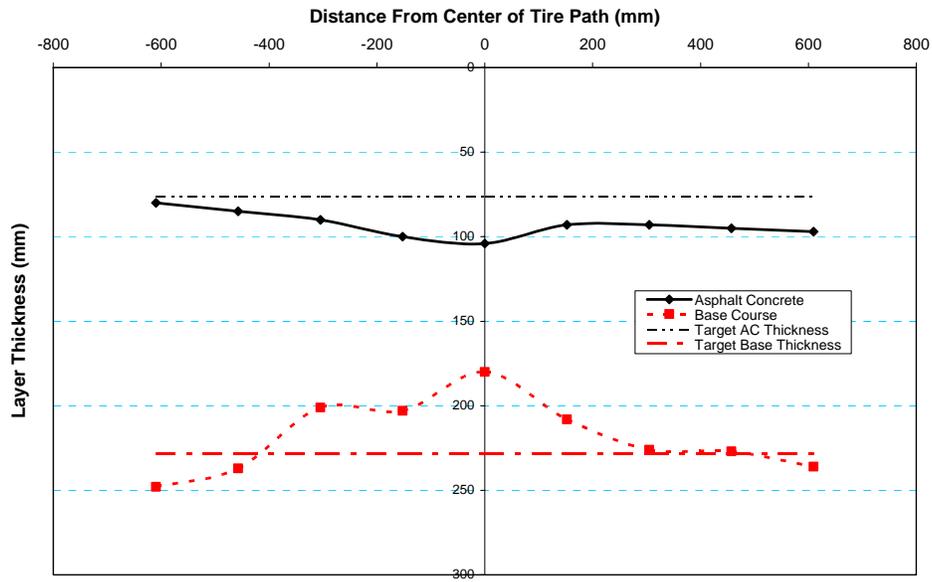
Figure 62. Layer thickness measurements across Test Window C6.

In Test Window 712c6 the average asphalt thickness was thicker than intended, but the base course was 25 mm (1 in.) thinner than intended at the center of the test window.

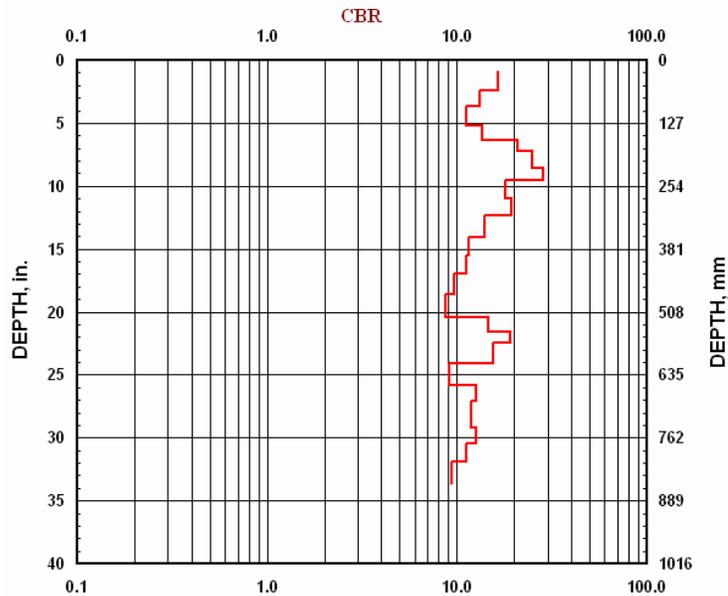
Figure 63. Subgrade CBR in Test Window C1.

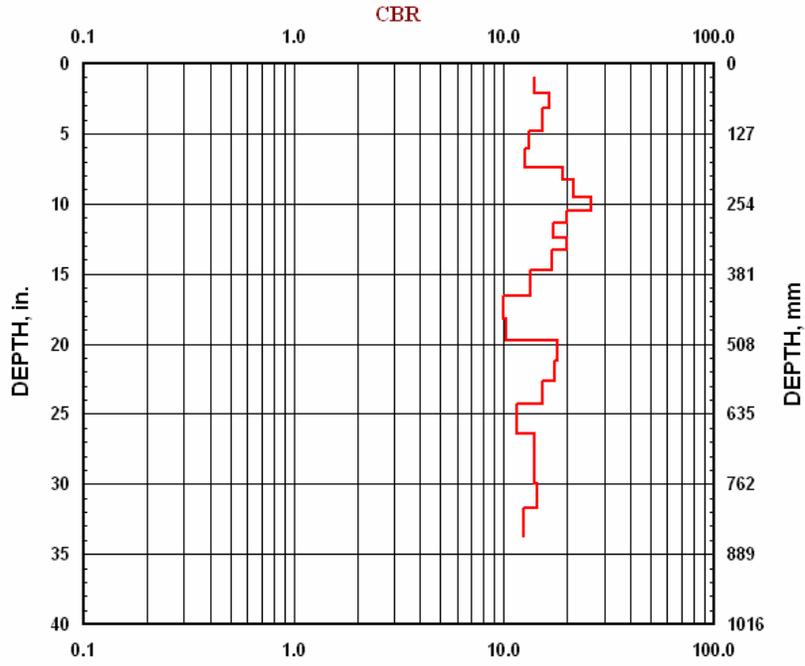
Figure 64. Subgrade CBR in Test Window C2.

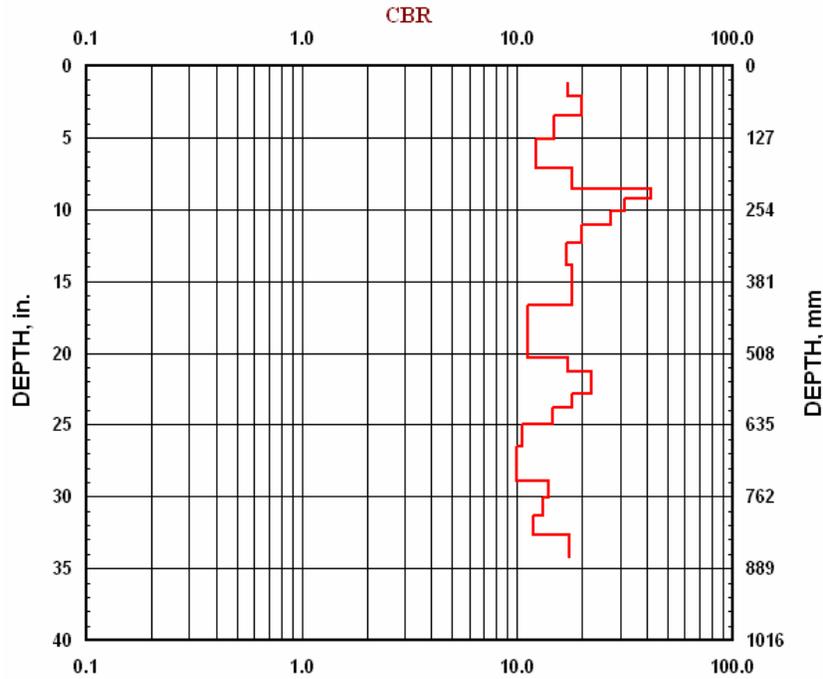
Figure 65. Subgrade CBR in Test Window C3.

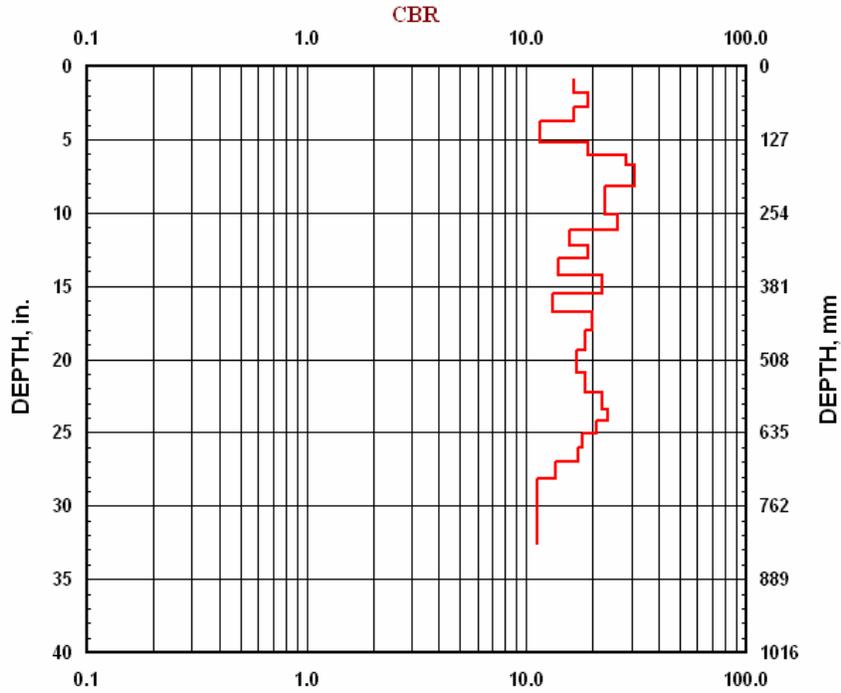
Figure 66. Subgrade CBR in Test Window C4.

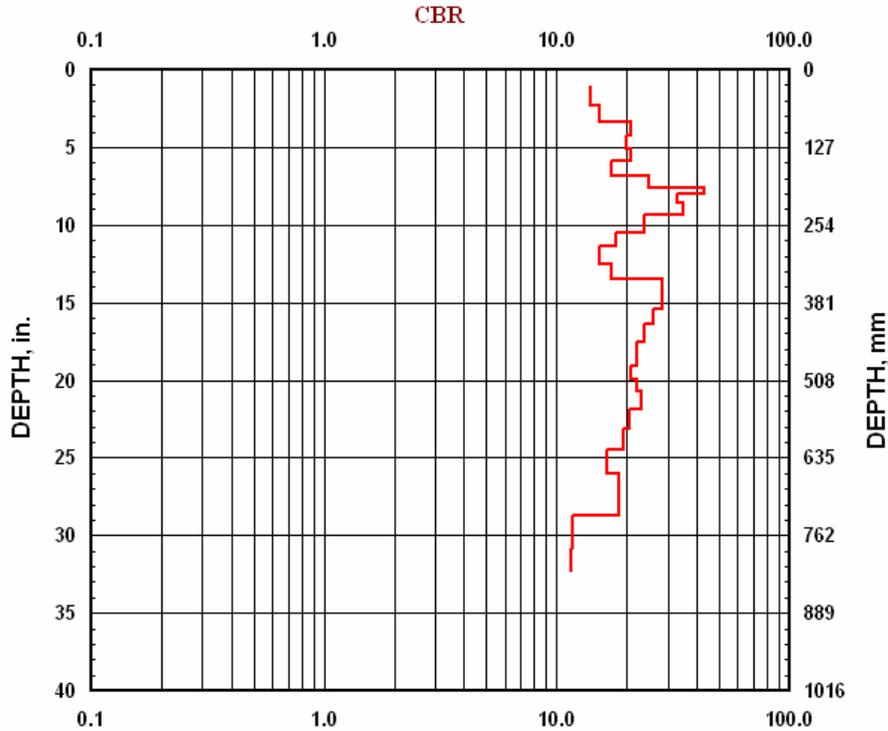
Figure 68. Subgrade CBR in Test Window C6.

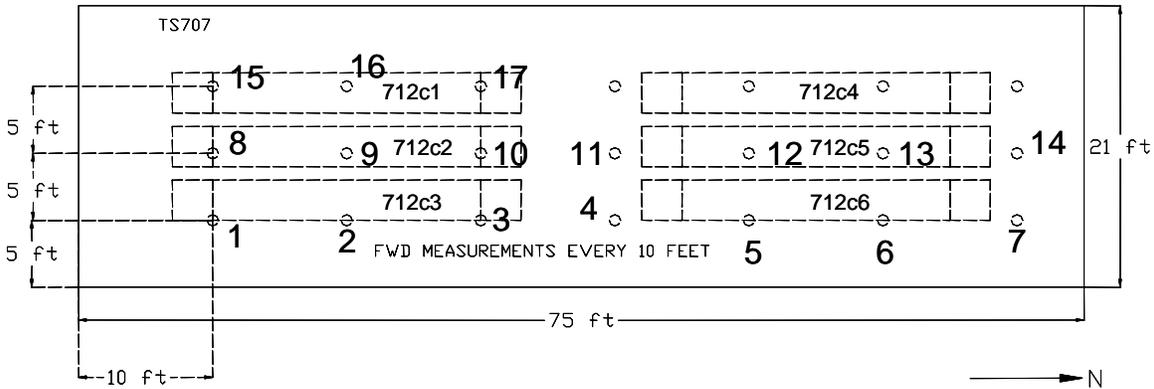
Figure F1. Location of FWD tests in Test Section 712.
