**TPF-5(238)**  
**Design and Fabrication Standards to Eliminate Fracture  
Critical Concerns in Two-Girder Bridge Systems**

Phase 2: Experimental Testing

May 2017

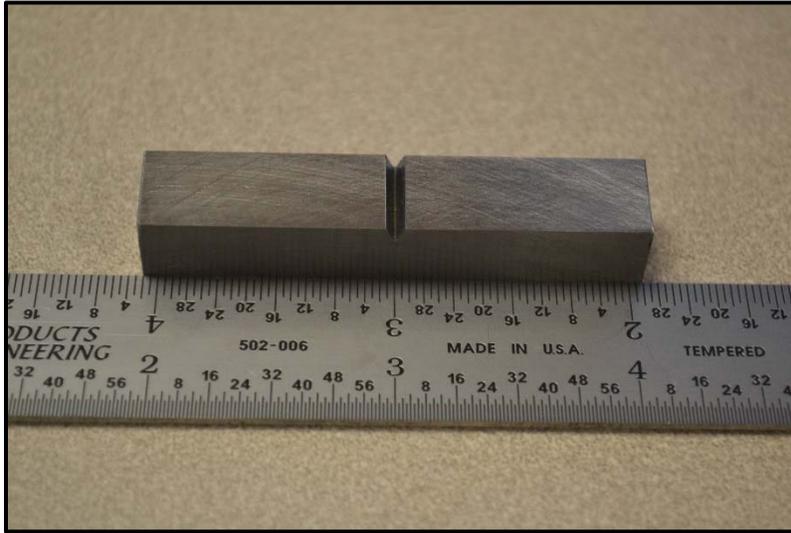
**Figure 3.3: Type A, 10 mm Charpy v-notch impact specimen**

18 CVN specimens machined and tested. Subsequently, 12 additional specimens were tested from Plates E and H as part of a plate variability study. CVN test results can be found in Section 3.10.1.3.

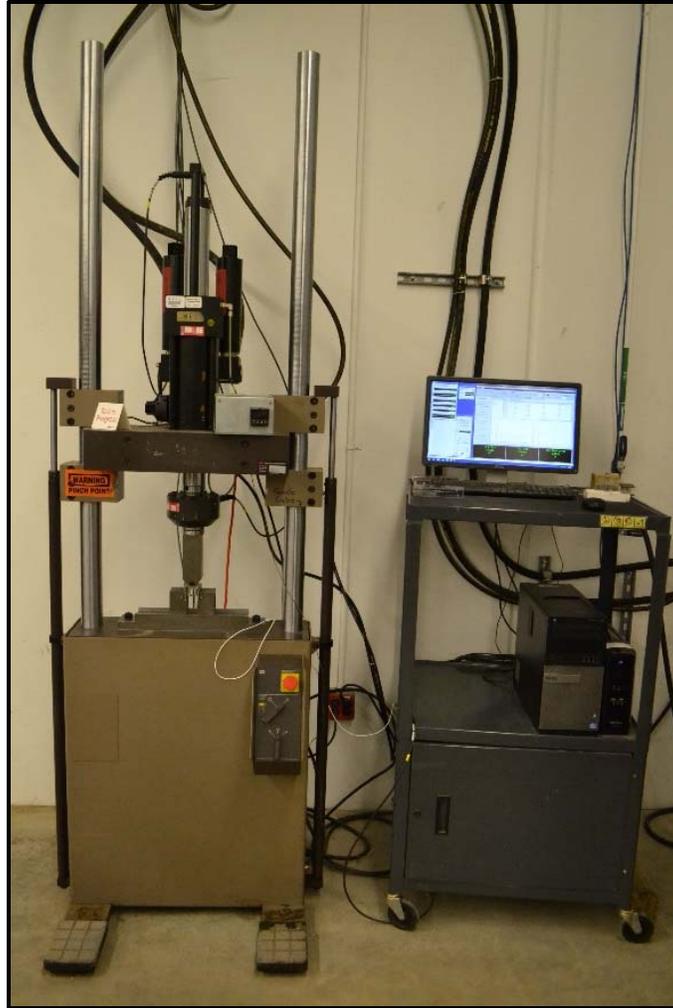
All reference temperature determination precracking and testing was completed in an MTS Model 318.10 load frame with an 11 kip capacity. The load frame was controlled through a FlexTest 60 controller running both MTS Series 793 and TestSuite MP Elite software. TestSuite contains a specialized software package for precracking and fracture toughness testing. A photograph of the load frame setup and controller is shown in Figure 3.7.

**Figure 3.7: MTS Model 318.10 load frame setup**

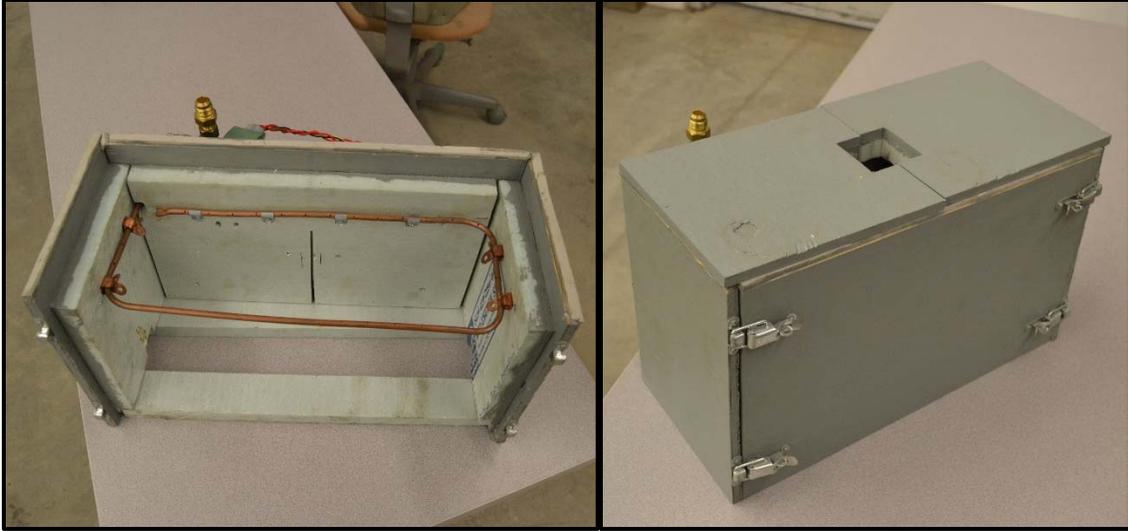
Reference temperature testing requires cleavage-type behavior; therefore, specimens were typically tested at cold temperatures. Specimens were cooled using a temperature chamber and liquid nitrogen. Cooling was controlled through an Asco normally-closed cryogenic solenoid valve, Omega CNi16 series temperature and process controller, and a type T thermocouple placed inside the temperature chamber. ASTM E1820-15a requires specimen temperature to be within  $\pm 5 \text{ }^\circ\text{F}$  for a minimum of 30 minutes for each inch of specimen thickness (ASTM, 2015a). Photographs of the temperature chamber are shown in Figure 3.9. Guidance on selecting an initial test temperature for reference temperature determination testing is described in ASTM E1921-13a (ASTM, 2013b).

**Figure 3.9: Fracture mechanics testing temperature chamber**

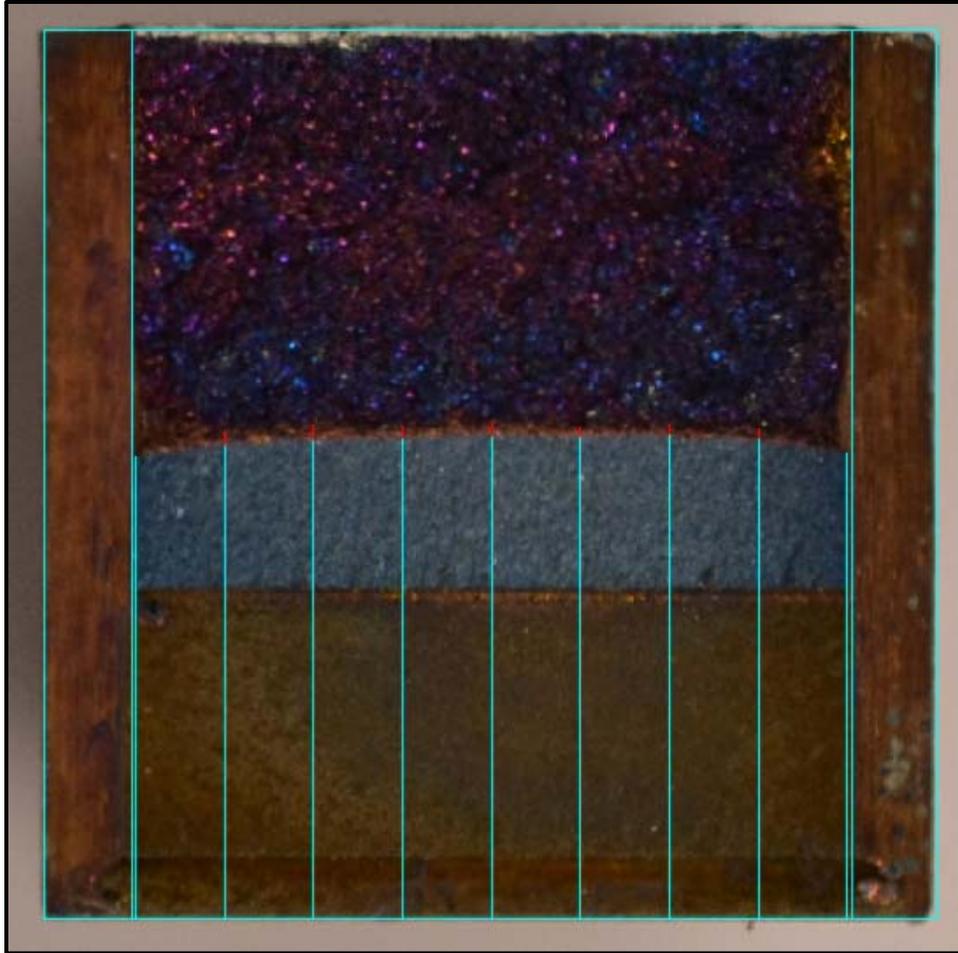
Raw data were extracted after testing each specimen to calculate the elastic-plastic stress intensity factor,  $K_{Ic}$ . Optical crack measurements were also required for each specimen. To facilitate optical measurements, each specimen was heat tinted immediately after testing. The initial fatigue crack length was measured as well as any stable tearing. All measurements were made according to the procedure outlined in ASTM E1921-13a (ASTM, 2013b). Nine equally spaced measurements were recorded. The two near-surface measurements were averaged and then averaged with the remaining seven measurements to calculate the final fatigue crack length. An example optical measurement with the measurement locations can be found in Figure 3.10.

**Figure 3.10: Example optical fatigue crack measurement**

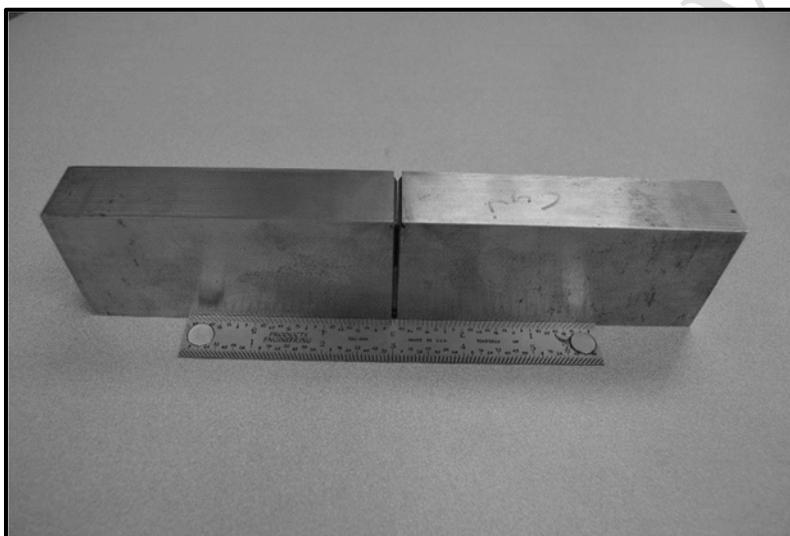
Fracture toughness testing was performed in accordance to ASTM E1820-15a (ASTM, 2015a). Specimens complying with the ASTM recommended single-edge bend specimen geometry were utilized for all testing. Once again, specimen notches were cut using an EDM and 45 degree angle side grooves were cut after precracking. All SE(B) specimen machining was performed by Homestead Machining LLC and Advanced Machining Solutions. General dimensions of the SE(B) specimen were 9.0 in. long by 1.0 in. wide by 2.0 in. tall. Design drawings for the fracture toughness specimen geometry can be found in Appendix A. A photograph of a completed fracture toughness specimen is shown in Figure 3.11.

**Figure 3.11: Fracture toughness specimen**

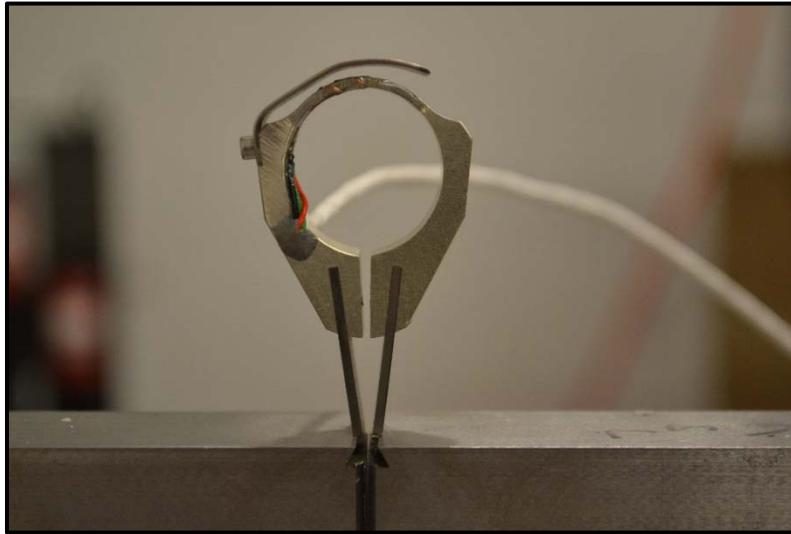
**Figure 3.12: 0.25 in. displacement gage**

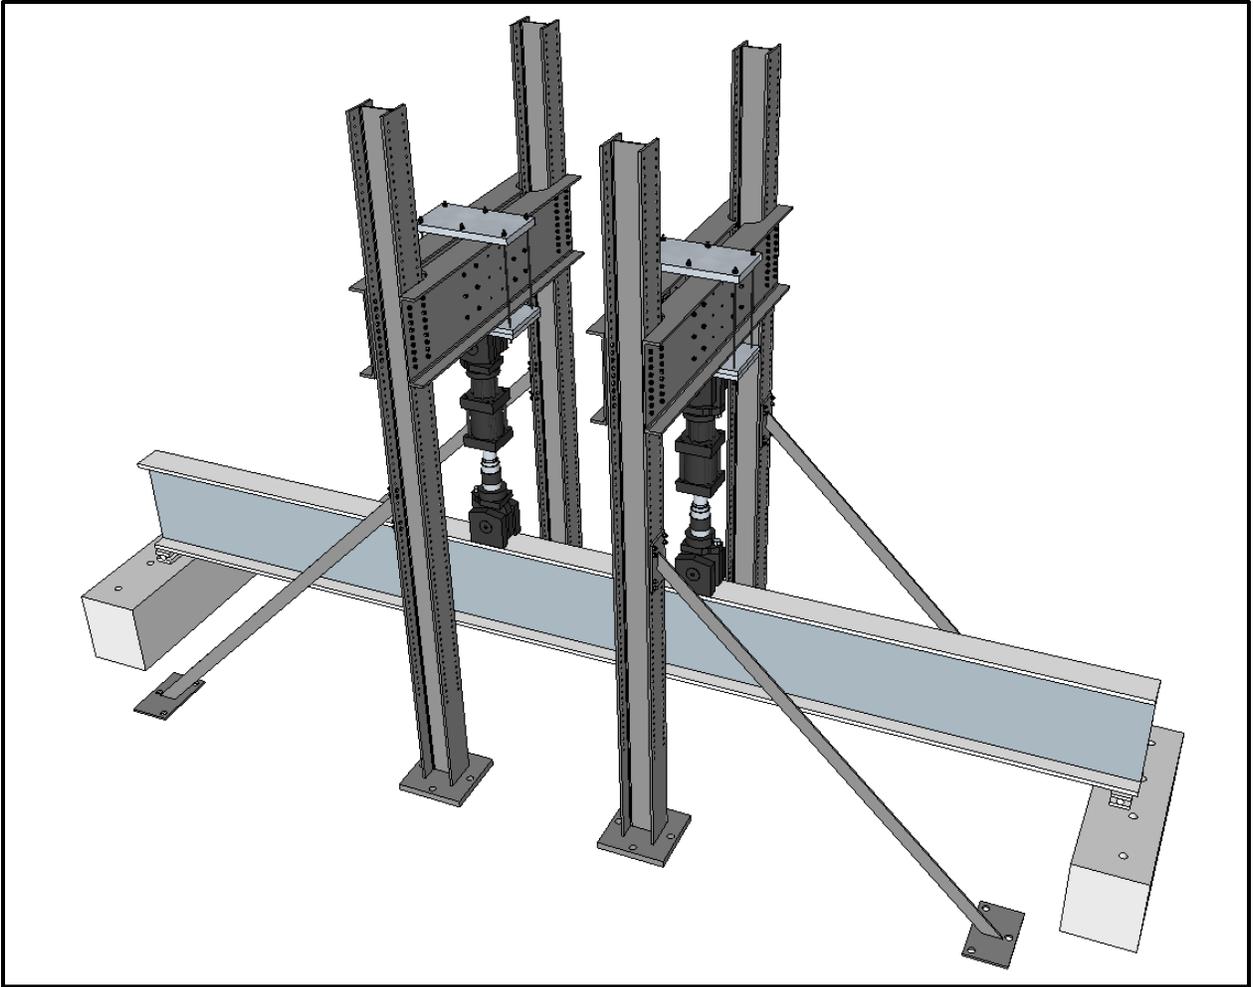
To maximize the potential of the bending specimens, new load frames were designed to utilize the largest pair of servo-hydraulic actuators available at the Bowen Laboratory at Purdue University. A schematic of a bending load frame is shown in Figure 3.15. Two 220 kip MTS 244.51 actuators were spaced at 8 ft. on center to create four point bending. Four point bending results in a constant moment region ideal for fracture testing because the uniform stress state allows the flaw to be placed anywhere within the constant moment region. Additionally, spacing the actuators for the four point bending configuration facilitated installation of a temperature chamber required to cool the specimens to the desired test temperature. Each load frame was braced to prevent lateral movement. All braces and load frames were post-tensioned to the laboratory reaction floor. Twin test setups were designed and fabricated as shown in Figure 3.16.

**Figure 3.15: Schematic view of bending load frame**

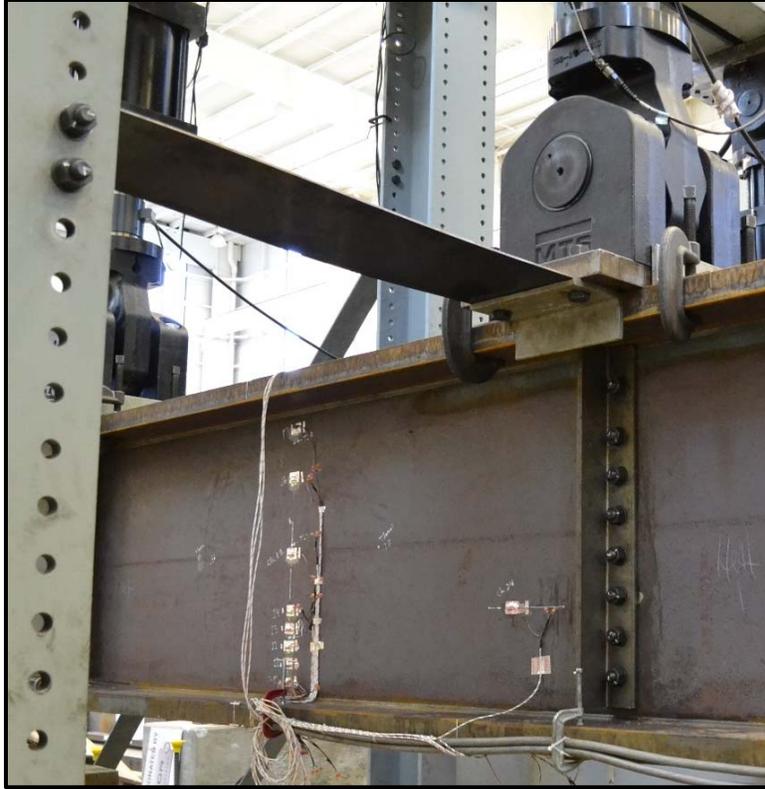
Lateral torsional buckling bracing was located on each side of the top flange at the load points for each bending specimen. The bracing consisted of a 12 in. x 3/16 in. steel plate fastened between the load frame column and the actuator loading plate as shown in Figure 3.19. Lateral forces were resisted through tension in the brace on one side of the specimen, while the brace on the opposite side of the specimen buckled. Due to the plate thickness, the LTB braces provided negligible vertical stiffness and minimally reduced the load from the actuators to the specimen.

**Figure 3.19: Lateral torsional buckling bracing**

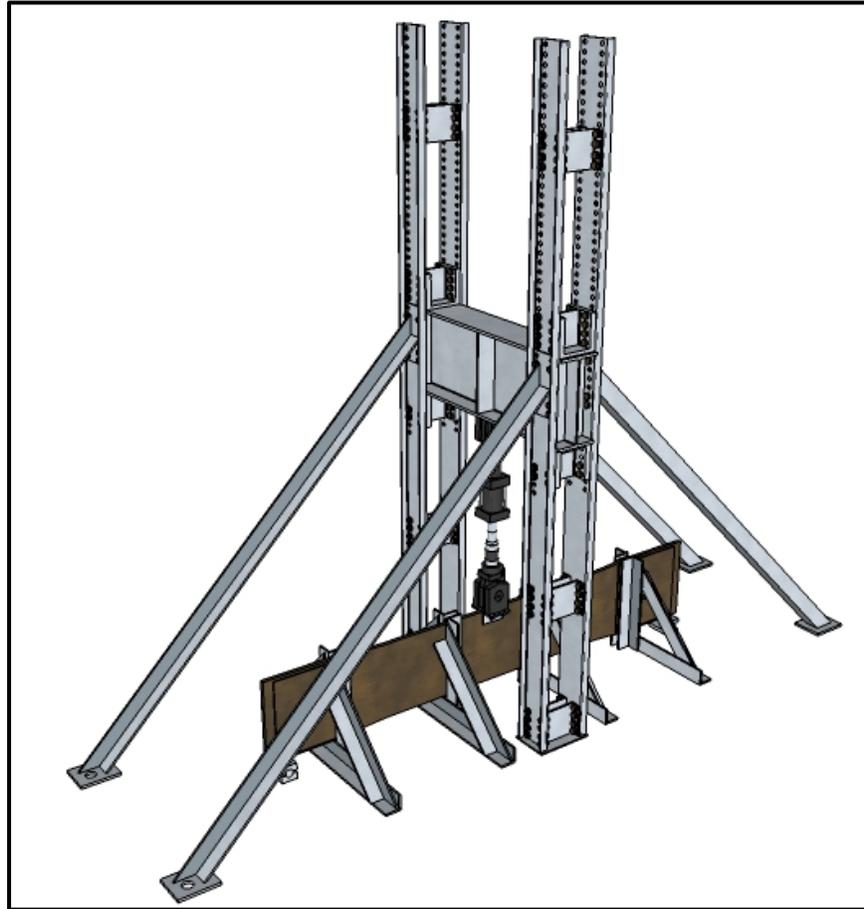
**Figure 3.20: Schematic view of axial test fatigue load frame**

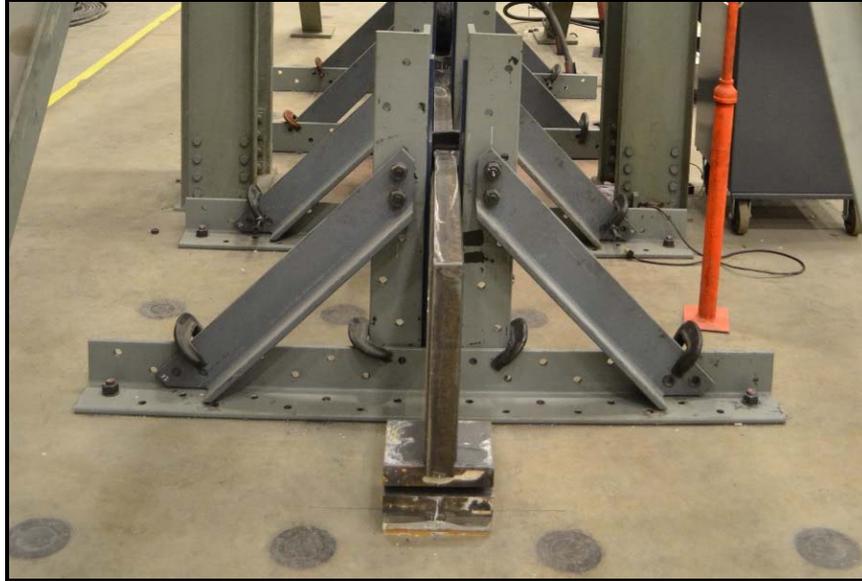
Bracing provided lateral stability during fatigue cycling. Four sets of braces were installed for each axial specimen. A set of braces were placed near each support and two sets of braces were placed near the load point. Braces were constructed from 6 in. x 4 in. x  $\frac{3}{4}$  in. and 6 in. x 6 in. x  $\frac{3}{4}$  in. angles and were connected by high strength bolts and bridge clamps. Using clamps allowed the braces to adapt to a variety of specimen thicknesses. Impact resistant slippery UHMW polyethylene bars were attached to the braces to minimize the load lost to friction. Figure 3.22 is a photograph of a set of lateral bracing.

**Figure 3.22: Axial fatigue test setup lateral bracing**

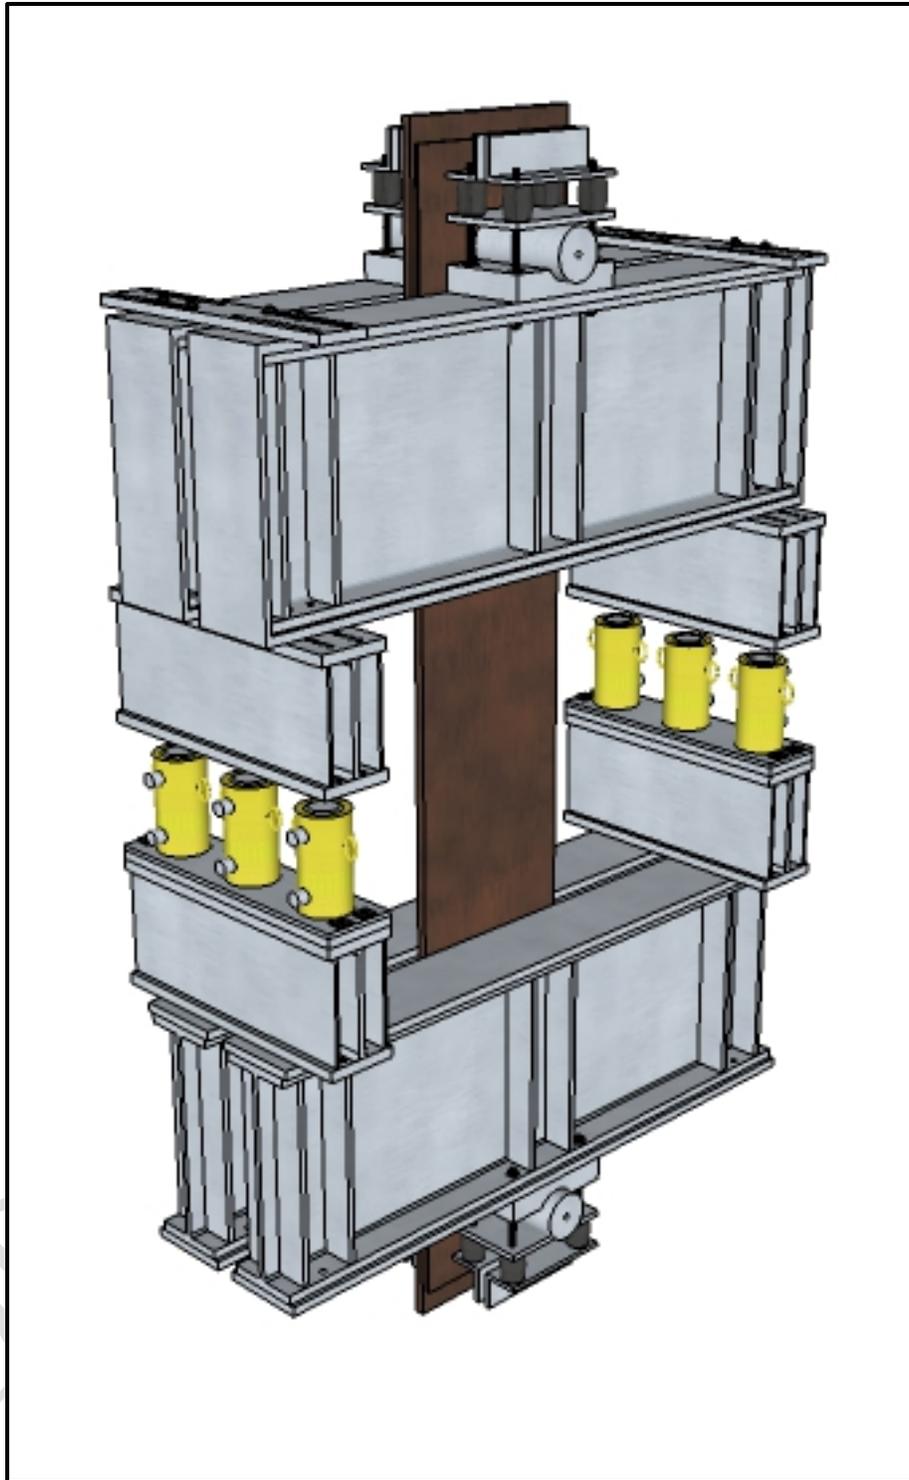
A new load frame was designed and fabricated to evaluate the fracture performance of the axial test specimens. Load was applied through six Enerpac RR-1506 double acting cylinders. The combination of cylinders resulted in a total available force of 1871 kips. The frame was self-reacting and oriented in the vertical position to eliminate any bending effects due to gravity. A schematic of the axial load frame can be found in Figure 3.23. A support frame was built around the axial load frame including four columns, stage beams, and bracing. Figure 3.24 is a photograph of the complete axial fracture test setup.

**Figure 3.23: Schematic view of axial test fracture load frame**

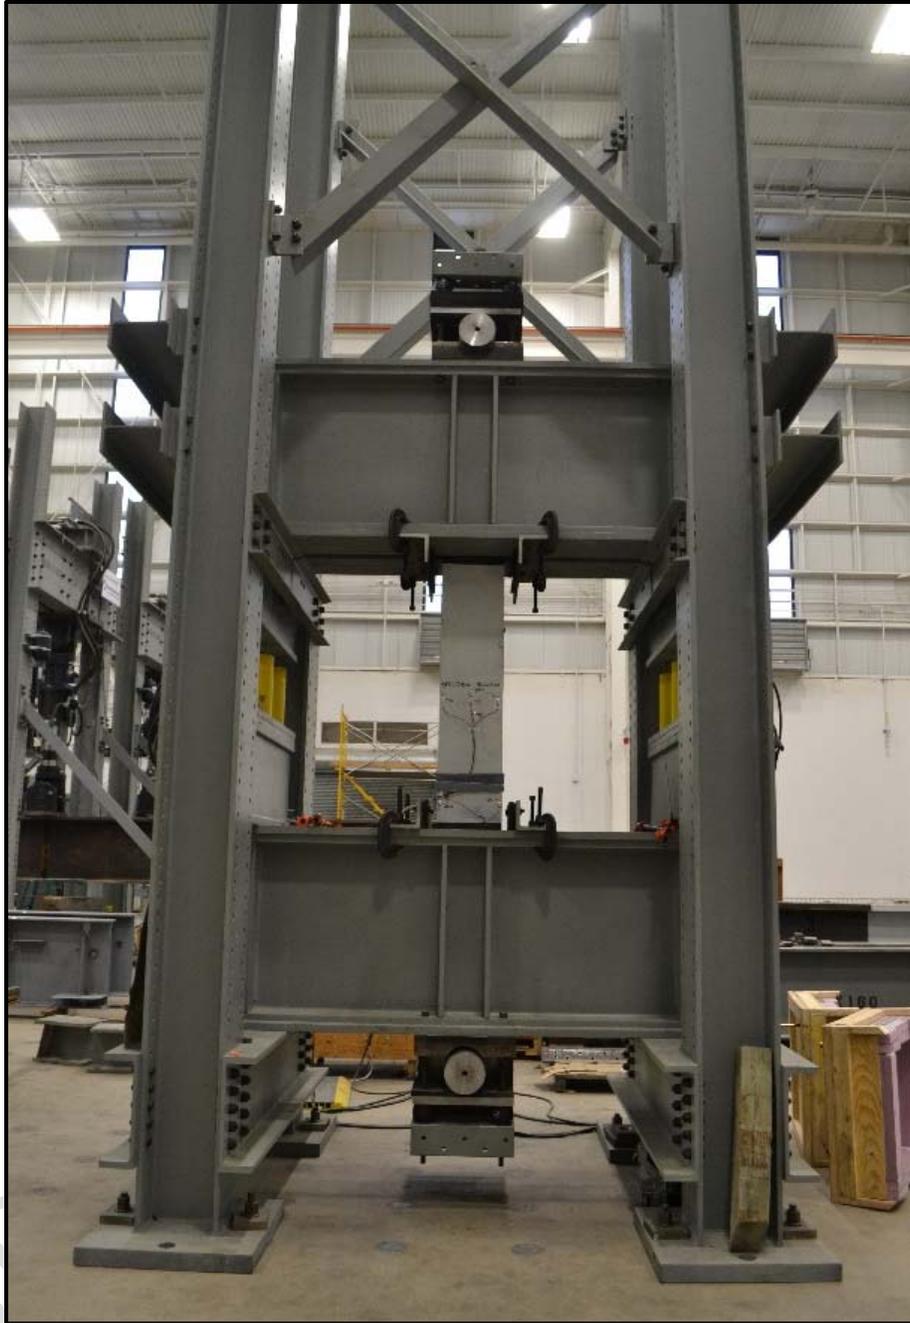
**Figure 3.24: Axial test fracture setup**

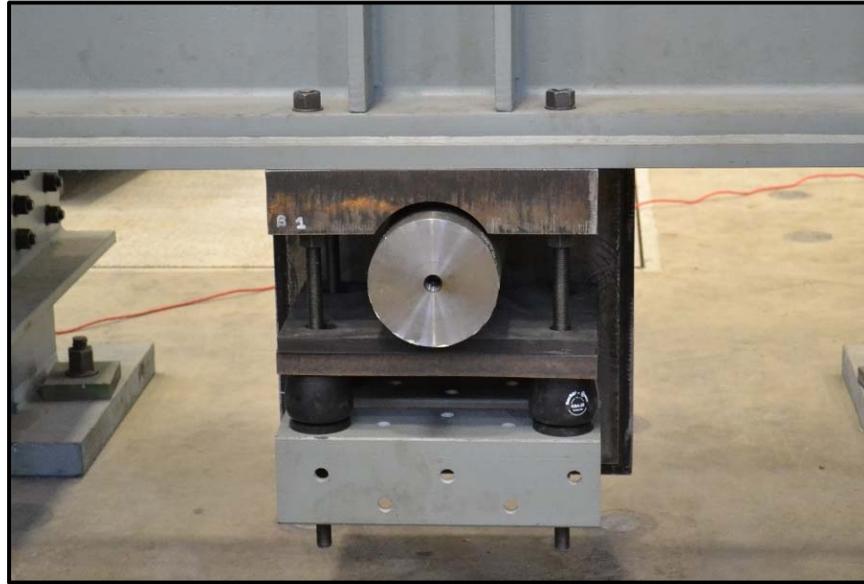
in Geneva, IL were also installed at each bearing location. The bumpers dissipated the energy released at fracture. Two of the bumper are also shown in Figure 3.25.

**Figure 3.25: Axial load frame pin connection**

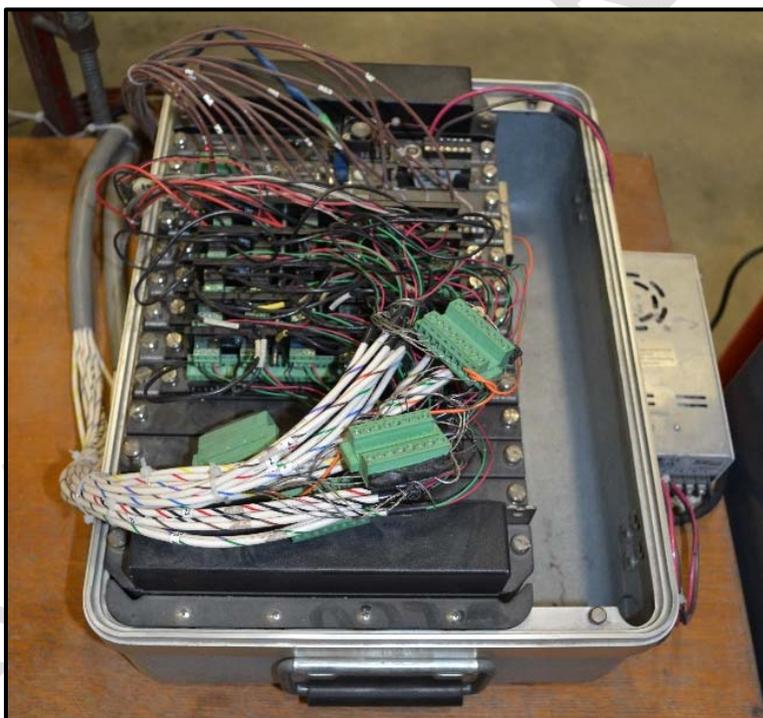
For the axial experiments, two different data logger card configurations were utilized. When temperature data were collected the data logger was configured with a single CR9050 module and two CR9052 modules. Whereas, if no temperature data were required, only two CR9052 modules were employed. Strain and pressure data were collected at a frequency of 100 Hz for all fracture experiments. When collected, temperature data were measured at a frequency of 1 Hz.

**Figure 3.29: CR9000X data logger**

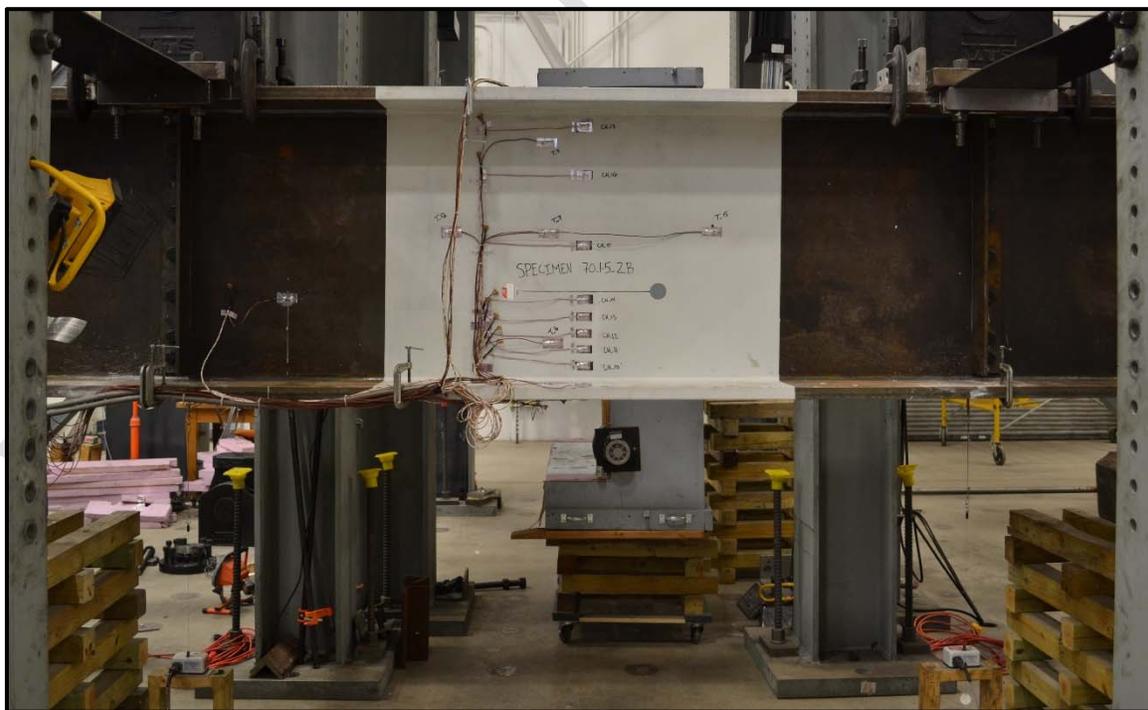
A total of 24 strain gages were installed for all bending test specimens. Strain gages were focused at two beam cross-sections. The primary cross-section was located at the notch location and was referred to as the “cracked section”. The cracked section corresponded to the midpoint of the span. Located 36 in. away from the cracked section was the second strain gage cross-section referred to as the “loading section”. A distance of 36 in. was used to ensure a portion of the strain gages were located outside the temperature chamber but still inside the constant moment region. The cracked section accounted for 20 strain gages and the remaining 4 strain gages were located at the loading section. All bending specimen strain gage locations can be found in the instrumentation plans located in Appendix B. An example bending specimen instrumentation layout is presented in Figure 3.30

**Figure 3.30: Example bending specimen instrumentation layout**

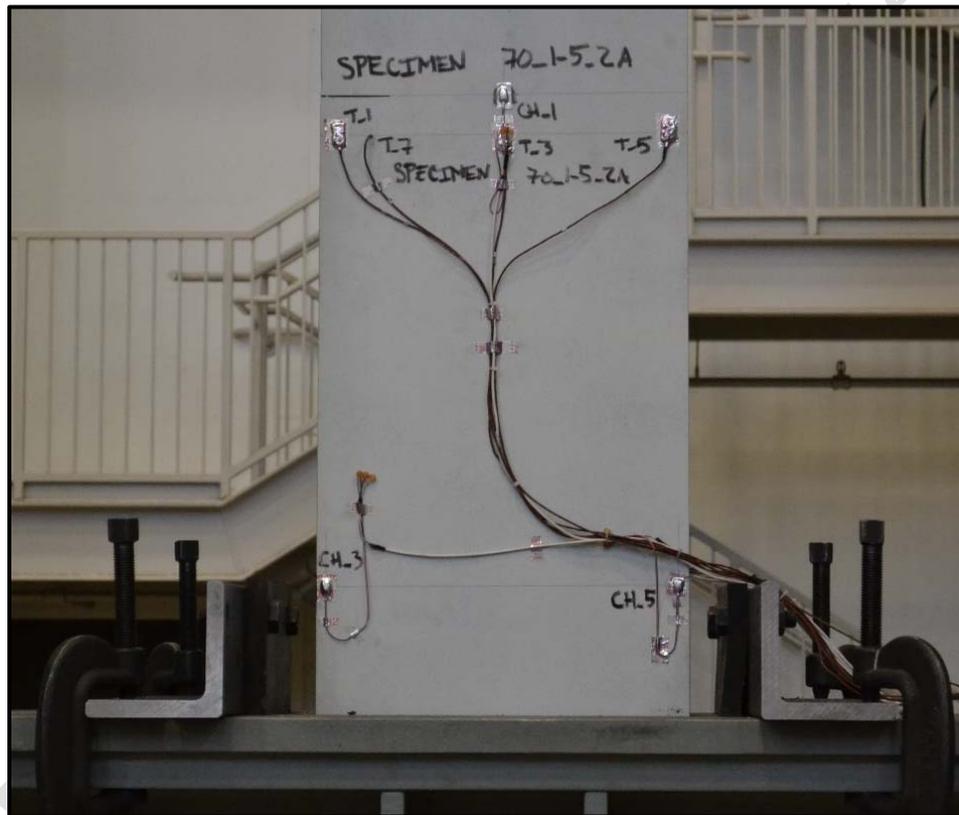
A total of six strain gages were installed on all axial test specimens. Strain gages were focused at two cross-sections. The first cross-section was located at the notch location. Two strain gages were installed at the notched cross-section at the specimen centerline. A second cross-section with four strain gages was located 24 in. below the notched cross-section. Four strain gages were utilized to account for in-plane and out-of-plane bending of the specimen and were located outside the temperature chamber. All axial specimen strain gage locations can be found in the instrumentation plans located in Appendix D. An example axial specimen instrumentation layout is presented in Figure 3.31.

**Figure 3.31: Example axial specimen instrumentation layout**

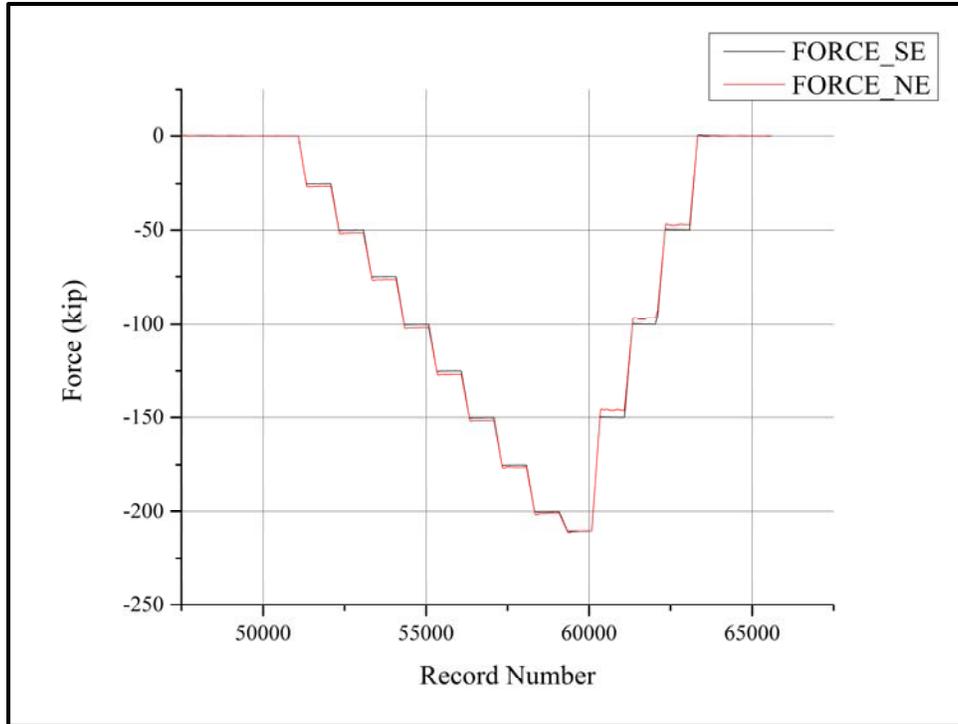
The bending load frames allowed for the entire test sequence to be performed in a single test frame. Prior to notching, static load tests were performed on the bending test specimens. Static tests provided baseline data as well as provided an opportunity to ensure the beam and test setup were performing as expected. Load was applied in steps of 25 kips per actuator up to the target fracture load. A minimum of three static tests were performed to confirm data consistency. Typically, data were recorded at a rate of 50 Hz during the static tests. A representative static load sequence can be found in Figure 3.35 with the resulting longitudinal stresses presented in Figure 3.36.

Figure 3.35: Representative static test load

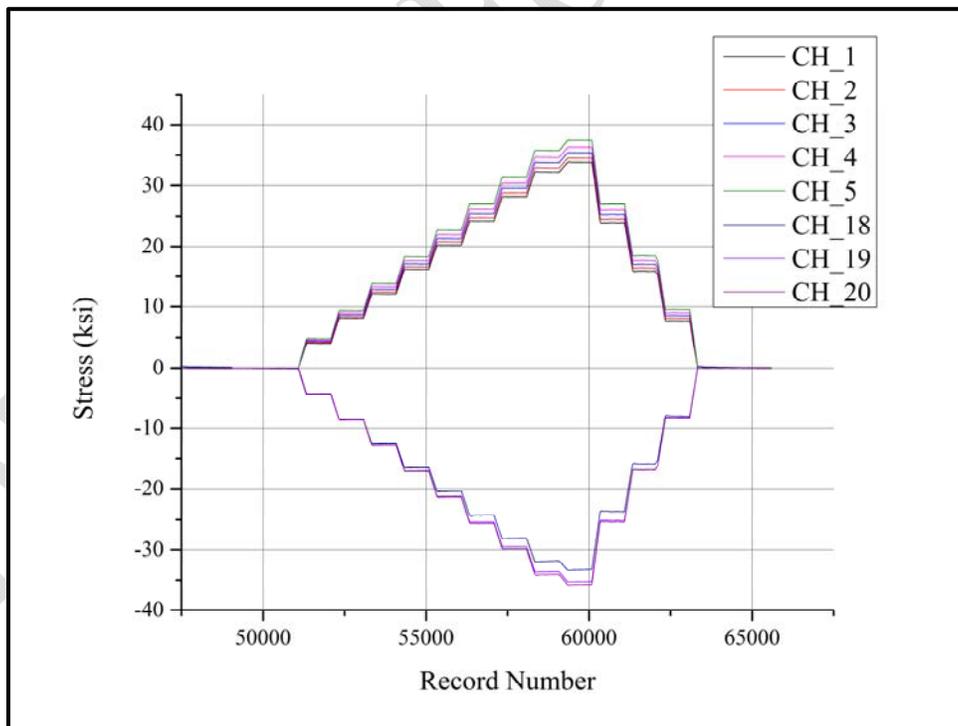
Figure 3.36: Representative static test longitudinal stress

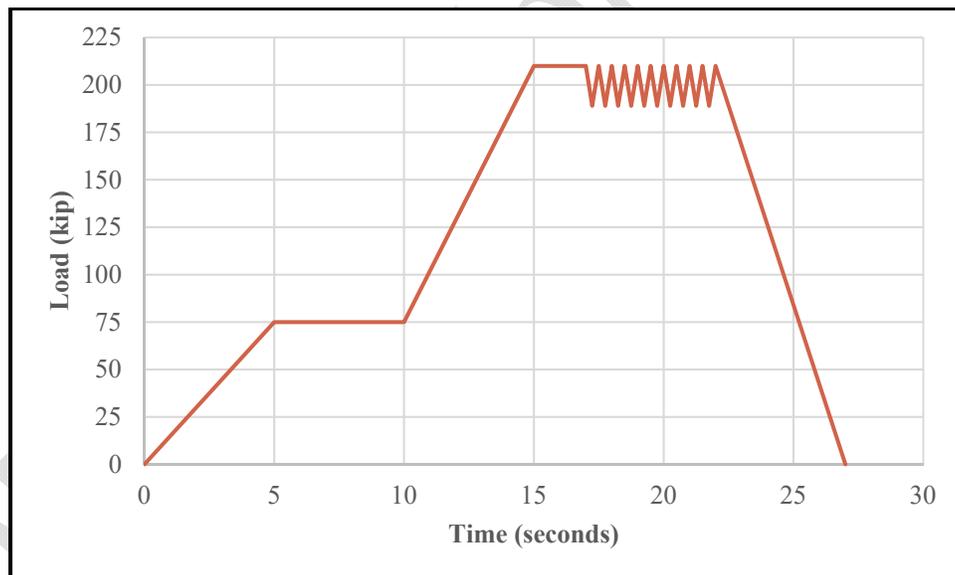
The fracture test process began by removing the temperature chamber. High definition and high speed cameras were positioned to record the fracture event. Loading was applied in three phases. The first phase provided a simulated dead load corresponding to the peak cyclic force. Dead load was applied over a period of 5 seconds. A dwell command was used to hold this load for a few seconds. The second phase applied the target load of  $0.75F_y$ . Exact peak loads will be detailed in the discussion of each test specimen. Early experiments applied the fracture load in 0.1 seconds. Later tests applied the fracture load over 5 seconds to ensure a uniform loading from the pair of actuators. If the beam did not fracture initially, the load was then held for 2 seconds followed by 10 cycles between 90% and 100% of the fracture load. Cycling at the fracture load was intended to simulate additional vibrations corresponding to a load crossing a bridge in real-world conditions. At the completion of cycling the load was removed. A similar test process was employed by Wright during his initial large-scale fracture experiments on HPS I-girders (Wright, 2003). Data were recorded at 10,000 Hz during the entire fracture test sequence. Figure 3.37 is an example of the loading sequence during a fracture test.

**Figure 3.37: Example fracture loading sequence**

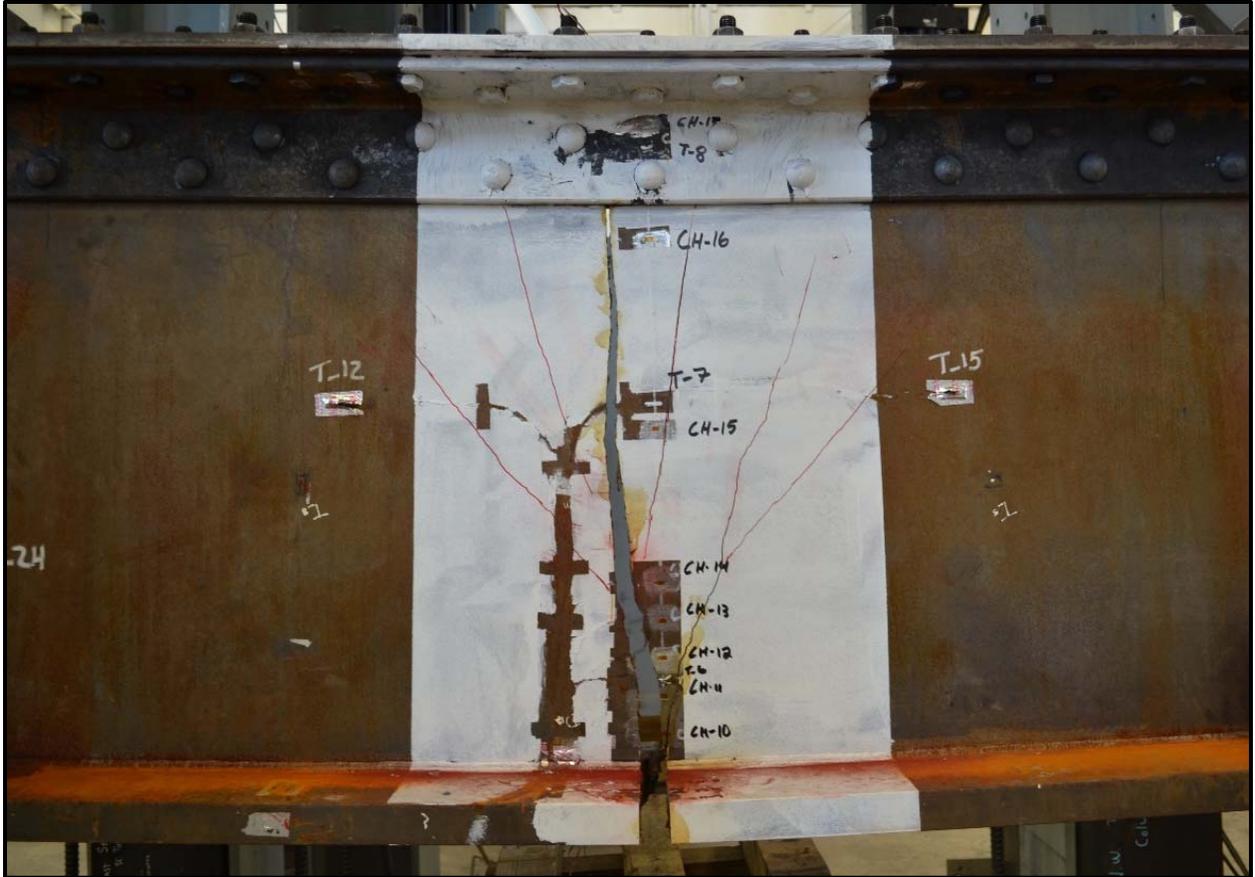
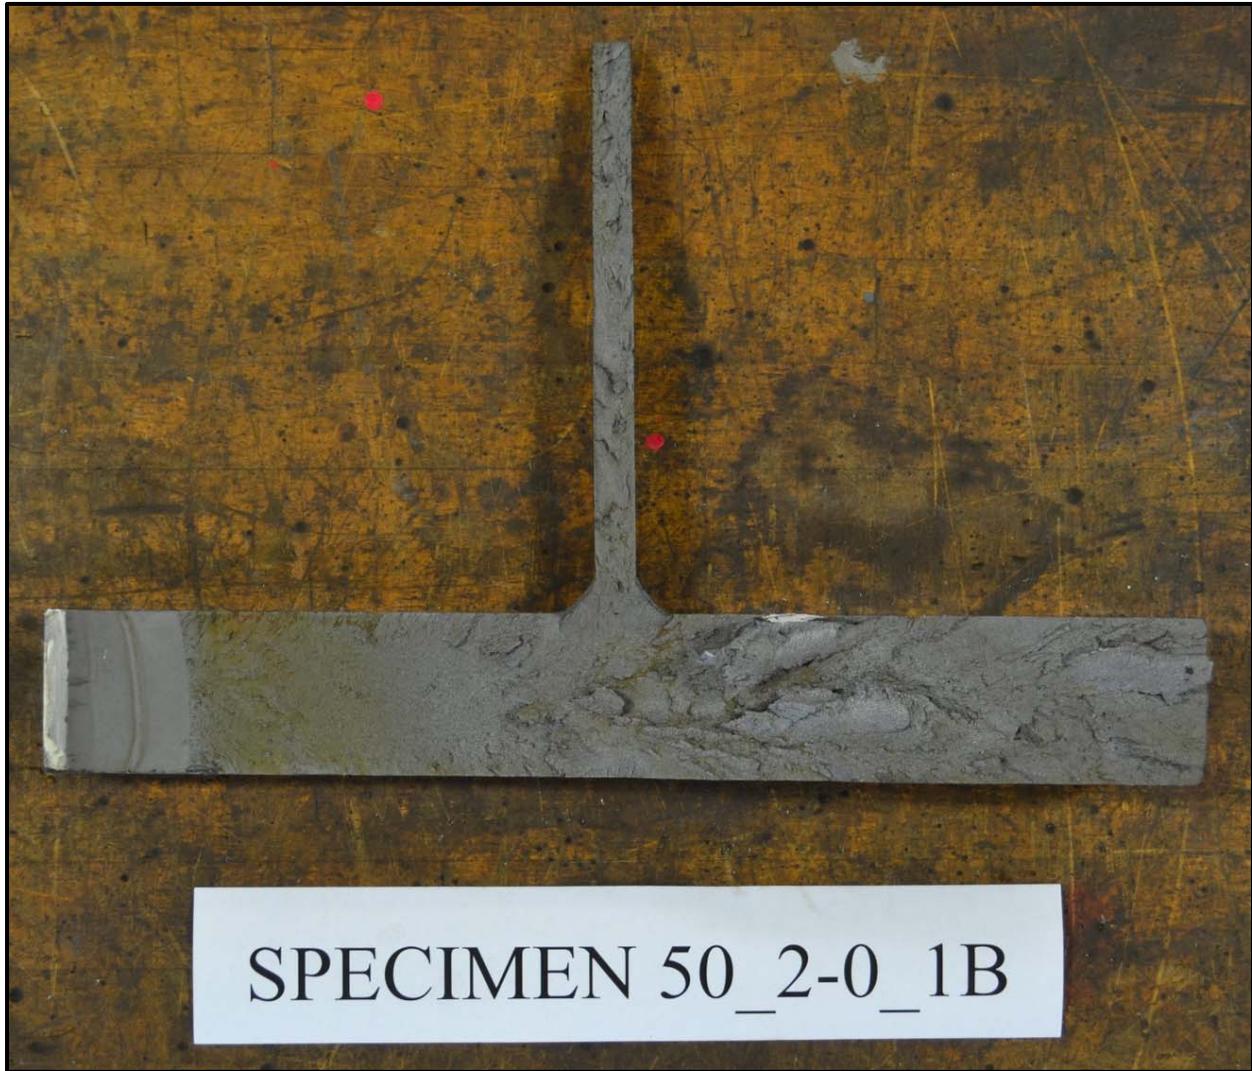
Specimen 50\_2-0\_1B was the first large-scale specimen tested. The bottom flange was notched to 0.25 in. with an angle grinder. A fatigue crack was grown to a length of 0.5 in. and a fracture test was performed. The test did not result in a fracture. At a length of 1.0 in. a second fracture test was performed and no fracture resulted. The crack was extended to 1.6875 in. and tested a third time resulting in a fracture of the bottom flange and web. The fracture arrested after severing the web and did not jump into the built-up components of the compression flange. An average actuator load of 149.2 kips was recorded at the time of fracture resulting in a bottom flange longitudinal stress of 26.3 ksi. A general photograph of Specimen 50\_2-0\_1B taken after fracture can be found in Figure 3.38. Figure 3.39 is a photograph of the fracture surface from Specimen 50\_2-0\_1B.

Figure 3.38: Specimen 50\_2-0\_1B

**Figure 3.39: Specimen 50\_2-0\_1B fracture surface**

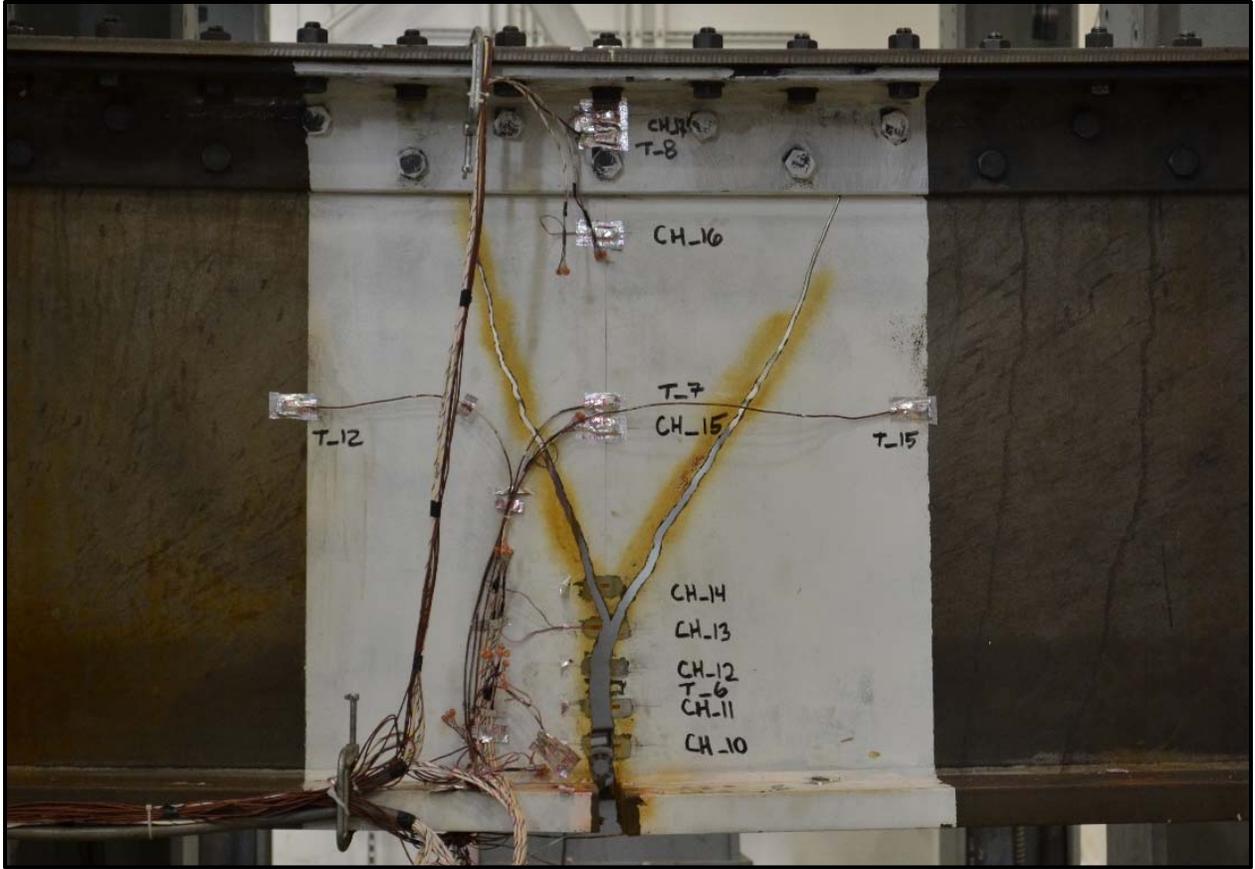
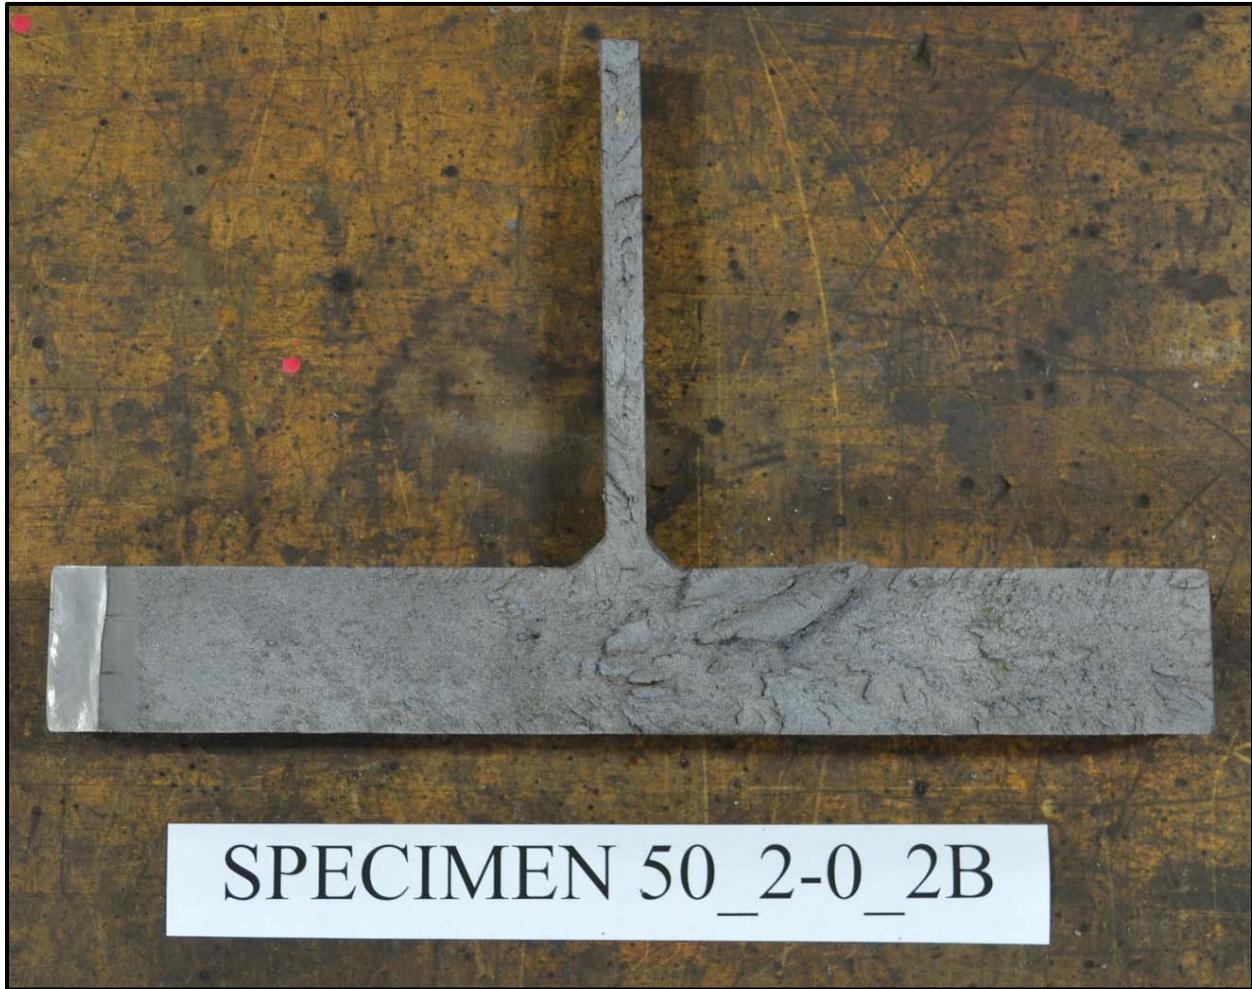
Specimen 50\_2-0\_2B was initially notched to 0.625 in. with an angle grinder. A fatigue crack was grown to 1.0625 in. and a fracture test was performed. The fracture test resulted in complete fracture of the tension flange as well as the web. The fracture did not jump to any of the built-up components of the compression flange. At fracture, the average actuator load was 128.6 kips. The calculated bottom flange stress was 22.6 ksi. A general photograph of Specimen 50\_2-0\_2B taken after fracture can be found in Figure 3.40. Figure 3.41 is a photograph of the fracture surface from Specimen 50\_2-0\_2B.

**Figure 3.40: Specimen 50\_2-0\_2B**

**Figure 3.41: Specimen 50\_2-0\_2B fracture surface**
