**TPF-5(238)**  
**Design and Fabrication Standards to Eliminate Fracture  
Critical Concerns in Two-Girder Bridge Systems**

Phase 2: Experimental Testing

May 2017

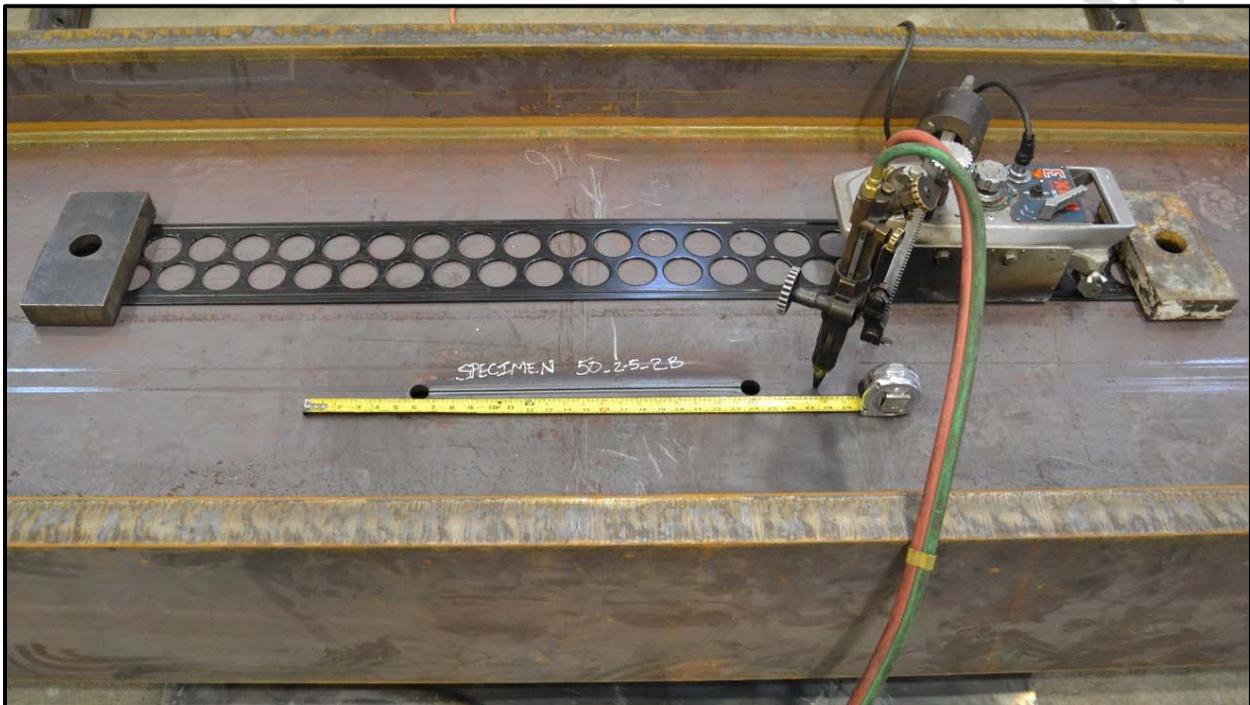
To prevent a fracture from completely severing the test specimen into two pieces, fracture arrest details were added to the 50\_2-5\_B specimens. The detail was known as a ‘dog-bone’. A dog-bone detail consisted of a pair of holes connected by a through-thickness cut. The holes in the 50\_2-5\_B specimens were 1.0625 in. in diameter and drilled with a magnetic drill. Center-to-center hole spacing was 18 in. The slot connecting the two holes was cut with an oxy-acetylene track torch resulting in a width of approximately 0.125 in. Figure 3.42 is a photograph of an example dog-bone fracture arrest detail.

**Figure 3.42: Example dog-bone fracture arrest detail**

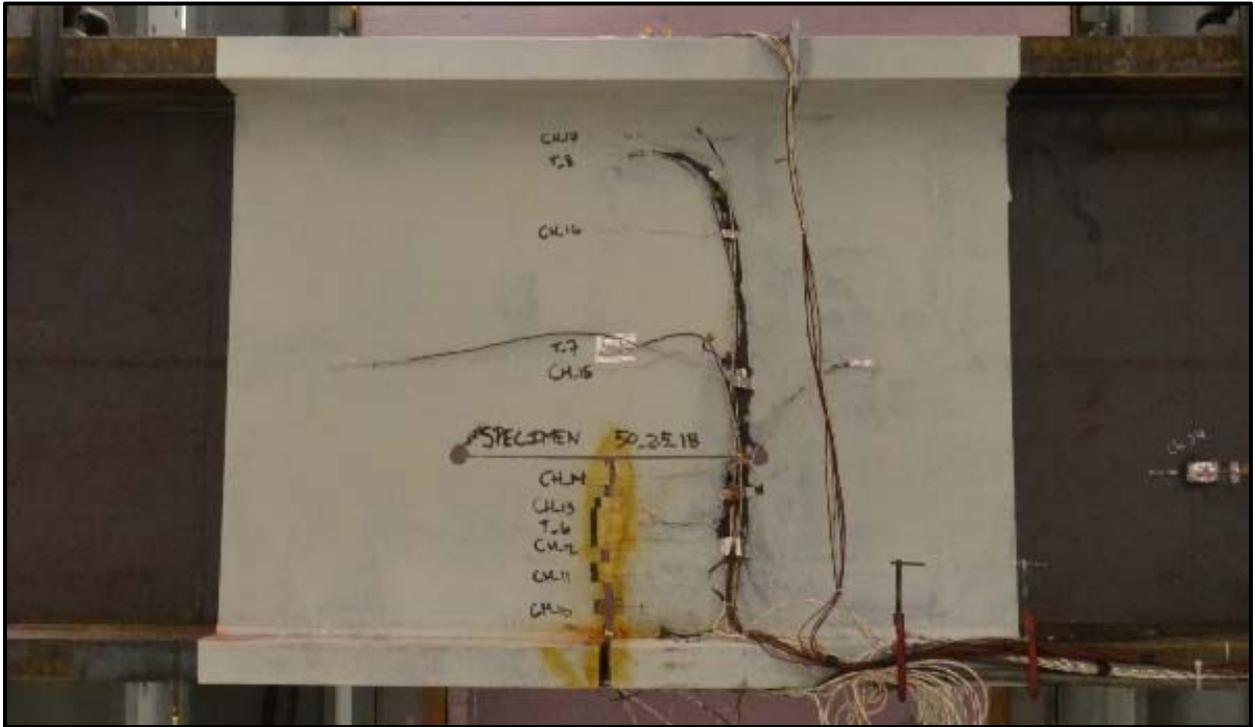
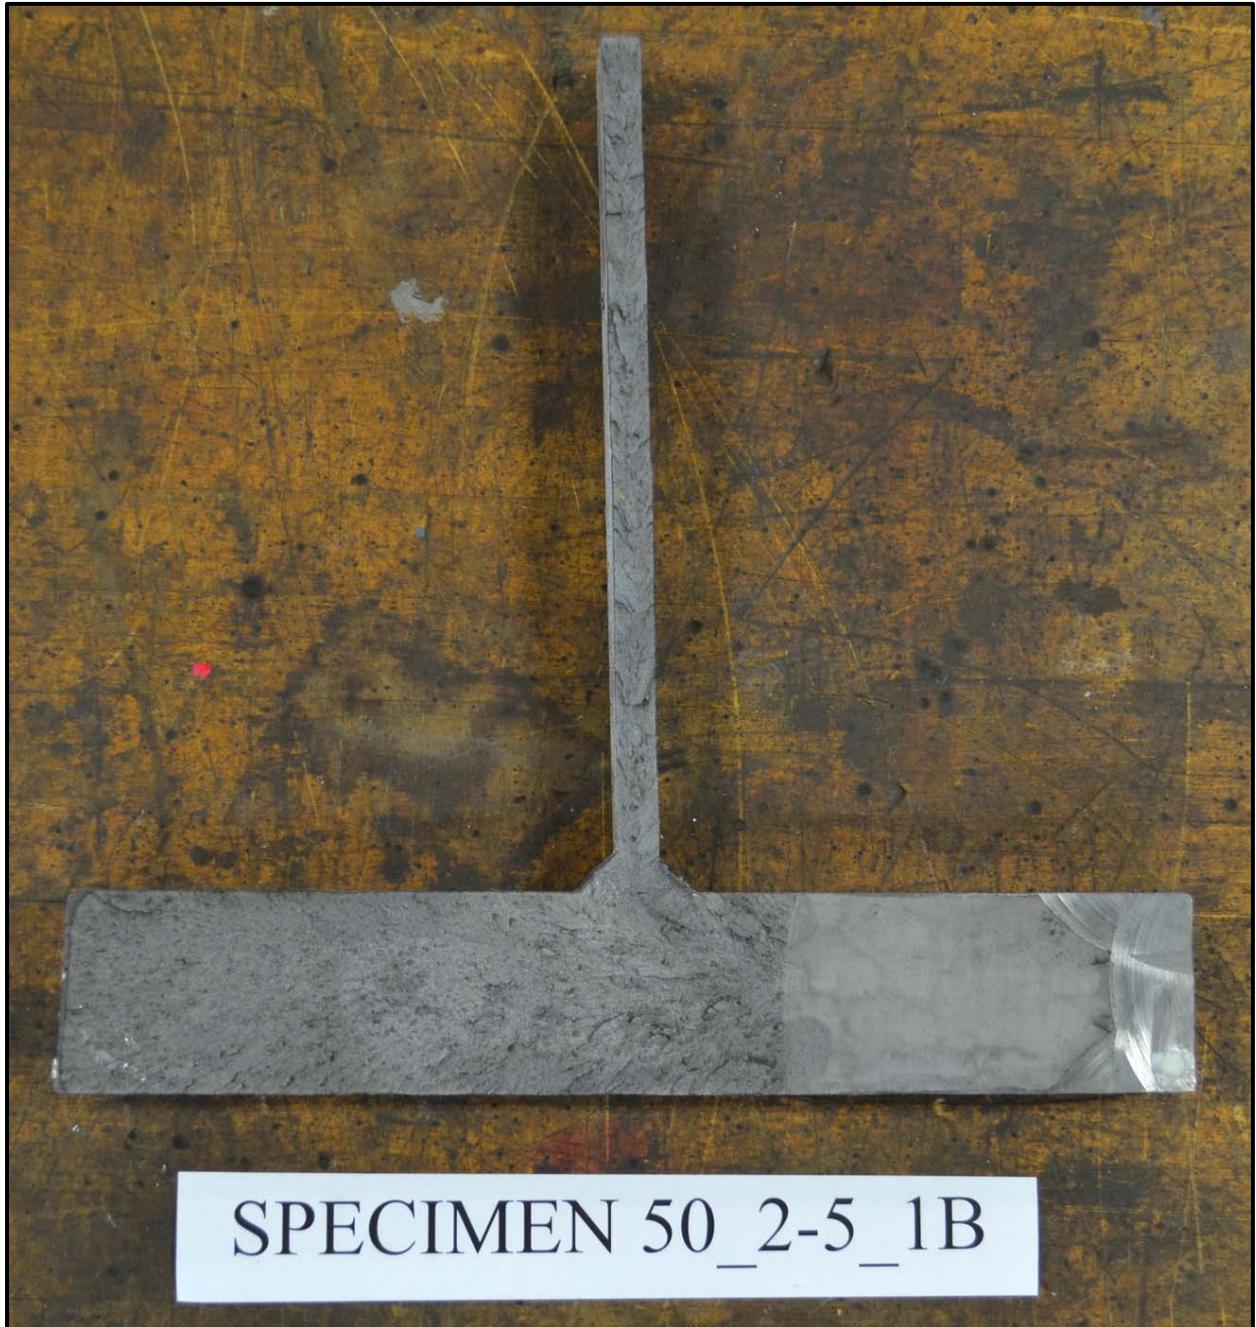
specimen fracture was prevented by the dog-bone detail. A general photograph of Specimen 50\_2-5\_1B taken after fracture can be found in Figure 3.43. Figure 3.44 is a photograph of the fracture surface from Specimen 50\_2-5\_1B.

**Figure 3.43: Specimen 50\_2-5\_1B**

**Figure 3.44: Specimen 50\_2-5\_1B fracture surface**

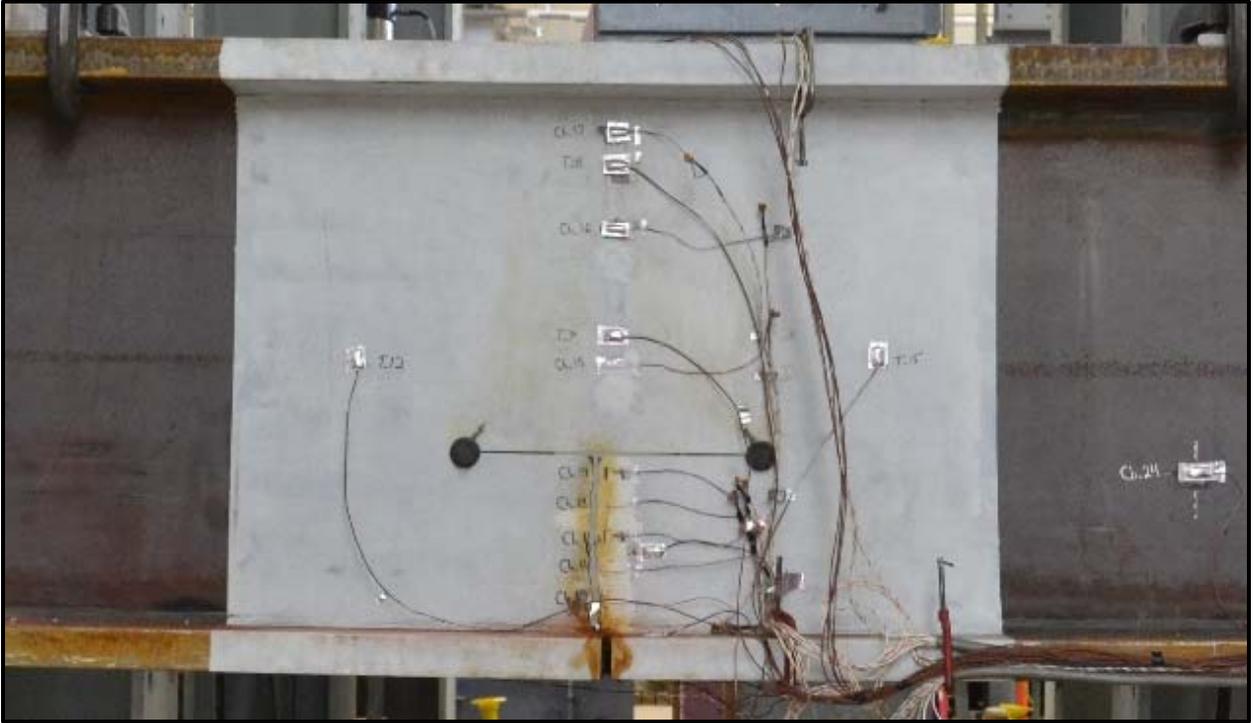
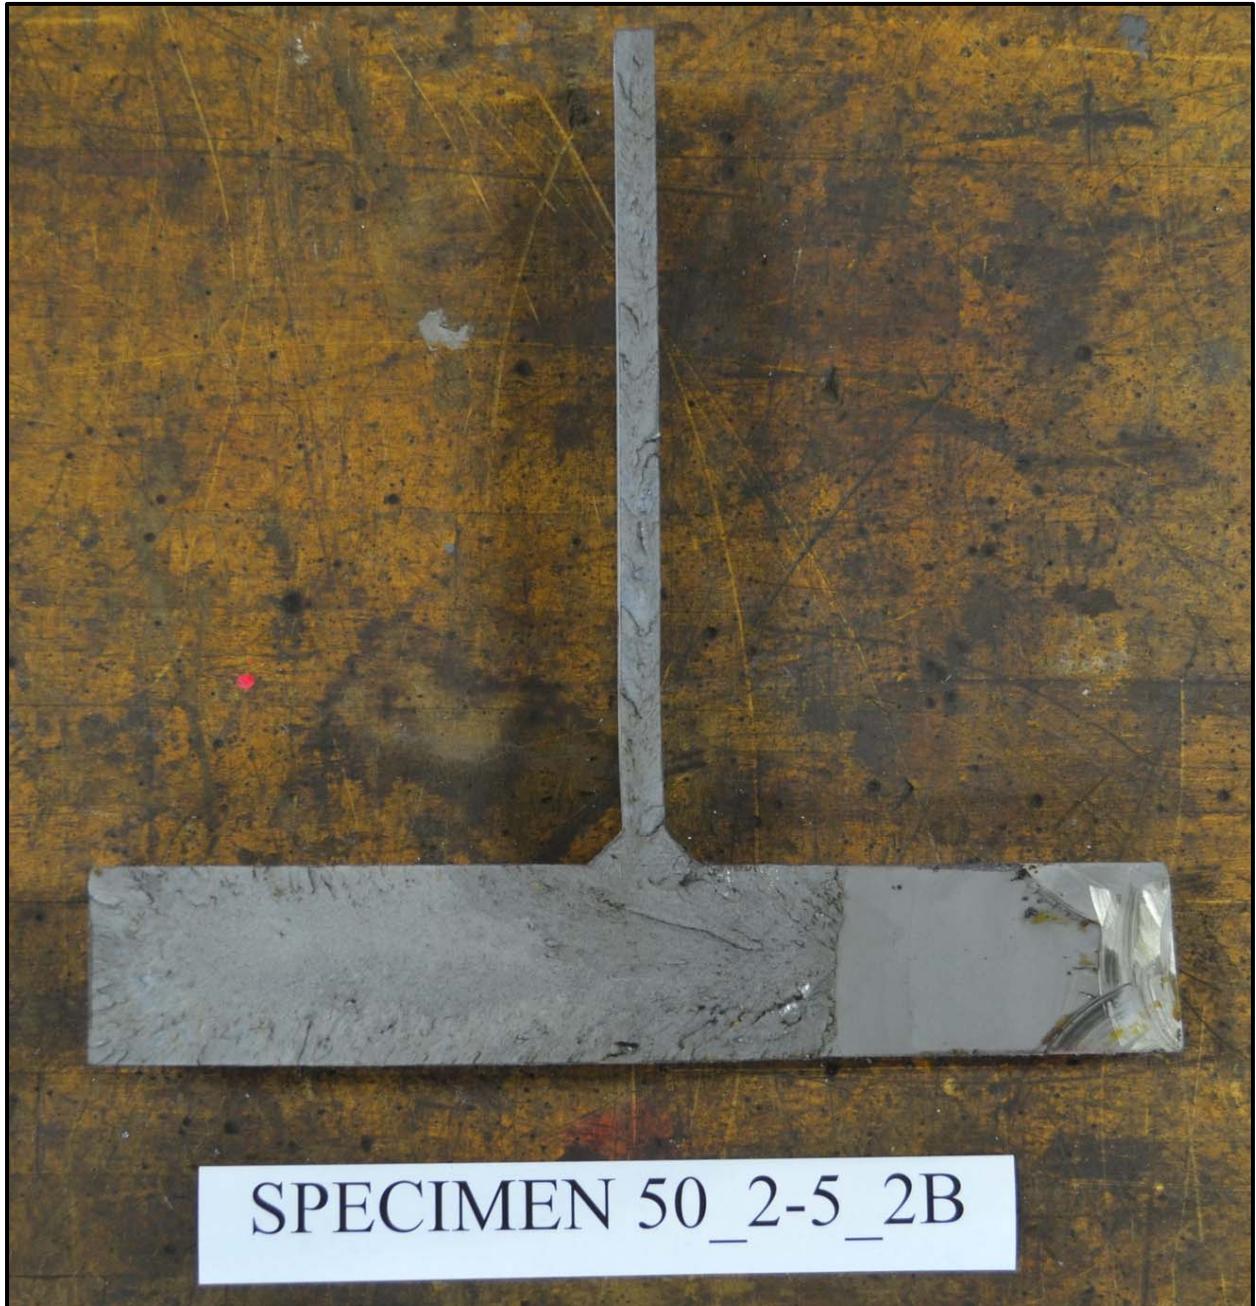
arrested by the detail. At fracture, the average actuator load was 163.3 kips. The resulting bottom flange stress was 29.2 ksi. A general photograph of Specimen 50\_2-5\_2B taken after fracture can be found in Figure 3.45. Figure 3.46 is a photograph of the fracture surface from Specimen 50\_2-5\_2B.

**Figure 3.45: Specimen 50\_2-5\_2B**

**Figure 3.46: Specimen 50\_2-5\_2B fracture surface**

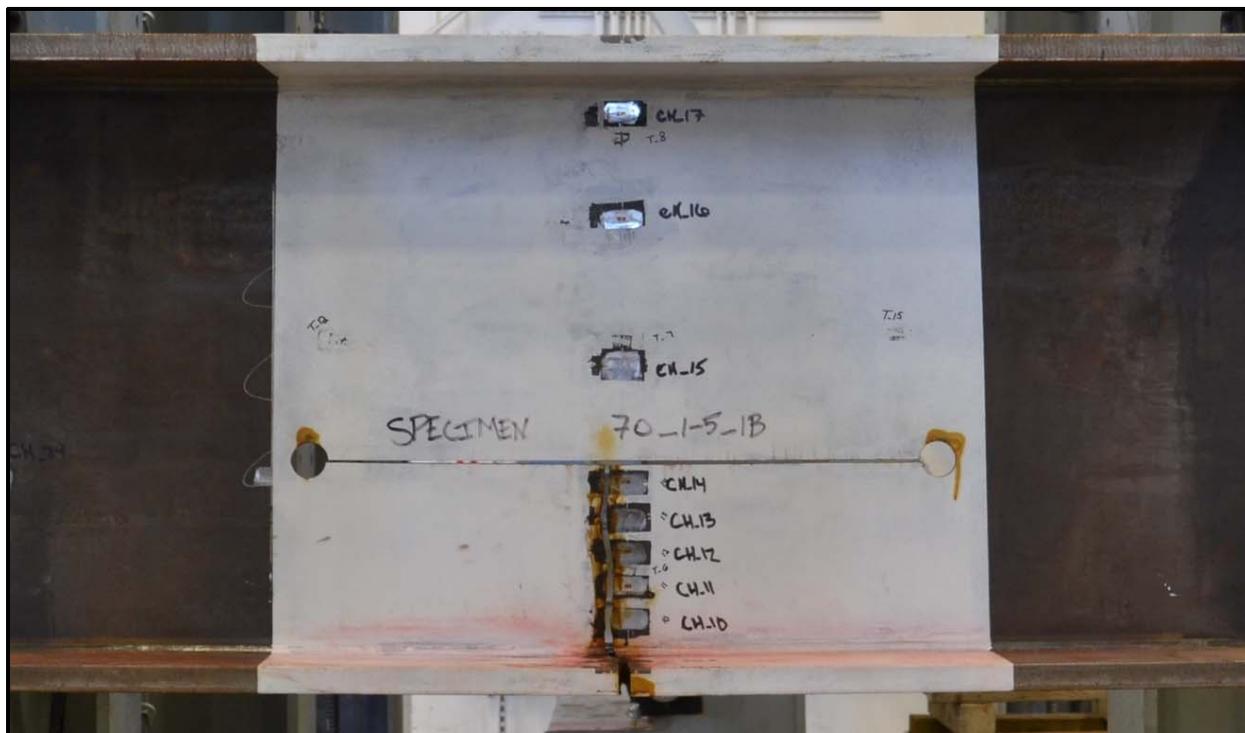
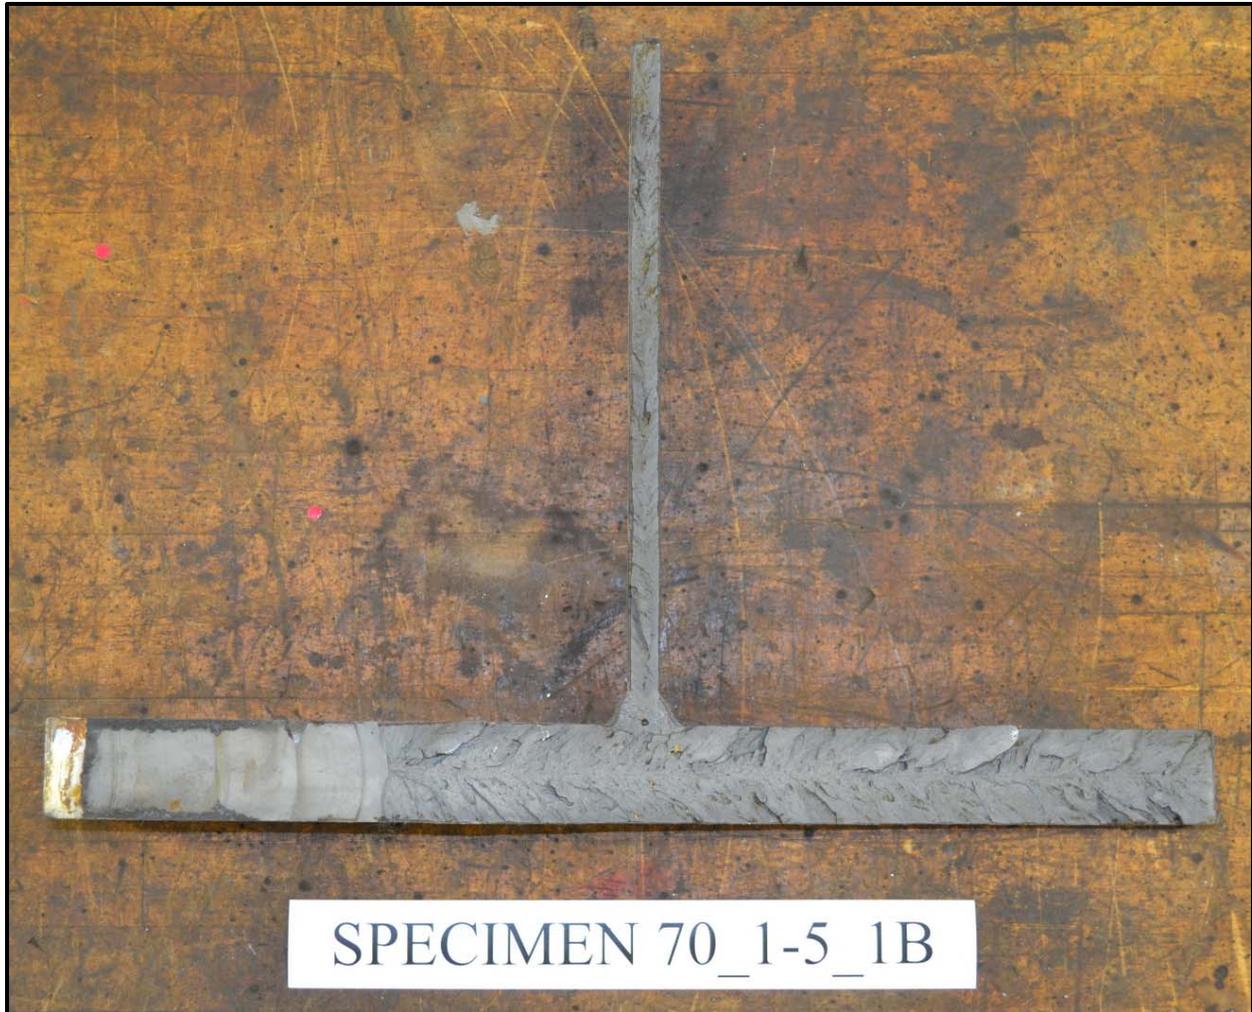
Specimen 70\_1-5\_1B was notched with a 0.625 in. through-thickness straight notch. The center-to-center hole spacing of the dog-bone detail was 36 in. for Specimen 70\_1-5\_1B. Unsuccessful fracture attempts were made at fatigue crack lengths of 1.0 in., 2.5 in., and 3.625 in. Specimen 70\_1-5\_1B fractured at a fatigue crack length of 5.0625 in. The average actuator load was 160.4 kips at fracture. The resulting bottom flange stress was 40.4 ksi. Complete specimen fracture was prevented by the dog-bone detail. A general photograph of Specimen 70\_1-5\_1B taken after fracture can be found in Figure 3.47. Figure 3.48 is a photograph of the fracture surface from Specimen 70\_1-5\_1B.

Figure 3.47: Specimen 70\_1-5\_1B

**Figure 3.48: Specimen 70\_1-5\_1B fracture surface**

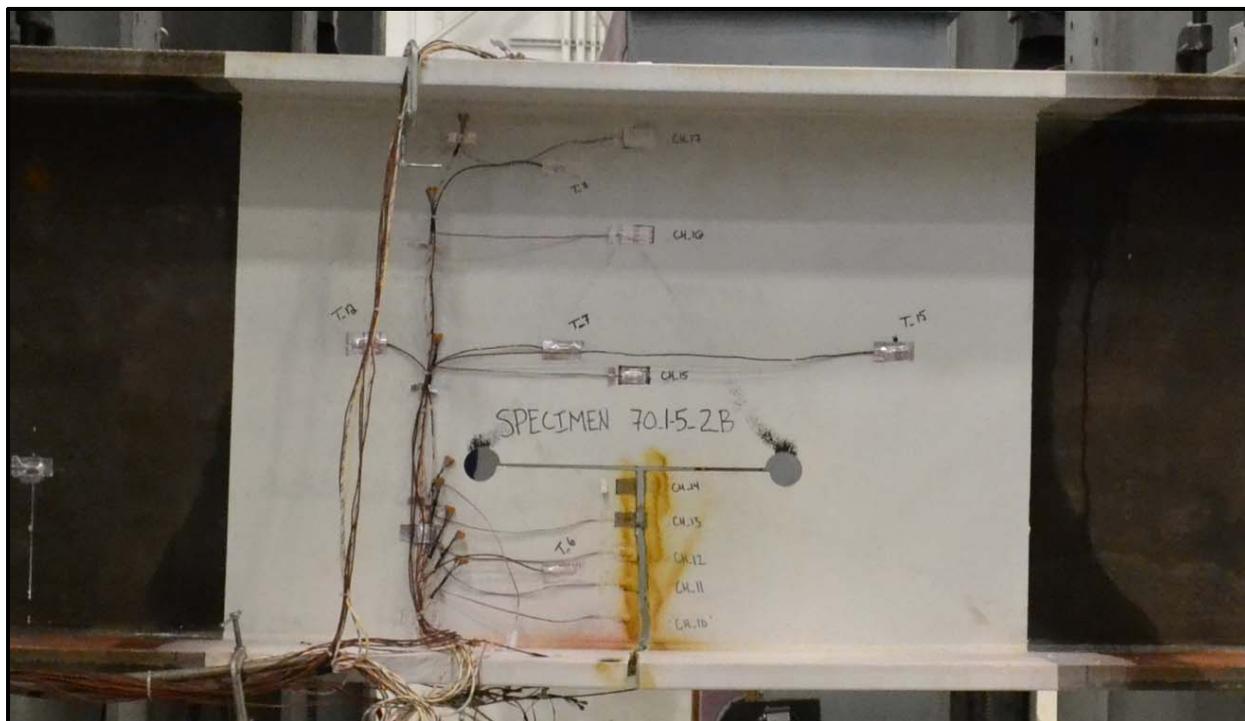
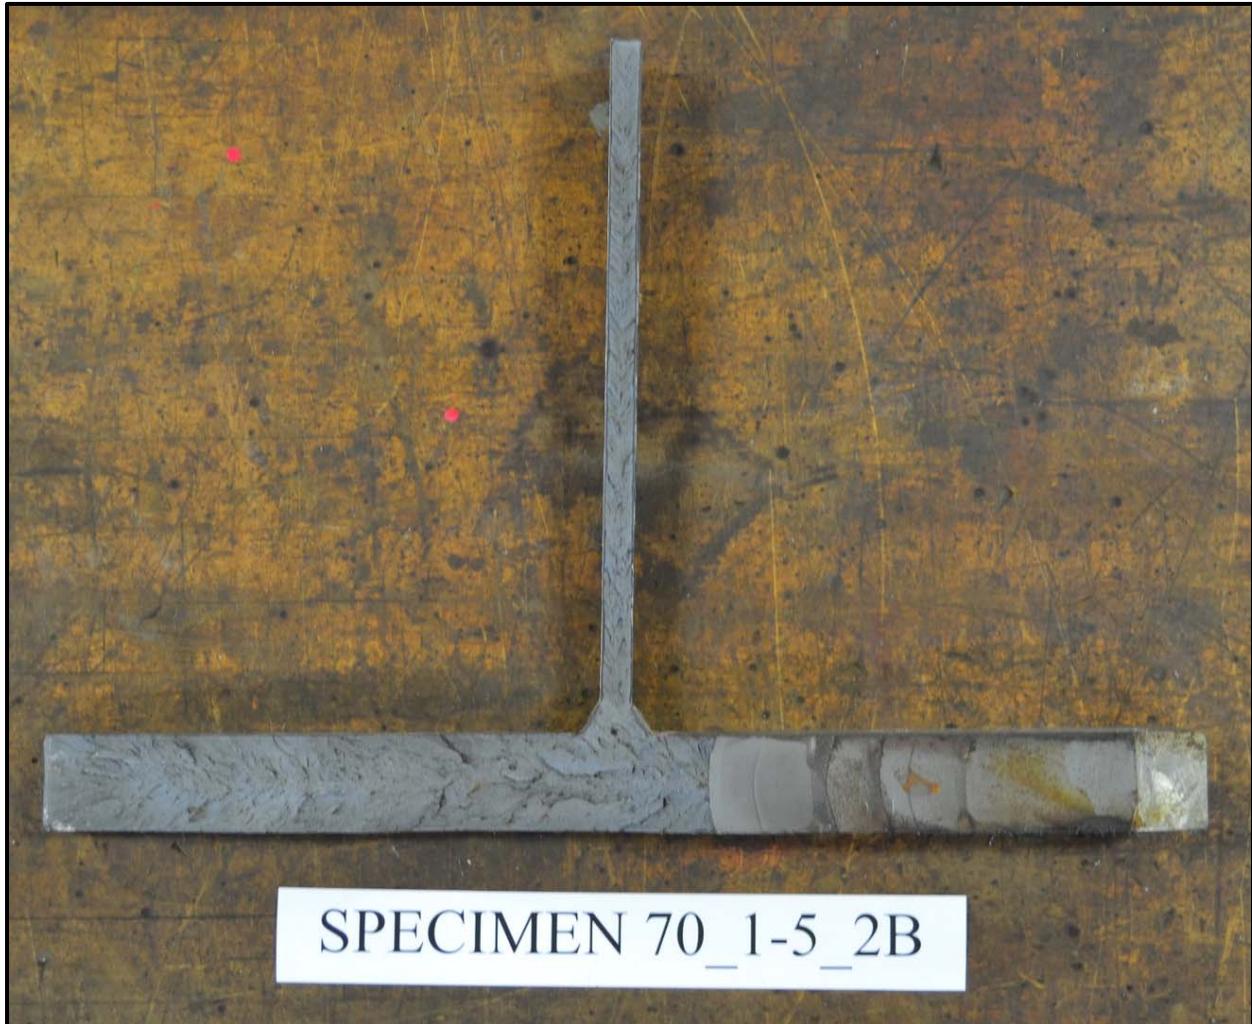
Specimen 70\_1-5\_2B was notched with a 1.125 in. through-thickness straight notch. The center-to-center hole spacing of the dog-bone detail was 18 in. for Specimen 70\_1-5\_2B. Unsuccessful fracture attempts were made at fatigue crack lengths of 3.625 in., 5.0 in., and 5.75 in. Specimen 70\_1-5\_2B fractured at a fatigue crack length of 7.5 in. The average actuator load was 164.6 kips at fracture. The resulting bottom flange stress was 41.5 ksi. Complete specimen fracture was prevented by the dog-bone detail. A general photograph of Specimen 70\_1-5\_2B taken after fracture can be found in Figure 3.49. Figure 3.50 is a photograph of the fracture surface from Specimen 70\_1-5\_2B.

**Figure 3.49: Specimen 70\_1-5\_2B**

**Figure 3.50: Specimen 70\_1-5\_2B fracture surface**

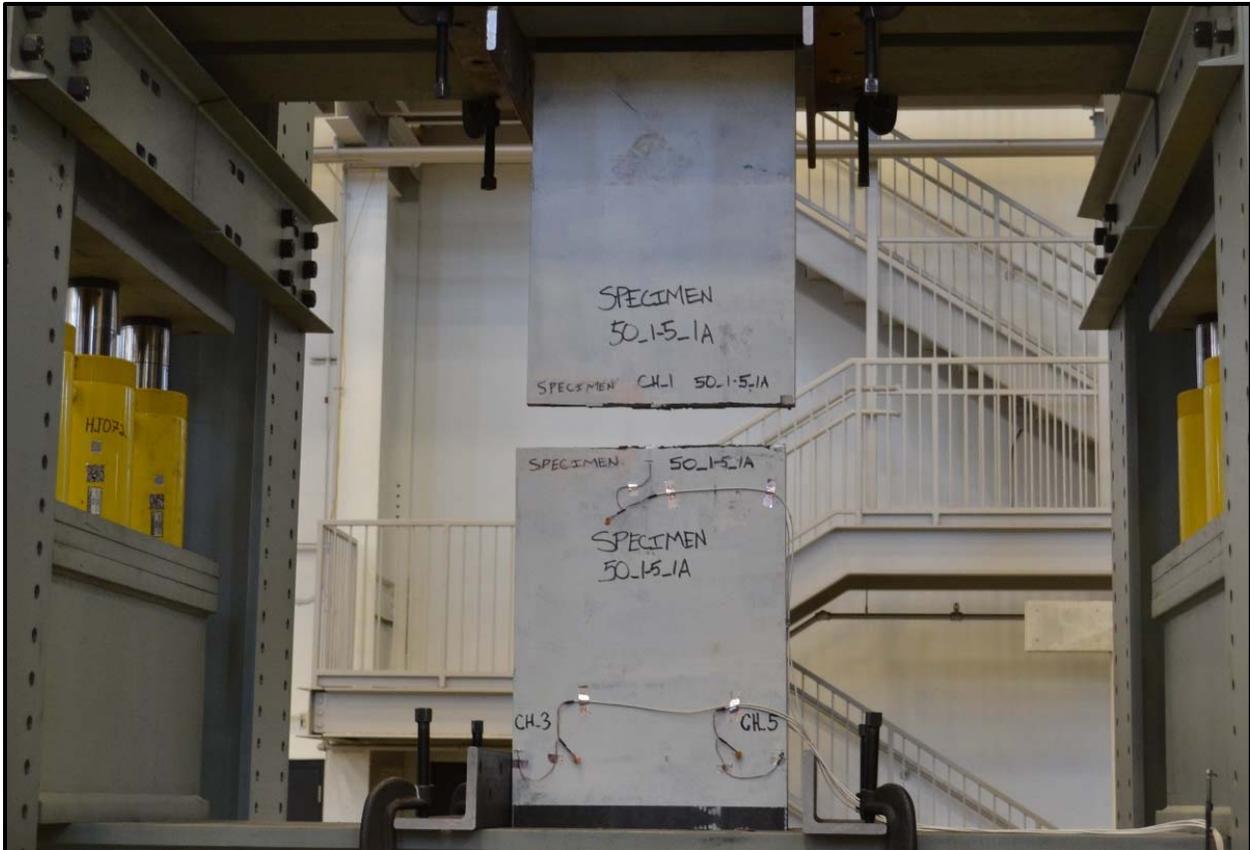
An initial v-notch was cut into Specimen 50\_1-5\_1A. The notch had a through-thickness length of 1.125 in. at which point a v-notch tapered to a final surface length of 2.0 in. An unsuccessful fracture attempt was performed at a fatigue crack length of 2.5 in. After the initial attempt, the fatigue crack was grown to 4.875 in. for a second fracture attempt. Fracture occurred at a load of 859.1 kips. The resulting stress was 26.0 ksi. A general photograph of Specimen 50\_1-5\_1A taken after fracture can be found in Figure 3.51. Figure 3.52 is a photograph of the fracture surface from Specimen 50\_1-5\_1A.

**Figure 3.51: Specimen 50\_1-5\_1A**

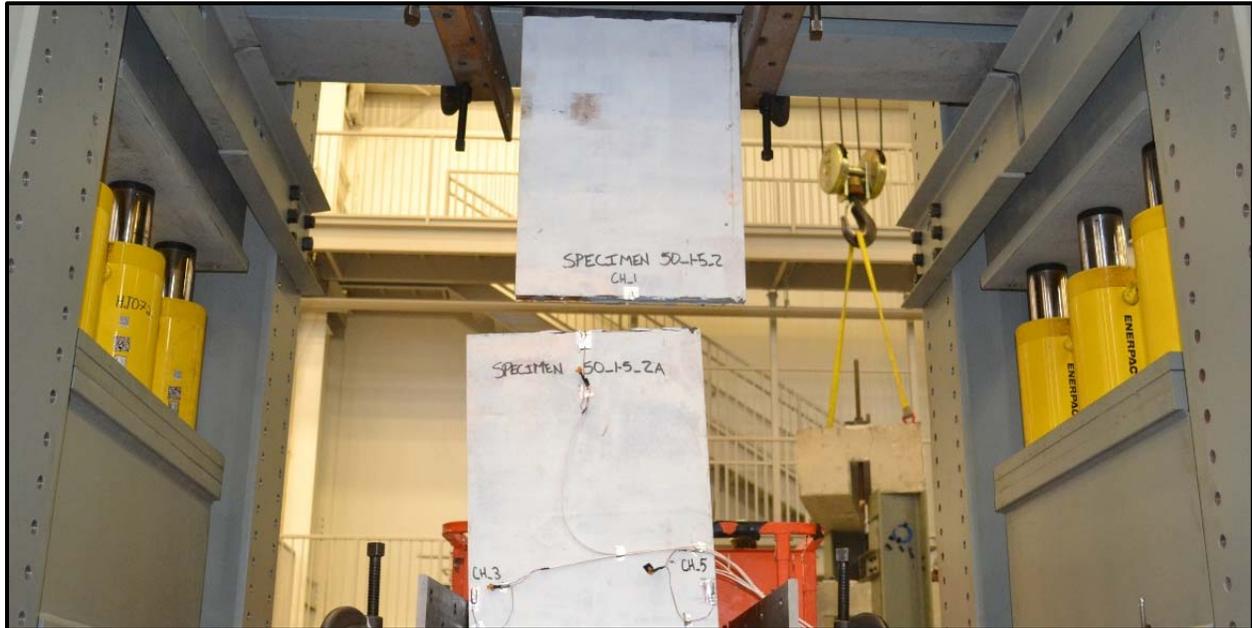
specimen. The notch was extended with the grinder to a length of 6.5 in. A fatigue crack was grown to a final length of 6.9375 in. for the second fracture attempt. Fracture occurred at a load of 728.3 kips. The resulting stress was 22.1 ksi. A general photograph of Specimen 50\_1-5\_2A taken after fracture can be found in Figure 3.53. Figure 3.54 is a photograph of the fracture surface from Specimen 50\_1-5\_2A.

**Figure 3.53: Specimen 50\_1-5\_2A**

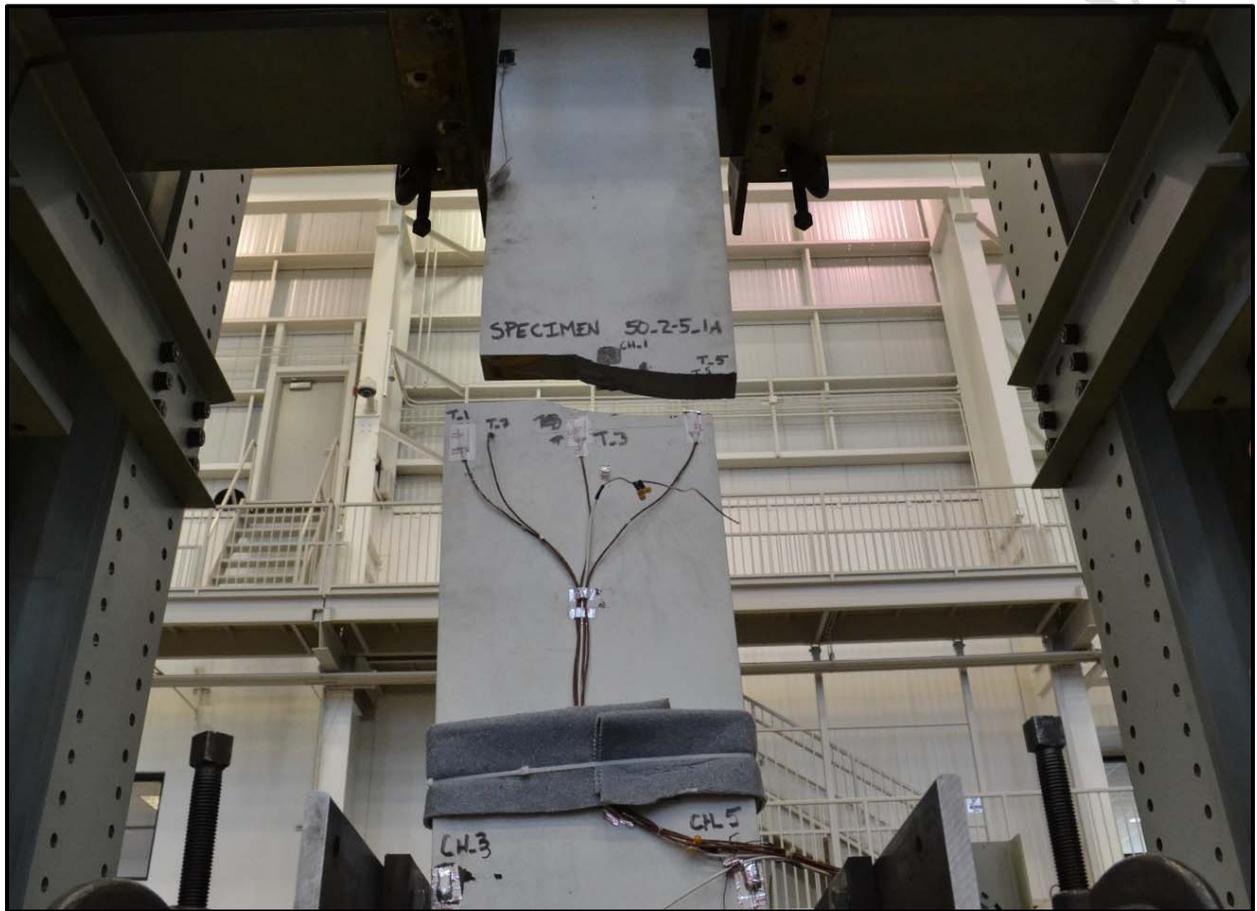
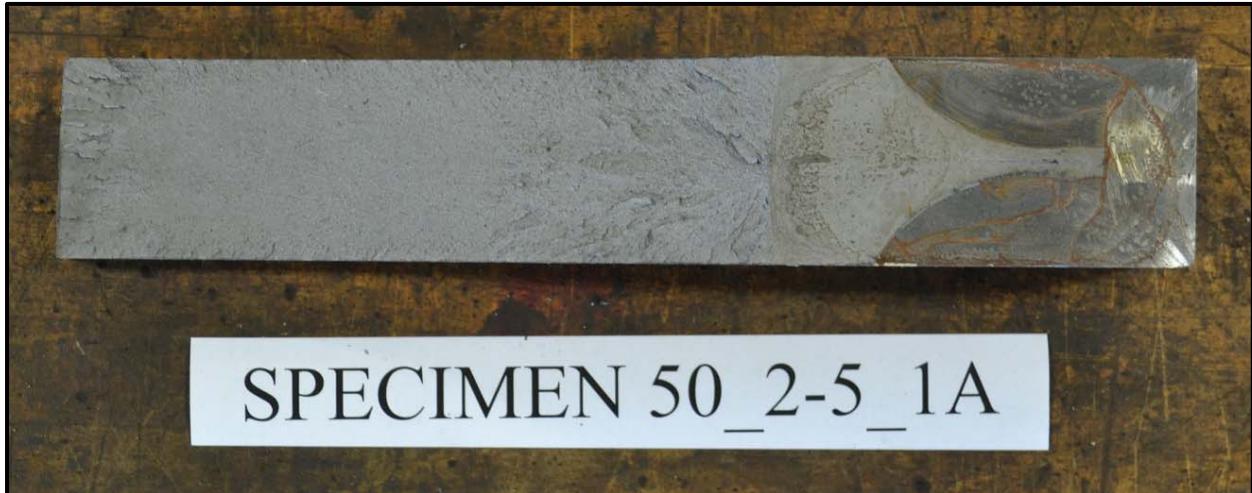
An initial v-notch with a trapezoidal front was cut into Specimen 50\_2-5\_1A. The notch had a through-thickness length of 1.125 in. The trapezoidal front tapered to a final surface length of 3.875 in. The final fatigue crack for Specimen 50\_2-5\_1A was grown to 4.9375 in. and fracture occurred at a load of 581.7 kips. The resulting stress was 16.6 ksi. A general photograph of Specimen 50\_2-5\_1A taken after fracture can be found in Figure 3.55. Figure 3.56 is a photograph of the fracture surface from Specimen 50\_2-5\_1A.

Figure 3.55: Specimen 50\_2-5\_1A

**Figure 3.56: Specimen 50\_2-5\_1A fracture surface**

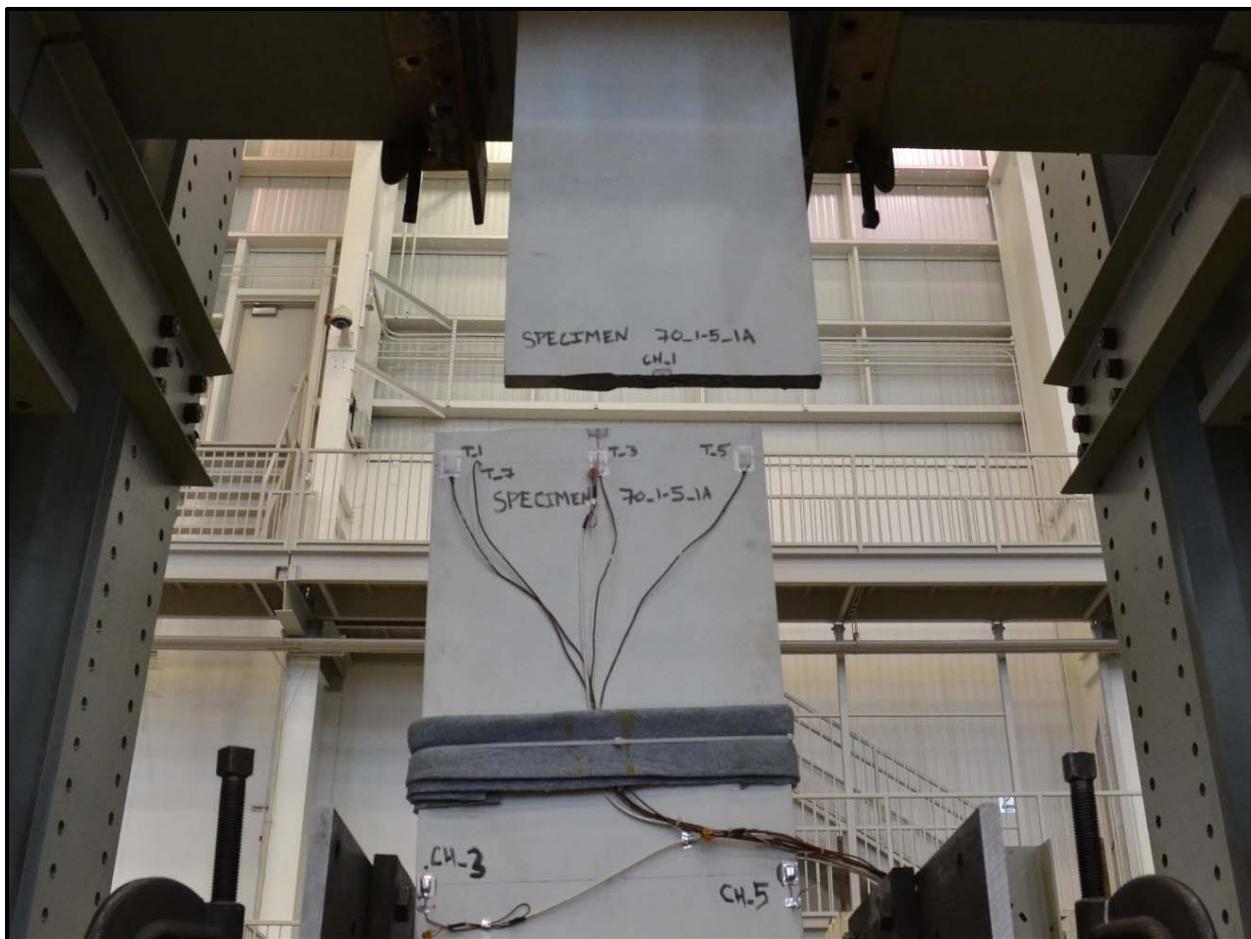
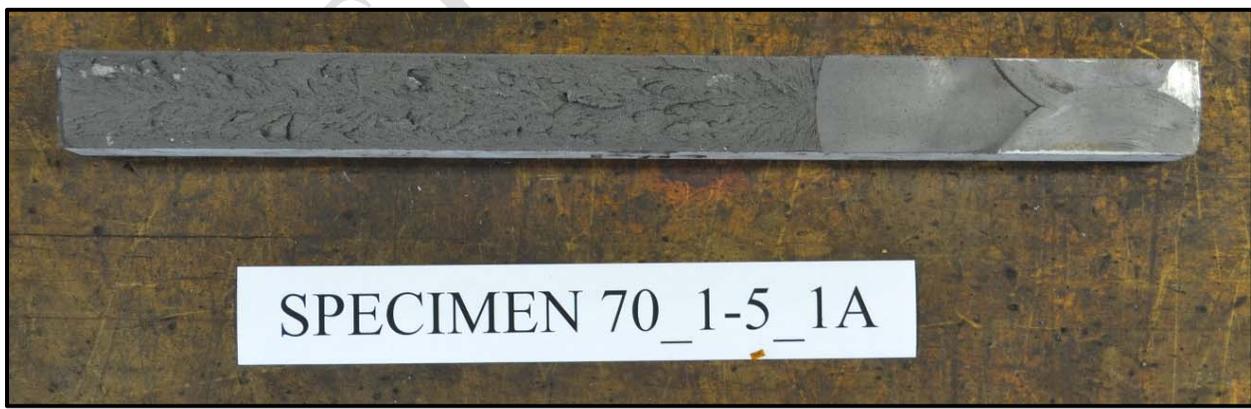
An initial v-notch was cut into Specimen 70\_1-5\_1A. The notch had a through-thickness length of 2.5 in. and a v-notch tapered to a surface length of 3.25 in. The fatigue crack for Specimen 70\_1-5\_1A was grown to 6.0 in. Fracture occurred at a load of 424.4 kips. The resulting stress was 15.7 ksi. A general photograph of Specimen 70\_1-5\_1A taken after fracture can be found in Figure 3.57. Figure 3.58 is a photograph of the fracture surface from Specimen 70\_1-5\_1A.

**Figure 3.57: Specimen 70\_1-5\_1A**

**Figure 3.58: Specimen 70\_1-5\_1A fracture surface**

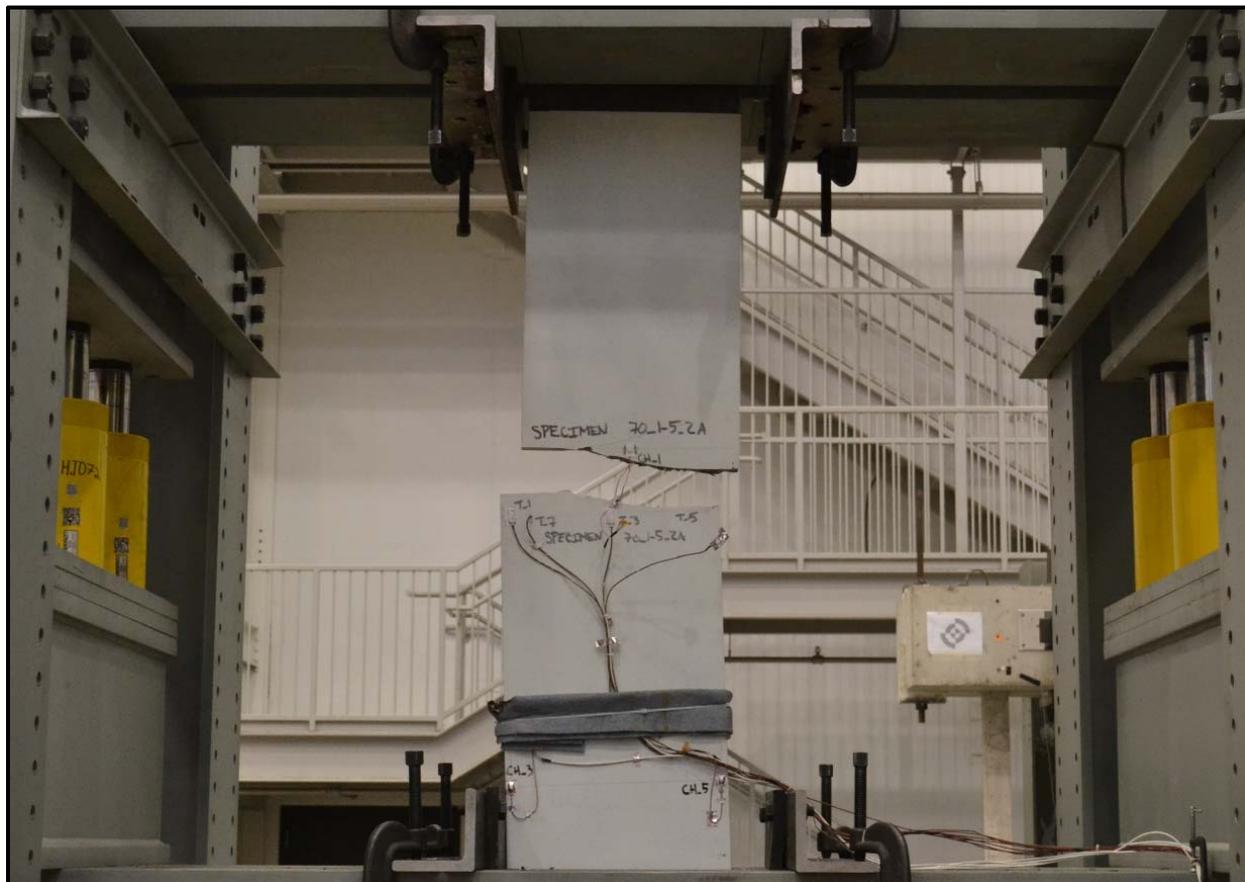
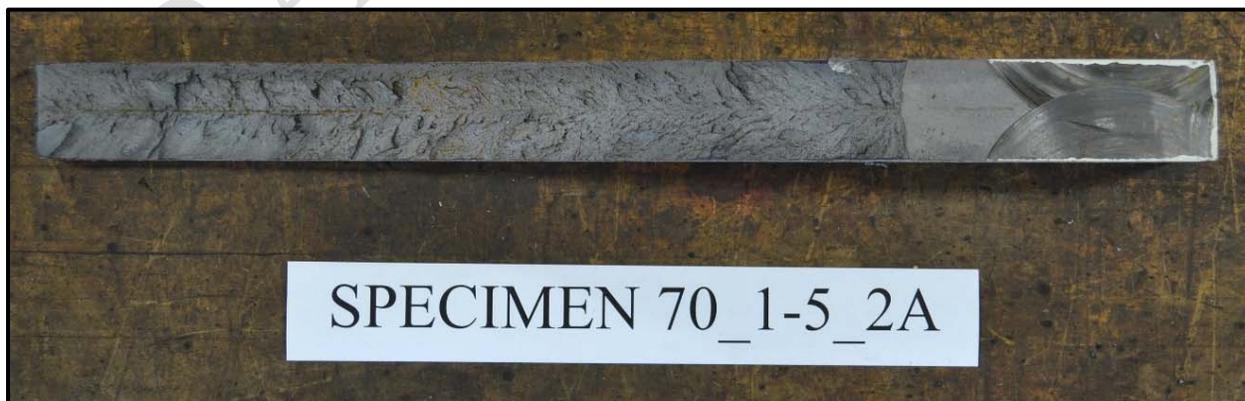
Specimen 70\_1-5\_2A was grown to 4.625 in. Fracture occurred at a load of 871.0 kips with a resulting stress of 32.3 ksi. A general photograph of Specimen 70\_1-5\_2A taken after fracture can be found in Figure 3.59. Figure 3.60 is a photograph of the fracture surface from Specimen 70\_1-5\_2A.

Figure 3.59: Specimen 70\_1-5\_2A

Figure 3.60: Specimen 70\_1-5\_2A fracture surface

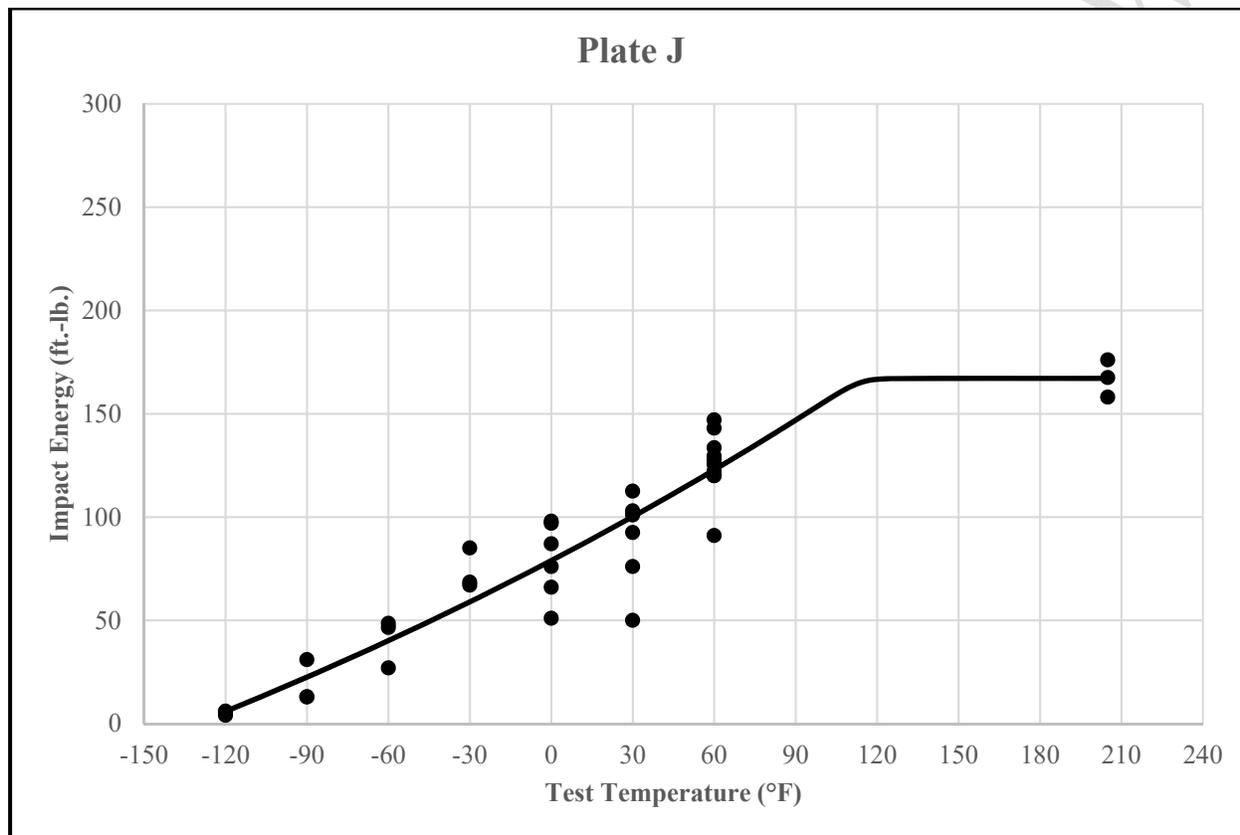
At the completion of large-scale testing, additional CVN impact specimens were prepared from each test plate. The additional specimens were used to evaluate the CVN impact variability throughout the test specimens. All five parameter sigmoidal fits were updated to include all tested CVN impact specimens for a given plate. The CVN impact results for all tested plates, including the raw data as well as the plots and five parameter sigmoidal fits, can be found in Appendix F. Figure 3.62 depicts a representative plot of CVN impact data for Plate J with the five parameter sigmoidal fit.

**Figure 3.62: Representative CVN impact data with sigmoidal fit**

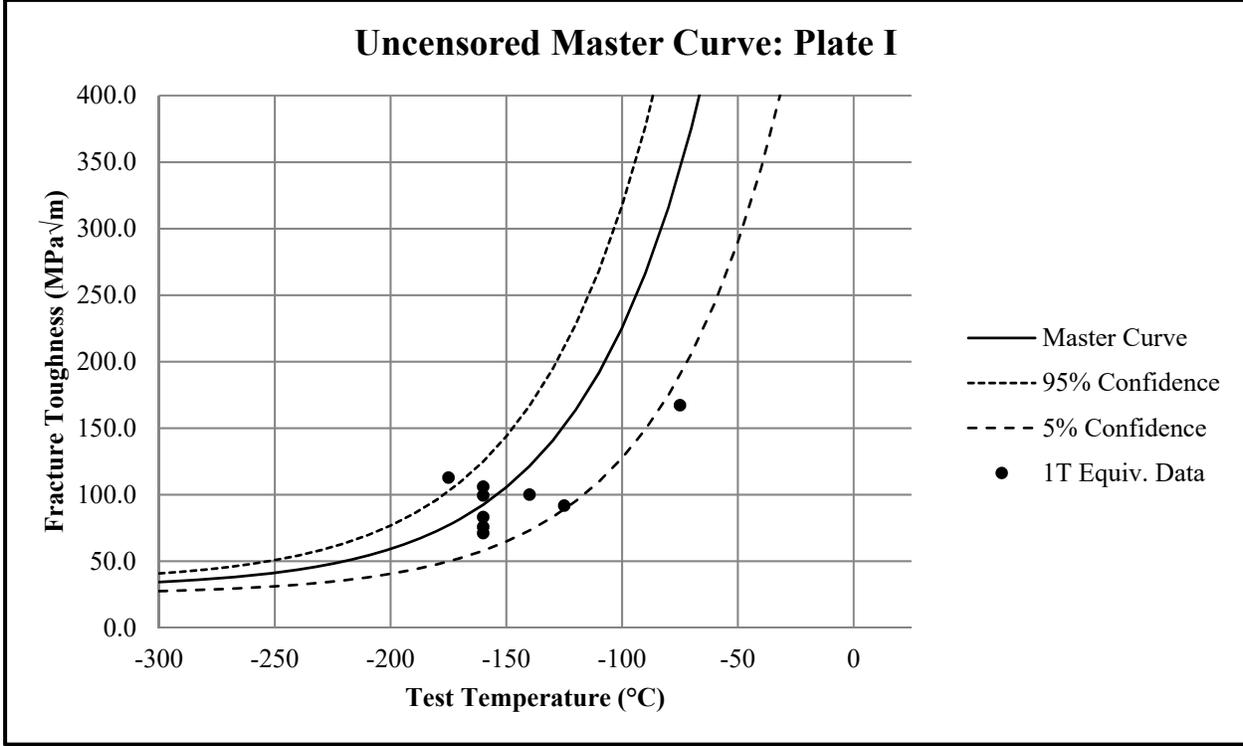
Figure 3.64: Representative uncensored master curve

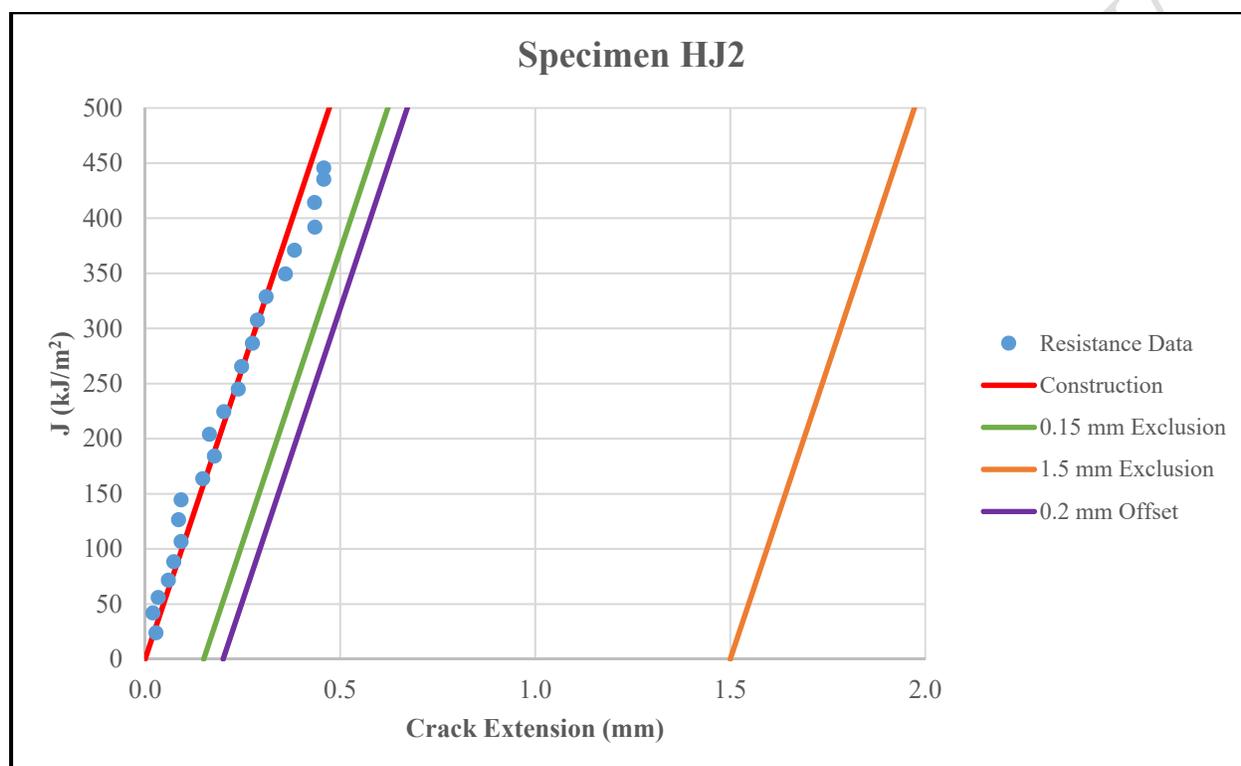
**Figure 3.65: Representative resistance curve**
