**TPF-5(238)**  
**Design and Fabrication Standards to Eliminate Fracture  
Critical Concerns in Two-Girder Bridge Systems**

Phase 2: Experimental Testing

May 2017

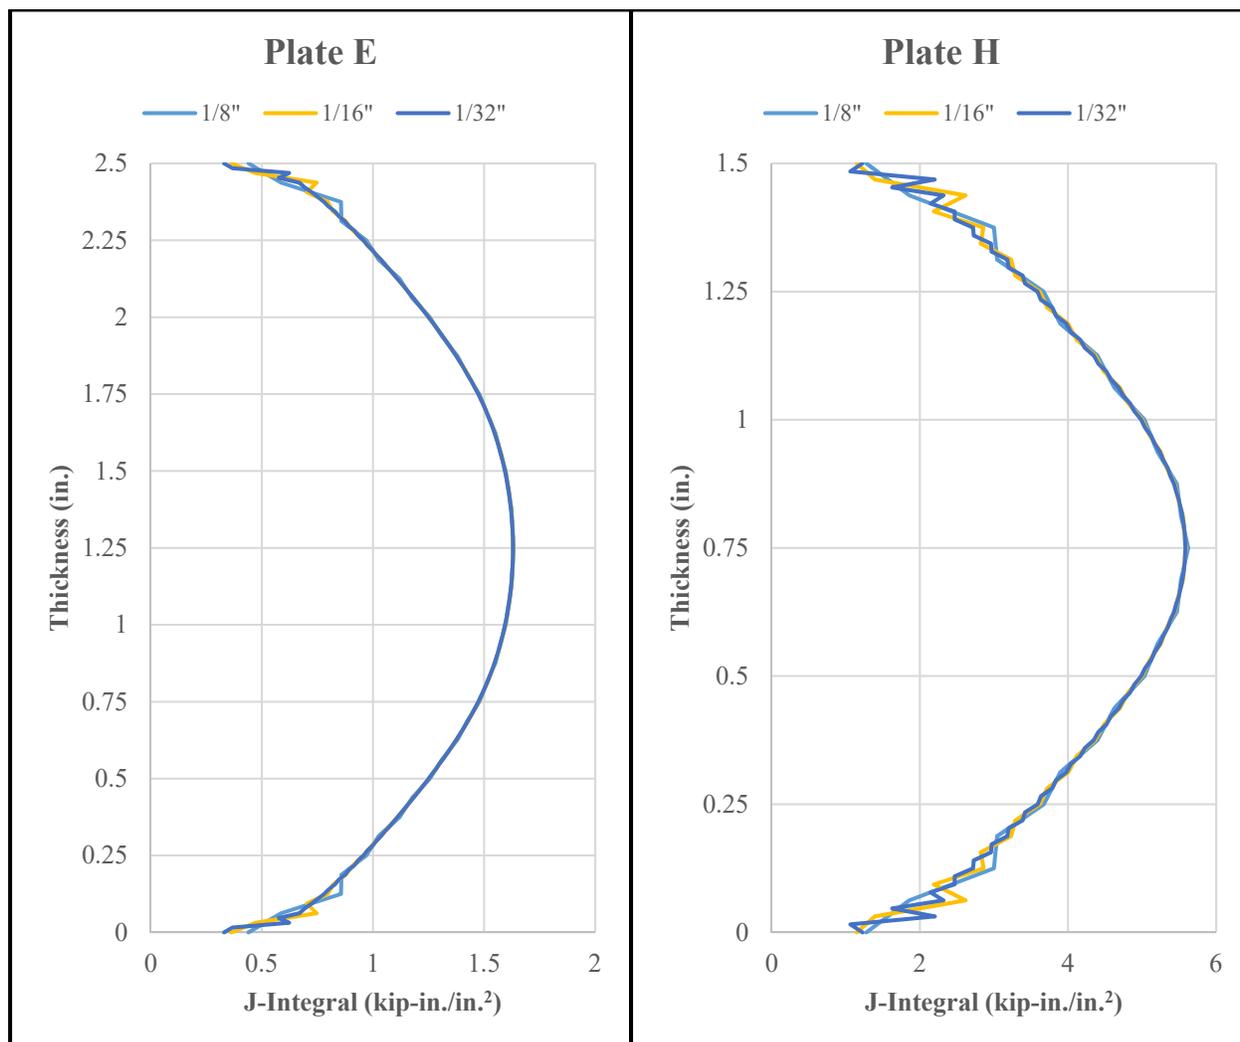
**Figure 4.1: Through-thickness mesh density for Plate E (left) and Plate H (right)**

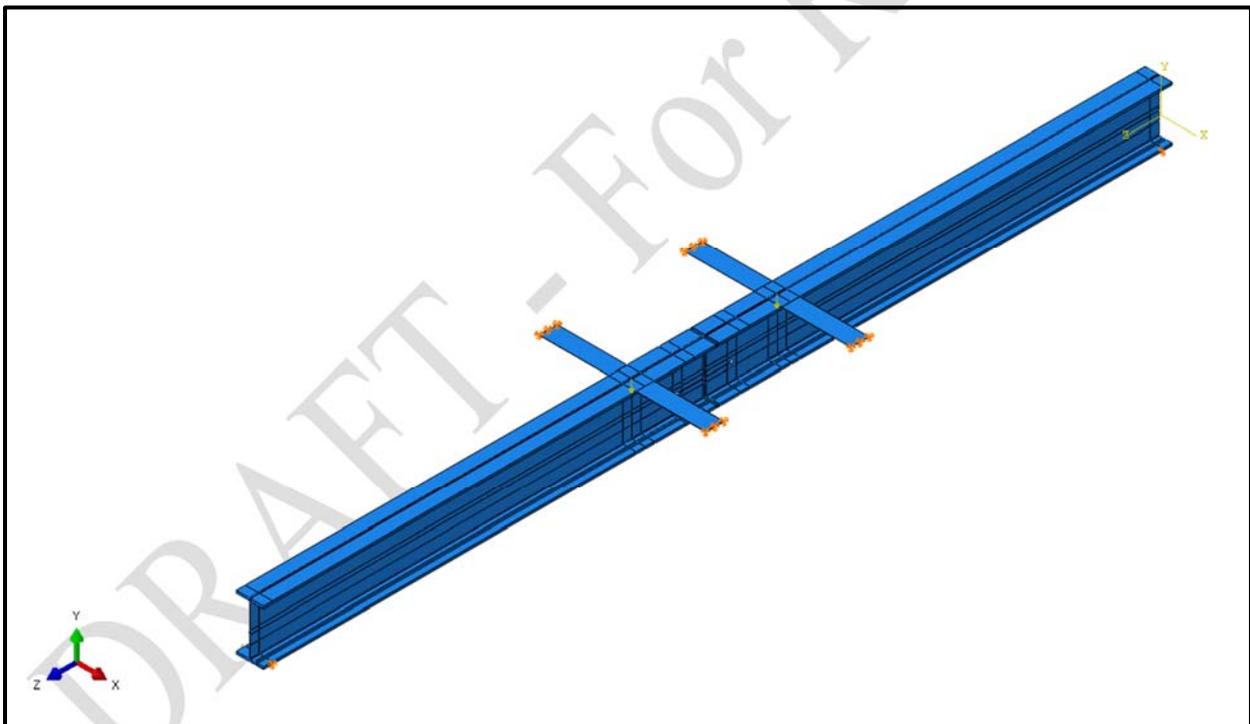
**Figure 4.2: Bending test specimen model example boundary conditions and loading**

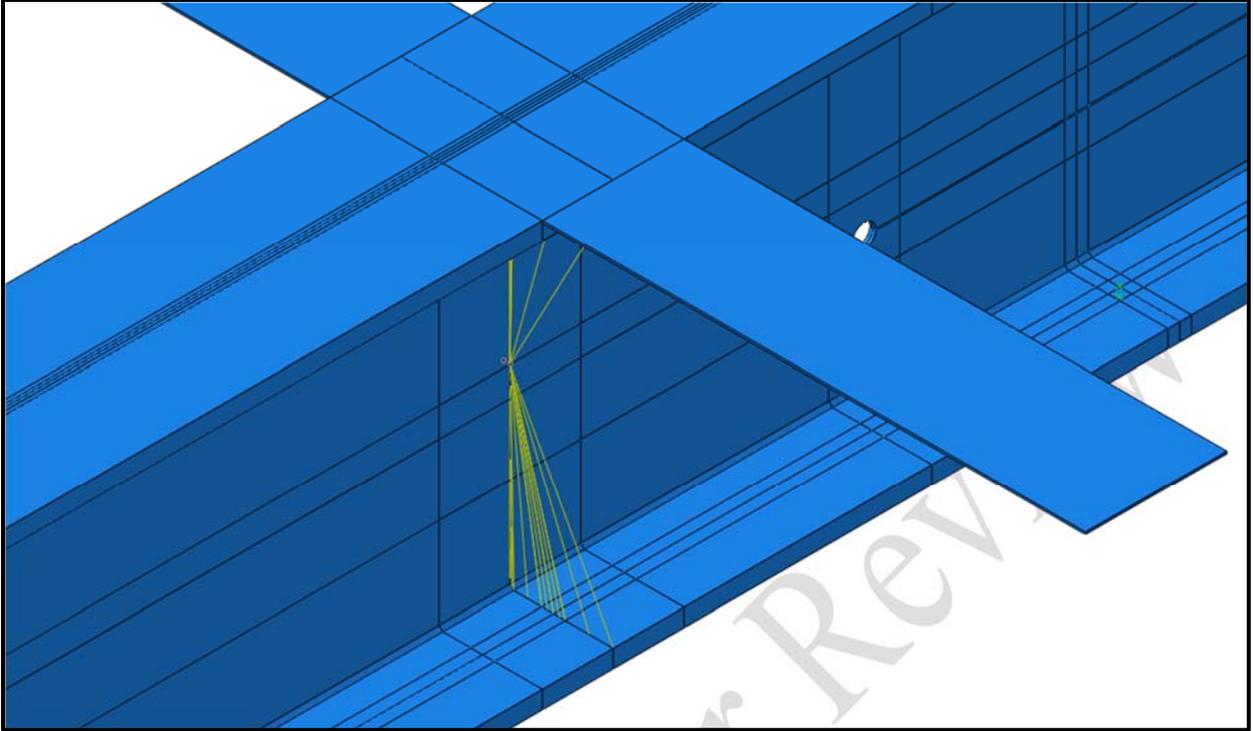
**Figure 4.3: Bending test specimen model example stiffener**

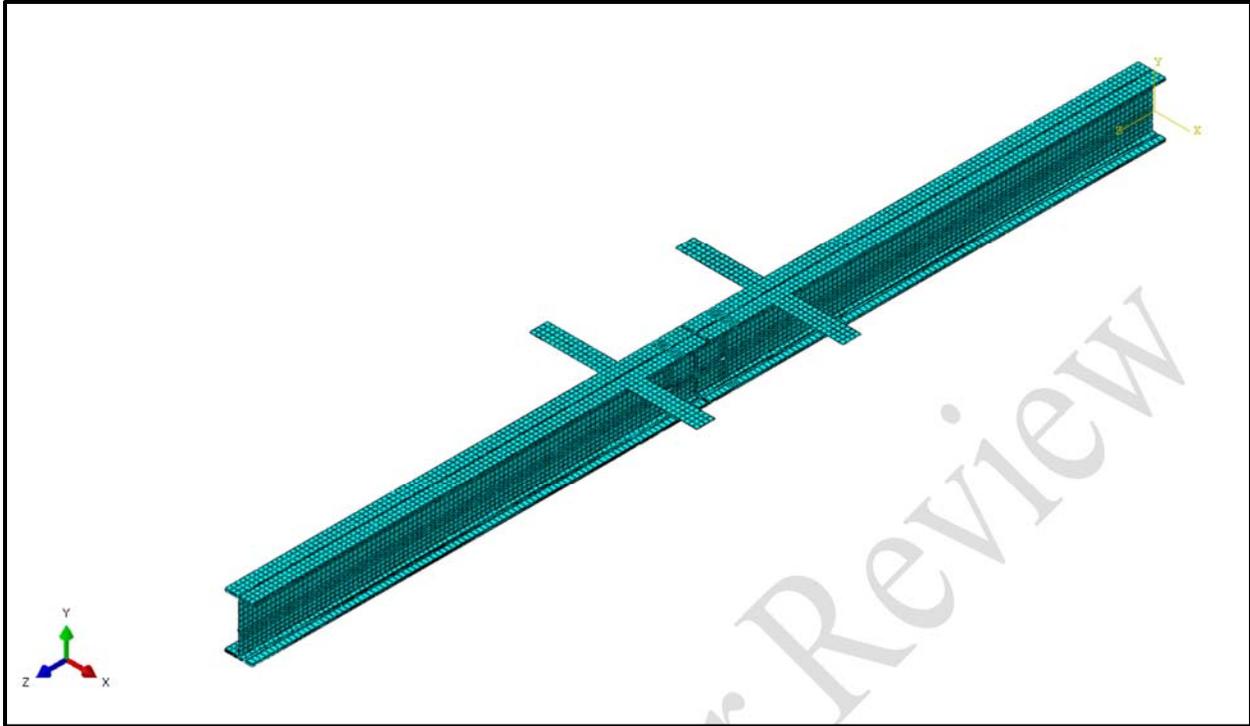
**Figure 4.4: Bending test specimen example model mesh**

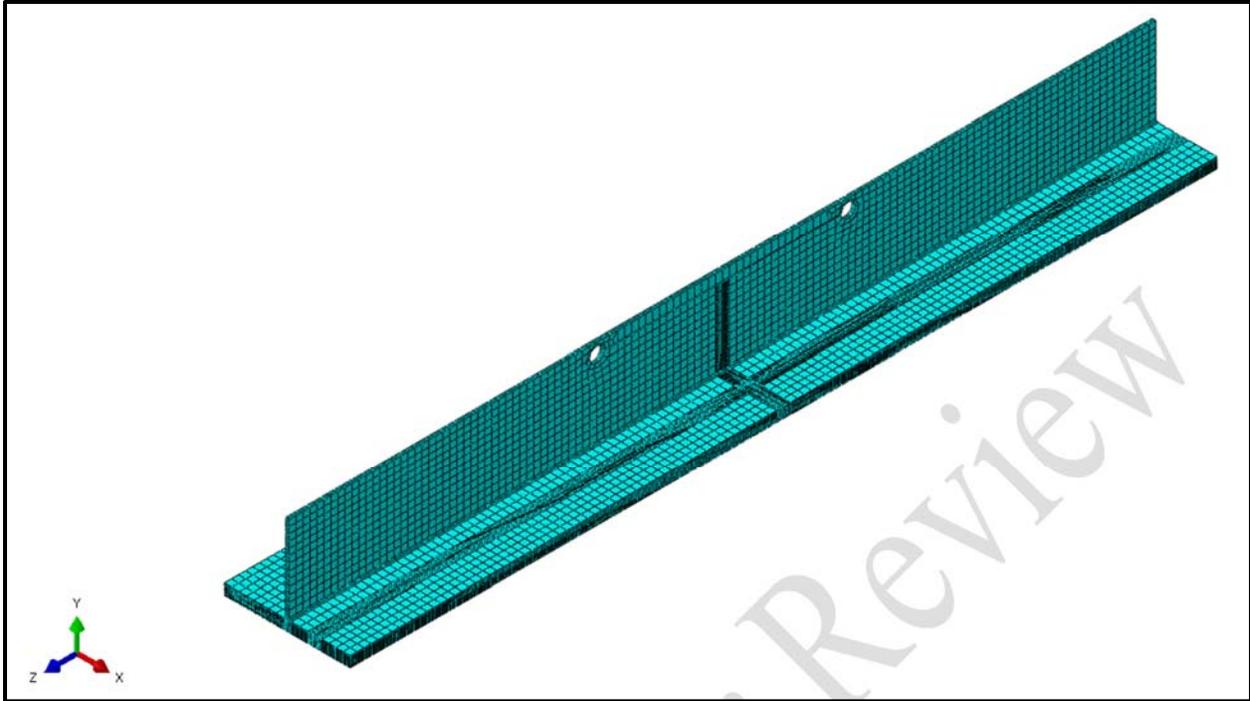
**Figure 4.5: Bending test specimen example submodel mesh**

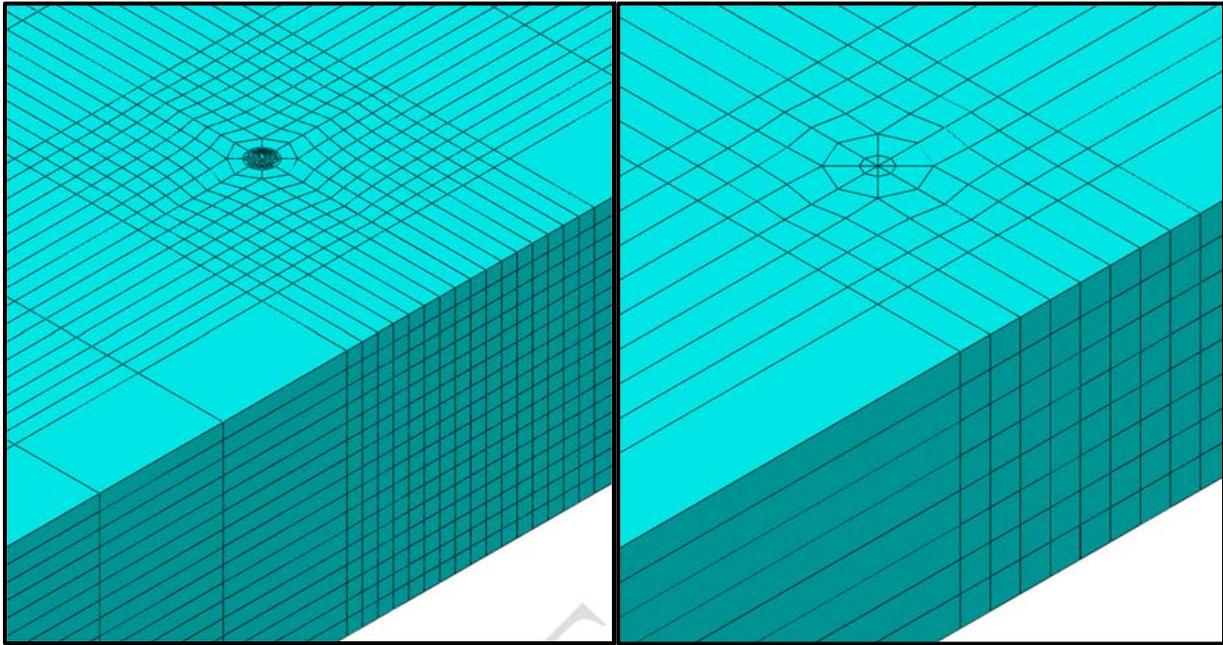
**Figure 4.6: Bending test specimen model example refined (right) and course (left) crack tip mesh**

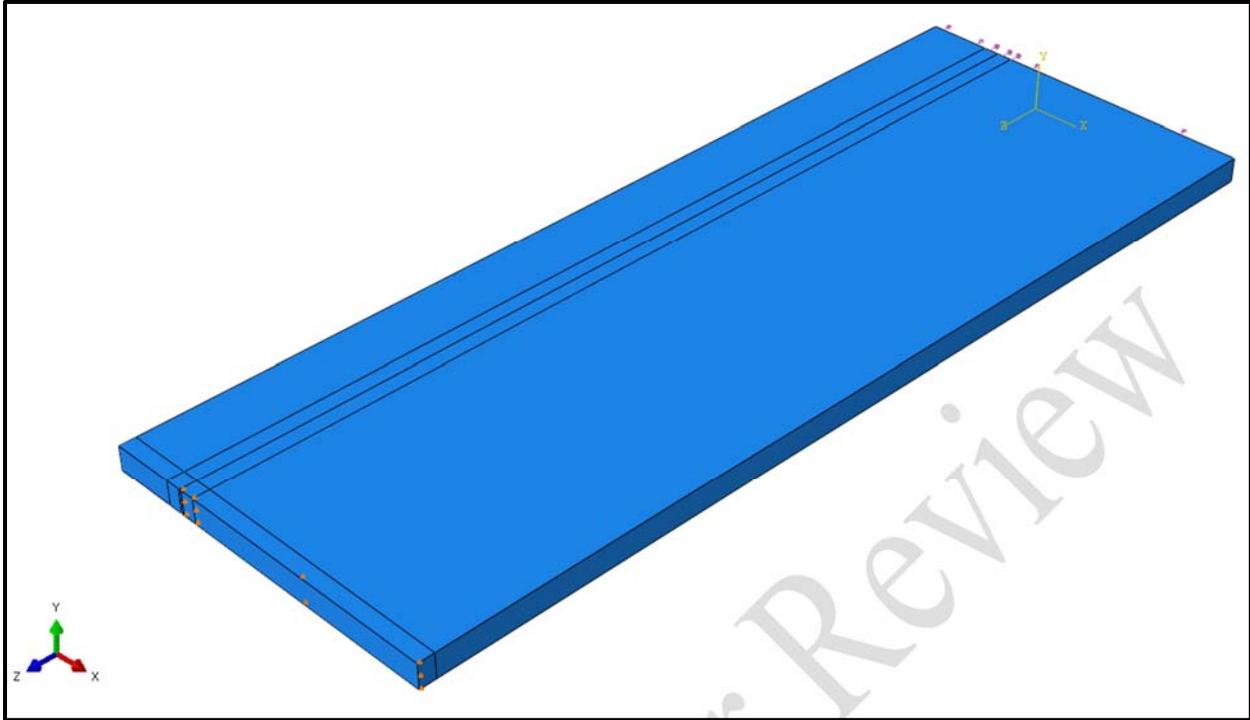
**Figure 4.7: Axial test specimen model boundary conditions and loading**

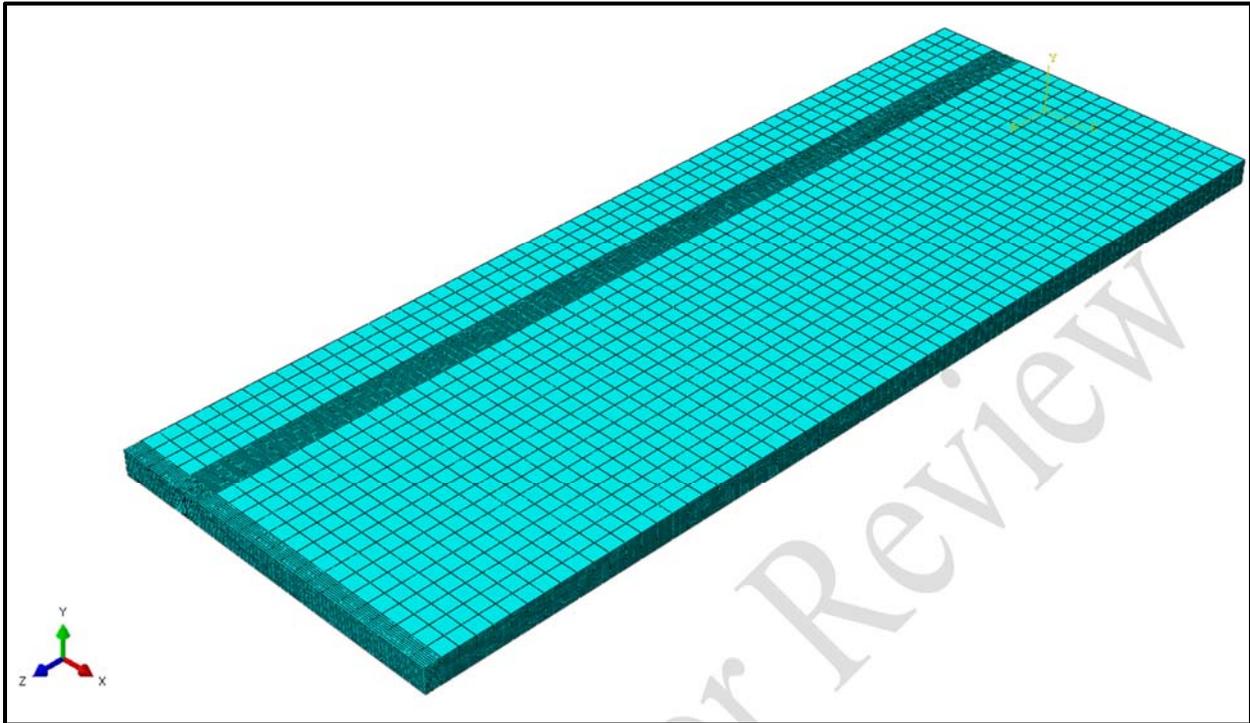
**Figure 4.8: Axial test specimen model mesh**

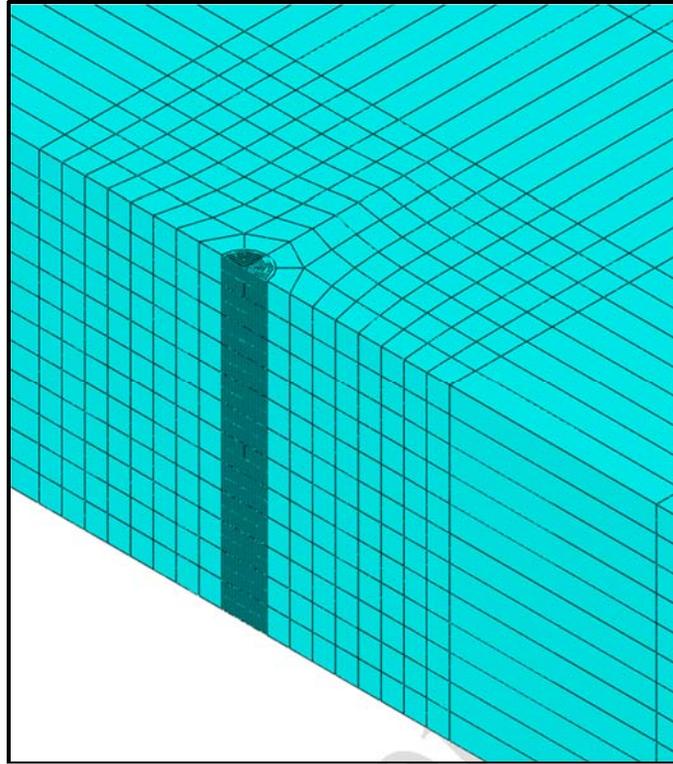
**Figure 4.9: Axial test specimen model crack tip mesh**

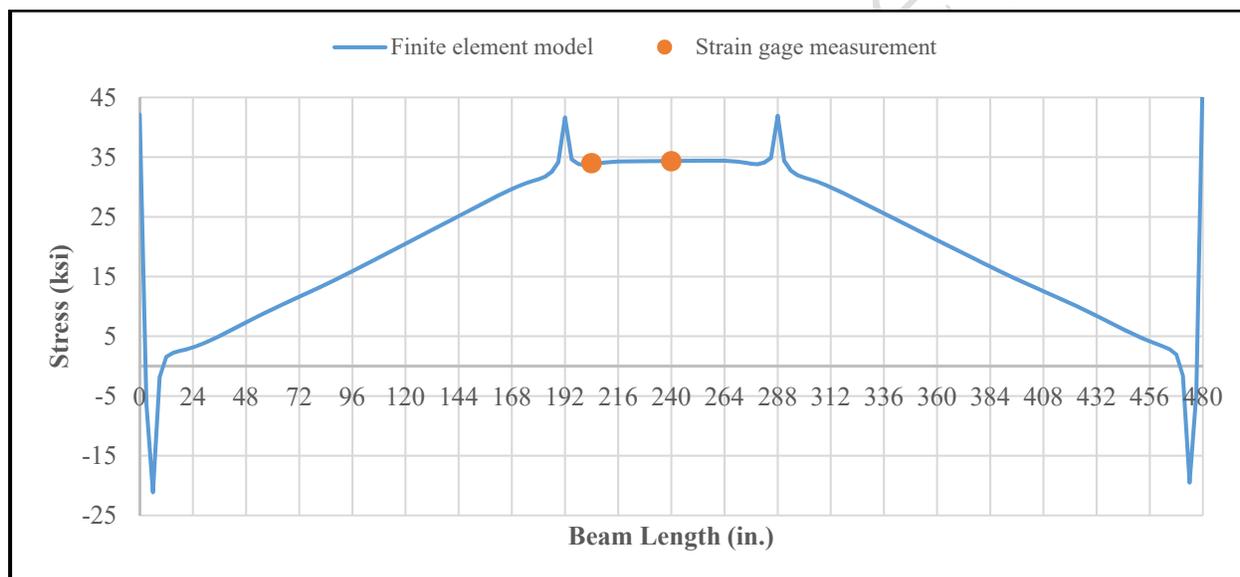
**Figure 4.10: Specimen 50\_2-0\_1B longitudinal stress at centerline**

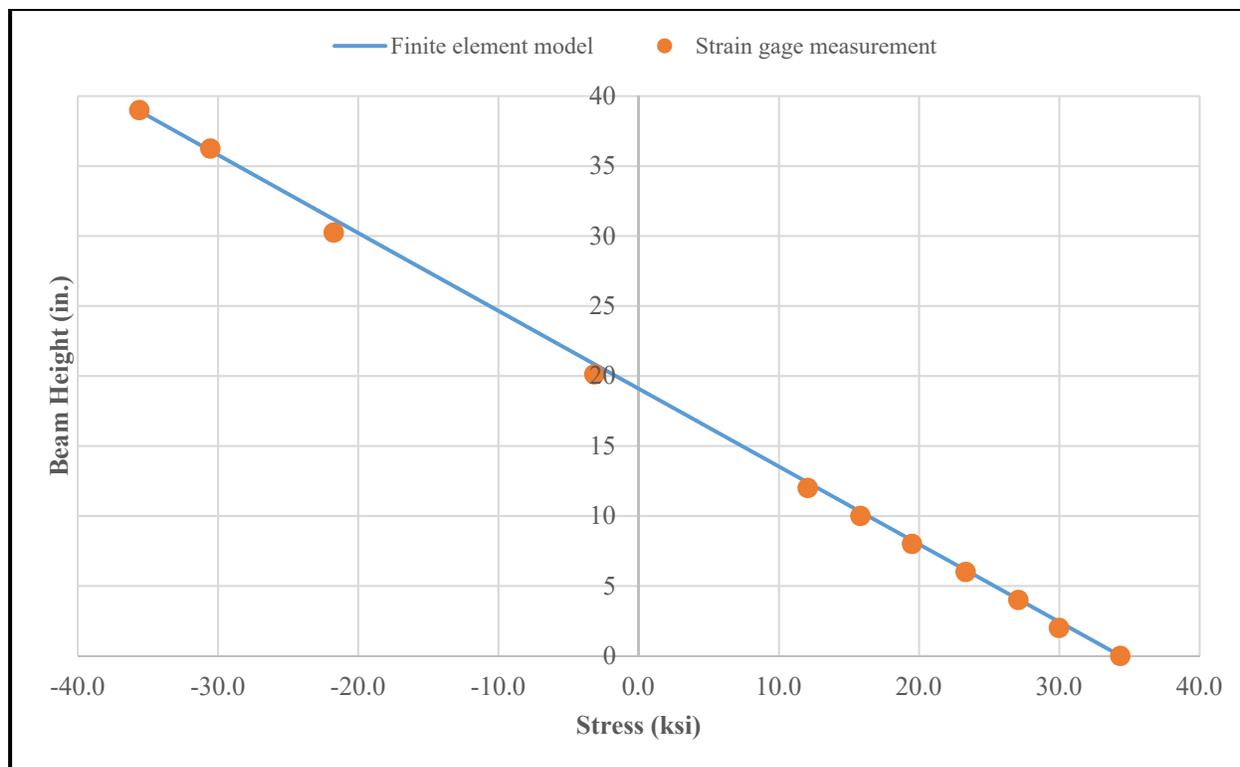
**Figure 4.11: Specimen 50\_2-0\_1B stress profile at midspan**

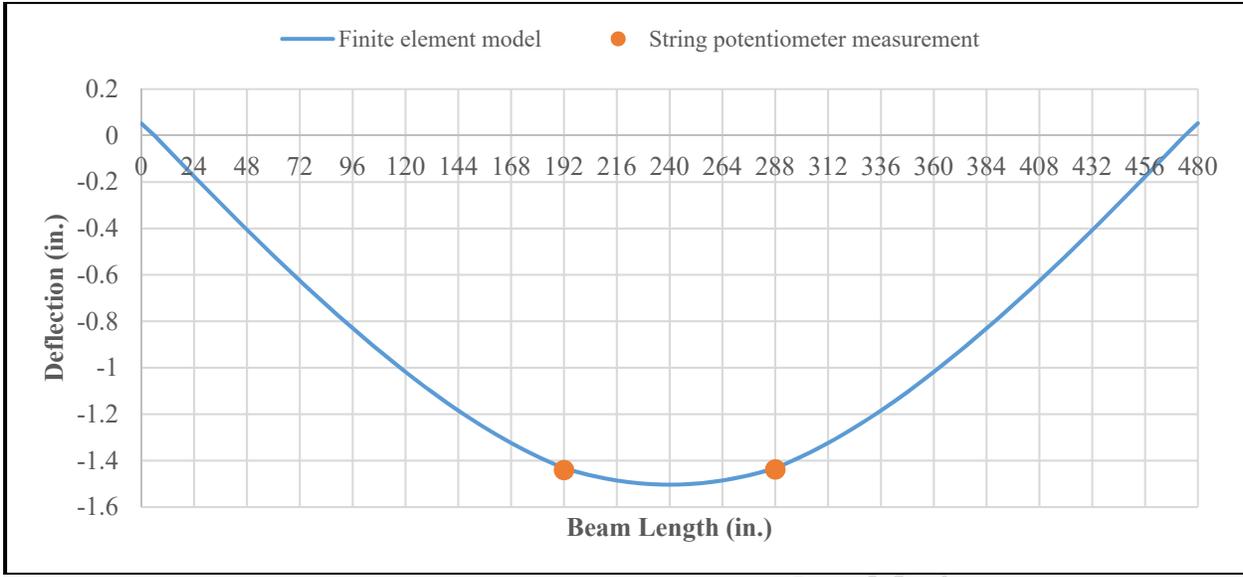
**Figure 4.12: Specimen 50\_2-0\_1B displacement at centerline**

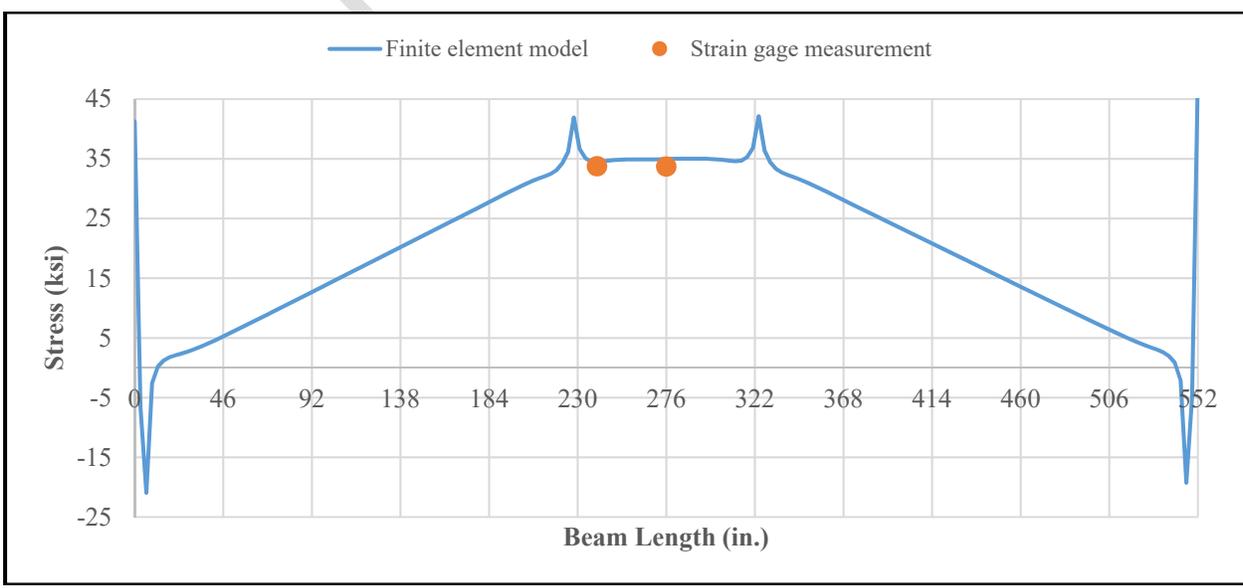
**Figure 4.13: Specimen 50\_2-5\_2B longitudinal stress at centerline**

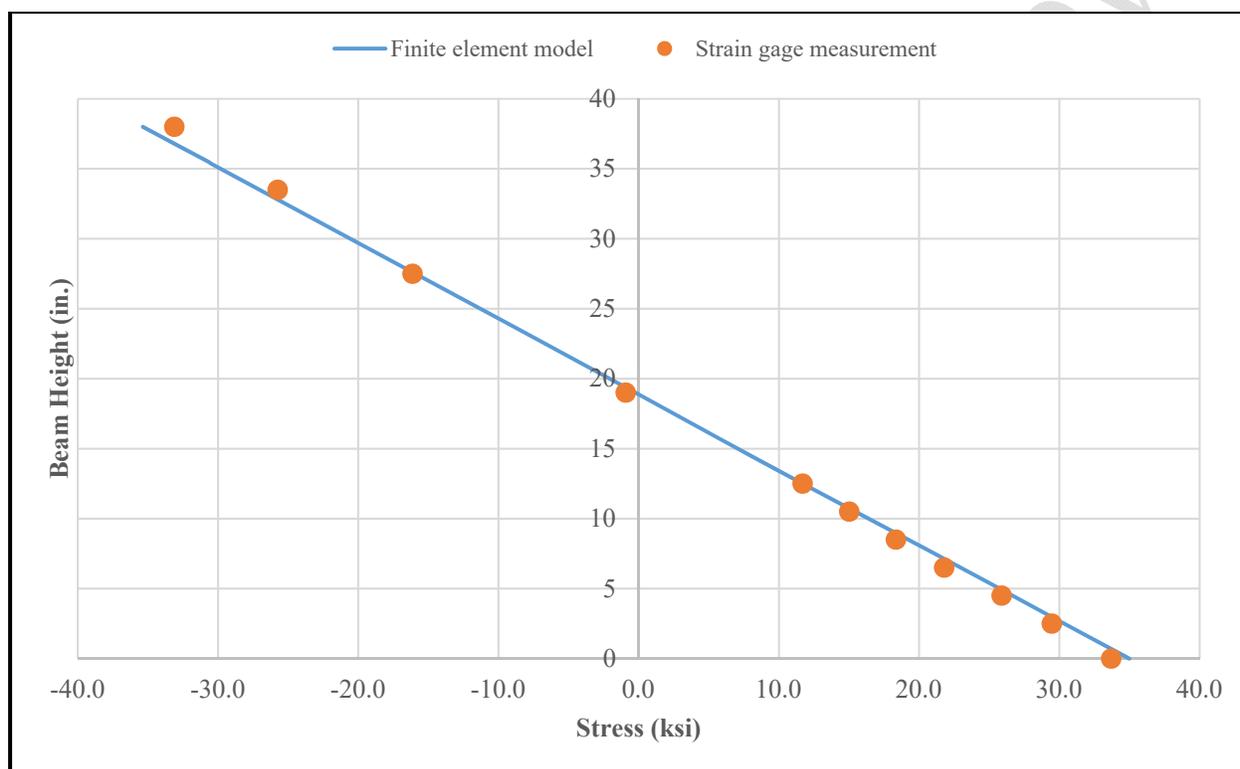
**Figure 4.14: Specimen 50\_2-5\_2B stress profile at midspan**

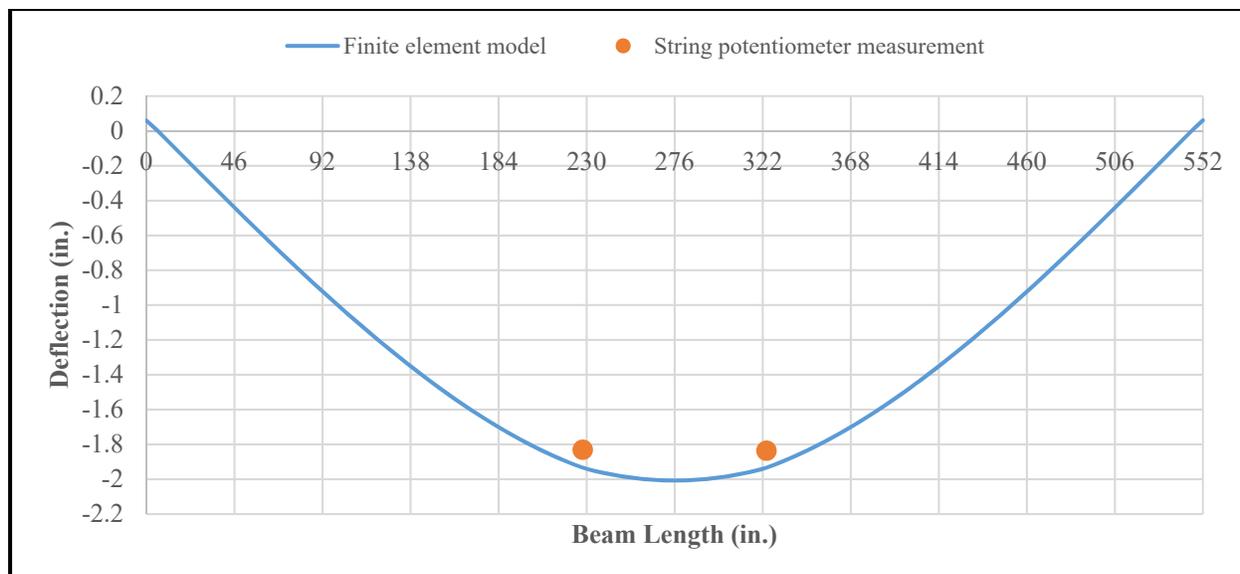
**Figure 4.15: Specimen 50\_2-5\_2B displacement at centerline**

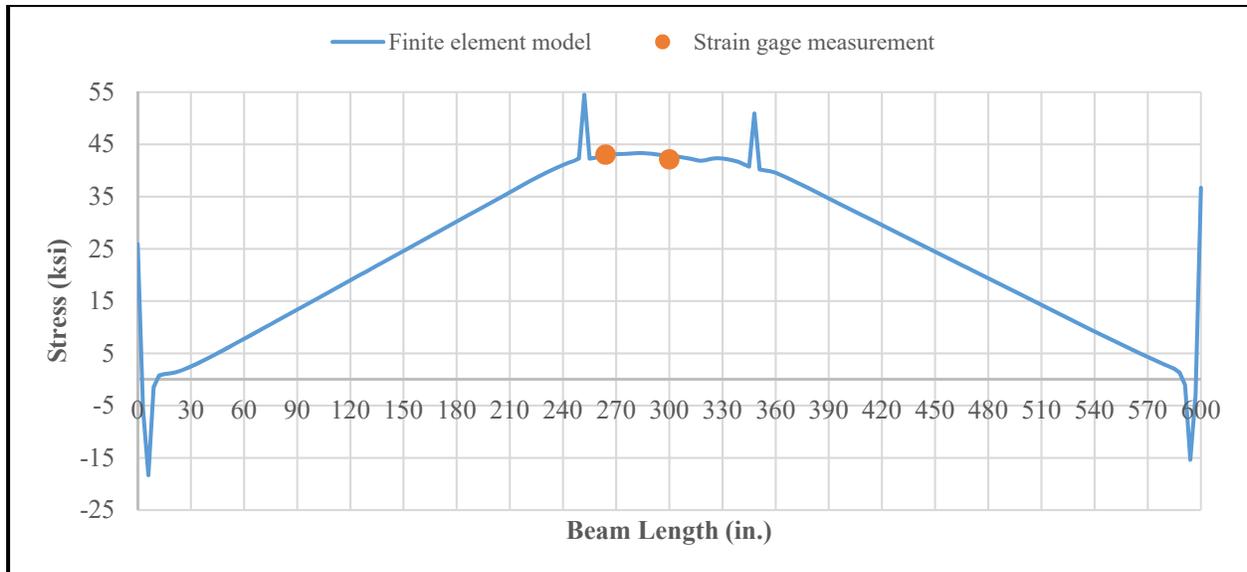
**Figure 4.16: Specimen 70\_1-5\_1B longitudinal stress at centerline**

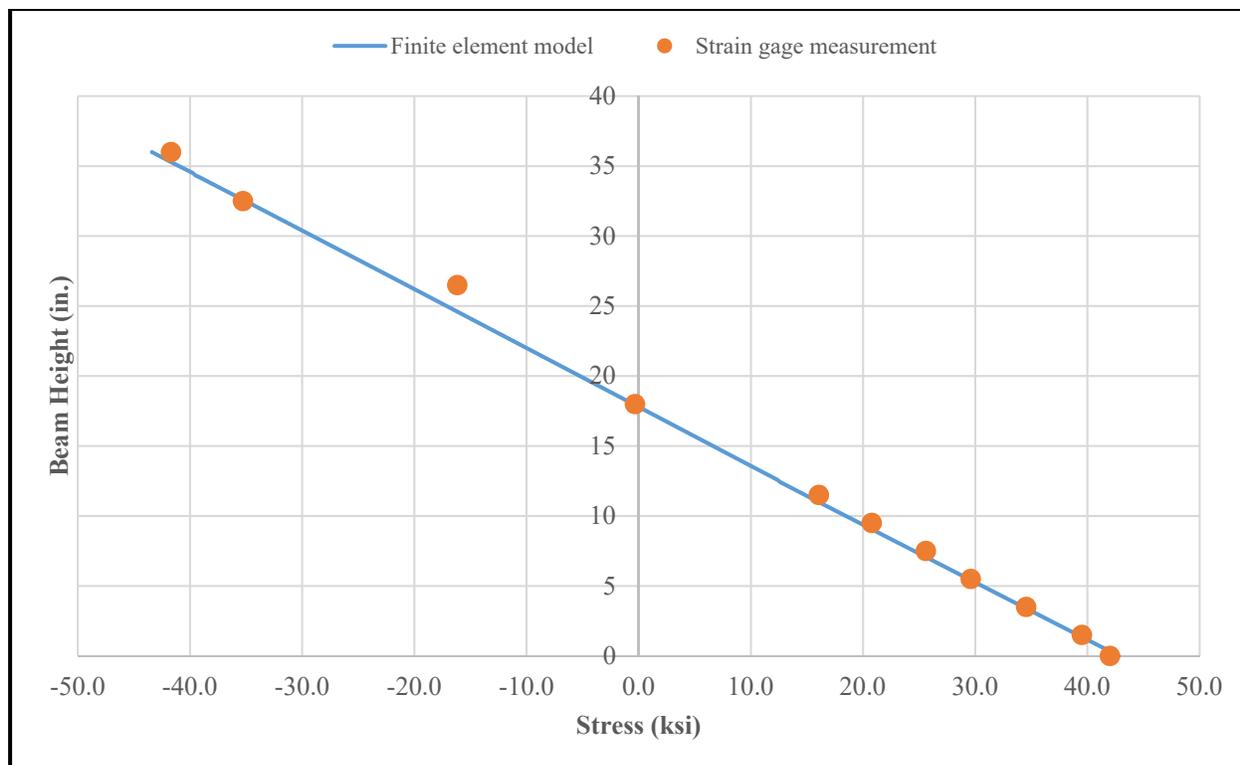
**Figure 4.17: Specimen 70\_1-5\_1B stress profile at midspan**

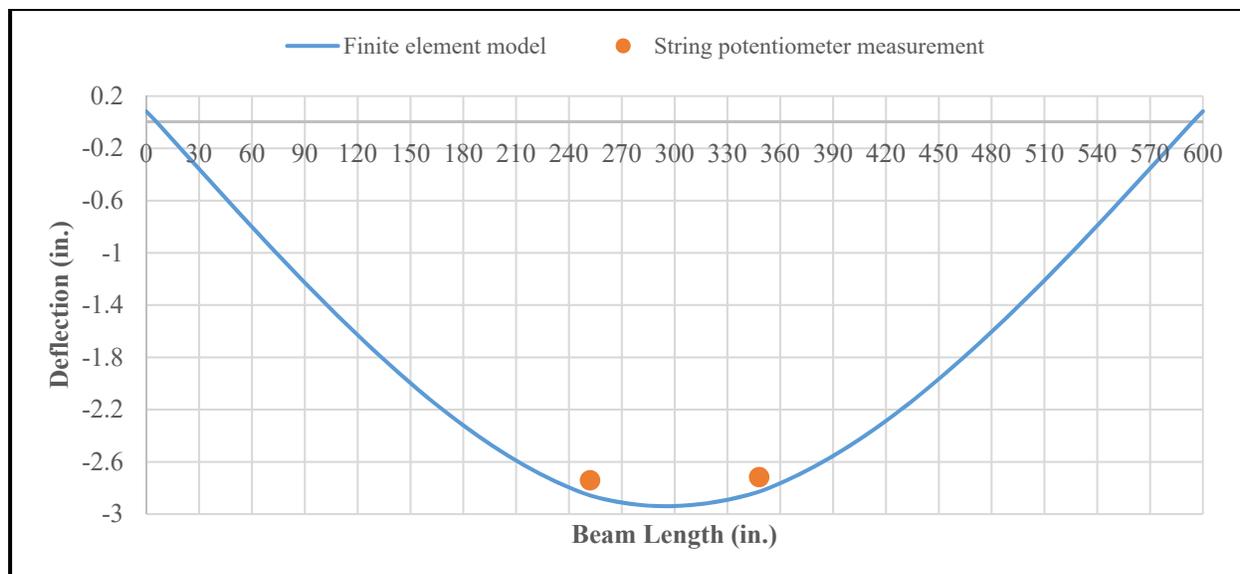
**Figure 4.18: Specimen 70\_1-5\_1B displacement at centerline**

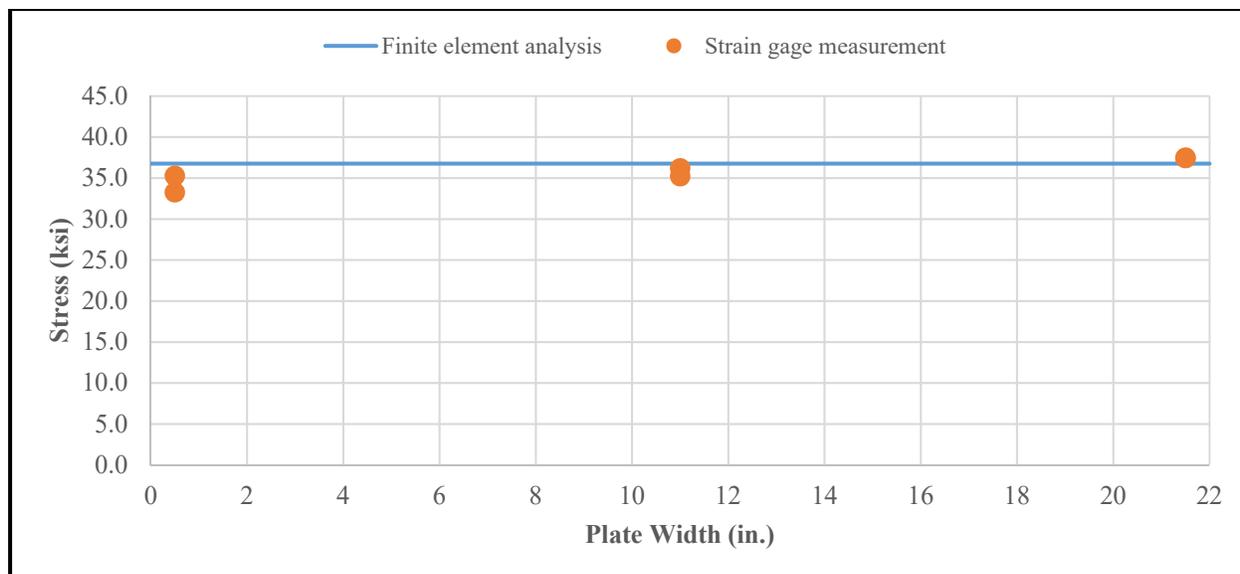
**Figure 4.19: Specimen 50\_1-5\_1A longitudinal stress at midpoint**

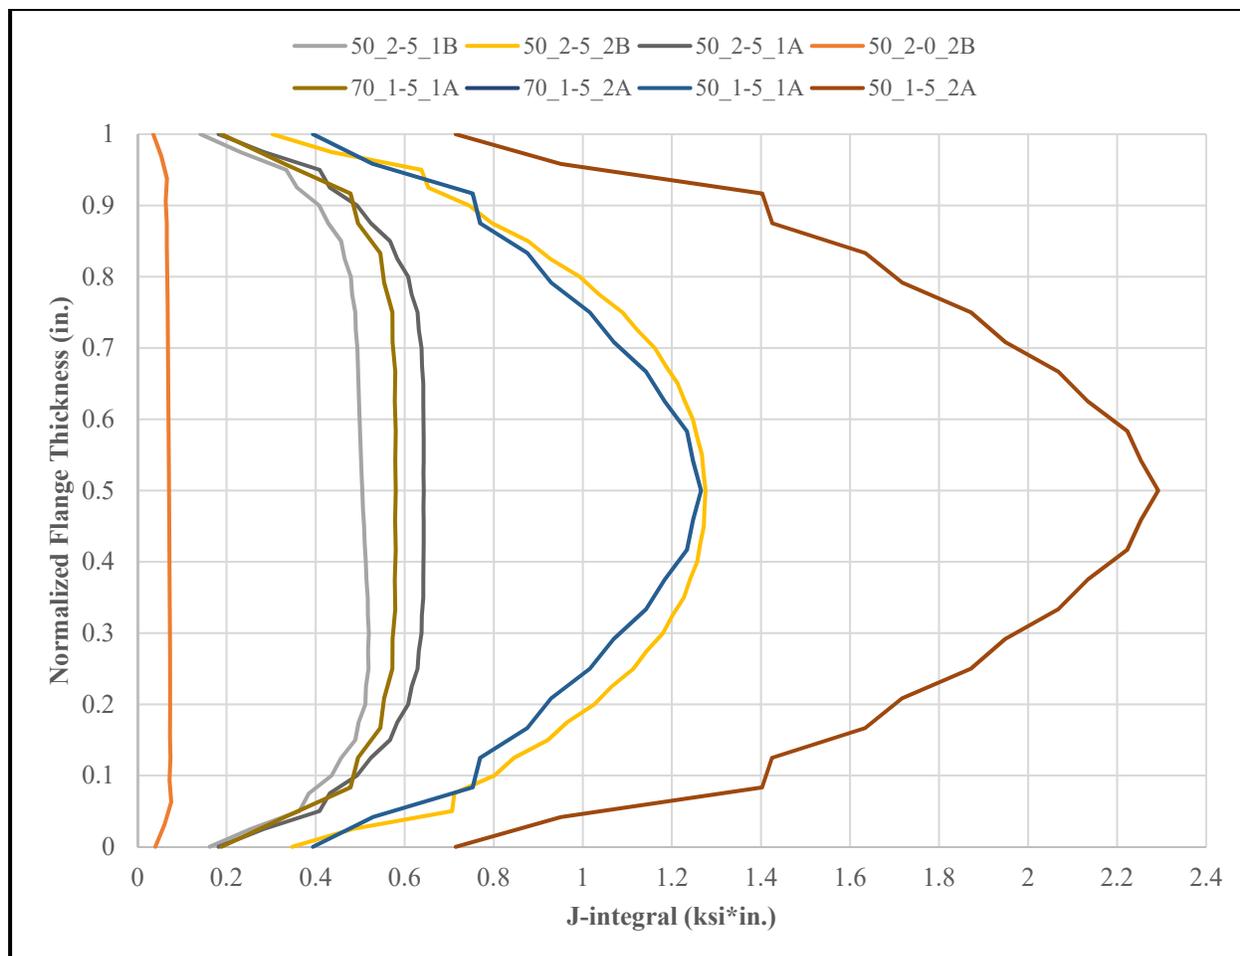
**Figure 4.21: Through-thickness j-integral demand**

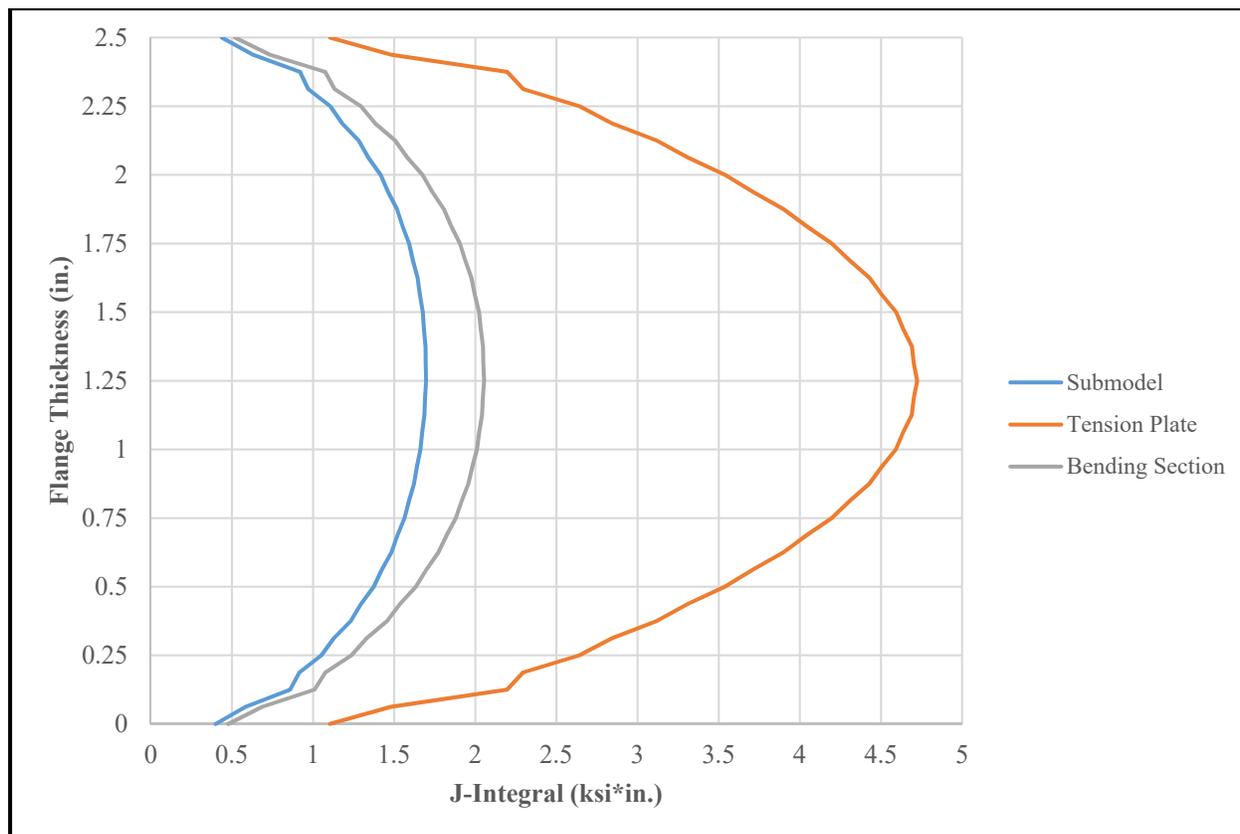
**Figure 4.22: Comparison of simplified modeling techniques**

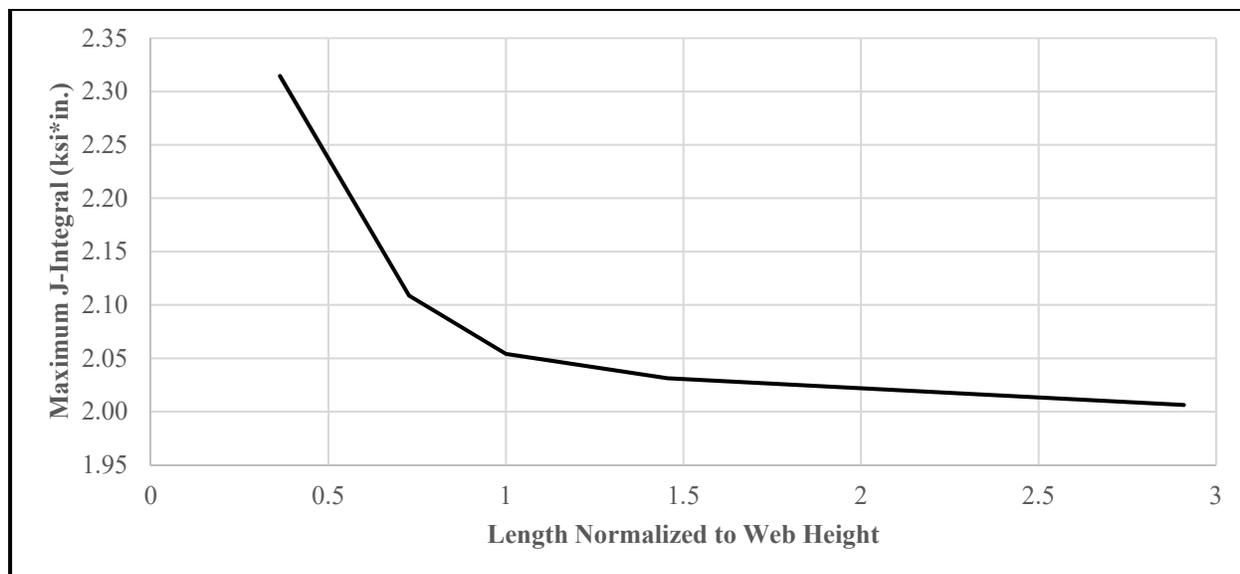
**Figure 4.23: Comparison of bending section length**

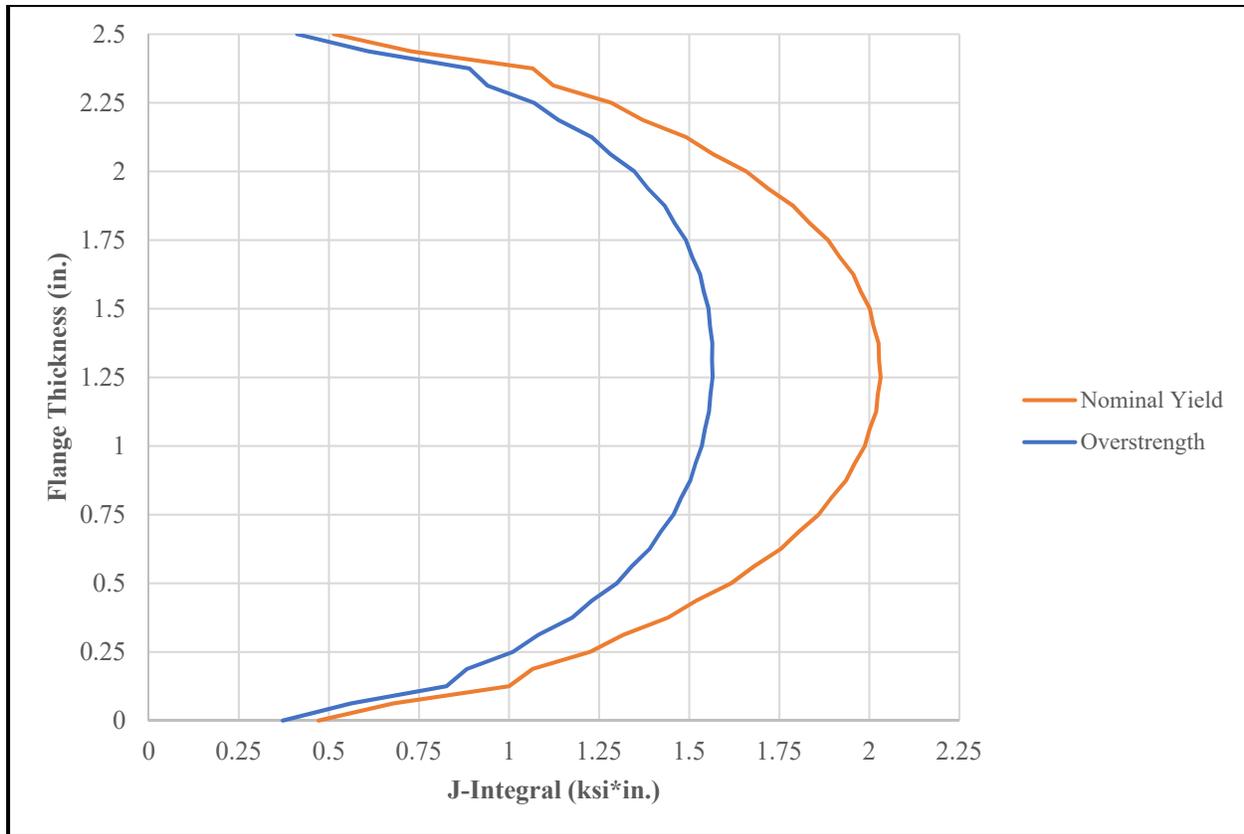
**Figure 4.24: Evaluation of overstrength factor**

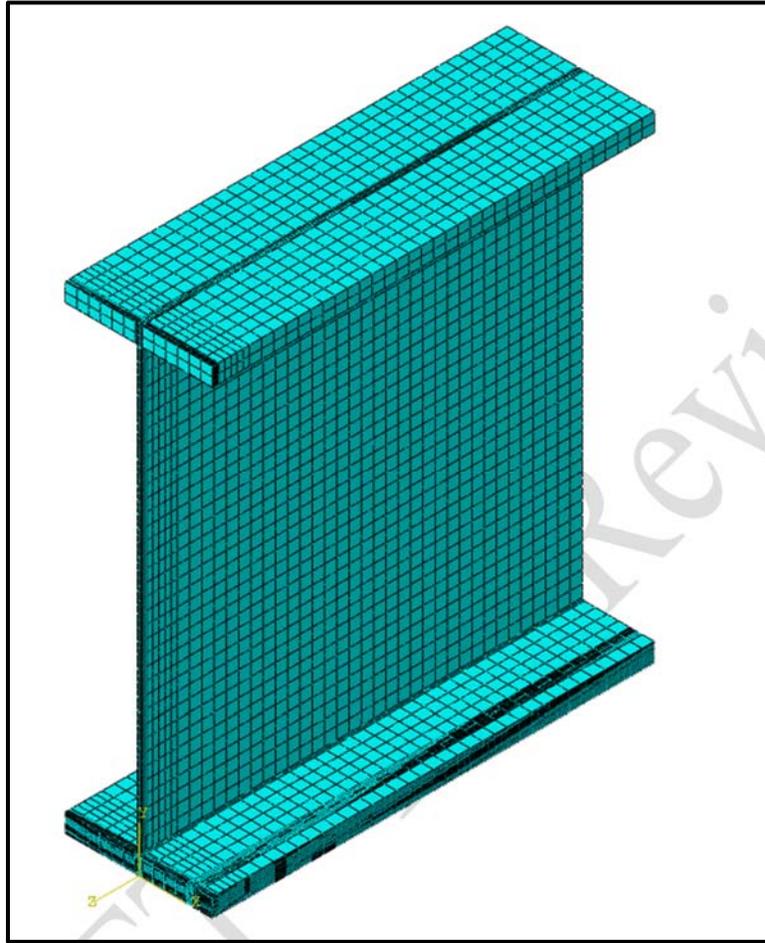
**Figure 4.25: Representative parametric study model**

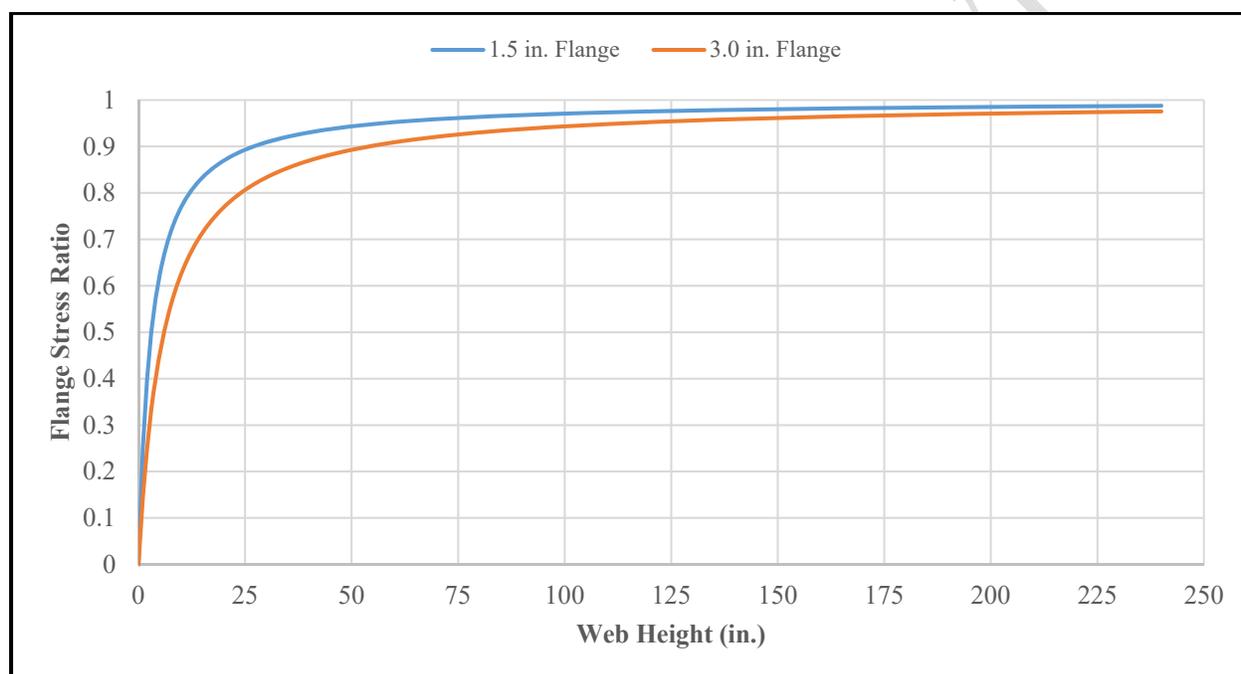
**Figure 4.26: Flange stress ratio**

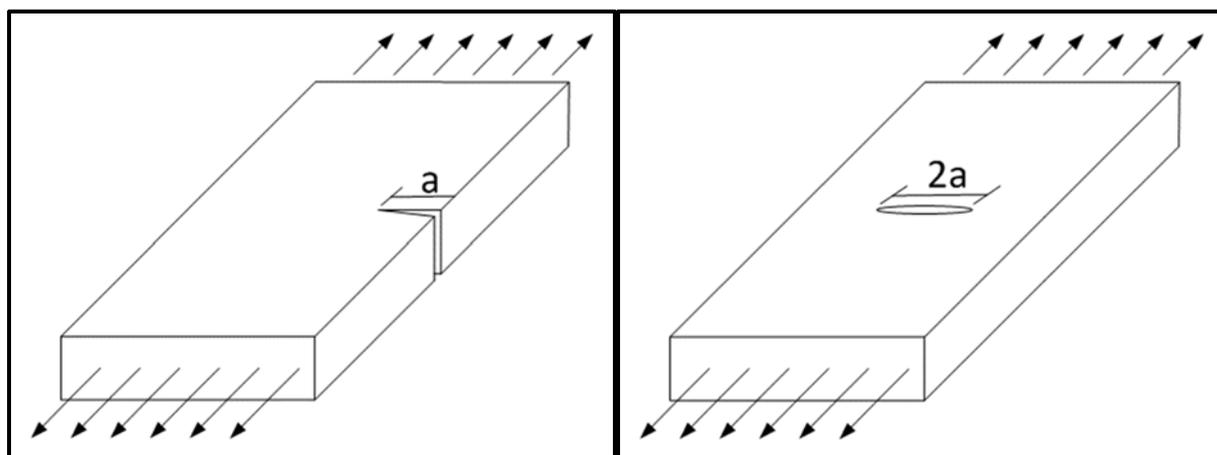
**Figure 5.1: Representative flanges with through-thickness edge (left) and center (right) cracks**
