# **NCAT Report 18-04**

# PHASE VI (2015-2017) NCAT TEST TRACK FINDINGS

**JULY 2019**

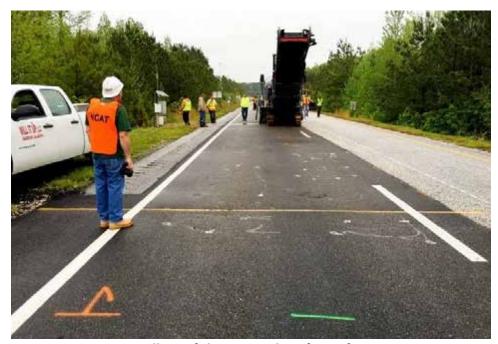
Figure 1 Milling of the Original Surface of Section N7

Repaving work started with the removal of the original pavement structure by milling on April 12, 2016, as shown in Figure 1. After compacting the aggregate base and verifying density requirements were met, paving of the base and intermediate asphalt courses started on April 13, 2016 (Figure 2). The surface layer of Section N7 was completed on April 15, 2016.

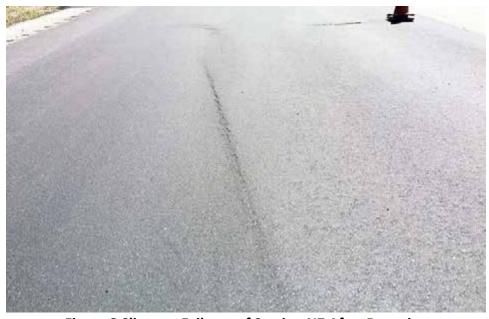
Figure 3 Slippage Failures of Section N7 After Repaving

Within one day after the first repave of Section N7 was complete, slippage failures were observed. Figure 3 shows one of the slippage failures seen at this stage. Observation of the asphalt mixture after peeling from its surface with a skid steer revealed an oily and wet interface between the surface and binder layers with an asphalt mixture that was softer than usual and was easily broken, as shown in Figure 4.

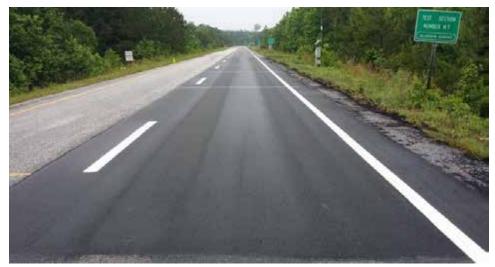
Figure 7 Section N7 After the Second Repave

After discussions with the sponsor, it was decided that the interaction between Delta S and the aged binder in the RAS should be further studied and that the wearing course of Section N7 would be replaced with a mixture containing only RAP materials. This mix would have 35% RAP with a recycled binder ratio similar to those of the original N7 and N8 surface mixes. Because this new design did not include RAS (even though it had a similar recycled binder ratio), the Delta S dosage was reduced to 5% by weight of the aged RAP binder, which was 5% lower than the dosage used in the original N7 mix with 20% RAP and 5% RAS. The N7 surface mixture was designed to compare directly with the N1 surface mix, which is the control mix for the Cracking Group experiment. Finally, it was determined that the mixture would be kept in a silo for two hours before paving. The second repave of Section N7 was started the week of May 9th, 2016. By May 12th, work was finished and trafficking was resumed. Figure 7 shows Section N7 after the second repave.

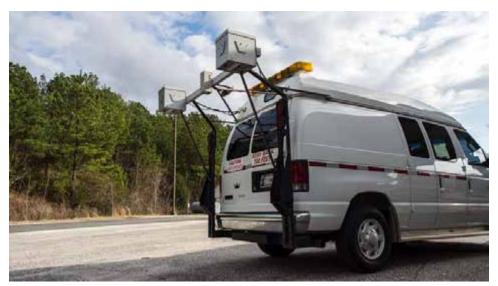
Figure 9 Inertial Profiler Used to Assess Ride Quality and Rutting Measurement

The Test Track produces an accelerated accumulation of traffic-produced damage over a reduced time. For each research cycle, 10 million ESALs are applied and pavement responses are constantly monitored. Traffic is suspended each Monday and the pavement sections are measured for ride quality, rutting, and cracking performance. Ride quality and rutting are measured with a Dynatest inertial profiler, shown in Figure 9, which determines the international roughness index (IRI) of each section. For cracking performance, sections are inspected visually, and when observed, cracks are mapped and measured (Figure 10). Cracks are considered to have an area of influence that is 6 inches to each side. Linear measurements of the cracks are performed to determine the cracked area of the sections. With these measurements, cracking is then calculated based on the percent lane area of each section.
