TRANSPORTATION POOLED FUND PROGRAM QUARTERLY PROGRESS REPORT

Transportation Pooled Fund Program Project # <i>(i.e., SPR-2(XXX), SPR-3(XXX) or TPF-5(XXX))</i> <u>TPF 5-436</u>		Transportation Pooled Fund Program - Report Period: <input type="checkbox"/> Quarter 1 (January 1 – March 31) <input checked="" type="checkbox"/> Quarter 2 (April 1 – June 30) <input type="checkbox"/> Quarter 3 (July 1 – September 30) <input type="checkbox"/> Quarter 4 (October 1 – December 31)	
Project Title: Development of Criteria to Assess the Effects of Pack-out Corrosion in Built-up Steel Members			
Name of Project Manager(s): Tommy E. Nantung		Phone Number: (765) 463-1521 ext. 248	E-Mail tnantung@indot.in.gov
Lead Agency Project ID:		Other Project ID (i.e., contract #):	Project Start Date: 9/1/2019
Original Project End Date: 8/31/2022		Current Project End Date: 8/31/2022	Number of Extensions: None

- 1) To develop AASHTO ready specifications for the evaluation of the effects of pack-out corrosion in built-up steel tension, compression, and flexural members.
- 2) Provide guidance on the need for repairs and corrosion rates that can be expected in various environments in order to assist owners in progra

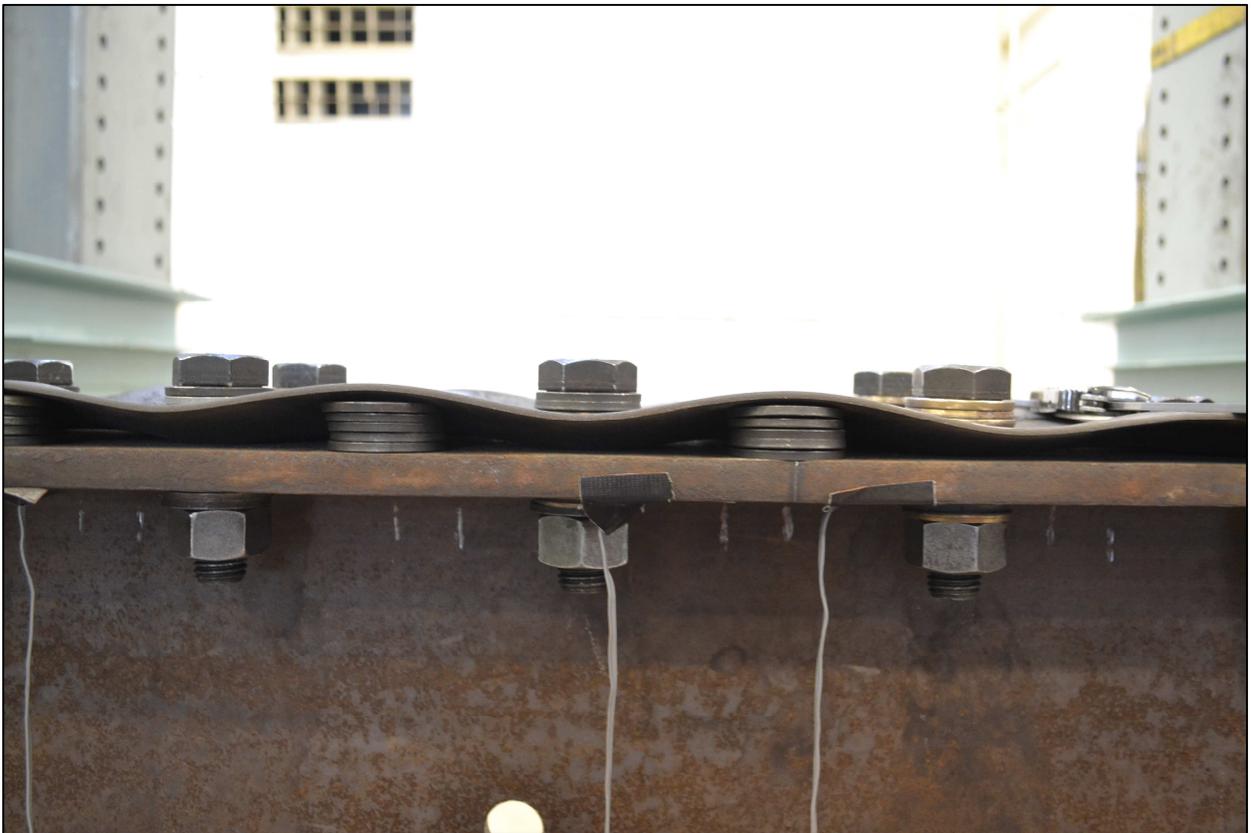
Figure 2 – Photographs of Specimen 3 showing simulated pack-out distortion and section loss. There was no load applied when this photograph was taken.

- Prototype testing focused on the compression flange of a beam is complete. Three tests in total have been performed, with two during the last quarter. Specifically, the second test included a girder with simulated section loss with no simulated distortion (See Figure 1) and a third specimen which included a cover plate having simulated section loss and with simulated pack out distortion (See Figure 2). The section loss was simulated by machining material away in a profile similar to what has been measured from real specimens. (See Figure 3)

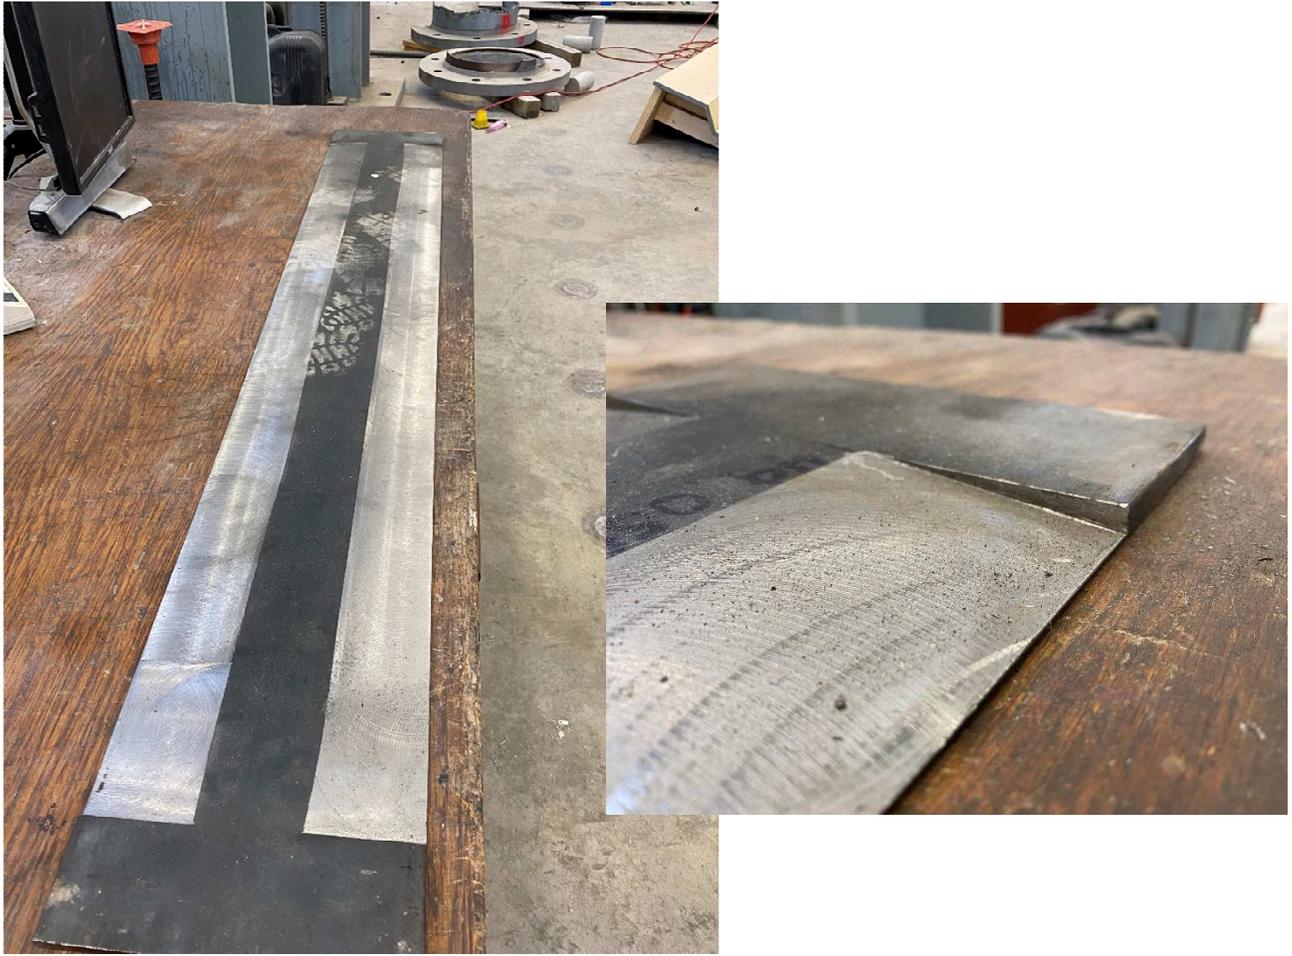
Figure 3 – Photograph of portion of coverplate in which edges are machined away to simulate section loss. The plate was originally 3/8 inches thick and is machined down to 1/8 inch at tips. Middle third is full thickness of 3/8 inch. Extension plates are then CJP welded onto each end so that the plate will run full length of the specimens.

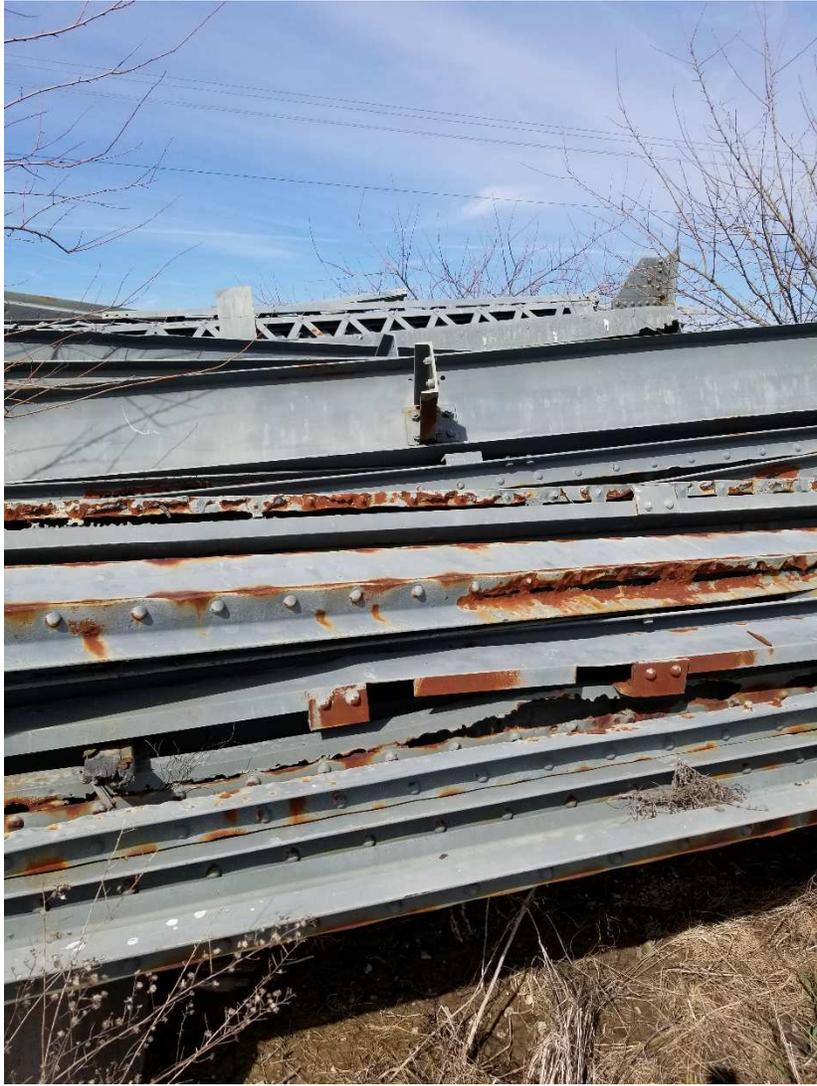
Figure 4 - Typical truss members obtained from INDOT with “real” pack-out and section loss

- An entire truss has been obtained from INDOT which *included* members with moderate to severe pack-out that has been taken out of service. (See Figure 4 for a photograph of some typical members with section loss and pack-out). Work is underway to develop tests which will utilize these members to evaluate the strength as well as fatigue/fracture performance.
