Technical Memorandum

Re. Forensic Desktop Study Report: California LTPP Test Section 06_7452

ATTACHMENT A. PAVEMENT CORES FROM SECTION 06_7452 OBTAINED IN FEBRUARY 2020.

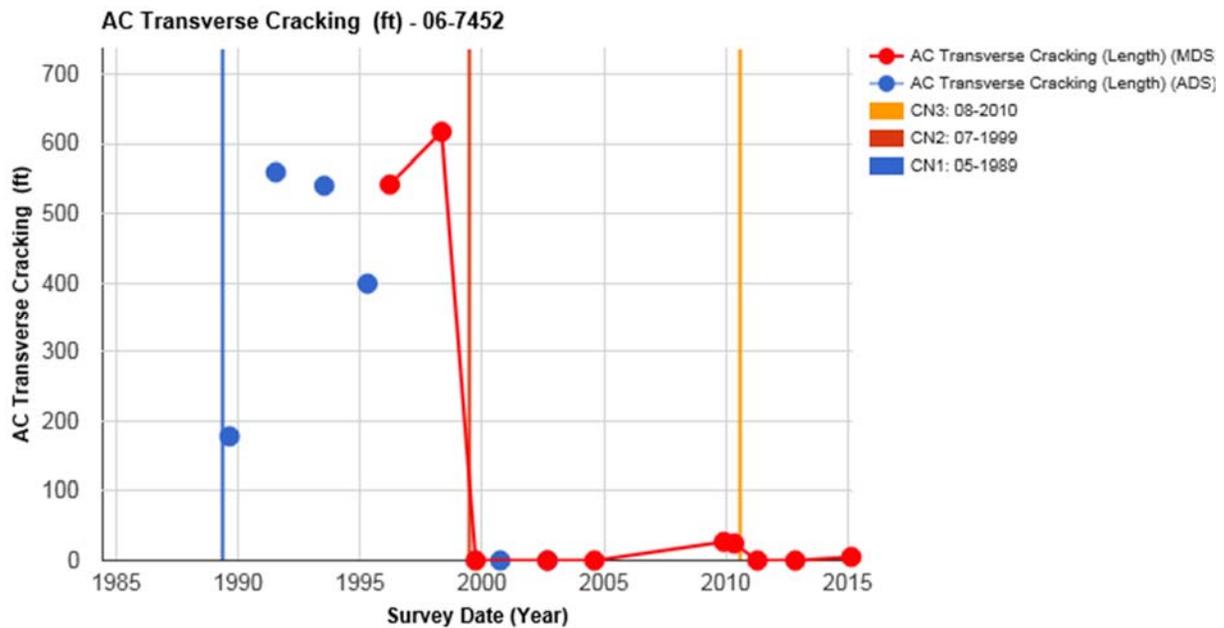
Figure 6. Time history of the length of transverse cracks.

Figures 5 and 6 show the time history of the number and length of transverse cracks. As shown in these two figures, the number of transverse cracks increases from 39 in 1989 to 100 in 1998, while the length of that cracking increases from 195 ft to 610 ft over the same time period. This would support the earlier theory that the backcalculated layer moduli for the lean concrete appears reasonable if the layer has developed a network of transverse cracks, which appears to be the case. It also supports the theory that the 1989 modulus value is high because the extent of transverses cracking had not yet fully developed, which again is supported by the transverse cracking data.

Figures 5 and 6 also show that the amount of transverse cracking remained very low after the application of the 1999 AC overlay; i.e., the transverse cracking did not reflect through either the 1999 or 2010 AC overlays. This raises an important issue that, if possible, needs to be investigated: why did transverse cracking reflect from the lean concrete base through the original AC surface layer, but not the overlays? One option, for example, would be to core at locations where transverse cracks were observed at the end of the CN = 1 period, but where transverse (reflection) cracks were not observed after placement of the first AC overlay in 1999.

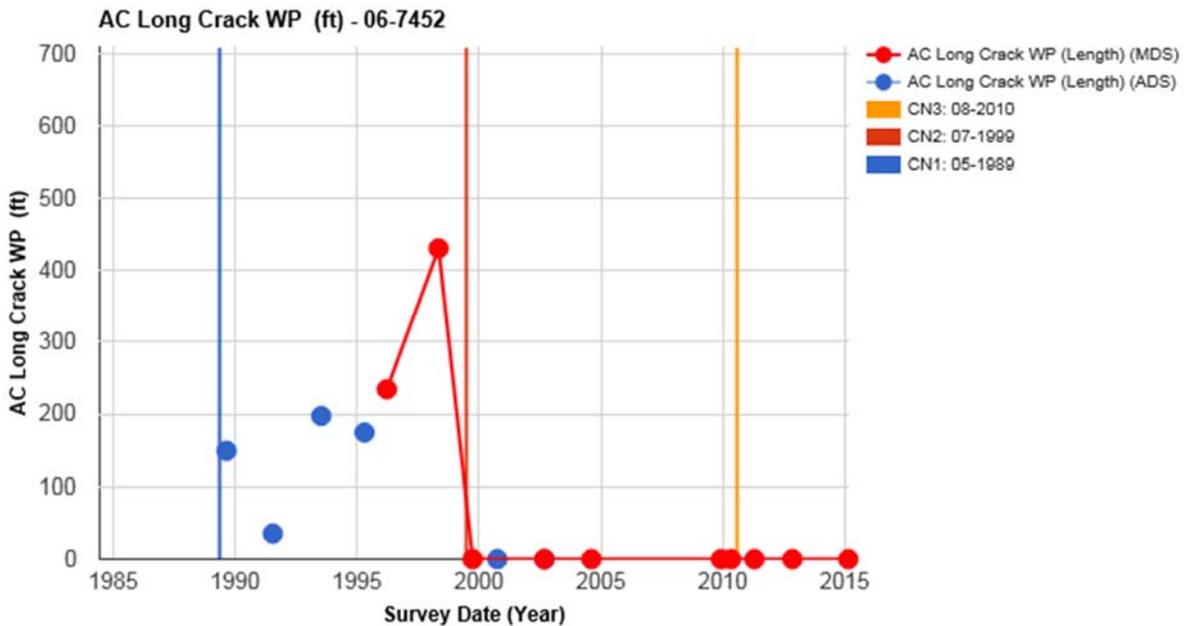
Figure 9. Time history of WP longitudinal cracking.

Figure 9 shows the time history plot of longitudinal cracking in the wheel path (WP). As indicated earlier, WP longitudinal cracking has the reverse trend of alligator cracking during the CN = 1 period, which appears to be related to changes in the rating of these two distress types in the early years of the LTPP

program. After application of the 1999 AC overlay, WP longitudinal cracking was eliminated and it has not re-appeared through 2015, which is when the last distress survey was performed.

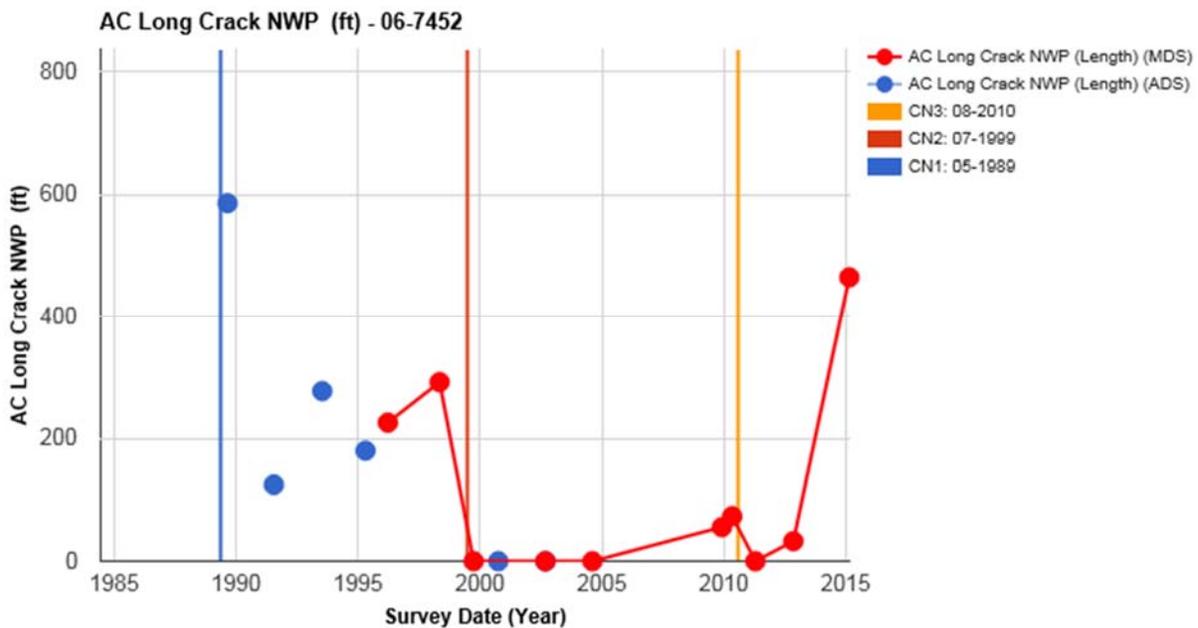
Figure 10. Time history of NWP longitudinal cracking.

Figure 10 shows the time history plots of longitudinal cracking not in the wheel path (NWP). The trend in NWP longitudinal cracking during CN = 1 appears odd (decreasing with time), but this is simply the effect of a high value (586 ft) in 1989, and then dropping to values between 125 ft and 292 ft during the 1991 to 1998 time period. It is possible that the high initial value of 586 ft in 1989 is influenced by:

- How the cracks at the lane edge were judged, i.e., there were changes in the way these cracks were rated over the years.
- Width of the distress survey which changed from 14.8 ft in 1989 to 13.8 ft in 1991, 13.0 ft in 1993, and 12.5 ft in 1995.

Moreover, without the 1989 value, the test section would show a more logical trend that increases with time, reaching a maximum value of 292 ft in 1998, prior to application of the 1999 AC overlay. After the overlay, NWP longitudinal cracking remained low, only reaching a maximum value of 74 ft prior to application of the 2010 AC overlay. Starting in 2011, however, NWP longitudinal cracking re-appears and its presence accelerates, reaching a value of 465 ft in 2015.
