## Technical Memorandum

**Re.** Forensic Desktop Study Report: Texas LTPP Test Section 48\_1096

LTPP test section 48\_1096 is located on U.S. 90, westbound, in Medina County, Texas. U.S. 90 is a rural principal arterial with two lanes in the direction of traffic. It is classified as being in a Wet, No-Freeze climate zone with an average annual precipitation ranging between 14 inches (2011) and 52 inches (2007). The test section has an annual average air freezing index ranging between 0 deg-F deg-days (multiple years) and 47 deg-F deg-days (1989) during the performance period in question. The coordinates (in degrees) of the test section are 29.3559, -98.83502. Photograph 1 shows the test section at Station 0+00 looking westbound in 2017, while Map 1 shows the geographical location of the test section relative to San Antonio, Texas.

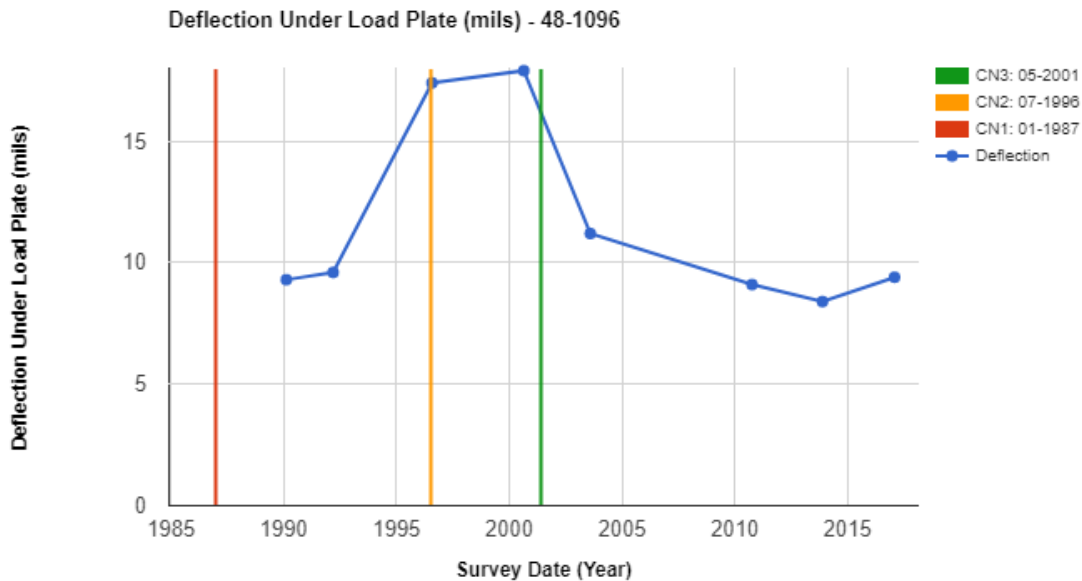
**Figure 1. Time history of average deflection for the sensor located in the load plate normalized to 9,000 lb. drop load.**

Figure 1 shows the average Falling Weight Deflectometer (FWD) deflection under the nominal 9,000-pound load plate over time. The deflection of the sensor located in the center of the load plate is a general indication of the total “strength” or response of all layers in the pavement structure to a vertically applied load. This deflection can be influenced by pavement temperature at the time of testing, precipitation, and moisture to name a few of the main factors. As depicted in Figure 1, the deflections observed on the site fluctuate over time. The reported deflections at the load plate are highest in June 1996 (17.4 mils) and August 2000 (17.9 mils), which correspond to high temperature (86°F) collection dates as depicted in Table 4. The next highest temperature (84°F) collection date occurred in August 2003, but the deflection observed was significantly lower (11.2 mils); however, this is likely the direct result of the 2.3 inch AC overlay applied in June 2001, which provided increased structural capacity. Overall, the measured deflections ranged between 8.4 and 17.9 mils from 1990 to 2017.

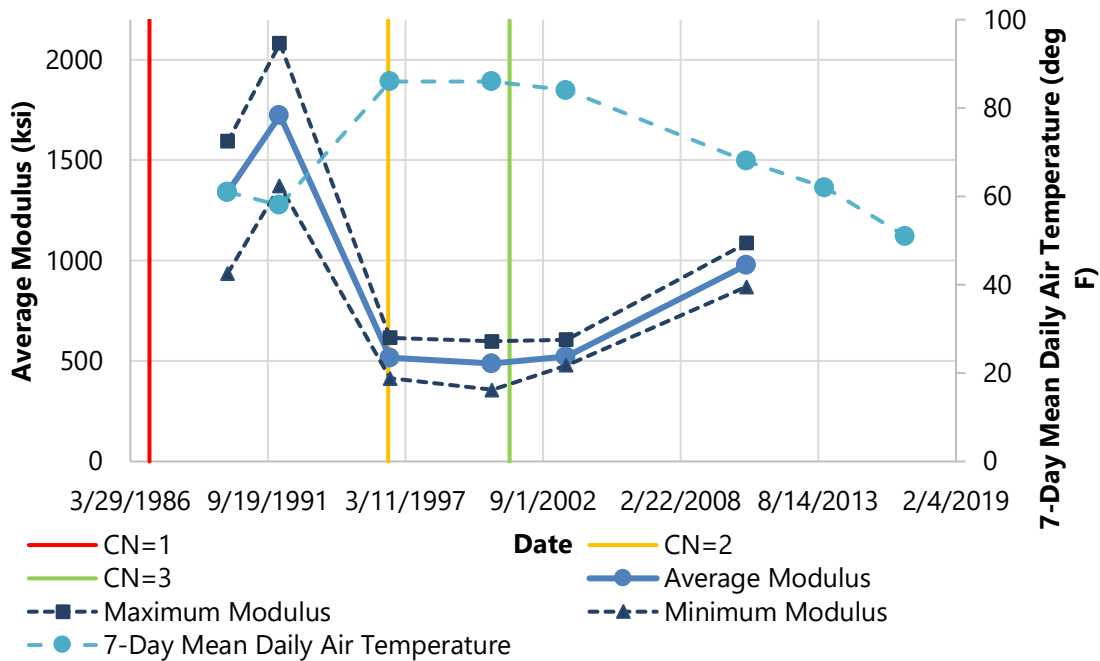
**Figure 2. Average backcalculated modulus for AC layer (Layer 1).**

Figure 2 shows the backcalculated AC layer moduli as well as the 7-day mean daily air temperature. As shown, the values range between 490 and 1,750 ksi, which appears to be quite reasonable. Moreover, there is a clear relationship between AC layer modulus and temperature – as the temperature goes up the modulus go down and vice-versa. The three lowest AC moduli (between 490 and 530 ksi) were backcalculated for the three test dates with the highest temperatures (between 84 and 86°F). Similarly, the two highest AC layer moduli (1,750 and 1,340 ksi) correspond to the two testing dates with the lowest temperatures (58 and 61°F).

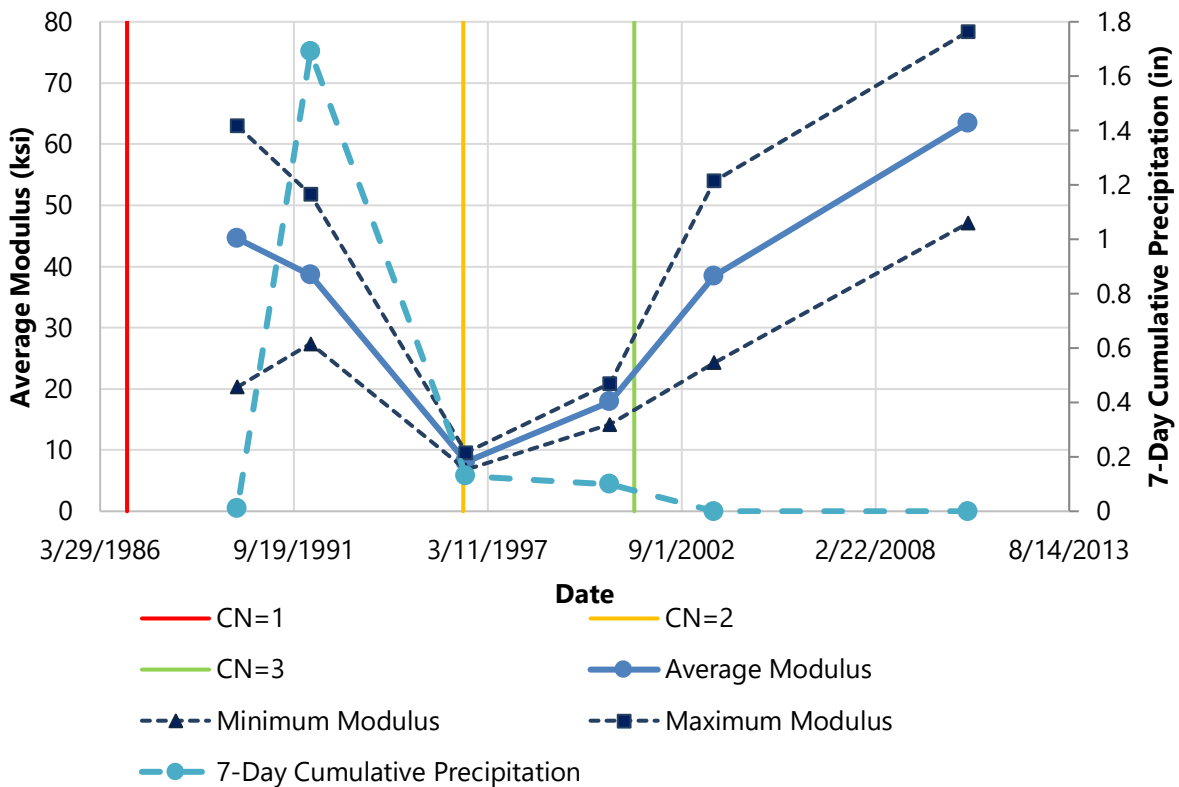
**Figure 3. Average backcalculated modulus for granular base (Layer 2).**

Figure 3 shows the backcalculated unbound granular base layer moduli as well as the cumulative precipitation on the seven days leading up to the test date (based on VWS data). As shown, layer moduli range between 8 and 63 ksi, which like the backcalculated AC layer moduli, appear quite reasonable. This is especially true when viewed in light of precipitation – in general, as precipitation decreases the backcalculated granular base layer moduli increases. For example, the highest moduli values (39, 45 and 63 ksi) occur when the 7-day cumulative precipitation is zero. The exceptions are in 1992 when a much lower moduli value would have been anticipated given the amount of precipitation and in 1996 when despite a low precipitation value the moduli did not substantially increase. Nonetheless, the results generally appear to be reasonable.

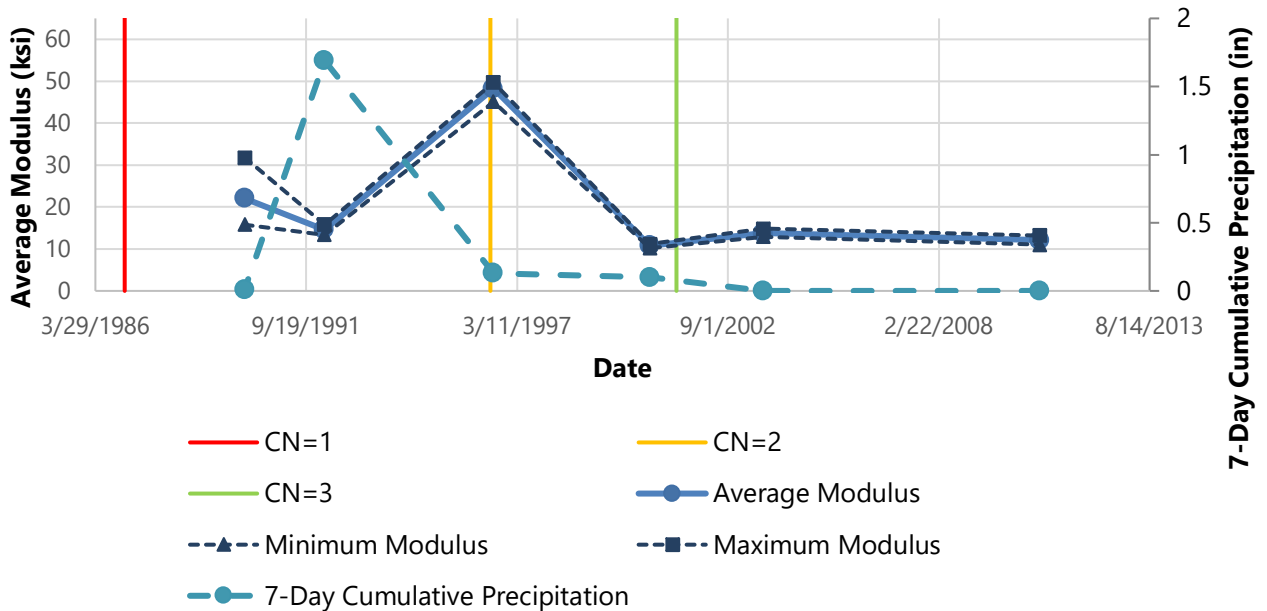
Figure 4. Average backcalculated modulus for fine subgrade (Layer 3).

Figures 4 and 5 show the backcalculated layer moduli for the top 30 inches of subgrade and for the subgrade below those 30 inches (assumed semi-infinite), respectively, as well as the cumulative precipitation on the seven days leading up to the test date (based on VWS data). For both layers the moduli vary over a small and reasonable range – about 11 to 15 ksi and 20 to 25 ksi, respectively. The most significant deviation occurs on the July 1996 testing date, when the modulus of the top 30 inches of

subgrade drastically increases to 48 ksi, while the value for the subgrade layer beneath significantly drops to 15 ksi. It is strongly suspected that this is the result of compensating layer moduli effects; i.e., during backcalculation one modulus value for one layer went up so the value of the other layer had to go down. The results also appear to indicate that the two subgrade layer moduli are not as sensitive to precipitation as was the case with the unbound granular base layer.

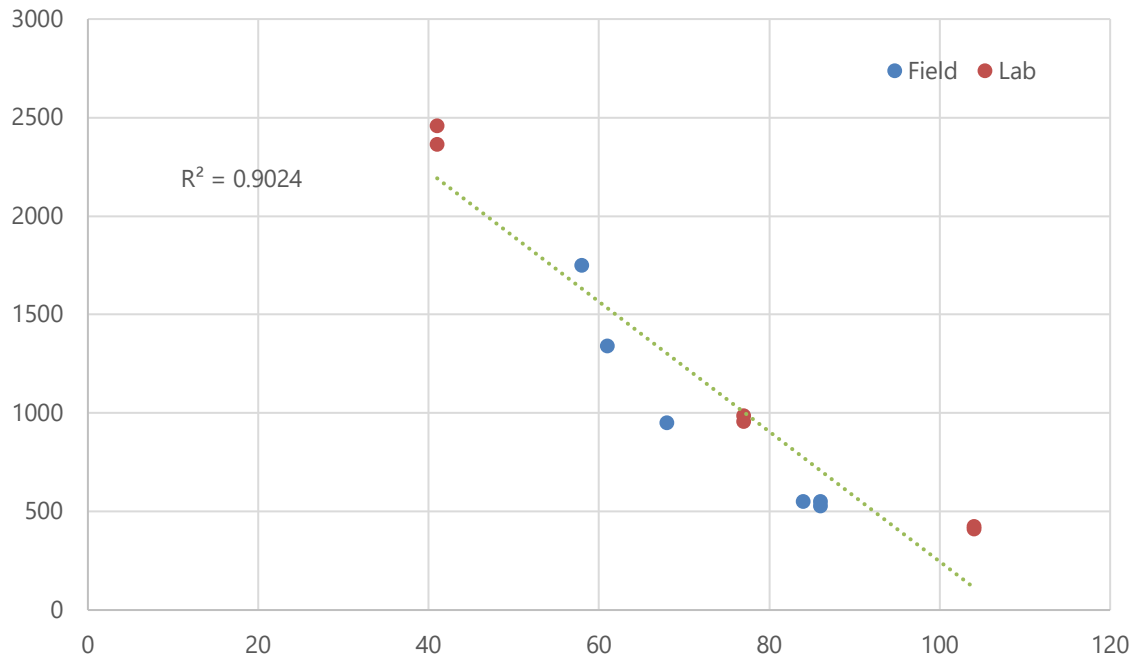
**Figure 6. Field- and lab-derived AC resilient modulus values.**

As shown in Figure 6, the AC modulus versus temperature relationship for the field- and lab-derived resilient modulus is excellent – i.e., the trend defined by the two datasets appears to be very reasonable. Similarly, the field- versus lab-derived resilient moduli for the granular base and subgrade layers moduli also appear to agree well. For the granular base layer, the field-derived values range between 8 and 63 ksi, while those from the lab range between 13 and 81 ksi. In the case of the subgrade layer, the field-derived values range between 10 and 50 ksi versus 5 to 13 ksi from the laboratory testing. A more precise comparison of the layer moduli for the unbound granular layers was considered beyond the scope of this study and hence it was not pursued. Such comparison would require (1) the computation of the universal resilient modulus equation coefficients (K1, K2 and K3) based on lab measured moduli at various stress states, (2) the estimation of the stress states for the pavement structure in question and assumed load(s) (e.g., 9,000 lbs), and (3) the computation of the representative modulus of the granular base and subgrade layers.

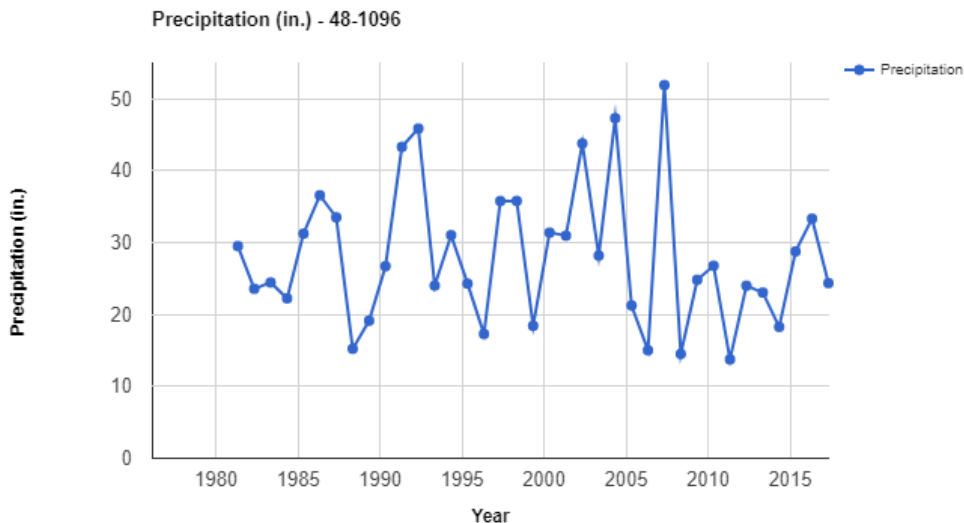
**Figure 7. Average yearly precipitation over time.**

The time history for average annual precipitation (from MERRA) since 1981 is shown in Figure 7. In 2007, the amount of precipitation appears to be a local high (52 inches), while the low (14 inches) was recorded in 2011. The mean precipitation recorded at the site is 28 inches for the period shown in Figure 7; in general, less precipitation was reported following 2007. While there are high amounts of precipitation reported on this section, no specific annual precipitation events are notable. Instead, the high amounts of precipitation reported near the test section is likely a result of recurrent storms that occur in this area. In addition to the reported precipitation, it was also noted there is an irrigation system adjacent to the test section, which may also lead to increased moisture at the site.

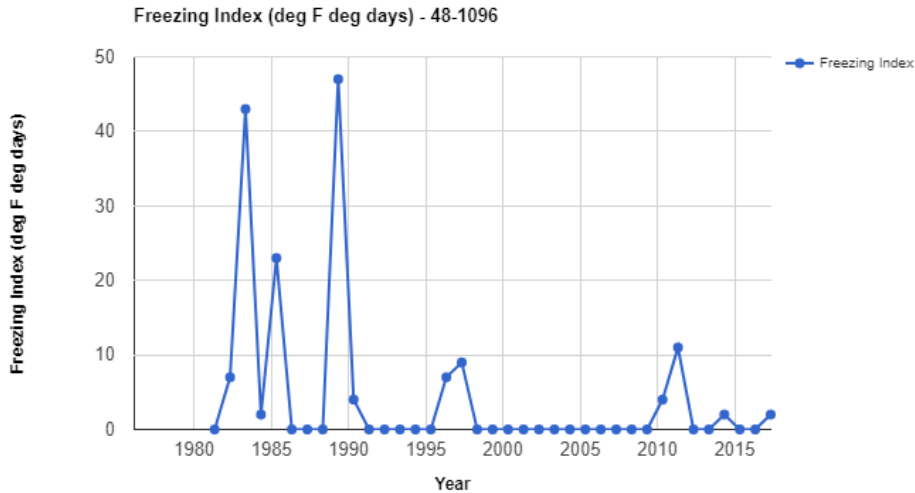
**Figure 8. Average annual freezing index over time.**

Figure 8 shows the time history of the average annual freezing index (from the MERRA) for the test site. The freezing index is the summation of the difference between freezing temperature and the average air temperature when it is less than freezing over a year’s time. This index is an indicator of the harshness of

the winter season relative to issues such as ground frost and low temperature cracking in pavements. As depicted in Figure 8, the freezing index values ranged from 0 (multiple years) to 47 (in 1989)—which is well below the 150 deg F deg days used to classify a freeze region—indicating it is not a likely factor negatively affecting test section performance.

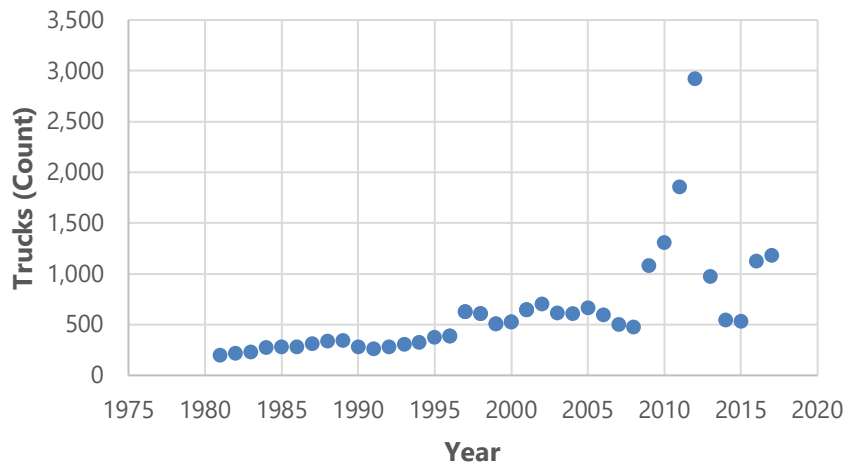
**Figure 9. Average annual daily truck traffic (AADTT) history.**

Figure 9 shows the annual average daily truck traffic (AADTT) data in the LTPP test lane by year. The annual truck traffic counts increase from 203 in 1981 to 1,181 in 2017, or approximately 27 additional trucks per year. While there is a consistent increase in truck traffic along this section, a spike in truck traffic is observed in between 2008 and 2012. This spike may be related to unrealistic monitored class data which are used to calculate the AADTT during that period. The average number of ESALS reported on this section also increased over time. The number of ESALS increased from 44,250 in 1981 to 362,095 in 2017, or approximately 8,829 ESALS per year as depicted in Figure 10. The figure also depicts the number of cumulative ESALS over time. At the time of the overlay in 2001, a cumulative 3,044,910 ESALS were reported. By 2017, a cumulative 7,820,348 ESALS were reported—further confirming the pavement structure as constructed was oversized.

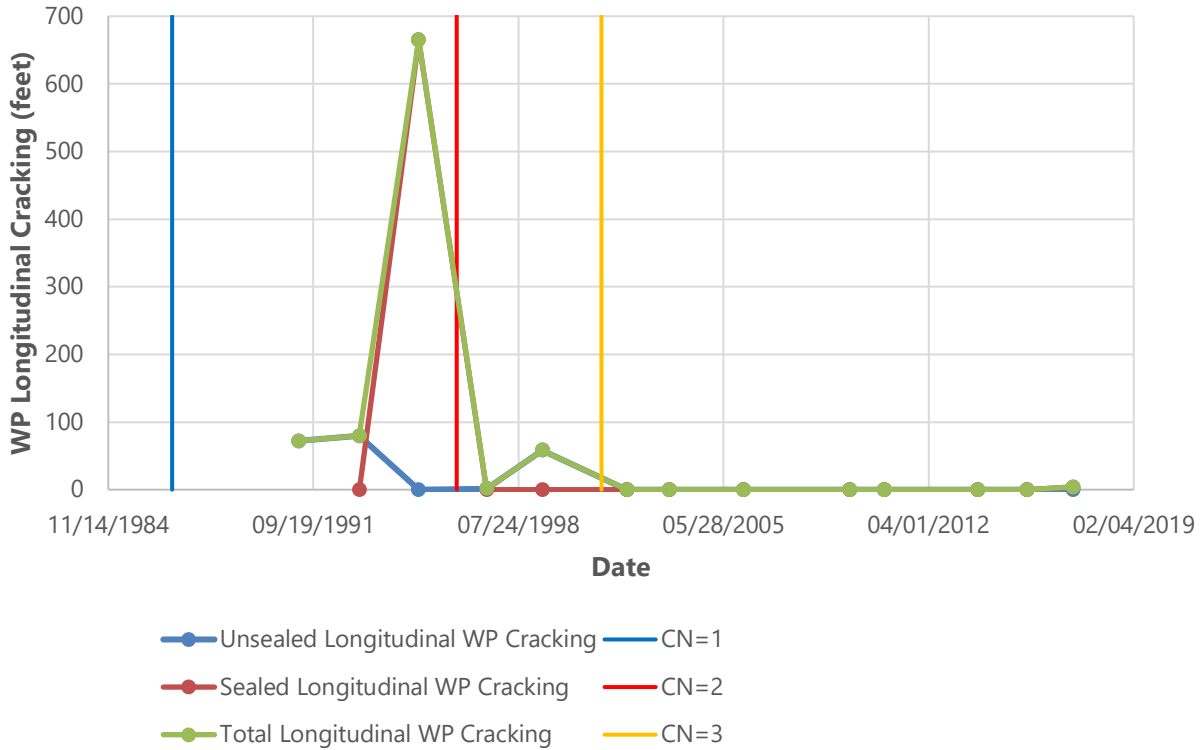
**Figure 13. Time history of the length of WP longitudinal cracks.**

Longitudinal cracking inside the wheel path (WP) appears along the section during the first reported manual distress survey in 1991, when 72 total feet of longitudinal WP cracking was reported. The amount

of WP longitudinal cracking continues to increase prior to the aggregate seal coat in 1996 (CN=2). Prior to the application of the chip seal, 665 feet of WP longitudinal cracking is observed on the section in 1995. Like NWP longitudinal cracking, the spike in WP longitudinal cracking reported in 1995 is likely the result of aggressive crack sealing applied between 1993 and 1995 as depicted in Figure 13. Based on the limited cracking observed in 1993, it is assumed the crack sealing applied during this time included areas of pavement that did not have cracking. Therefore, the spike in cracking during this period is related to an increase in sealed "cracks" rather than a spike in cracking. Following CN=2 in 1996, the WP longitudinal cracking observed on the section dropped to nearly zero (1.3 feet observed in 1997). Notable WP longitudinal cracking was not observed again until 1999, 3 years after the application of the chip seal, when 58 feet of WP longitudinal cracking was observed. After the application of the AC overlay in 2001, WP longitudinal cracking was not reported again until 2017, 16 years after CN=3, when 4 feet of WP longitudinal cracking was observed. In summary, other than the 1995 spike, limited WP and NWP longitudinal cracking has occurred on the test section.

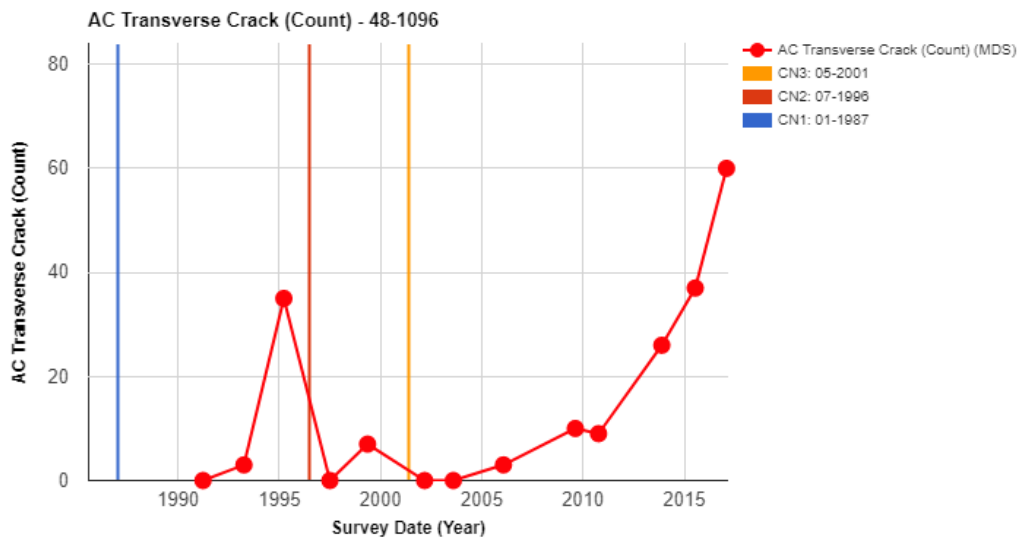
Figure 15. Time history of the number of transverse cracks.

Data on transverse cracking was collected between 1991 and 2017 as shown in Figures 15 and 16. Transverse cracking was first reported in 1993, 12 years after the construction of the test section, when 8 feet (3 cracks) of cracking was reported. The transverse cracking spiked in 1995 when 127 feet (35 cracks) of cracking was observed. Like longitudinal cracking, the spike in transverse cracking reported in 1995 is likely the result of aggressive crack sealing applied between 1993 and 1995. Based on the limited cracking observed in 1993, it is assumed the crack sealing applied during this time included areas of pavement that did not have cracking. Therefore, the spike in cracking during this period is related to an increase in sealed "cracks" rather than a spike in cracking.

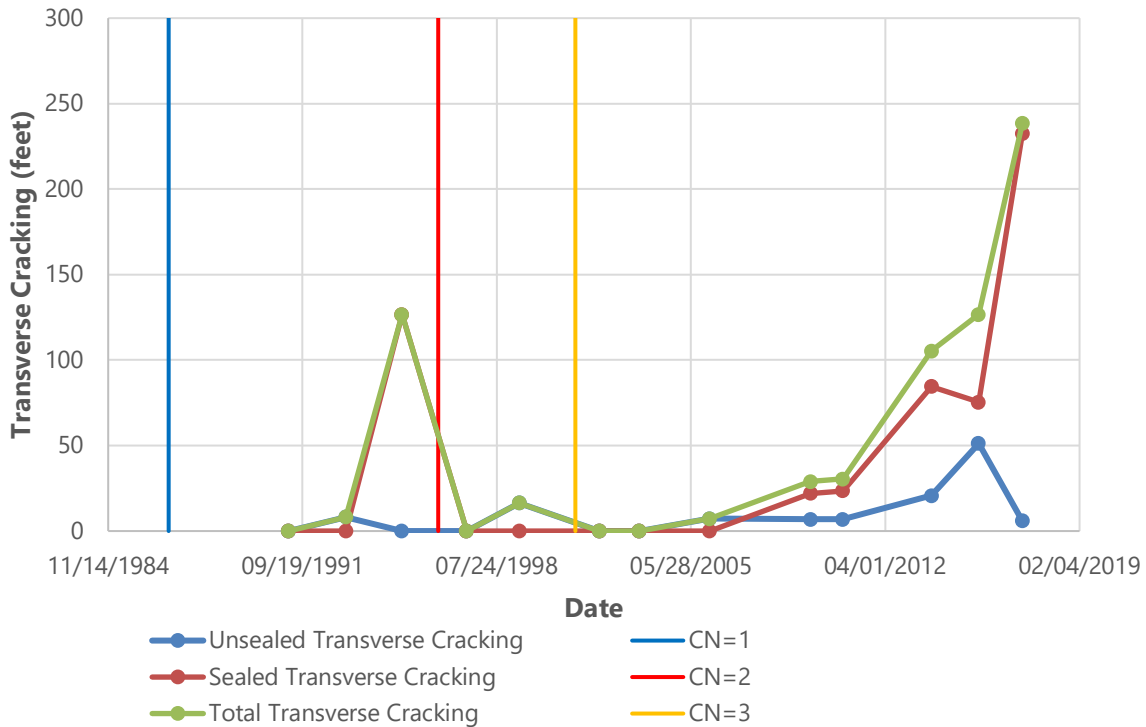
**Figure 16. Time history of the length of transverse cracking.**

Following CN=2 in 1996, no transverse cracking is observed again until 1999 when 16 feet (7 cracks) was observed. The transverse cracking observed drops to zero following the AC overlay in 2001. It is not until 2006, 5 years after CN=3, that 7 feet of transverse cracking (3 cracks) is reported. Once the cracking initiated, it propagated at a rate of 21 feet/year between 2006 and 2017. In 2017, 239 feet of transverse cracking was reported, which is the equivalent of a full transverse crack every 20 ft along the length of the test section.

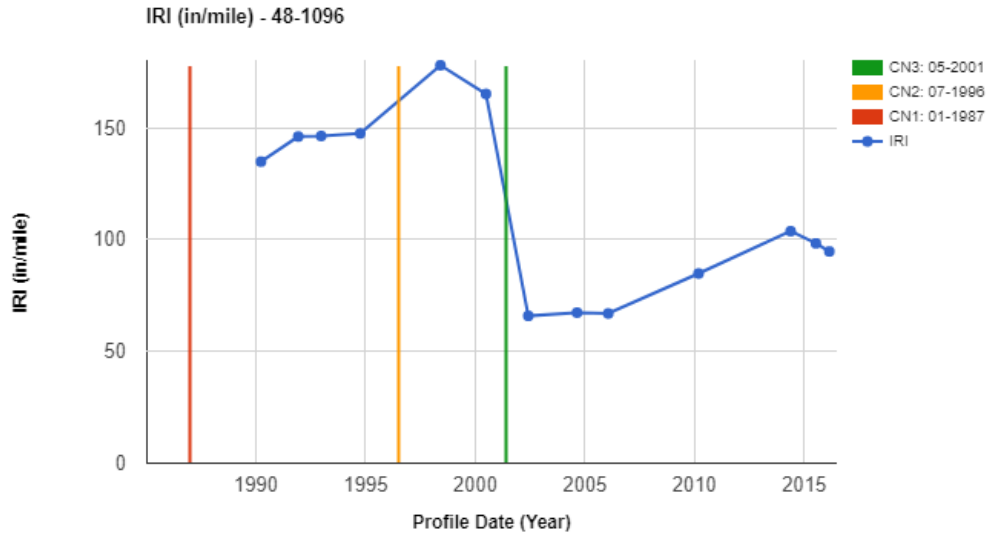
**Figure 17. Time history plot of pavement roughness.**

The average IRI measurements for the test section over time are shown in Figure 17. Prior to the AC overlay in 2001, the IRI reported on the test section increased from 135 in/mile in 1990 to 165 in/mi in 1998, at a rate of 3.75 in/mile/year. The pavement's IRI performance was classified as "Fair" based on FHWA performance definitions. Following the AC overlay in 2001, the IRI on the section dropped to 66 in/mile in 2002. The IRI reported subsequently increased to 95 in/mile in 2016, increasing at a rate of 2 in/mile over 14 years. The pavement's IRI performance was classified as "Good" during this period based on FHWA performance definitions.

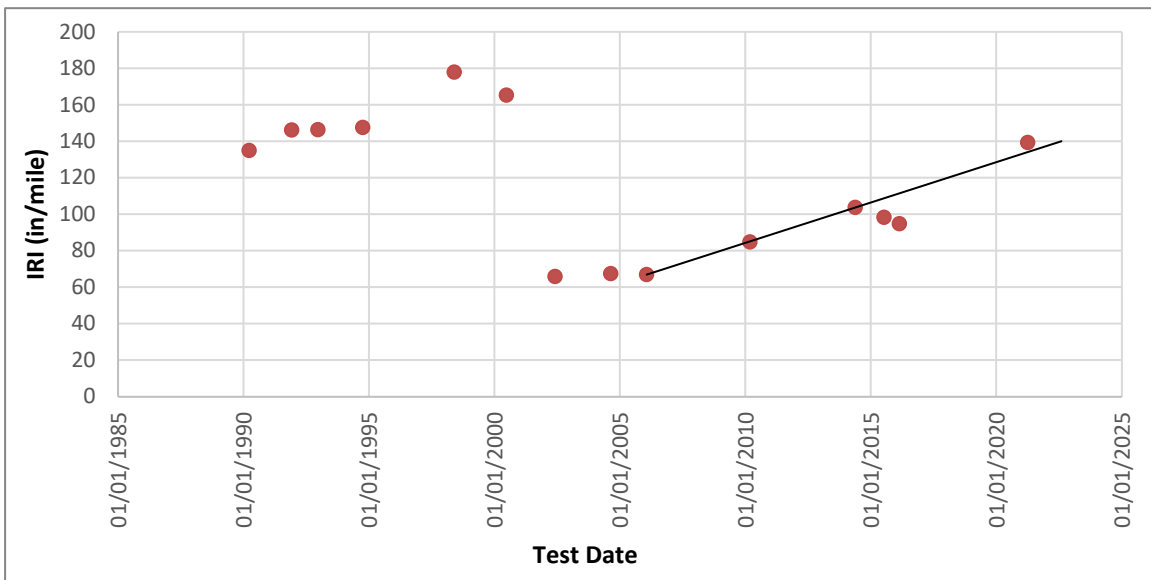
**Figure 22. IRI values over time.**

The distress data collected as part of the April 8, 2021 site visit is summarized in Table 8. The recent seal coat covered a lot of the existing distresses, though some of the cracking was visible in the seal coat and recorded. Therefore, the reductions in cracking between 2017 and 2021 were not unexpected. The IRI increased at a rate of 8.9 in/mile per year between 2016 and 2021, as shown in Figure 22. Given the consistent increase in the IRI values between 2006 and 2015, it is projected that the IRI will reach approximately 134 in/mile in 2021.

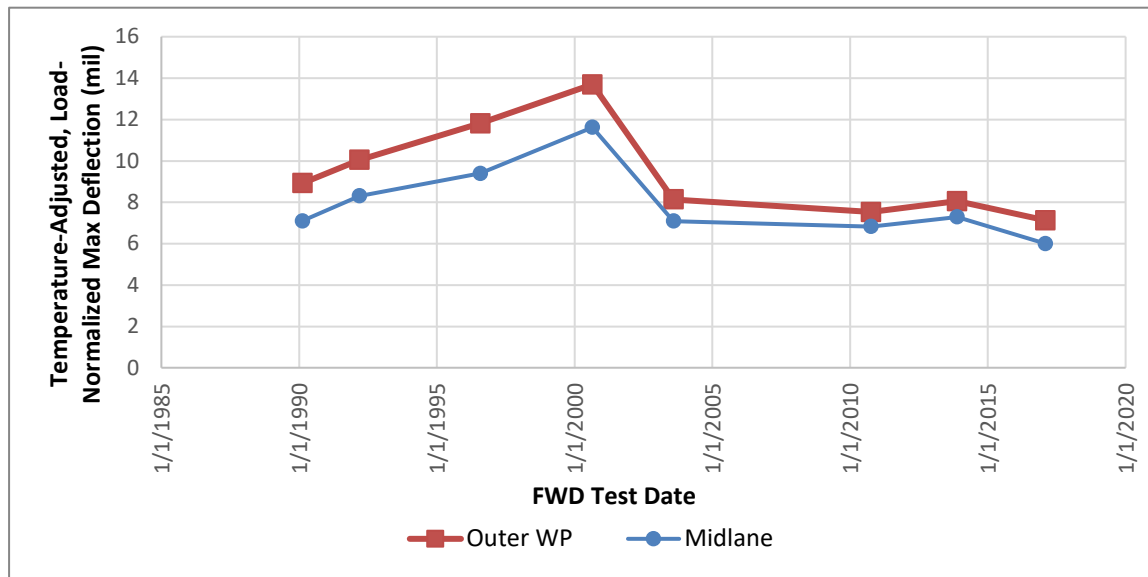
**Figure 24. Maximum deflections from OWP and Mid-lane on test section 48\_1096.**

FWD data for test section 48\_1096 were downloaded from InfoPave™. The maximum deflections were temperature-adjusted using Figure 5.6 of the AASHTO 1993 Guide and normalized to a 9,000 pound load. The results (Figure 24) showed that the deflections increased between 1990 and 2000 and the deflections in the outer wheel path (OWP) were on average 18% higher compared to the mid-lane deflections. This would indicate the pavement structure is stiffer in the mid-lane compared to the OWP.

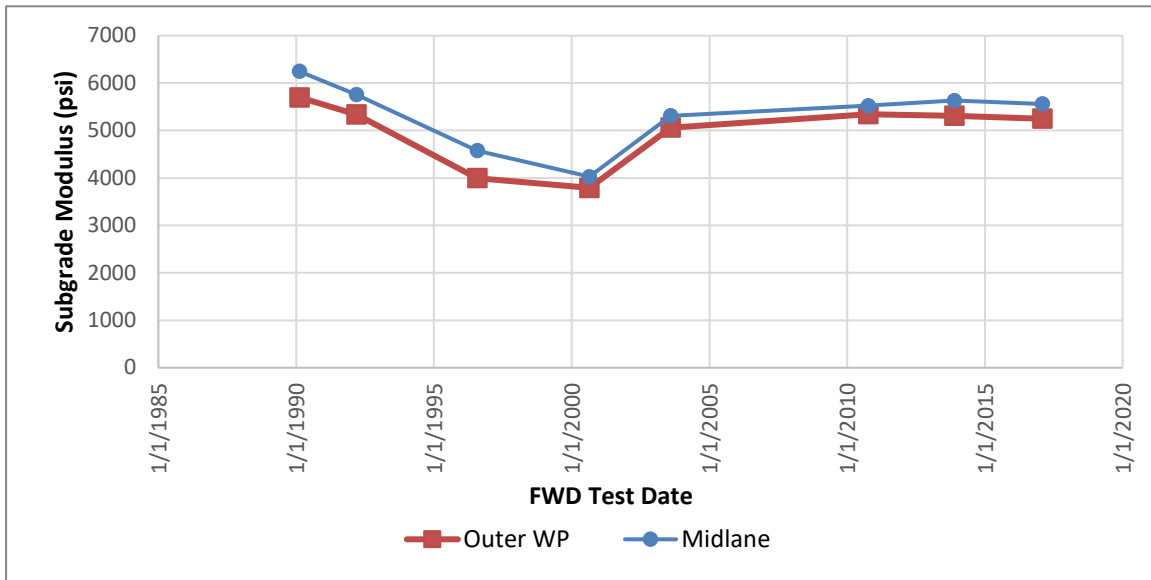
**Figure 25. Average subgrade modulus from OWP and Mid-lane on test section 48\_1096.**

The subgrade modulus values for both the OWP and mid-lane were also calculated, as depicted in Figure 25. The results show the subgrade modulus dropped between 1990 and 2000 and then increased and stabilized after placement of the 2001 overlay. Additionally, the data also showed that the subgrade modulus in the OWP was on average 7% lower compared to the midline subgrade moduli values.

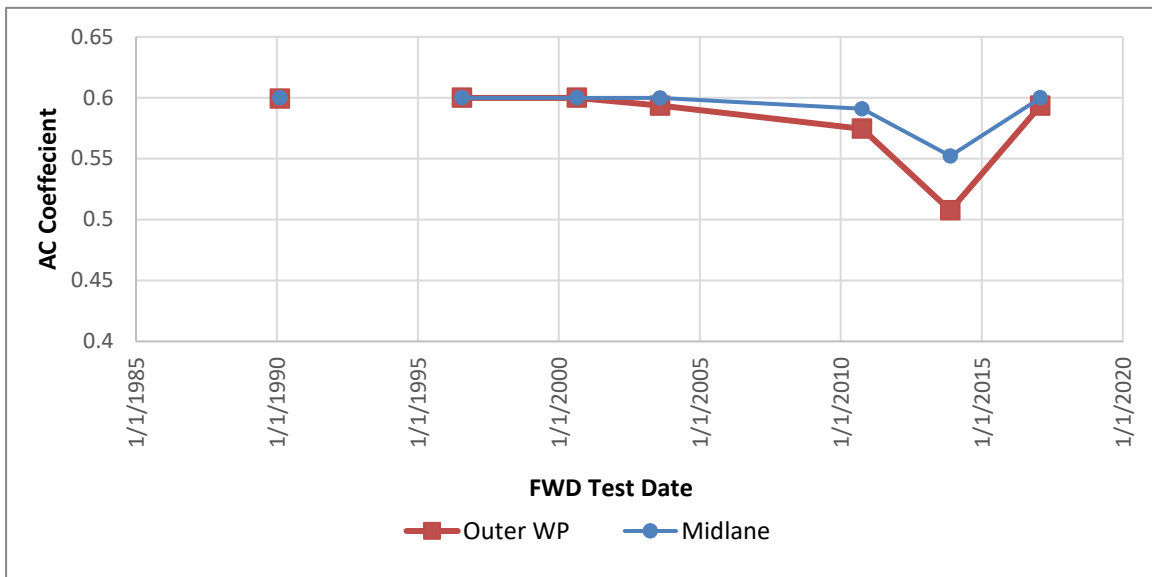
**Figure 27. Average AC layer coefficient.**

Figure 27 shows the average AC layer coefficient as calculated using the backcalculated moduli values and the AASHTO 1993 Guide to convert modulus to a layer coefficient. The layer coefficients were limited to a maximum value of 0.6 to prevent excessively high values. The results show the AC layer coefficient was very high prior to the AC overlay in 2001. In 2011, the AC layer coefficients began to drop and reached lower values in 2013 before jumping up in 2017. The results show the decreasing layer coefficient was lagging behind the development of fatigue cracking.

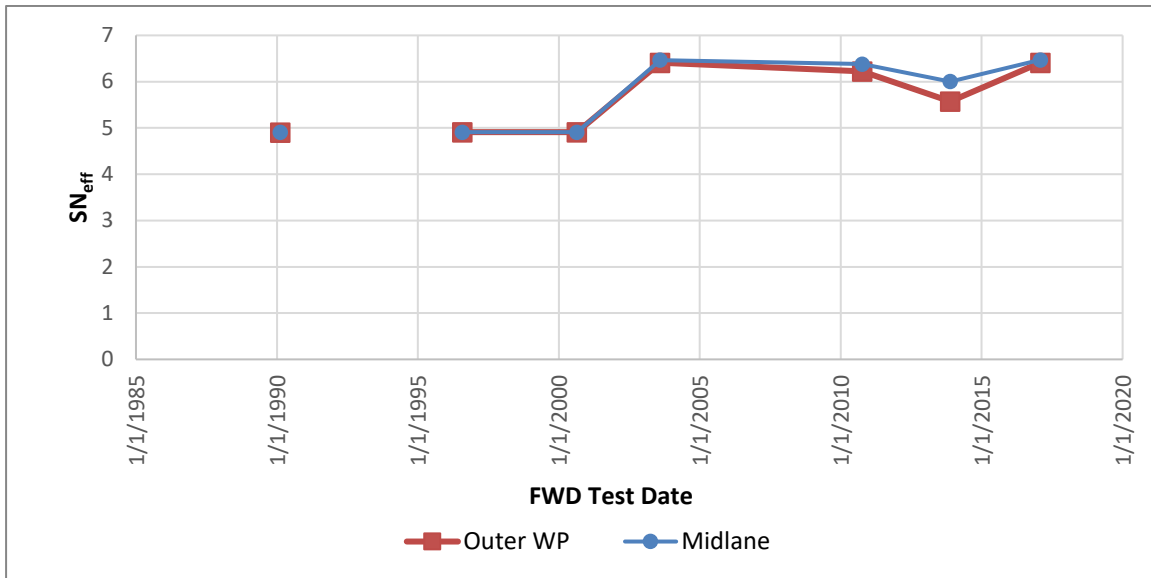
**Figure 28. Average effective structural number.**

Figure 28 shows the calculated effective structural number of the pavement as determined from the backcalculated moduli values. The results show the effective structural number remained relatively stable pre-overlay and then hovered around 6 after placement of the overlay. The structural number after placement of the AC overlay was higher than before the overlay, and as stated in the desktop study the original pavement appeared to be over-designed. Placement of the overlay has only increased the structural capacity, which would mean the cracking observed on the pavement surface is likely not full-depth structural cracking, but instead top-down cracking caused by a combination of AC oxidation, poor bonding between the overlay and the original AC surface, and the stresses resulting from tire-pavement interactions such as vehicle braking and accelerating.
