Report No. UT-002

**NON-DESTRUCTIVE AND
DESTRUCTIVE INVESTIGATION
OF AGED-IN-THE FIELD CARBON
FRP-WRAPPED COLUMNS**

New York State Department of
Transportation &
Utah Department of Transportation

October 2009

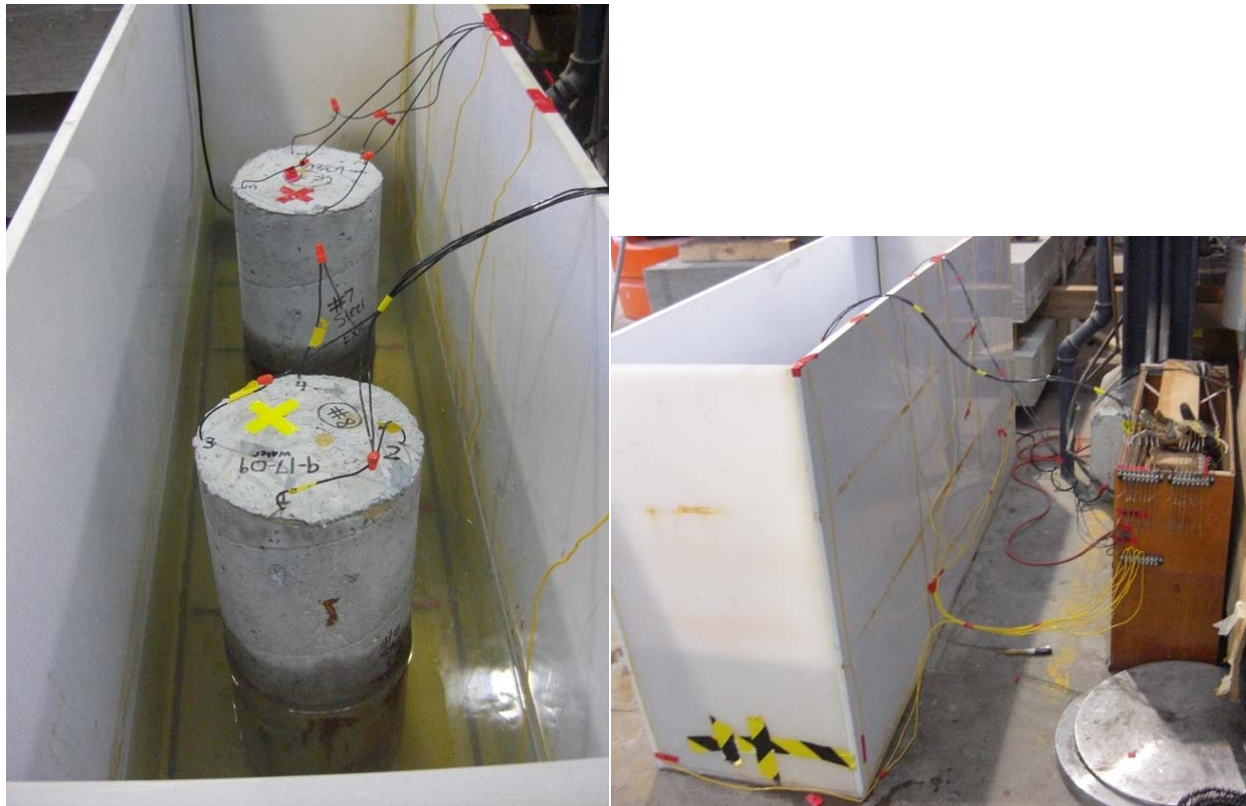
Figure 1. Corrosion system for small-scale steel reinforced columns.

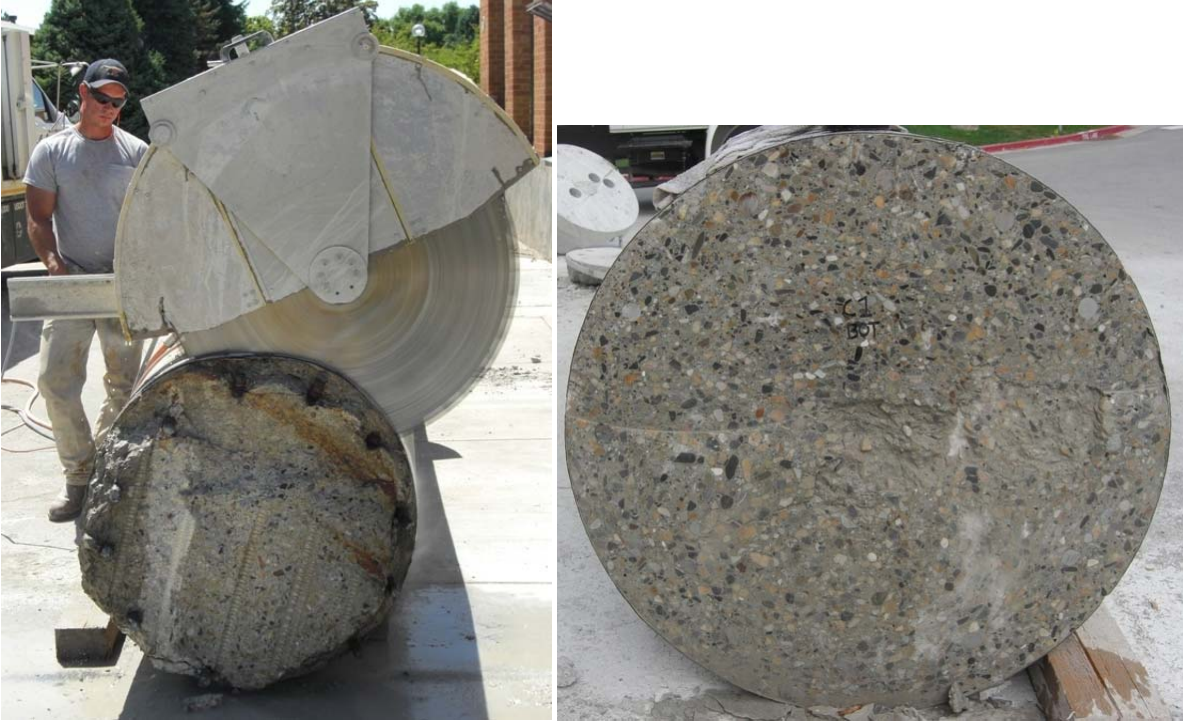
The two columns removed from the Highland Drive Bridge at I-80 in Salt Lake City, rehabilitated with carbon FRP composites, were saw-cut at their ends, on August 20, 2009, as shown in Figure 3. The saw-cut was performed using 36 in. diameter diamond blades with three movements of the location of the blade at approximately 120 degrees to be able to cut the 36 in. diameter column. The cut face of the top of one of the columns is also shown in Figure 3. The original specified concrete strength of the columns in the design drawings was 3000 psi.

Figure 3. Saw-cut of 36 in. diameter column from Highland Drive Bridge.

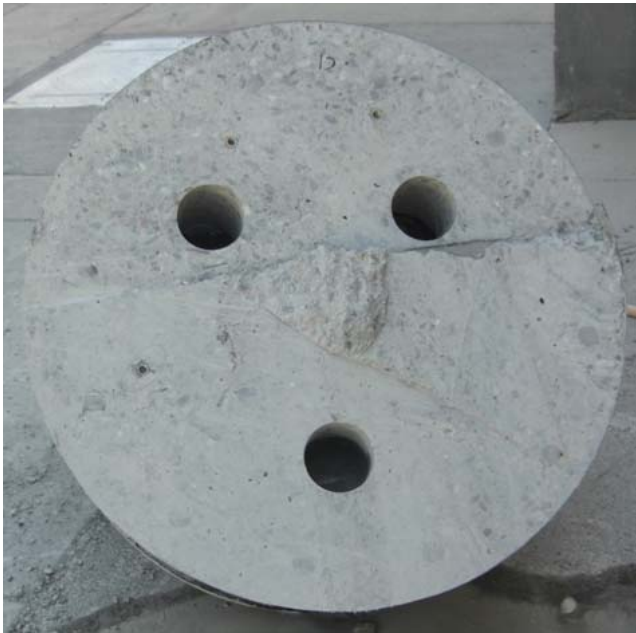
Concrete cores 4 in. in diameter were taken from the cut-off column sections, as shown in Figure 4, to determine the compressive strength of the concrete; this will be evaluated on the day of the axial load tests of the two full-scale columns.

Figure 4. Concrete cores from cut-off column section.
