Investigation of Deterioration of Joints in Concrete Pavements

National Concrete Pavement
Technology Center

Final Report
August 2012

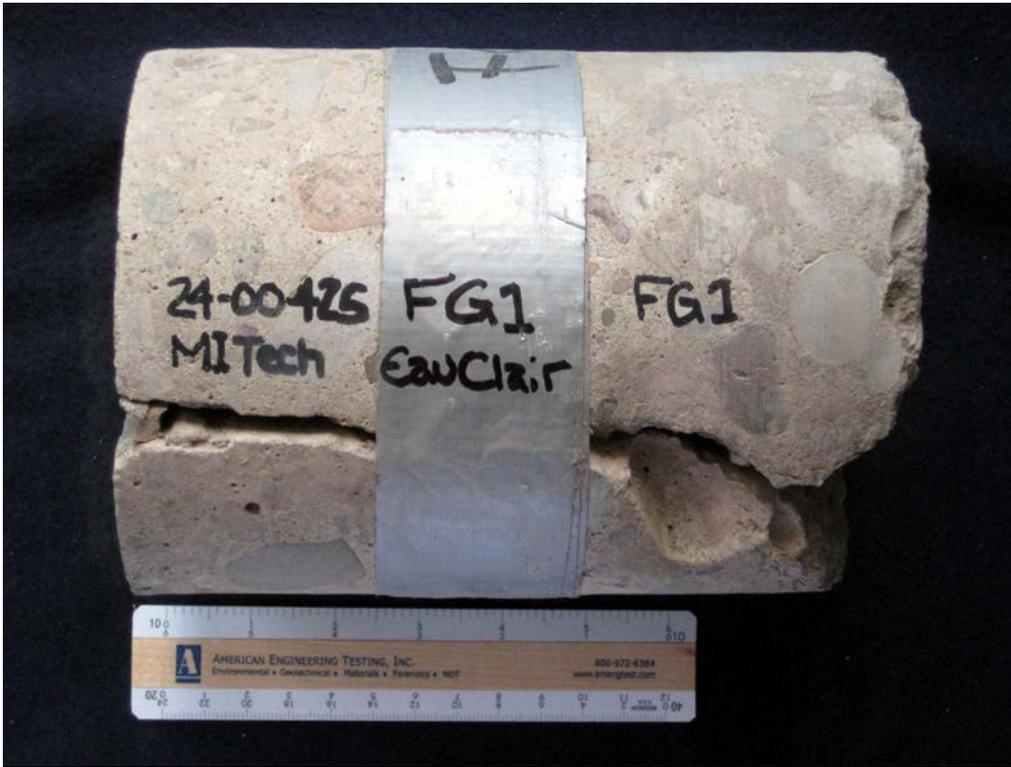
PHOTO: 1

3. Core FG1 was centered and taken directly through a silicone sealed, sawcut control joint. The top surface of the core exhibited minor mortar erosion. The silicone sealant was intermittently de-bonded on both side of the joint and the sawcuts were in relatively pristine condition; apart from "rounding" and wear of the top surface edges. The distress in core FG1 is confined to mass lost, incipient vertical spalling, and altered paste generally below the depth of the greatest extent of the pilot sawcut of the jointing (53mm). The greatest mass loss of approximately 15mm of concrete occurs between approx. 105mm and 135mm depth in the core. The greatest extent of incipient distress (vertical spalling) occurs generally below 142mm depth in the joint and becomes more horizontal in orientation within 30mm of the bottom surface of the core.

SAMPLE ID: FG1 DESCRIPTION: Core sample taken directly through a joint as received. Top surface is left.

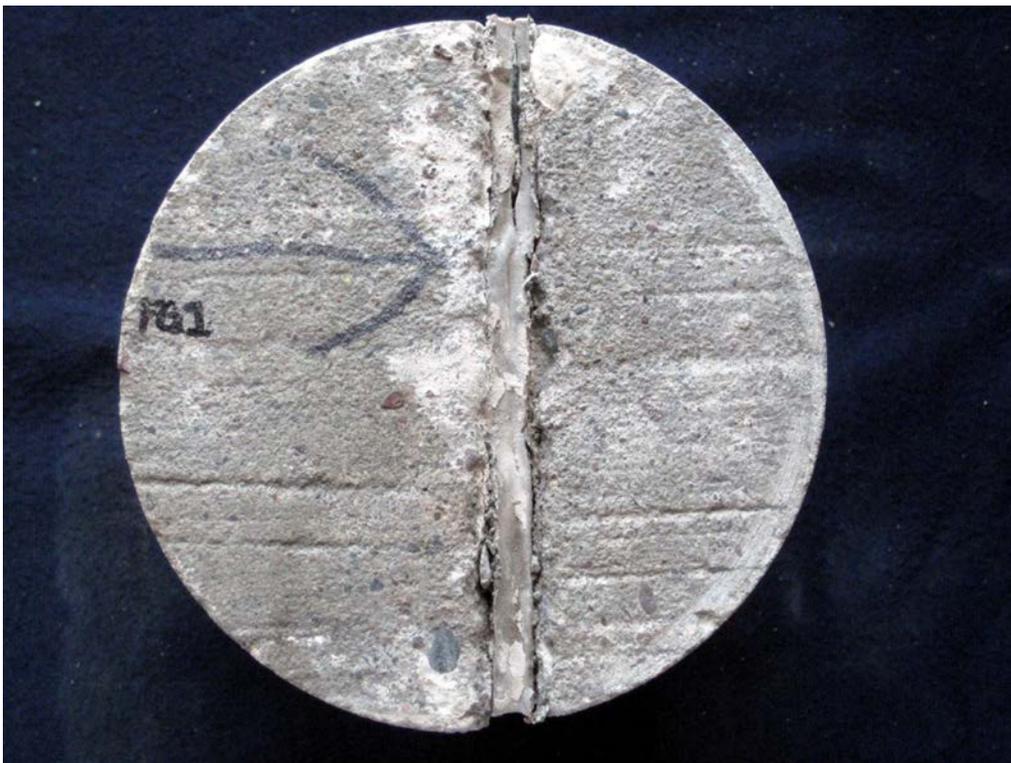
PHOTO: 2

SAMPLE ID: FG1 DESCRIPTION: Top surface of the core as received. Note core was taken through a sawcut and silicone sealed control joint.

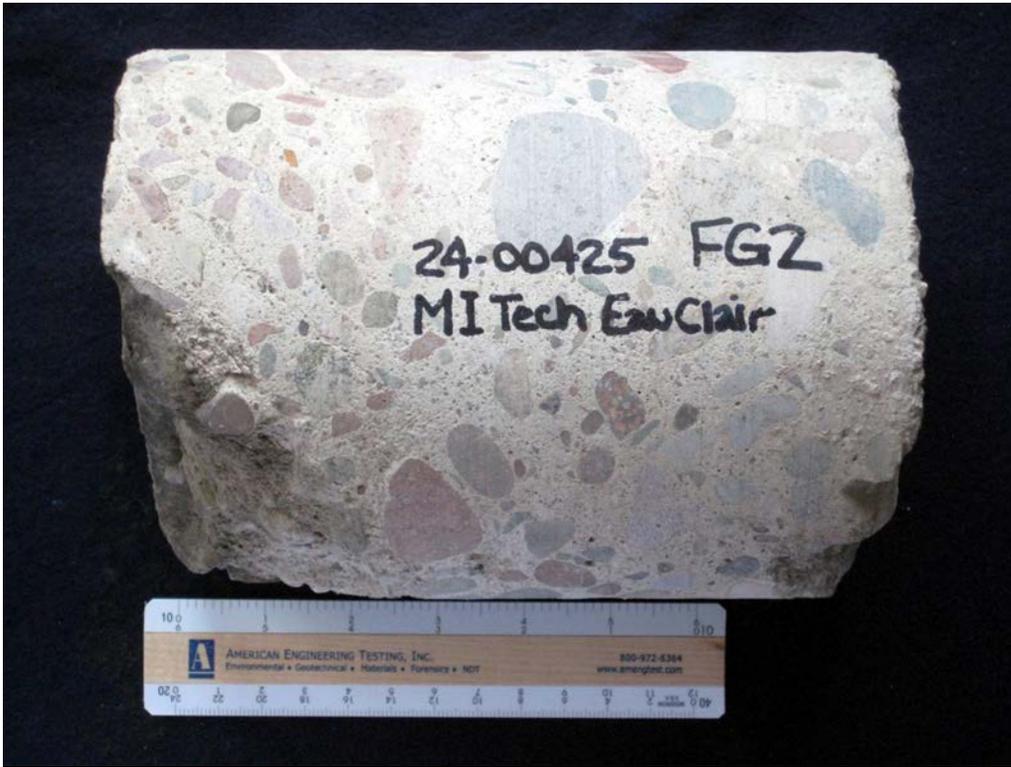
PHOTO: 3

4. Core FG2 was taken offset from the joint and no evidence of the resulting joint crack was intersected. The distress in the core was characterized by a loss of the top surface of the concrete at an approx. 45° to 50mm depth into the joint. Incipient damage, in a similar orientation, extends to 106mm depth into the core. No evidence of sawcutting or joint sealant remains with the sample.

SAMPLE ID: FG2 DESCRIPTION: Core sample taken directly through a joint as received. Top surface is left.

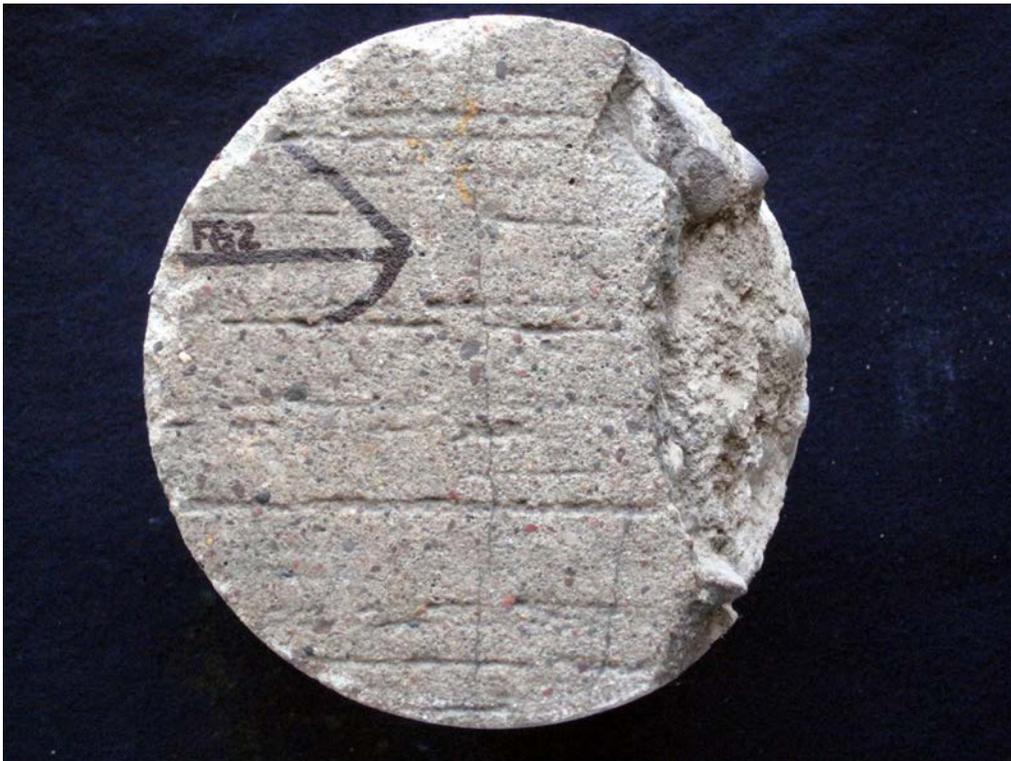
PHOTO: 4

SAMPLE ID: FG2 DESCRIPTION: Top surface of the core as received. Note core was taken in distress apparently directly adjacent to a control joint..

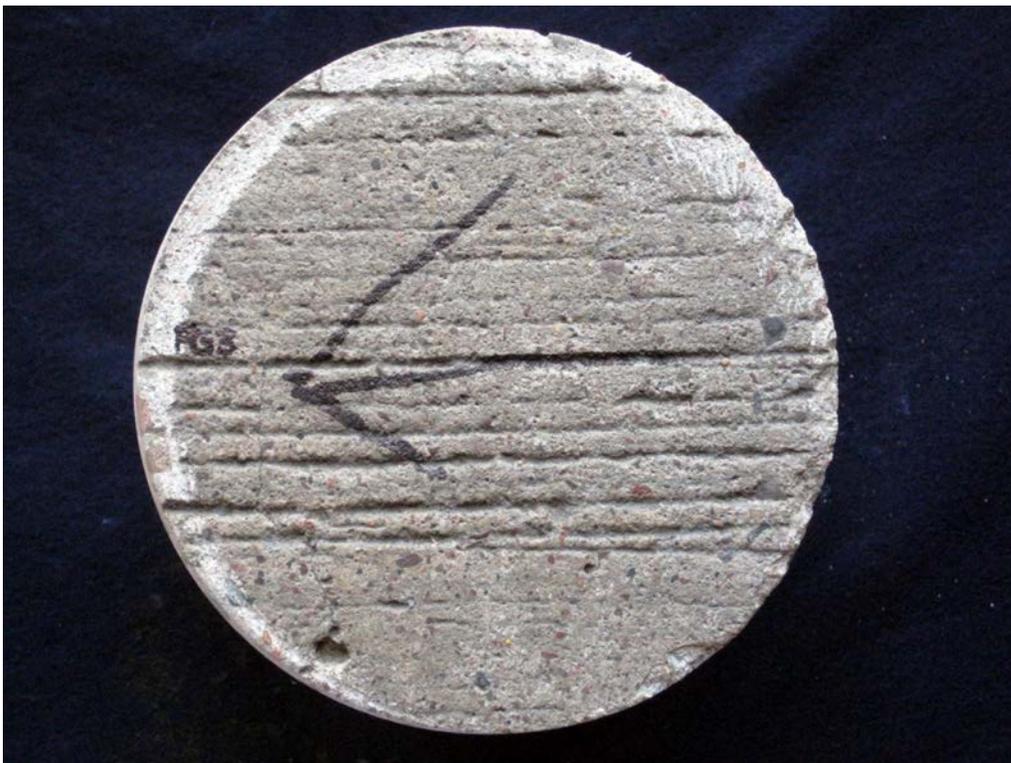
PHOTO: 6

SAMPLE ID: FG3 DESCRIPTION: Screeded, tined and traffic worn top surface of the core as received.

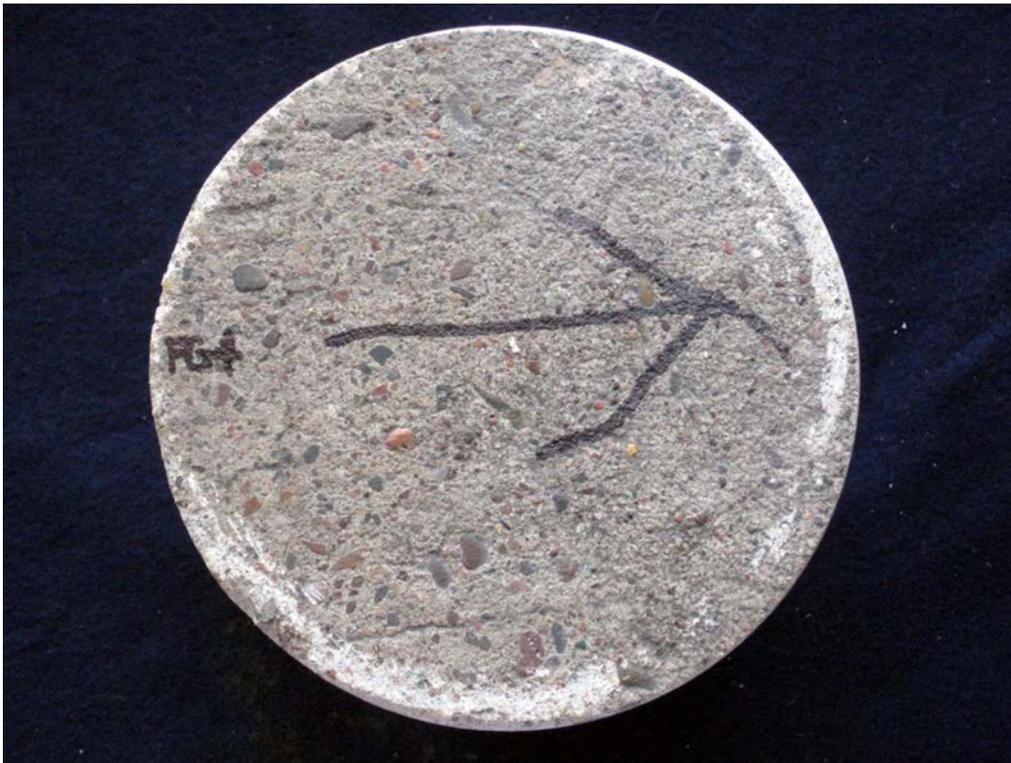
PHOTO: 8

SAMPLE ID: FG4 DESCRIPTION: Mortar eroded top surface of the core as received.

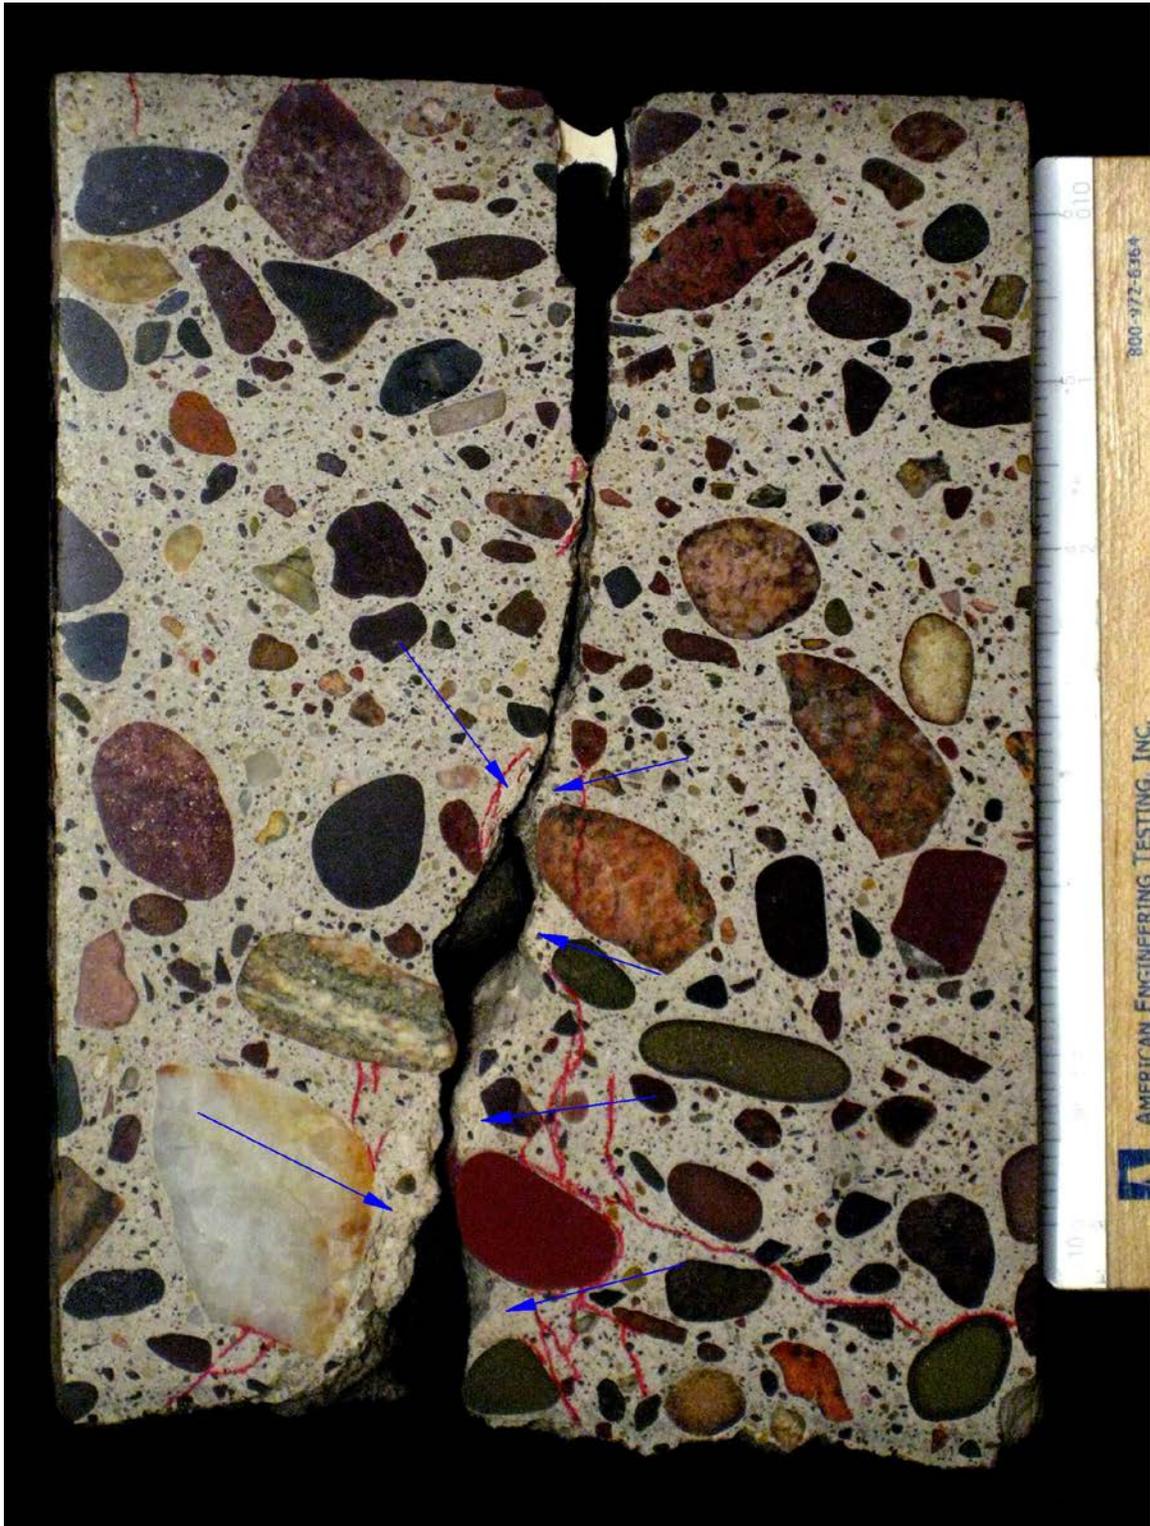
PHOTO: 9

SAMPLE ID: FG-1 **DESCRIPTION:** Sawcut and lapped cross section of core taken through a sawcut control joint. Some microcracking is mapped in red ink. Heavily concentrated microcracking and distressed paste is marked with arrows.

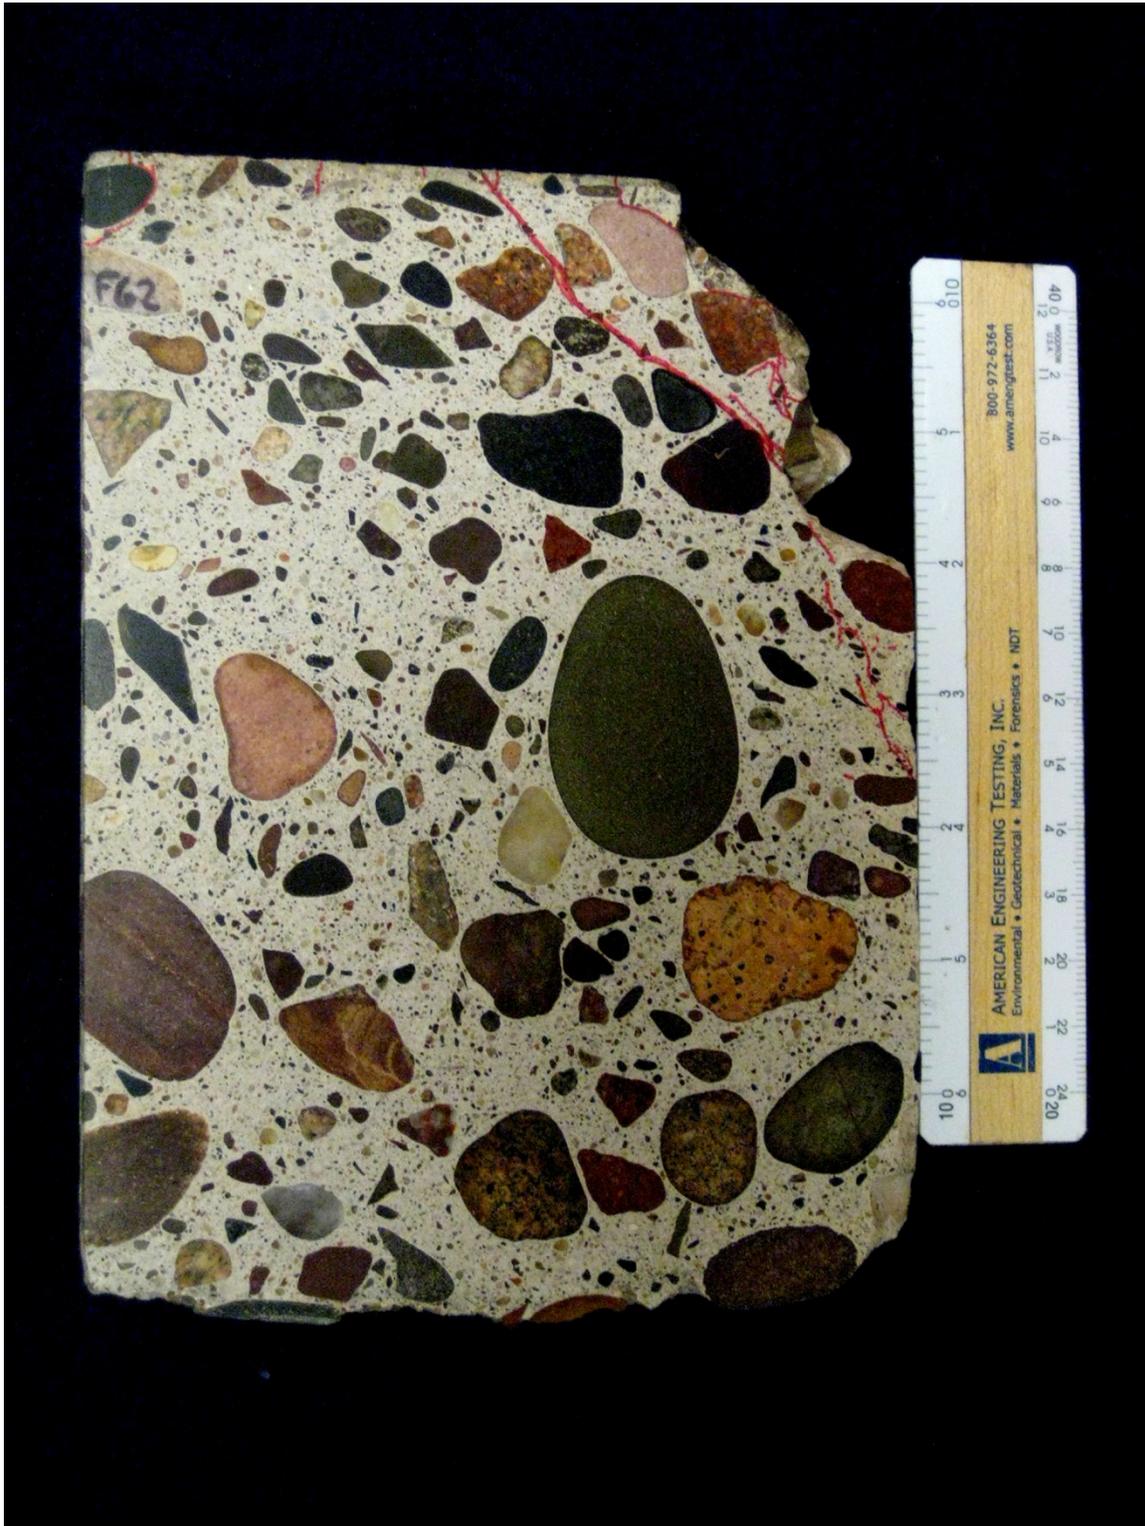
PHOTO: 10

SAMPLE ID: FG-2 DESCRIPTION: Sawcut and lapped cross section of core apparently taken directly adjacent to a distressed control joint. Microcracking is mapped in red ink.

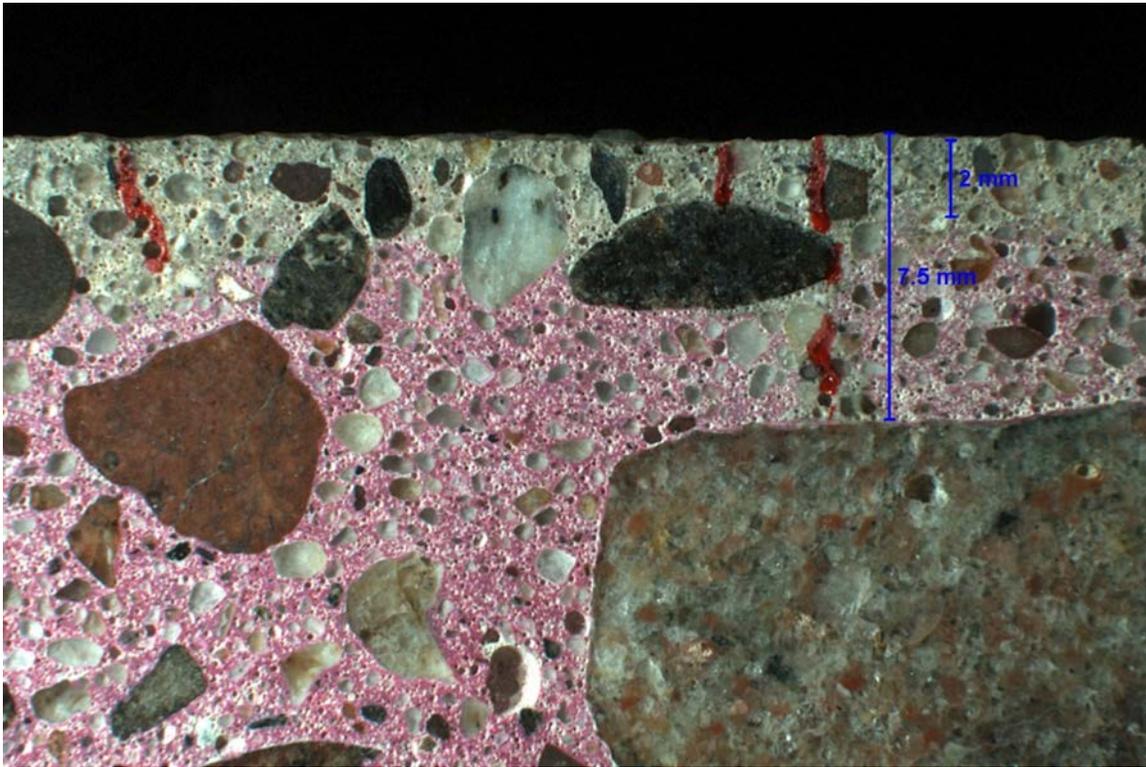
PHOTO: 11

SAMPLE ID: FG1 DESCRIPTION: Carbonation (unstained paste) ranges from 2mm to 7.5mm depth (in this view) along fine drying shrinkage microcracking mapped in red ink.
MAG: 5x

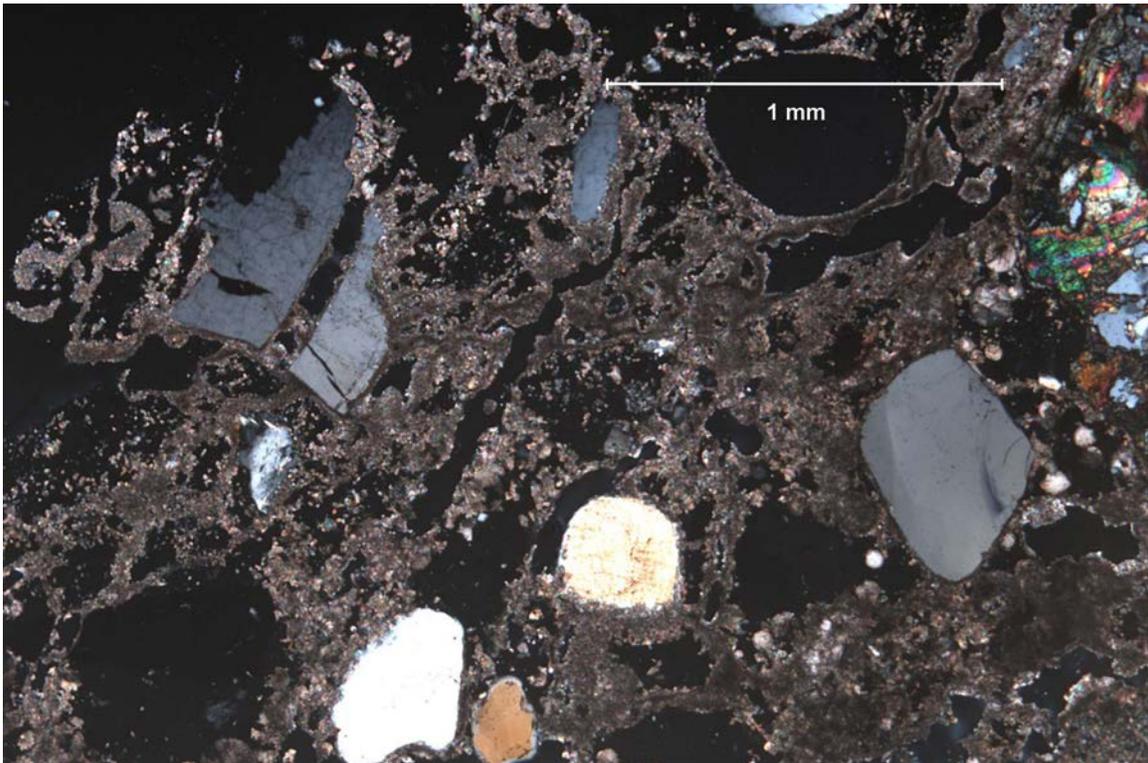
PHOTO: 16

SAMPLE ID: FG1 DESCRIPTION: Previous view of the concrete thin section under cross polarized light. Note brightly colored, carbonated to "bi-carbonated" paste.
MAG: 40x

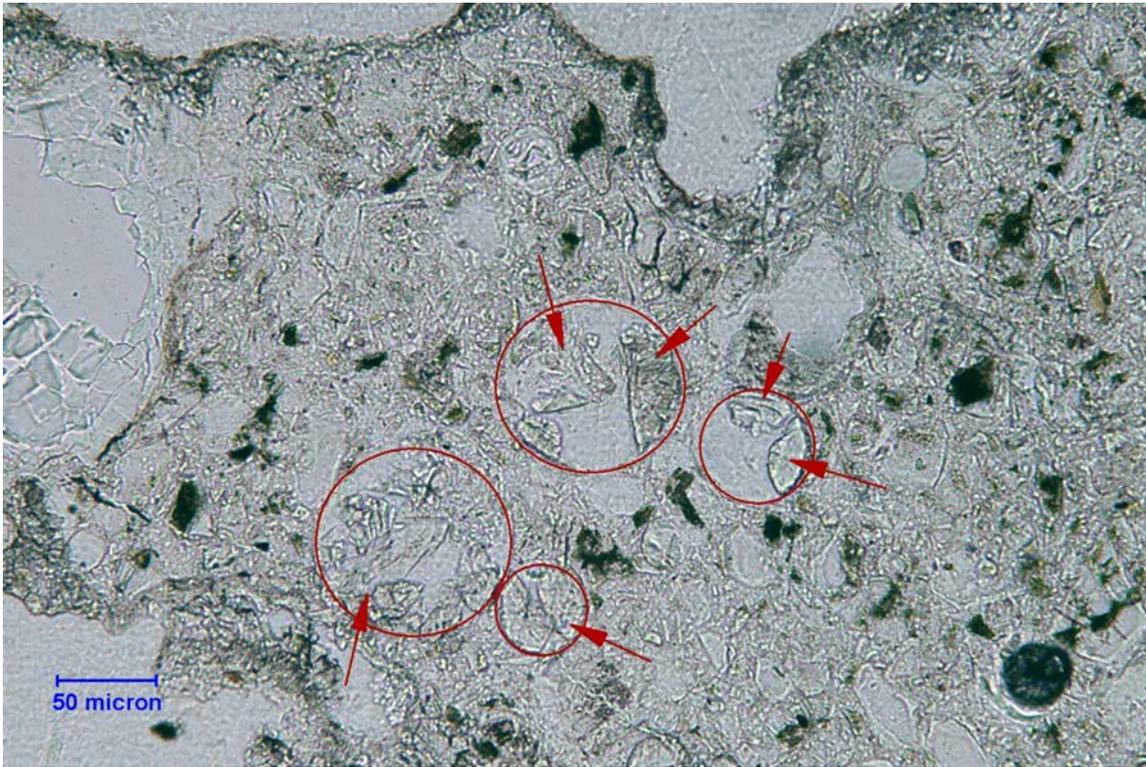
PHOTO: 17

SAMPLE ID: FG1 DESCRIPTION: Secondary calcite spar in voidspaces (outlined in red) in the carbonated paste directly adjacent to the distressed joint plane (top of image); in thin section of concrete paste under plane polarized light.
MAG: 200x

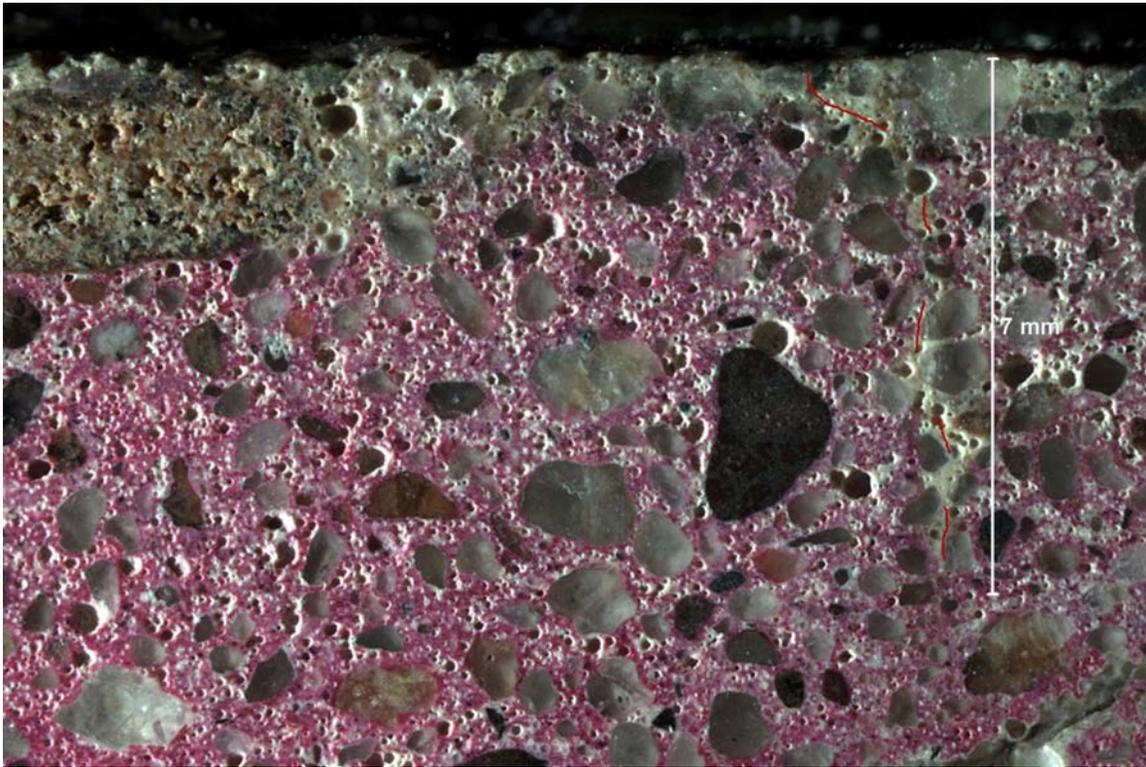
PHOTO: 19

SAMPLE ID: FG2 DESCRIPTION: Carbonation (unstained paste) ranges from <1mm to 7mm depth (in this view) along fine drying shrinkage microcracking mapped in red dashed line.
MAG: 10x

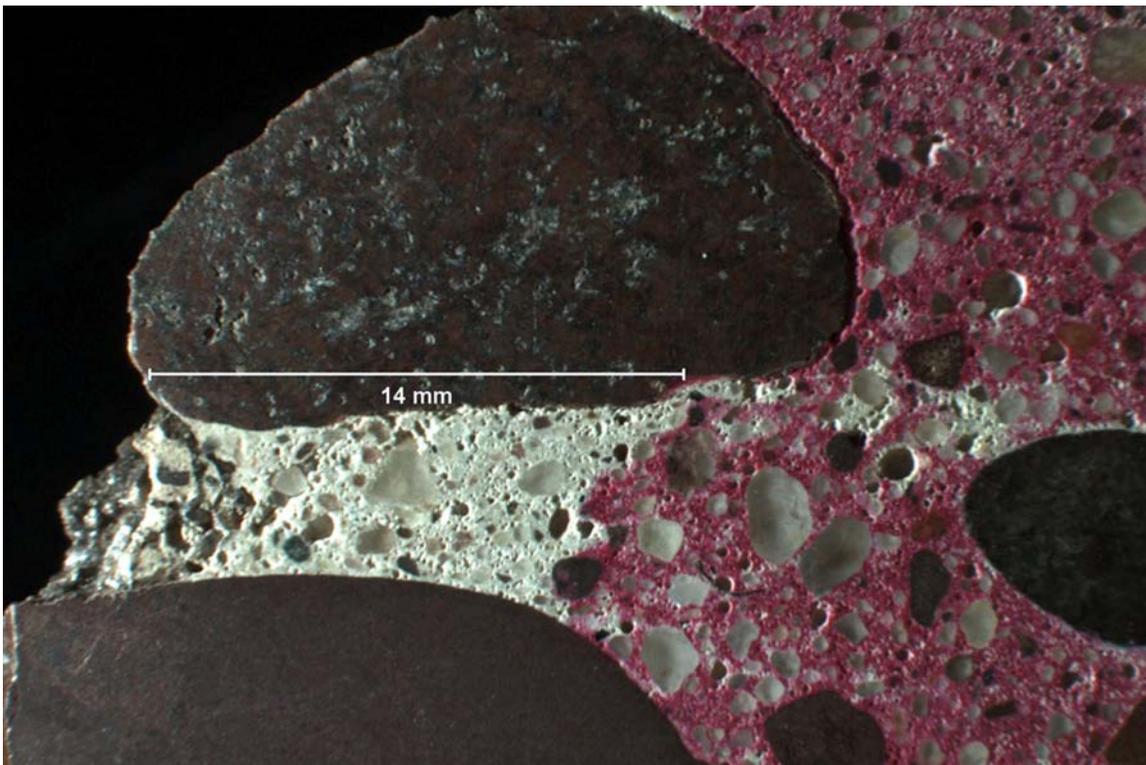
PHOTO: 20

SAMPLE ID: FG2 DESCRIPTION: Carbonation (unstained paste) proceeds continuously to 14mm from the distressed joint plane at approx. 16mm depth in the core.
MAG: 5x

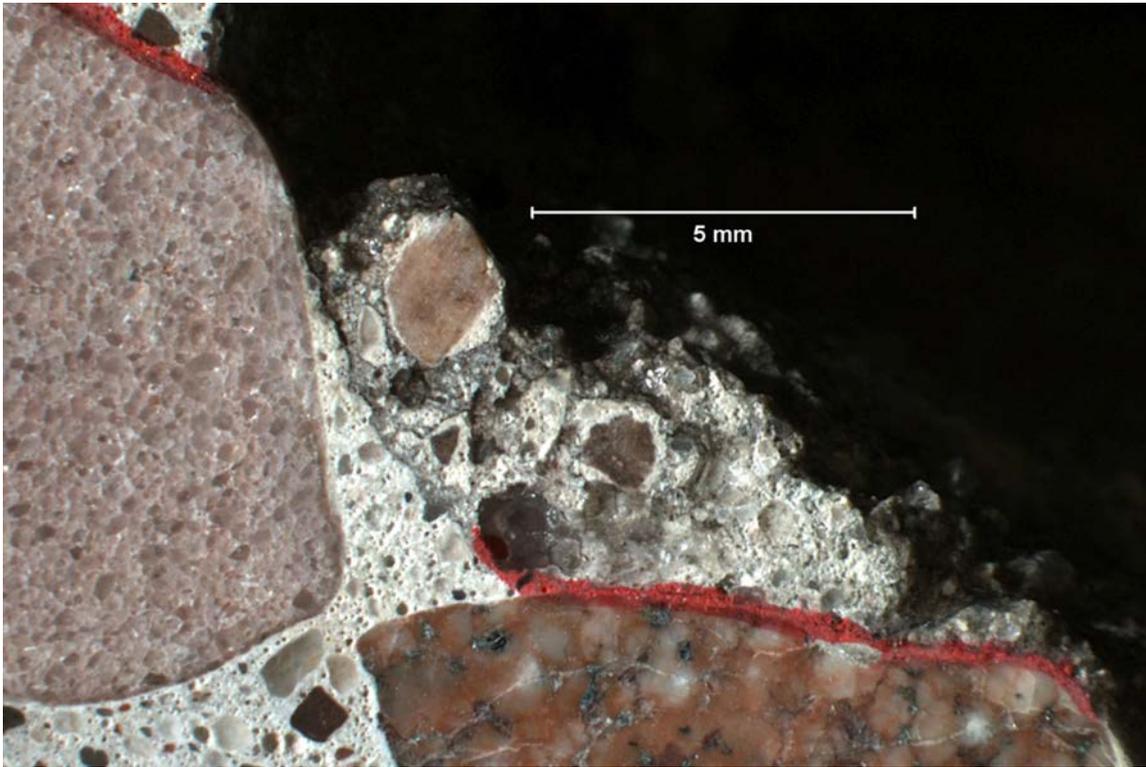
PHOTO: 21

SAMPLE ID: FG2 DESCRIPTION: Concrete fragments along the distressed edge of the core; apparently lightly cemented with calcite and stabilized with epoxy for preparation.
MAG: 10x

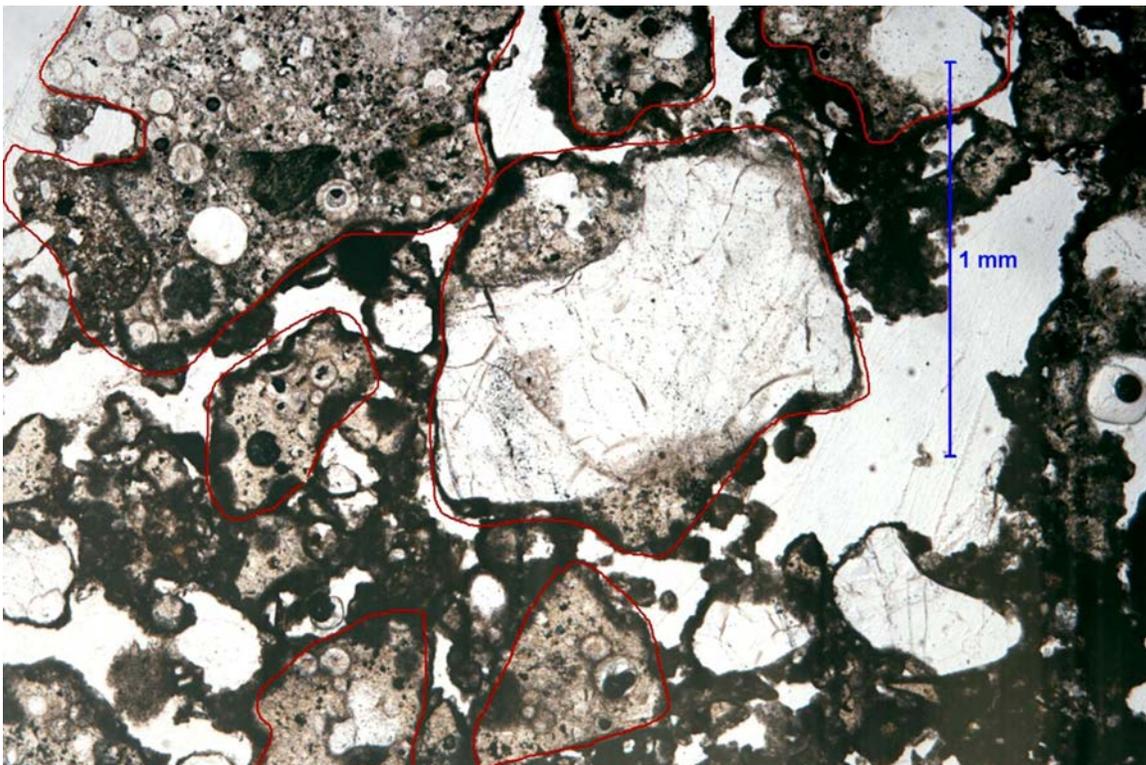
PHOTO: 22

SAMPLE ID: FG2 DESCRIPTION: Concrete fragments in thin section (outlined in red) along the distressed edge of the core; apparently lightly cemented with calcite and stabilized with epoxy for preparation
MAG: 40x

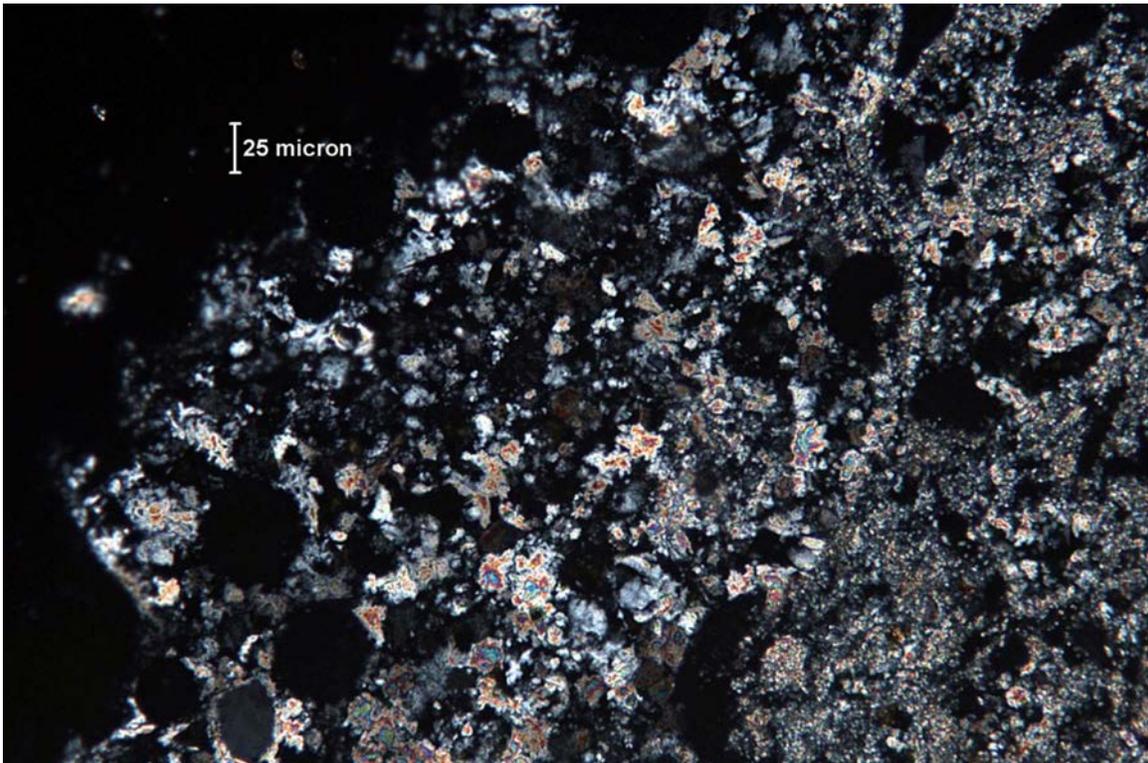
PHOTO: 24

SAMPLE ID: FG2 DESCRIPTION: The paste directly adjacent to the distressed surface appears "bi-carbonated" and exhibits a relatively coarse crystalline appearance under cross polarized light.
MAG: 200x

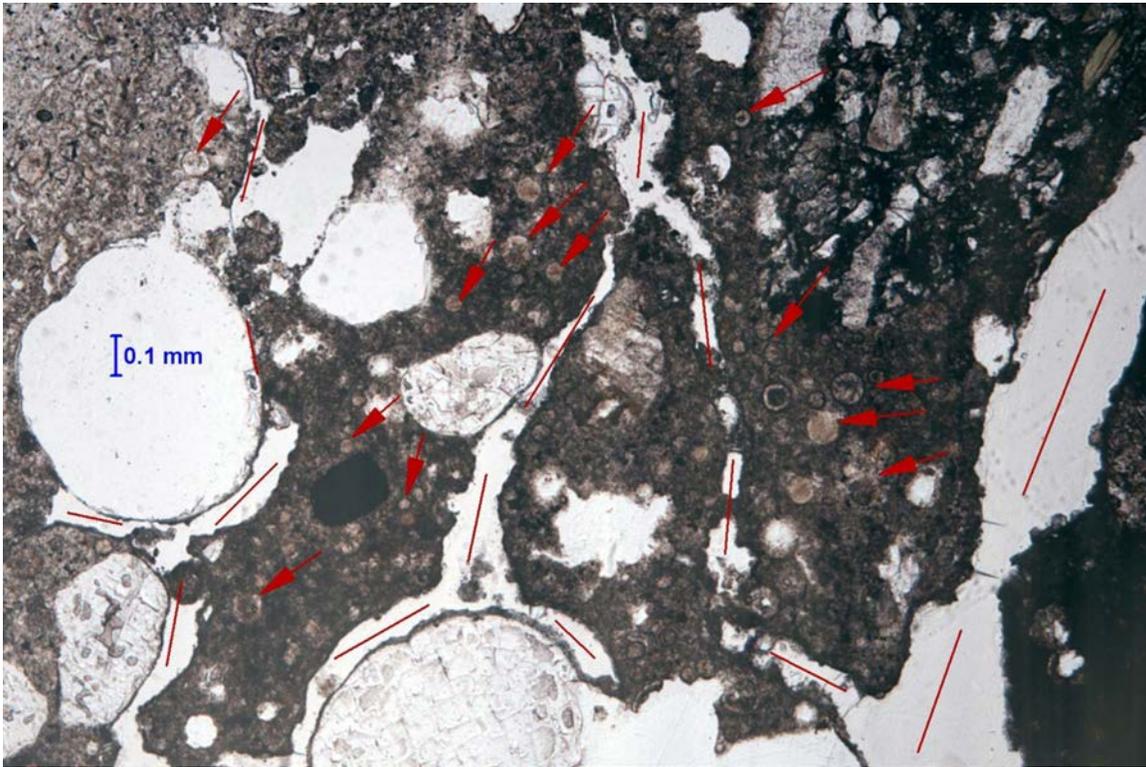
PHOTO: 25

SAMPLE ID: FG2 DESCRIPTION: The paste within a few millimeters of the distressed surface exhibits significant secondary ettringite air void fillings (outlined in red); in thin section of heavily microcracked paste (red dashed lines) under plane polarized light.
MAG: 40x

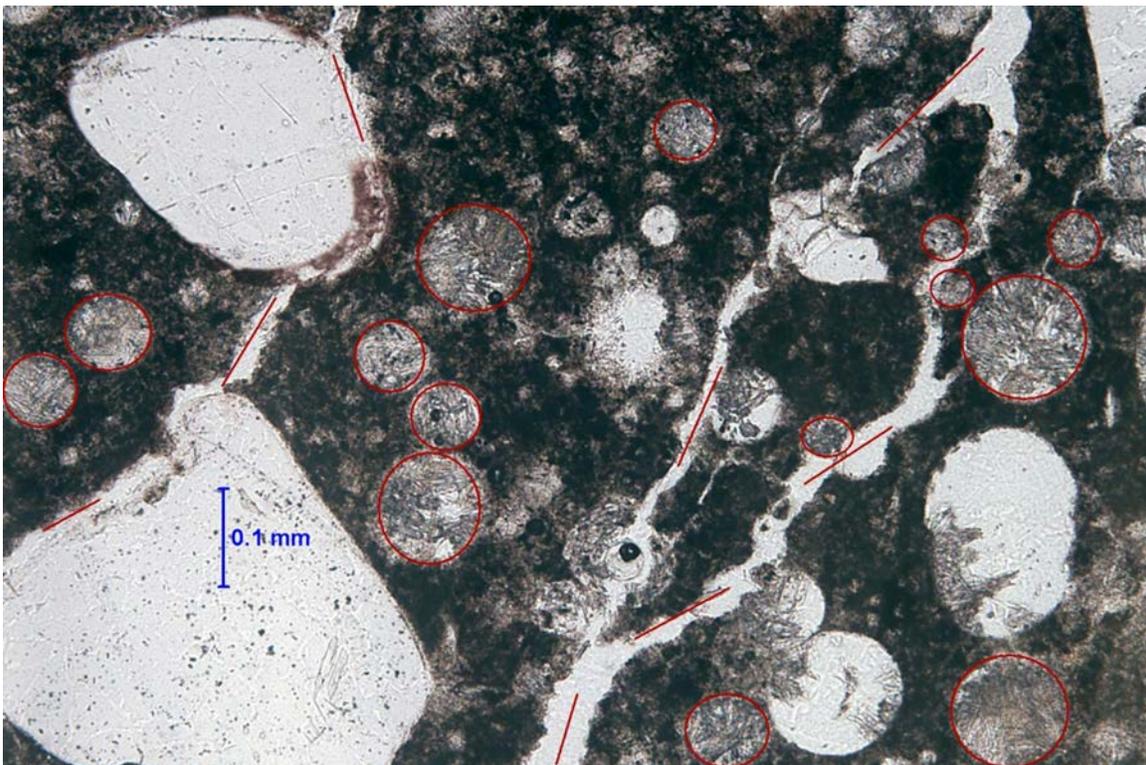
PHOTO: 26

SAMPLE ID: FG2 DESCRIPTION: The paste within a few millimeters of the distressed surface exhibits significant secondary ettringite air void fillings (outlined in red); in thin section of heavily microcracked paste under plane polarized light.
MAG: 100x

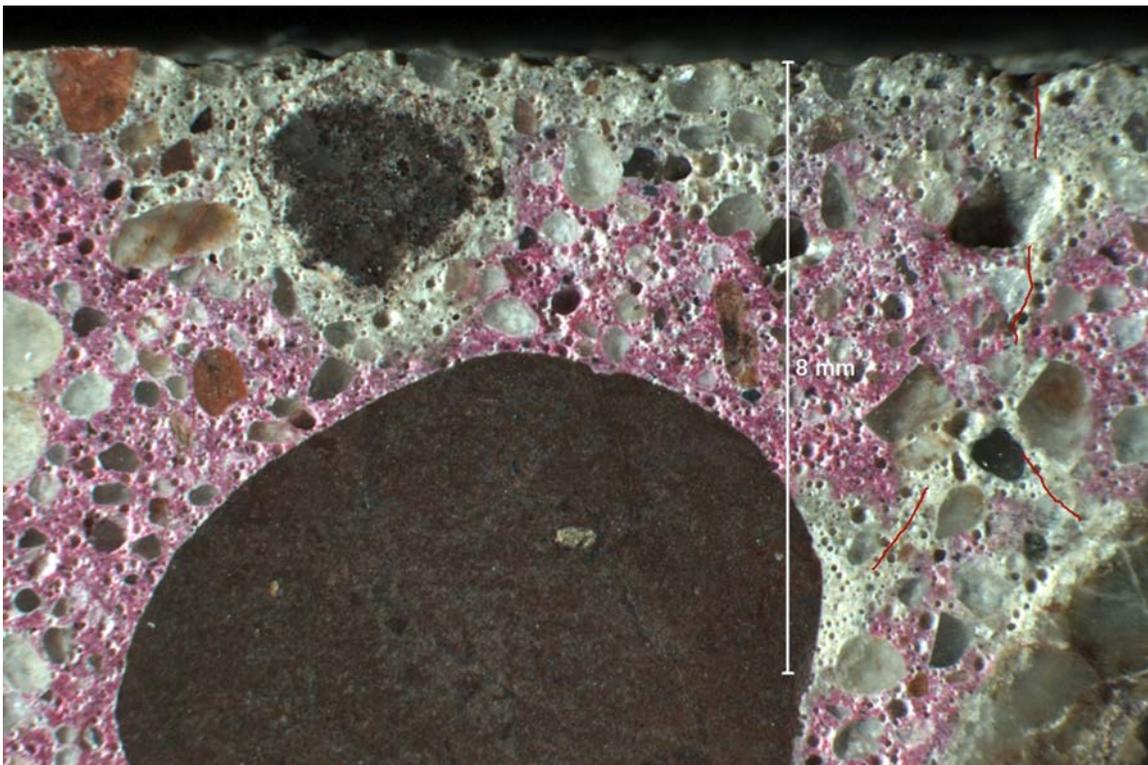
PHOTO: 28

SAMPLE ID: FG3 DESCRIPTION: Carbonation (unstained paste) proceeds up to 8mm depth from the top surface, "spiking" along sub-vertical drying shrinkage microcracking mapped in red dashed line.

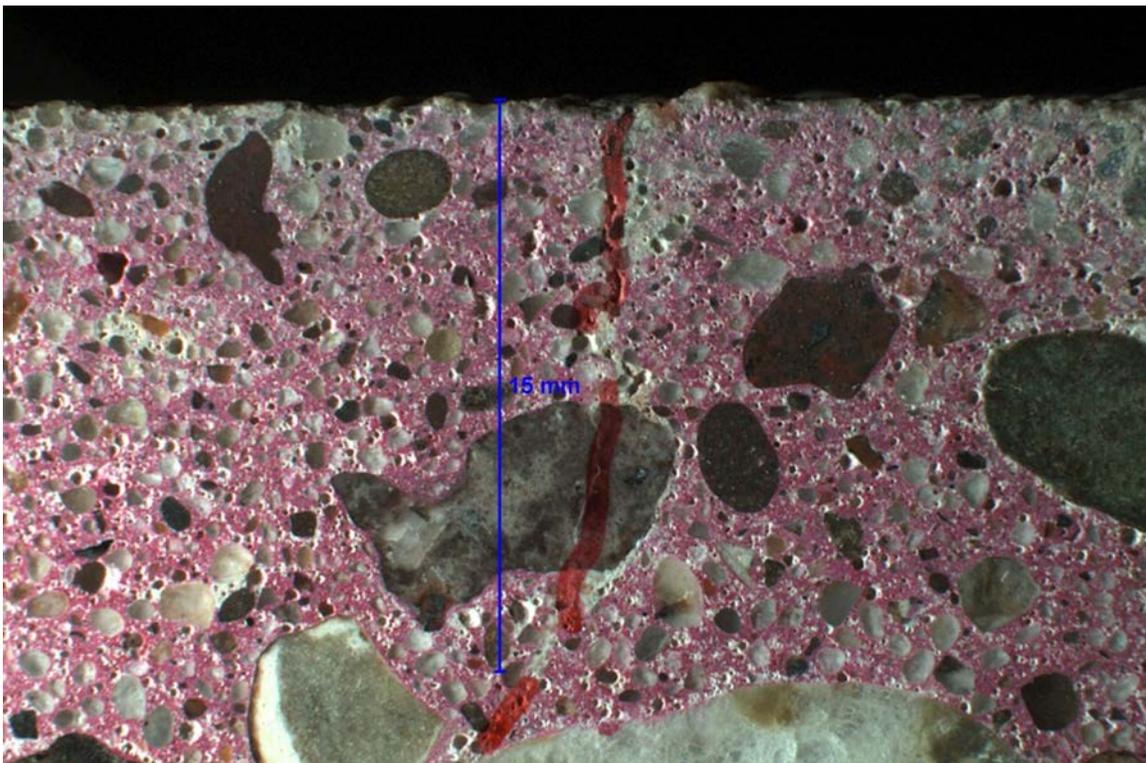
PHOTO: 32

SAMPLE ID: FG4 DESCRIPTION: Carbonation (unstained paste) ranges from negligible up to 15mm depth, intermittently, from the top surface of the core, along sub-vertical drying shrinkage microcracking; mapped in red ink.

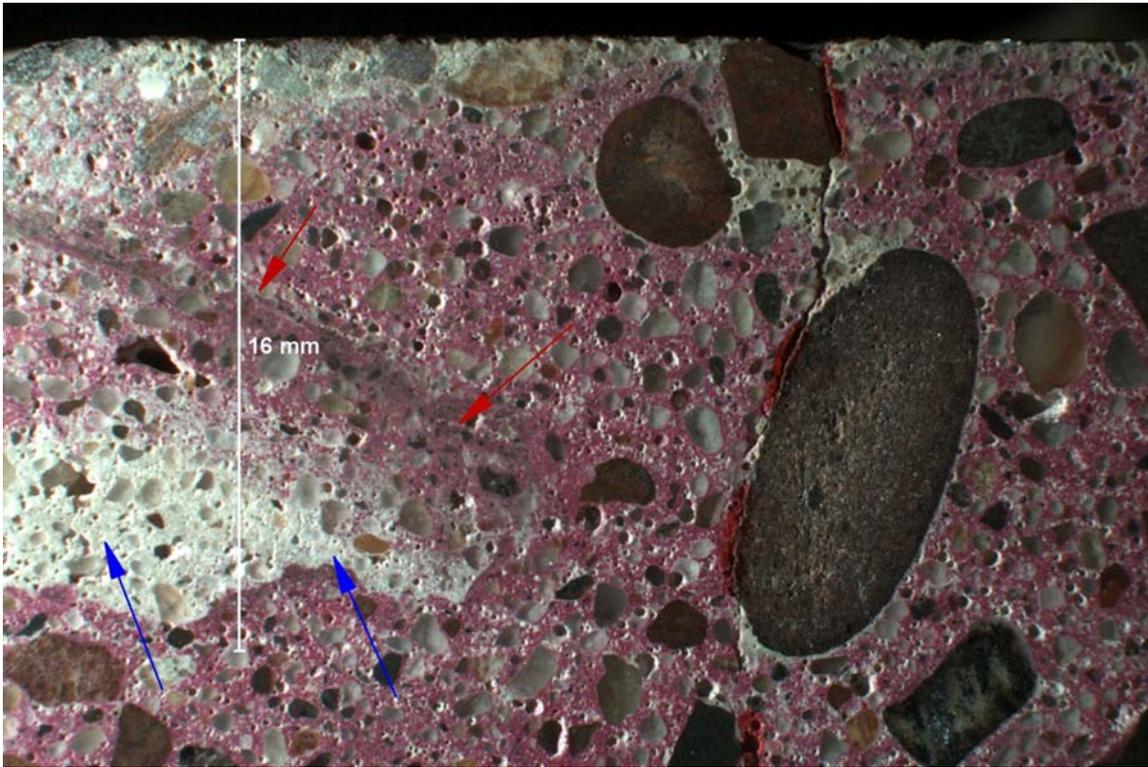
PHOTO: 33

FG4 **DESCRIPTION:** Mixing anomaly within 16mm of the top surface of the core. Note darker, denser layer of concrete (red arrows) and layer of carbonated (unstained paste) excessive w/cm paste (blue arrows).

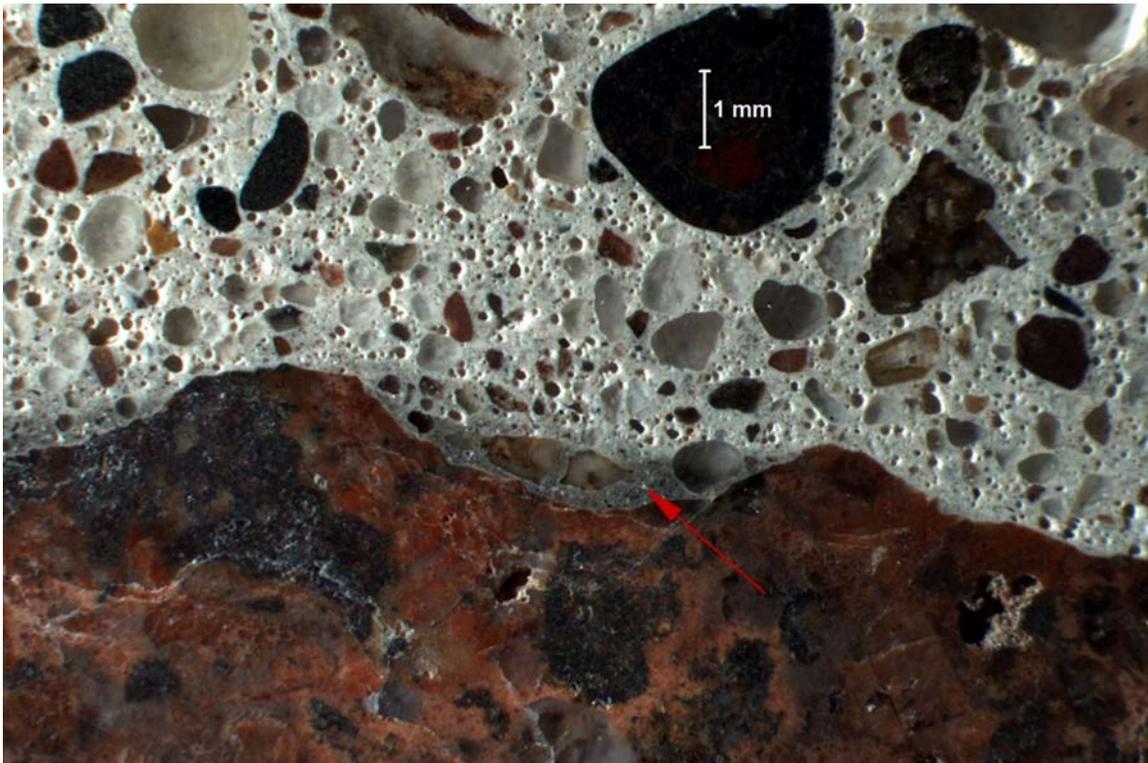
PHOTO: 34

FG4 **DESCRIPTION:** Darker colored, denser paste in concave coarse aggregate notch suggest multiple additions of water to the concrete.

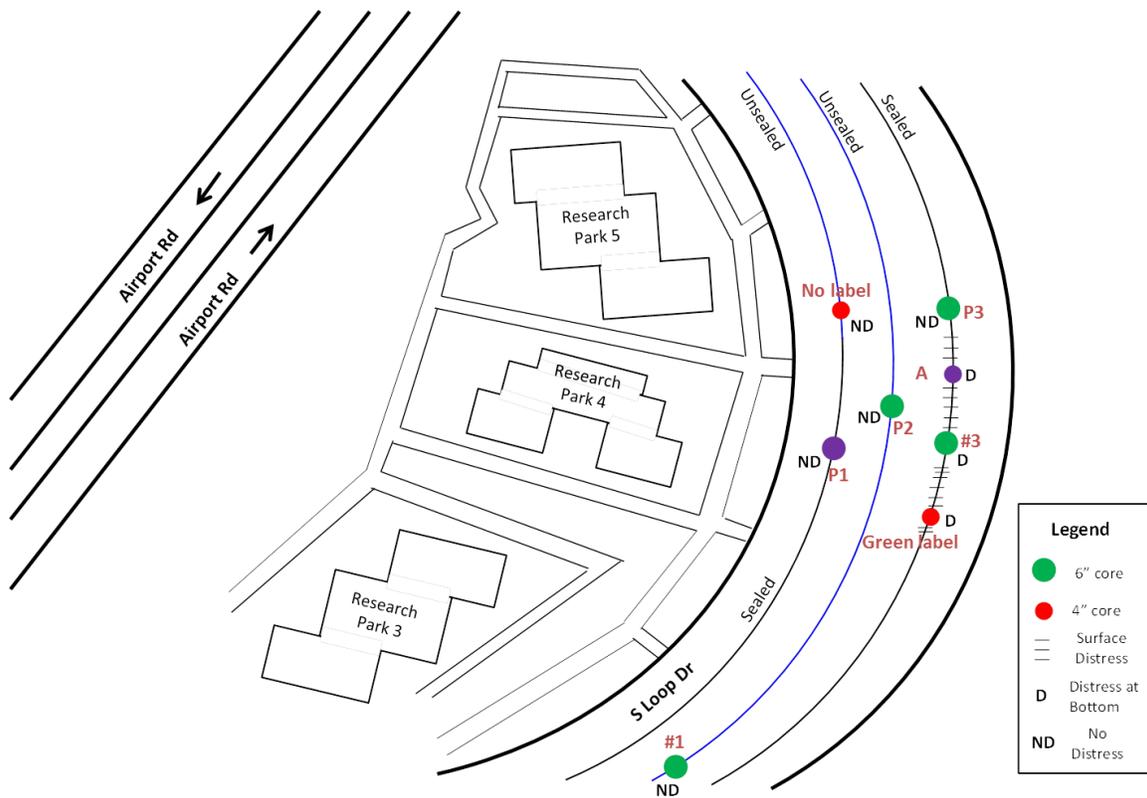
Figure 2. Plan of coring and distress

The extent of the distress was mapped, along with details of where joints had been sealed. (Figure 2).

Several cores were extracted from the pavement over a period of two years. Two cores were sent for petrographic examination. One is marked as D for distressed in purple in Figure 2, from a distressed joint, and the other is marked as ND for no distress, also in purple, from a sound joint.
