Investigation of Deterioration of Joints in Concrete Pavements

National Concrete Pavement
Technology Center

Final Report
August 2012

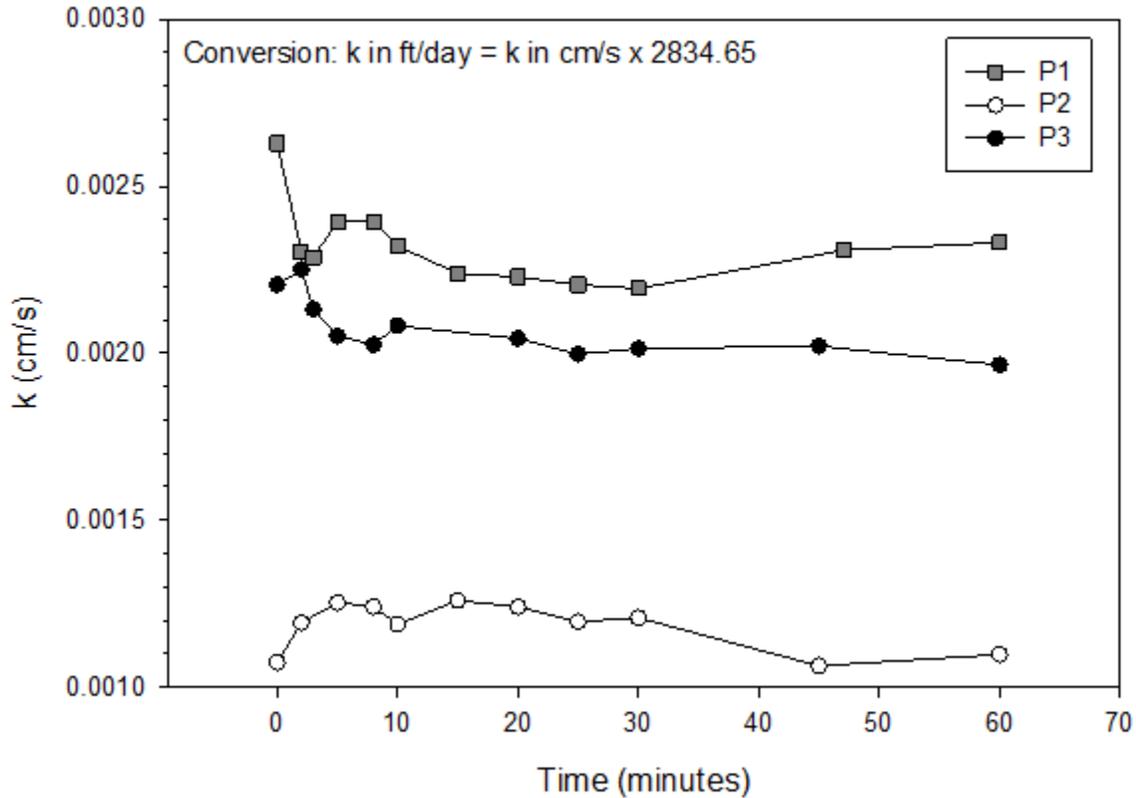
Figure 8. Permeability results

The lowest permeability was observed under the center-line joint. There is little difference between the area with or without distress. There is no trend associated with the sealed and unsealed areas.

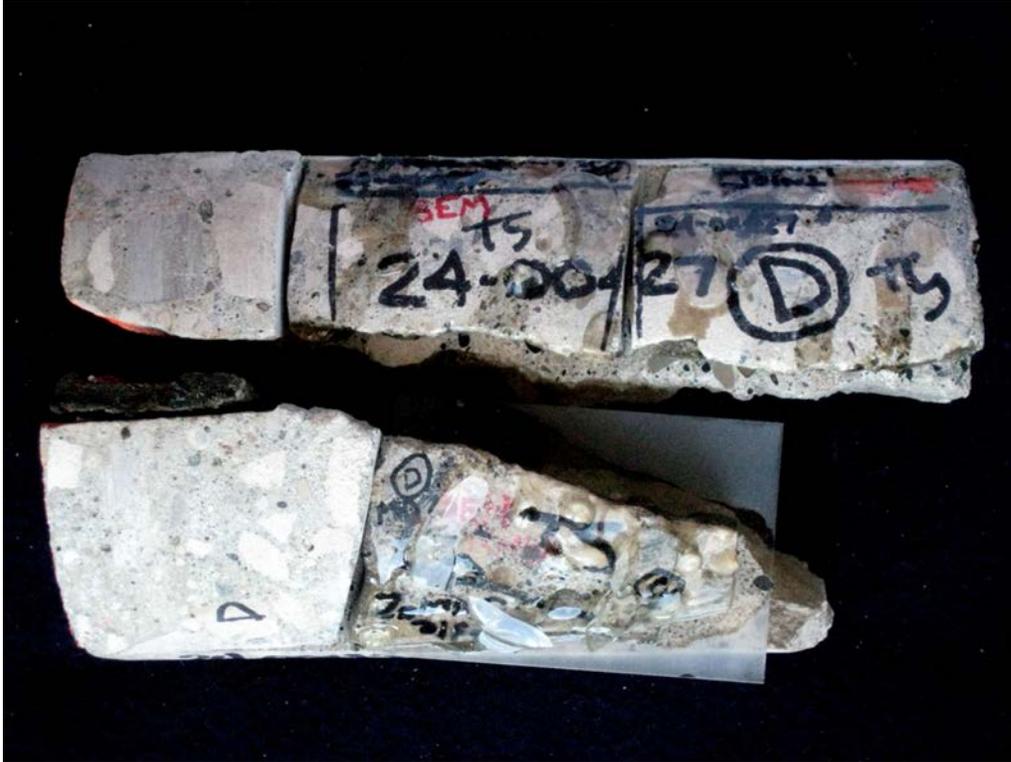
PHOTO: 5

SAMPLE ID: D DESCRIPTION: Locations of the thin section produced for analysis.

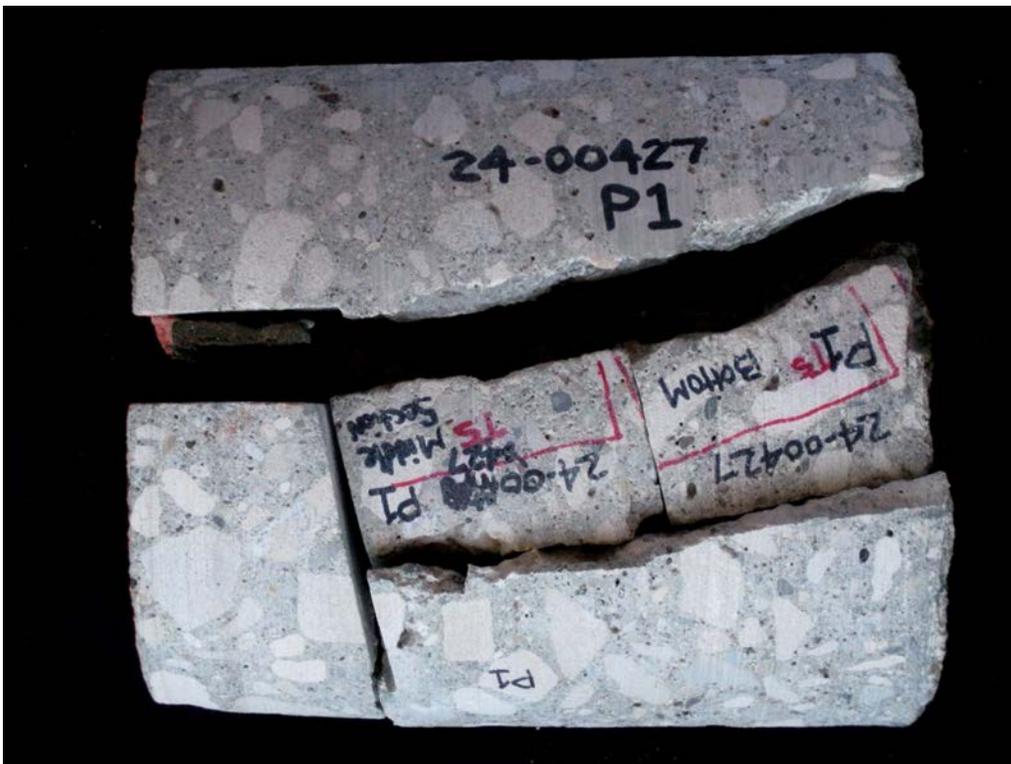
PHOTO: 6

SAMPLE ID: P1 DESCRIPTION: Locations of the thin section produced for analysis.

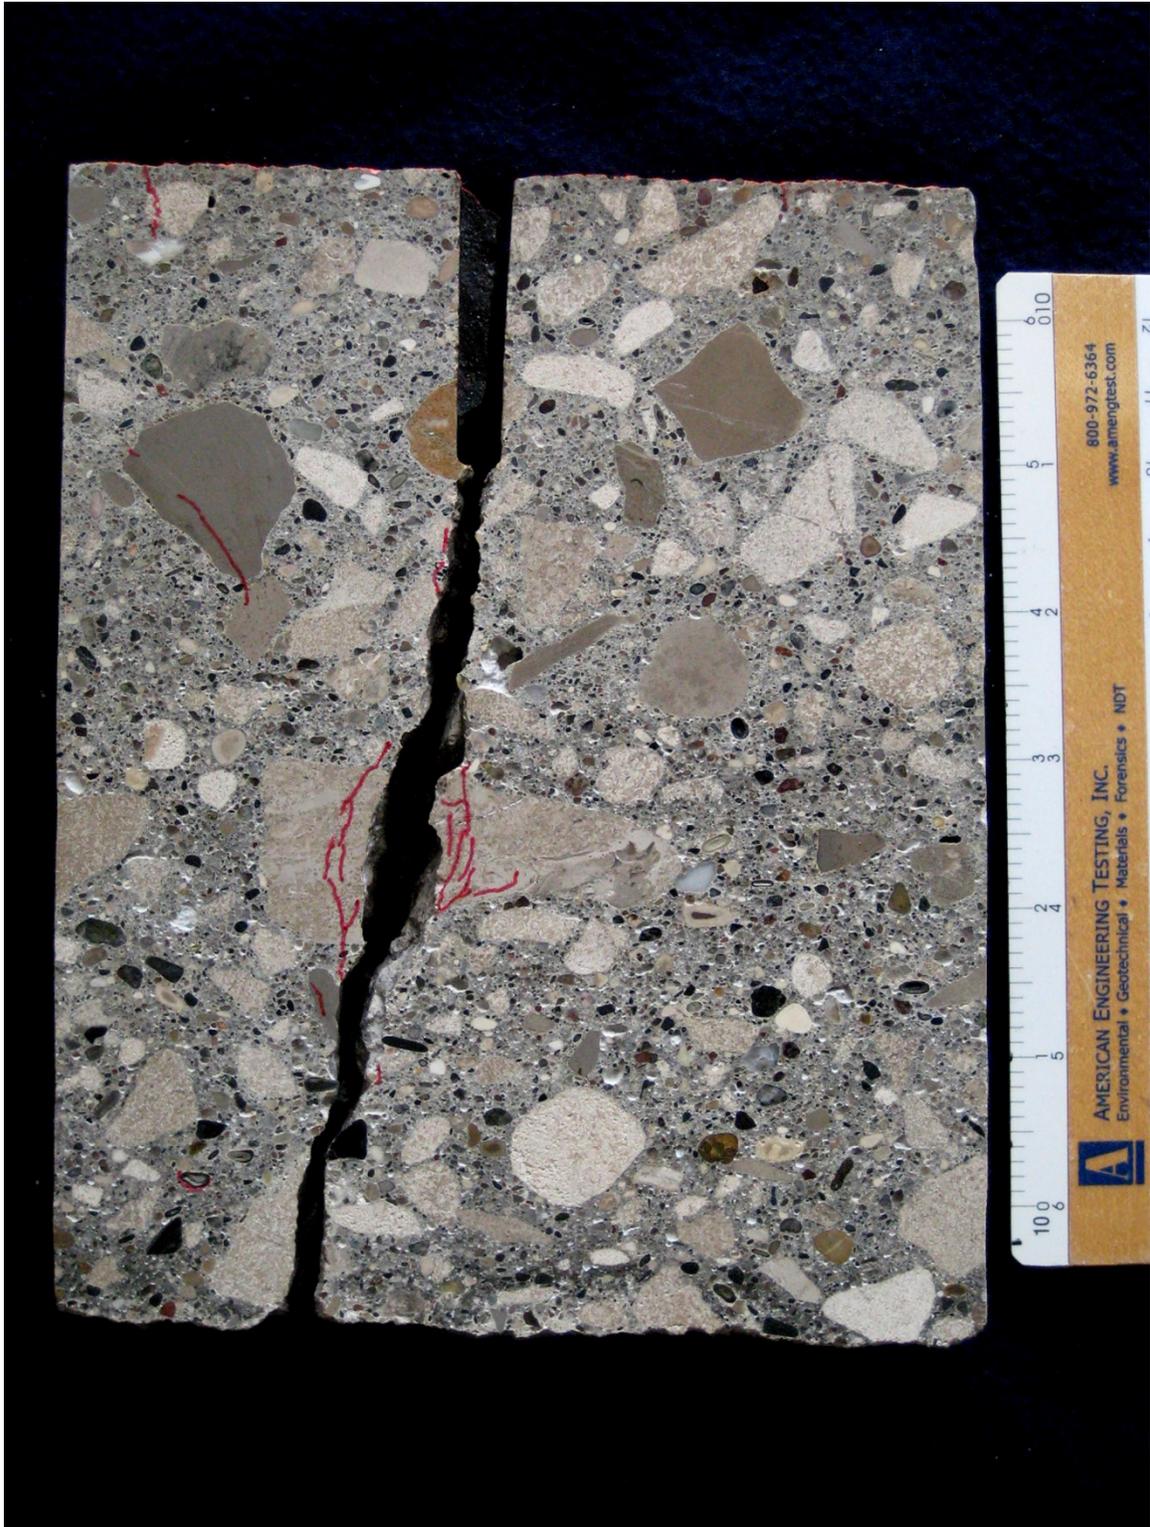
PHOTO: 8

SAMPLE ID: P1 **DESCRIPTION:** Sawcut and lapped cross section of core taken through joint. Microcracking is mapped in red ink. Note mass lost along the joint crack and cracking within the coarse aggregate particle bisected by the joint.

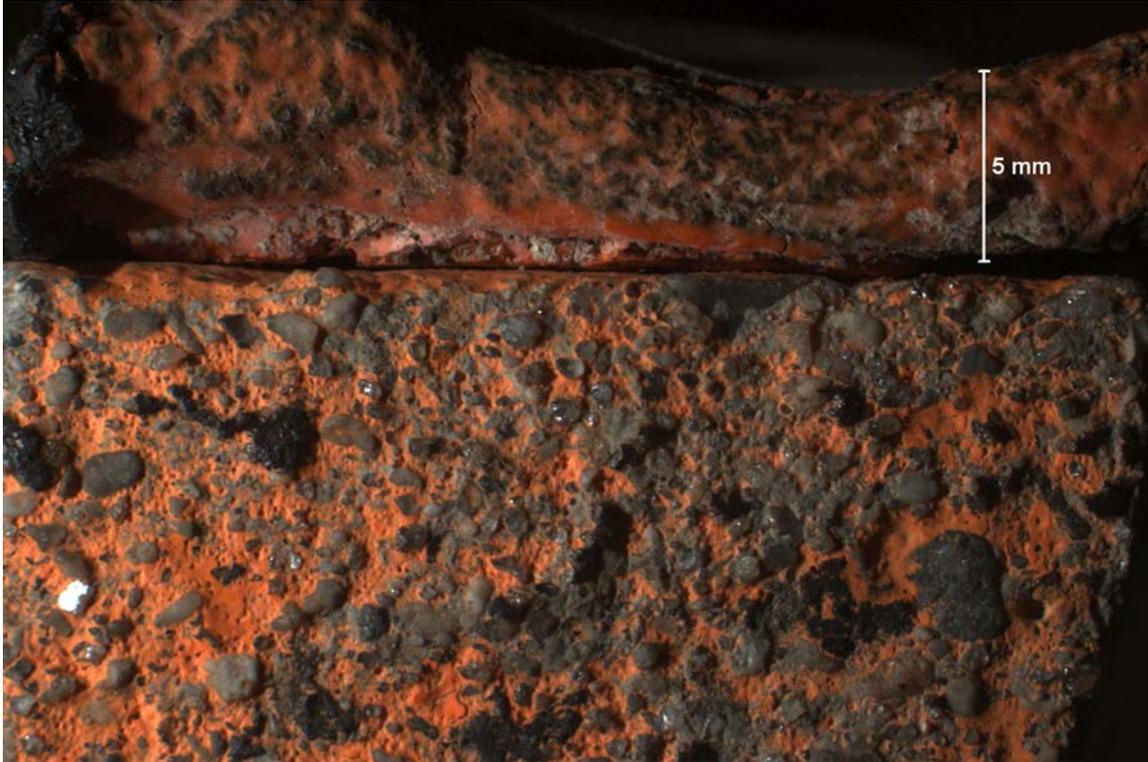
PHOTO: 9

SAMPLE ID: D DESCRIPTION: Mortar-eroded top surface mostly cleaned of orange marking paint.

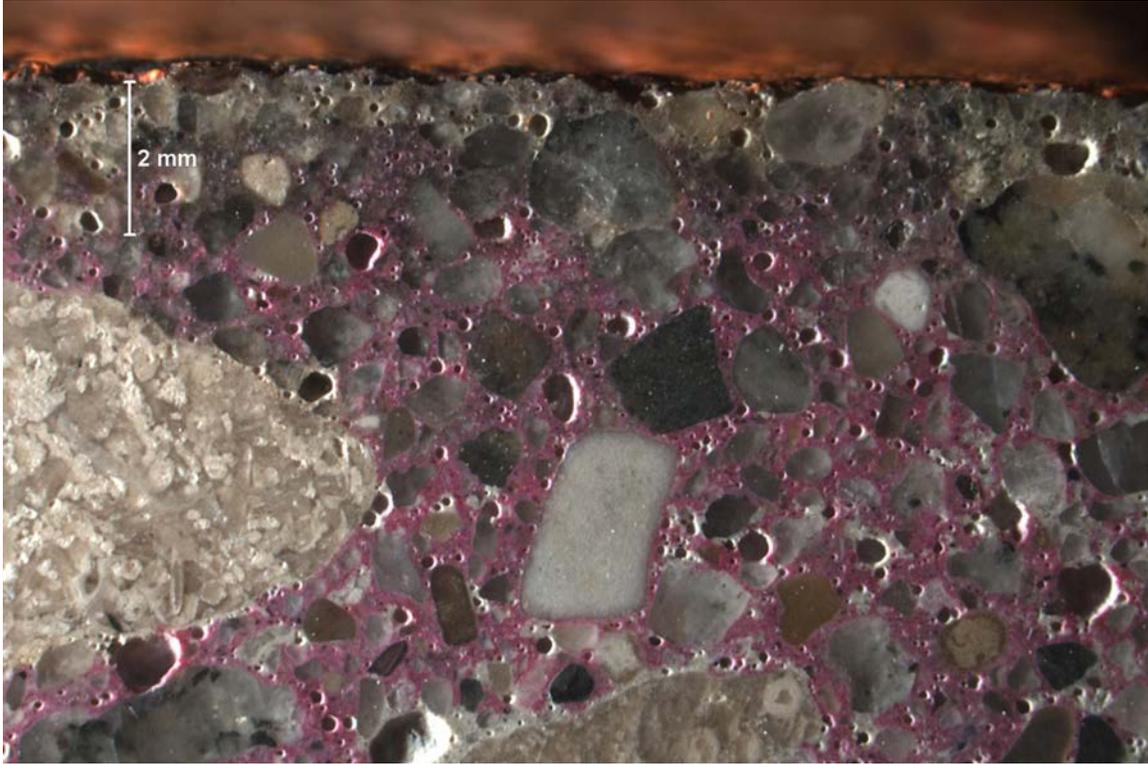
PHOTO: 13

5. Carbonation ranges from negligible up to 6mm depth from the top surfaces of the cores; generally proceeding along fine, sub-vertical, drying shrinkage microcracks. The carbonation is relatively minor and expected for the w/cm and age of the concrete. Both concretes were placed at a "moderately-low" w/cm, estimated to be between 0.40 and 0.47. Carbonation ranged from negligible to 12mm depth from the joint crack plane in core "D" and from negligible to 4mm depth from the joint crack plane in core "P1". No other chemical alteration of the paste was detected.

SAMPLE ID: D DESCRIPTION: Carbonation (unstained paste) to 2mm depth from the top surface, in this view.

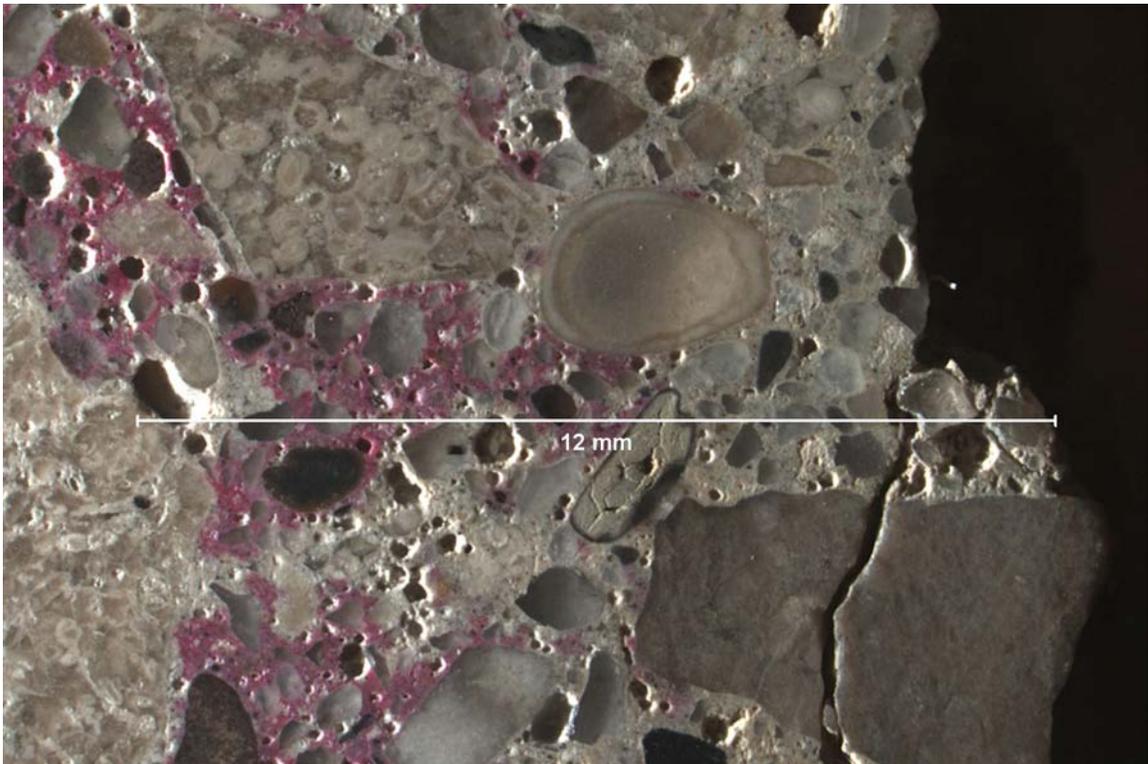
PHOTO: 14

SAMPLE ID: D DESCRIPTION: Apparent carbonation (unstained paste) proceeds up to 12mm depth from the distressed joint plane at approx.75mm depth from the top surface.

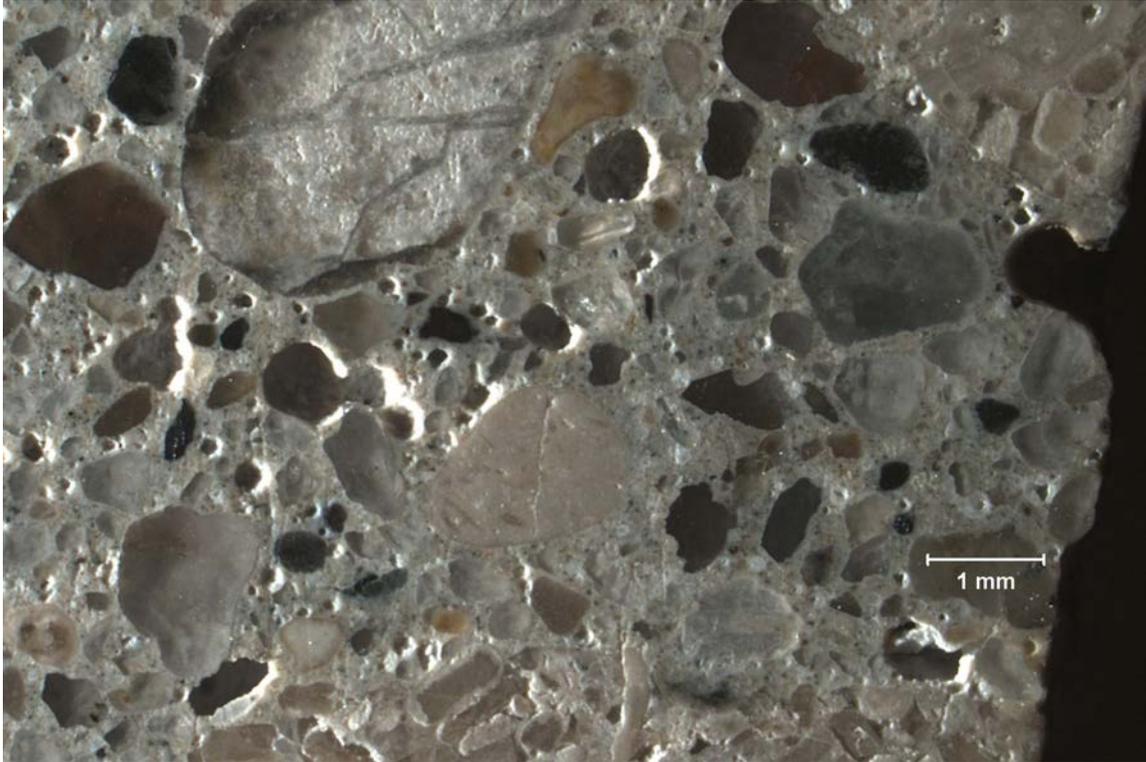
PHOTO: 15

1. The cause of the distress observed in core "D" was cyclic freeze/thaw action on saturated concrete which originally contained an entrained air void system of good quality. The air void system has been compromised by secondary crystalline fillings. Excessive secondary ettringite deposition has filled many of the smallest air voids in the paste adjacent to the joint and created "non-durable" concrete.

SAMPLE ID: D DESCRIPTION: The great majority of fine spherical entrained air voidspaces at 60mm depth in the core and directly adjacent to the distressed joint (left) are filled with secondary ettringite.
MAG: 15x

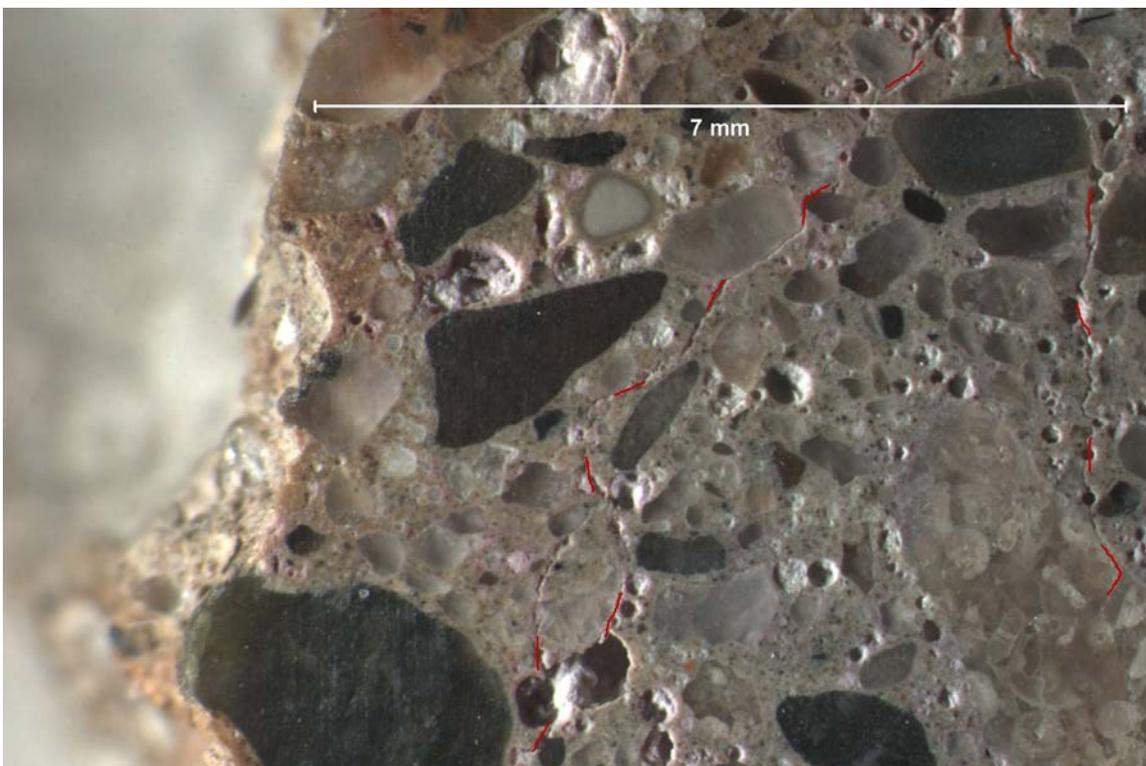
PHOTO: 16

SAMPLE ID: D DESCRIPTION: The great majority of fine spherical entrained air voidspaces at 98mm depth in the core and directly adjacent to the distressed joint (left) are filled with secondary ettringite. Microcracking, oriented sub-parallel to the distressed joint plane, is marked in red dashed line.
MAG: 15x

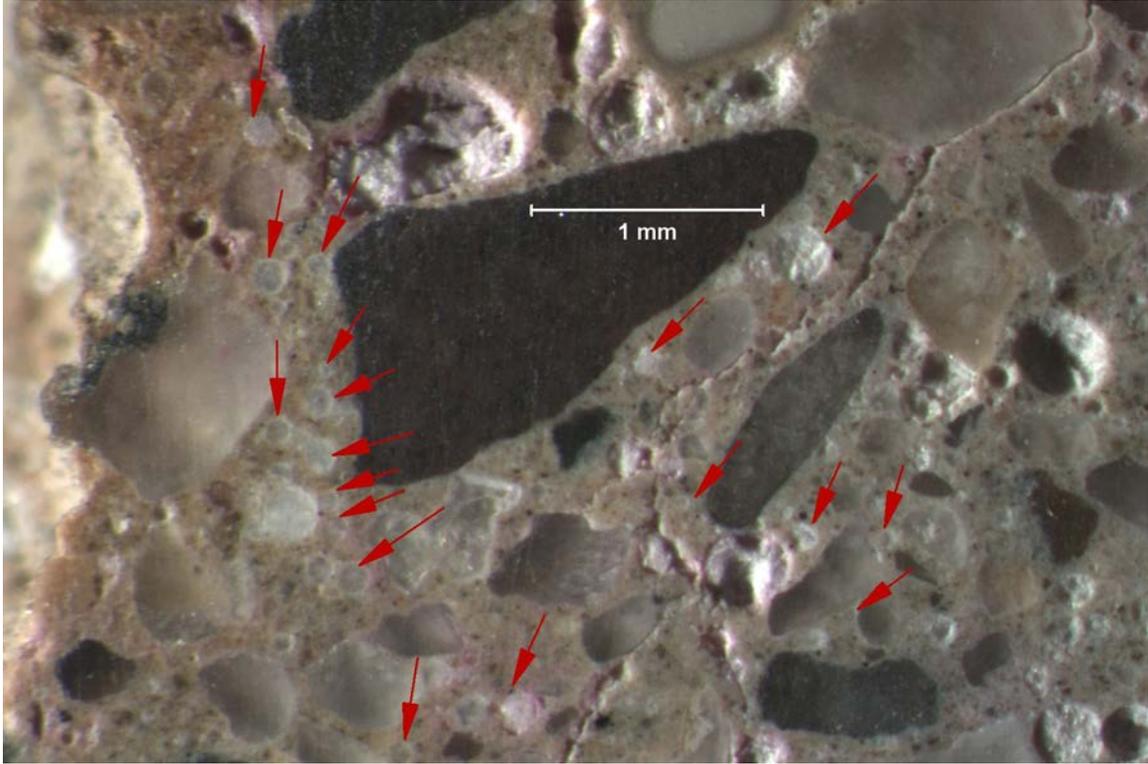
PHOTO: 17

DESCRIPTION: The great majority of fine spherical entrained air voidspaces at 98mm depth in the core and directly adjacent to the distressed joint (left) are filled with secondary ettringite.

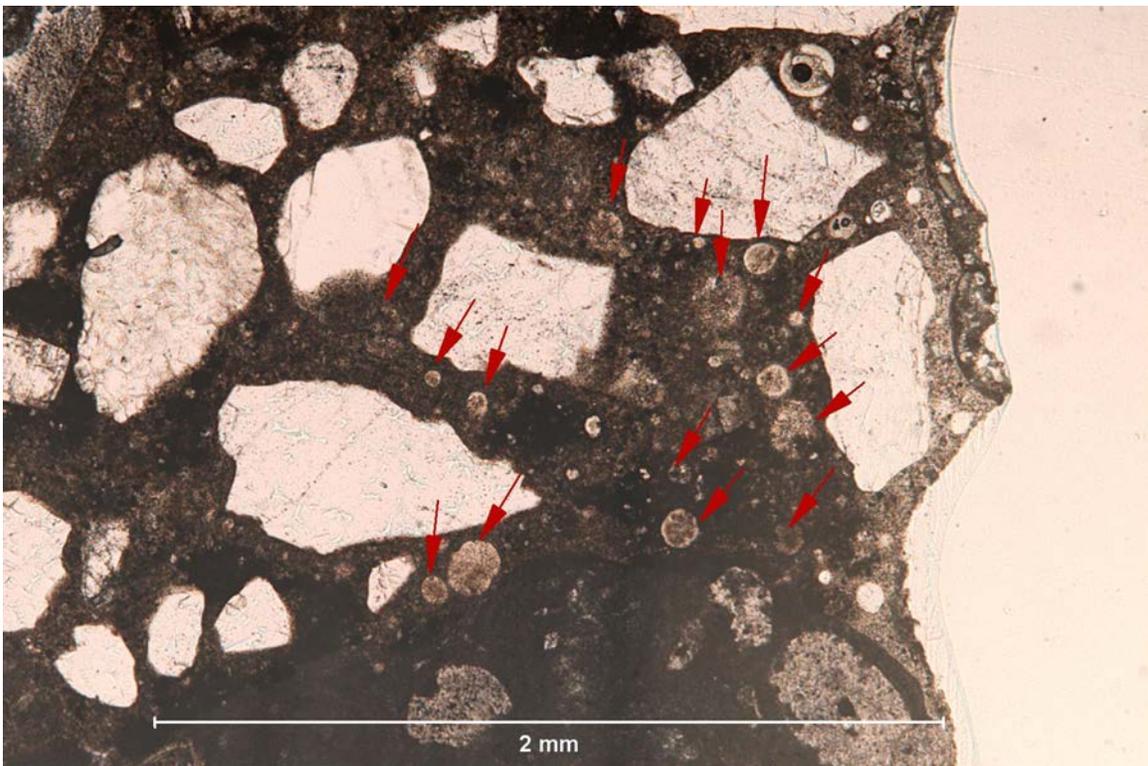
PHOTO: 18

DESCRIPTION: Fine spherical entrained air voidspaces at depth in the core, and directly adjacent to the distressed joint (right) are filled with secondary ettringite; in thin section under plane polarized light.

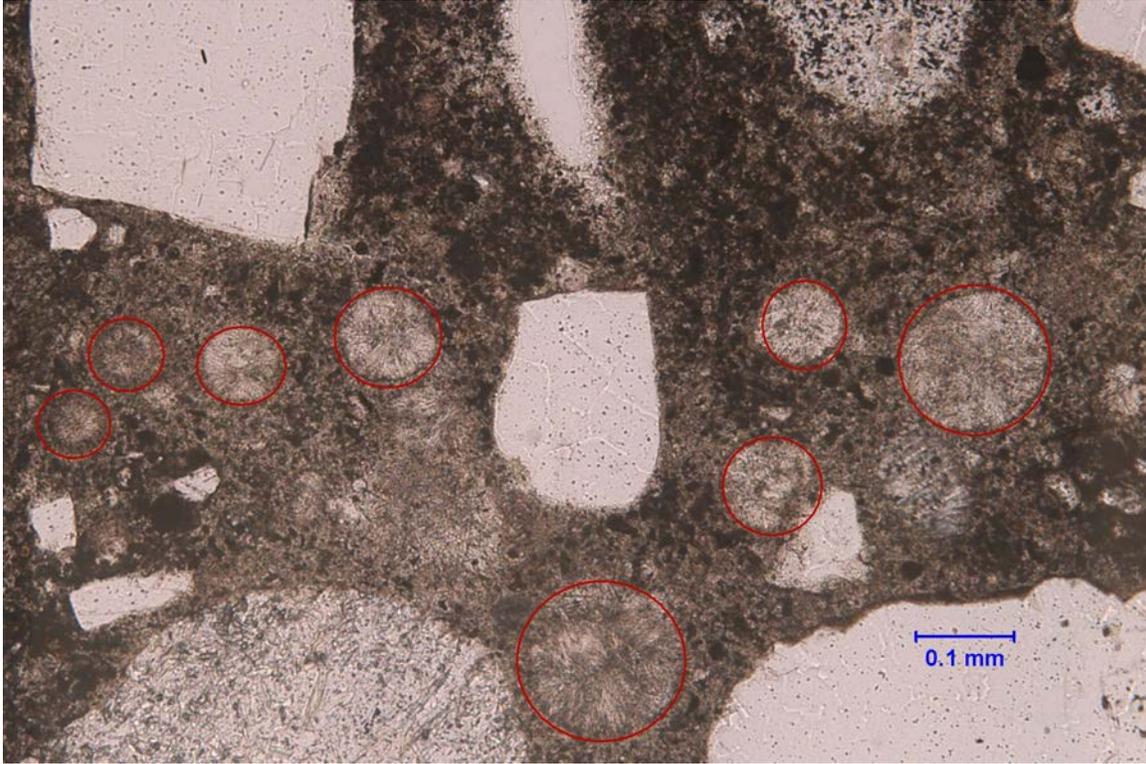
PHOTO: 19

SAMPLE ID: D DESCRIPTION: The great majority of fine spherical entrained air voidspaces at depth in the core and directly adjacent to the distressed joint, are filled with secondary ettringite.
MAG: 100x

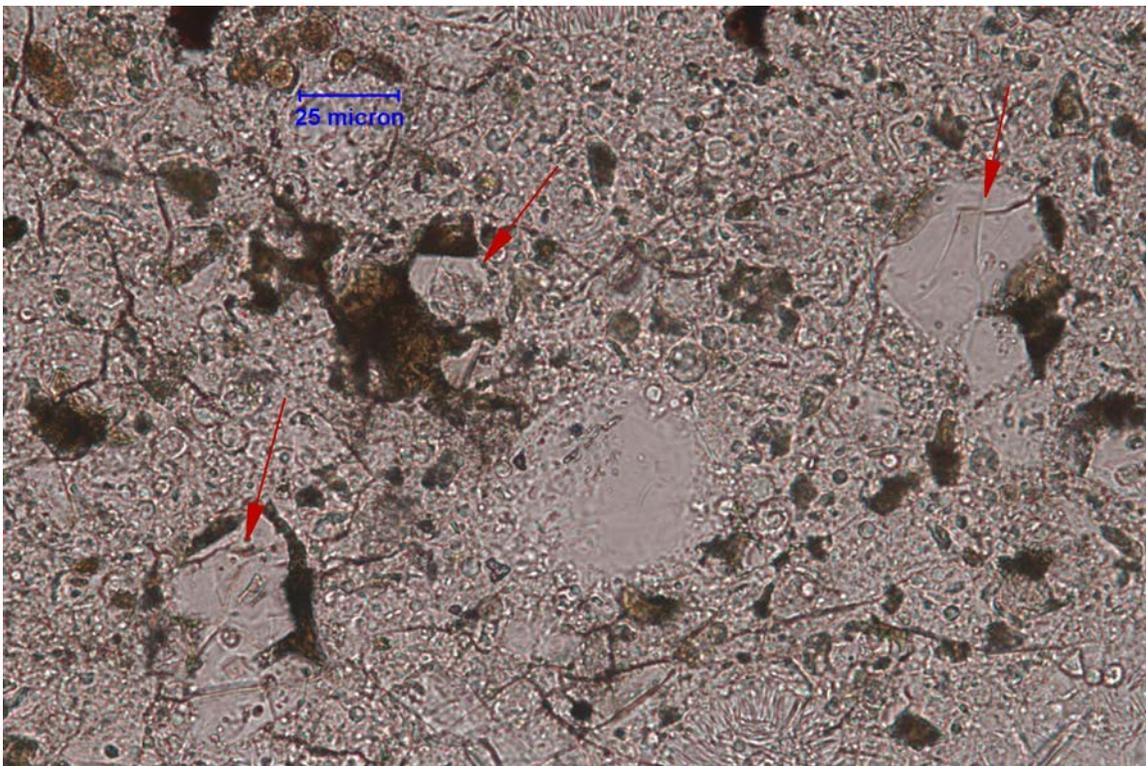
PHOTO: 20

SAMPLE ID: D DESCRIPTION: Fully hydrated alite portland cement clinker relicts (arrows) in thin section of concrete paste under plane polarized light. Note abundant spherical flyash pozzolan particles.
MAG: 400x

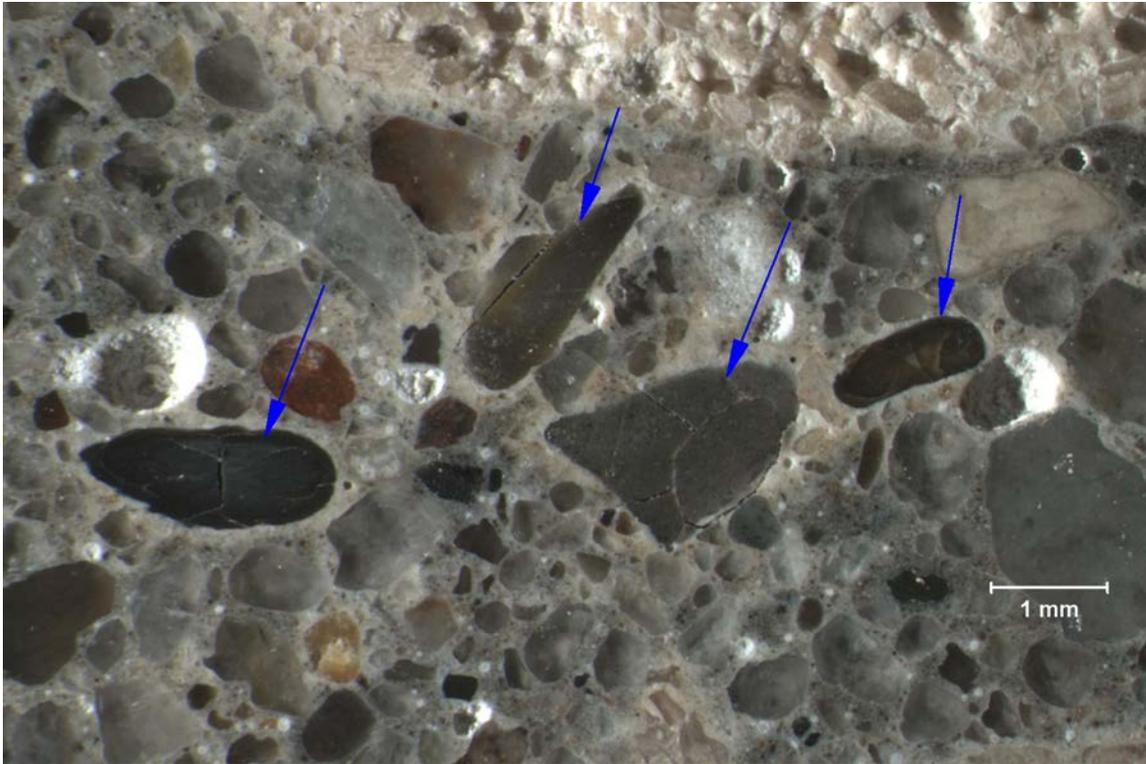
PHOTO: 25

SAMPLE ID: P1 DESCRIPTION: Abundant reactive shale particles at depth in the core.

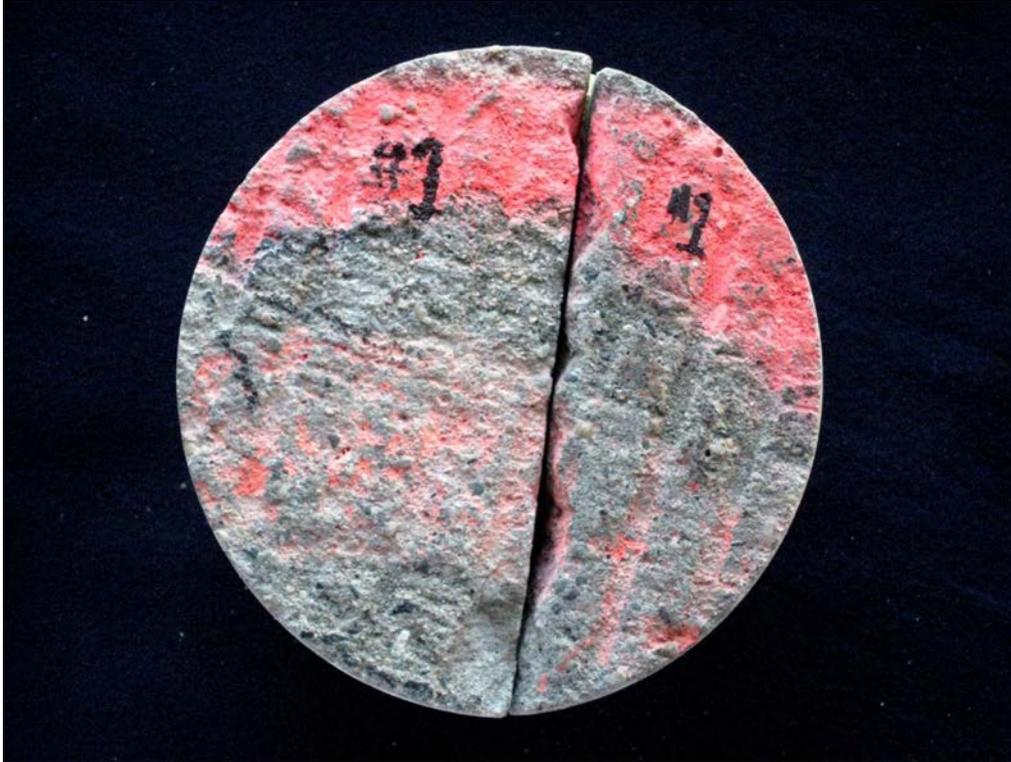
PHOTO: 3

SAMPLE ID: #1 DESCRIPTION: Top surface of the core sample, taken directly through a joint, as received.

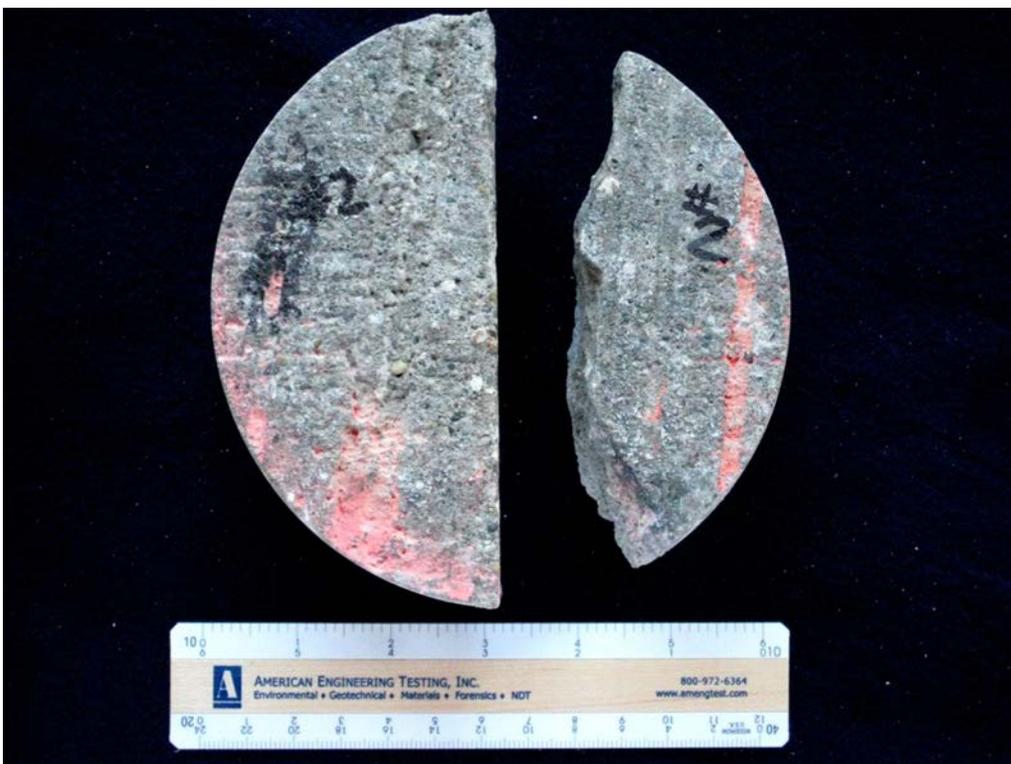
PHOTO: 4

SAMPLE ID: #2 DESCRIPTION: The top surface of the core sample, taken directly through a joint, as received.

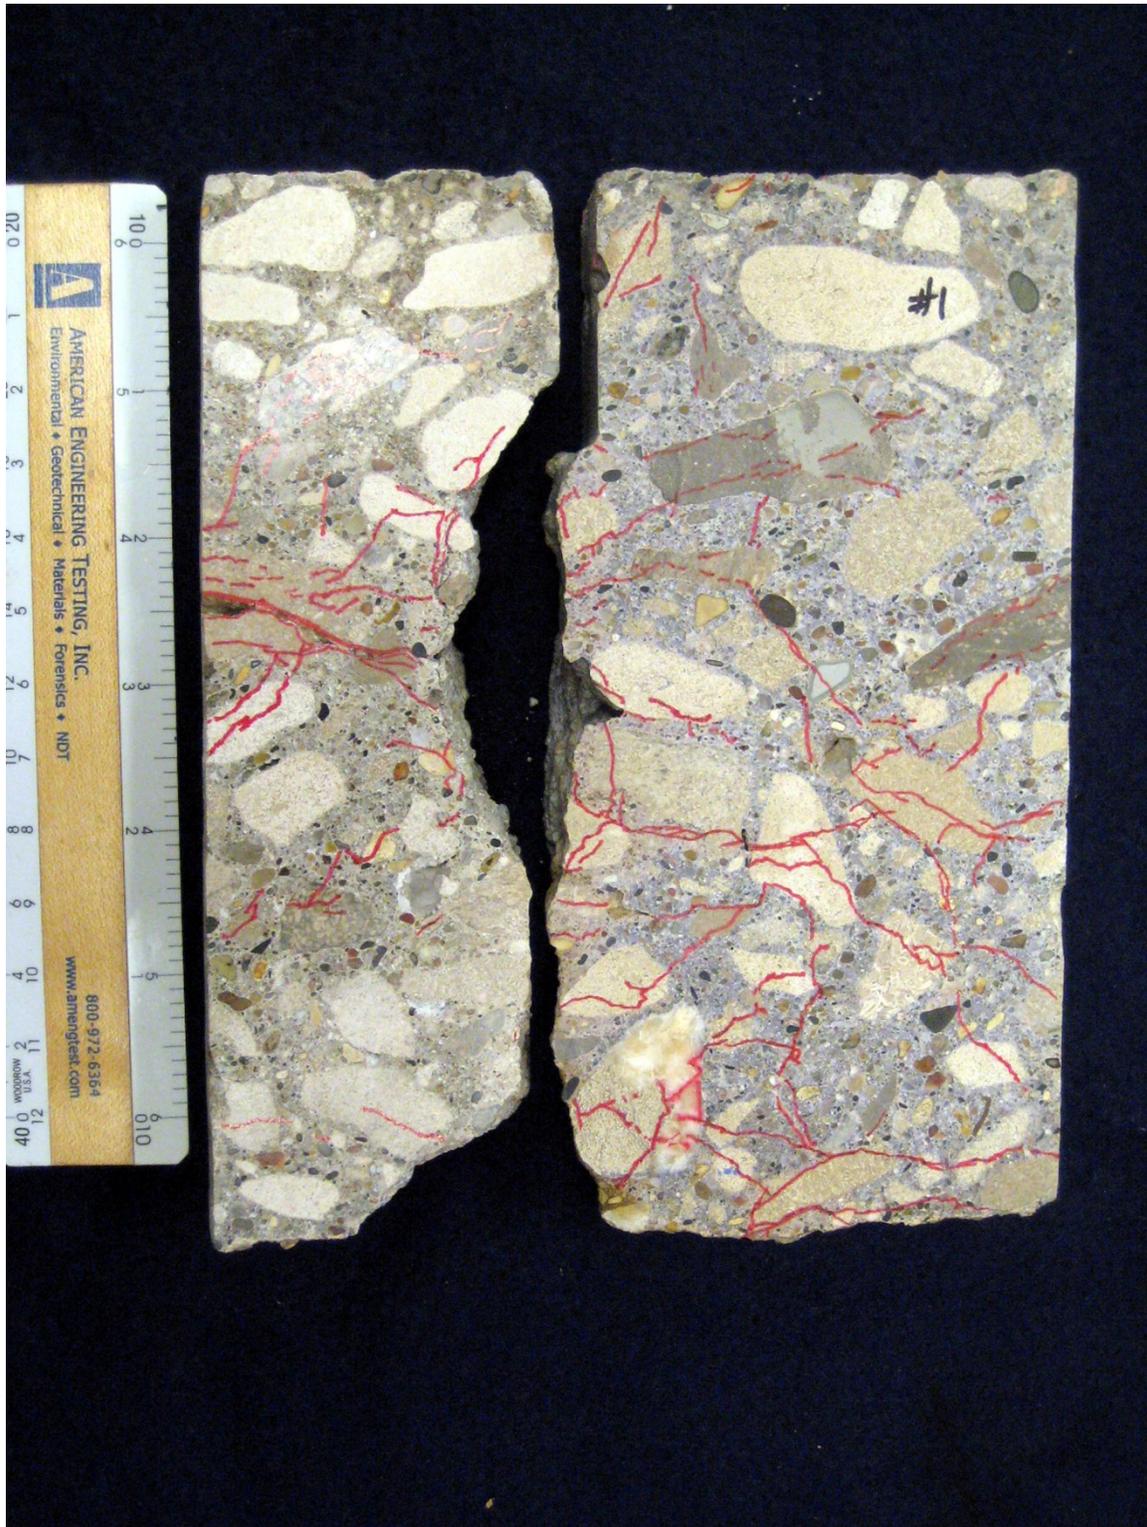
PHOTO: 5

SAMPLE ID: #1 **DESCRIPTION:** Sawcut and lapped cross section of core taken through joint. Microcracking is mapped in red ink. Note mass lost along the joint crack and cracking generally concentrated within coarse aggregate particles.

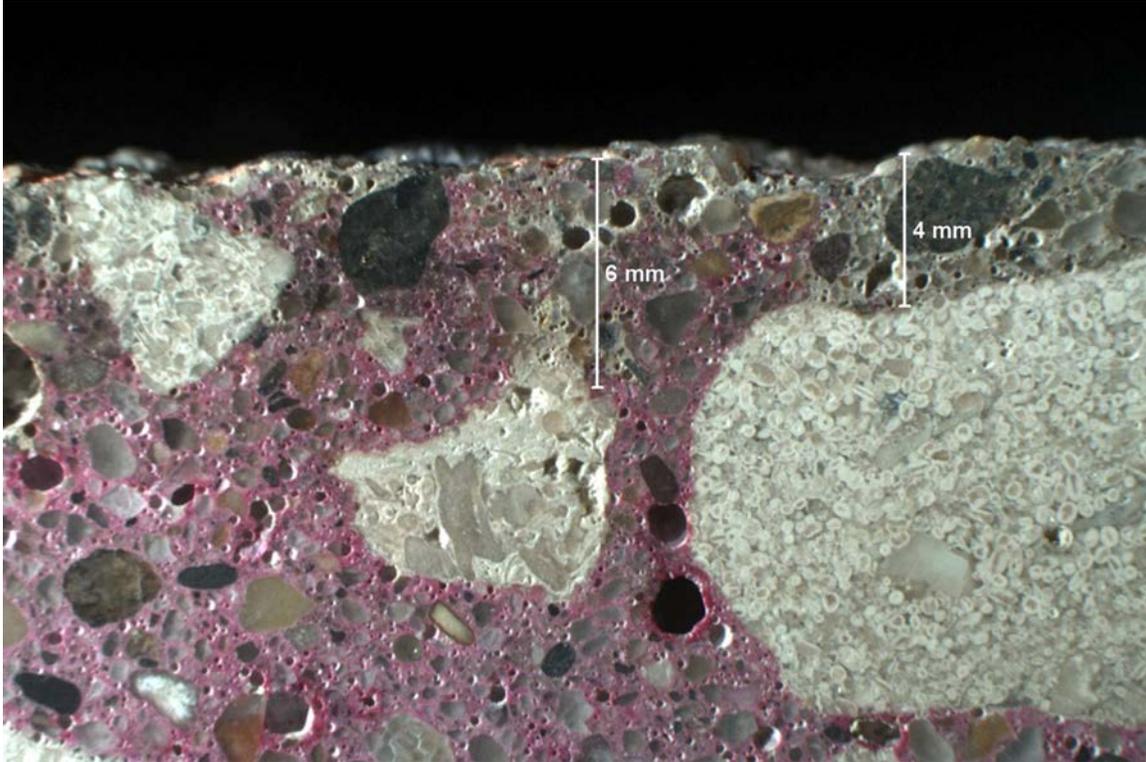
PHOTO: 8

SAMPLE ID: #1 DESCRIPTION: Carbonation (unstained paste) proceeds up to 6mm depth from the mortar eroded top surface of the core sample.
MAG: 5x

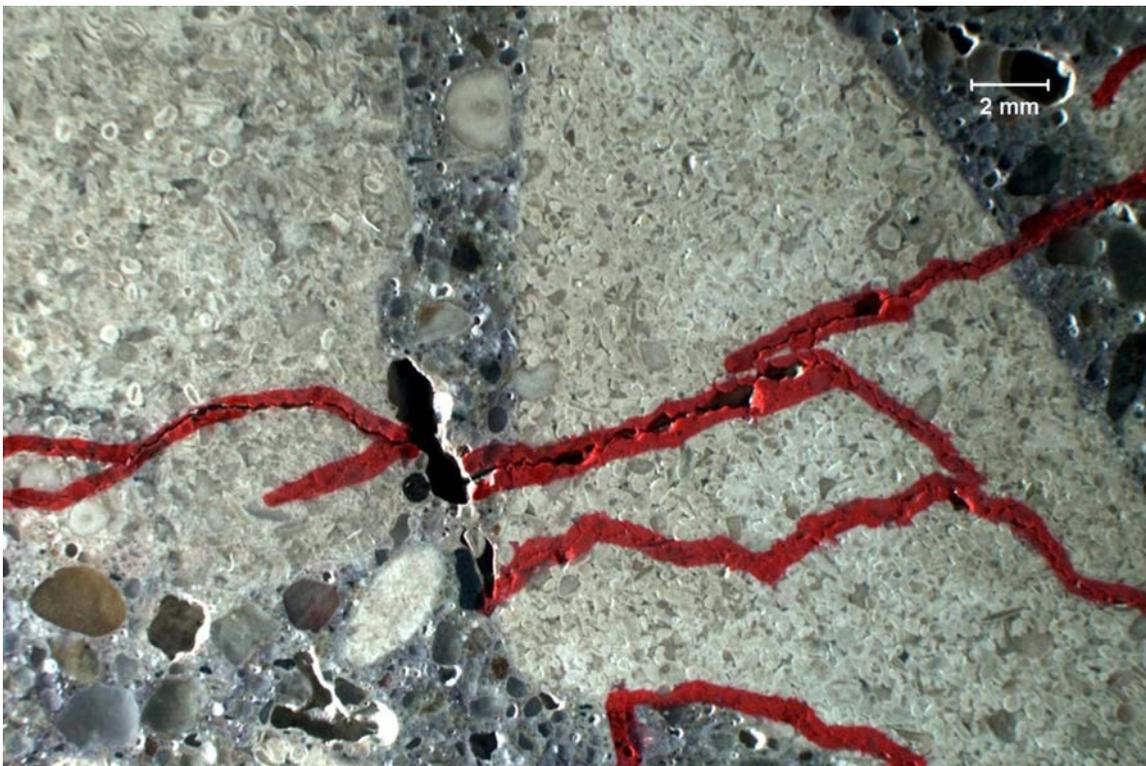
PHOTO: 9

SAMPLE ID: #1 DESCRIPTION: Microcracking, proceeding through coarse aggregates at depth in the core, is mapped in red ink.
MAG: 5x

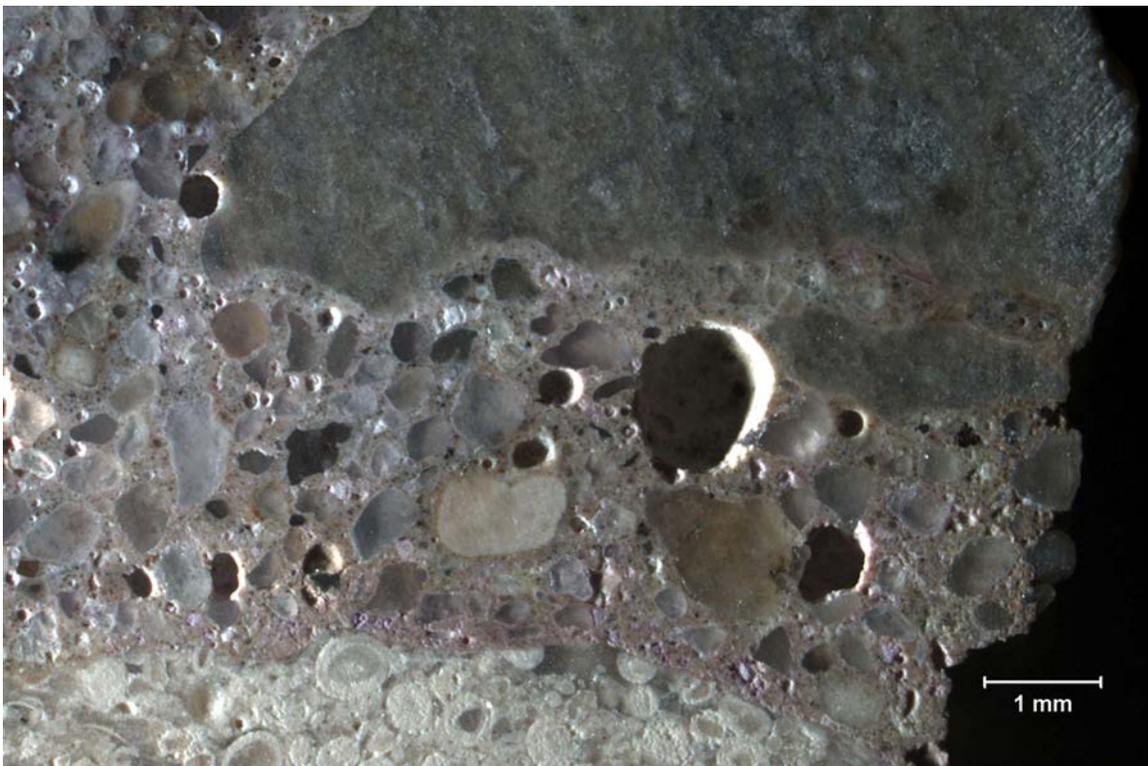
PHOTO: 11

SAMPLE ID: #1 DESCRIPTION: Much of the air voids proximate to the joint and at 140mm depth from the top surface are filled with secondary ettringite.

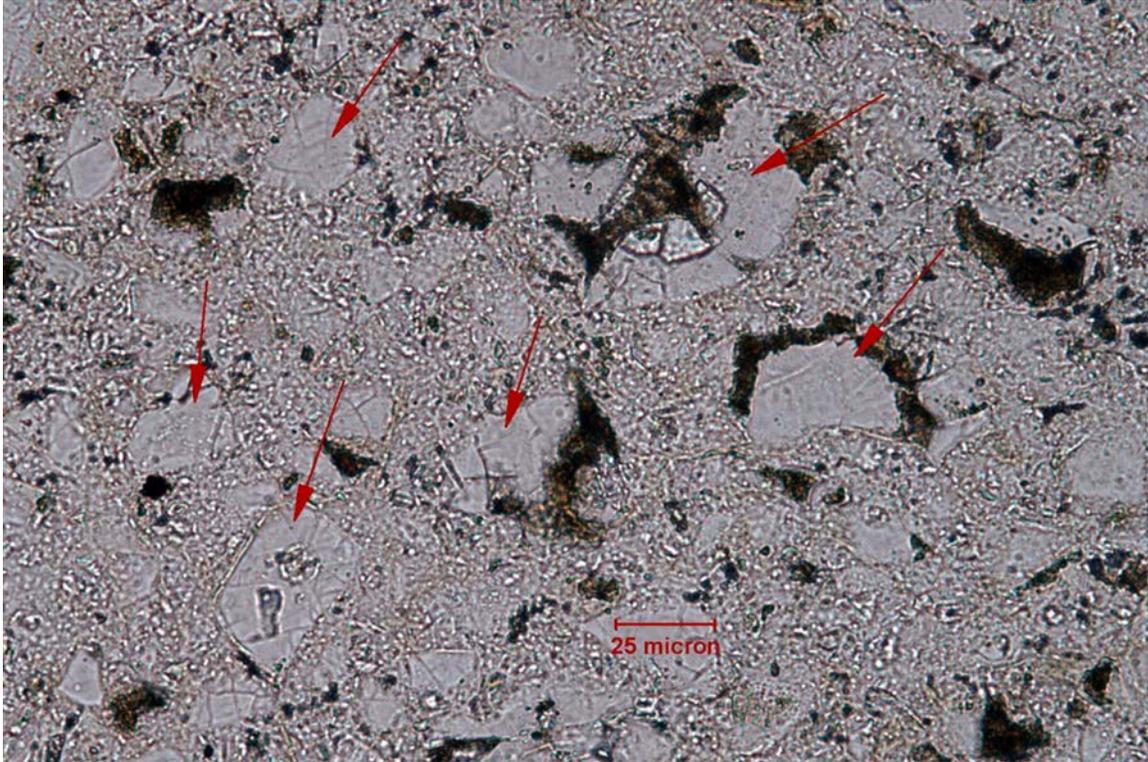
PHOTO: 14

SAMPLE ID: #1 DESCRIPTION: Well to fully hydrated alite portland cement clinker particles in thin section of concrete paste under plane polarized light.
MAG: 400x

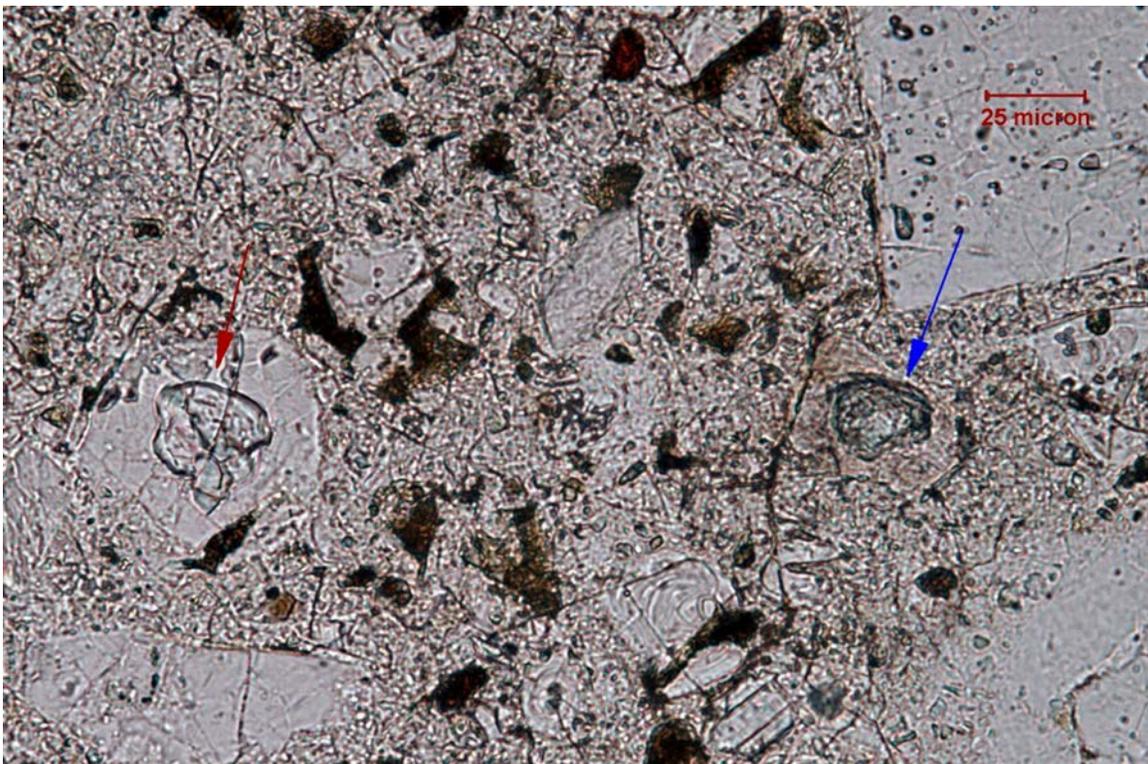
PHOTO: 15

SAMPLE ID: #2 DESCRIPTION: Well hydrated alite (red arrow) and well hydrated belite (blue) portland cement clinker particle in thin section of concrete paste under plane polarized light.
MAG: 400x

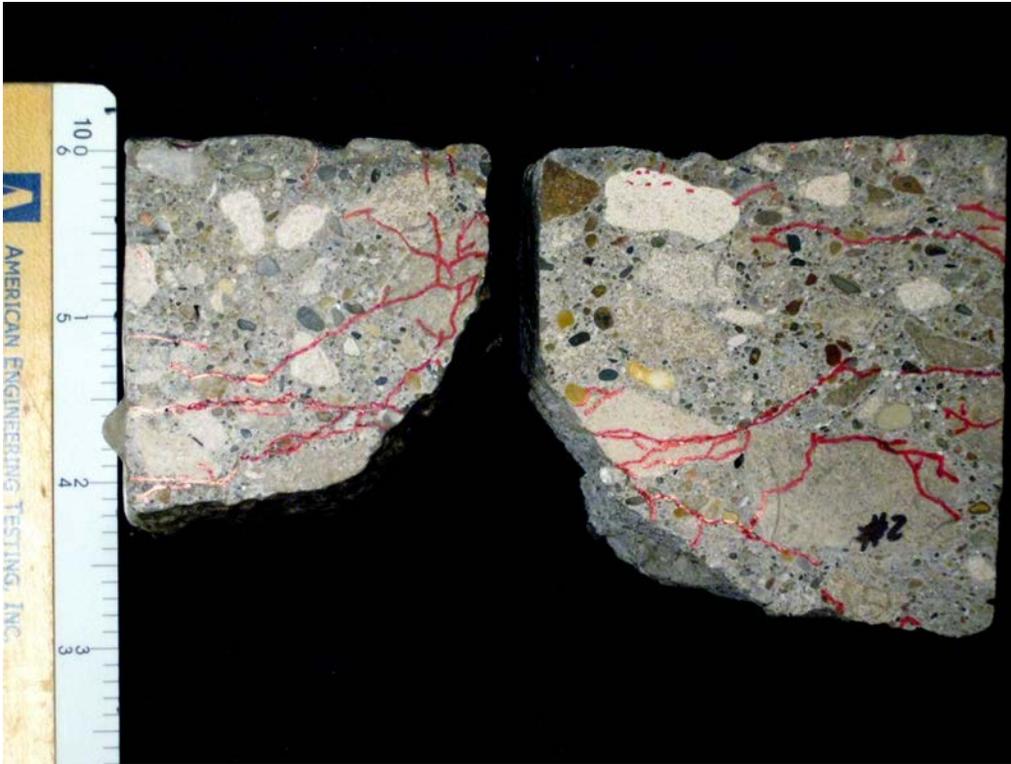
PHOTO: 16

SAMPLE ID: #2 DESCRIPTION: Sawcut and lapped cross section of core taken through a distressed joint. Microcracking is mapped in red ink. Note some concentration within coarse aggregate particles.
