Investigation of Deterioration of Joints in Concrete Pavements

National Concrete Pavement
Technology Center

Final Report
August 2012

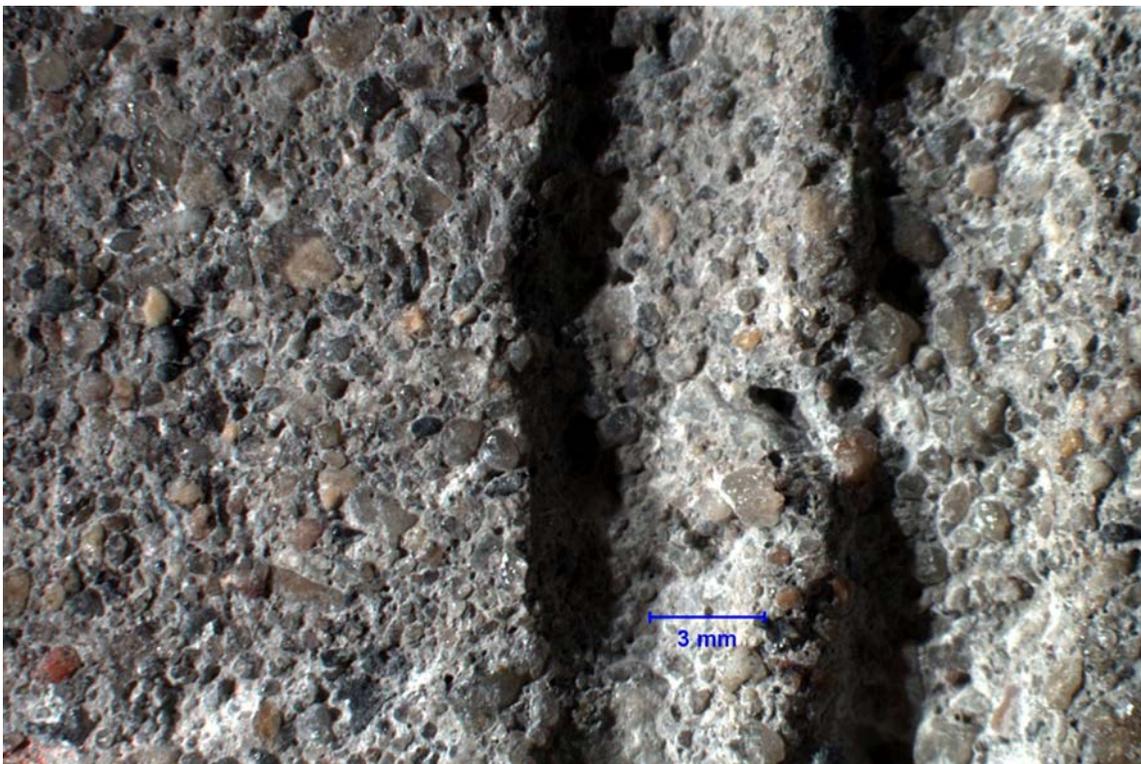
PHOTO: 17

SAMPLE ID: #2 DESCRIPTION: The top surface of the core has undergone moderate mortar erosion exposing many fine aggregates.

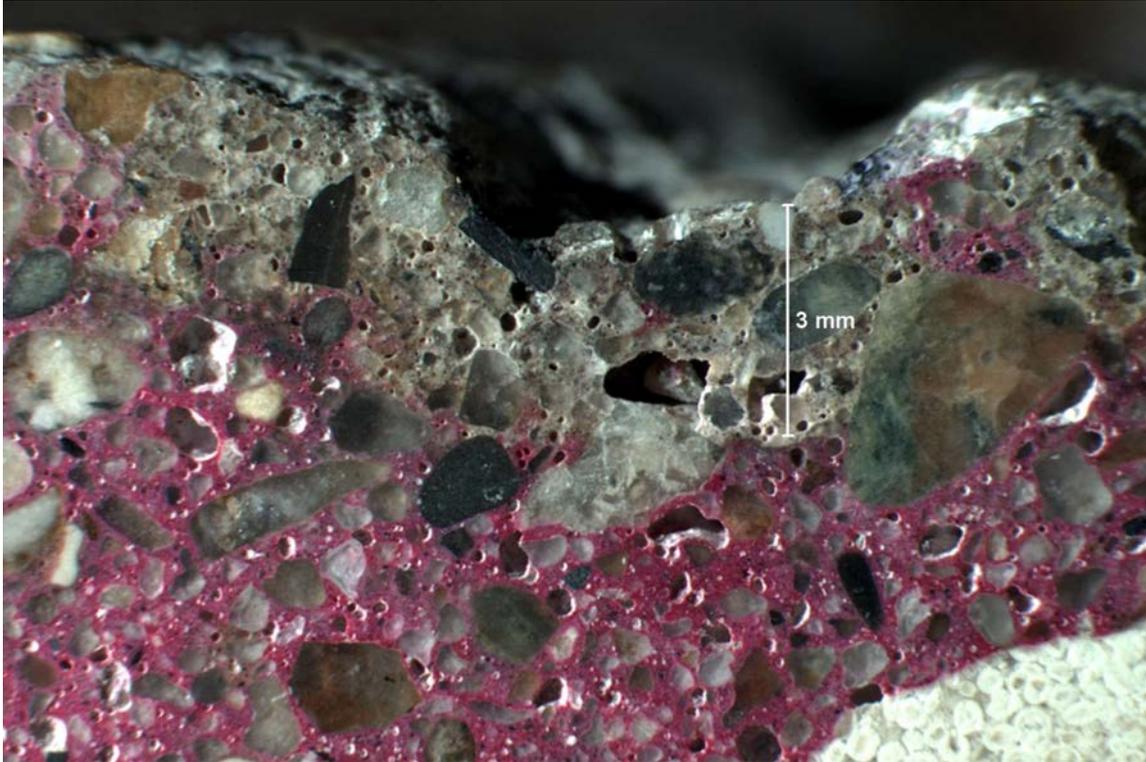
PHOTO: 18

SAMPLE ID: #2 DESCRIPTION: Carbonation (unstained paste) ranges from negligible to 3mm depth from the top surface of the core. In freshly sawcut and lapped cross section of core exposed to phenolphthalein pH indicator.
MAG: 10x

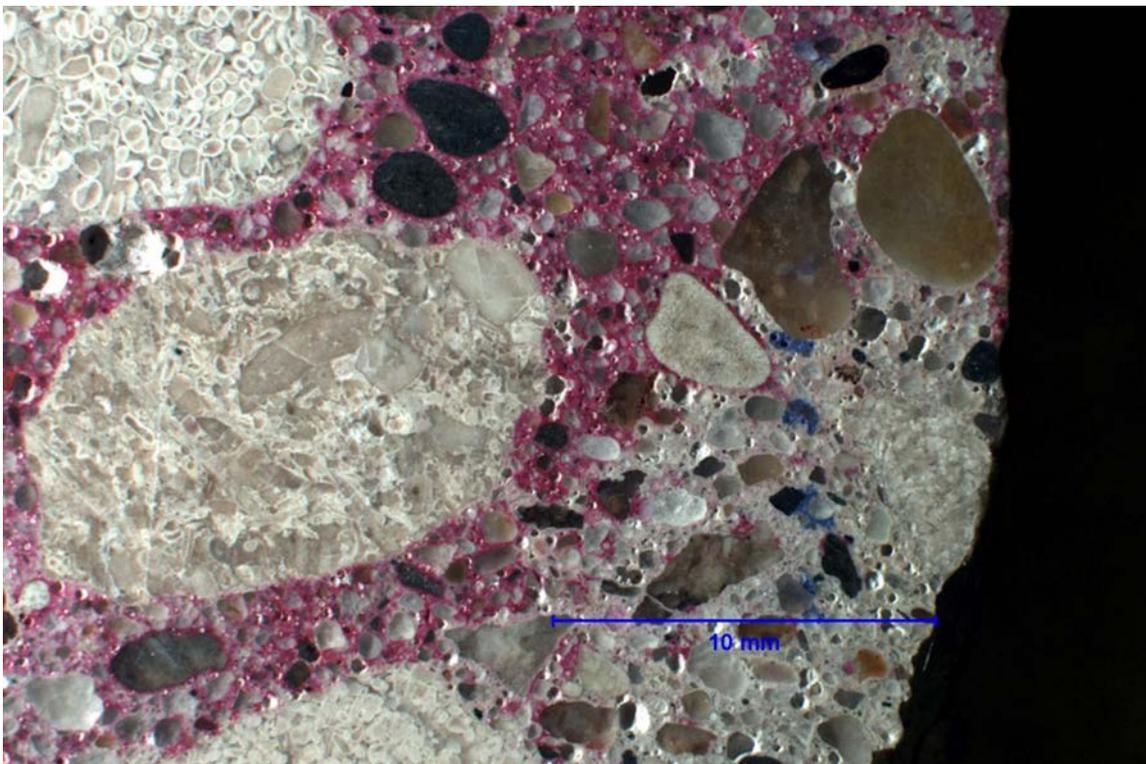
PHOTO: 19

SAMPLE ID: #2 DESCRIPTION: Carbonation (unstained paste) ranges from negligible to 10mm depth from the sawcut and distressed joint surface of the core (R).
MAG: 5x

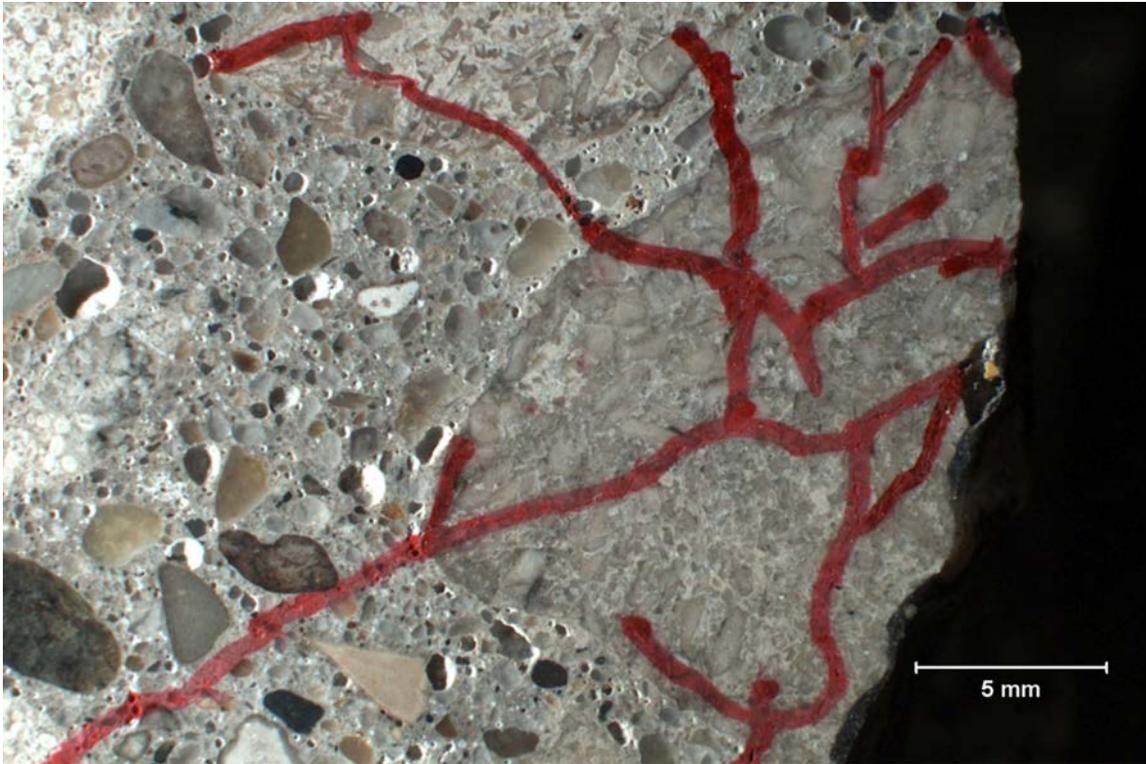
PHOTO: 20

SAMPLE ID: #2 DESCRIPTION: Microcracking, mapped in red ink, appears to concentrate within a coarse aggregate particle at the distressed joint plane.
MAG: 5x

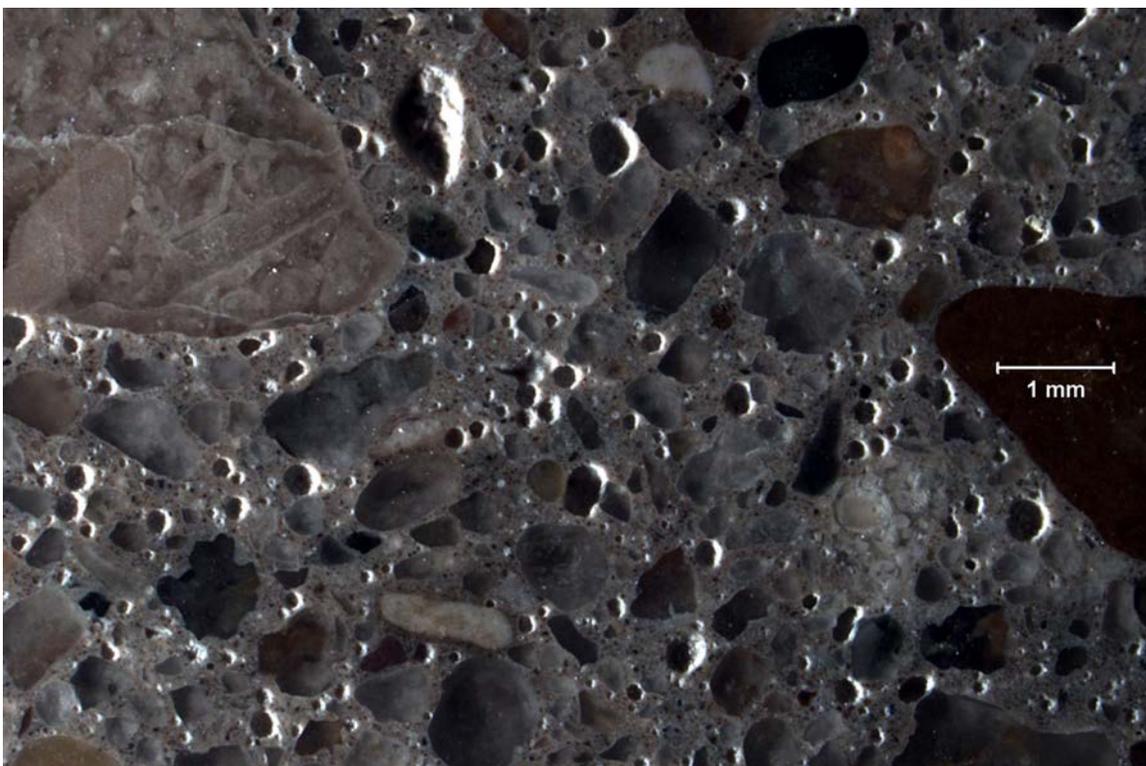
PHOTO: 21

SAMPLE ID: #2 DESCRIPTION: Overall hardened air void content proximate to the top surface.
MAG: 15x

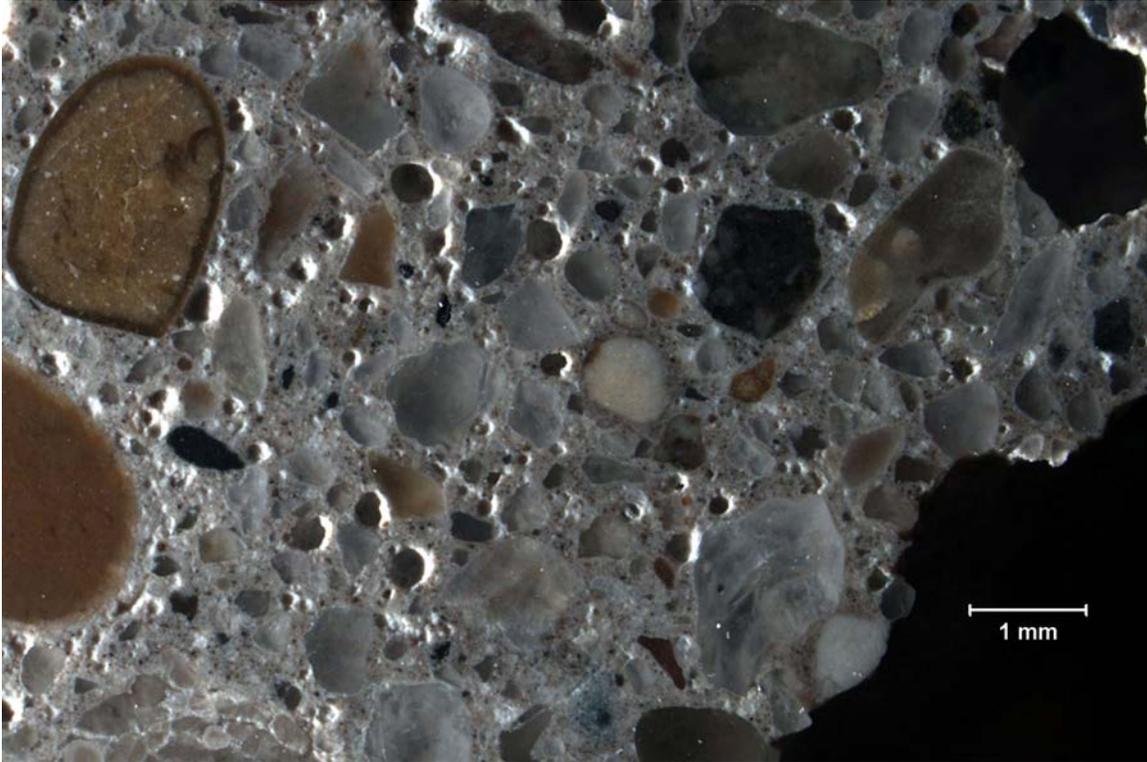
PHOTO: 22

SAMPLE ID: #2 DESCRIPTION: Much of the finer air voidspaces in the concrete paste, proximate to the joint distress and at 55mm depth in the core, are filled with secondary ettringite
MAG: 5x

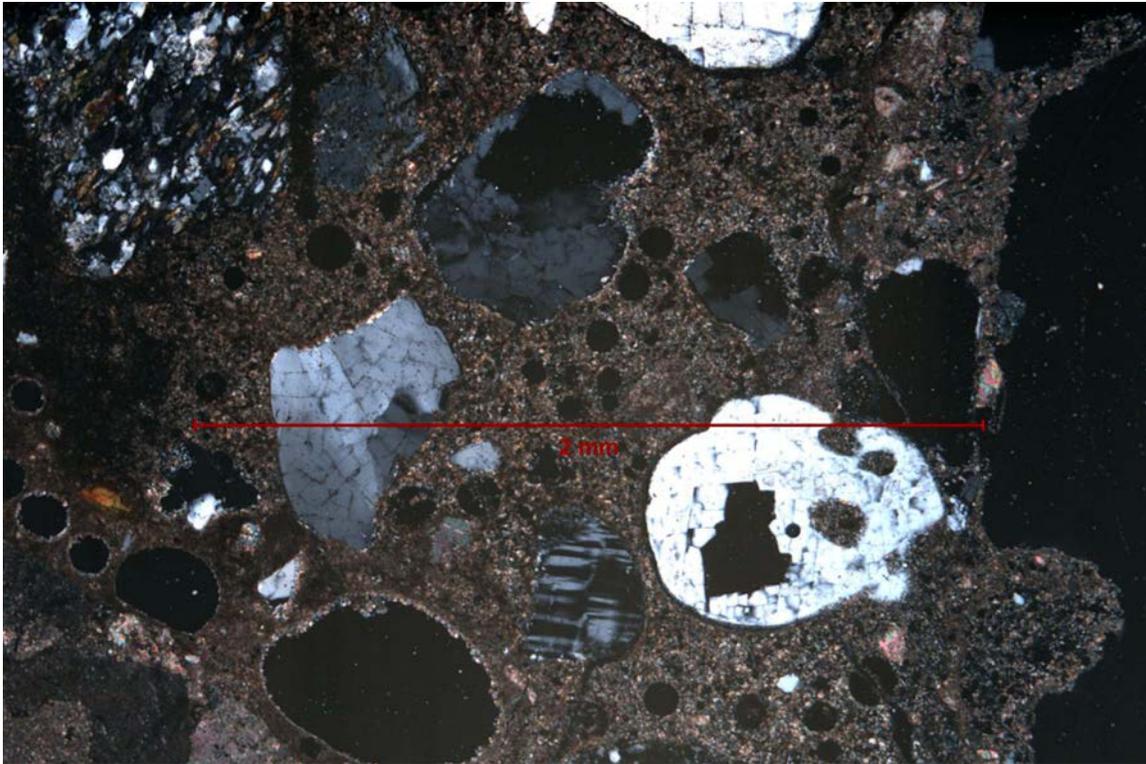
PHOTO: 24

SAMPLE ID: #2 DESCRIPTION: Brightly colored, carbonated concrete paste to 2mm depth from the joint distress plane (right); in thin section of concrete under cross polarized light.
MAG: 40x

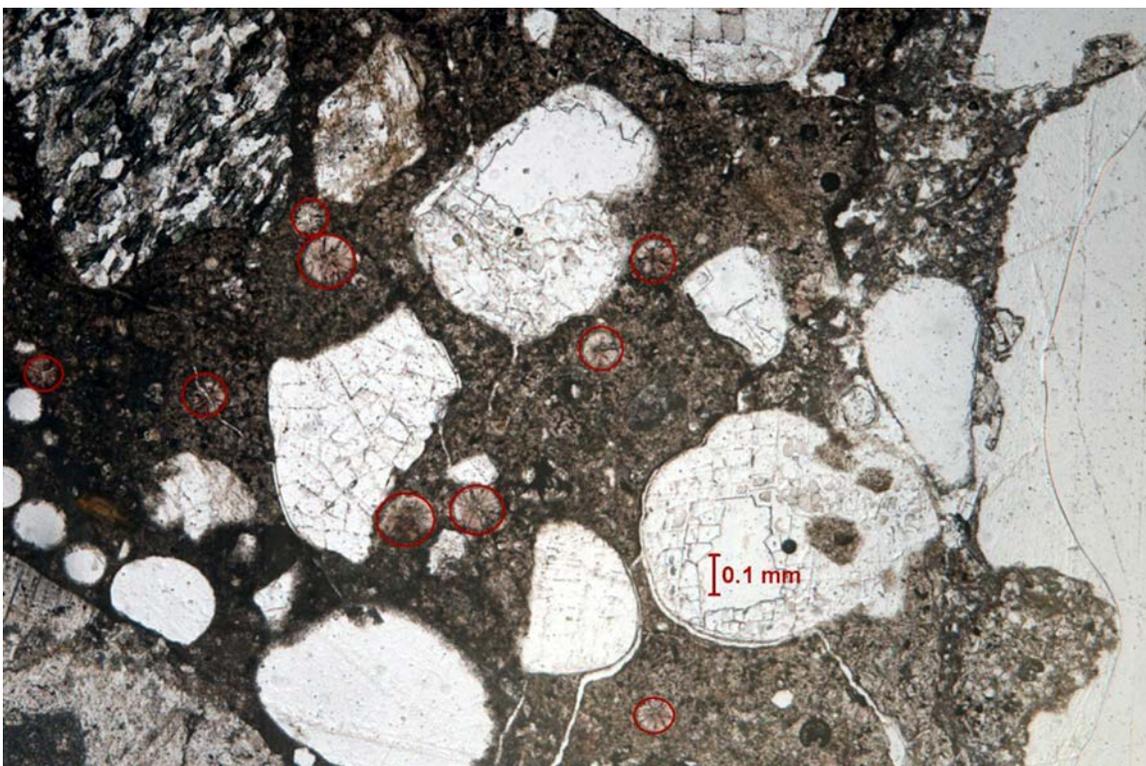
PHOTO: 25

SAMPLE ID: #2 DESCRIPTION: Much of the air voids proximate to the joint are filled with secondary ettringite; outlined in red in thin section under plane polarized light.
MAG: 40x

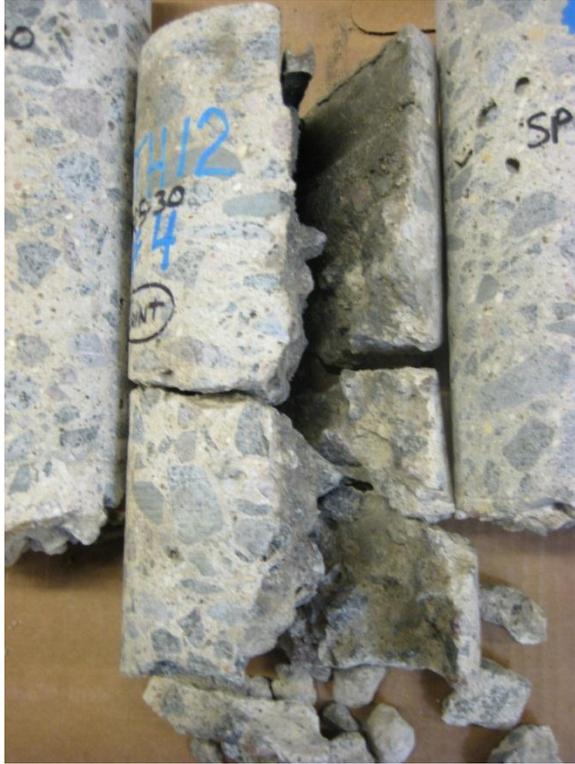
Figure 1. 4705-30 Core 4

Two cores were taken from Route 12 west of Minneapolis. One, labeled 4 (Figure 1), was selected as representing a distressed joint, while the other, labeled 7, appeared to be in better condition (Figure 2).

- The silicone sealant in both joints was de-bonded from the concrete
- Both joints were cracked out
- Damage in Core 7 was extensive but some damage was observed in Core 4
- Cracking is typical of freeze-thaw distress
- Both cores exhibited air voids filled with ettringite and the depth of ettringite-filled voids is greater in Core 4, indicating greater permeability in this core
- Carbonation is slightly deeper in Core 4 than Core 7, also indicating greater permeability
- The air void parameters are shown in Table 1
- Both samples contained 15-25% fly ash
- Top surface of both cores was in good condition

3. Core "4" was centered and taken directly through a silicone sealed (with backer rod), sawcut control joint. The top surface of the core exhibited minor mortar erosion. The silicone sealant was mostly de-bonded on both sides of the joint and the sawcuts were in relatively pristine condition; apart from "rounding" and wear of the top surface edges. Apart from the very thin top few millimeters (meniscus) of the silicone, the joint sealant mostly "cleanly" de-bonded from the sawcut and the vertical surfaces of the sealant in contact with the concrete are darkly stained. The distress in core "4" was characterized by mass lost along the entire depth of the resulting joint crack; with the greatest loss of 10mm to 20mm between approx. 95mm and 182mm depth in the core. Some incipient distress (sub-vertical microcracking) was observed between 115mm and 135mm depth in the joint. The concrete was purposefully air entrained and originally contained a well-distributed air void system considered freeze-thaw resistant under severe exposure conditions. Overall original air void parameters include a 6.9% entrained-sized void volume and a 0.004" spacing factor. Secondary ettringite, with some portlandite, fills most of the smaller entrained sized voidspaces within approx. 10mm of the joint plane/crack surface; rendering this layer of concrete non-durable. Void fillings decrease with depth from this zone. Sub-horizontal fractures and microcracking of unknown origin was present below 83mm depth in the core. The fracture plane at approx. 130mm depth was stained and aged and not a result of coring.

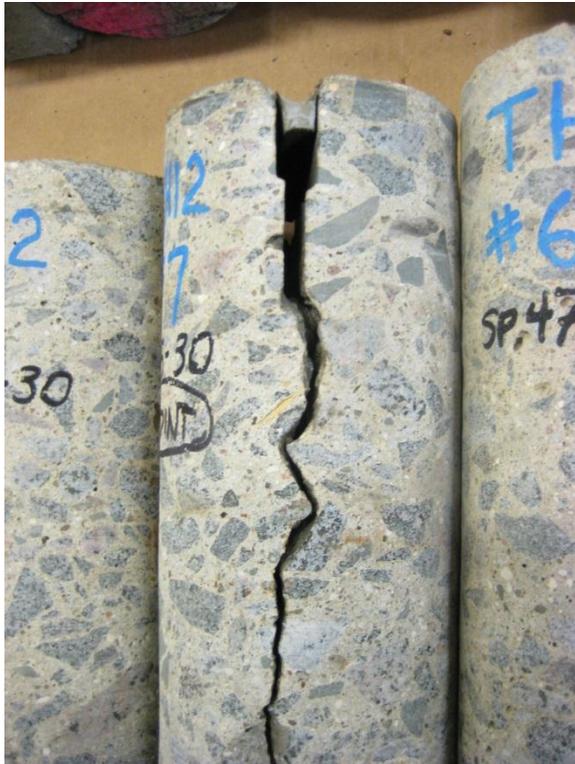
Figure 2. 4705-30 Core 7

4. Core "7" was centered and taken directly through a silicone sealed (with backer rod), sawcut control joint. The top surface of the core exhibited minor mortar erosion. The silicone sealant was mostly de-bonded on both sides of the joint and the sawcuts were in relatively pristine condition; apart from "rounding" and wear of the top surface edges. In general, apart from the very thin top few millimeters (meniscus) of the silicone, the joint sealant mostly "cleanly" de-bonded from the sawcut and the vertical surfaces of the sealant in contact with the concrete are darkly stained. The distress in core "7" was characterized by mass lost along the entire depth of the resulting joint crack; with the greatest loss of 10mm to 20mm between approx. 95mm and 182mm depth in the core. Some incipient distress (sub-vertical microcracking) was observed between 115mm and 135mm depth in the joint. The concrete was purposefully air entrained and originally contained a well-distributed air void system considered freeze-thaw resistant under severe

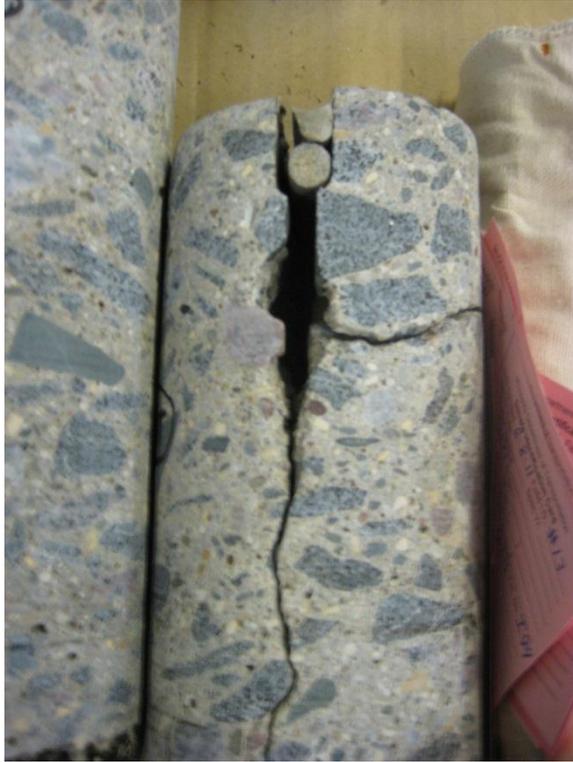
Figure 3. 7380 Core 7009

Two cores were taken from Route 94 near Brainerd. One, labeled 7009 (Figure 3), was selected as representing a distressed joint including a so-called tunnel at the bottom of the joint, while the other, labeled 7012, appeared to be in better condition (Figure 4).

- The silicone sealant was de-bonded from the concrete in core 7009 but bonded in core 7012
- Both joints were cracked out
- Damage typical of freeze-thaw distress was extensive in Core 7009 and no damage was observed in Core 7012
- Both cores exhibit air voids filled with ettringite but the extent is greater in Core 7009
- Carbonation is slightly deeper in Core 7012 than Core 7009
- The air void parameters are shown in Table 1
- Both samples contained 15-25% fly ash
- Top surface of both cores was in good condition

6. Core "7009" was centered and taken directly through a silicone sealed (with backer rod), sawcut control joint. The top surface of the core exhibited minor mortar erosion. The silicone sealant was completely de-bonded from one side of the joint and the sawcuts were in relatively pristine condition; apart from "rounding" and wear of the top surface edges. In general, apart from the very thin top few millimeters (meniscus) of the silicone, the joint sealant was "cleanly" de-bonded from the one side of the sawcut and the vertical surface of the sealant in contact with the concrete are darkly stained. The distress in core "7009" was characterized chiefly by "tunneling"; an oval shaped loss of paste to 22mm in width between approx. the base of the reservoir sawcut and approx. 90mm depth in the core. Significant incipient distress (sub-vertical microcracking) was observed on both sides of the joint crack to 20mm depth laterally and between 120mm depth and the bottom surface of the core. Measured "existing" air void parameters in the 0 to 25mm of the paste directly adjacent to the joint crack and in the lower half of the core are poor and include a loss of 1.5% entrained sized air void volume and a spacing factor which rose from 0.006" to 0.010".

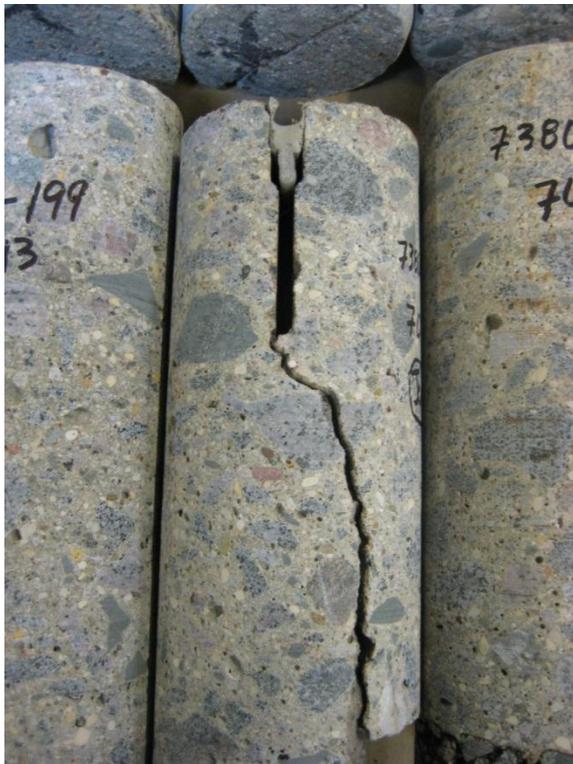
Figure 4. 7380 Core 7012

7. Core "7012" was centered and taken directly through a silicone sealed (with backer rod), sawcut control joint. The top surface of the core exhibited minor mortar erosion. The silicone sealant was well bonded to both sides of the joint and the sawcuts were in relatively pristine condition; apart from "rounding" and wear of the top surface edges. The silicone sealant exhibits good bond and contact along its entire thickness. No distress was observed along the entire depth of the joint. the concrete was purposefully air entrained and exhibits high quality parameters for freeze-thaw resistance under severe exposure conditions. Secondary ettringite does fill some of the smaller entrained sized voidspaces within 3mm of the joint crack plane and within several millimeters of the base of the pilot sawcut.

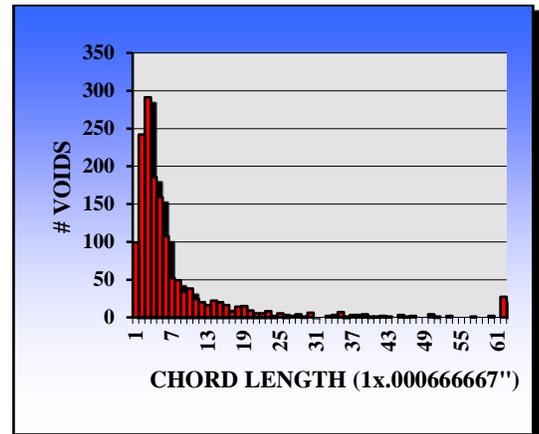
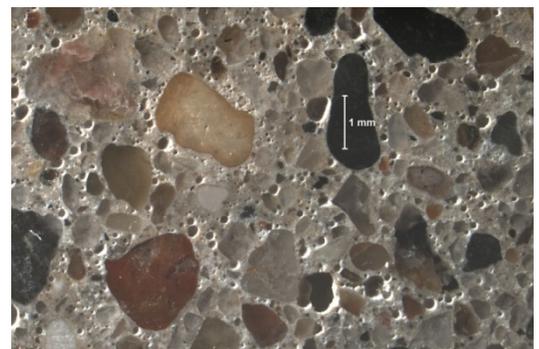
Air Void Content %	9.6
Entrained, % < 0.040"(1mm)	6.9
Entrapped, % > 0.040"(1mm)	2.7
Air Voids/inch	15.3
Specific Surface, in ² /in ³	640
Spacing Factor, inches	0.004
Paste Content, % estimated	26
Magnification	75x
Traverse Length, inches	100
Test Date	1/31/2012

Magnification: 15x
Description: Hardened air void system 20mm from the top surface.

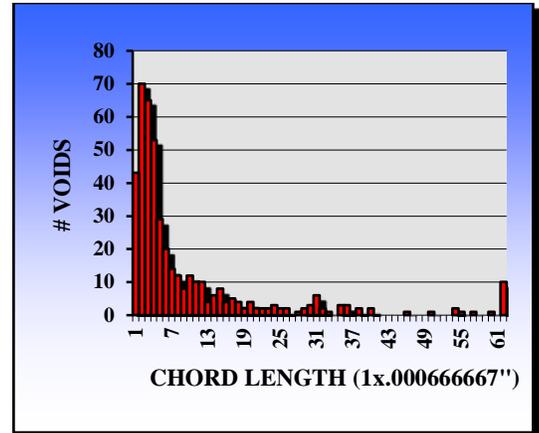
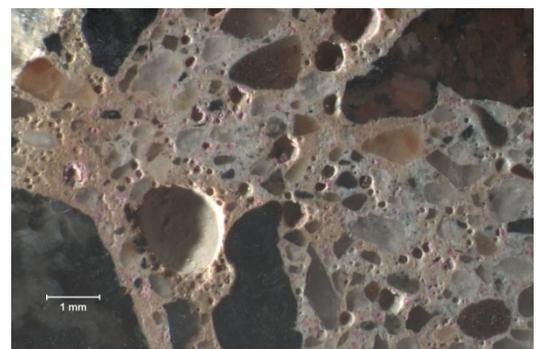
Test Data: By ASTM C:457
Air Void Content % 8.3
Entrained, % < 0.040"(1mm) 4.8
Entrapped, % > 0.040"(1mm) 3.5
Air Voids/inch 8.8
Specific Surface, in²/in³ 420
Spacing Factor, inches 0.007
Paste Content, % estimated 26
Magnification 75x
Traverse Length, inches 50
Test Date 1/31/2012

Magnification: 15x
Description: Hardened air void system 150mm from the top surface and at the joint crack.

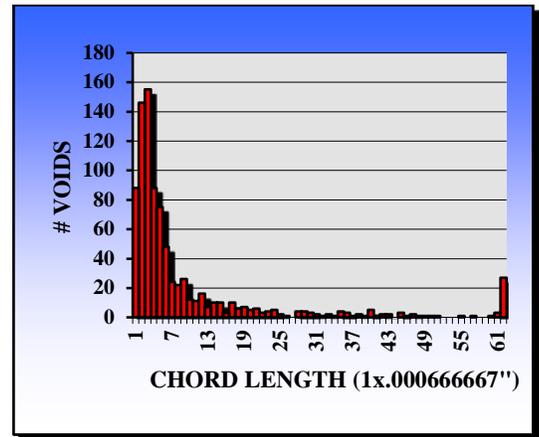
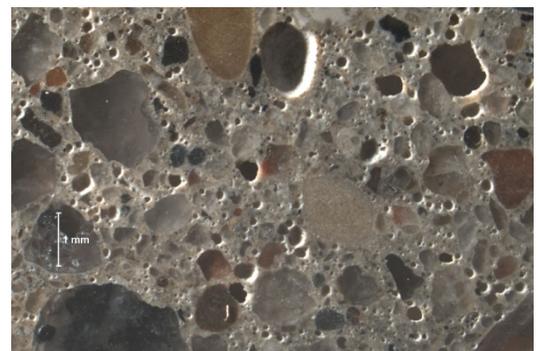
Air Void Content %	6.7
Entrained, % < 0.040"(1mm)	4.3
Entrapped, % > 0.040"(1mm)	2.4
Air Voids/inch	8.7
Specific Surface, in ² /in ³	520
Spacing Factor, inches	0.007
Paste Content, % estimated	26
Magnification	75x
Traverse Length, inches	100
Test Date	1/31/2012

Magnification: 15x
Description: Hardened air void system 10mm from the top surface.

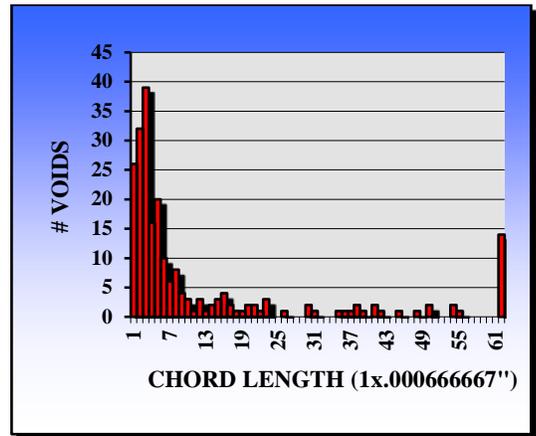
Test Data: By ASTM C:457
 Air Void Content % 4.6
 Entrained, % < 0.040"(1mm) 2.5
 Entrapped, % > 0.040"(1mm) 2.1
 Air Voids/inch 4.5
 Specific Surface, in²/in³ 390
 Spacing Factor, inches 0.013
 Paste Content, % estimated 26
 Magnification 75x
 Traverse Length, inches 50
 Test Date 1/31/2012

Magnification: 30x
 Description: Filled air void system 120mm from the top surface and 8mm from the joint crack.

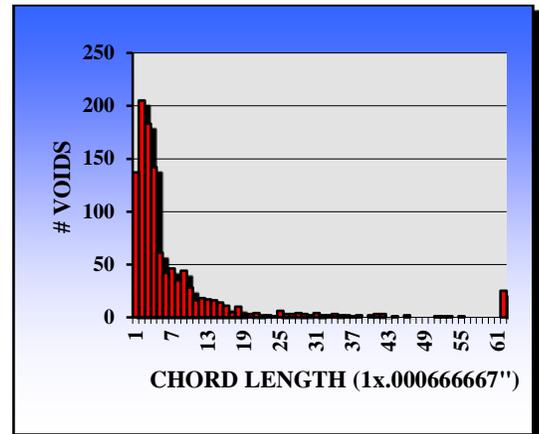
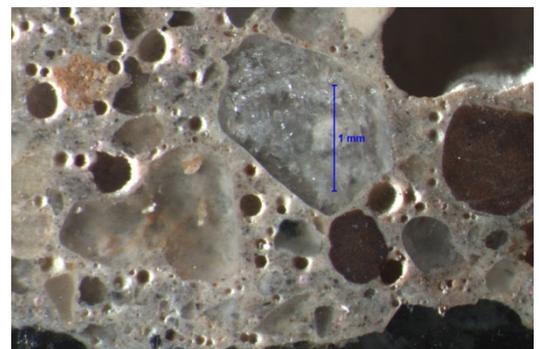
Air Void Content %	7.0
Entrained, % < 0.040"(1mm)	4.9
Entrapped, % > 0.040"(1mm)	2.1
Air Voids/inch	11.5
Specific Surface, in ² /in ³	660
Spacing Factor, inches	0.006
Paste Content, % estimated	26
Magnification	75x
Traverse Length, inches	98
Test Date	2/29/12

Magnification: 30x
Description: Hardened air void system 70mm from top; 45mm from joint.

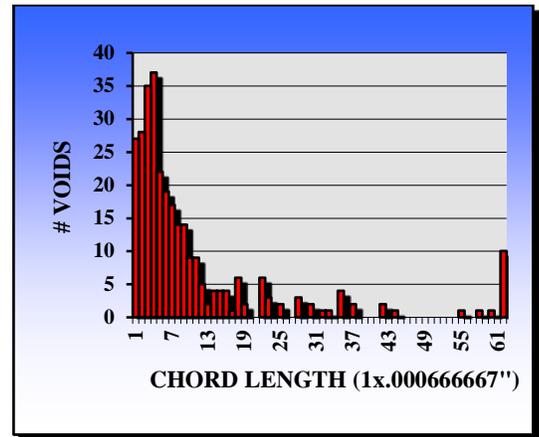
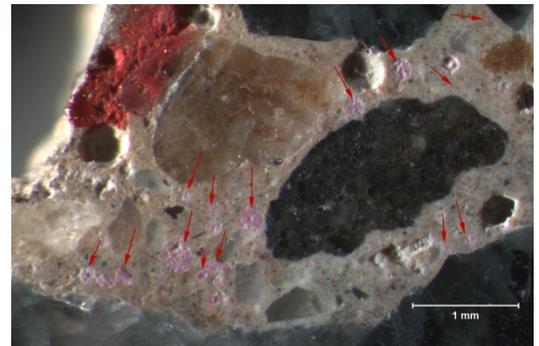
Air Void Content %	4.9
Entrained, % < 0.040"(1mm)	3.4
Entrapped, % > 0.040"(1mm)	1.5
Air Voids/inch	6.10
Specific Surface, in ² /in ³	500
Spacing Factor, inches	0.010
Paste Content, % estimated	26
Magnification	75x
Traverse Length, inches	49
Test Date	2/29/12

Magnification: 30x
Description: Hardened air void system 70mm from top; 0mm from joint.

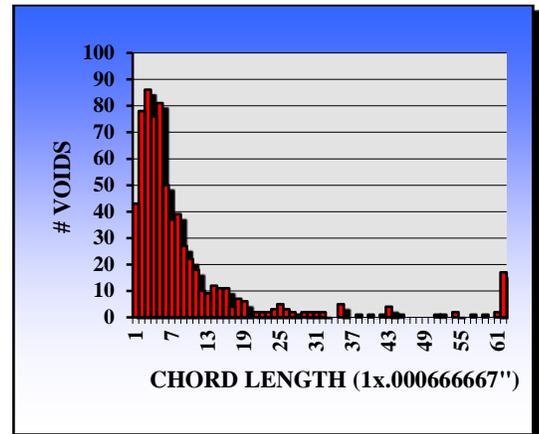
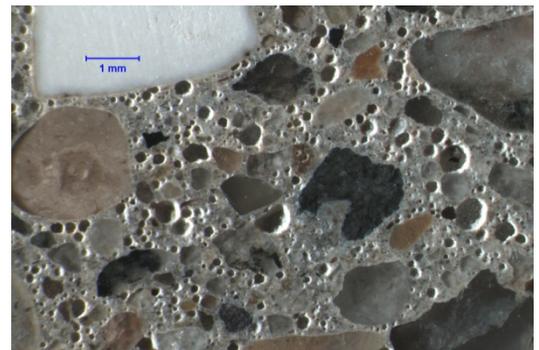
Air Void Content %	11.0
Entrained, % < 0.040"(1mm)	8.2
Entrapped, % > 0.040"(1mm)	2.8
Air Voids/inch	15.4
Specific Surface, in ² /in ³	570
Spacing Factor, inches	0.004
Paste Content, % estimated	26
Magnification	75x
Traverse Length, inches	45
Test Date	2/29/12

Description: Overall view of hardened air void system.

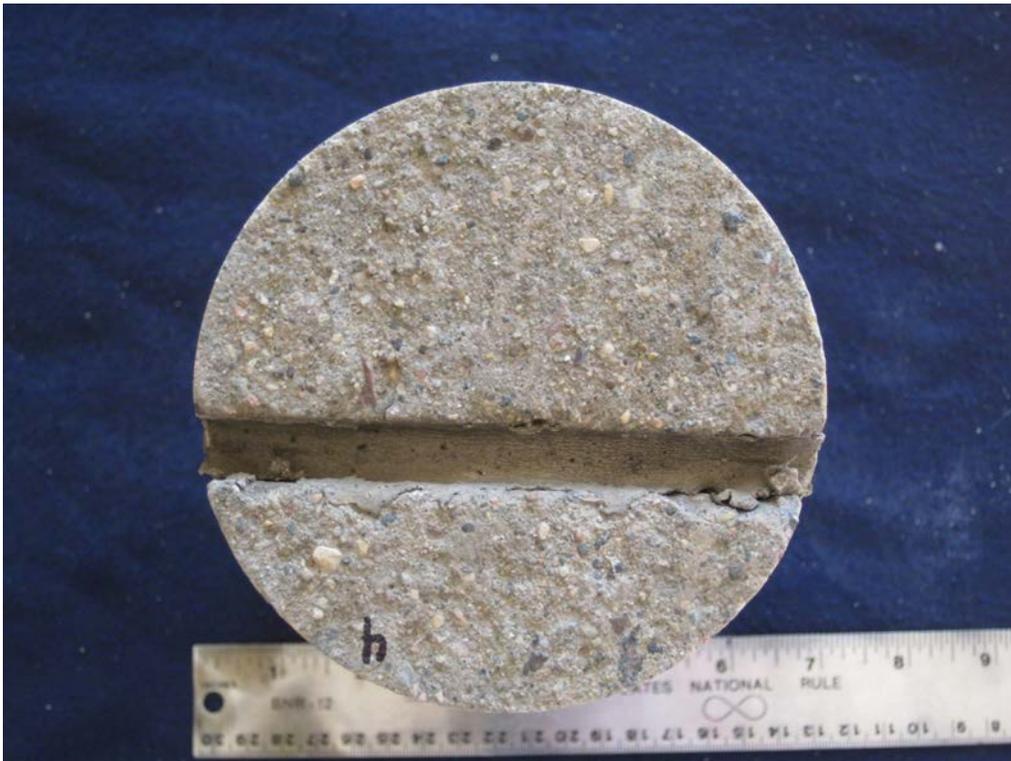
PHOTO: 2

SAMPLE ID: 4, 4705-30 DESCRIPTION: Top surface of the core as received. Note core was taken through a sawcut and silicone sealed control joint.

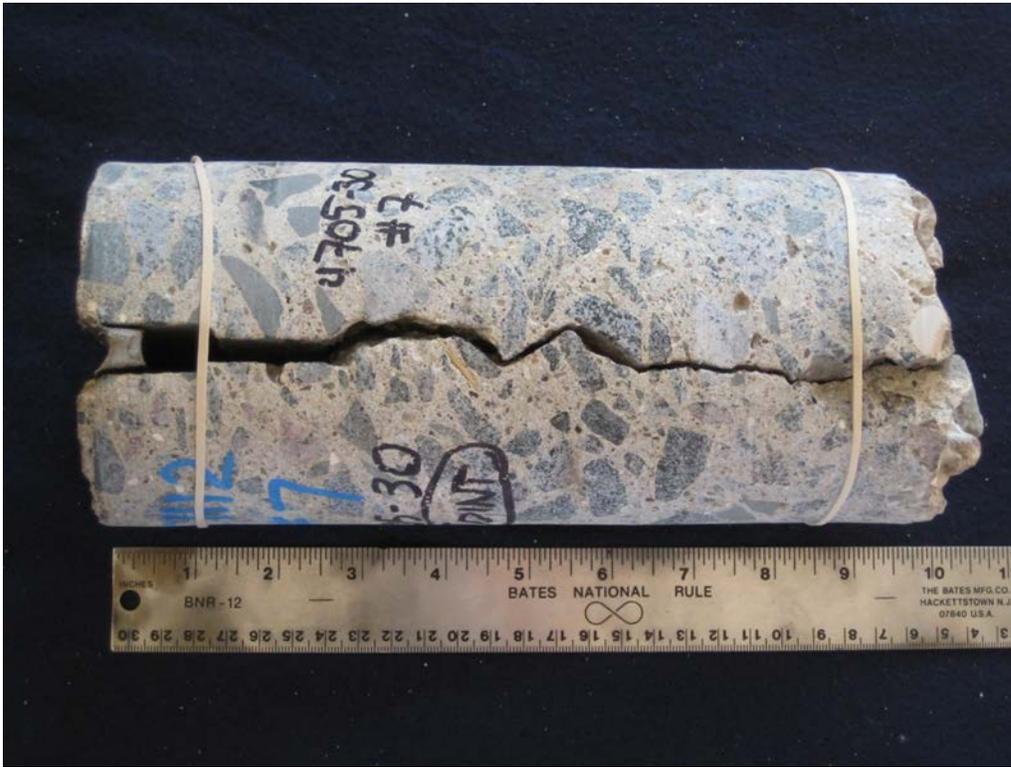
PHOTO: 3

SAMPLE ID: 7, 4705-30 DESCRIPTION: Core sample taken directly through a pavement joint, as received. Top surface is left.

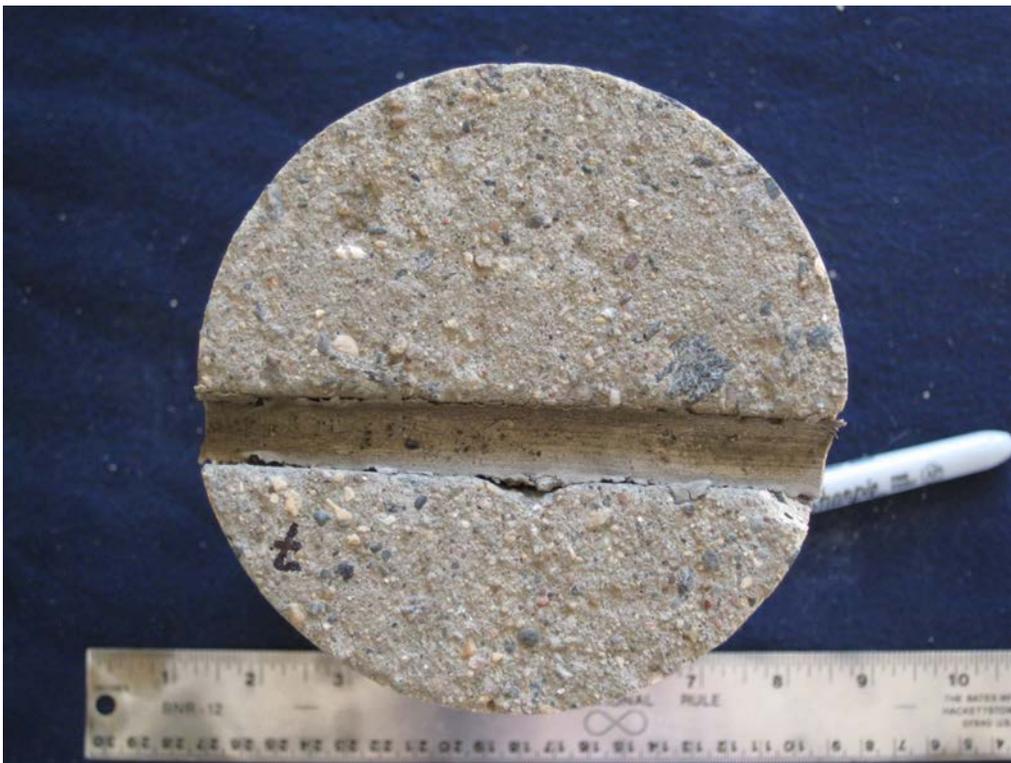
PHOTO: 4

SAMPLE ID: 7, 4705-30 DESCRIPTION: Top surface of the core as received. Note core was taken through a sawcut and silicone sealed control joint.

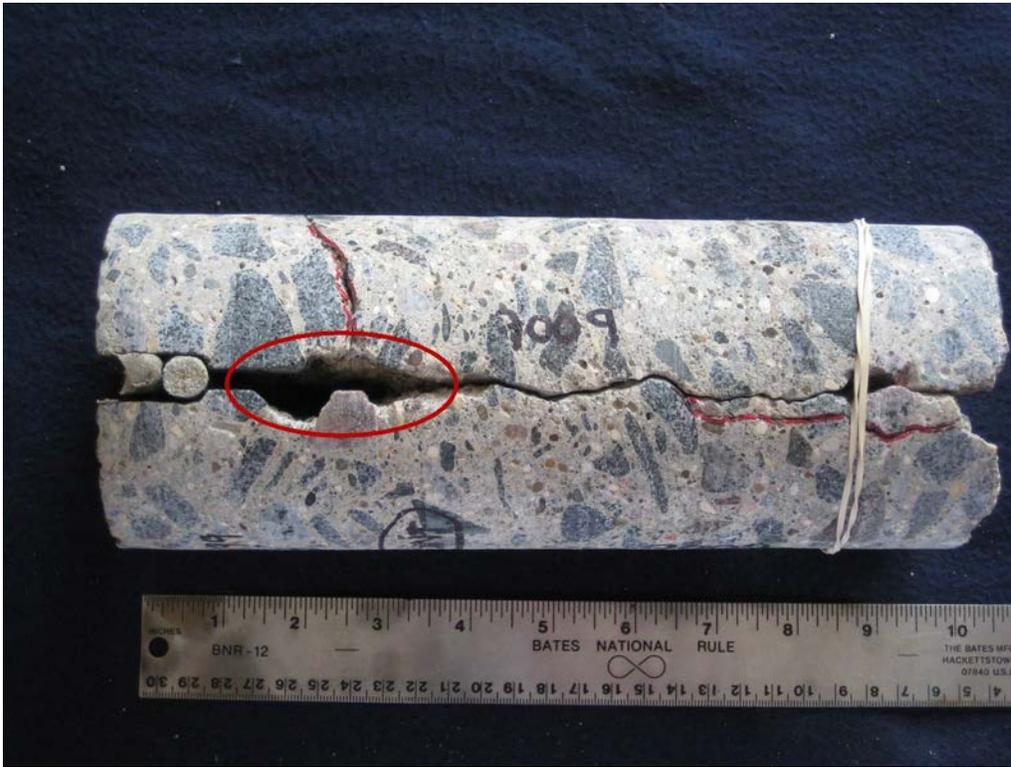
PHOTO: 5

DESCRIPTION: Core sample taken directly through a pavement joint, as received. Top surface is left. Note "tunneling" below the sawcut (circled).

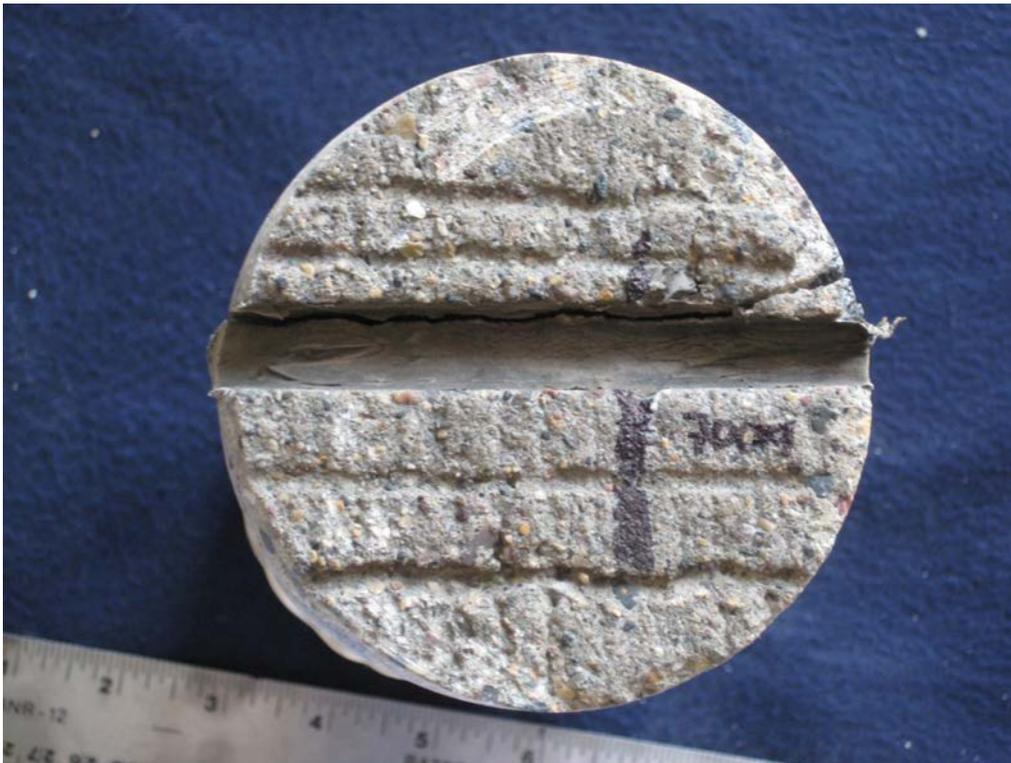
PHOTO: 6

DESCRIPTION: Top surface of the core as received. Note core was taken through a sawcut and silicone sealed control joint.

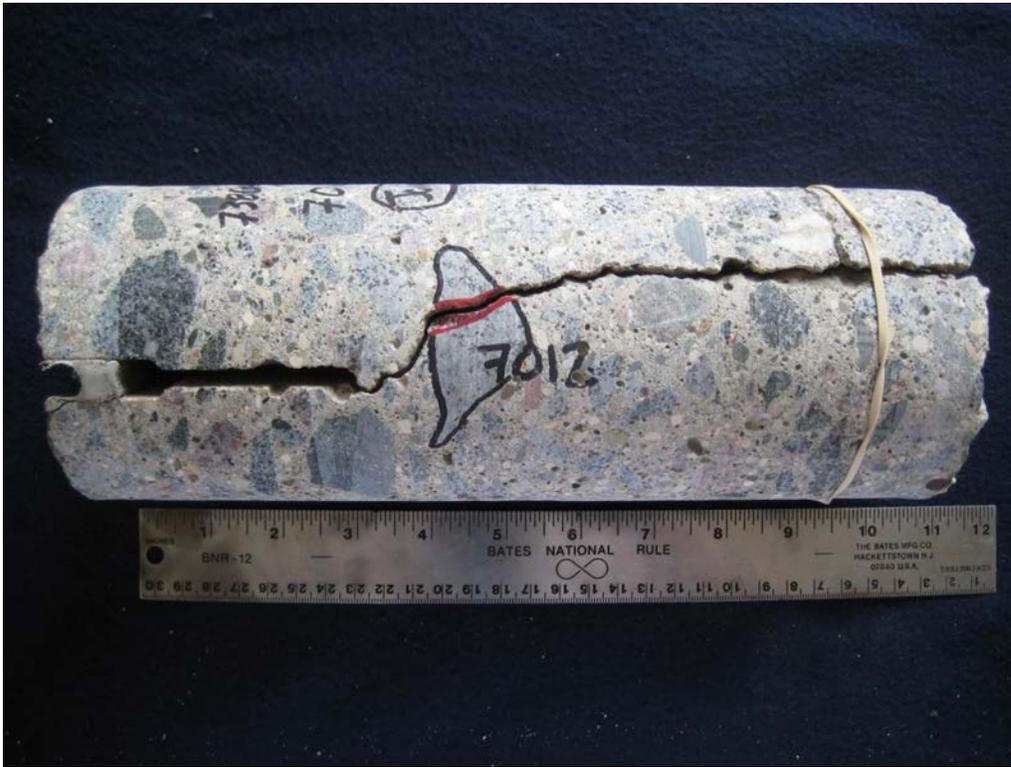
PHOTO: 7

DESCRIPTION: Core sample taken directly through a pavement joint, as received. Top surface is left. Note joint crack bisects a large coarse aggregate particle (outlined in black).

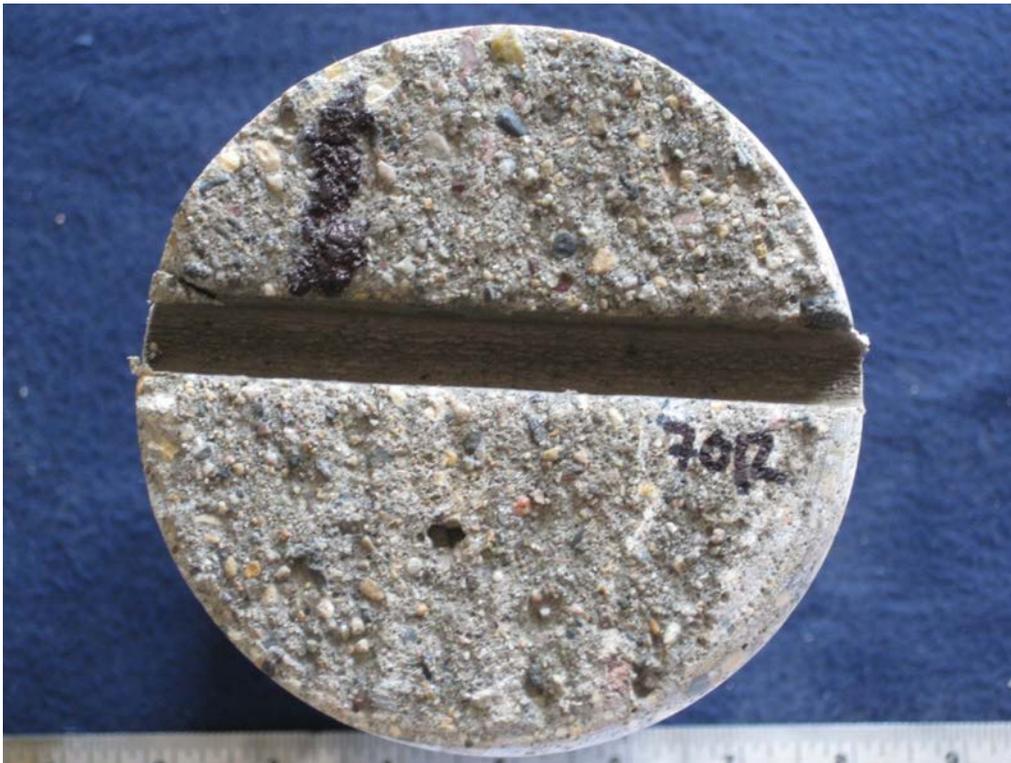
PHOTO: 8

DESCRIPTION: Mortar-eroded top surface of the core as received. Note core was taken through a sawcut and silicone sealed control joint.

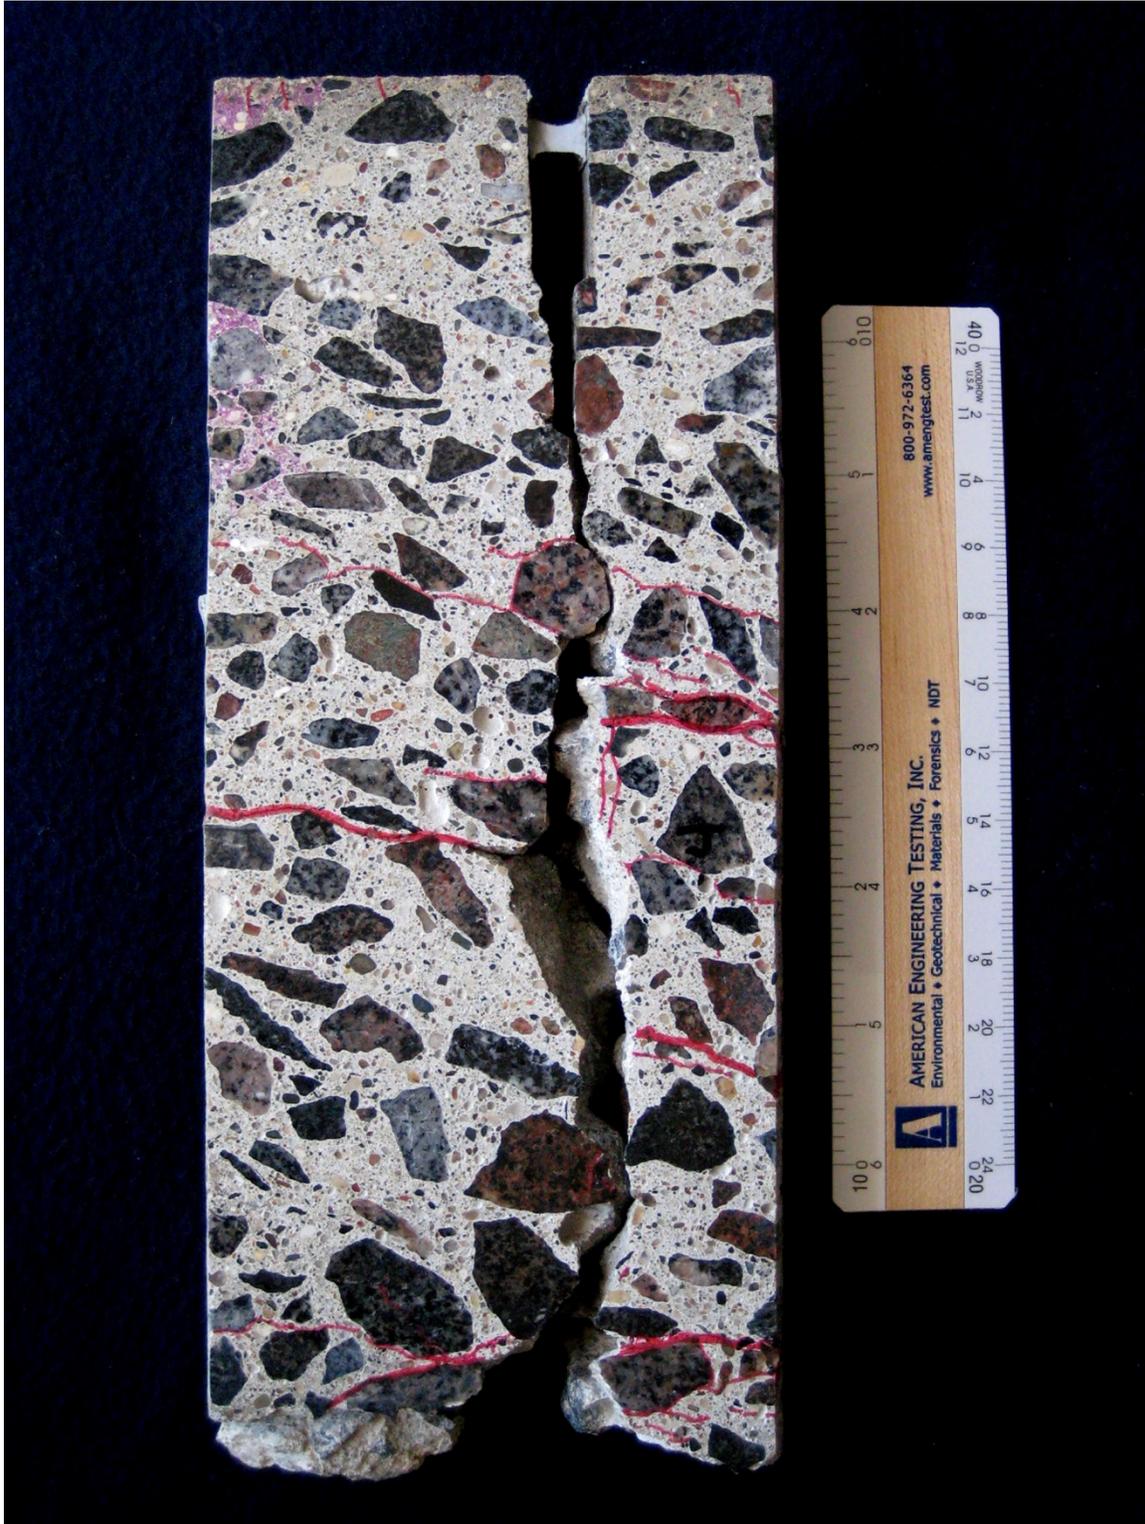
PHOTO: 9

SAMPLE ID: 4, 4705-30 DESCRIPTION: Sawcut and lapped cross section of core. Mostly sub-horizontally oriented fractures and microcracking are mapped in red ink.
