Investigation of Deterioration of Joints in Concrete Pavements

National Concrete Pavement
Technology Center

Final Report
August 2012

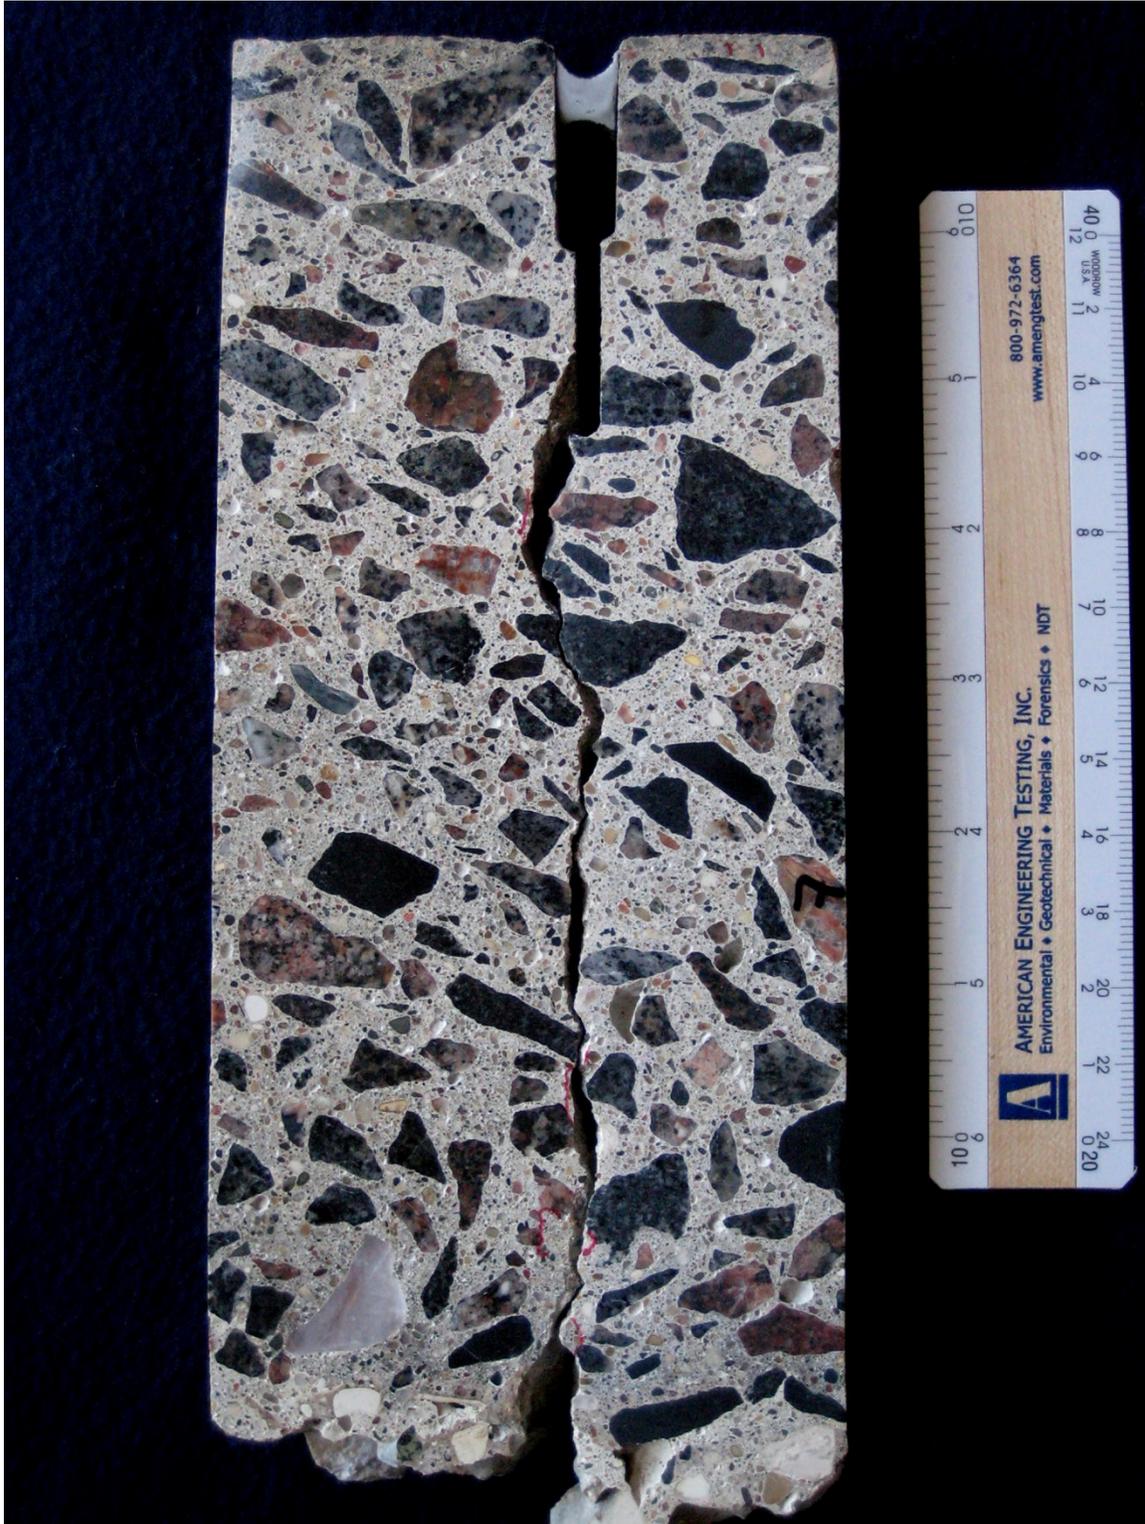
PHOTO: 10

SAMPLE ID: 7, 4705-30 **DESCRIPTION:** Sawcut and lapped cross section of core. Some fine sub-vertically oriented microcracks along the joint crack are mapped in red ink.

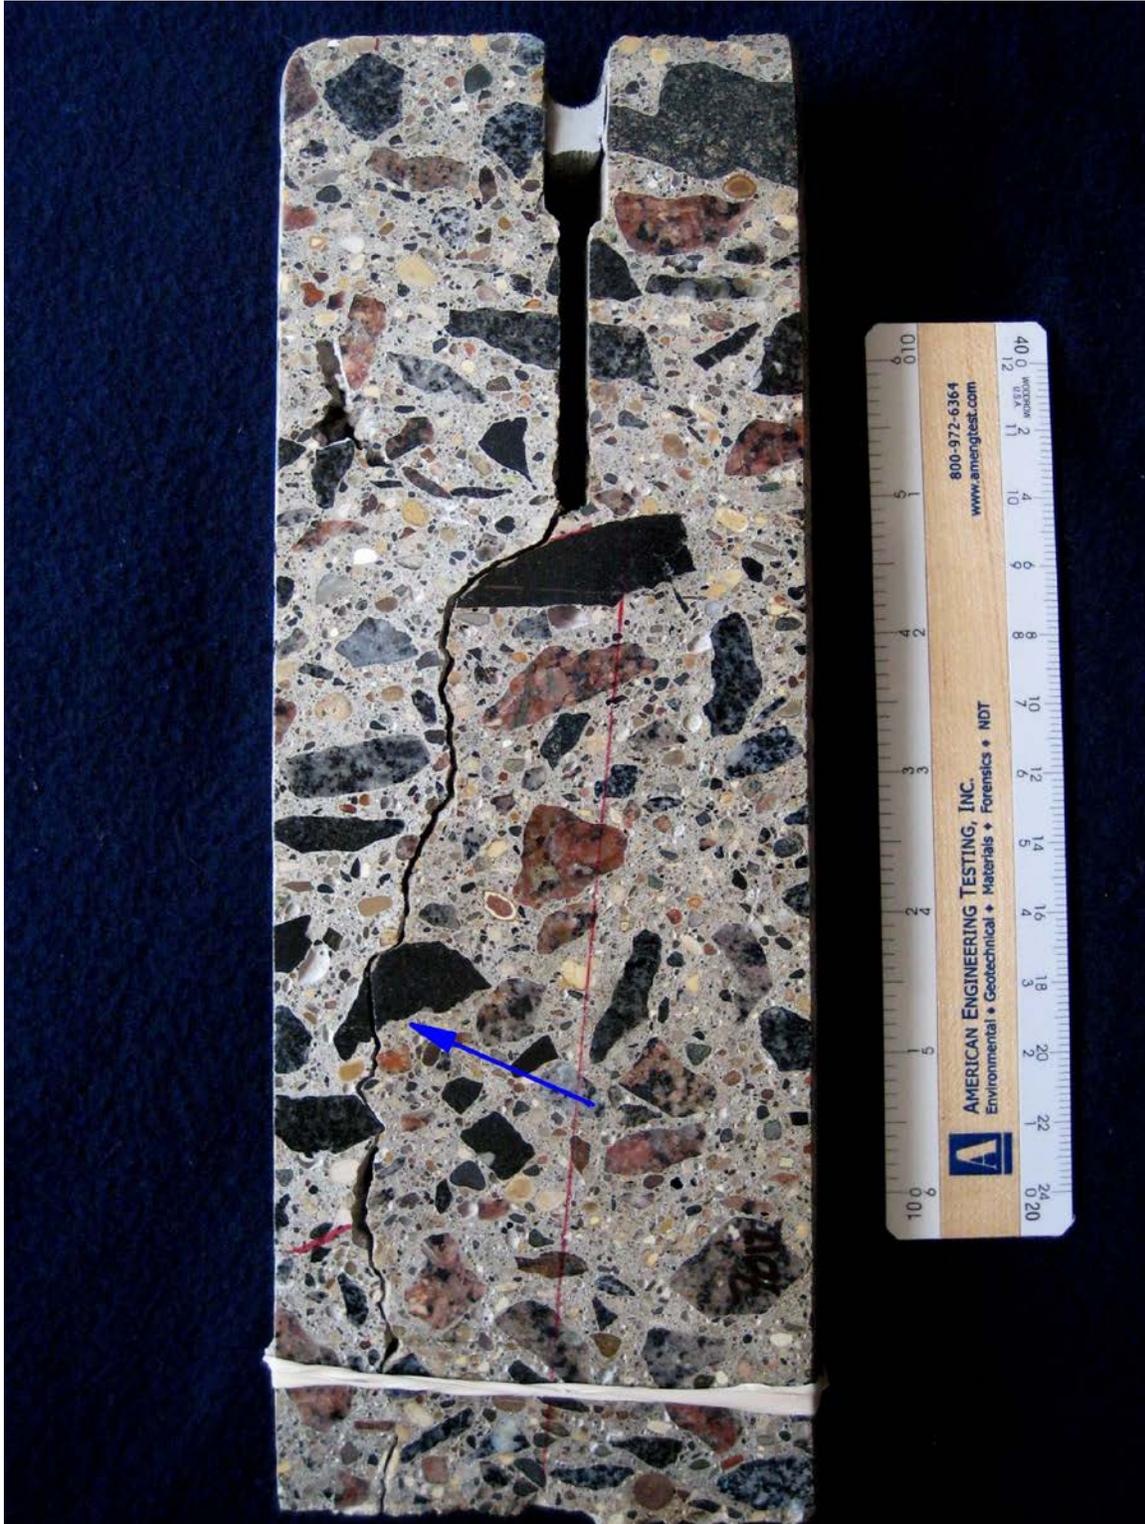
PHOTO: 12

DESCRIPTION: Sawcut and lapped cross section of core taken through a joint. Note resulting crack bisects a coarse aggregate (arrow).

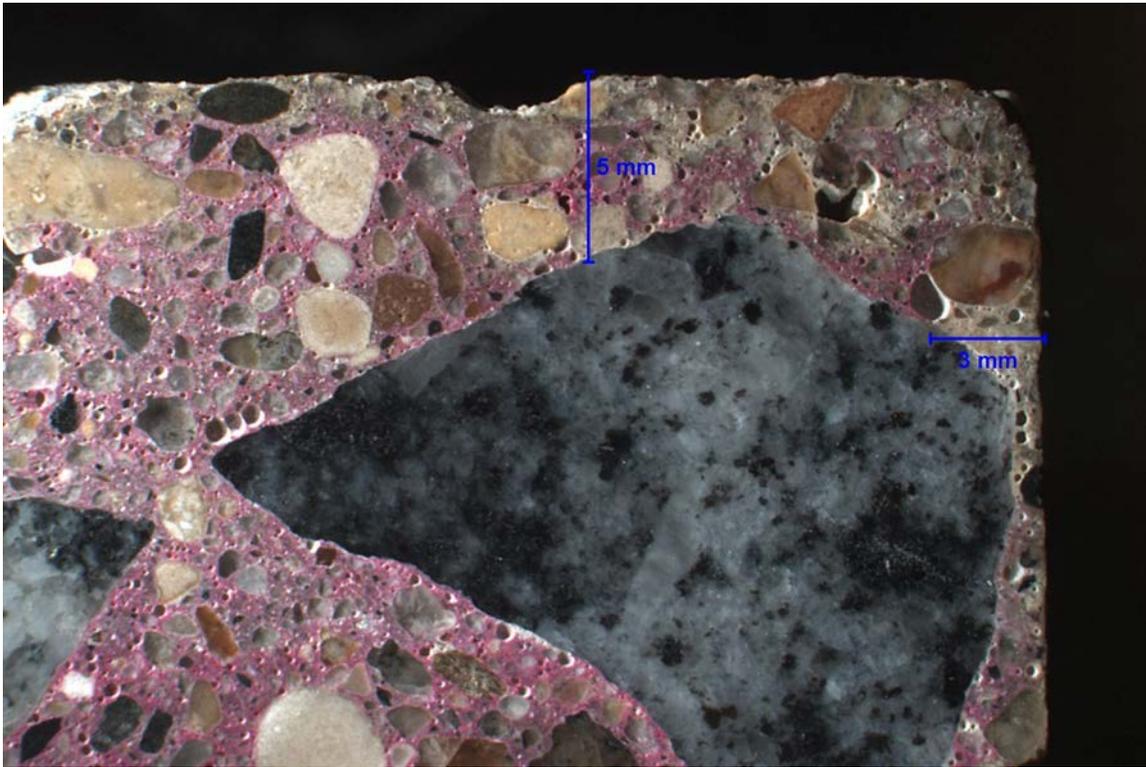
PHOTO: 13

SAMPLE ID: 4, 4705-30 DESCRIPTION: Carbonation (unstained) proceeds up to 5mm depth from the top surface and up to 3mm depth from the sawcut joint surface; in this view of sawcut and lapped cross section of core exposed to phenolphthalein pH indicator.

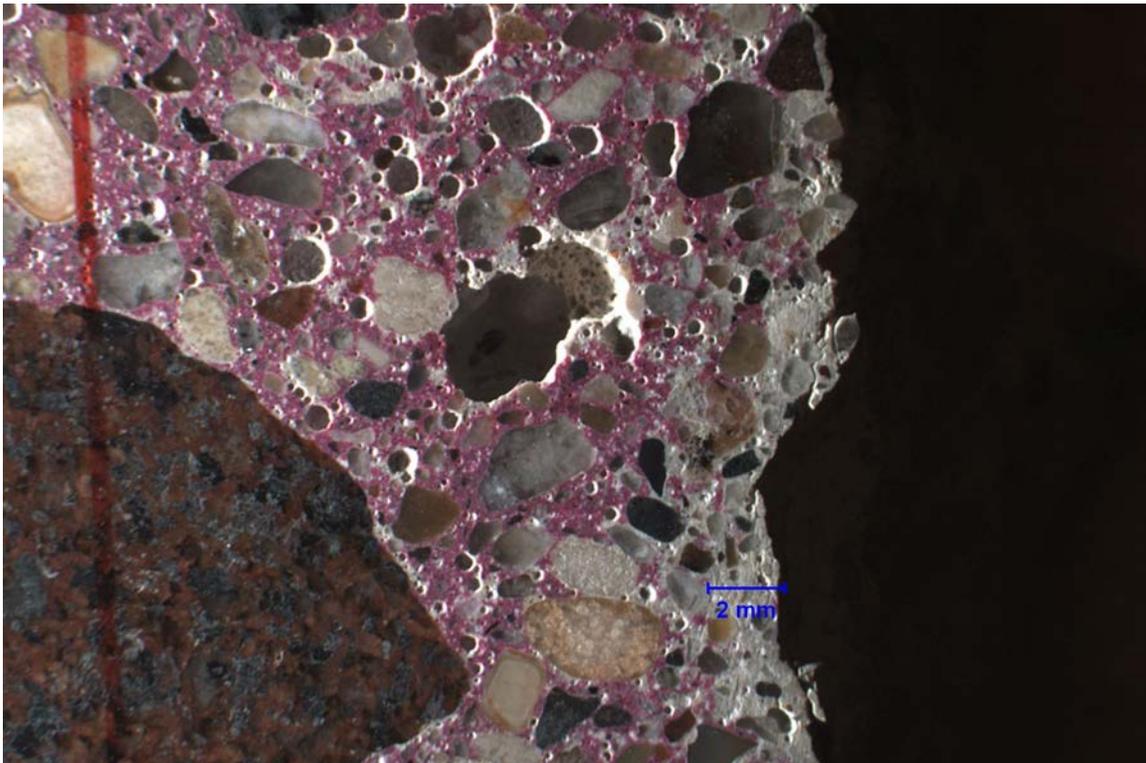
PHOTO: 14

SAMPLE ID: 4, 4705-30 DESCRIPTION: Carbonation (unstained paste) proceeds up to 2mm depth from the distressed joint plane at 100mm depth in the core.

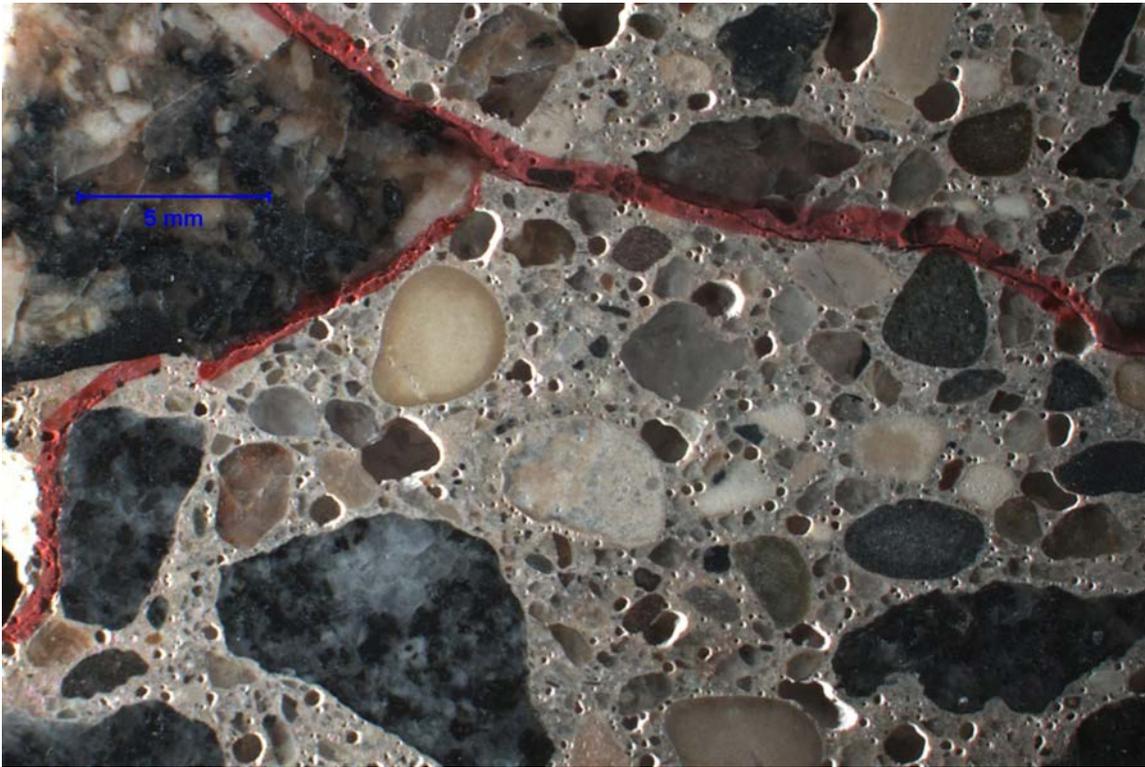
PHOTO: 15

DESCRIPTION: Overall view of air void system at 60mm depth in the core. Not loss of fine air voidspaces on left 1/3 of image from secondary ettringite fillings.

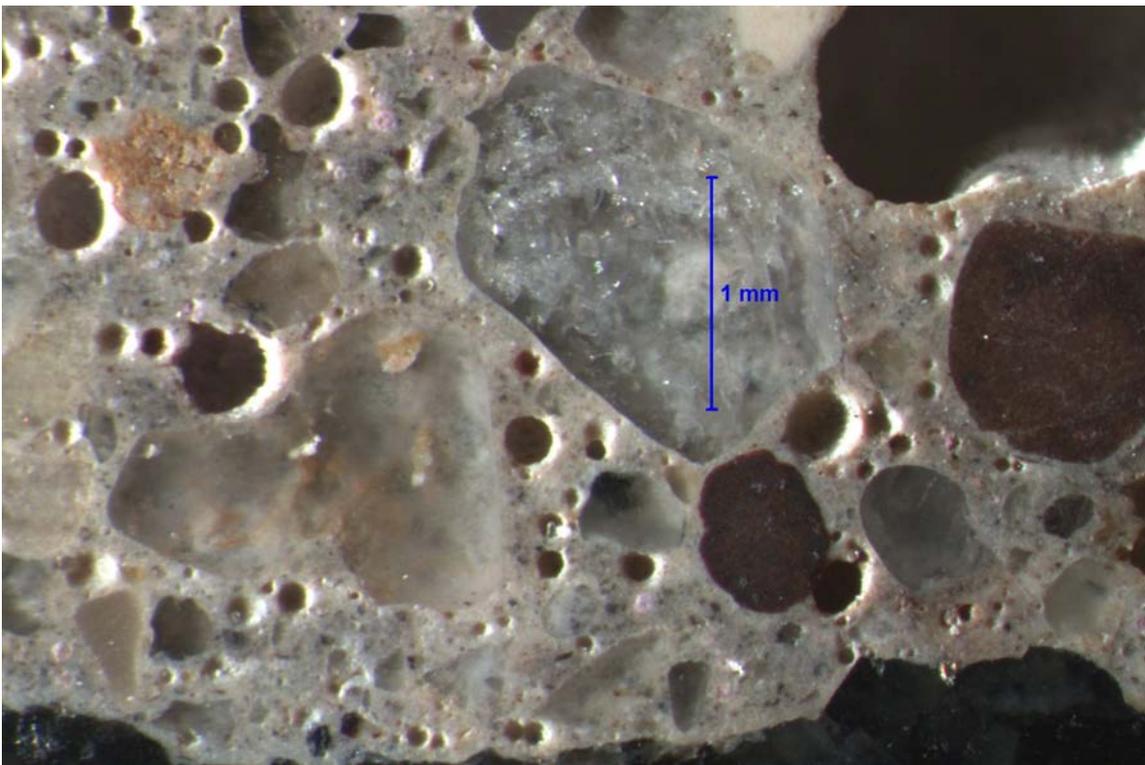
PHOTO: 16

DESCRIPTION: Air void system at 70mm depth in the core and 45mm depth from the distressed joint plane.

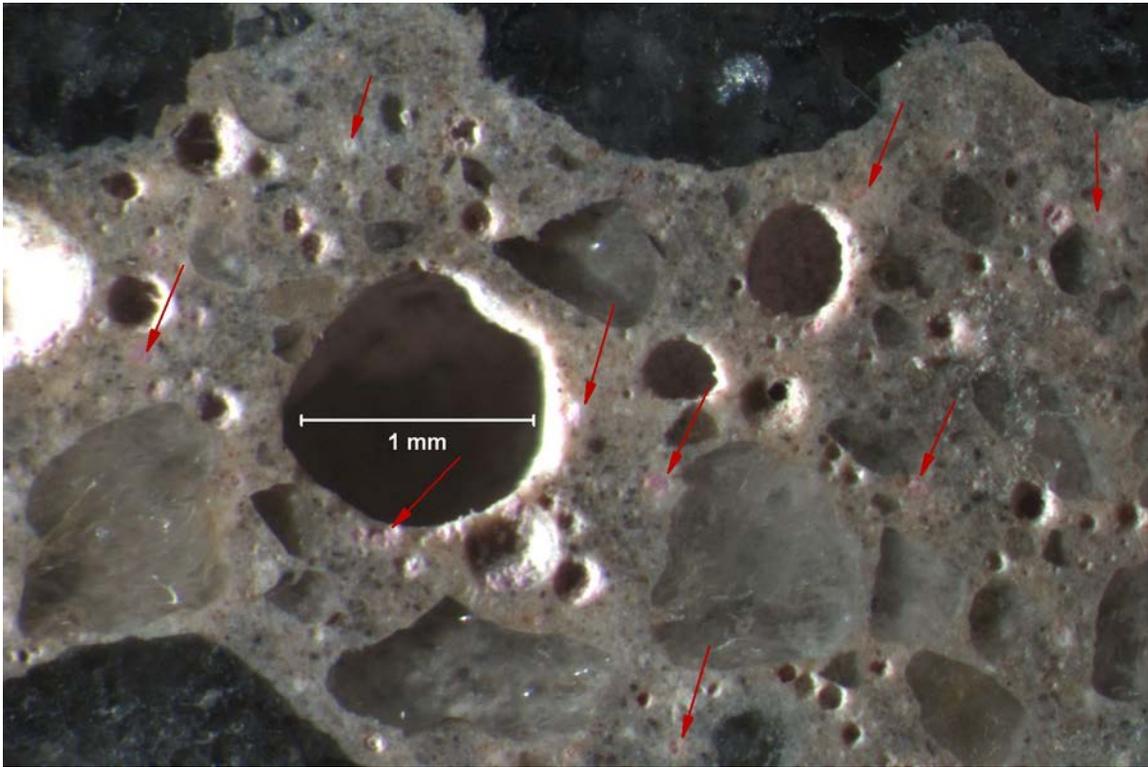
PHOTO: 17

DESCRIPTION: Overall view of air void system at 70mm depth in the core and 25mm from the distressed joint plane. Note (stained) ettringite-filled air voidspaces (arrows).

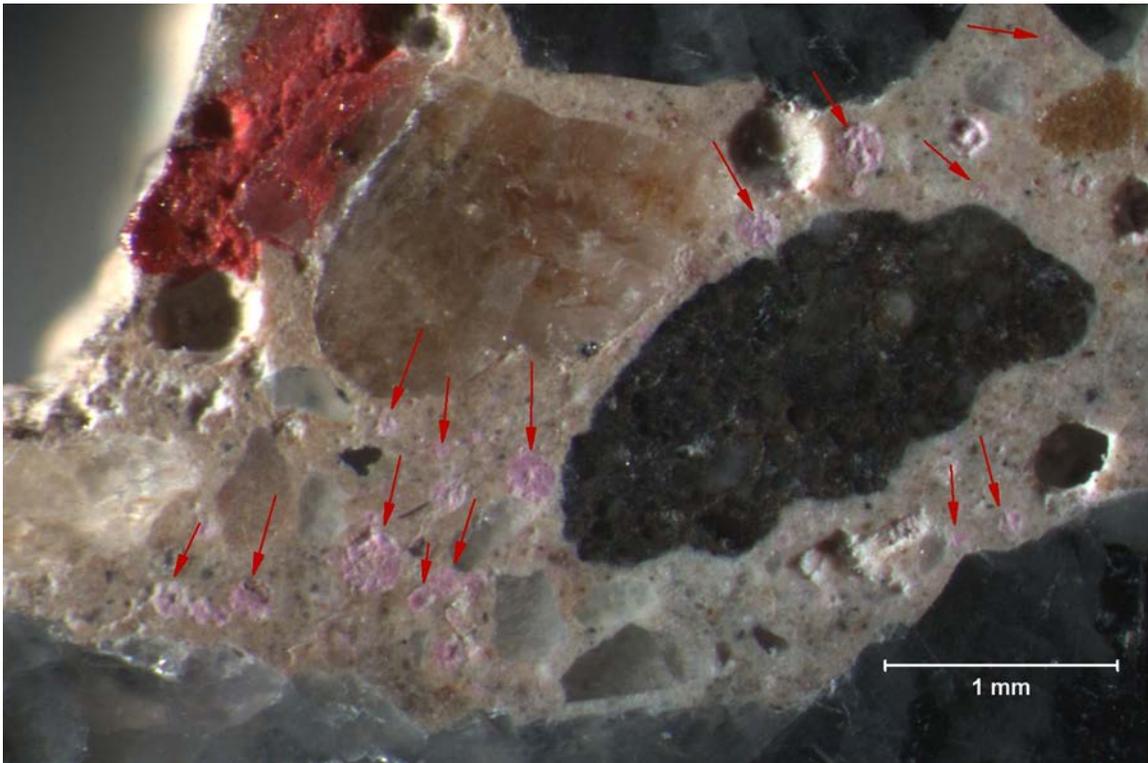
PHOTO: 18

DESCRIPTION: Air void system at 70mm depth in the core and at the distressed joint plane (L). Note stained ettringite-filled voidspaces marked with arrows.

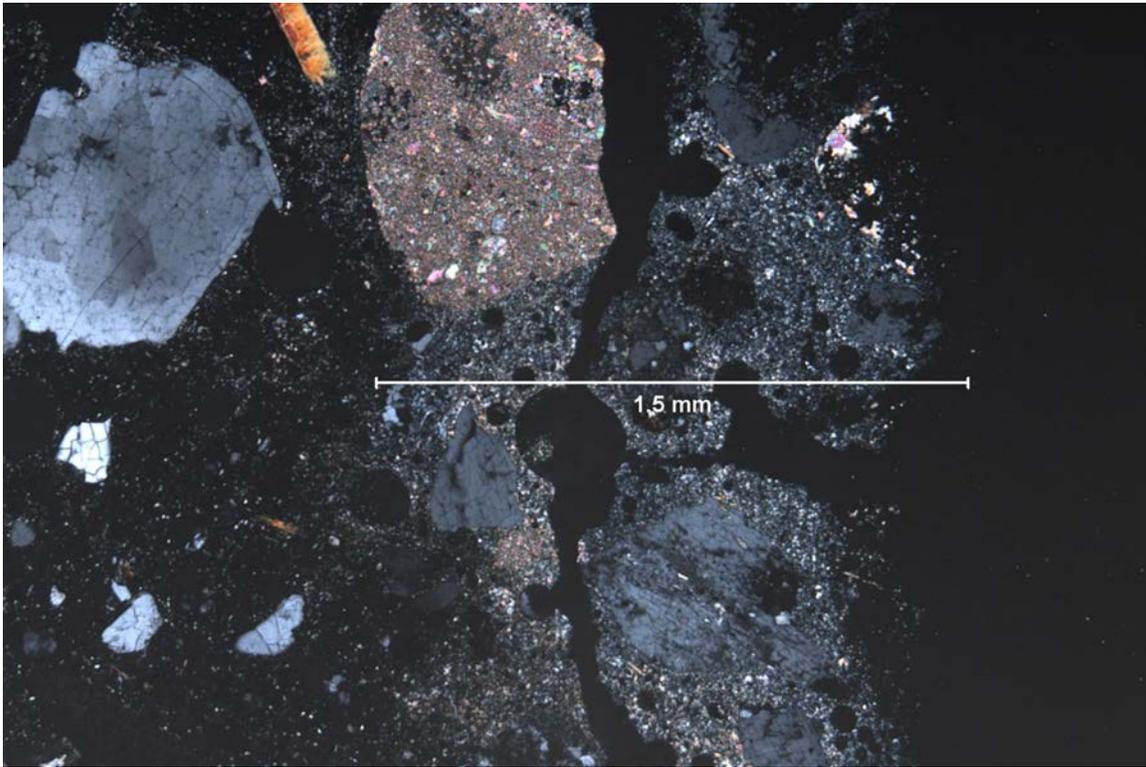
PHOTO: 19

DESCRIPTION: Overall view of brightly colored carbonated paste to 1.5mm depth from the distressed joint plane; in thin section of concrete under cross polarized light.

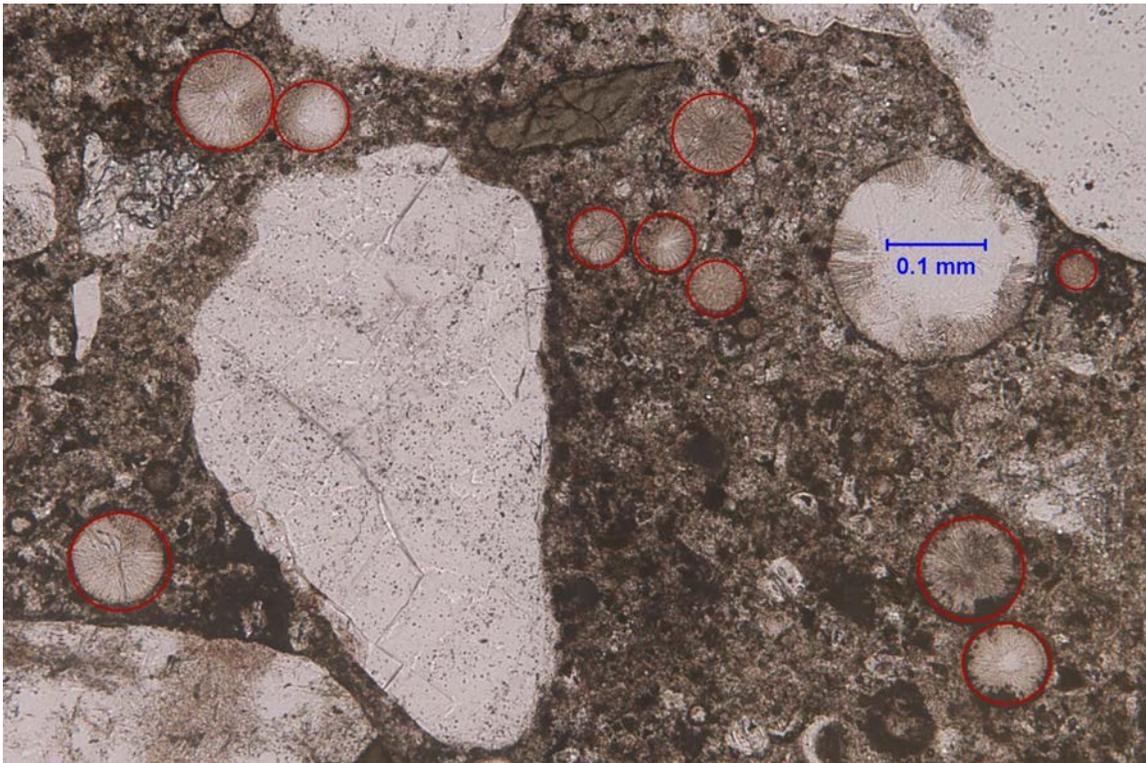
PHOTO: 20

DESCRIPTION: Ettringite-filled voidspaces, outlined in red, in thin section of concrete paste adjacent to the distressed joint plane, under plane polarized light.

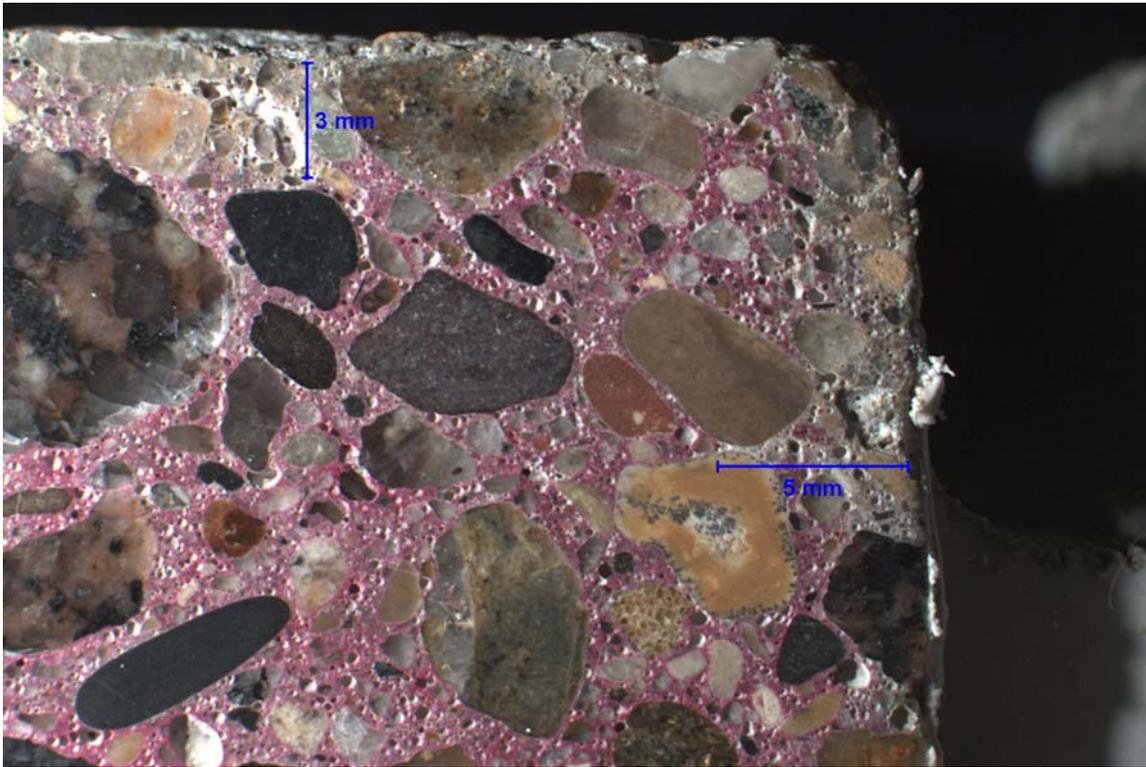
PHOTO: 21

DESCRIPTION: Carbonation (unstained) ranged from negligible up to 3mm depth from the top surface and ranged from negligible up to 5mm depth from the sawcut joint surface; in this view of sawcut and lapped cross section of core exposed to phenolphthalien pH indicator.

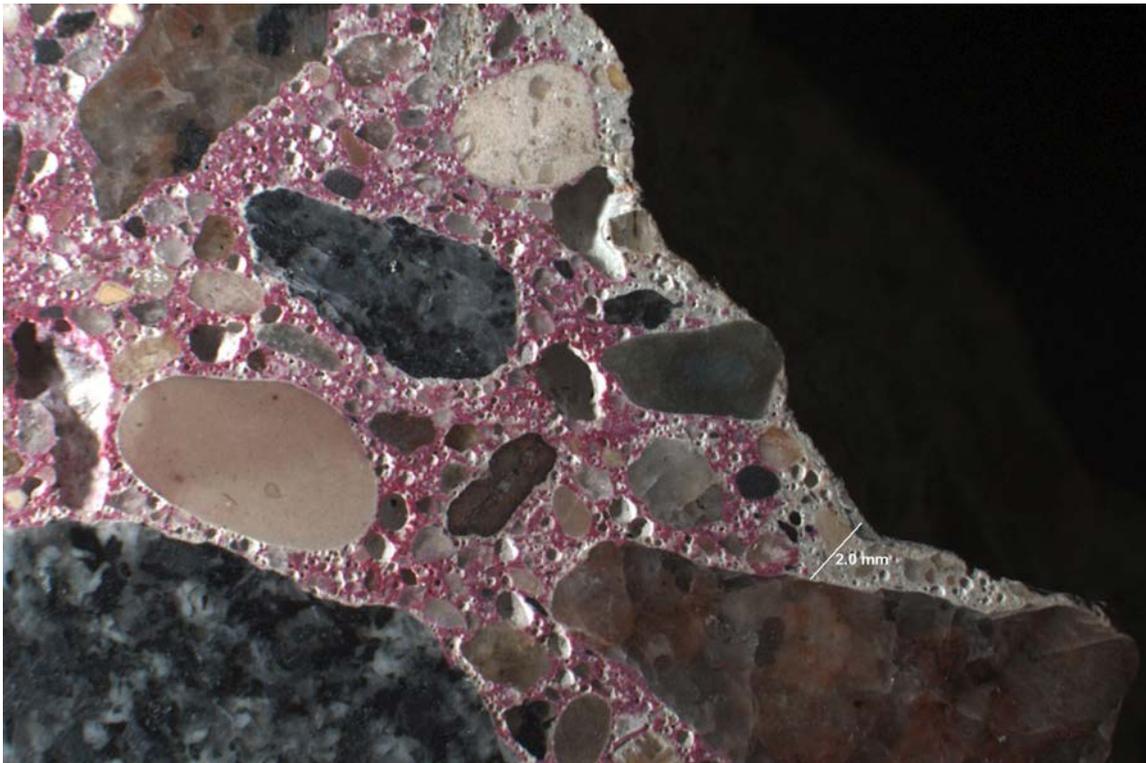
PHOTO: 22

DESCRIPTION: Carbonation (unstained paste) proceeds up to 2mm depth from the stressed joint plane at 105mm depth in the core.

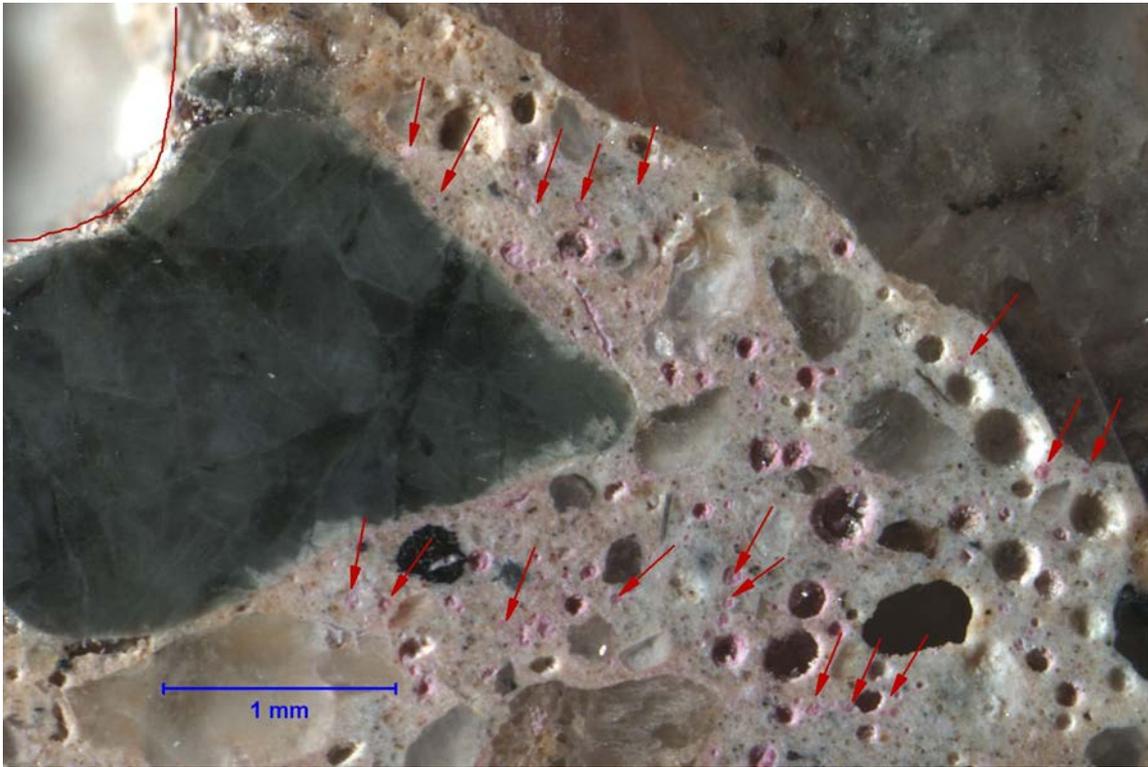
PHOTO: 25

SAMPLE ID: 7012, 7380-199 DESCRIPTION: Closer view of fine, ettringite-filled voids at the base of the sawcut.
MAG: 30x

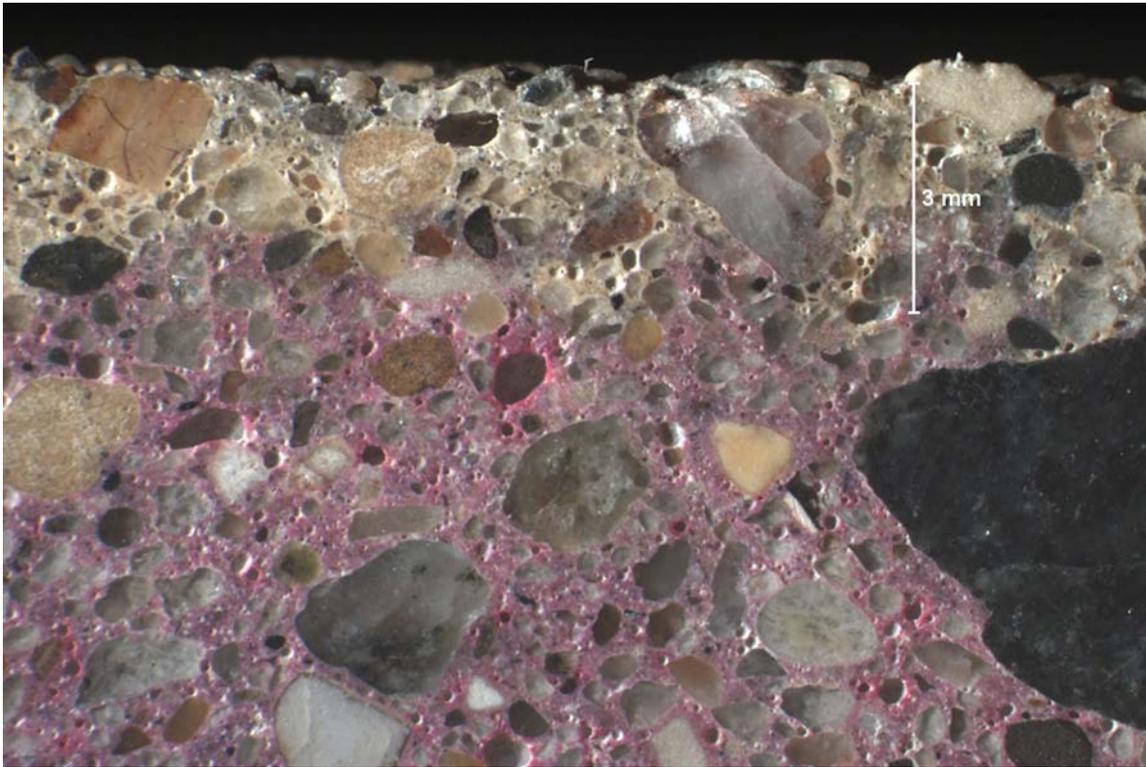
PHOTO: 29

SAMPLE ID: 4, 4705-30 DESCRIPTION: Carbonation (unstained paste) proceeds up to 3mm depth (in this image) from the top surface of the core.
MAG: 10x

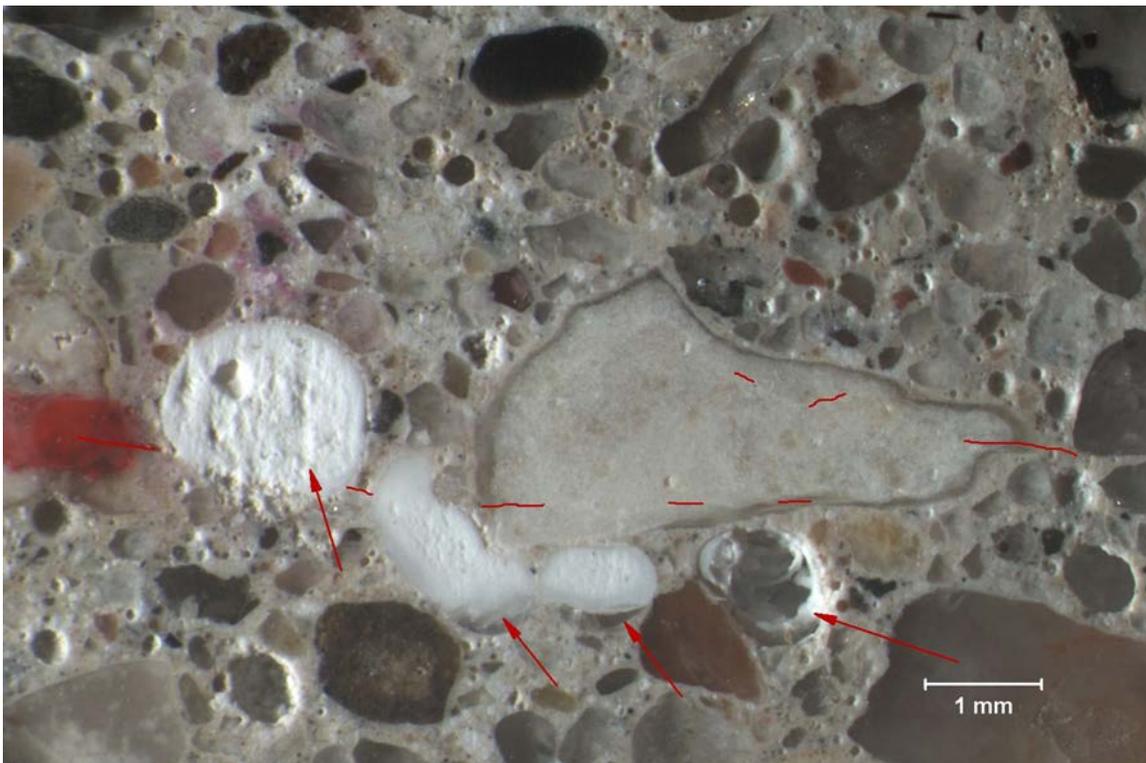
PHOTO: 30

SAMPLE ID: 4, 4705-30 DESCRIPTION: White to clear ASR gel product lines or fills voidspace adjacent to a reactive chert fine aggregate particle. Internal and radiating microcracking is mapped in red dashed lines.
MAG: 400x

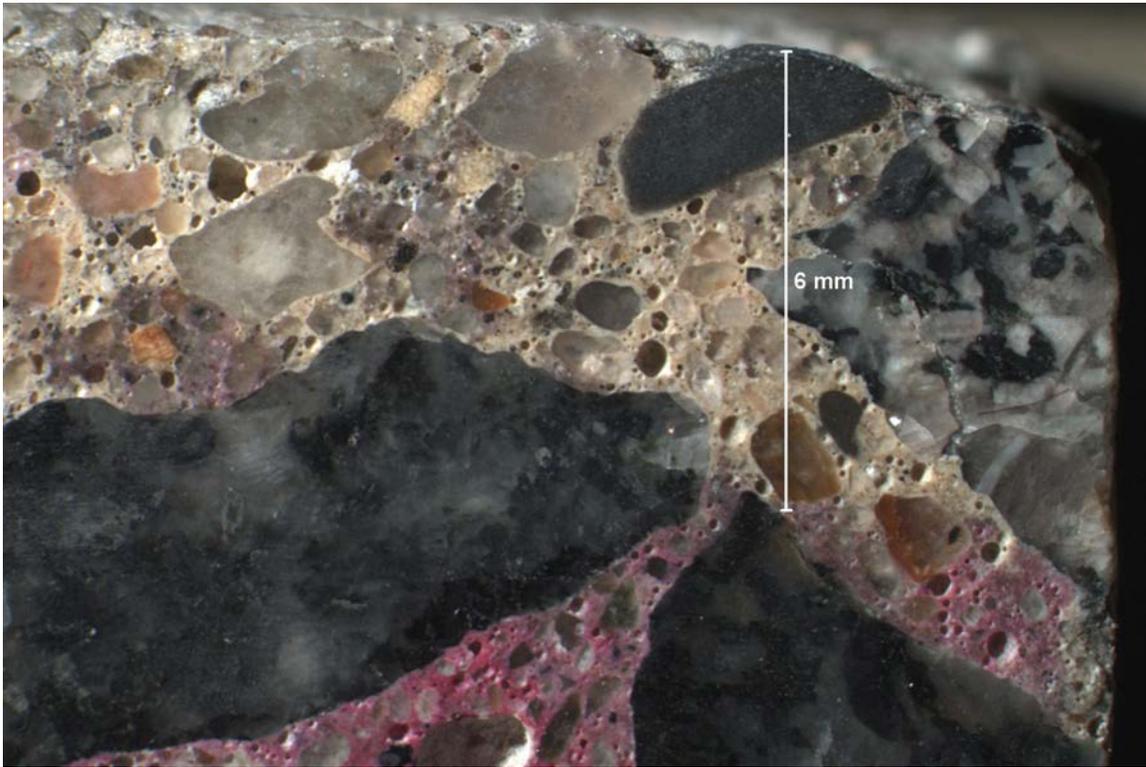
PHOTO: 33

SAMPLE ID: 7, 4705-30 DESCRIPTION: Carbonation (unstained paste) proceeds up to 6mm depth from the top surface of the core.
MAG: 5x

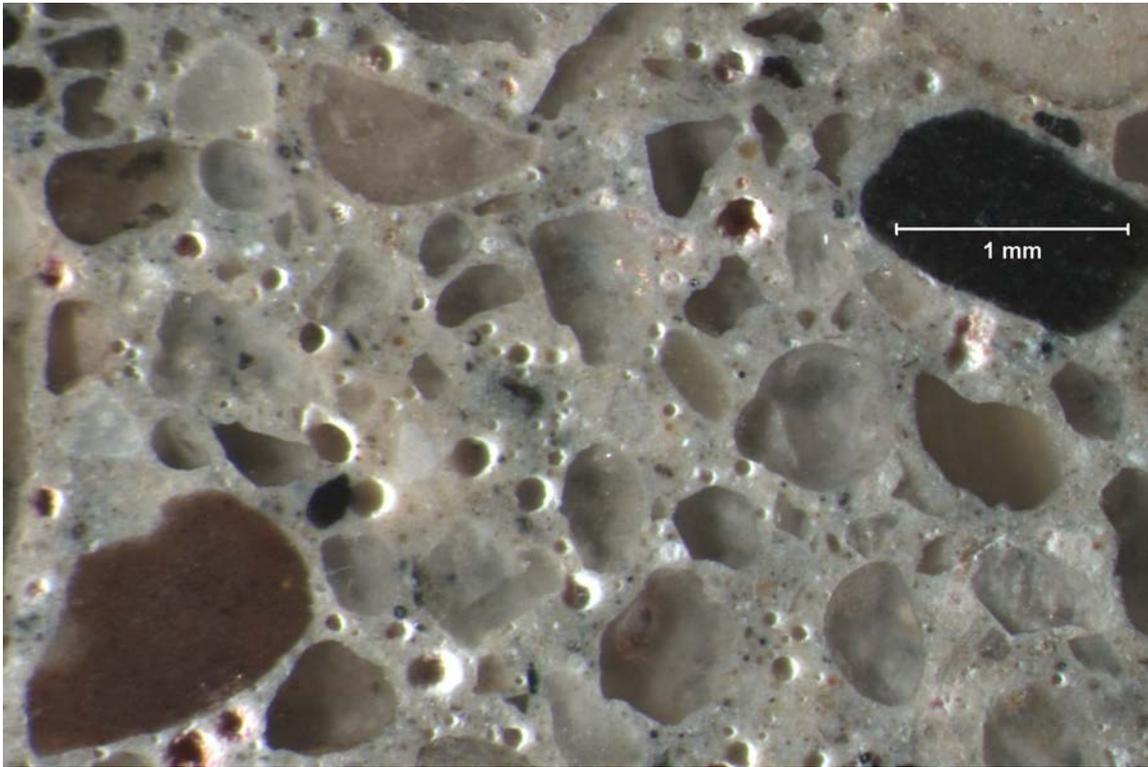
PHOTO: 35

SAMPLE ID: 7, 4705-30 DESCRIPTION: Overall view of the air void system at 112mm depth from the top surface of the core and 40mm depth from the joint plane.
MAG: 30x

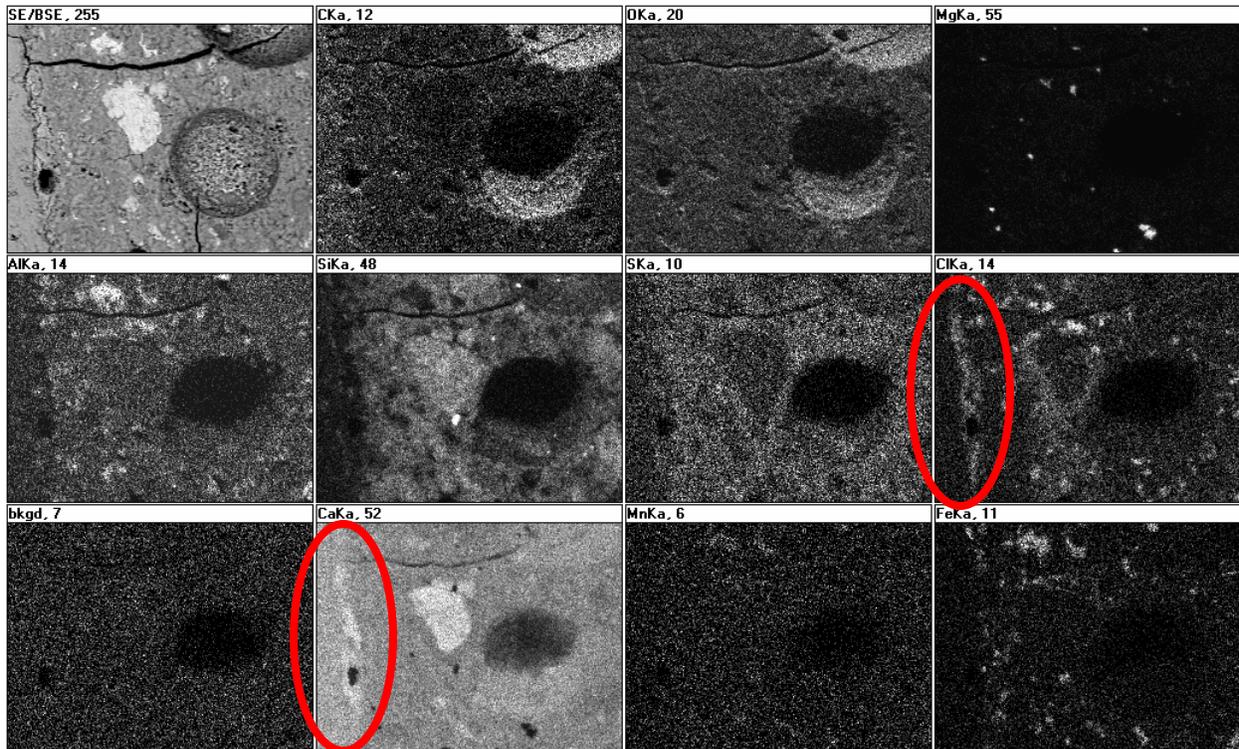
Figure 3. SEM analysis on distressed samples under cyclic freeze thaw in CaCl₂ solution

The original external face of the sample is horizontal and about 3/8 in. above the top of the image. The field of view is about 400 μ m. A coarse aggregate particle is visible to the left of the image.

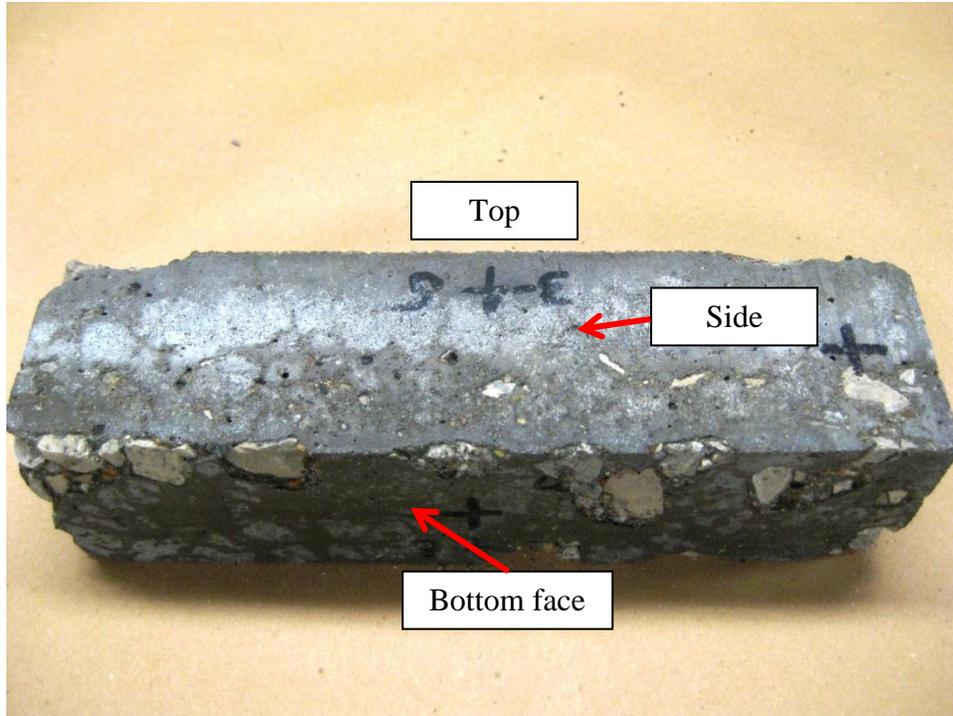
Figure 4. Typical sample after 300 cycles

The visual rating shows, as expected, that the wet portion of the samples have more distress than the dry portion and the bottom side of the samples have the most distress (Figure 4).

It was noted that material loss was primarily in the paste, leaving the coarse aggregate particles clean (Figure 4). This is consistent with field observations.

The bottom face shows the most damage, while the amount of damage does not extend far above the water level (approximately at the + on the top face of the samples, as shown).

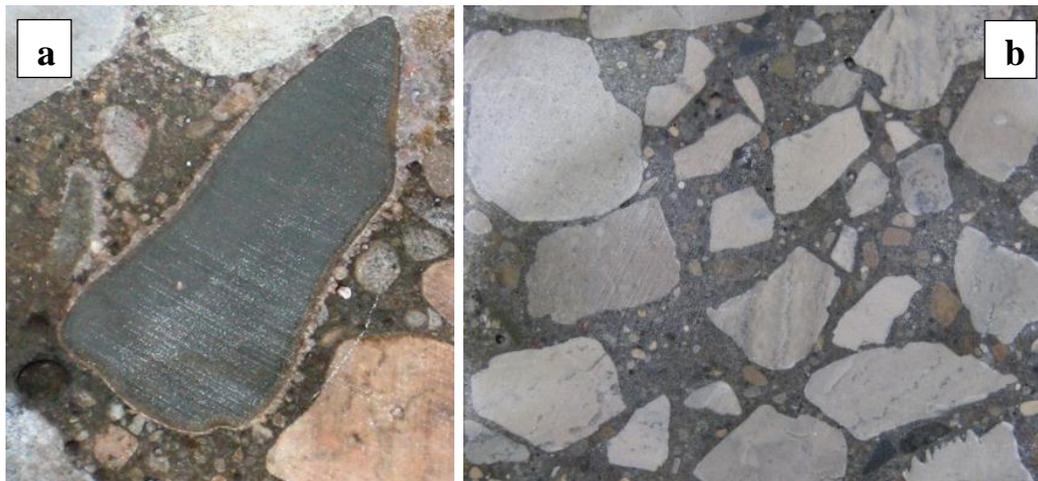
Figure 10. Samples tested in salt, cut, then treated with silver nitrate to highlight presence of chlorides (a) 0.5 - 0%SF - gravel (b) 0.4 - 5%SF - limestone

The samples treated with silver nitrate showed a white ring around some of the aggregate particles. This seems to indicate that the salt solution preferentially penetrated into the concrete through the interfacial zone. The limestone aggregates show fewer rings than the sample made with gravel. The sample mixed with gravel also had a higher w/cm without any silica fume.

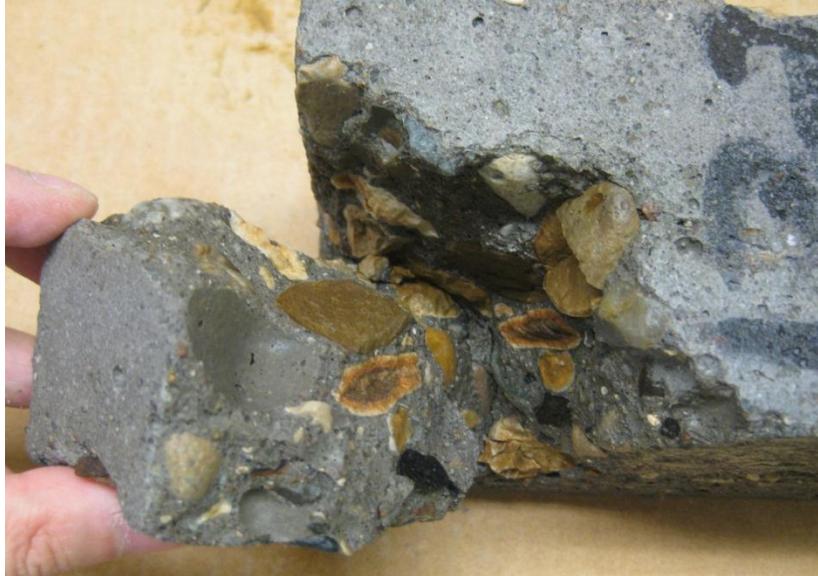
Figure 11. Laboratory observation of distress incurred during freezing and thawing

All are factors likely leading to a more dominant interfacial zone. As an example, some typical distress is shown in Figure 11 with damage to a sample containing gravel, $w/cm = 0.5$, and 5% silica fume (SF).

The failure surface includes both cracks through and around aggregate particles. Failures around the aggregates are likely associated with the ITZ because it is normally unusual to see aggregate particles without paste adhering to them, unless the mechanism of stress is adjacent to the surface.
