Investigation of the Long Term Effects of Magnesium Chloride and Other Concentrated Salt Solutions on Pavement and Structural Portland Cement Concrete

Project Number: SD2002-01

Quarterly Report

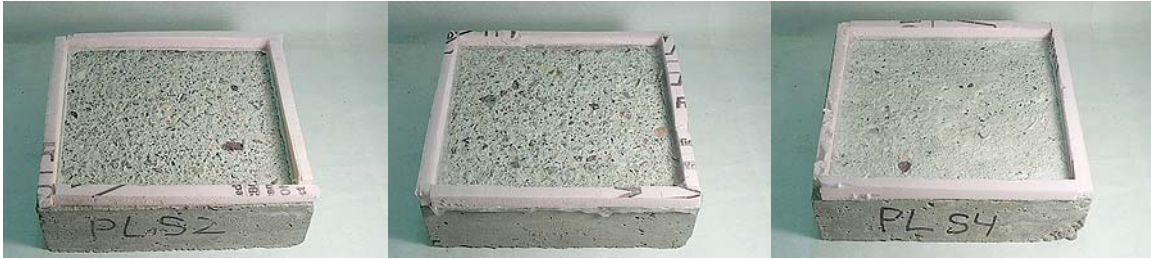
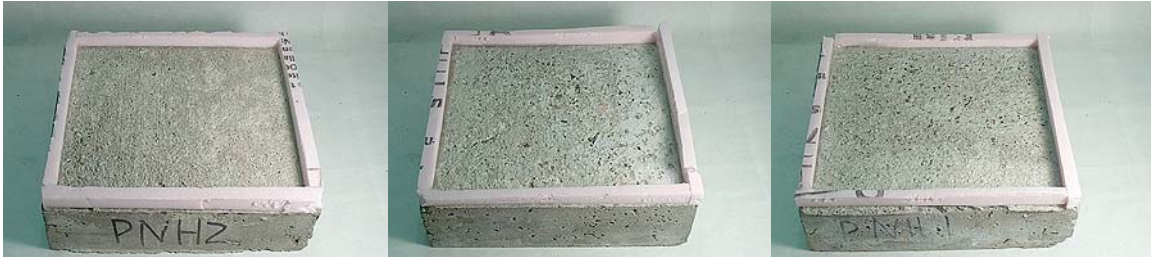
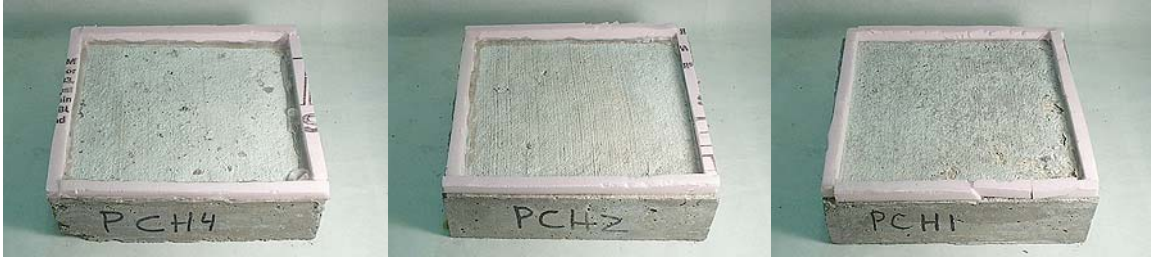
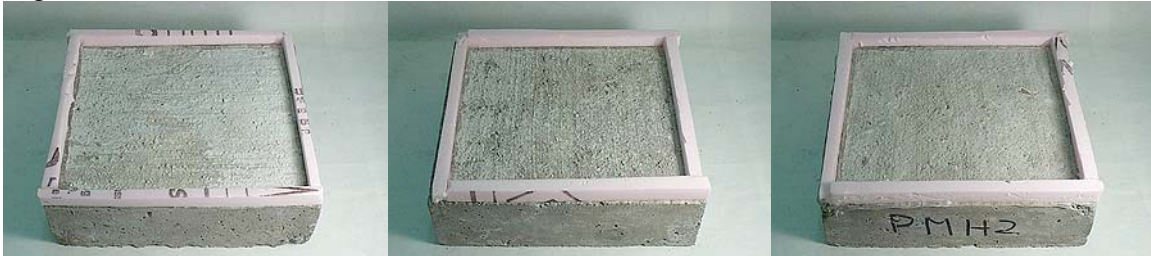
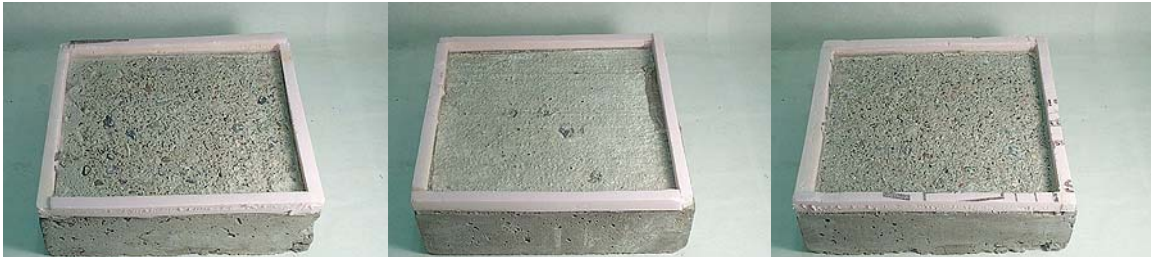
Lime solution

NaCl solution

CaCl₂ solution

MgCl₂ solution

CMA solution

Figure 30: Prisms representative of the five different solutions after 56 days of ASTM C 672 testing.
