**CRACK SURVEYS OF LOW-CRACKING
HIGH-PERFORMANCE CONCRETE
BRIDGE DECKS IN KANSAS
2009-2010**

**CONSTRUCTION OF CRACK-FREE BRIDGE DECKS
TRANSPORTATION POOLED-FUND STUDY
PROJECT NO. TPF-5(174)**

**Structural Engineering and Engineering Materials
SL Report 11-3**

**THE UNIVERSITY OF KANSAS CENTER FOR RESEARCH, INC.
LAWRENCE, KANSAS
October 2011**

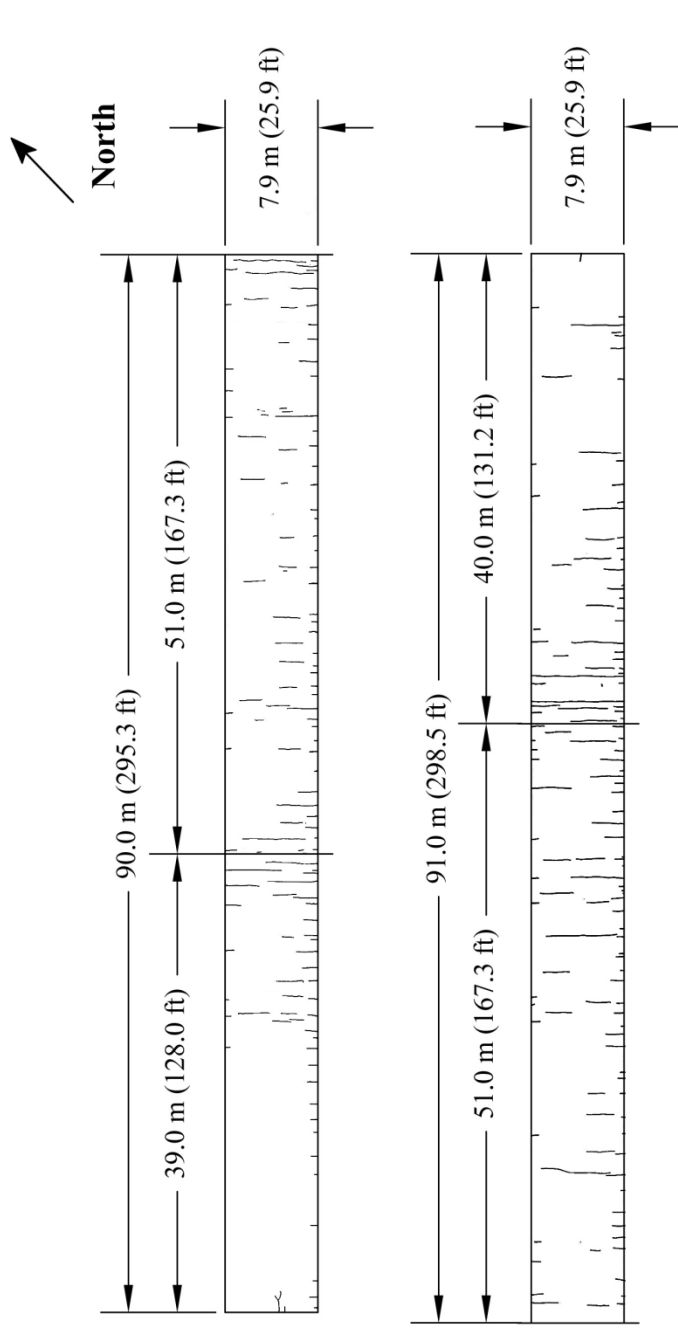
Figure 20: LC-HPC-6 (Survey 2)

Surveys 2 and 3 of LC-HPC-6, at 19.7 and 31.4 months, are included in this report. The crack density for LC-HPC-6 at 19.7 months was 0.238 m/m^2 , as shown in Figure 20. This is a high crack density for a LC-HPC deck, nearly twice as high as LC-HPC-5, at 19.4 months of age. The previous crack survey at 6.5 months yielded a crack density of 0.063 m/m^2 (Gruman et al. 2009). The crack density at 31.4 months has remained nearly constant, at 0.231 m/m^2 (Figure 21). As with LC-HPC-5, the majority of the cracks have propagated transversely above the reinforcing steel from the southeastern edge of the deck where the deck is superelevated.

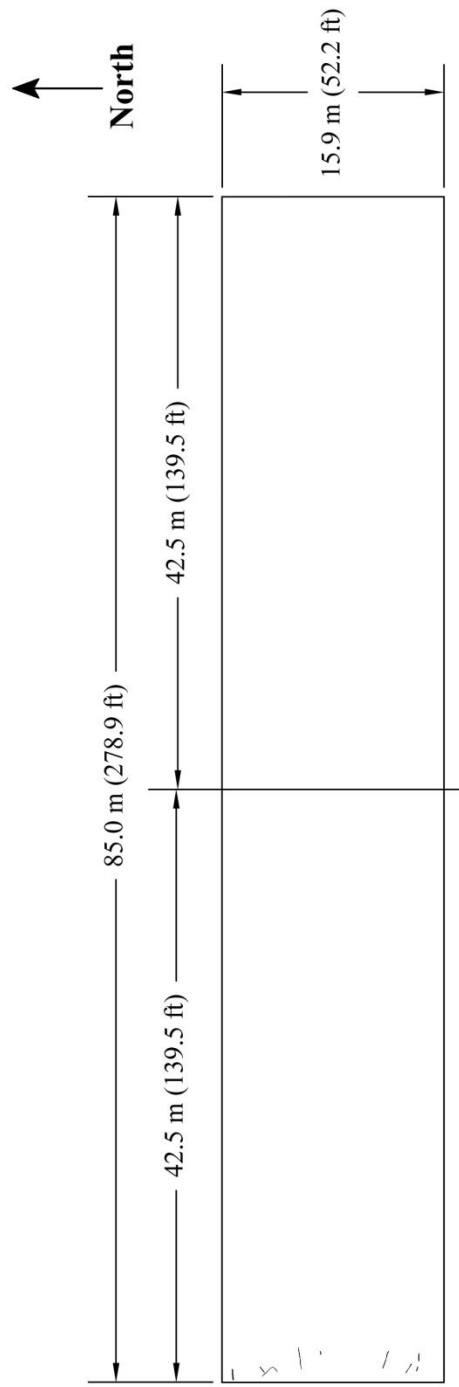
Figure 25: LC-HPC-7 (Survey 4)

Surveys 3 and 4 of LC-HPC-7, at 34.8 and 46.8 months, are included in this report. The bridge deck with the lowest crack density of all those surveyed is LC-HPC-7. At 34.8 months, the crack density was 0.012 m/m^2 , as shown in Figure 24. Small longitudinal cracks were found at the west end near the abutment. In the previous survey at 24.2 months, the crack density was higher at 0.019 m/m^2 (Gruman et al. 2009). The survey at 46.8 months yielded a crack density of 0.005 m/m^2 (Figure 25). The differences in these three crack densities are not significant enough to state that the bridge deck has decreased cracking with time. The cracks that were not marked in the most recent surveys were small and could have been overlooked by the surveyors. The surveys at 34.8 months and 46.8 months were both completed on May 18 of their respective years, while the survey at 24.2 months was completed on July 1. The higher temperatures in July could have expanded the steel girders and widened the deck cracks. This point will be evaluated further as the study continues.

Bridge Number: 43-33 (KU #7)	Bridge Length: 85.0 m (278.9 ft)	Bridge Age: 46.8 months
Bridge Location: Co. Rd. 150 over US-75	Bridge Width: 15.9 m (52.2 ft)	Crack density: 0.005 m/m ²
Construction Date: 6/24/2006	Skew: 0°	Span 1: 0.011 m/m ²
Crack survey Date: 5/18/2010	Number of Spans: 2	Span 2: 0.000 m/m ²
	Span 1 (West): 42.5 m (139.5 ft)	
	Span 2 (East): 42.5 m (139.5 ft)	
	Number of Placements: 1

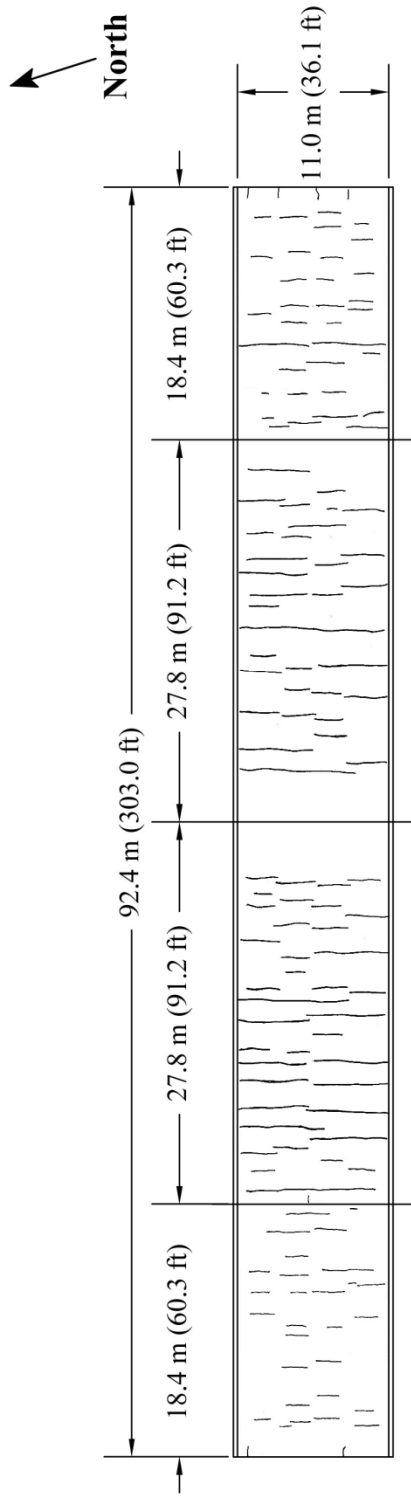
Surveys 1 and 2 of LC-HPC-8, at 20.9 and 31.8 months, are included in this report. LC-HPC-8 is one of two LC-HPC bridges with precast, prestressed concrete girders. The crack density for LC-HPC-8 at 20.9 months was 0.298 m/m^2 , as shown in Figure 28, increasing to 0.348 m/m^2 at 31.8 months, as shown in Figure 29. The majority of the cracks consist of long, transverse cracks that nearly extend across the entire width of the deck parallel with the top reinforcement, likely due to shrinkage and settlement. The cracks are evenly spaced along the entire length of the deck. No increase in cracking is observed near the piers. A small decrease in cracking is observed near the center pier, perhaps due to a combination of increased girder shrinkage and camber. A few small longitudinal cracks are observed propagating from each abutment.

Bridge Number: 54-53 (KU 8)
Bridge Location: E 1350 Rd over US-69
Construction Date: 10/3/2007
Crack survey Date: 5/27/2010

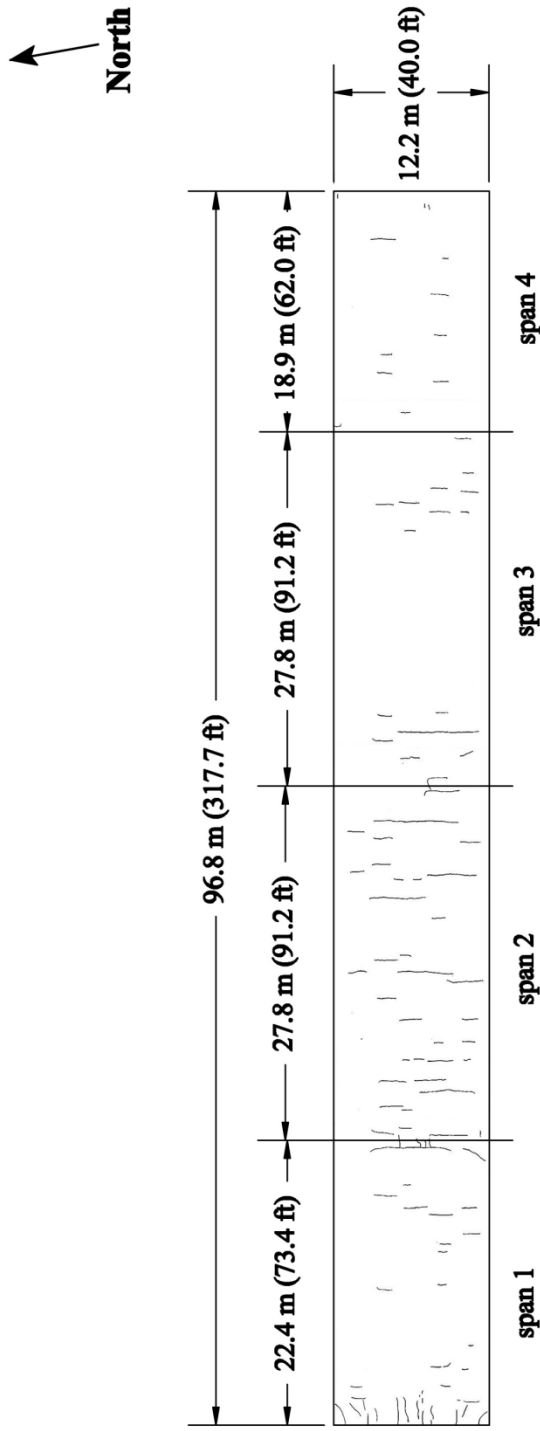
Figure 30: Control-8/10 (Survey 3)

Surveys 3 and 4 of Control-8/10, at 25.5 and 37.3 months, are included in this report. Control-8/10 is the only control bridge with precast, prestressed concrete girders. At 25.5 months, the deck had a crack density of 0.127 m/m^2 , as shown in Figure 30. The previous crack density at 14.4 months was greater, at 0.177 m/m^2 (Gruman et al. 2009). The most recent survey at 37.3 months yielded a crack density of 0.137 m/m^2 , as shown in Figure 31. The majority of the cracks occur in spans 1 and 2 on the west end of the deck. Most cracks are transverse, extending nearly across the entire deck width. An increase in cracking occurs near the pier between spans 1 and 2. Short longitudinal cracks extend from the west abutment.

Bridge Number: 54-59 (KU #8-#10 Control)	Bridge Length: 96.8 m (317.7 ft)	Bridge Age: 25.5 months
Bridge Location: K-52 over US-69	Bridge Width: 12.2 m (40.0 ft)	Crack density: 0.127 m/m ²
Construction Date: 4/16/2007	Skew: 0°	Span 1: 0.172 m/m ²
Crack survey Date: 5/31/2009	Number of Spans: 4	Span 2: 0.199 m/m ²
	Span 1: 22.4 m (73.4 ft)	Span 3: 0.075 m/m ²
	Span 2: 27.8 m (91.2 ft)	Span 4: 0.046 m/m ²
	Span 3: 27.8 m (91.2 ft)	
	Span 4: 18.9 m (62.0 ft)	
	Number of Placements: 1

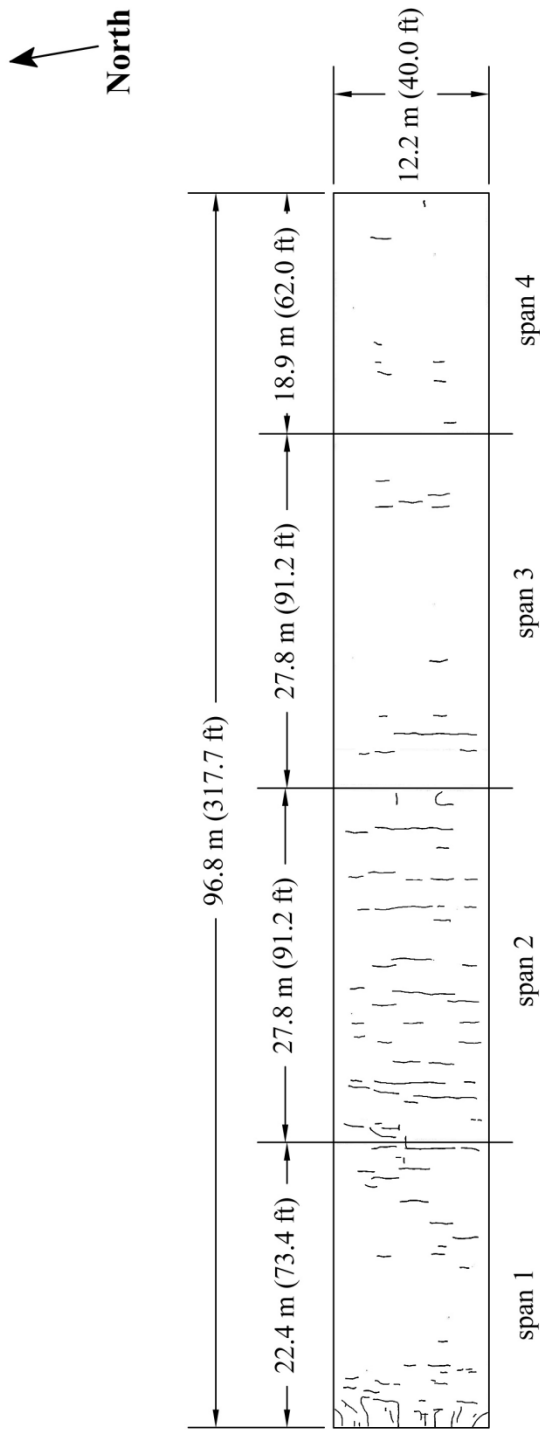
Figure 31: Control-8/10 (Survey 4)

Bridge Age: 37.3 months
Crack density: 0.137 m/m²
Span 1: 0.210 m/m²
Span 2: 0.229 m/m²
Span 3: 0.060 m/m²
Span 4: 0.030 m/m²

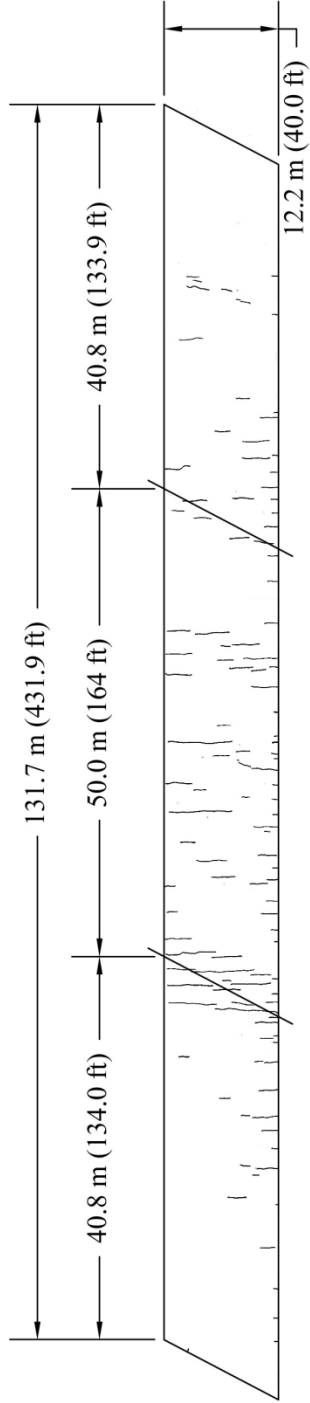
Figure 32: LC-HPC-9 (Survey 1)

LC-HPC-9 has only been surveyed once, at 13.6 months, yielding a crack density of 0.130 m/m^2 , as shown in Figure 32. The majority of the cracks are transverse, parallel with the top reinforcement, and located near the piers and middle of center span. More cracks propagated from southeastern edge of the deck than from the northeastern edge.

Bridge Age: 13.6 months
Crack density: 0.130 m/m²
Span 1 (South): 0.101 m/m²
Span 2 (Middle): 0.203 m/m²
Span 3 (North): 0.069 m/m²

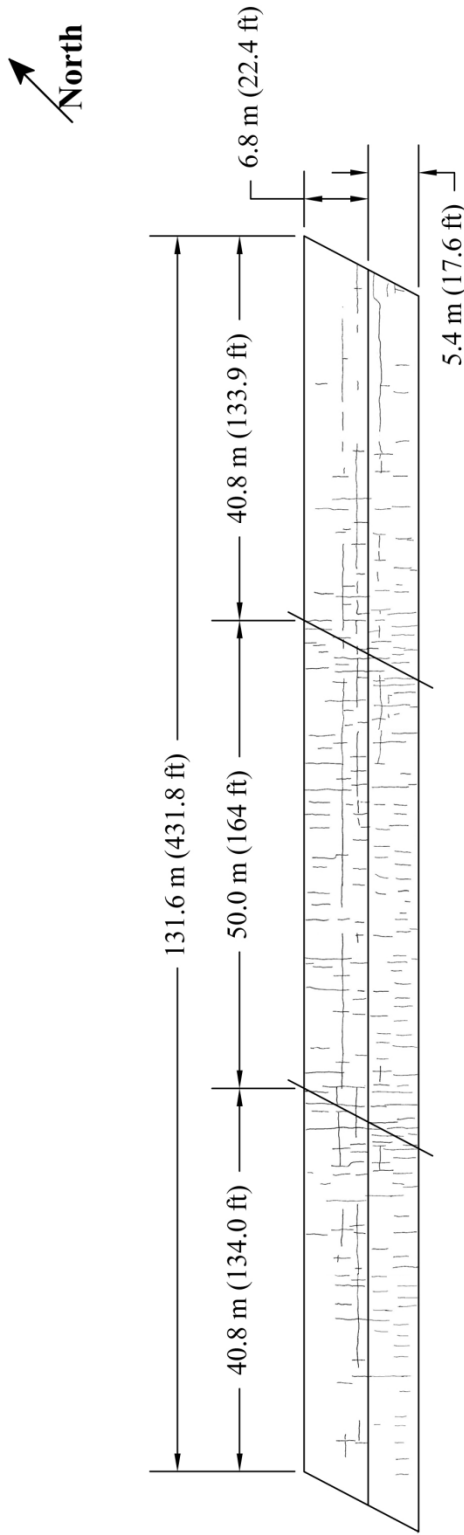
Control-9 has been surveyed one time. It was constructed in two placements eight days apart. Survey 1 at 24.0 and 24.2 months is included in this report. At 24.2 months, Placement 1 has a crack density of 0.395 m/m^2 , while Placement 2 has a crack density of 0.368 m/m^2 at 24.0 months. The overall crack density for Control-9 is 0.390 m/m^2 , as shown in Figure 33. Transverse cracks are observed along the entire bridge deck, increasing in density near the piers and middle span. A few longitudinal cracks on both sides of the joint between placements continue along nearly the entire length of the deck.

Bridge Number: 54-58 (Control #9)
Bridge Location: NB US-69 over
 Marair Des Cygnes Rv
Construction Date:
 Placement 1 (West): 5/21/2008
 Placement 2 (East): 5/29/2008
Crack survey Date: 5/28/2010

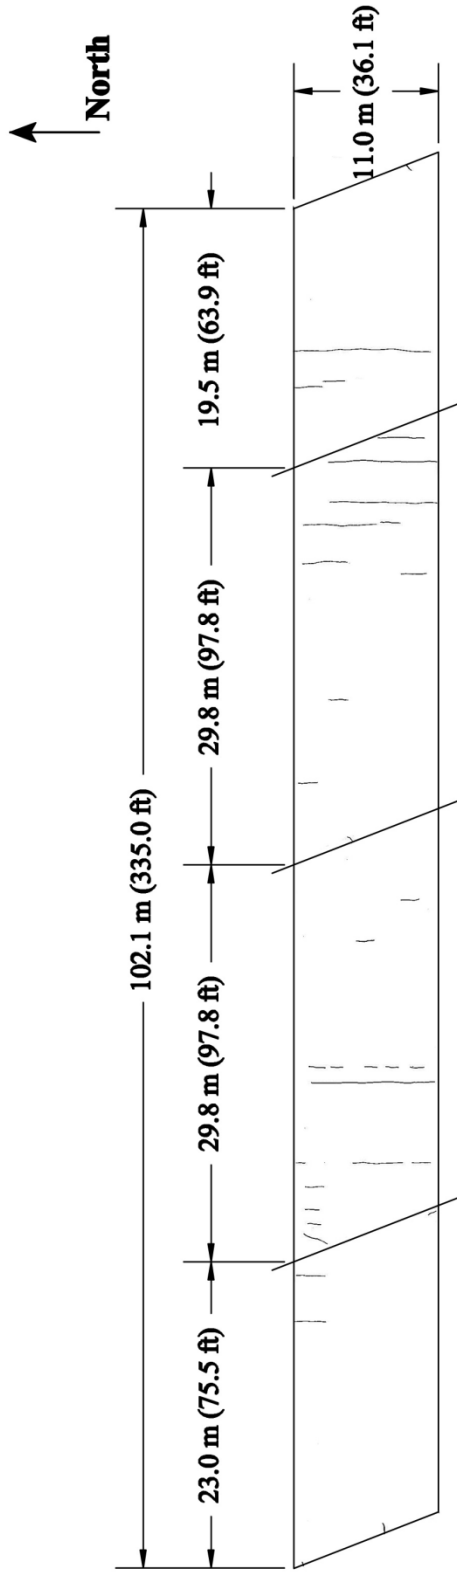
Figure 34: LC-HPC-10 (Survey 1)

Surveys 1 and 2 of LC-HPC-10, at 25.4 and 36.2 months, are included in this report. LC-HPC-10 is the second of two LC-HPC bridges with precast, prestressed concrete girders. At 25.4 months, LC-HPC-10 had a crack density of 0.076 m/m^2 , as shown in Figure 34. Transverse cracks occurred near the eastern pier and extended nearly across the entire bridge width. Minor transverse cracking was observed near the western pier. Little to no cracking had developed near the middle pier. At 36.2 months, the deck yielded a lower crack density of just 0.029 m/m^2 , as shown in Figure 35.

Bridge Age: 25.4 months
Crack density: 0.076 m/m²
Span 1 (West): 0.025 m/m²
Span 2 (West): 0.088 m/m²
Span 3 (East): 0.109 m/m²
Span 4 (East): 0.069 m/m²

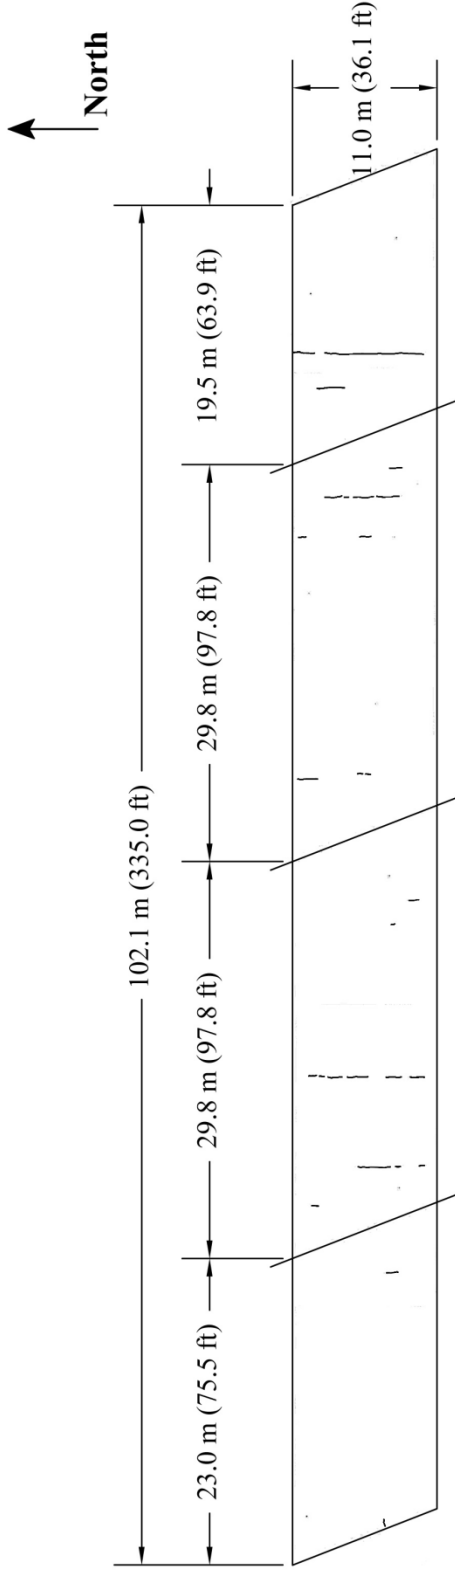
Figure 35: LC-HPC-10 (Survey 2)

Bridge Age: 36.2 months
Crack density: 0.029 m/m²
Span 1 (West): 0.005 m/m²
Span 2 (West): 0.033 m/m²
Span 3 (East): 0.029 m/m²
Span 4 (East): 0.051 m/m²

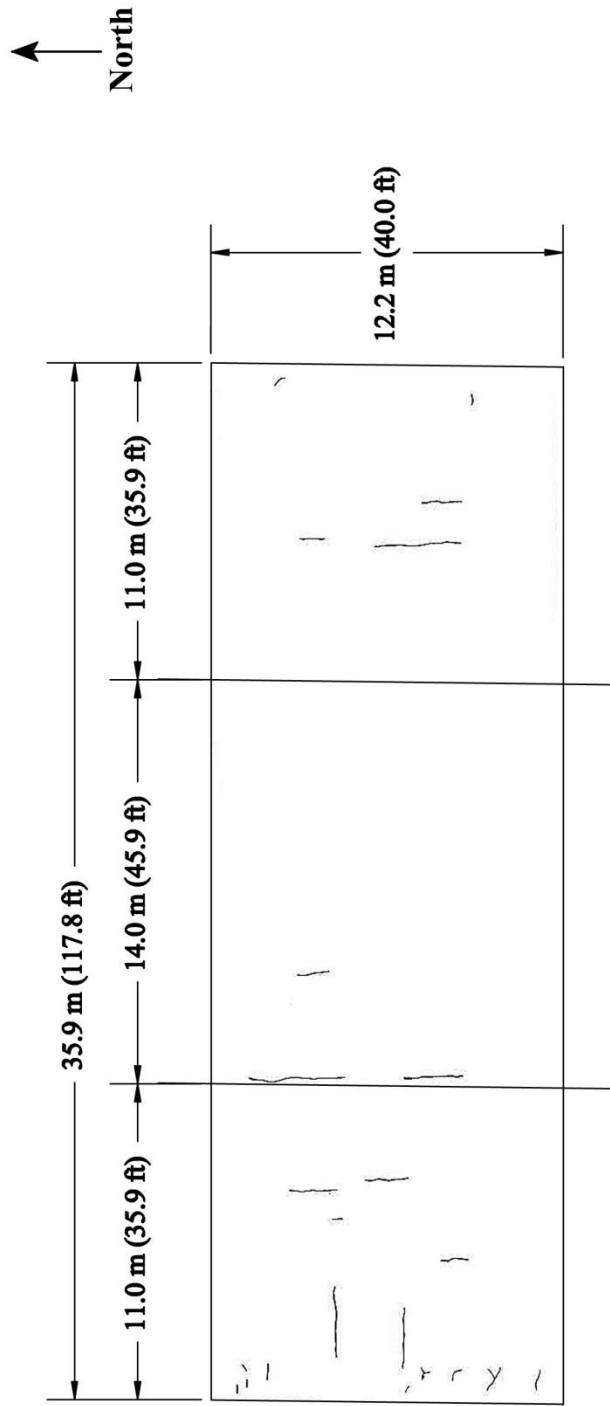
Figure 36: LC-HPC-11 (Survey 1)

Bridge Age: 23.4 months
Crack Density: 0.059 m/m²
Span 1: 0.091 m/m²
Span 2: 0.038 m/m²
Span 3: 0.046 m/m²

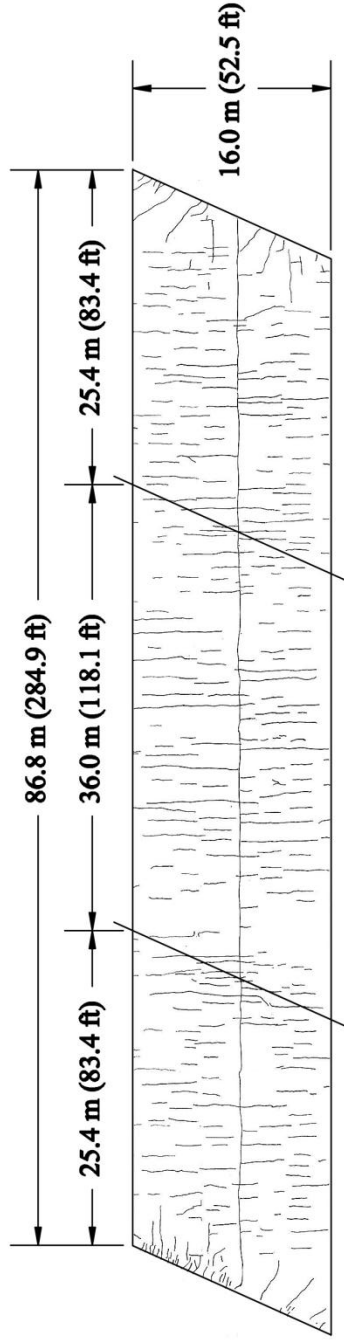
Figure 38: Control-11 (Survey 3)

Surveys 3 and 4 of Control-11, at 37.8 and 50.2 months, are included in this report. Control-11 experienced a large amount of cracking, with a crack density of 0.599 m/m^2 at 37.8 months (Figure 38). This crack density is over two times larger than the crack density of LC-HPC-11 at 36.2 months. The crack density for Control-11 at 50.2 months is 0.636 m/m^2 , as shown in Figure 39. This deck exhibits transverse cracks across the width of the deck that are distributed parallel to and above the top reinforcement along the deck length. Longitudinal cracks extend perpendicularly from each abutment. A single, longitudinal crack extends the

Bridge Number: 56-155 (KU #11 Control)	Bridge Length: 86.8 m (284.9 ft)	Bridge Age: 37.8 months
Bridge Location: US-50 over BNSF Railroad, Emporia, KS	Bridge Width: 16.0 m (52.5 ft)	Crack Density: 0.599 m/m ²
Construction Date: 3/28/2006	Skew: 24.3°	Span 1: 0.608 m/m ²
Crack Survey Date: 5/21/2009	Number of Spans: 3	Span 2: 0.575 m/m ²
	Span 1: 25.4 m (83.4 ft)	Span 3: 0.624 m/m ²
	Span 2: 36.0 m (118.1 ft)	
	Span 3: 25.4 m (83.4 ft)	
	Number of Placements: 1

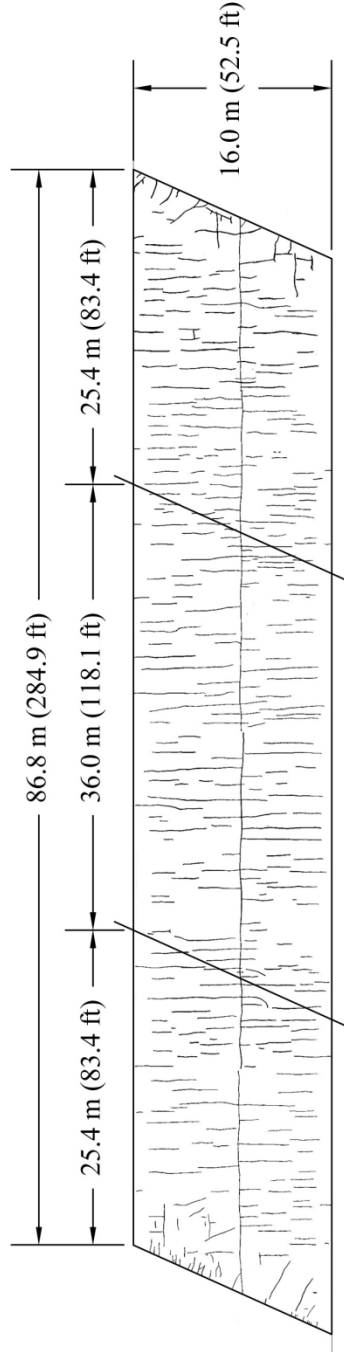
Figure 39: Control-11 (Survey 4)

Bridge Number: 56-155 (KU #11 Control)	Bridge Length: 86.8 m (284.9 ft)	Bridge Age: 50.2 months
Bridge Location: US-50 over BNSF Railroad, Emporia, KS	Bridge Width: 16.0 m (52.5 ft)	Crack Density: 0.636 m/m ²
Construction Date: 3/28/2006	Skew: 24.3°	Span 1: 0.596 m/m ²
Crack Survey Date: 6/2/2010	Number of Spans: 3	Span 2: 0.638 m/m ²
	Span 1: 25.4 m (83.4 ft)	Span 3: 0.677 m/m ²
	Span 2: 36.0 m (118.1 ft)	
	Span 3: 25.4 m (83.4 ft)	
	Number of Placements: 1

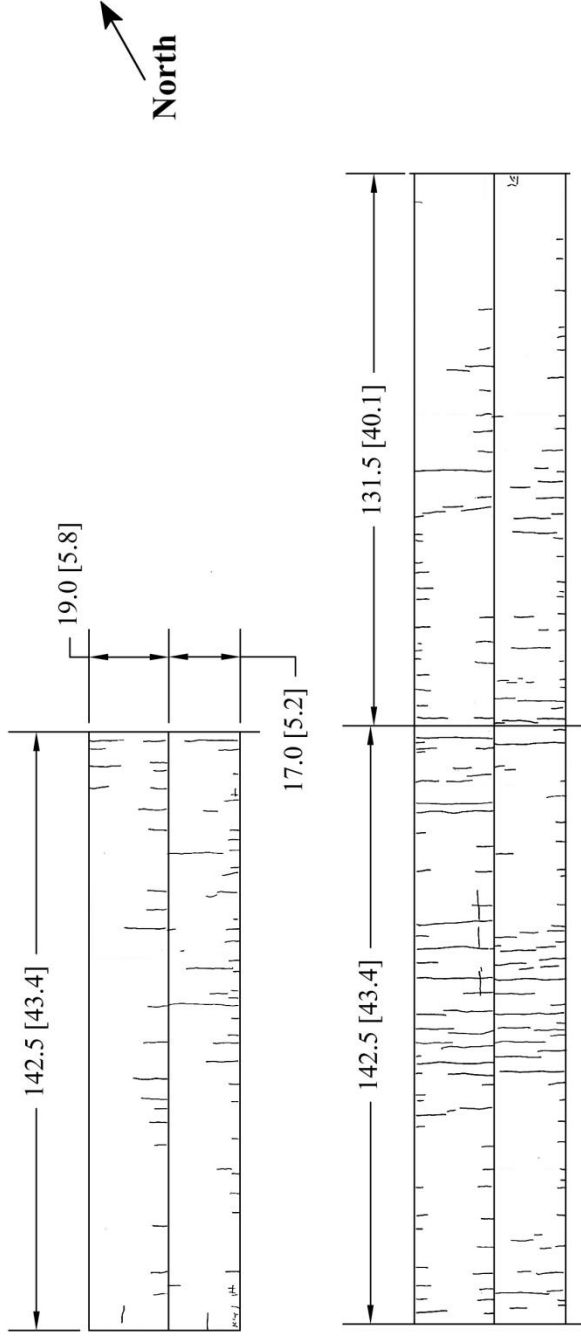
Figure 40: LC-HPC-12 (Survey 1)

The deck on LC-HPC-12 was cast using phased construction in two placements, 11.4 months apart. Survey 1 at 4.9 and 16.3 months and Survey 2 at 15.4 and 26.8 months are included in this report. The first survey was conducted at ages of 16.3 months for Placement 1 and 4.9 months for Placement 2 and yielded crack densities of 0.271 m/m^2 and 0.254 m/m^2 , respectively. The overall crack density was 0.262 m/m^2 , as shown in Figure 40. Transverse cracks extended from both edges of the deck from the longitudinal construction joint. The crack density was highest in the middle of the center span. No increased cracking occurred near the piers. During construction of Placement 2, construction equipment, including a crane, was placed on the completed Placement 1 to simplify construction. This increased loading may have affected the cracking behavior of Placement 1 due to increased torsional loading on the bridge. The second survey was conducted at 26.8 months for Placement 1 and 15.4 months for Placement 2, and the crack densities were 0.256 m/m^2 and 0.244 m/m^2 , respectively, with an overall crack density of 0.250 m/m^2 (Figure 41).

Bridge Number: 56-057 (KU 12)	Bridge Length: 416.5' (126.95m)	Bridge Age:
Bridge Location: K-130 over Neosho Rv Unit 2	Bridge Width: 36' (10.97m)	Placement 1: 16.3 months
Construction Date:	Skew: 0°	Placement 2: 4.9 months
Placement 1: 4/4/2008	Number of Spans: 3	Crack Density: 0.262 m/m ²
Placement 2: 3/18/2009	Span 1 (West): 142.5' (43.43m)	Placement 1: 0.271 m/m ²
	Span 2 (Mid): 142.5' (43.43m)	Placement 2: 0.254 m/m ²
	Span 3 (East): 131.5' (40.08m)	Span 1: 0.182 m/m ²
Crack Survey Date: 8/13/2009	Number of Placements: 2	Span 2: 0.408 m/m ²

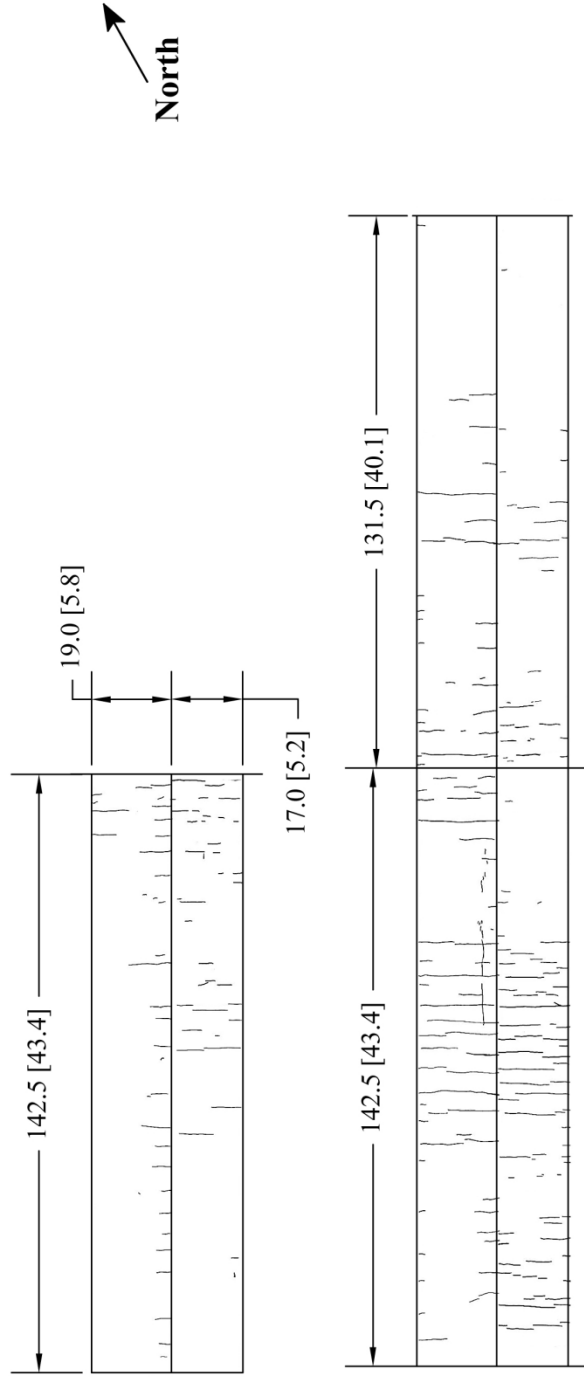
Figure 41: LC-HPC-12 (Survey 2)

Bridge Number: 56-057 (KU 12)	Bridge Length: 416.5' (126.95m)	Bridge Age:
Bridge Location: K-130 over Neosho Rv Unit 2	Bridge Width: 36' (10.97m)	Placement 1: 26.8 months
Construction Date:	Skew: 0°	Placement 2: 15.4 months
Placement 1(east): 4/4/2008	Number of Spans: 3	Crack Density: 0.250 m/m ²
Placement 2(west): 3/18/2009	Span 1 (West): 142.5' (43.43m)	Placement 1: 0.256 m/m ²
	Span 2 (Mid): 142.5' (43.43m)	Placement 2: 0.244 m/m ²
	Span 3 (East): 131.5' (40.08m)	Span 1: 0.157 m/m ²
Crack Survey Date: 6/29/2010	Number of Placements: 2	Span 2: 0.445 m/m ²

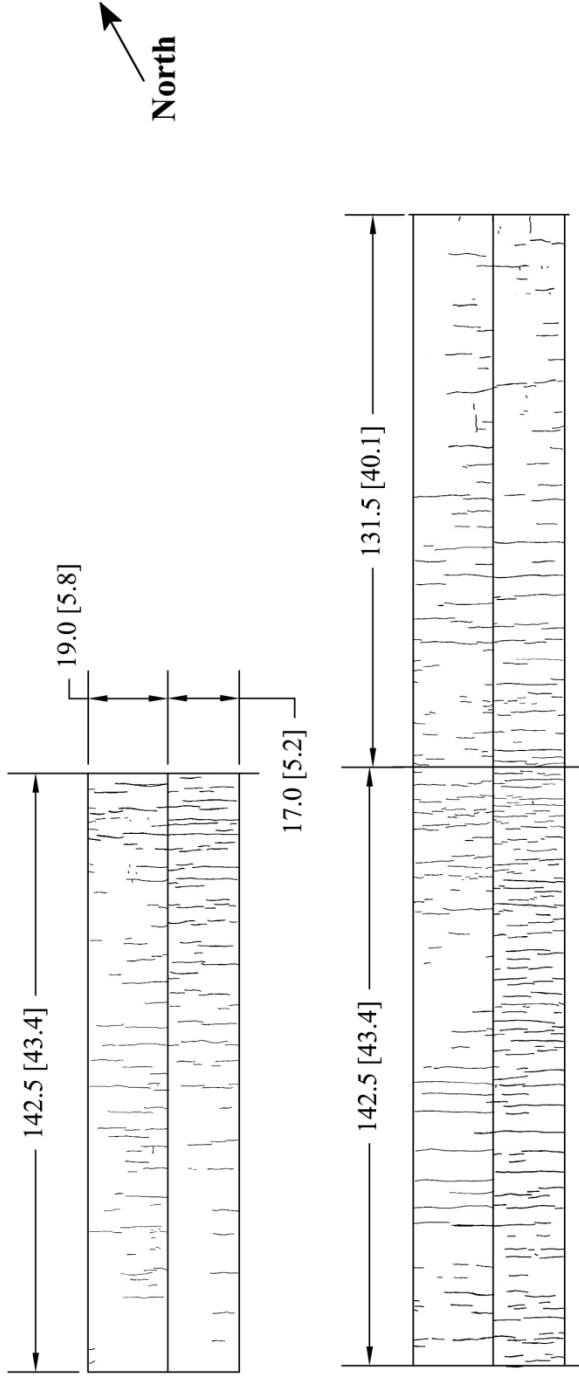
Figure 43: Control-12 (Survey 2)

14.5 months for Placement 2, giving crack densities of 0.669 m/m² and 0.442 m/m², respectively. The overall crack density was 0.548 m/m², as shown in Figure 43. Control-12 once again exhibited crack densities more than two times that of LC-HPC-12 at similar placement ages. Transverse cracking was found throughout the bridge deck, with the cracks extending nearly across the entire bridge width at most locations. Less cracking was experienced near the ends of the deck. As with LC-HPC-12, construction equipment had been placed on Placement 1 during the construction of Placement 2.

Bridge Number: 56-057 (Control 12)	Bridge Length: 416.5' (126.95m)	Bridge Age:
Bridge Location: K-130 over Neosho Rv Unit 1	Bridge Width: 36' (10.97m)	Placement 1: 26.9 months
Construction Date:	Skew: 0°	Placement 2: 14.5 months
Placement 1: 4/1/2008	Number of Spans: 3	Crack Density: 0.548 m/m ²
Placement 2: 4/14/2009	Span 1 (West): 142.5' (43.43m)	Placement 1: 0.669 m/m ²
Crack Survey Date: 6/29/2010	Span 2 (Mid): 142.5' (43.43m)	Placement 2: 0.442 m/m ²
	Span 3 (East): 131.5' (40.08m)	Span 1: 0.468 m/m ²
	Number of Placements: 2	Span 2: 0.747 m/m ²
		Span 3: 0.421 m/m ²

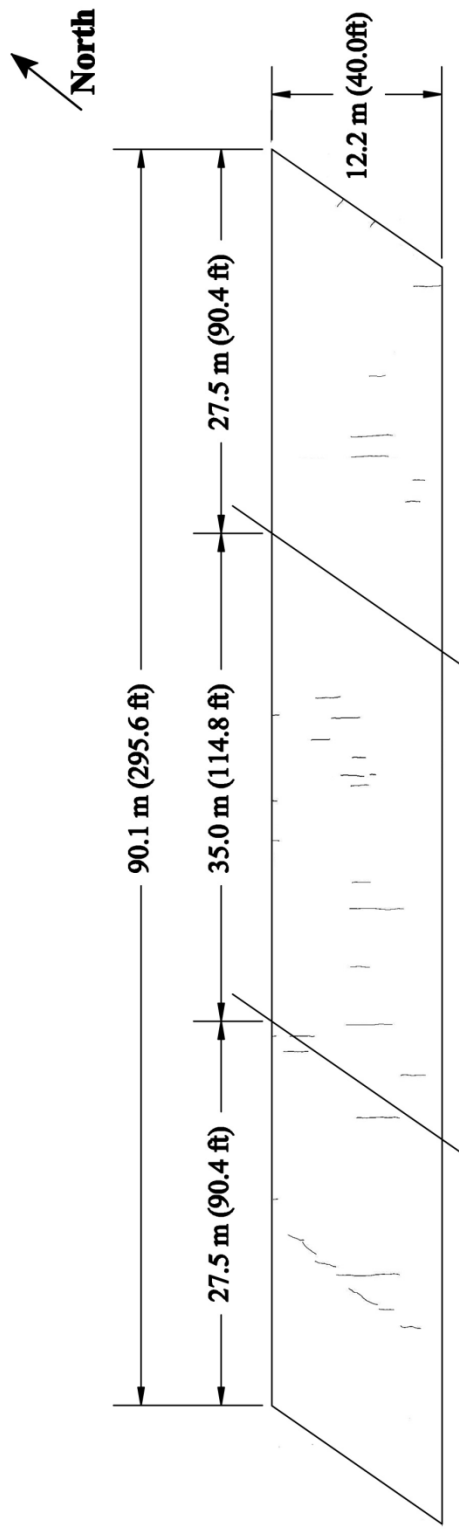
Figure 44: LC-HPC-13 (Survey 1)

Surveys 1 and 2 of LC-HPC-13, at 13.8 and 24.8 months, are included in this report. LC-HPC-13 had a crack density of 0.050 m/m² at 13.8 months (Figure 44). The cracks were primarily transverse with lengths of 1 to 2 m (3 to 6 ft) spread throughout the deck. Due to the skew of the bridge, the transverse cracks were parallel with the top reinforcement, but not parallel with the piers. This observation indicates the cracking was most likely caused by settlement and shrinkage at the top reinforcement. No increase in cracking was observed near the piers or abutments. A pattern of cracks extending nearly across the entire deck width parallel to the top reinforcement developed at the center of the west span. At 24.8 months, the crack density had increased to 0.129 m/m², as shown in Figure 45. Transverse cracks with length of 1 to 2 m (3 to 6 ft) once again made up the majority of the cracking. Less cracking had developed in the east span compared to the middle and west span. LC-HPC-13 was one of two LC-HPC decks that used a double drum roller screed for finishing.

Bridge Age: 13.8 months
Crack density: 0.050 m/m²
Span 1 (West): 0.058 m/m²
Span 2 (middle): 0.056 m/m²
Span 3 (East): 0.035 m/m²

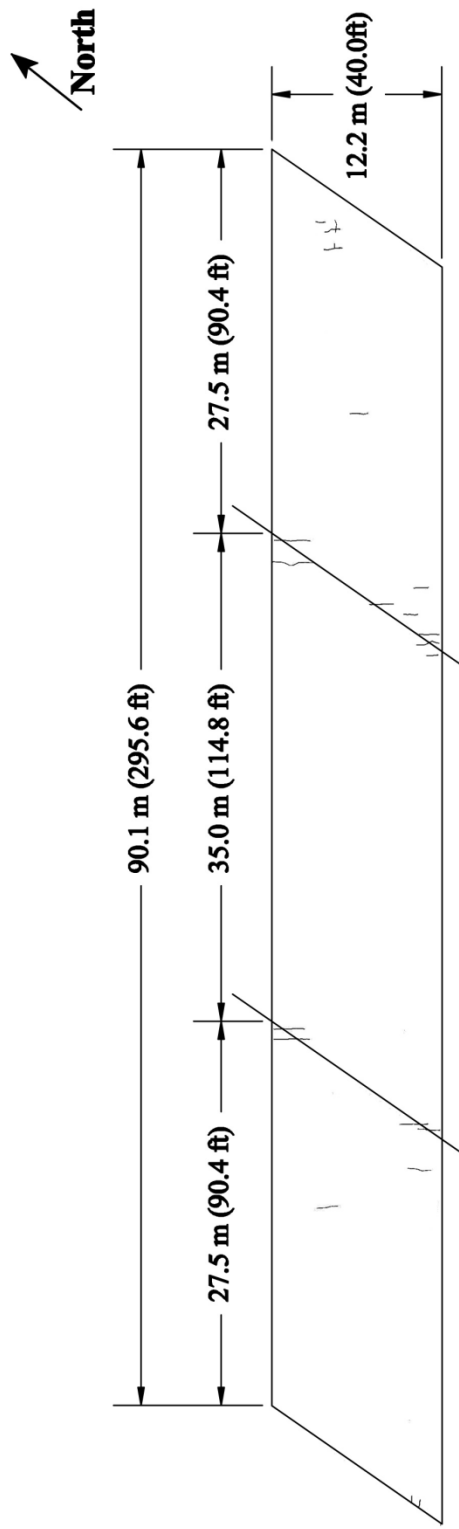
Figure 46: Control-13 (Survey 1)

Surveys 1 and 2 of Control-13, at 11.0 and 21.9 months, are included in this report. At 11.0 months, Control-13 had a crack density of just 0.028 m/m², as shown in Figure 46. Nearly all of the cracks were transverse and located near the piers. The crack density at 21.9 months increased to 0.154 m/m², slightly more than the crack density of LC-HPC-13 at 24.8 months. Significant map cracking developed near the east end of the deck (Figure 47). Increased transverse cracking developed near both piers.

Bridge Age: 11.0 months
Crack density: 0.028 m/m²
Span 1 (West): 0.031 m/m²
Span 2 (middle): 0.025 m/m²
Span 3 (East): 0.035 m/m²

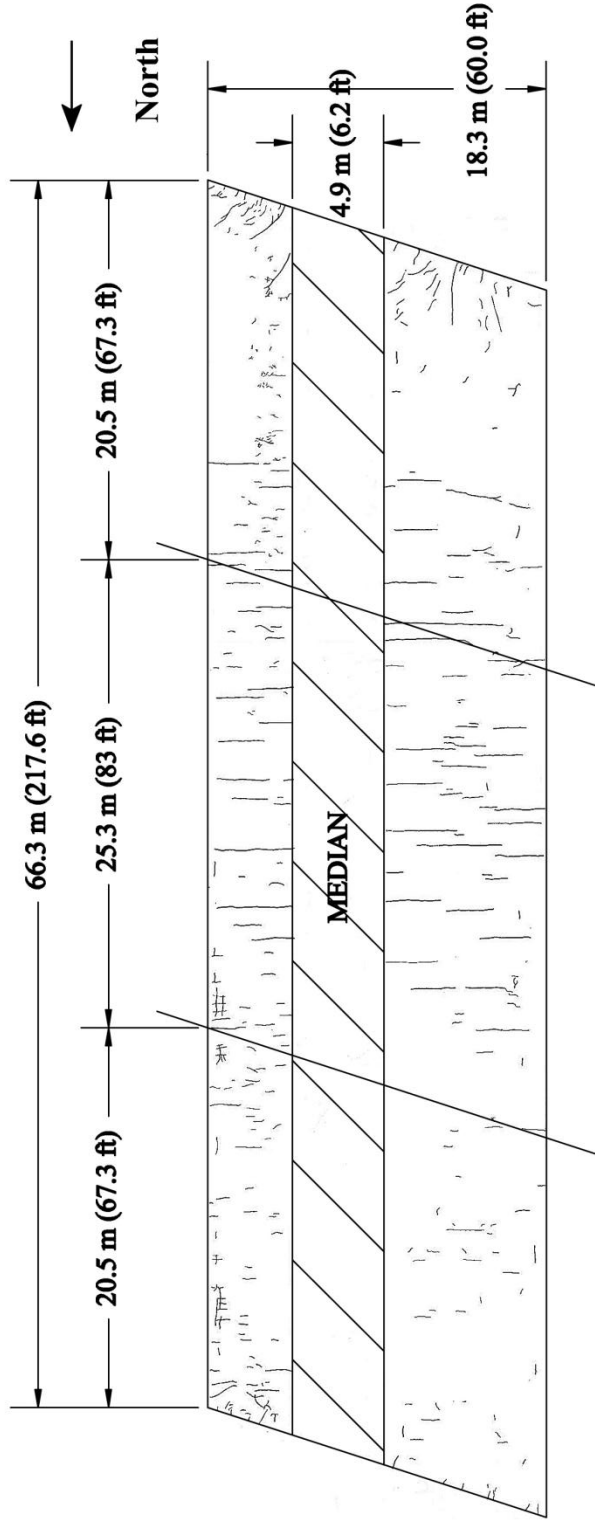
Figure 48: OP Bridge – Placement 1 (Survey 1)

Surveys 1 and 2 of OP Bridge – Placement 1, at 18.3 and 30.0 months, are included in this report. The OP deck has a considerably higher crack density than any of the other bridge decks constructed under LC-HPC specifications. The contractor did not follow and the owner did not enforce many of the key provisions of the LC-HPC specifications (McLeod et al. 2009), and the higher crack densities are most likely due to the myriad of issues that arose during construction. Placement 1 was completed on two separate dates due to concrete pumping issues. After only thirty feet of deck placement, construction was halted due to concrete backing up in the pump. This concrete was later removed from the deck and a second attempt was successfully completed several weeks later. During the second attempt, some of the concrete used in the deck had slumps above 5 in. Concrete consolidation proved to be inadequate, with coarse aggregate visible at the concrete surface after the vibrators were removed. The vibrators were also removed from the concrete too quickly, leaving holes at the vibrator locations. The contractor spent considerable time finishing the deck by bullfloating, leaving the deck overfinished at times, with an excess amount of cement paste at the deck surface (Lindquist et al. 2008). The time to burlap placement after finishing exceeded the ten minute limit throughout construction, primarily

due to the overfinishing. The contractor used water from the fogging equipment as a finishing agent (McLeod et al. 2009). At 18.3 months, Placement 1 had a crack density of 0.341 m/m^2 , as shown in Figure 48. Transverse cracks extended nearly across the bridge width above the top reinforcement in the middle of the center span. Longitudinal cracks extended from the south abutment. A large number of short map cracks developed on the two outside spans. No increased cracking was detected at the piers. By 30.0 months, the crack density had increased to 0.502 m/m^2 , as shown in Figure 49. The cracking patterns were similar to those in the first survey.

Bridge Number: 46-363 placement 1 (KU #14)	Bridge Length: 66.3 m (217.6 ft)	Bridge Age: 18.3 months
Bridge Location: Metcalf Ave over Indian Creek, OP, Kansas	Bridge Width: 18.3 m (60.0 ft)	Crack Density: 0.341 m/m ²
Construction Date: 12/19/2007	Skew: -18 °	Span 1: 0.243 m/m ²
Crack Survey Date: 6/23/2009 and 7/1/2009	Number of Spans: 3	Span 2: 0.404 m/m ²
	Span 1: 20.5 m (67.3 ft)	Span 3: 0.361 m/m ²
	Span 2: 25.3 m (83.0 ft)	
	Span 3: 20.5 m (67.3 ft)	
	Number of Placements: 1

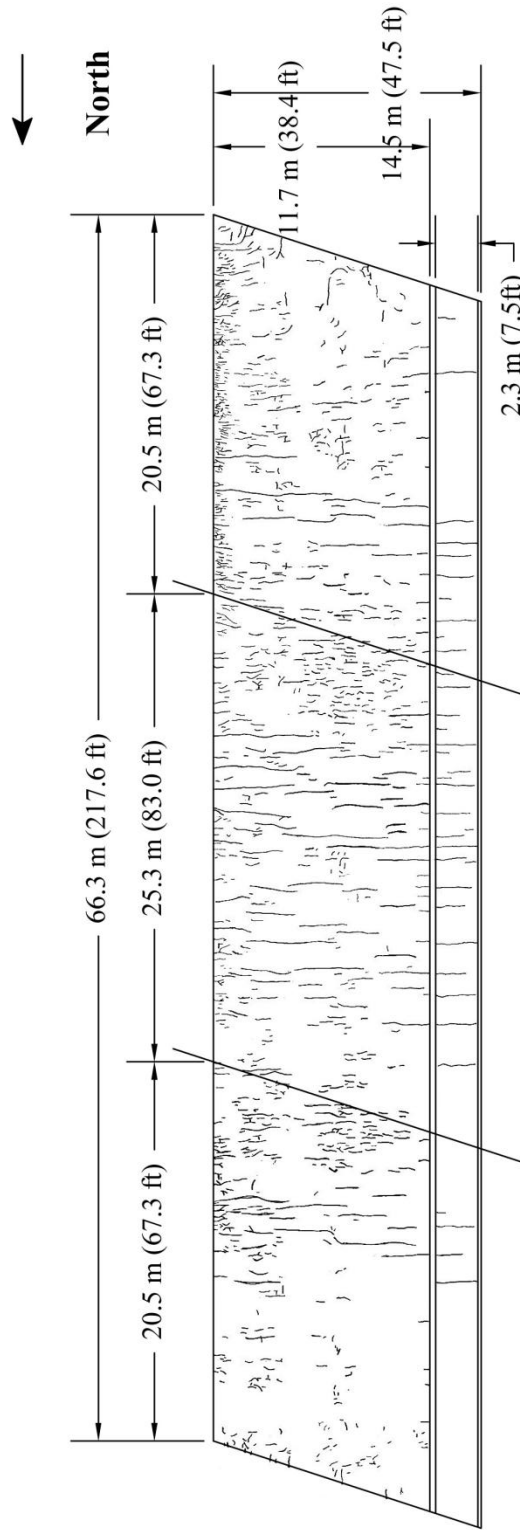
Surveys 1 and 2 of OP Bridge – Placement 2, at 13.7 and 25.5 months, are included in this report. Placement 2 for the OP deck also has considerably higher crack densities compared to the other decks constructed under LC-HPC specifications. Once again, problems developed during construction that are the likely causes of these high crack densities. The concrete placed in the deck generally had a higher slump and air content than specified in the LC-HPC specifications. High slumps place the deck at risk for settlement cracking. Heavy rain from the previous night made it difficult for the concrete supplier to accurately determine the aggregate moisture contents. A double-drum roller was used for finishing on this placement, possibly contributing to overfinishing of the concrete and increased cement paste at the deck surface. The time of burlap placement after finishing exceeded the ten minute limit throughout construction. During a delay in concrete delivery, a portion of the concrete was shoveled from a wingwall and placed into the deck. At 13.7 months, Placement 2 had a crack density of 0.640 m/m^2 (Figure 50). Significant transverse cracking developed from the center of the north span to the center of the south span. Extensive map cracking developed throughout the deck. The crack density is

Bridge Number: 46-363 placement 2 (KU #14)
Bridge Location: Metcalf Ave over Indian Creek, OP, Kansas
Construction Date: 5/2/2008
Crack Survey Date: 6/23/2009

Bridge Length: 66.3 m (217.6 ft)
Bridge Width: 14.5 m (47.5 ft)
Skew: -18°
Number of Spans: 3
Span 1: 20.5 m (67.3 ft)
Span 2: 25.3 m (83.0 ft)
Span 3: 20.5 m (67.3 ft)
Number of Placements: 1

Bridge Age: 13.7 months
Crack Density: 0.640 m/m²
Span 1: 0.609 m/m²
Span 2: 0.756 m/m²
Span 3: 0.528 m/m²

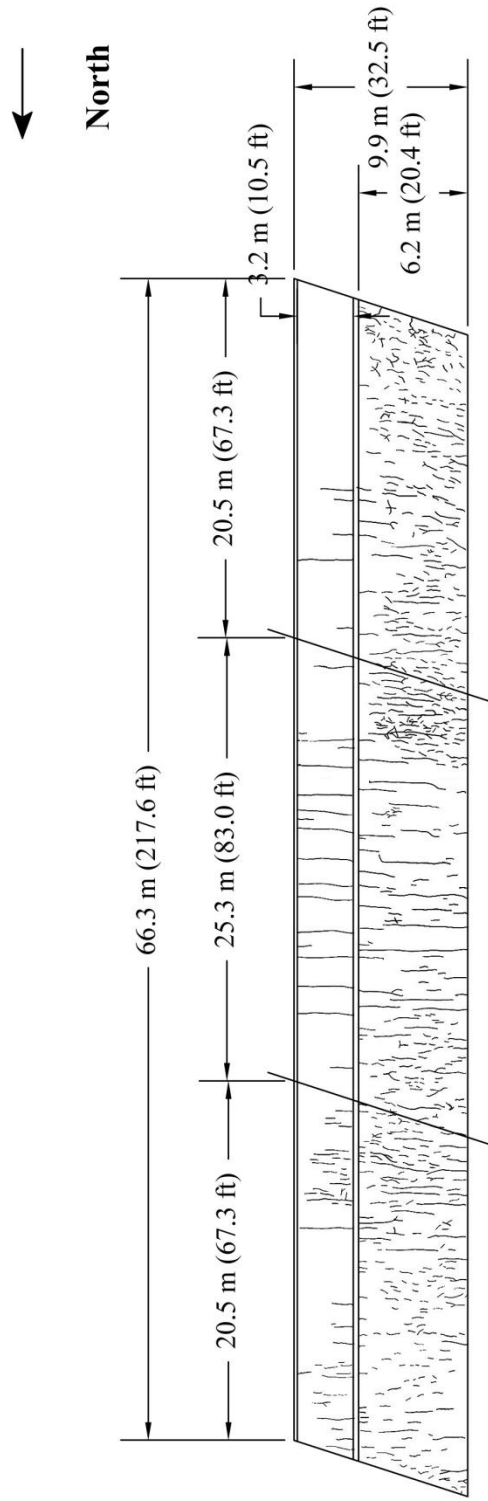
Figure 52: OP Bridge – Placement 3 (Survey 1)

Surveys 1 and 2 of OP Bridge – Placement 3, at 13.3 and 24.9 months, are included in this report. Placement 3 also had problems during the construction process leading to increased crack densities. The concrete used in this placement had very high slumps and high air contents. Deck reinforcement was observed to be not tightly supported and had a tendency to spring up, potentially increasing the risk of settlement cracking. As with Placement 2, a double-drum roller screed was used for finishing. Placements 2 and 3 of the OP Bridge were the only LC-HPC specified bridges that used a double-drum roller screed for finishing. The majority of locations exceeded the ten minute limit for wet burlap placement after finishing (Gruman et al. 2009). The crack density for Placement 3 at 13.3 months was 0.421 m/m^2 , as shown in Figure 52. The majority of cracks were transverse and located in the middle span. Shorter transverse cracks developed in each of the outside spans. At 24.9 months, the crack density more than doubled to 0.871 m/m^2 , as shown in Figure 53. Extensive map cracking has developed throughout the outer spans. Longer transverse cracks are located within the middle span.

Bridge Number: 46-363 placement 3 (KU #14)
Bridge Location: Metcalf Ave over Indian Creek, OP, Kansas
Construction Date: 5/21/2008
Crack Survey Date: 7/1/2009
Bridge Length: 66.3 m (217.6 ft)
Bridge Width: 9.9 m (32.5 ft)
Skew: -18 °
Number of Spans: 3
Span 1: 20.5 m (67.3 ft)
Span 2: 25.3 m (83.0 ft)
Span 3: 20.5 m (67.3 ft)
Number of Placements: 1
Bridge Age: 13.3 months
Crack Density: 0.421 m/m²
Span 1: 0.296 m/m²
Span 2: 0.629 m/m²
Span 3: 0.290 m/m²

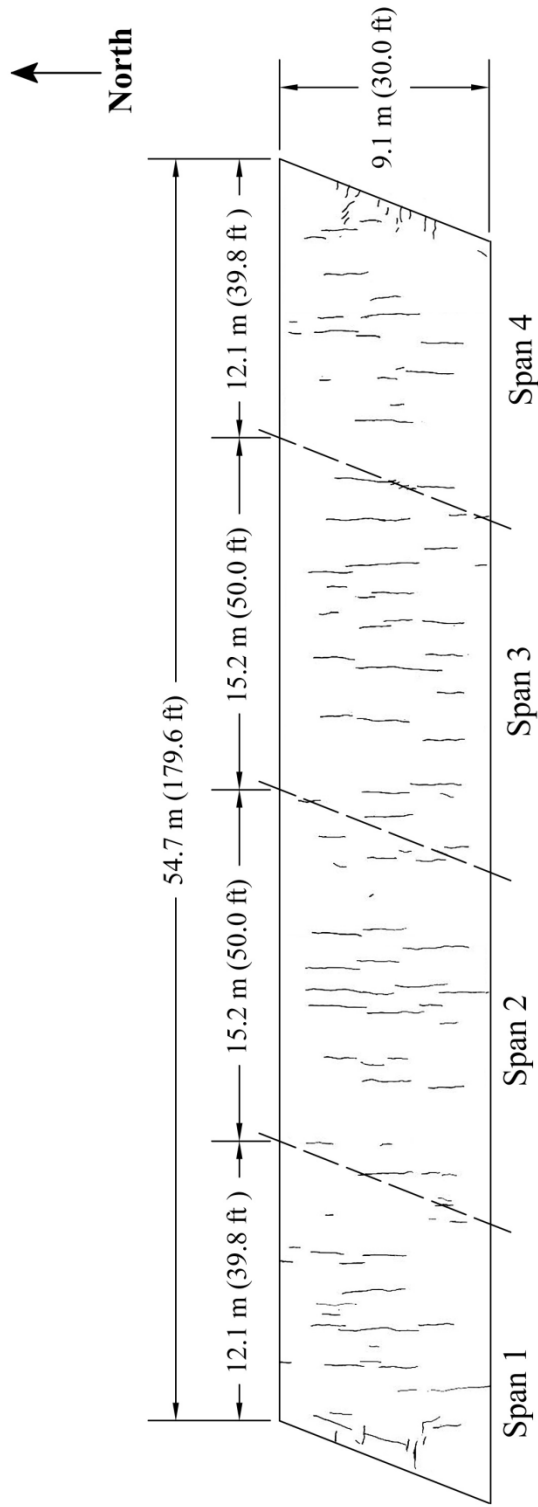
Figure 54: Control-Alt (Survey 4)

Control-Alt is located in Emporia, KS and was chosen as an additional control structure because it is a monolithic deck, like all LC-HPC decks. All other control decks have a silica fume overlay. Surveys 4 and 5 of Control-Alt, at 47.5 and 60.7 months, are included in this report. The alternate control had a crack density of 0.265 m/m^2 at 47.5 months, as shown in Figure 54. The cracks are primarily transverse and spread throughout the bridge deck. No

Bridge Number: 56-49	Bridge Length: 54.7 m (179.6 ft)	Bridge Age: 47.5 months
Bridge Location: K-99 over I-335	Bridge Width: 9.1 m (30.0 ft)	Crack density: 0.265 m/m ²
Construction Date: 6/2/2005	Skew: -21.5°	Span 1 : 0.283 m/m ²
Crack survey Date: 5/19/2009	Number of Spans: 4	Span 2 : 0.281 m/m ²
	Span 1 : 12.1 m (39.8 ft)	Span 3 : 0.277 m/m ²
	Span 2 : 15.2 m (50.0 ft)	Span 4 : 0.208 m/m ²
	Span 3 : 15.2 m (50.0 ft)	
	Span 4 : 12.1 m (39.8 ft)	
	Number of Placements: 1

increase in cracking was observed near or parallel to the piers. The crack locations suggest that most cracking was due to shrinkage and settlement of the concrete at the reinforcing steel, as opposed to cracking induced by tensile stresses at the negative moment regions near the piers. Minimal longitudinal cracking was also found at each abutment. The crack density of the alternate control increased to 0.316 m/m^2 at 60.7 months (Figure 55). More transverse cracking above the top reinforcement developed throughout the bridge and a minimal increase in longitudinal cracking occurred at the east abutment.

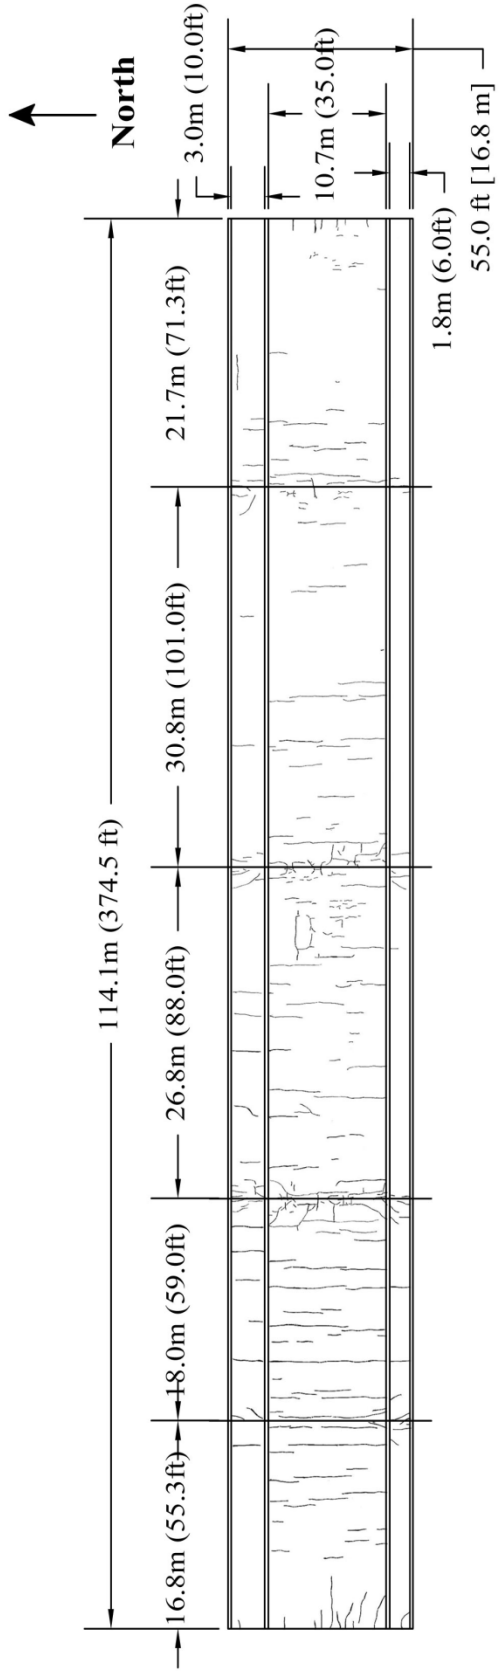
Figure 56: OP-Extra (Survey 1)

Surveys 1 and 2 of OP-Extra, at 13.4 and 23.3 months, are included in this report. An extra precast, prestressed concrete girder control bridge was surveyed in Overland Park in 2009 and 2010. The bridge was constructed by the contractor of the OP Bridge. The deck yielded a crack density of 0.284 m/m^2 at 13.4 months, as shown in Figure 56. At 23.3 months, the crack density increased to 0.302 m/m^2 (Figure 57). Considerable cracking developed near each pier in both transverse and longitudinal directions. Transverse cracks that extend nearly the entire bridge width above the reinforcing steel are found throughout the deck, but are more prominent on the west end. Longitudinal cracks extended from each abutment. This deck had a similar crack density at 23.3 months as LC-HPC-8, another prestressed girder bridge, at 20.9 months (0.302 m/m^2 vs. 0.298 m/m^2). OP-Extra had nearly four times the crack density at 23.3 months as LC-HPC-10 at 25.4 months (0.302 m/m^2 vs. 0.076 m/m^2) and more than two times the crack density as Control-8/10 at 25.5 months (0.302 m/m^2 vs. 0.127 m/m^2), all prestressed girder bridges.

Bridge Number: Overland Park extra
Bridge Location: 132nd street over
 US 69, OP,KS
Construction Date: 6/30/2008
Crack Survey Date: 8/12/2009

Bridge Length: 114.1 m (374.5 ft)
Bridge Width: 16.8 m (55.0 ft)
Skew: 0°
Number of Spans: 5
Span 1: 16.8 m (55.3 ft)
Span 2: 18.0 m (59.0 ft)
Span 3: 26.8 m (88.0 ft)
Span 4: 30.8 m (101.0 ft)
Span 5: 21.7 m (71.3 ft)
Number of Placements: 1

Bridge Age: 13.4 months
Crack Density: 0.284 m/m²
Span 1: 0.278 m/m²
Span 2: 0.490 m/m²
Span 3: 0.344 m/m²
Span 4: 0.214 m/m²
Span 5: 0.137 m/m²
