Technical Memorandum

Re: Forensic Desktop Study Report: Arkansas LTPP SPS-8 Test Sections

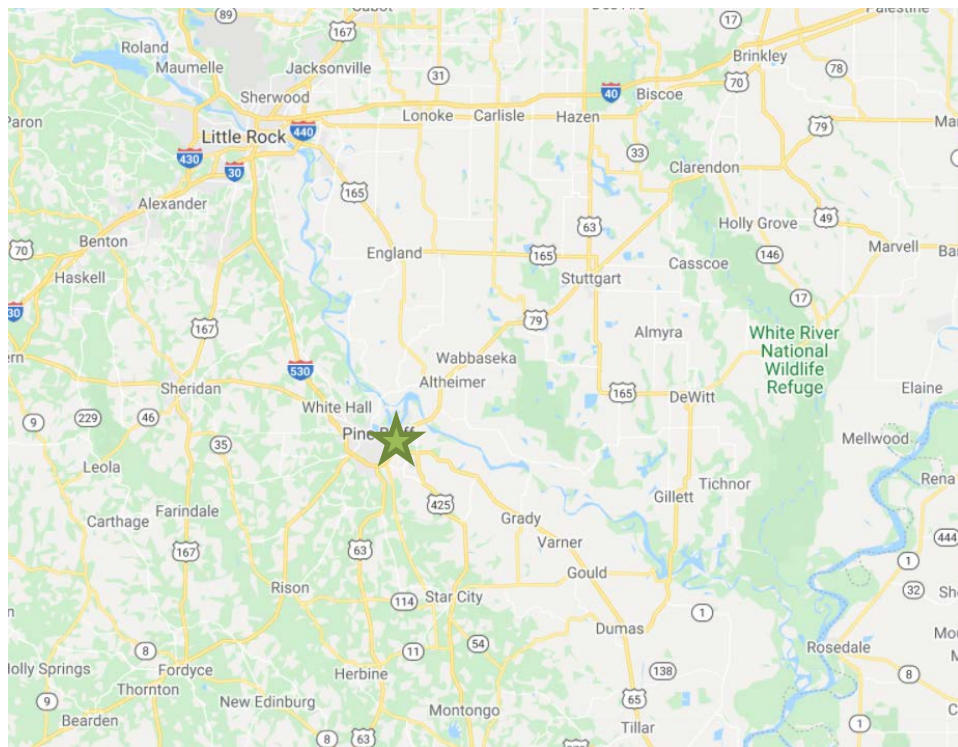
Map 1. Geographical location of test sections.

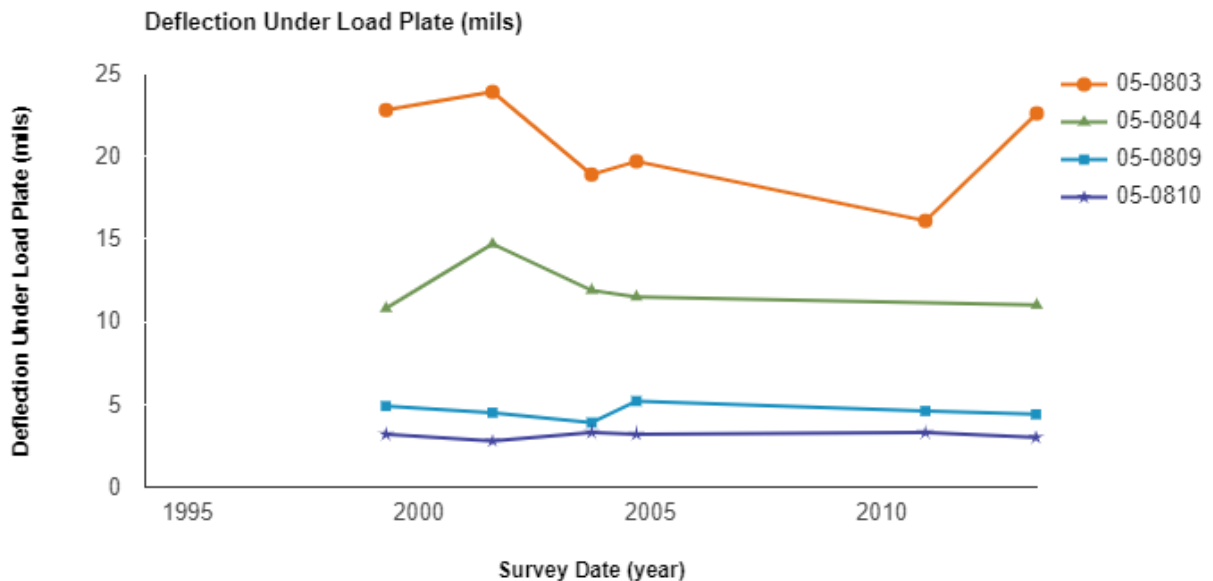
Figure 1. FWD deflections under the load plate over time.

Figure 1 shows the average FWD deflections under the nominal 9,000-pound load plate. The deflection of the sensor located in the center of the load plate is a general indication of the total “strength” or response of all layers in the pavement structure to a vertically applied load. As shown in Figure 1, the deflections reported for the JPCP test sections were lower than those reported for the AC test sections, as expected. Test section 05_0810, the thicker JPCP test section, reported the lowest deflection values, which ranged from 2.8 to 3.3 mils. The other JPCP test section, test section 05_0809, reported the second lowest deflection values, which ranged from 3.9 to 5.2 mils. Of the two AC test sections, the test section with the thicker pavement structure, 05_0804, reported the third lowest deflections over time, ranging from 10.8 to 14.7 mils, while test section 05_0803 reported the highest deflections, ranging from 16.1 to 23.9 mils. For all four test sections, the reported deflections were relatively constant over time, indicating structurally sound pavement structures.

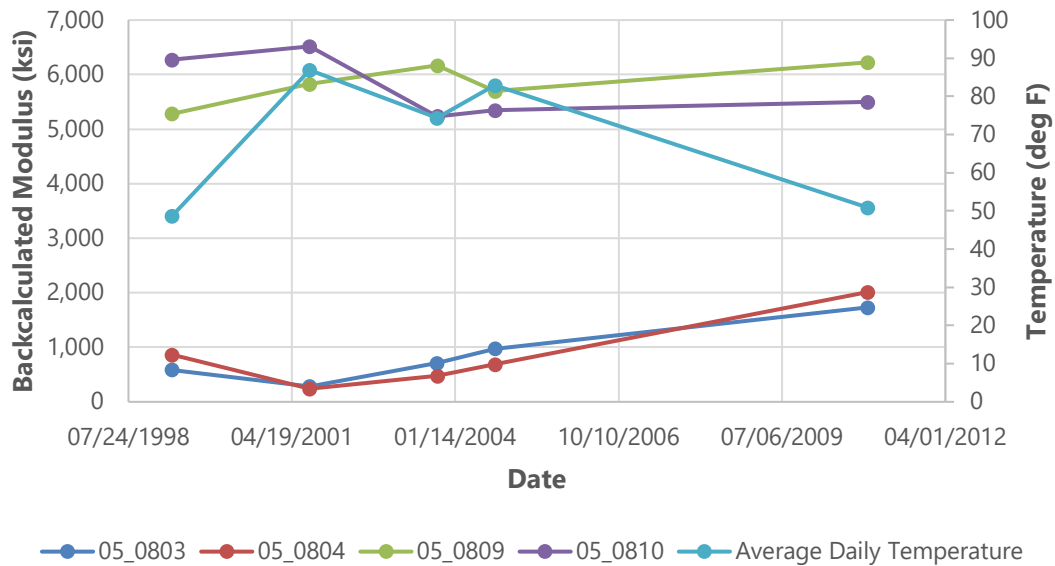
Figure 2. Average backcalculated modulus for surface layer (Layer 1).

The backcalculated moduli were fairly consistent for each test section over time. For Layer 1, the surface layer, the JPCP test sections reported higher backcalculated moduli, ranging from 5,232 to 6,518 ksi, and the AC test sections reported lower moduli, ranging from 240 to 2,012 ksi. While the moduli reported on the AC test sections appear to be reasonable between 1999 and 2004, the values reported in 2010 are notably higher than previous years. This is likely a result of the temperature reported at the time the FWD data was collected. As shown in Figure 2, the highest AC moduli values occur on the days with the coldest average daily temperature (from MERRA), as expected. Layers 2 and 3 (base and fine-grained subgrade) reported similar moduli values for the four test sections. Exceptions include the modulus value reported

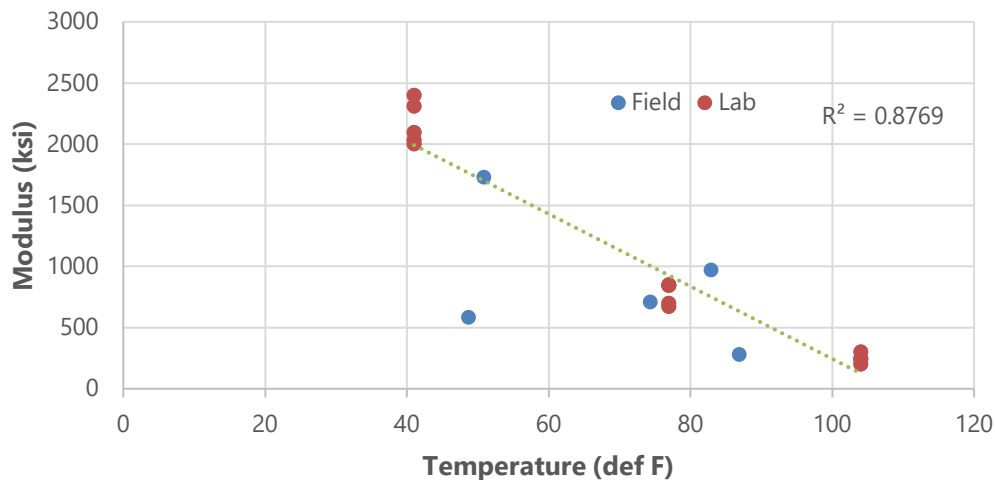
Figure 6. Field- and lab-derived AC resilient modulus values.

The reasonableness of the backcalculated layer moduli was compared to moduli derived from laboratory resilient modulus testing. Table 3 summarizes the laboratory test results for the AC layers, PCC layers, base layers, and subgrade layers. For the AC layers, moduli values are shown for three test temperatures – 41, 77, and 104°F, respectively. As depicted in Figure 6, the AC modulus versus temperature relationship for the field- (FWD-derived backcalculated moduli) and lab-measured resilient moduli appears to be reasonable; there is a clear trend between temperature and the pavement modulus. For the PCC layers, the values reported from the lab testing were notably lower than the field reported values. These differences may be related to the age of the material at the time of lab testing versus the age of the pavement at the time FWD testing was conducted. For the base and subgrade layers, various statistical analyses were conducted for the range of stress states (confining and deviatoric stresses) to which the laboratory samples were subjected. The values of the subgrade and base layers from laboratory testing were similar to the field-reported values.

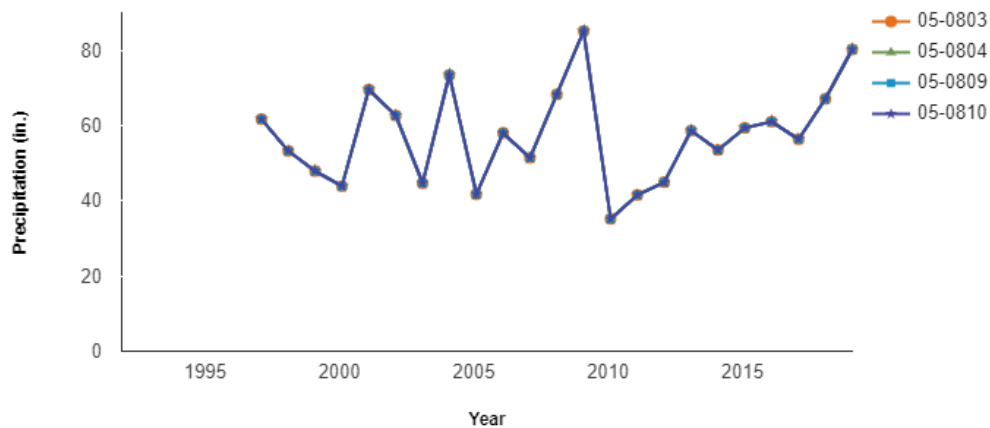
Figure 7. Average yearly precipitation over time.

The time history for average annual precipitation (from MERRA) since 1997 is shown in Figure 7. The average annual precipitation observed over the analysis period fluctuated on a year-to-year basis. However, between 1997 and 2009 and again between 2010 and 2019, the precipitation on the test sections appeared to increase over time. Between 1997 and 2009, the average yearly precipitation observed increased from 62 in in 1997 to 85 in in 2009. From 2010 to 2019, the average yearly precipitation steadily increased from 35 in in 2010 to 80 in in 2019. While some of the spikes in average annual precipitation reported on or near the test section locations were related to unusually high amounts of precipitation reported throughout the year, such as the spike in precipitation recorded in 2009, the high level of average annual precipitation reported in 2019 is in part due to the flooding reported in June 2019. The event, which was the result of severe weather and heavy rainfall, led to the flooding of the Arkansas River basin and the surrounding areas. This likely had an impact on the pavement distresses reported in 2019 as will be discussed later in the memorandum.

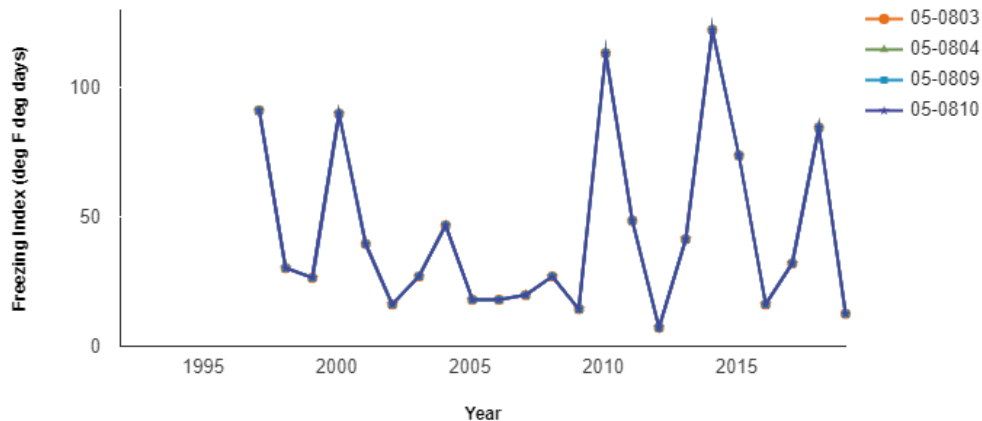
Figure 8. Average annual freezing index over time.

Figure 8 shows the time history of the average annual freezing index (from MERRA) for the test sites. The freezing index is the summation of the difference between freezing temperature and the average air temperature when it is less than freezing over a year's time. This index is an indicator of the harshness of the winter season relative to issues such as ground frost and low temperature cracking in pavements. As the test sections were in a No-Freeze climate, the freezing index of the test sections was relatively low throughout time. Values ranged from 7.2 deg F deg days in 2012 to 122.4 deg F deg days in 2014.

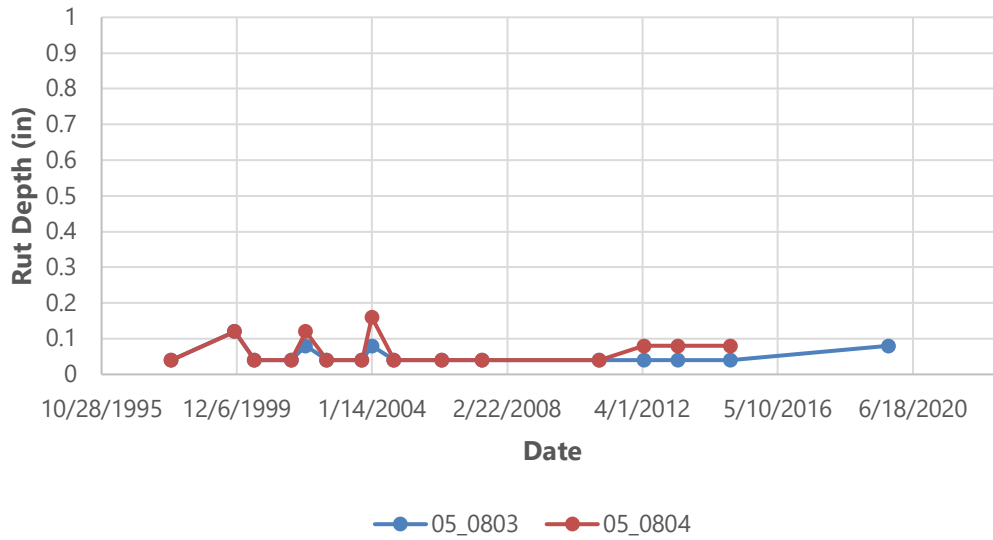
Figure 15. Time history plot of average rut depth.

The average rut depths observed for the AC test sections between 1997 and 2019 are shown in Figure 15. Both test sections reported relatively low rut depths over time. Test section 05_0803 reported rut depths between 0.04 in and 0.12 in (1999) while test section 05_0804 reported rut depths between 0.04 in and 0.16 in (2004). Both test sections showed variability in rut depths reported over time, but this variability was mostly within error.³

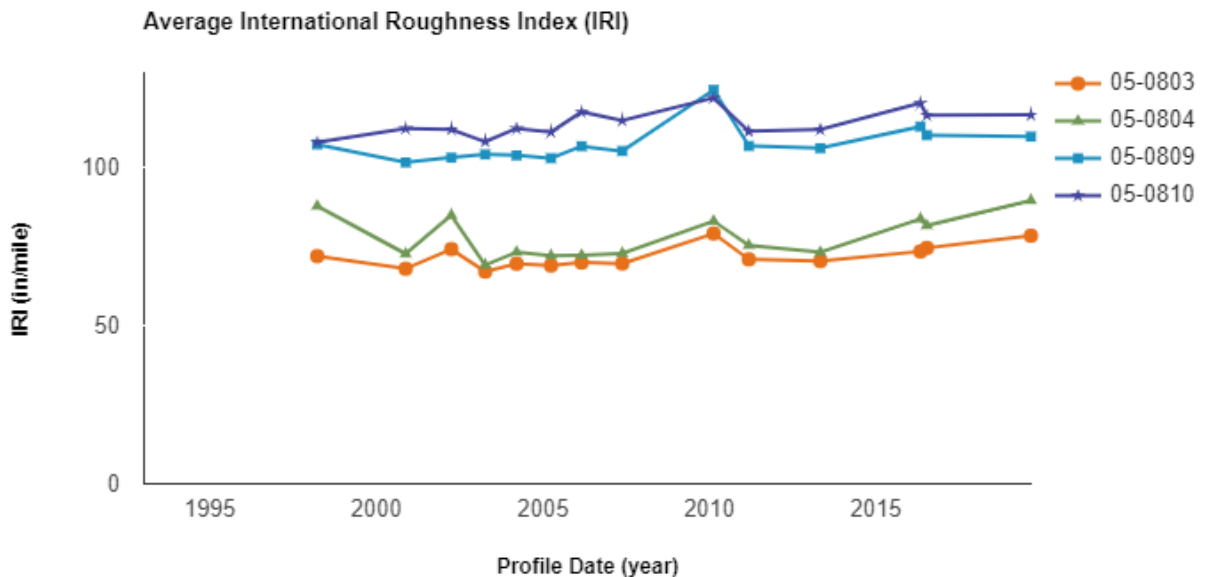
Figure 17. Time history plot of pavement roughness.

JPCP test sections is affected by the faulting and joints along the sites. Test section 05_0803 reported the lowest average IRI measurements, which increased from 72 in/mi in 1998 to 79 in/mi in 2019, while test section 05_0804 reported the second lowest IRI measurements, which increased from 88 in/mi in 1998 to 90 in/mi in 2019. The average IRI for both the AC test sections is classified as “Good” based on FHWA performance definitions. For the JPCP sites, test section 05_0809 reported the lower average IRI measurements, increasing from 107 in/mi in 1998 to 110 in/mi in 2019, while test section 05_0810 reported the highest average IRI measurements, which increased from 108 in/mi in 1998 to 117 in/mi in 2019. The average IRI for the JPCP test sections is classified as “Fair” based on FHWA performance definitions. It is important to note that the smoother a pavement is during the construction of the pavement, the slower the expected deterioration rate over time.⁴ Therefore, the initial smoothness of each test section, likely played a role in how each test section performed over the analysis period.
