Technical Memorandum

Re: Forensic Desktop Study Report: Arizona SPS-2 Test Sections 0214, 0215, 0217 and 0262

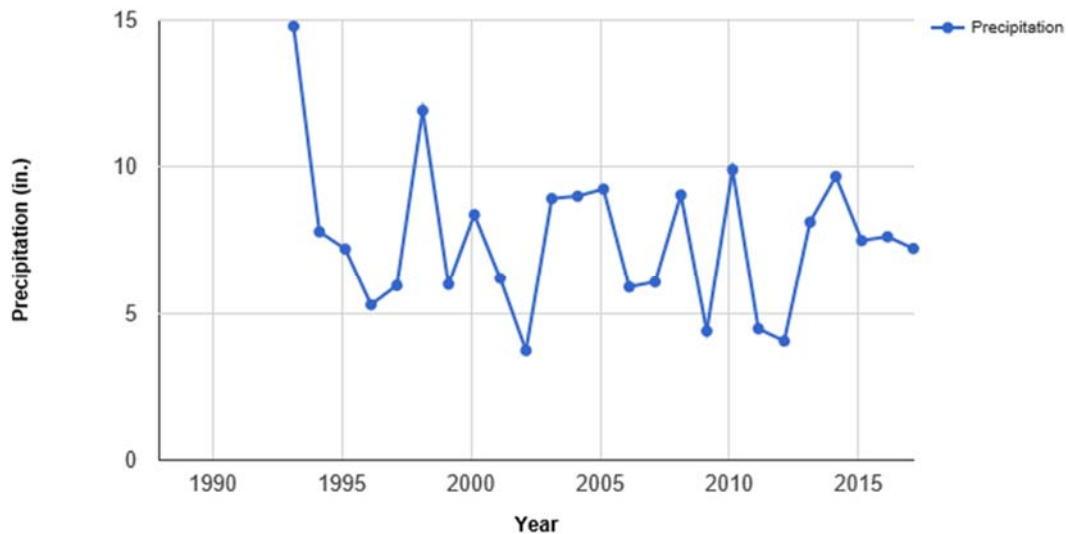
Figure 8. History of annual precipitation starting in 1993.

The time history for annual average precipitation since 1993 is shown in Figure 8. Except for 1993 and 1998, average precipitation was between 4 and 10 inches. Annual precipitation was nearly 15 inches in 1993 and 12 inches in 1998. These data indicate that the construction year experienced a higher than usual precipitation. All other years have annual precipitation values that are

expected for an arid, desert climate (dry, no-freeze). This location does not experience freeze-thaw cycles.

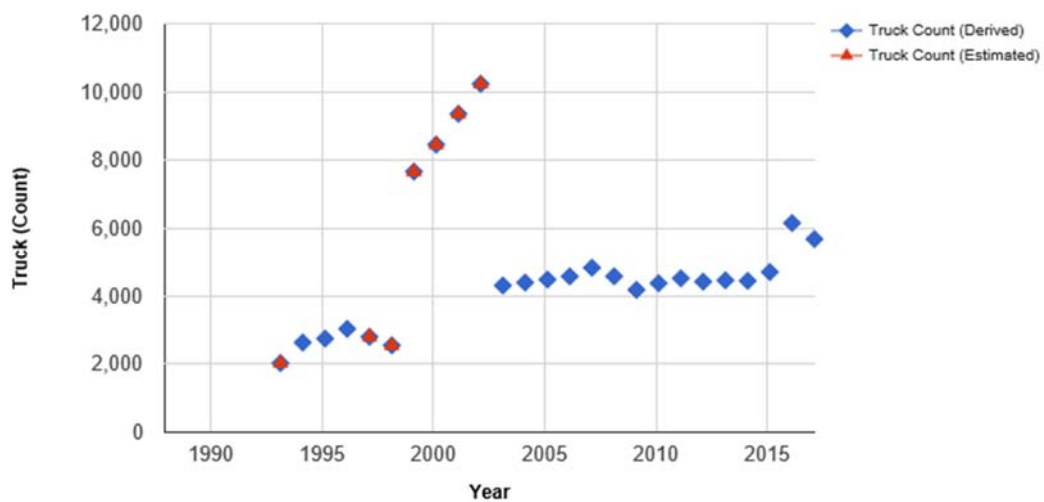
Figure 9. Average annual daily truck traffic on project 040200 based on state supplied estimates and monitoring measurements.

Figure 9 shows annual truck volume data in the LTPP test lane by year. The triangles represent estimated data provided by Arizona State DOT. The blue diamonds are truck counts based on monitoring data, reported to or collected by LTPP. Estimated truck count data from 1999 to 2002 were provided by the agency; they were not collected directly from the Weigh-In-Motion (WIM) stations. For analysis purposes, it is recommended that the truck counts from 1999 to 2002 be ignored due to data not coming from the WIM, but from agency estimated information.
