Technical Memorandum

Re. Forensic Desktop Study Report: Florida SPS-5 Project

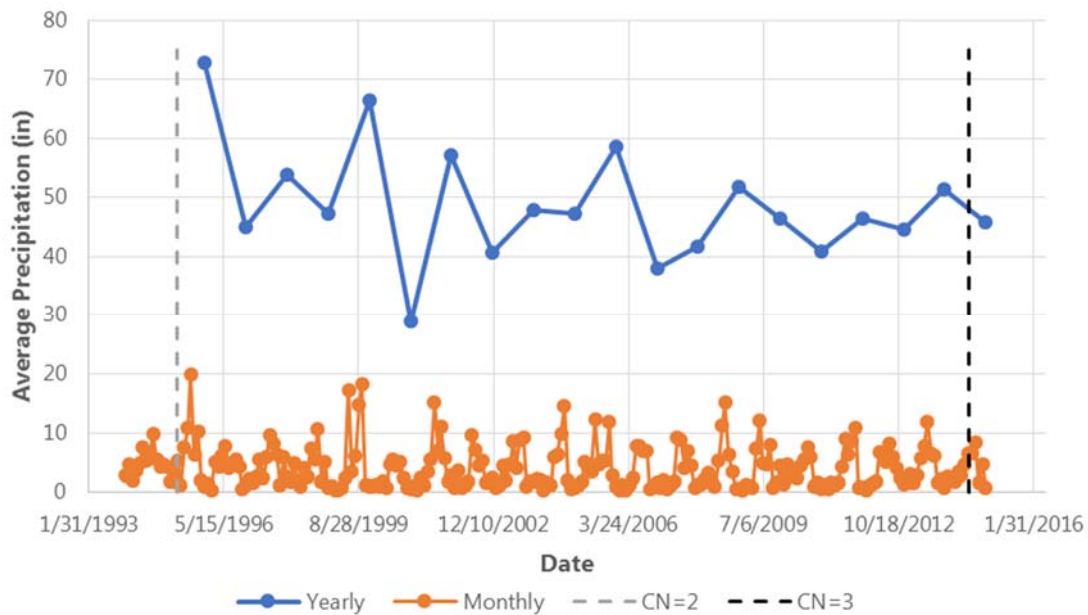
Figure 2. Average monthly and annual precipitation over time.

The monthly and annual average precipitation for the test sections between 1994 and 2014 are shown in Figure 2. The period of interest for this study is between 1995 and 2014. The average annual amount of precipitation reported at the sections had a large spread; the reported annual precipitation ranged from 28.9 in. in 2000 to 72.7 in. in 1995. The variability in annual average precipitation reported each year is largely related to the extreme weather events, such as hurricanes and tropical storms. Over the life of the Florida SPS-5, the test sections were subjected to the several of these major rain events including named hurricanes and tropical storms. For example, the hurricanes included Keith and Chris in 1988, Ana in 1991, Gordon in 1994, Jerry and Erin in 1995, Mitch in 1998, Harvey and Irene in 1999, Ivan, Frances and Jeanne in 2004, Ophelia, Wilma, Katrina and Tammy in 2005, Ernesto in 2006, Andrea in 2007, Fay in 2008, Nicole and Bonnie in 2010, Dorian in 2013 and Arthur in 2014.

In terms of precipitation observed following the application of the AC overlays in 1995, a spike in the average annual precipitation was observed in 1995 and 1999 where 72.7 in. and 66.4 in. of precipitation were reported, respectively. The spikes may be related to the weather events that occurred during these years: Hurricane Erin and Tropical Storm Jerry in 1995 and Hurricane Irene and Tropical Storm Harvey in 1999. For example, the average monthly precipitation in August 1995 was 19.9 inches and in October 1999 it was 18.2 inches. The increase in precipitation observed on these sites likely had an impact on the performance of the test sections and will be explored further in subsequent sections. It should be noted that the unbound pavement layers at this site are largely coarse grained which are typically associated good drainage

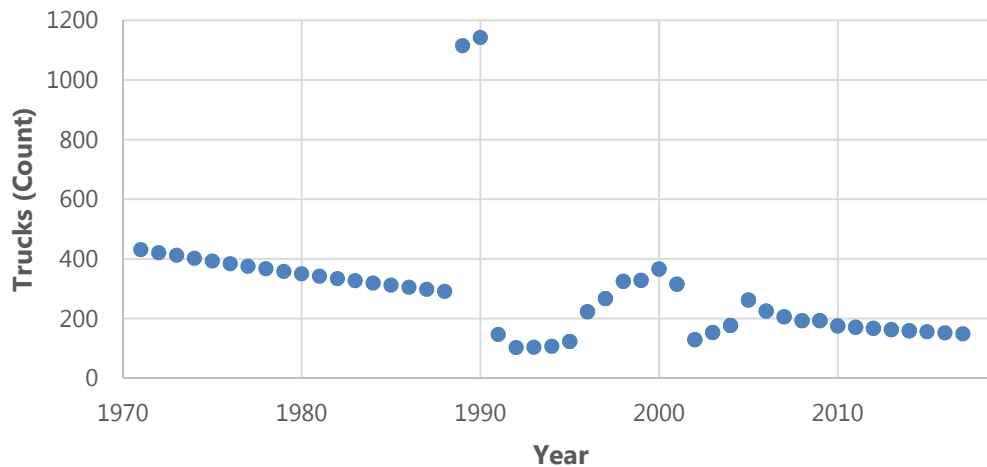
Figure 3. Average annual daily truck traffic (AADTT) history.

Figure 3 shows the computed or estimated annual average daily truck traffic (AADTT) in the LTPP test lane for all sections by year (derived from the TRF_TREND table). The counts reported were a combination of

counts calculated using a compound growth function (1971-1988 and 2009-2017), historical AADTT (1989), state provided AADTT (1990, 1996, and 2001), monitored AADTT (1991, 1992, and 1997), and calculated from monitored Class data (1993-1995, 1998-2000, and, 2002-2009). The AADTT was reported for the test sections between 1971 and 2017 and shows an overall decrease in truck traffic over time. Initially, 431 trucks/day were observed on the site locations in 1971. By 2017, the number of trucks observed had decreased to 149/day, nearly a 65% decrease in truck traffic since 1971. While there is an overall decrease in trucks, there is variability in the truck traffic reported, as can be observed by the 1989 and 1990 count spikes. These spikes may be attributed to the source of the estimated AADTT data as 1989 represents a historical AADTT value and 1990 was a state provided value.

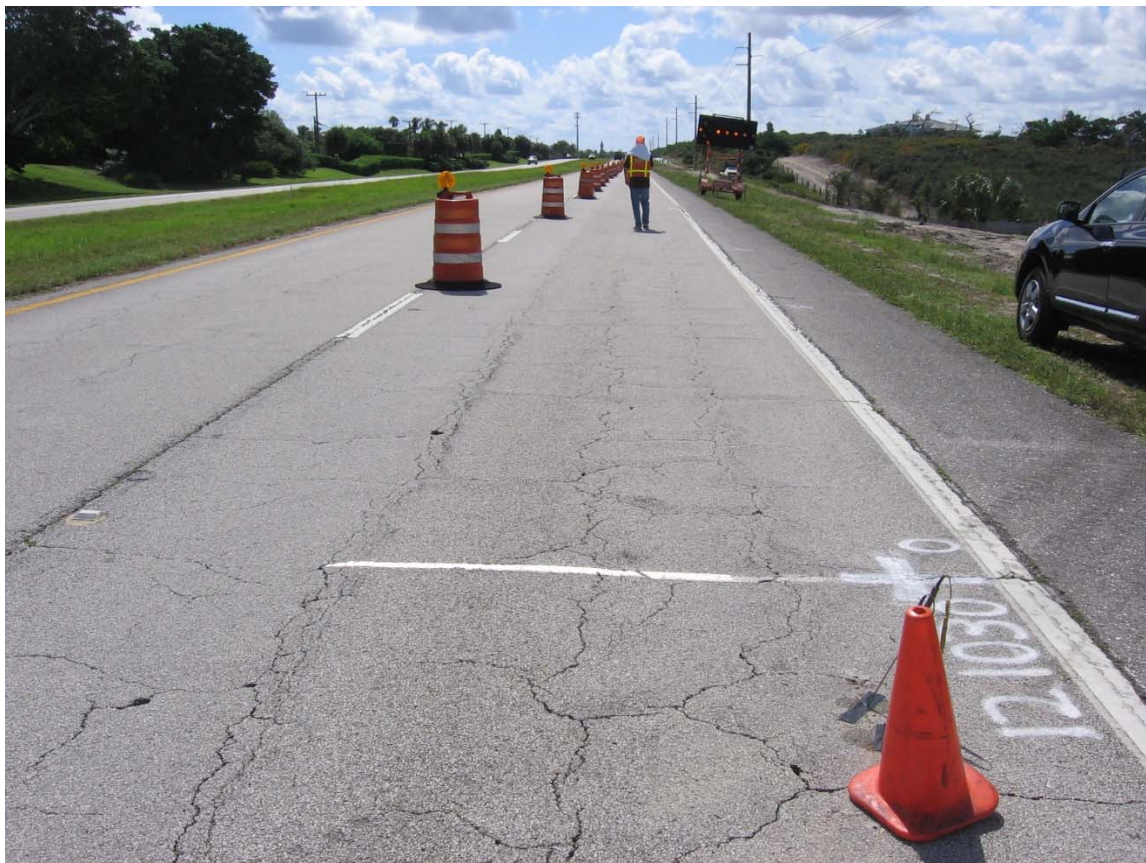
Photograph 15. Picture of test section 12_1030 in 2014 (Station 0+00 looking southbound).

Based on the information gathered and analysed in the above sections, further desktop evaluation of anomalies within section 12_1030 appears to be warranted. The study team will develop Data Analysis Operational Feed Back reports and submit them to LTPP staff to investigate correction of some of the issues discovered during this study. No follow-up field investigations are recommended at this time until resolution of what appears to be errors in the interpretation of LTPP measurements are corrected.
