## Technical Memorandum

**Re:** Forensic Desktop Study Report: Georgia LTPP Test Section 13\_7028

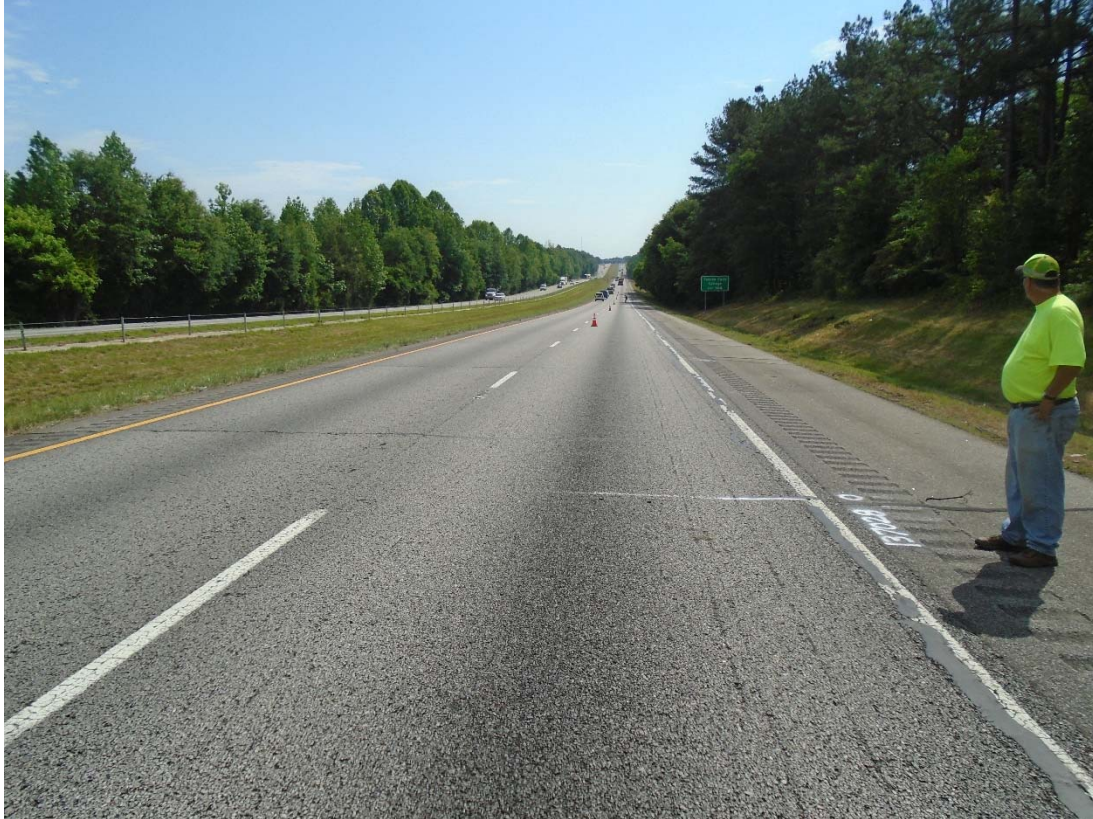
**Photograph 1. LTPP Section 13\_7028 at Station 0+00 looking northbound in 2016.**

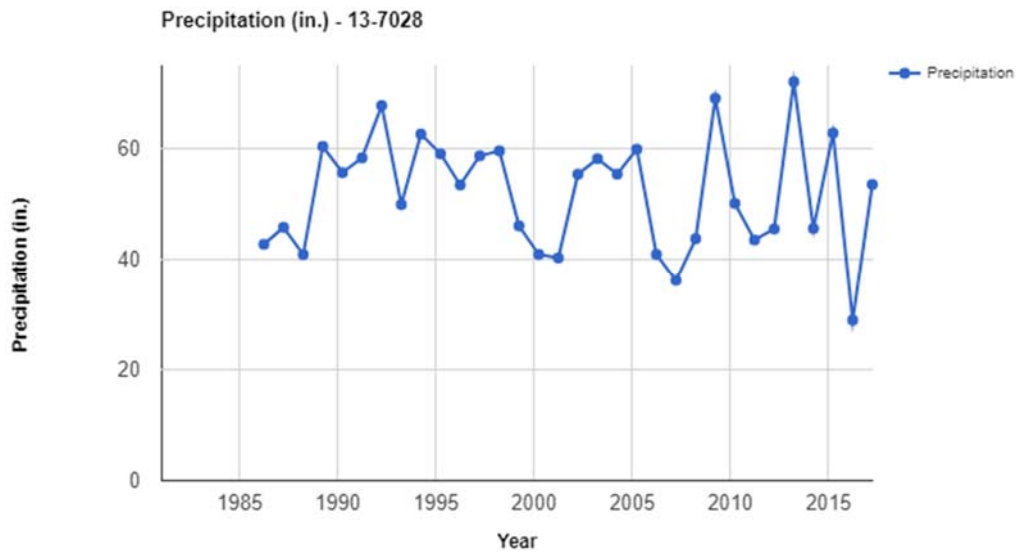
The time history for average annual precipitation (from MERRA) since 1986 is shown in Figure 3. In 2015, the amount of precipitation appears to be a local high (72 inches), while the low (29 inches) was recorded in 2016. The mean precipitation recorded at the site is 52 inches for the period shown in Figure 3. The high amounts of precipitation reported on this section may be attributed flooding events such as those that occurred in this region in February 2009 and December 2015, as well as hurricanes and tropical storms that occurred in October 1990 (Tropical Storm Marco), July 1994 (Tropical Storm Alberto), June 1995 (Hurricane Allison), August 1995 (Tropical Storm Jerry), October 1995 (Hurricane Opal), September 2004 (Hurricane Frances), July 2005 (Hurricane Dennis), October 2005 (Tropical Storm Tammy), and August 2008 (Tropical Storm Fay).

**Figure 3. Average yearly precipitation over time.**

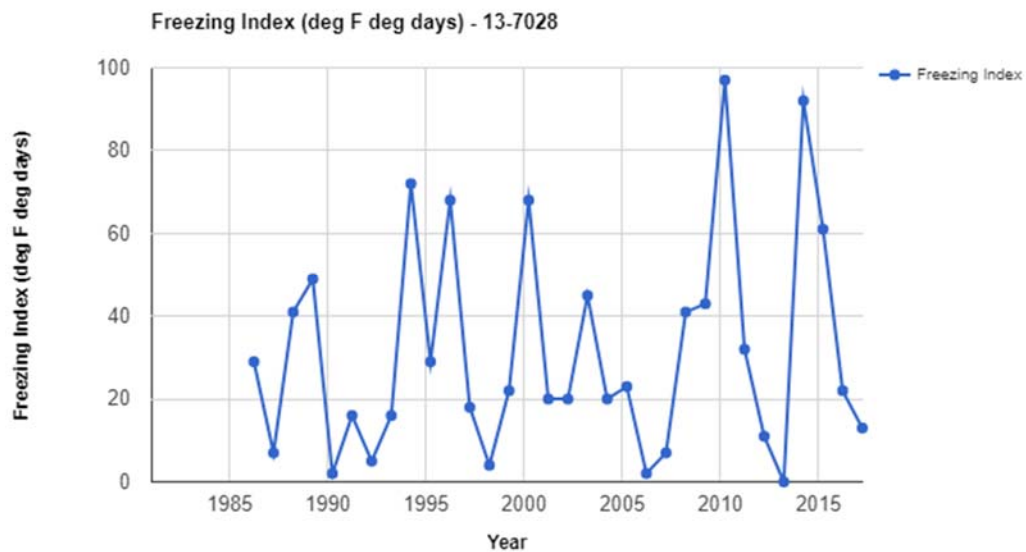
Figure 4 shows the time history of the average annual freezing index (from the MERRA) for the test site. The freezing index is the summation of the difference between freezing temperature and the average air temperature when it is less than freezing over a year's time. This index is an indicator of the harshness of the winter season relative to issues such as ground frost and low temperature cracking in pavements. As depicted in Figure 8, the freezing index values ranged from 0 (2013) to 97 (in 2010)—which is well below the 150 deg F deg days used to classify a freeze region—indicating it is not a likely factor affecting the performance of the test section.

**Figure 4. Average annual freezing index over time.**

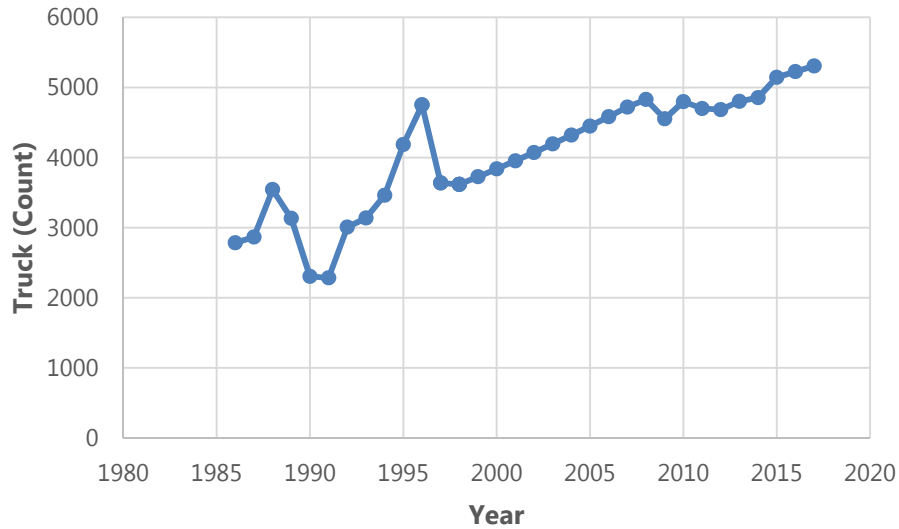
Figure 5 shows the annual average daily truck volume data in the LTPP test lane by year. The annual truck traffic counts increase from 2,785 in 1986 to 5,307 in 2017, or approximately 81 additional annual trucks per year. While there is a consistent increase in truck traffic along this section, a spike in truck traffic is observed in 1996. This spike may be related to the 1996 Summer Olympics which were held in Atlanta and surrounding areas (including Lake Lanier just southwest of the test section). The annual number of equivalent single axle loads (ESALS) reported on this section also increased over time. The number of ESALS increased from 1,570,934 in 1981 to 2,994,069 in 2017, or approximately 39,532 ESALS per year as depicted in Figure 6.

**Figure 5. Average annual daily truck traffic (AADTT) history.**

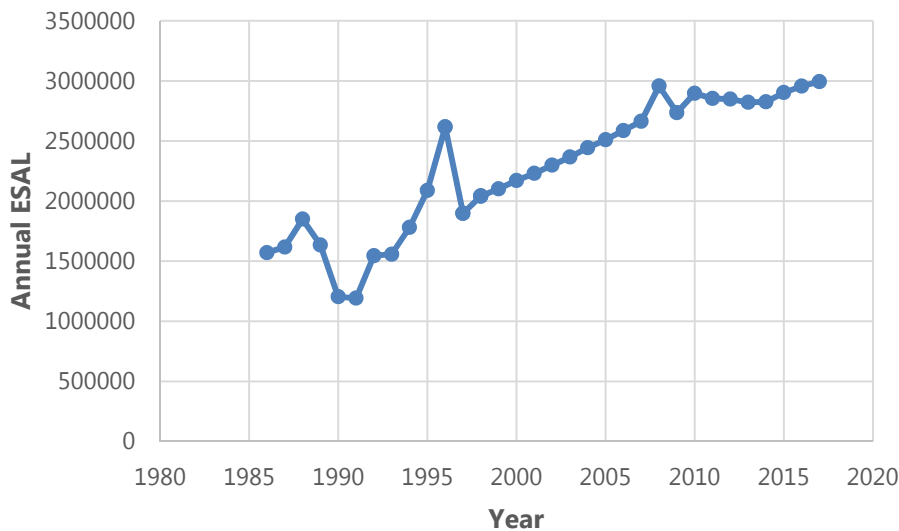
**Figure 6. Estimated annual ESAL for vehicle classes 4-13 over time.**
