Technical Memorandum

Re: Forensic Desktop Study Report: Maryland LTPP Test Section 24_1634

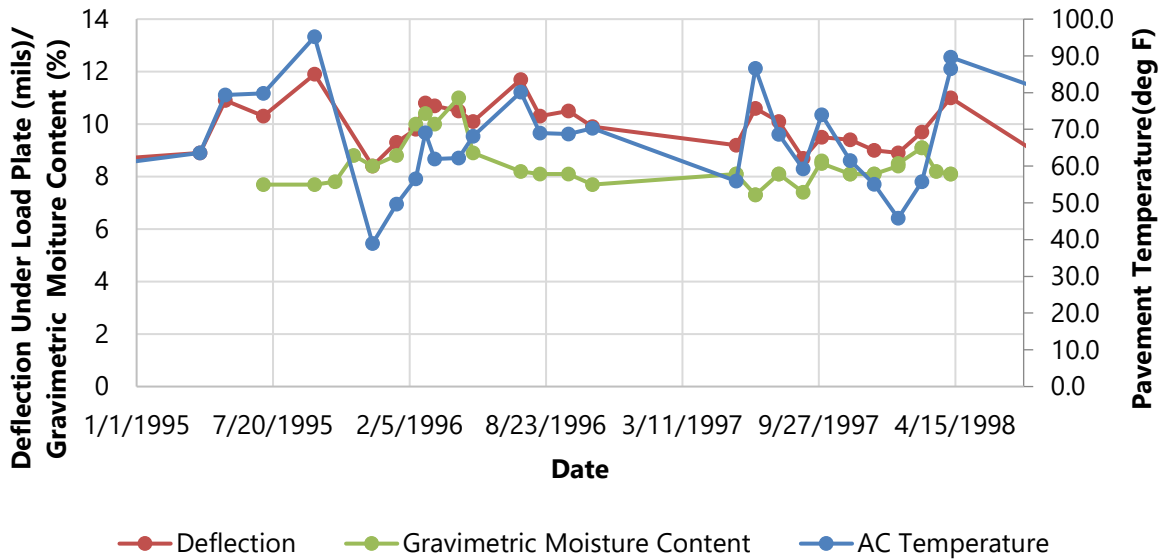
Figure 2. Comparison of a) FWD deflections under the load plate (Sensor 1), b) the average temperature of the pavement taken at a depth of 0.98 inches below the surface, and c) the gravimetric moisture content at a depth of 26 inches below the surface of the pavement (TDR 3).

As depicted in Figure 2, the change in deflection under the load plate over time appears to be directly related to the change in pavement temperature over time. For the most part, increases and decreases in deflections correspond to increases and decreases in the pavement temperature. Exceptions include the decrease in the average deflection observed in May 1996 and the decrease in average deflection in October 1996 despite an increase in pavement temperature for those two months. The relationship between the average deflection and moisture content of the test section is less clear under the center load plate. It is generally expected that as the moisture content and pavement temperature increase, deflections will also increase, but this does not appear to be the case for the gravimetric moisture content.

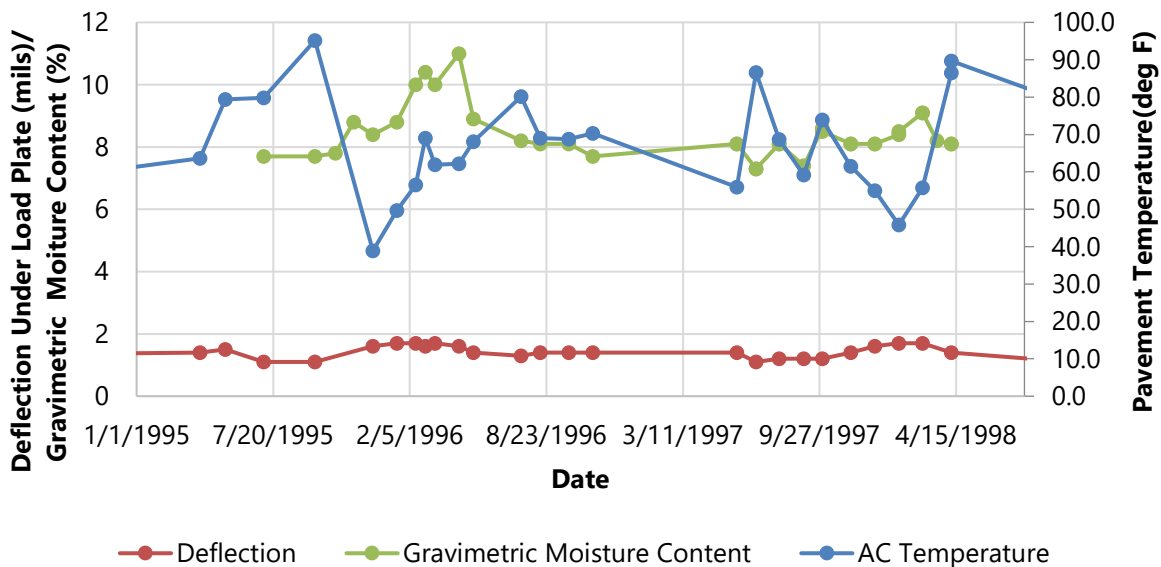
Figure 3. Comparison of a) FWD deflections 48" from the load plate (Sensor 7), b) the average temperature of the pavement taken at a depth of 0.98 inches below the surface, and c) the gravimetric moisture content at a depth of 26 inches below the surface of the pavement (TDR 3).

In Figure 3, the opposite seems to be the case—the change in deflection 48 inches from the load plate (Sensor 7) appears to be related to the change in moisture content over time, but not to the change in temperature over time. For the most part, as the moisture content increases, the average deflections increase, and as the moisture content decreases, the average deflections also decrease. The relationship between deflection and temperature is less clear; as shown in the figure, it appears that the pavement deflection increases as the temperature decreases and vice versa.

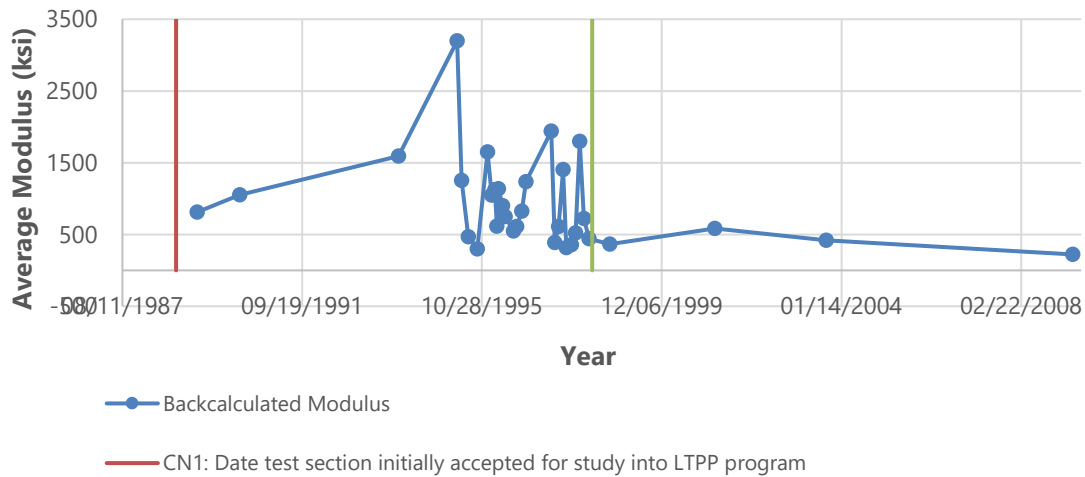
Figure 4. Average backcalculated modulus for AC (Layer 1).

For the most part, the moduli values calculated for each layer appear to be reasonable. Some exceptions include the moduli values reported for the AC layer and AC treated base in April of 1995. These moduli values, which reach over 3,000 ksi, appear to be outliers and not representative of the actual moduli values of these two layers. In addition to the outlier values, following the overlay in 1998, there seems to be compensating layer effects occurring between the subgrade layers and base and AC layers. The compensating layer effect is the result of the way the modulus of each layer is calculated, from the subgrade upward. While the values of the subgrade moduli appear to be reasonable, the values collected

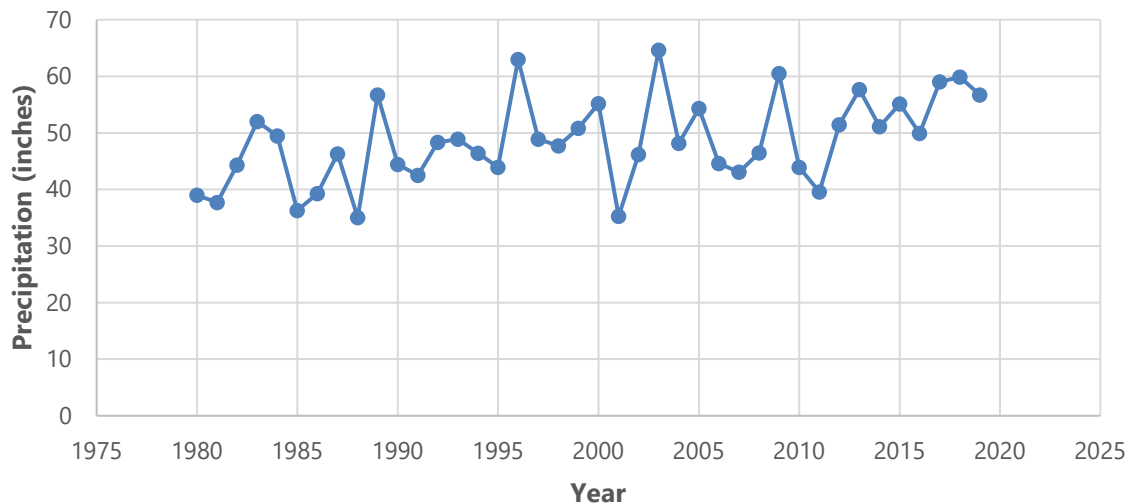
Figure 10. Average yearly precipitation over time.

The time history for average annual precipitation (from Modern-Era Retrospective analysis for Research and Applications or MERRA) since 1980 is shown in Figure 12. The mean precipitation recorded at the section was 49 inches for the period of analysis. Spikes in precipitation are observed in 1996, 2003, and 2009 when 63, 65, and 61 inches of precipitation were reported, respectively. The section is located near the Atlantic Ocean (approximately 10 miles away) and has been in the path of several hurricanes and tropical storms. Accordingly, the measured precipitation has likely played an important role in the overall performance of the test section.

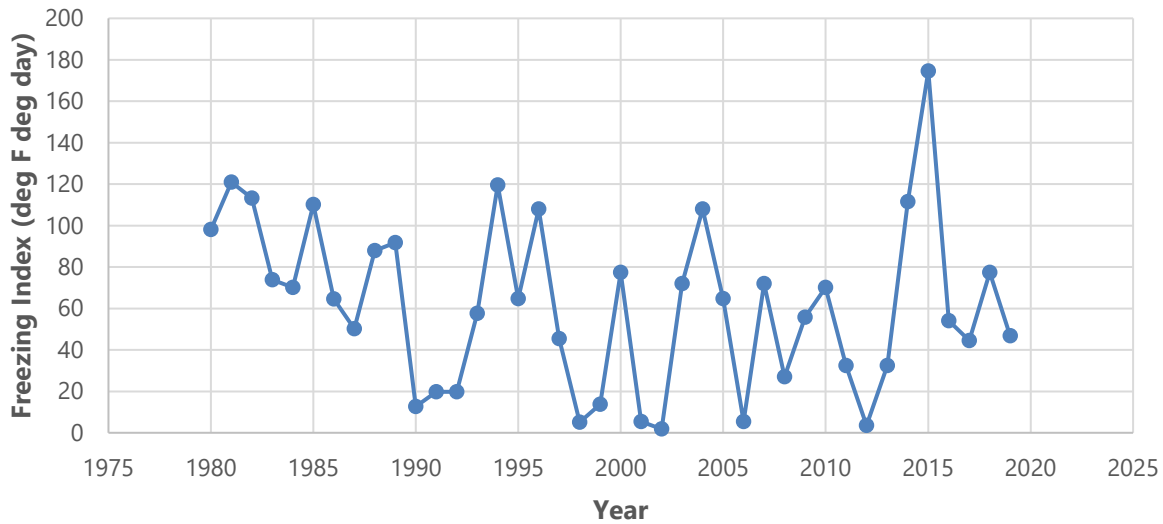
Figure 11. Average annual freezing index over time.

Figure 13 shows the time history of the average annual freezing index (from MERRA) for the test site. The freezing index is the summation of the difference between freezing temperature and the average air temperature when it is less than freezing over a year's time. This index is an indicator of the harshness of the winter season relative to issues such as ground frost and low temperature cracking in pavements. As depicted in Figure 13, the freezing index values ranged from 1.8 deg F deg days (2002) to 174.6 deg F deg days (2015). Besides the spike in 2015, all freezing indices reported during the analysis period are well

below the 150 deg F deg days used to classify a freeze region. In turn, this indicates the freezing index is not likely a factor affecting the performance of the test section.

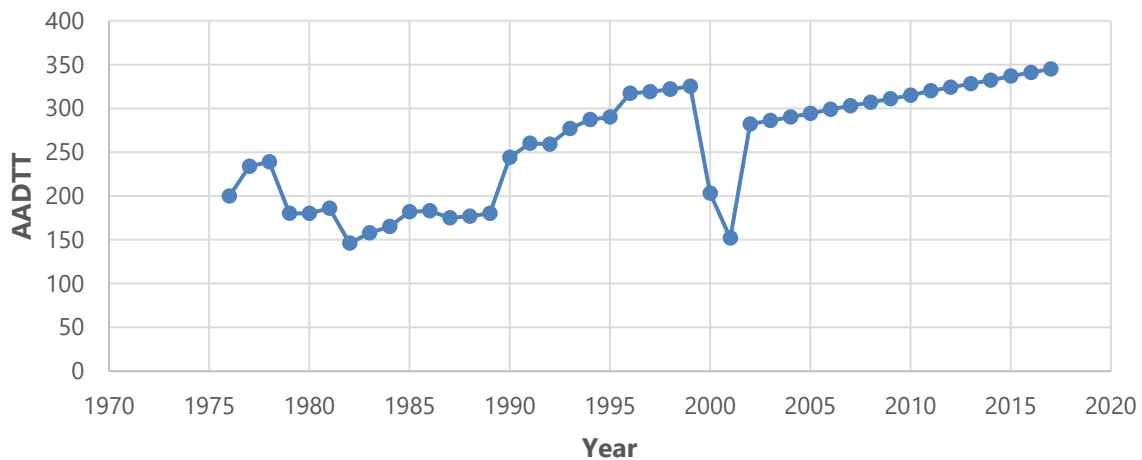
Figure 12. Average annual daily truck traffic (AADTT) history.

Figure 14 shows the annual average daily truck traffic (AADTT) data in the LTPP test lane by year. The annual truck traffic counts increase from 200 in 1976 to 345 in 2017, or approximately 4 additional trucks per day per year. The average number of ESALS reported on the section also increased over time as depicted in Figure 15. The number of ESALS increased from 31,827 in 1976 to 52,757 in 2017. The fluctuations in both the AADTT and ESALS reported for the test section are likely a result of the source of the data used over time. A combination of historical AADTT values, state provided AADTT values, monitored values (2000 and 2001), and values calculated using a linear growth function were used to report traffic along these test sections. The monitored data is based on counts collected over 20 days in 2000 and 146 days in 2001, indicating that the AADTT and ESALS calculated following 2001 are overreported.

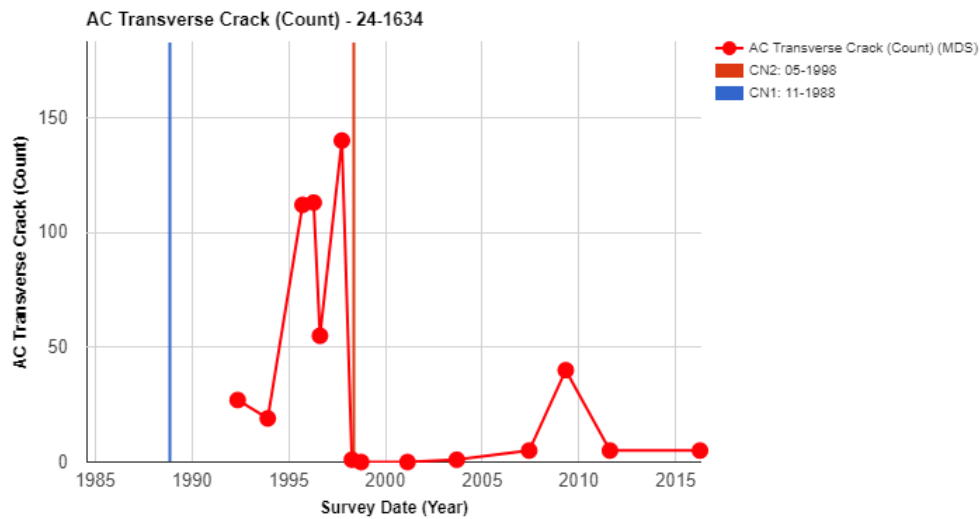
Figure 18. Time history of the number of transverse cracks.

Data on transverse cracking was collected between 1992 and 2016 as shown in Figure 20 and Figure 21. Unlike the fatigue/alligator cracking and NWP longitudinal cracking observed on the section, most of the transverse cracking observed occurred prior to the overlay in 1998. Transverse cracking was first reported during the manual distress survey in 1992, when 54 ft of cracking (27 cracks) was observed. The transverse cracking fluctuated between 1992 and 1997, reaching 225 ft (140 cracks) in 1997. However, the length of transverse cracks observed abruptly fell to 5 ft (1 crack) in April 1998, just prior to the AC overlay. The transverse cracking observed prior to this event consisted of short (1.5 ft), low severity cracks every 2 to 5 feet as shown in Figure 22. Given the typical length and severity, these cracks may have been difficult for raters to see and therefore, accurately report. After the overlay in May 1998, no transverse cracking was observed again until 2003 when 2 ft of transverse cracking (1 crack) was reported. Once observed, transverse cracking spiked in 2009 when 60 ft of cracking (40 cracks) was reported, and subsequently decreased reaching 10 ft (5 cracks) in 2016. This spike appeared to be the result of fatigue/alligator cracking being misidentified or reported as transverse cracking in 2009.
