Technical Memorandum

Re. Forensic Desktop Study Report: Montana LTPP Test Sections 30_8129

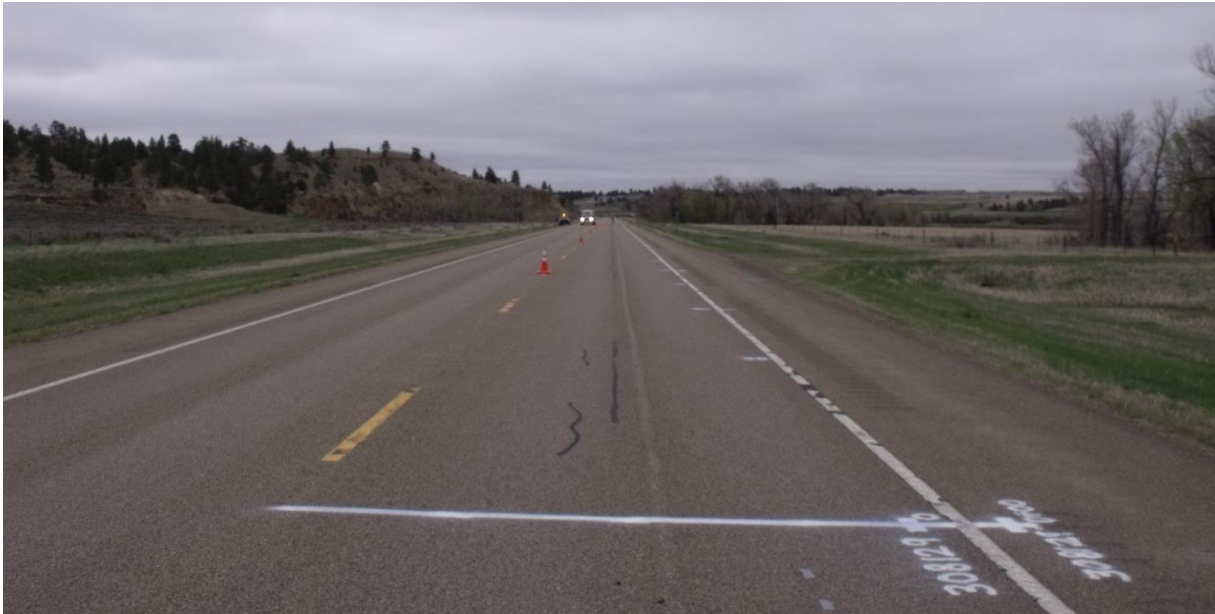
Photograph 1. LTPP Section 30_8129 at Station 0+00 looking eastbound in 2016.

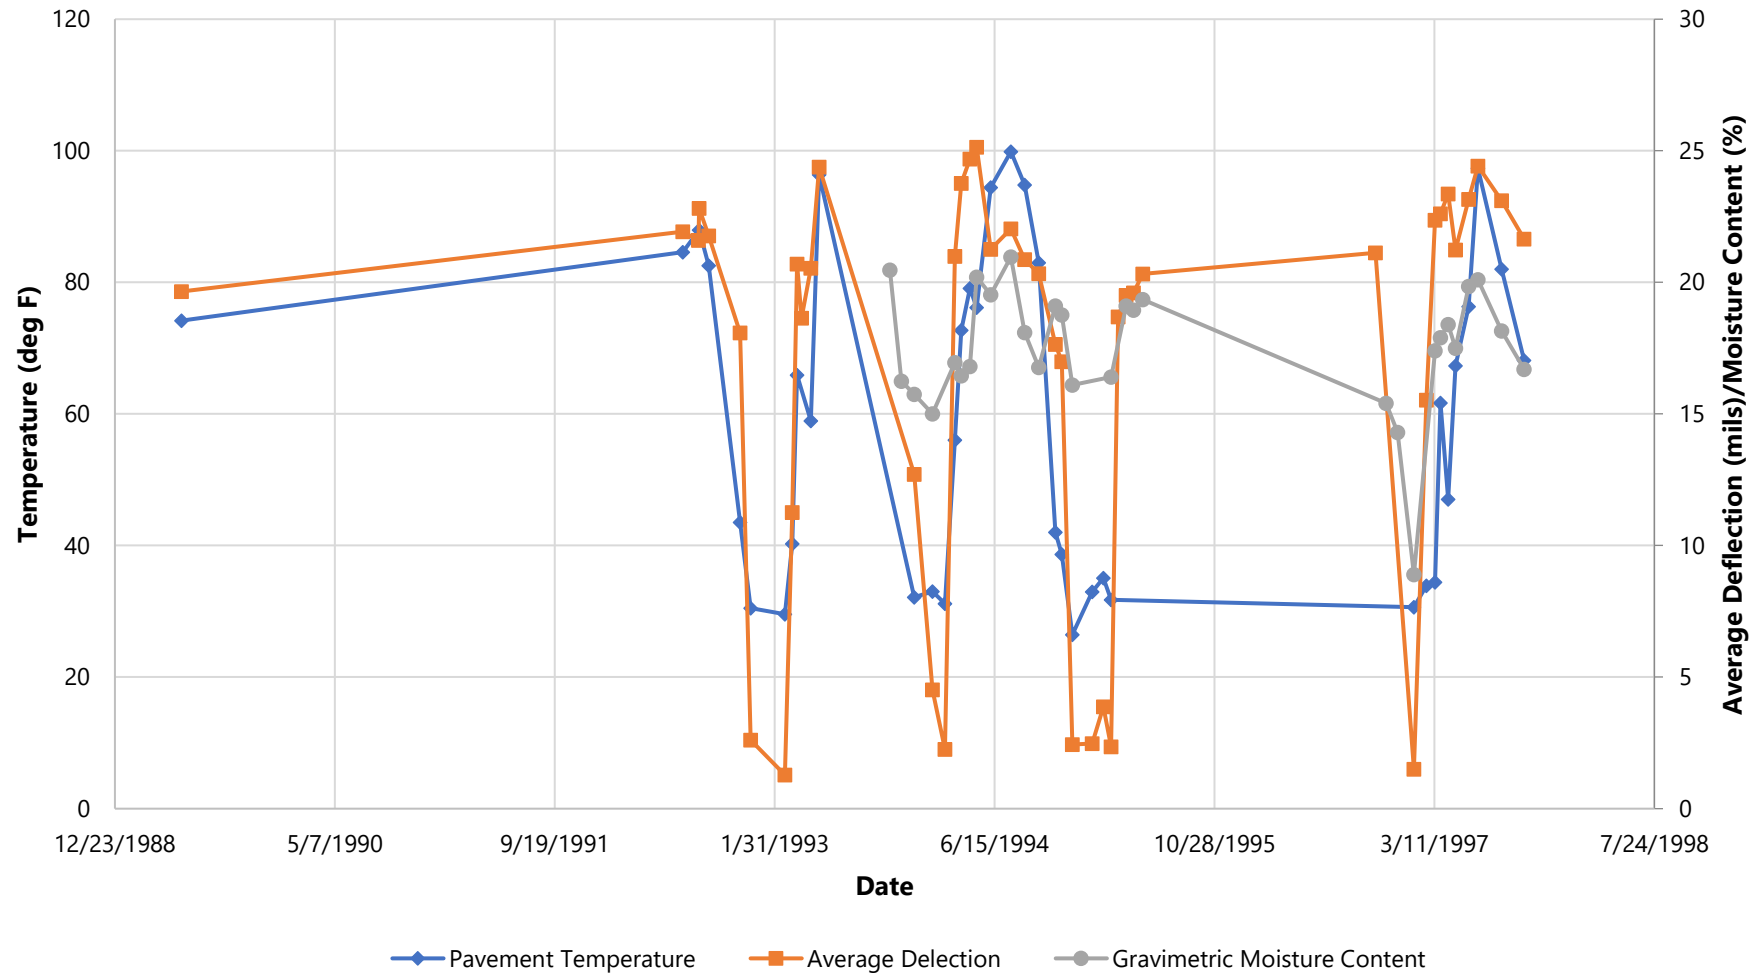
Figure 1. Comparison of a) FWD deflections under the load plate (Sensor 1), b) the average daily temperature of the pavement taken at an average depth of 1.85 inches below the surface, and c) the gravimetric moisture content at a depth of 33 inches below the surface of the pavement (TDR 5).

As depicted in Figures 1 and 2, the change in deflection over time appears to be directly related to the change in pavement temperature and subgrade moisture content over time. For the most part, increases and decreases in deflections correspond to increases and decreases in the pavement temperature and subgrade moisture content. Exceptions include the decrease in average deflection observed in June 1994 despite an increase in pavement temperature and the sharp increase in average deflection observed in March 1995 despite a decrease in pavement temperature; however, in both cases the average deflections increase and decrease as the subgrade moisture content increase or decrease. Another observation that can be made is that, with temperature taken into consideration, the largest increases in deflections observed in Figures 1 and 2 correspond to spring months when it is postulated the subgrade is weakest due to thawing of frost zones. Similarly, the largest decreases in deflections observed correspond to winter months.

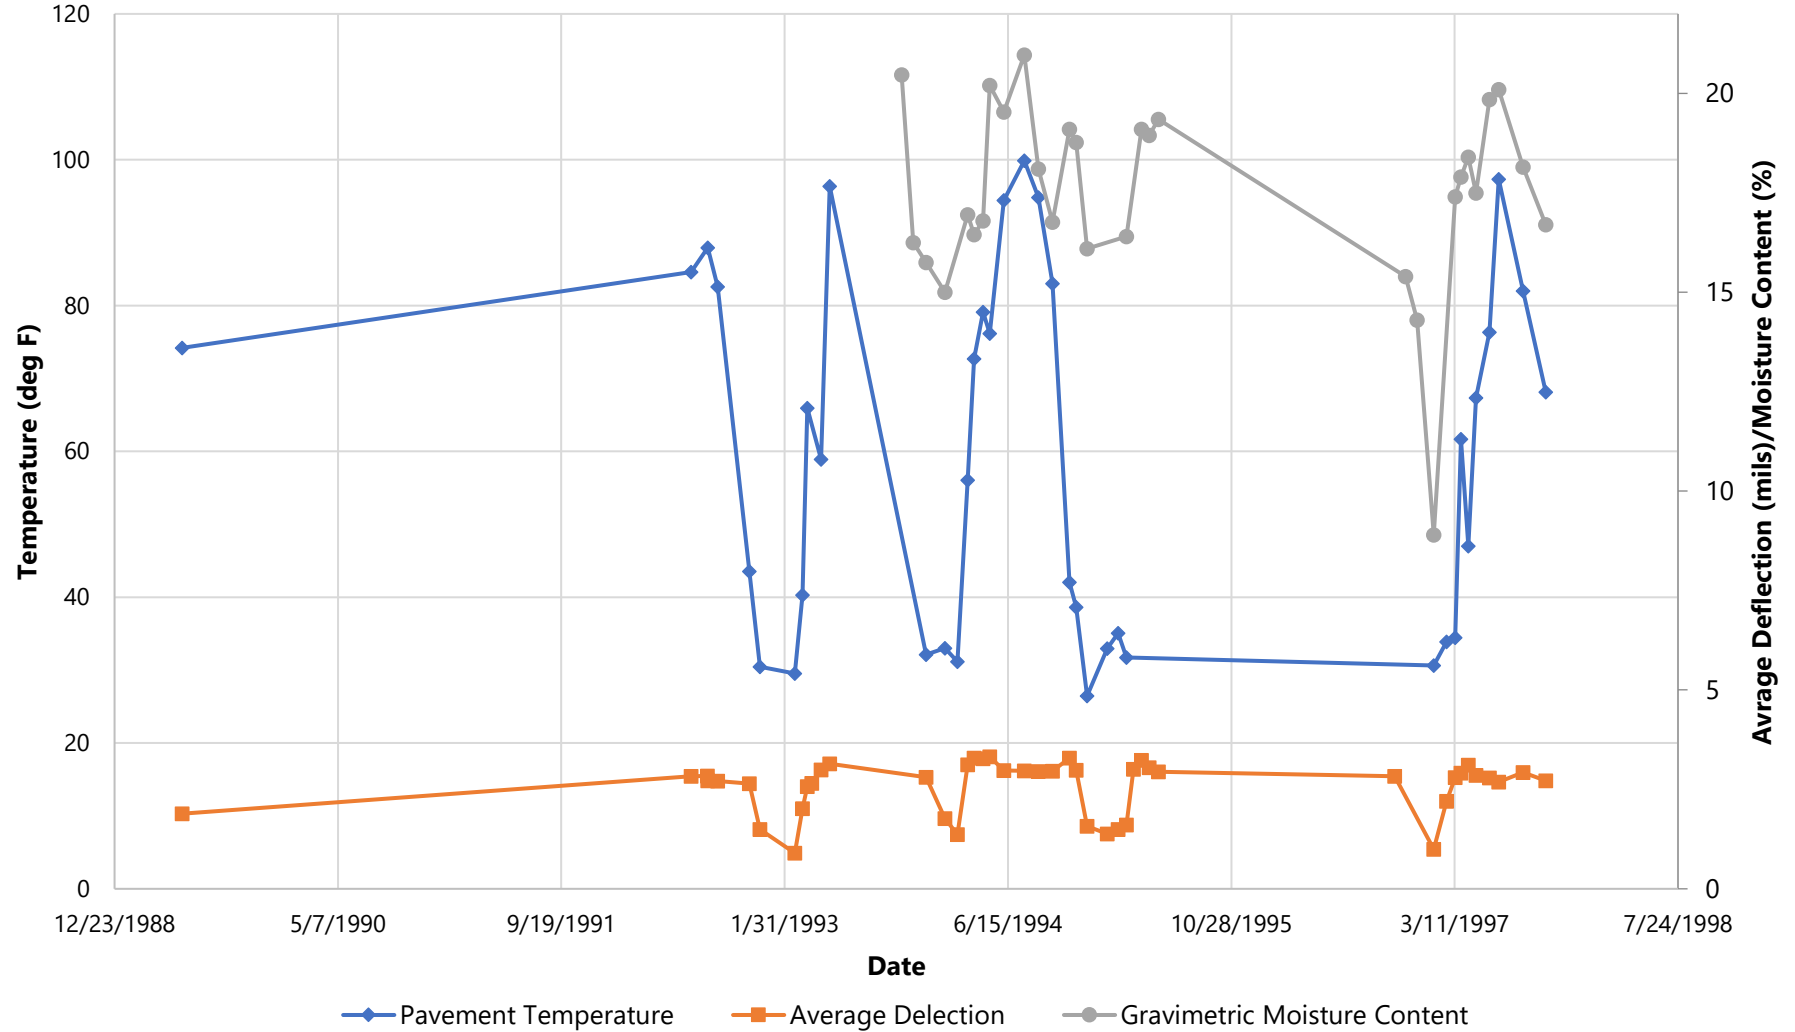
Figure 2. Comparison of a) FWD deflections 48" from the load plate (Sensor 7), b) the average daily temperature of the pavement taken at an average depth of 1.85 inches below the surface, and c) the gravimetric moisture content at a depth of 33 inches below the surface of the pavement (TDR 5).

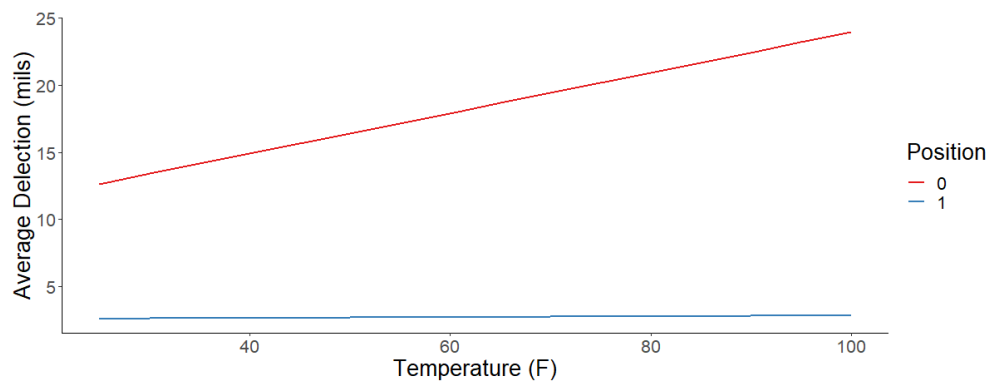
The effect of temperature–position and moisture–position interactions on the deflections were also considered. The interaction between two factors is said to occur when the magnitude of the effect of one factor on the dependent variable changes as the level of the other variable changes. Table 3 shows that these interaction effects are statistically significant and that they have a negative effect on the pavement deflection. The impacts of these interactions are shown graphically in Figures 7 and 8. Figure 7 shows that the effect of pavement temperature on deflection is significant for position 0, while it is less significant in

Figure 7. Interaction plot of temperature and position.

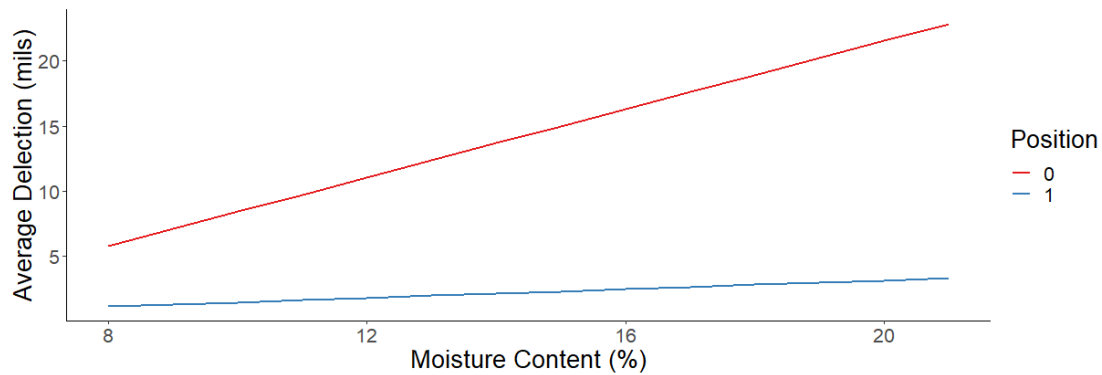
position 1. Similarly, Figure 8 shows that the deflection measurements captured in position 0 are more sensitive to change in moisture content as compared to position 1.

Figure 8. Interaction plot of temperature and position.

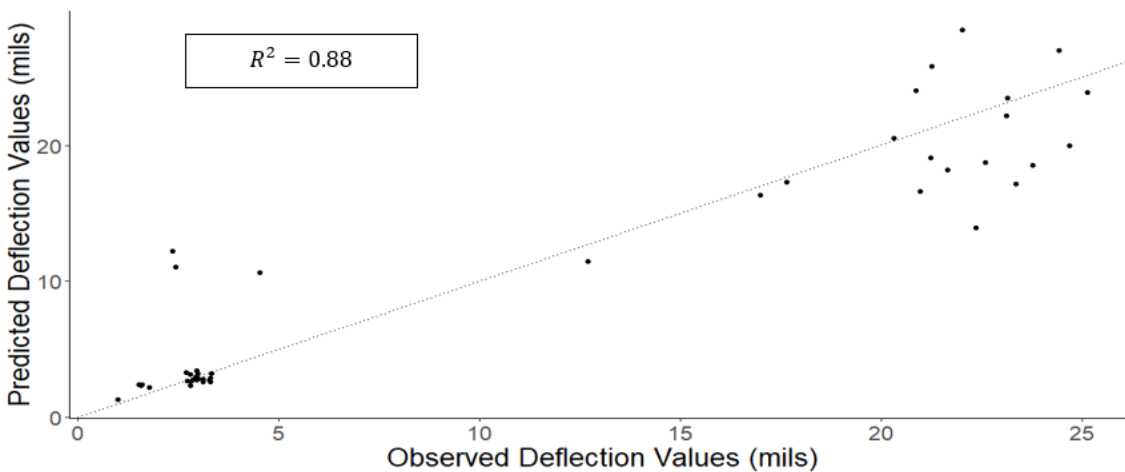
The scatter plot of the predicted deflection values from the model versus the actual measured deflection values is shown in Figure 9. This plot shows a good correlation between measured and predicted deflection values with a coefficient of determination (R^2) of 0.88. The R^2 shows that 88% variability of deflection data can be explained by the variables in the model.

Figure 9. Predicted versus observed values of pavement deflection.

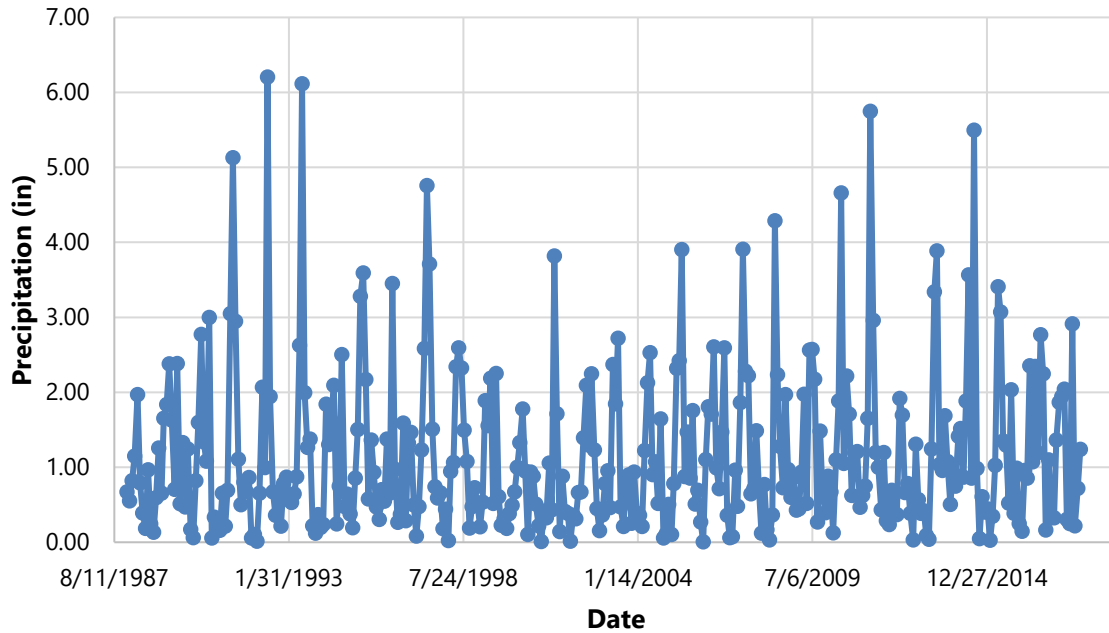
The time history for the monthly average precipitation (from the VWS) between 1988 and 2017 is shown in Figure 10. This time history covers more than just CN=1 which was used for the previous part of this investigation. In June 1992, the amount of precipitation is the local high (6.2 inches), while the low (0 inches) was recorded in February 2006. These measurements seem to spike in the spring and summer months (May, June, July, and August) indicating more precipitation occurs during these seasons.

The high levels of precipitation in June 1992, July 1993, and May 2011 may correspond to flooding events at the Musselshell River, just south of the project site. Specifically, the high levels of precipitation observed in May 2011 is likely related to the 150-year flood event. The flood event, which began May 21st, was the result of 8 inches of rain on top of existing snow melt. While the result of the flood event was much worse downstream, the test section may have been impacted by this event and similar high precipitation/flooding events.

Figure 10. Average monthly precipitation over time.

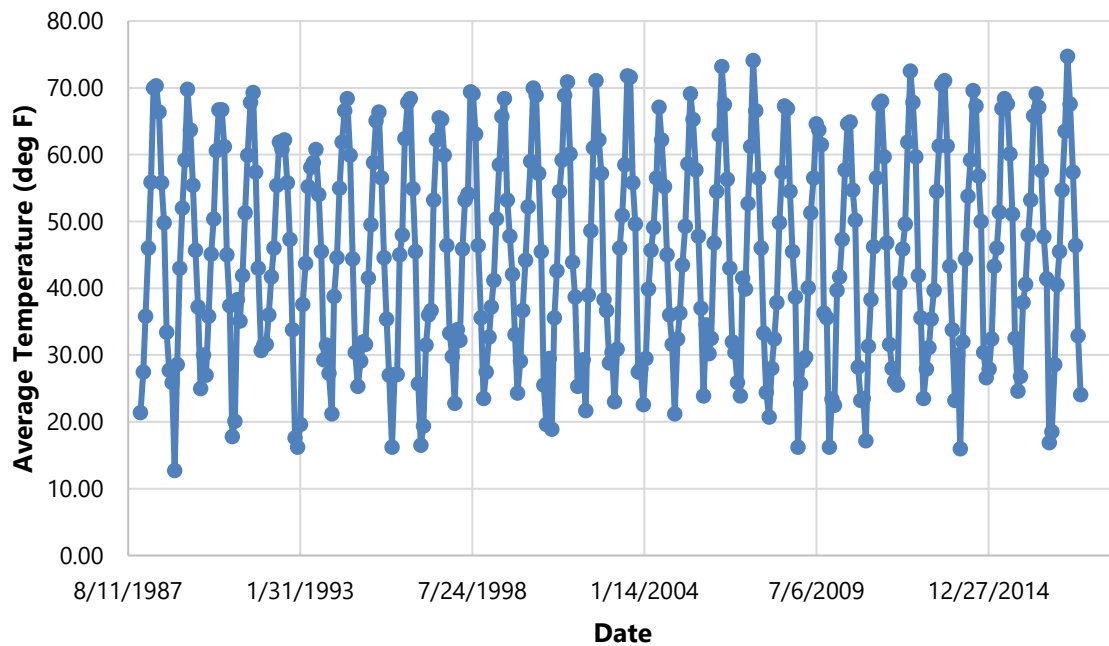
Figure 11 shows the time history of the average monthly air temperature (from the VWS) over the history of this test section. As shown in Figure 11, the lowest average air temperature (12.7 deg F) occurred in February 1989, while the highest value (74.7 deg F) occurred in July 2017.

Figure 11. Average monthly air temperature over time.

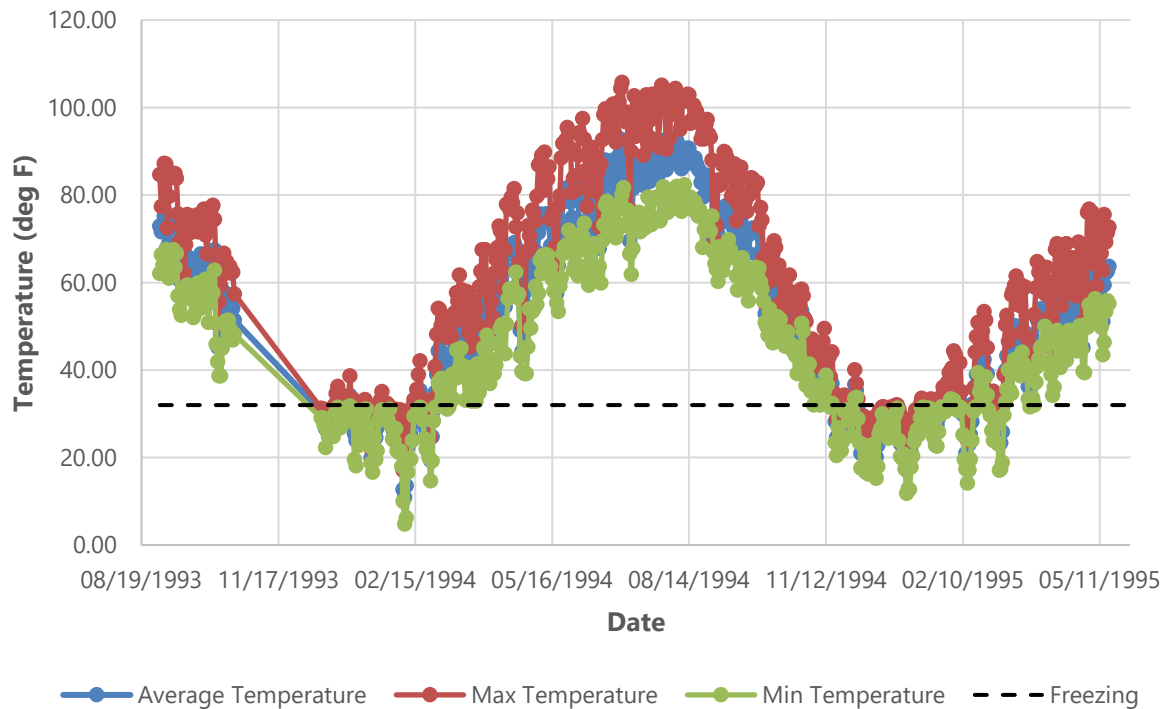
Figure 12 depicts the average, maximum, and minimum temperature of the material surrounding the site thermistor (Sensor 4) at a depth of 4.68 inches, i.e. near the top of the base layer. The figure is useful in

identifying when the pavement structure is frozen as material temperatures dip below the freezing temperature of 32 degrees Fahrenheit. However, as the figure shows, this only occurs during a small window of the winter months (early December through end of February). In this figure, the very low temperatures observed near the top of the base layer had the lowest recorded temperatures corresponding to the low deflection measurements and high modulus values during the winter of 1993-1994.

Figure 12. Average, maximum, and minimum temperature of the material surrounding the site thermistor (Sensor 4) at a depth of 4.68 inches.

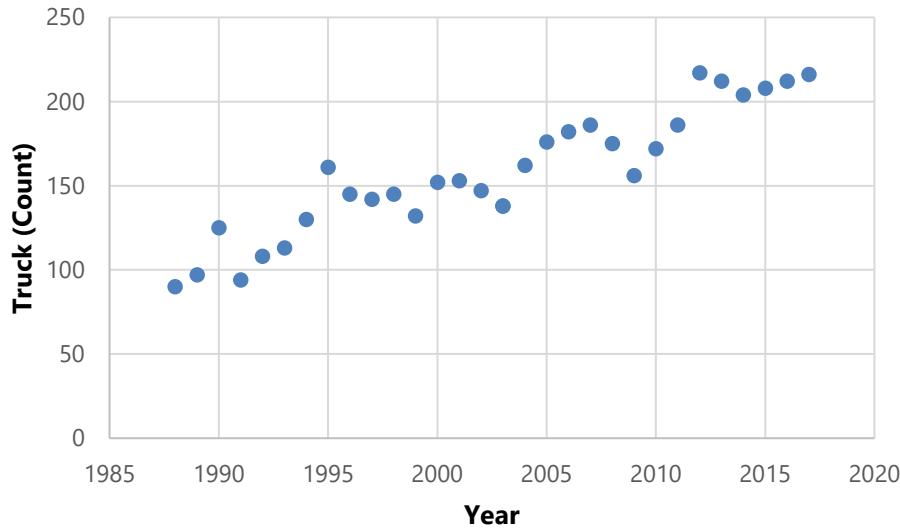
Figure 13 shows the annual average daily truck volume data in the LTPP test lane by year. The annual truck traffic counts increase from 90 in 1988 to 216 in 2017, or approximately 4 additional trucks per year, effectively doubling the truck counts during the period in question. The total annual 18-kip ESALs reported between 2000 and 2013 also increased. The number of 18-kip ESALS increased from 60 in 2000 to 145 in 2013 or by approximately 6.5 18-kip ESALS/year. In terms of either truck or ESAL counts, the traffic at the test section in question is low, which is clearly reflected in the more significant distresses being environment-related (i.e., not load-related) as shown in the next sections.

Figure 13. Average annual daily truck traffic (AADTT) history.
