## Technical Memorandum

**Re:** Forensic Desktop Study Report: Indiana LTPP Test Section 18\_1037

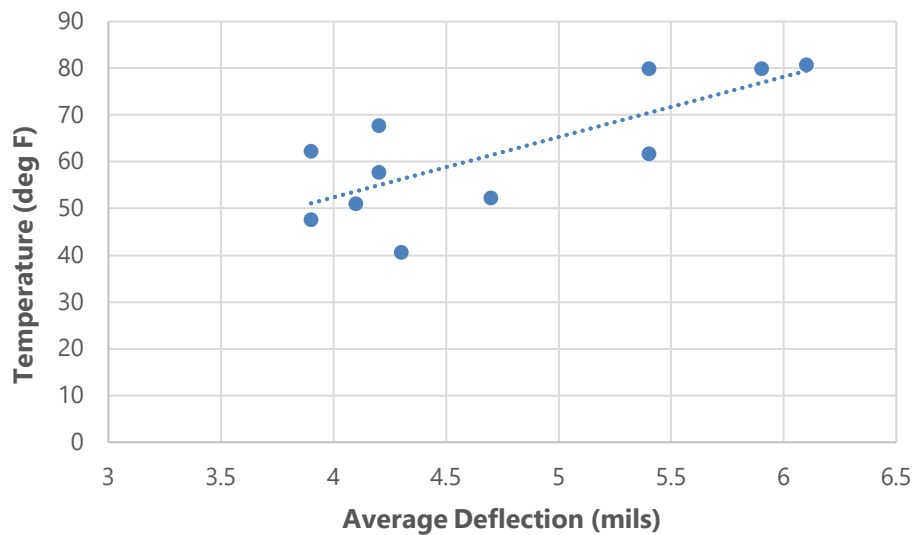
**Figure 2. Relationship between deflection under the load plate and average daily temperature (using MERRA data).**

Figure 1 shows the average FWD deflections under the nominal 9,000-pound load plate during the entire period the test section was in study. The deflection of the sensor located in the center of the load plate is a general indication of the total “strength” or response of all layers in the pavement structure to a vertically applied load. As shown in Figure 1, the deflections reported were relatively low, ranging from 3.9 mils (1993) to 6.1 mils (2005), likely because of the overall thickness of AC layer of the pavement. The deflections observed appear to fluctuate based on the temperature at the time of collection. As the temperature increased, the deflections reported also increased, with the highest deflections observed in July and August. This relationship, which is further confirmed in Figure 2, helps explain the increase in the deflections observed following the overlay events. However, this observation still fails to explain why the reported deflections in 1994 and 1995 remained the same despite an increase in temperature between the two test dates.

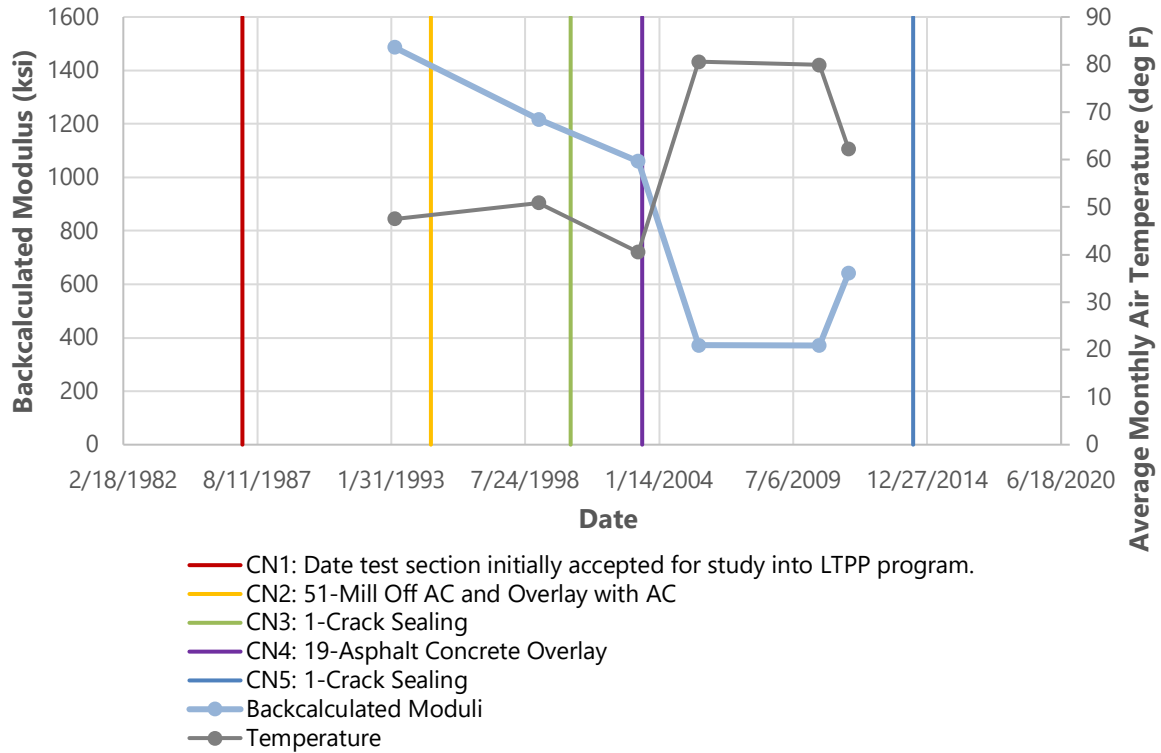
**Figure 3. Average backcalculated modulus for AC (Layer 1) and average daily temperature (using MERRA data).**

As shown in the figures above, while the backcalculated moduli for Layer 3 appear to be reasonable and consistent throughout time, the reported backcalculated moduli for Layers 1 and 2 fluctuate over time. The moduli for Layer 1, the AC layer, appears to be related to the change in temperature over time. As depicted in Figure 2, as the average daily temperature reported at the test section increases, the moduli reported for Layer 1 also increases and vice versa. This helps explain why the modulus reported continued to decrease between the two overlay events, as the temperature at the time of testing also decreased over this period. Exceptions to this relationship include the decrease in the modulus in August 2005 despite the increase in temperature, which is likely related to changes in the pavement structure, and the increase in the modulus observed in 2011 despite a decrease in temperature. The moduli for Layer 2, the top 24 inches of the subgrade layer, seem to be affected by the moisture at the test section. As shown in Figure 4, as the average monthly precipitation reported at the test section increases, the modulus reported for Layer 2 also increases and vice versa. One exception to this relationship is the increase in the modulus reported in August 2005, despite a decrease in the average monthly precipitation.

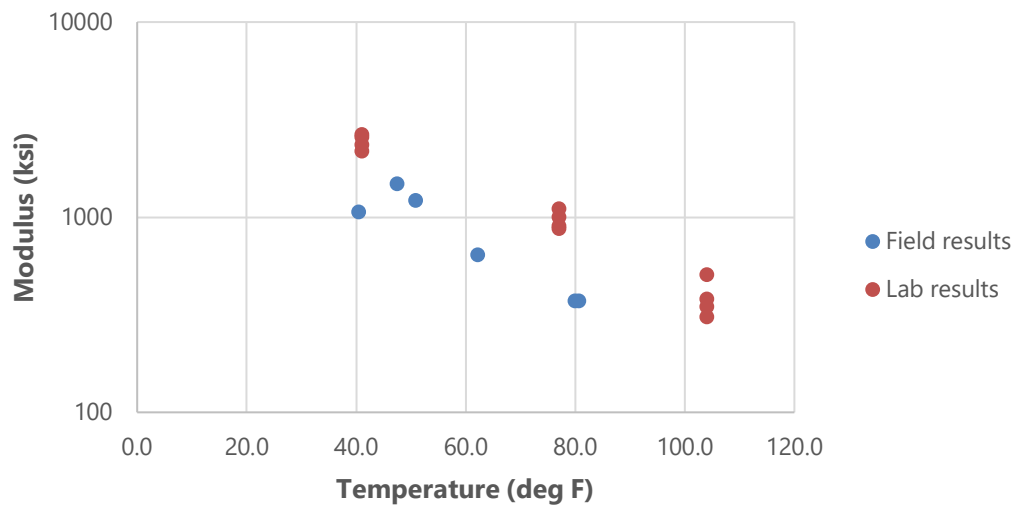
**Figure 6. Field- and lab-derived AC resilient modulus values.**

The reasonableness of the backcalculated layer moduli was compared to moduli derived from laboratory resilient modulus testing. Table 4 summarizes the laboratory test results for the two AC overlay layers, conducted in 2004, and the subgrade layer, conducted in 1995 and 1996. For the AC layers, moduli values are shown for three test temperatures – 41, 77, and 104°F, respectively. As shown in Figure 6, the AC modulus versus temperature relationship for the field- (FWD-derived backcalculated moduli) and lab-derived resilient moduli appears to be reasonable; there appears to be a clear trend between temperature and the pavement modulus. For the subgrade layer, various statistical analyses were conducted for the range of stress states (confining and deviatoric stresses) to which the laboratory samples were subjected. The laboratory values for the subgrade were lower than the backcalculated moduli reported.

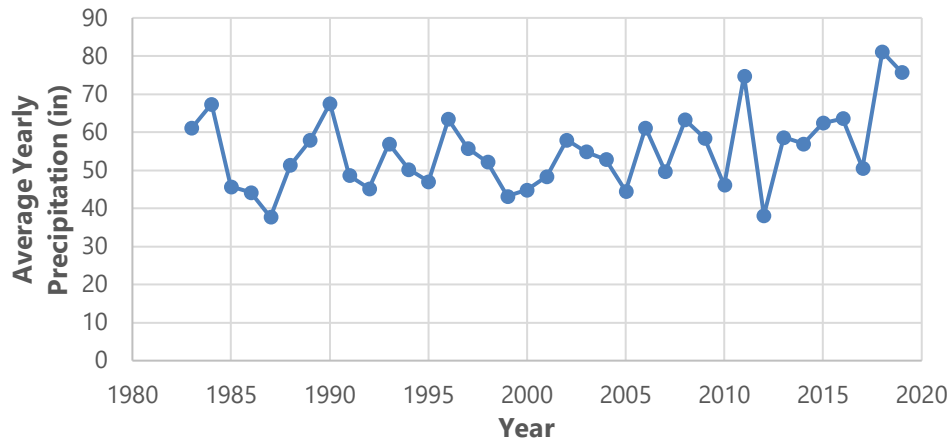
**Figure 7. Average yearly precipitation over time.**

The time history for average annual precipitation (from MERRA) since 1983 is shown in Figure 7. The mean precipitation recorded at the section was 55 inches for the period of analysis. Notable spikes in precipitation were observed in 2011 and 2018, when 75 and 81 inches of precipitation were reported, respectively.

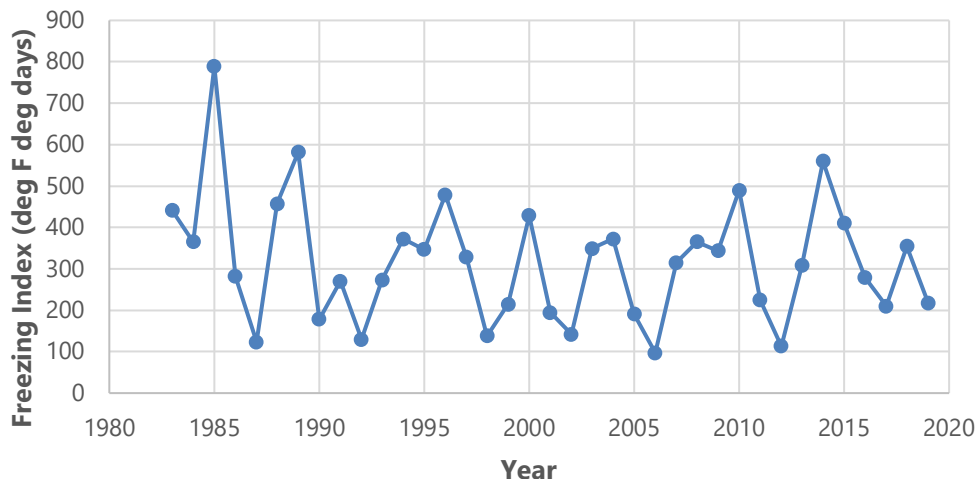
**Figure 8. Average annual freezing index over time.**

Figure 8 shows the time history of the average annual freezing index (from MERRA) for the test site. The freezing index is the summation of the difference between freezing temperature and the average air temperature when it is less than freezing over a year's time. This index is an indicator of the harshness of the winter season relative to issues such as ground frost and low temperature cracking in pavements. As depicted in Figure 8, the freezing index values ranged from 97.2 deg F deg days (2006) to 581.4 deg F deg days (1989) during the analysis period. For the most part, all freezing indices reported during the analysis period are above the 150 deg F deg days used to classify a freeze region, and therefore, as stated earlier, this site would be classified as a being in a Freeze climate.

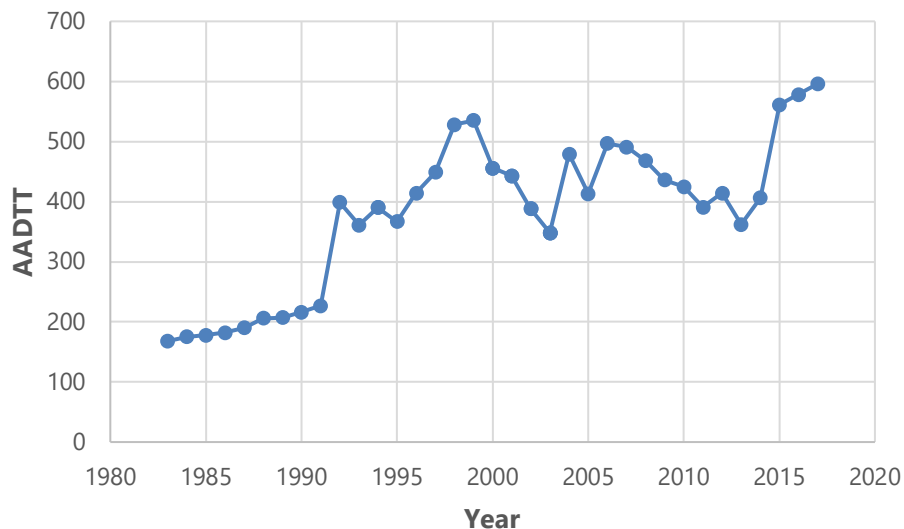
**Figure 9. Average annual daily truck traffic (AADTT) history.**

Figure 8 shows the annual average daily truck traffic (AADTT) data in the LTPP test lane by year. The annual truck traffic counts increase from 168 in 1983 to 596 in 2017, or approximately 13 additional trucks per day per year. The average number of ESALs reported on the section also increased over time as depicted in Figure 9. The number of ESALS increased from 29,434 in 1983 to 104,419 in 2017. The fluctuations in both the AADTT and ESALS reported for the test section are likely a result of the source of the data used over time. A combination of historical AADTT values (1983-1989), state provided AADTT values (1990-1991 and 2002), monitored values (1994, 1997, 1999, 2000, 2003, 2010, 2014), monitored values calculated from class data (1992, 1993, 1995, 1996, 1998, 2001, 2004, 2006-2009, 2011-2013), and values calculated using a compound growth function (2005 and 2015-2017) were used to report traffic along these test sections. Additionally, for the ESAL data reported in years when a major construction event occurred (such as the mill and overlay in 1994 and the overlay in 2003), the average annual ESALS was reported twice—once using data collected prior to the construction event and a second time using monitored data collected after the construction event. For example, in 1994, when the mill and overlay event occurred on the test section, the average annual ESALS for the section was calculated using monitored data collected before the September mill and overlay (monitored data collected between January and September of 1994) and separately using data collected after the mill and overlay event (monitored data collected between September and December of 1994). While in the figure below, the average annual ESALS reported in 1994 and 2003 is based on the data collected for a larger proportion of the year (the January to September monitored data for 1994), the average annual ESALS may be underrepresented because it is based on data collected for only a part of the year.
