Technical Memorandum

Re. Forensic Desktop Study Report: Oklahoma LTPP Test Sections 40_AA**

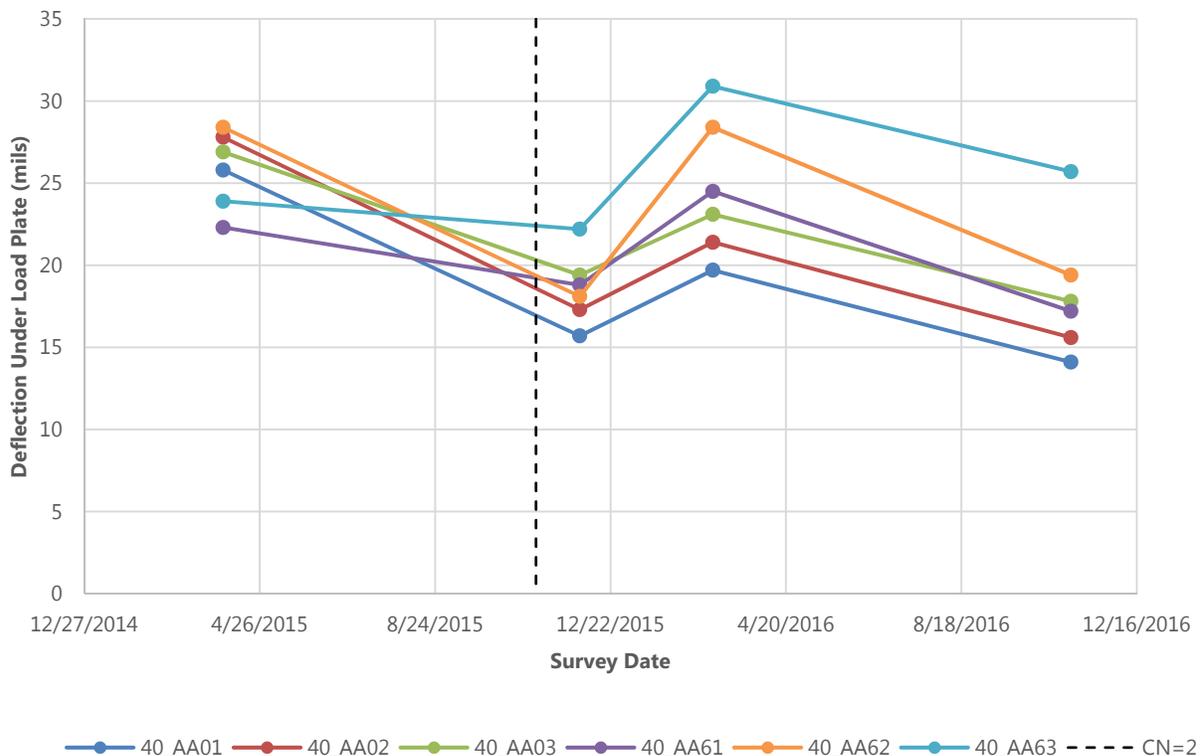
Figure 2. Average deflection for the sensor located in the load plate normalized to 9,000 lb. drop load over time.

The pavement structures of the test sections, prior to the treatment of the sections with the AC overlay in November of 2015, reported similar deflections; the initial reported deflections ranged from 22.3 mils (for Section 40_AA61) to 28.4 mils (for Section 40_AA62). As expected, following the application of the AC

overlay, the deflections observed for each of the test sections decreased as the AC overlay provided additional structural capacity to the pavement. Section 40_AA01 reported the lowest levels of deflection after the AC overlay was applied, 15.7 mils, while Section 40_AA63 reported the highest deflections of the test sections, 22.2 mils. These results appear to directly related to the total thickness of the AC layers – as shown in Table 4, the total AC thickness for Section 40_AA01 is 9.4 inches (lowest value), while the total AC thickness for Section 40_AA63 is 10.8 inches (second highest value) and for Section 40_AA02 is 11.0 (highest value and second lowest deflection after Section AA_AA01). The deflections observed for each of the test sections increased by November 2016 with the SMA overlay exhibiting the highest deflections of the test sections and the HMA overlay reporting the lowest. The deflections observed ranged between 14.1 mils (Section 40_AA01) and 25.7 mils (Section 40_AA63).

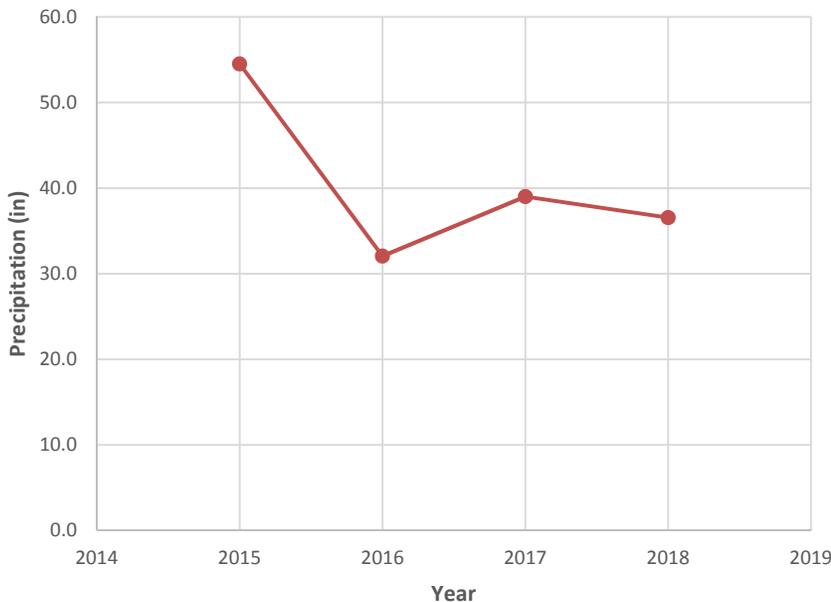
The historical annual average precipitation for the test sections is depicted in Figure 3. Despite the test sections being collocated along a 1.8 mile section, the annual average precipitation was reported for two groups of test sections; one group consisted of sections 40_AA01, 40_AA02, 40_AA03, and 40_AA61 while the second group consisted of sections 40_AA61 and 40_AA63. Therefore, an average of these two groups is reported in Figure 3. In 2015, the average amount of precipitation reported was a maximum of 54.5 inches—which is nearly 60 percent more than the amount of precipitation observed in 2016. The minimum annual average precipitation was reported in 2016 at 32.1 inches.

Figure 3. Average annual precipitation over time.

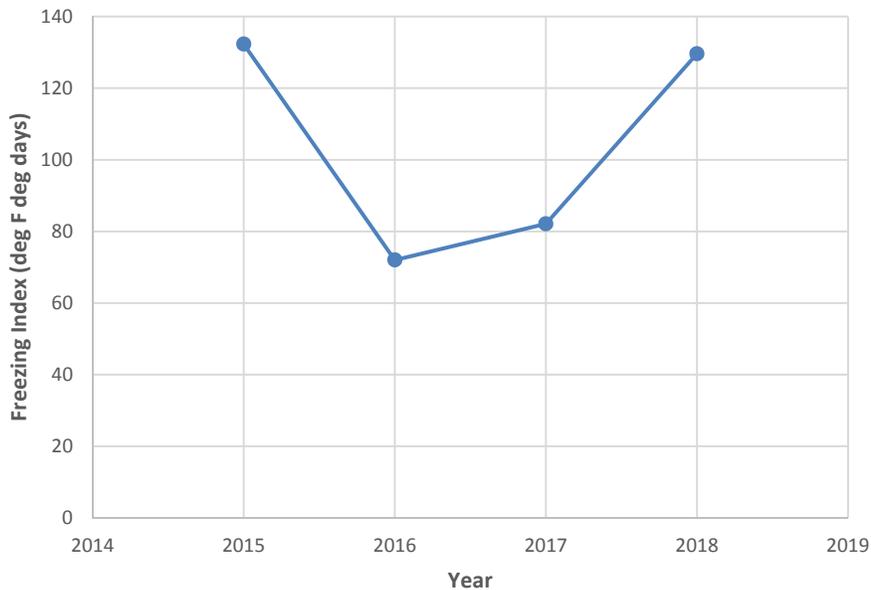
Figure 4 shows the time history of the average annual freezing index for the test sections. Again, despite the test sections being collocated along a 1.8 mile section, the average annual freezing index was also reported for the same two groups of test sections as for precipitation; i.e., one group consisted of sections 40_AA01, 40_AA02, 40_AA03, and 40_AA61, while the second group consisted of sections 40_AA61 and 40_AA63. This means that this location is at the boundary between two Modern Era Retrospective-Analysis for Research and Applications (MERRA) cells that are approximate 43 miles wide by 30 miles tall. An annual average of these two MERRA cells is reported in Figure 4. The freezing index is the sum of the difference between 32 degrees F and the average air temperature when it is less than freezing and 32 degrees F for each day, which is summed over a year's time. This index is an indicator of the harshness of the winter season relative to issues such as ground frost and low temperature cracking in pavements. As shown in Figure 4, the freezing index values ranged from 72 deg F deg days (in 2016) to 132.3 deg F deg days (in 2015). The annual freezing indices reported are considered moderate to approaching the classification as a freeze zone. An average annual freezing index over 150 deg F days is classified by LTPP as a freeze zone.

Figure 4. Average annual air temperature freezing index over time.

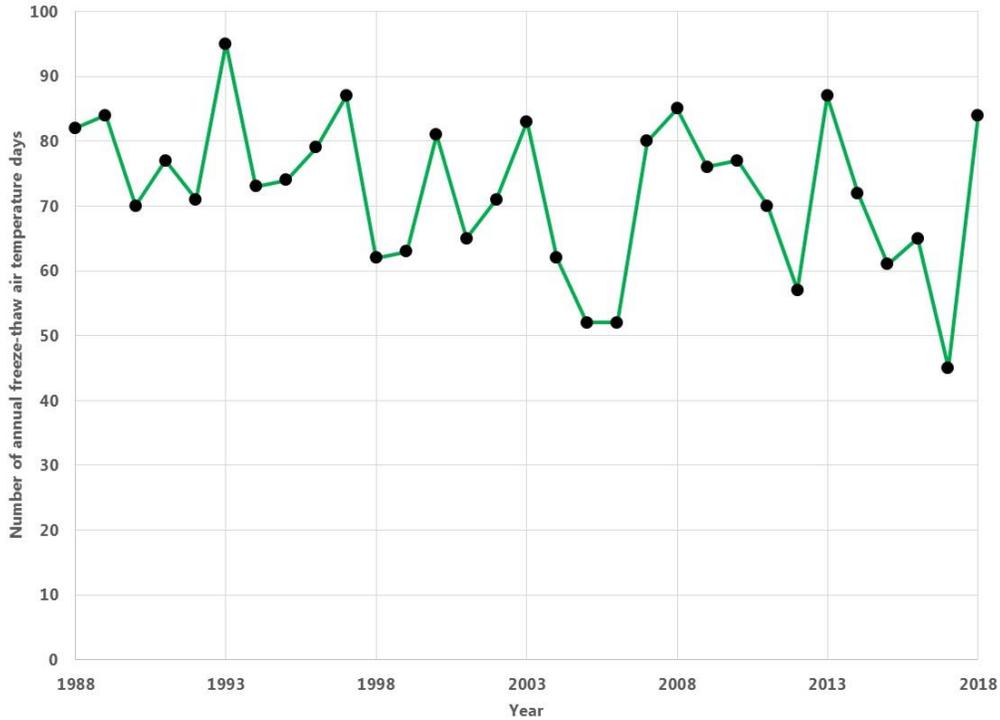
This project site is in a climate that experiences a large number of freeze thaw cycles every year. It has been postulated that this zone can be more damaging to a pavement since the unbound layers can go through more freeze thaw cycles in a year than in deep freeze areas, where the unbound materials freeze once and thaw out once in each winter cycle. Figure 5 shows the annual number of air temperature freeze-thaws days. A freeze thaw day is where the maximum air temperature day is greater than 32 deg F and the minimum air temperature is less than 32 deg F on each day, summed up for the calendar year. A value of 90 indicates that within a year, there was roughly the equivalent of three months where the air temperature air transitioned the freezing point of water. The time history for this parameter starts in 1988 to provide a broader time scale since the existing pavement structure temperature was subjected to these patterns. It is interesting that since placement of the overlays in 2015, the number of freeze thaw cycles was very low and reached a minimum value in 2017.

Figure 5. Annual days of air temperature freeze thaw cycles.

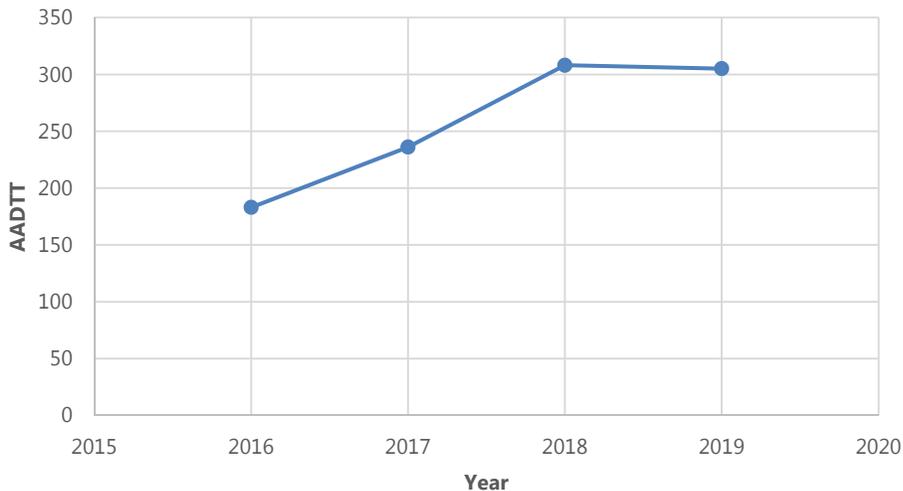
A weight-in-motion (WIM) was installed at the Oklahoma SPS-10 in 2016. Figure 6 shows the annual average daily truck traffic (AADTT) data in the LTPP test lane for all sections by year. Based on the figure, the test sections received an increase in truck traffic over time. In 2016, or the year after the overlay was applied, the AADTT was reported as 183 on the test sections. The AADTT reported in 2017 and 2018 increased to 236 and 308, respectively. By 2019, 305 trucks per day were observed on the six test sections, which represents an approximately 60% increase in truck traffic over a three-year period and which is significant and could have impacted on the performance of the pavement test sections.

Figure 6. Average annual daily truck traffic (AADTT) history.

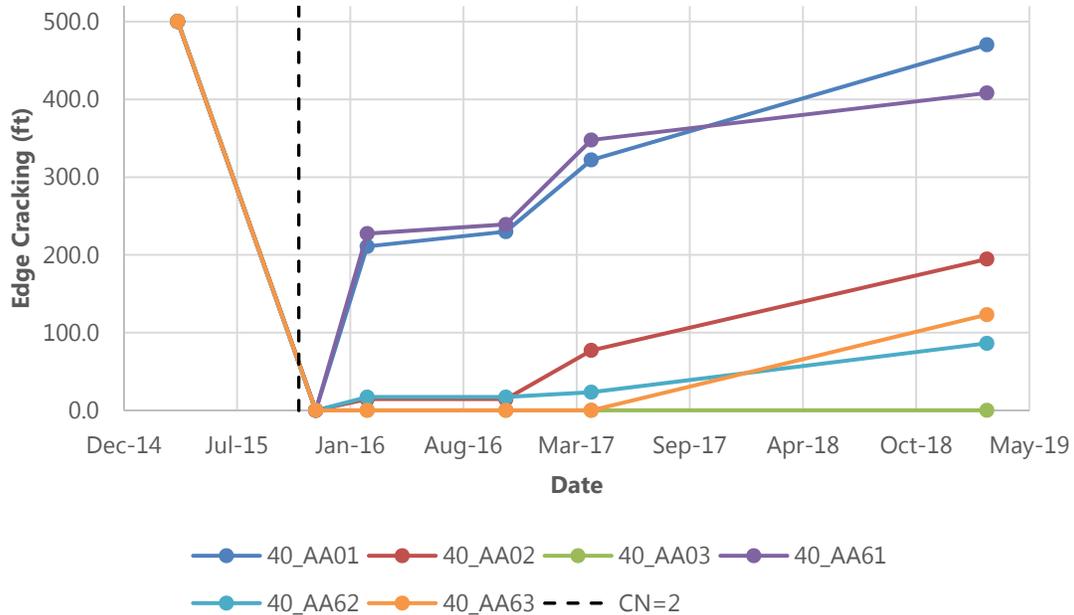
Edge cracking is defined by LTPP as crescent-shaped or fairly continuous cracks that intersect the outside edge of a pavement that has unpaved shoulders. Longitudinal cracks within 2 feet of the outside lane edge are also classified as edge cracks. Figure 17 summarizes the total length of edge cracking that was observed prior to and after the application of the AC overlay in November 2015. Edge cracking prior to the overlay was the same for all six sections; each section had 500 ft of edge cracking, which is the full length of the test sections. Figures 8 and 15 provide an example of what was rated as full test-section length edge cracking. A relatively small longitudinal crack at the edge of the fog line, or outside lane edge stripe, is what was being rated as full test-section-length edge cracking. Following the overlay, edge cracking began to be observed four months after the application of the AC overlay for sections 40_AA01, 40_AA02, 40_AA61, and 40_AA62 with edge cracking ranging from 14.4 feet for section 40_AA02 and 227.3 feet for test section 40_AA61 in March 2016. By March 2019, five of the six test sections had edge cracking ranging from 86.3 ft for section 40_AA62 and 470.2 ft for section 40_AA01. Test section 40_AA03 was the only section where edge cracking did not reappear by March 2019 following the overlay.

Figure 17. Time history of the total length of edge cracking.

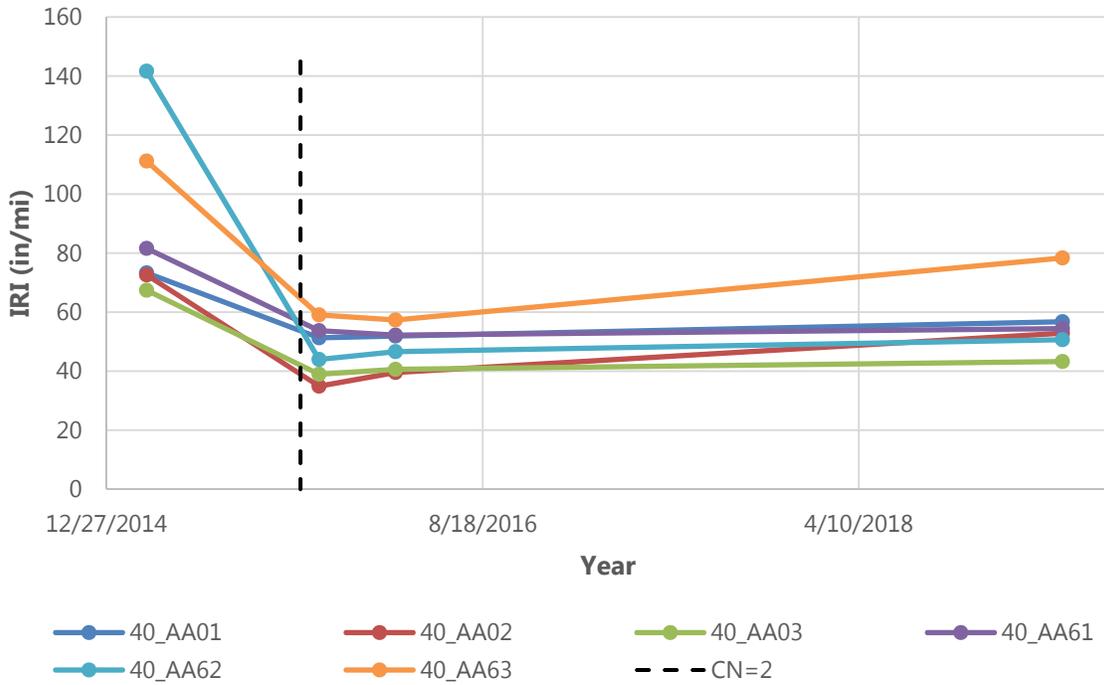
The IRI observed for the test sections over time is shown in Figure 18. Prior to the application of the AC overlay, the measured IRI values on the test sections ranged from 67.4 in/mi (excellent condition) on section 40_AA03 to 141.7 in/mi (very poor condition) on section 40_AA62. Following the application of the overlay, there was a significant decrease in the IRI of the test sections, with values in 2015 (after overlay) ranging between 38 and 60 in/mile. The IRI in 2016 remained low with values ranging from 40.6 in/mi (section 40_AA02) to 57.3 in/mi (section 40_AA63), but slowly increased to values ranging from 43.3 in/mi (section 40_AA03) to 78.4 in/mi (section 40_AA63) in 2019.

Figure 18. Time history plot of pavement roughness.

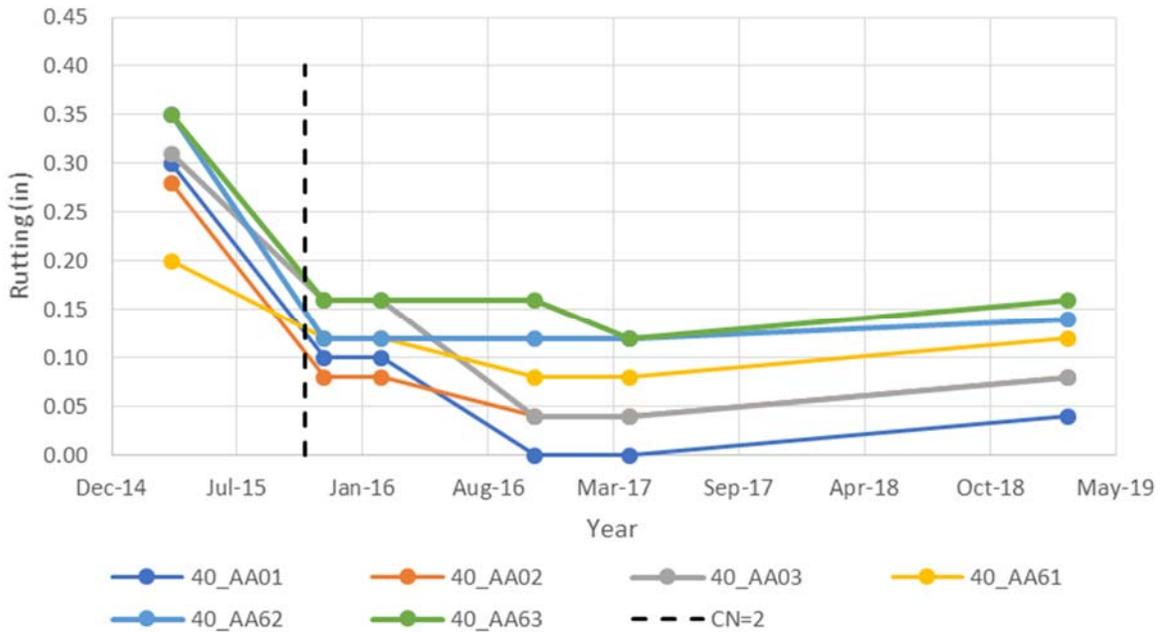
The measured rutting (average of maximum rut depth measurements on left and right sides of lane using 6-foot straightedge) over time for the sections is shown in Figure 19. Prior to the application of the AC overlay, the rutting values observed on the test sections ranged from 0.2 in (section 40_AA61) to 0.35 in (sections 40_AA62 and 40_AA63). Following the milling and application of the AC overlay, there was a significant decrease in rutting, with values in 2016 ranging between 0.0 in (section 40_AA01) and 0.12 in (sections 40_AA62 and 40_AA63). Rutting measured in 2016 remained consistent through 2017, with values ranging from 0.0 in (Section 40_AA01) to 0.12 in (Sections 40_AA62 and 40_AA63) by 2017. Prior to and after application of overlay, Sections 40_AA63 and 40_AA62 reported similar rutting values.

Figure 19 also shows that rutting values decrease further with time with values below 0.15 inches by 2017. However, it must be recognized that the rutting values in question are small and the changes in question are within the device's measurement error range (± 0.08 inches).

Figure 19. Time history plot of average rut depth computations.

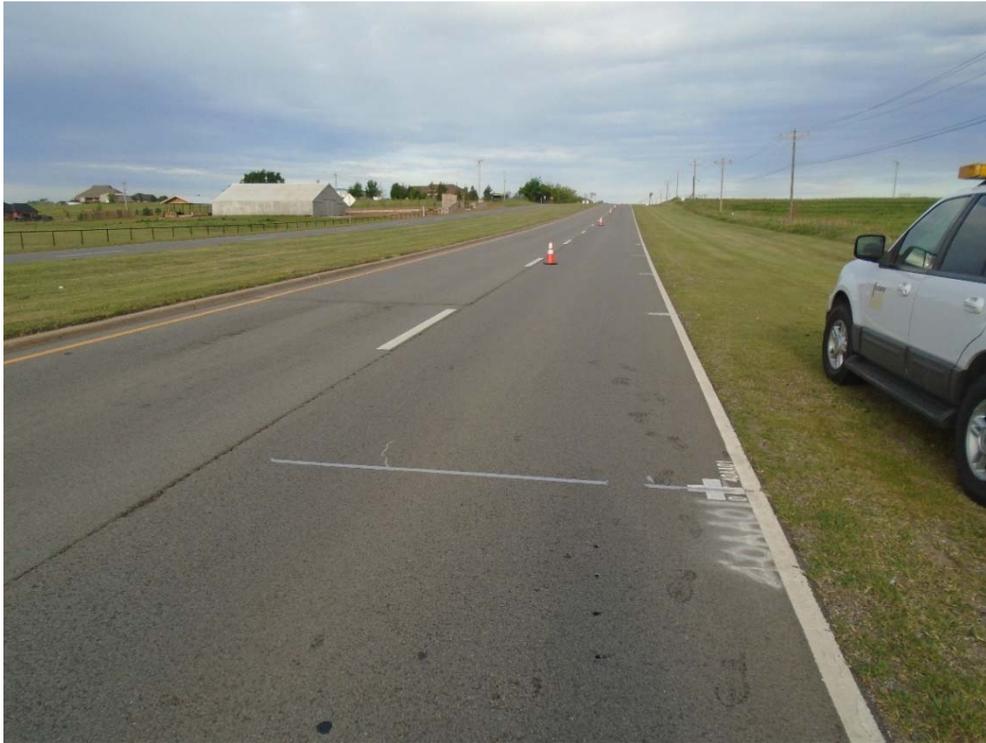
Photograph 1. Picture of test section 40_AA01 in 2017 (Station 0+00 looking westbound).

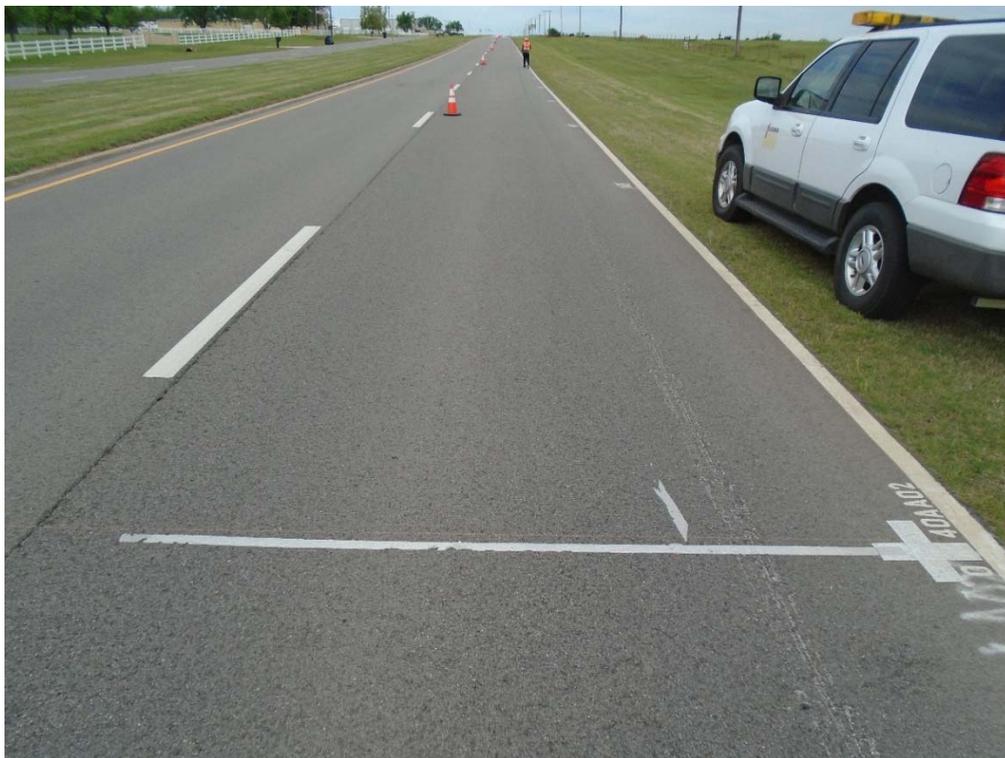
Photograph 2. Picture of test section 40_AA02 in 2017 (Station 0+00 looking westbound).

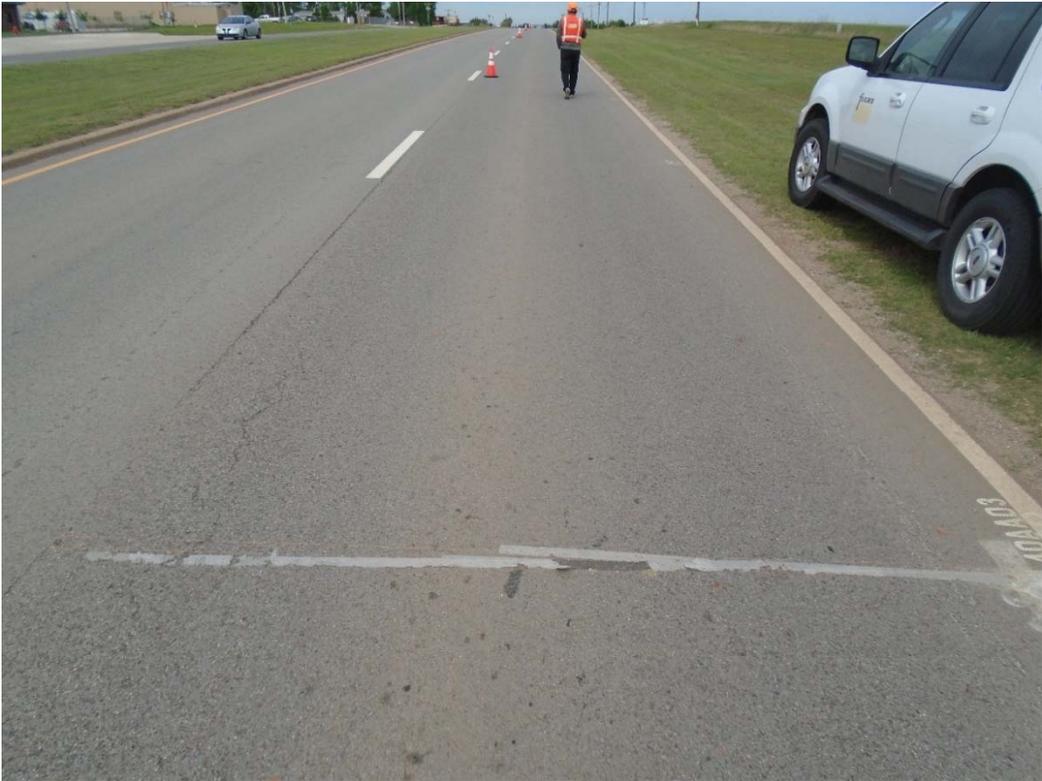
Photograph 3. Picture of test section 40_AA03 in 2017 (Station 0+00 looking westbound).

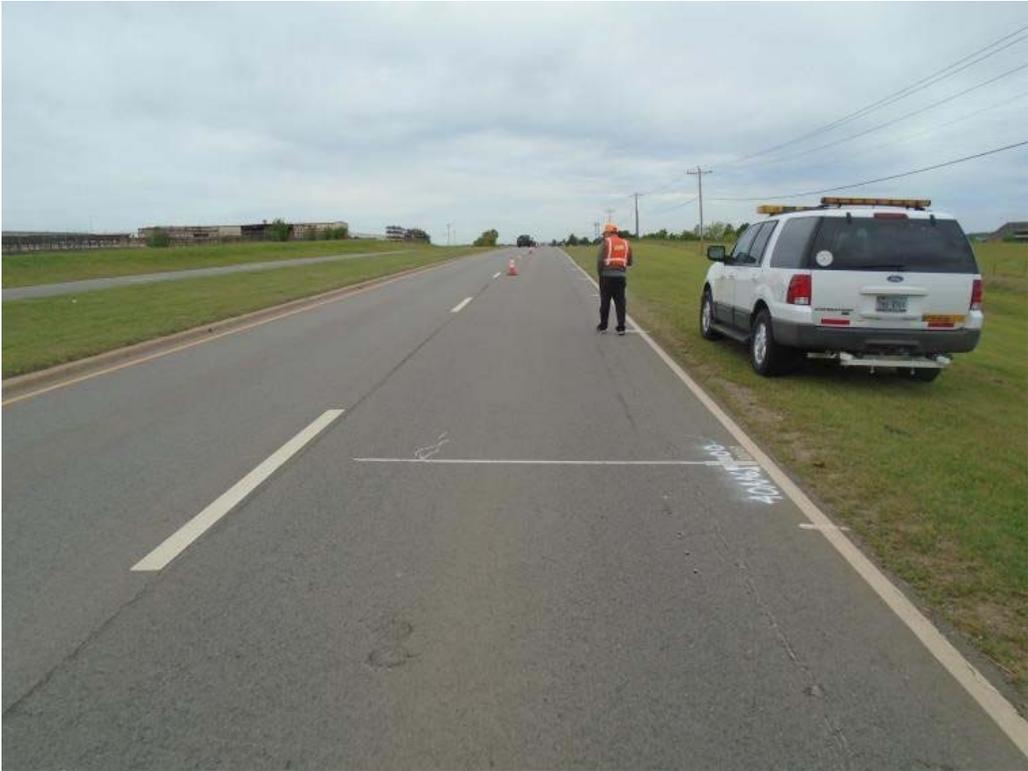
Photograph 4. Picture of test section 40_AA61 in 2017 (Station 0+00 looking westbound).

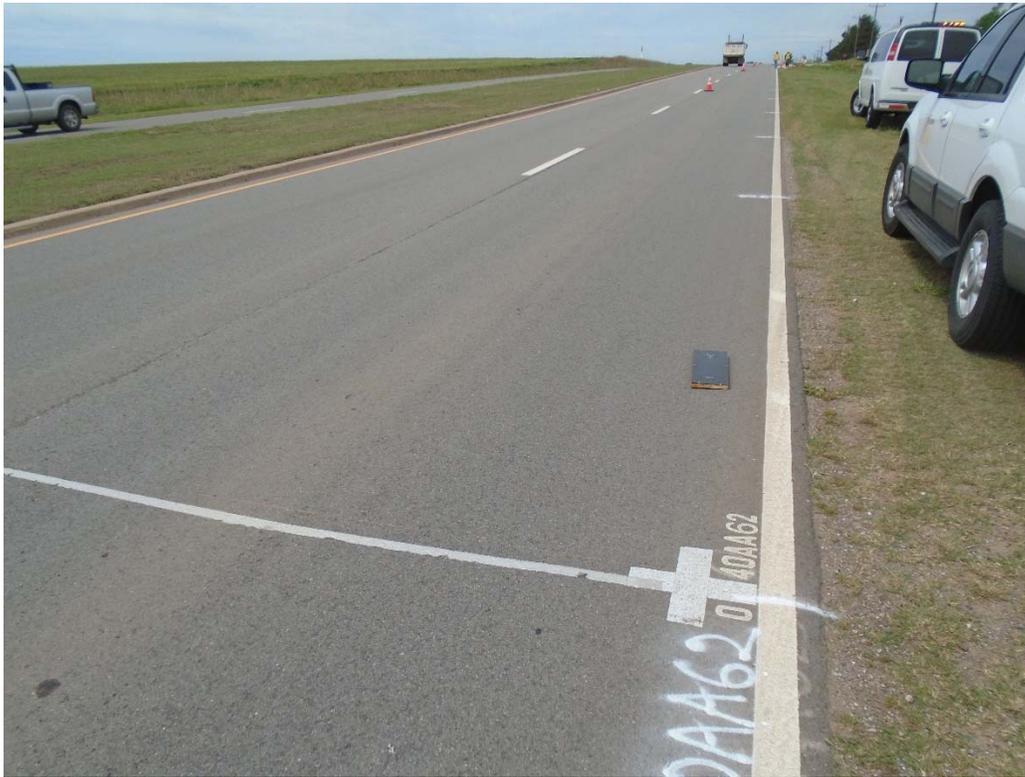
Photograph 5. Picture of test section 40_AA62 in 2017 (Station 0+00 looking westbound).

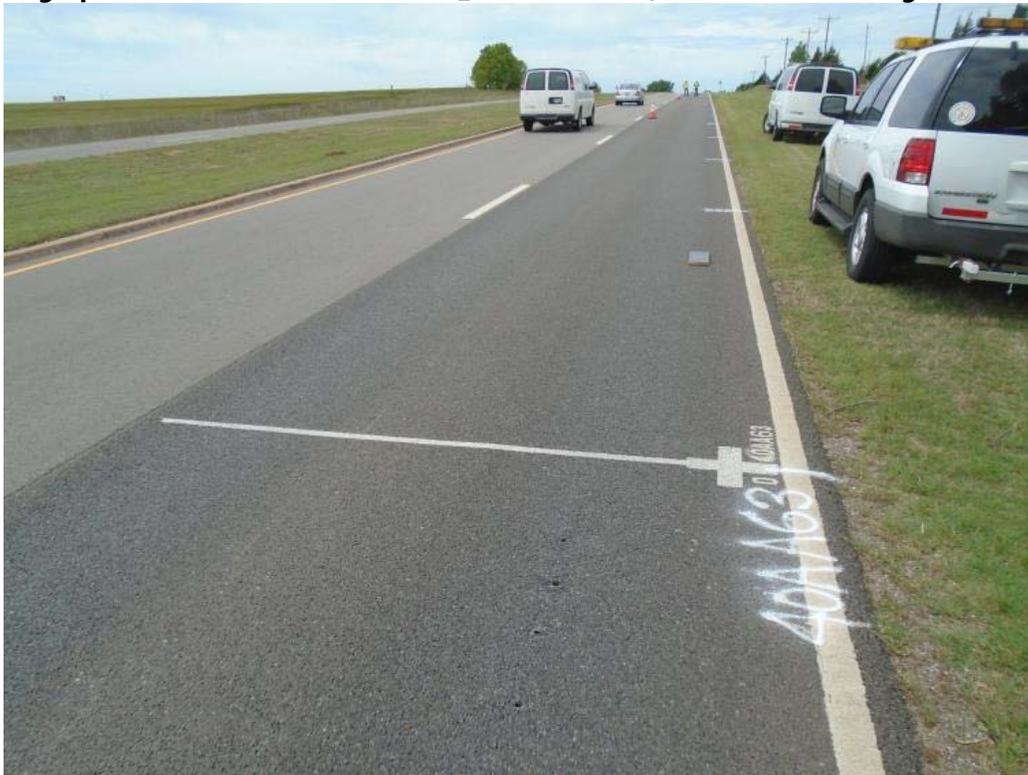
Photograph 6. Picture of test section 40_AA63 in 2017 (Station 0+00 looking westbound).
