Technical Memorandum

Re: Forensic Desktop Study Report: Maine LTPP Test Section 23_1028

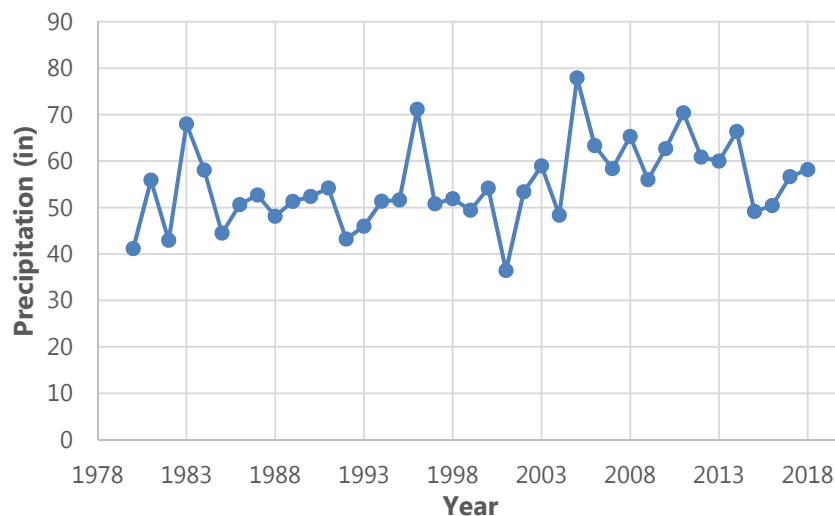
Figure 6. Average yearly precipitation over time.

The time history for average annual precipitation (from MERRA data) is shown in Figure 6. In 2005, the amount of precipitation appears to be a local high (78 inches), while the low (36 inches) was recorded in 2001. The mean precipitation recorded at the site is 55 inches for the period shown in Figure 6. Overall, the site has reported high amounts of precipitation over time, which is expected for a Wet climate. Most notable is from 2005 to 2014, when on average over 60 inches of precipitation was observed each year.

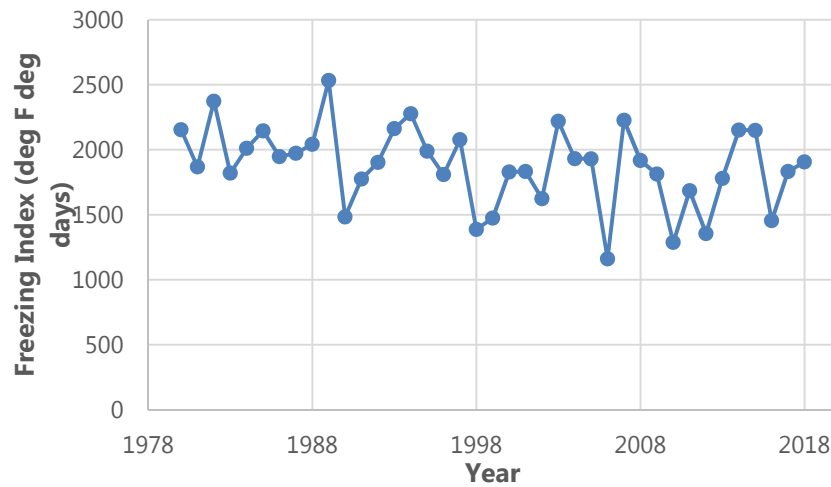
Figure 7. Average annual freezing index over time.

Figure 7 shows the time history of the average annual freezing index (from MERRA data) for the test site. The freezing index is the summation of the difference between freezing temperature and the average air temperature when it is less than freezing over a year's time. This index is an indicator of the harshness of the winter season relative to issues such as ground frost and low temperature cracking in pavements. As

depicted in Figure 7, the freezing index values ranged from 1,161 (2006) to 2,353 (in 1989)—which is well above the 150 deg F deg days used to classify a freeze region—indicating it may be a factor affecting the performance of the test section.

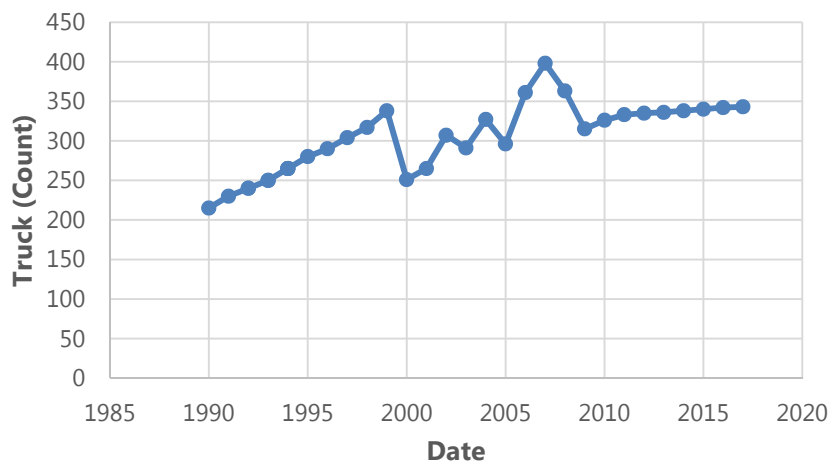
Figure 8. Average annual daily truck traffic (AADTT) history.

Figure 8 shows the annual average daily truck traffic (AADTT) data in the LTPP test lane by year from 1990 to 2017. While the section was incorporated into the LTPP program in 1988, the AADTT reported prior to 1990 relied on historical AADTT estimations from the State, which grossly overestimated the AADTT and ESALs during this time period and therefore, was not included in the figure. The annual truck traffic counts increase from 215 in 1,990 to 343 in 2017, or approximately 5 additional trucks per day per year. The overall increase in reported AADTT is not consistent throughout time. This is likely a result of source of AADTT data over time. Between 1990 and 1999, the reported AADTT values are state provided, from 2000 to 2010, monitored data is reported, and between 2011 and 2017, AADTT is computed using a compound growth function. The average number of ESALs reported on this section also increased over time from 165,000 in 1990 to 255,398 in 2017 as depicted in Figure 9. Like the AADTT, the reported ESALs fluctuated over time, likely as a result of the data source.
