Technical Memorandum

To: Kim Schofield
From: Lauren Gardner, Gonzalo Rada, and Kevin Senn
cc: Mustafa Mohamedali
Date: June 18, 2021
Re. Forensic Desktop Study Report: Oklahoma LTPP Test Section 40_4157

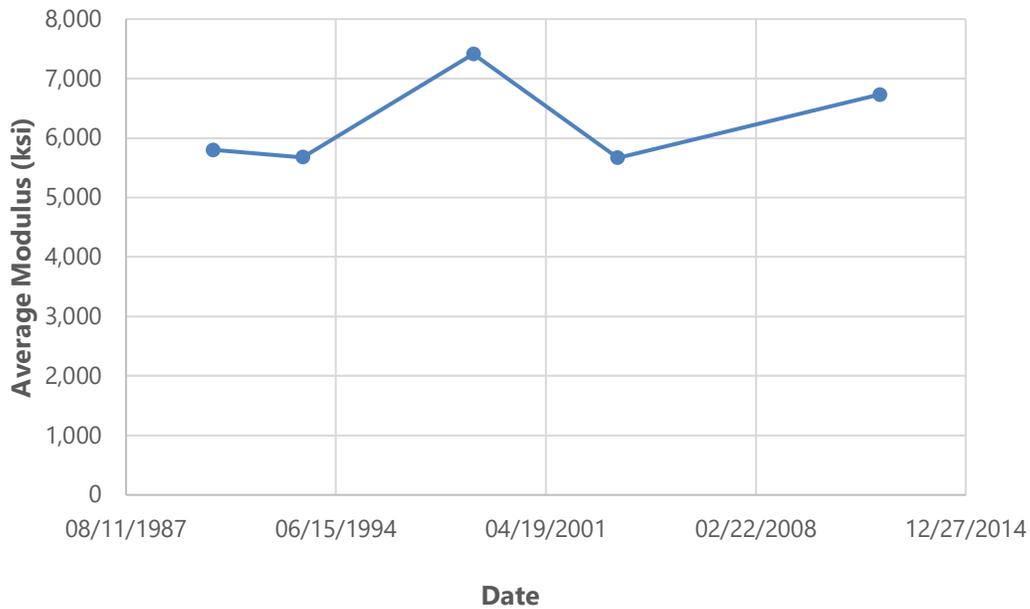
Figure 2. Average backcalculated modulus for PCC (Layer 1).

The layer moduli backcalculated from the deflection data were also assessed for the test section. The pavement structure for test section 40_1597 was modeled as 9.1 inches of PCC and 3.8 inches of asphalt-treated base over coarse subgrade and bedrock. The backcalculated moduli for the five collection dates between June 1990 and March 2012 are shown in Figure 2 through Figure 4. The assumed modulus for the bedrock layer was 500 ksi and therefore, was not plotted. The collection of FWD data in 2015 was performed after the completion of the LTPP contract to backcalculate moduli data; therefore, backcalculated moduli for this test date were also not included in the LTPP database.

The moduli reported for each layer ranged from 5,666 ksi to 7,414 ksi, 17 ksi to 29 ksi, and 73 ksi to 722 ksi for the PCC, asphalt treated base, and subgrade respectively. The modulus values of the asphalt-treated base were also considered within the context of the average daily air temperature (based on MERRA data). As depicted in Figure 3, there appeared to be an inverse relationship between the backcalculated modulus values and the average daily air temperature; as the temperature increased, the backcalculated modulus tended to decrease. This is aligned with expectation—pavements tend to stiffen in cold temperatures

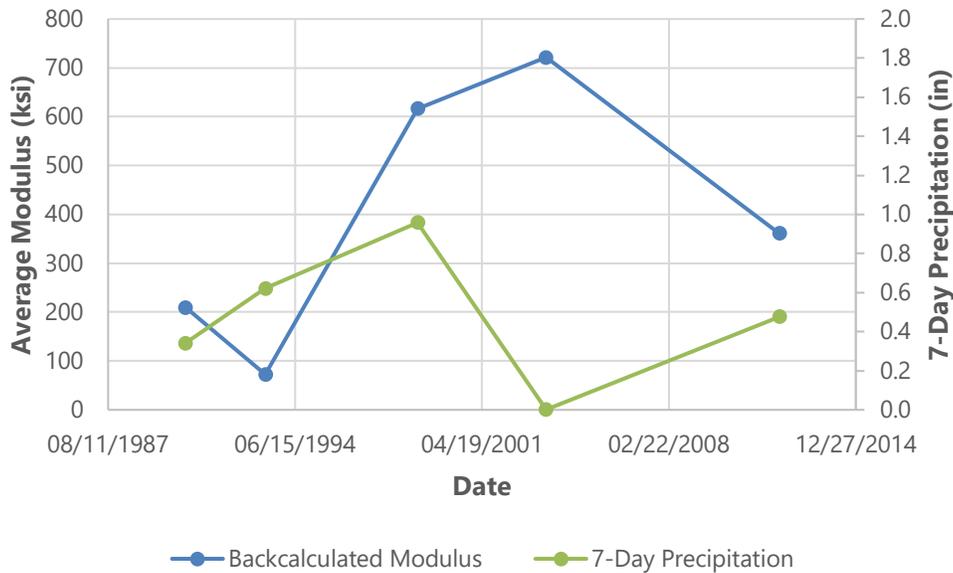
Figure 4. Average backcalculated modulus for the subgrade (Layer 3).

leading to an increased modulus. The relationship between moisture (measured as the cumulative precipitation reported the 7 days leading up to the FWD collection dates) and the subgrade layer backcalculated moduli was also assessed. Figure 4 shows no clear relationship between the backcalculated moduli and the 7-day precipitation.

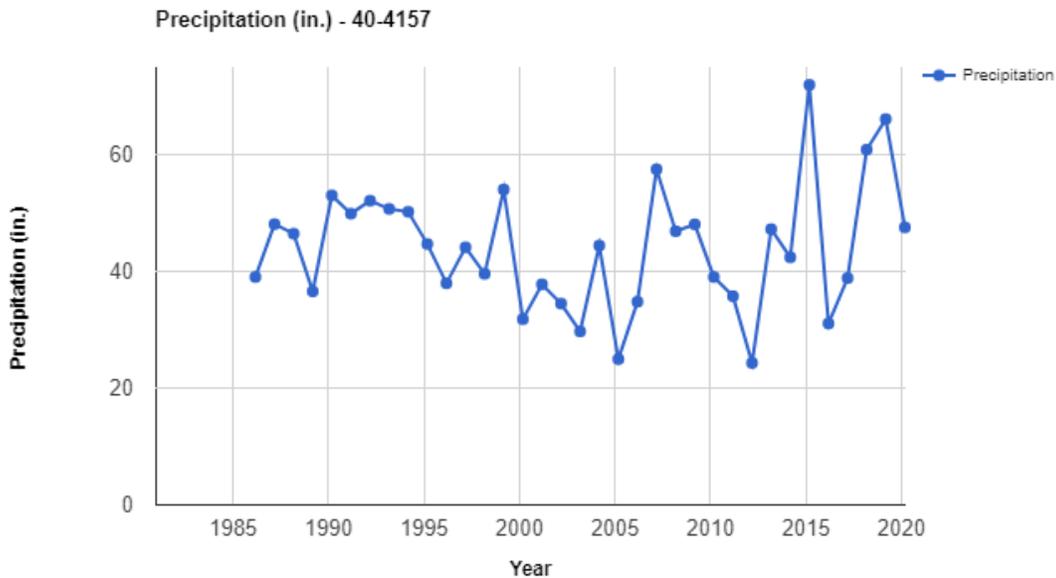
Figure 6. Average yearly precipitation over time.

The time history for average annual precipitation (from MERRA) since 1986 is shown in Figure 6. As shown in the figure, between 1987, when the test section was incorporated into the LTPP program, and 2020, the average annual precipitation at the test section was essentially unchanged (48.2 inches in 1987 and 47.6 inches in 2020). However, the average annual precipitation observed from year-to-year, was more consistent prior to 2005. The average annual precipitation during this period ranged from 25 inches (2005) to 54 inches (1999), whereas after 2005, the average annual precipitation ranged from 24 inches (2012) to 72 inches (2015). Additionally, notable spikes in precipitation were observed in 1999, 2007, 2015, and 2019, when 54, 58, 72, and 66 inches of precipitation were reported, respectively. These notable spikes may be tied to extreme weather events such as flooding, and snow and ice storms reported during those years. Overall annual average precipitation is 44 inches and overall average annual temperature is 59.6 F

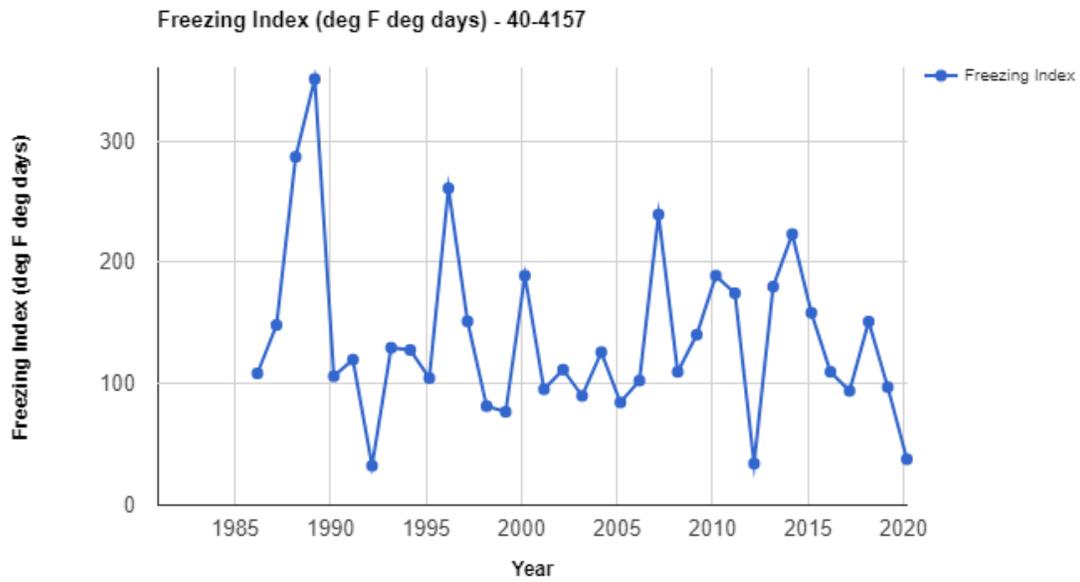
Figure 7. Average annual freezing index over time.

Figure 7 shows the time history of the average annual freezing index (from MERRA) for the test site. The freezing index is the summation of the difference between freezing temperature and the average air temperature when it is less than freezing over a year's time. This index is an indicator of the harshness of the winter season relative to issues such as ground frost and low temperature cracking in pavements. As depicted in Figure 7, the freezing index values ranged from 32 deg F deg days (1992) to 351 deg F deg days (1989) during the analysis period. As shown in the figure, the overall trend of the freezing index is decreasing over time, indicating the climate is getting warmer. This trend could have implications on the overall performance of the pavement over time. Overall annual average freeze index is 138 deg F deg days. This lack of freezing may contribute to the observed excellent performance of the test section.

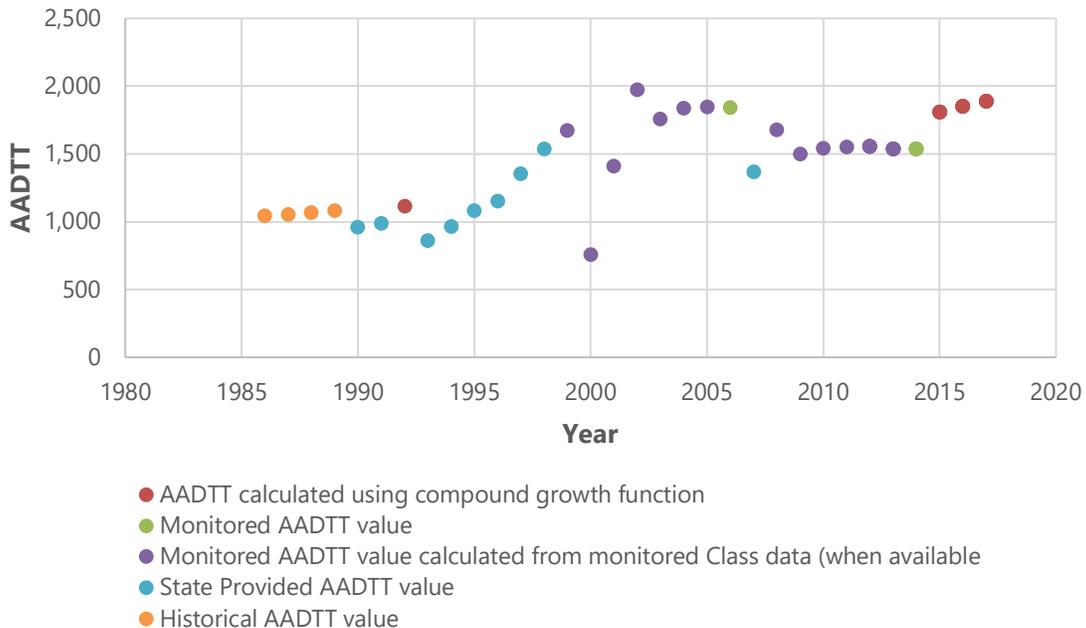
Figure 8. Average annual daily truck traffic (AADTT) history.

Figure 8 shows the annual average daily truck traffic (AADTT) data in the LTPP test lane by year. The AADTT increased between 1986 and 2017 from 1,040 to 1,888. The figure also shows the fluctuation in the reported traffic data which is likely a result of the source from which the data was gathered. The average number of ESALS reported on the test section followed a similar trend, increasing from 445,083 ESALS in 1986 to 985,442 in 2017 as depicted in Figure 9. Overall, the test section reported a high amount of truck traffic and ESALS over time.
