## Technical Memorandum

**Re.** Forensic Desktop Study Report: Idaho LTPP Test Section 16\_1020

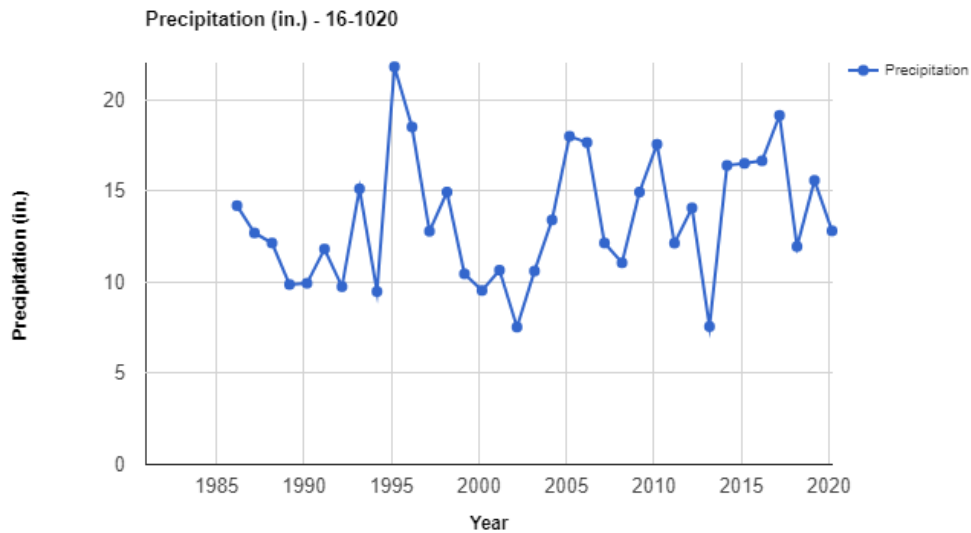
**Figure 7. Average yearly precipitation over time.**

Figure 7 shows the time history of average annual precipitation (from MERRA-2) at the test section since 1986. The average annual precipitation observed over the analysis period fluctuated on a year-to-year

basis with a notable increase in precipitation reported in 1995. However, overall, the reported average annual precipitation remained low at an average of 13.4 inches per year.

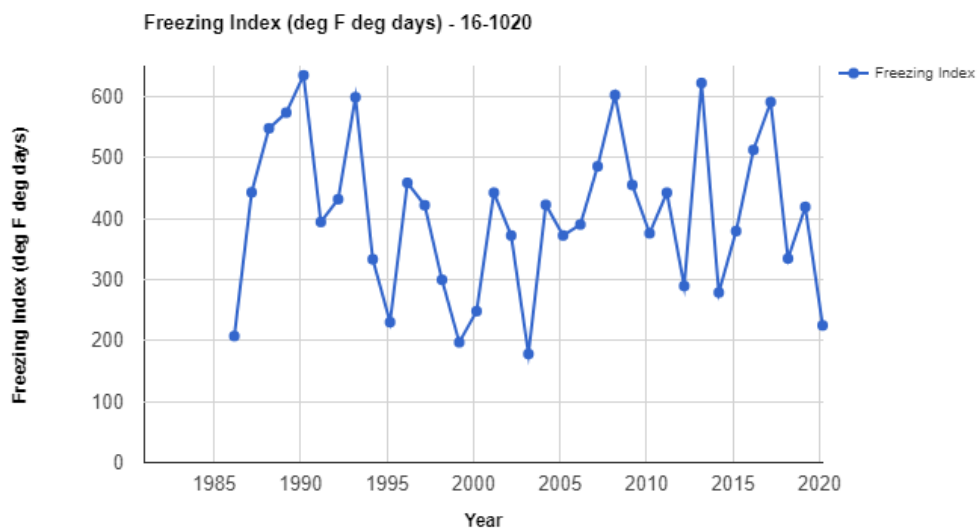
**Figure 8. Average annual freezing index over time.**

Figure 8 shows the time history of the average annual freezing index (from MERRA-2) for the test site. The freezing index is the summation of the difference between freezing temperature and the average air temperature when it is less than freezing over a year's time. This index is an indicator of the harshness of the winter season relative to issues such as ground frost and low temperature cracking in pavements. As depicted in Figure 8, the freezing index values ranged from 178 deg F deg days (2003) to 635 deg F deg days (1990) during the analysis period. The overall trend of the freezing index fluctuated over time with an average freezing index of 406 deg F deg days. During an interview with ITD staff, it was noted that freeze-thaw should not have played a major role at this test section due to the subgrade not being susceptible to freeze-thaw changes.

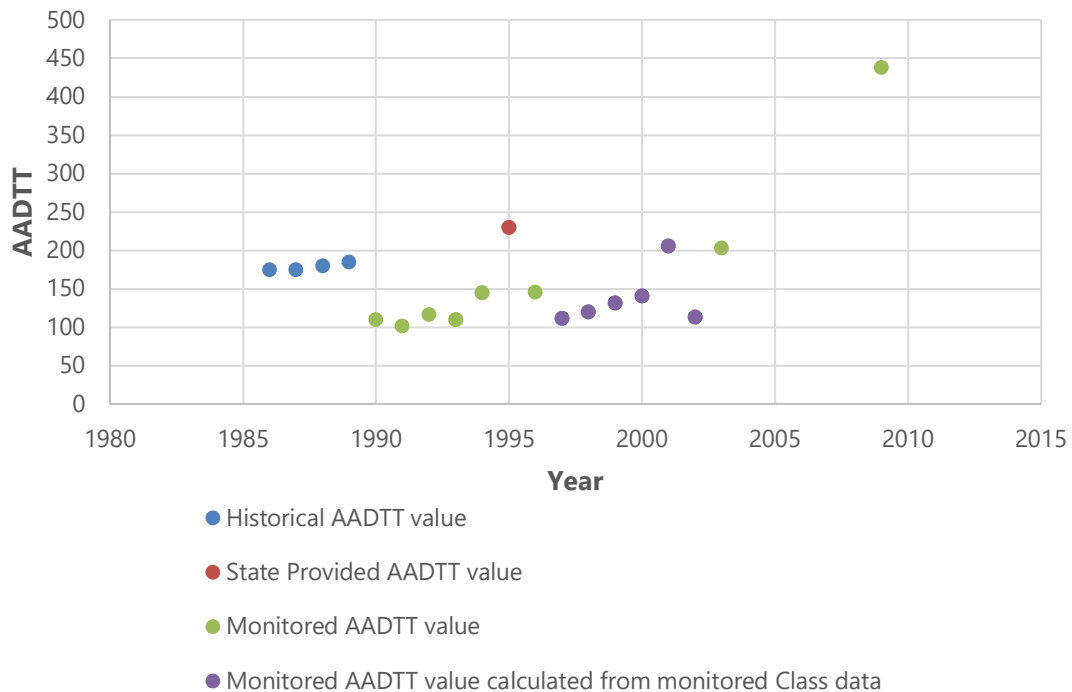
**Figure 9. Average annual daily truck traffic (AADTT) history.**

Figure 9 shows the annual average daily truck traffic (AADTT) data in the LTPP test lane by year. The average annual daily truck traffic increased from 175 in 1986 to 438 in 2009. The average number of ESALs reported on the section also increased over time as depicted in Figure 10. In 1986, 18,574 ESALs were reported annually on the test section whereas by 2009, the average annual ESALs increased to 139,087. While the figures that follow only report the values associated with historical, state provided, and monitored values, additional traffic data were reported in the LTPP database. These data, which was calculated using a linear growth function (2004-2008 and 2010-2017), was not included in the analysis because it appeared to underestimate the traffic experienced on this test section over time. Based on an interview with ITD staff familiar with this test section, traffic on the test section has increased significantly since the early 2000s due to an increase in agricultural and construction-related truck traffic in the area. Additional data, provided by the ITD, confirmed the accuracy of the AADTT reported in 2009; the data showed the initial two-way ADDTT on the test section was 871. The discrepancy between the non-monitored traffic reported (which was approximately  $\frac{1}{4}$  of the actual AADTT) in the LTPP database and the monitored traffic counts is significant finding of this study and will be submitted as a Data Analysis/Operations Feedback Report (DAOFR) to be further addressed by the LTPP program. Overall, in spite of the sharp increase in traffic loading on this test section, the test section performed well as will be discussed in the sections to follow.

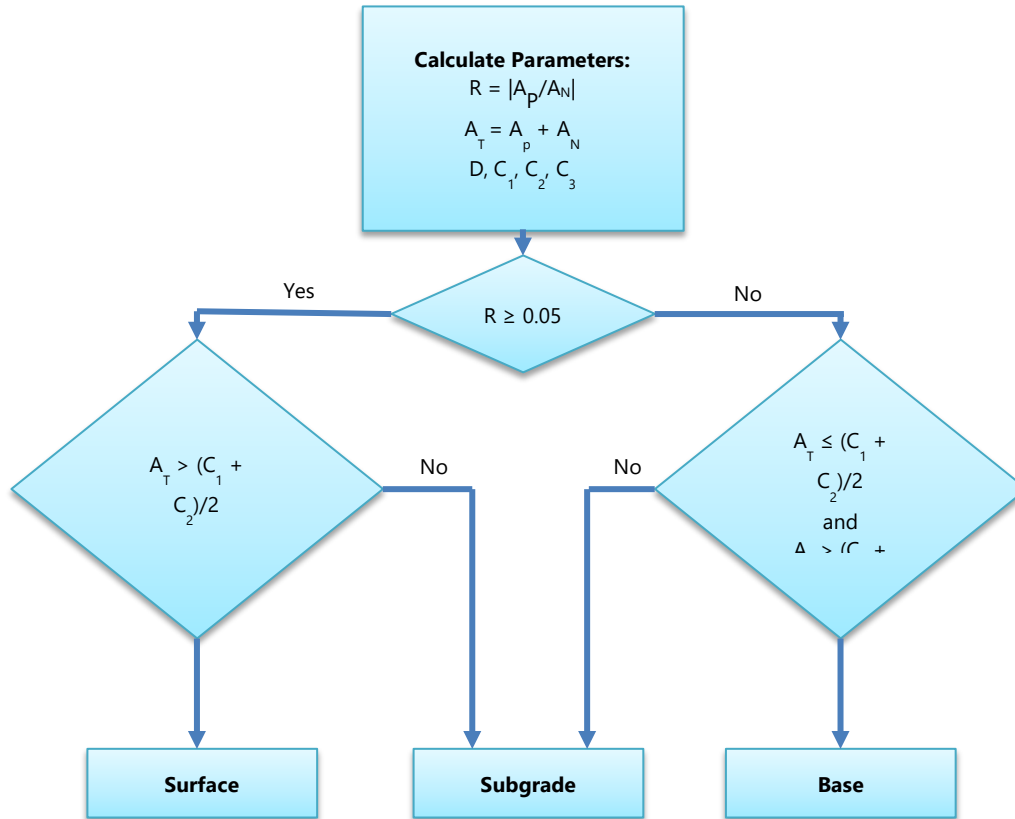
**Figure 18. Failure layer determination using methodology by White et al. (2002)**

The methodology consists of two key steps: calculation of distortion parameters and the use of criteria to classify the lowest layer in the pavement structure contributing to the ruts. Distortion parameters include the maximum rut depth ( $D$ ), positive area, and negative area of a transverse profile. For each profile, the wire method is used to assess the maximum rut depth, which is the greatest perpendicular distance measured from the pavement surface to the wire reference line as depicted in Figure 17. Similarly, the positive area ( $A_P$ ) and negative area ( $A_N$ ) are the sum of the areas above and below the transverse profile reference line, respectively. Using these parameters, the ratio of positive area to negative area ( $R$ ), total area ( $A_T$ ), and the theoretical total areas for the HMA, base, and subgrade failure ( $C_1$ ,  $C_2$ , and  $C_3$ , respectively) are calculated and used to assess the failed layer. The assessment of the parameters used to determine the lowest layer contributing to the pavement's surface deformation is described in Figure 18.

Based on the analysis conducted for each of the transverse profiles of the test section (profiles spaced at 50 ft) for the collection dates between September 1989 and June 2013, the predominant lowest layer contributing to rutting was calculated for each date of collection at multiple locations along the section. For most years, the predominant layer contributing to rutting was the surface layer as shown in Table 4. Based on an interview with ITD staff, it is hypothesized that the rutting observed prior to 1990 may have been related to the AC thickness, annual pavement temperature, the binder used, and to a lesser extent, the increase in agricultural and constructed-related traffic along the roadway. Additionally, while there may have been some studded tires used on this road, studded tire and chain abrasion in the winter months were not considered as significantly impacting rut measurements.
