Technical Memorandum

To: Jeff Uhlmeier
From: Lauren Gardner, Gonzalo Rada, and Kevin Senn
cc: Mustafa Mohamedali
Date: December 11, 2020
Re. Forensic Desktop Study Report: Minnesota LTPP Test Section 27_6251

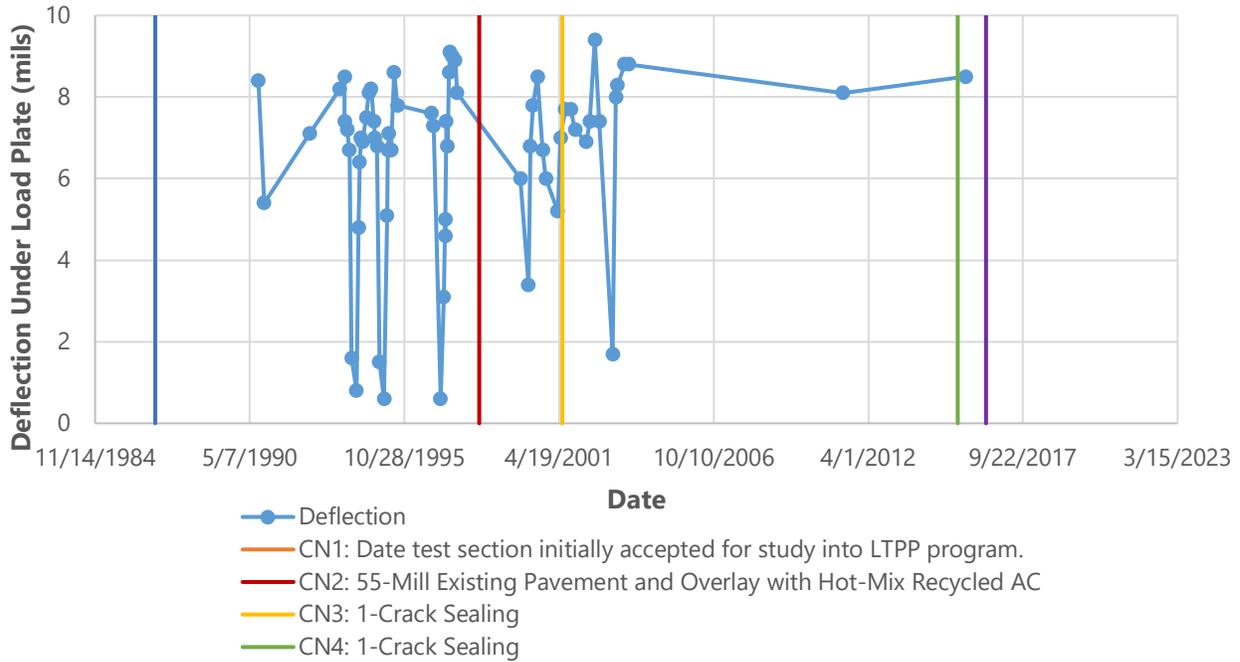
Figure 1. FWD deflections under the load plate over time.

Figure 1 and Figure 2 show the average Falling Weight Deflectometer (FWD) deflections under the nominal 9,000-pound load plate during the entire period the test section was in study (Figure 1) and during the SMP analysis period (Figure 2). The deflection of the sensor located in the center of the load plate is a general indication of the total "strength" or response of all layers in the pavement structure to a

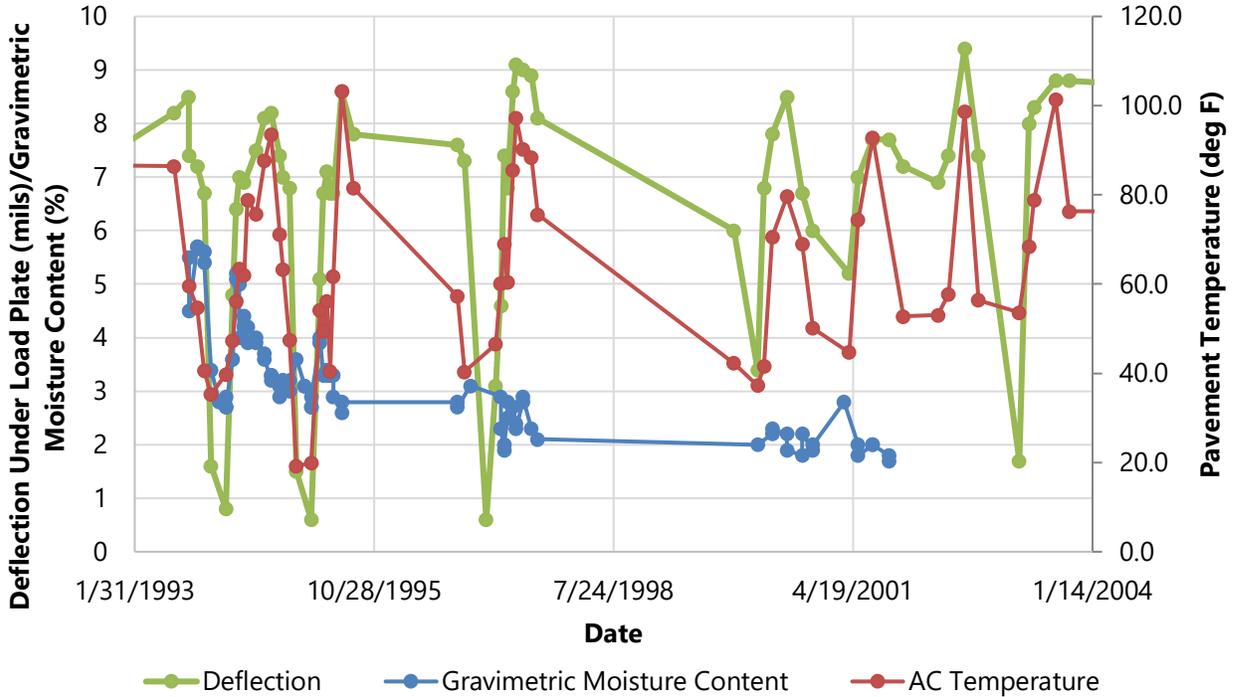
Figure 2. Comparison of a) FWD deflections under the load plate (Sensor 1), b) the average temperature of the pavement taken at a depth of 1-inch below the surface, and c) the gravimetric moisture content at a depth of 24 inches below the surface of the pavement (TDR 3).

As depicted in Figure 2, the change in deflection under the load plate over time appears to be directly related to the change in pavement temperature over time. For the most part, increases and decreases in deflections correspond to increases and decreases in the pavement temperature. The relationship between the average deflection and moisture content of the test section is less clear. It is generally expected that as the moisture content increases, deflections will also increase, but this does not appear to be the case.

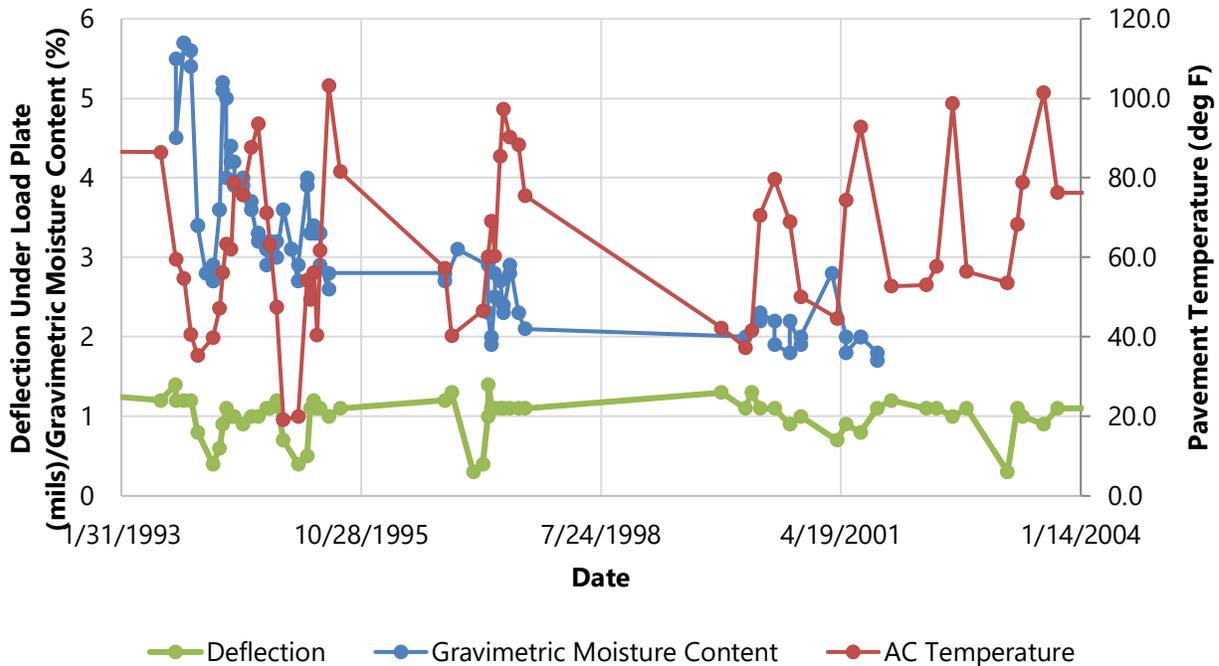
Figure 3. Comparison of a) FWD deflections the sensor farthest from the load plate (60”), b) the average temperature of the pavement taken at a depth of 1-inch below the surface, and c) the gravimetric moisture content at a depth of 24 inches below the surface of the pavement (TDR 3).

Because of how the FWD (or other) load is distributed on an AC pavement, deflections at the farthest sensor are due almost in their entirety to the subgrade response (i.e., little to no influence from AC and base layers). As shown in Figure 2 and Figure 3, the deflections observed can be influenced by pavement temperature at the time of testing and moisture conditions. The gravimetric moisture content shown in both figures was calculated from Time Domain Reflectometry (TDR) sensor data collected at a depth of 24 inches below the surface of the pavement, i.e., within the subgrade. The pavement temperature depicted in the figures represents the average pavement temperature at the time of testing 1-inch below the surface (measured during FWD testing), i.e., within the AC layer.

In Figure 3, on the other hand, the change in deflection measured at the farthest sensor from the load plate appears to have little relationship with both the change in moisture content and the change in temperature over time. It is generally expected that as the moisture content increases, deflections will also increase, but this does not appear to be the case.

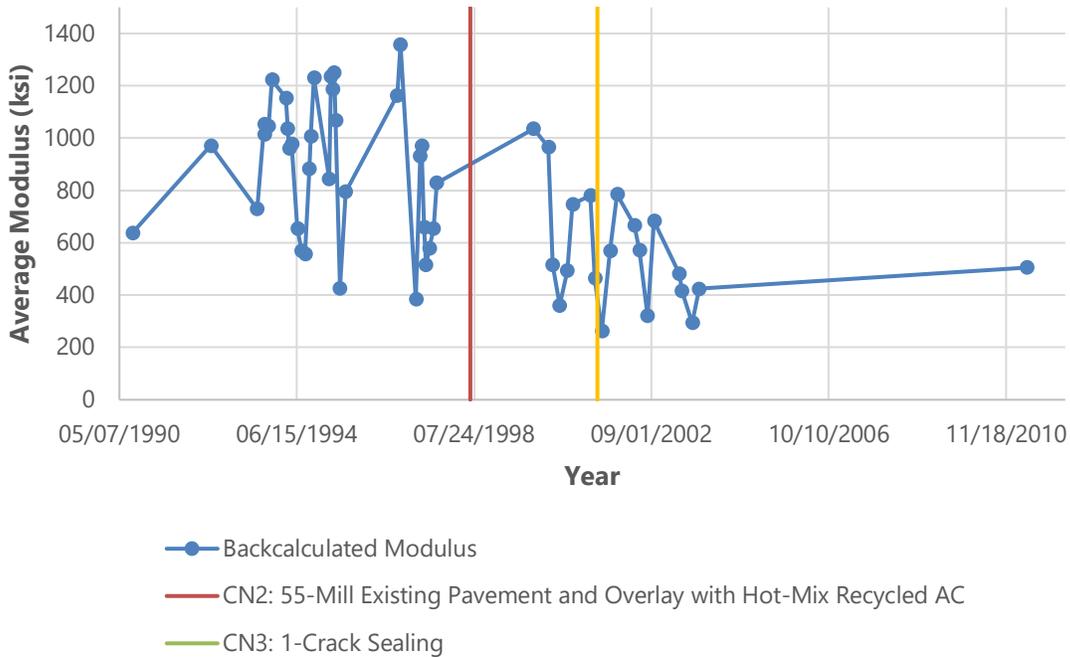
Figure 4. Average backcalculated modulus for AC (Layer 1).

For the most part, the range of moduli values calculated for each layer appear to be reasonable. However, for each layer, statistical outliers were removed from the dataset. This included data from:

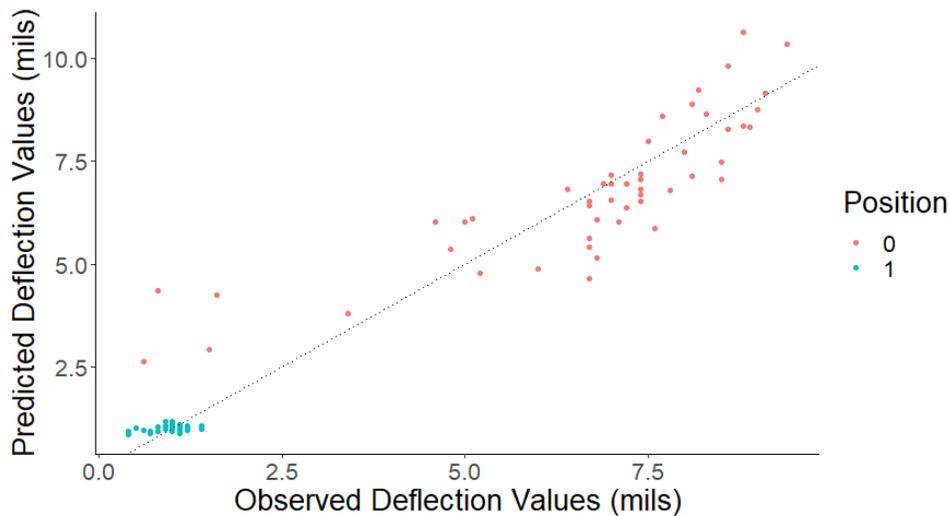
Figure 11. Predicted versus observed values of pavement deflection.

The scatter plot of the predicted deflection values from the model versus the actual measured deflection values is shown in Figure 11. This plot shows a good correlation between measured and predicted deflection values with a coefficient of determination (R²) of 0.92. The R² shows that 92% variability of deflection data can be explained by the variables in the model.

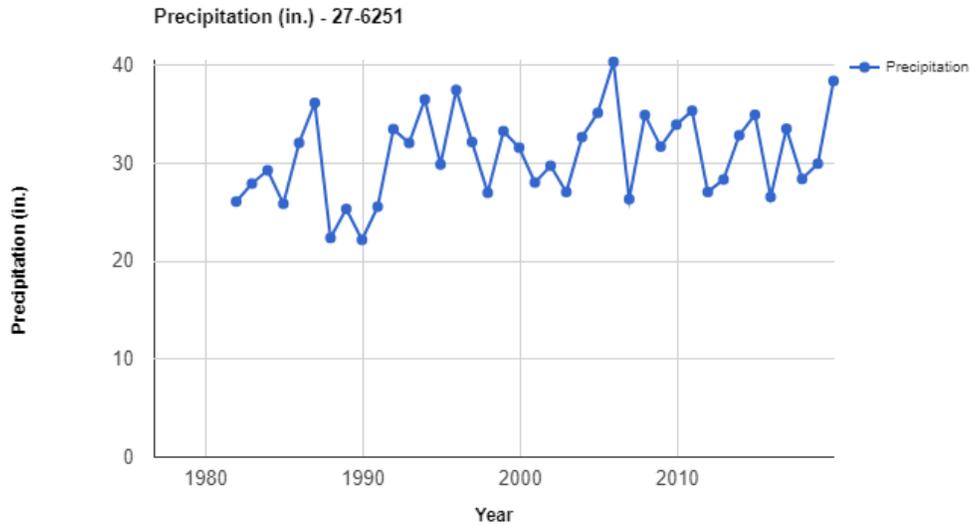
Figure 12. Average yearly precipitation over time.

The time history for average annual precipitation (from Modern-Era Retrospective analysis for Research and Applications or MERRA) since 1981 is shown in Figure 12. Prior to the mill and overlay event in 1998, the average yearly precipitation was approximately 29.5 inches. Following the mill and overlay event, the average yearly precipitation was slightly higher; approximately 31.8 inches.

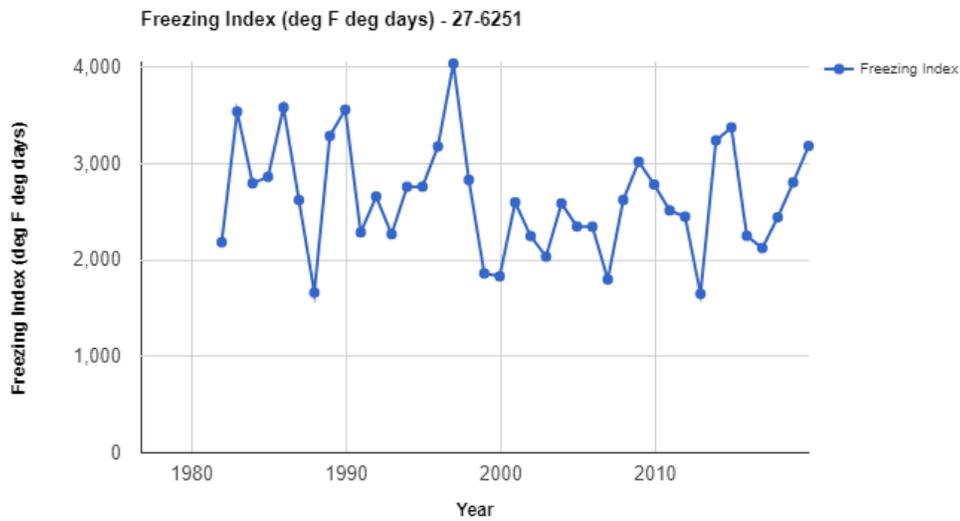
Figure 13. Average annual freezing index over time.

Figure 13 shows the time history of the average annual freezing index (from MERRA) for the test site. The freezing index is the summation of the difference between freezing temperature and the average air temperature when it is less than freezing over a year’s time. This index is an indicator of the harshness of the winter season relative to issues such as ground frost and low temperature cracking in pavements. As depicted in Figure 13, the freezing index values ranged from 1,649 deg F deg days (2012) to 4,037 deg F deg days (1996). During the first performance period, prior to the mill and overlay event (1981-1997), the average annual freezing index was 2,875 deg F deg days. Following the mill and overlay event, between 1998 and 2019, the average annual freezing index decreased to 2,459 deg F deg days. All freezing indices reported during the analysis period are well above the 150 deg F deg days used to classify a freeze region.

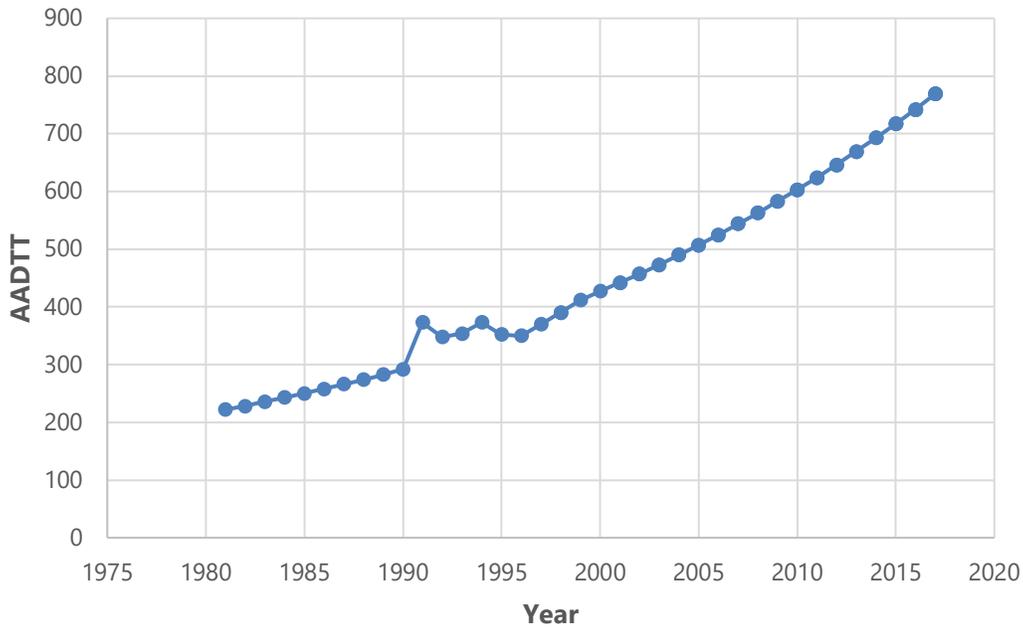
Figure 14. Average annual daily truck traffic (AADTT) history.

Figure 14 shows the annual average daily truck traffic (AADTT) data in the LTPP test lane by year. The annual truck traffic increased from 222 in 1981 to 769 in 2017, or approximately 15 additional trucks per day per year. The average number of ESALs reported on the section also increased over time as depicted in Figure 15. The number of ESALs increased from 11,029 in 1981 to 151,570 in 2017. A combination of historical AADTT values (1981-1989), state provided AADTT values (1990 and 1996-1998), monitored values (1991-1995), and values calculated using a compound growth function (1999-2017) were used to report traffic along these test sections. Additionally, for the ESAL data reported in years when a major construction event occurred (such as the mill and overlay in 1998 and crack sealing in 2001 and 2015), the average annual ESALs was reported twice—once using data collected prior to the construction event and a second time after the construction event. For example, in 1998, when the mill and overlay event occurred
