Technical Memorandum

Re. Forensic Desktop Study Report: Colorado SPS-2 Test Sections 0216, 0218, 0223 and 0224

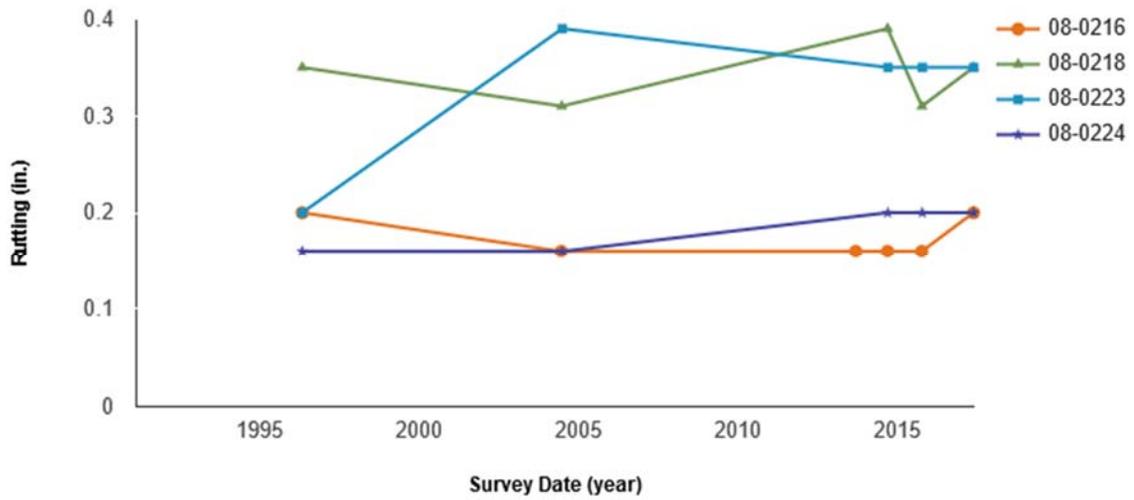
Although typically collected on asphalt pavements, a Dipstick[®] was occasionally used to measure transverse profile on the four concrete SPS-2 sections in this study. For concrete pavements, wheel path ruts develop as a result of surface wear (paste and aggregate) and the distress is classified as rutting in LTPP. Figure 21 shows the rutting time history from Dipstick[®] data. Rut depths measured in March 1996, three years after construction began, ranged from 0.16 to 0.35 inches. Some questions have been raised regarding whether these measurements are a true indication of rutting.

Figure 21. Time history plot of average rut depth computations.

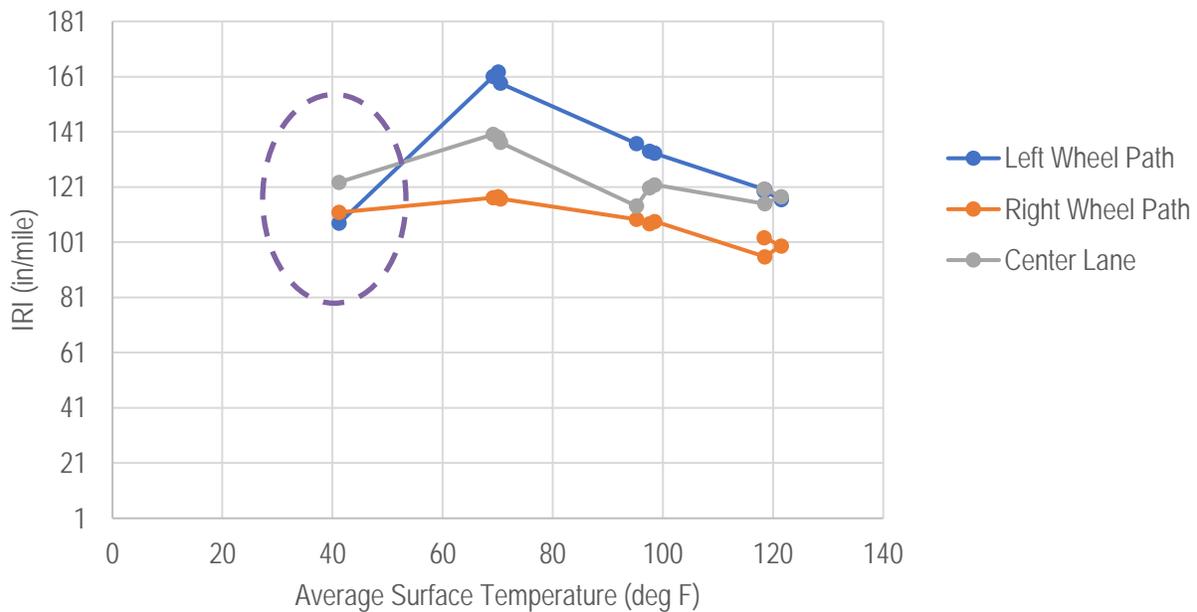
The 2019 diurnal profile testing and 2020 profile data were plotted and compared for each section. On sections 080216 and 080224 (Figures 29 and 32), the 2020 IRI values decrease as the temperature decreases when compared to the 2019 IRI values. This would mean the IRI values follow a slight concave down trend, where the IRI values start low at low temperatures and increase as temperatures increase, then start to decrease as temperature further increases. For section 080218 (Figure 30), the center lane and left wheel path IRI values remain constant as the temperature decreased from about 70°F in 2019 to 44°F in 2020 while the right wheel path IRI decreases from about 165 inches/mile in 2019 to 132 inches/mile in 2020. Lastly, for section 080223 (Figure 31) the IRI values for the center lane and both left and right wheel path remain the same in 2020 when compared to the early morning IRI values from 2019, indicating the IRI could remain low at low temperatures, but then being to increase at temperatures above 80°F.

Figure 29. Section 080216 IRI versus temperature, 2019 and 2020 (circled) profile data.

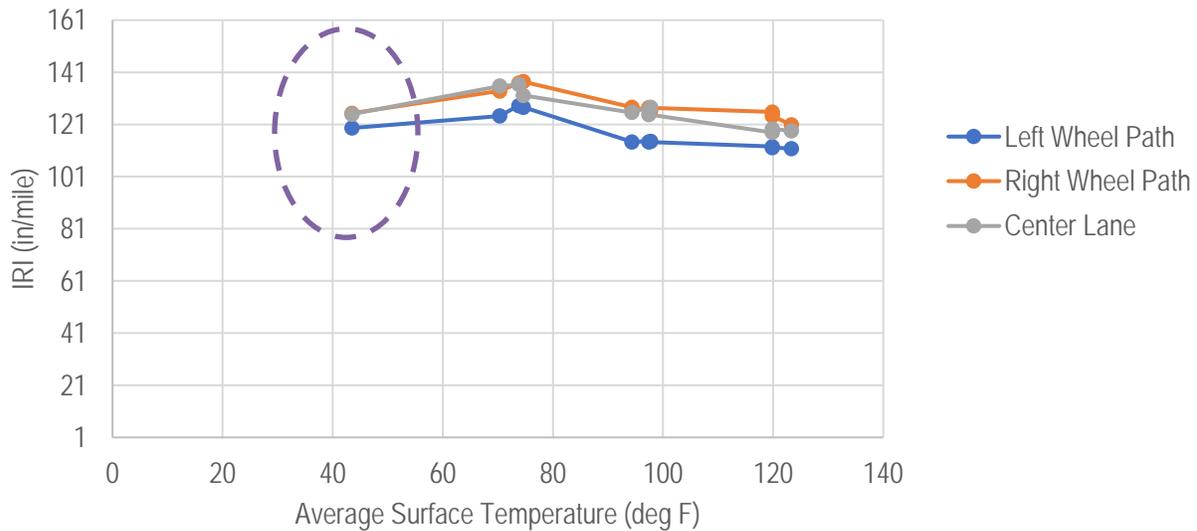
Figure 32. Section 080224 IRI versus temperature, 2019 and 2020 (circled) profile data.

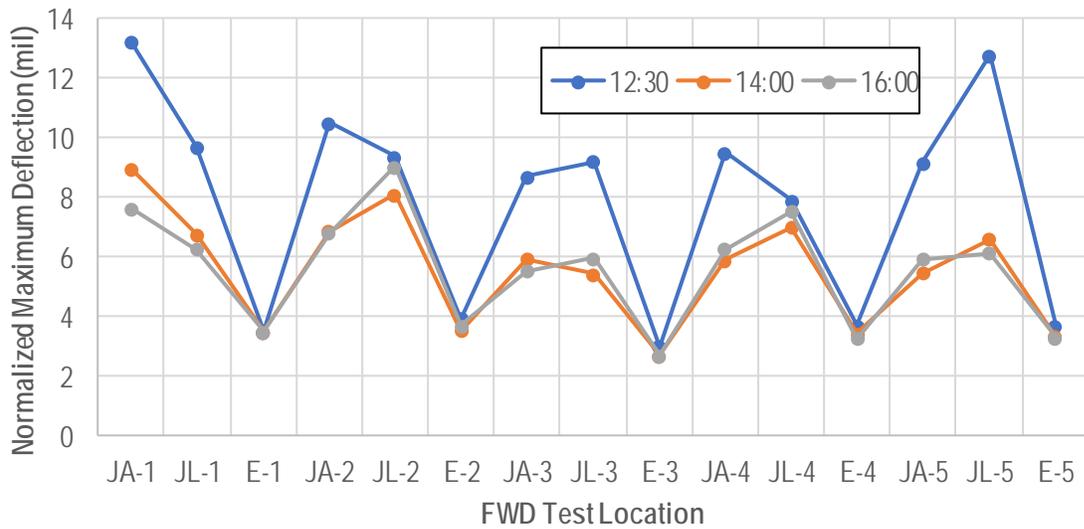
Nominal maximum deflections were also plotted per FWD test point for sections 080223 and 080224 as illustrated in Figure 35 and Figure 36, respectively. JA-X represents an approach side of a joint, JL-X represents the leave side of a joint, E-X represents a slab edge, and X representing the joint or slab edge number. On both sections, the larger deflections occur at the joints, with section 080223 experiencing a larger drop from the morning to early afternoon tests compared to section 080224. The deflections then remain unchanged from the early afternoon to late afternoon for both sections.

An observation of note is the deflections at the slab edges remain virtually identical across all three test times for both sections. It is possible the slab edges are still tied to the shoulder and have limited curling movement associated with changing temperature. The decrease in deflections at the joints could be due to the slab having a downward curvature as the slab temperature increases and the slabs come into higher contact with the base layer. This would provide additional stiffness that would cause a reduction in deflections with this change in temperature.

Figure 35. Normalized maximum deflection per test point for 080223.

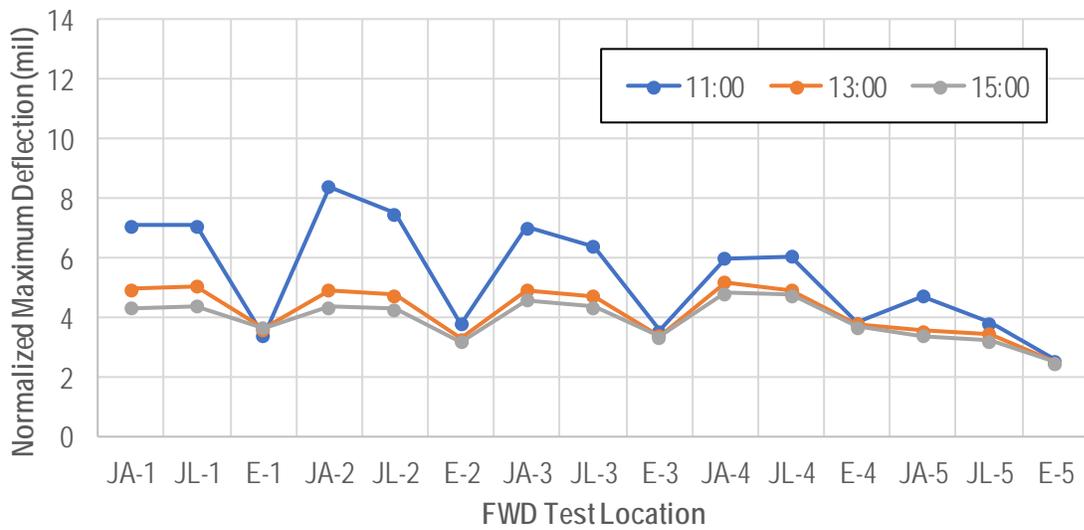
Figure 36. Normalized maximum deflection per test point for 080224.

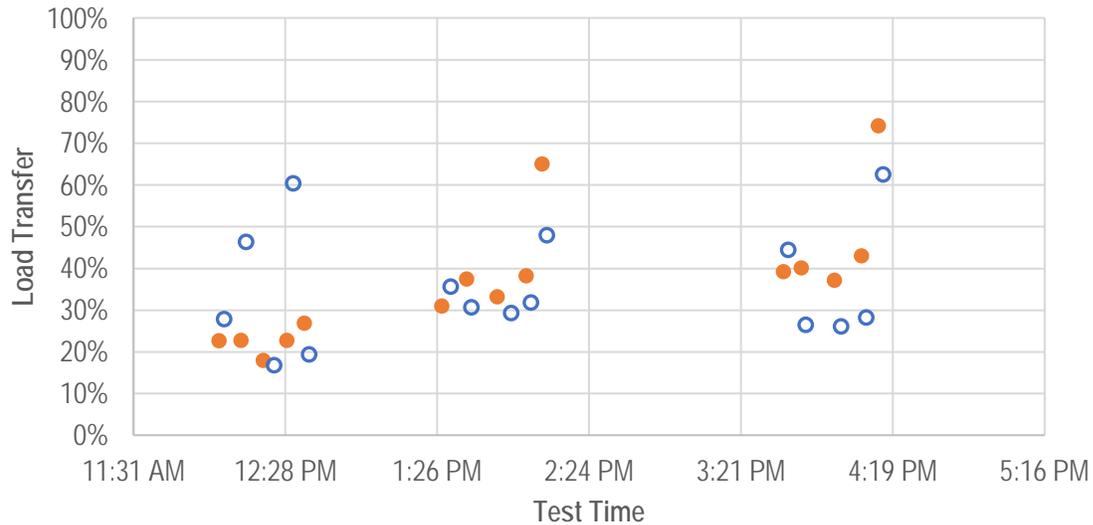
Load transfer across each joint was calculated on both the approach and leave sides of each joint. Figures 37 and 38 illustrate the load transfer for sections 080223 and 080224, respectively. The average load transfers for both sections compare favorably to the values shown in Figure 17. On section 080223, the load transfer values are low in the morning and increase throughout the day. On Section 080224, the load transfer values are very high in the morning and slightly decrease throughout the day.

the additional support provided by the base layer, resulting in lower deflections on the loaded joint and causing the load transfer to increase.

Figure 37. Time history plot of load transfer efficiency at approach (solid orange) and leave (blue) joints for 080223.
