Technical Memorandum

Re. Forensic Desktop Study Report: New Mexico LTPP Test Sections 35_0801 and 35_0802

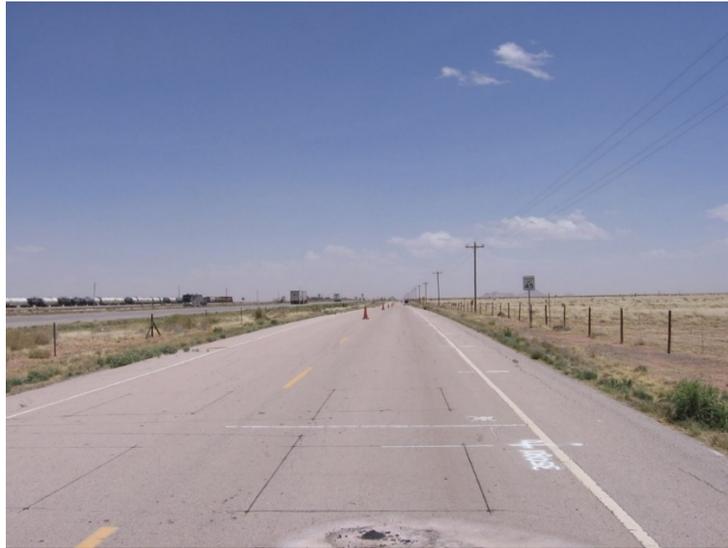
Photograph 1. Picture of test section 35_0801 (start of section) in 2014 looking eastbound.

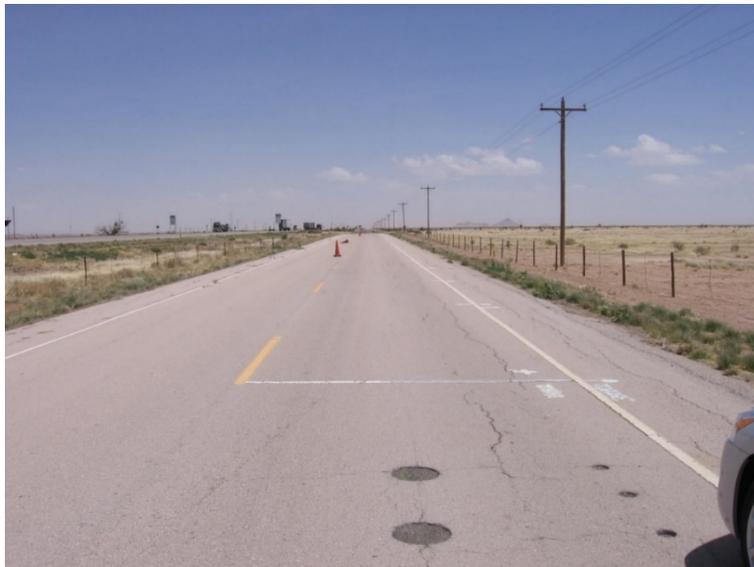
Photograph 2. Picture of test section 35_0802 (beginning of section) in 2014 looking eastbound.

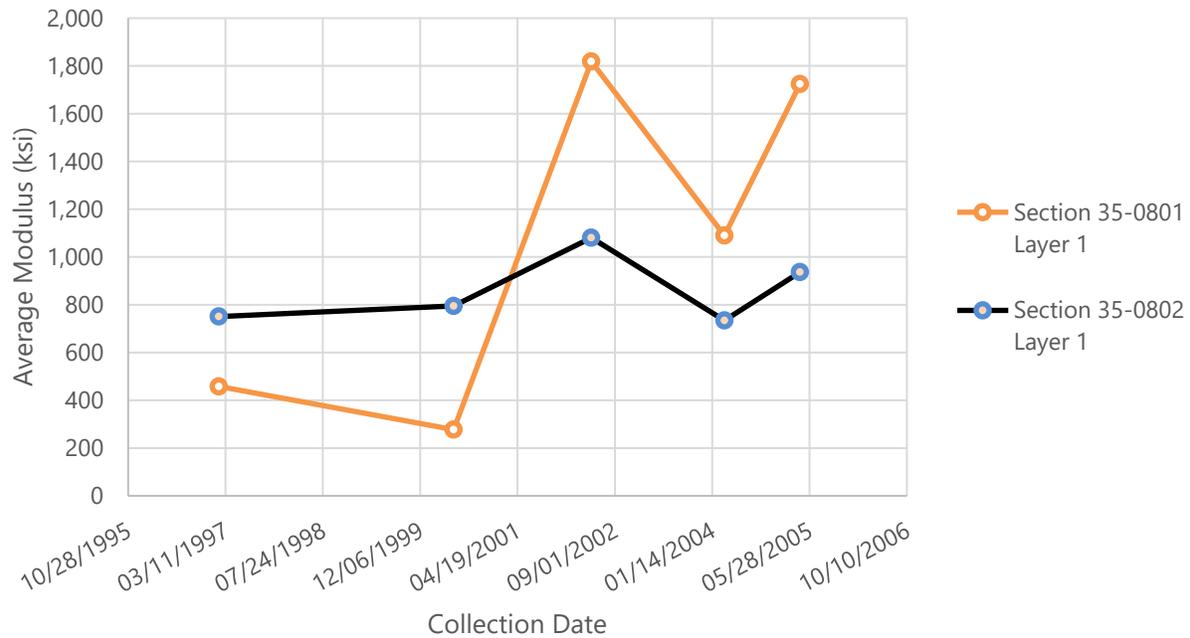
Figure 2. Average modulus of AC layers for test sections over time.

Based on the results provided, one potential cause for the unreasonable values reported for the asphalt and base layers is that compensating layer effects occurred during backcalculation. The compensating layer effect is the result of the way the modulus of each layer is calculated, from the subgrade upward. While the values of the subgrade moduli appear to be reasonable, the values collected in subsequent layers (i.e. base and asphalt layers) result in calculated values that over or underestimate the modulus as the model aims to compensate for errors incurred through the iterative backcalculation process. Therefore, high values for a base layer may result in low moduli values for the asphalt layer as is the case for section 35_0802 between 1997 and 2000. However, the compensating layer effect does not describe all behaviors described by the data after 2000. Another round of FWD testing and moduli analysis is recommended to better understand and confirm these results.

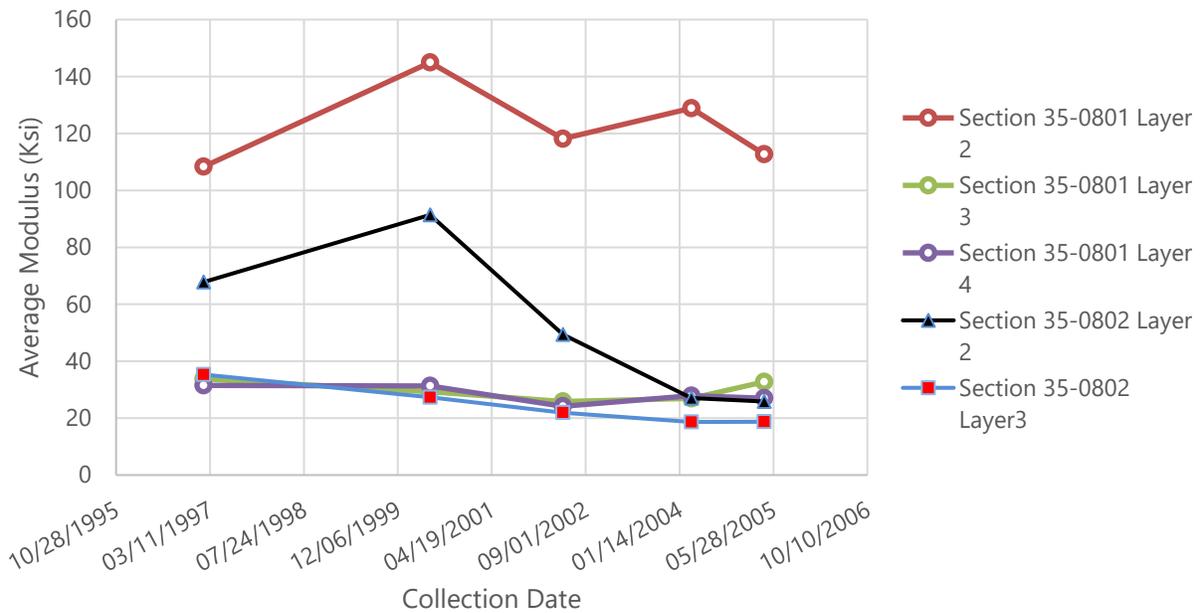
2. The average modulus of the coarse granular base (Layer 2) of section 35_0801 is consistently greater than the average modulus for the same layer in section 35_0802, and the moduli reported for the section are unreasonably high. The average modulus during the 1997 collection date was 108 ksi and 68 ksi for section 35_0801 and section 35_0802, respectively, while in 2005 the average modulus was 113 ksi and 26 ksi, respectively. Additionally, as depicted in Figure 3, the average modulus for the granular base of section 35_0802 drops after the 2000 data collection. This behavior may indicate an increase in moisture in this layer over time.

Figure 3. Average modulus of base and subgrade layers for test sections over time.

- The average moduli of the two test sections for the coarse subgrade layers is similar throughout time. The reported subgrade modulus of section 35_0801 was 34 ksi and 31 ksi in 1997, while for section 35_0802 it was 35 ksi. The reported subgrade modulus of section 35_0801 was 33 ksi and 27 ksi in 1997, while for section 35_0802 it was 19 ksi.

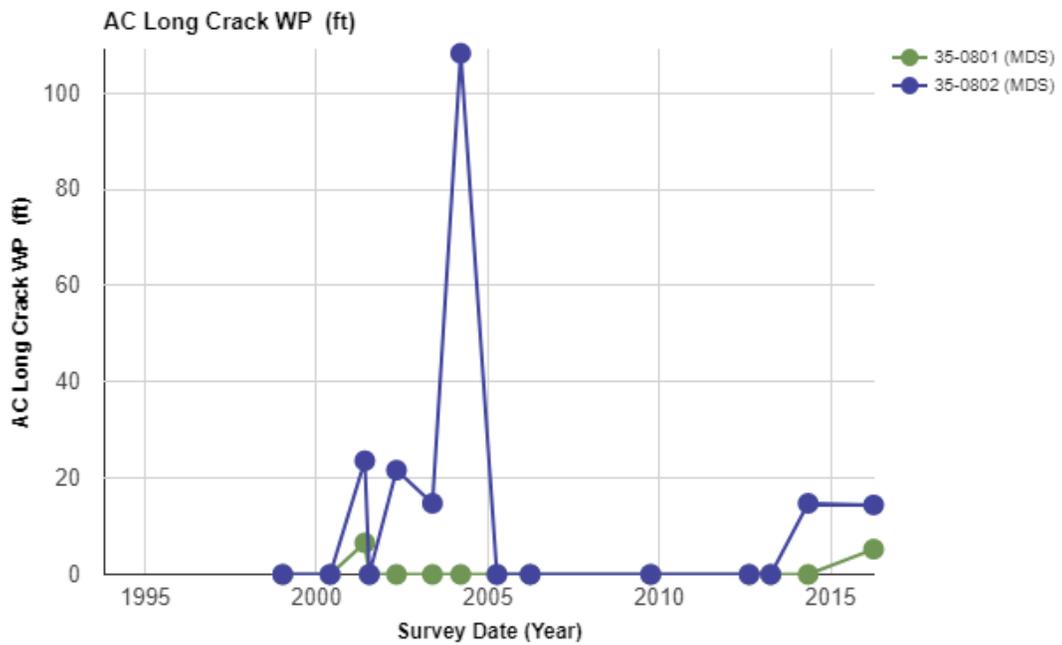
Data on longitudinal cracking, inside and outside the wheelpath of the test sections, was collected between 1999 and 2016 as shown in Figures 8 and 9. For both sections, minimal longitudinal cracking was observed inside the wheelpath. In test section 35_0801, 5.25 feet of longitudinal cracking was observed during the last survey of the site while 14.43 feet of longitudinal cracking was observed inside the wheelpath of test section 35_0802 during the last data collection at the site. In Figure 8, a few of the collection years indicate spikes in the amount of longitudinal cracking inside the wheelpath. However, these spikes may be attributed to the inconsistent interpretation of low severity longitudinal cracking within the wheelpath and fatigue cracking – fatigue cracking is associated with “random cracking and meandering,” which is difficult to objectively determine in some cases.

Figure 8. Total longitudinal cracking on the wheelpath over time.

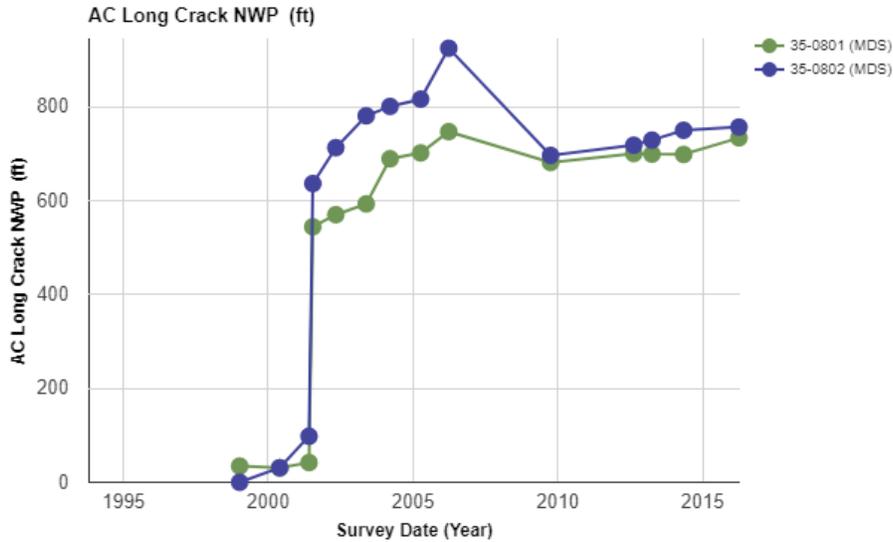
Figure 9. Total longitudinal cracking, non-wheelpath over time.

Unlike longitudinal cracking observed inside the wheelpath, the non-wheelpath (NWP) longitudinal cracking for both test sections increased over time. Figure 9 depicts the increase in NWP longitudinal cracking observed on both sections between 1999 and 2016. Both test sections experienced a steady increase in NWP longitudinal cracking between 1999 and 2001, followed by a sharp increase in July of 2001. By 2009, both test sections' NWP longitudinal cracking plateaued. The final measurement of NWP longitudinal cracking observed for test section 35_0801 was 733.74 feet, while the final measurement observed for section 35_0802 was 756.70 feet. Throughout the distress history of both sections, the NWP longitudinal cracking measurements are consistent between the two sections. The increase in NWP longitudinal cracking is likely a reflection of changes made to the distress survey definitions. In the early days of the LTPP program, non-wheelpath cracking was restricted to inside the edge of lane lines despite multiple cracks being observed on or very near the lane marking. The jump in longitudinal cracking observed is reflective of changes in the non-wheelpath longitudinal cracking definition where cracks on or near pavement markings were only included in the total count after 2001.

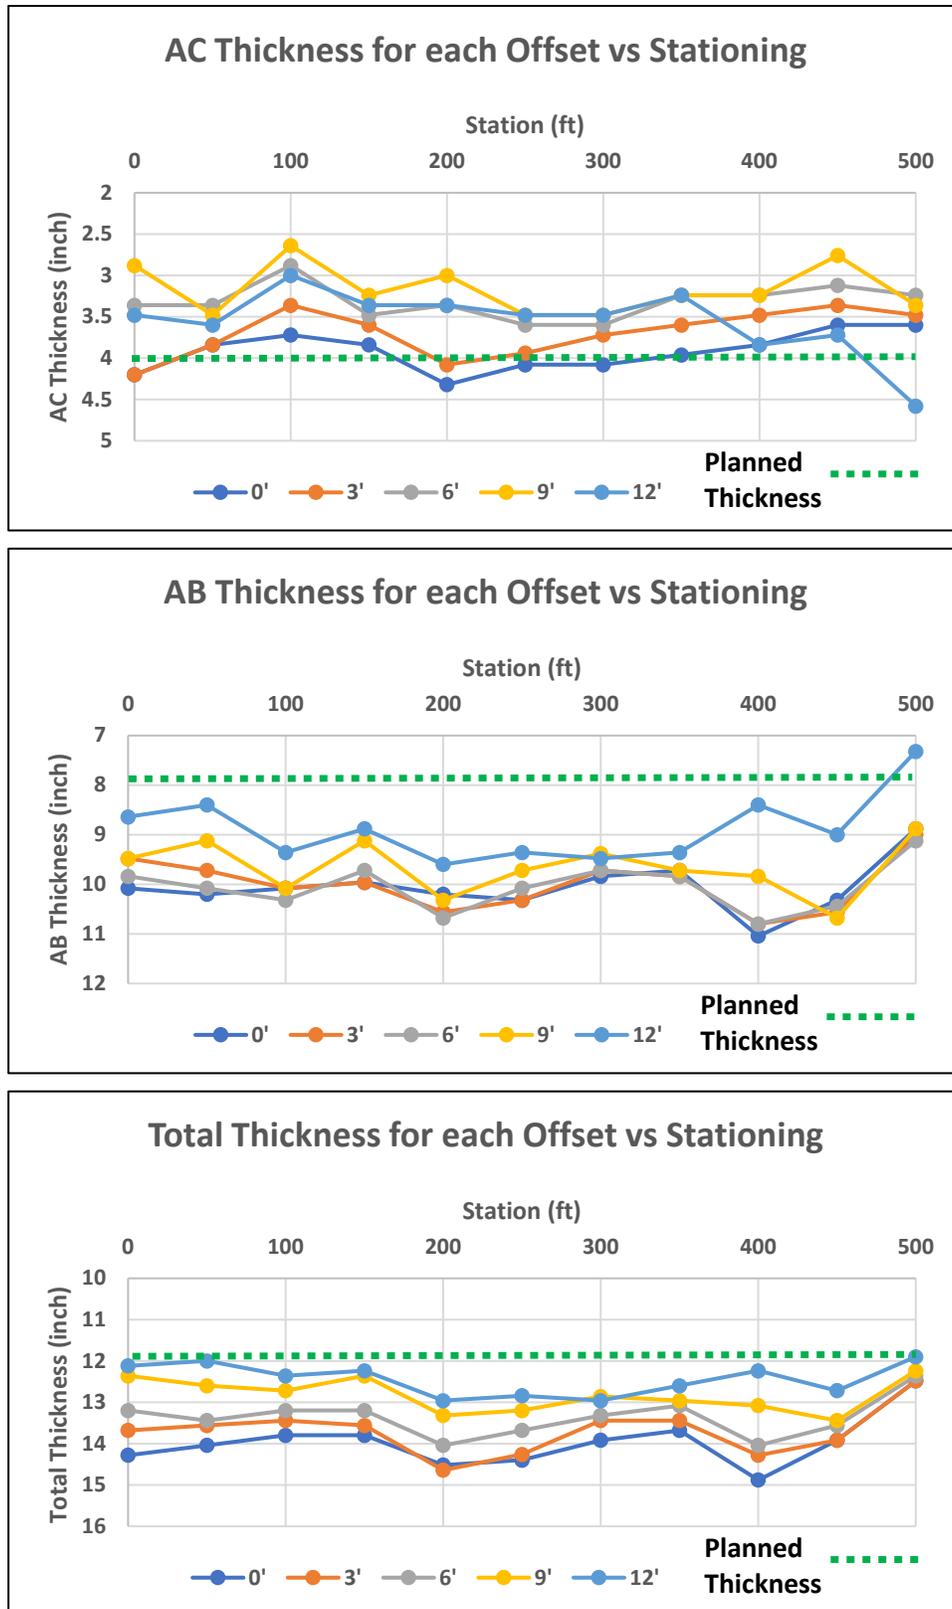
The report also noted that despite several attempts to provide a uniform AB thickness, the aggregate base layer of test section 35_0801 ranged from 7.3 to 11 inches (despite having a planned thickness of 8 inches), when measured with a rod and level. Similarly, the AC thickness of test section 35_0801 also varied, ranging from 2.6 to 4.6 inches (compared to a planned thickness of 4 inches and the average thickness of 3.9 inches estimated from the cores). Test section 35_0802 showed similar variation in layer thicknesses. The AB thickness of test section 35_0802 ranged from 10 inches to 14 inches (despite having a planned thickness of 12 inches), while the AC thickness ranged from 5.6 inches to 7.5 inches (compared to a planned thickness of 7 inches and the average thickness of 6.8 inches estimated from the cores). The variation in the AC layer thicknesses was compared to the observed fatigue/alligator cracking reported in the manual distress surveys for the test sections to determine if the variations in layer thicknesses played a role in the fatigue cracking observed or specifically, if areas of fatigue/alligator cracking were associated with areas where the AC layer was thinnest. However, it was found that there was no clear relationship between the amount and severity of the fatigue/alligator cracking in areas with thinner AC layers. Figures 15 and 16 illustrate the layer thicknesses for each section at 50-foot intervals.

Figure 15. Summary of AC (top), AB (middle), and Total Pavement Thickness (bottom) for test section 35_0801, with the green line representing the planned thickness for each layer.

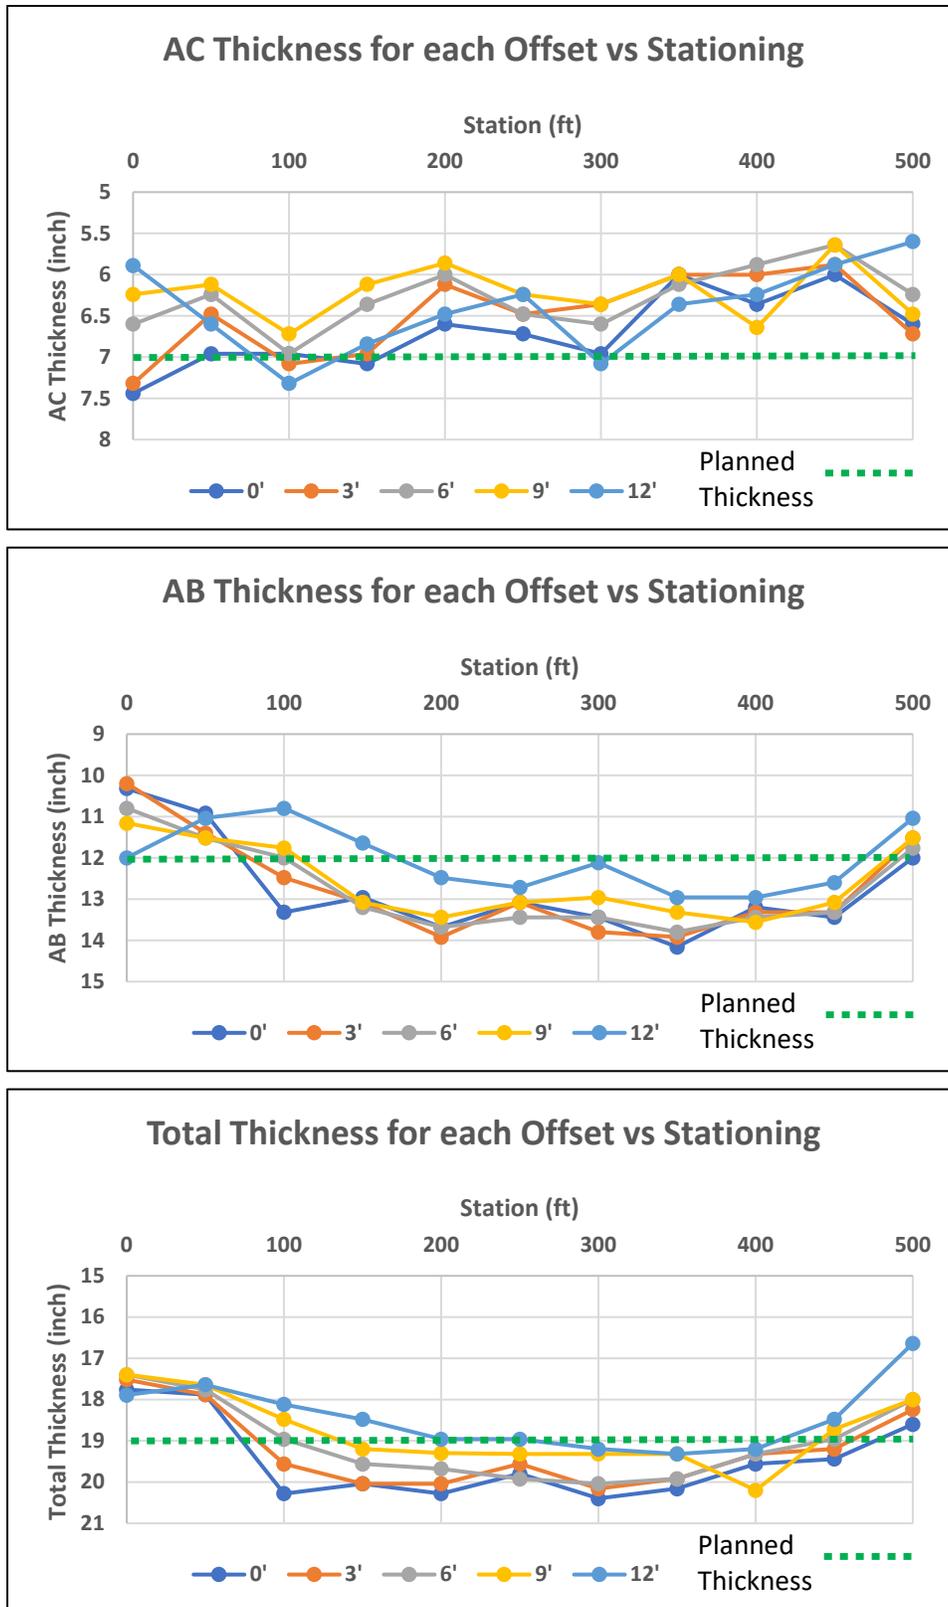
Figure 16. Summary of AC (top), AB (middle), and Total Pavement Thickness (bottom) for test section 35_0802, with the green line representing the planned thickness for each layer.
