Technical Memorandum

Date: August 15, 2019 (original), June 30, 2020 (revised)

Re: Forensic Desktop Study Report: LTPP Test Section 48_1111

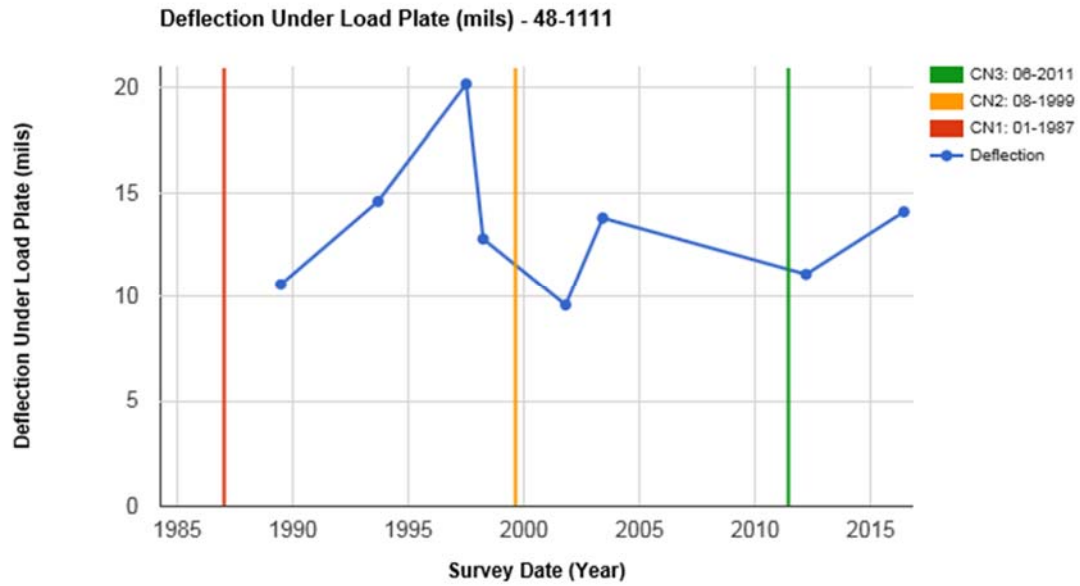
Figure 1. Time history of average deflection for the sensor located in the load plate normalized to 9,000 lb. drop load.

Figure 1 shows the time history average FWD deflection plot under the nominal 9,000 lb. load from the sensor position in the load plate. The deflection of the sensor located in the load plate is a general indication of the total “strength” or response of all layers in the pavement structure to a vertically applied load. This deflection can be influenced by pavement temperature at the time of testing, precipitation, and changes in pavement structure. As shown, deflections have remained relatively constant between 10 and 15 mils, over the life of the pavement, with the exception of the ~20 mil measurement in 1997. The 1999 overlay appears to have provided added structural capacity as reflected by the smaller deflections in 2002, and to a lesser degree the 2011 chip seal. Overall, the center sensor (under the load plate) deflection time history magnitudes are judged to be relatively consistent with respect to natural variations in FWD measurements and low for a rural principal arterial AC pavement. This indicates a “strong” pavement structure.

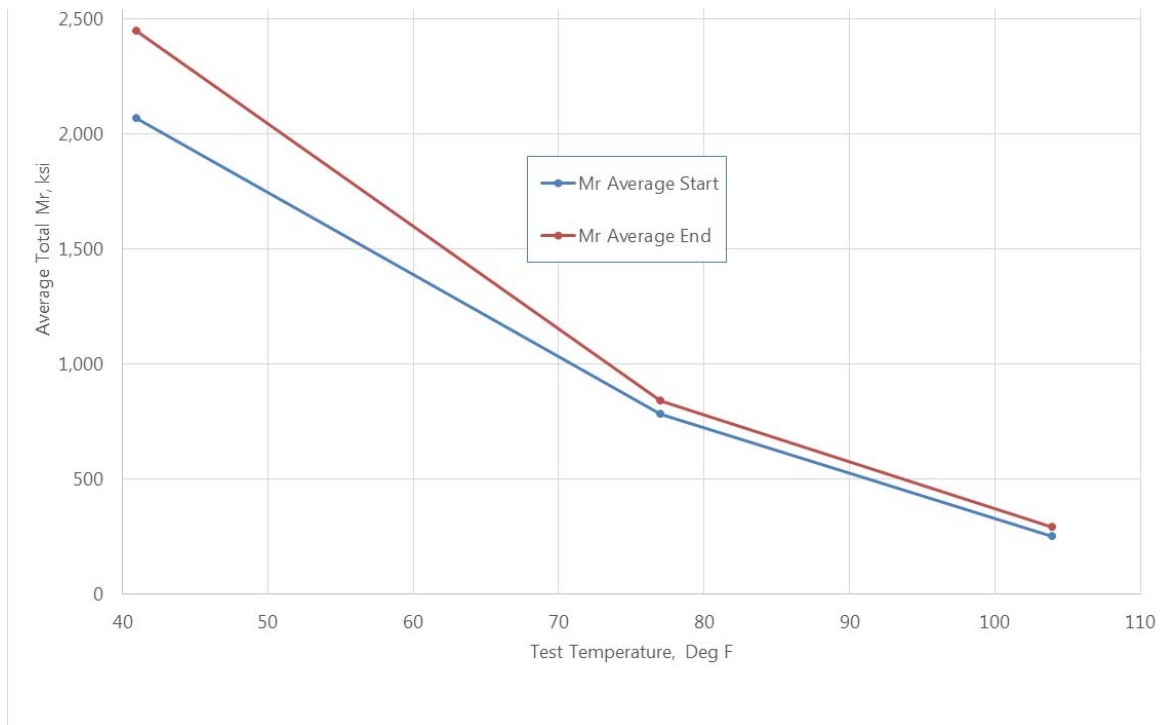
Figure 2. Average total resilient modulus versus test temperature from laboratory tests on samples of the overlay placed in 1999 from the start and end of the test section.

Figure 2 shows the laboratory measured average total resilient modulus - temperature relationship for the 2.6-inch overlay layer placed in 1999. This is the only AC pavement layer for which laboratory resilient modulus results are available. While the results in this plot only come from the top 2.3 inches of the total 9.5 inch AC layer thickness, they are consistent with the layer moduli backcalculated from the field FWD deflection data, which ranged between 200 and 750 ksi.

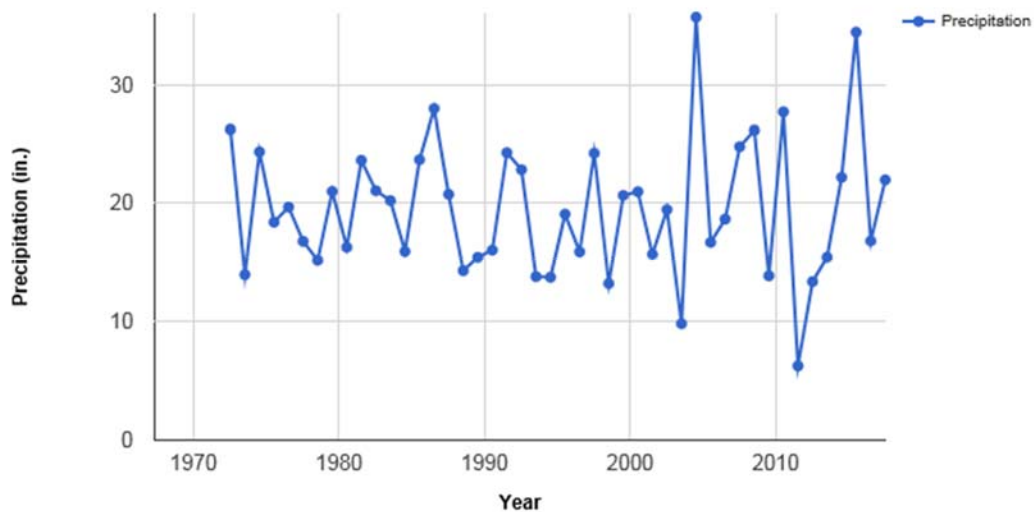
Figure 3. History of annual precipitation starting in 1973.

The time history for annual average precipitation since 1972 is shown in Figure 3. In 2004, the amount of precipitation appears to be a local high (37.4 inches) at the site, while the low (6.3 inches) was recorded in 2011. Neither of these measurements are considered to drastically deviate from the mean at the site (19.6 inches for time period in question), nor do they appear to have resulted in drastic changes in pavement distresses or pavement response.

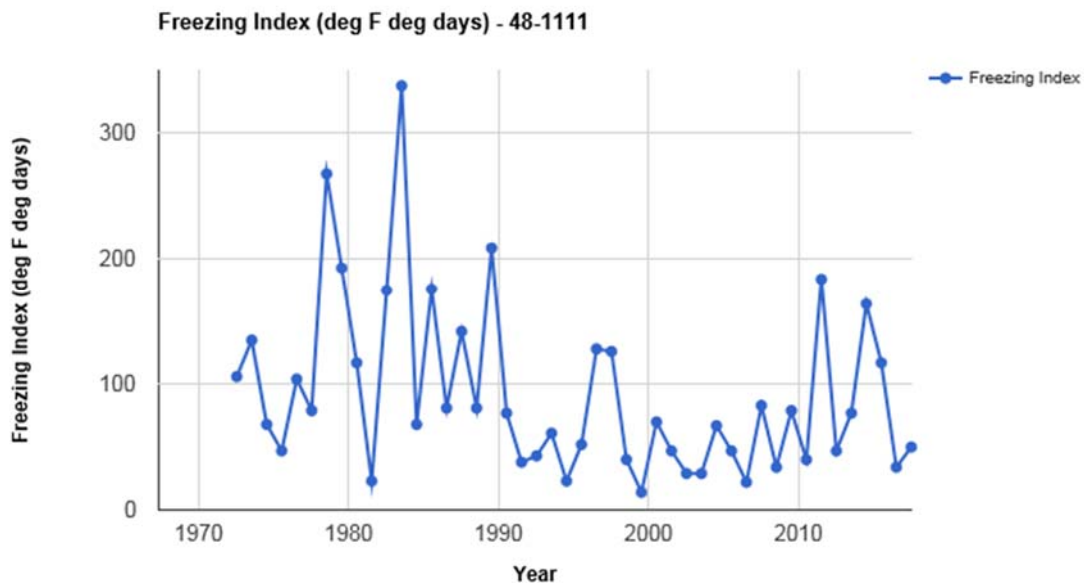
Figure 4. Time history of annual air temperature freezing index.

Figure 4 shows the time history of the annual freezing index over the history of this test section. The freezing index is the sum of the difference between 32 degrees F and when the average air temperature is less than freezing and 32 degrees F for each day, which is summed over a year's time. This index is an indicator of the harshness of the winter season relative to issues such as ground frost and low temperature cracking in pavements. A large spike in extreme low temperatures can be observed in 1983, well before the test section was incorporated into the LTPP program; however, there does not appear to be any significant impacts on the performance of the pavement.

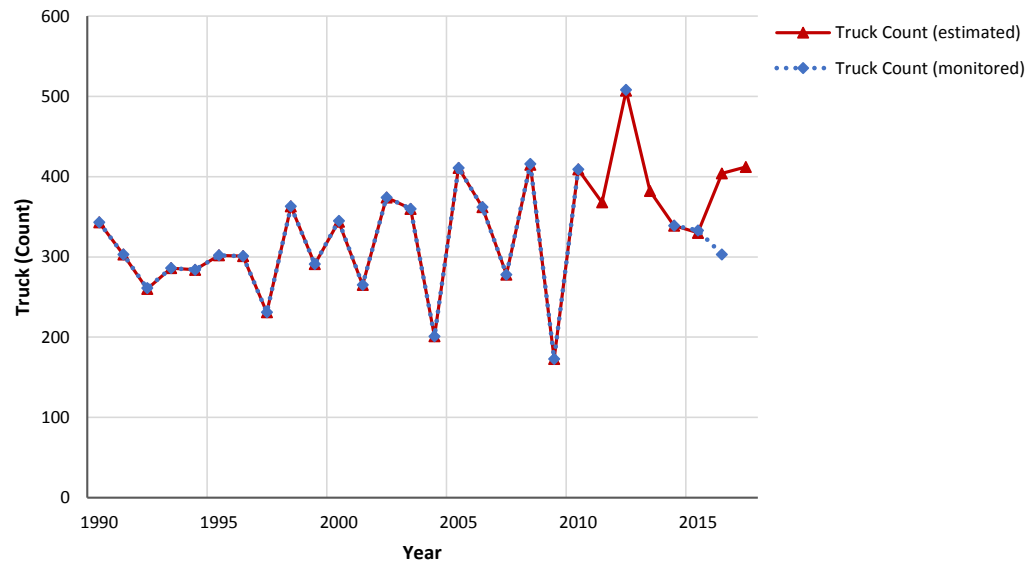
Figure 5. Average annual daily truck traffic on test section 531005 based on state supplied estimates and monitoring measurements.

Figure 5 shows the annual truck volume data in the LTPP test lane by year. The red triangles are data provided by the Texas DOT (TxDOT) from historical records. The blue diamonds are truck counts based on monitoring data reported to LTPP by TxDOT. While not perfect, there appears to be agreement between the estimated and monitored counts. The figure also shows that there has been a gradual annual increase in truck volumes.

The desktop study discusses the historical traffic volumes in the LTPP test lane as determined by TxDOT, which is illustrated in Figure 5. The results show that up until 2010 the estimated average daily truck traffic on the LTPP section was around 400 trucks per day. The data then indicates a substantial increase of up to 300 trucks per day after 2010.

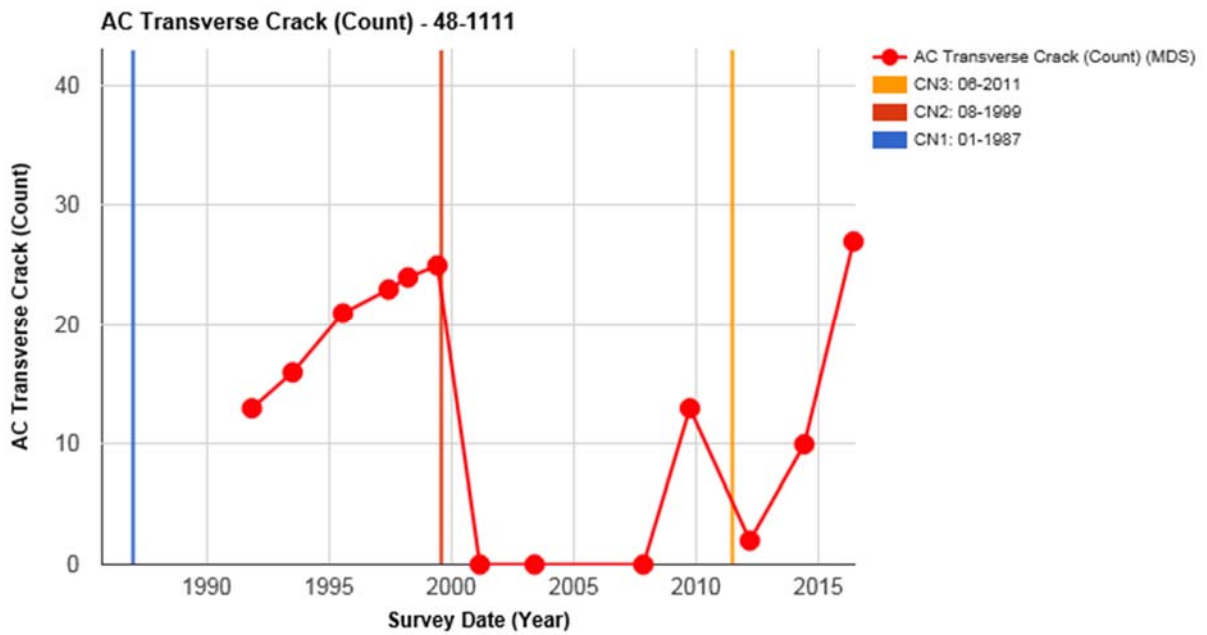
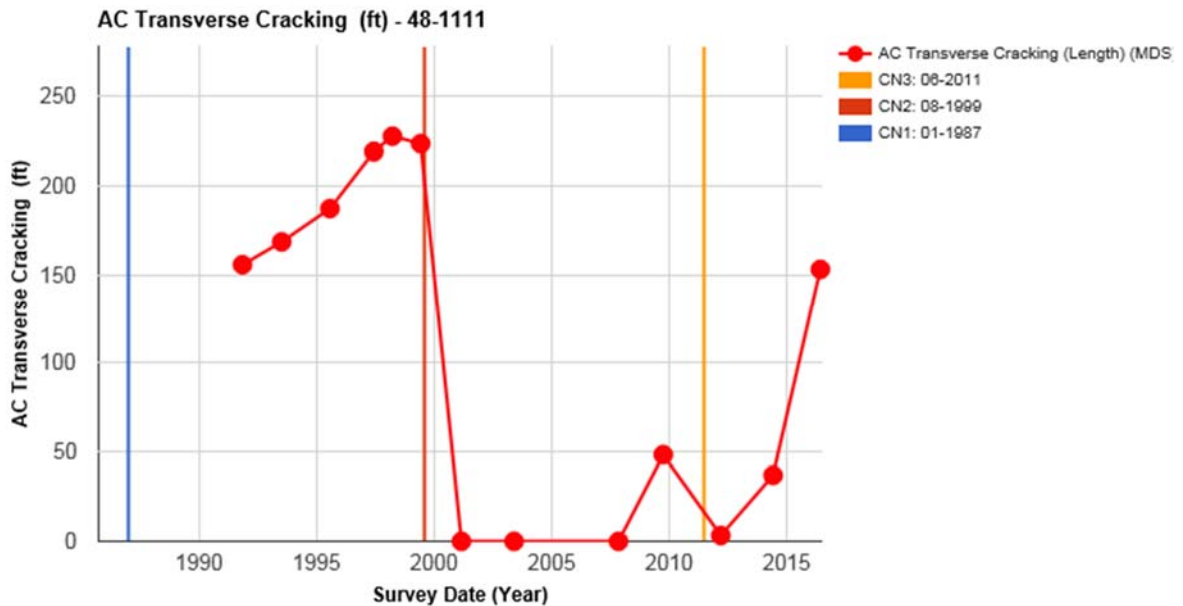
While there are no significant distresses on this test section, the following paragraphs address those distresses observed at the test section between 1991 and 2016. Figures 6 and 7 show the time history of the number and length of transverse cracks, respectively, on the pavement. In this figure, the construction events are shown with vertical lines – the period this investigation focuses on goes from the start of CN = 2 in 1999 to date, which captures the performance of the asphalt concrete overlay. The distress data shown are from manual distress surveys. As shown in these two figures, the number and length of transverse cracking steadily increased when the test section was first introduced into the LTPP program, but then dropped to zero after the 1999 AC overlay, and it remained at that level until around 2010, when it again began to steadily increase.

Figure 6. Time history of the number of transverse cracks.

Figure 7. Time history of length of transverse cracks.

- It is suggested that the influence of the woven geotextile on the performance of the pavement test section be investigated. A possible way of doing this is to do transverse cracking coring to see if the cracks on surface are reflection cracks from previous transverse cracks, which would support the idea that the fabric retarded reflection cracking for an extended period of time.

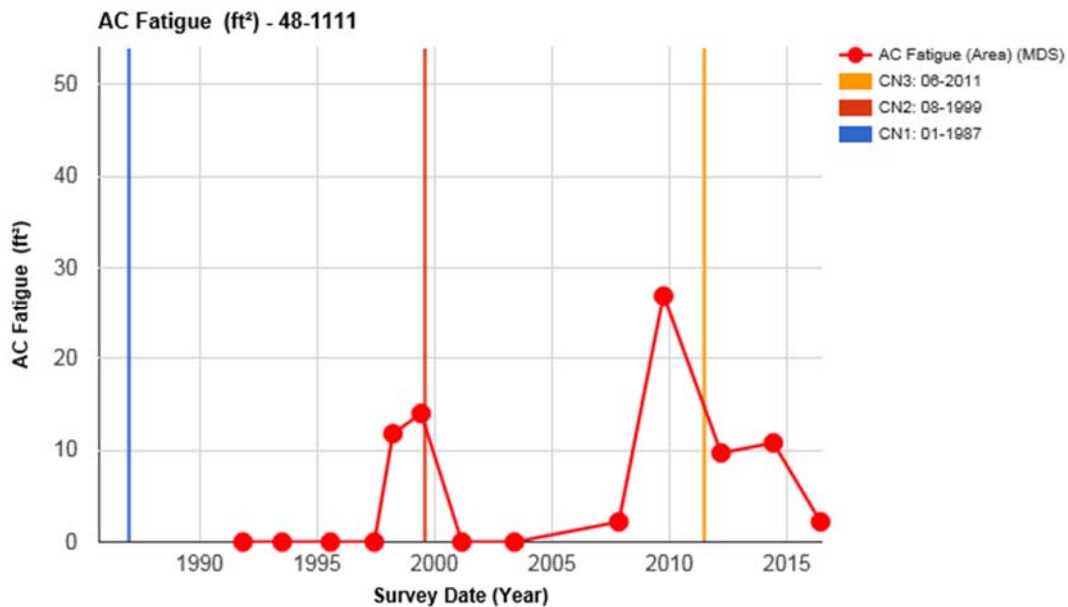
Figure 8. Time history of area of alligator cracking.

Figure 8 shows the time history plot of alligator cracking data on LTPP test section 48_1111. While the plot is labeled fatigue cracking, in the LTPP distress rating system, this is alligator cracking that is not limited to the wheel path. As shown, the amounts of alligator cracking on this test section are relatively low. Figure 8 also shows that the chip seal placed in 2011 reduced the amount of alligator cracking and appears to have helped keep it low for the next several years. However, it is noted on the distress survey form that the reason for the drop in area of alligator cracking from 2014 to 2016 was due to apparent healing of the surface, i.e. excess asphalt intrusion into the previous cracks. Bleeding was also noted in the wheel paths where this alligator cracking occurred.

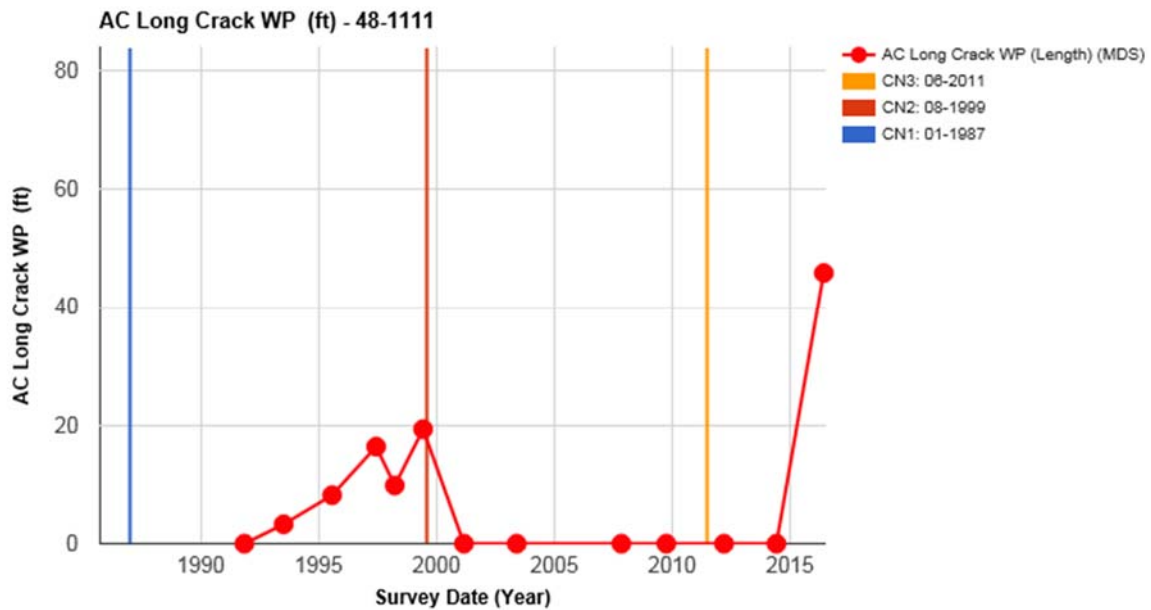
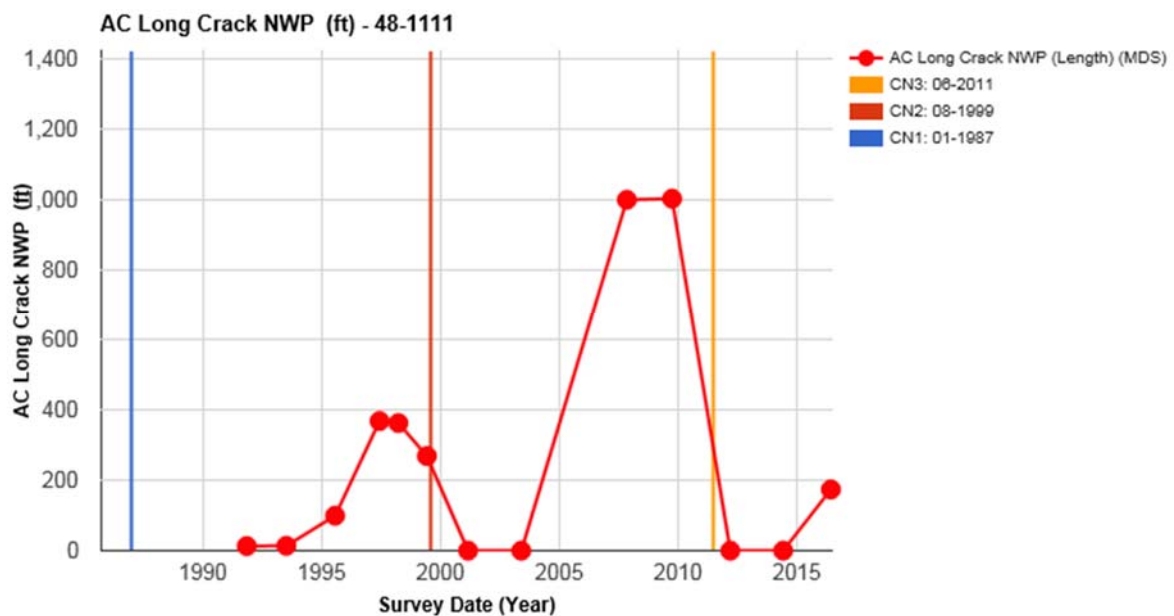
Figure 9 shows the time history plot of longitudinal cracking in the wheel path (WP), which can be considered as an indicator of fatigue cracking on a pavement, while Figure 10 shows the time history plot of longitudinal cracking not in the wheel path (NWP). As shown in Figure 9, WP longitudinal cracking after the 1999 overlay was non-existent until the 2016 distress survey. Figure 10, on the other hand, shows that NWP longitudinal cracking was eliminated after the AC overlay, but resurfaced in 2008 and remained constant until after application of the 2011 chip seal, which eliminated the cracking until 2014. In 2016, NWP longitudinal cracking, which is located at the longitudinal joint between the lanes, re-appeared.

Figure 9. Time history of longitudinal cracking in the wheel path.

Figure 10. Time history of longitudinal cracking not in the wheel path.

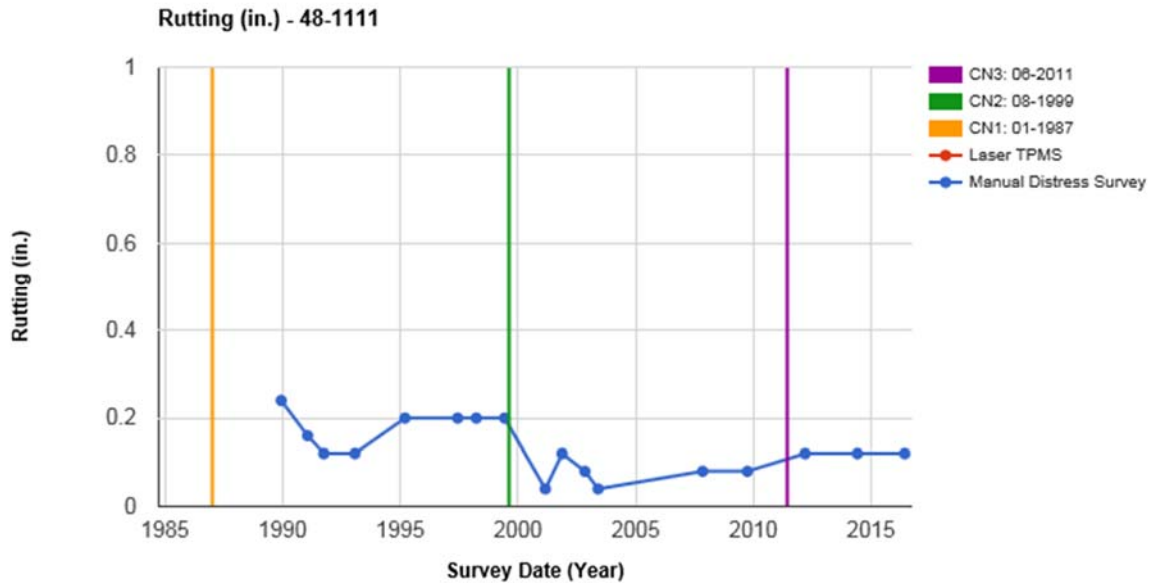
Figure 11. Time history plot of average rut depth computations.

The time history plot of rutting on the test section is shown in Figure 11. As shown, rutting of the pavement test sections has remained under 0.2 inches throughout the life of the pavement and close to 0.1 inches since the application of the 2.6 inch AC overlay in 1999.

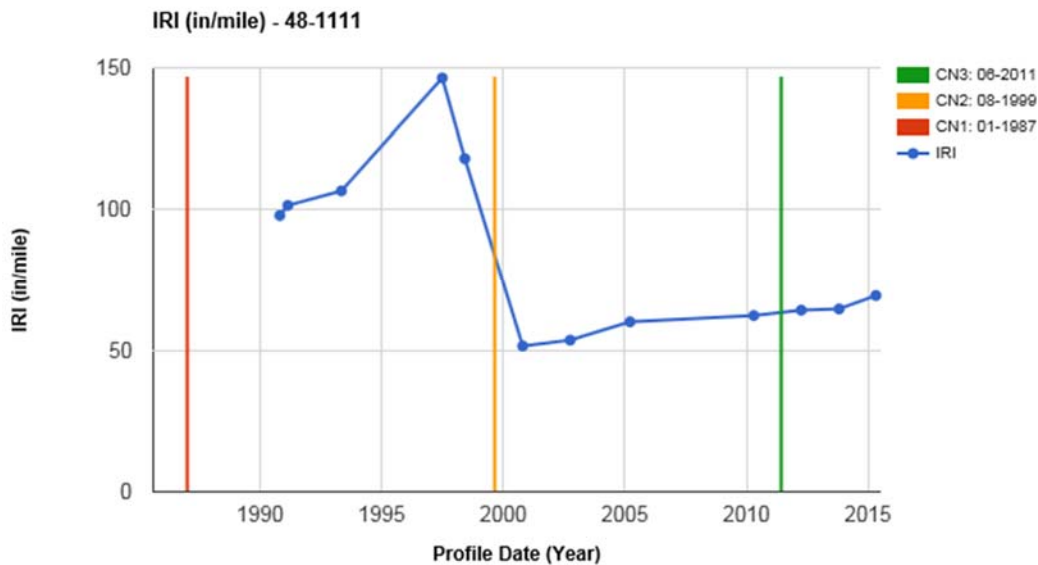
Figure 12. Time history plot of pavement roughness.

Similarly, the time history of roughness measurements is shown in Figure 12. As shown, after placement of the AC overlay in 1999, the IRI of the pavement test section dropped to around 52 inches/mile and it has only increased 17 inches/mile to 69 inches/mile by 2015, which is the date of the last survey – a fairly constant increase of ~1 inch/mile per year. Another interesting fact is that the IRI before and after the 2011 chip seal is nearly identical.

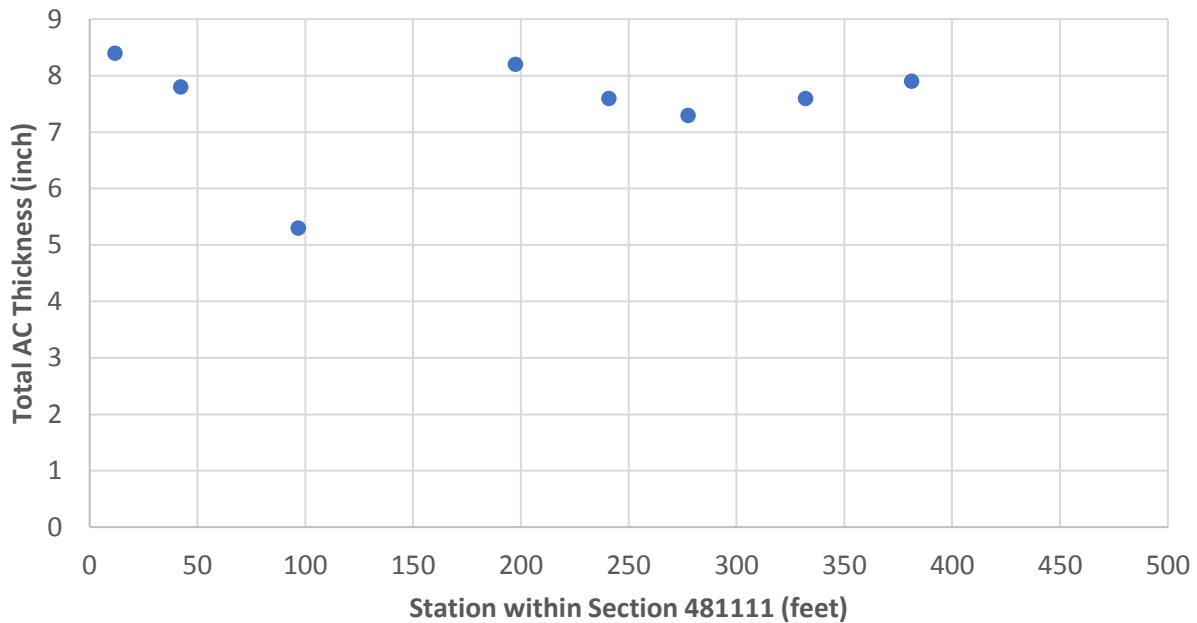
Figure 14. Plotted total AC thicknesses from cores obtained within section 48_1111.

Eight core samples were obtained from Section 48_1111. Two additional cores were planned between stations 381 and 500 but, due to time constraints and equipment problems, were not obtained. The cores show that the chip seal and AC overlay are relatively uniform in thickness, ranging from a combined 2.2 inches to 2.4 inches. There is some layer variation in the lower AC layers, which show a wider range of thicknesses. The total thickness of the AC section on top of the aggregate base varies from 5.3 inches up to 8.4 inches. The core measurements are summarized in Table 7 and total AC thickness shown in Figure 14.

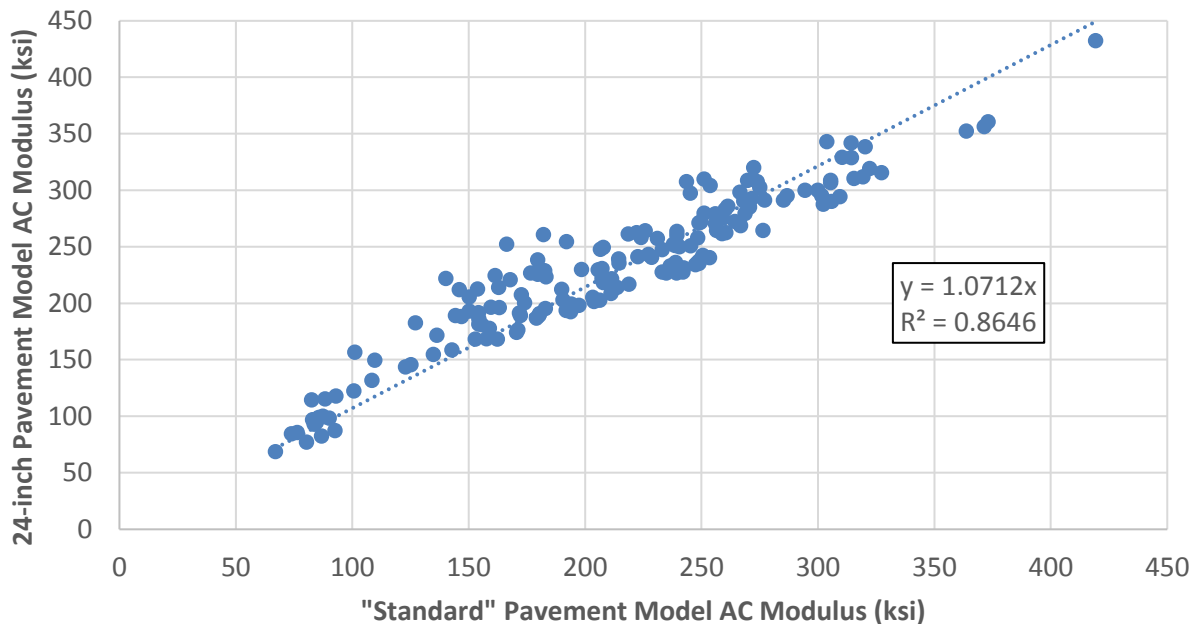
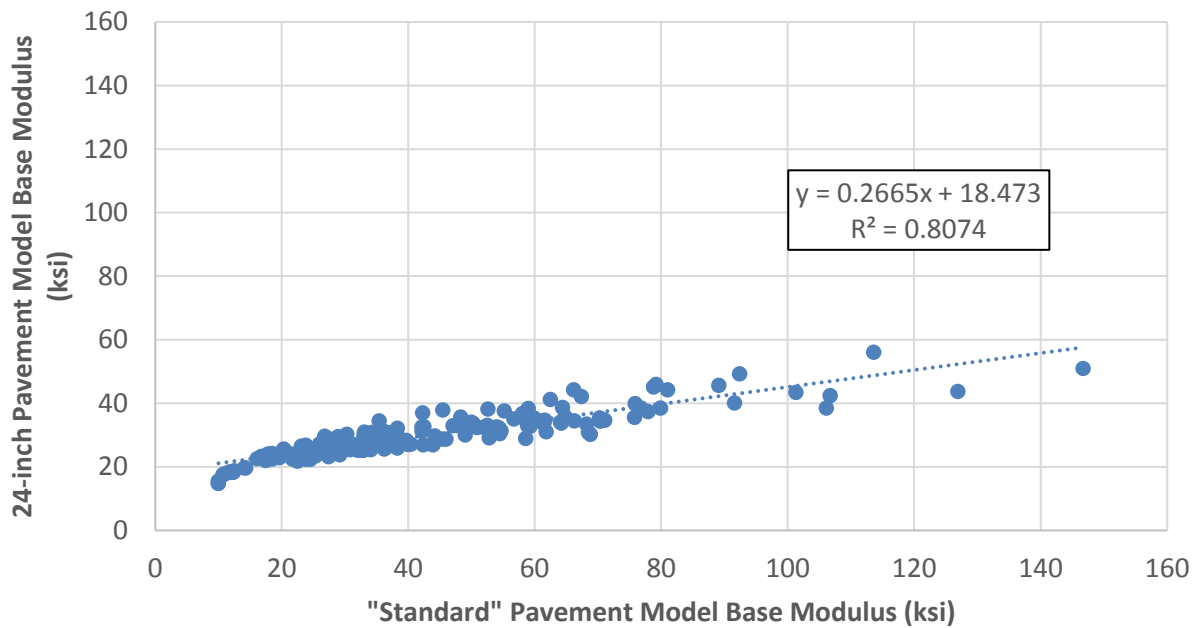
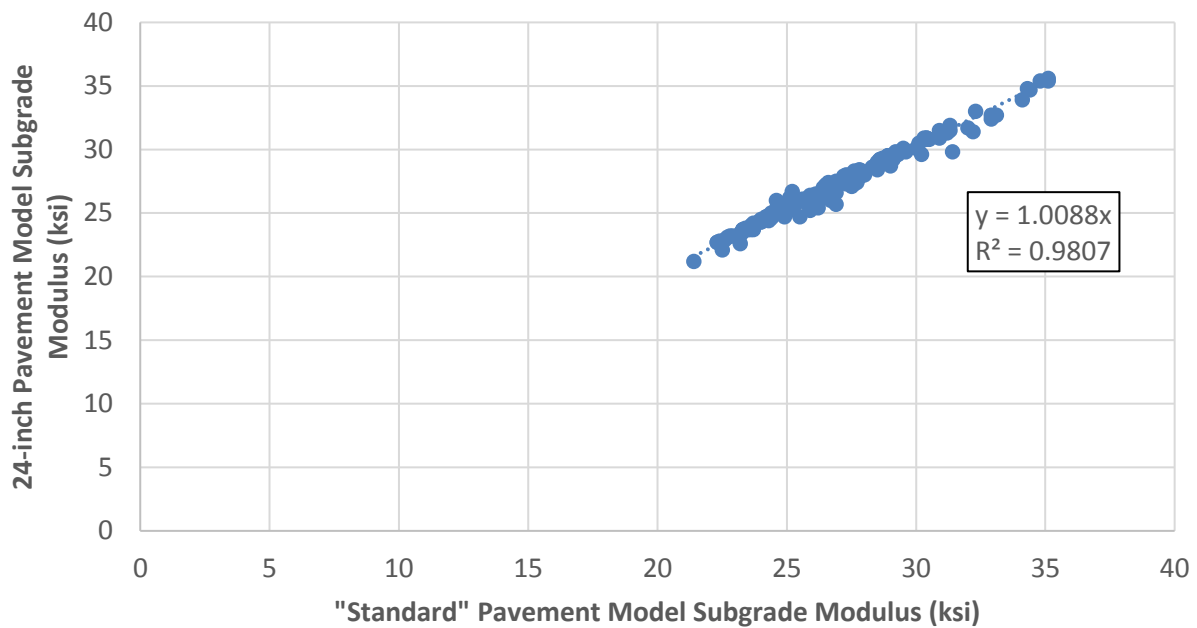
includes 9.5 inches of AC on top of 24 inches of Base/SG on top of a third semi-infinite layer representing the subgrade. Moduli values obtained through backcalculation are dependent on the model used to represent the pavement structure. In this case, combining the 8.4 inches of aggregate base with 15.6 inches of subgrade will impact the moduli values for all three layers compared to a pavement model that modeled the 8.4 aggregate base separately from the subgrade soil. The EVERCALC software was used to backcalculate moduli values from the FWD data. Two pavement models were used, the first representing the same model discussed in Table 4, the second representing the actual pavement thicknesses where the base and subgrade were not combined in the middle layer. The backcalculated moduli values for each pavement model are summarized in Table 10 and Figures 15 to 17.

Figure 15. Plotted AC moduli values from standard pavement model compared to 24-inch pavement model.

Figure 16. Plotted aggregate base moduli values from standard pavement model compared to 24-inch pavement model.

Figure 17. Plotted subgrade moduli values from standard pavement model compared to 24-inch pavement model.

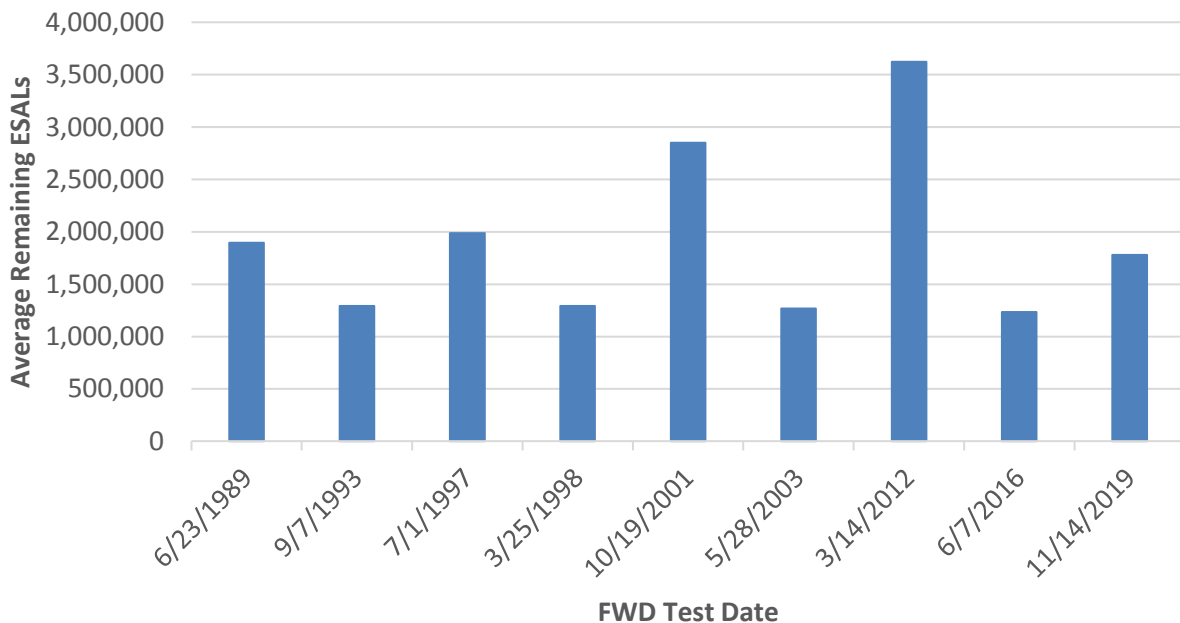
Figure 18. Plotted average remaining ESALs values from FWD data over life of section 48111.

determine the structural number of an existing pavement from FWD test data. This effective structural number (SN_{eff}) can be used to estimate the number of ESALs the pavement can withstand before reaching failure, defined as reaching a PSI values of 2.5. In addition to the recently collected 2019 FWD data, all of the FWD data from section 48_111 was obtained from the Infopave™ website and analyzed according to this backcalculation procedure. The results are summarized in Table 11 and illustrated in Figure 18.

The remaining ESAL values show the existing pavement could withstand between 1.3 and 2 million ESALs prior to the overlay construction in August of 1999. Analysis of the FWD data collected since overlay constructed showed the remaining ESAL values ranged between 1.2 and 3.6 million ESALs. While the numbers do not show a clear trend, it is interesting how the values from 1993 and 1998 compare favorably to the values from 2003 and 2016. The remaining ESALs is based on the AC structural design equation; but instead of starting with a design ESAL value and determining structural number, the FWD determines the structural number and the "design" ESAL value is calculated. The AASHTO 1993 design methodology is based on stiffness, a stiffer pavement section will give a higher structural number and can accommodate a

higher number of ESALs. The failure criteria is based on reaching a terminal pavement serviceability index of 2.5, which is a function of surface cracking.

The fact that the remaining ESAL values for these four years ('93, '98, '03, '16) are similar would indicate the pavement's overall stiffness has remained relatively constant. If that is the case, surface cracks should begin to form as the pavement is subjected to additional truck loadings. However, the surface distresses have not manifested as quickly as the remaining ESAL values would indicate. This could be due to the truck traffic consisting of under-loaded trucks, resulting in a low ESAL-per-truck number and a low number of ESALs the pavement carries per year. However, it must be noted the ASHTO 93 design guide was developed without assessing the impact of geosynthetics, such as the one placed between the existing pavement and 1999 overlay on section 48_1111.
