Pooled Fund Study TPF-5(332) LTPP Forensic Evaluations

WA-RD 905.1

June 2021

Final Report
Pooled Fund Study TPF-5(332)
LTPP Forensic Evaluations
WA-RD 905.1

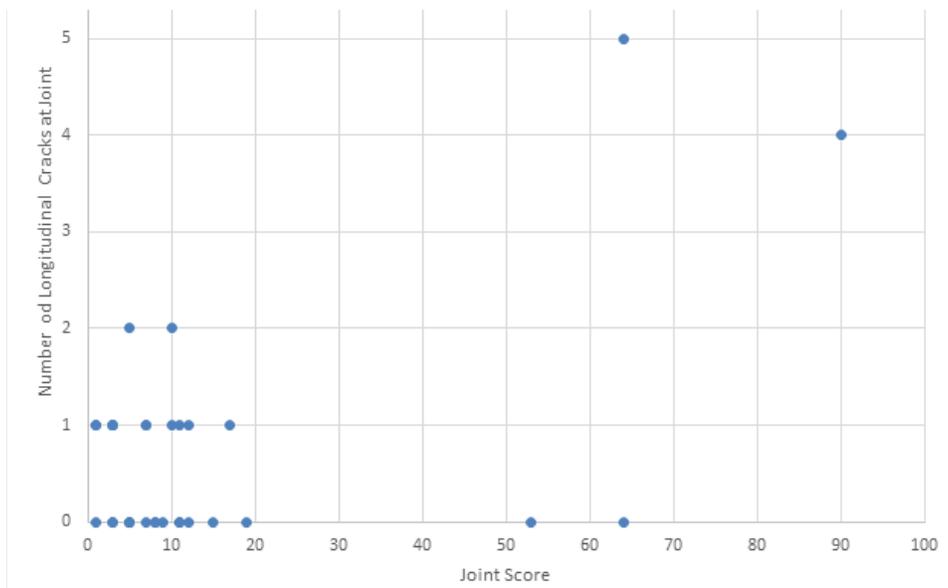
Figure 13. Number of longitudinal joints at transverse joints versus joint score from MIT measurements for test section 20_0201.

The desktop study also aimed to examine the relationship between the magnetic induction tomograph (MIT) measurements of dowel bar alignment with the test section performance related to the joints in the PCC pavement. To do so, the project team developed a dataset of LTPP joint faulting data and information on the number of longitudinal cracks at each transverse joint, as summarized in Figure 13. An assessment of this information revealed variability in the MIT dowel bar data. The data reported ranged from -2.4 to 18.3 inches, which indicates dowel

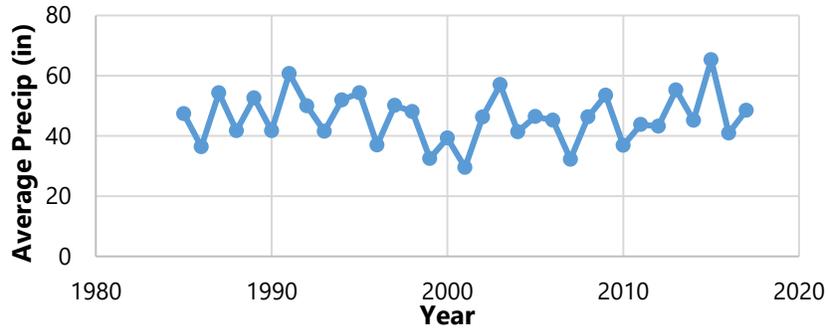
Figure 23. Chart. Average annual precipitation over time.

The increase in reported pavement distresses following 2015 seemed to be related to an increase in precipitation on the test site in 2015. The increase, depicted in Figure 23, is likely related to a flooding event that occurred in South Carolina in early October of 2015. The flooding, which was caused in part by Hurricane Joaquin, resulted in more than 20 inches of rainfall in nearby Columbia, SC (NOAA, 2016). The high amount of precipitation observed in 2015 is likely the cause of the increased cracking and the sand deposits observed on the test section in 2016. Figure

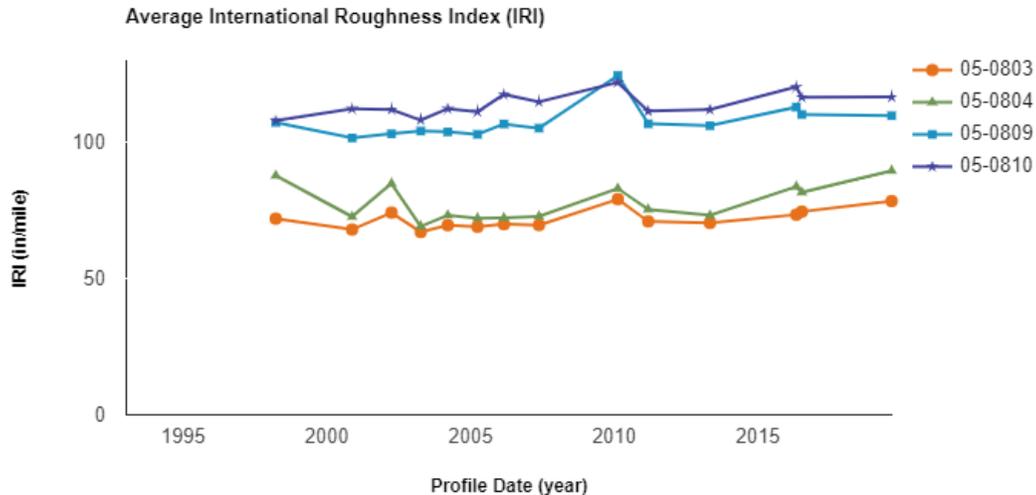
Figure 35. Chart. Time history of pavement roughness on Arkansas SPS-8 test sections.

The desktop study provided insight on the causes of the increase in fatigue, longitudinal, and transverse cracking observed on the AC test sections (05_0803 and 05_0804) over time. Between 2014 and 2019, the amount of fatigue cracking exhibited at the test sections increased at an abnormally high level for a low-traffic roadway. Some of the increase in fatigue/alligator cracking was related to other cracking types in the wheel path evolving into fatigue/alligator cracking starting in 2019; most of the additional fatigue cracking observed in 2019 was located in areas where wheel path longitudinal cracking and transverse cracking already existed, as depicted in Figure 33 and Figure 34. Hypothesized causes for the increase in fatigue/alligator cracking along the test sections included the high levels of precipitation due to a flooding event in 2019, aging/oxidation of the AC layers, and construction or material inconsistencies. The increase and subsequent drop in NWP and WP longitudinal cracking and transverse cracking on the AC test sections was related to the fatigue/alligator cracking observed on the test sections as discussed previously.
