TPF-5(291) FINAL REPORT:

EVALUATING THE IMPACT OF NON-EXPERIMENTAL FACTORS ON PAVEMENT PERFORMANCE:

Task 3: Review of SPS-2 Early Failures

Prepared On Behalf Of:	Date	Project Number
State Pooled Fund Study TPF-5(291)	October 2021	56A0418-008 (TPF 5(291)) 219.03.10 (NCE)

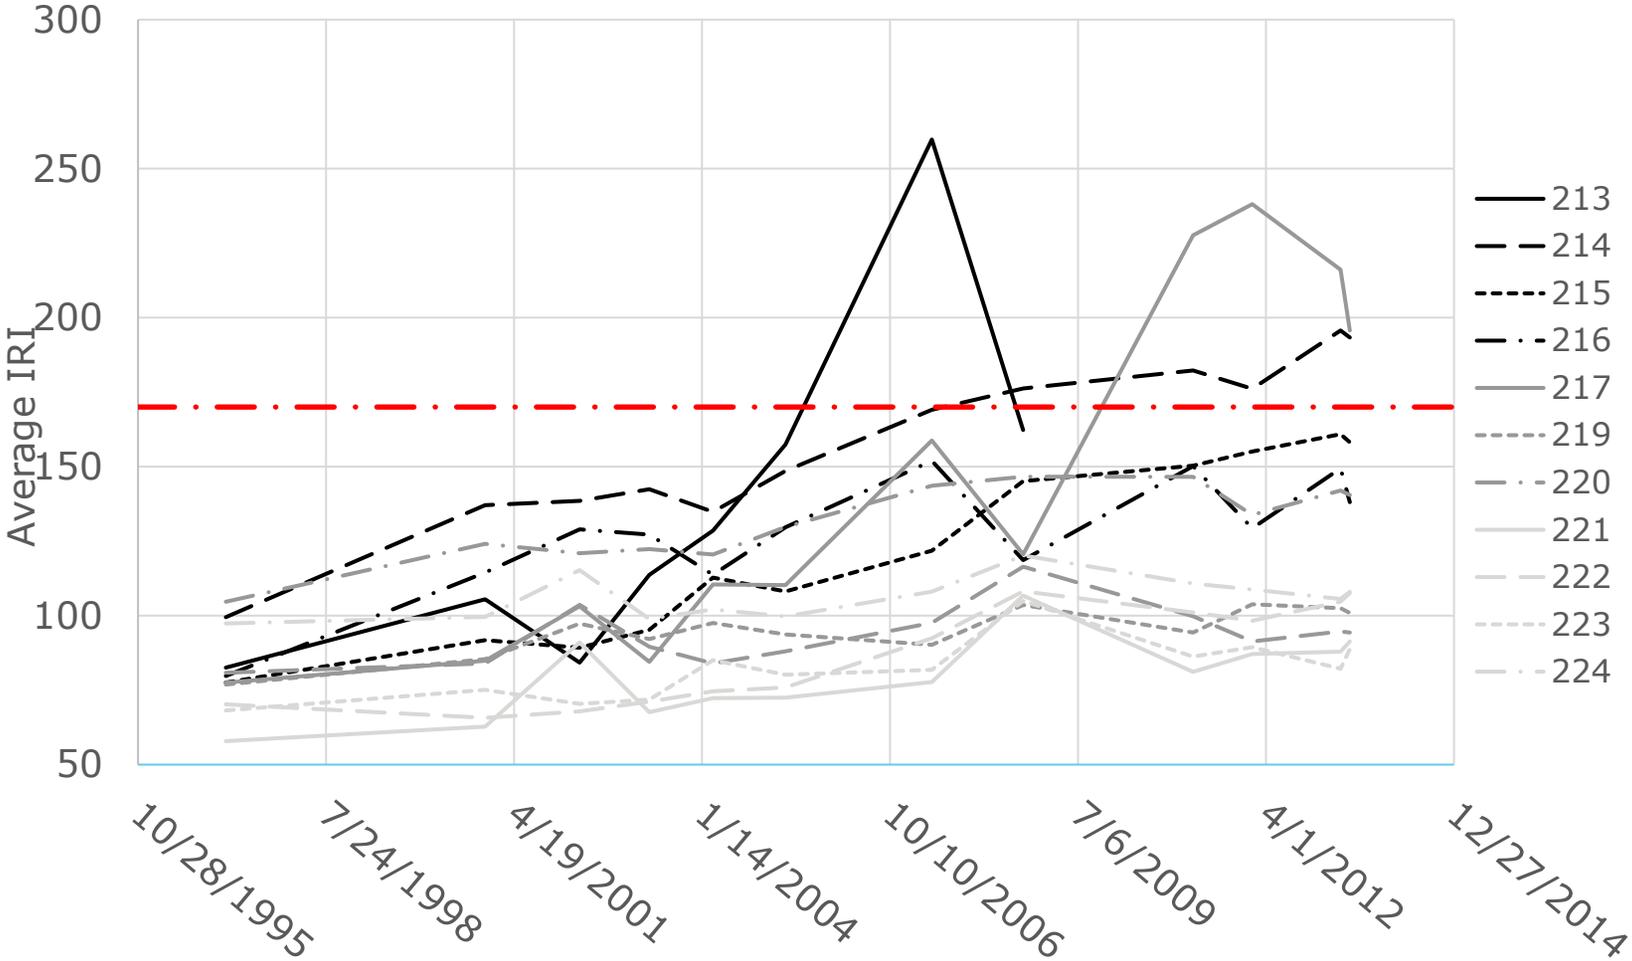
Figure 4. Average Measured Roughness (in IRI) for Arkansas SPS-2 Test Sections

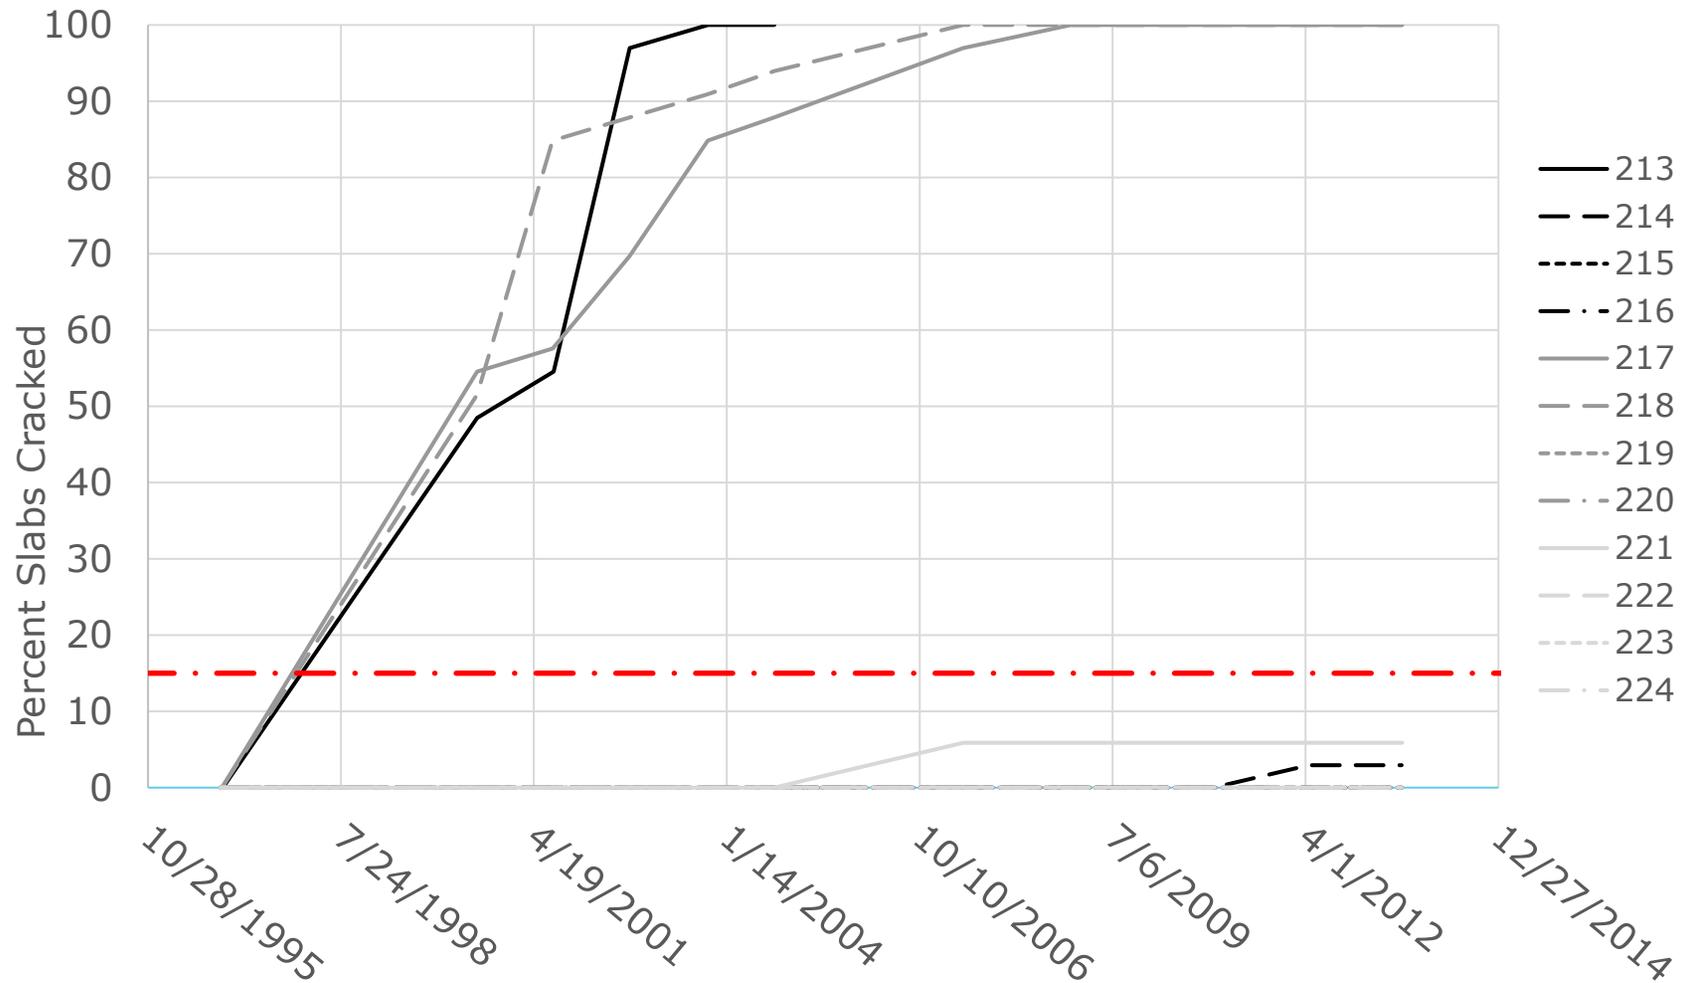
Figure 6. Average Percentage of Slabs Cracked for Arkansas SPS-2 Test Sections

It can be seen that four test sections received ratings of poor performance for both surface roughness and for percent cracking during the life of the pavement. This is corroborated with the plots, which indicate that test sections 050213, 050214, and 05217 exhibited poor performance with respect to roughness while no test sections exhibited poor performance due to wheel-path faulting, though test section 050215 was trending upward to the poor performance threshold. However, test sections 050213, 050217, and 050218 all exhibited excessive slab cracking, achieving 100% slabs cracked within ten years of construction.

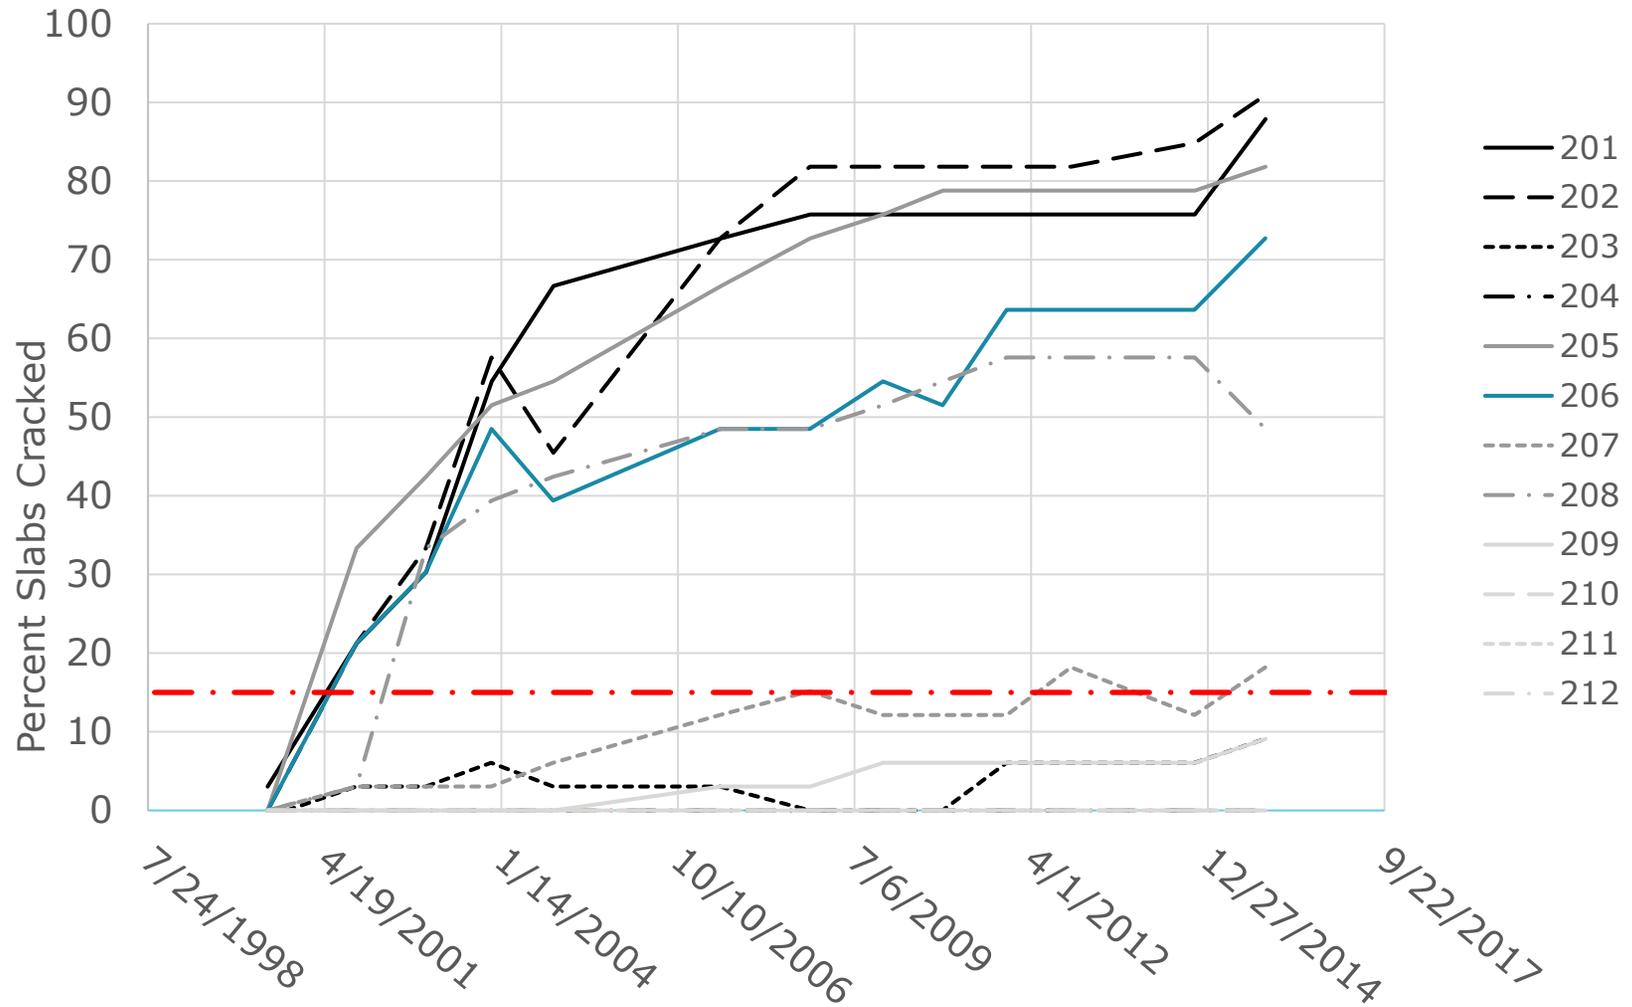
Most test sections exhibited fair performance across performance metrics, with the exception of slab cracking. Individualized plots of these performance metrics by year are given in Figure 7, Figure 8, and Figure 9 below.

Figure 9. Average Percentage of Slabs Cracked for California SPS-2 Test Sections

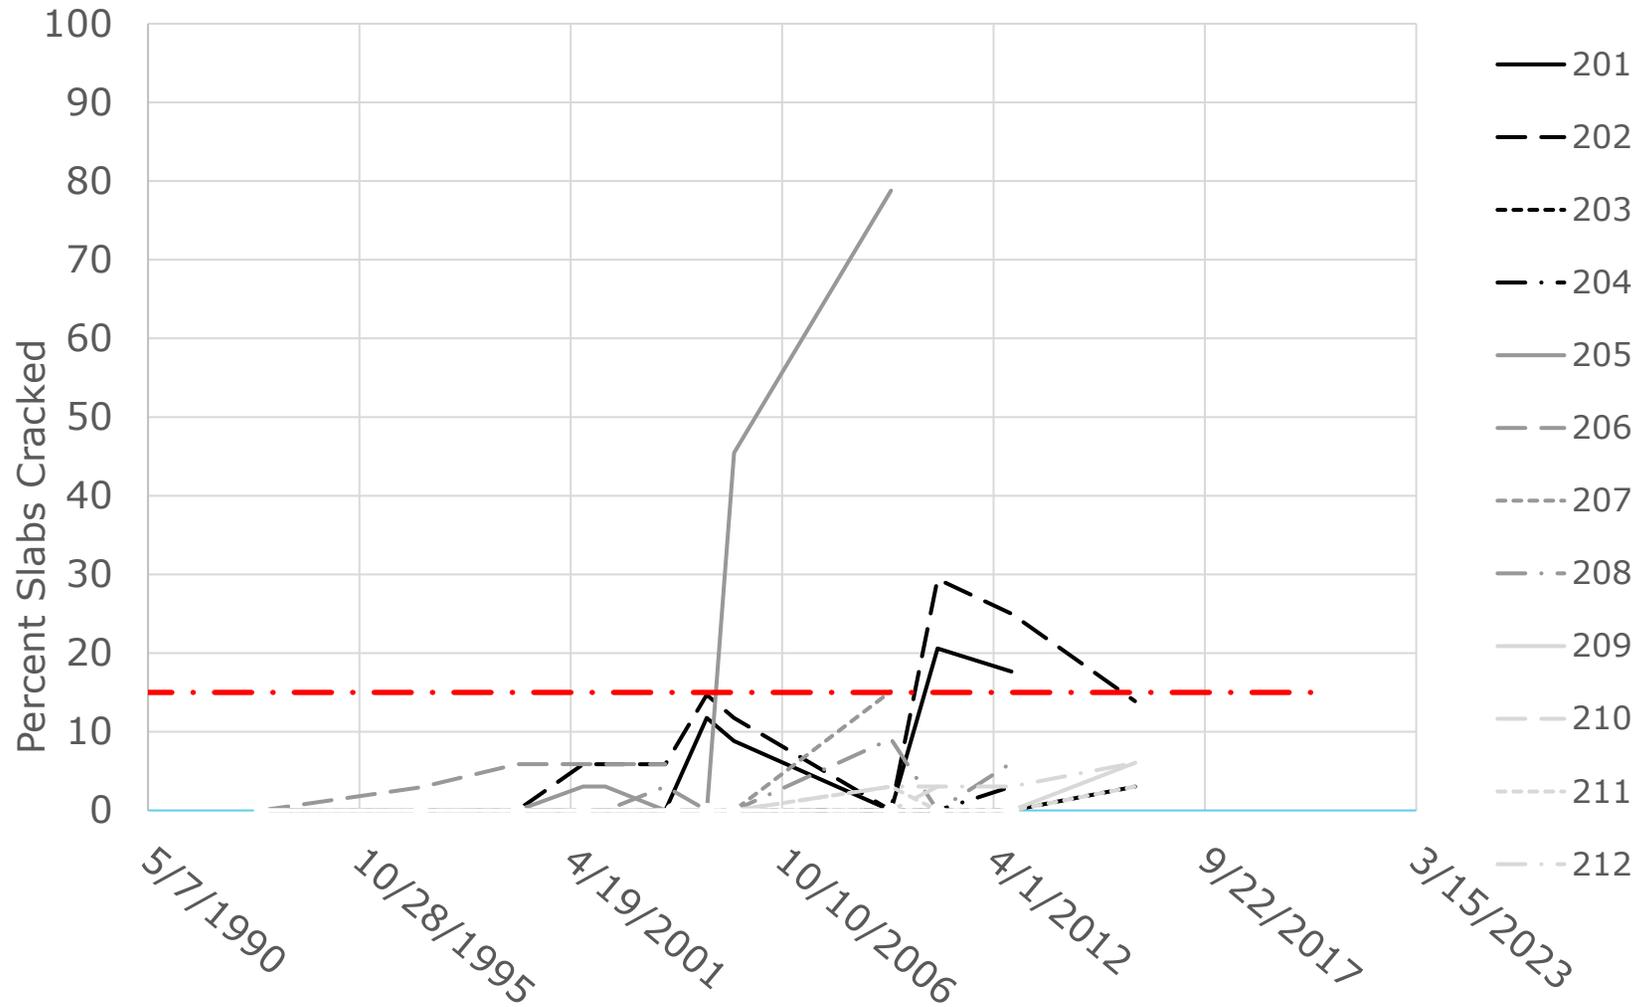
Figure 21. Average Percent Slabs Cracked of Kansas SPS-2 Test Sections

In 1992, 13 experimental sections for the SPS-2 experiment were constructed in Kansas, a wet-freeze climatic region. All of these test sections remain in study and seem to have an overall moderate performance. Three test sections exhibited early failure, as defined previously. The timeline of the progression of this failure can be seen previously in Figure 19, Figure 20, and Figure 21. A summary of the structural characteristics of these test sections is given in *Table 77* below.

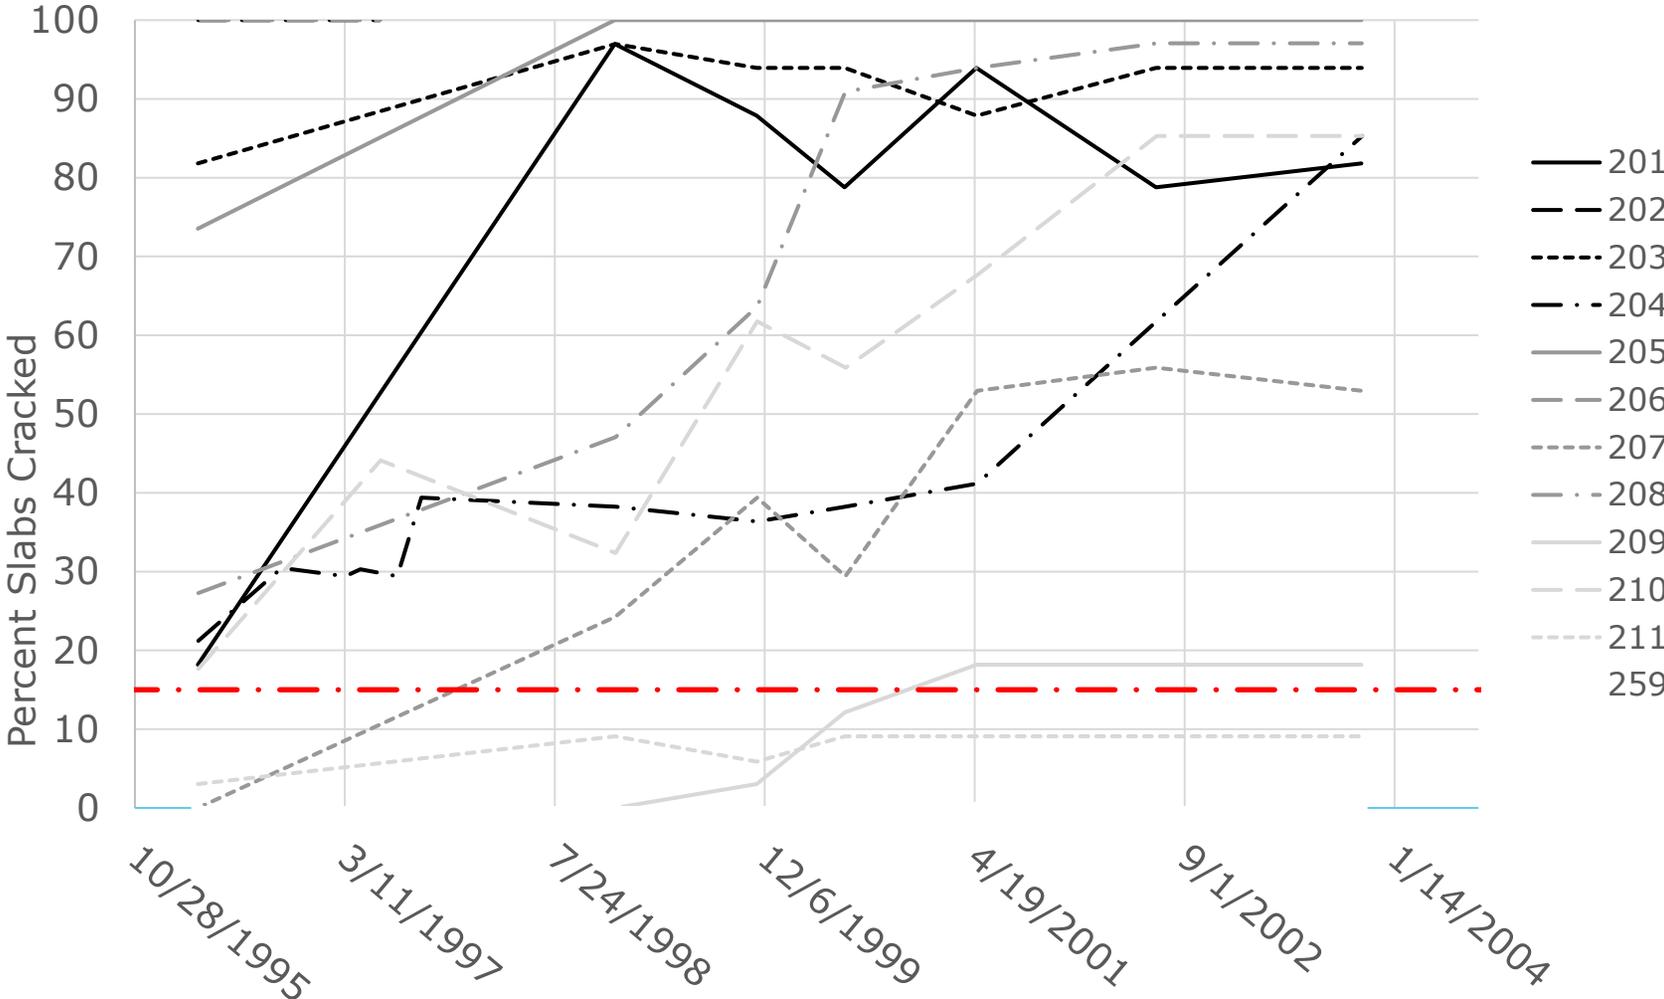
Most test sections exhibited fair performance across performance metrics, with the exception of slab cracking, with most test sections exhibiting poor performance shortly after construction. Individualized plots of these performance metrics by year are given in Figure 27, Figure 28, and Figure 29 below.

Figure 29. Average Percent Slabs Cracked for Nevada SPS-2 Test Sections
