# EVALUATION OF ALTERNATIVE DOWEL BAR MATERIALS AND COATINGS

## Final Report

Ohio Department of Transportation  
Office of Research and Development

November 2011

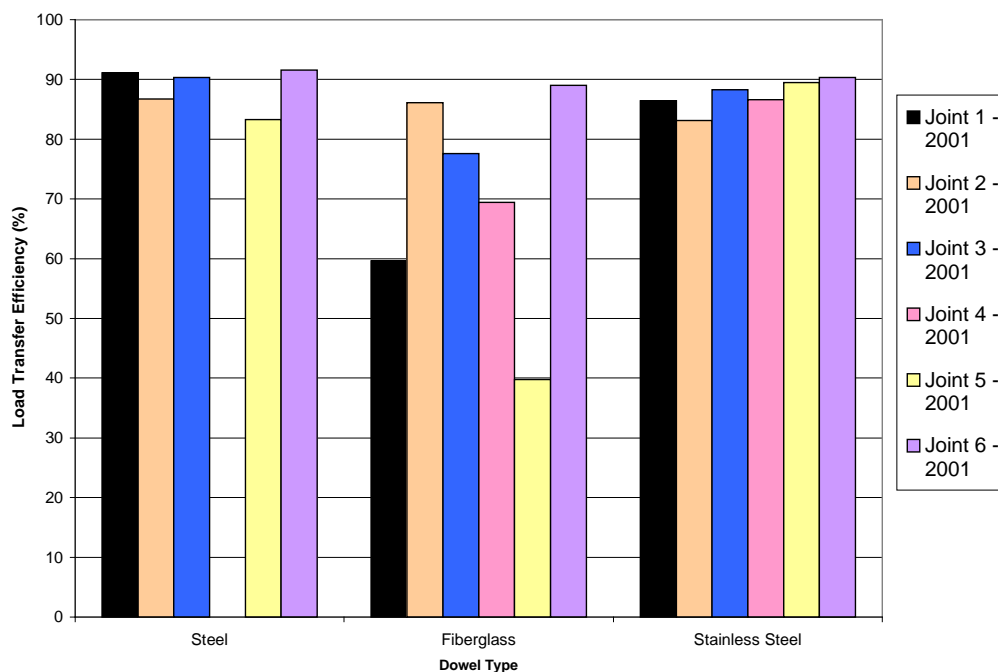
The load transfer efficiencies on the OH 2 project from 2001 are shown in Figure 2. The Type 318 stainless steel clad dowels installed in 1998 on US 50 westbound were not included in this evaluation.

Figure 2. LTE measurements for OH 2 project.

Additional FWD testing and coring was performed on this project in 2004. The 4-in (102-mm) diameter cores (selected photos of which are included in Appendix C) of the epoxy-coated dowels and of the concrete-filled Type 304 stainless steel showed delaminations of the concrete at the dowel bar level. As corrosion of the stainless steel dowel at this age is unlikely, the cause of the cracking is most likely due to the high early environmental stresses noted during construction and/or the poor support provided by the New Jersey unstabilized permeable base combined with the more rigid steel dowel bar properties.

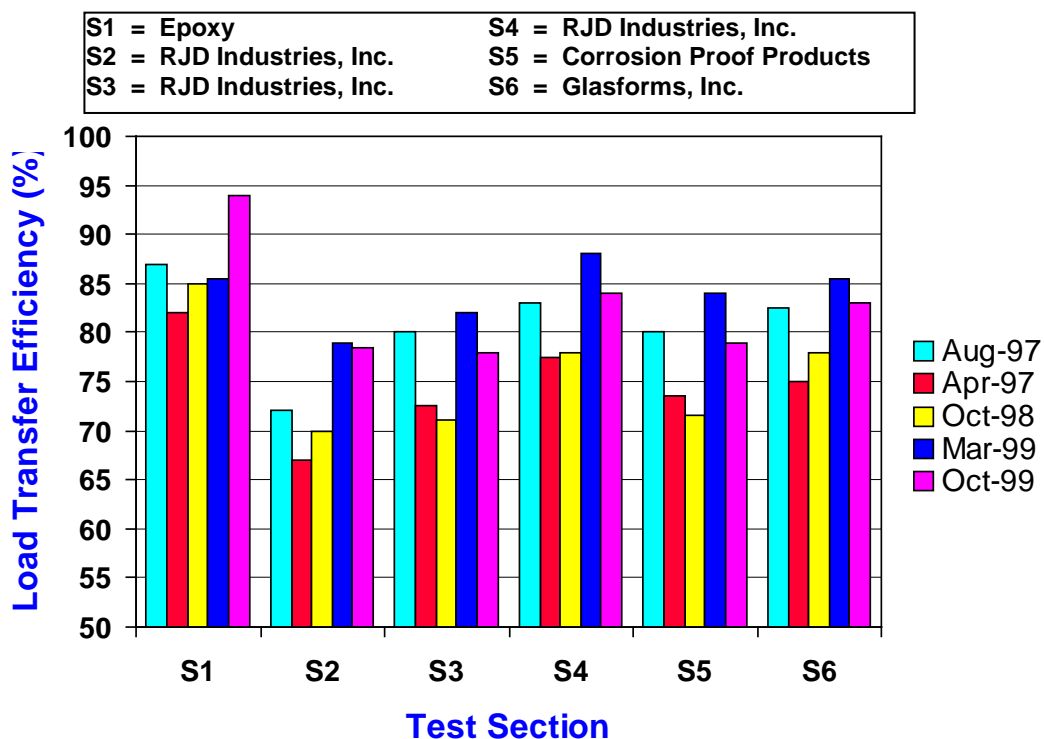
The 1997 project, IL 2, consisted of five different FRP sections and the epoxy-coated dowel bar control section. A plot of the LTE measurements is provided in Figure 3. This shows that all five FRP sections had LTEs less than 85 percent soon after construction. Overall performance of the FRP joints (range 65 to 80 percent LTE after 6 years and 1.3 million ESALs) appears to be very close to the behavior of the epoxy-coated steel control set (minimum of 83 percent LTE after 6 years). This project had a granular subbase.

Figure 3. LTE measurements on IL 2 project (Gawedzinski 2000).

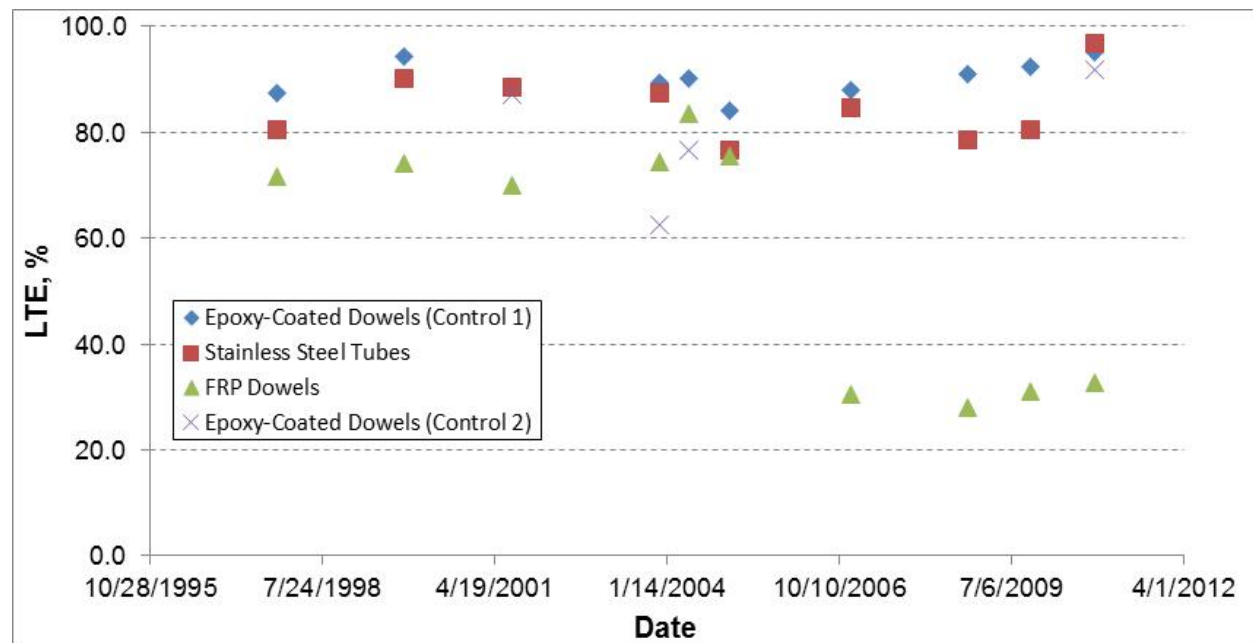
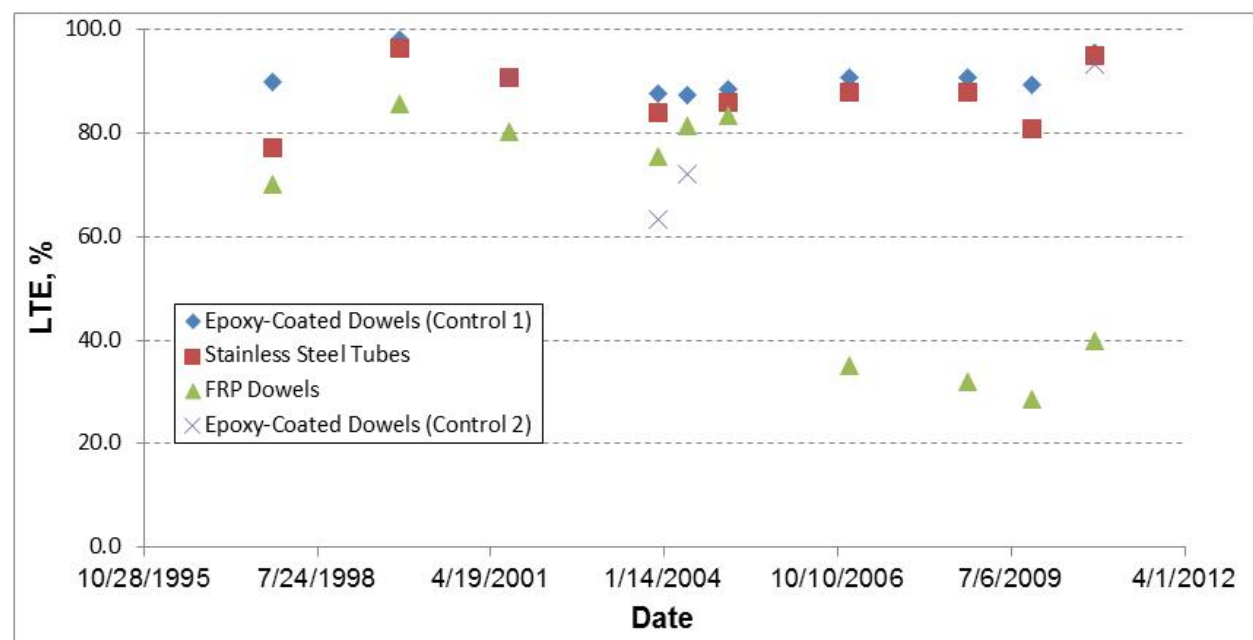
The summary data provided in Table 3 are presented graphically in Figures 6a and 6b. These figures clearly show that the polyester resin FRP dowels evaluated in the OH 2 project exhibit far lower LTE values than their counterparts. The three types of polyester resin FRP dowels (two types furnished by RJD Industries and one type furnished by CEF, Inc.) all have LTE values averaging less than 40 percent since 2006. The most recent data indicate that LTE values obtained on 10/30/09 averaged 31.3 percent on the approach joint and 28.5 percent on the leave joint, whereas the LTE values measured on 11/03/10 averaged 33.1 percent on the approach joint and 39.9 percent on the leave joint. In general, a deflection-based LTE of 70 percent or less represents less than 50 percent stress load transfer and it is considered a critical threshold level.

The poor performance of the polyester resin FRP dowels might be related to its increased moisture adsorption capacity, as noted previously. In addition, there are other factors that may also be contributing to the performance of these sections, including the poor stability of the unstabilized New Jersey permeable base and the poor quality of the concrete (cores revealed some deterioration at the depth of the dowel bar).

Figure 6a. Summary of historical load transfer efficiency data for OH 2 EB (approach joint).

Figure 6b. Summary of historical load transfer efficiency data for OH 2 EB (leave joint).

Even though the sections with FRP bars are not performing well (as evidenced by the extremely low LTEs), the sections with the other two dowel bar types are still exhibiting satisfactory LTEs after nearly 14 years of service. The Type 304 stainless steel tubes (mortar filled) average 78.6 percent on the approach joint and 87.9 percent on the leave joint in 2008. Similarly, the epoxy-coated mild steel dowels used as a control averaged 91.3 percent on the approach joint and 90.7 percent on the leave joint. The 1.5-in (38-mm) FRP polyester resin dowels appear to be much more susceptible to poor support (concrete quality and/or base/subbase/subgrade) than the conventional and alternative steel dowels. This suggests that for poor support conditions, vinyl ester resin FRP dowels of diameter greater than 1.5-in (38-mm) will be required. The percentage and type of glass fibers is also a critical design variable in addition to the resin type.

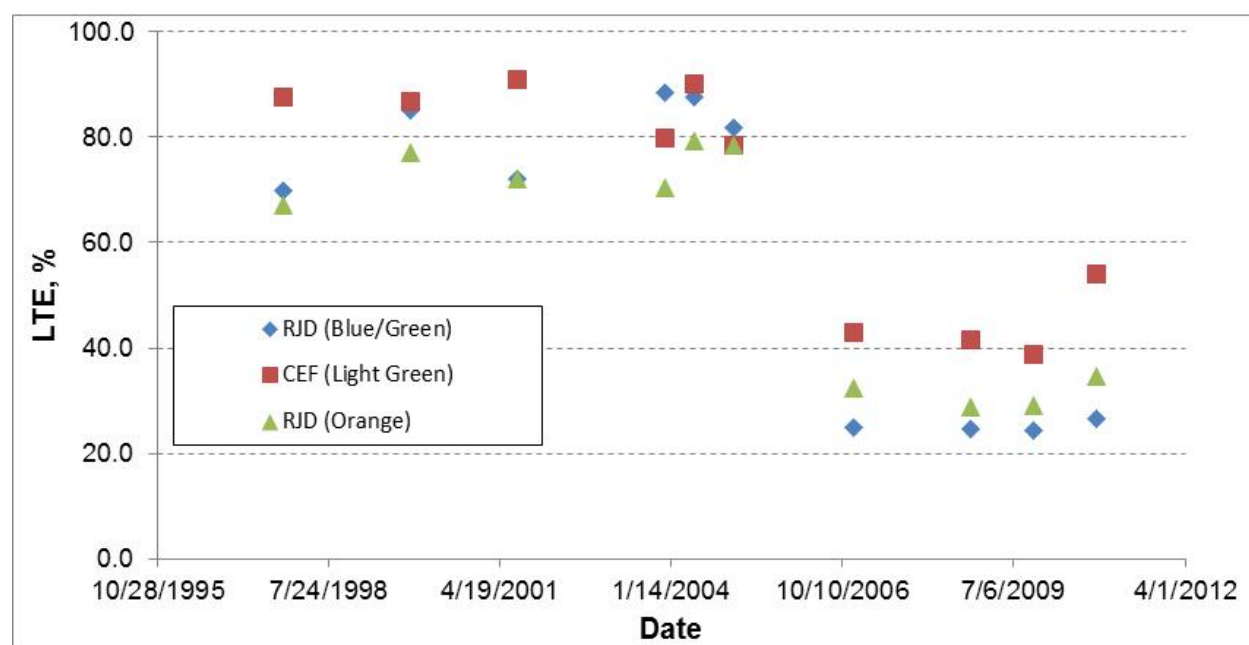
The three different types of polyester resin FRP bars used on this project (two manufactured by RJD Industries and one by CEF, Inc.) exhibited similar LTE trends over the 16-year monitoring period (see Figure 7). All FRP dowels maintained relatively good levels of LTE until 2006, at which time the LTE values dropped off considerably. The CEF bars are exhibiting slightly higher LTE values than the RJD varieties.

Figure 7. Average LTE (approach and leave) for FRP bars on OH 2.

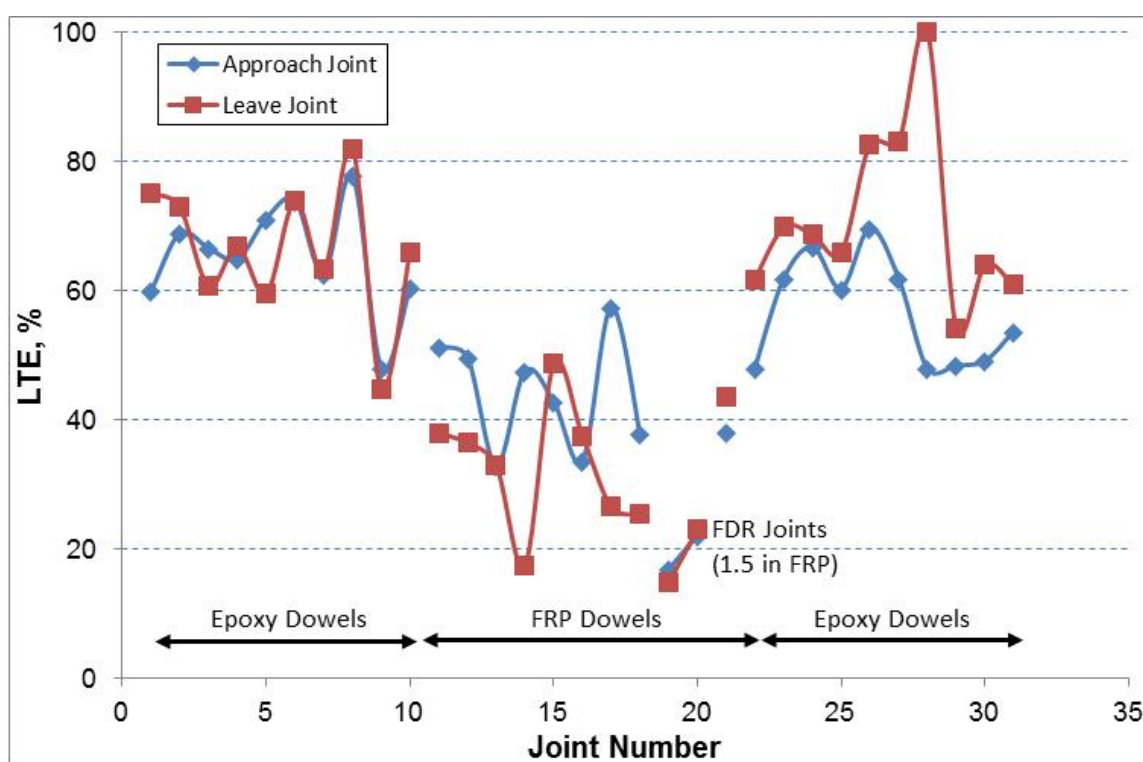
Coring of dowel bars on BEL-7 (see Table C-3 in Appendix C) showed that the only FRP bar retrieved was exhibiting no deterioration, whereas epoxy-coated bars in nearby adjacent joints were showing various types of deterioration, including the splitting of the epoxy coating, rusting of the bar under the coating, and some pitting where the steel had been exposed. It is interesting that the 1.25-in (32-mm) diameter vinyl ester resin with 78 percent E-glass FRP dowels on SR 7 performed significantly better than the 1.5-in (38-mm) polyester resin FRP dowels on U.S. 50, based on similar age comparisons (SR 7 data in 1998 from the MDA [1998] report after 15 years of service, and the U.S. 50 data collected in 2011 after 14 years of service).

Figure 10. 2011 LTE data for BEL-7.

The data from this project suggest that larger diameter vinyl ester or epoxy resin dowels and ECR glass (minimum fiber content in the range of 75 to 80 percent) are still needed to ensure good long-term performance from FRP dowels. Furthermore, it should be noted that the 1.5-in (38-mm) polyester dowels used for the full-depth repair placed in 1998 to repair the 1.25-in (32-mm) vinyl ester doweled joint removed for laboratory testing, exhibited lower LTE values (ranging from 14.7 to 23.0 percent) than the smaller vinyl ester FRP bars at the other joints.

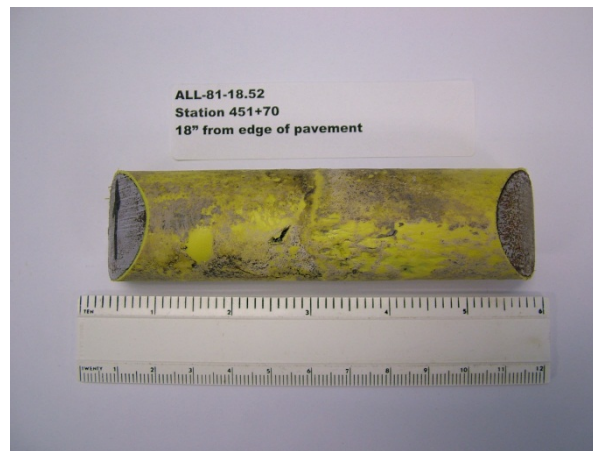
All bars had a black paste type material, possibly grease or asphalt cement, between the coating and the bar. This material protected the bar from extensive rusting when the coating was split or abraded. Almost all bars had a ridge in the joint area which is probably due to movement of the coating and paste material. Joints were tight.

A photo of the dowel coating from a typical core (see Figures 11 and 12) and two photos of the excellent condition of the surface of the pavements (see Figures 13 and 14) demonstrate the outstanding performance of the plastic-coated dowels. Over their 33-year service lives, the pavements on Route 81 in Allen County had sustained nearly 10 million ESAL applications whereas the pavements on Route 59 in Summit County had sustained approximately 6 million ESAL applications.

Figure 11. Photo of plastic-coating of dowel on State Route 81 after 33 years of service.

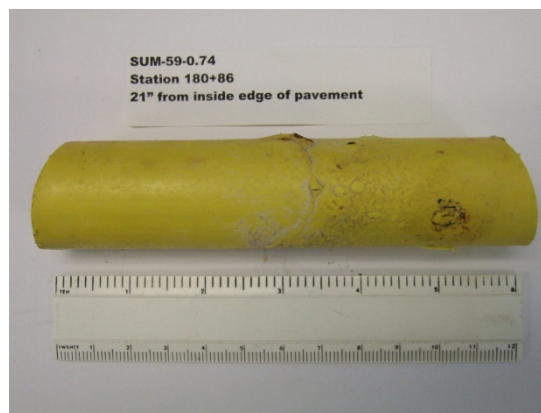
Figure 12. Photo of plastic-coating of dowel on State Route 59 after 33 years of service.

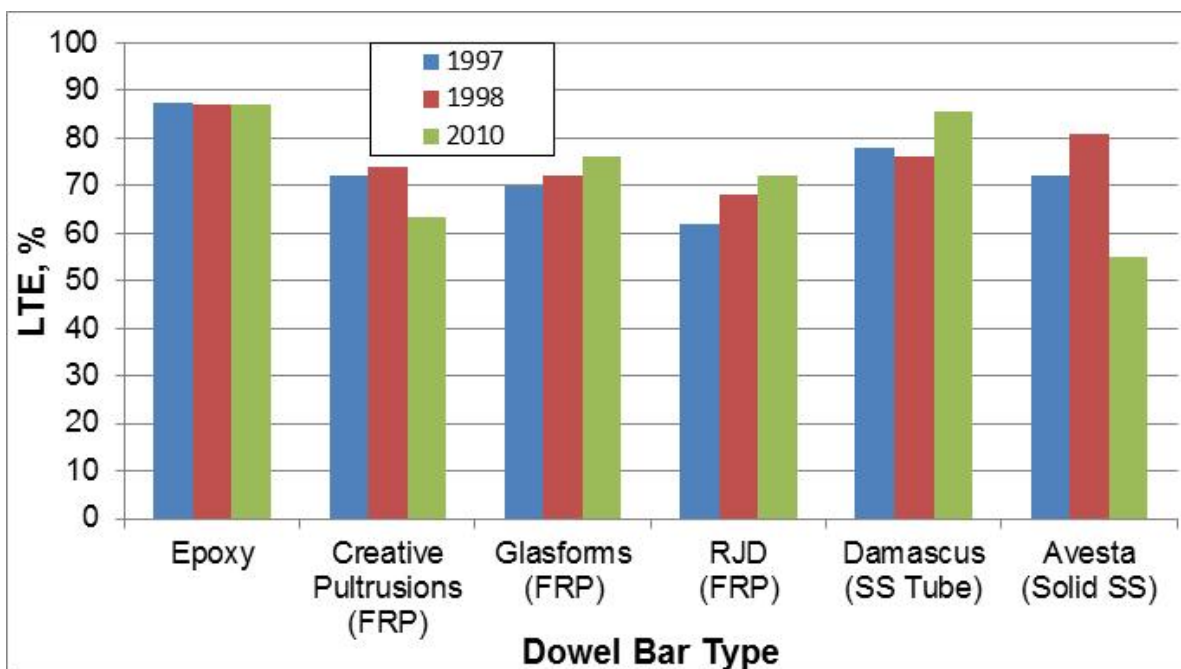
Figure 15 presents a summary of the available LTE data by dowel bar type (2010 data). This figure shows that the epoxy-coated dowel bars have maintained nearly constant LTE values over the nearly 13-year evaluation period, while the FRP bars (Creative Pultrusions, Glasforms, and RJD) are somewhat lower. The sections containing stainless steel tubes still show acceptable LTE values, but the most recent data for the sections with solid stainless steel bars are very low (just over 50 percent). However, it should be noted that the solid stainless steel dowels on this project were placed in two alternative configurations (one with three dowels per wheelpath and one with four dowels per wheelpath), which likely explains the differences.

Figure 15. Summary of aggregated, historical LTE values for WI 2.

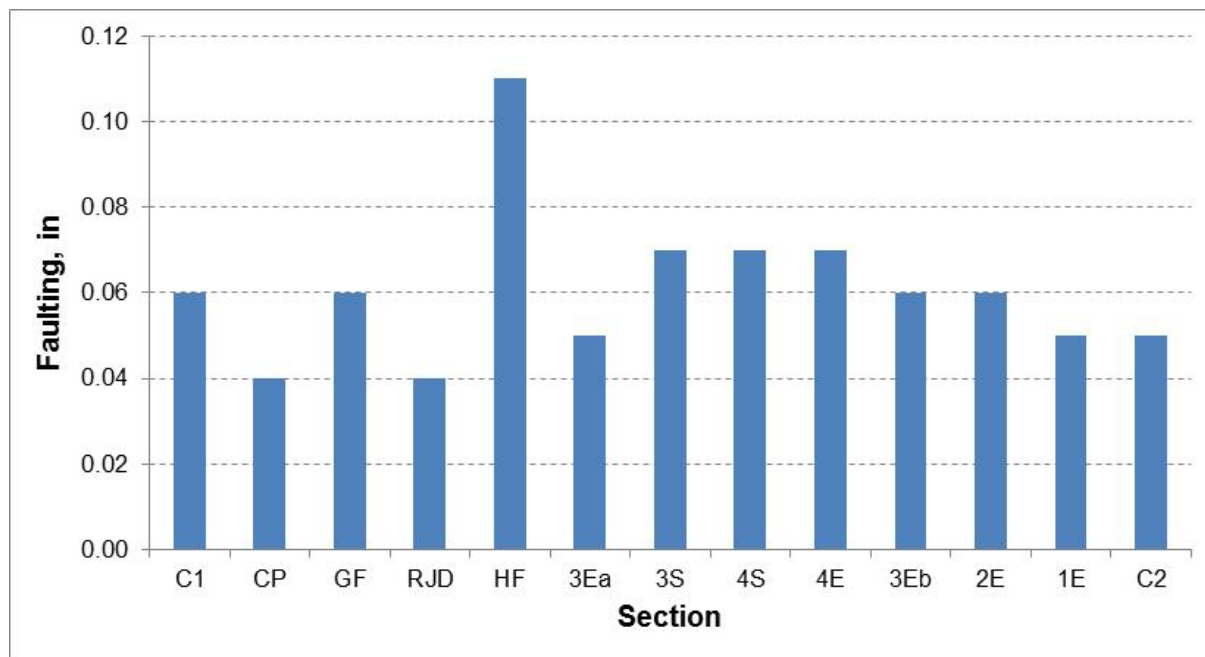
Figure 18 presents the average 2010 faulting data for each of the WI 2 sections. The faulting levels are generally reasonable for a 13-year-old pavement, with levels exceeding about 0.1 in (2.5 mm) beginning to have a noticeable effect on ride. To date, only one section has exceeded that value (HF, the section with stainless steel tubes).

Figure 18. Average 2010 faulting values for WI 2 sections.

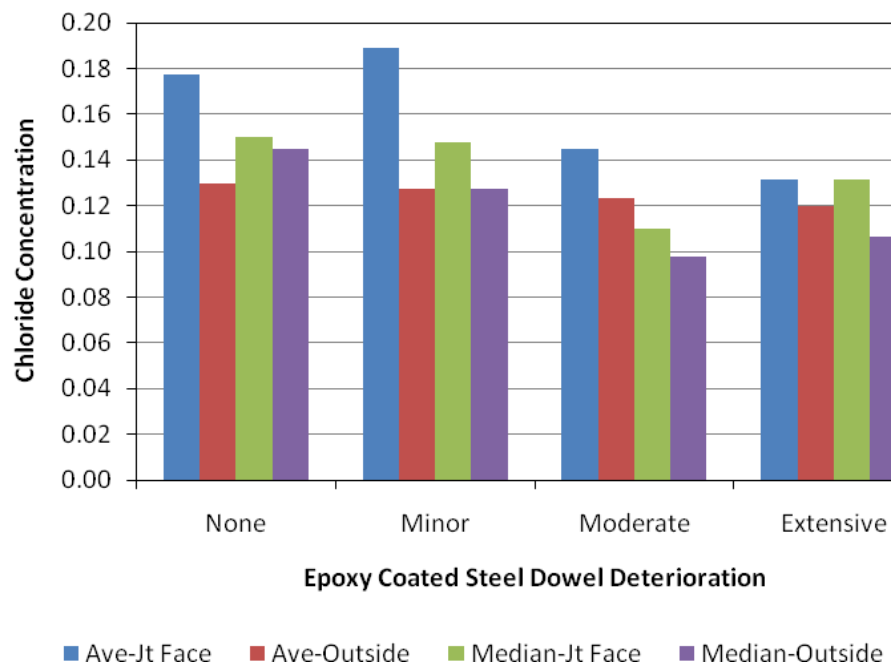
The limited investigation of the dowel bars on this experimental section after 13 years of traffic verified the low LTEs on the FRP dowel sections, which likely will affect their long-term performance. Larger diameter dowels or closer dowel spacing will be required to help increase the LTE. The greater flexibility of the FRP dowels also appears to decrease performance compared to the epoxy-coated mild steel dowels used as control when poor support conditions (poor durability of the concrete at the joint, or poor support of the base/subbase/subgrade) are present. There was minor corrosion/deterioration of one of the FRP dowels likely due to abrasion of the surface. One of the four epoxy-coated dowels removed from the cores showed loss of a small section of coating at the joint and one dowel bar had some loss of section due to corrosion at the joint.

Figure 19. Chloride concentration vs. dowel bar condition.

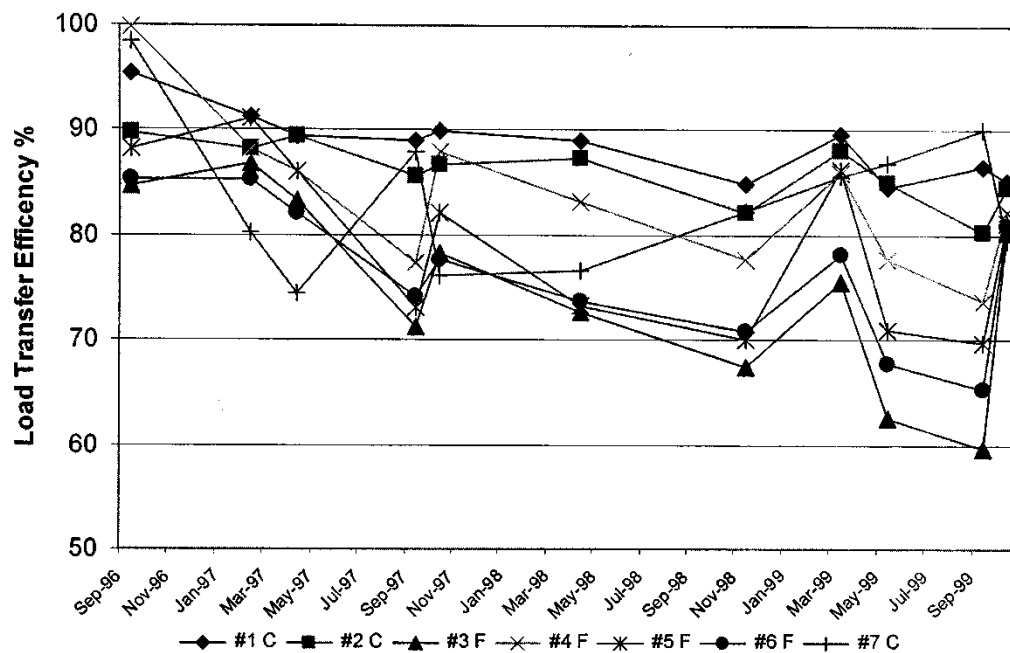
Figure 5. Load transfer efficiency on IL 1 (Gawedzinski 2000).

A gradual decrease in overall load transfer efficiency is observed in figure 5, with the conventional steel dowel bars consistently showing higher levels of load transfer than the fiber composite bars. But, as seen in figure 6, the largest deflection is consistently shown by one of the conventional doweled joints, although the other two conventional doweled joints show consistently low deflections. However, for both load transfer types, the load transfer efficiency is still relatively high and the magnitude of the joint deflections relatively low.

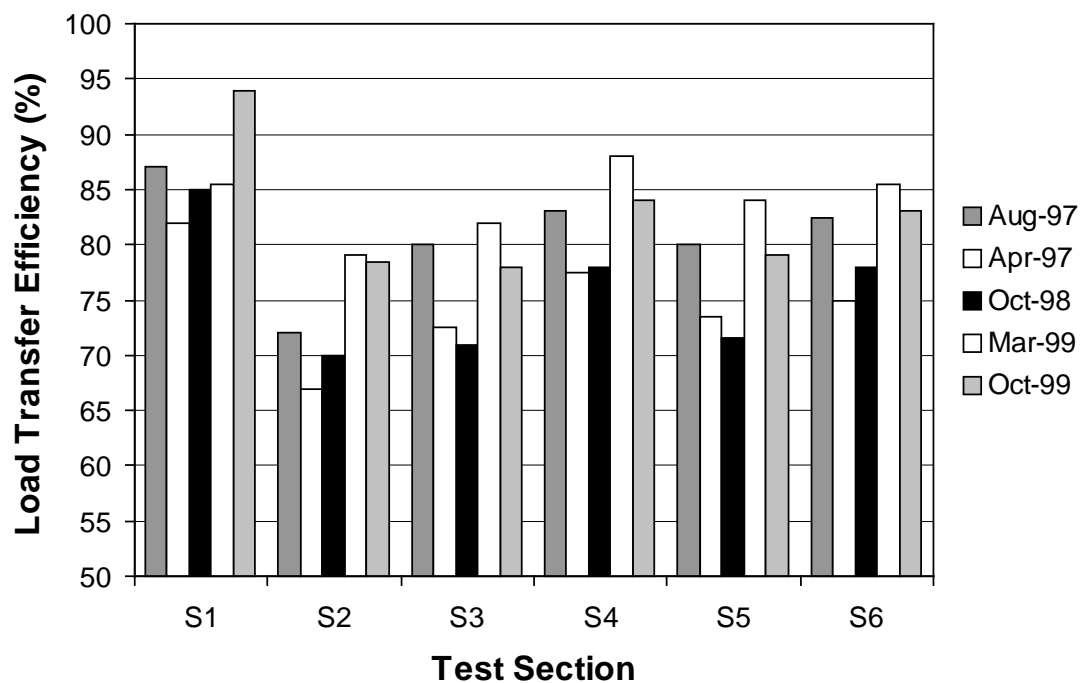
Figure 9. Load transfer efficiency on IL 2 (Gawedzinski 2000).

The best overall load transfer is exhibited by section 1, which contains the conventional steel dowel bars. The other sections all vary from about 70 to 85 percent, but it is interesting to note how the load transfer fluctuates over time, presumably because of the season and the temperature at the time of testing. Figure 10 shows that the maximum deflections for all joints is increasing over time, with the maximum deflection at the most recent testing (October 1999) significantly larger for all six sections than the previous maximum deflection values.

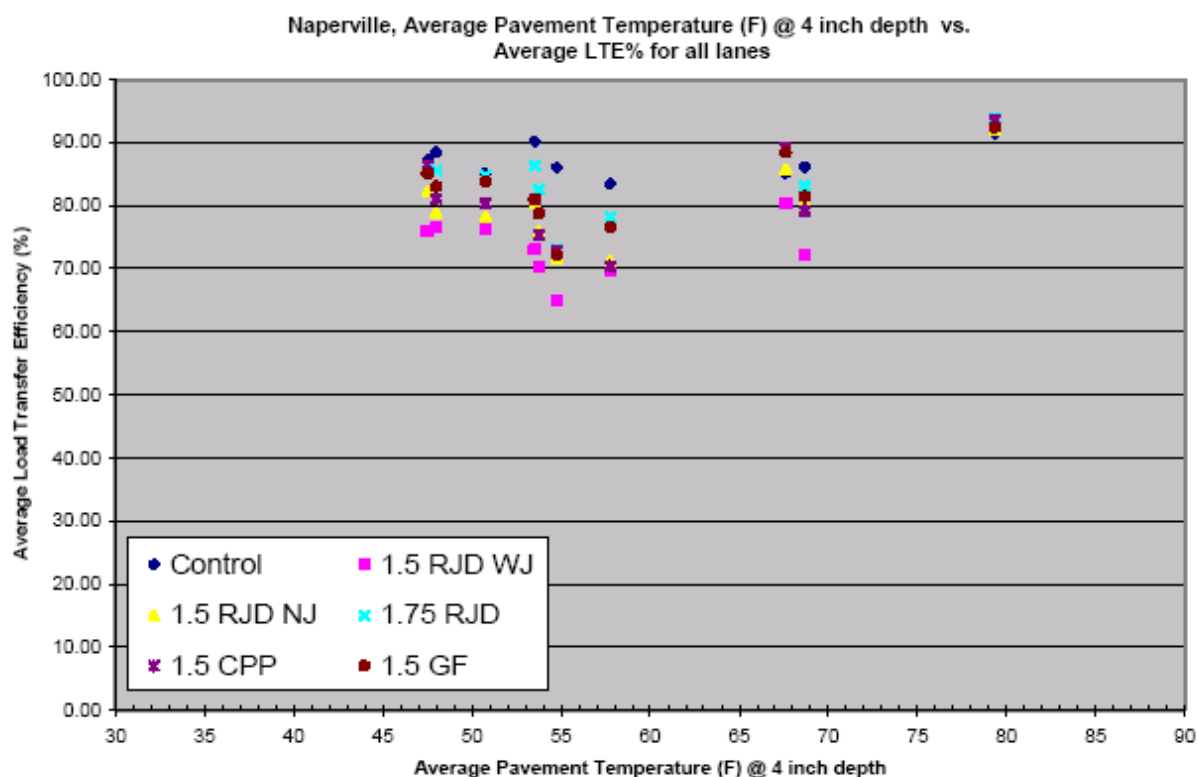
Figure 14. Average Load Transfer Efficiency vs. Pavement Temperature for all Lanes (Gawedzinski 2004).

Observations of the LTE% vs. time and ESALs graphs, as well as the joint deflection vs. time and ESALs graphs, show somewhat consistent behavior for joint deflection, with sections averaging between 3 to 5 mils. LTE% graphs show behavior consistent with a decrease in joint deflection. Figure 14 shows the same type of behavior displayed at the Williamsville, IL test site (Illinois 1). Plots of average values show no relationship between LTE% or joint deflection and average pavement temperature. The control bars (1½" Ø epoxy coated carbon steel) have a higher LTE% and lower joint deflection than any of the fiber composites, but the overall performance of the fiber composite bars appears to be very close to the behavior of the epoxy coated steel control set.

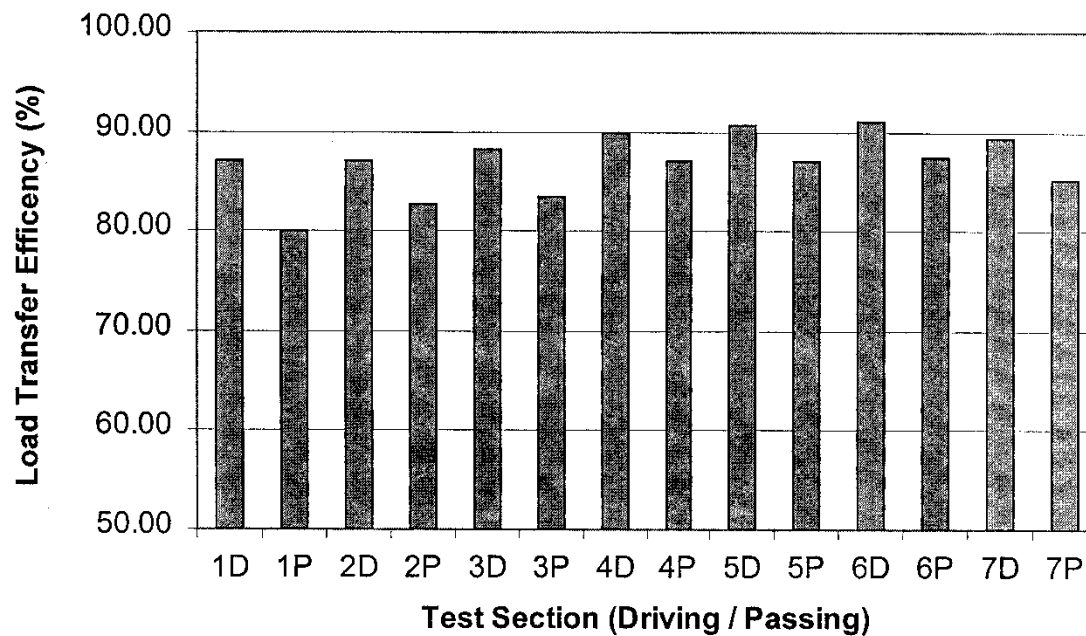
Figure 13. Load transfer efficiency on IL 3 (Gawedzinski 2000).

Before the pavement was opened to traffic, IDOT conducted FWD testing on the experimental sections in June 1999. Results from the FWD testing program are plotted in figures 13 and 14 (Gawedzinski 2000). Figure 13 shows the average load transfer for the seven experimental sections in both the driving and passing lanes, whereas figure 14 shows the average maximum joint deflection measured for each of the seven experimental sections in both the driving and passing lanes. Although the joint deflections are low, the load transfer efficiencies are not as high as might be expected for a new concrete pavement. These initial FWD results will serve as a baseline for comparison with future testing values.

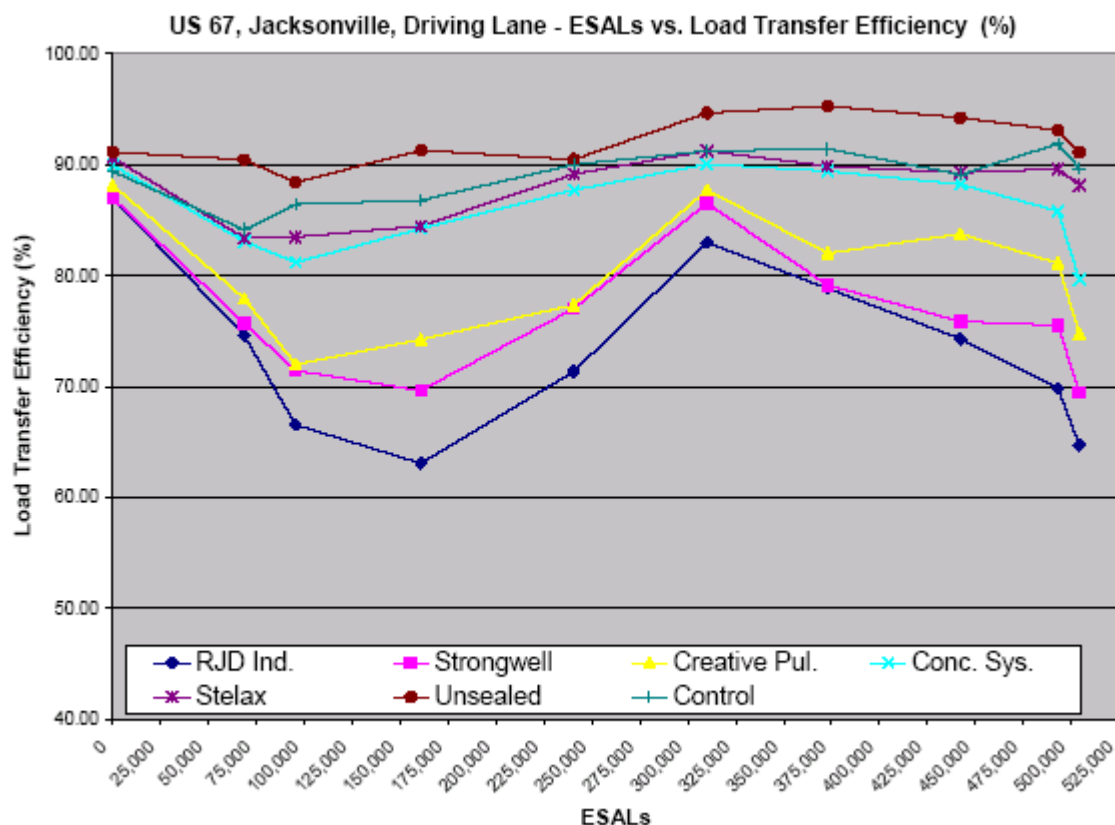
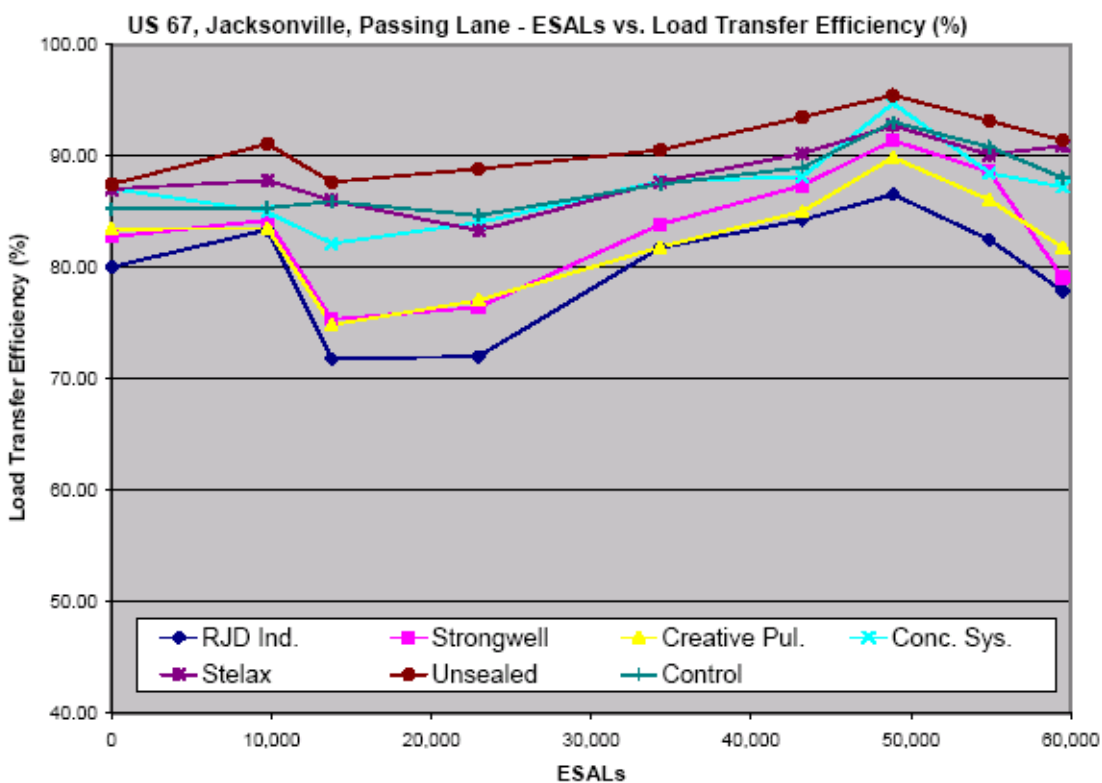
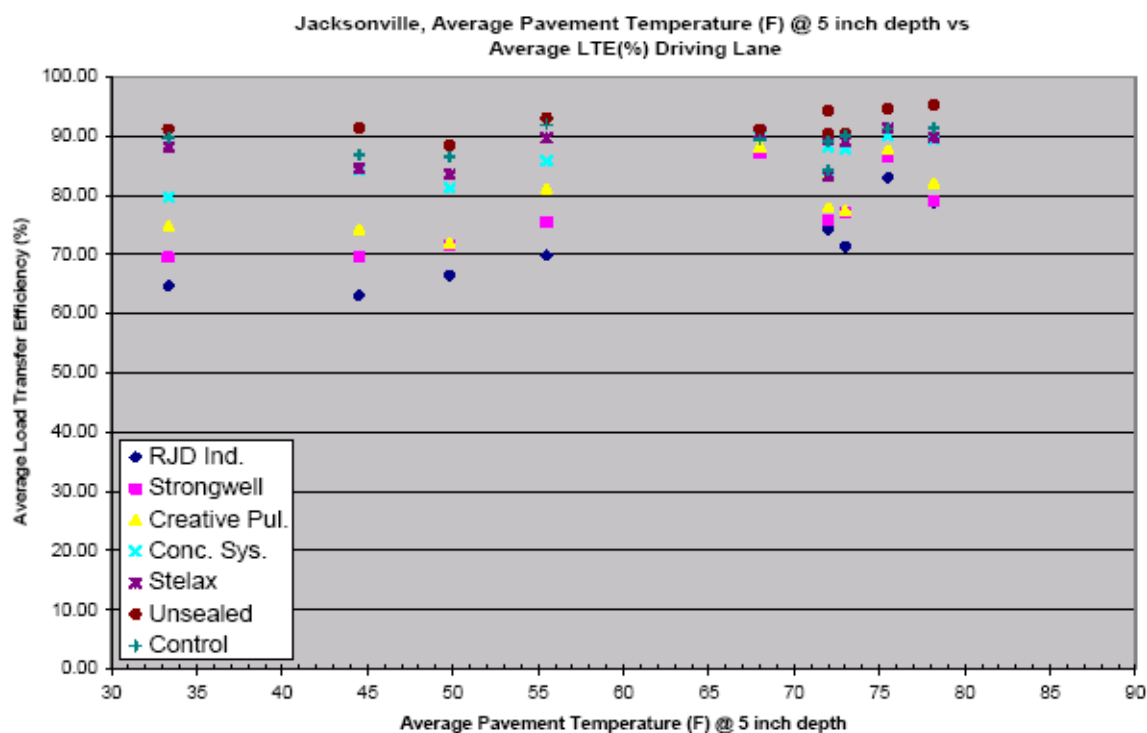
Similar behavior as observed at the older two sites (IL 1 & IL2) is shown in the following figures. The control set (1½" Ø epoxy coated steel), unsealed epoxy coated steel bars, stainless steel clad carbon steel bars, and fibrillated wound fiber composite bars exhibit better LTE and

lower joint deflections than the pultruded fiber composite bars, but do not show excessive joint deflection indicating failure of the joints. Pavement at Jacksonville (IL 3) was constructed on a cement aggregate mixture subbase (CAM2 w/ a minimum of 200 lbs of cement per cubic yard) rather than a granular subbase as in Naperville (IL 2) or a bituminous aggregate mixture subbase (BAM) at Williamsville (IL 1).

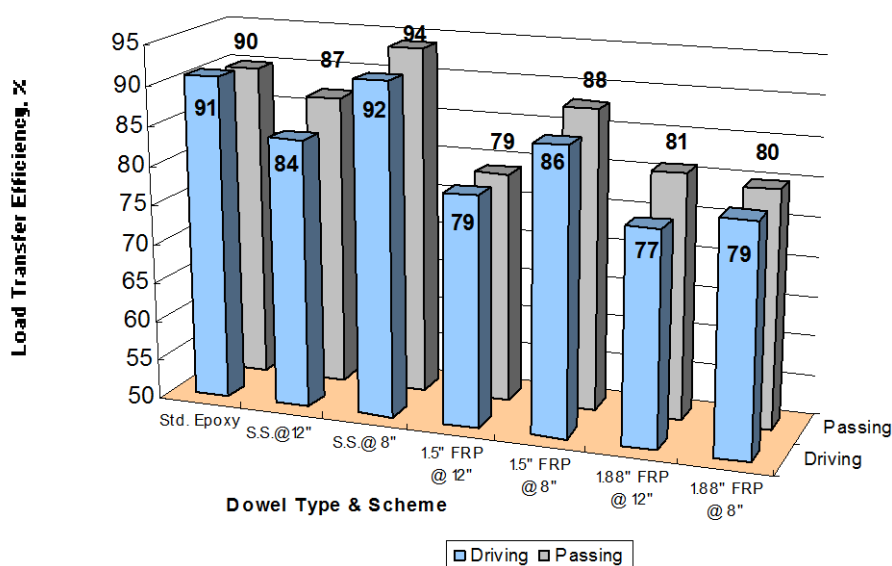
Figure 20. Average Load Transfer Efficiency.

- All dowel materials tested are performing equally in terms of load transfer, joint movement, and faulting over the five-year analysis period.
- Stainless steel dowels do provide load transfer performance equal to or greater than epoxy-coated steel dowels in this study on the average over five years.
- FRP dowels of the sizes tested in this research should be spaced no greater than 8 inches (203 mm) apart to gain load transfer performance at the same level as epoxy-coated steel dowels at 12-inch (305 mm) spacing.
- No deterioration due to road deicers was found on any of the dowel materials retrieved in the 2002 coring operation.

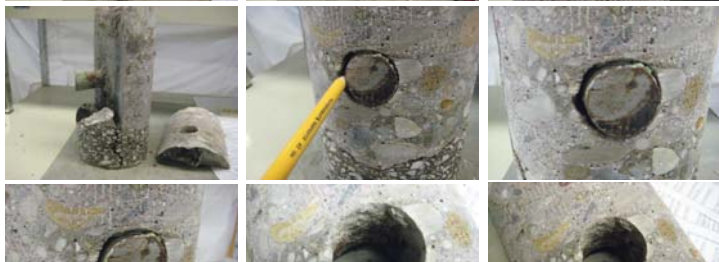
Core Intact, Y or N	Yes			
Type of Joint Sealant	NA			
Socketing around dowel	Yes			
Corrosion of dowel at concrete interface	Minor			
Abrasion of the dowel surface at the crack face	Minor, some orange color spots at ends face			
Dowel Deterioration	Minor			
Dowel Type	Epoxy Coated			
PCC Deterioration	No			
PCC Stain	Yes, dark and brown colors at dowel placement areas			
Signs of Defect in Core-holes

Date when core was taken	NA			
Dowel/Concrete Slab Interface				
Base Material Noted				
General Comments: The AC Overlay layer is attached to PCC as well as the dowel.

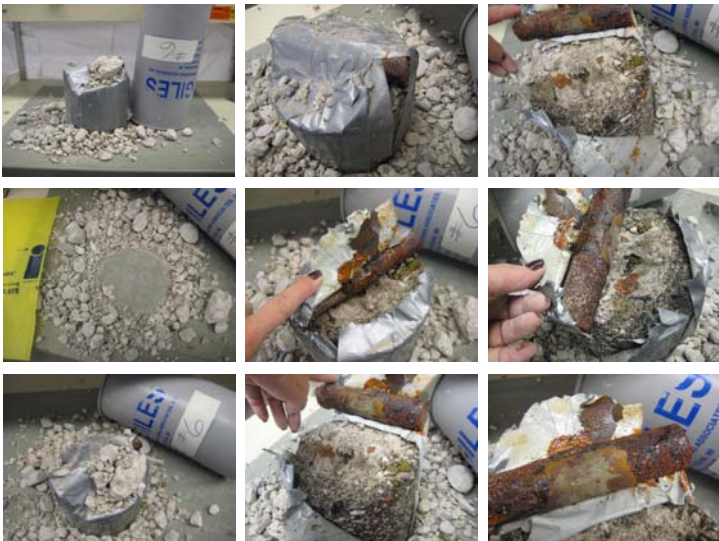
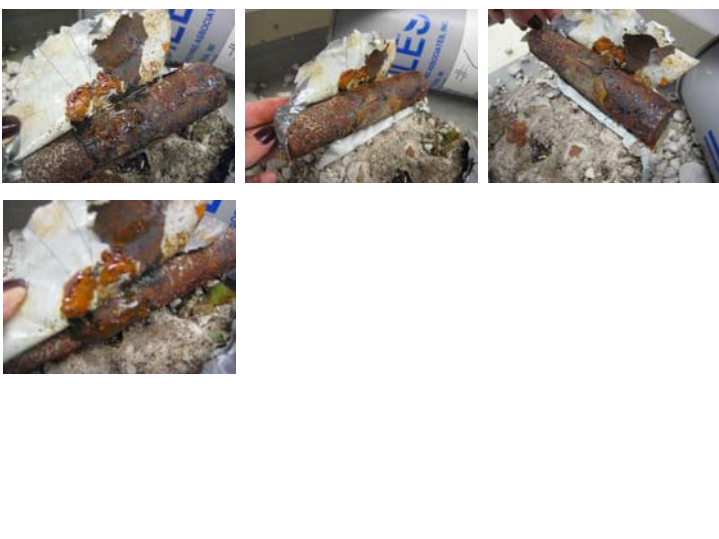
Signs of Defects in Cores Taken	Description	Photos
Core Number	STH67-Waukesha-C6

Core Intact, Y or N	No	
Type of Joint Sealant	NA	
Socketing around dowel	Extensive	
Corrosion of dowel at concrete interface	Extensive	
Abrasion of the dowel surface at the crack face	Extensive	
Dowel Deterioration	Extensive	
Dowel Type	Epoxy Coated	
PCC Deterioration	Yes, complete disintegration	
PCC Stain		
Signs of Defect in Core-holes

Date when core was taken	NA	
Dowel/Concrete Slab Interface		
Base Material Noted		
General Comments: The core has an AC overlay layer. The PCC portion is disintegrated completely. After the duck tape was removed, water was found on the dowel and around that area. The water seemed to come from condensation (all wrapped with duck tape) from the coring process.

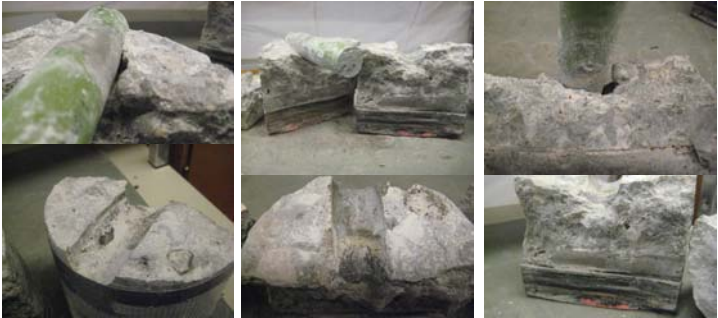
Core Intact, Y or N	No (3 pieces)	
Type of Joint Sealant	Neoprene	
Socketing around dowel	Yes, minor	
Corrosion of dowel at concrete interface	Minor	
Abrasion of the dowel surface at the crack face	Minor	
Dowel Deterioration	Minor	
Dowel Type	Epoxy Coated	
PCC Deterioration	No	
PCC Stain	Yes, starting to show some yellowish spots, there is one dark area	
Signs of Defect in Core-holes

Date when core was taken	NA	
Dowel/Concrete Slab Interface		
Base Material Noted		
General Comments: The bottom was opened with a hammer to be able to see the dowel. There are a total of 4 pieces.

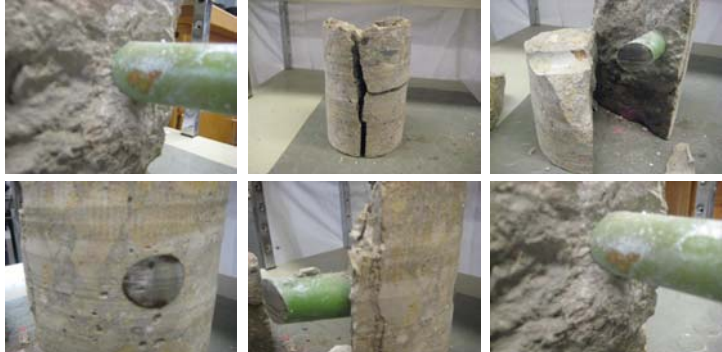
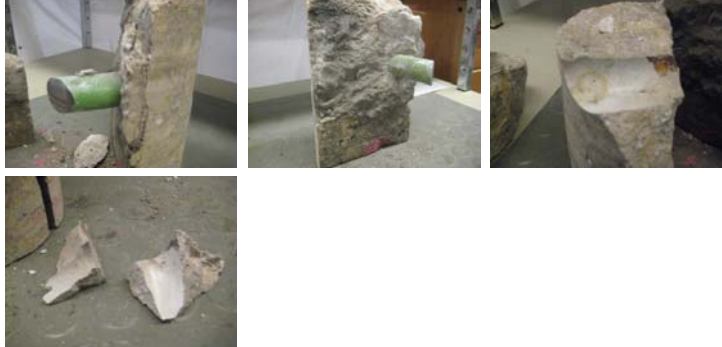
Core Intact, Y or N	Yes			
Type of Joint Sealant	NA			
Socketing around dowel	No			
Corrosion of dowel at concrete interface	No			
Abrasion of the dowel surface at the crack face	No			
Dowel Deterioration	One small spot, light brown			
Dowel Type	Epoxy Coated			
PCC Deterioration	Some after core was opened with electrical hammer.			
PCC Stain				
Signs of Defect in Core-holes

Date when core was taken	6-17-2009			
Dowel/Concrete Slab Interface				
Base Material Noted				
General Comments: The core was opened with an electrical hammer to be able to observe the dowel. The core was broken into 3 big pieces, 3 medium and a lot of small ones.

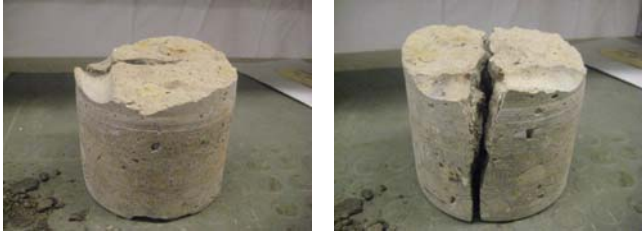
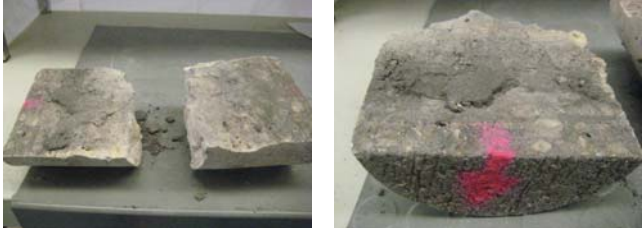
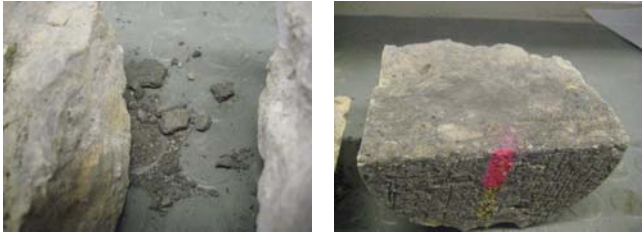
Signs of Defects in Cores Taken	Description	Photos
Core Number	<b>USH18-Dane-S14-Jt2-D11</b>

Core Intact, Y or N	No (2 pieces)	
Type of Joint Sealant	NA	
Socketing around dowel	No	
Corrosion of dowel at concrete interface	No Dowel to evaluate	
Abrasion of the dowel surface at the crack face	NA	
Dowel Deterioration	NA	
Dowel Type	NA	
PCC Deterioration	No	
PCC Stain	Yes, some spots and dark material at joint.	
<b>Signs of Defect in Core-holes</b>

Date when core was taken	6-17-2009	
Dowel/Concrete Slab Interface		
Base Material Noted		
General Comments: No dowel was available to evaluate.

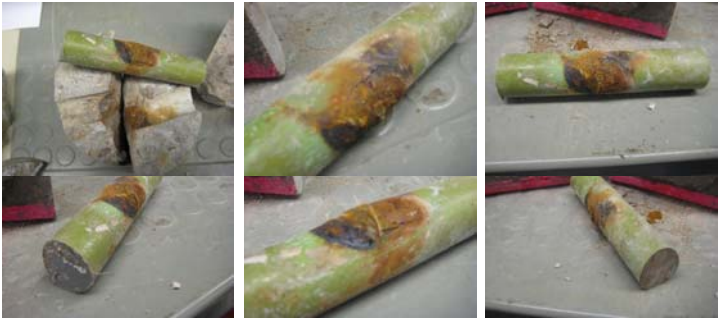
Core Intact, Y or N	No	
Type of Joint Sealant	NA	
Socketing around dowel	Minor	
Corrosion of dowel at concrete interface	Moderate	
Abrasion of the dowel surface at the crack face	Moderate	
Dowel Deterioration	Yes	
Dowel Type	Epoxy Coated	
PCC Deterioration	Minor	
PCC Stain	Yes, dark browns and oranges by corroded areas.	
Signs of Defect in Core-holes

Date when core was taken	6-30-2009	
Dowel/Concrete Slab Interface		
Base Material Noted		
General Comments: There are 4 big pieces and one medium. The dowel is loose.

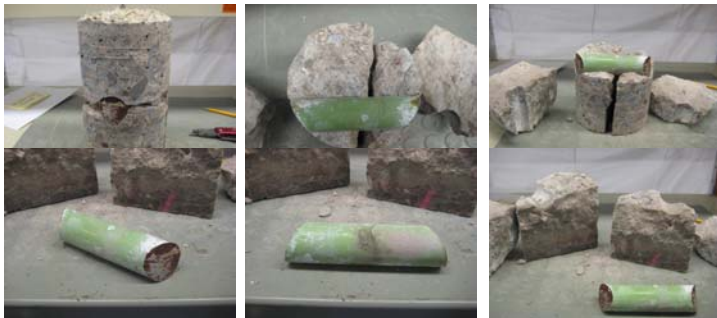
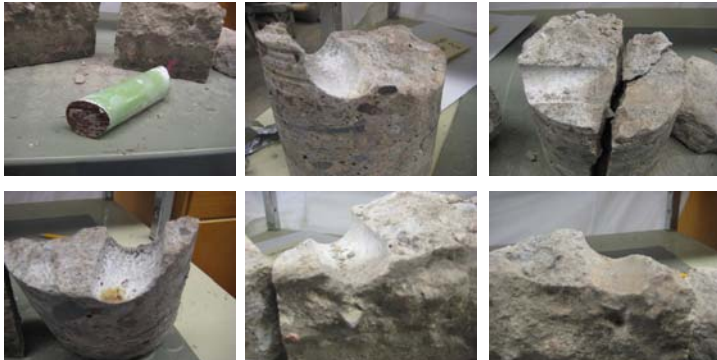
Core Intact, Y or N	No			
Type of Joint Sealant	NA			
Socketing around dowel	No			
Corrosion of dowel at concrete interface	Minimal, there is brown spots at edges

Abrasion of the dowel surface at the crack face	Minor			
Dowel Deterioration	Minor			
Dowel Type	Epoxy Coated			
PCC Deterioration	No

PCC Stain	One spot light yellow			
Signs of Defect in Core-holes				
Date when core was taken	10-20-2009

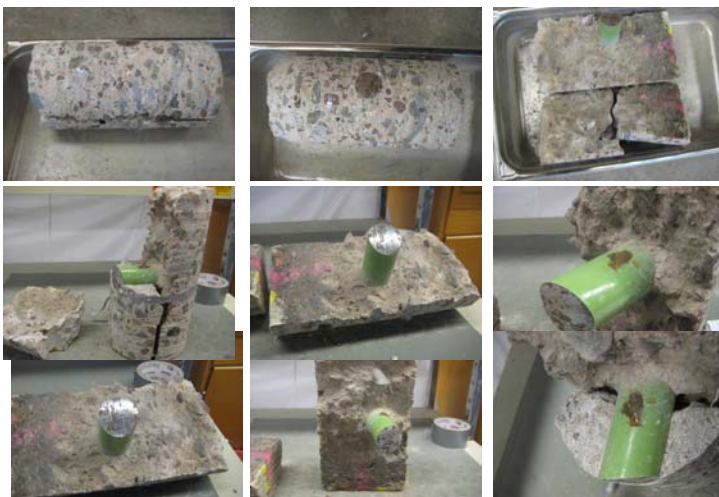
Signs of Defects in Cores Taken	Description	Photos		
Core Number	STH29-Clark-C1-Jt6-D3

Core Intact, Y or N	Yes			
Type of Joint Sealant	NA			
Socketing around dowel	No			
Corrosion of dowel at concrete interface	Minor			
Abrasion of the dowel surface at the crack face	Minor			
Dowel Deterioration	No			
Dowel Type	Epoxy Coated Steel			
PCC Deterioration	No			
PCC Stain	One spot very dark			
Signs of Defect in Core-holes

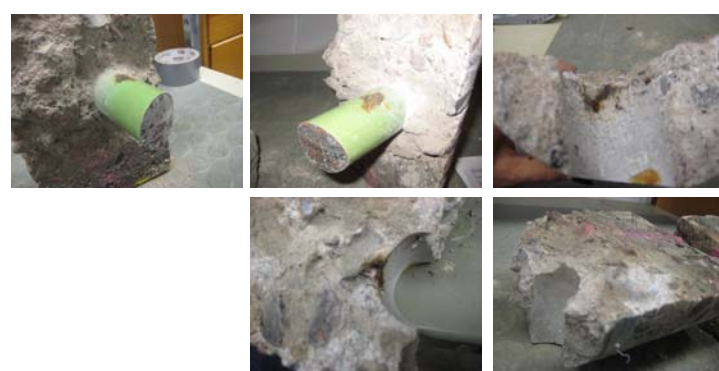
Date when core was taken	10/21/2009			
Dowel/Concrete Slab Interface				
Base Material Noted				
General Comments: The core was hammered to be able to observe the dowel and PCCC. There are now 3 big pieces.
