# EVALUATION OF ALTERNATIVE DOWEL BAR MATERIALS AND COATINGS

## Final Report

Ohio Department of Transportation  
Office of Research and Development

November 2011

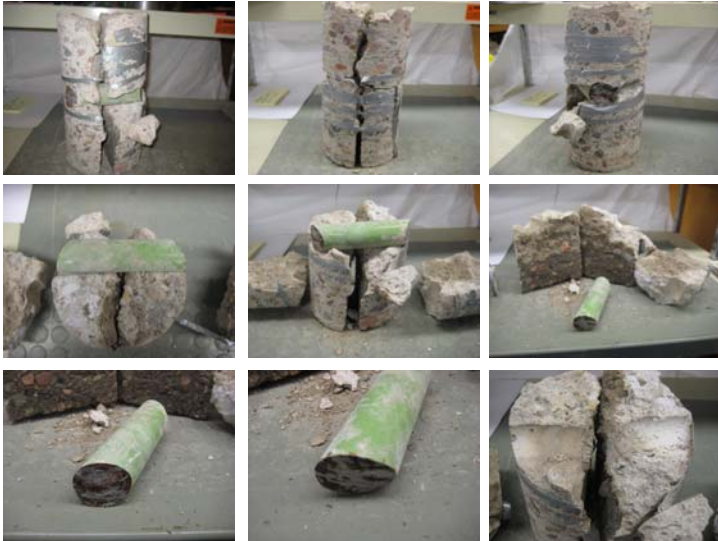
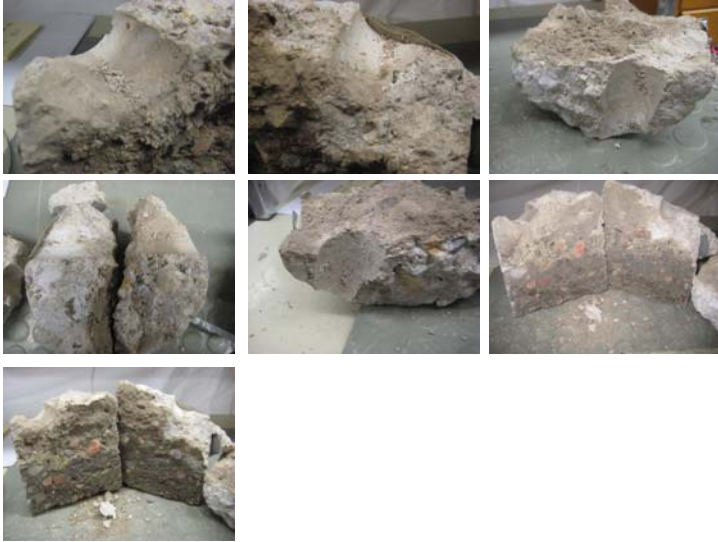
Signs of Defects in Cores Taken	Description	Photos		
Core Number	STH29-Clark-C1-Jt6-D11

Core Intact, Y or N	No			
Type of Joint Sealant	NA			
Socketing around dowel	No			
Corrosion of dowel at concrete interface	No			
Abrasion of the dowel surface at the crack face	No			
Dowel Deterioration	Yes, some oxidation at cut areas.			
Dowel Type	Epoxy Coated Steel			
PCC Deterioration	Minor			
PCC Stain	None			
Signs of Defect in Core-holes

Date when core was taken	10/21/2009			
Dowel/Concrete Slab Interface				
Base Material Noted				
General Comments: There are 4 big pieces, 1 medium and the dowel is loose.

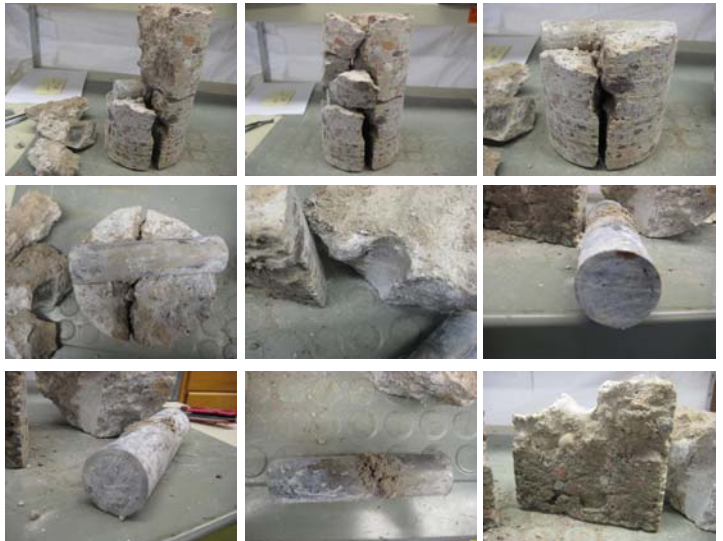
Signs of Defects in Cores Taken	Description	Photos		
Core Number	STH29-Clark-HF-Jt8-D3

Core Intact, Y or N	No (6 pieces)			
Type of Joint Sealant	NA			
Socketing around dowel	No			
Corrosion of dowel at concrete interface	No			
Abrasion of the dowel surface at the crack face	No			
Dowel Deterioration	No			
Dowel Type	Mortar-Filled Stainless Steel Tube			
PCC Deterioration	Minor			
PCC Stain	Only one dark area			
Signs of Defect in Core-holes
