**CRACK SURVEYS OF LOW-CRACKING HIGH-PERFORMANCE CONCRETE
BRIDGE DECKS IN KANSAS
2014-2015**

**By
Abdallah Alhmoody
David Darwin
Matt O'Reilly**

**Structural Engineering and Engineering Materials
SL Report 15-3**

**THE UNIVERSITY OF KANSAS CENTER FOR RESEARCH, INC.
LAWRENCE, KANSAS
September 2015**

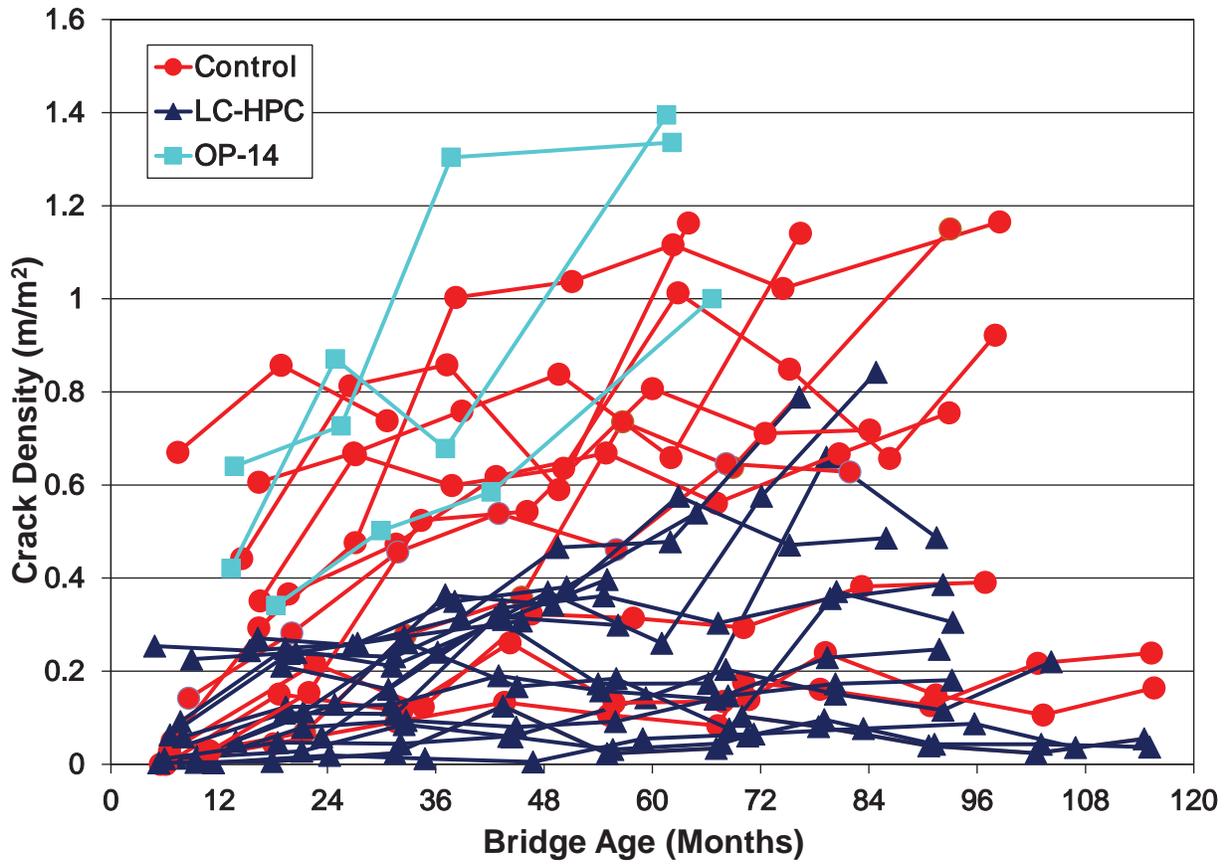
Figure 2: LC-HPC and Control Decks Crack Densities Versus Deck Age

Tables 4 and 5 summarize the crack density for the bridge decks surveyed in 2014 and 2015, respectively. The crack maps for these surveys are included in this section. The results of the surveys performed in 2006, 2007, and 2008 were reported by Gruman, Darwin, and Browning (2009), those performed in 2009 and 2010 were reported by Pendergrass, Darwin, and Browning (2011), and those performed in 2011, 2012, and 2013 were reported by Bohaty, Riedel, and Darwin (2013); the earlier results are summarized in Appendix B. Figure 2 shows crack densities over time for all the bridges included in this study. It can be concluded that the average trend of the LC-HPC decks is lower than the average trend of the control decks. The fact that some LC-HPC decks exhibited greater crack density values than some control decks is because they have experienced different conditions. This report includes individual comparisons for each LC-HPC and control deck pair. In most cases, LC-HPC decks performed better than their controls.

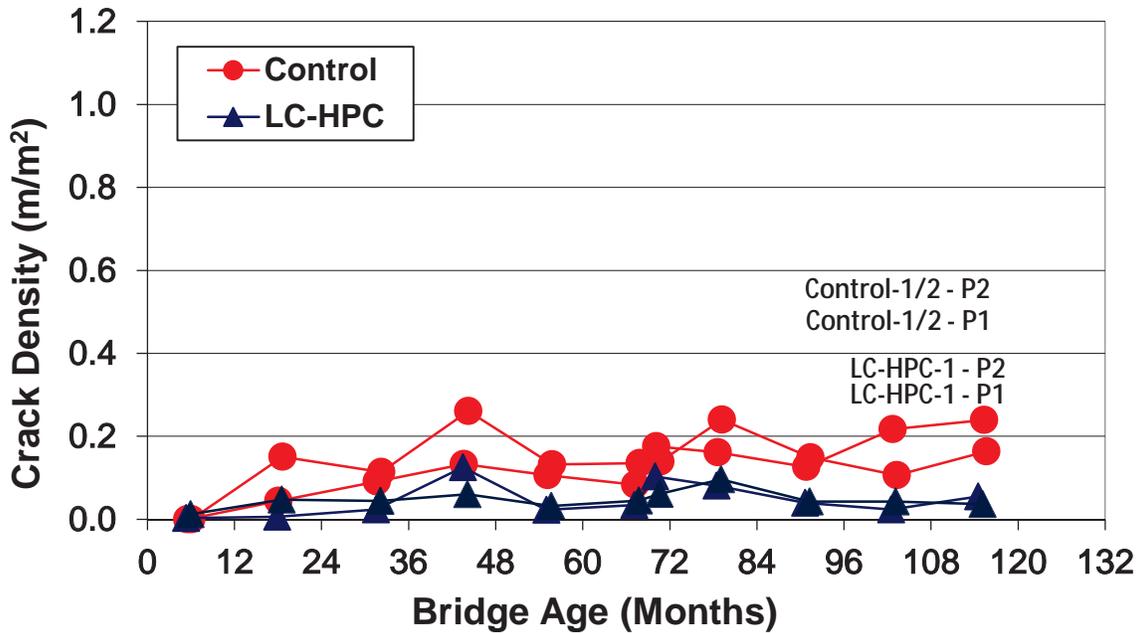
Figure 7: LC-HPC-1 and Control-1/2 Crack Densities Versus Deck Age

The crack densities for LC-HPC-1 and Control-1/2 are compared in Figure 7. The crack densities for both placements of Control-1/2 have been greater than the crack densities for LC-HPC-1. In almost all cases, this has been universally true for the past few surveys.

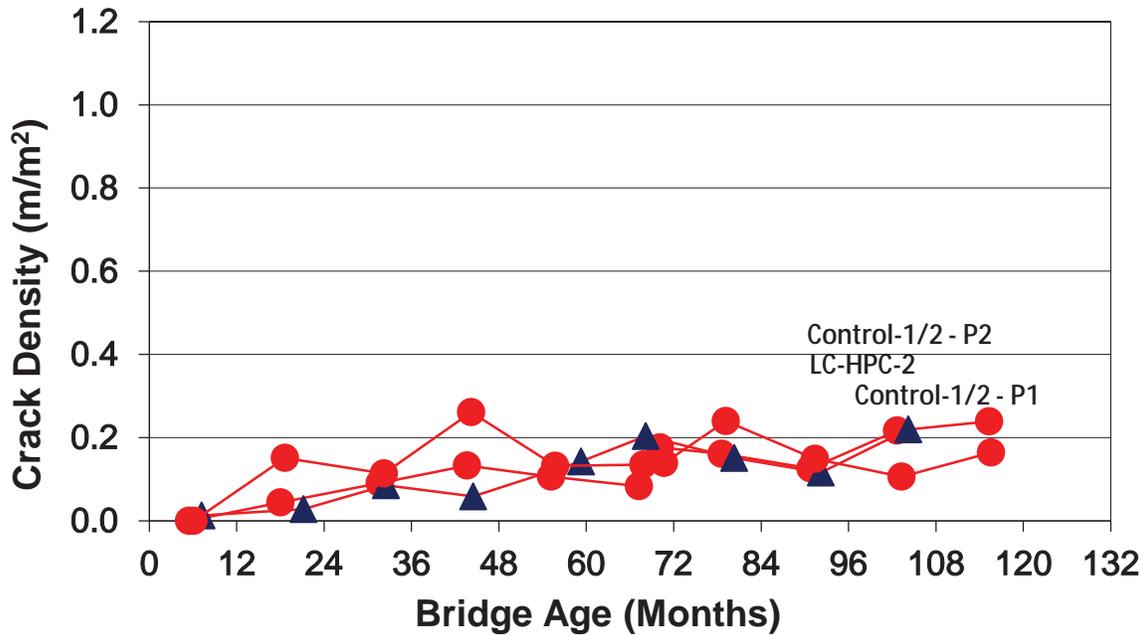
Figure 10: LC-HPC-2 and Control-1/2 Crack Densities Versus Deck Age

As shown in Figure 10, the two decks are exhibiting similar cracking behavior. Placement 2 of Control-1/2 has a higher crack density than LC-HPC-2 and Placement 1 of Control-1/2. Placement 1 of Control-1/2 has a lower crack density than LC-HPC-2. Control-1/2 is the best performing control deck in the study.

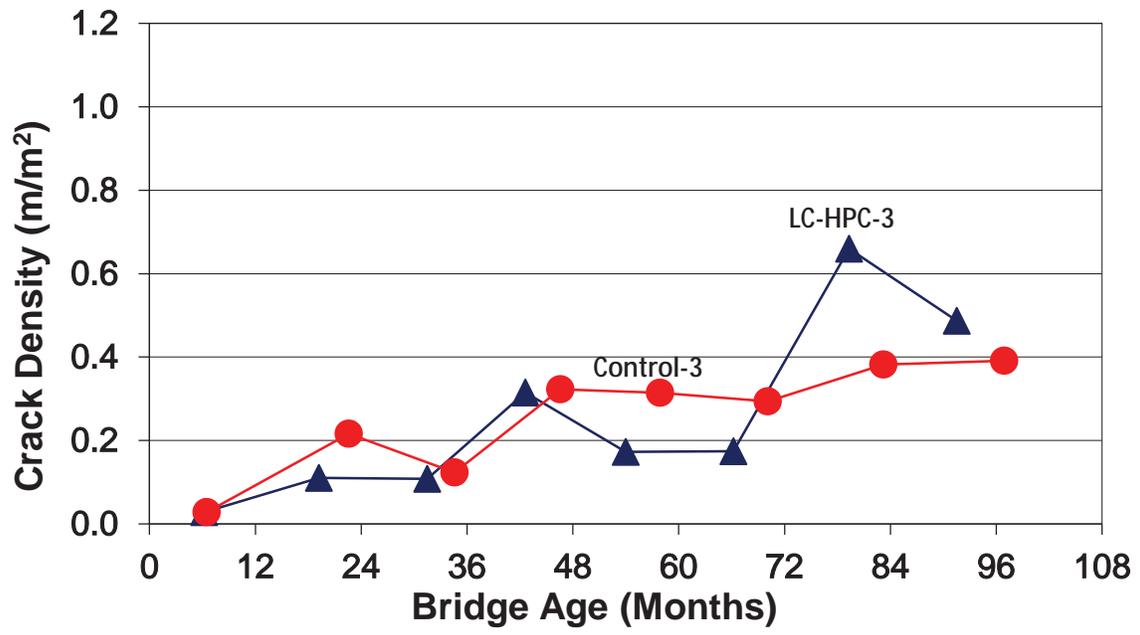
Figure 15: LC-HPC-3 and Control-3 Crack Densities Versus Deck Age

Figure 15 compares crack densities of LC-HPC-3 and Control-3, as a function of age. Control-3 has performed better than LC-HPC-3 during the past three surveys. Further surveys may be needed to understand the cracking behavior of these bridges. The majority of cracks marked on Control-3 are transverse cracks that may have occurred due to settlement cracking. Some cracks propagate longitudinally from both ends of the deck near the abutments.

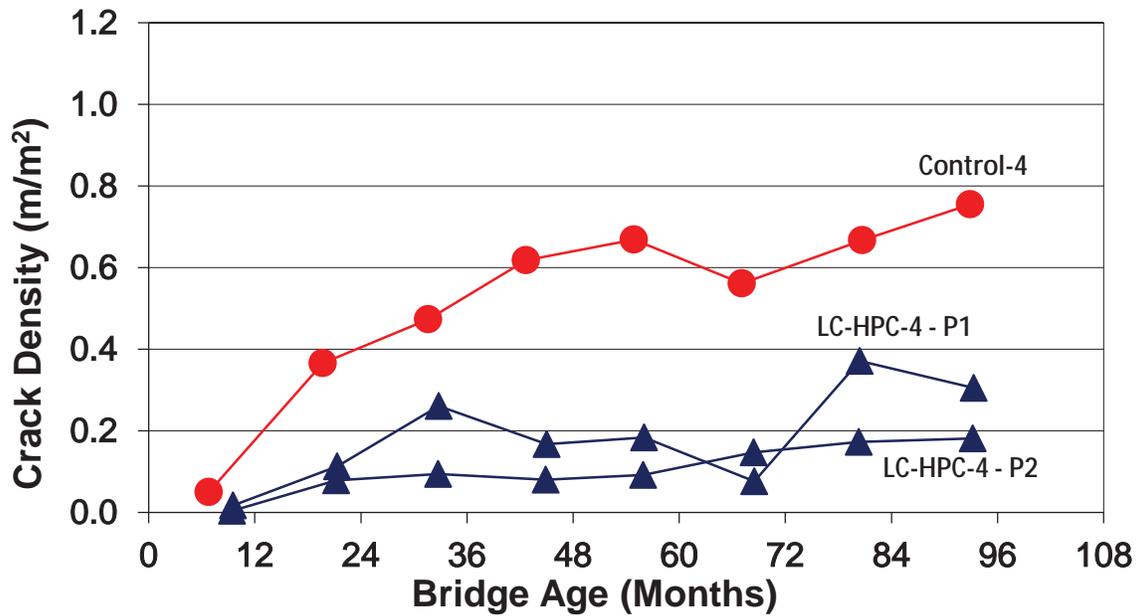
Figure 20: LC-HPC-4 and Control-4 Crack Densities Versus Deck Age

Figure 20 compares crack densities of LC-HPC 4 and Control-4 over time. As shown in Figure 20, both LC-HPC-4 placements are exhibiting much less cracking than Control-4.

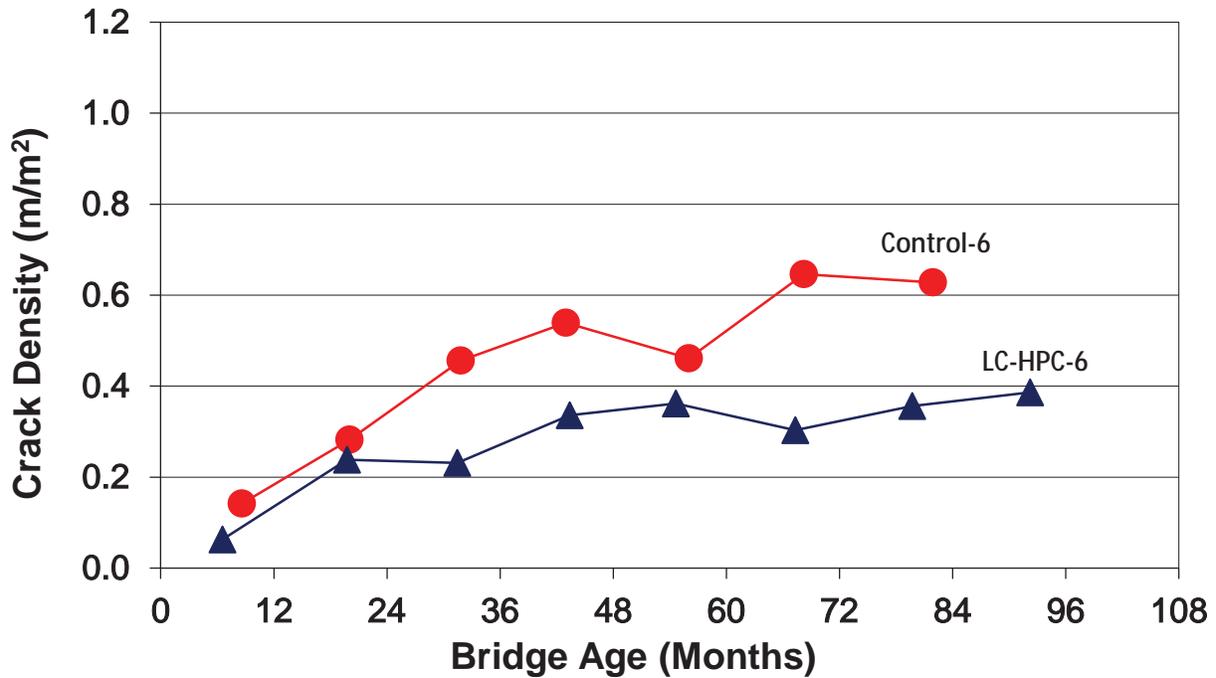
Figure 29: LC-HPC-6 and Control-6 Crack Densities Versus Deck Age

Figure 29 compares the crack densities between LC-HPC-6 and Control-6 over time. LC-HPC-6 deck has performed better than the Control-6 deck over the lifetime of the decks.

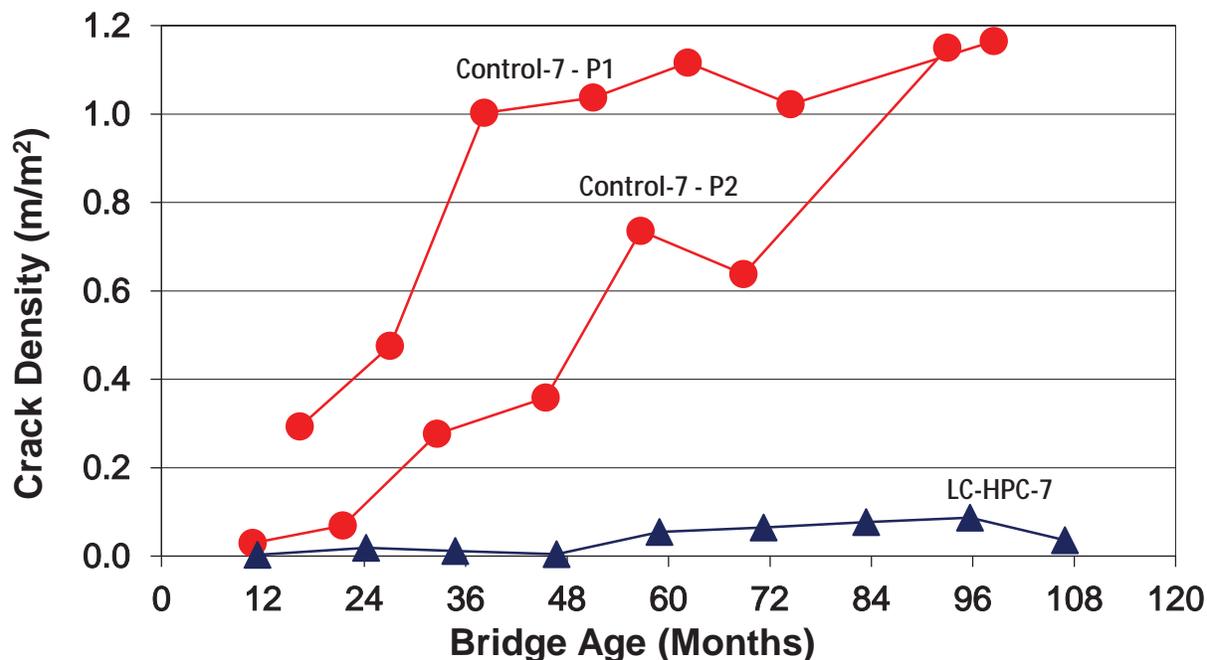
Figure 33: LC-HPC-7 and Control-7 Crack Densities Versus Deck Age

Figure 33 compares the crack densities over time for LC-HPC 7 and Control-7 over time. It can be concluded that LC-HPC-7 has maintained a much lower crack density than Control 7. Noticeably, Control-7 experienced a significant jump in crack density after the second year.

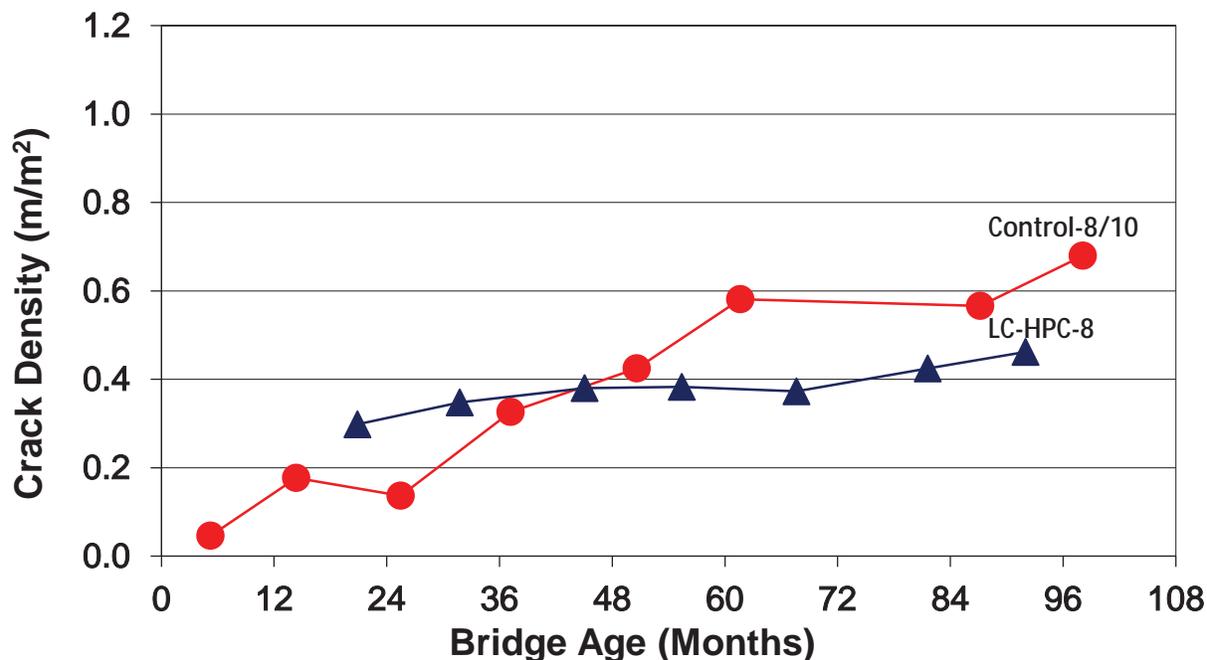
Figure 38: LC-HPC-8 and Control-8/10 Crack Densities Versus Deck Age

Figure 38 compares the crack densities for LC-HPC-8 and Control-8/10 over time. LC-HPC-8 showed higher cracking than Control-8/10 during the early ages of the deck, but has exhibited lower densities since the third survey.

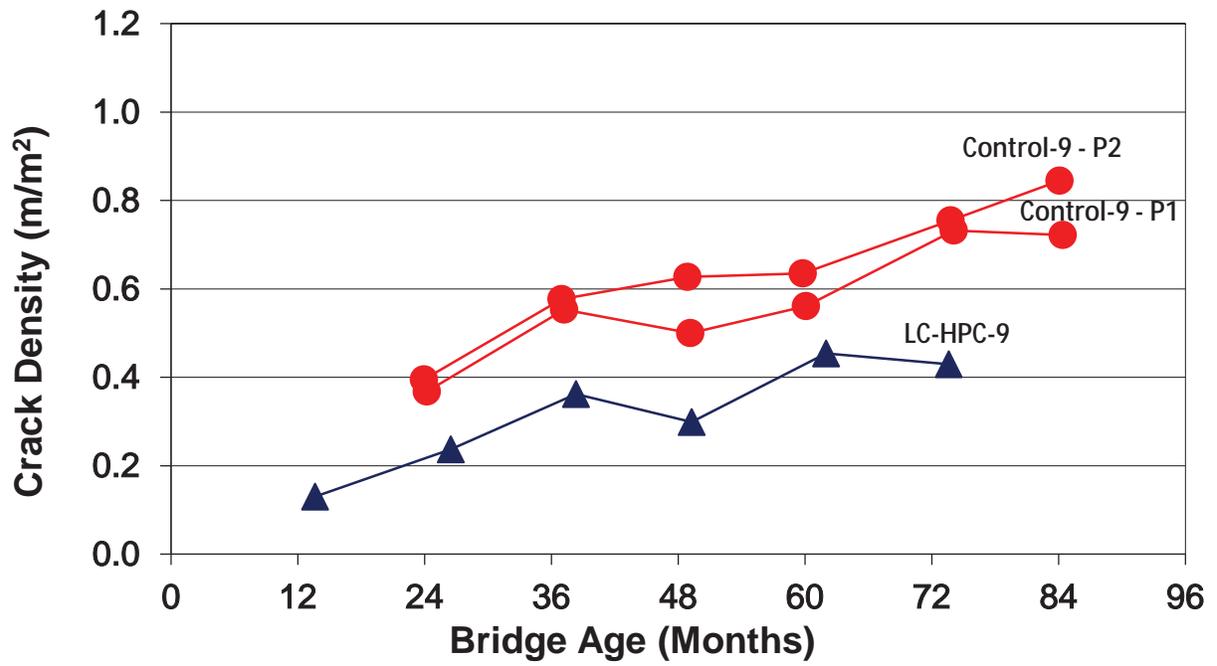
Figure 43: LC-HPC-9 and Control-9 Crack Densities Versus Deck Age

Figure 43 compares the crack densities for LC-HPC-9 and Control-9 over time. LC-HPC-9 has a significantly lower crack density than either placement of Control-9.

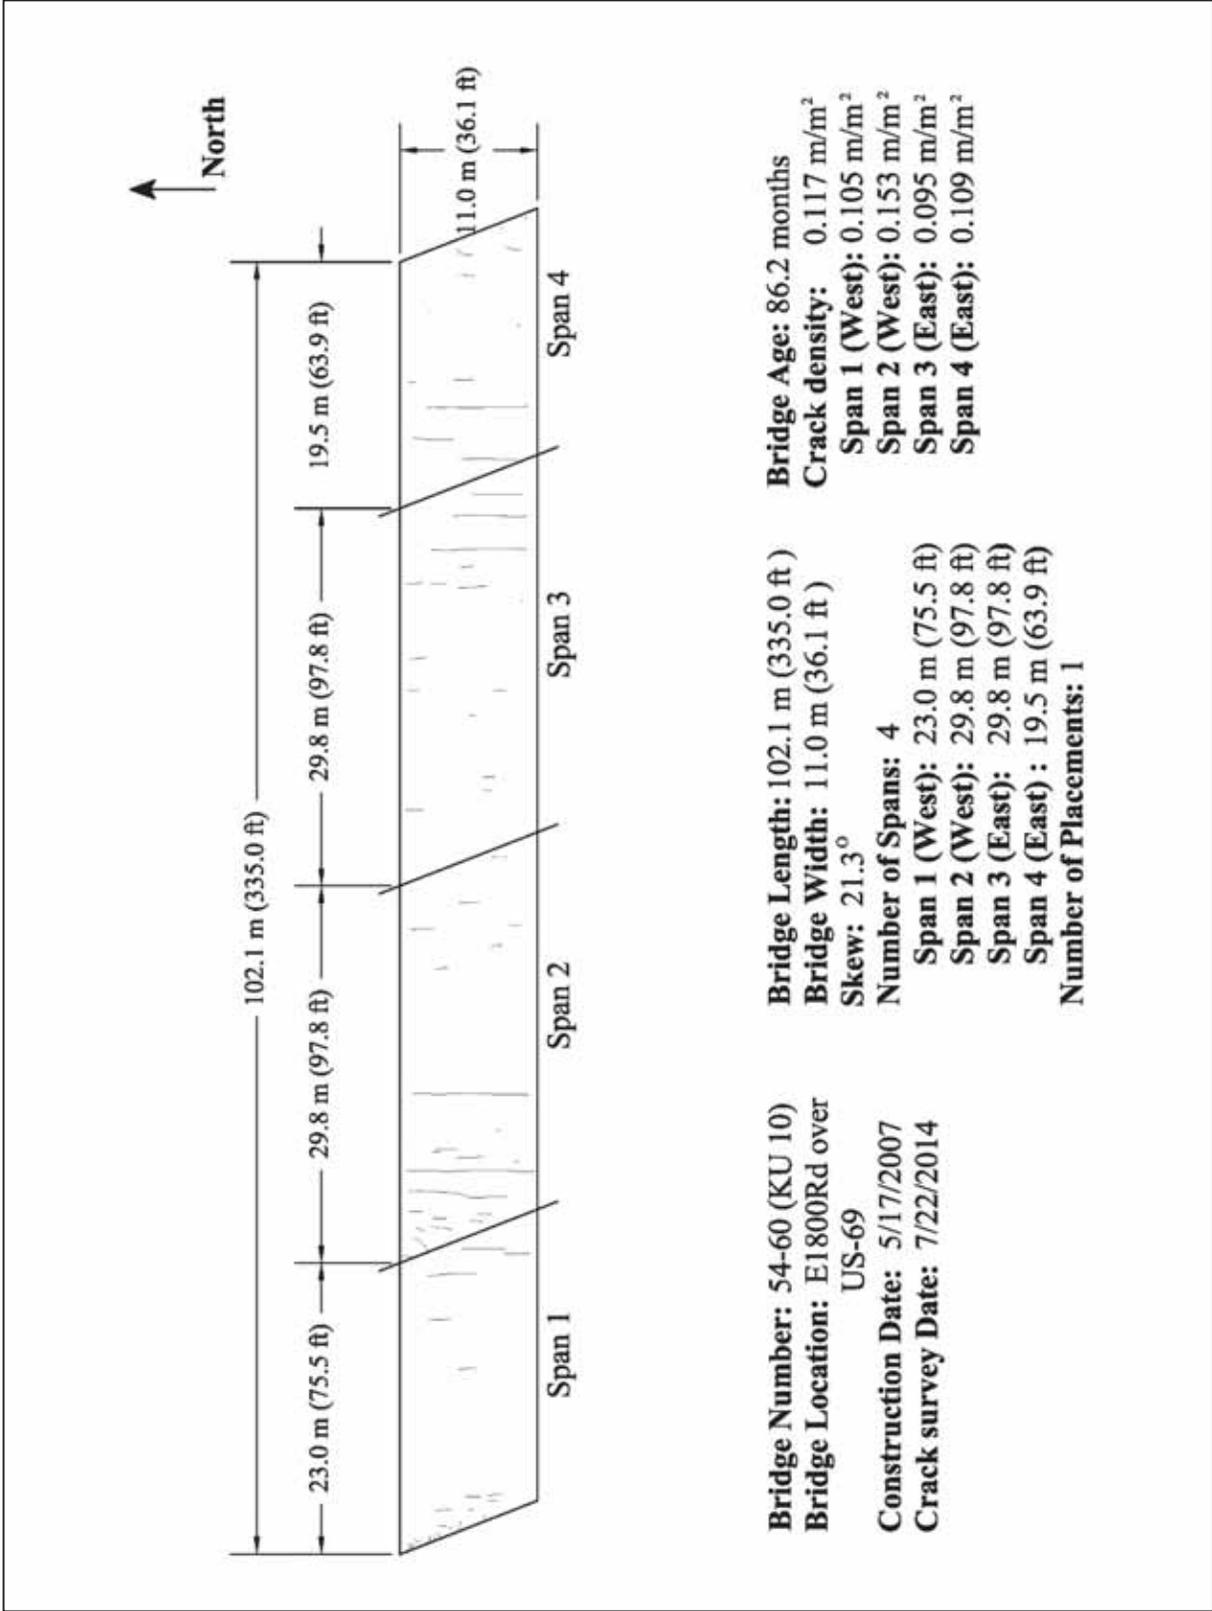
Figure 44: LC-HPC-10 (Survey 7)

Bridge deck LC-HPC-10 is supported by precast-prestressed girders and was constructed on 05/17/2007. LC-HPC-10 deck has been surveyed eight times. The results of Surveys 7 and 8 of LC-HPC-10 are included in this report. Survey 7 was performed at a deck age of 86.2 months; the crack map is displayed in Figure 44. Survey 8 was performed at a deck age of 96.8 months; the crack map is displayed in Figure 45. A crack density of 0.117 m/m^2 was observed in Survey 7 (Figure 44). The crack density for the survey completed in 2013, 0.125 m/m^2 , as reported by Bohaty et al. (2013), is higher than recorded in Survey 7. In Survey 8, a crack density of 0.125 m/m^2 was observed (Figure 45). The first survey of this deck, exhibiting a higher crack density when compared to Control-8/10, was considered as an outlier in previous reports. However, the crack density dropped for the next two surveys, perhaps because of force transferred to the deck from the precast-prestressed girders. Therefore, it cannot be considered as an outlier and must be included in the study to provide a full understanding of the deck behavior. Most of the cracks that are present on LC-HPC-10 are transverse. Table 6 lists the new survey numbers for LC-HPC-10 since it now includes the first survey.

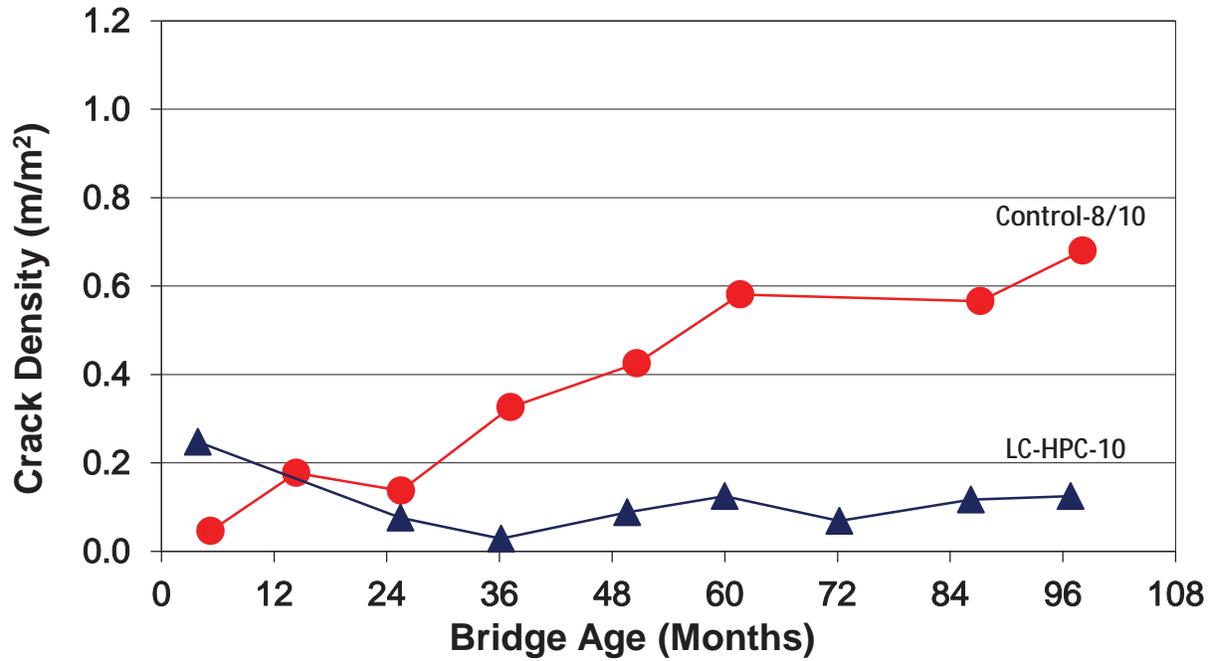
Figure 46: LC-HPC-10 and Control-8/10 Crack Densities Versus Deck Age

Figure 46 compares the crack densities of LC-HPC-10 and Control-8/10 over time. LC-HPC-10 has exhibited much less cracking than Control-8/10 most of the time since the decks were constructed.

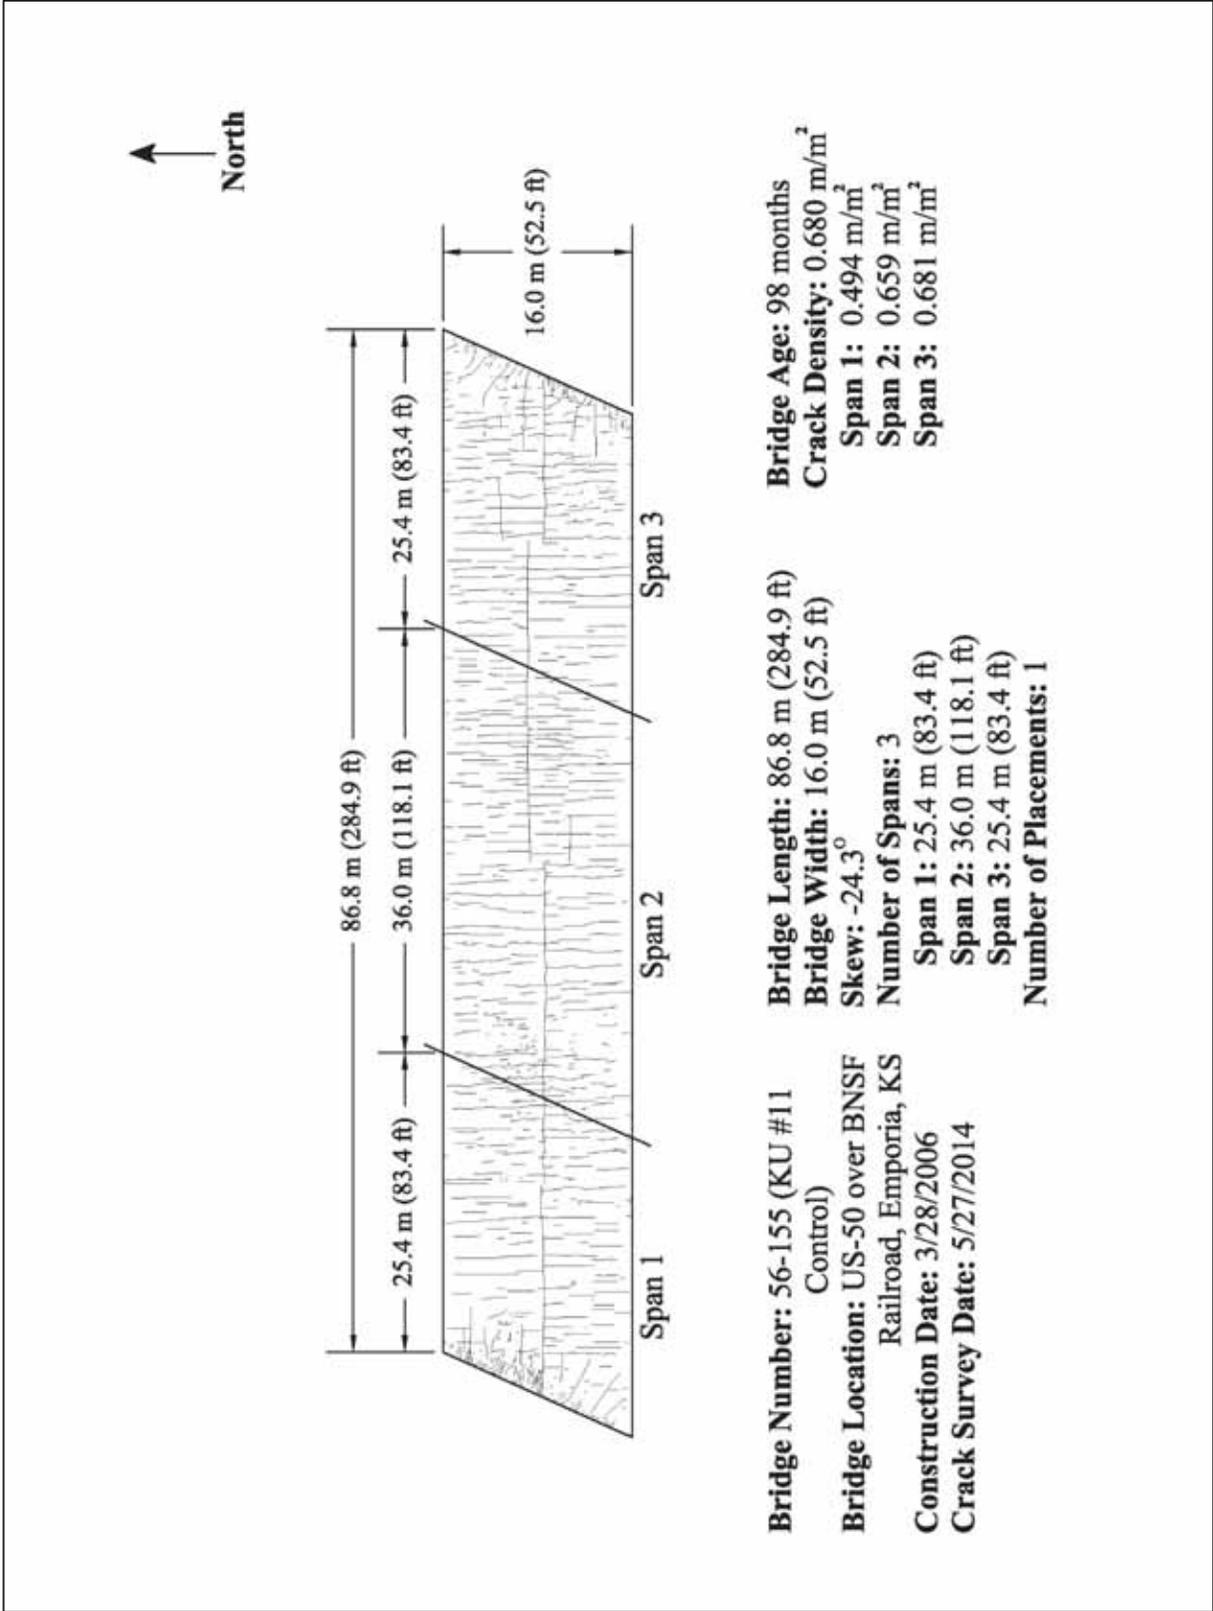
Figure 49: Control-11 (Survey 8)

Bridge deck Control-11 was placed on 3/28/2006 and has been surveyed 8 times. The results of Survey 8 are included in this report. Survey 8 was completed at a deck age of 98.0 months; the crack map is shown in Figure 49. In Survey 8, a crack density of 0.922 m/m^2 was observed (Figure 48). This value is considerably higher than recorded during Survey 7, 0.657 m/m^2 (Bohaty et al. 2013). Survey 8 is considered to be the final crack survey of Control-11 because of high cracking of the bridge deck. Most of the cracks are transverse and spaced uniformly. A longitudinal crack runs the full length of the deck. Cracks have propagated perpendicular to the abutments.

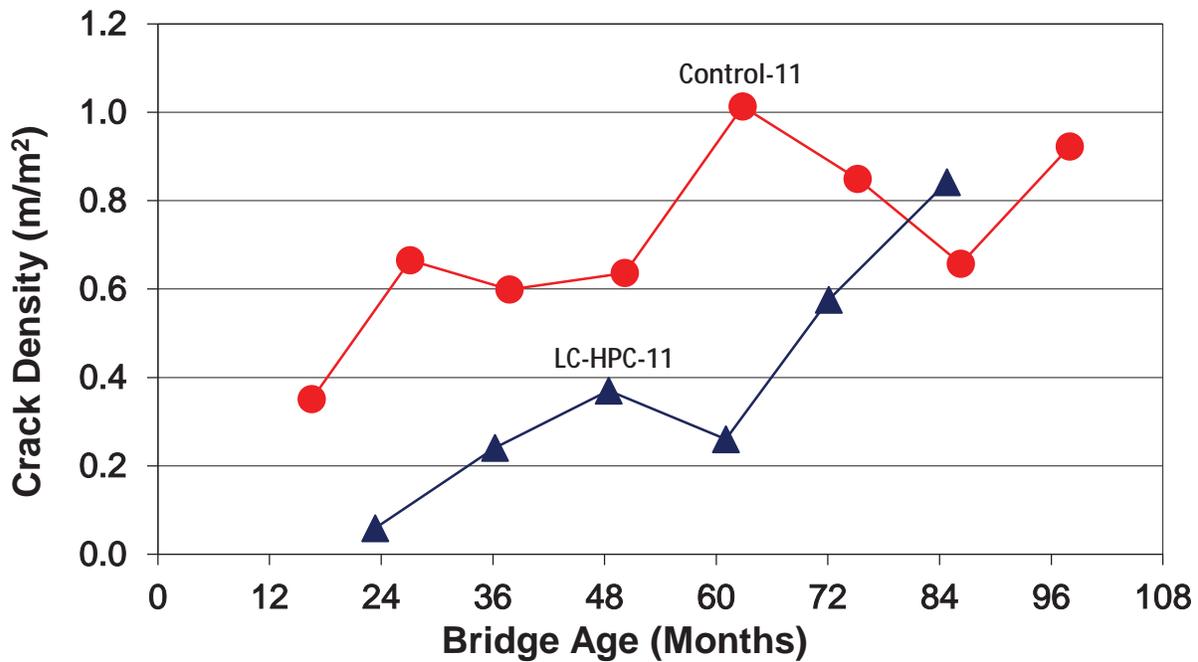
Figure 49: LC-HPC-11 and Control-11 Crack Densities Versus Deck Age

Figure 49 compares crack densities for LC-HPC-11 and Control-11 over time. Although both bridge decks show high crack densities, LC-HPC-11 has exhibited lower crack densities most of the time since the decks were constructed.

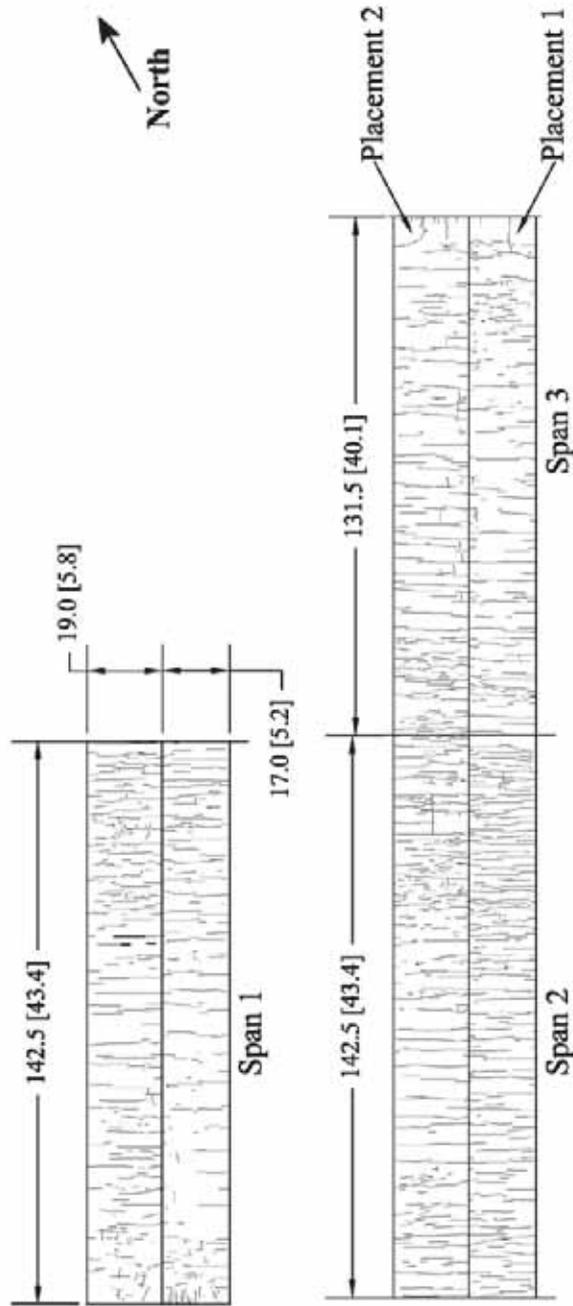
Figure 51: Control-12 (Survey 6)

Like LC-HPC-12, Control-12 was constructed in two placements; Placement 1 was cast on 4/1/2008 and Placement 2 was cast on 4/14/2009. LC-HPC-12 and Control-12 are one bridge spanning over the Neosho River, and Control-12 is the southern portion of this bridge. This deck has been surveyed six times, and the results of Survey 6 are included in this report. Survey 6 was performed at 76.4 and 64.0 months for Placements 1 and 2, respectively; the crack map is displayed in Figure 51. In Survey 6, crack densities of 1.152 m/m² overall, and 1.141 and 1.163 m/m² for Placements 1 and 2 were observed (Figure 51). These values are higher than recorded for Survey 5, 0.858, 0.838, and 0.880 m/m² (Bohaty et al. 2013). Survey 6 marks the last survey of this deck due to its high densities. The majority of the cracks are long transverse cracks. They are very closely spaced compared to the transverse cracks present on LC-HPC-12. Some longitudinal cracks are also present. The middle span exhibits the greatest amount of cracking.

Bridge Age:
 Placement 1: 76.4 months
 Placement 2: 64 months
Crack Density: 1.152 m/m²
 Placement 1: 1.141 m/m²
 Placement 2: 1.163 m/m²
 Span 1: 0.967 m/m²
 Span 2: 1.420 m/m²
 Span 3: 1.063 m/m²

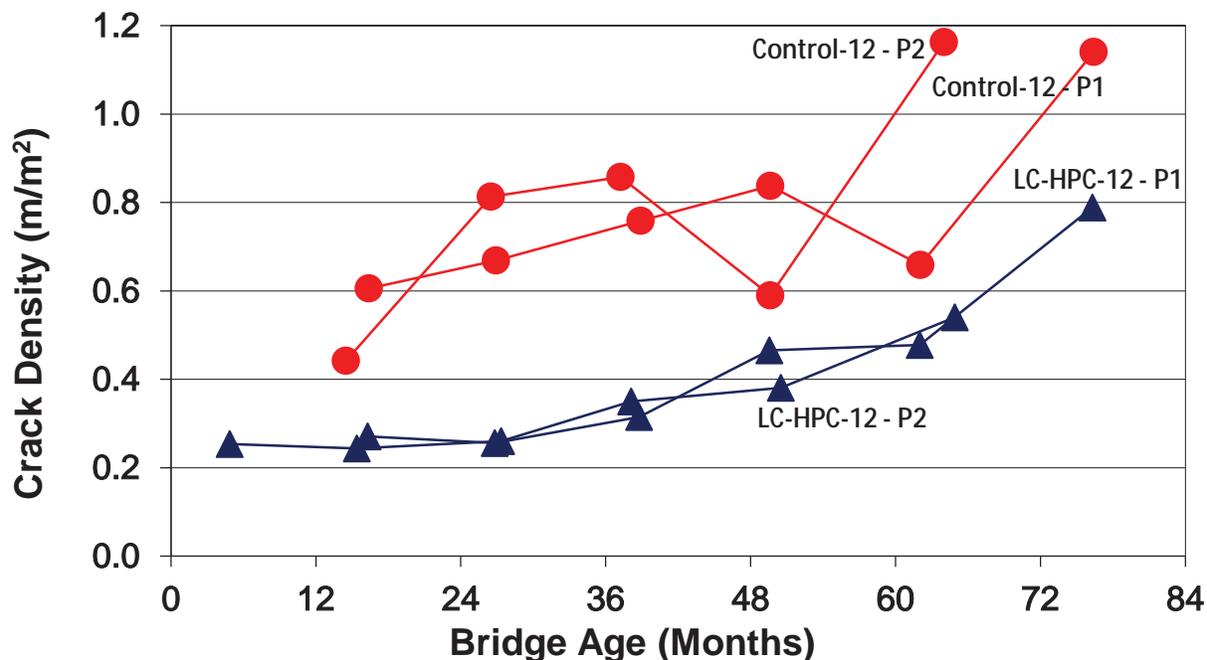
Figure 52: LC-HPC-12 and Control-12 Crack Densities Versus Deck Age

Figure 52 compares the crack densities for LC-HPC-12 and Control-12 over time. Although cracking has been high in LC-HPC-12, its performance has consistently exceeded that of Control-12.

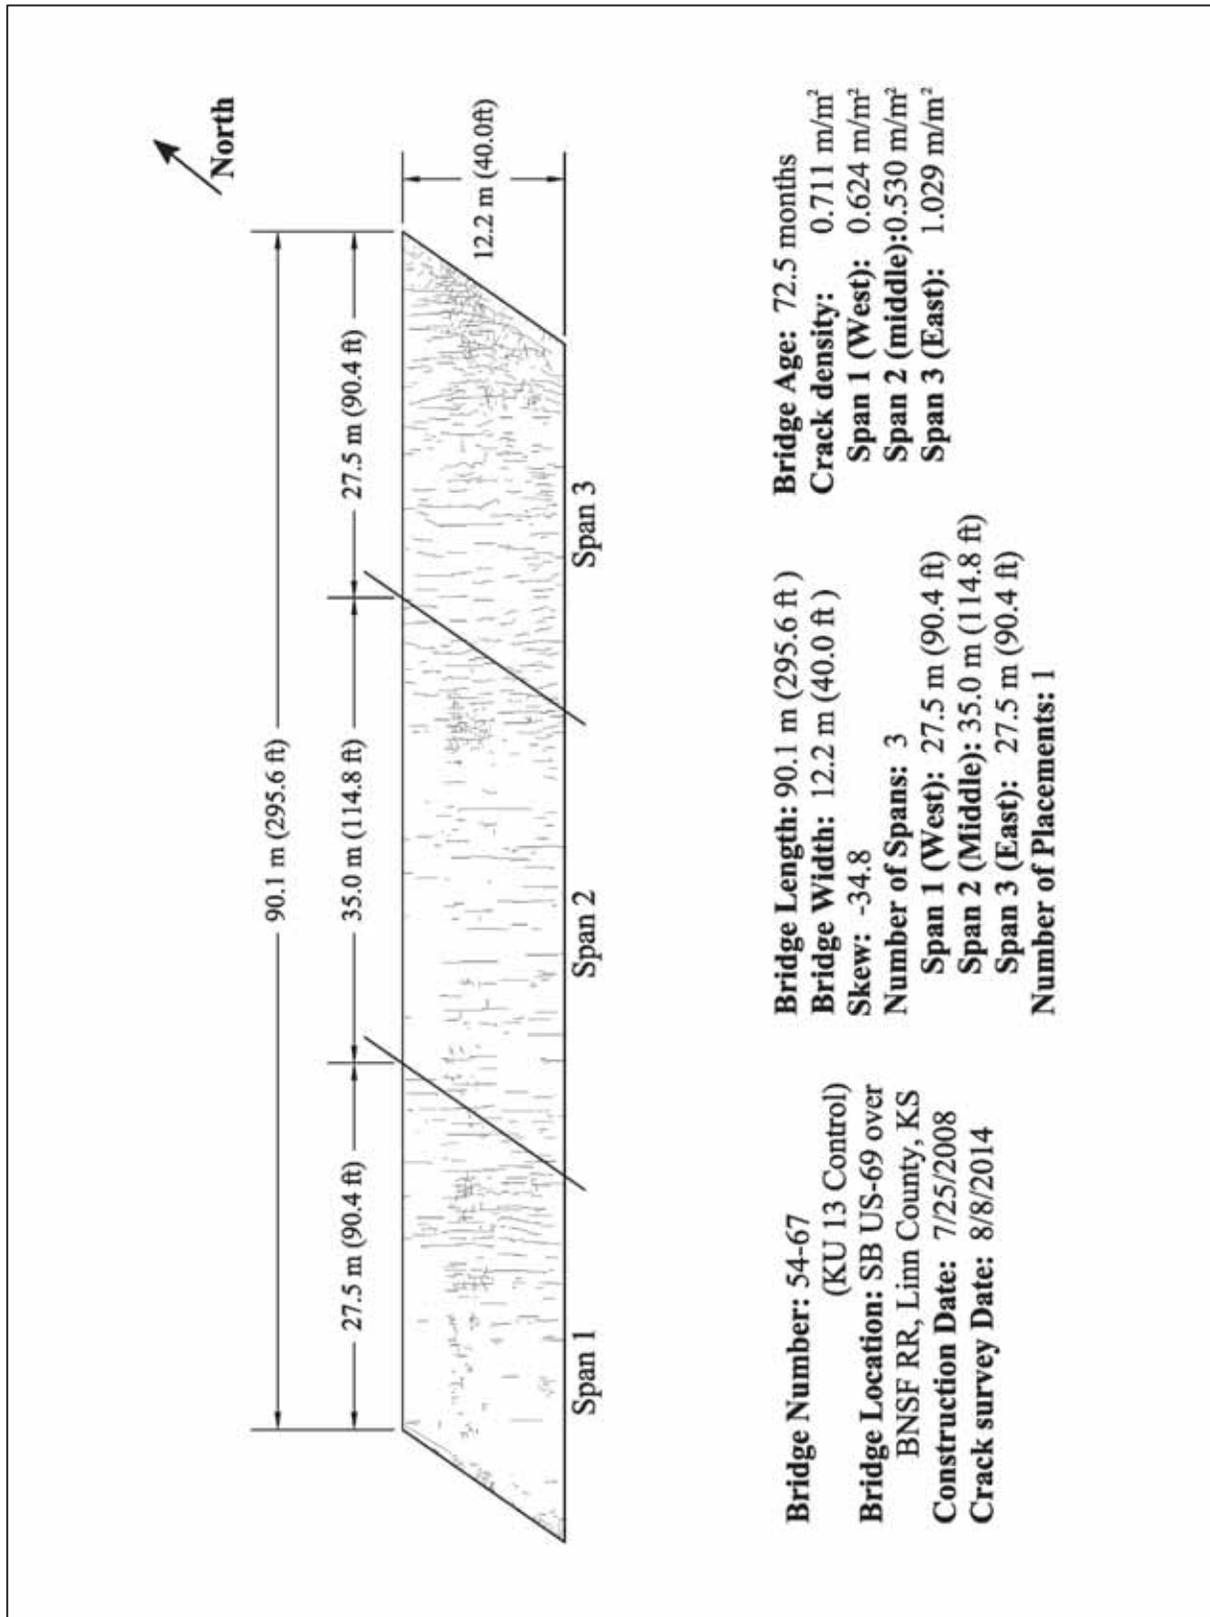
Figure 55: Control-13 (Survey 6)

Bridge deck Control-13 was placed on 7/25/2008 and has been surveyed seven times. The results of Surveys 6 and 7 are included in this report. Survey 6 was completed at a deck age of 72.5 months; the crack map is shown in Figure 55. Survey 7 was completed at a deck age of 84.1 months; the crack map is shown in Figure 56. In Survey 6, a crack density of 0.711 m/m^2 was observed (Figure 55). Survey 6 has a lower crack density than Survey 5, 0.807 m/m^2 (Bohaty et al. 2013). In Survey 7, a crack density of 0.718 m/m^2 was observed (Figure 56), which is slightly higher than Survey 6. Similar to LC-HPC-13, Survey 5 can be considered as an outlier. As shown in Figures 55 and 56, it can be seen that there are moderate-length transverse cracks distributed over the whole area of the bridge. Map cracking is present at some locations on the deck. Short cracks have propagated perpendicular to both abutments.

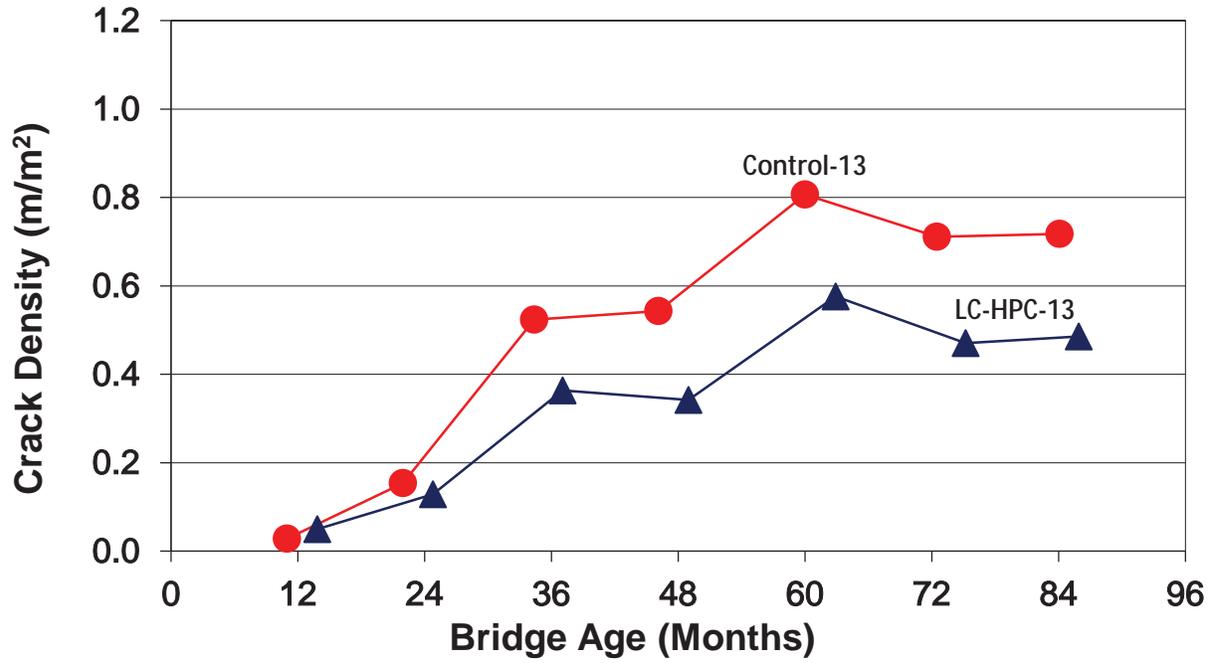
Figure 57: LC-HPC-13 and Control-13 Crack Densities Versus Deck Age

Figure 57 compares the crack densities for LC-HPC-13 and Control-13 over time. LC-HPC-13 has consistently exhibited less cracking density than Control-13 over the life of the decks.

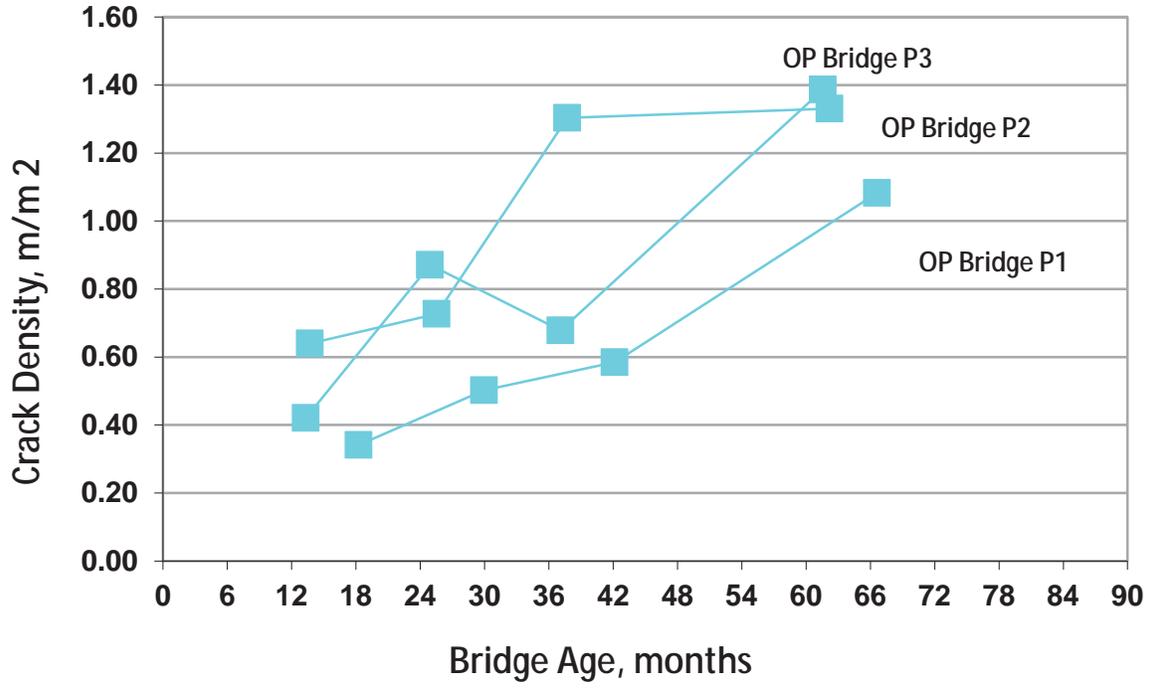
Figure 58: OP-14 Crack Densities Versus Deck Age (Bohaty et al. 2013)

Placement 1 of OP-14 was constructed on two separate dates because the concrete pump clogged after placing the first 30 ft (9 m) of the deck. This portion of the deck was demolished before the second construction attempt. For some concrete batches during the second attempt, the measured slump was much higher than the maximum slump specified for LC-HPC decks. Inadequate consolidation was observed during the construction: the gang vibrators were removed too quickly leaving visible holes at the deck surface. Excessive bullfloating was used on the deck surface, which resulted in excessive cement paste to the surface. The specified ten-minute time between finishing and placing burlap was exceeded throughout the deck construction. Also, water was used as finishing aid. Placements 2 and 3 of OP-14 had the same construction issues as Placement 1, resulting in high deck cracking. During the construction of Placement 2, concrete trucks were delayed and the contractor removed concrete from a previously placed wingwall and used it to complete a portion of the deck. During the construction of Placement 3, the deck reinforcement was not fully supported, resulting in reinforcement vibration. This issue may have

increased the potential for settlement cracking (Lindquist et al. 2008, Gruman et al. 2009, and McLeod et al. 2009).

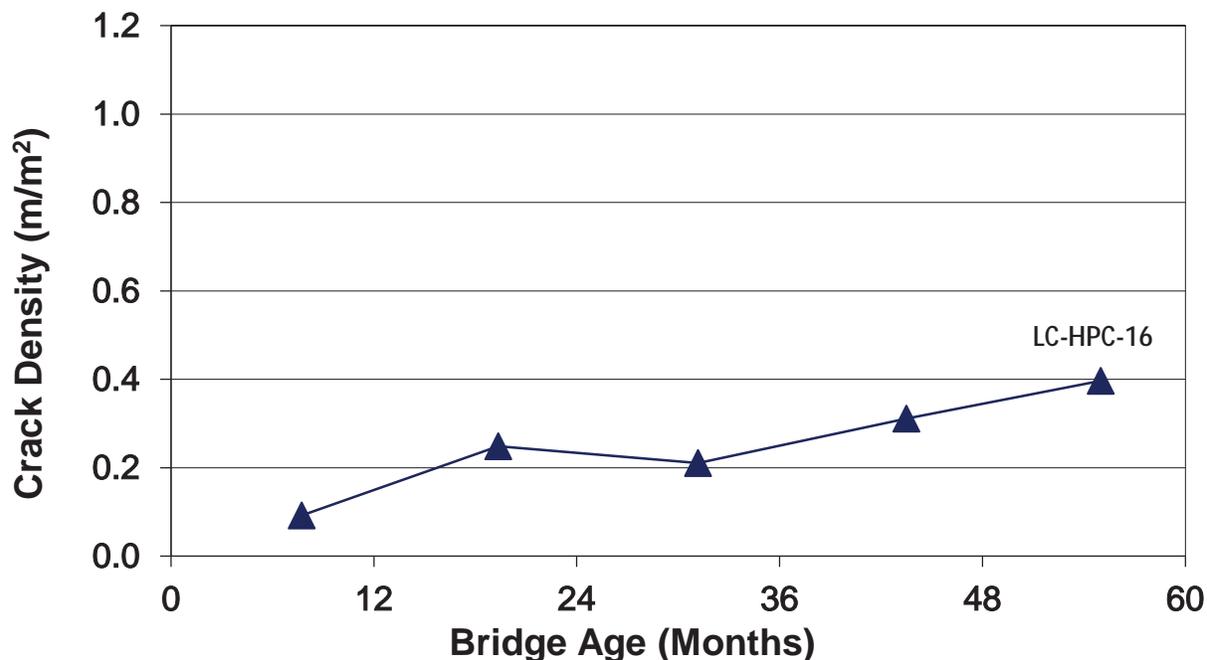
Figure 64: LC-HPC-16 Crack Densities Versus Deck Age

Bridge deck LC-HPC-16 was constructed on 6/11/2014. This bridge does not have a control deck for comparison. This deck has been surveyed five times. The results of Surveys 4 and 5 of LC-HPC-16 are discussed in this report. Survey 4 was completed at a deck age of 43.5 months; the crack map is displayed in Figure 62. Survey 5 was completed at a deck age of 55.0 months; the crack map is displayed in Figure 63. A crack density of 0.311 m/m² was observed in Survey 4 (Figure 62) compared to a crack density of Survey 3, 0.211 m/m² (Bohaty et al. 2013). In Survey 5, a crack density of 0.397 m/m² was observed (Figure 63). Most of the cracks are transverse (Figures 62 and 63). Map cracking is also present on some portions of the deck. Near the abutments, some cracks have propagated longitudinally. Figure 64 shows the crack density as a function of age for LC-HPC-16.

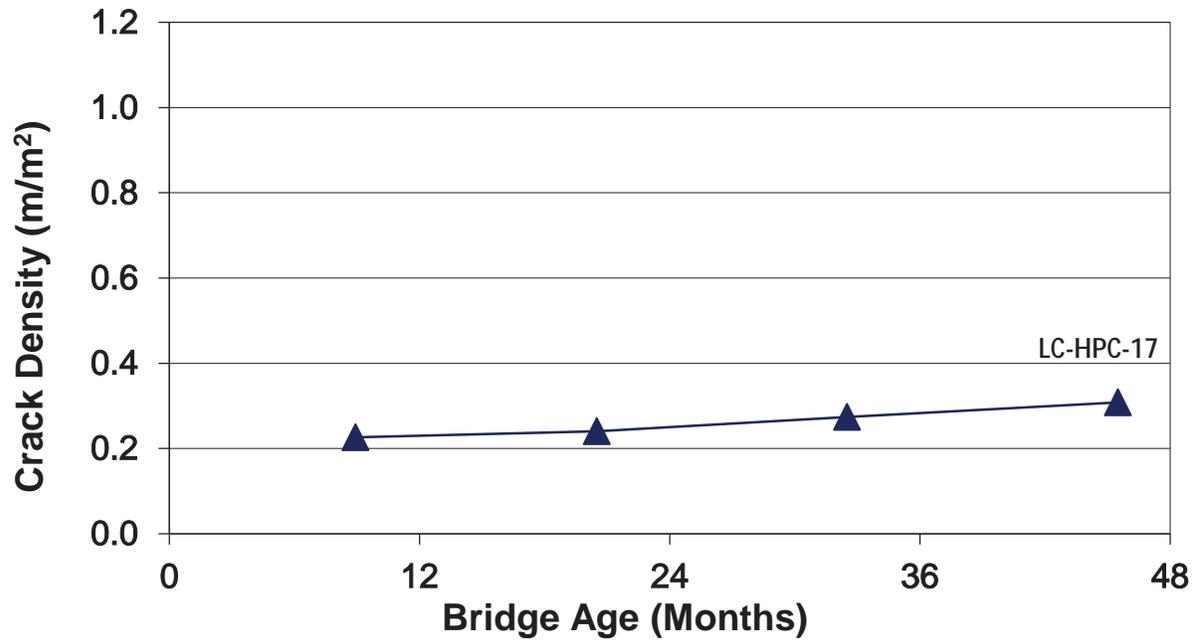
Figure 67: LC-HPC-17 Crack Densities Versus Deck Age

Bridge deck LC-HPC-17 was placed on 9/28/2011. There is no control deck for this bridge. This deck has been surveyed four times, and the results of Surveys 3 and 4 are included in this report. Survey 3 was performed at a deck age of 32.5 months; the crack map is shown in Figure 65. Survey 4 was performed at a deck age of 45.5 months; the crack map is shown in Figure 66. In Survey 3, an overall crack density of 0.274 m/m² was observed (Figure 65), slightly higher than the value reported by Bohaty et al. (2013) for Survey 2, 0.240 m/m². An overall crack density of 0.308 m/m² was observed in Survey 4 (Figure 66). The surveys do not include the sidewalks. As shown in Figures 65 and 66, the majority of the cracks are transverse and located near the mid-span. There are, also, some transverse cracks above the pier. Survey 4 recorded some small areas of map cracking near the east abutment. Cracks also propagate longitudinally near the west abutment. Figure 67 shows the crack density for LC-HPC-17 over time.
