**CRACK SURVEYS OF LOW-CRACKING HIGH-PERFORMANCE CONCRETE
BRIDGE DECKS IN KANSAS
2014-2015**

**By
Abdallah Alhmoody
David Darwin
Matt O'Reilly**

**Structural Engineering and Engineering Materials
SL Report 15-3**

**THE UNIVERSITY OF KANSAS CENTER FOR RESEARCH, INC.
LAWRENCE, KANSAS
September 2015**

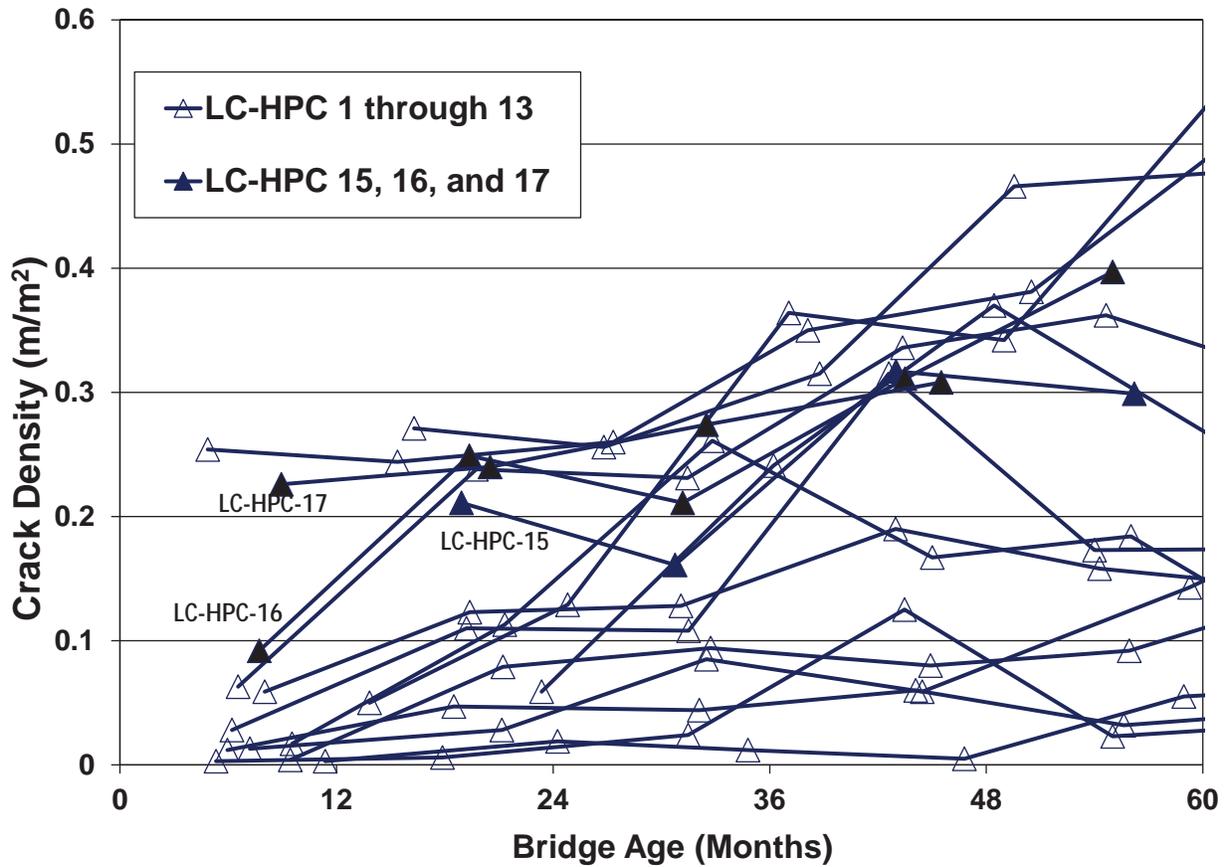
Figure 68: LC-HPC 1 through 13 and LC-HPC 15, 16, and 17 Crack Densities Versus Deck Age

Figure 68 compares paired LC-HPC decks (LC-HPC 1 through 13) to the unpaired LC-HPC decks (LC-HPC 15, 16, and 17) over time. The crack densities for the three unpaired LC-HPC decks fall just under the upper boundary of paired 13 LC-HPC decks. LC-HPC-16 started with a crack density similar to most of the unpaired LC-HPC-decks. However, the crack density jumped in the second and subsequent surveys. The majority of paired LC-HPC decks have exhibited lower crack densities during the first 60 months since construction.
