**CRACK SURVEYS OF LOW-CRACKING
HIGH-PERFORMANCE CONCRETE
BRIDGE DECKS IN KANSAS
2011-2013**

**By
Brent Bohaty
Elizabeth Riedel
David Darwin**

**A Report on Research Sponsored by
CONSTRUCTION OF CRACK-FREE BRIDGE DECKS
TRANSPORTATION POOLED-FUND PROGRAM
PROJECT NO. TPF-5(174)**

**Structural Engineering and Engineering Materials
SL Report 13-6**

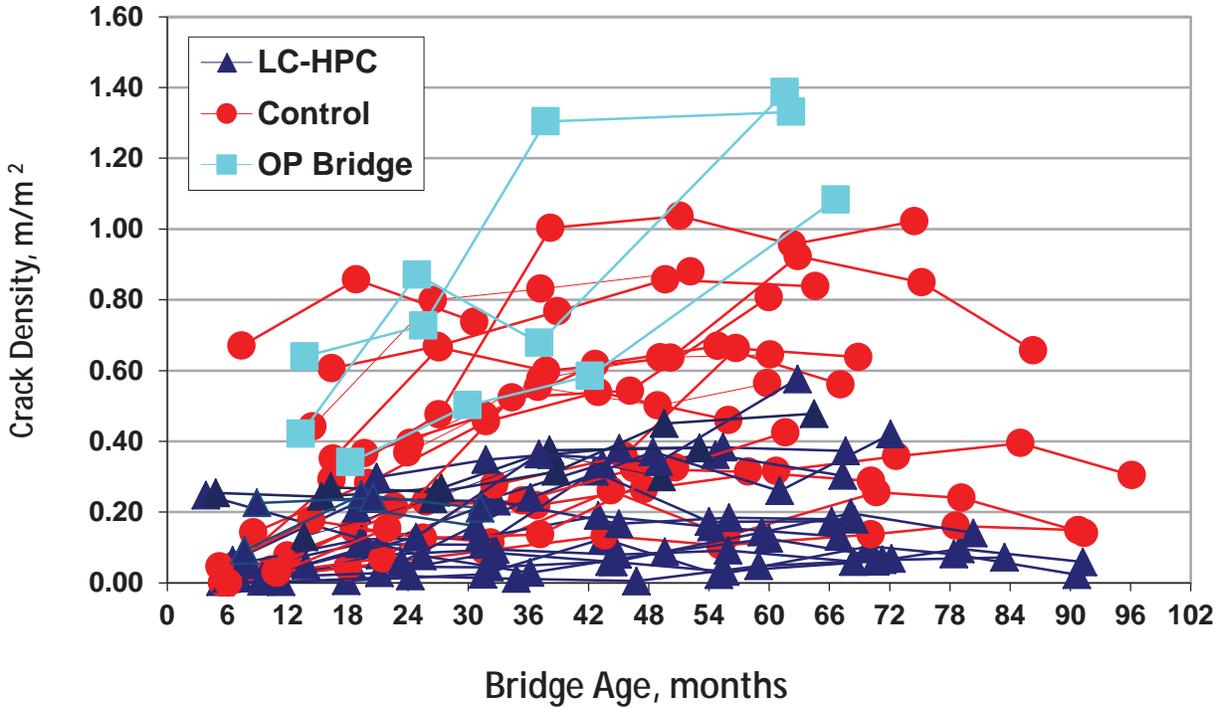
Figure 2: Crack Densities of LC-HPC and Control Decks

decks in the project are shown in Figure 2. In-depth comparisons of LC-HPC and control decks follow.

As shown in the individual comparisons of the LC-HPC and control decks, at the same age, with few exceptions, the LC-HPC decks exhibit less cracking than the control decks. Crack densities for surveys completed in 2011, 2012, and 2013 are shown in Tables 4, 5, and 6, respectively. These tables also indicate for each LC-HPC/Control pair, which bridge had the lower crack density in that survey year. Because of differences in the dates of placement, comparisons based on the year of the survey do not match the age of the decks in all cases. In 2011, of the thirteen LC-HPC bridge decks with a corresponding control deck, eleven had lower crack densities than their control counterpart. In 2012, of the twelve LC-HPC bridge decks with a corresponding control deck (due to the overlay of Control-5), eleven had lower crack densities than their control counterpart. It is apparent that the LC-HPC bridge decks are performing significantly better than their respective control decks. This is also demonstrated in Figure 2,

which provides a plot of crack densities versus age for the bridge decks in the study. The OP Bridge was not constructed in accordance with several provisions of the LC-HPC specifications, and therefore does not represent either an LC-HPC or a control deck. To date, the highest crack density on an LC-HPC bridge deck is 0.576 m/m² (LC-HPC-13 at 62.9 months; see Figure 80). The highest crack density on a control deck is 1.037 m/m² (Control-7 Placement 1 at 51.1 months). Overall, in the three *survey years* included in this report, there are only 3 instances in which an LC-HPC bridge had a higher crack density than its control counterpart: LC-HPC-2 and LC-HPC-8 in 2011, and LC-HPC-2 in 2012. Finally, although LC-HPC-2 appears to have a higher crack density than Control-1/2 by examination of Tables 4 through 6, Figure 13 shows that, on the whole, LC-HPC-2 performs just as well as, if not better than, Control-1/2.

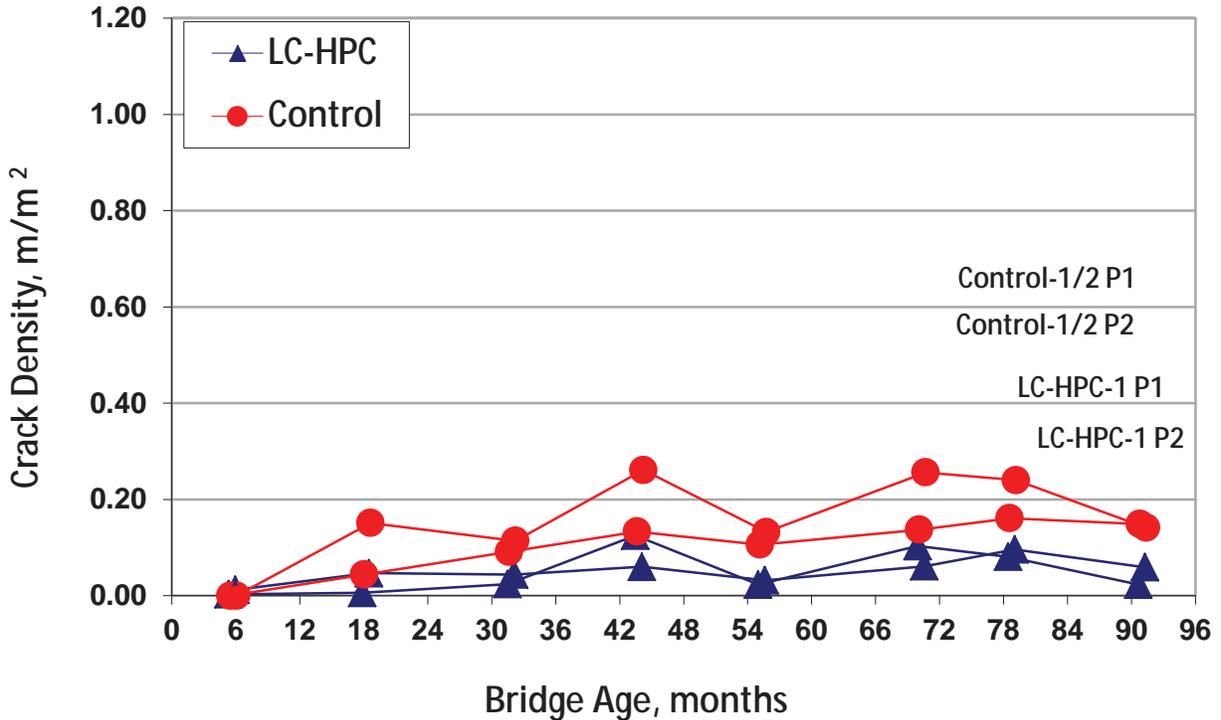
Figure 9: LC-HPC-1 and Control-1/2 Crack Densities

corners of the bridge. Figure 9 compares cracking on Control-1/2 to LC-HPC-1 over time. Crack densities on both placements of Control-1/2 have been consistently higher than densities on both placements of LC-HPC-1 over time.

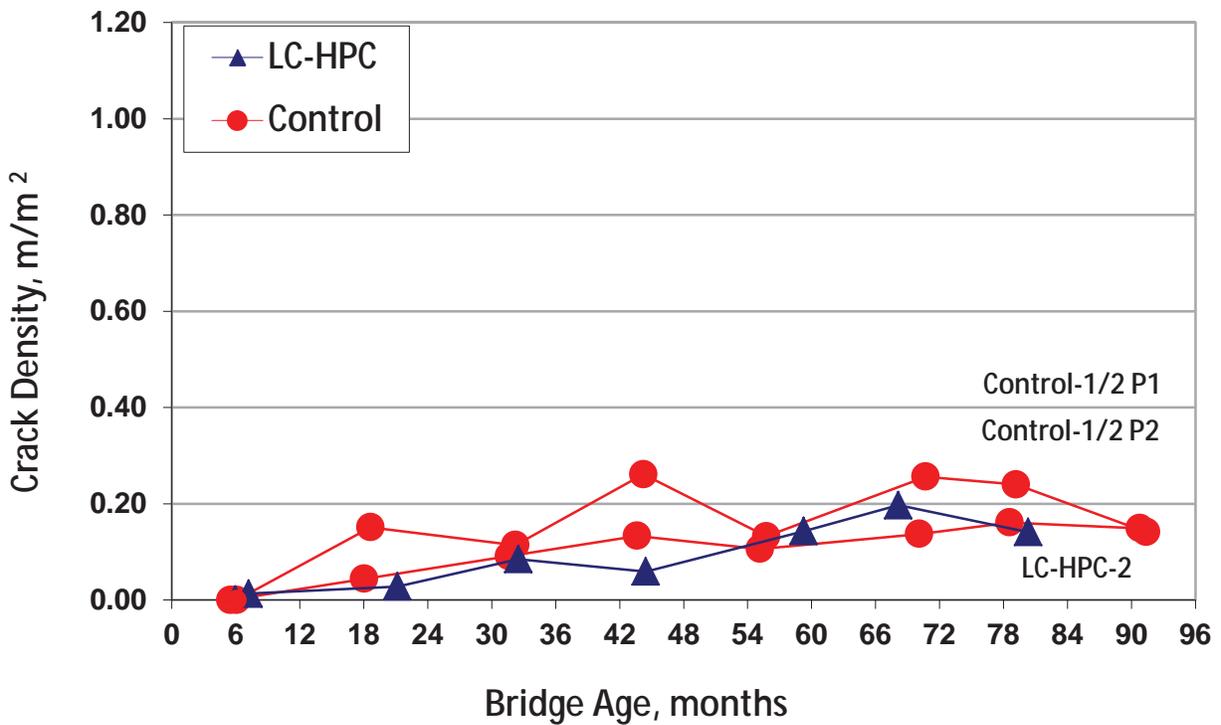
Figure 13: LC-HPC-2 and Control-1/2 Crack Densities

prominent in the negative moment region above the pier, with small cracks extending from the northern edge of the deck and distributed throughout the entire deck. The crack map for Survey 6 shows many small cracks throughout the deck that were not captured in any previous surveys, likely the result of mistaking aggregate boundaries for cracks. Figure 13 compares cracking on LC-HPC-2 to Control-1/2 over time. It is evident that cracking on LC-HPC-2 has increased over time, experiencing a sharp rise after 42 months, and has moved closer in value to the crack densities for Control-1/2 in recent years.

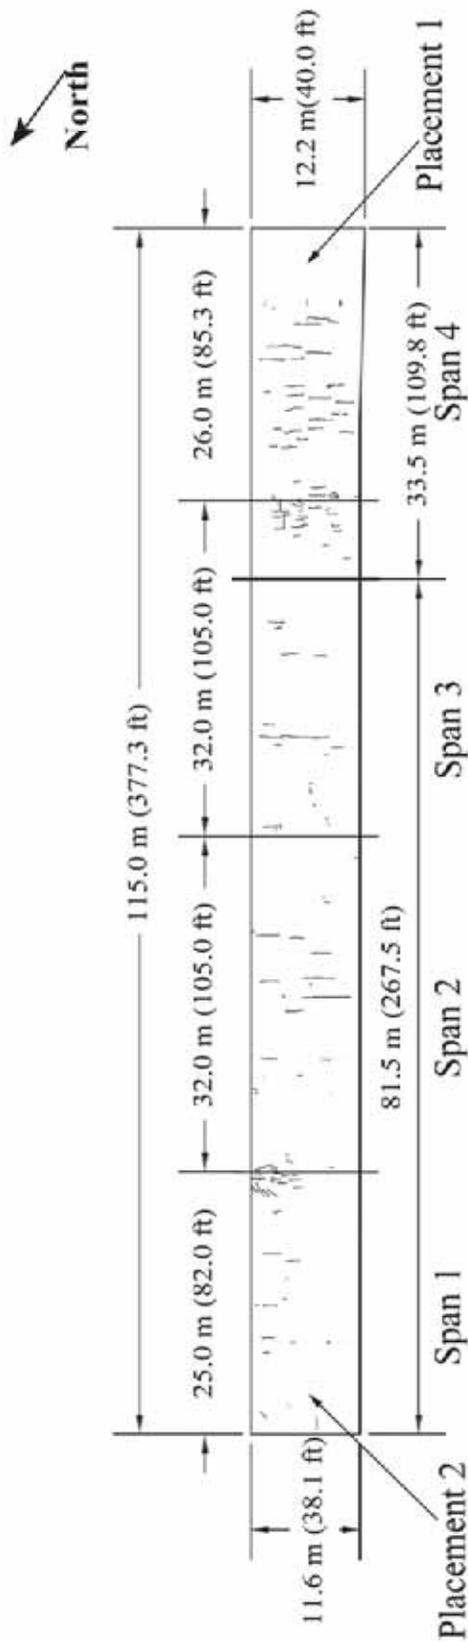
Figure 21: LC-HPC-4 (Survey 4)

LC-HPC-4 was constructed in two placements three days apart. The results of Survey 4 at 45.0 and 44.9 months, Survey 5 at 56.0 and 55.9 months, and Survey 6 at 68.5 and 68.4 months are included in this report. Crack maps for Surveys 4, 5, and 6 are shown in Figures 21, 22, and 23. At ages of 45 months for Placement 1 and 44.9 months for Placement 2, the overall crack density was 0.107 m/m², with Placement 1 having a density twice that of Placement 2 (0.167 m/m² and 0.080 m/m²). This represents a decrease from the crack densities measured in Survey 3 at 32.8 months for Placement 1 and 32.7 months for Placement 2: 0.146 m/m² overall, 0.261 m/m² for Placement 1, and 0.094 m/m² for Placement 2 (Pendergrass et al. 2011). At ages of 56 months for Placement 1 and 55.9 months for Placement 2 (Survey 5), the overall crack density was 0.120 m/m², an increase from Survey 4, but still lower than the crack density measured in Survey 3. Furthermore, the crack density of Placement 1 is still twice as large as the density of

Bridge Number: 46-339 Unit 1
(LC-HPC-4)
Bridge Location: Flyover Ramp
US-69S to I-435W
Construction Date:
Placement 1 (South): 9/29/2007
Placement 2 (North): 10/2/2007
Crack Survey Date: 6/30/2011

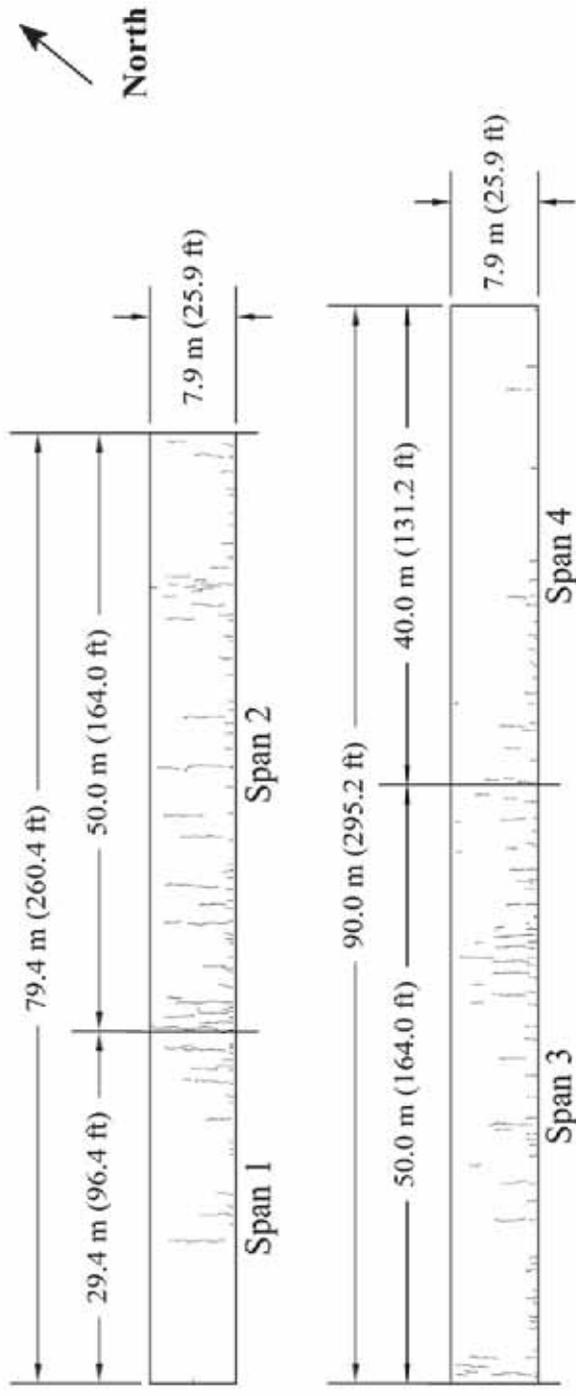
Figure 28: LC-HPC-5 (Survey 4)

The results of Surveys 4, 5, and 6 of LC-HPC-5, at 43.0, 54.2, and 67.0 months, are included in this report. The crack density of LC-HPC-5 at 43.0 months was 0.190 m/m², shown in Figure 28, represents an increase from the Survey 3 result at 31.1 months, 0.128 m/m² (Pendergrass et al. 2011). The crack densities from Surveys 5 and 6 show decreases from Survey 4. The crack density for LC-HPC-5 at 54.2 months was 0.158 m/m², as shown in Figure 29. The crack density for LC-HPC-5 at 67.0 months was 0.131 m/m², as shown in Figure 30. Due to the small amount of cracking in the deck, overlooking just a few cracks can make an impact in the crack density, and is likely the cause of this decrease. Most of the cracks are transverse, propagating from the south side of the deck. The south side is superelevated, which

Bridge Number: 46-340 Unit 1 (LC-HPC-5)
Bridge Location: Flyover Ramp US-69 to I-435 W
Construction Date: 11/14/2007
Crack survey Date: 6/14/2011

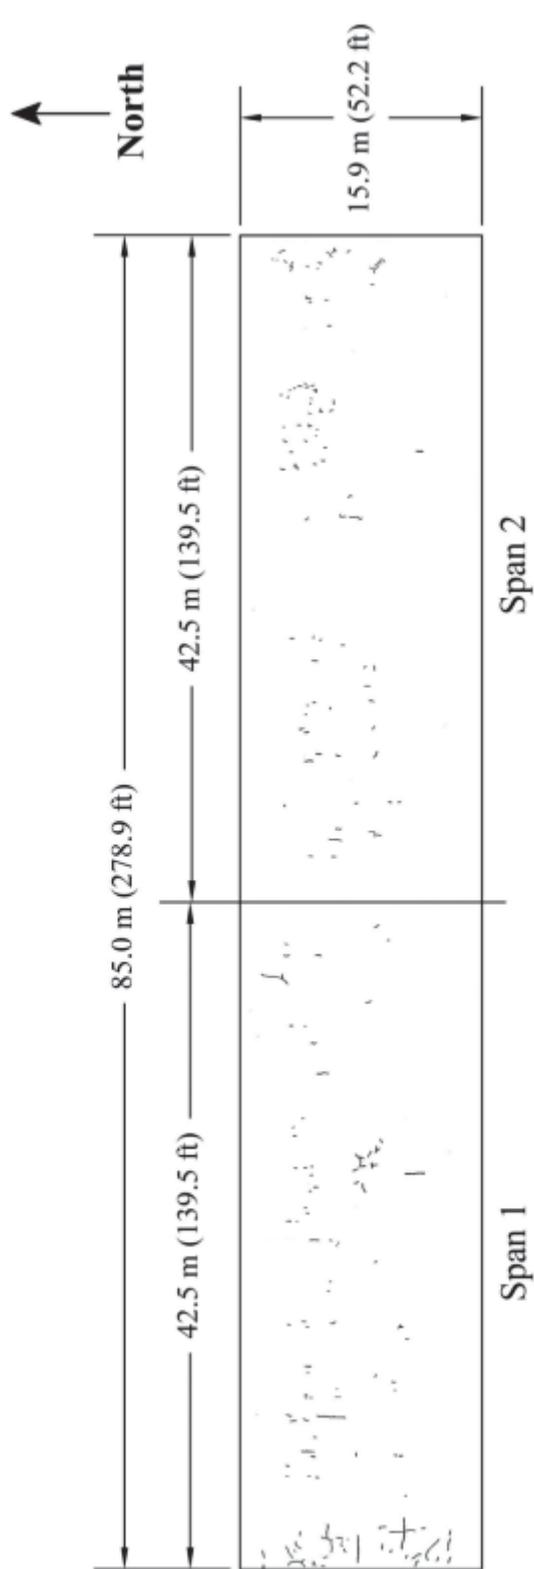
Figure 40: LC-HPC-7 (Survey 5)

The results of Surveys 5, 6, and 7 of LC-HPC-7, at 58.9, 71.3, and 83.4 months, are included in this report. The crack density of LC-HPC-7 at 58.9 months is 0.048 m/m^2 , as shown in Figure 40. This represents an increase from Survey 4 at 46.8 months, when the deck had a crack density of just 0.005 m/m^2 (Pendergrass et al. 2011). The crack density of LC-HPC-7 at 71.3 months was 0.065 m/m^2 , as shown in Figure 41. The crack density of LC-HPC-7 at 83.4 months was 0.072 m/m^2 , as shown in Figure 42. LC-HPC-7 has some of the lowest crack densities of all of the bridges in the project. There are some small-to-medium length longitudinal cracks near and propagating from the west abutment and the remainder of the cracks are very short and distributed along the entire length of the bridge.

Bridge Number: 43-33 (LC-HPC-7)	Bridge Length: 85.0 m (278.9 ft)	Bridge Age: 58.9 months
Bridge Location: Co. Rd. 150 over US-75	Bridge Width: 15.9 m (52.2 ft)	Crack density: 0.048 m/m ²
Construction Date: 6/24/2006	Skew: 0°	Span 1: 0.062 m/m ²
Crack survey Date: 5/23/2011	Number of Spans: 2	Span 2: 0.033 m/m ²
	Span 1 (West): 42.5 m (139.5 ft)	
	Span 2 (East): 42.5 m (139.5 ft)	
	Number of Placements: 1

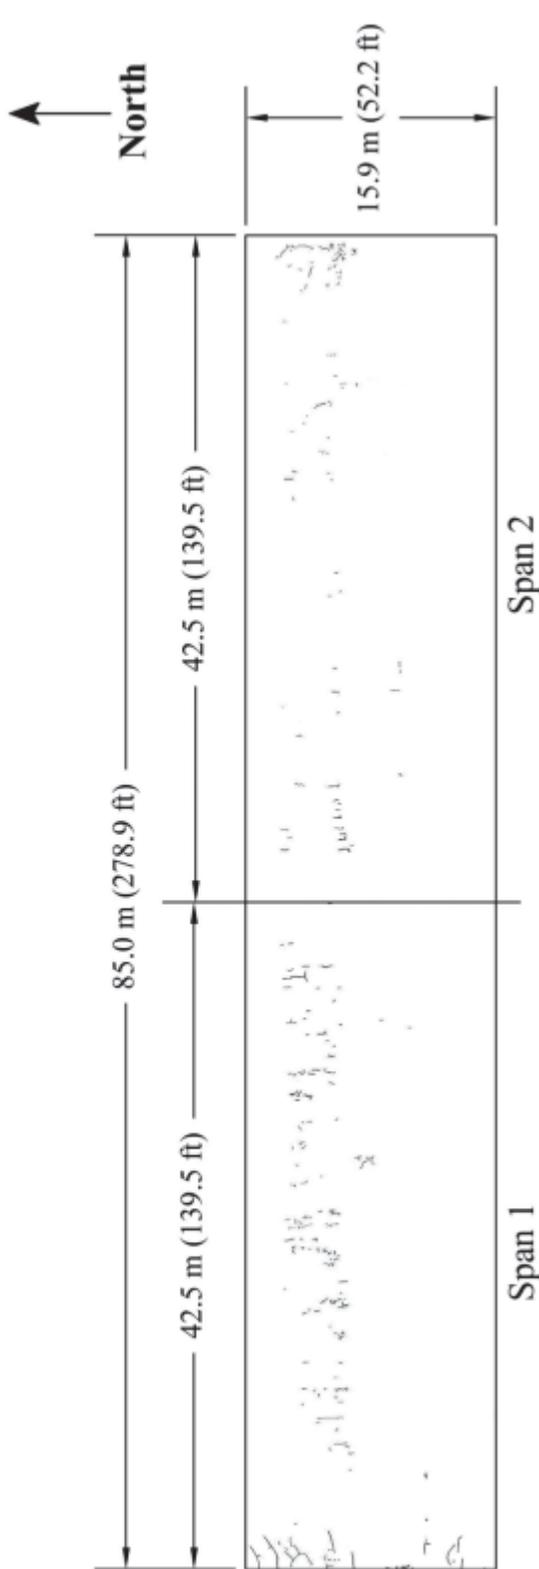
Figure 41: LC-HPC-7 (Survey 6)

Bridge Age: 71.3 months
Crack density: 0.065 m/m²
Span 1: 0.088 m/m²
Span 2: 0.036 m/m²

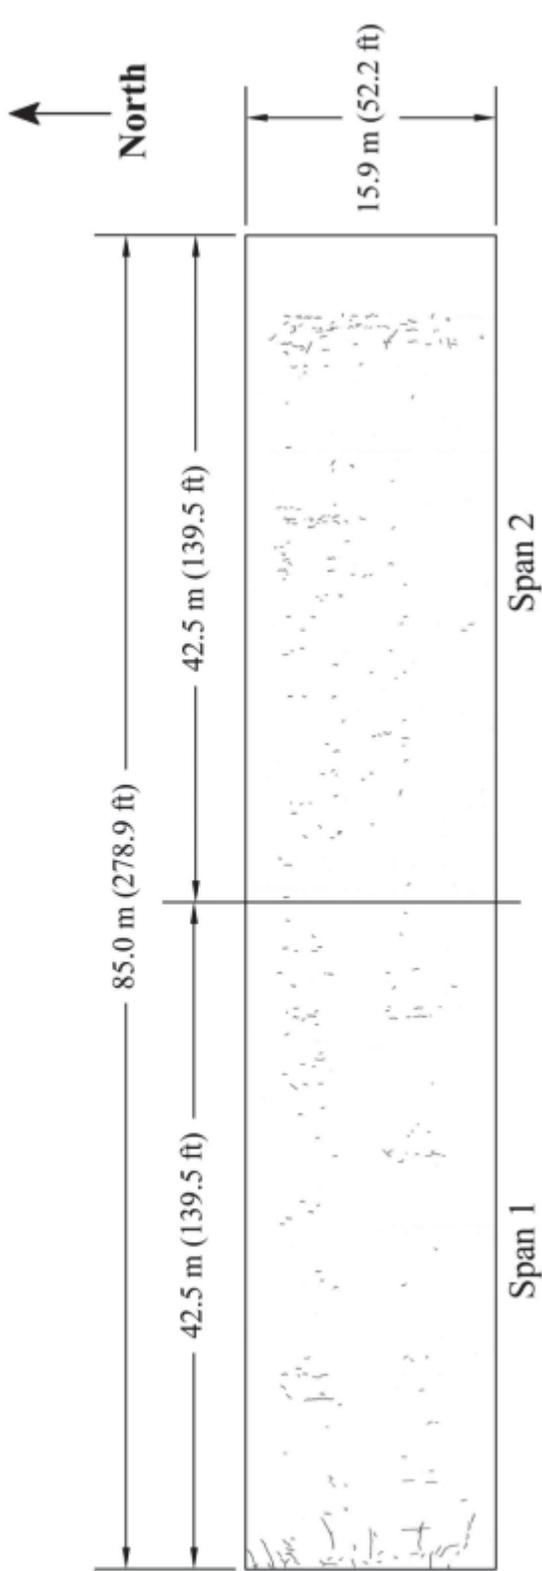
Figure 42: LC-HPC-7 (Survey 7)

Bridge Number: 43-33 (LC-HPC-7)	Bridge Length: 85.0 m (278.9 ft)	Bridge Age: 83.4 months
Bridge Location: Co. Rd. 150 over US-75	Bridge Width: 15.9 m (52.2 ft)	Crack density: 0.072 m/m ²
Construction Date: 6/24/2006	Skew: 0°	Span 1: 0.080 m/m ²
Crack survey Date: 6/7/2013	Number of Spans: 2	Span 2: 0.064 m/m ²
	Span 1 (West): 42.5 m (139.5 ft)	
	Span 2 (East): 42.5 m (139.5 ft)	
	Number of Placements: 1

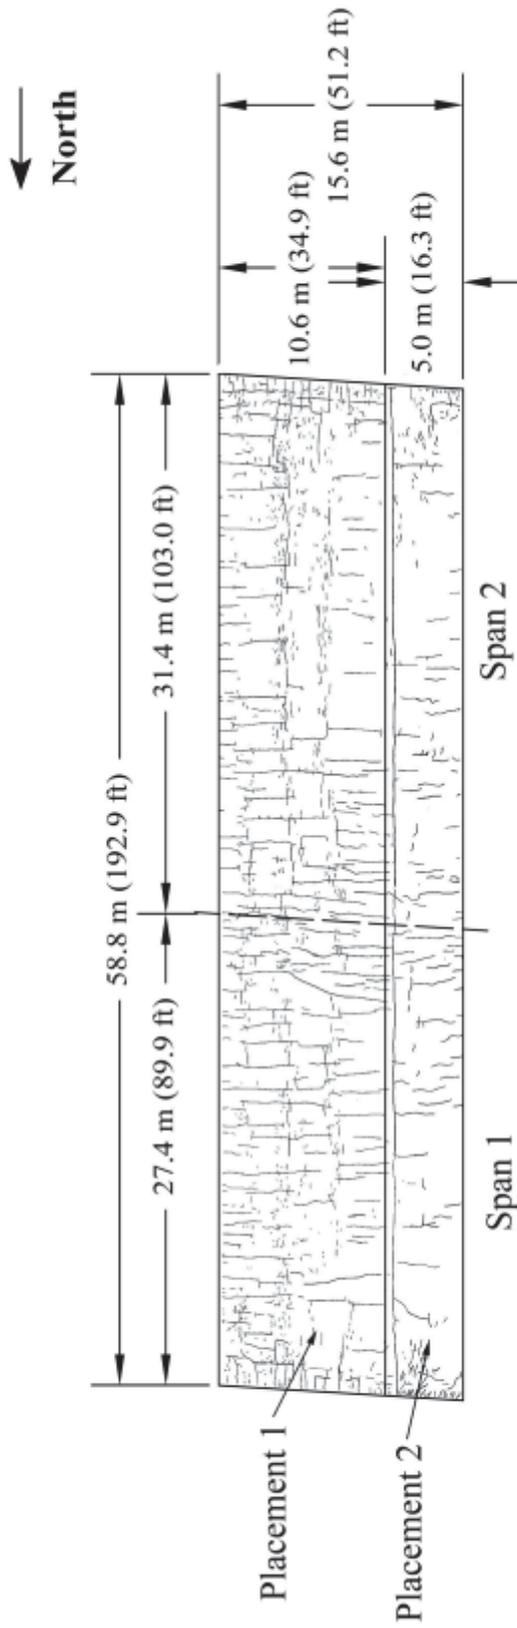
Figure 43: Control-7 (Survey 5)

Control-7 was constructed in two placements, six months apart. The results of Survey 5 at 62.3 and 56.7 months and Survey 6 at 74.5 and 68.9 months are included in this report. The crack density of Placement 1 measured in Survey 5 was 0.957 m/m^2 (see Figure 43), while Placement 2 had a crack density of 0.663 m/m^2 , nearly double the crack density of Placement 2 from Survey 4. The overall crack density was 0.856 m/m^2 . Although the crack density of Placement 1 decreased from Survey 4, there was an overall increase in cracking from Survey 4, for which the crack densities were 1.037 m/m^2 , 0.359 m/m^2 , and 0.819 m/m^2 for Placement 1, Placement 2, and overall, respectively (Pendergrass et al. 2011). The crack densities measured during Survey 6 were 1.022 m/m^2 at 74.5 months for Placement 1 and 0.638 m/m^2 at 68.9 months for Placement 2 (see Figure 44). The overall crack density resulting from Survey 6 was 0.899 m/m^2 . These values are slightly smaller than the corresponding crack densities from Survey 5. All of the surveys have shown much higher cracking for Control-7 than for LC-HPC-7.

Bridge Number: 46-334 (Control-7)	Bridge Length: 58.8 m (192.9 ft)	Bridge Age:
Bridge Location: NB Antioch over I-435	Bridge Width: 15.6 m (51.2 ft)	Placement 1: 62.3 months
Construction Date:	Skew: -3.3°	Placement 2: 56.7 months
Placement 1 (East): 3/29/2006	Number of Spans: 2	Crack density: 0.856 m/m ²
Placement 2 (West): 9/15/2006	Span 1 (North): 27.4 m (89.9 ft)	Span 1: 0.897 m/m ²
Crack survey Date: 6/7/2011	Span 2 (South): 31.4 m (103.0 ft)	Span 2: 0.824 m/m ²
	Number of Placements: 2	Placement 1: 0.957 m/m ²
		Placement 2: 0.663 m/m ²

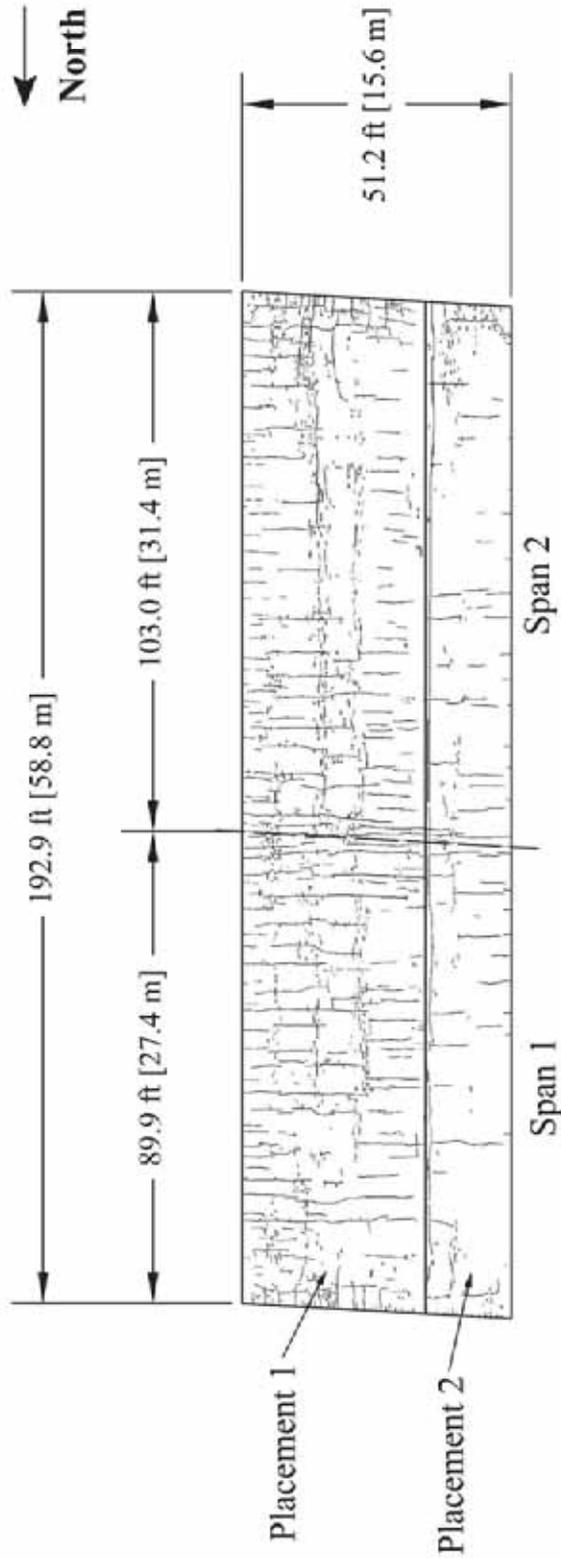
Figure 44: Control-7 (Survey 6)

Bridge Number: 46-334 (Control-7)	Bridge Length: 58.8 m (192.9 ft)	Bridge Age:
Bridge Location: NB Antioch over I-435	Bridge Width: 15.6 m (51.2 ft)	Placement 1: 74.5 months
Construction Date:	Skew: -3.3°	Placement 2: 68.9 months
Placement 1 (East): 3/29/2006	Number of Spans: 2	Crack density: 0.899 m/m ²
Placement 2 (West): 9/15/2006	Span 1 (North): 27.4 m (89.9 ft)	Span 1: 0.904 m/m ²
Crack survey Date: 6/12/2012	Span 2 (South): 31.4 m (103.0 ft)	Span 2: 0.895 m/m ²
	Number of Placements: 2	Placement 1: 1.022 m/m ²
		Placement 2: 0.638 m/m ²

Placement 1 has transverse cracks throughout, but the cracks are more concentrated near the pier. There are also longitudinal cracks propagating from both abutments and small longitudinal cracks running the length of the deck. Placement 2 has a continuous longitudinal crack parallel and adjacent to the joint, as well as some transverse cracking and small longitudinal cracks propagating from both abutments. Figure 45 compares cracking on Control 7 to cracking on LC-HPC-7 over time. Throughout both bridge lives, LC-HPC-7 has had significantly less cracking than either placement of Control 7. While Control 7 experienced sharp increases in cracking between 12 months and 60 months of age, cracking on LC-HPC-7 has been relatively stable, experiencing relatively small increases after 48 months.

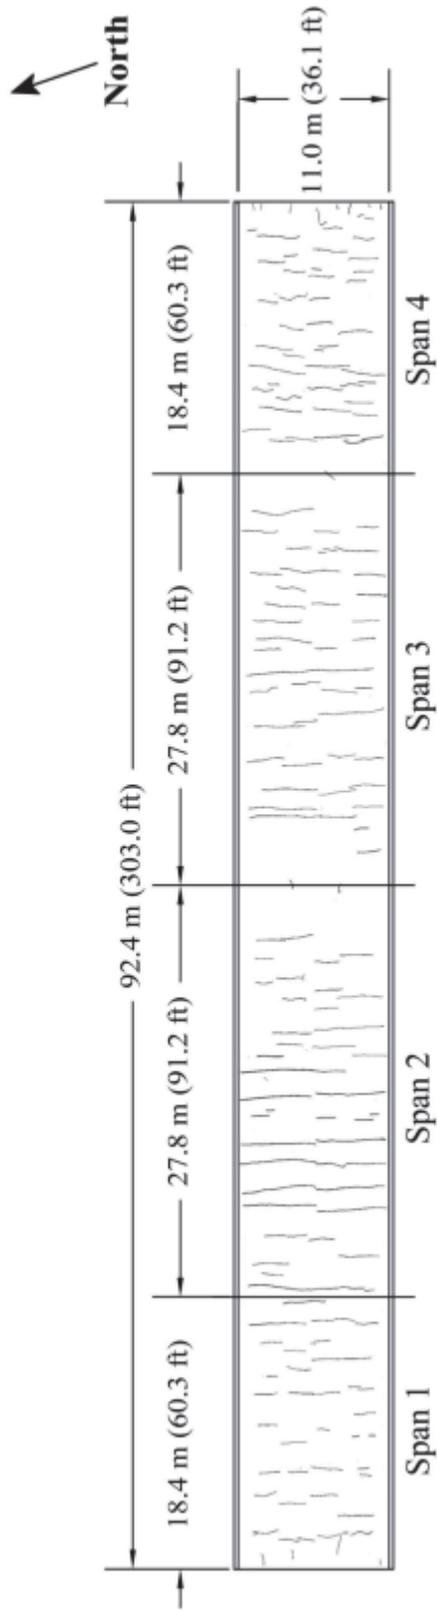
Figure 46: LC-HPC-8 (Survey 3)

The results of Surveys 3, 4, and 5 of LC-HPC-8 at 45.0, 55.4, and 67.7 months, respectively, are included in this report. LC-HPC-8 is one of two LC-HPC bridges in this study with precast, prestressed concrete girders. The crack density of LC-HPC-8 at 45.0 months was 0.380 m/m^2 , shown in Figure 46, represents an increase from Survey 2 at 31.8 months, when the crack density was 0.348 m/m^2 (Pendergrass et al. 2011). Cracking has been stable since, with values of 0.383 m/m^2 at 55.4 months (Figure 47) and 0.373 m^2 at 67.7 months (Figure 48). Most of the cracks are long transverse cracks, evenly spaced along the deck. There is less cracking near the center pier, which could be a result of camber and increased girder shrinkage. There is also a small amount of longitudinal cracking at each abutment.

Bridge Age: 45.0 months
Crack density: 0.380 m/m²
Span 1 (West): 0.310 m/m²
Span 2 (West): 0.408 m/m²
Span 3 (East): 0.369 m/m²
Span 4 (East): 0.412 m/m²

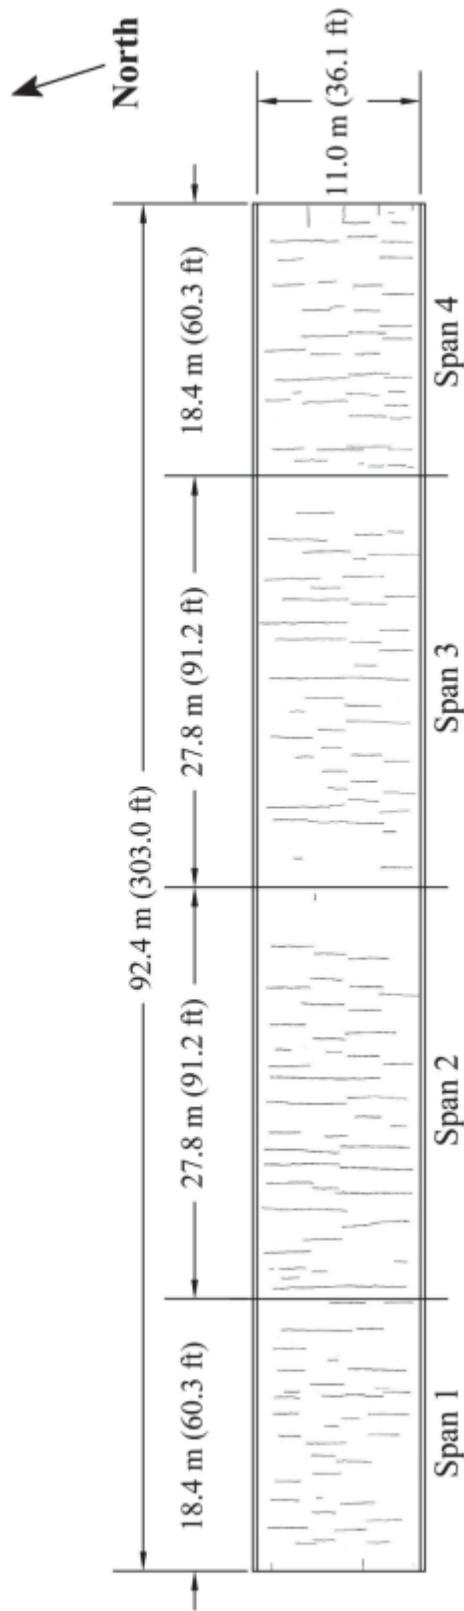
Figure 47: LC-HPC-8 (Survey 4)

Bridge Age: 55.4 months
Crack density: 0.383 m/m²
Span 1 (West): 0.341 m/m²
Span 2 (West): 0.400 m/m²
Span 3 (East): 0.357 m/m²
Span 4 (East): 0.425 m/m²

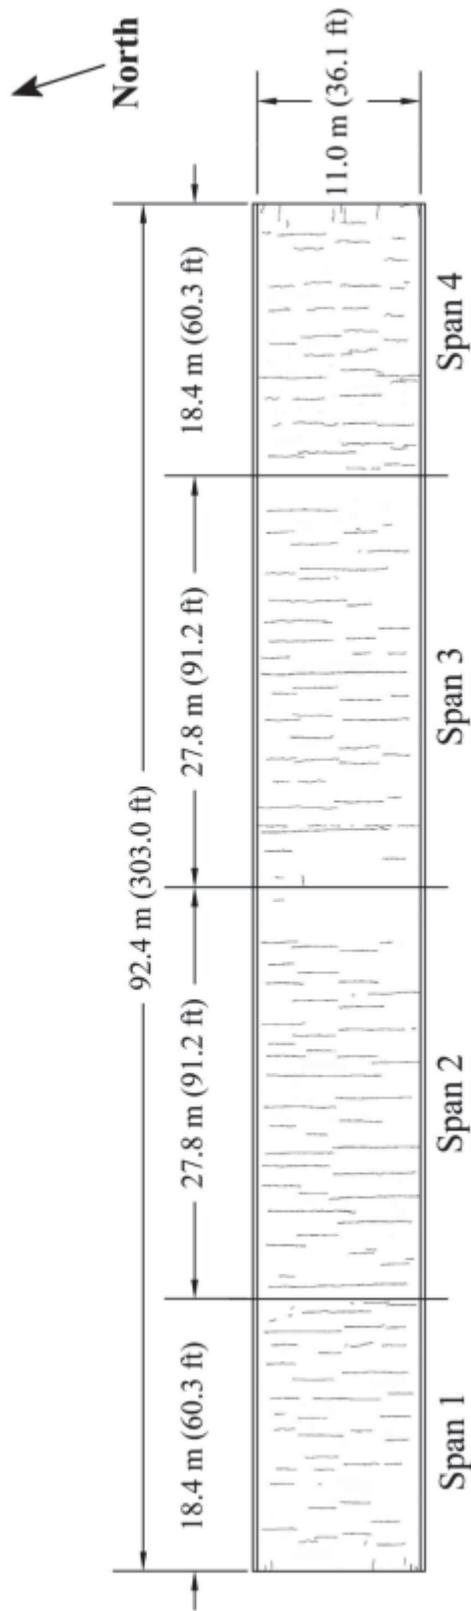
Figure 48: LC-HPC-8 (Survey 5)

Bridge Age: 67.7 months
Crack density: 0.373 m/m²
Span 1 (West): 0.351 m/m²
Span 2 (West): 0.406 m/m²
Span 3 (East): 0.350 m/m²
Span 4 (East): 0.357 m/m²

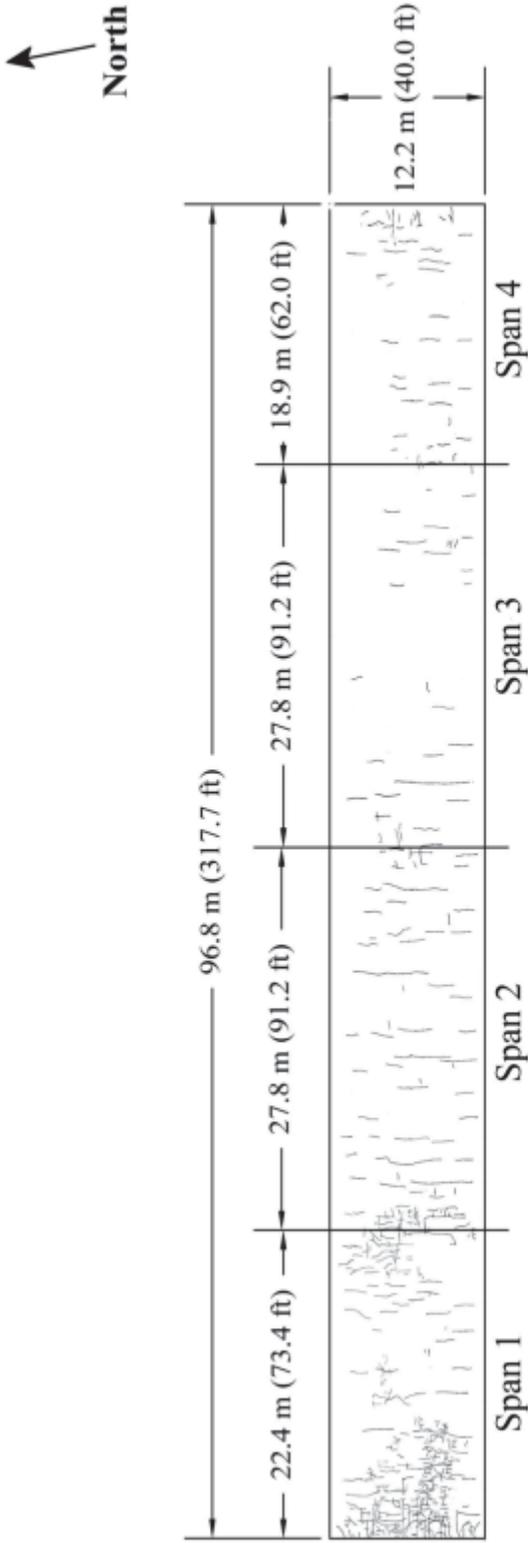
Figure 49: Control-8/10 (Survey 4)

Like LC-HPC-8 and LC-HPC-10, Control-8/10 is a monolithic deck cast on precast, prestressed girders. The results of Surveys 4, 5 and 6 at 50.6, 61.6, and 75.5 months, respectively, are included in this report. The crack density of Control-8/10 at 50.6 months was 0.326 m/m^2 , as shown in Figure 49. This crack density is more than double the value from Survey 3 at 37.2 months, 0.137 m/m^2 (Pendergrass et al. 2011). The crack density has continued to increase with values of 0.425 m/m^2 and 0.581 m/m^2 , respectively, measured during Surveys 5 and 6. The crack maps from Surveys 5 and 6 are shown in Figures 50 and 51. The cracking on Control-8/10 consists of a small number of medium-length transverse cracks, as well as a large number of smaller cracks. Map cracking is prevalent on Control-8/10, particularly near the west abutment, where map cracking has increased drastically over the past three surveys. Control 8/10 had less cracking at 50.6 months than LC-HPC-8 at 45.0 months, but has had more cracking in the two most recent surveys. Figure 52 compares cracking on Control 8/10 to cracking on LC-

Bridge Number: 54-59 (Control-8/10) **Bridge Length:** 96.8 m (317.7 ft) **Bridge Age:** 50.6 months
Bridge Location: K-52 over US-69 **Bridge Width:** 12.2 m (40.0 ft) **Crack density:** 0.326 m/m²
Construction Date: 4/16/2007 **Skew:** 0° **Number of Spans:** 4
Crack survey Date: 7/5/2011 **Span 1:** 22.4 m (73.4 ft) **Span 2:** 27.8 m (91.2 ft) **Span 3:** 27.8 m (91.2 ft) **Span 4:** 18.9 m (62.0 ft)
Number of Placements: 1 **Span 1:** 0.655 m/m² **Span 2:** 0.334 m/m² **Span 3:** 0.135 m/m² **Span 4:** 0.212 m/m²

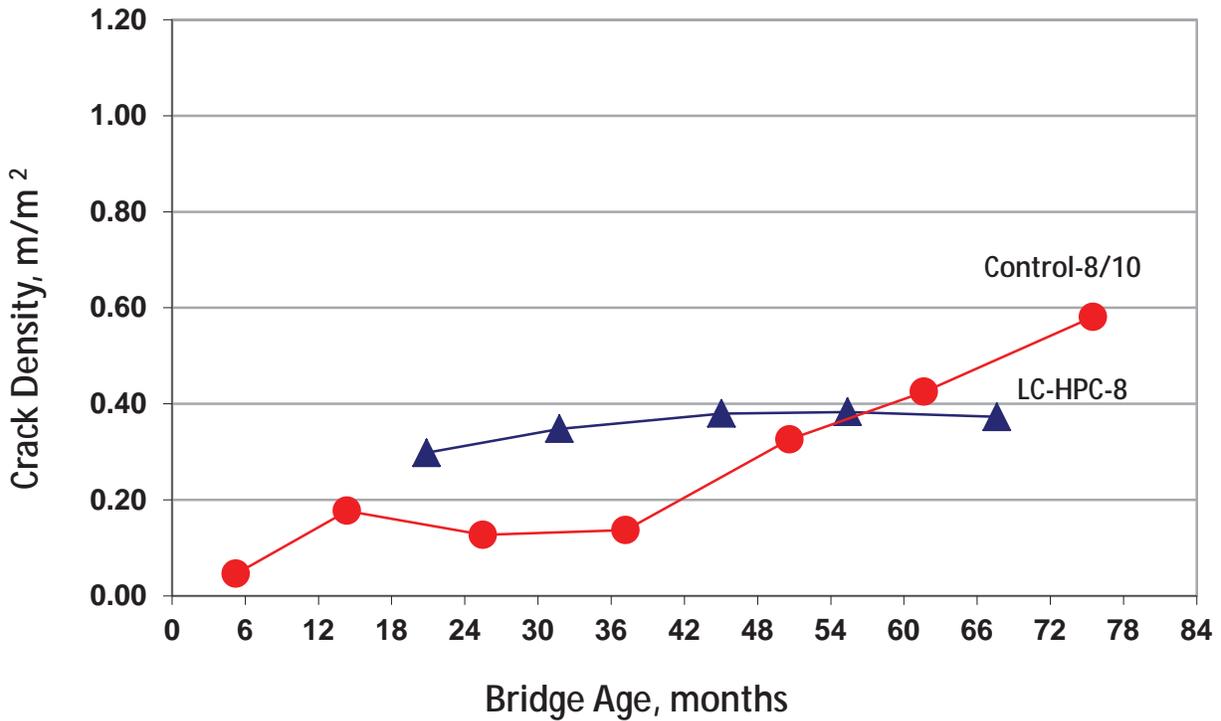
Figure 52: LC-HPC-8 and Control-8/10 Crack Densities

over time. LC-HPC-8 is one of the only decks in the project which has experienced significantly higher cracking than its control deck. However, Control 8/10 has experienced a marked rise in crack density after 36 months of age and is now experiencing more cracking than LC-HPC-8.

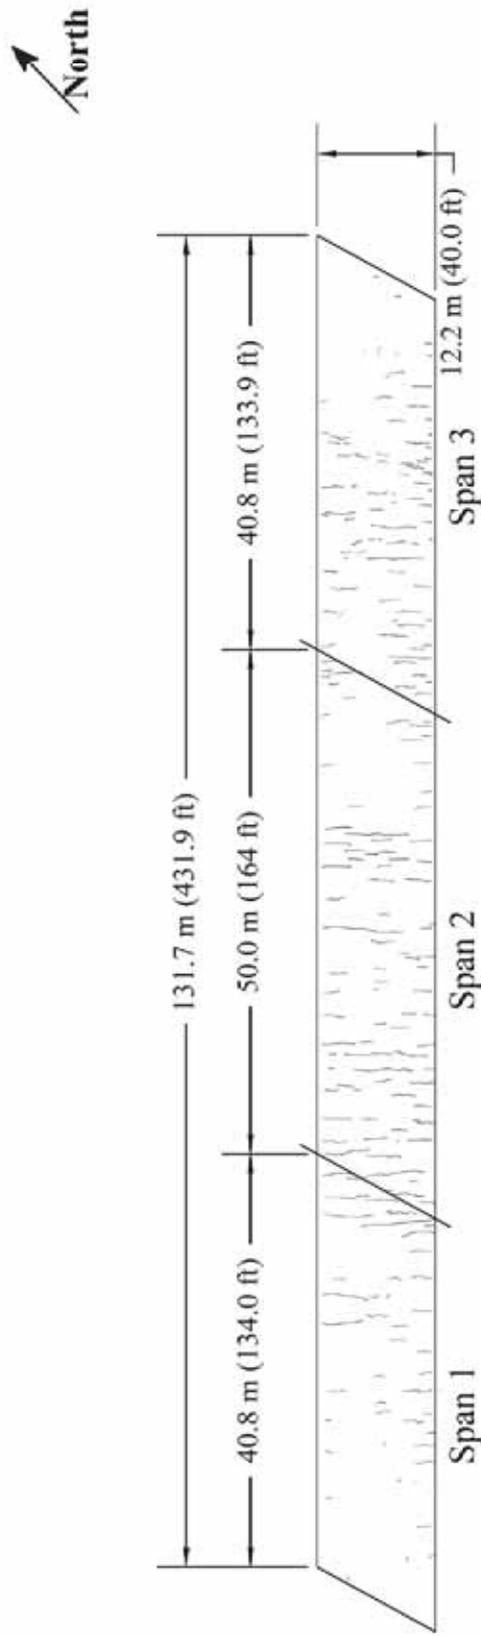
Figure 53: LC-HPC-9 (Survey 2)

The results of Surveys 2, 3, and 4 of LC-HPC-9, at 26.5, 38.3, and 49.3 months, are included in this report. The crack density of LC-HPC-9 at 26.5 months was 0.237 m/m², shown in Figure 53, represents an increase from the previous survey at 13.3 months, for which the crack density was 0.130 m/m² (Pendergrass et al. 2011). The crack density at 38.3 months increased to 0.362 m/m² (Figure 54) and dropped back to 0.299 m/m² at 49.3 months (Figure 55). The cracking is mainly transverse. There is very little cracking near the abutments.

Bridge Age: 26.5 months
Crack density: 0.237 m/m²
Span 1 (South): 0.174 m/m²
Span 2 (Middle): 0.281 m/m²
Span 3 (North): 0.221 m/m²

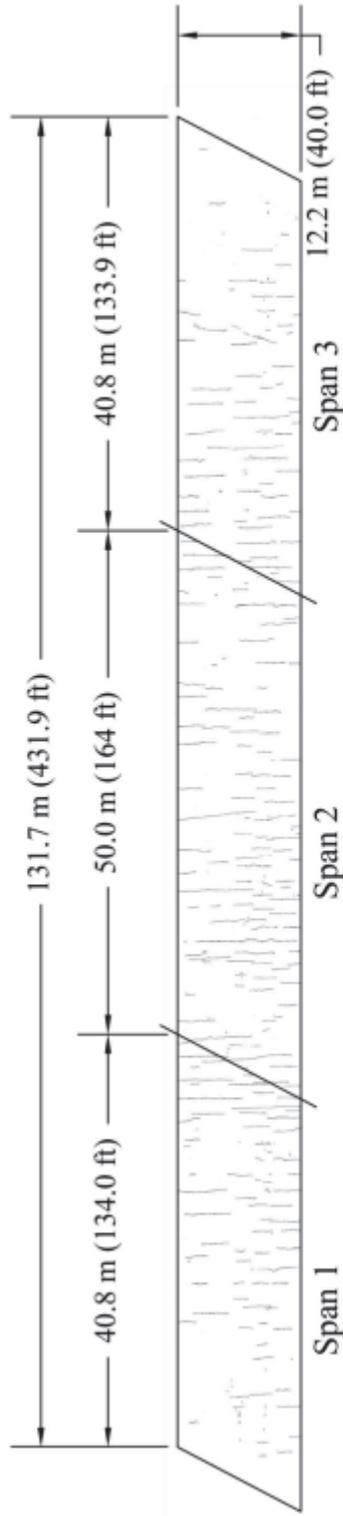
Figure 54: LC-HPC-9 (Survey 3)

Bridge Age: 38.3 months
Crack density: 0.362 m/m²
Span 1 (South): 0.319 m/m²
Span 2 (Middle): 0.421 m/m²
Span 3 (North): 0.325 m/m²

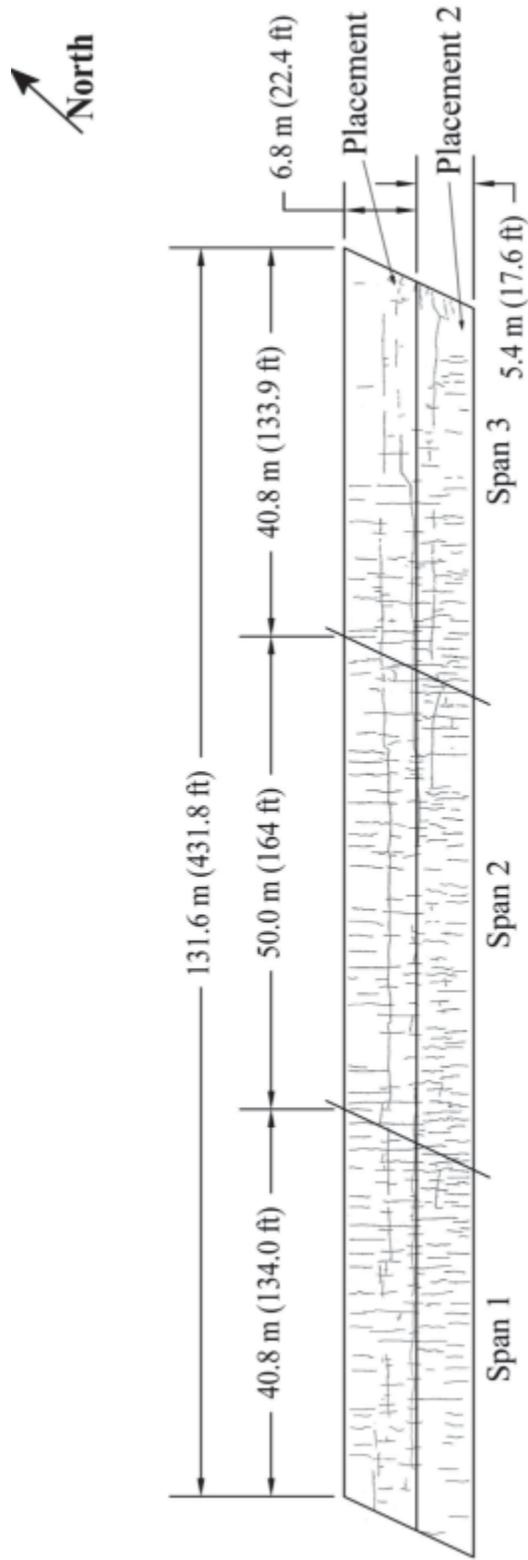
Figure 56: Control-9 (Survey 2)

Control-9 was constructed in two placements eight days apart. The results of Survey 2 at 37.0 and 37.2 months, Survey 3 at 48.9 and 49.1 months, and Survey 4 at 59.8 and 60.1 months are included in this report. At 37.2 months, Placement 1 had a crack density of 0.553 m/m^2 (see Figure 56). Placement 2 had a crack density of 0.577 m/m^2 at 37.0 months, and the overall crack density resulting from Survey 2 was 0.568 m/m^2 . This represents an increase from Survey 1 for which the crack densities were, respectively, 0.395 m/m^2 , 0.368 m/m^2 , and 0.390 m/m^2 for Placement 1, Placement 2, and the overall crack density (Pendergrass et al. 2011). Placement 1 had a crack density of 0.637 m/m^2 at 49.1 months and Placement 2 had a crack density of 0.501 m/m^2 at 48.9 months (see Figure 57). The overall crack density was 0.577 m/m^2 . The crack densities measured during Survey 4 were 0.645 m/m^2 at 60.1 months for Placement 1 (see Figure 58) and 0.564 m/m^2 at 59.8 months for Placement 2, resulting in an overall crack density of 0.609 m/m^2 . Both placements have long transverse cracks throughout, with fewer near the abutments. Both placements have continuous longitudinal cracks running nearly the entire length of the bridge, as well as some longitudinal cracking propagating from the abutments. Crack densities have been consistently higher for Control-9 than for LC-HPC-9 over the past three surveys. Figure 59 compares cracking on Control 9 to cracking on LC-HPC-9 over time. LC-HPC-9 has maintained a crack density lower than either placement of Control 9 over time. LC-HPC-9 and Control 9 experienced similar increases in crack density early on, but LC-HPC-9 has less overall cracking because of its significantly lower initial density.

Bridge Number: 54-58 (Control-9)	Bridge Length: 131.6 m (431.8 ft)	Bridge Age:
Bridge Location: NB US-69 over Marair Des Cygnes Rv	Bridge Width: 12.2 m (40.0 ft)	Placement 1: 37.2 months
Construction Date:	Skew: -27.2°	Placement 2: 37.0 months
Placement 1 (West): 5/21/2008	Number of Spans: 3	Crack density: 0.568 m/m ²
Placement 2 (East): 5/29/2008	Span 1 (South): 40.8 m (134.0 ft)	Placement 1: 0.553 m/m ²
Crack survey Date: 6/28/2011	Span 2 (Middle): 50.0 m (164.0 ft)	Placement 2: 0.577 m/m ²
	Span 3 (North): 40.8 m (133.8 ft)	Span 1 (South): 0.571 m/m ²
	Number of Placements: 2	Span 2 (Middle): 0.624 m/m ²
	Placement1(West): 6.8 m (22.4 ft)	Span 3 (North): 0.486 m/m ²
	Placement2 (East): 5.4 m (17.6 ft)

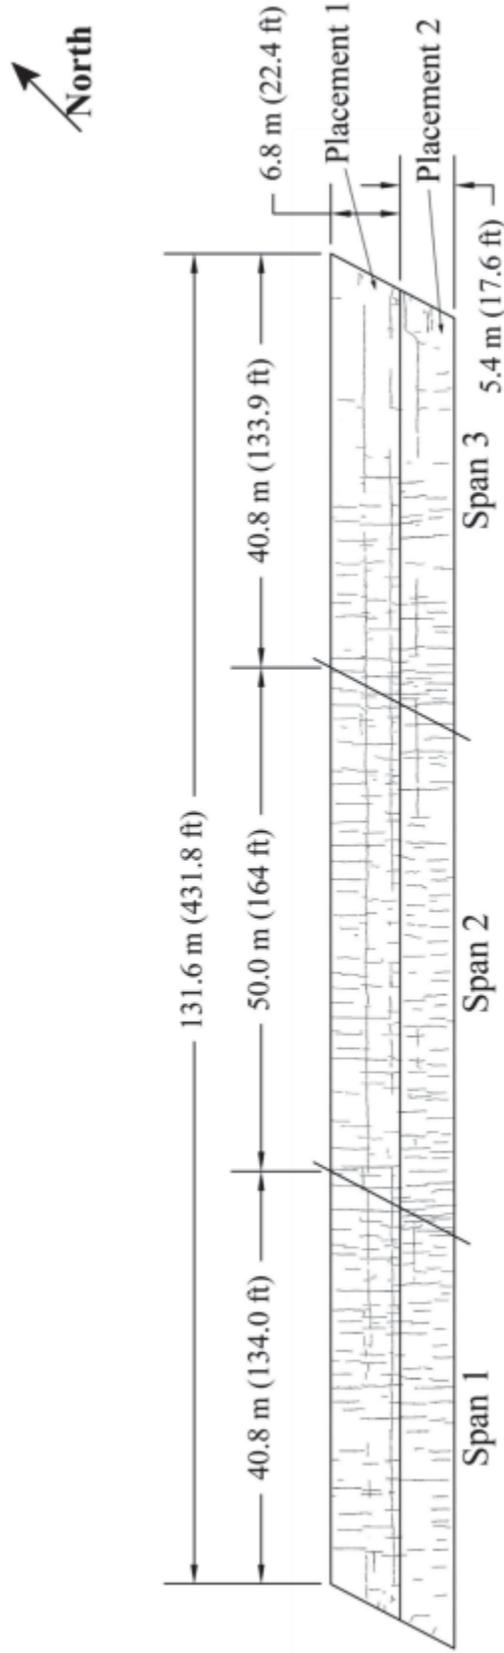
Figure 57: Control-9 (Survey 3)

Bridge Age:
 Placement 1: 49.1 months
 Placement 2: 48.9 months
Crack density: 0.577 m/m²
 Placement 1: 0.637 m/m²
 Placement 2: 0.501 m/m²
Span 1 (South): 0.574 m/m²
Span 2 (Middle): 0.651 m/m²
Span 3 (North): 0.486 m/m²

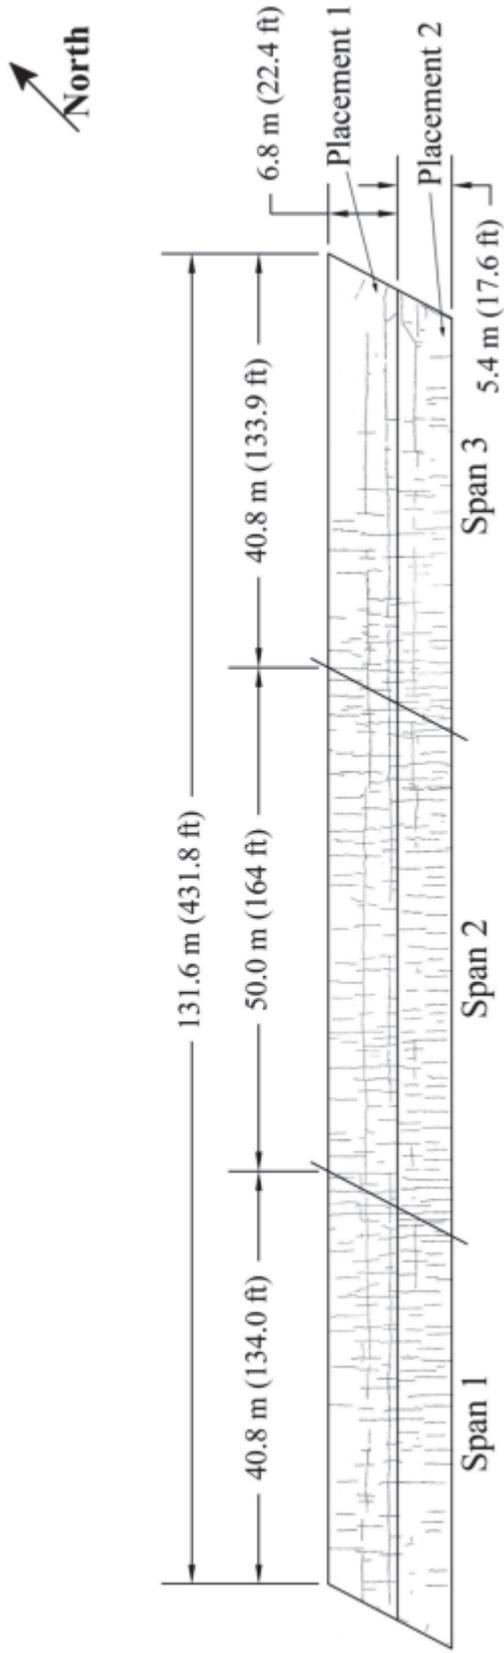
Figure 58: Control-9 (Survey 4)

Bridge Age:
 Placement 1: 60.1 months
 Placement 2: 59.8 months
Crack density: 0.609 m/m²
 Placement 1: 0.645 m/m²
 Placement 2: 0.564 m/m²
Span 1 (South): 0.601 m/m²
Span 2 (Middle): 0.699 m/m²
Span 3 (North): 0.508 m/m²

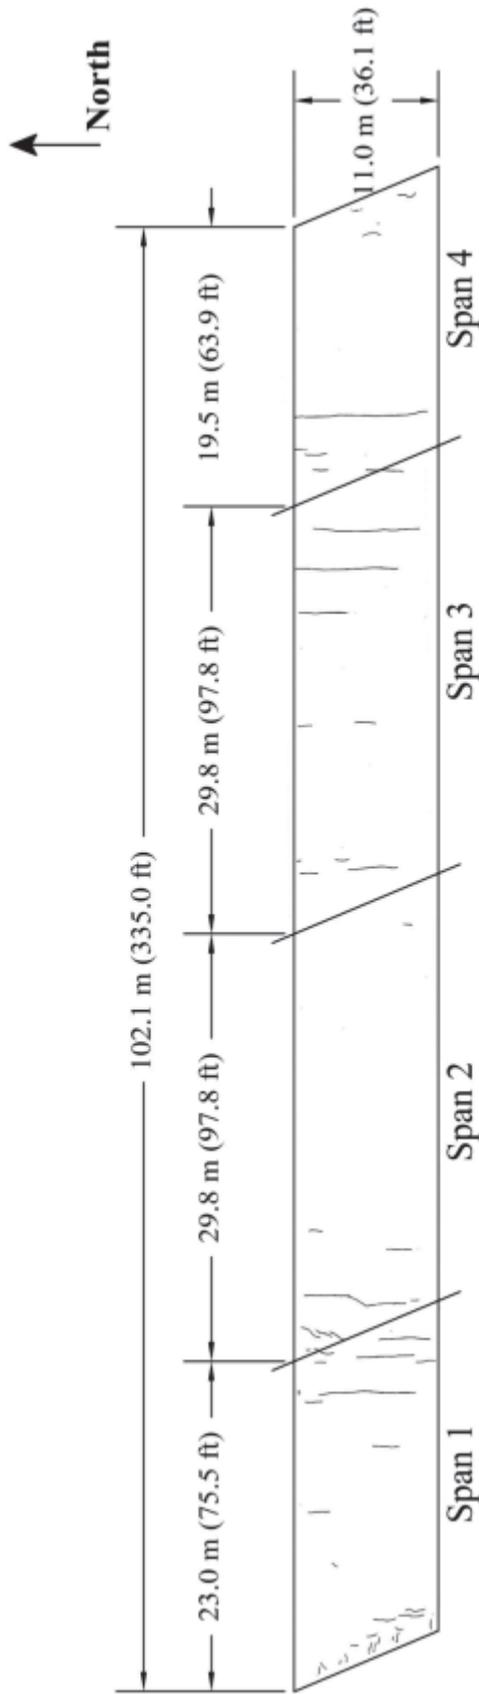
Figure 60: LC-HPC-10 (Survey 3)

The results for Surveys 3, 4, and 5 of LC-HPC-10, at 49.6, 60.0, and 72.2 months, are included in this report. LC-HPC-10 is the second of two LC-HPC bridges with precast, prestressed concrete girders. At 49.6 months, the crack density of LC-HPC-10 was 0.088 m/m², as shown in Figure 60. This represents an increase from Survey 2 at 36.2 months, when the crack density was 0.029 m/m² (Pendergrass et al. 2011). The crack density of LC-HPC-10 was 0.125 m/m² at 60.0 months (Figure 61), but only 0.069 m/m² at 72.2 months (Figure 62). Most of the cracks are long transverse cracks near the outer two piers, with a small amount of cracking near the center pier and abutments. Figure 63 compares cracking on LC-HPC-10 to cracking on Control 8/10 over time. For most of its life, LC-HPC-10 has experienced less cracking than Control 8/10. LC-HPC-10 started out with a larger density than Control 8/10 because it was

Bridge Number: 54-60 (LC-HPC-10)	Bridge Length: 102.1 m (335.0 ft)	Bridge Age: 49.6 months
Bridge Location: E1800Rd over US-69	Bridge Width: 11.0 m (36.1 ft)	Crack density: 0.088 m/m ²
Construction Date: 5/17/2007	Skew: 21.3°	Span 1 (West): 0.141 m/m ²
Crack survey Date: 7/5/2011	Number of Spans: 4	Span 2 (West): 0.046 m/m ²
	Span 1 (West): 23.0 m (75.5 ft)	Span 3 (East): 0.091 m/m ²
	Span 2 (West): 29.8 m (97.8 ft)	Span 4 (East): 0.086 m/m ²
	Span 3 (East): 29.8 m (97.8 ft)	
	Span 4 (East): 19.5 m (63.9 ft)	
	Number of Placements: 1
