**CRACK SURVEYS OF LOW-CRACKING
HIGH-PERFORMANCE CONCRETE
BRIDGE DECKS IN KANSAS
2011-2013**

**By
Brent Bohaty
Elizabeth Riedel
David Darwin**

**A Report on Research Sponsored by
CONSTRUCTION OF CRACK-FREE BRIDGE DECKS
TRANSPORTATION POOLED-FUND PROGRAM
PROJECT NO. TPF-5(174)**

**Structural Engineering and Engineering Materials
SL Report 13-6**

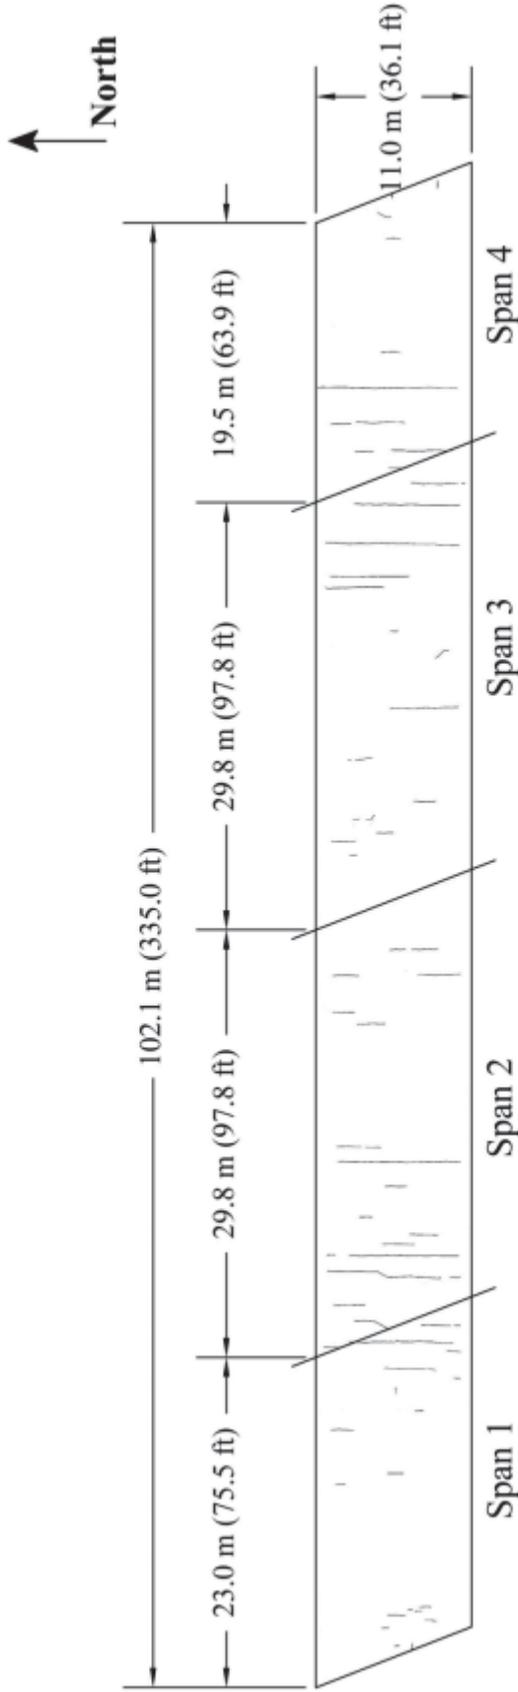
Figure 61: LC-HPC-10 (Survey 4)

Bridge Age: 60.0 months
Crack density: 0.125 m/m²
Span 1 (West): 0.091 m/m²
Span 2 (West): 0.156 m/m²
Span 3 (East): 0.128 m/m²
Span 4 (East): 0.114 m/m²

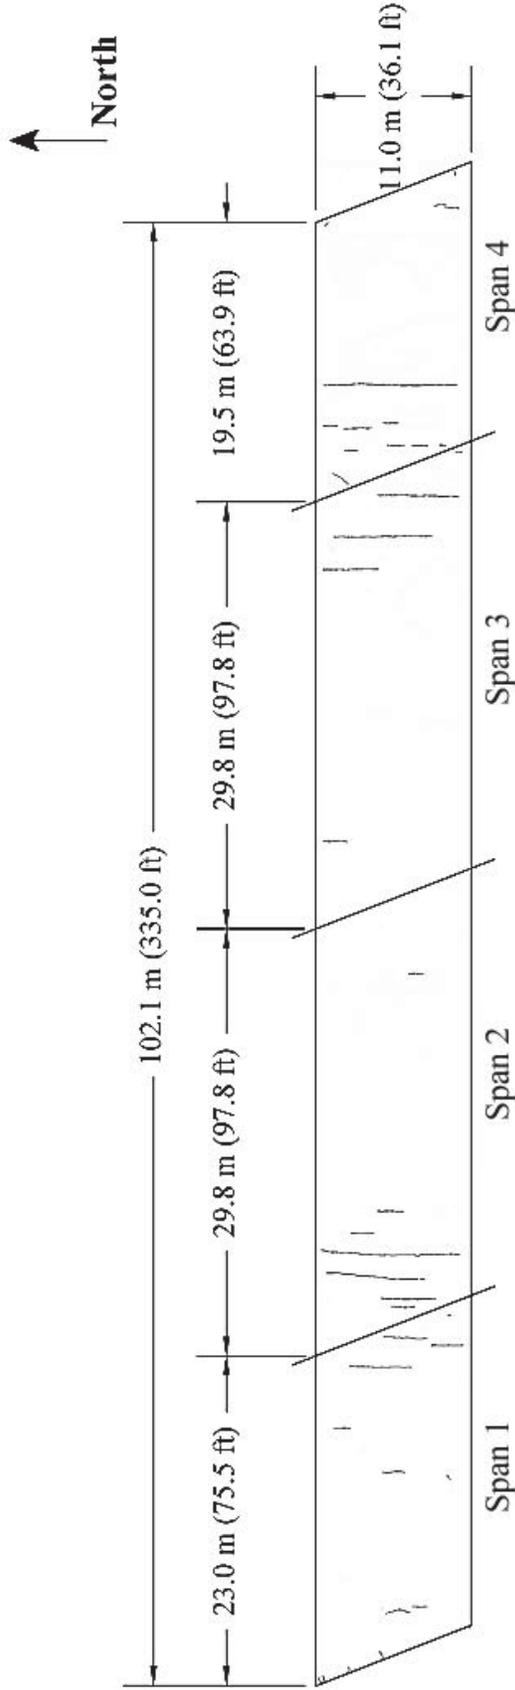
Figure 62: LC-HPC-10 (Survey 5)

Bridge Age: 72.2 months
Crack density: 0.069 m/m²
Span 1 (West): 0.059 m/m²
Span 2 (West): 0.070 m/m²
Span 3 (East): 0.051 m/m²
Span 4 (East): 0.089 m/m²

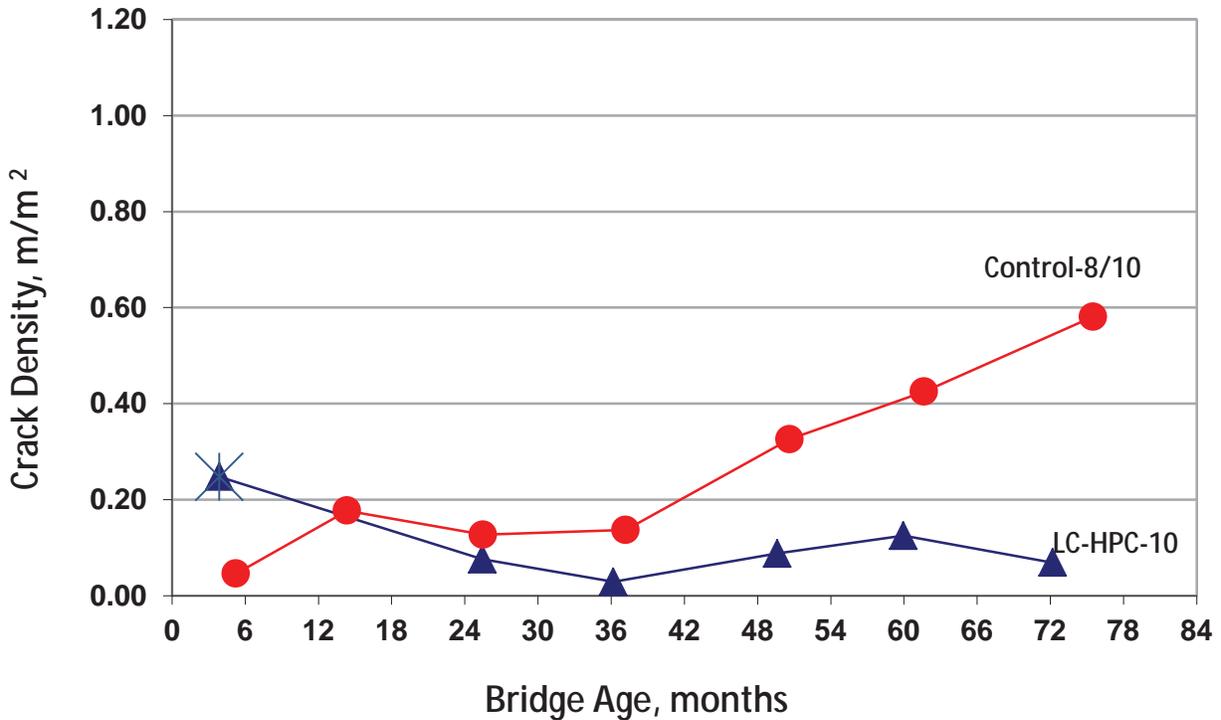
Figure 63: LC-HPC-10 and Control-8/10 Crack Densities

The results for Surveys 3, 4, and 5 of LC-HPC-10, at 49.6, 60.0, and 72.2 months, are included in this report. LC-HPC-10 is the second of two LC-HPC bridges with precast, prestressed concrete girders. At 49.6 months, the crack density of LC-HPC-10 was 0.088 m/m², as shown in Figure 60. This represents an increase from Survey 2 at 36.2 months, when the crack density was 0.029 m/m² (Pendergrass et al. 2011). The crack density of LC-HPC-10 was 0.125 m/m² at 60.0 months (Figure 61), but only 0.069 m/m² at 72.2 months (Figure 62). Most of the cracks are long transverse cracks near the outer two piers, with a small amount of cracking near the center pier and abutments. Figure 63 compares cracking on LC-HPC-10 to cracking on Control 8/10 over time. For most of its life, LC-HPC-10 has experienced less cracking than Control 8/10. LC-HPC-10 started out with a larger density than Control 8/10 because it was

first surveyed when the deck was not grooved. Following grooving, the cracking was not as significant and fell below values on Control 8/10.

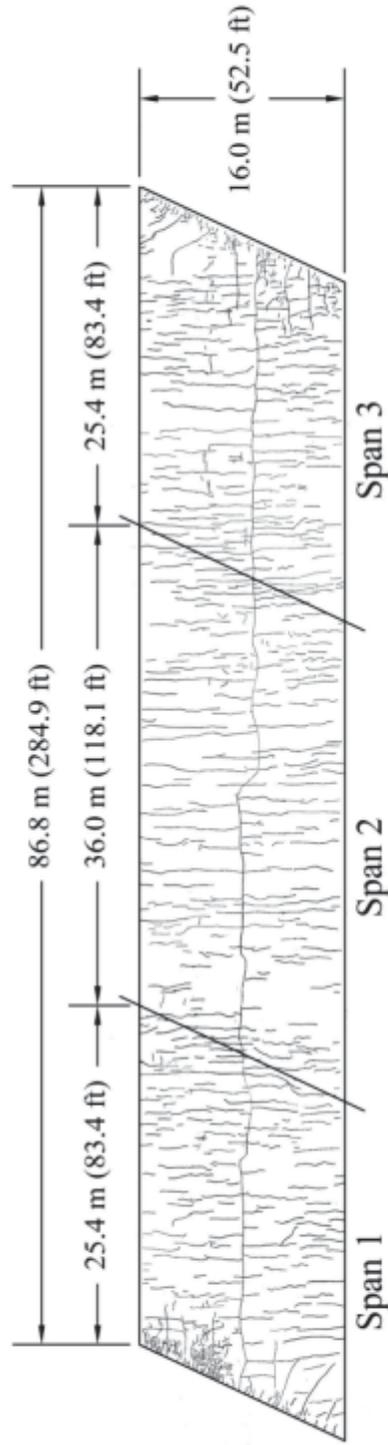
Figure 67: Control-11 (Survey 5)

The results of Surveys 5, 6, and 7 of Control-11, at 62.9, 74.2, and 86.3 months, are included in this report. The crack density of Control-11 at 62.9 months, 0.923 m/m^2 (Figure 67), was 45% higher than the value at 50.2 months, 0.636 m/m^2 (Pendergrass et al. 2011). The crack density of Control-11 decreased to 0.849 m/m^2 at 75.2 months (Figure 68), and decreased even further to 0.657 m/m^2 at 86.3 months (Figure 69). Cracking is higher on Control-11 than on LC-HPC-11 at similar ages. Specifically, Control-11 had a crack density of 0.923 m/m^2 at 62.9 months, which is three times the density of LC-HPC-11 at 61.0 months, 0.260 m/m^2 . Similarly, Control-11 had a crack density of 0.849 m/m^2 at 75.2 months, which is more than twice the density on LC-HPC-11 at 72.1 months, 0.420 m/m^2 . There are many small, narrow cracks on the deck that may have been overlooked in Surveys 6 and 7, leading to smaller crack densities. Most of the cracks are transverse, spread across the deck parallel to and above the reinforcement. There is a single longitudinal crack in the middle of the deck stretching across the entire length of the bridge, as well as smaller longitudinal cracks propagating from the abutments. Figure 70 compares cracking on Control 11 to cracking on LC-HPC-11 over time. While LC-HPC-11 has had less cracking than Control 11 over time, both decks have experienced significant swings in crack density.

Bridge Age: 62.9 months
Crack Density: 0.923 m/m²
Span 1: 1.001 m/m²
Span 2: 0.804 m/m²
Span 3: 1.005m/m²

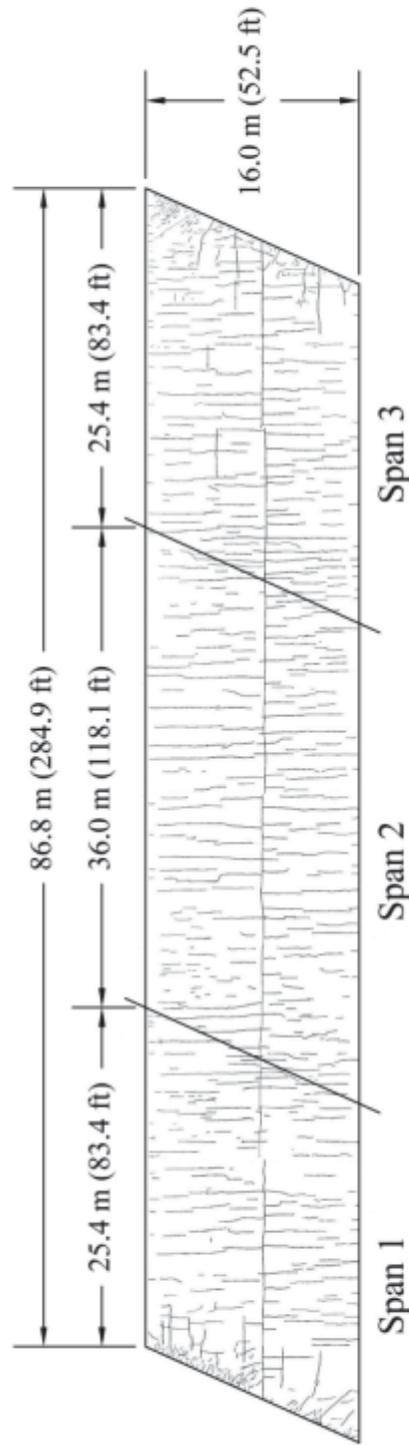
Figure 68: Control-11 (Survey 6)

Bridge Age: 75.2 months
Crack Density: 0.849 m/m²
Span 1: 0.830 m/m²
Span 2: 0.793 m/m²
Span 3: 0.945 m/m²

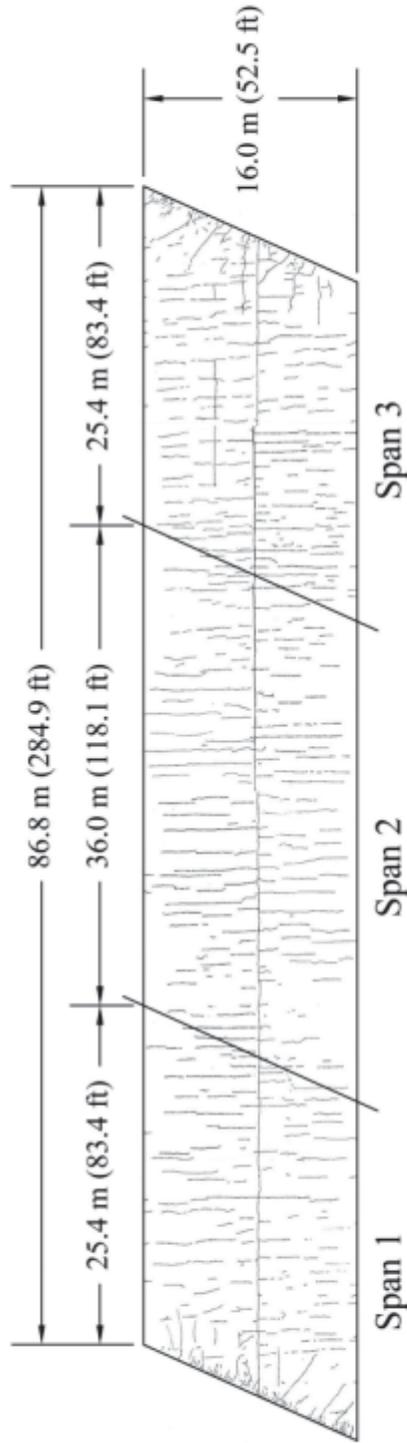
Figure 69: Control-11 (Survey 7)

Bridge Age: 86.3 months
Crack Density: 0.657 m/m²
Span 1: 0.621 m/m²
Span 2: 0.608 m/m²
Span 3: 0.754 m/m²

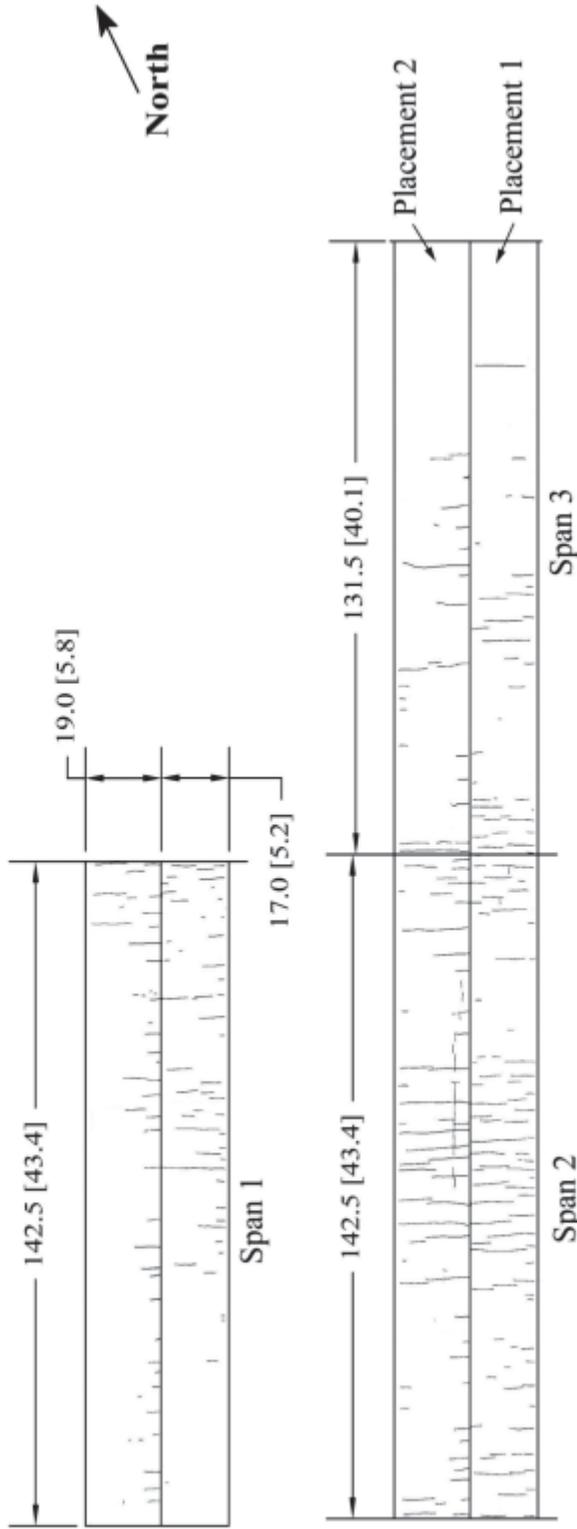
Figure 71: LC-HPC-12 (Survey 3)

LC-HPC-12 was constructed in two placements, 11.4 months apart. The results of Survey 3 at 27.4 and 38.8 months, Survey 4 at 38.1 and 49.5 months, and Survey 5 at 53.1 and 64.5 months are included in this report. At 38.8 months, Placement 1 had a crack density of 0.315 m/m² (see Figure 71). Placement 2 had a crack density of 0.268 m/m² at 27.4 months, resulting in an overall crack density of 0.289 m/m². This represents an increase from Survey 2 of LC-HPC-12, which recorded crack densities of 0.256 m/m², 0.244 m/m², and 0.250 m/m², respectively, for Placement 1, Placement 2, and overall (Pendergrass et al. 2011). In Survey 4, Placement 1 had a crack density of 0.450 m/m² at 49.5 months and Placement 2 had a crack density of 0.375 m/m² at 38.1 months (see Figure 72), producing an overall crack density of 0.410 m/m². These values are all larger than the corresponding crack densities from Survey 3. For Survey 5, Placement 1 had a crack density of 0.478 m/m² at 64.5 months (see Figure 73), and

Bridge Number: 56-057 (LC-HPC-12)	Bridge Length: 416.5' (126.95m)	Bridge Age:
Bridge Location: K-130 over Neosho Rv Unit 2	Bridge Width: 36' (10.97m)	Placement 1: 38.8 months
Construction Date:	Skew: 0°	Placement 2: 27.4 months
Placement 1 (east): 4/4/2008	Number of Spans: 3	Crack Density: 0.289 m/m ²
Placement 2 (west): 3/18/2009	Span 1 (West): 142.5' (43.43m)	Placement 1: 0.315 m/m ²
Crack Survey Date: 6/28/2011	Span 2 (Mid): 142.5' (43.43m)	Placement 2: 0.268 m/m ²
	Span 3 (East): 131.5' (40.08m)	Span 1: 0.216 m/m ²
	Number of Placements: 2	Span 2: 0.474 m/m ²
		Span 3: 0.168 m/m ²

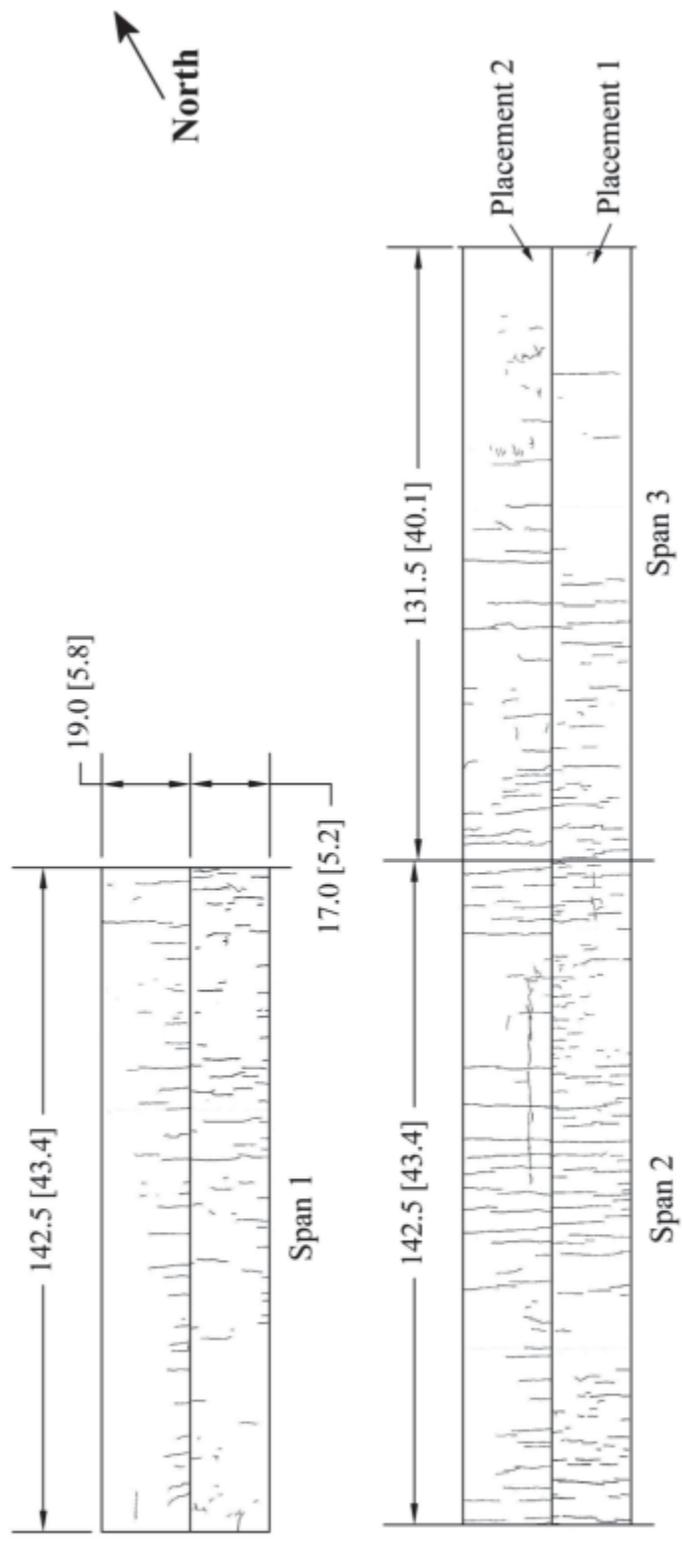
Figure 72: LC-HPC-12 (Survey 4)

Crack Density: 0.410 m/m²
 Placement 1: 0.450 m/m²
 Placement 2: 0.375 m/m²

Span 1: 0.283 m/m²
Span 2: 0.604 m/m²
Span 3: 0.331 m/m²

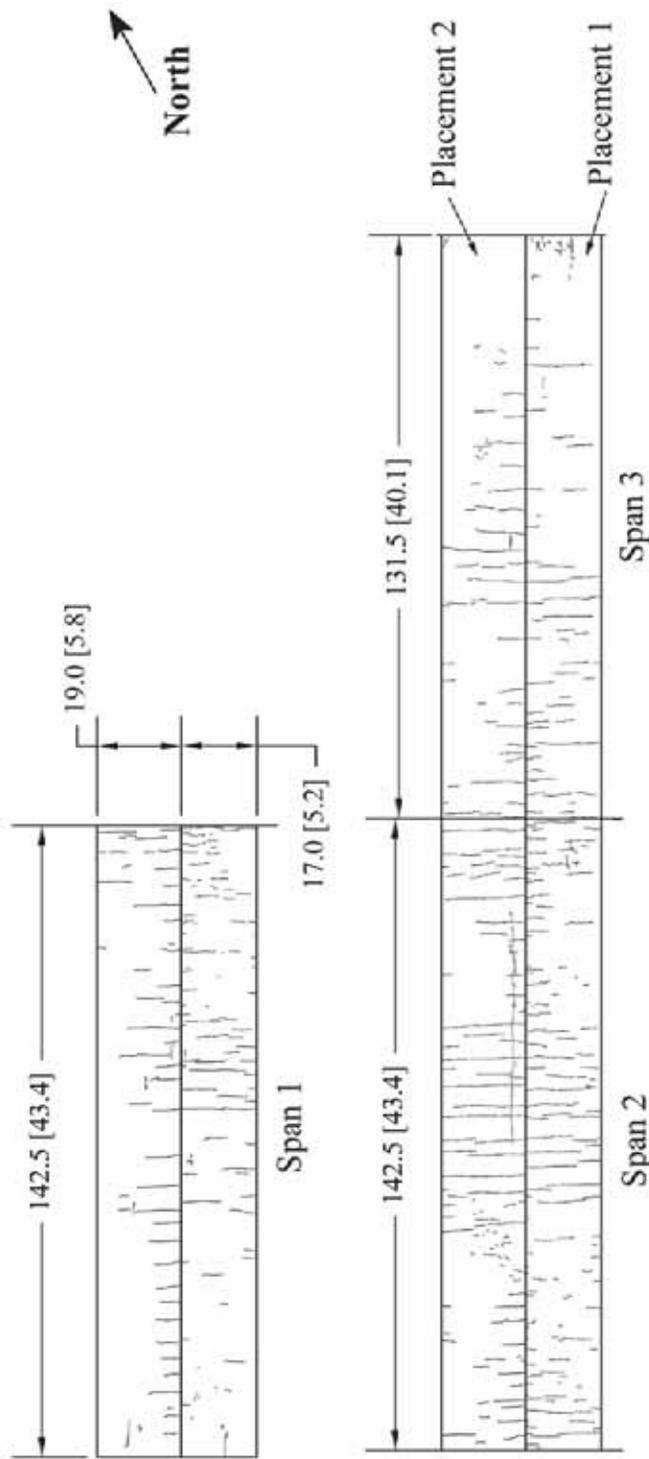
Crack Density: 0.431 m/m²
 Placement 1: 0.478 m/m²
 Placement 2: 0.381 m/m²
Span 1: 0.349 m/m²
Span 2: 0.610 m/m²
Span 3: 0.327 m/m²

Placement 2 had a crack density of 0.381 m/m^2 at 53.1 months, resulting in an overall crack density of 0.431 m/m^2 . These values are again higher than the densities measured in Survey 4. Both placements have transverse cracks extending from the longitudinal construction joint, with less cracking near the abutments and a greater crack density in the middle of the center span (Span 2). The crack density of Placement 1 has been higher, likely because of the torsional loading caused by equipment that was placed on this portion of the deck during the construction of Placement 2.

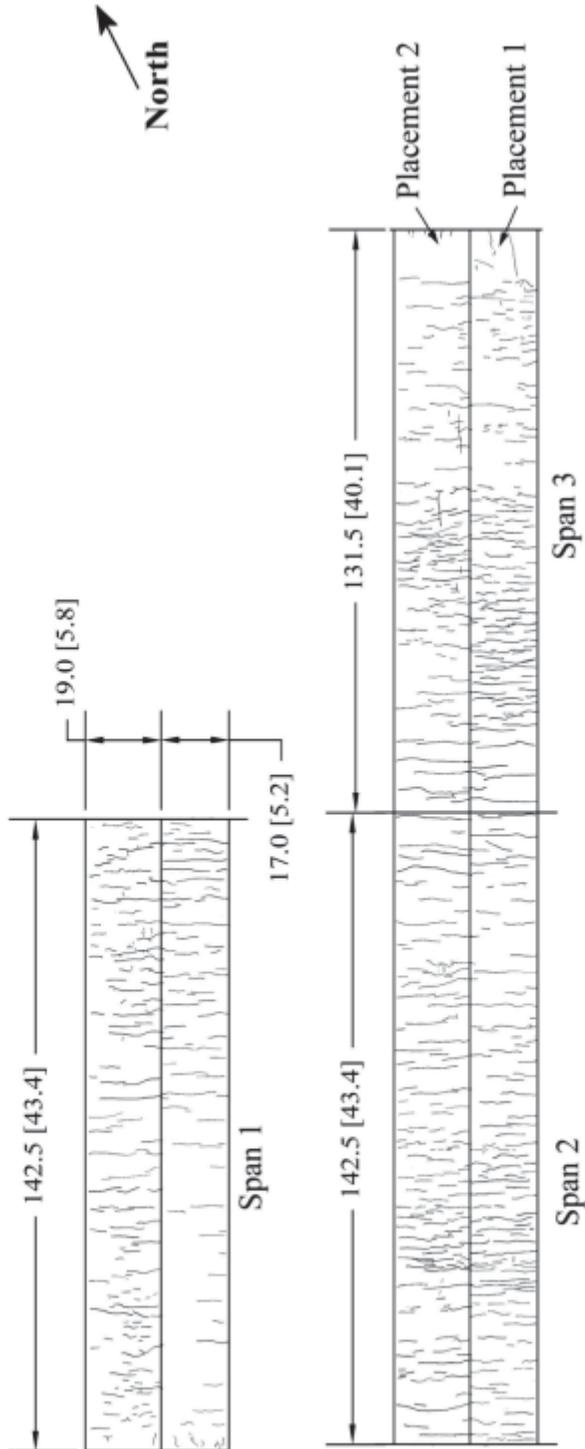
Figure 74: Control-12 (Survey 3)

Control-12, the southern half of the same bridge as LC-HPC-12, was also constructed in two placements, 12.4 months apart. The results of Survey 3 at 26.5 and 38.9 months, Survey 4 at 37.2 and 49.6 months, and Survey 5 at 52.2 and 64.6 months are included in this report. At 38.9 months, Placement 1 had a crack density of 0.767 m/m^2 (see Figure 74) and at 26.5 months, Placement 2 had a crack density of 0.799 m/m^2 , resulting in an overall crack density of 0.788 m/m^2 . This represents an increase from Survey 2, for which the crack densities were 0.669 m/m^2 , 0.442 m/m^2 , and 0.548 m/m^2 for Placement 1, Placement 2, and overall, respectively (Pendergrass et al. 2011). For Survey 4, Placement 1 had a crack density of 0.857 m/m^2 at 49.6 months and Placement 2 had a crack density of 0.831 m/m^2 at 37.2 months, resulting in an overall crack density of 0.843 m/m^2 (see Figure 75). These values are all larger than the corresponding crack densities from Survey 3. For Survey 5 at 64.6 months, Placement 1 had a crack density of 0.838 m/m^2 , and at 52.2 months, Placement 2 had a crack density of 0.880 m/m^2 , resulting in an overall crack density of 0.858 m/m^2 for Survey 5 (See Figure 76). This represents an increase from Survey 4 for Placement 2, but not for Placement 1, which had a crack density that remained unchanged from Survey 4. Control-12 consistently has had crack

Bridge Age:
 Placement 1: 38.9 months
 Placement 2: 26.5 months
Crack Density: 0.788 m/m²
 Placement 1: 0.767 m/m²
 Placement 2: 0.799 m/m²
Span 1: 0.636 m/m²
Span 2: 0.892 m/m²
Span 3: 0.829 m/m²

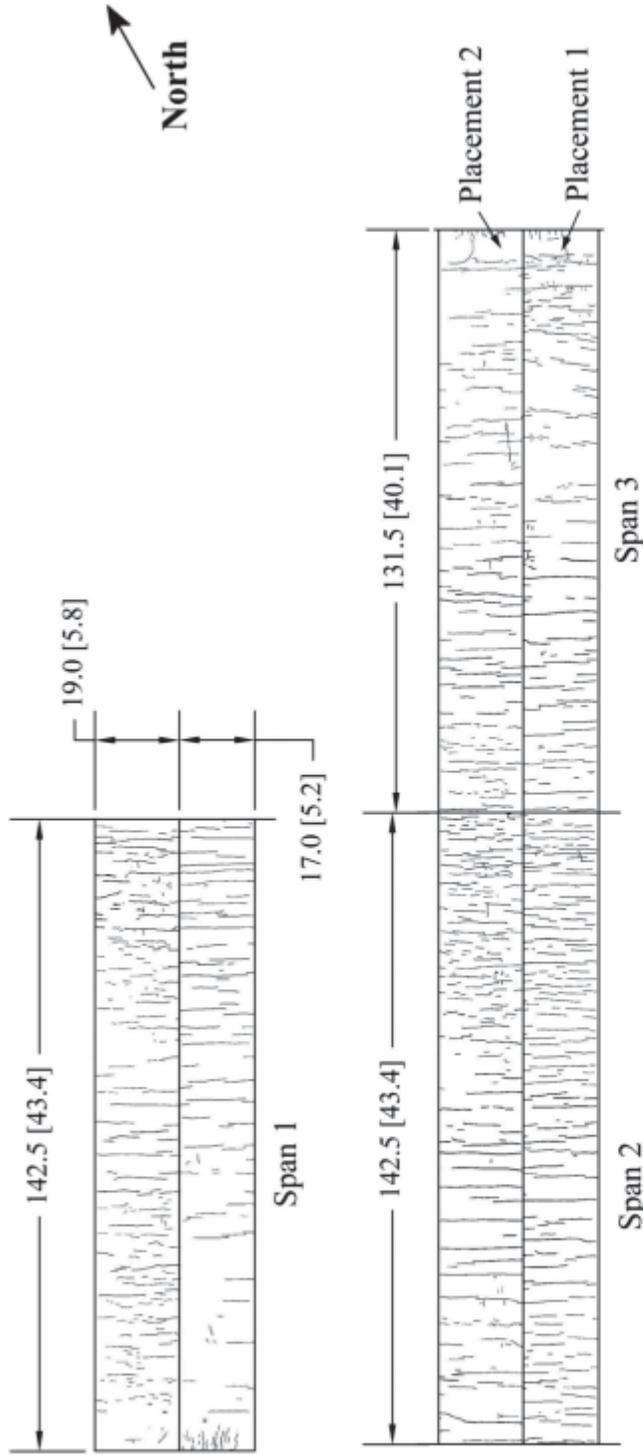
Figure 75: Control-12 (Survey 4)

Bridge Number: 56-057 (Control-12)	Bridge Length: 416.5' (126.95m)	Bridge Age:
Bridge Location: K-130 over Neosho	Bridge Width: 36' (10.97m)	Placement 1: 49.6 months
Construction Date: Rv Unit 1	Skew: 0°	Placement 2: 37.2 months
Placement 1(east): 4/1/2008	Number of Spans: 3	Crack Density: 0.843 m/m ²
Placement 2(west): 4/14/2009	Span 1 (West): 142.5' (43.43m)	Placement 1: 0.857 m/m ²
Crack Survey Date: 5/21/2012	Span 2 (Mid): 142.5' (43.43m)	Placement 2: 0.831 m/m ²
	Span 3 (East): 131.5' (40.08m)	Span 1: 0.723 m/m ²
	Number of Placements: 2	Span 2: 1.015 m/m ²
		Span 3: 0.786 m/m ²

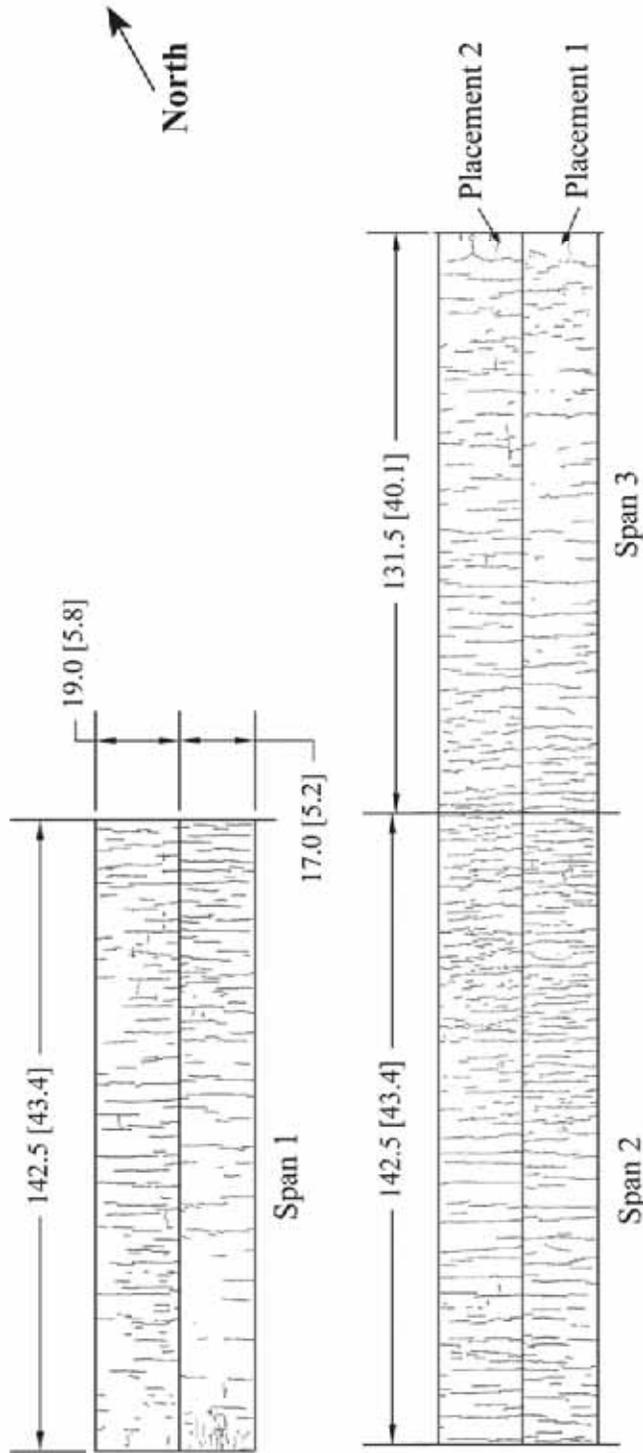
Figure 76: Control-12 (Survey 5)

Bridge Number: 56-057 (Control-12)	Bridge Length: 416.5' (126.95m)	Bridge Age:
Bridge Location: K-130 over Neosho Rv Unit 1	Bridge Width: 36' (10.97m)	Placement 1: 64.6 months
Construction Date:	Skew: 0°	Placement 2: 52.2 months
Placement 1 (East): 4/1/2008	Number of Spans: 3	Crack Density: 0.858 m/m ²
Placement 2 (West): 4/14/2009	Span 1 (West): 142.5' (43.43m)	Placement 1: 0.838 m/m ²
Crack Survey Date: 8/19/2013	Span 2 (Mid): 142.5' (43.43m)	Placement 2: 0.880 m/m ²
	Span 3 (East): 131.5' (40.08m)	Span 1: 0.750 m/m ²
	Number of Placements: 2	Span 2: 1.085 m/m ²
		Span 3: 0.728 m/m ²

densities about twice those of LC-HPC-12. Long transverse cracks span the length of both placements, and there are small longitudinal cracks propagating from both abutments. Similar to LC-HPC-12, construction equipment was placed on Placement 1 during the construction of Placement 2. Figure 77 compares cracking on Control-12 to cracking on LC-HPC-12 over time. LC-HPC-12 has performed significantly better throughout the life of the decks. It appears that crack growth has begun to stabilize on both decks.

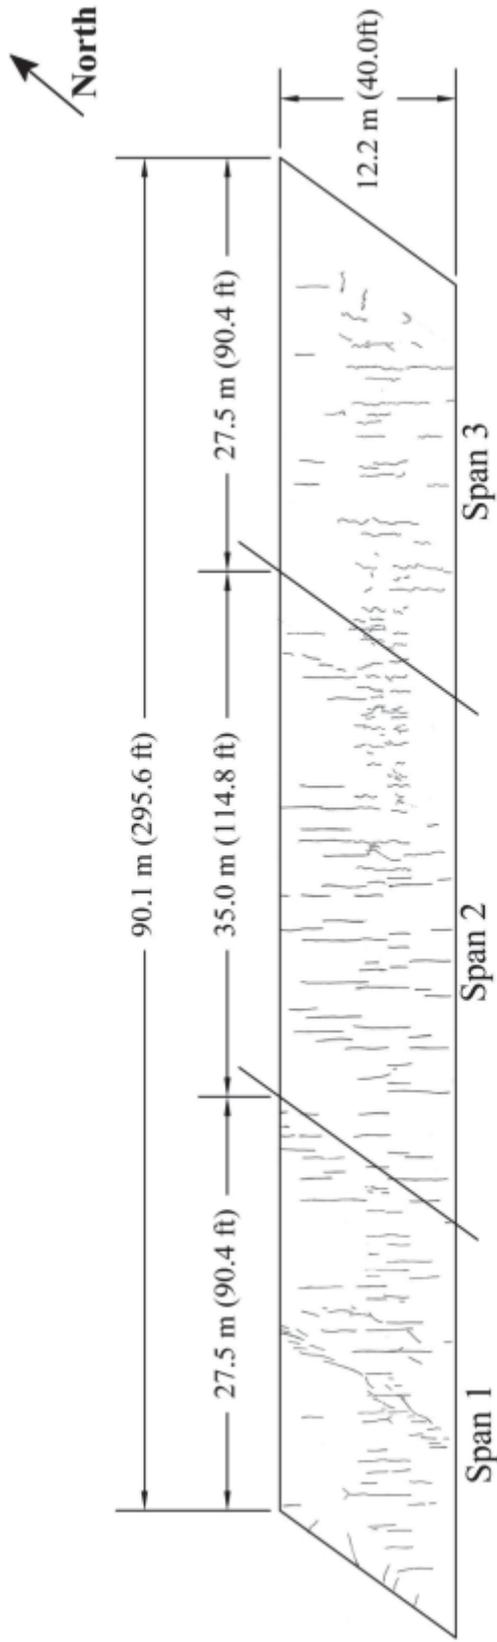
Figure 78: LC-HPC-13 (Survey 3)

The results of Surveys 3, 4, and 5 of LC-HPC-13, at 37.1, 49.0, and 62.9 months, are included in this report. The crack density of LC-HPC-13 was 0.364 m/m² at 37.1 months (Figure 78), which represents an increase from 0.129 m/m² at 24.8 months (Pendergrass et al. 2011). The crack density of LC-HPC-13 at 49.0 months was 0.342 m/m² (Figure 79), and increased to 0.576

Crack density: 0.364 m/m²

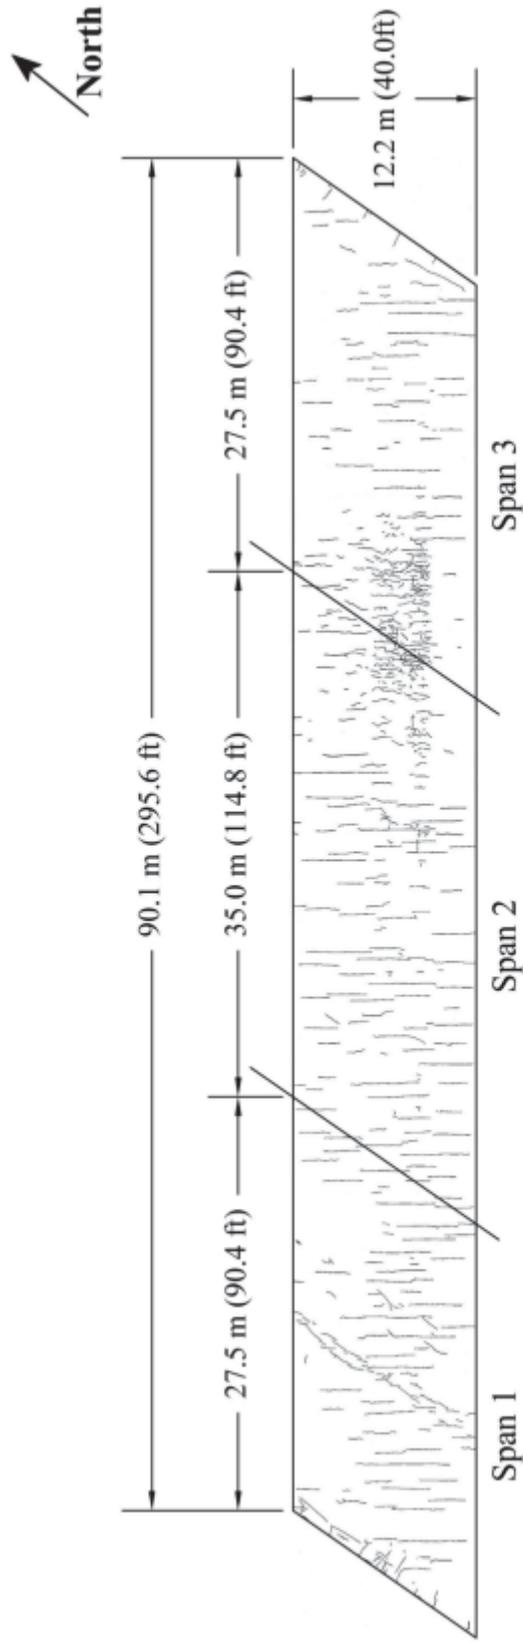
Figure 80: LC-HPC-13 (Survey 5)

m/m² at 62.9 months (Figure 80). Most of the cracks are transverse, parallel to and directly above the top reinforcement and, therefore, likely due to settlement and shrinkage. Map cracking is present above the second pier along with cracks that propagate perpendicular to the abutments and cracking parallel to the skew of the bridge in the center of the first span.

Bridge Age: 62.9 months
Crack density: 0.576 m/m²
Span 1 (West): 0.579 m/m²
Span 2 (middle): 0.604 m/m²
Span 3 (East): 0.536 m/m²

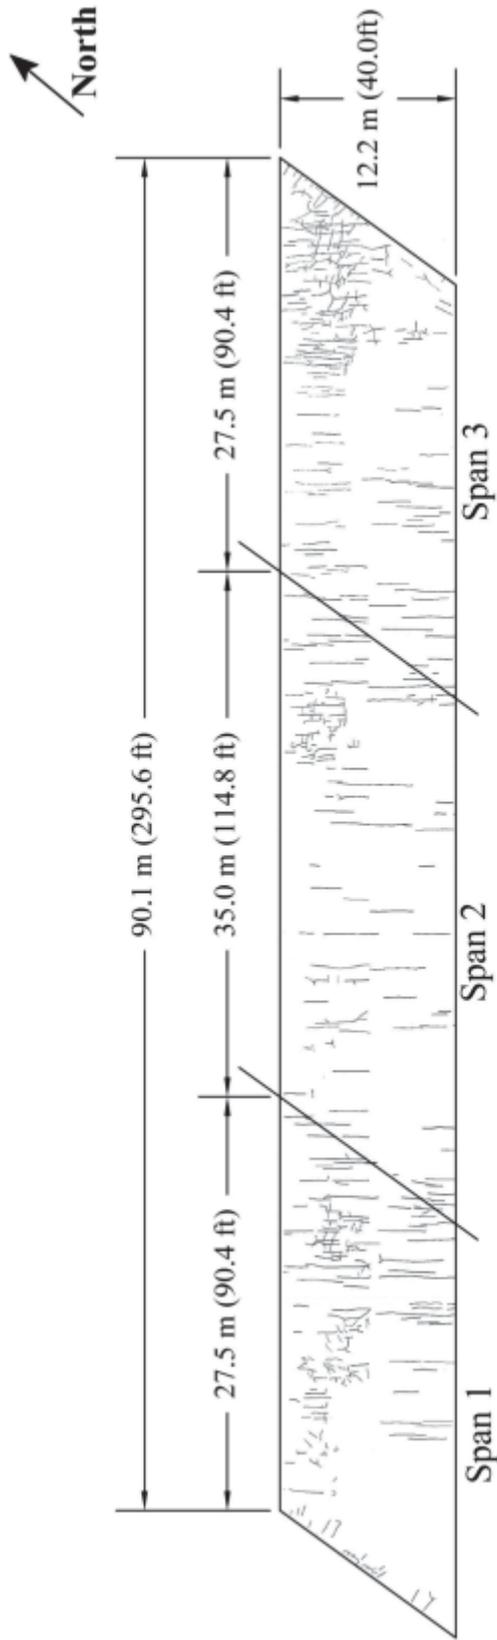
Figure 81: Control-13 (Survey 3)

The results of Surveys 3, 4, and 5 of Control-13, at 34.4, 46.1, and 60.0 months, are included in this report. The crack density of 0.524 m/m² at 34.4 months (Figure 81) represents an increase from the crack density of 0.154 m/m² measured in Survey 2 (Pendergrass et al. 2011) and is 44% higher than the density of LC-HPC-13 at 37.1 months, 0.364 m/m². The crack density of Control-13 at 46.1 months was 0.543 m/m² (Figure 82) and increased to 0.807 m/m² at 60.0 months (Figure 83), 59% and 40% higher, respectively, than densities on LC-HPC-13 at 49.0 and 62.9 months, 0.342 m/m² and 0.576 m/m². Significant map cracking is present at the east abutment, as well as in the middle of the first span. Transverse cracks have developed throughout the deck, with somewhat higher densities near the piers. Small cracks propagate perpendicular to the abutments. Figure 84 compares cracking on Control-13 to cracking on LC-HPC-13 over time. It is clear that LC-HPC-13 has experienced less cracking than Control-13 over the entire life of both bridges. Both decks have remarkably similar crack growth trends, with both decks experiencing an increase from 12 to 36 months, a plateau from 36 to 48 months, and another increase after 48 months. Cracking does not seem to have stabilized on either deck.

Bridge Age: 34.4 months
Crack density: 0.524 m/m²
Span 1 (West): 0.568 m/m²
Span 2 (middle): 0.393 m/m²
Span 3 (East): 0.648 m/m²

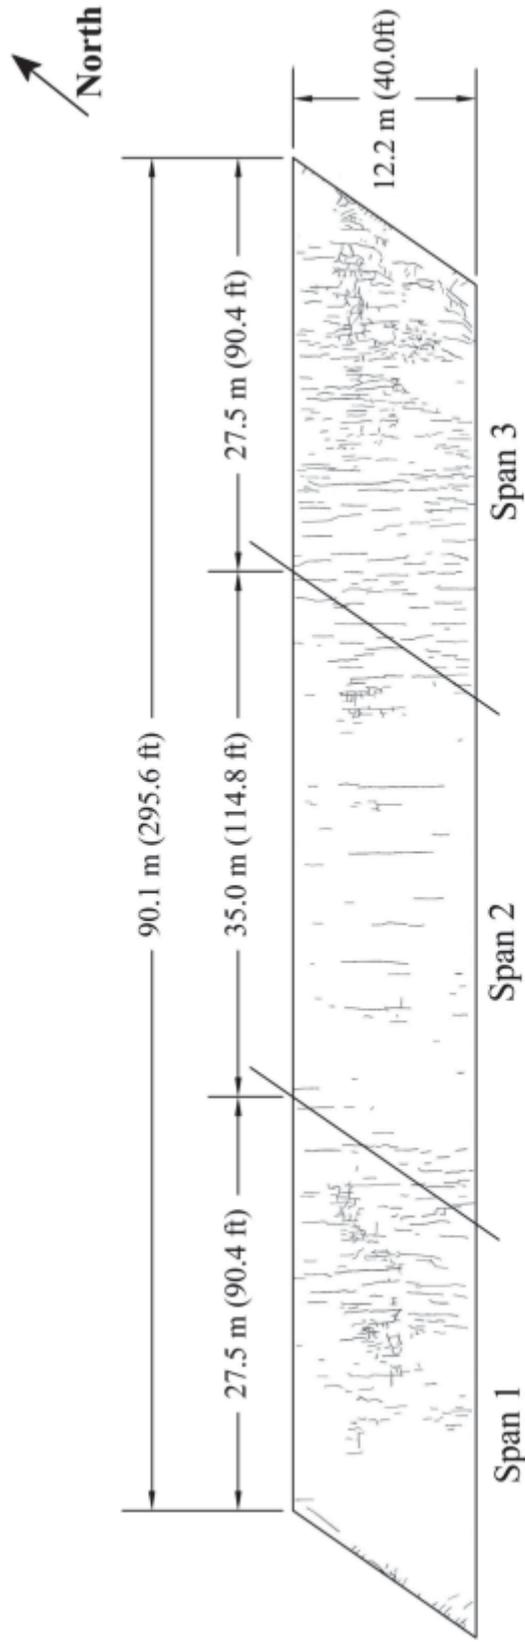
Bridge Number: 54-67
 (Control-13)
Bridge Location: SB US-69 over
 BNSF RR, Linn County, KS
Construction Date: 7/25/2008
Crack survey Date: 6/6/2011

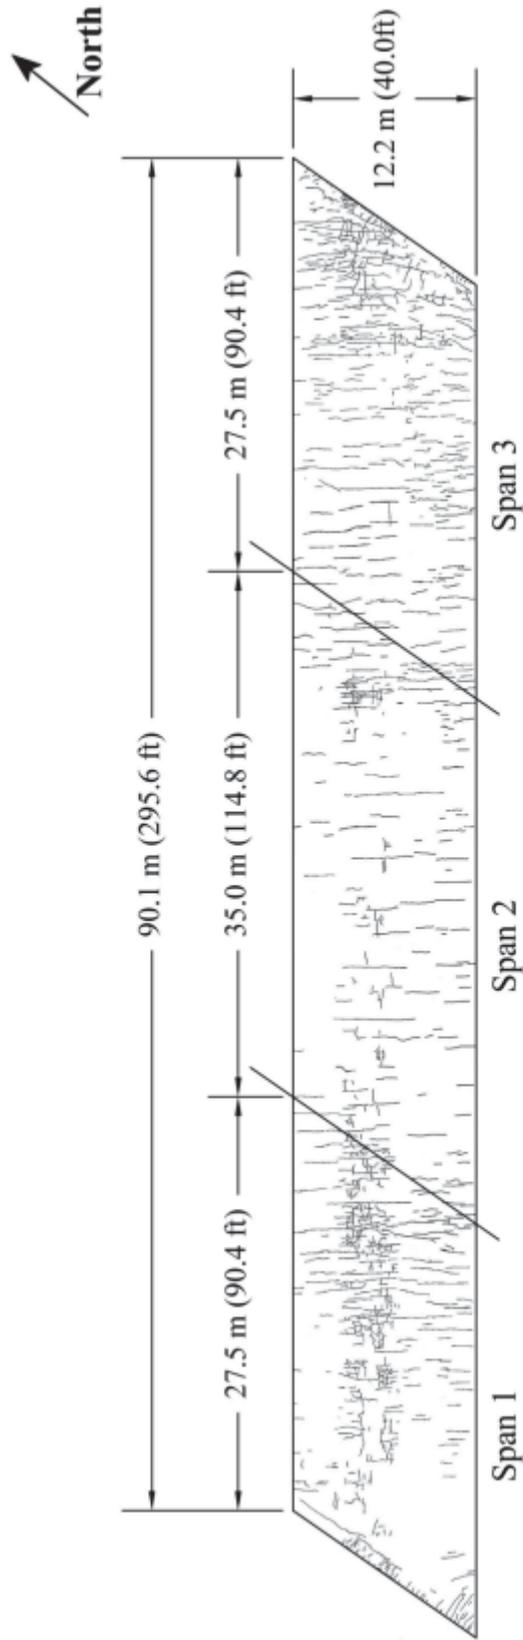
Figure 82: Control-13 (Survey 4)

Bridge Number: 54-67
 (Control-13)
Bridge Location: SB US-69 over
 BNSF RR, Linn County, KS
Construction Date: 7/25/2008
Crack survey Date: 5/29/2012

Bridge Age: 46.1 months
Crack density: 0.543 m/m²
Span 1 (West): 0.494 m/m²
Span 2 (middle): 0.268 m/m²
Span 3 (East): 0.927 m/m²

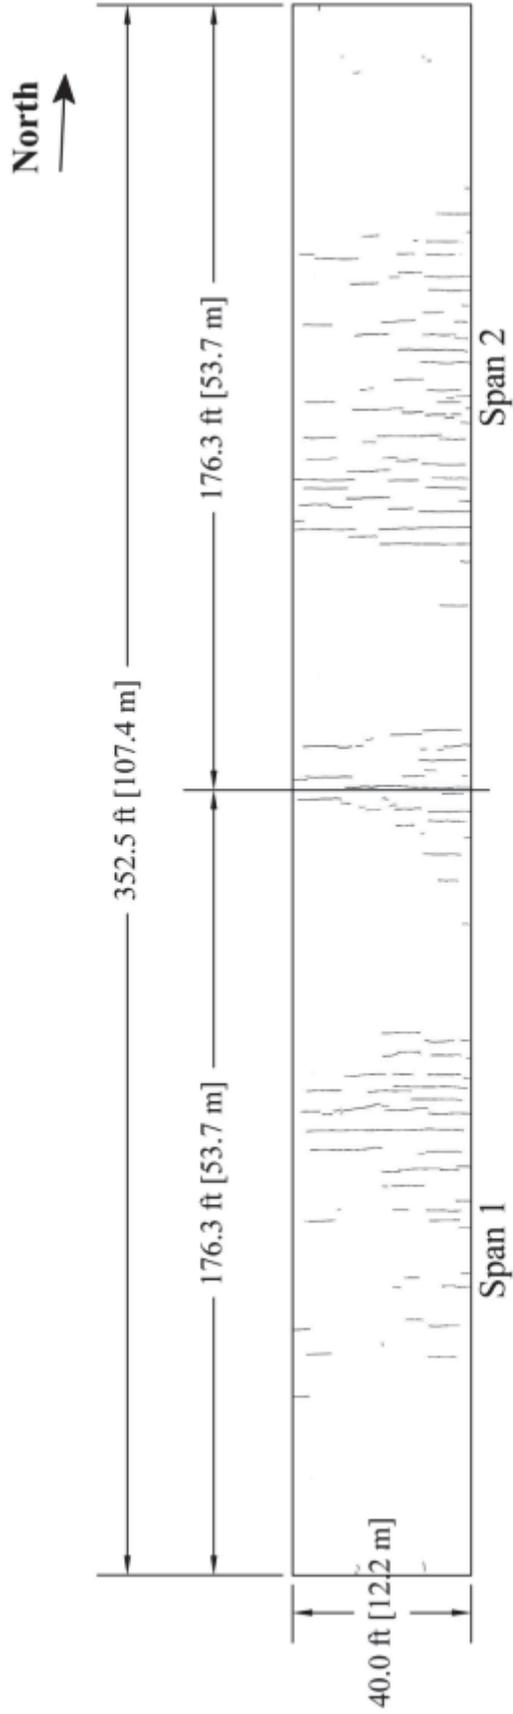
Figure 85: LC-HPC-15 (Survey 1)

The results of Surveys 1 and 2 of LC-HPC-15, at 18.9 and 30.8 months, are included in this report. The crack density was 0.211 m/m² at 18.9 months (Figure 85) and decreased to 0.161 m/m² at 30.8 months (Figure 86). The decrease in crack density is most likely due to several long transverse cracks in the first span that may have been overlooked. The cracks are transverse, mainly clustered near the pier and centers of the spans. Figure 87 shows cracking on LC-HPC-15 over time.

Bridge Number: 46-351 (LC-HPC-15)	Bridge Length: 352.5 ft (118.2 m)	Bridge Age: 18.9 months
Bridge Location: NB K-7 over Johnson Dr./55th St.	Bridge Width: 40.0 ft(12.2 m)	Crack Density: 0.211 m/m ²
Construction Date: 11-10-10	Skew: 0°	Span 1: 0.183 m/m ²
Crack Survey Date: 6-8-2012	Number of Spans: 3	Span 2: 0.236 m/m ²
	Span 1: 176.25 ft (36.7 m)	
	Span 2: 176.25 ft (44.8 m)	
	Number of Placements: 1

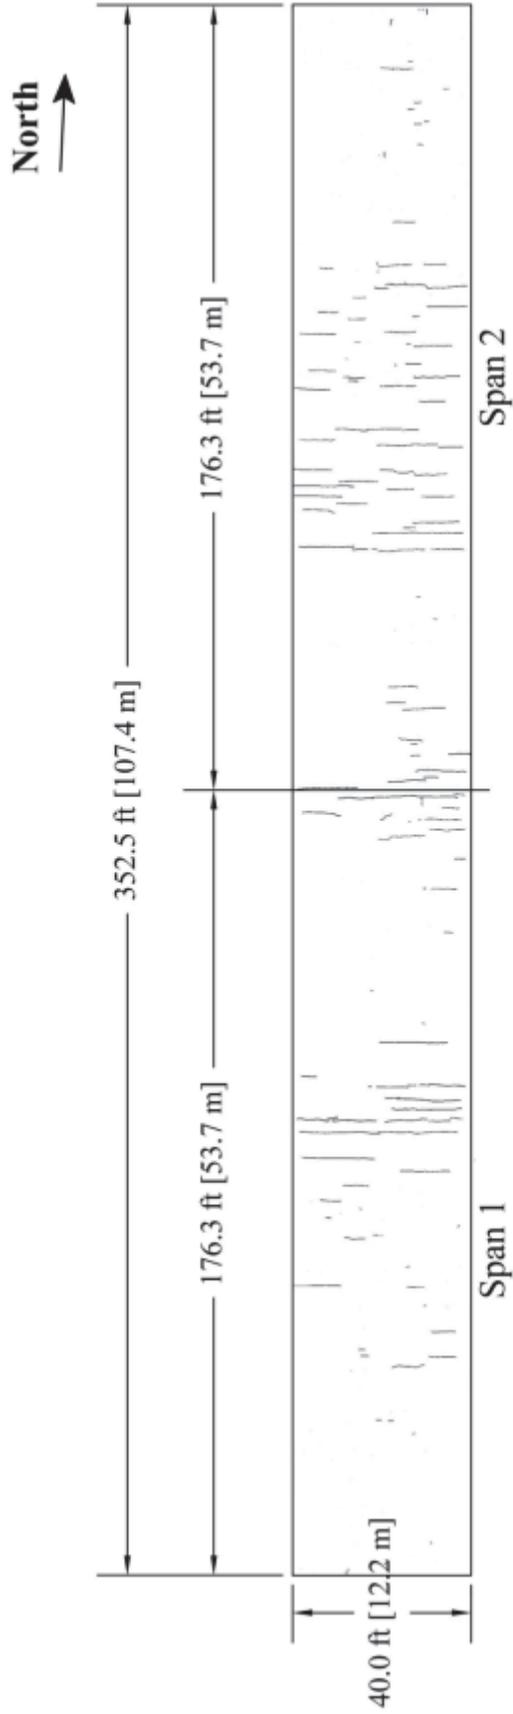
Figure 86: LC-HPC-15 (Survey 2)

Bridge Number: 46-351 (LC-HPC-15)	Bridge Length: 352.5 ft (118.2 m)	Bridge Age: 30.8 months
Bridge Location: NB K-7 over Johnson Dr./55th St.	Bridge Width: 40.0 ft(12.2 m)	Crack Density: 0.161 m/m ²
Construction Date: 11-10-10	Skew: 0°	Span 1: 0.134 m/m ²
Crack Survey Date: 6-3-2013	Number of Spans: 3	Span 2: 0.182 m/m ²
	Span 1: 176.25 ft (36.7 m)	
	Span 2: 176.25 ft (44.8 m)	
	Number of Placements: 1

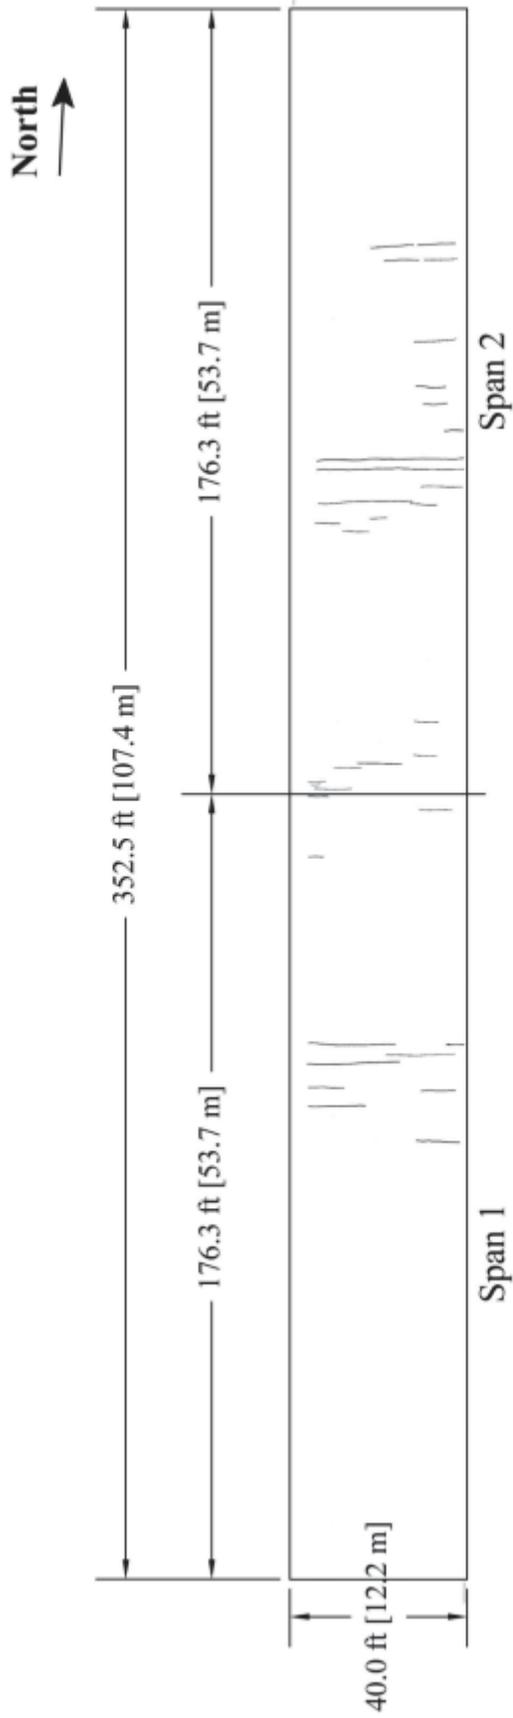
Figure 88: LC-HPC-16 (Survey 1)

The results of Surveys 1, 2 and 3 of LC-HPC-16, at 7.70, 19.4 and 31.2 months, are included in this report. The crack density was only 0.092 m/m² at 7.70 months (Figure 88), and grew to 0.249 m/m² at 19.4 months (Figure 89). The crack density then decreased to 0.211 m/m² at 31.2 months (Figure 90). The cracks are transverse, mainly clustered near the pier and centers of the spans, similar to LC-HPC-15. Figure 91 shows cracking on LC-HPC-16 over time.

Bridge Number: 46-352 (LC-HPC-16)	Bridge Length: 352.5 ft (118.2 m)	Bridge Age: 7.7 months
Bridge Location: SB K-7 over Johnson Dr./55th St.	Bridge Width: 40.0 ft(12.2 m)	Crack Density: 0.092 m/m
Construction Date: 10-28-2010	Skew: 0°	Span 1: 0.058 m/m ²
Crack Survey Date: 6-20-2011	Number of Spans: 3	Span 2: 0.119 m/m ²
	Span 1: 176.25 ft (36.7 m)	
	Span 2: 176.25 ft (44.8 m)	
	Number of Placements: 1

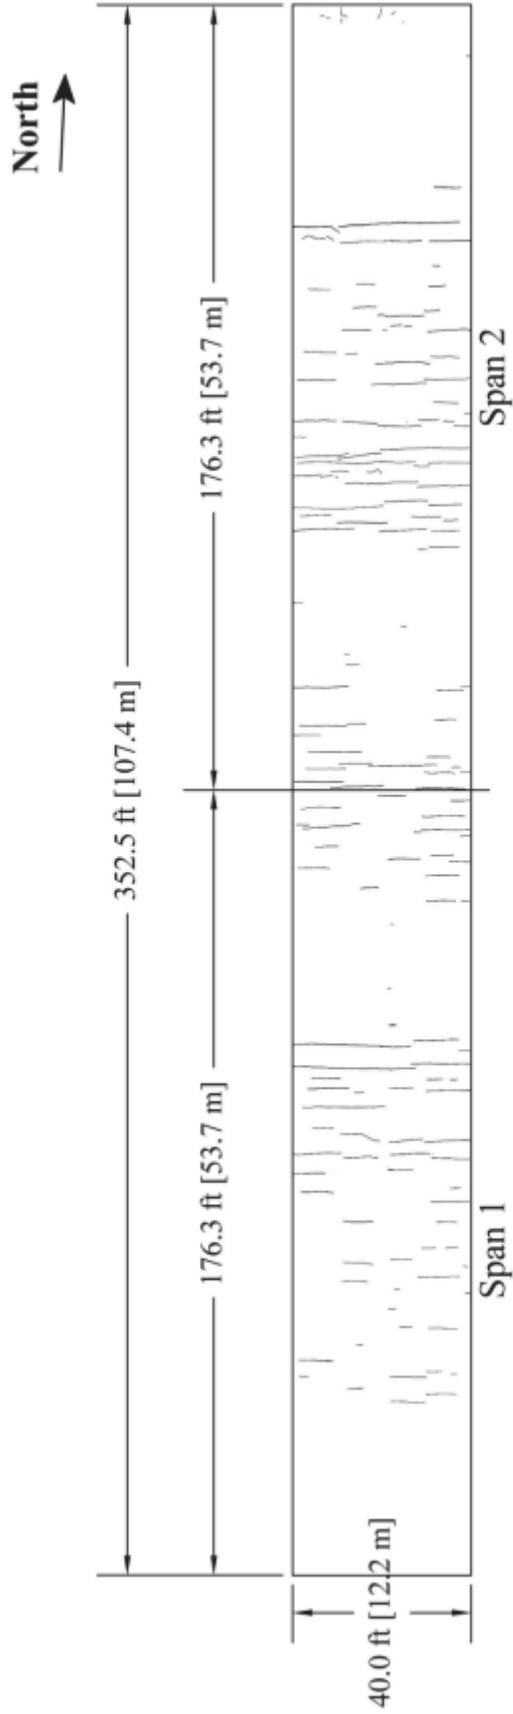
Figure 89: LC-HPC-16 (Survey 2)

Bridge Number: 46-352 (LC-HPC-16) **Bridge Length:** 352.5 ft (107.4 m) **Bridge Age:** 19.4 months
Bridge Location: SB K-7 over Johnson Dr./55th St. **Bridge Width:** 40.0 ft(12.2 m) **Crack Density:** 0.249 m/m²
Construction Date: 10-28-2010 **Skew:** 0° **Number of Spans:** 2 **Span 1:** 0.204 m/m²
Crack Survey Date: 6-8-2012 **Number of Placements:** 1 **Span 2:** 0.287 m/m²
