**CRACK SURVEYS OF LOW-CRACKING
HIGH-PERFORMANCE CONCRETE
BRIDGE DECKS IN KANSAS
2011-2013**

**By
Brent Bohaty
Elizabeth Riedel
David Darwin**

**A Report on Research Sponsored by
CONSTRUCTION OF CRACK-FREE BRIDGE DECKS
TRANSPORTATION POOLED-FUND PROGRAM
PROJECT NO. TPF-5(174)**

**Structural Engineering and Engineering Materials
SL Report 13-6**

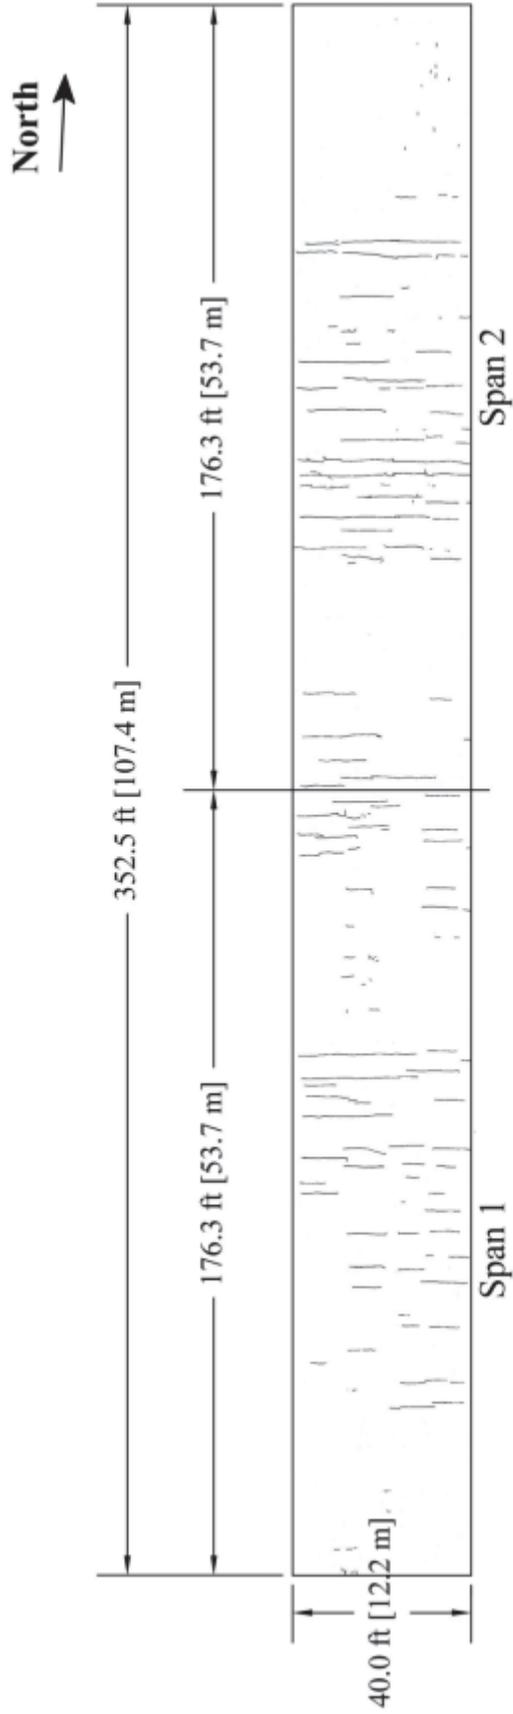
Figure 90: LC-HPC-16 (Survey 3)

The results of Surveys 1, 2 and 3 of LC-HPC-16, at 7.70, 19.4 and 31.2 months, are included in this report. The crack density was only 0.092 m/m² at 7.70 months (Figure 88), and grew to 0.249 m/m² at 19.4 months (Figure 89). The crack density then decreased to 0.211 m/m² at 31.2 months (Figure 90). The cracks are transverse, mainly clustered near the pier and centers of the spans, similar to LC-HPC-15. Figure 91 shows cracking on LC-HPC-16 over time.

Bridge Number: 46-352 (LC-HPC-16) **Bridge Length:** 352.5 ft (107.4 m) **Bridge Age:** 31.2 months
Bridge Location: SB K-7 over Johnson Dr./55th St. **Bridge Width:** 40.0 ft(12.2 m) **Crack Density:** 0.211 m/m²
Construction Date: 10-28-2010 **Skew:** 0° **Span 1:** 0.196 m/m²
Crack Survey Date: 6-3-2013 **Number of Spans:** 2 **Span 2:** 0.225 m/m²
Number of Placements: 1

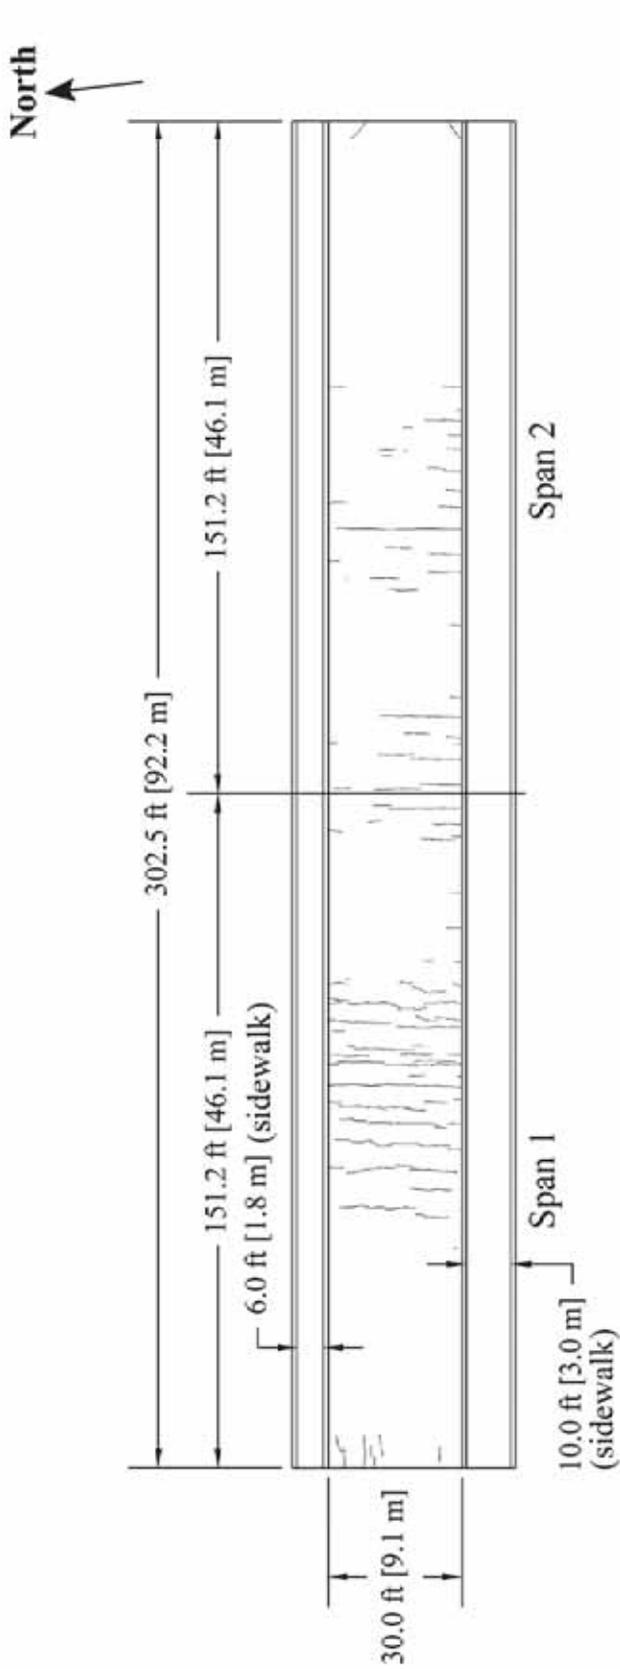
Figure 92: LC-HPC-17 (Survey 1)

The results of Surveys 1 and 2 of LC-HPC-17, at 8.94 and 20.5 months, are included in this report. The crack density was 0.226 m/m² at 8.94 months (Figure 92), and increased to 0.240 m/m² at 20.5 months (Figure 93). The sidewalks on LC-HPC-17 were not surveyed because the concrete was stamped and colored, making it difficult to discern cracks. Similar to LC-HPC-15 and LC-HPC-16, there are transverse cracks near the pier and centers of the spans. There is also a small amount of longitudinal cracking at the west abutment. Figure 94 shows cracking on LC-HPC-17 over time.

Bridge Number: 46-373 (LC-HPC-17) **Bridge Length:** 302.5 ft (92.2 m) **Bridge Age:** 8.94 months
Bridge Location: Clear Creek **Bridge Width:** 48.0 ft (14.6 m) **Crack Density:** 0.226 m/m²
Parkway over K-7 **Skew:** 0° **Span 1:** 0.302 m/m²
Construction Date: 09-28-11 **Number of Spans:** 2 **Span 2:** 0.145 m/m²
Crack Survey Date: 6-26-2012 **Span 1:** 151.25 ft (46.1 m) **Number of Placements:** 1
Span 2: 151.25 ft (46.1 m)

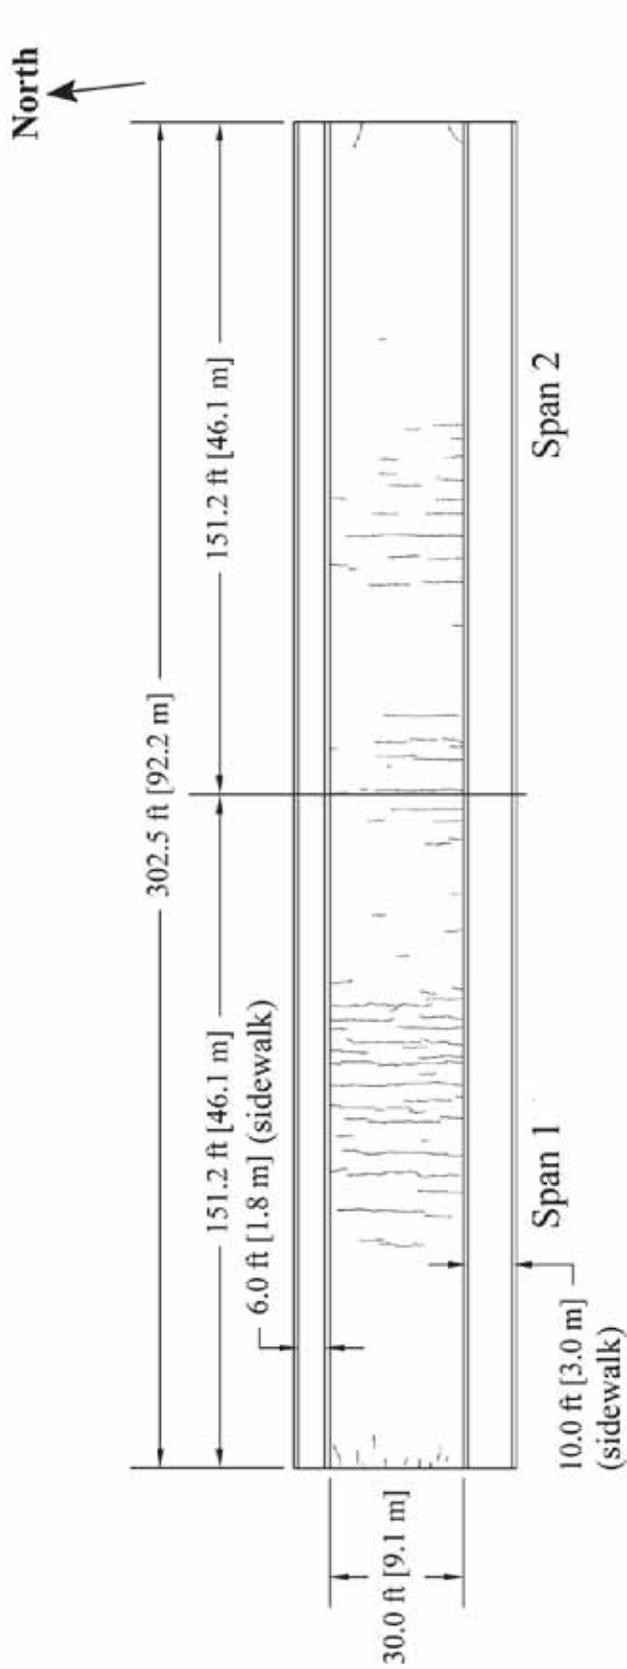
Figure 93: LC-HPC-17 (Survey 2)

Bridge Number: 46-373 (LC-HPC-17)
Bridge Location: Clear Creek Parkway over K-7
Construction Date: 09-28-11
Crack Survey Date: 6-14-2013

Bridge Age: 20.5 months
Crack Density: 0.240 m/m²
Span 1: 0.314 m/m²
Span 2: 0.157 m/m²

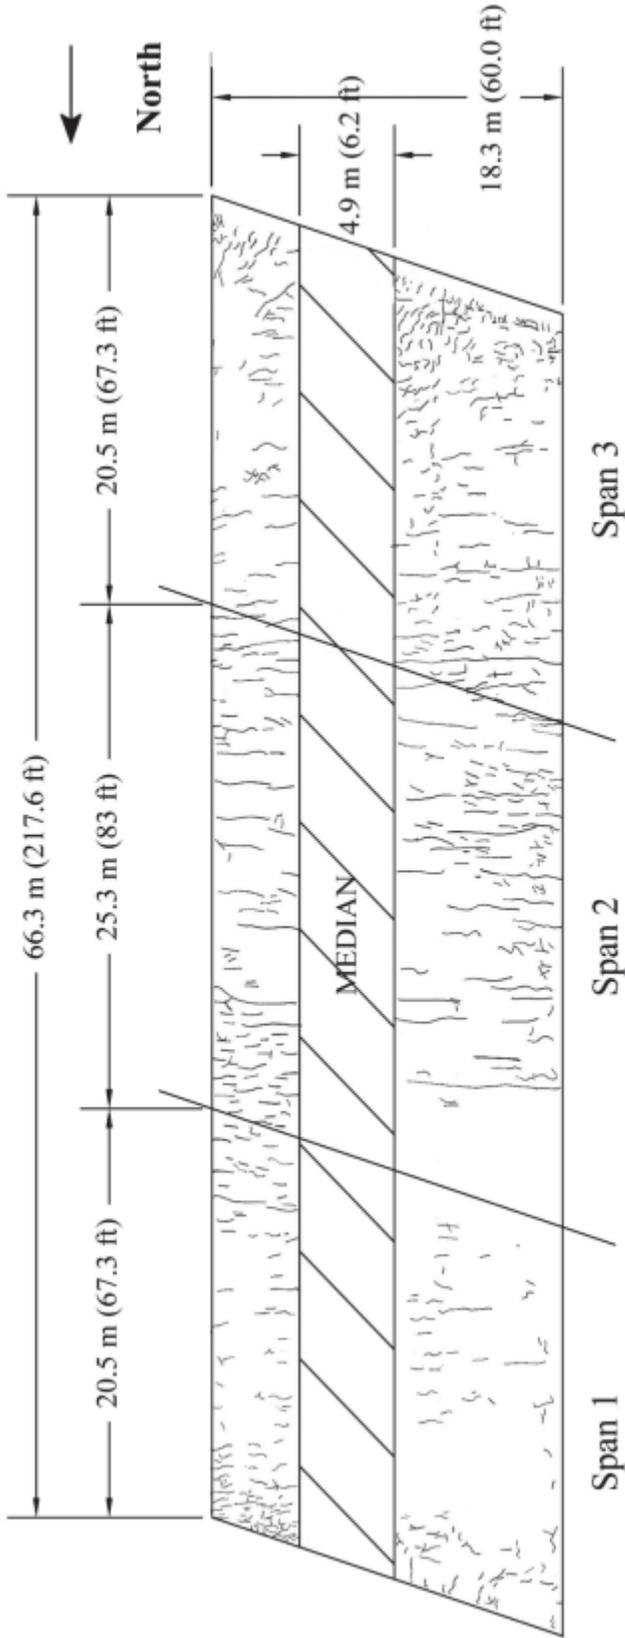
Figure 95: OP Bridge – Placement 1 (Survey 3)

The results of Surveys 3 and 4 of OP Bridge – Placement 1, at 42.2 and 66.6 months, are included in this report. The contractor did not follow and the owner did not enforce many of the key LC-HPC specifications (McLeod et al. 2009), causing the OP Bridge deck to have a much higher crack density than any of other decks bid under an LC-HPC specification. Placement 1 was constructed on two separate dates due to a concrete pumping problem. Thirty feet of concrete was placed before construction was halted because concrete was clogging the pump. This portion of the deck was removed and the entire deck, with the exception of the abutment, was placed on the second attempt. Some of the concrete used in the second attempt had a slump greater than 5 in. Consolidation of the concrete was inadequate, with coarse aggregate visible at the surface after removal of the vibrators. The vibrators were also removed too quickly, leaving holes in the concrete at the locations where the vibrators had been inserted. The contractor spent

a considerable amount of time bullfloating, bringing excess cement paste to the surface and leaving the concrete overfinished in many locations (Lindquist et al. 2008 and McLeod et al. 2009). The elapsed time between deck finishing and burlap placement exceeded the ten-minute limit throughout construction, mainly due to the overfinishing. The contractor used water from the fogging equipment as a finishing agent (McLeod et al. 2009). The crack density of OP Bridge – Placement 1 was 0.585 m/m^2 at 42.2 months (Figure 95), a slight increase from 0.502 m/m^2 at 30.0 months (Pendergrass et al. 2011). The crack density of OP Bridge – Placement 1 at 66.6 months more than doubled to 1.083 m/m^2 (Figure 96).

Bridge Number: 46-363 (OP Bridge - Placement 1)
Bridge Location: Metcalf Ave over Indian Creek, OP, Kansas
Construction Date: 12/19/2007
Crack Survey Date: 6/24/2011

Bridge Age: 42.2 months
Crack Density: 0.585 m/m²
Span 1: 0.410 m/m²
Span 2: 0.621 m/m²
Span 3: 0.718 m/m²

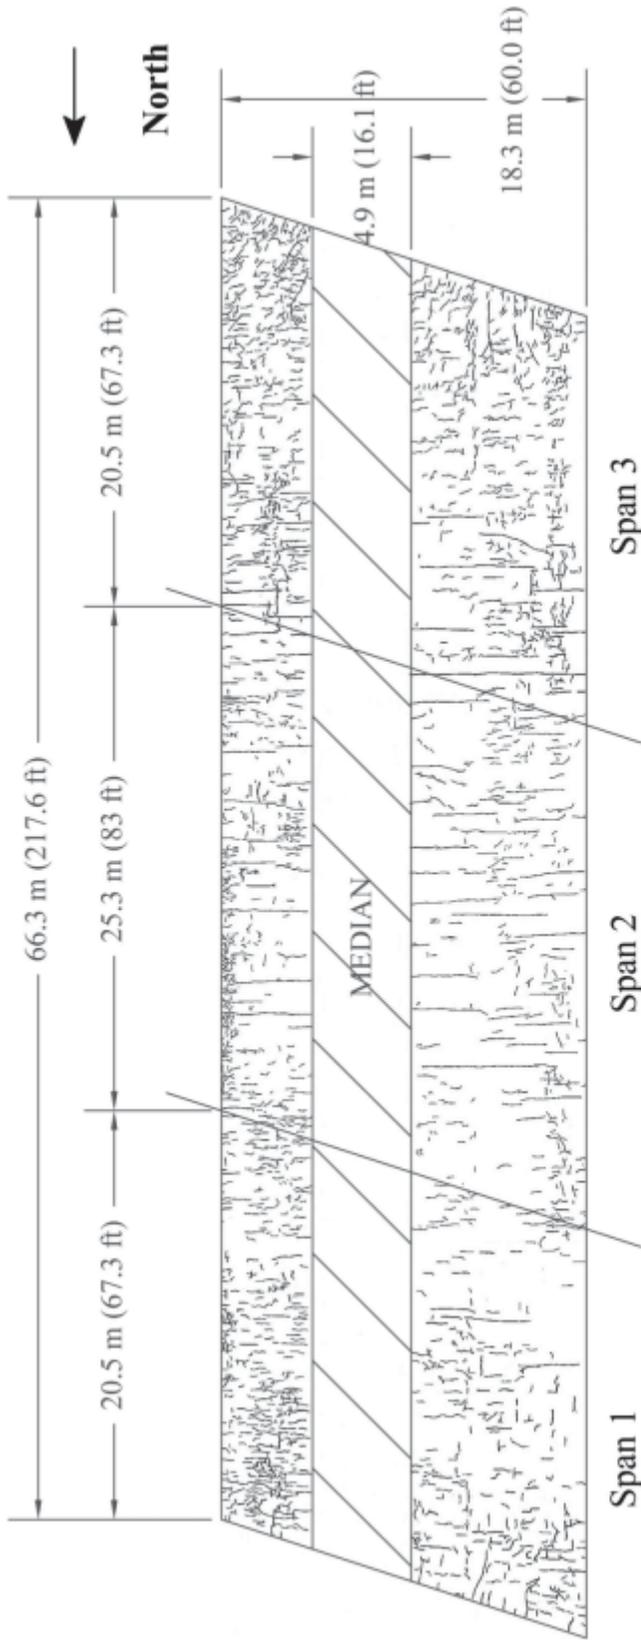
Figure 96: OP Bridge – Placement 1 (Survey 4)

Bridge Number: 46-363 (OP Bridge - Placement 1)
Bridge Location: Metcalf Ave over Indian Creek, OP, Kansas
Construction Date: 12/19/2007
Crack Survey Date: 7/8/2013

Bridge Age: 66.6 months
Crack Density: 1.083 m/m²
Span 1: 1.040 m/m²
Span 2: 0.903 m/m²
Span 3: 0.985 m/m²

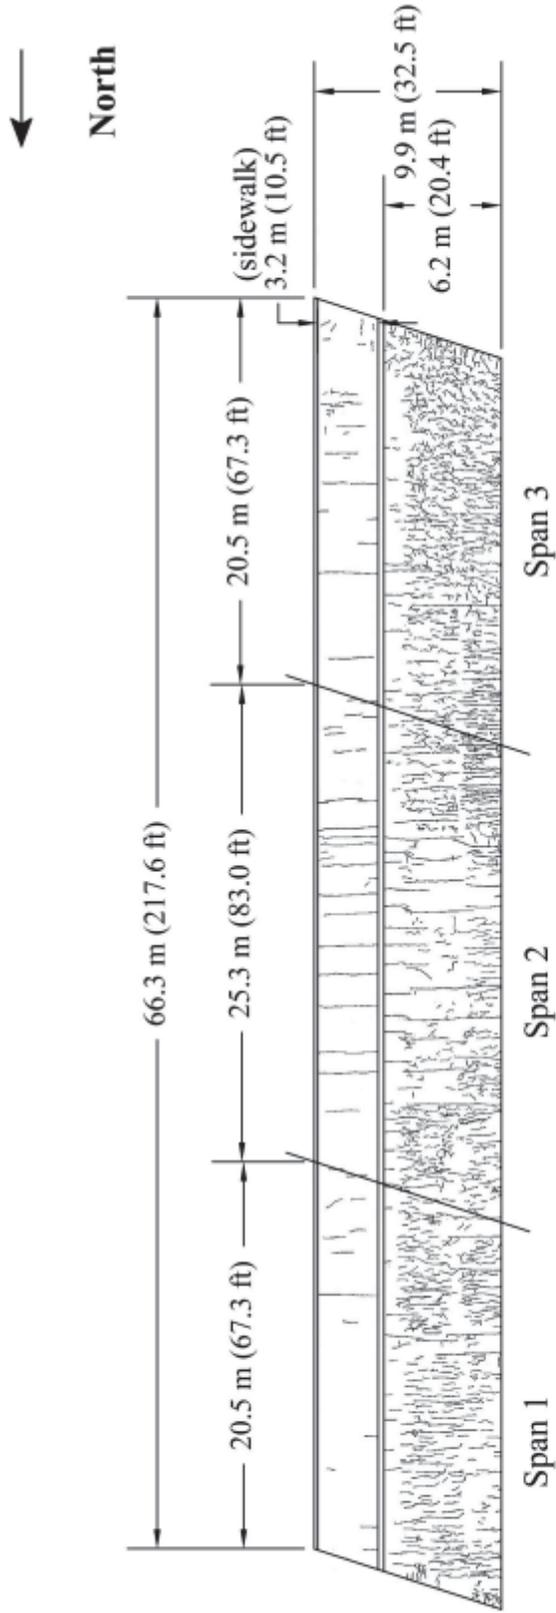
Figure 100: OP Bridge – Placement 3 (Survey 4)

The results of Surveys 3 and 4 of OP Bridge – Placement 3, at 37.1 and 61.6 months, are included in this report. Placement 3 had similar problems during construction as Placements 1 and 2, causing higher crack densities than the LC-HPC decks. The concrete used had very high slumps and high air contents. Additionally, it was observed that the reinforcement was not strongly supported, causing it to spring up and possibly increase the amount of settlement cracking. As with Placement 2, a double-drum roller was used for finishing. The time between finishing and burlap placement exceeded 10 minutes over most of the deck (Gruman et al. 2009). For Survey 3, the crack density was 0.678 m/m^2 at 37.1 months (Figure 99), less than the crack density at 24.9 months of 0.871 m/m^2 (Pendergrass et al. 2011). Many of the cracks in Placement 3 are small and may have been overlooked in Survey 3, leading to the lower crack density. The crack density more than doubled to 1.387 m/m^2 at 61.6 months (Figure 100). Transverse cracks have formed along the length of the deck, but the majority of cracks are very small. There are also short cracks extending from the eastern edge of the placement, and longitudinal cracks have formed at both abutments. Similar to Placement 2, the sidewalk of Placement 3 has experienced less cracking than the remainder of the placement. Figure 101 compares cracking for the three OP Bridge placements over time. It is evident that all three placements have experienced high crack growth, which can be attributed to the lack of adherence to the LC-HPC specifications

Bridge Number: 46-363 (OP Bridge - Placement 3)	Bridge Length: 66.3 m (217.6 ft)	Bridge Age: 61.6 months
Bridge Location: Metcalf Ave over Indian Creek, OP, Kansas	Bridge Width: 9.9 m (32.5 ft)	Crack Density: 1.387 m/m ²
Construction Date: 5/21/2008	Skew: -18°	Span 1: 1.248 m/m ²
Crack Survey Date: 7/8/2013	Number of Spans: 3	Span 2: 1.369m/m ²
	Span 1: 20.5 m (67.3 ft)	Span 3: 1.555 m/m ²
	Span 2: 25.3 m (83.0 ft)	
	Span 3: 20.5 m (67.3 ft)	
	Number of Placements: 1

during construction. While Placement 3 experienced an apparent decline in crack density between ages 24 and 38 months, it now has the highest crack density of the three placements.

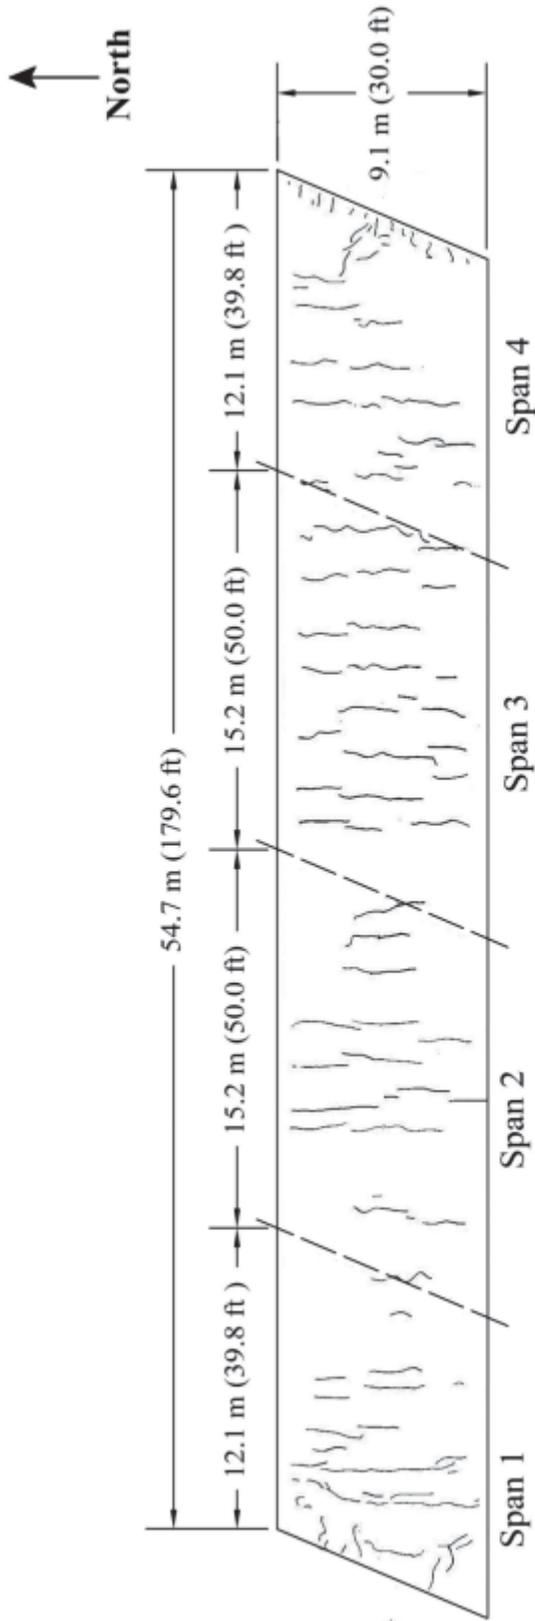
Figure 102: Control-Alt (Survey 6)

Control-Alt, located in Emporia, KS, was chosen as an additional control deck because it is a monolithic deck. All LC-HPC decks in the project are also monolithic, and all of the other control decks except for Control-8/10 have a silica fume overlay. The results of Surveys 6, 7, and 8 of Control-Alt at 72.6, 85.0, and 96.0 months, are included in this report. The crack density of Control-Alt at 72.6 months was 0.358 m/m² (Figure 102), representing an increase from the value of 0.316 m/m² measured in Survey 5 (Pendergrass et al. 2011). The density increased to 0.395 m/m² at 85.0 months (Figure 103), then decreased to 0.304 m/m² at 96.0 months (Figure 104). The cracks are mainly transverse and are evenly distributed along the length of the bridge

Bridge Number: 56-49 (Control-Alt)
Bridge Location: K-99 over I-335
Construction Date: 6/2/2005
Crack survey Date: 6/23/2011

Bridge Age: 72.6 months
Crack density: 0.358 m/m²
Span 1: 0.417 m/m²
Span 2: 0.309 m/m²
Span 3: 0.367 m/m²
Span 4: 0.346 m/m²

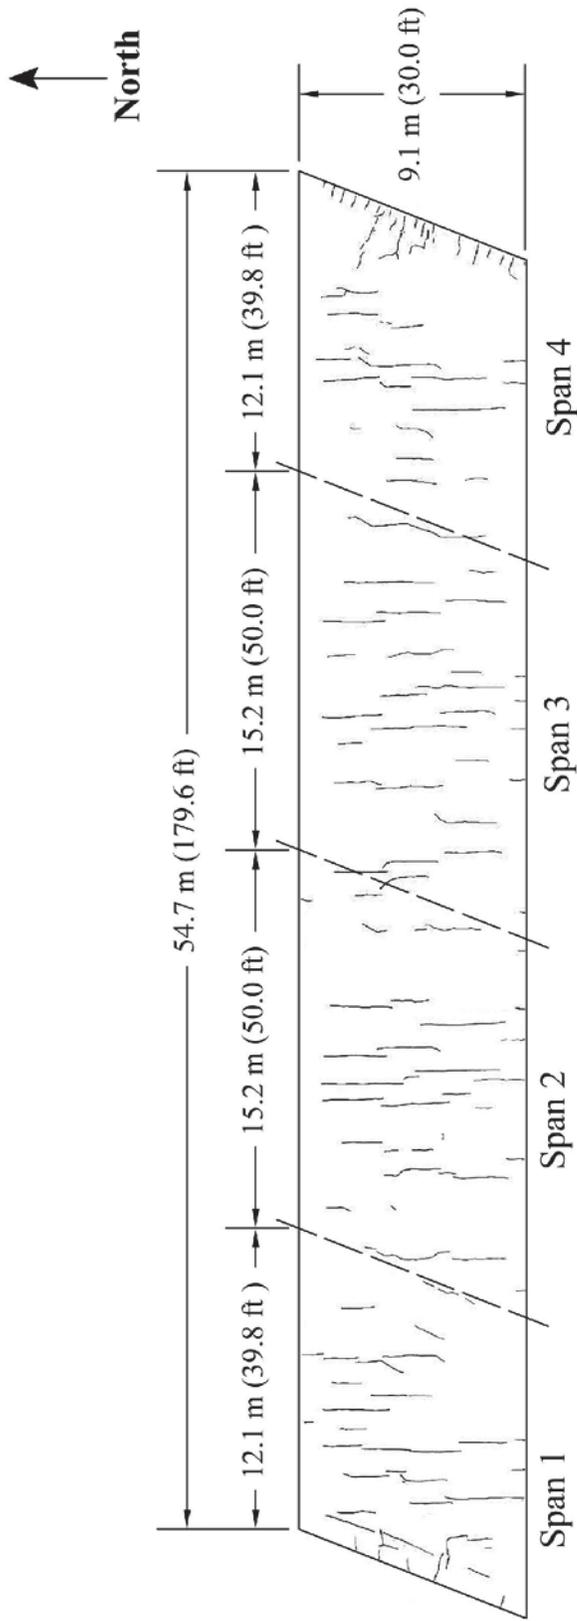
Figure 103: Control-Alt (Survey 7)

Bridge Number: 56-49 (Control-Alt)
Bridge Location: K-99 over I-335
Construction Date: 6/2/2005
Crack survey Date: 7/3/2012

Bridge Age: 85.0 months
Crack density: 0.395 m/m²
Span 1: 0.443 m/m²
Span 2: 0.365 m/m²
Span 3: 0.382 m/m²
Span 4: 0.389 m/m²

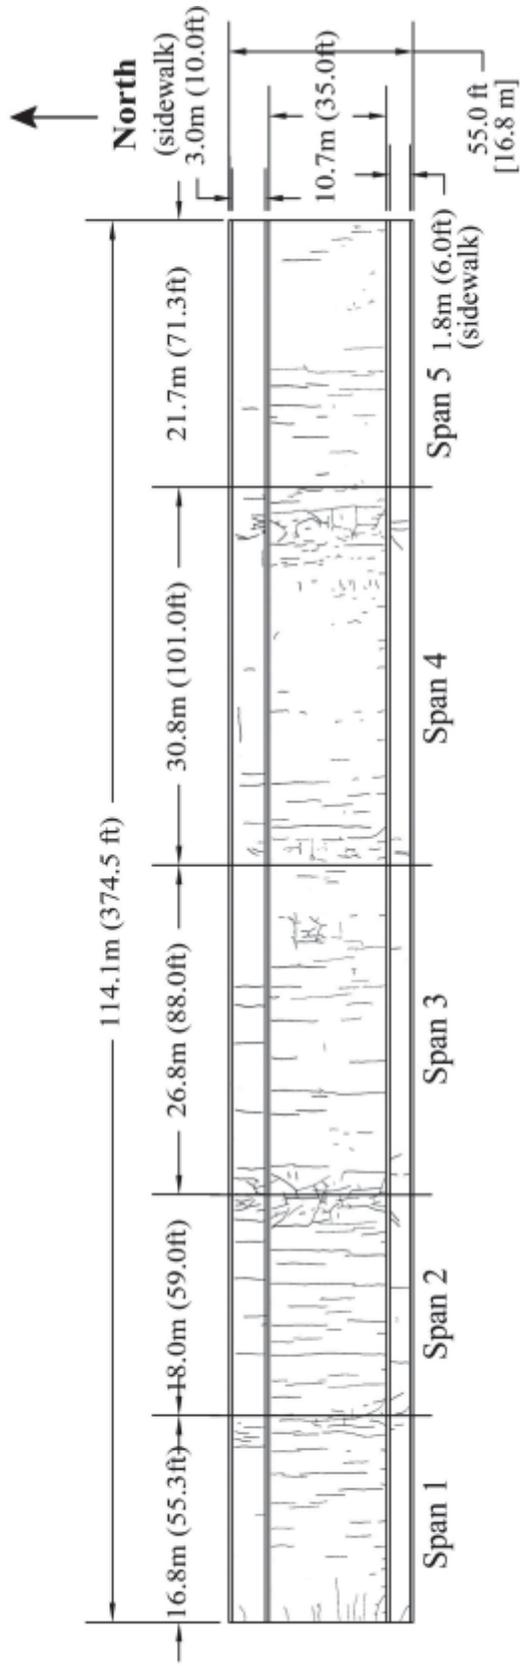
Figure 106: OP-Extra (Survey 3)

OP-Extra is a precast, prestressed concrete girder control bridge in Overland Park, KS constructed by the same contractor as the OP Bridge. The deck is monolithic. The results of Surveys 3, 4, and 5 of OP-Extra at 35.0, 46.7, and 59.2 months, are included in this report. The crack density was 0.344 m/m² at 35.0 months (Figure 106), representing an increase from the crack density measured in Survey 2, 0.302 m/m² (Pendergrass et al. 2011). At 35.0 months, the crack density of OP-Extra was slightly less than that of LC-HPC-8, another precast, prestressed concrete girder bridge, at a similar age. It was much greater than the density of LC-HPC-10 and Control-8/10,

Bridge Number: Overland Park extra
Bridge Location: 132nd street over US 69, OP, KS
Construction Date: 6/30/2008
Crack Survey Date: 5/27/2011 and 6/3/2011

Bridge Age: 35.0 months
Crack Density: 0.344 m/m²
Span 1: 0.381 m/m²
Span 2: 0.551 m/m²
Span 3: 0.308 m/m²
Span 4: 0.324 m/m²
Span 5: 0.169 m/m²

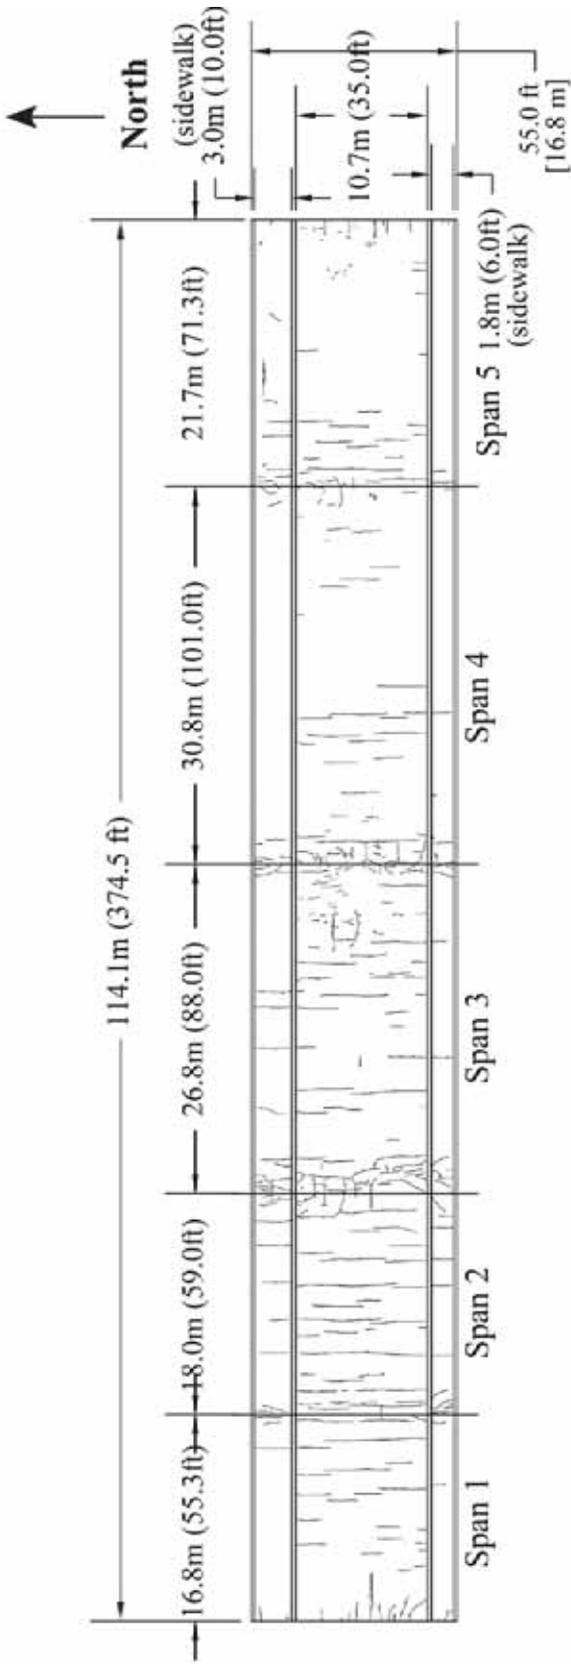
Figure 107: OP-Extra (Survey 4)

also precast, prestressed concrete girder bridges. The crack density was again 0.344 m/m^2 at 46.7 months (Figure 107), slightly higher than the crack density of Control-8/10 at a similar age (0.326 m/m^2), and remained lower than the density of LC-HPC-8 and higher than the density of LC-HPC-10 at similar ages (0.380 and 0.088 m/m^2). The crack density decreased to 0.300 m/m^2 at 59.2 months (Figure 108), less than the crack densities of Control-8/10 and LC-HPC-8 (0.425 and 0.383 m/m^2), but still greater than the crack density of LC-HPC-10 (0.125 m/m^2) at similar ages. OP-Extra has transverse cracking over nearly the entire deck, as well as longitudinal cracking above the piers and the west abutment. Figure 109 compares cracking on OP-Extra with cracking on LC-HPC-8, LC-HPC-10, and Control-8/10 over time. The deck has experienced relatively stable cracking, falling between 0.20 and 0.40 m/m^2 throughout its life. At about 60 months, cracking on LC-HPC-8 and Control-8/10 is very similar to that on OP-Extra, although the crack density on Control-8/10 is increasing rapidly. Cracking on LC-HPC-10 is consistently lower than that on OP-Extra.

Bridge Number: Overland Park extra
Bridge Location: 132nd street over
 US 69, OP,KS
Construction Date: 6/30/2008
Crack Survey Date: 5/22/2012

Bridge Age: 46.7 months
Crack Density: 0.344 m/m²
 Span 1: 0.318 m/m²
 Span 2: 0.531 m/m²
 Span 3: 0.429 m/m²
 Span 4: 0.215 m/m²
 Span 5: 0.227 m/m²

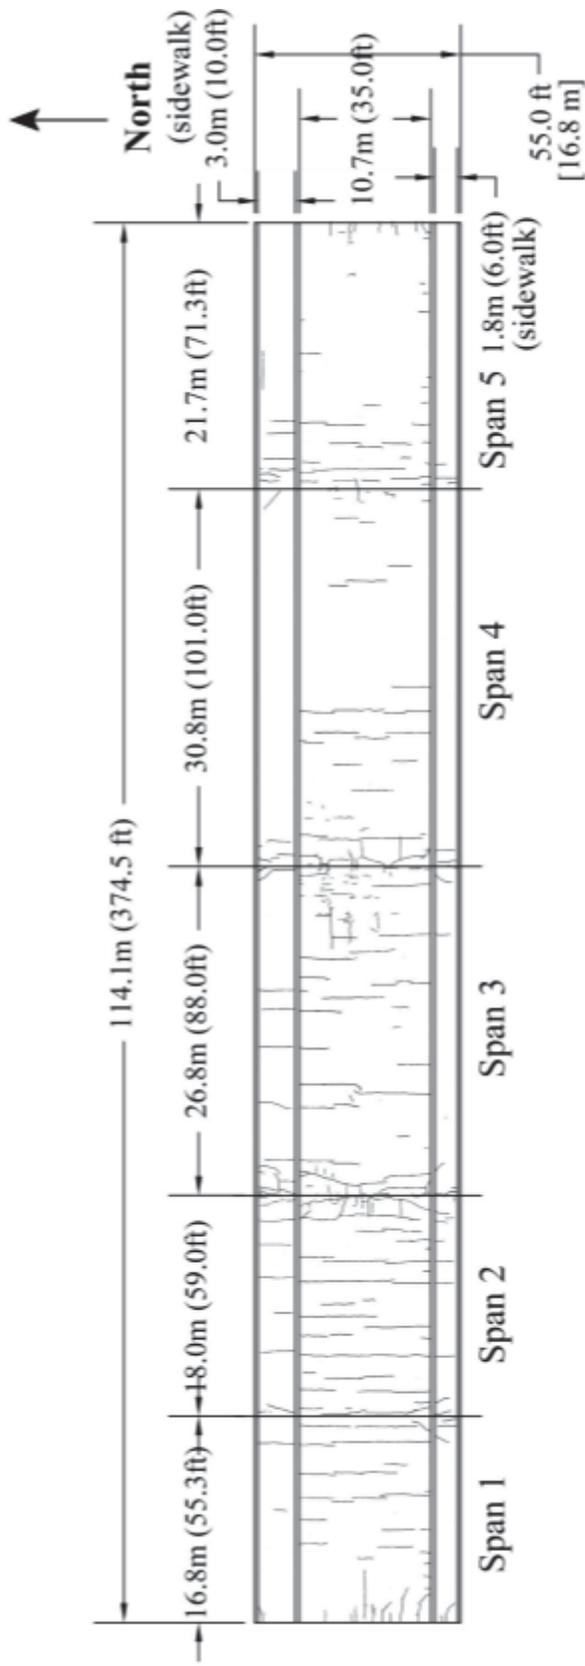
Figure 108: OP-Extra (Survey 5)

Bridge Number: Overland Park extra
Bridge Location: 132nd street over
 US 69, OP,KS
Construction Date: 6/30/2008
Crack Survey Date: 6/06/2013

Bridge Age: 59.2 months
Crack Density: 0.3 m/m²
 Span 1: 0.299 m/m²
 Span 2: 0.498 m/m²
 Span 3: 0.331 m/m²
 Span 4: 0.178 m/m²
 Span 5: 0.197 m/m²
