Underwater Inspection of Bridge Substructures Using Imaging Technology

June 14, 2018

Sponsored by
Federal Highway Administration
Office of Infrastructure
FHWA-HIF-18-049

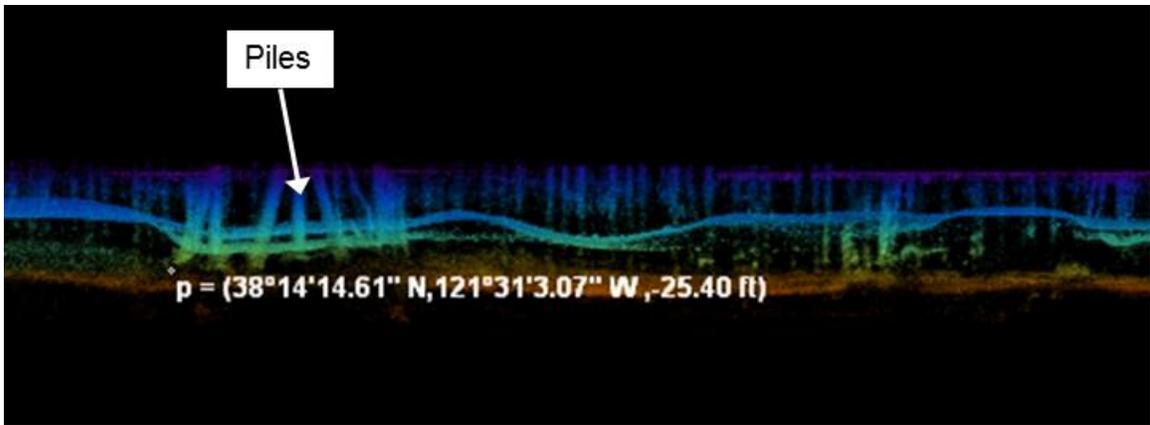
Figure 26. Image. Piles from back side of the fender (Georgiana Slough).

Using a real-time multibeam sonar, inspection team A collected data in the field that produced images that captured general pile features. The images in figure 26 and figure 27 reveal the piles supporting the fender in profile and plan view, respectively. In the profile view, it is evident that several piles are not aligned vertically. In the plan view, the curved alignment of the set of piles is clearly seen.

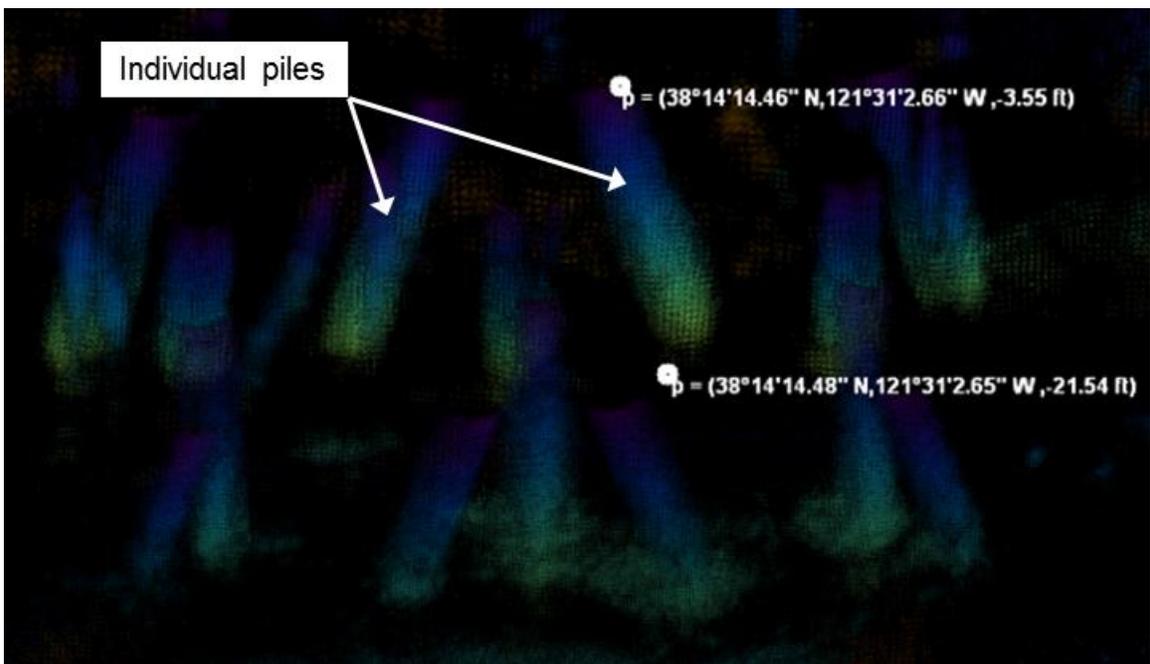
Figure 28. Image. Coordinates from which length of a pile is estimated (Georgiana Slough).

Figure 28 displays a close-up of several piles. With the x,y,z capability, it is possible to estimate feature dimensions such as object length.

Figure 28 shows how the size of debris can be obtained such as for the pile-like objects shown in the figure. This assessment can be conducted by a bridge engineer with a small amount of training on the system and software. The precision of dimensional estimates can be affected by a number of factors, but the approach offers a quick assessment of the bridge structure, as well as a complete image of a potential diving site that can be used to guide a subsequent dive to critical locations quickly and safely.

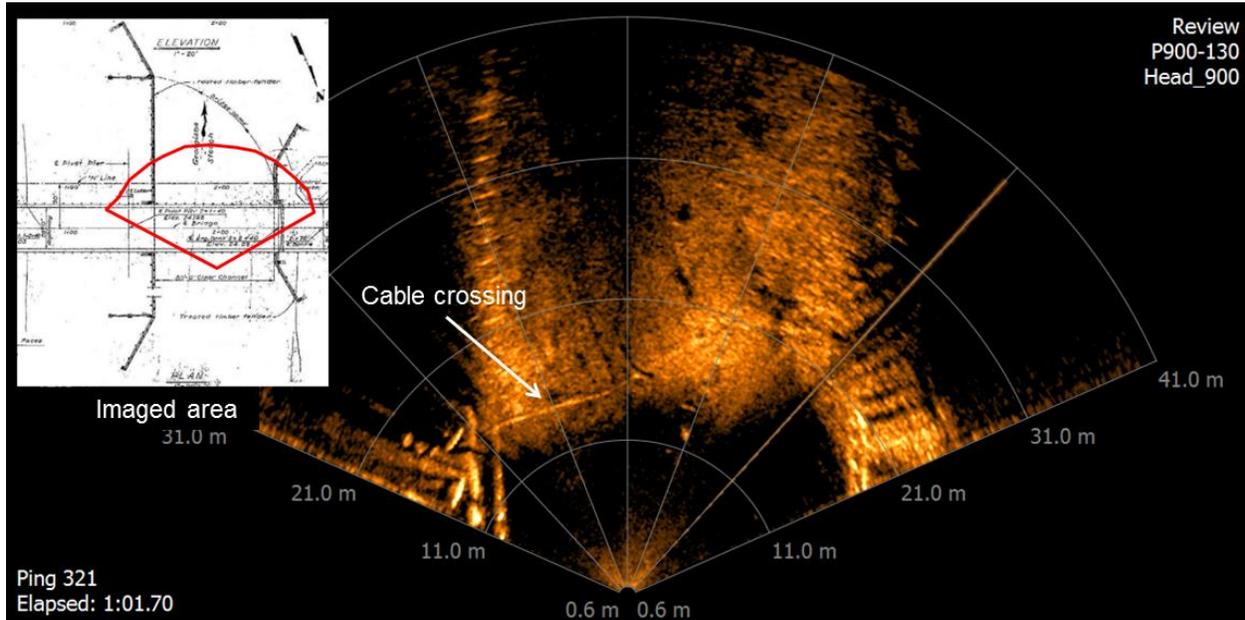
Figure 29. Image. 2D image from a single ping at Georgiana Slough (plan view).

Inspection team B employed two sonar technologies for the inspection of the Georgiana Slough Bridge. Figure 29 shows an example image from a 2D multibeam sonar along with the inset providing the location of the image at the site. The image resulted from a single ping and was captured from boat-mounted equipment. The piles on either side of the channel are evident as is a cable crossing the channel.

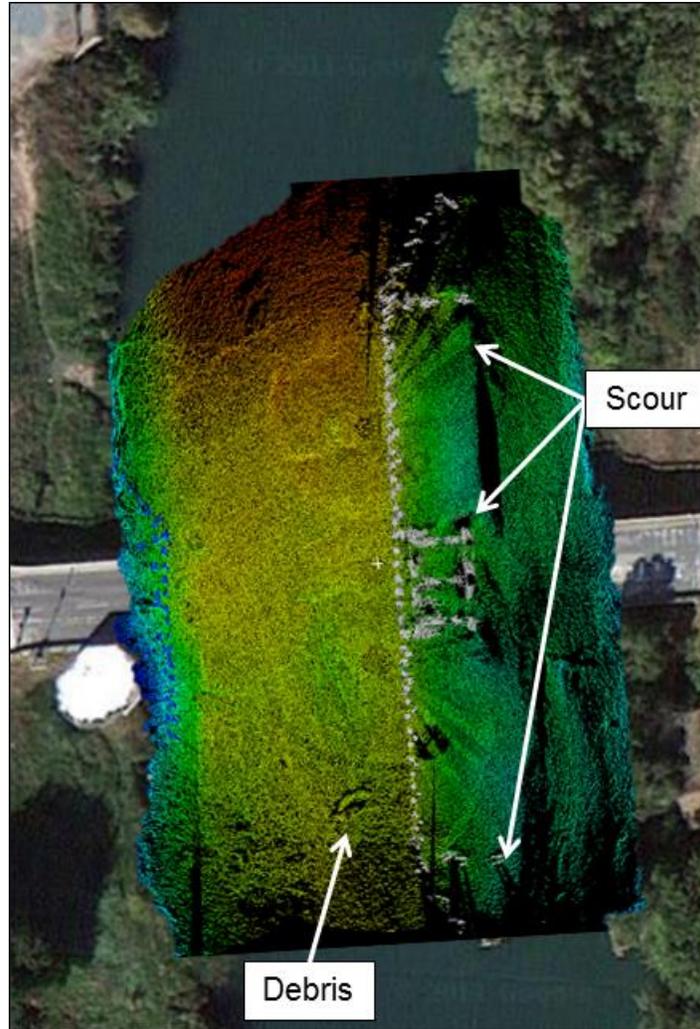
Figure 32. Image. Indications of scouring from 3D image (Georgiana Slough).

Figure 32 provides a sonar image overlain on an aerial photo that highlights darker areas indicative of minor scour around the structures. The image also shows moderate levels of debris, including tree limbs and tires, but no visible damage to the substructure.

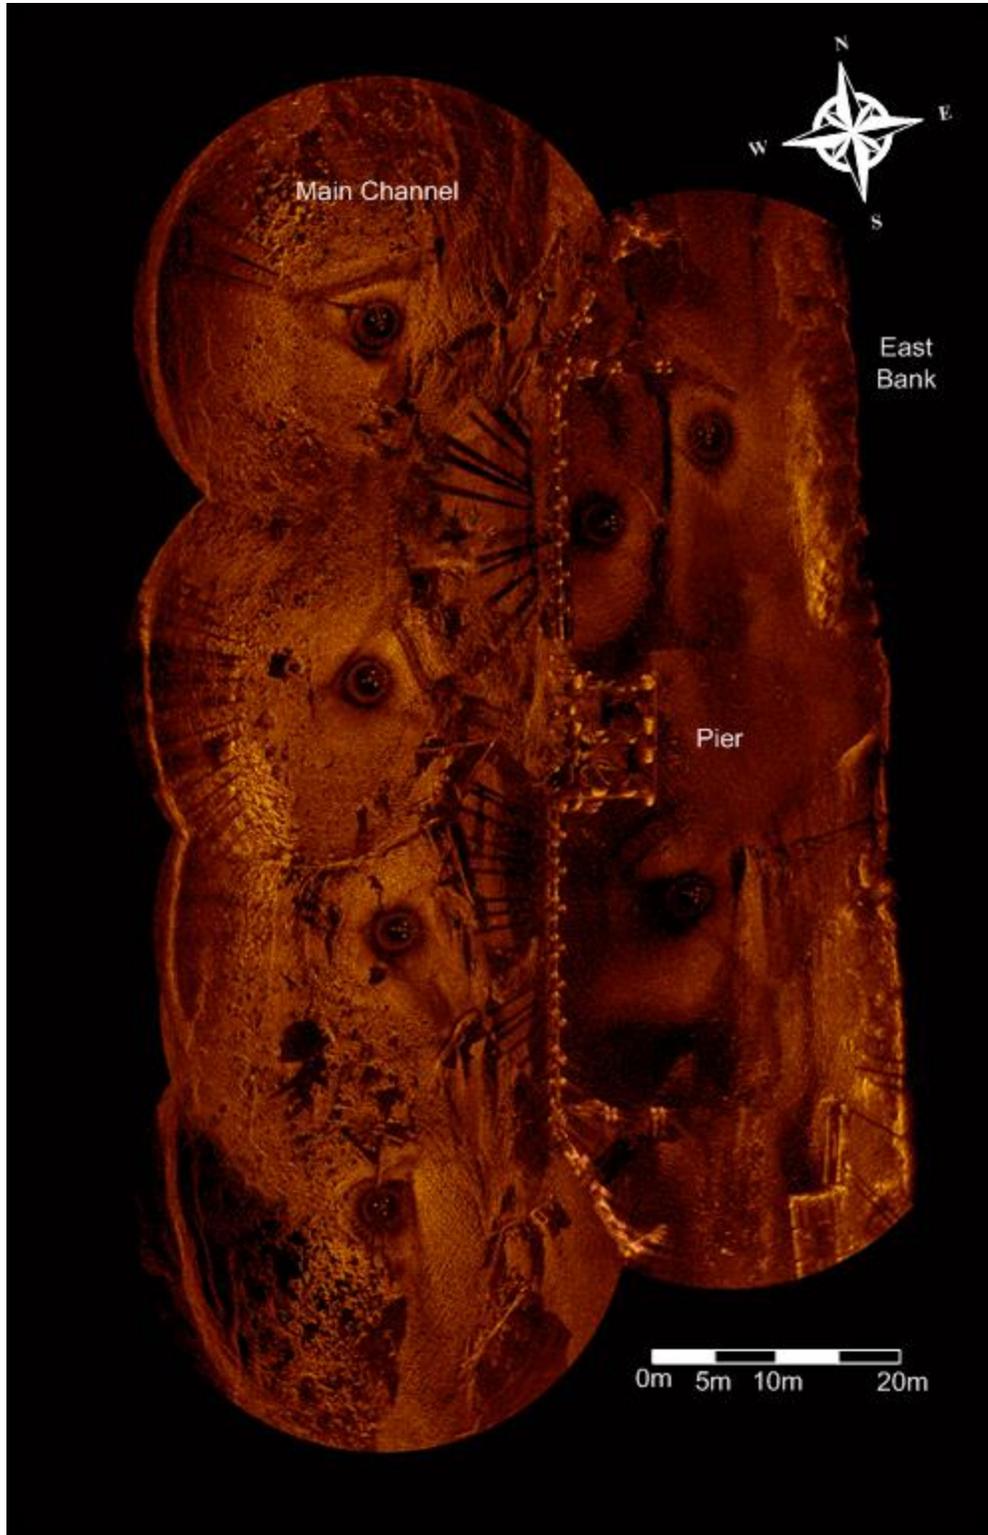
Figure 34. Image. Mosaic of bottom drop images.

Inspection team C used 2D sector-scanning sonar and 3D profiler sonar to collect riverbed and vertical visualization scans of the underwater portion of pier 2 of the Georgiana Slough Bridge. Bottom scans, taken with the sonar head fitted onto a tripod, were collected adjacent to the structure. The bottom scan locations are shown in figure 33 with a resulting mosaic of the drop images shown in figure 34. The bridge pier, piling, bathymetry, and some debris are visible.

In the main channel the imaging data showed different stratigraphic units comprised of gravel, or possibly, hardpan clays. The imaging also showed the complexity of the generally stable river bottom. A box-shaped target was observed near the fender piles on the main channel downstream side; this target was confirmed by divers to be an old refrigerator. There are several angular targets in the main channel; their angularity and out of character nature to the natural bottom suggest they are human debris.

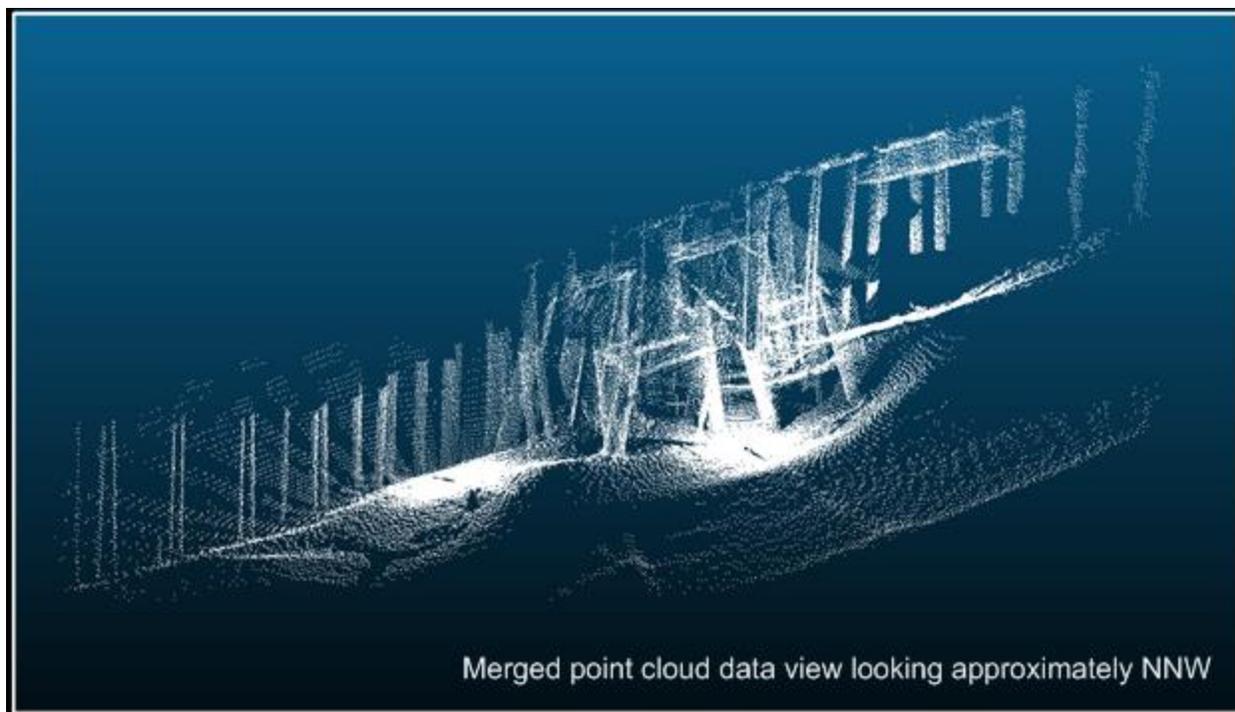
Figure 35. Image. Merged point cloud data at Georgiana Slough Bridge.

After completing the bottom drops, the head was horizontally mounted on a pole and positioned three feet below the surface to vertically scan the fender wall. The data collected from the bottom drops and vertical scans were merged to create 3D representations as shown in figure 35.

The inspection team observed in both the imaging and profiling datasets that although the fender system is there to protect the structure from vessel traffic, it appears to have caused localized scour on the upstream side of the pier. This local scour has induced sediment degradation on the upstream nose and aggregation on the downstream side of the structure. The fender system

appears to be structurally sound with no breaks or splits in the piles. Debris build up was noted on the upstream dogleg. The team reported that the vertical and batter pipe piles appeared to be structurally sound with no visible impact damage or structural deterioration.

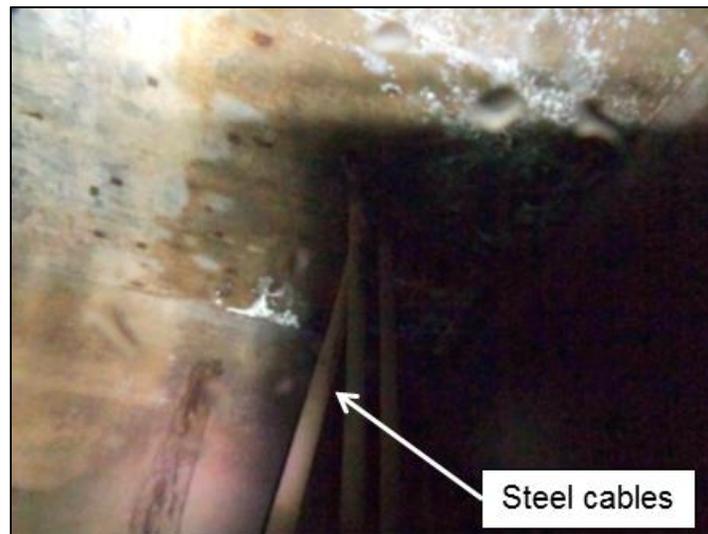
Figure 37. Photo. Above water view of steel cables.

- Three 4-inch (100 mm) diameter steel cables were observed extending vertically from the northwest quadrant of the south bay to the channel bottom as shown in figure 37.

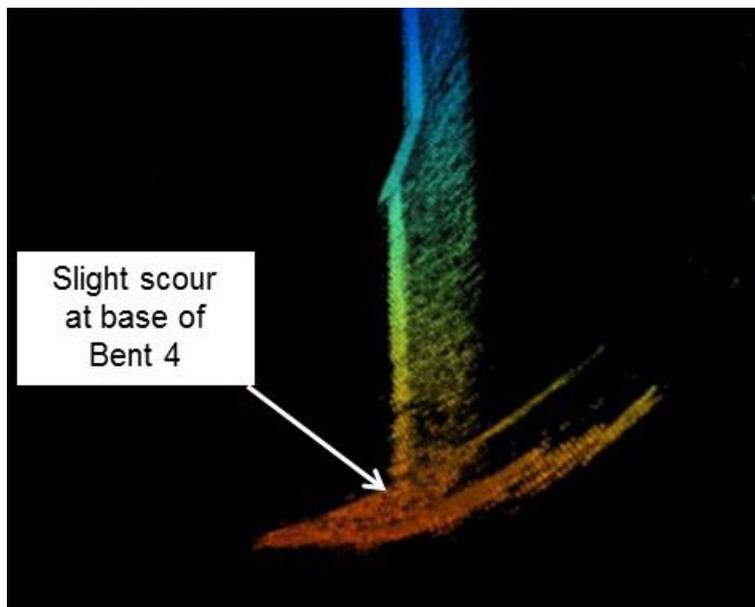
Figure 42. Image. Bent 4 mud line side image.

Figure 40 shows the image of bent 4 captured by the sonar. A symbol representing the data collection boat is also shown to illustrate the range required of the sonar at this site. Figure 41 is a data mosaic showing bents 4 and 5 as viewed from the west side of the bridge. The annotations on the figure demonstrate how structure dimensions can be obtained from the image. Close analysis of the images may reveal reportable observations. For example, a closer view of the base of bent 4 shown in figure 42 provides an indication of scour at the base of the bent.

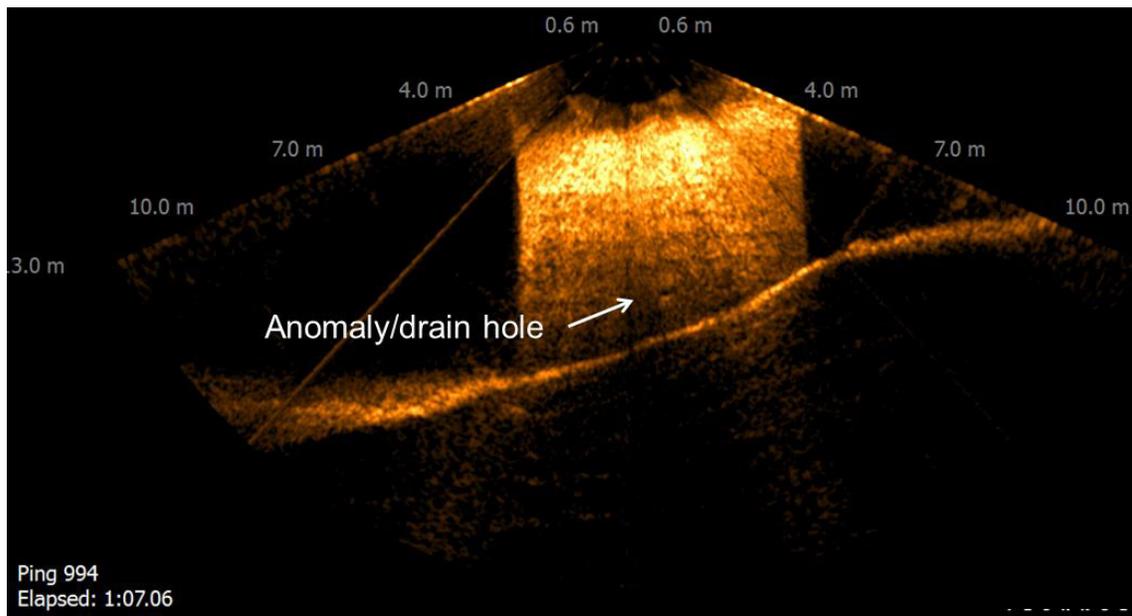
Figure 44. Image. Sonar wing at the bottom of face 3.

Figure 43 displays a plan view of the James E. Roberts Bridge with the naming convention used by inspection team B to label data and images on bent 4. Figure 44 is a sonar wing close-up of the base of face 3 that reveals evidence of an anomaly on the surface.

Overall, the inspection team reported a steep and rocky reservoir bottom at the base of bent 4. Further they observed low scour levels, little debris, and no visible damage to the substructure. They reported that the substructure edges were sharp and the concrete face was smooth.

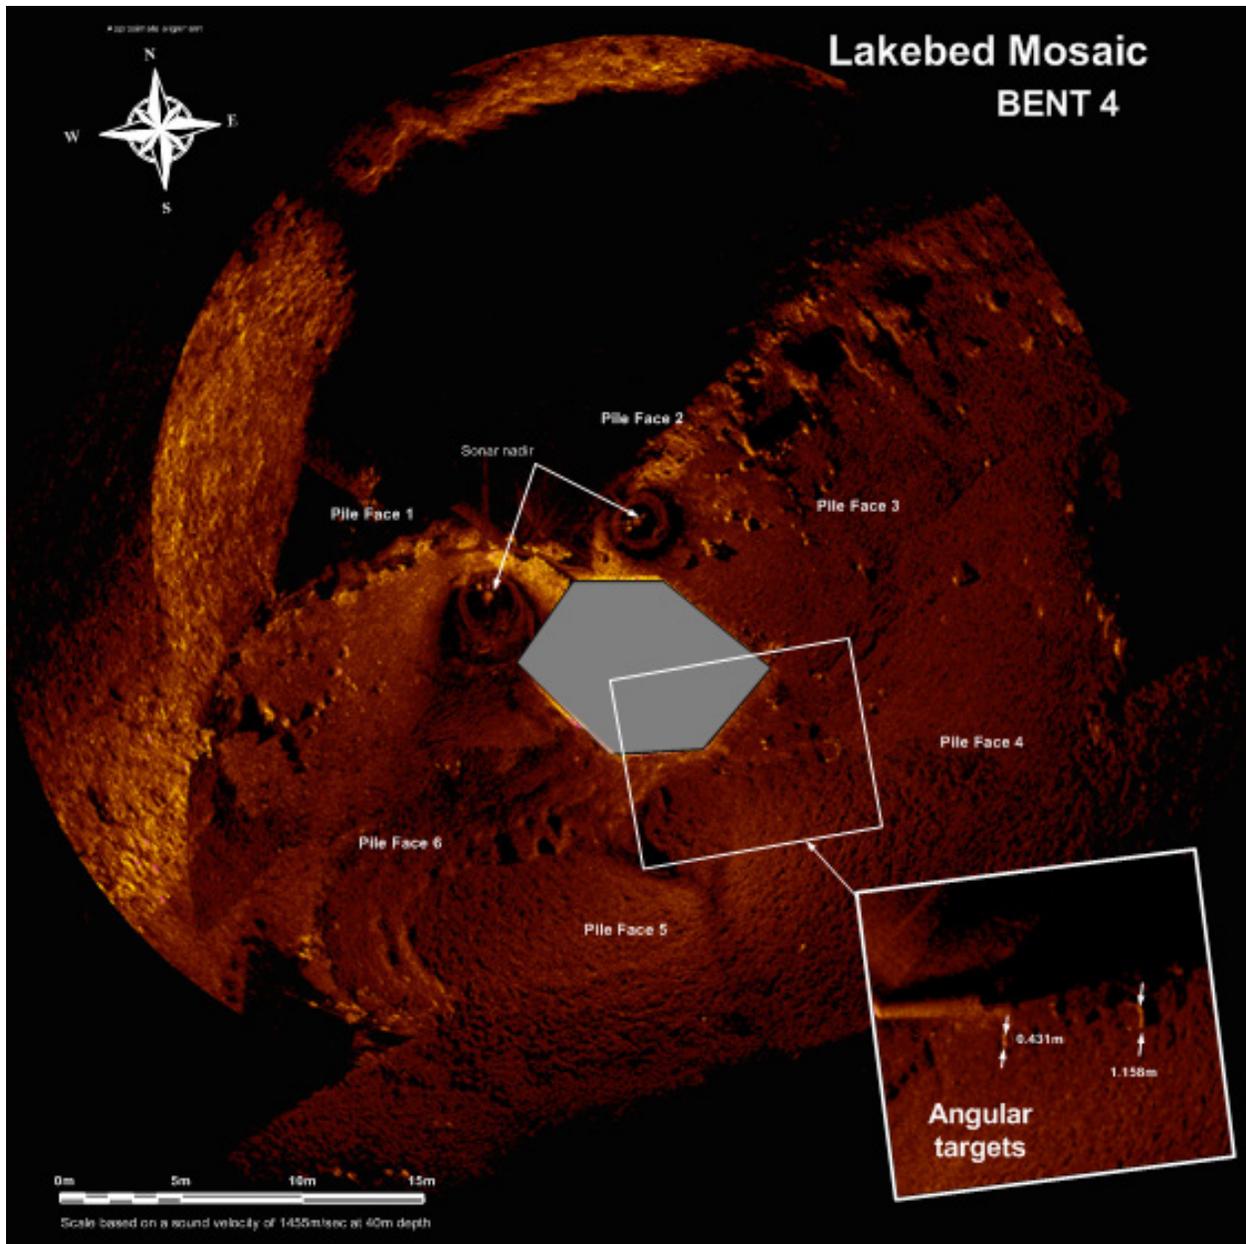
Figure 46. Image. Mosaic bed image of the James E. Roberts Bridge.

A total of six 98 ft (30 m) radius scans were collected. These were combined into a mosaic of the vicinity around bent 4 as shown in figure 46. The bottom shows significant upward elevation change to the northwest of bent 4 (shaded area). This elevation difference has resulted in some acoustic distortion in plotting the shape of the base of bent 4 as the record cannot be slant-range corrected to a single elevation plane without introducing additional range errors. There are a few angular targets situated close to the structure; their shape suggests they are not natural objects. There is no indication of bottom scour adjacent to the structure or of slope instability in this mosaic.

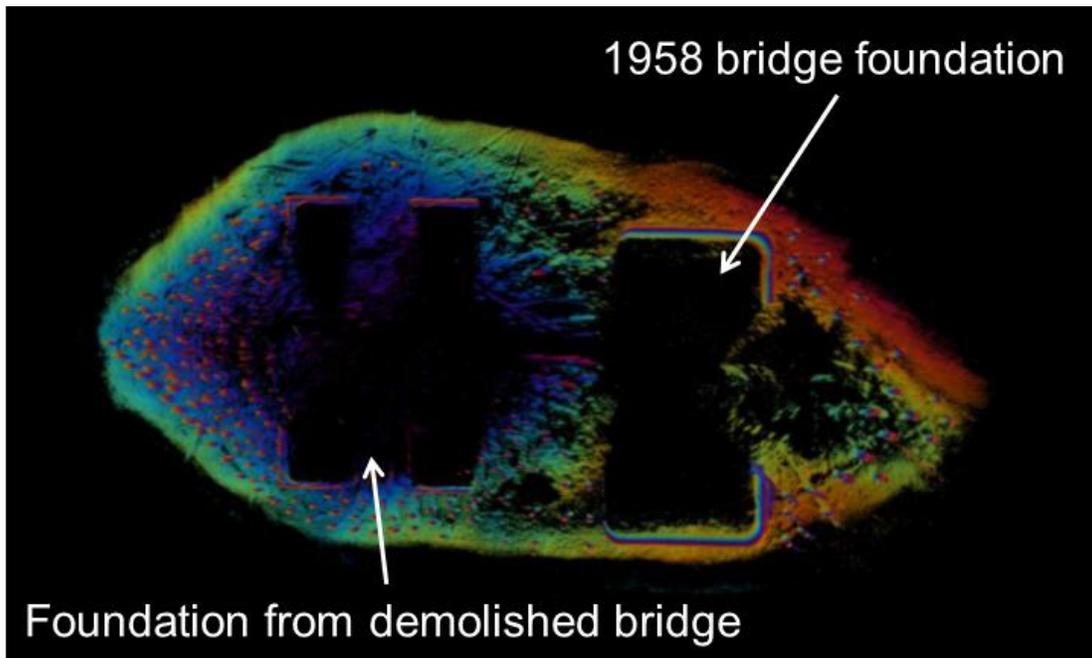
Figure 54. Image. Pier 3 plan view.

Water depth at the pier at the time of the inspection by team A was approximately 75 ft (23 m) on both the north and south sides of the pier. A plan view of the sonar results is shown in figure 54. The foundation for the 1958 bridge is the dark area on the right; the darker area on the left is the remaining foundation from the demolished 1927 bridge. A fender is shown to enclose both foundations. Figure 55 and figure 56 show views from the north and the south, respectively. The partial demolition of the 1927 foundation is clearly visible.

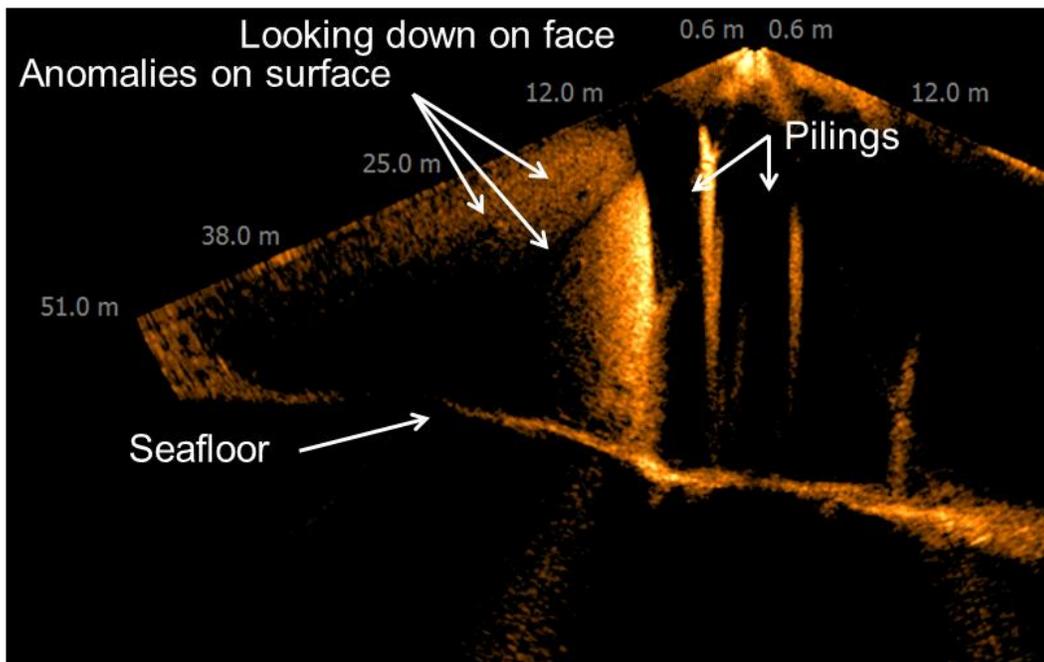
Figure 58. Image. 2D sonar image.

Inspection team C performed a combination of 2D and 3D scanning of the 1958 Carquinez Bridge. Figure 57 displays the areas on the pier foundation subject to inspection. An example of the 2D imaging is shown in figure 58. The reference location for this image is indicated in figure 57. An example of one of the 3D images, that among other features reveals a downed pile, is shown in figure 59.

Overall, the inspection team reported little evidence of scour and moderate to high levels of debris. Several small anomalies were noted on the concrete footings and many downed piles were identified.

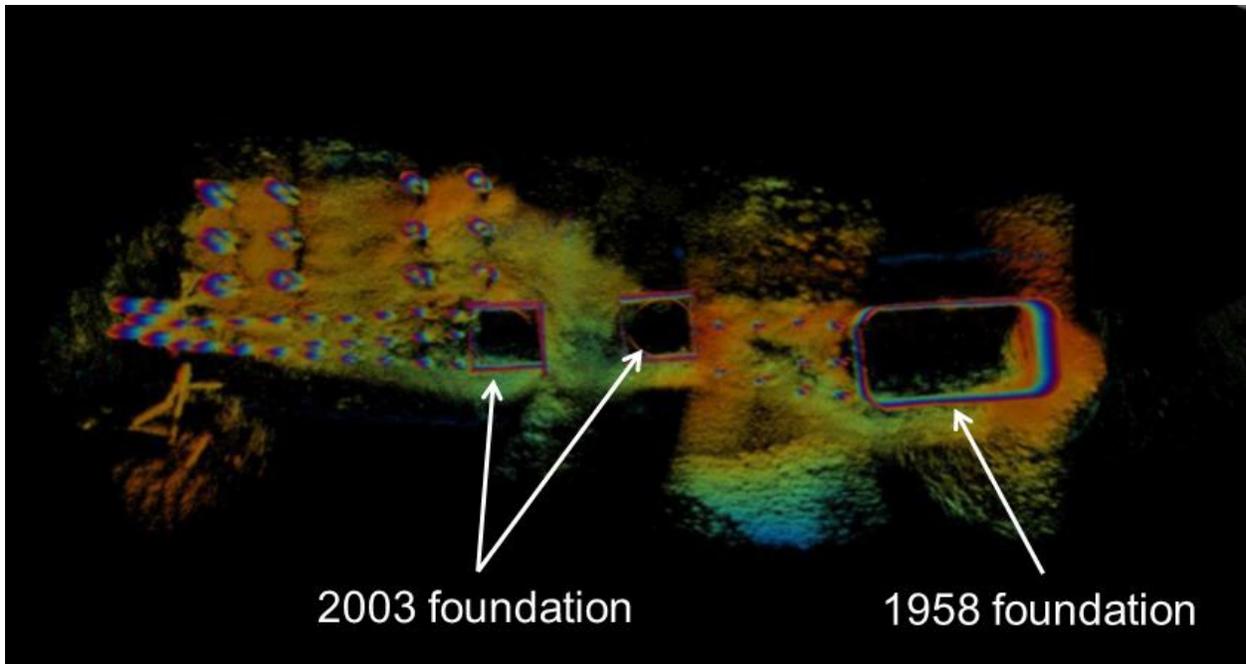
Figure 64. Image. Tower 3 plan view.

Water depth at tower 3 at the time of the inspection by team A was approximately 50 ft (15 m) on the west side and 80 ft (24 m) on the east side. A plan view of the sonar results is shown in figure 64. Figure 65 and figure 66 show views from the north and the south, respectively.

Overall, the inspection team reported little evidence of scour and moderate levels of debris to the west with little debris elsewhere. No indication of structural damage was identified.

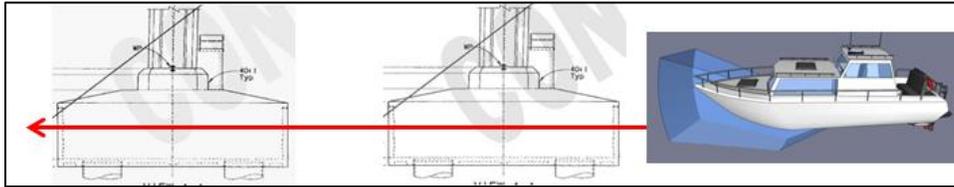
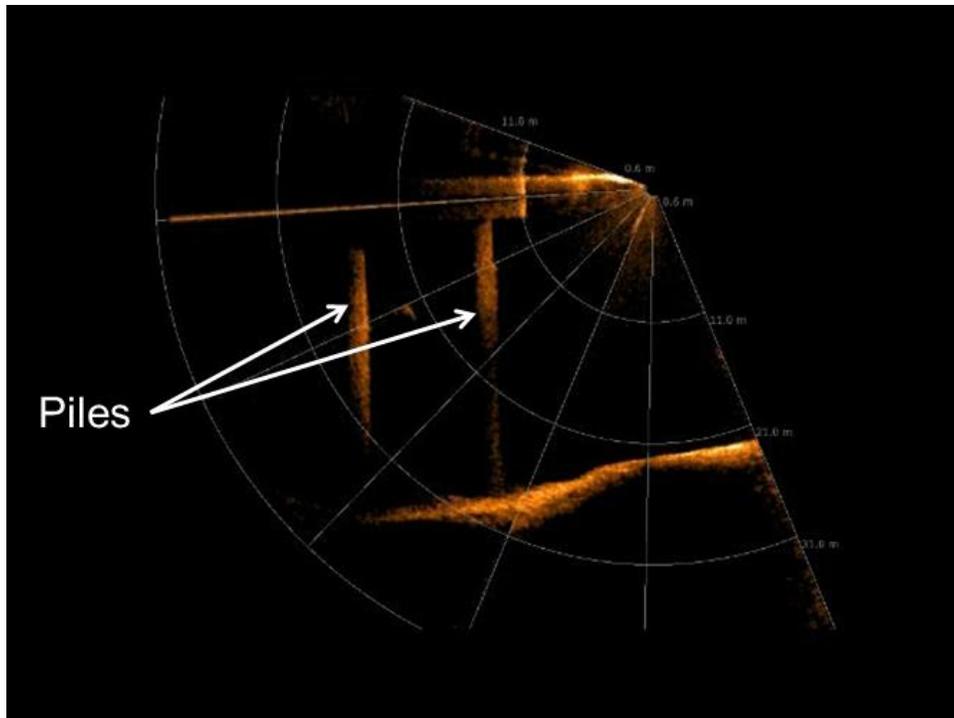
Figure 67. Image. 2D image from an eastward scanning pass.

Inspection team B performed a combination of 2D and 3D scanning of the 2003 Carquinez Bridge. An example of the 2D imaging is shown in figure 67. The figure is an image of the north pilings imaged as the boat was traveling from west to east using the 2D multibeam sonar in the vertical orientation. An example of 3D imaging is shown in figure 68 where several signs of debris are apparent.

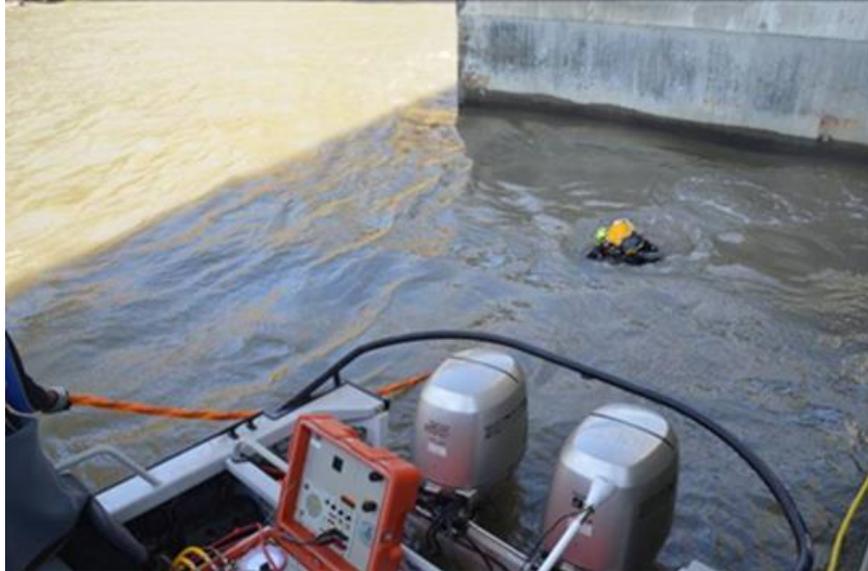
Figure 69. Photos. Wave and current condition during the diving operation.

With respect to the diving team at the Carquinez Bridge, the first dive was timed close to a slack tide. Overall, the current was manageable, but challenging for the divers. Examples of the water surface conditions are shown in figure 69. In addition, the depth was approximately 90 ft (27 m). The diver used the maximum amount of time allowed for the depth (30 min) to inspect one pile including one level II cleaning. The second dive occurred at a time between slack tide and maximum current. Inspection was nearly impossible because of the current. While the estimated current was likely between 2 ft/s (0.6 m/s) and 3 ft/s (0.9 m/s), the diver reported experiencing an approximately 4 ft/s (1.2 m/s) equivalent current. Based on the post-dive description and observation of the flow condition, it was hypothesized that the blockage caused by the massive pile cap might have produced a high velocity area some distance below the bottom face of the pile cap. This condition was hazardous for the diver.

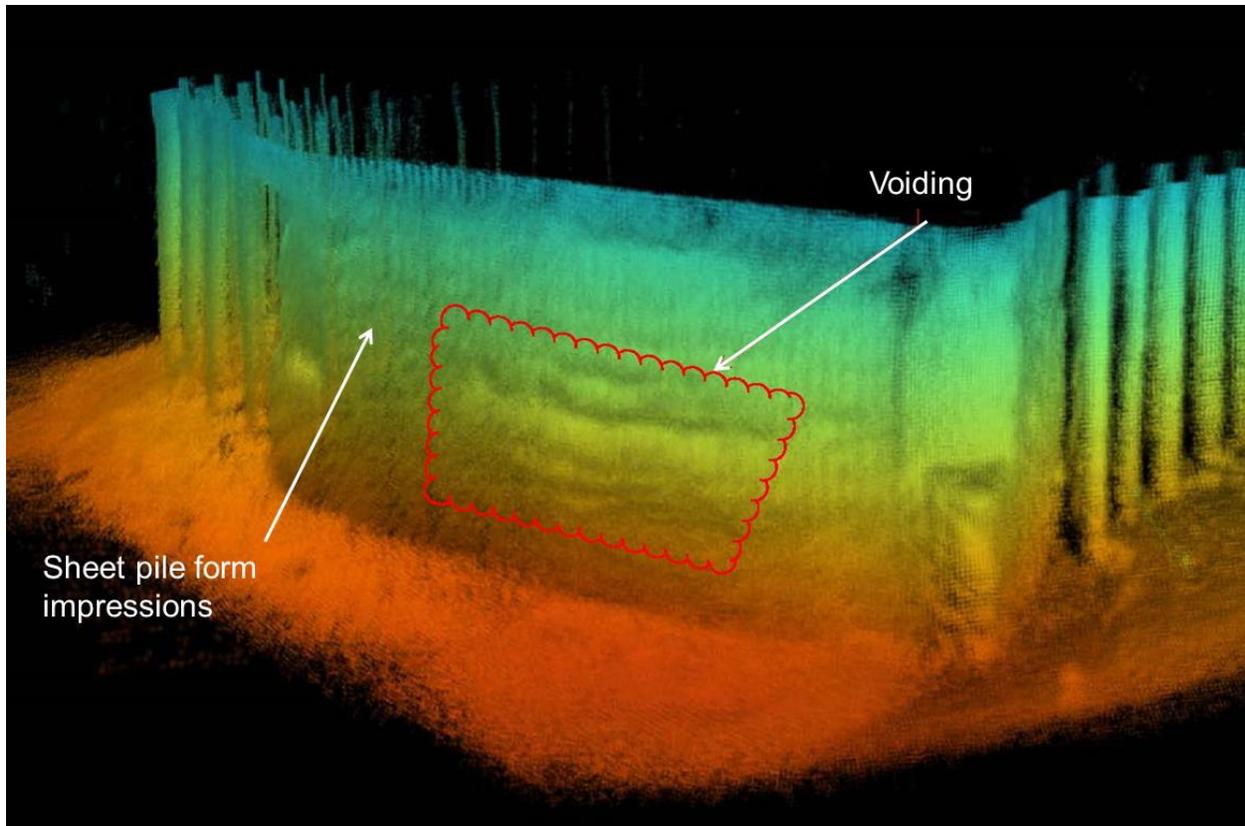
Figure 79. Image. Pier W2 viewed from the east.

The piles from old Wharf Pier 24 prevented access to the south and west faces of the concrete caisson for inspection team A. Team A reported that sheet pile form impressions were visible on all inspected faces (east and north) of pier W2. As shown in figure 79, the underwater acoustic imaging results show areas of voiding along the east face of pier W2. These horizontal bands varied in size, up to a maximum of 50 ft (15 m) long by 4 ft (1.2 m) high by 1.5 ft (0.46 m) deep, and are located near the center of the east face, ranging from approximately 10 ft (3 m) above the channel bottom to approximately 30 ft (9 m) above the channel bottom.

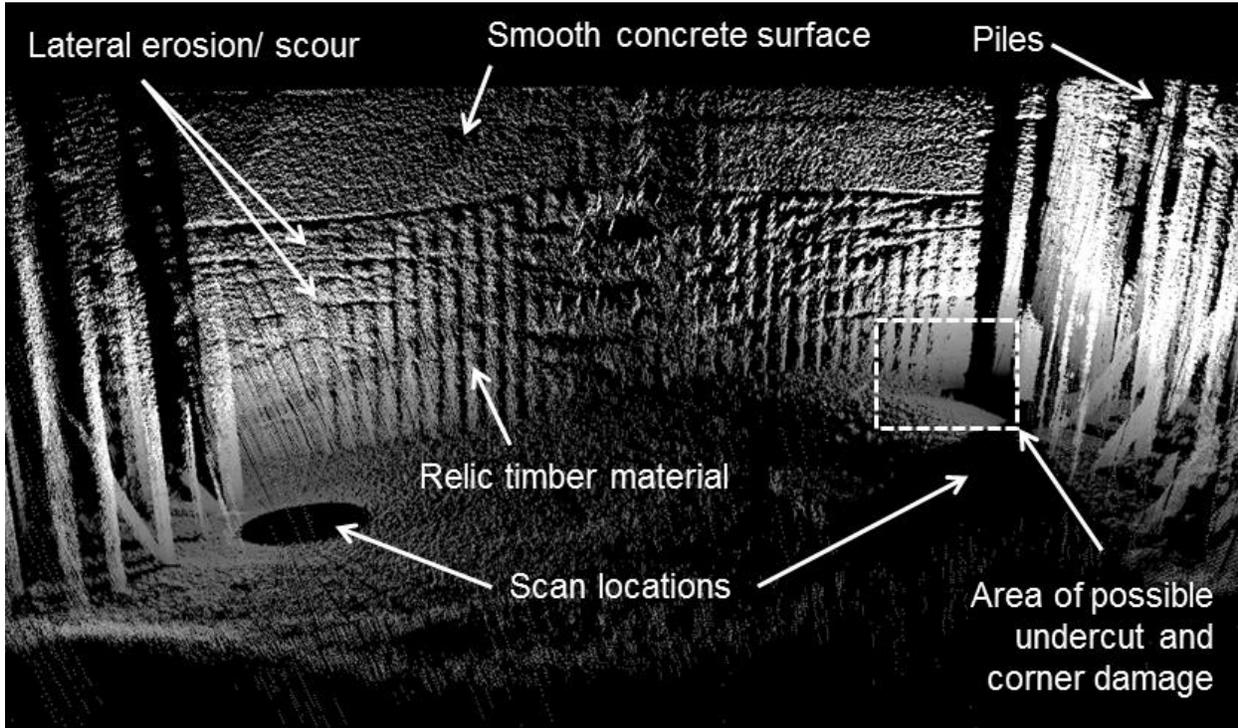
Figure 80. Image. Pier W2 3D data viewed from west.

Inspection team B reported that much of the sheet pile appears to have deteriorated from the submerged portions of the caisson at pier W2. As shown in figure 80, there were intermittent horizontal bands of voiding in the concrete caisson throughout the lengths of the entire east and west faces, with a maximum height of approximately 6 ft (1.8 m) and a maximum depth of approximately 1 to 2 ft (0.3 to 0.6 m). On the east face, the voids were most prominent at approximately 15 ft (4.6 m) and 30 ft (9.1 m) above the channel bottom. On the west face, the voids were evident beginning just below the top of the sheet pile form and extending down to approximately 8 ft (2.4 m) above the channel bottom near the center of the face. These voids were also visible on the northeast and southeast corners of the caisson.

analyst identified the transition from smooth concrete in the upper portion of the image to where the original concrete forms had been removed. They further identified numerous lateral erosion pockets, which were easily discernable in the data.

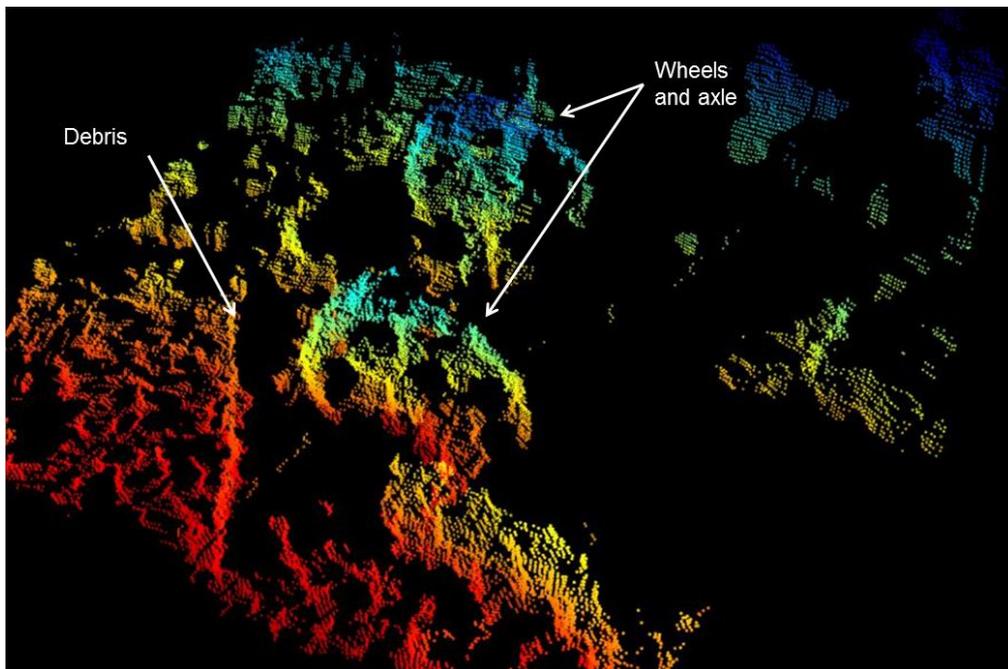
Figure 81. Image. Detail at bed near pier W2.

Inspection team B also identified debris on the bed near pier W2. The image in figure 81 shows evidence of debris including an axle with a pair of wheels.

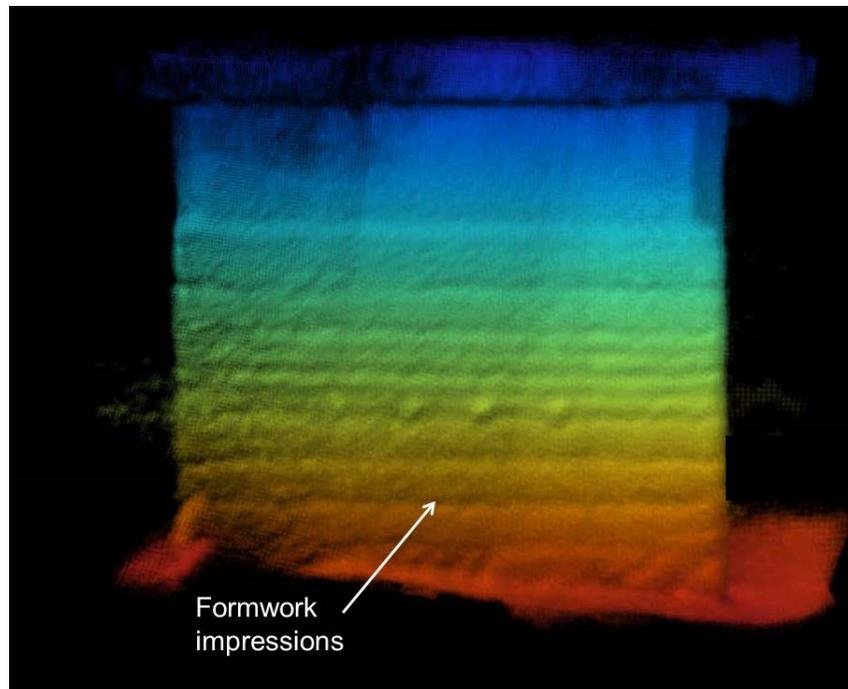
Figure 84. Image. Pier W6 viewed from the west.

Inspection team A reported that there were no significant deficiencies visible at pier W6. The report identified that formwork impressions are visible on all submerged faces of the caisson as shown in figure 84. The change from the smooth concrete to the formwork is visible in the figure.

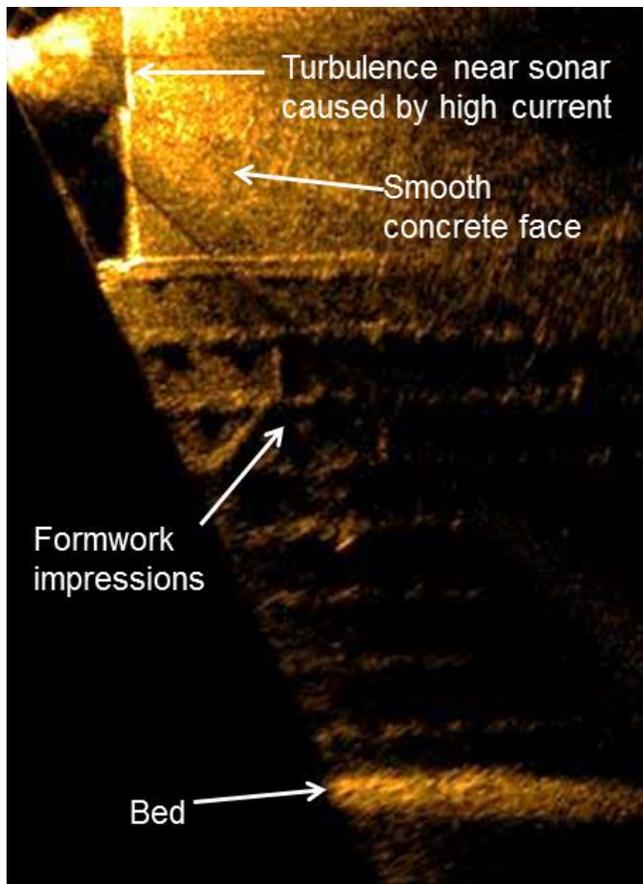
Figure 85. Image. South face of pier W6 in a 2D sonar image.

Inspection team B noted formwork impressions visible on the submerged caisson as shown in figure 85. A possible area of abrasion is distinguishable at the southeast corner, near the top of the caisson, just below the step-out.

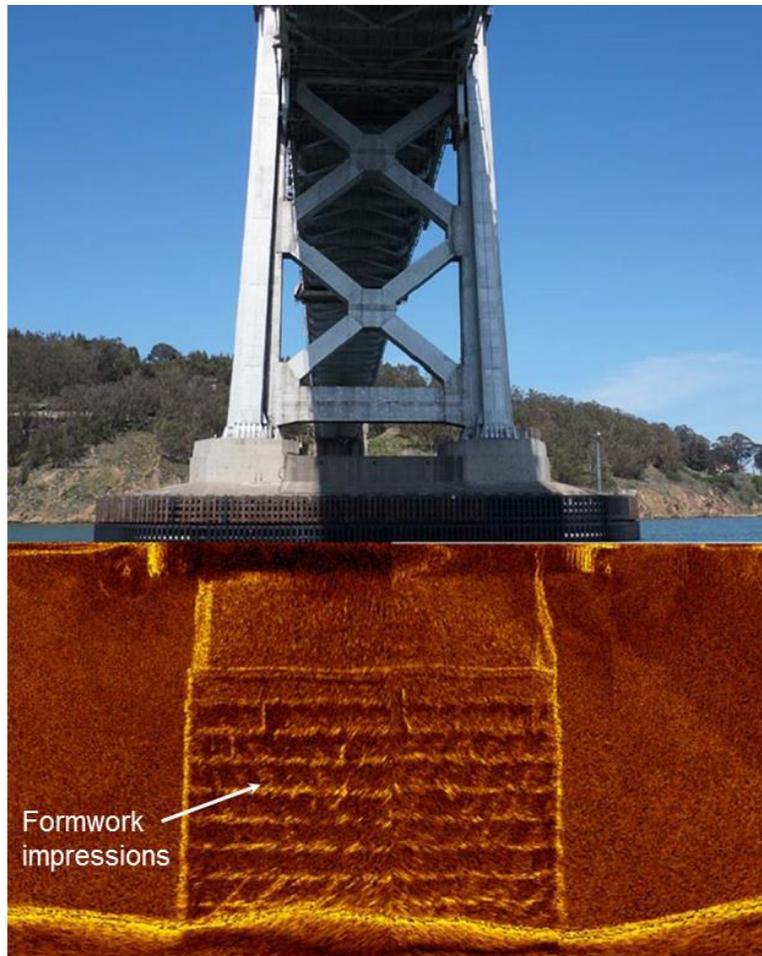
Figure 86. Image. West face of pier W6.

Inspection team C also noted formwork impressions visible on the submerged caisson at pier W6 as shown in figure 86. There are also possible diagonal sheathing remnants or impressions visible on the south and west faces near the southwest corner.

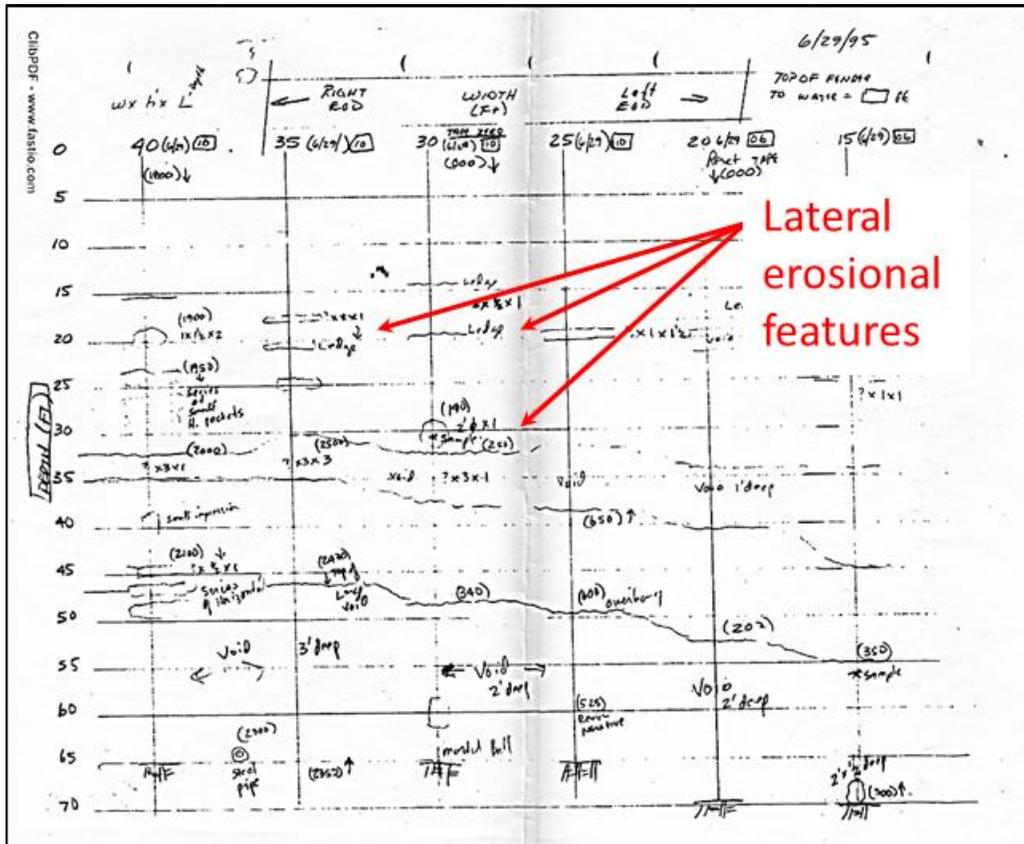
Figure 87. Image. Page from the 1995 diver inspection report on SF-OBB pier W2.

Analysts from sonar team B noted that the 1995 dive inspection report pertaining to pier W2 showed many linear features as shown in figure 87. They stated that similar features are readily noticeable in both the 2D multibeam images and the 3D mechanical multibeam point cloud data. For example, the analyst estimated that the lateral erosion was approximately 2 to 3 ft (0.6 to 0.9 m) deep from the image shown in figure 88. In addition, using the image shown in figure 80, the

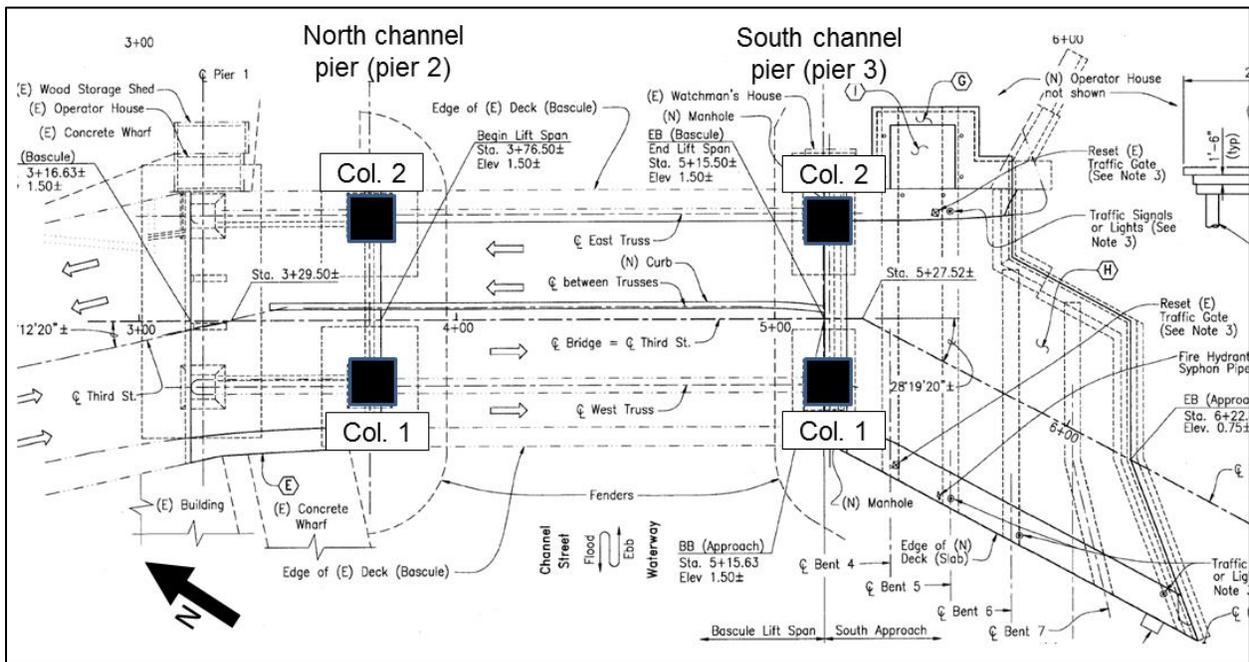
Figure 92. Drawing. Plan view of the Third Street Bridge.

Figure 92 highlights the location and orientation of the pier columns subject to inspection for this study. The inspection reports also refer to specific columns supporting the piers. The middle concrete box is not shown in the figure.

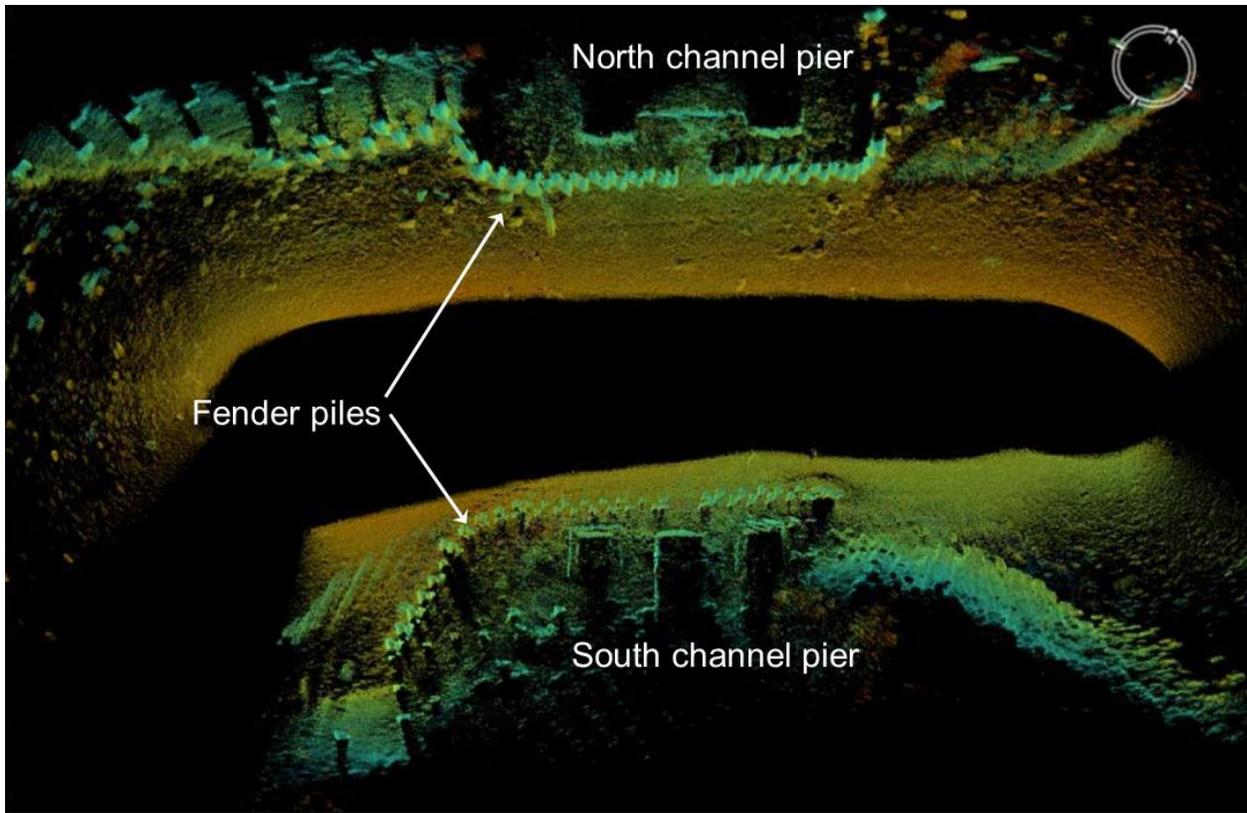
Figure 93. Image. North and south piers of the Third Street Bridge.

An image of both piers from sonar inspection team A is shown in figure 93. The report from sonar team A states that acoustic imaging of both the south channel pier (figure 94) and the north channel pier (figure 95) revealed no major deficiencies. The team reported that because of limited access, in-depth scanning was limited to the east support (column 2) of the north channel pier.
