Underwater Inspection of Bridge Substructures Using Imaging Technology

June 14, 2018

Sponsored by
Federal Highway Administration
Office of Infrastructure
FHWA-HIF-18-049

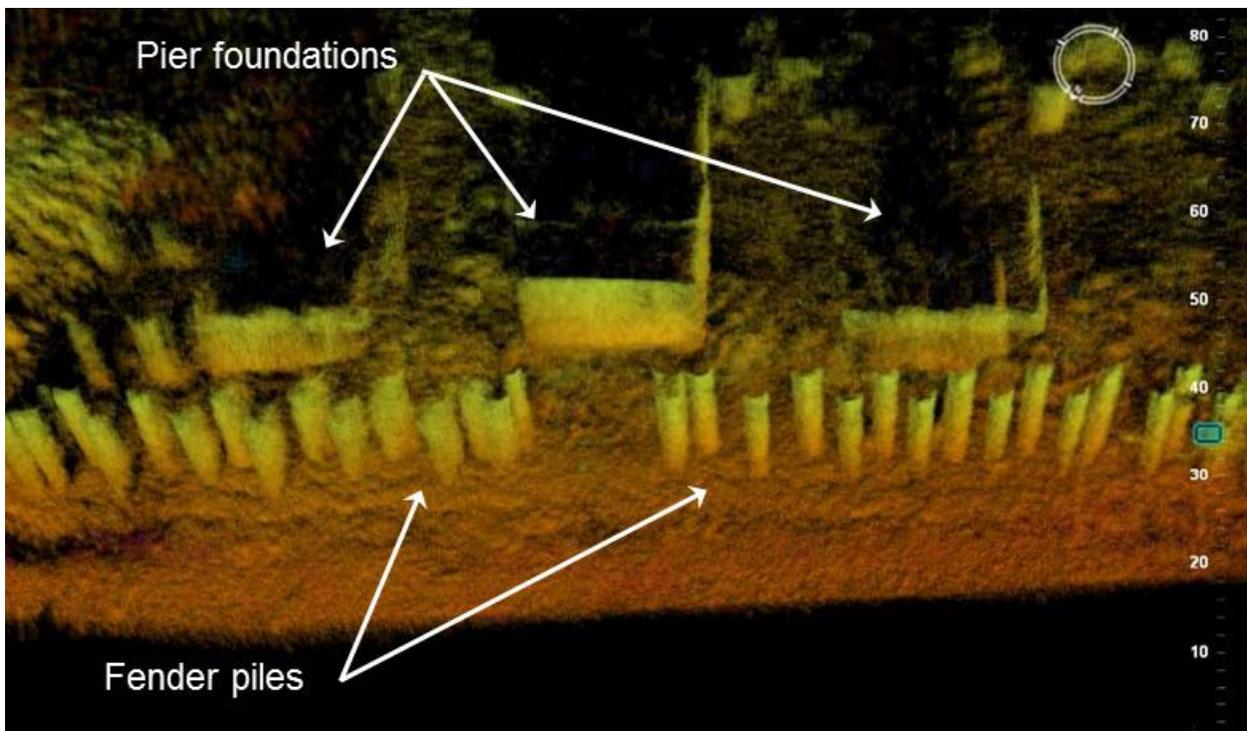
Figure 94. Image. Close-up of the south channel pier (Third Street Bridge).

An image of both piers from sonar inspection team A is shown in figure 93. The report from sonar team A states that acoustic imaging of both the south channel pier (figure 94) and the north channel pier (figure 95) revealed no major deficiencies. The team reported that because of limited access, in-depth scanning was limited to the east support (column 2) of the north channel pier.

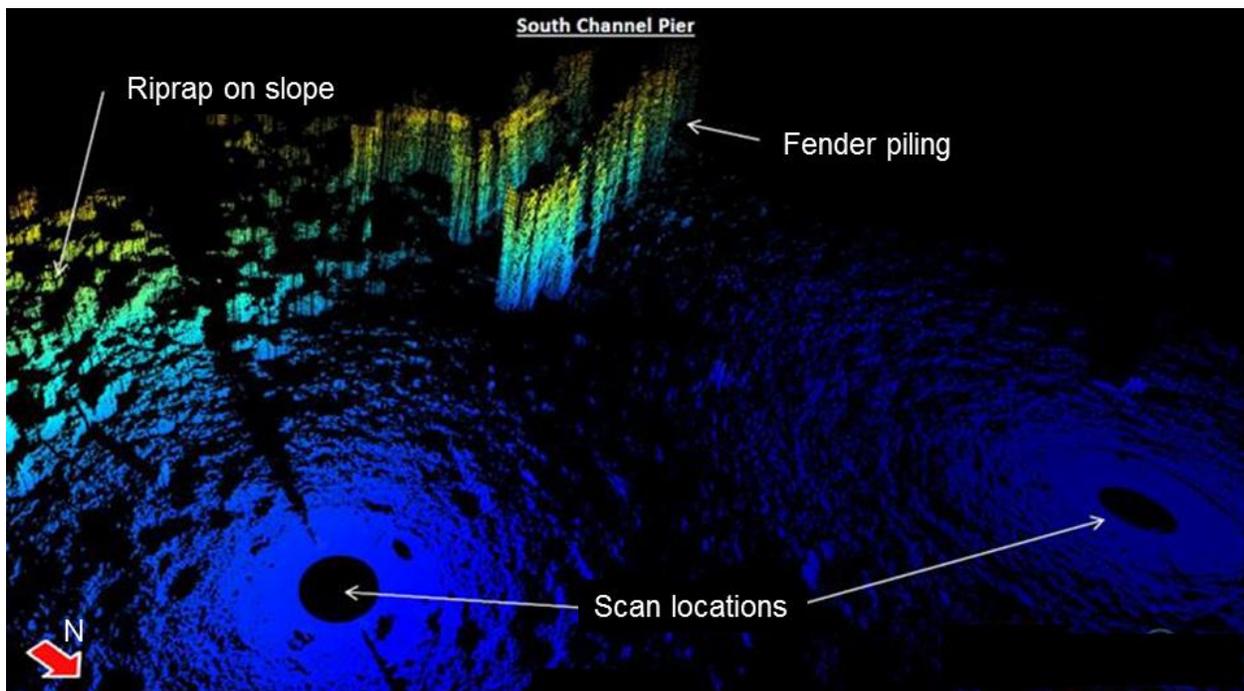
Figure 96. Image. South channel pier viewed from the northeast.

Inspection team B noted that because of limited access and time constraints, scanning of the south channel pier was limited to a few scans of the east support (column 2). These images, such as found in figure 96, revealed no significant deficiencies.

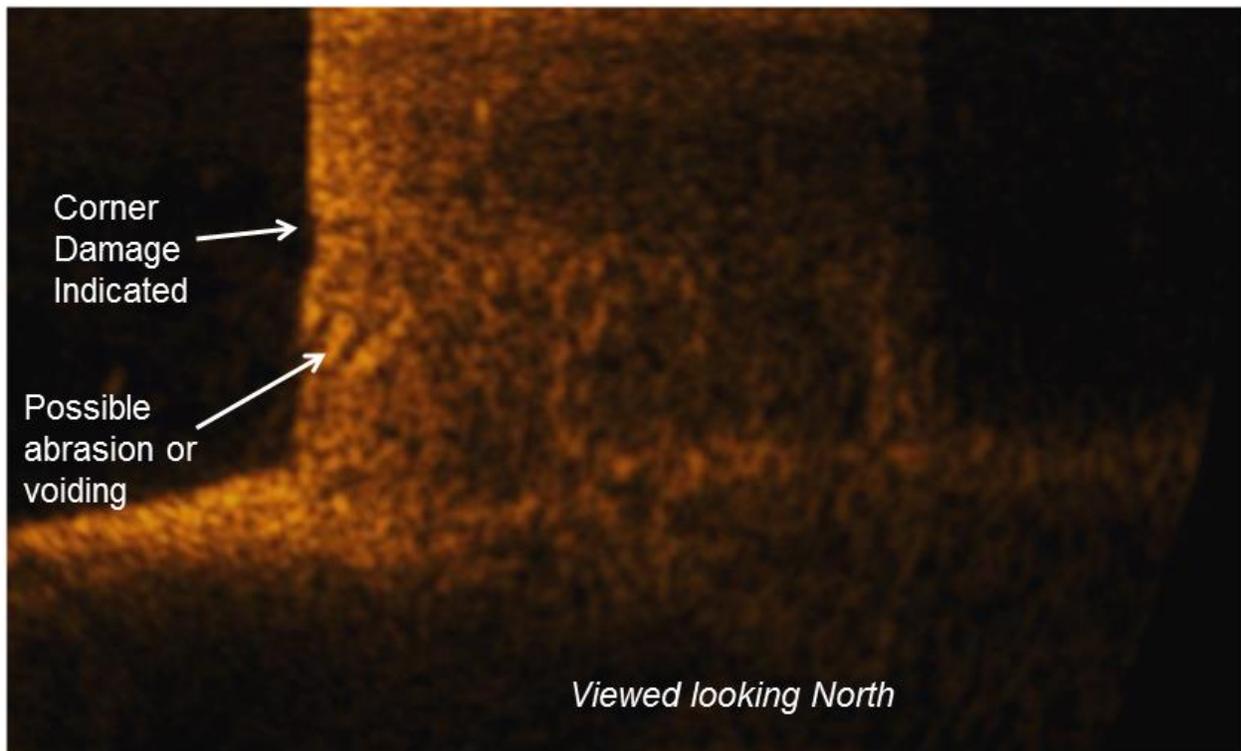
Figure 97. Image. Detail of south face of west support of the north channel pier.

With respect to the west support (column 1) of the north channel pier, team B did identify possible abrasion damage or voiding along the west end of the south face as shown in figure 97. This area was reported as approximately 3 ft (0.9 m) long by 2 ft (0.6 m) high and positioned

approximately 5 ft (1.5 m) above the channel bottom. On the northwest corner of the same support column, the report also noted two possible areas of corner spalling or abrasion. These areas were reported as being approximately 1 to 2 ft (0.3 to 0.6 m) high by up to approximately 3 inches (76 mm) deep and located approximately 5 to 8 ft (1.5 to 2.4 m) above the channel bottom.

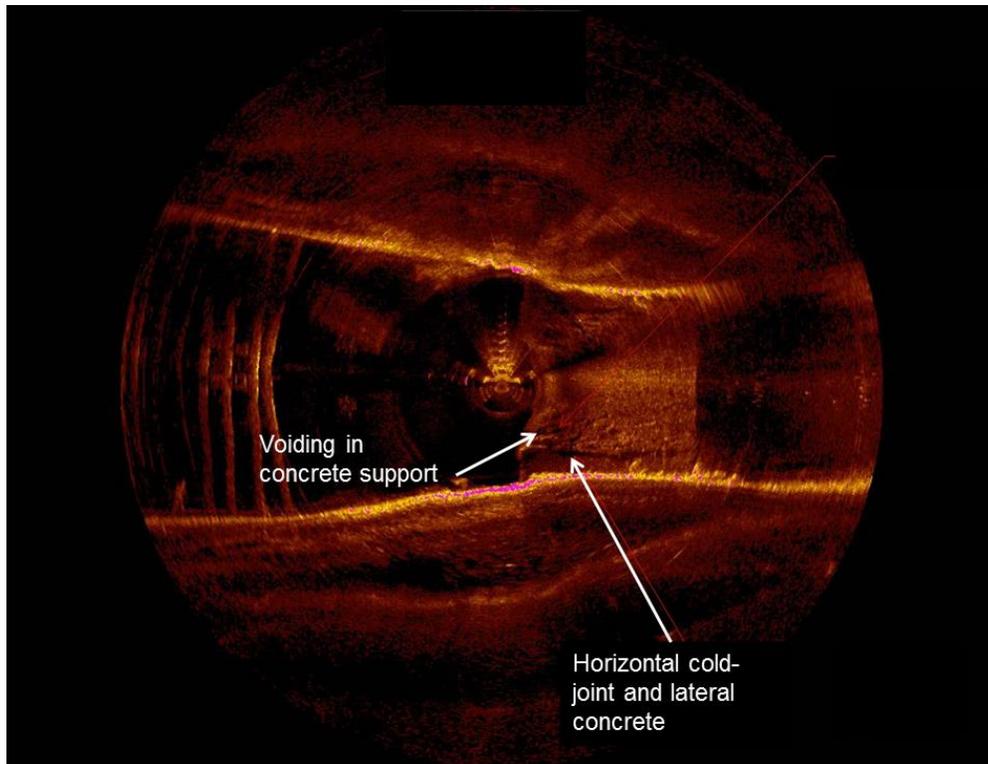
Figure 98. Image. Raw image of north channel pier, east support, south face.

At the north channel pier, the inspection report noted horizontal cold-joints and associated latent concrete visible on the supports as shown in figure 98 as well as vertical and horizontal

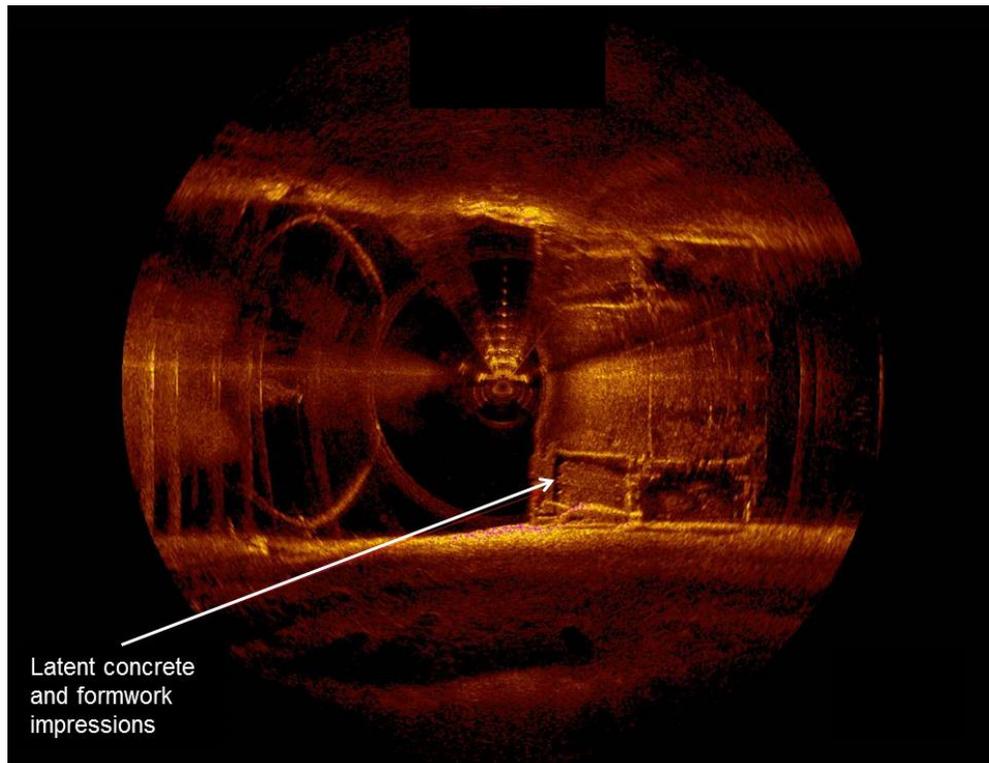
Figure 99. Image. Raw image of north channel pier, west support south face.

formwork impressions as shown in figure 99. In addition, the report noted voiding on the east support of the north channel pier. On the east face a void ranging from approximately 0.5 ft (0.15 m) to 2 ft (0.6 m) high located approximately 12 ft (3.7 m) below the top of the concrete support was identified. The report noted this voiding extended intermittently along the entire length of the east face and continued around the northeast corner to the north face for approximately 5 ft (1.5 m). Additional voiding at the east end of the south face approximately 5 ft (1.5 m) long by 6 inches (150 mm) high positioned approximately 19 ft (5.8 m) below the top of the concrete support was reported.
