Purdue University

Steel Bridge Research, Inspection, Training, and Engineering (S-BRITE) Center

Member-level Redundancy of Built-up Steel Girders Subjected to Flexure

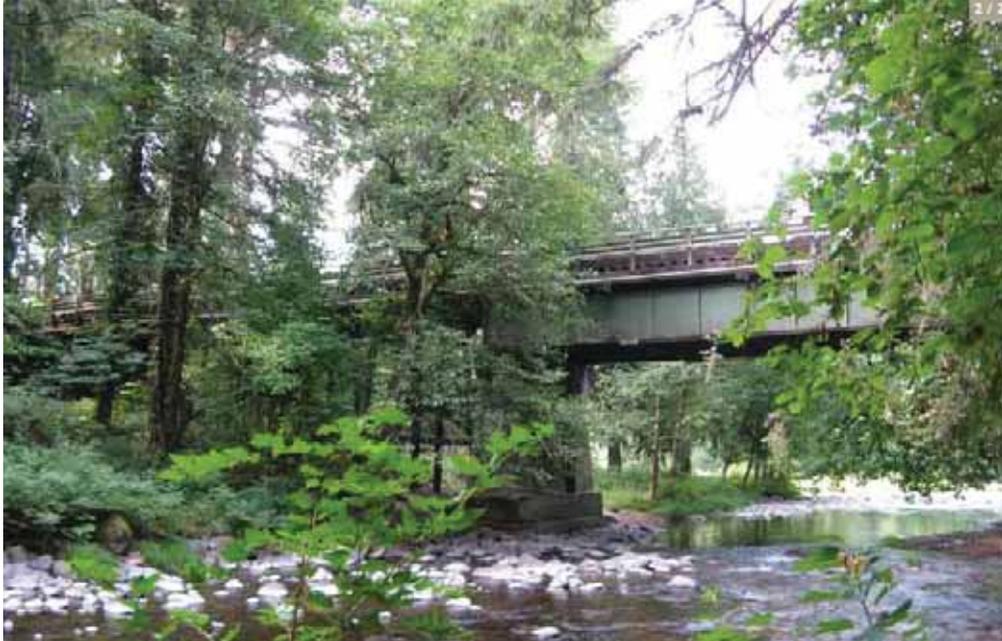
Figure 2-1 North Fork Mollala River Bridge, Oregon (OBEC, 2012)

Located in Clackamas County, Oregon, the North Fork Mollala River Bridge was a built-up riveted, two-girder fracture critical bridge built in 1966 (Figure 2-1). In 2001, during a fracture critical inspection, both flange angles of a riveted built-up steel girder (with no cover plate) were found to be fractured (Lovejoy, 2001). One of the main girders had sustained both fractures near a flange splice (see Figure 2-2). It was determined that the fractures had both initiated at fabrication defects resulting from punched holes. The corrosion product on each surface implied that the fractures occurred at separate unrelated

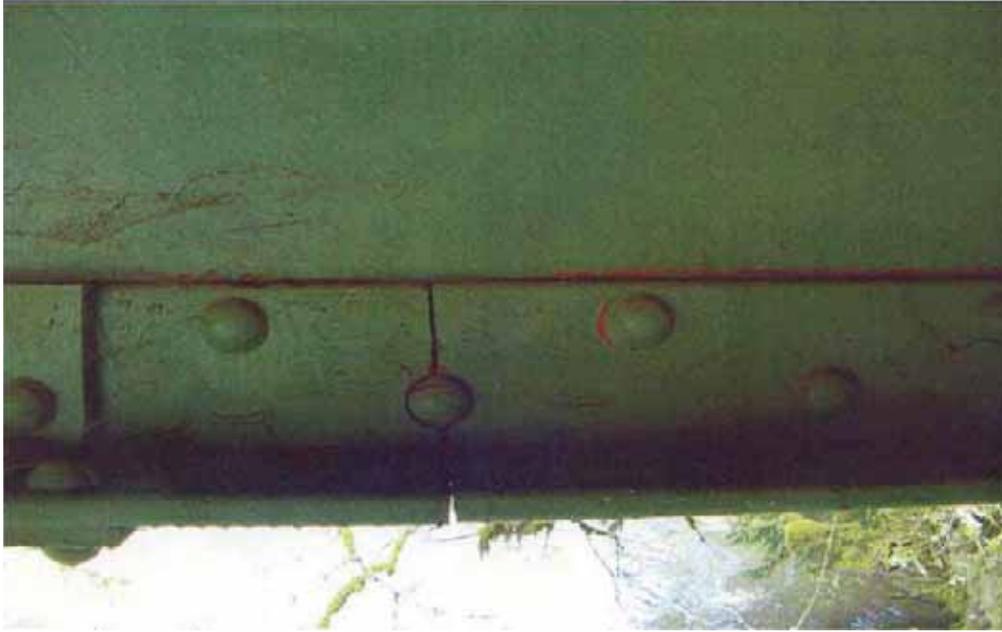
Figure 2-2 Interior view of fractured flange angle (Lovejoy, 2001)

times. While the fracture dates were not able to be determined, the bridge clearly carried service loads until the time of inspection and repairs were made. While plastic deformation was observed in the web directly above the fractures, no web cracks were found.

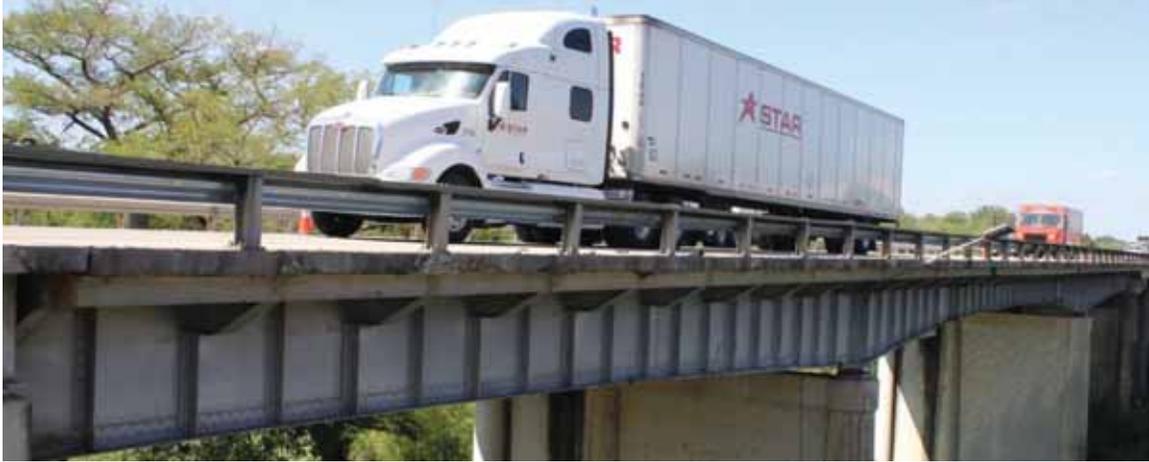
Figure 2-3 Elevation view of Texas Research Project Bridge (Fasl, 2013)

A three-span, two-girder, non-composite, riveted built-up bridge was monitored by researchers at the University of Texas at Austin as part of a research project investigating wireless data acquisition systems (see Figure 2-3). The age and location of the bridge were not made available per the owner's request. The two longitudinal girders are continuous over the interior supports and extend approximately one-quarter of the center span to where the center section is suspended by hangers. The longitudinal girders are haunched and cover plated over the interior supports.

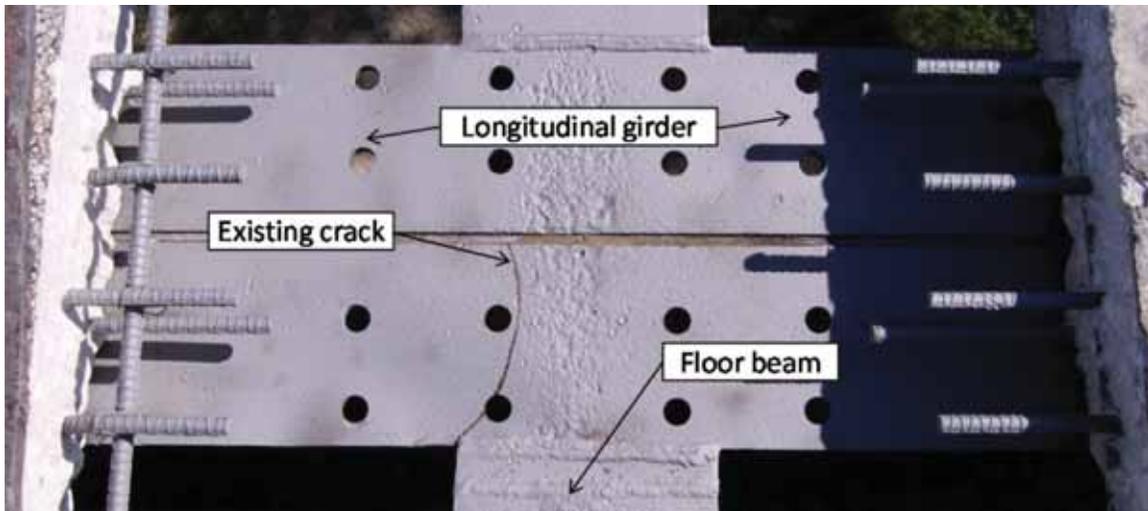
Figure 2-4 Cracked top flange angle (Fasl, 2013)

Approximately 40 years after construction, as part of a bridge widening project, transverse cantilever floor beams were added. These floor beams were riveted to transverse stiffeners and welded at the top and bottom flanges. The welded top flange connection resulted in a Category E fatigue detail. Cracks were later found during fracture critical inspections. Initiating at the weld toe of the cantilever floor beam, the cracks had grown the entire width of one of the top flange angles. Similar cracks were found at several locations along the length of the main girder. The cracks were clearly visible during a retrofit effort in which the concrete deck was removed (see Figure 2-4). The discontinuities between components of the built-up member (providing member-level redundancy) was credited with preventing the cracks from growing into the remaining top flange angle or the web plate (Fasl, 2013)

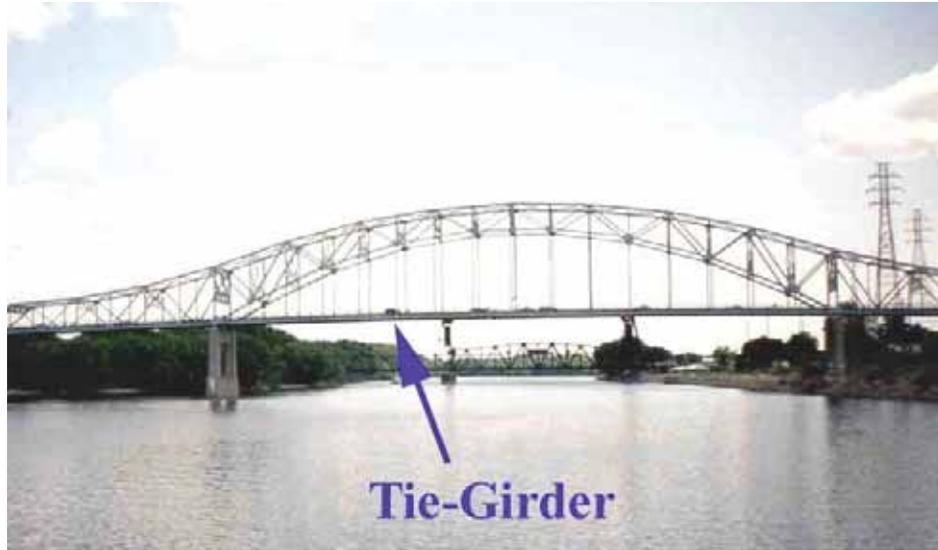
Figure 2-5 Hastings Bridge, Minnesota (Niemann, 1999)

Two separate fracture critical inspections revealed two partial member fractures on the Hastings Bridge in Minnesota in 1997 and 1998. The bridge is a tied-arch through truss bridge built in 1949 with riveted built-up members (see Figure 2-5). Both fractures occurred in the same plate of the tie girder. While the first fracture arrested in adjacent rivet holes, the second fracture propagated through the entire tie girder web plate (see Figure 2-6). Initiating, at a tack weld used to improve fabrication adjacent to a floor beam gusset plate, the second fracture ran the entire length of the web plate. It was determined that a single plate used in the fabrication of the tie girder had very low toughness causing each of these fractures to occur (Niemann, 1999). The internal member redundancy of the built-up members prevented the fracture from propagating into adjacent components.

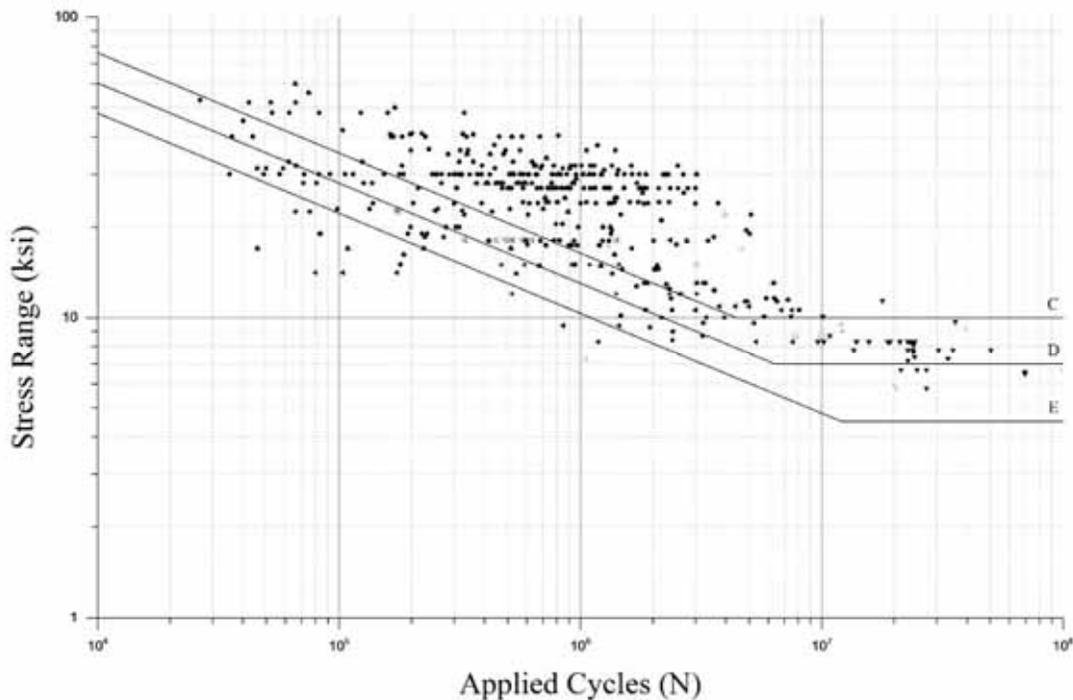
Figure 2-7 Fatigue data from previous research

A thorough literature review was made to determine the extent of fatigue tests on riveted members that have been performed. The majority of testing, however, focuses on the initial fatigue life of riveted members, most commonly defined as the number of cycles until a single component is completely cracked. Figure 2-7 shows a compiled summary of the fatigue life of specimens tested and found in the following documents: Adamson & Kulak, 1995; Åkesson, 2010; Baker & Kulak, 1982, 1985; Baron, Larson, & Kenworthy, 1955; Brühwiler, Smith, & Hirt, 1990; DiBattista & Kulak, 1995; Fisher, Yen, Wang, & Mann, 1987; Out, Fisher, & Yen, 1984; Parola, Chesson, & Munse, 1965; Reemsnyder, 1975; Seong, 1983; Wilson & Thomas, 1938; Zhou, 1994.

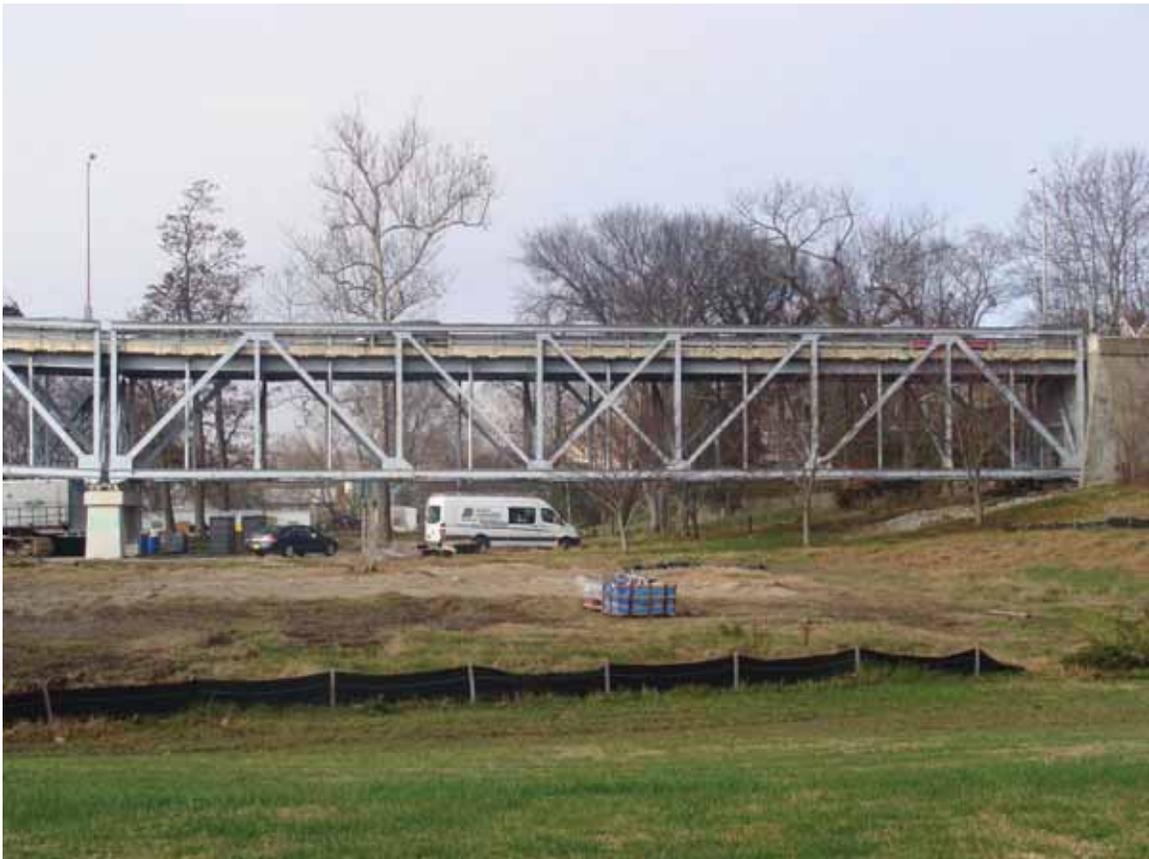
Figure 2-8 Approach span of Milton Madison Bridge, Indiana

Construction of a new bridge to replace the structurally deficient and functionally obsolete Milton Madison Bridge began in 2010. The bridge was originally built in 1929 as a riveted built-up cantilevered through-truss crossing the Ohio River. As part of the demolition of the old bridge, a study was conducted to investigate both member-level and system-level redundancy. A Pratt Truss approach span was selected for the test due to its accessibility and geometry (see Figure 2-8). The span was instrumented, and then loaded with sand to simulate a loading condition greater than any seen on the bridge during long-term monitoring. After an analysis of the bridge members, the bottom chord at the center panel of the span was selected to be severed in two locations to measure member-level redundancy and system-level redundancy of the bridge. The bottom chord of the truss consisted of two built-up channel shapes connected with lattice. The lattice of the double built-up channel bottom chord was removed adjacent to the simulated fracture locations as well as the outstanding legs of the built-up channel. Two shape charges were used to sever the remaining components. The first shape charge was detonated, cutting through one of

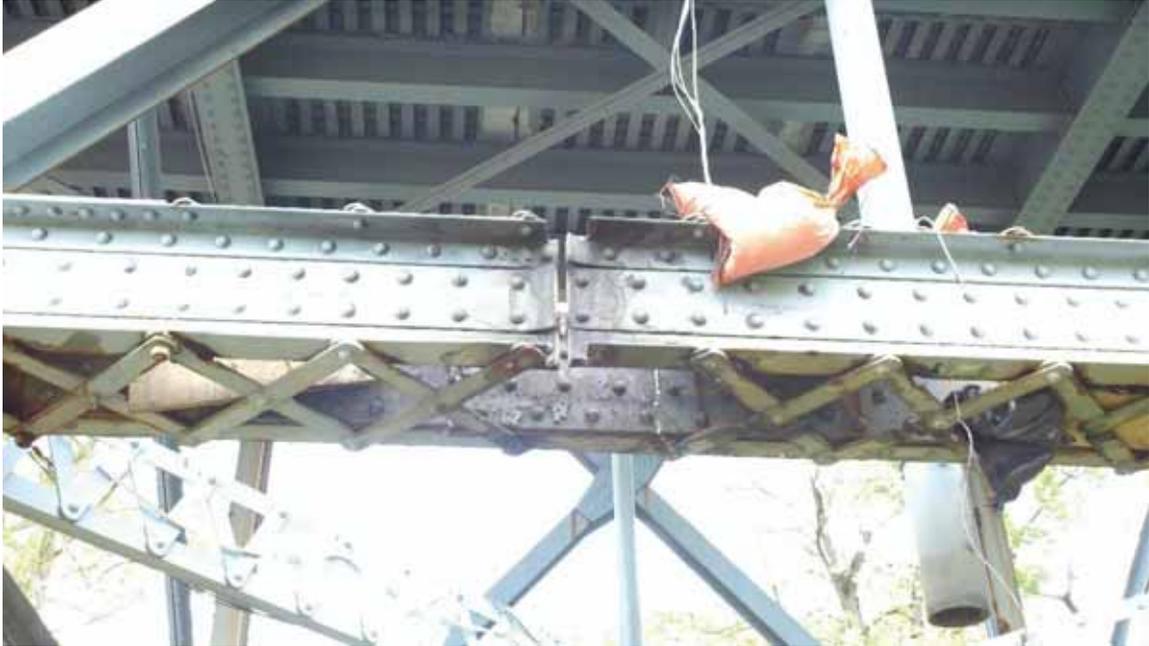
Figure 2-9 Partially severed bottom chord, Milton Madison Bridge approach span

the built-up C shaped components to evaluate member-level redundancy (see Figure 2-9). The detonation of half of the cross-sectional area represented an extreme amount of section loss. The resulting stress increase in the remaining bottom chord built-up channel approximately doubled as expected. However, even with the energy release of the fracture, coupled with the energy imposed on the system due to the shape charge, the second bottom chord channel did not fracture or exhibit signs of any other cracks in adjacent components. Later the second shape charge was detonated in the remaining web plate, testing system level redundancy (Diggelmann, 2012).

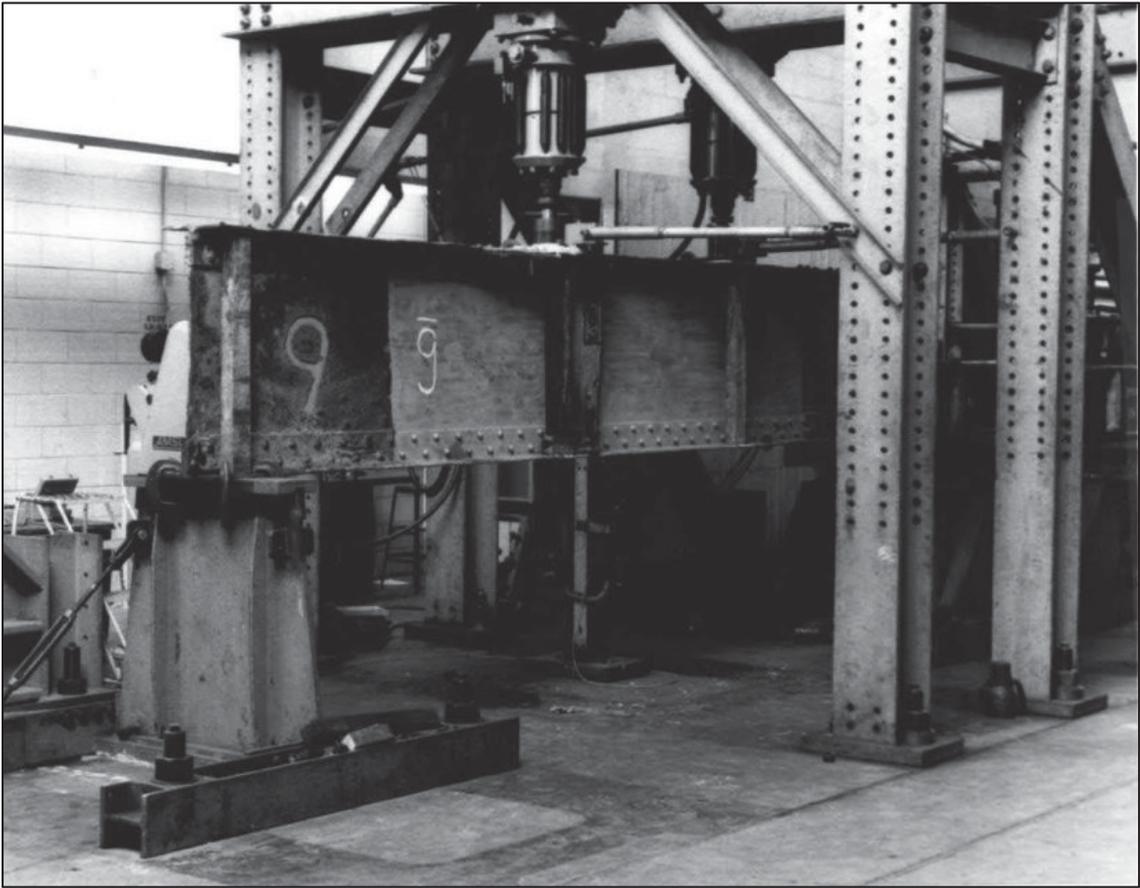
Figure 2-10 Fatigue testing of weathered section (Out, 1984)

A study performed under the direction of the FHWA Office of Research by researchers at Lehigh University found significant redundant behavior in deteriorated steel built-up girders. Six riveted built-up stringer specimens with top and bottom flanges consisting of two flange angles (no cover plates), which had been removed from an existing railroad bridge, were tested in fatigue to determine their fatigue capacity. The specimens had components with a reduced area of 5% to 40% due to advanced corrosion. Two of the specimens were cycled at reduced temperatures in an attempt to induce a fracture. Of these two specimens, only one sustained a component fracture. However, cracks of significant length were present in both flange angles and the web plate when all remaining portions of the flange angles and the majority of the web fractured. The other specimen had a flange

angle with a fatigue crack through 95% of the cross section but still did not fracture. After dismantling the failed specimens, it was determined that the holes for the rivets had likely been punched. For two specimens the number of cycles were recorded between the first component failure and the final specimen failure. Before complete member failure of the specimens, 590,000 and 600,000 fatigue cycles at an original, uncracked net section stress range of 10.9 ksi and 9.4 ksi (respectively) were noted (Out et al., 1984).

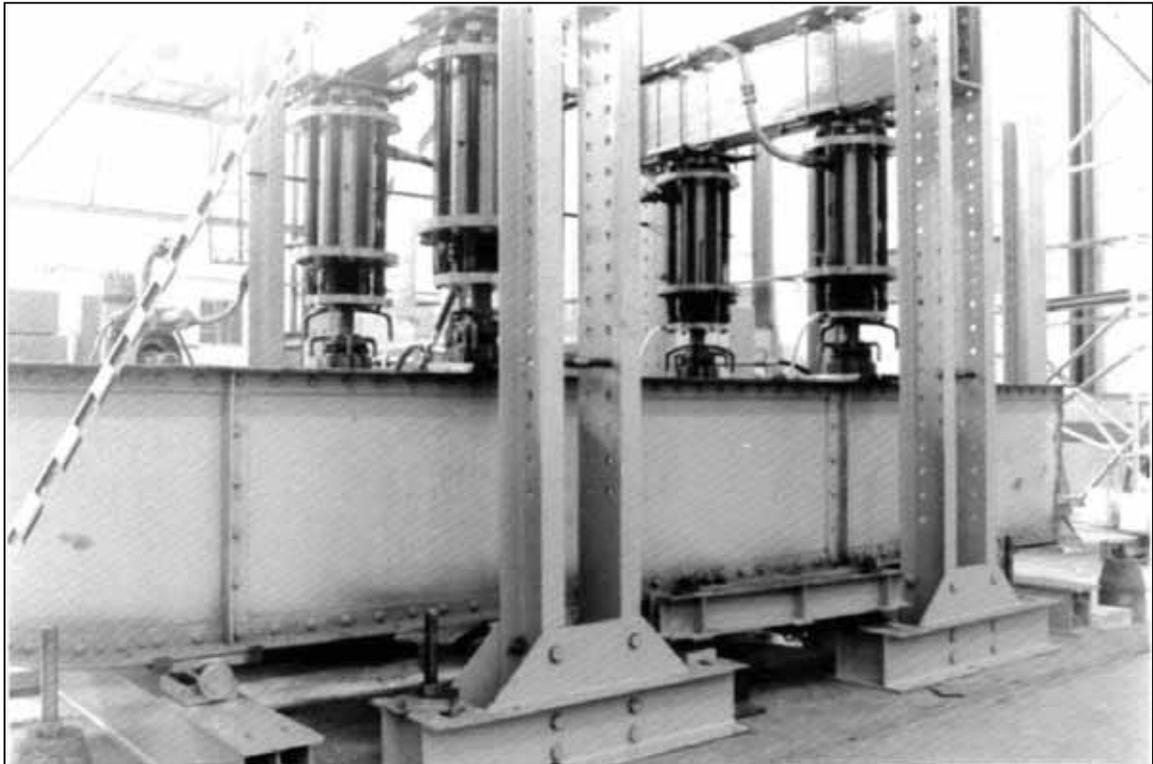
Figure 2-11 Fatigue testing of historical built-up stringers (Åkesson, 2010)

Nine built-up riveted stringers were tested in fatigue as part of this research study. The specimens were removed from a railway bridge over the Vindel River in Vännäsby, Sweden in 1993. The arch truss bridge was originally built in 1896, but, at the time of demolition, was deemed functionally obsolete. The specimens consisted of a top and bottom flange consisting of two flange angles (see Figure 2-11). Rivet holes were found to be punched.

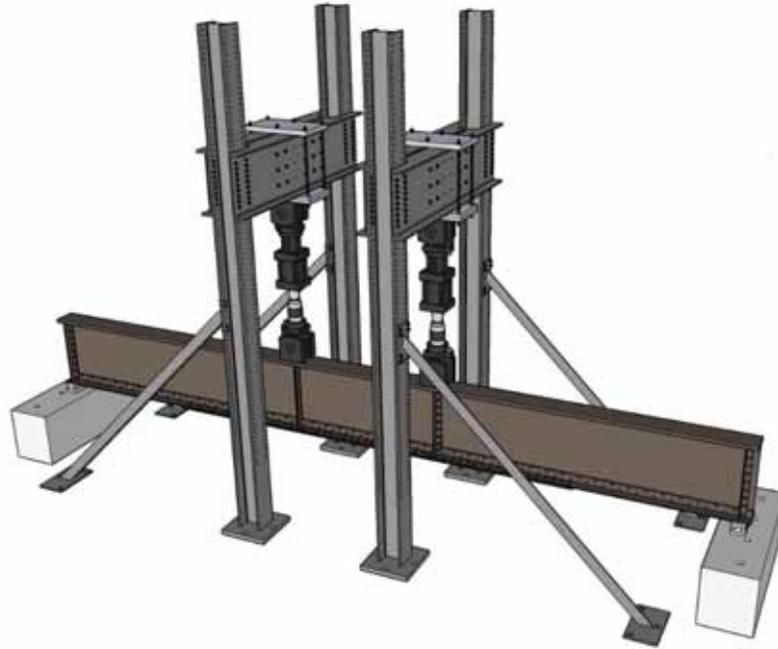
Figure 3-1 Schematic view of test setup

Due to the need to obtain data for large, full-scale bridge members, a load frame capable of maximizing the available laboratory equipment was designed (see Figure 3-1) and fabricated. Two 220 kip MTS 244.51 Servo hydraulic actuators were used to apply load to a single specimen in four-point bending. Each actuator was equipped with a 72-103 Moog valve having a capacity of 60 gallons per minute (gpm). The actuators were controlled with an MTS 293.22 Hydraulic Service Manifold (100 gpm capacity) which was supplied by an MTS 505.120 Hydraulic Power Unit (HPU) pump with a pressure capacity of 3000 psi and a flow capacity of 120 gpm. The actuators were spaced at 8'-0" centered on the specimen to create a constant moment region. This resulted in a distance of constant stress in unflawed specimens that facilitated the measurement of stress redistribution during specimen degradation. A separate load frame supported each individual actuator and was braced to prevent lateral movement. Each load frame and brace was post-tensioned to the laboratory strong-floor to react against the actuator forces. Two separate test setups were fabricated and erected to allow two specimens to be tested simultaneously (see Figure 3-2).

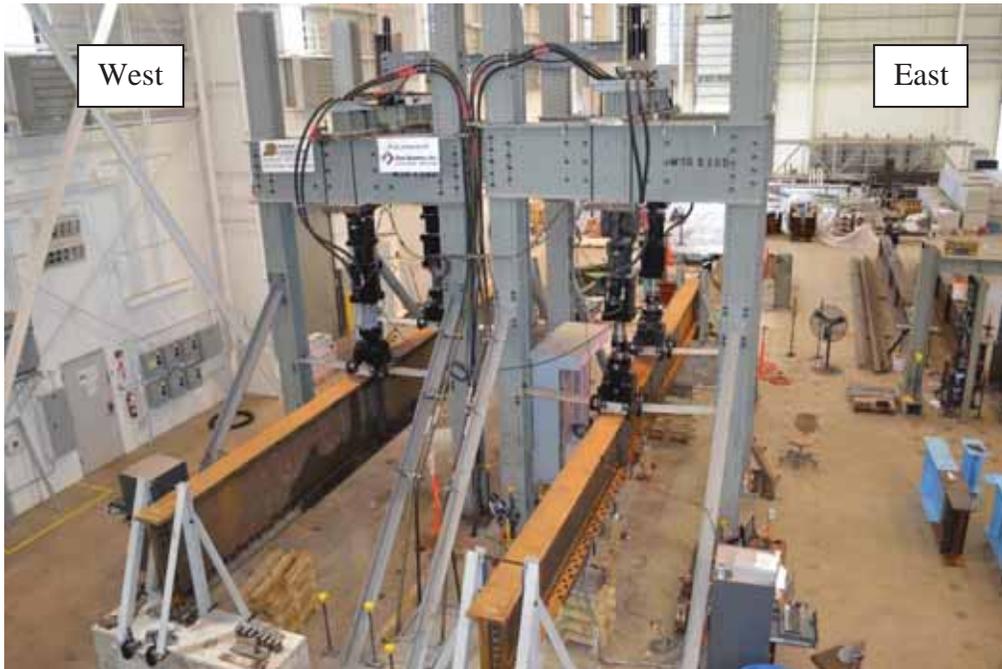
Figure 3-2 Twin test setups

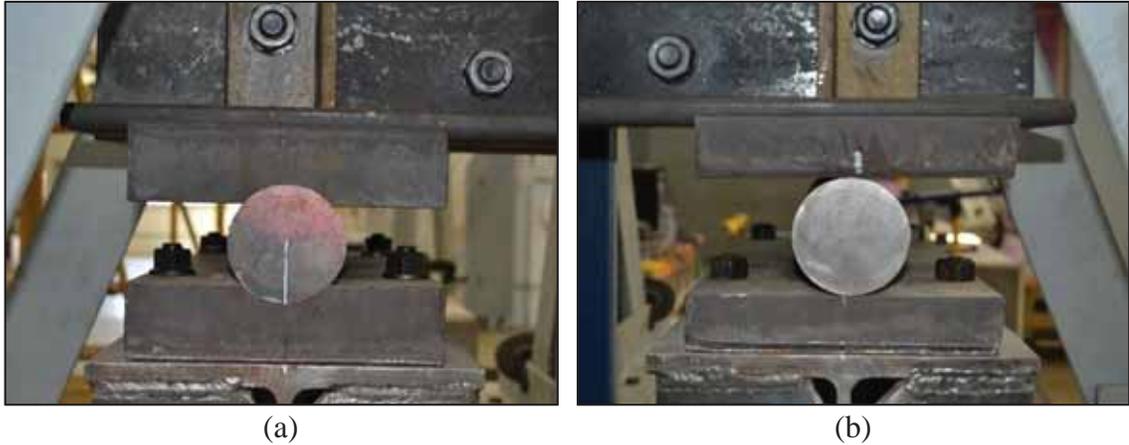
Figure 3-3 (a) Pin bearing, (b) Roller bearing

Specimens were supported at each end by steel bearings placed on concrete reaction blocks having a height of 36 inches to allow adequate room for inspection below the specimen. As shown in Figure 3-3, a pin bearing was used on the south end of each specimen and a roller bearing was used on the north end of each specimen to allow longitudinal movement resulting from actuator loading and subsequent displacement.

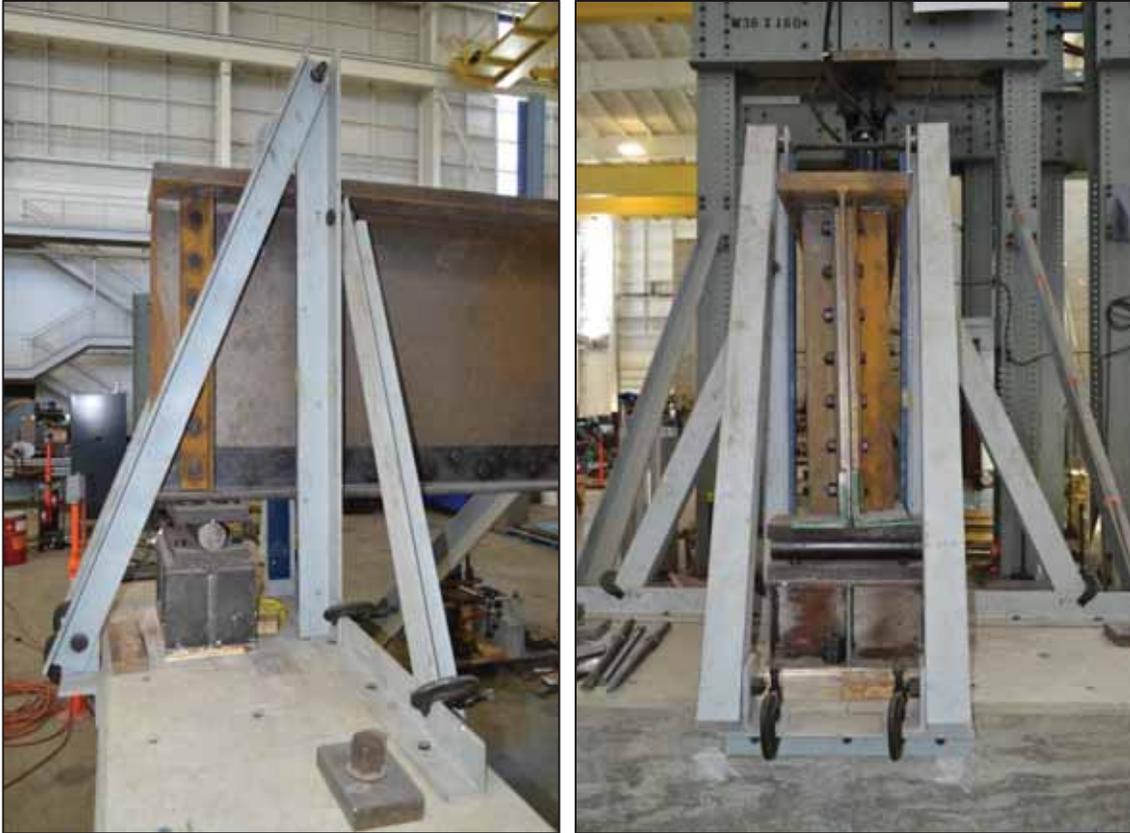
Figure 3-4 Lateral torsional bracing at specimen ends

Bracing was used at discrete locations along the length of the beam to prevent out-of-plane bending and to prevent instability of the test setup. At each end of the specimen 4"x4"x1/2" L's with an abrasion resistant UHMW Polyethylene bearing shim (to allow longitudinal rotational movement) were fastened at the top flange of the specimen and braced against an angle attached to the concrete reaction block with expansion anchors (see Figure 3-4). An additional angle was attached in the longitudinal direction to the reaction block which resulted in the stiffening of the end bracing.

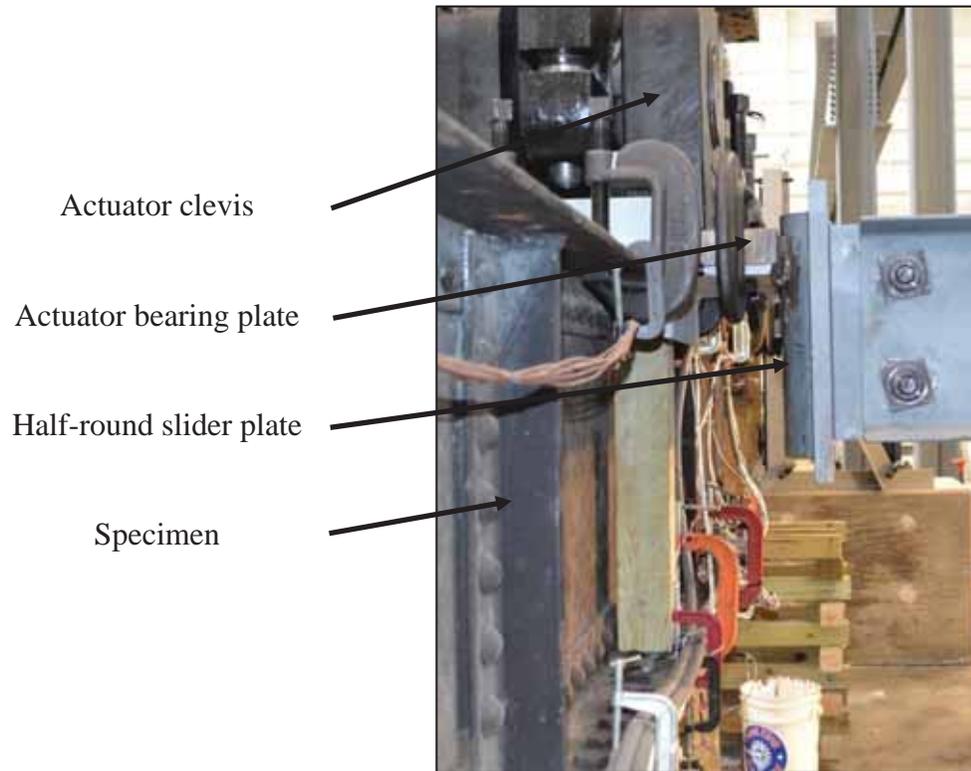
Figure 3-5 Lateral torsional buckling bracing (half-round slider plate method)

The top flange of each specimen was also braced at the location of each actuator to prevent compression flange buckling. The first specimen (Specimen 23-1) was braced with stationary half-round slider plates attached to the load frame allowing the specimen to deflect vertically but preventing lateral movement (see Figure 3-5). Each half-round slider plate was greased to allow the specimen to deflect vertically with minimal friction. However due to the required frequency of lubricating the bearing plates and the resulting loud noise created as the specimen skidded along the slider plate, an alternate bracing method was devised for subsequent specimens. A 12"x1/8" plate was attached from the load frame column to the actuator bearing plate on each side of the specimen (see Figure 3-6). The plate was designed to resist any lateral forces from out-of-plane bending through

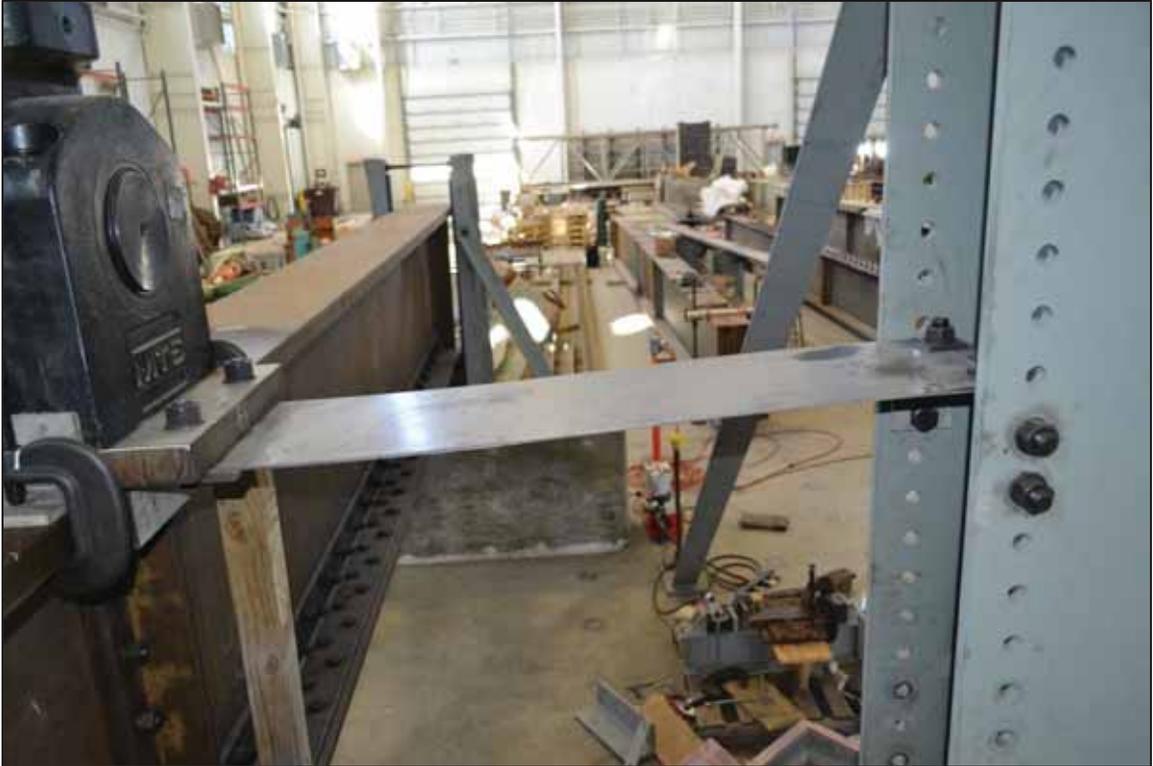
Figure 3-6 Lateral torsional buckling bracing (thin plate method)

tension from one side of the plate while allowing buckling of the brace on the opposite side. The thickness of the plate provided negligible stiffness in the vertical direction and therefore did not diminish the load applied to the specimen from the actuators.

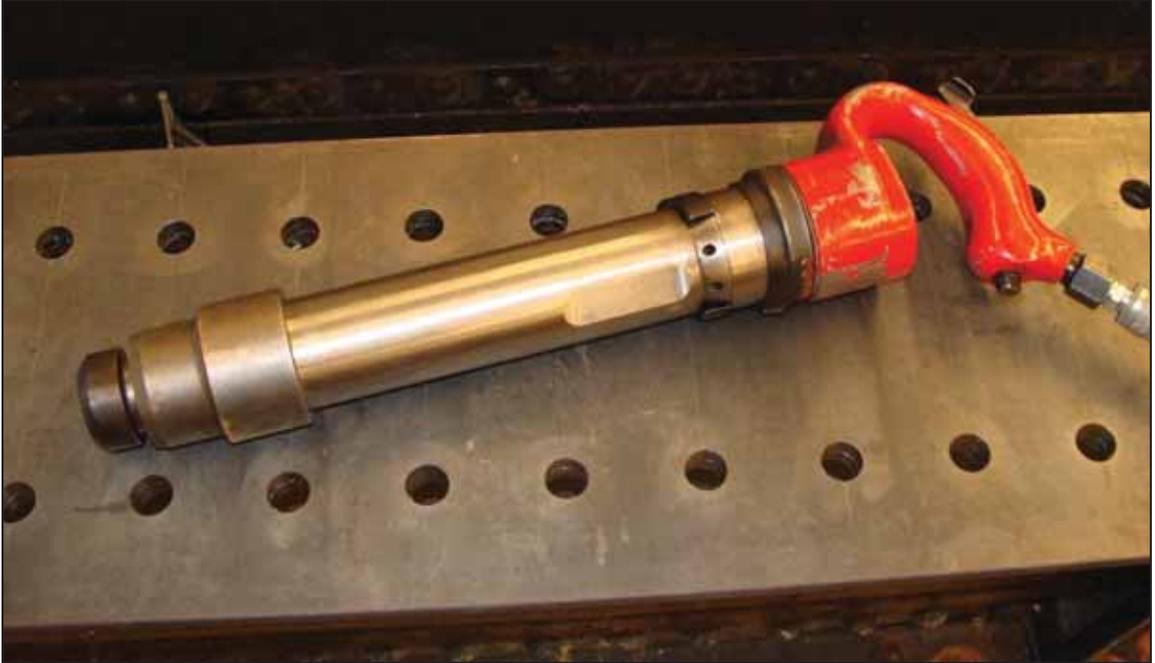
Figure 3-7 Chicago Pneumatic CP-80RB Rivet Buster

Refurbished rivet driving equipment from the late 1950s was purchased from Michigan Pneumatic Tool to drive the rivets. A Chicago Pneumatic CP-80RB rivet buster was used to drive the rivets (see Figure 3-7). This rivet buster is a long stroke boyer valve style rivet hammer capable of driving rivets up to 1-1/8" in diameter (Webster, 1920). A Chicago Pneumatic CP-AA-Offset holder-on was used to hold the shop head of the rivet in place during driving (see Figure 3-8). The holder-on works as a pneumatic piston

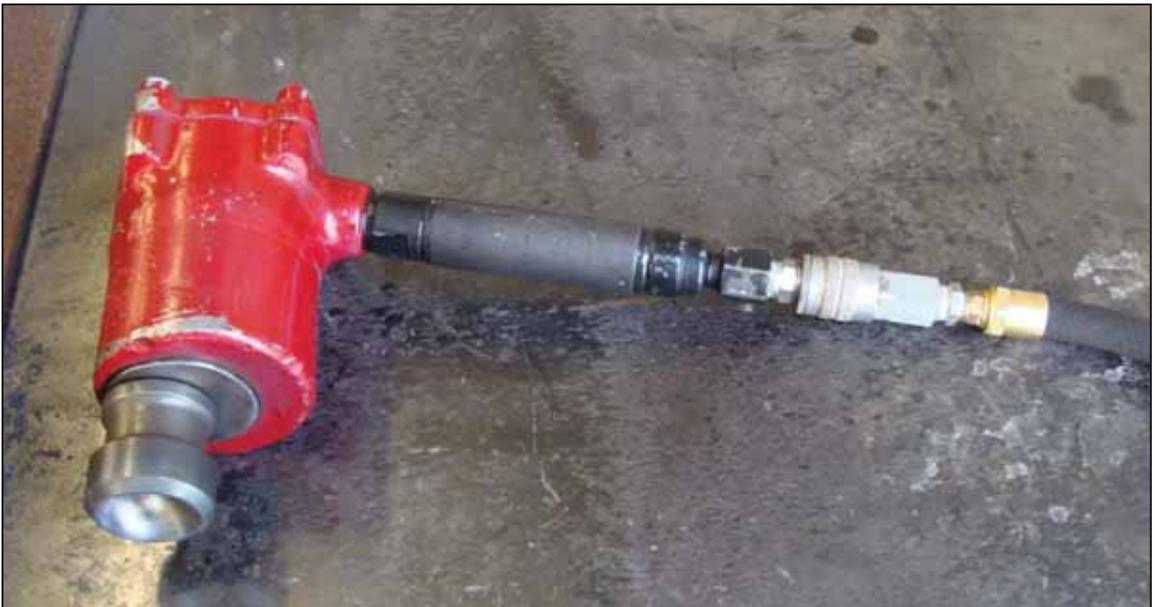
Figure 3-8 Chicago Pneumatic CP-AA-Offset holder-on

designed to react against a sturdy object (typically the opposite interior flange of an I-shaped beam).

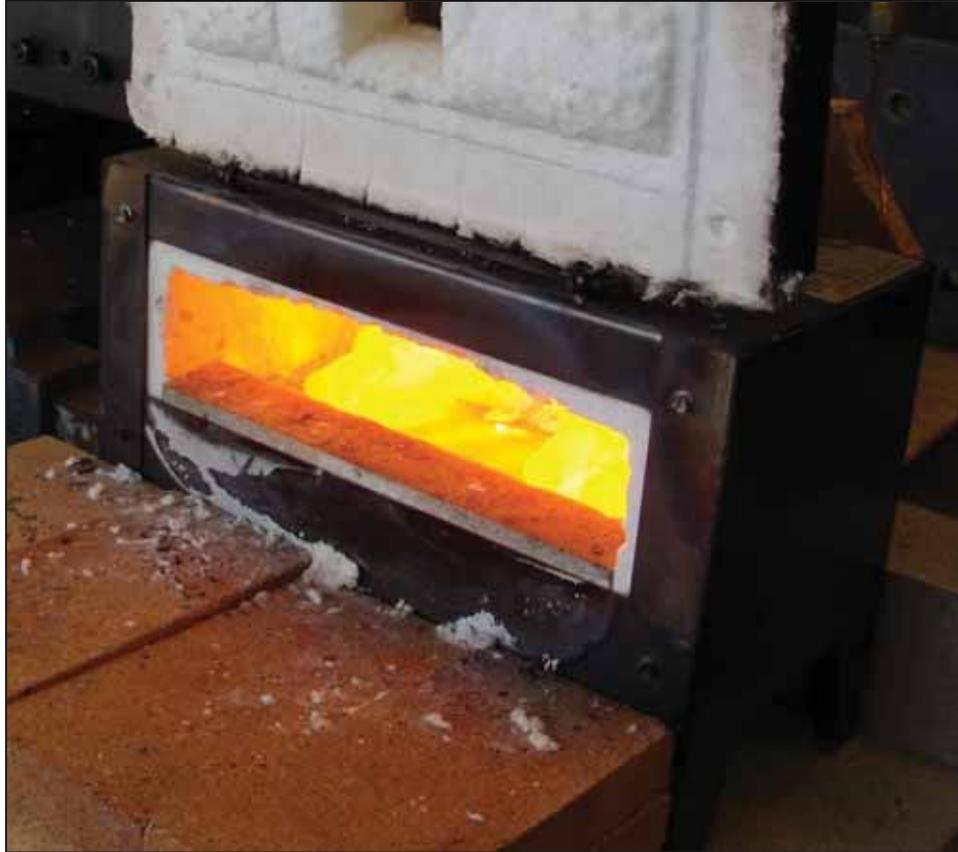
Figure 3-9 Propane fueled rivet forge

Rivets were heated in a propane fuel forge until they reached approximately 1900°F - 2100°F as measured by an Omega HH802U thermometer with a type K thermocouple probe placed adjacent to the heating rivets. This temperature correlated to a bright orange color. While little recorded guidance was found on the proper methods of heating and driving rivets, those references found on the subject suggest that during historical fabrication a bright cherry red to bright orange color was typically desired to ensure proper rivet heating (Champion, 1914; Hechtman, 1948). The author found that it was nearly impossible to pneumatically drive rivets that are only heated to a cherry red color since they are still too stiff at such a temperature. Instead, the rivets were driven at a bright orange color which resulted in proper forming of the rivet heads. During specimen fabrication, both temperature and color were monitored to ensure consistent quality rivets were driven. All rivets used for the current research were C1018 steel. The material properties can be found in APPENDIX D.

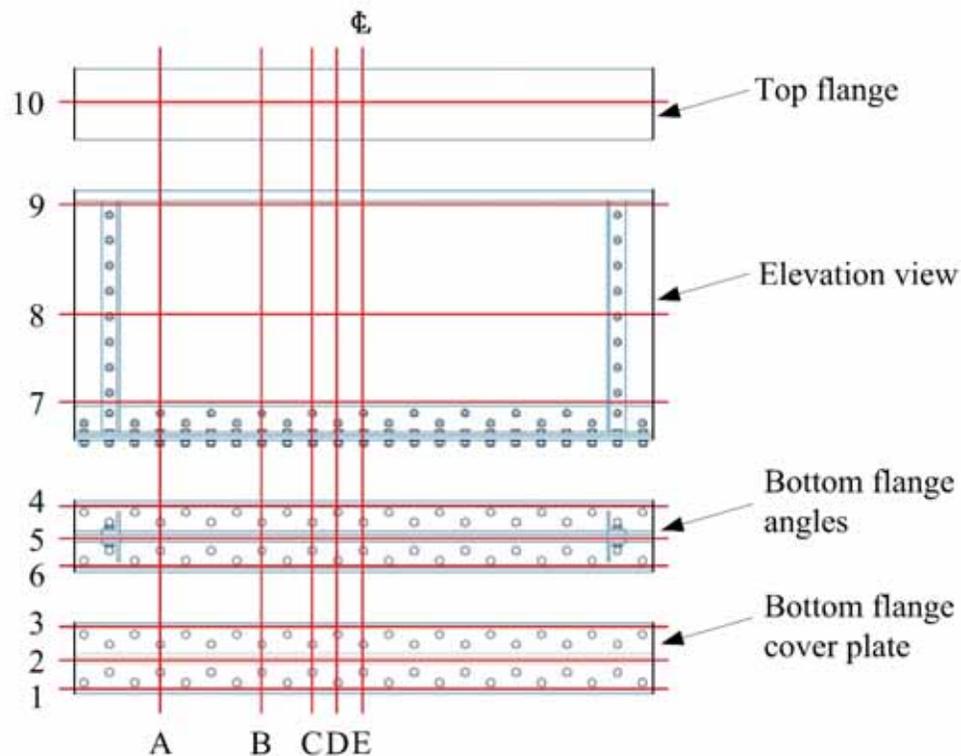
Figure 3-10 Typical strain gage gridline layout

instrumented due to the symmetry of the loading conditions. Numerical gridlines (1, 2, 3, etc.) were used along the transverse length of the specimen. Numbering started with '1' at the west end of each component and progressed to the east and vertically (e.g. for a specimen with a single cover plate, gridlines: 1, 2, 3 were on the cover plate; gridlines 4, 5, 6 were on the flange angle; gridlines 8, 9, 10 were on the web plate). Figure 3-10 shows the typical gridlines used for most specimens. Strain gages were given names with a combination of gridlines (e.g. A1, A2, B1, B2, etc.). Figure 3-11 shows a typical gage plan for the bottom flange (flange angles and two cover plates) of the 36 inch specimens. Initial specimens had more strain gages than later specimens as some of the strain gages on the initial specimens were found to be redundant or less relevant.

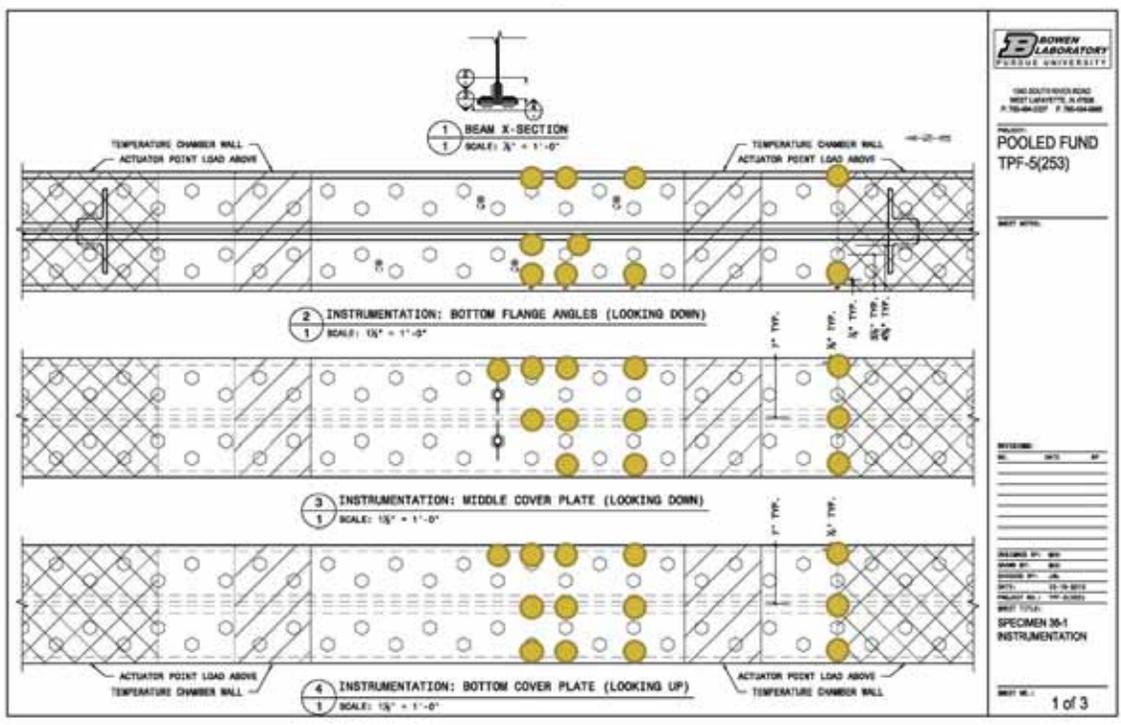
Figure 3-11 Typical 36 inch specimen bottom flange instrumentation

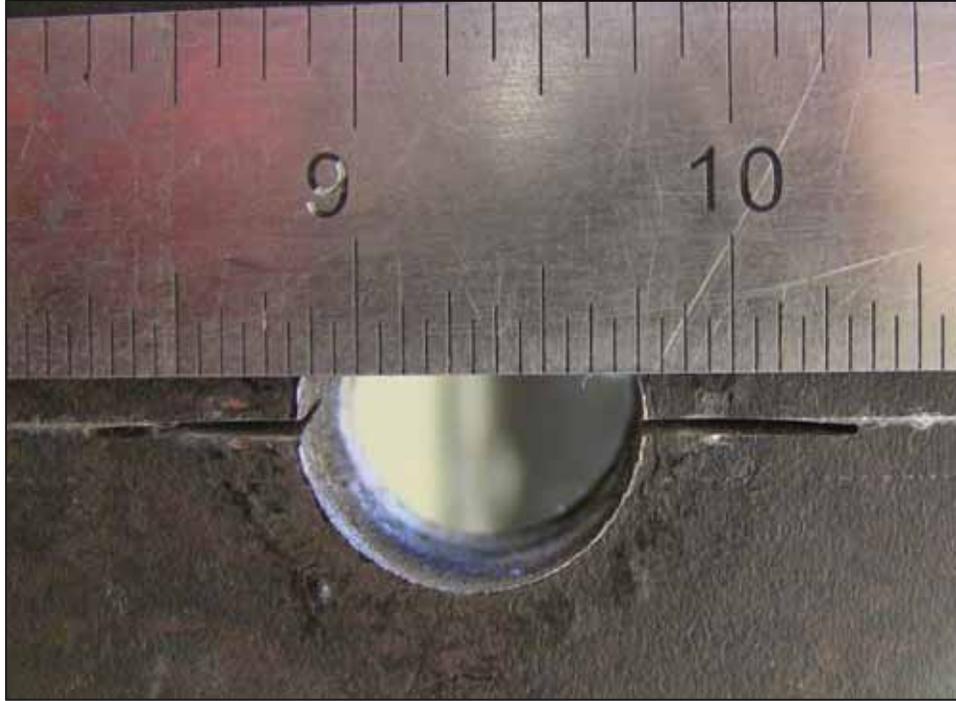
Figure 3-12 Typical hole notch with Dremel 409 cutting wheel

A study was made to determine the most effective method for creating notches at holes. Due to the limited access required to cut notches at the interior portion of a hole a Dremel 409 cutting wheel was selected as the best method. The 409 cutting wheel had a thickness of 0.025" and a diameter of 15/16". A thin wheel was most desirable to create as sharp a notch as possible to increase the stress concentration (see Figure 3-12 for resulting notch). A small diameter cutting wheel was selected in order to minimize the length of the cut while still cutting as deep through the thickness as possible. While initial specimen notches were created as short as possible, notches in later specimens were cut to be slightly shorter than the critical crack length calculated from linear elastic fracture mechanics.

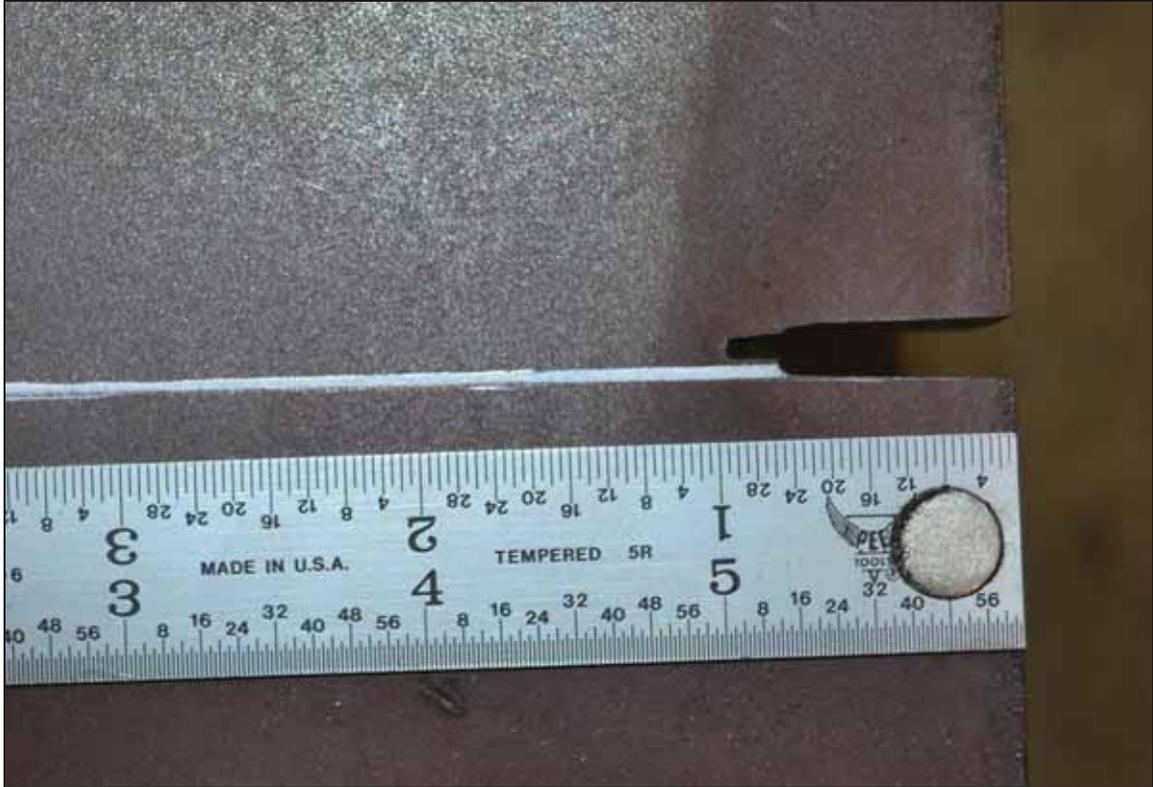
Figure 3-13 Typical edge notch geometry

It was found to be much easier to fabricate notches at the edge of a component than at holes. Access to the exterior edge of plate allowed more flexibility in the tools that could cut the notch as well as increased control throughout the notching process. After an evaluation of several different methods a combination notch was made with a grinding wheel and a cutoff wheel on a 4½” angle grinder. A ¾” deep notch was cut into the edge of the plate with the grinding wheel which was 3/16” thick. Next a ¼” deep notch was cut at the center of the first notch using the cutoff wheel which had a thickness of 0.04”. Figure 3-13 shows a plan view of the end result after both the grinding wheel and cutoff wheel were used.

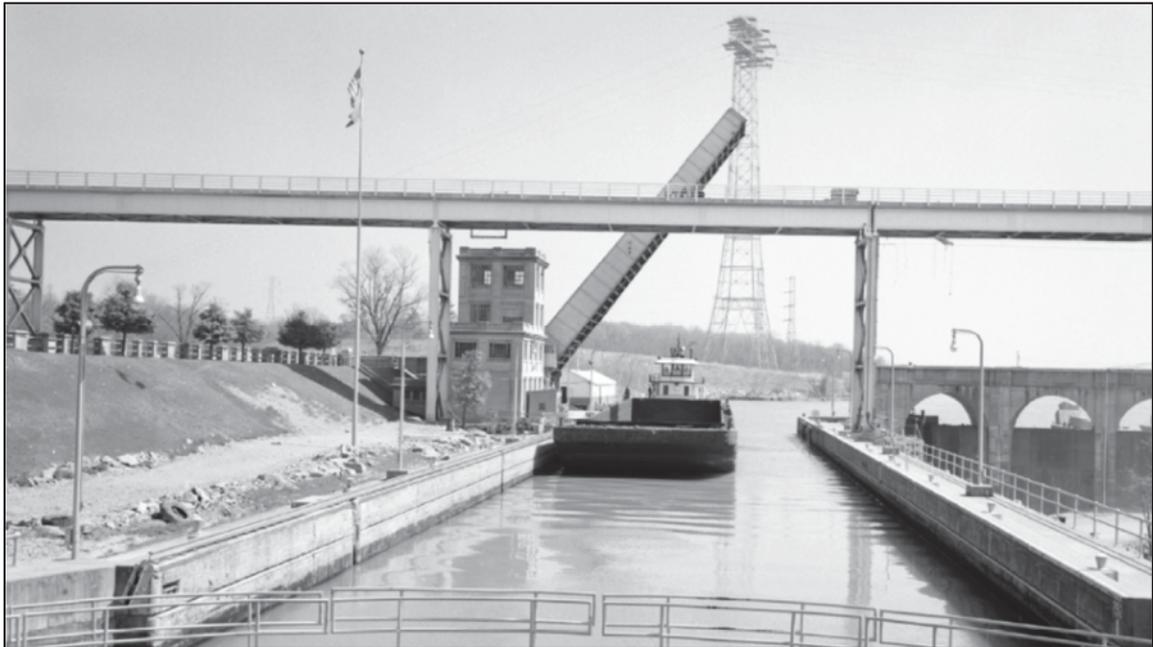
Figure 3-14 Wilson Dam Bascule Bridge in raised position in the background, 1958 (Williamson, 2012)

The 23 inch tall specimens (labeled 23-xx) were obtained from the Wilson Dam Bascule Bridge (Figure 3-14), which was removed from service in 2012. The specimens were riveted built-up steel beams with a usable span of 22'-0" (after removal). The bridge was built in 1926 as an access route over the lock at Wilson Dam, in Lauderdale County, Alabama on the Tennessee River (Williamson, 2012). Selected original design drawings of the bridge and floor beams can be found in APPENDIX A. The specimens were used as floor beams spanning between the bascule girders of the bridge.
