Purdue University

Steel Bridge Research, Inspection, Training, and Engineering (S-BRITE) Center

Member-level Redundancy of Built-up Steel Girders Subjected to Flexure

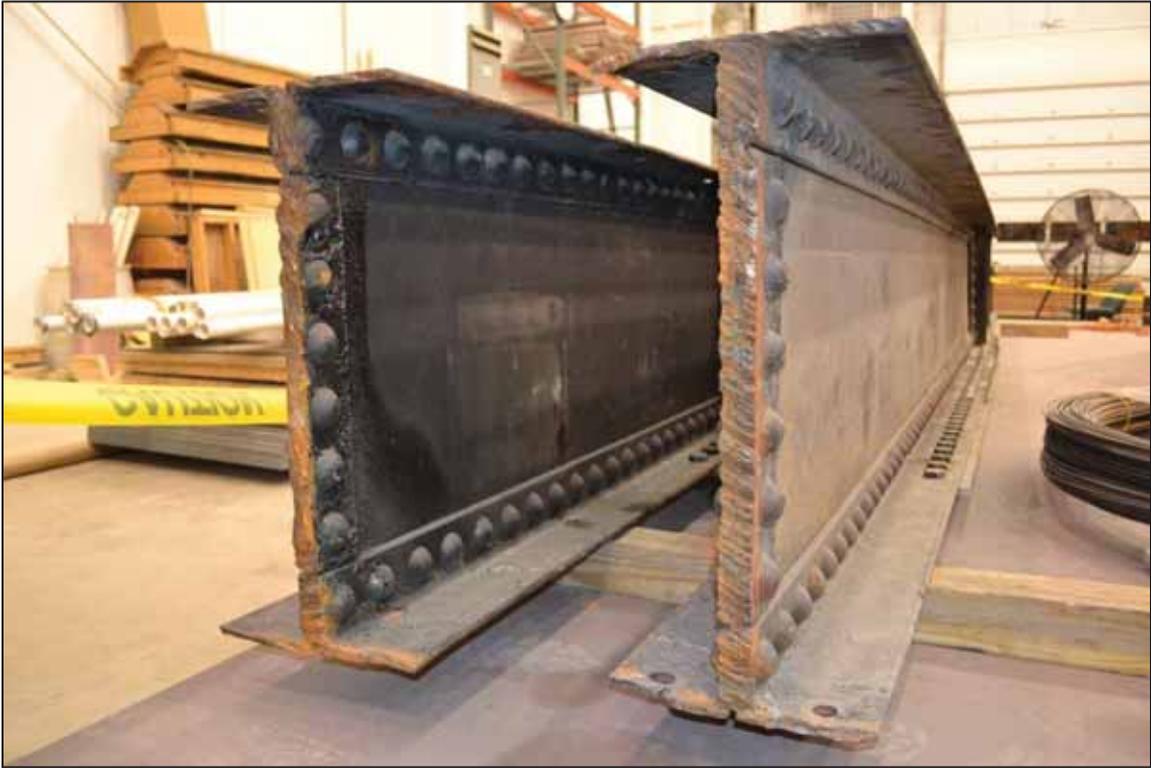
Figure 3-15 Wilson Dam Bascule Bridge specimens

The cross section of the floor beams was composed of a 23"x3/8" web plate riveted to two 5x3½"x7/16" flange angles (long legs horizontal) on the top and bottom flange (see Figure 3-15). A cover plate was added to the bottom flange of each specimen for the

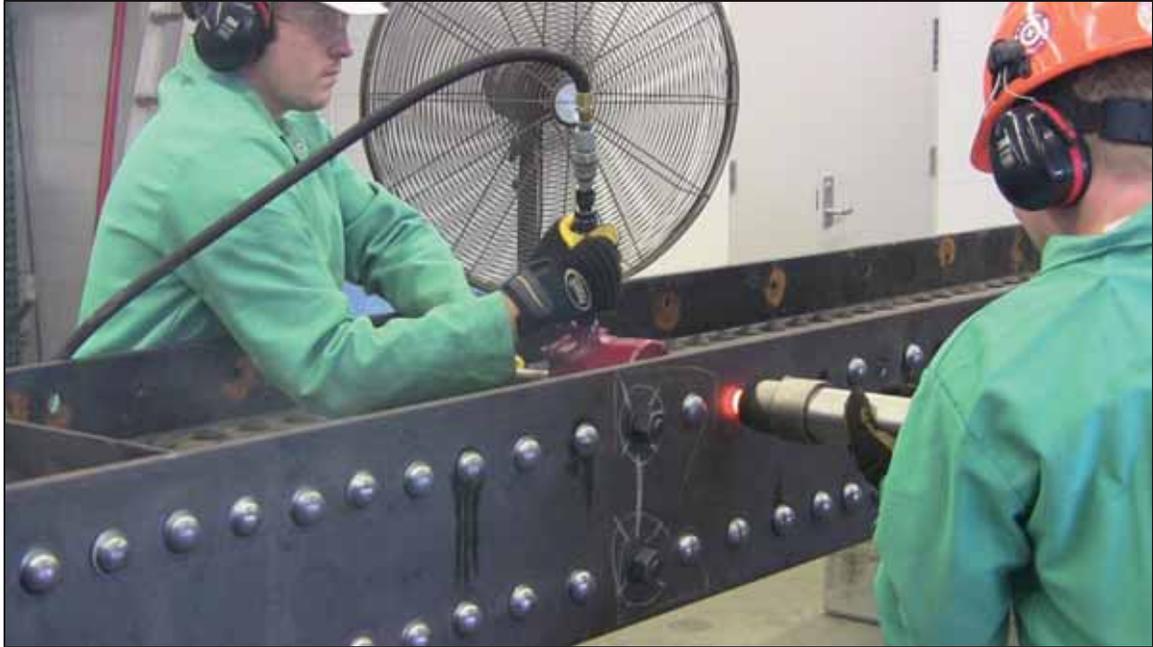
Figure 3-16 Cover plate installation on historical specimens

purposes of the current research test. Holes were drilled in the horizontal leg of the flange angles as well as the cover plate. New rivets were driven in the holes connecting the cover plate to the flange angles (see Figure 3-16). Design drawings of the modified sections can be seen in APPENDIX A.

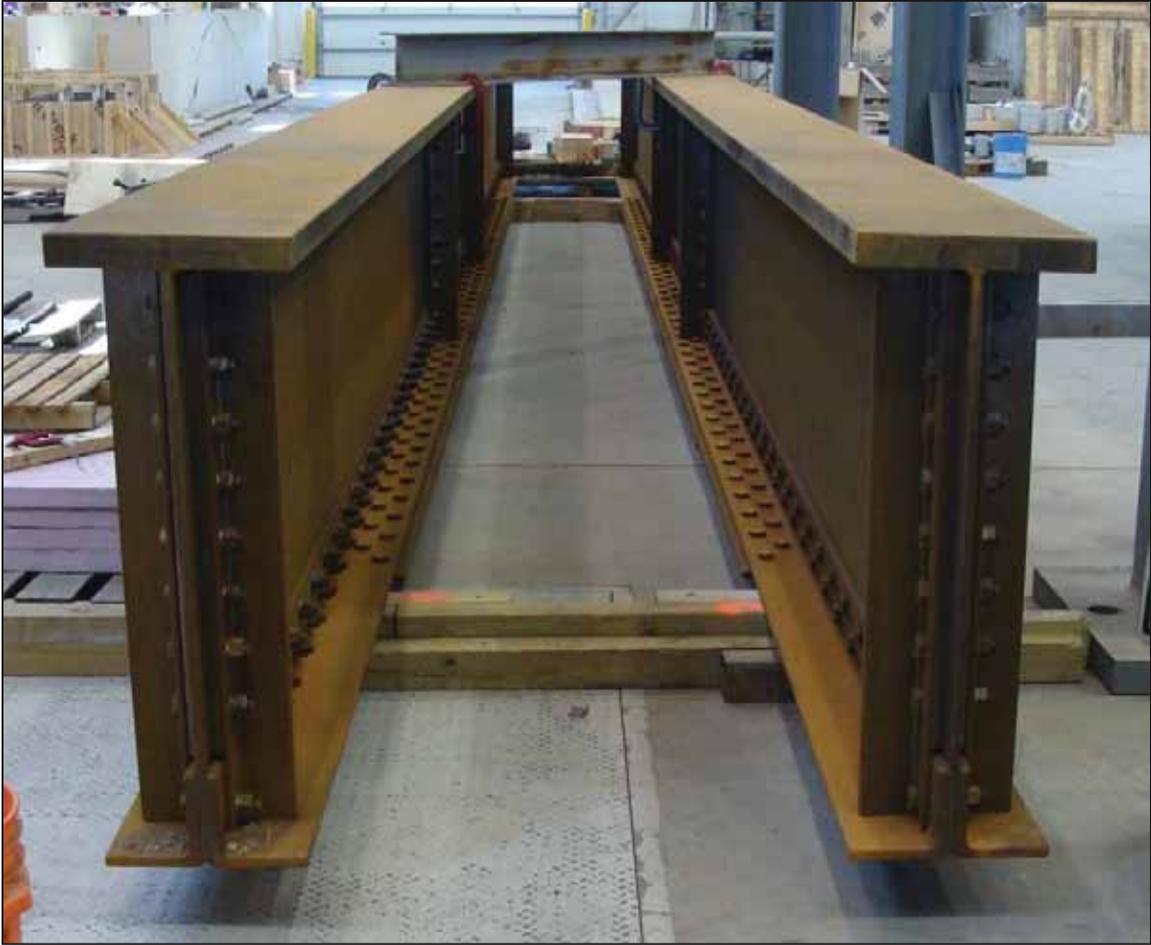
Figure 3-17 Fabricated Specimens (46" Web Height)

welded to the web (see Figure 3-17 for typical fabrication). Bottom flange angles were fabricated using 6"x6"x3/4" L's and attached to both the web plate and the 14"x3/4" cover plate(s) with 7/8"Ø bolts or rivets (depending on the specimen). The 30" and 46" specimens were fabricated with a single cover plate on the bottom flange which was stepped at the location where the bending moment required a larger section modulus. Similarly, the 36" specimens were fabricated with two cover plates on the bottom flange which were also stepped to meet bending moment demand. Web plates were 1/2" thick with heights of 30", 36", and 46" for the three different specimens. The span length of the newly fabricated specimens was 39'-0" from centerline to centerline of bearings. The girders extended an additional 6 inches beyond the centerline of the bearing for an overall specimen length of 40'-0". See APPENDIX C for detailed design drawings of the specimens.

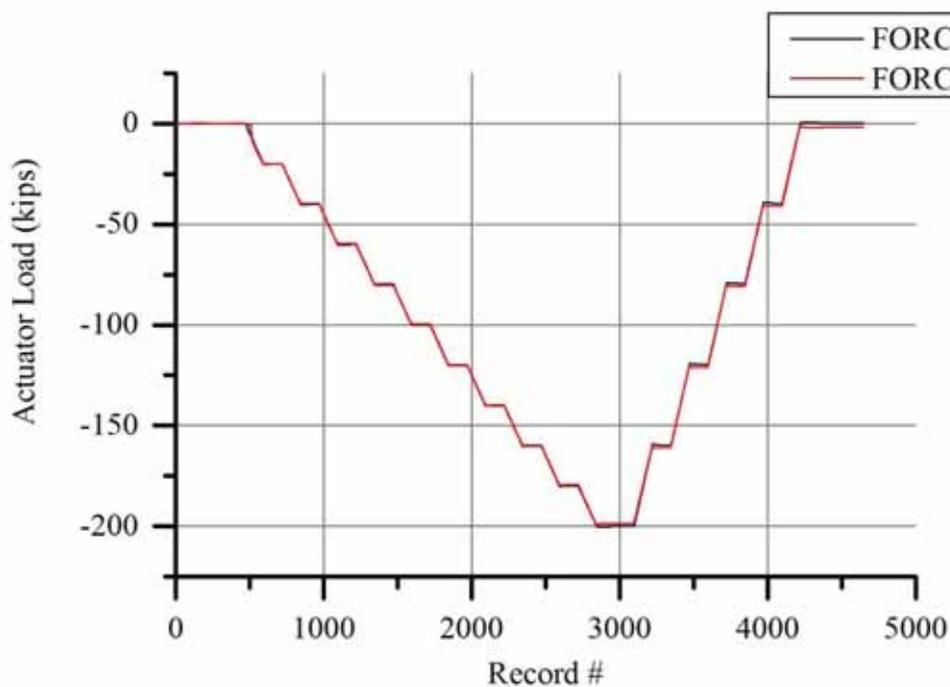
Figure 3-18 Typical static test loading rate

Data was collected at several points throughout the test process. The primary data that was evaluated was measured during static tests performed at discrete times or after a significant event. A typical example of the static test can be seen in Figure 3-18 in which the load was incrementally increased, then decreased, from 0 kips to 200 kips.

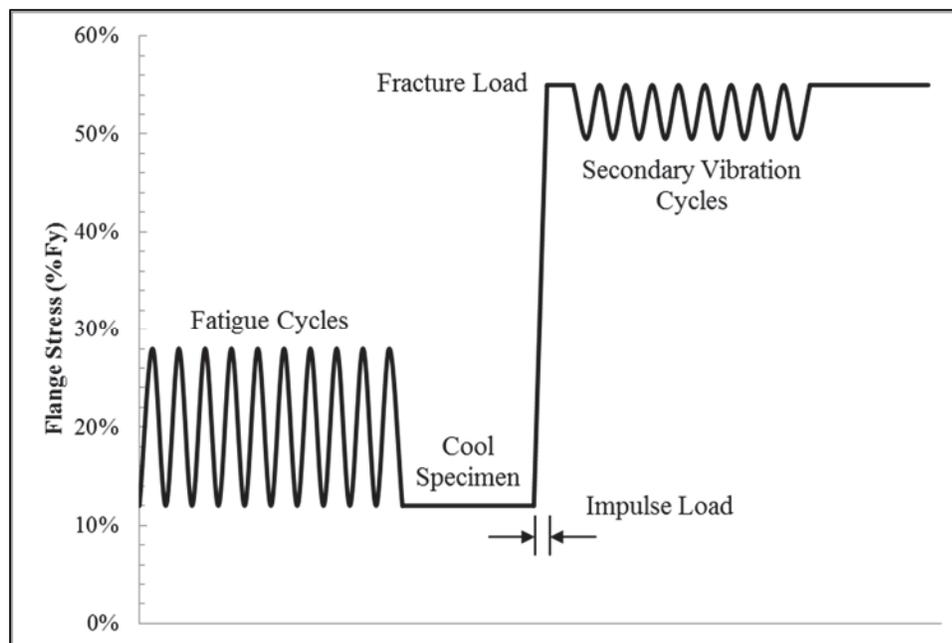
Figure 3-19 Fracture loading protocol

Figure 3-19 illustrates the loading protocol of the test. The specimens were first cyclically loaded to create a sharp crack tip, and then loaded with an impulse load to induce a brittle fracture, similar to the loading protocol used in the work performed by Wright (2003), who was testing fracture resistance of high-performance steel girders. As is described further in Section 3.3.3, each specimen was cooled to low temperatures prior to the application of load. An impulse load creating a stress corresponding to $0.55F_y$ was applied as fast as the actuators were able to apply the load (approximately 0.5-0.75 seconds). The load was held at this point for 2 seconds and then the actuators were cycled between 90% and 100% of the maximum load for 25 cycles to represent secondary vibration that could occur during a traffic loading condition. This further increased the likelihood of fracture under the applied loading. The general approach described by Wright was believed to be a reasonable approach.

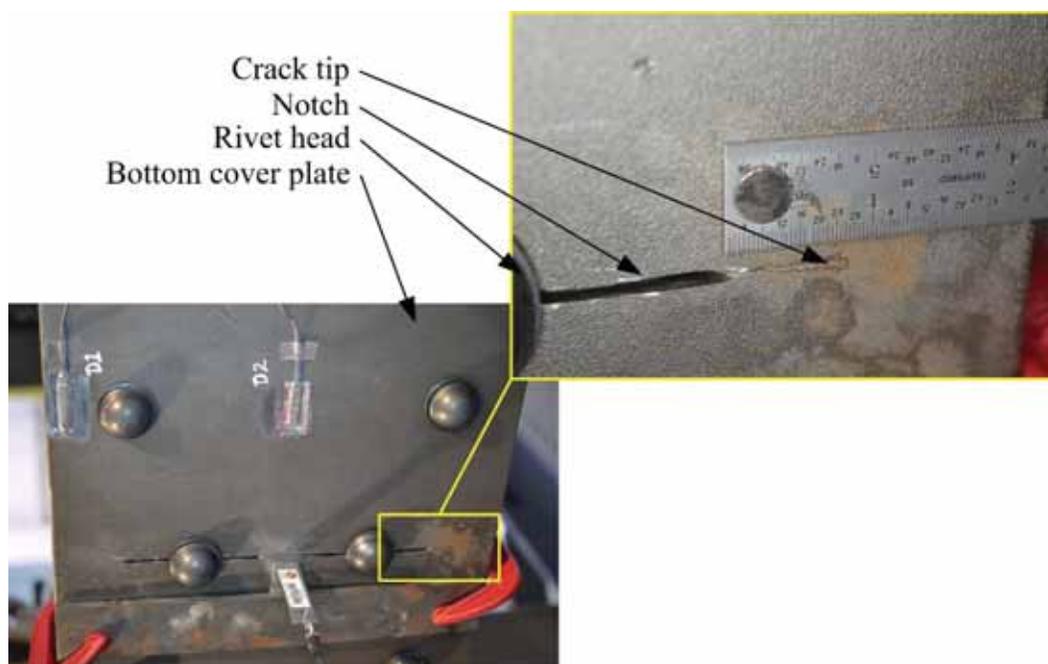
Figure 3-20 Crack growth from notch at a hole (Specimen 46-3)

For the fatigue cycling method a specimen was first notched by one of the methods described in Section 3.2.3. Then the specimen was cyclically loaded to create a fatigue crack at the notch location. Notches were created at close to the calculated critical crack length to minimize the required time to have the crack reach its critical length and thereby decrease the duration of the specimen testing. A typical fatigue crack grown from a notch at a hole can be seen in Figure 3-20.

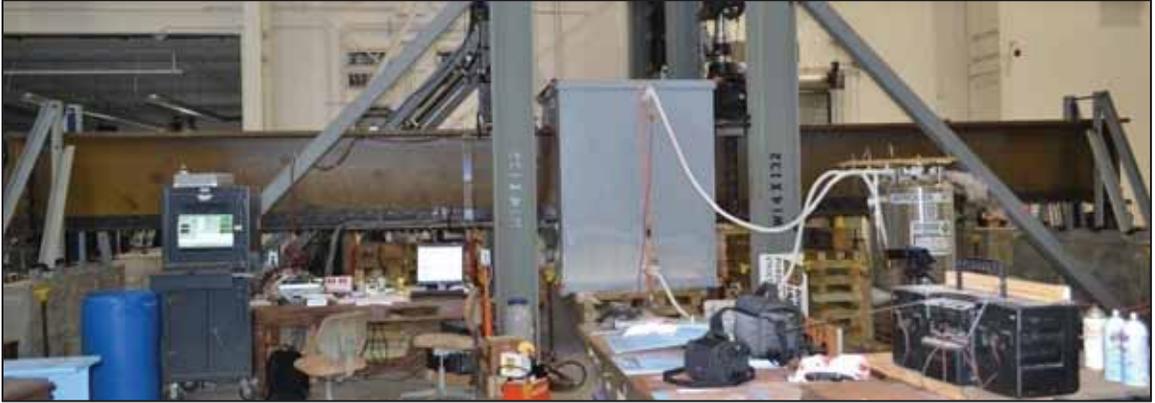
Figure 3-21 Temperature chamber installed on beam (side view)

The chamber was constructed in a clamshell fashion with two halves on either side of the specimen. Each half of the clamshell was constructed with four layers of 2” rigid insulation to insulate the specimen during cooling. Two layers of 2” rigid insulation was used at the two longitudinal ends where the specimen emerged from the chamber. At this location the rigid insulation was custom cut for each specimen to ensure proper fit-up and minimal leakage.

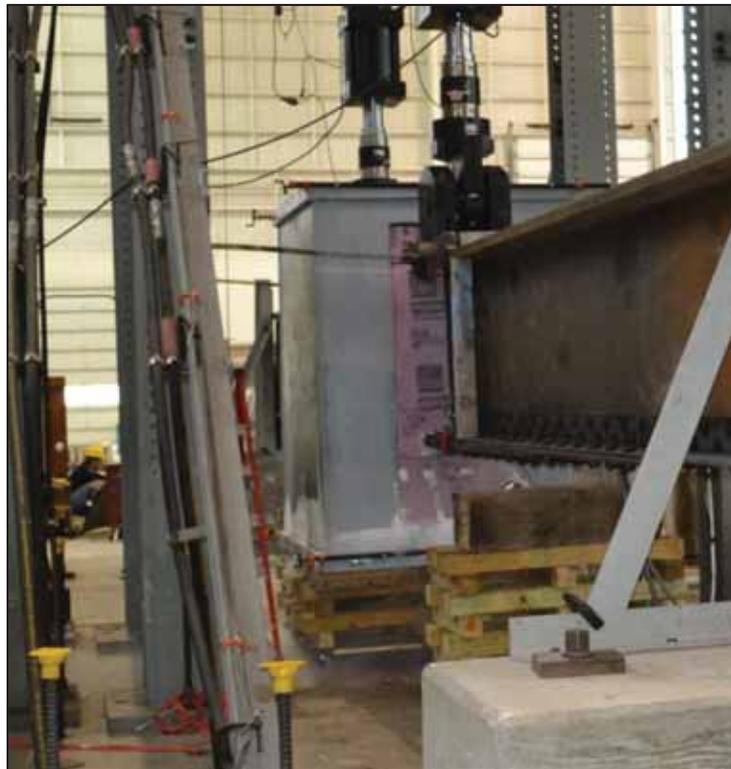
Figure 3-22 Temperature chamber installed on beam (end view)

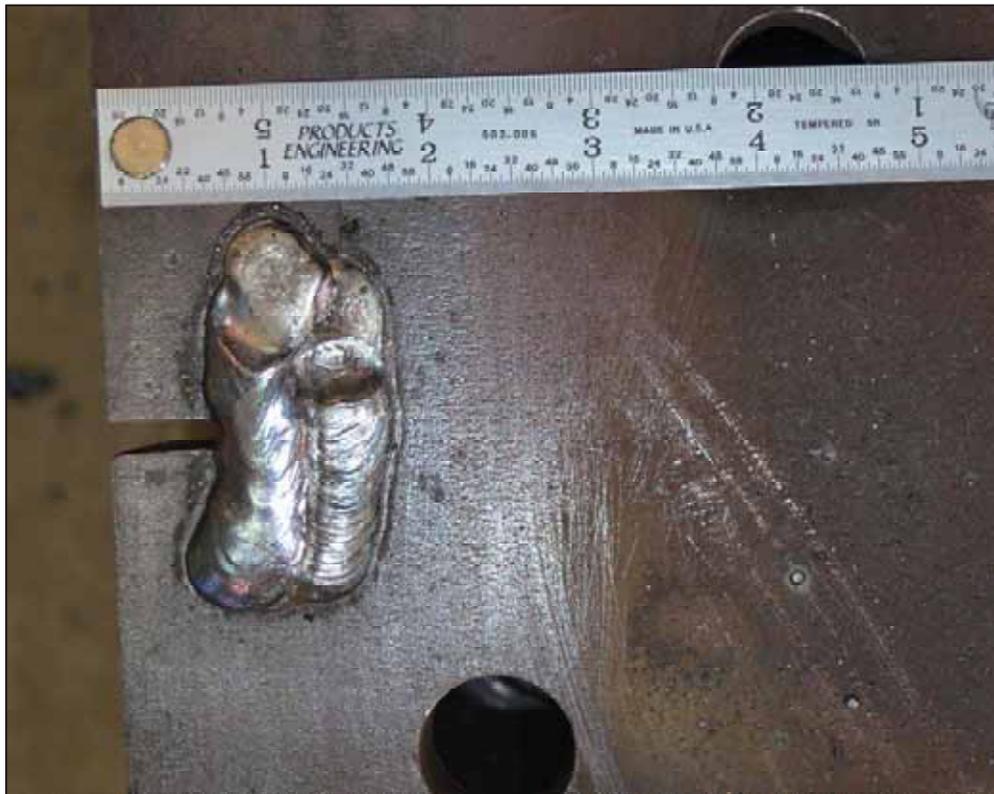
Figure 3-24 Edge notch with Wearshield ME weld at notch tip

not found to be a reliable method for creating fractures. However, they were found to be an advantageous method in producing a sharp crack tip at the tip of a notch with no fatigue cracking required. They were utilized in conjunction with the wedge method as described in Section 3.3.3.2.2. Two beads of Wearshield ME were placed orthogonal to an edge notch as shown in Figure 3-24. The beads were placed at the top and bottom of each plate face as well as on each side. In order to allow proper fit-up of adjacent components a groove was ground into the interior face of a component which was subsequently filled with the hardfacing weld rod.

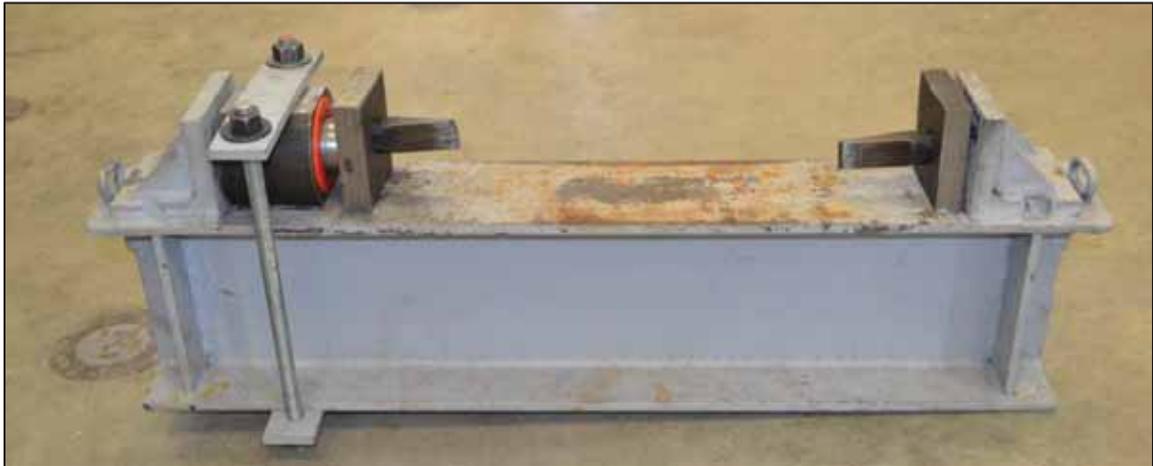
Figure 3-25 Driven wedge apparatus

Due to the required displacement of the specimen, it was decided that a self-reacting assembly attached directly to the specimen would allow the appropriate movement without affecting the capacity during a test. A small steel beam was constructed with gusset reinforced reaction angles welded to the top flange (see Figure 3-25). The purpose of the beam was to span the transverse distance of the cover plates with additional space for wedges and loading equipment. Web stiffeners were added to increase the shear capacity

of the beam. A 20 ton hydraulic ram (Power Team RSS202) with 1 ¾" stroke was used to drive a wedge on one side of the bottom flange, while the wedge on the opposite side of the flange reacted solely against the reaction angle attached to the beam. The beam was allowed to move in the transverse direction so that equal loads were applied to each wedge. Bracing angles were clamped to the bottom flange of the web to ensure movement of the bracing beam was restrained to the transverse direction of the specimen (see Figure 3-26).

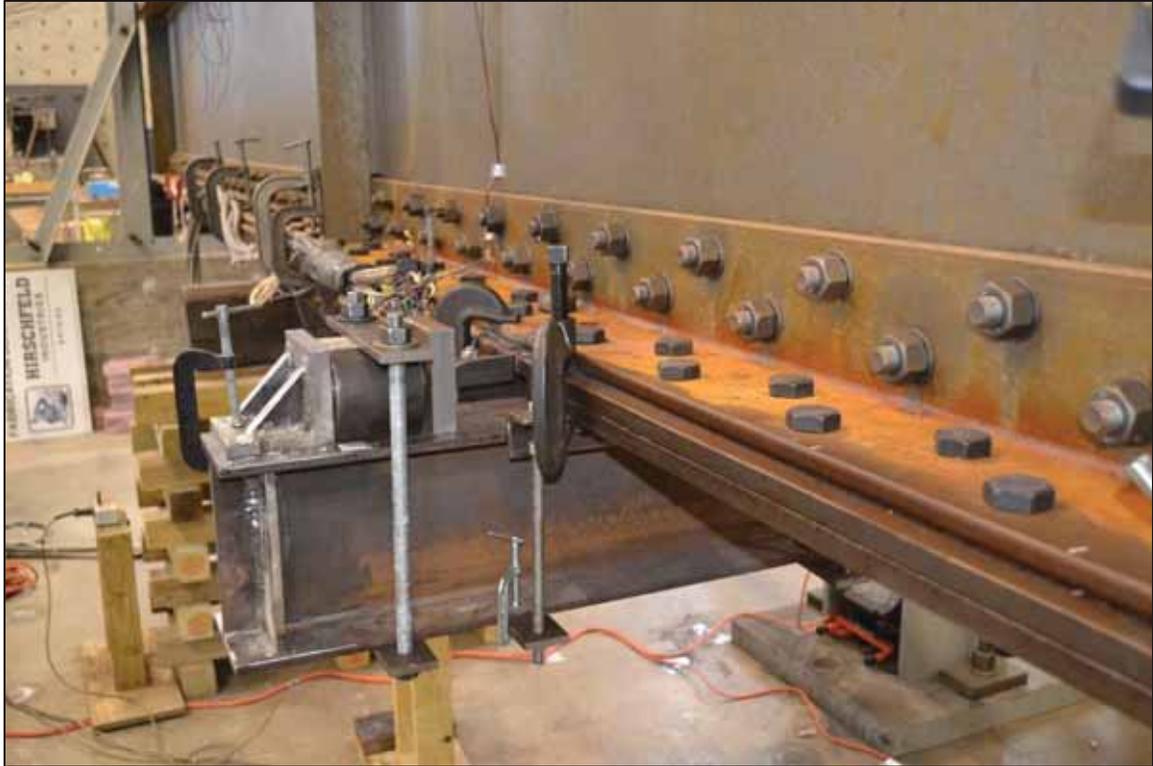
Figure 3-26 Driven wedge apparatus installed on Specimen 36-2

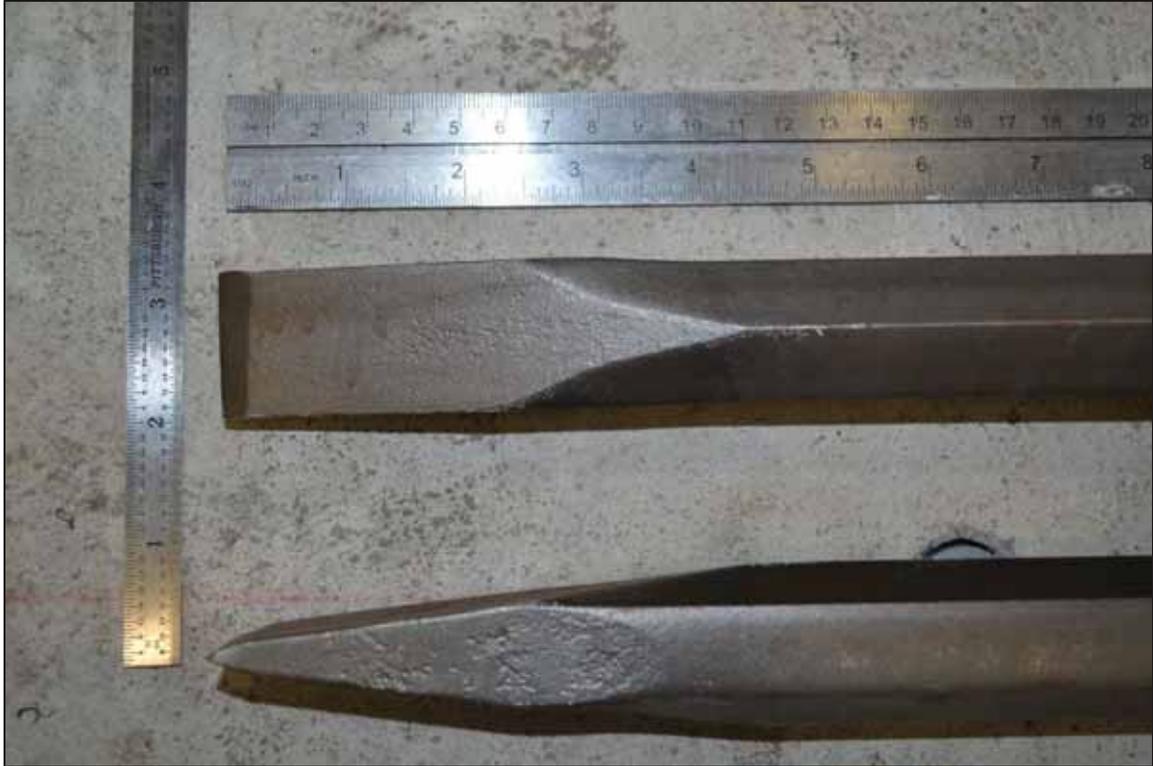
Figure 3-27 Wedge geometry

Wedges with small and angular tips were desired to maximize the mechanical advantage, force applied to the edges of the notch, and thereby increase the stress concentration. Wedges were made by cutting the ends from 1-1/8"x6x14 standard demolition chisels. A side and top view of the chisels can be seen in Figure 3-27. The wedges had a width of 1-1/8", length of 4 1/4", a depth of 1/4". The wedge angle was 8.9° and a mechanical advantage of 3.2. This resulted in a maximum force (at full hydraulic pressure) of 128 kips applied longitudinally to the notch faces. The resulting load was applied in the longitudinal axis of the specimen, which significantly increased the stress concentration at the notch tip.

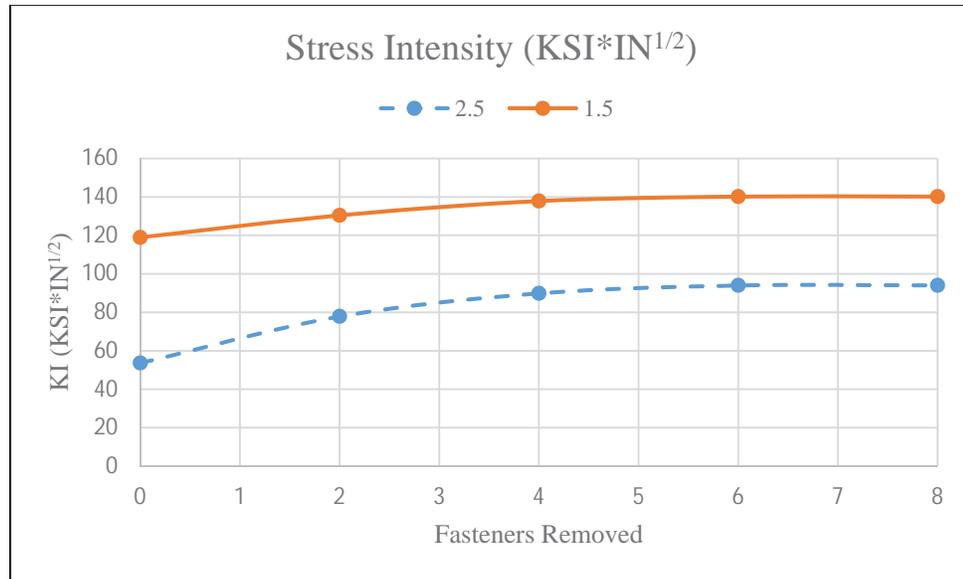
Figure 3-28 Stress intensity vs. number of fasteners removed

After initial attempts using the driven wedge method were found to be inconsistent, it was discovered that the constraint of nearby fasteners played a large role in the fracture of a built-up specimen component. The constraint and proximity of fasteners was investigated. A small finite element parametric study was made to determine the effect of the constraint of local fasteners to the stress intensity at the crack tip for two different notch lengths (2½” and 1½”). A 14”x¾” plate was modeled using half symmetry. Fasteners were spaced in the plate with the same dimensions (pitch, and gage) as the 36” specimens. The first model was constructed with all required fasteners. In subsequent models fasteners were removed two at a time (one on each side of the notch plane). Figure 3-28 shows the results of the study. The stress intensity was affected by removing up to six bolts (three on

either side of the notch plane) after which there was minimal impact. The stress intensity for 1½” notches (similar to the notch size used in the test setup) increased by approximately 17%. Based on the outcomes of this study, two fasteners were removed from the remaining specimens during the fracture phase of the test. This resulted in much more reliable and predictable fractures.

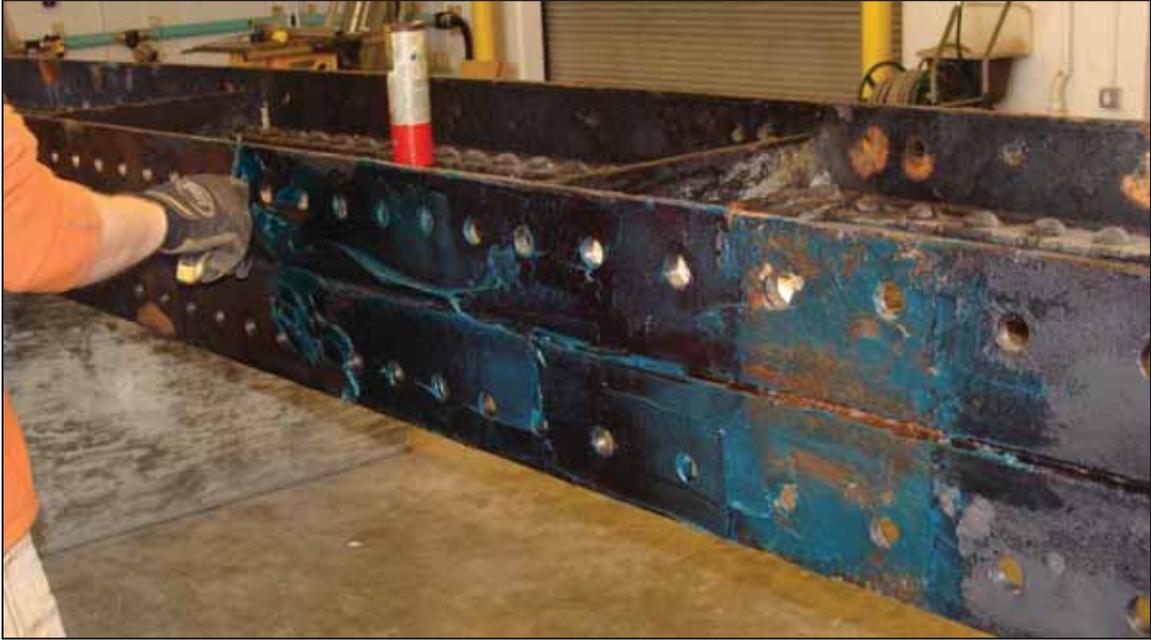
Figure 3-29 Specimen 23-1 application of grease between components

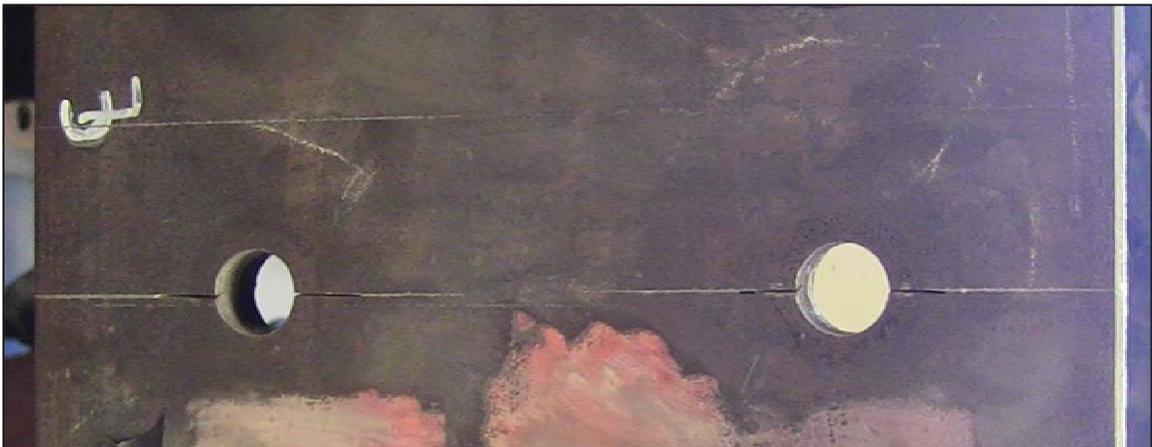
Figure 3-30 Specimen 23-1 hole notches

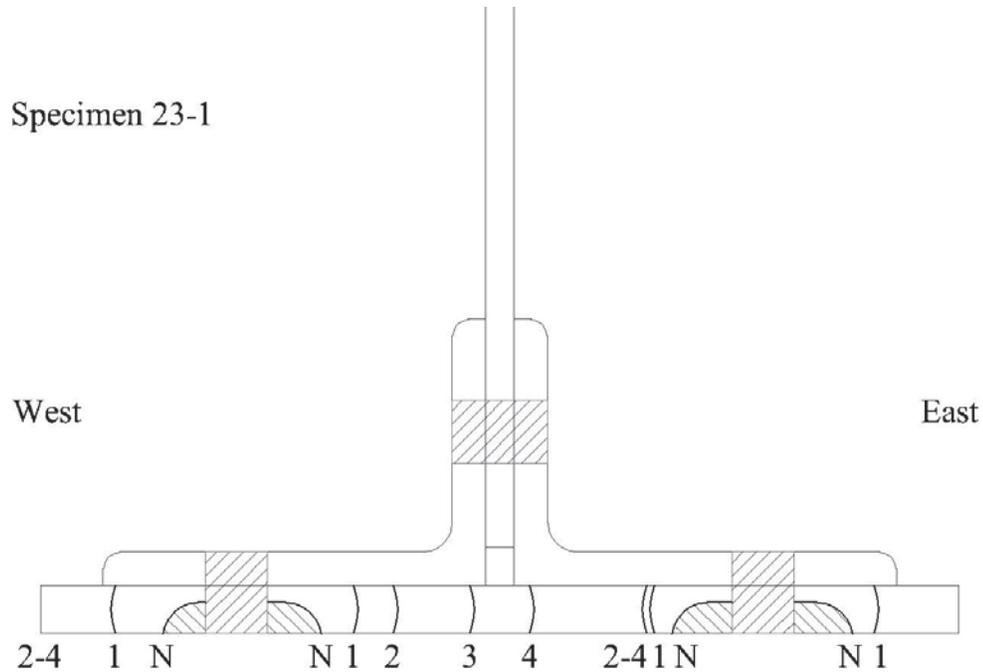
Figure 3-31 Specimen 23-1 cover plate crack growth

At 1.85 Million cycles the cracks in the notches were measured to be at 1.18", 1.12", 1.01", and 1.05" (from west-to-east) measured from the edge of the hole to the tip of the crack. Using an assumed fracture toughness (as material testing had not been performed at this stage) the cracks were near the critical crack length. Later, material testing showed that the critical crack length for the plates was approximately 0.8" in length based on linear elastic fracture mechanics and the stress intensity factor found per Newman (1971). An attempt was made to fracture the specimen using the protocol described in Section 3.3.3 at a bottom flange temperature of -66° F, however no fracture occurred. The specimen was allowed to warm back up to ambient temperature and then cycled further to extend the crack lengths. Three more attempts were made to fracture the bottom cover plate at increasing crack lengths. The temperature at the three additional fracture attempts was -79° F, -75° F, and -11° F (due to a depletion of the liquid nitrogen). Figure 3-31 shows the

notch lengths and crack lengths at each of the four fracture attempts. In the image, 'N' represents the original notch length, and each of the numbers (1-4) represent the crack length at each fracture attempt. During the fatigue cycling of the specimen, after the fourth fracture attempt, the cover plate failed. The total number of cycles applied to the specimen was 2.14 million cycles.

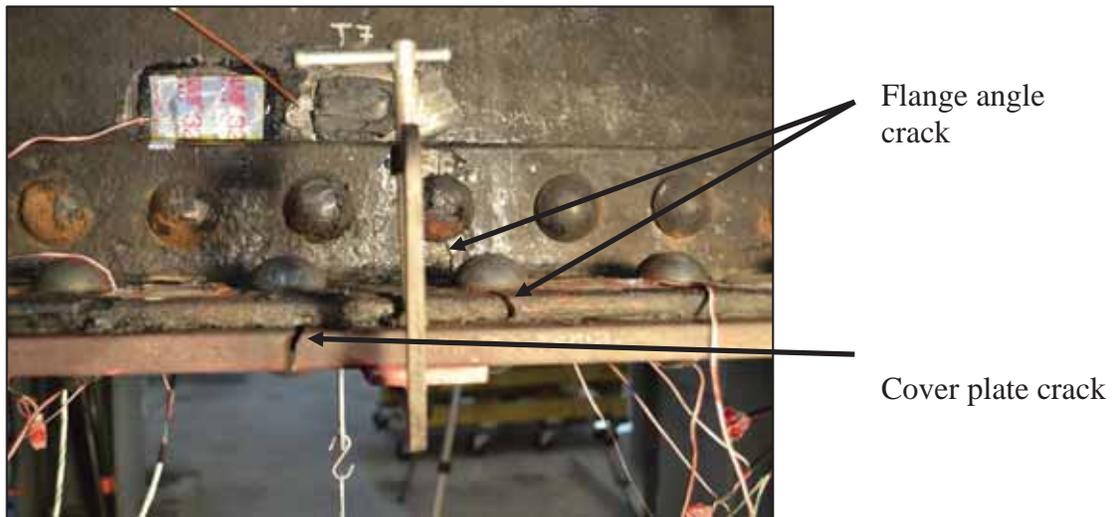
Figure 3-32 Specimen 23-1 failed flange angle and cover plate

section after the failure of the cover plate. The calculated net section stress range of the remaining net section was 25.6 ksi. After cycling for 355,000 cycles, the east flange angle failed (one hole north of the crack in the failed cover plate) and the test was stopped (see Figure 3-32). The fatigue data can be seen plotted with other test results in Section 3.5.2.

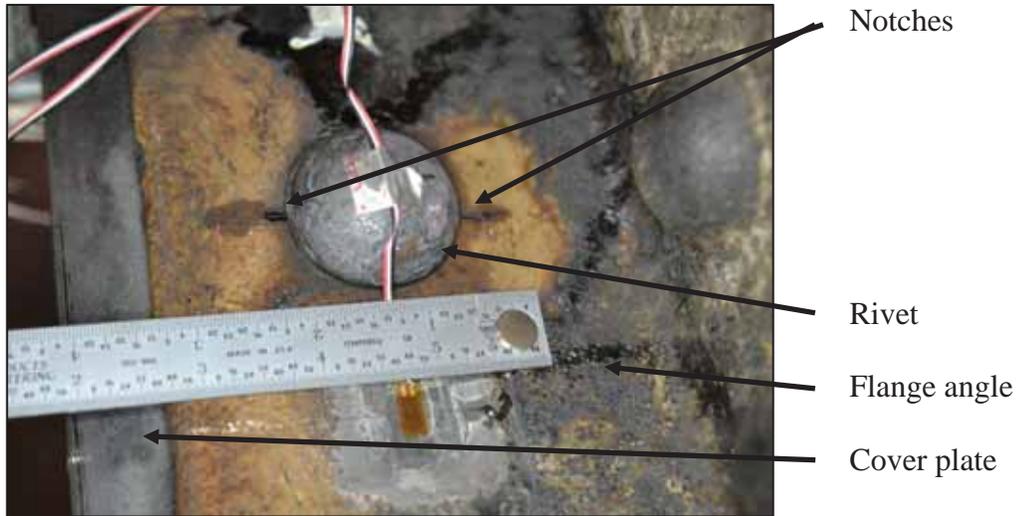
Figure 3-33 Specimen 23-2 hole notches

The east flange angle of Specimen 23-2 was notched at a rivet hole (see Figure 3-33) to investigate the behavior of a beam when the cross section was asymmetrical resulting from a component failure. A 12"x1/2" A36 steel cover plate was attached to the bottom flange of the specimen with hot driven rivets. The cover plate was covered with a thin layer of packing grease prior to the installation in order to minimize the friction contribution to stress transfer between the components. The material properties of each component are reported in APPENDIX D. The notches were cut prior to the addition of the cover plate and were cut from the bottom and the top of the angle giving each notch a quarter circle shape at each face of the angle leg.

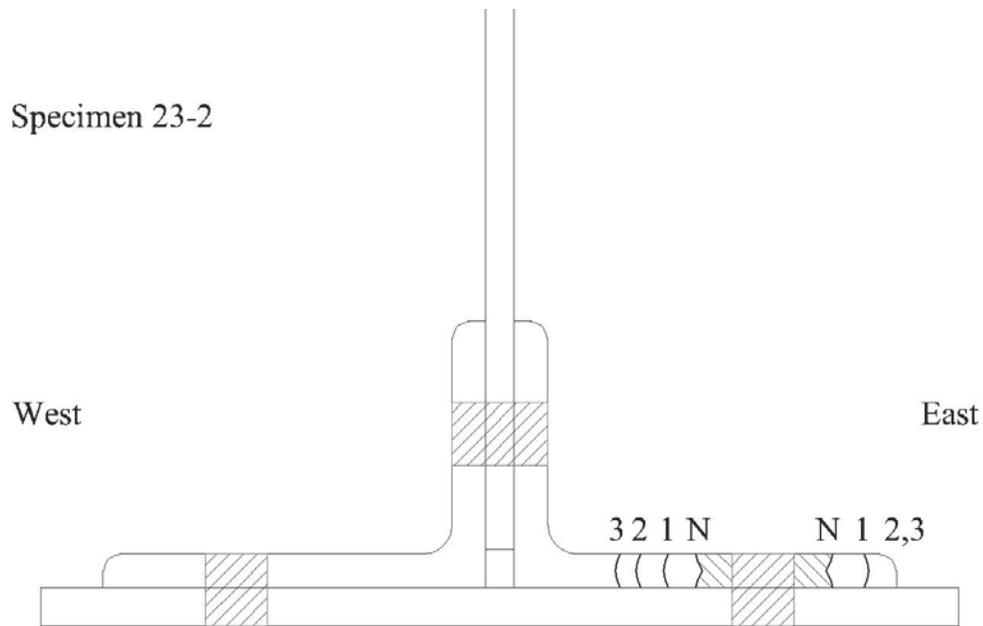
Figure 3-34 Specimen 23-2 crack growth in east flange angle

The calculated critical crack length for Specimen 23-2 was 0.25", less than the original notch lengths. However, in order to create a sharp crack tip at each notch the cracks were grown in fatigue. After 319,000 cycles, cracks had grown from the notches on both sides of the rivet hole in the east flange angle. The specimen was cooled in the temperature chamber to -74°F and an attempt was made to fracture the flange angle. Since the specimen did not fracture, it was allowed to warm and cycled in fatigue to increase the length of the crack. The specimen was tested for fracture two additional times at temperatures of -66°F and -64°F (see Figure 3-34 for crack lengths at different attempts) with no fracture occurring in the flange angle.

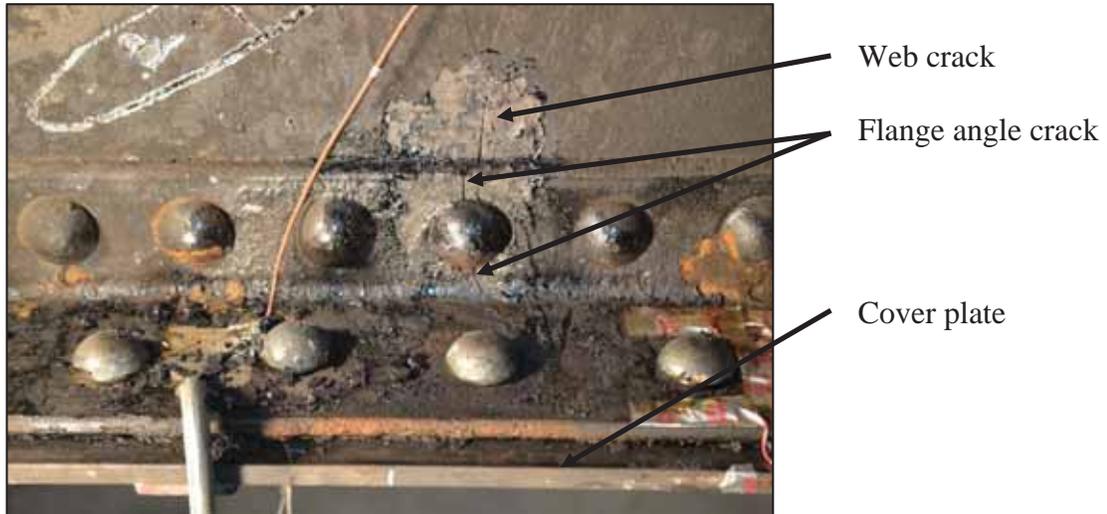
Figure 3-35 West side of failed Specimen 23-2

angle of the west flange angle as well as the web plate (Figure 3-35), the test was stopped. The compiled fatigue data is described in Section 3.5.2.

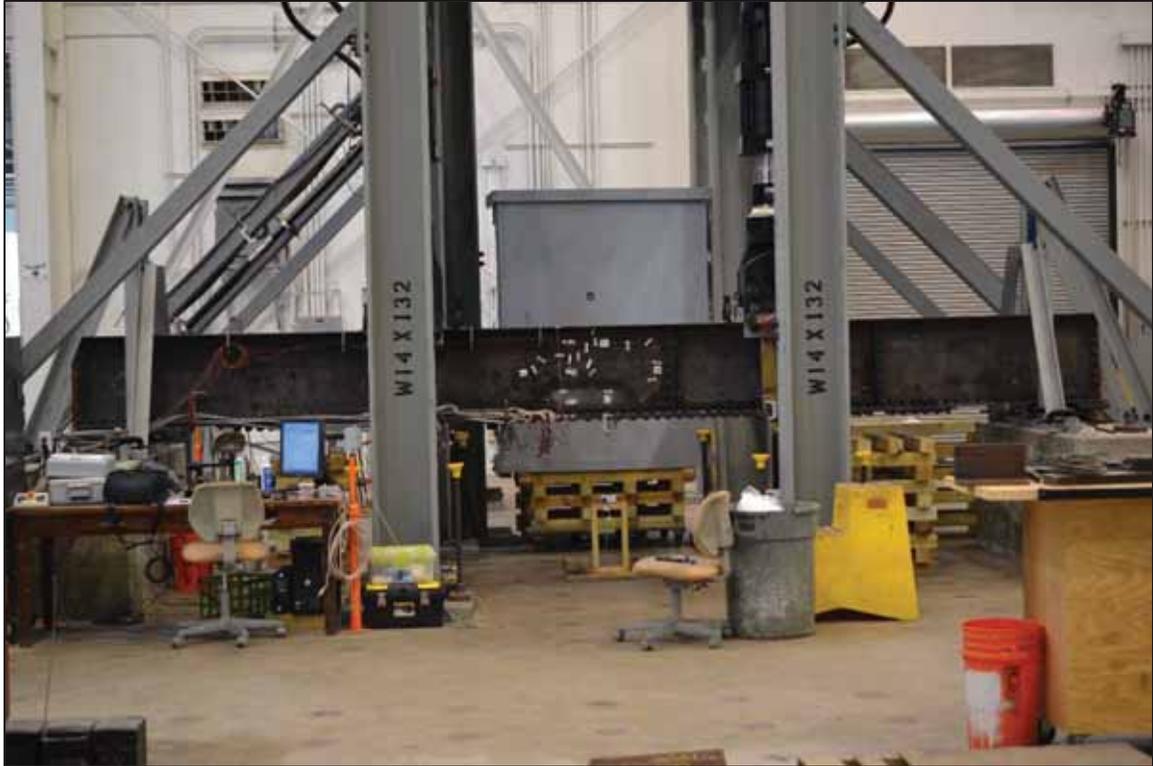
Figure 3-36 Specimen 23-3 test setup

Specimen 23-3 was fabricated with the same components and notched in the same location as Specimen 23-2 (12"x1/2" A36 cover plate riveted to the historical floor beam with packing grease between the cover plate and bottom flange angles). APPENDIX D lists the material properties. Figure 3-36 shows Specimen 23-3 in the test setup. The hole notches in the east flange angle were 0.64" and 0.39" (from west to east) and were cut from the top and bottom of the angle.

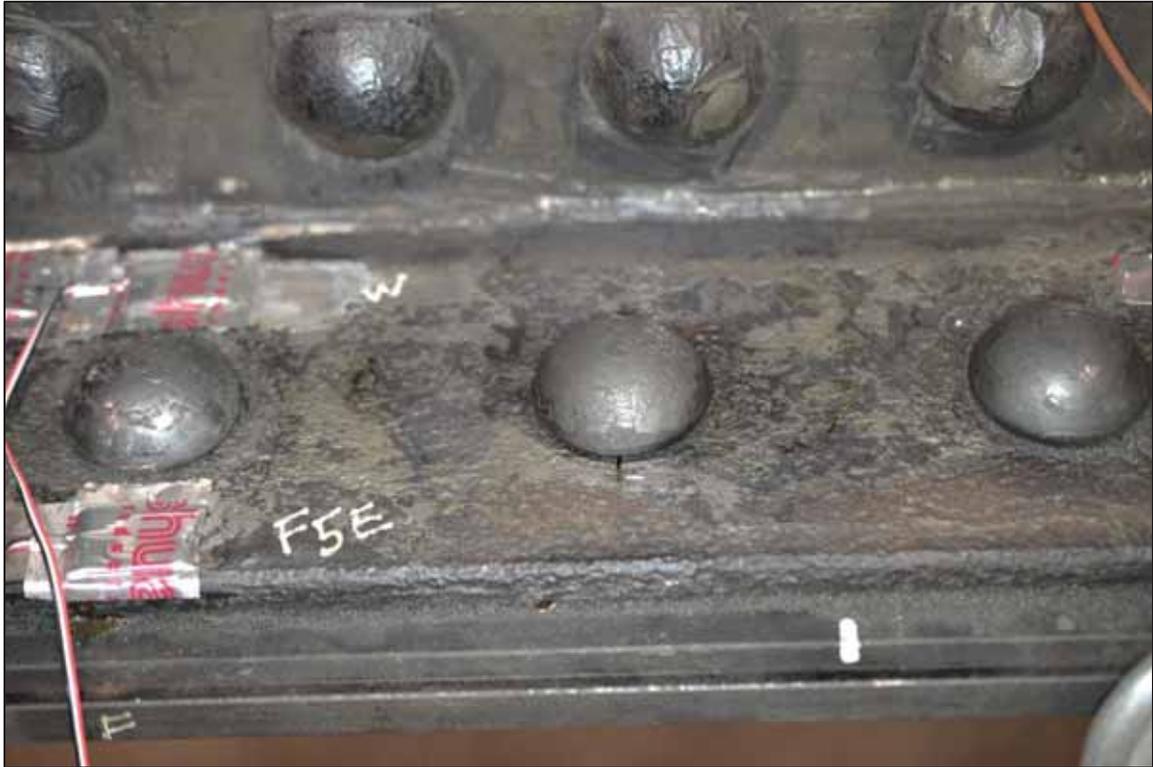
Figure 3-37 Crack growth from Specimen 23-3 hole notch

The specimen was again cycled in fatigue to create a sharp crack tip at the hole notches in the flange angle (Figure 3-37). Based on the results of Specimen 23-1 and Specimen 23-2, the cracks were allowed to grow further (prior to the fracture test being attempted) with the hope of inducing a fracture. Cracks were detected in both notches of the flange angle after 383,000 cycles. The crack grew quicker than expected through the exterior edge of the angle. At this point the total length of the crack was 3.6” (measured from the edge of angle through the hole) and the specimen was prepared for the fracture phase of the test. The specimen was first cooled to -77° F and then the actuators were loaded to 50 kips each (resulting in a calculated net section stress of 21.1 ksi in the bottom

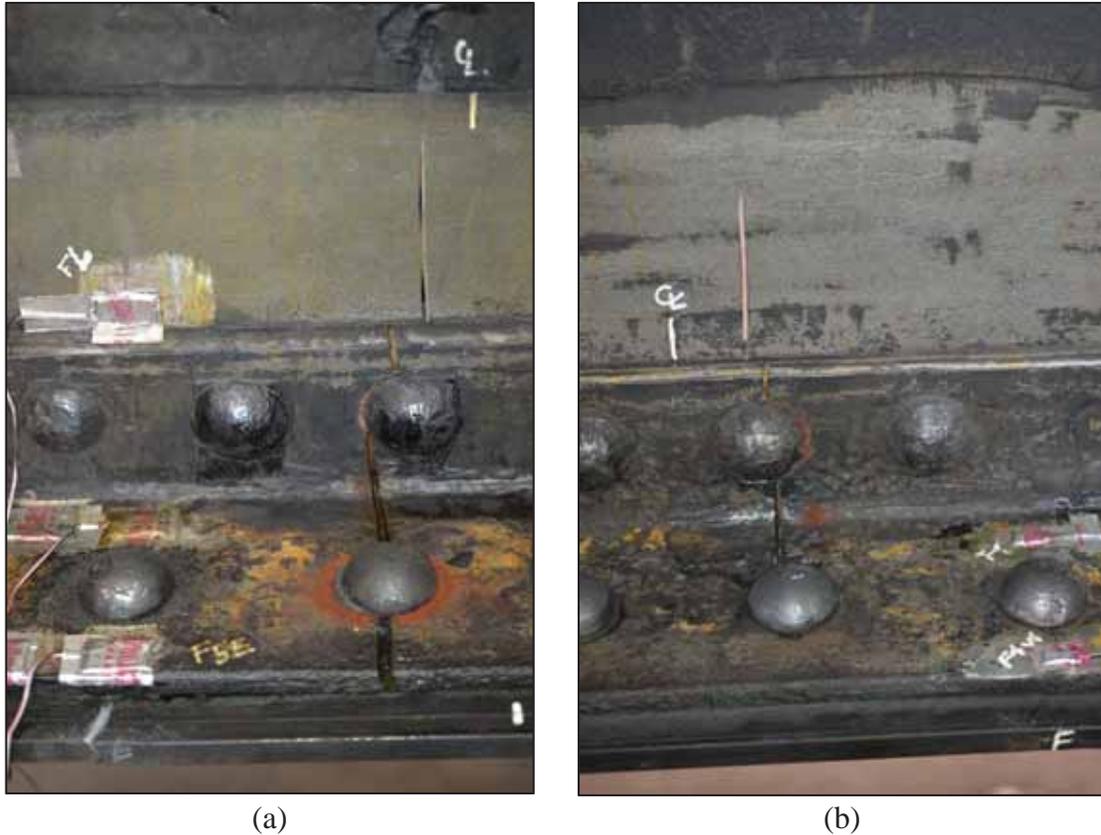
Figure 3-38 Cracks in Specimen 23-3; (a) East side, (b) West side

The cyclic loading applied to the actuators was between 15 kips and 50 kips on each jack. This load equated to a calculated net section stress range of 16.1 ksi in the bottom cover plate. After 3.31 million cycles, cracks were detected in the cover plate on the east side. The cracks were located one hole south of the original crack location in the

east flange angle. Shortly thereafter (52,000 cycles) a crack was detected growing in the web plate (directly above the original flange angle crack). Cracks were detected 184,000 cycles later in the vertical leg of the west flange angle in the same longitudinal location as the original east flange angle cracks. After another 237,000 cycles the test was stopped. At this point the east flange angle was completely cracked, the cover plate had a crack running from the east side, through the east rivet hole and had arrested in the west rivet hole. Additionally, the west flange angle had a crack through the entire vertical leg and had arrested in the rivet hole of the horizontal leg, and the web plate had a 7.2" crack. Figure 3-38 shows the extents of the cracks (under load) at the end of the test. A total of 3.78 million cycles were accumulated between the failure of the horizontal leg of the east flange angle and the time that the test was stopped.

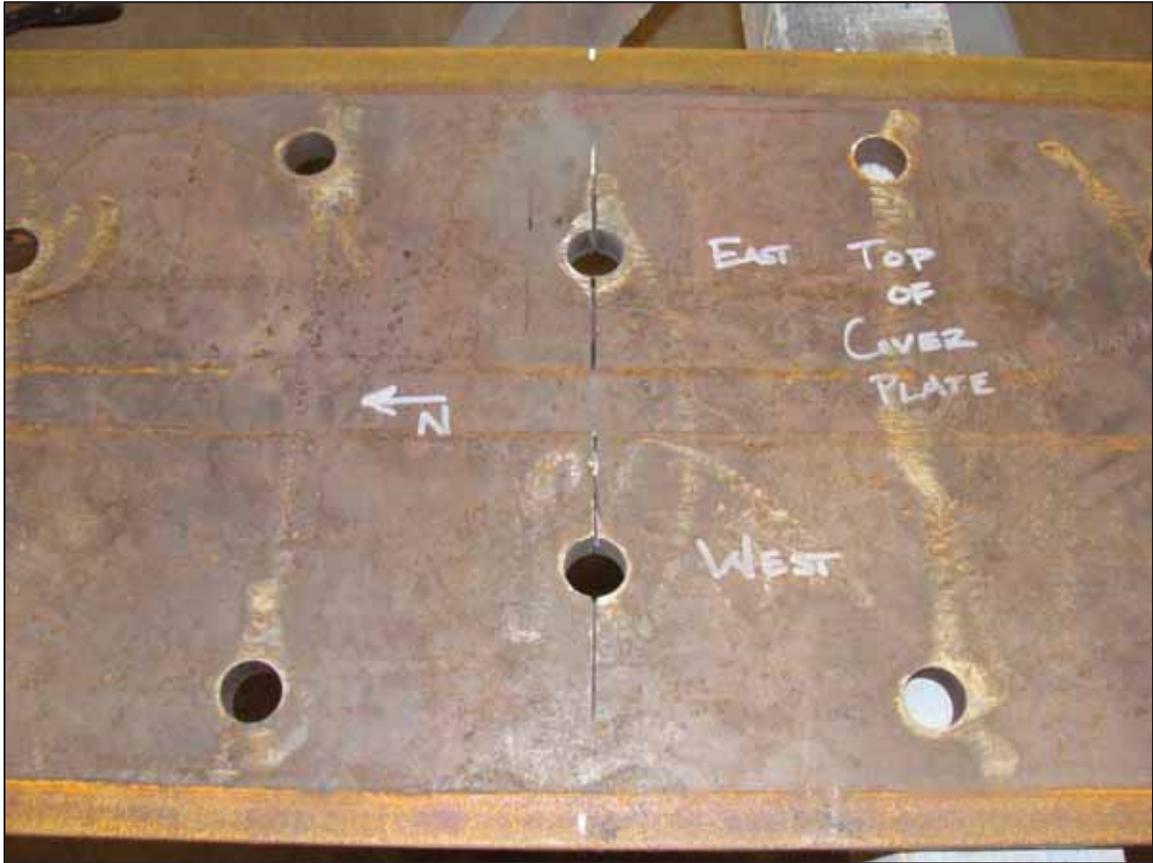
Figure 3-39 Specimen 46-1 cover plate hole notches

Specimen 46-1 was the first of the ‘new’ fabricated specimens to be tested. All components of this specimen were fabricated by Hirschfeld Industries Bridge. The holes in the flange angles were punched, however all other holes were drilled. The components were connected with A325 bolts which were fully pretensioned by the turn-of nut method (RCSC, 2009). A thin layer of packing grease was applied to the contact surface between the cover plate and flange angles to simulate a low friction condition and investigate the impact of friction in the stress transfer between components. The material properties can be seen in APPENDIX D. The cover plate holes were prepared with 1.75” long notches at

the centerline of the specimen (as shown in Figure 3-39) prior to connecting the cover plate and flange angles.

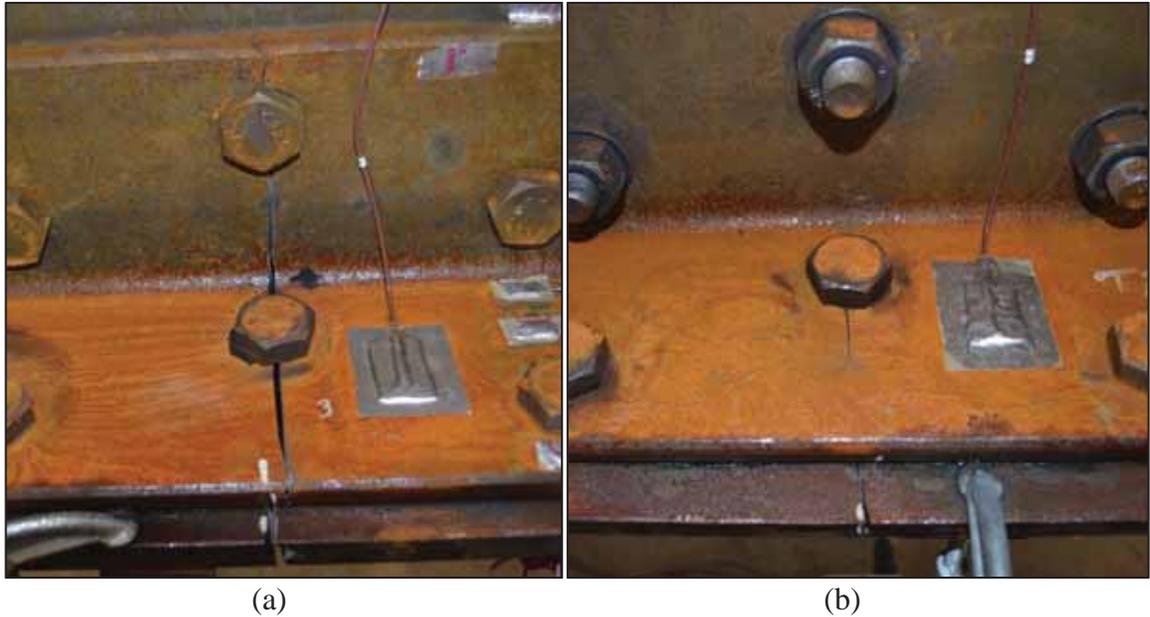
Figure 3-40 Specimen 46-1 cracked flange angles; (a) East, (b) West

The specimen was cyclically loaded from 80 kips to 180 kips to measure the fatigue life of the remaining components. The test was kept continuously running throughout the day and night to decrease the duration of the test. The east flange angle was found completely cracked through one morning. Additional cracks were also found in the hole of the horizontal leg of the west flange angle. Based on the cyclic load frequency and the data collected, it was calculated that the east flange angle had failed after approximately 74,400 cycles at a calculated net section stress range of 24.2 ksi. Figure 3-40 shows the cracked flange angles and cover plate on the east and west side of the specimen.
