Purdue University

Steel Bridge Research, Inspection, Training, and Engineering (S-BRITE) Center

Member-level Redundancy of Built-up Steel Girders Subjected to Flexure

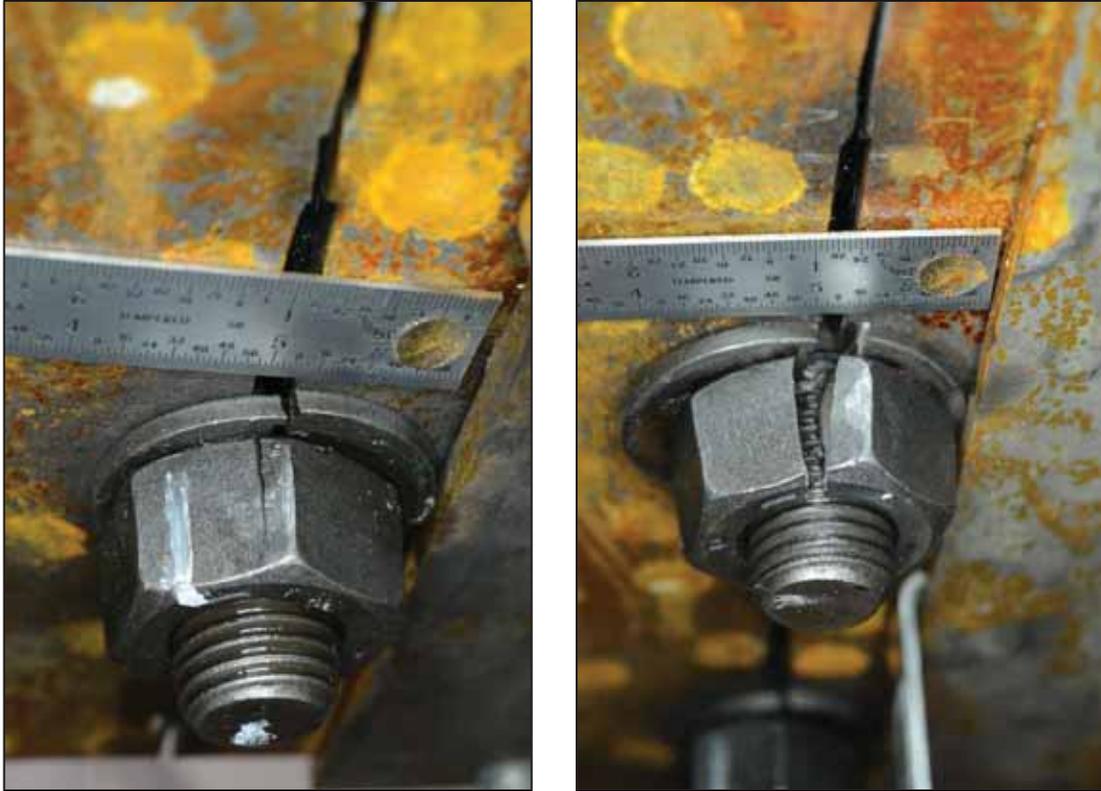
Figure 3-41 Specimen 46-1 cracked nuts

Both the high-strength nuts and washers that were attached to the bolts at the location of the cover plate notch were found to have significant fatigue cracks (see Figure 3-41). As the specimen was cyclically loaded it went through a cyclic displacement which resulted in a gap opening of the failed cover plate. It was believed that the frictional force between the nut, washer, and cover plates (which was caused by the pretension in the fastener) resulted in cyclic axial forces (out-of-plane for both the bolt and washer) which resulted in the fatigue of the washers and bolts.

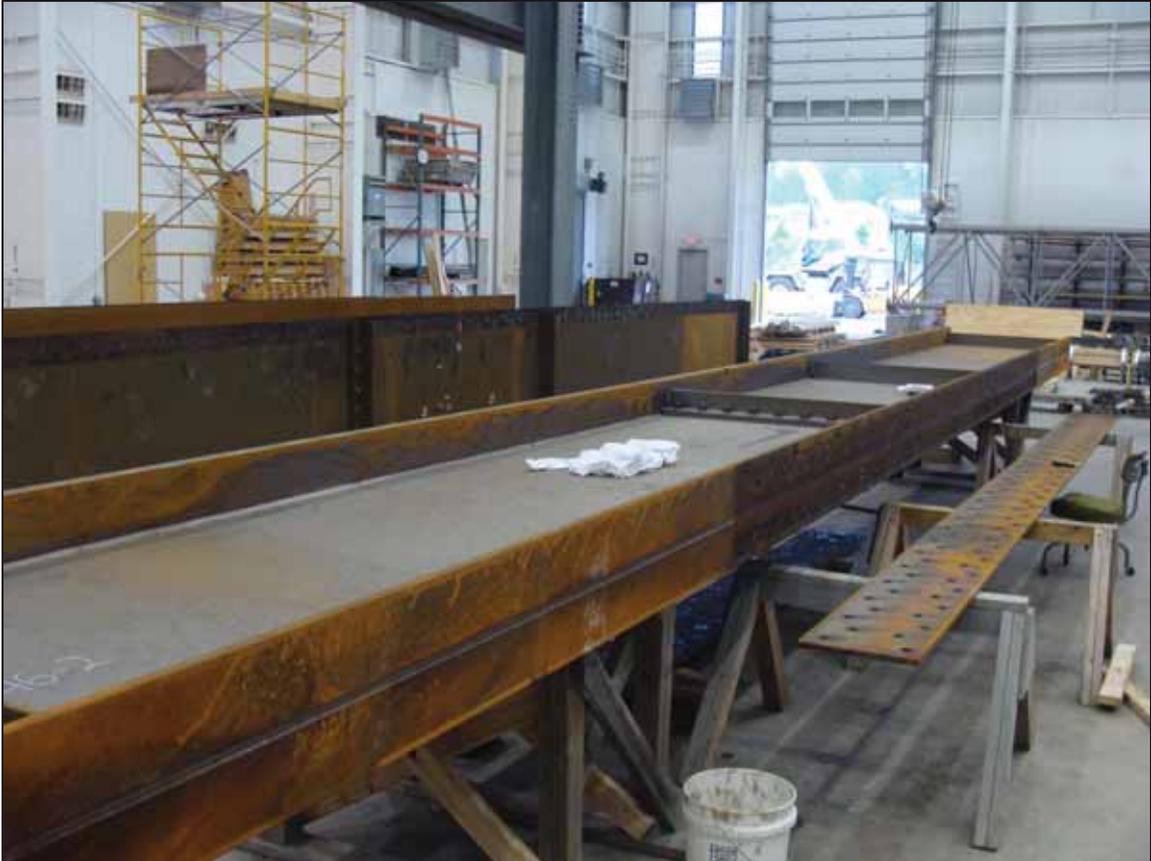
Figure 3-42 Specimen 46-2 fabrication

Specimen 46-2 was assembled in much the same way as Specimen 46-1. Holes in the flange angles were punched but all others were drilled. However, no grease was used between the cover plate and angles to investigate a more realistic condition where friction would play a role in the stress transfer between components. High-strength bolts with the turn-of-nut tightening procedure were used to fasten the cover plate, angles, and web together. Figure 3-42 shows the specimen after the cover plate was notched and prior to it being bolted to the beam.

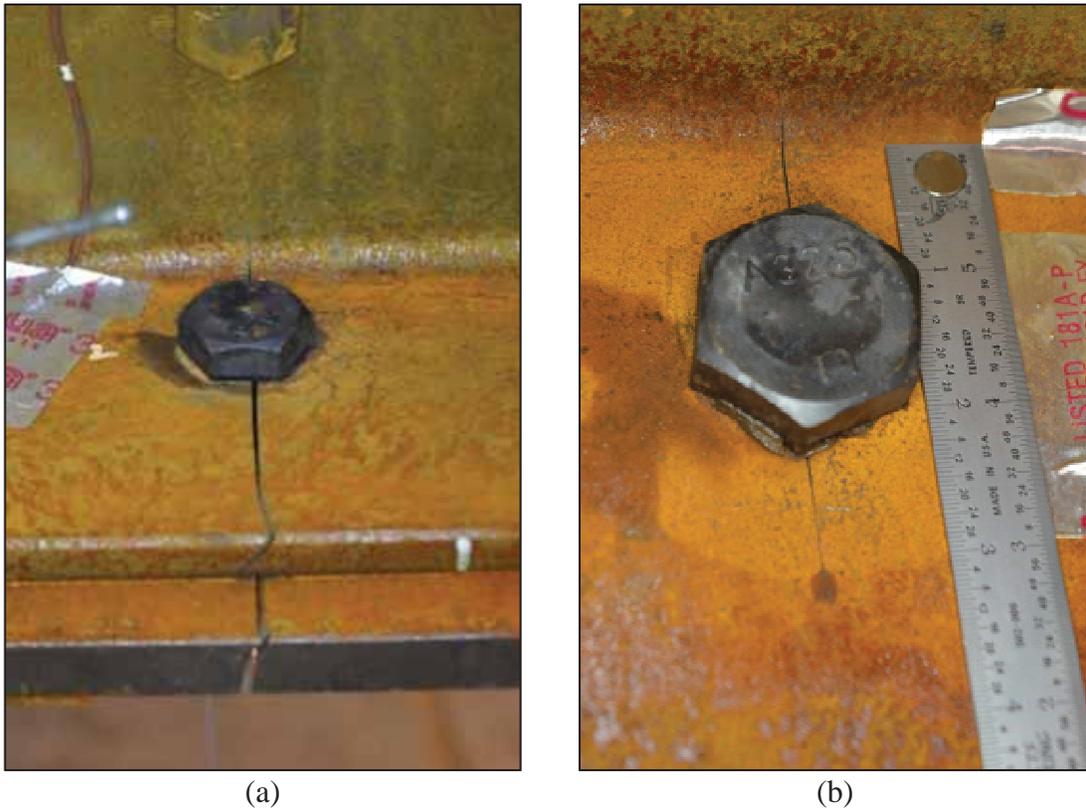
Figure 3-43 Specimen 46-2 cracked flange angles; (a) West, (b) East

The specimen was loaded cyclically at the same magnitude which created a calculated net section stress range of 24.2 ksi on the remaining bottom flange components. After 21,000 cycles cracks were detected in both the east and west flange angles as well as the nut on the east side at the location of the cracked cover plate. After a total of 31,200 cycles, cracks had grown through the entire length of the horizontal leg of the west flange angle and the test was stopped (see Figure 3-43). At this point 56% of the horizontal leg of the east flange angle was also cracked. The fatigue data is presented along with other specimens in Section 3.5.2. The nuts and washers on the bolts at the location of the cover plate crack initiated fatigue cracks in this specimen, similar to Specimen 46-1.

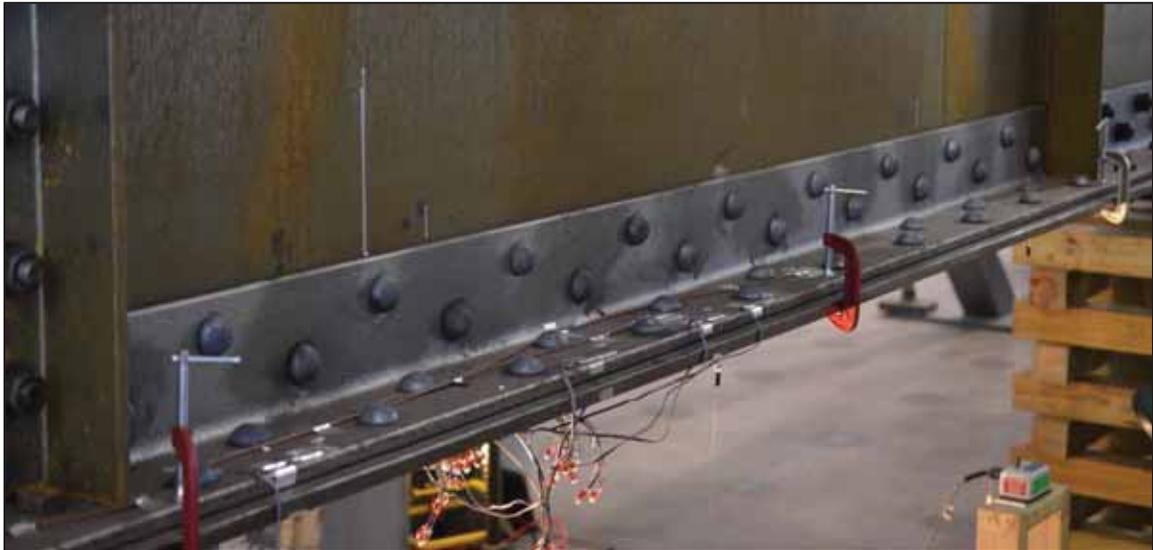
Figure 3-44 Specimen 46-3 bottom flange

Specimen 46-3 used the same web plate and top flange as Specimen 46-1. The holes in the flange angles were punched. All holes in the other components were drilled. The holes at the centerline of Specimen 46-3 were notched to a length of 1.75". The bottom flange angles, cover plate, and web were riveted together in the constant moment region (see Figure 3-44). All other holes were fastened with snug tightened bolts to simulate the pretension resulting from rivets. No grease was applied to the cover plate.

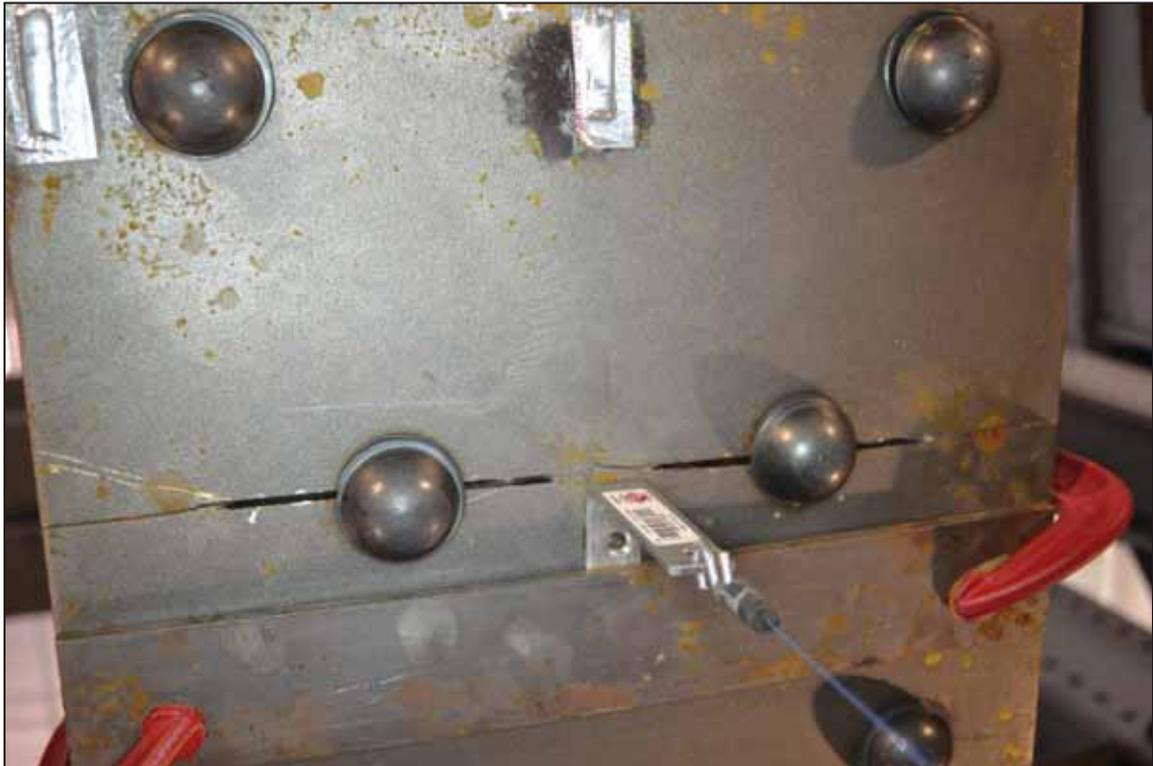
Figure 3-45 Specimen 46-3 fractured cover plate (from below)

interior portion of the cover plate had grown together. The total lengths of the cracks were 1.84", 2.21", 2.55", and 2.39" (from west-to-east). The specimen was prepared for the fracture test by cooling to a temperature of -75°F . A load of 200 kips was applied on each actuator. At this point the cover plate of the specimen fractured. After a thorough inspection, no other cracks were found in any of the other components. Figure 3-45 shows the cover plate of the specimen after the fracture (from below).

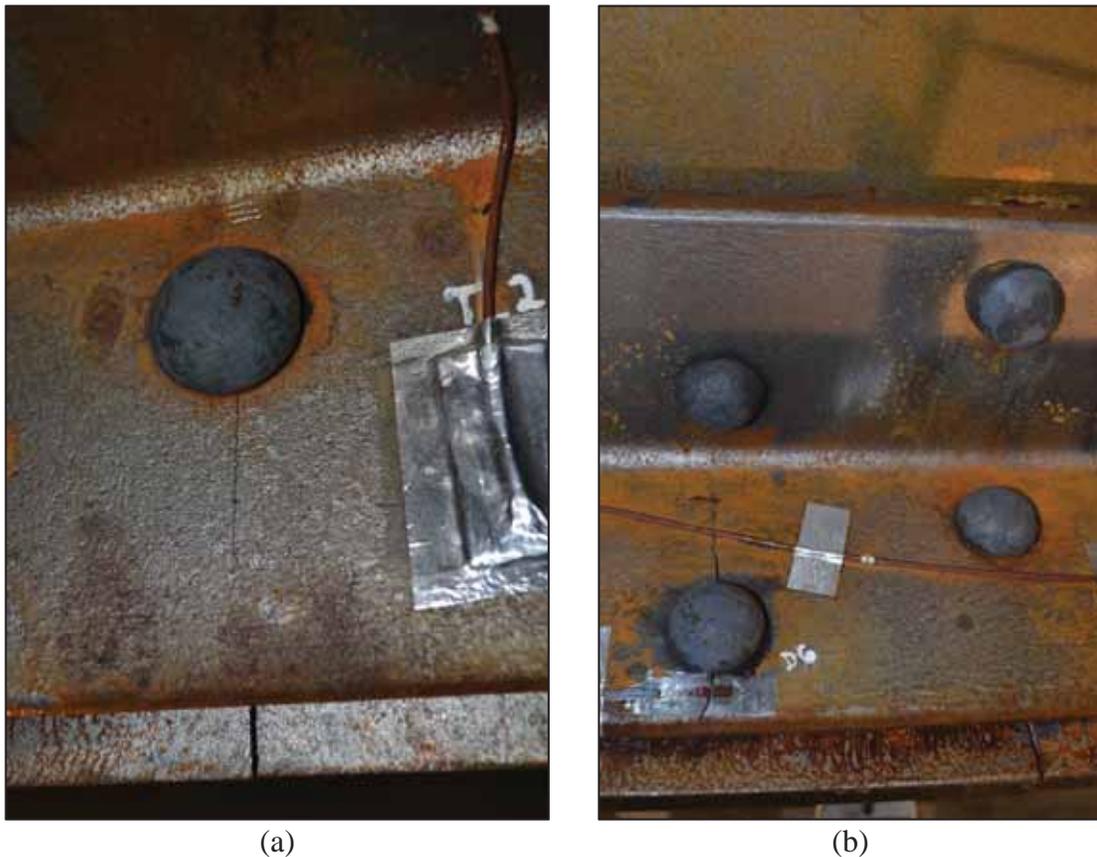
Figure 3-46 Specimen 46-3 cracked flange angles; (a) West, (b) East

west flange angle. After another 58,000 cycles, cracks were detected on both sides of the rivet hole in the horizontal leg of the east flange angle. The crack growth rate increased due to the increased length of the crack. When the total cracked portion of the horizontal leg of the east flange angle was 80%, the test was stopped to prevent damage to the web of the specimen (to allow its use for further specimens). The total number of cycles from the time the cover plate fractured until the test was stopped was 153,000.

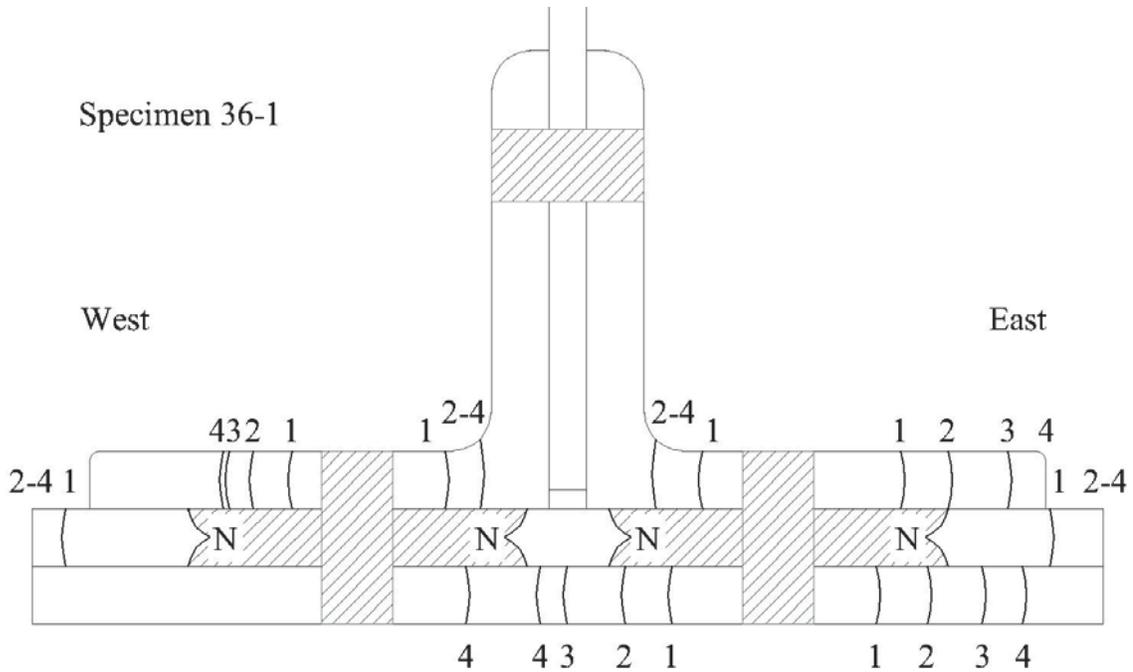
Figure 3-48 Specimen 36-1 crack growth and fracture attempts

The specimen was cyclically loaded between 80 kips and 180 kips which resulted in a calculated net section stress range of 16.8 ksi in the upper cover plate. The crack detection gages were checked prior to the initiation of any fatigue cycles and one gage at an interior notch was found to be faulty. However, due to the location, it was impossible to correct the issue without dismantling the specimen and was therefore abandoned. After 116,000 cycles, the second interior crack detection gage was triggered. In another 94,000 cycles the west exterior crack detection gage was triggered. Due to previous failed attempts to fracture specimens, the test was continued to cycle to attempt to get all four crack tips to a critical length prior to the fracture test. After a total of 404,000 cycles, the fourth crack detection gage stopped working. It was at this point, however, that cracks were also detected in both flange angles and the lower cover plate (cracks were present in all bottom flange components). The specimen was then cooled to -65° F and prepared for the fracture test. No fracture occurred at this point. The specimen was allowed to warm to ambient temperature, the cracks were grown through cyclic loading, and the fracture was reattempted three more times at temperatures of -72° F, -70° F, and -64° F. Figure 3-48 shows the notch locations in the upper cover plate as well as the crack lengths at each of the four different fracture attempts.

Prior to the fourth fracture attempt, the cracks had grown completely through the upper cover plate, and completely through the horizontal leg of the east flange angle. Thirty four percent (34%) of the lower cover plate and 29% of the west flange angle were all that remained of the bottom flange at the centerline. With such a large portion of the cross section cracked, the resulting calculated net section stress was 37% above yield. The stresses in the remaining portions of the bottom flange components were also greater than the nominal allowable yield stress during the second, third, and fourth fracture attempts.

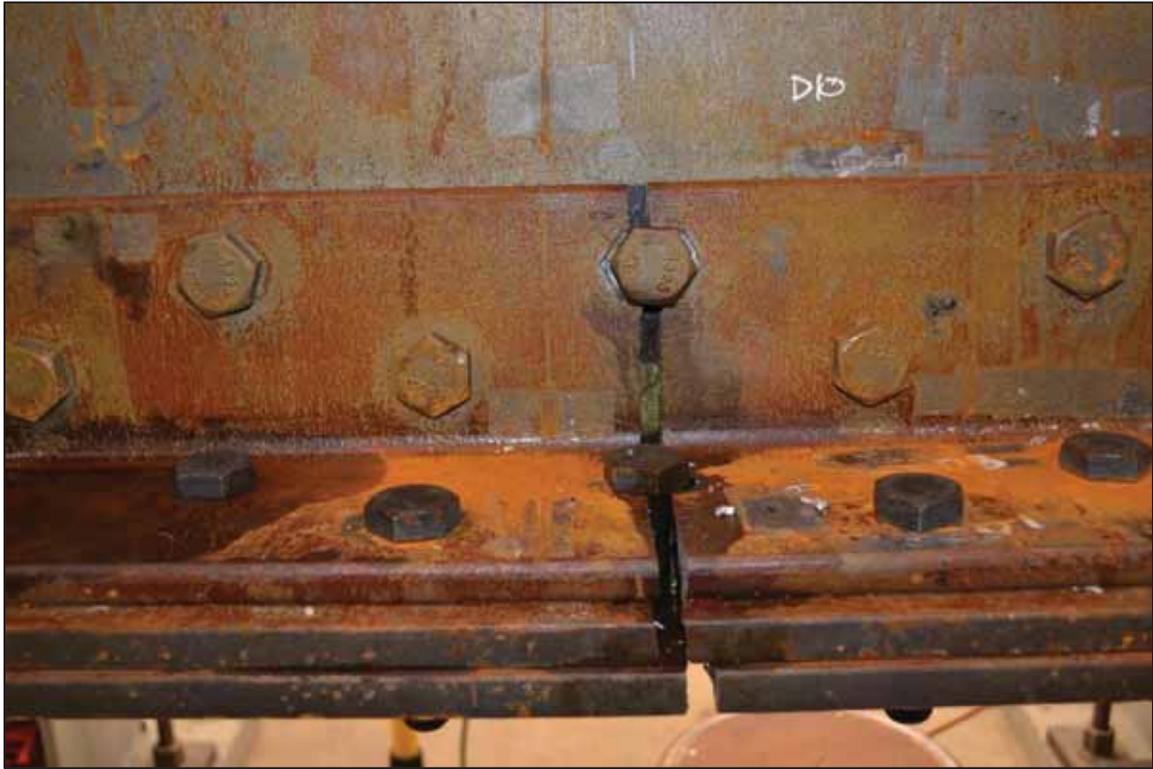
Figure 3-49 Specimen 36-1 fractured bottom flange components (east side)

MTS hydraulic software and the hydraulic pressure was shut off for the test. Figure 3-49 shows the east flange angle and both cover plates in the failed condition. Figure 3-50 shows the failure surface of the lower cover plate after disassembly.

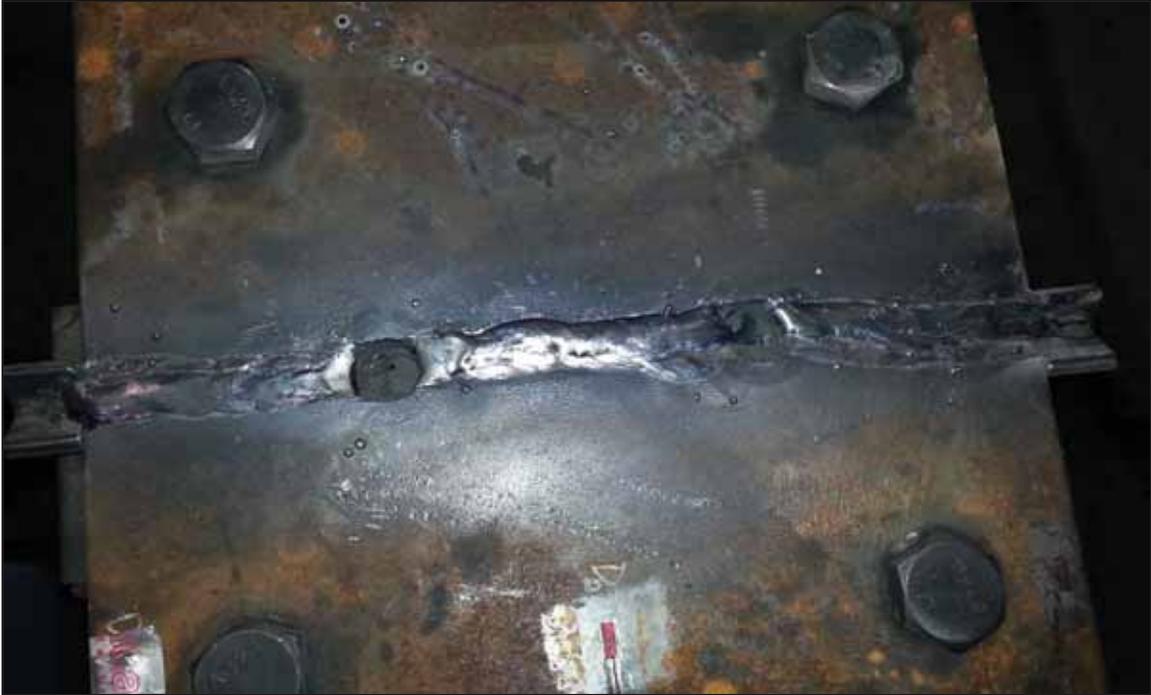
Figure 3-51 Specimen 36-2 welded lower cover plate

Specimen 36-2 was constructed by components received from Hirschfeld Industries Bridge. The flange angles were punched, but all other components were drilled. All components were connected with high-strength A325 bolts which were tensioned using the turn-of-nut procedure. The lower cover plate was constructed from the failed lower cover plate from Specimen 36-1. The lower cover plate was welded back together and used as the initial component to fail. The failure surface of the cover plate was ground to a double bevel and welded with a full penetration weld (see Figure 3-51).

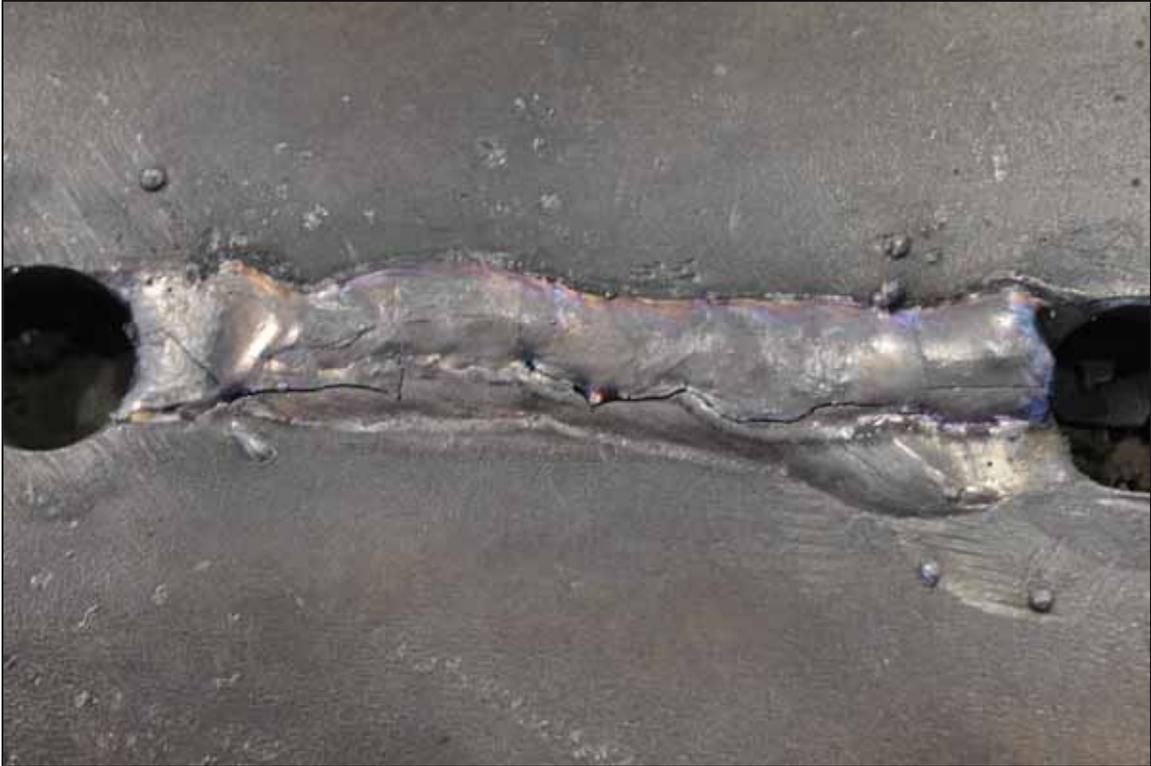
Figure 3-52 Specimen 36-2 cracks in lower cover plate weld

The weld was composed of Lincoln Electric Excalibur 7018 MR welding rod layered with Lincoln Electric Wearshield ME hardfacing welding rod. The intention was to create a 'bad' weld by layering the two weld metals together which would be used as a fuse element to increase the likelihood of a fracture. Figure 3-52 shows the substandard weld with many cracks which were expected to initiate a fracture. It was found that after three layers of the hardfacing weld were laid, the quality of the joint quickly decreased, creating multiple types of flaws including porosity and longitudinal cracks (in conjunction with the transverse cracks).

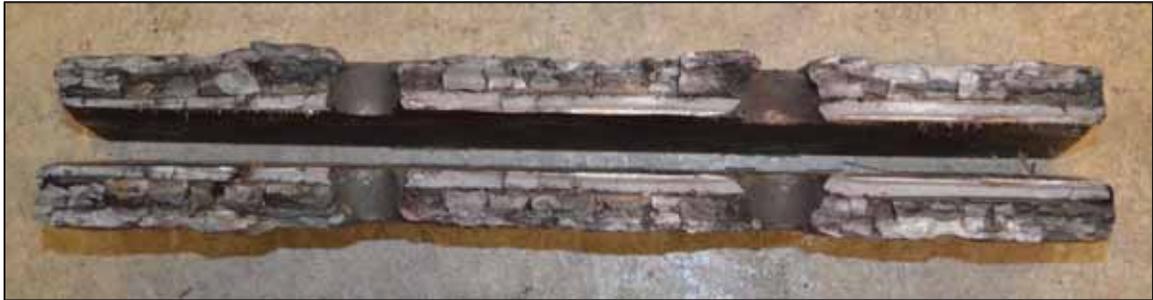
Figure 3-53 Specimen 36-2 lower cover plate failure surfaces

Figure 3-53 shows the two failure surfaces of the lower cover plate after removal from the specimen. The weld defects are readily apparent in the photograph.

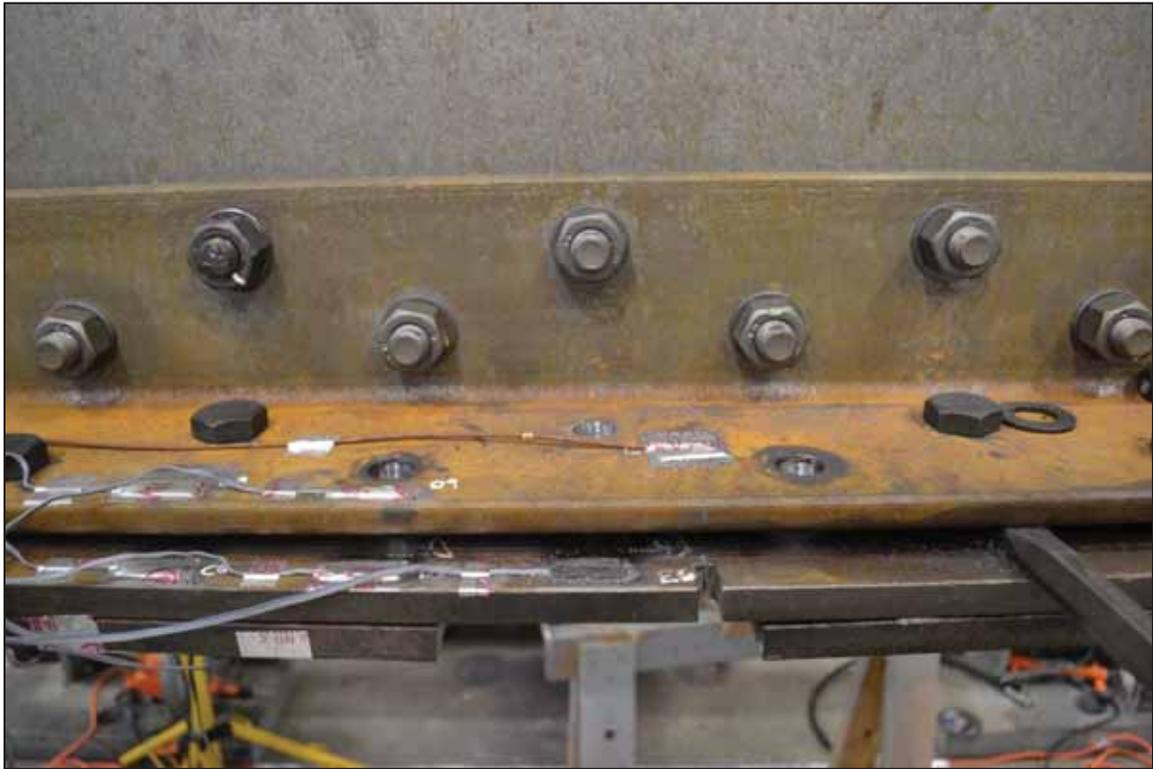
Figure 3-54 Specimen 36-2 notched upper cover plate

Following the termination of the fatigue portion of the test it was decided to further test this specimen by determining the effect of a second cover plate failure. Several bolts were removed connecting the bottom flange angles with the cover plates, and wedges were inserted to allow access to the cover plates without compromising the flange angles. A portion of the lower cover plate was removed (at the previously failed location). In addition, the upper cover plate was notched to allow the driven wedge method of fracture initiation (see Figure 3-54).

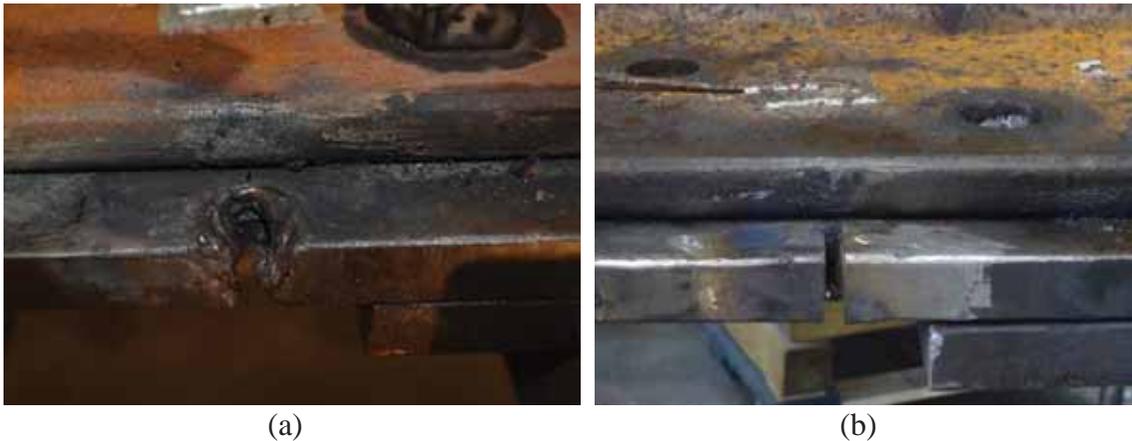
Figure 3-55 Specimen 36-2 upper cover plate notches (a) 2nd attempt (b) 3rd attempt

F, the actuators were loaded to 180 kips, and the upper cover plate was loaded using the driven wedge (with a load of 40 kips on the wedges). The specimen did not fracture, so it was allowed to warm up to ambient temperature. Due to the localized deformation at the notch edge it was necessary to close the gap before further use of the wedge. Weld material was added to the notches to decrease the gap so that the wedge could be reused on the same notch (see Figure 3-55a). In addition, hardfacing weld material was used at the notch edges to introduce a sharp crack tip (due to the cross-cracking). The specimen was then cyclically loaded from 80 kips to 180 kips (a stress range of 21.8 ksi). After 71,000 cycles, cracks were detected at each notch tip. The specimen was again cooled to -110°F and a fracture was attempted using the same loads as the previous attempt. The specimen did not fracture. It was decided that the notch geometry was a large factor in the failure of the wedge method. The notch was ground out and completely filled with weld metal, then a new notch was cut into the specimen (see Figure 3-55b).

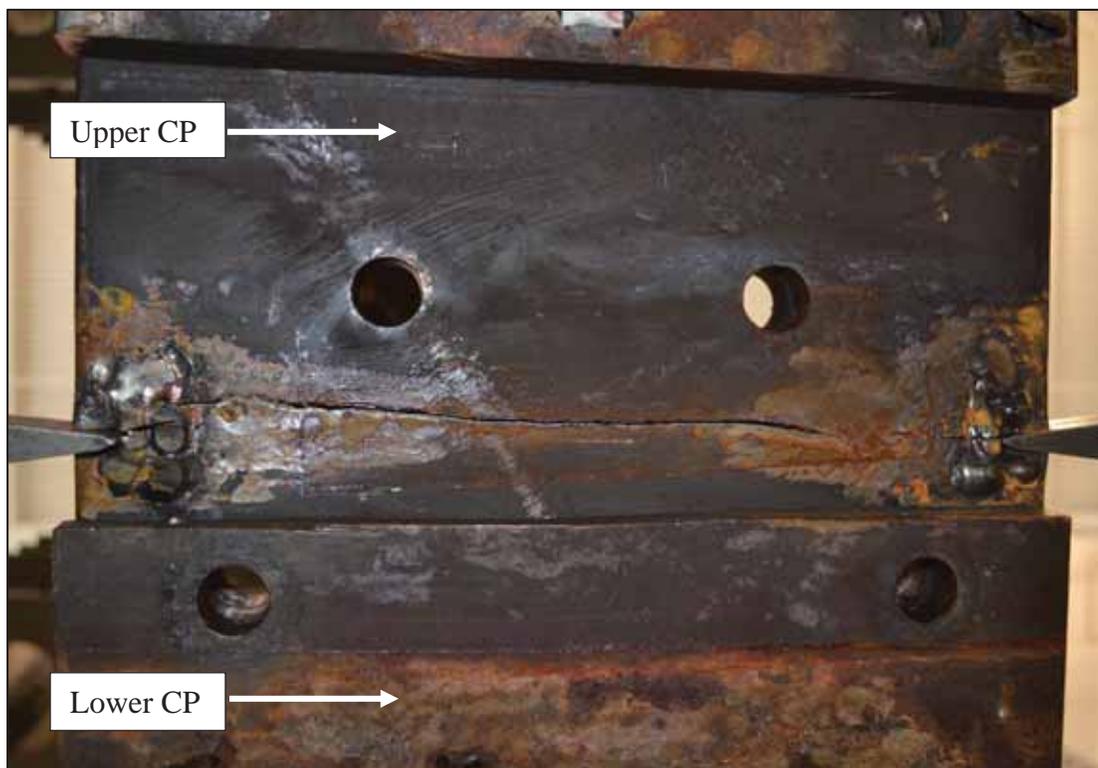
Figure 3-56 Specimen 36-2 failed upper cover plate (from below)

wedges were driven with a force of 40 kips at the notches. This stress concentration increase resulting from the wedges resulted in the fracture of the upper cover plate (see Figure 3-56). No other components (the remaining flange angles and web) were found to have cracks. Additionally, the specimen resisted the total load until it was manually removed and the test terminated.

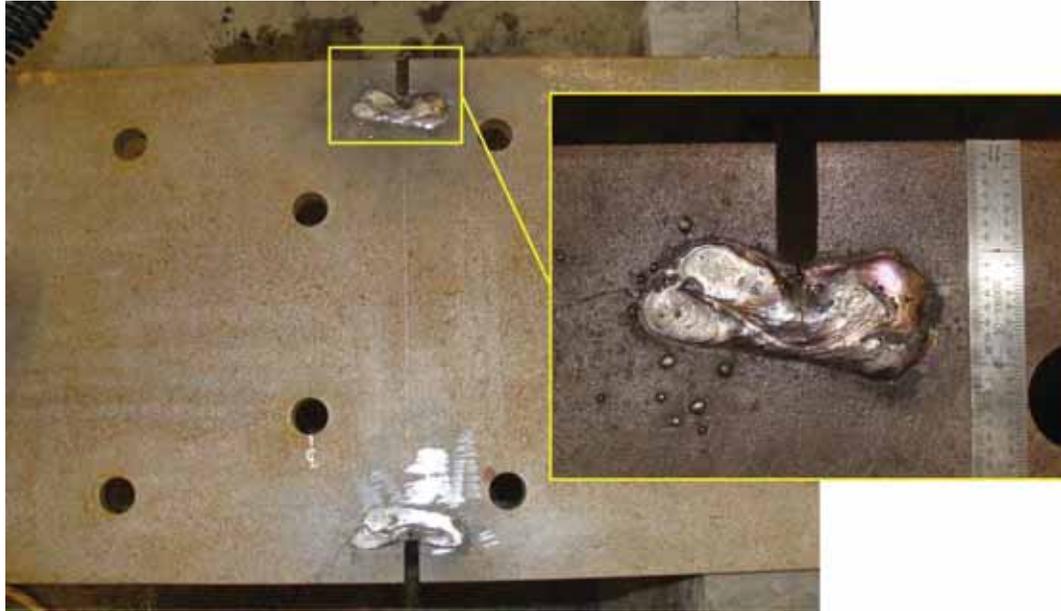
Figure 3-57 Specimen 46-4 edge notches

components and were tightened by the turn-of-nut procedure. Notches were cut into the cover plate 2.5" from the centerline of the beam (see Figure 3-57). Two layers of hardfacing weld were placed at each notch tip to create a sharp crack tip at the notch tip.

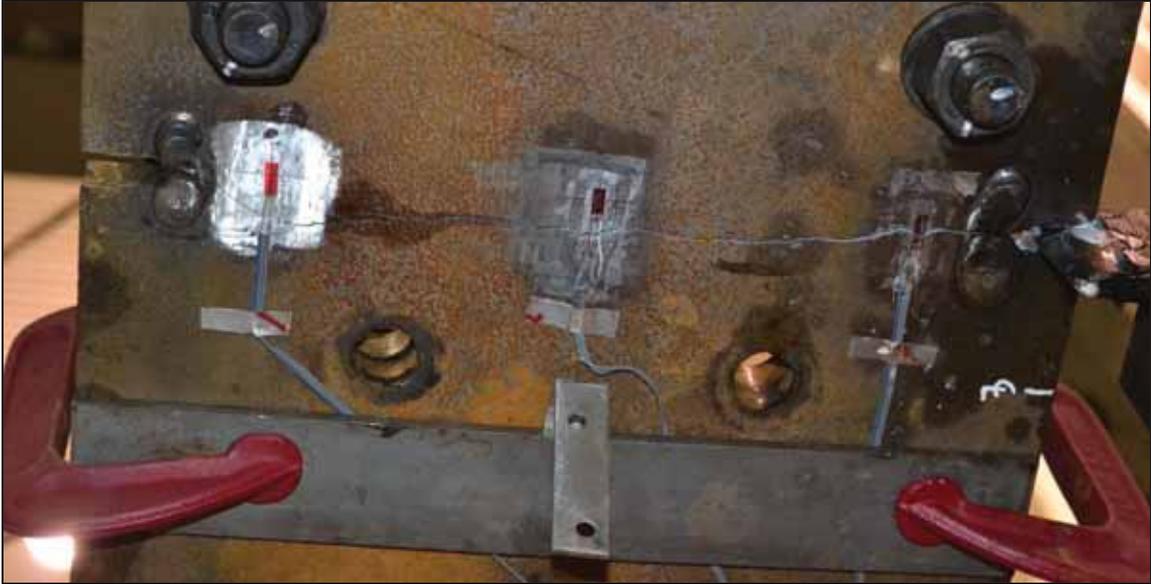
Figure 3-58 Specimen 46-4 fractured cover plate

After an initial static test to determine the original stress distribution, the specimen was cooled to -117° F. The actuators were then loaded to 180 kips with no resulting fracture. The wedges were driven into the notches with 40 kips. Three separate attempts were made to fracture the girder in this way. Modifications were made to the driven wedge setup to improve alignment and stability. On the third attempt the cover plate of the specimen fractured (see Figure 3-58). A thorough visual inspection of the specimen indicated that no other components had cracked.

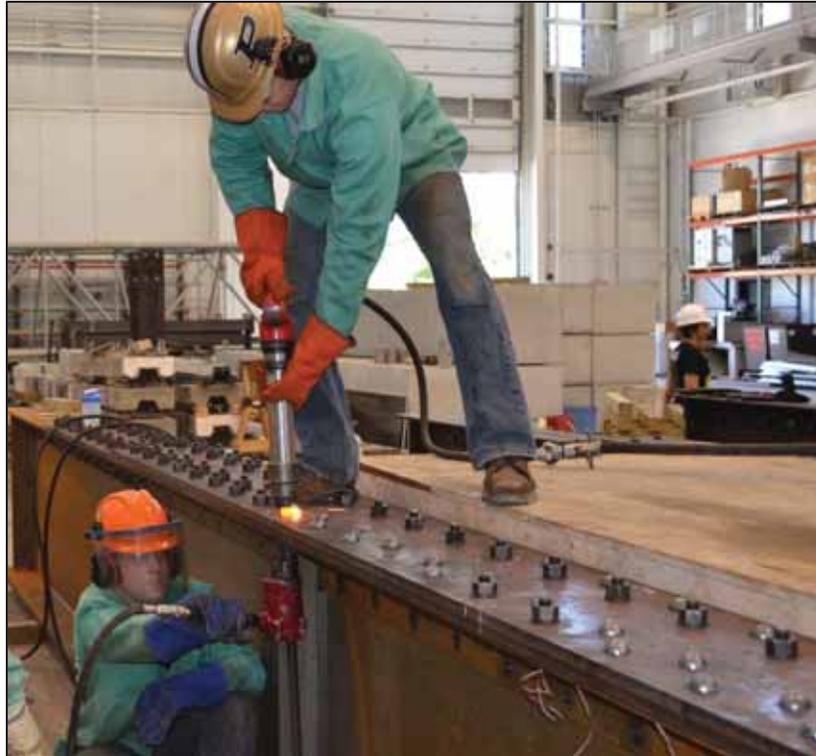
Figure 3-59 Specimen 36-3 fabrication: riveting cover plates

The cover plates were purchased as flat plate and then were drilled by staff at the laboratory. Hot driven rivets were used to connect the bottom flange components in the constant moment region (see Figure 3-59). Outside the constant moment region A325 snug tightened bolts were used to simulate the pretension of rivets. Edge notches were cut into the lower cover plate and then two layers of hardfacing weld were applied at the notch tips.

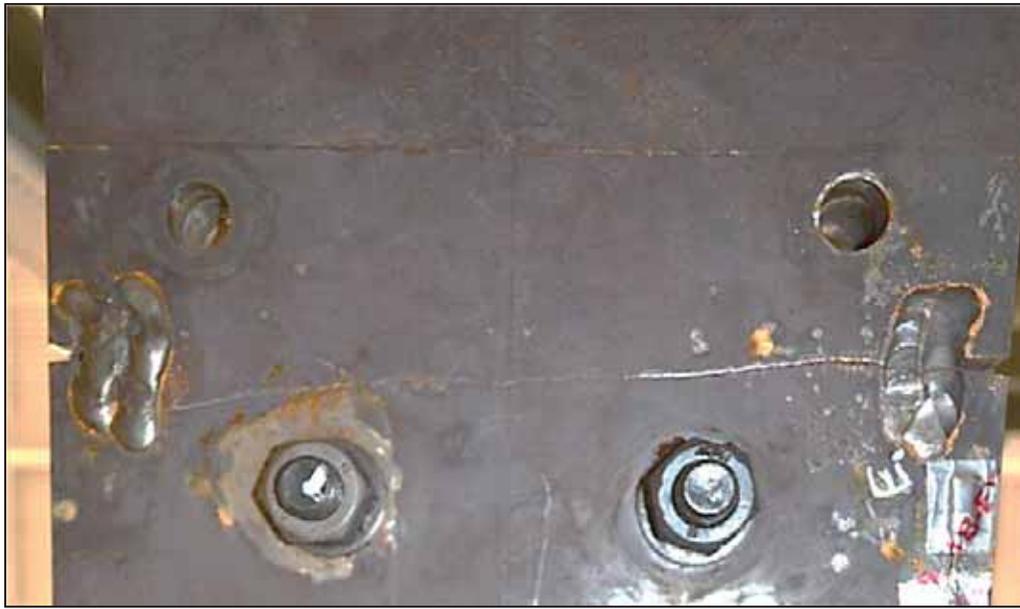
Figure 3-60 Specimen 36-3 fractured lower cover plate

described in Section 3.3.3, a small parametric study verified this hypothesis. To minimize the possibility of this occurring on this specimen eight rivets were left out (two rows of two on either side of the notch location). The specimen was cooled to -81°F . The actuators were loaded to 200 kips which resulted in a stress of 33.5 ksi. Because no fracture occurred with the actuator loads, the wedges were then driven with 40 kips into the notches which resulted in the fracture of the lower cover plate (see Figure 3-60). A visual inspection did not find any cracks in any of the remaining components.

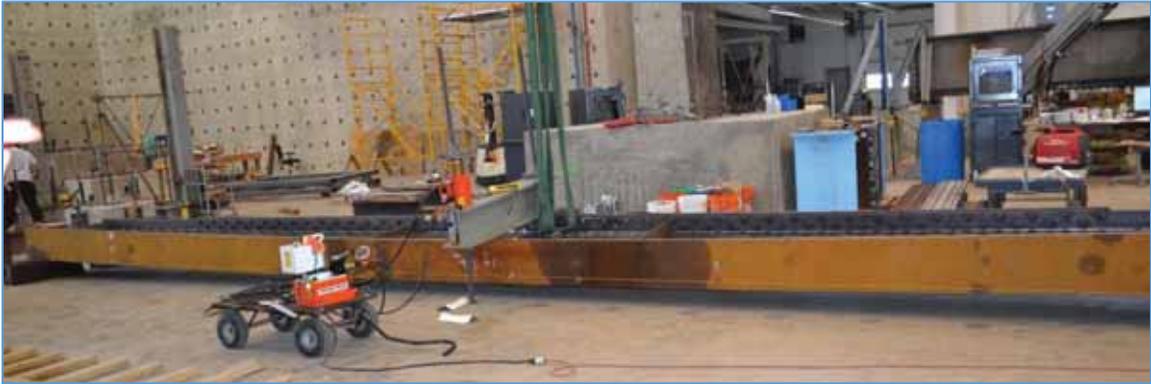
Figure 3-61 Specimen 36-4 cold worked top flange

through the strong floor. A hydraulic jack was used to cold work the top flange back to its original position. Figure 3-61 shows the jack at its peak displacement during the cold working of the specimen. The specimen was then reinstalled into the test setup and prepared for the fracture test.

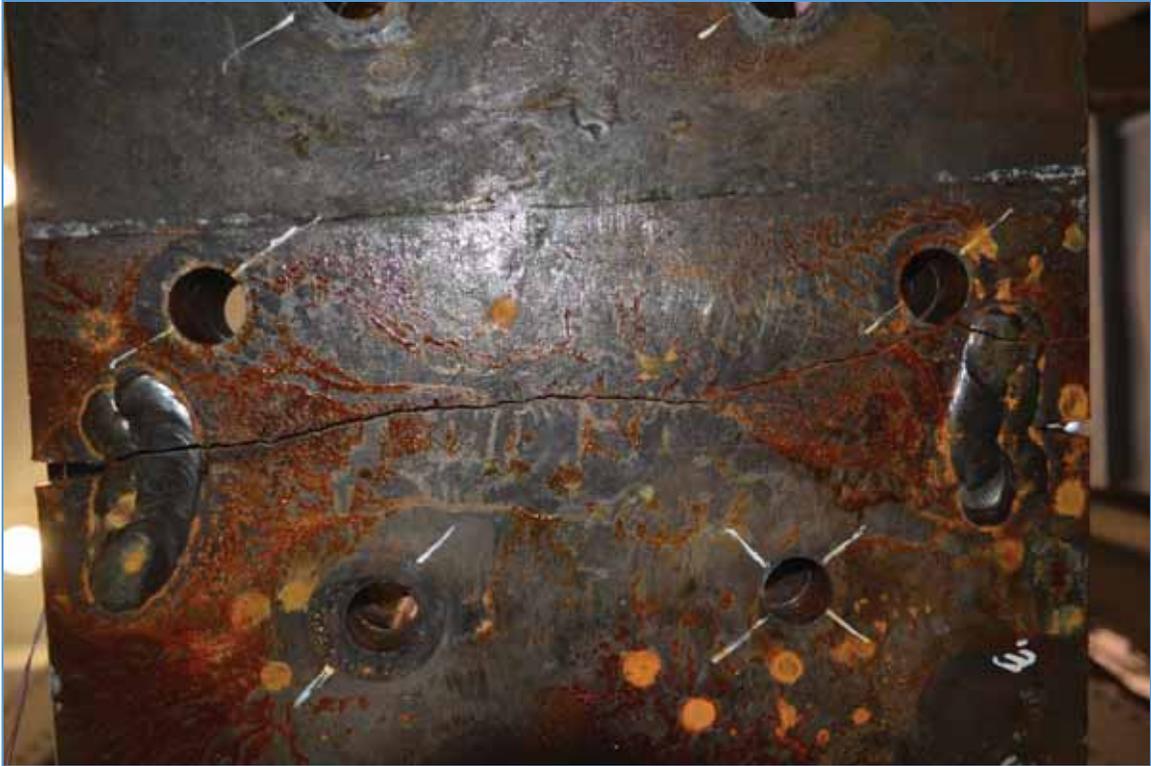
Figure 3-62 Specimen 36-4 fractured cover plate

Specimen 36-4 was prepared with edge notches and two layers of hardfacing weld material at the tip of each notch. The specimen was cyclically loaded from 80 to 180 kips for 200 cycles to settle the components. The specimen was then cooled to -103°F in the temperature chamber in preparation for the fracture test. A load of 200 kips was applied to each actuator. Wedges were driven into each notch with a force of 40 kips. This resulted in a fracture of the lower cover plate (see Figure 3-63). No cracks were found in any other components.

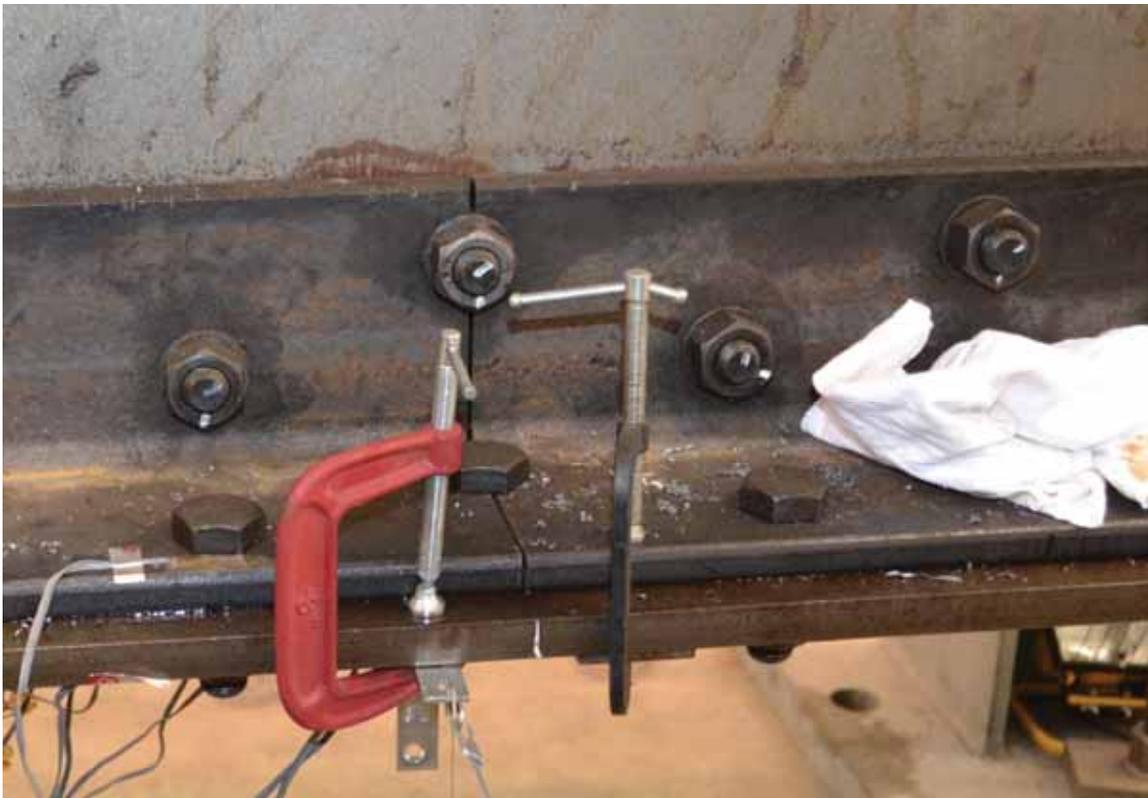
Figure 3-63 Specimen 46-5 severed flange angle

Specimen 46-5 was fabricated from the same web plate and top flange as Specimen 46-2 and Specimen 46-4. The bottom flange angles and cover plate were obtained from Hirschfeld Industries Bridge and were all drilled. Fully pretensioned A325 bolts were used to fasten the bottom flange components. The east flange angle was entirely cut (see Figure 3-63) prior to the test to measure out-of-plane effects of nonsymmetrical failure in a cross section. A string potentiometer was installed at the top flange and another at the bottom flange at the centerline of the specimen to measure any out-of-plane horizontal deflection (see Figure 3-64).

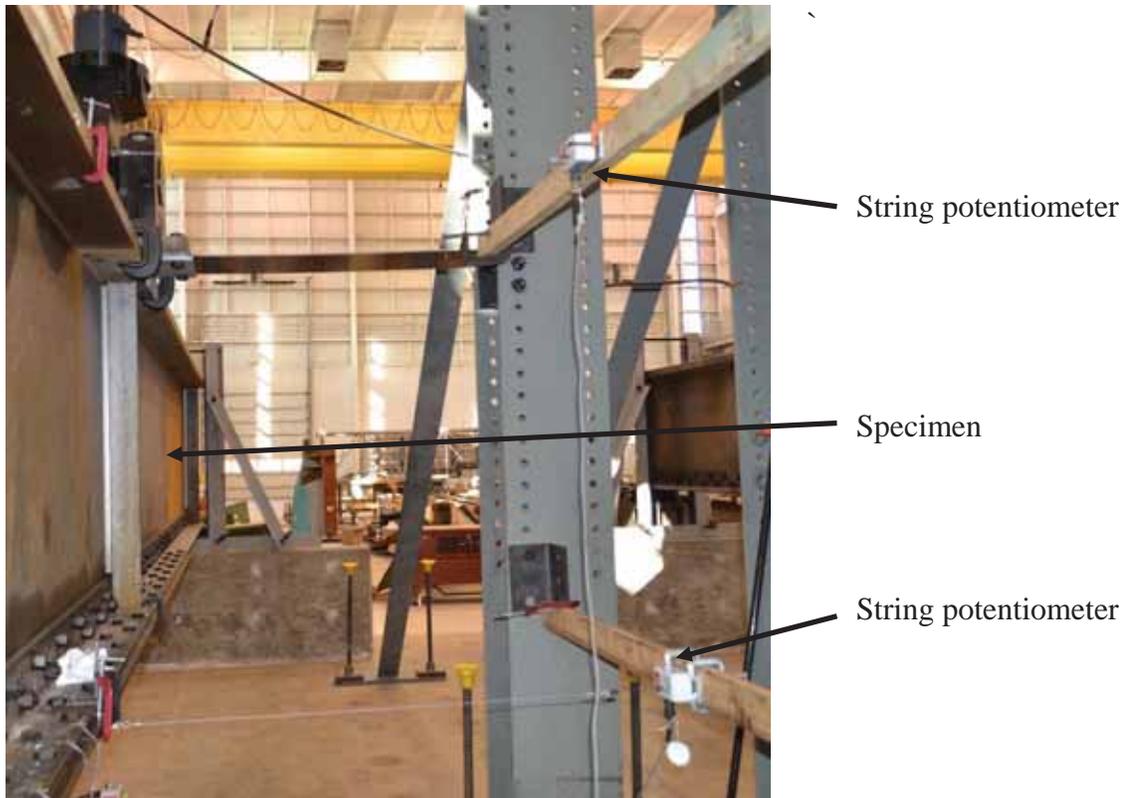
Figure 3-64 Specimen 46-5 string potentiometers

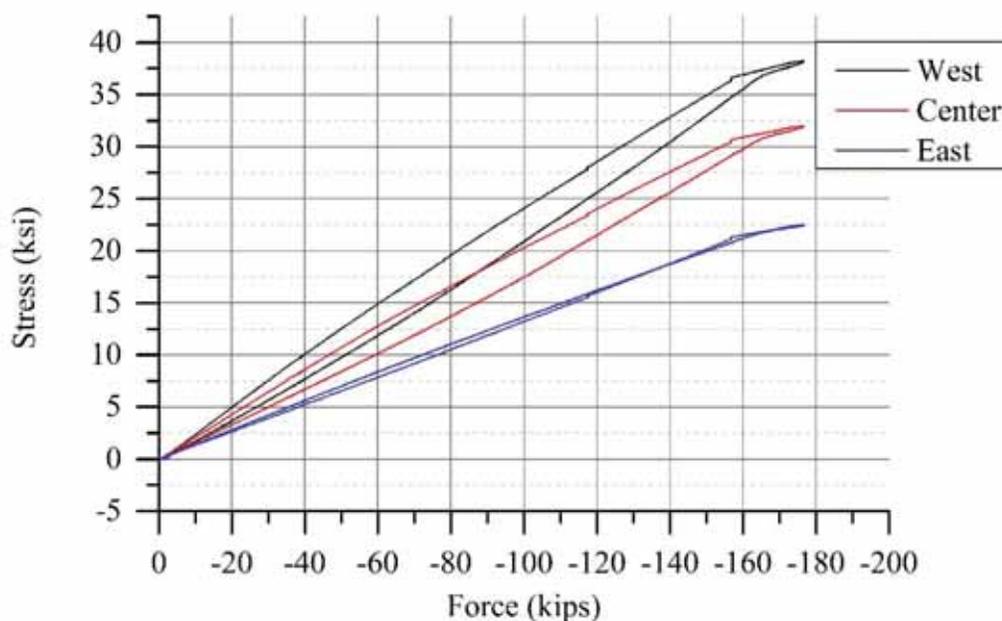
Figure 3-65 Specimen 46-5 out-of-plane stress gradient

Prior to the static test the specimen was cycled from 80 kips to 180 kips (which resulted in a calculated net section stress range of 19.9 ksi) for 1,100 cycles to settle the components of the bottom flange. The specimen was then statically loaded from 0 kips to 180 kips in increments of 20 kips. The out-of-plane deflection of the top and the bottom flange were both 0.035" at the peak load. A stress gradient of 15 ksi was measured across the cover plate at the centerline location of the severed flange angle (see Figure 3-65).

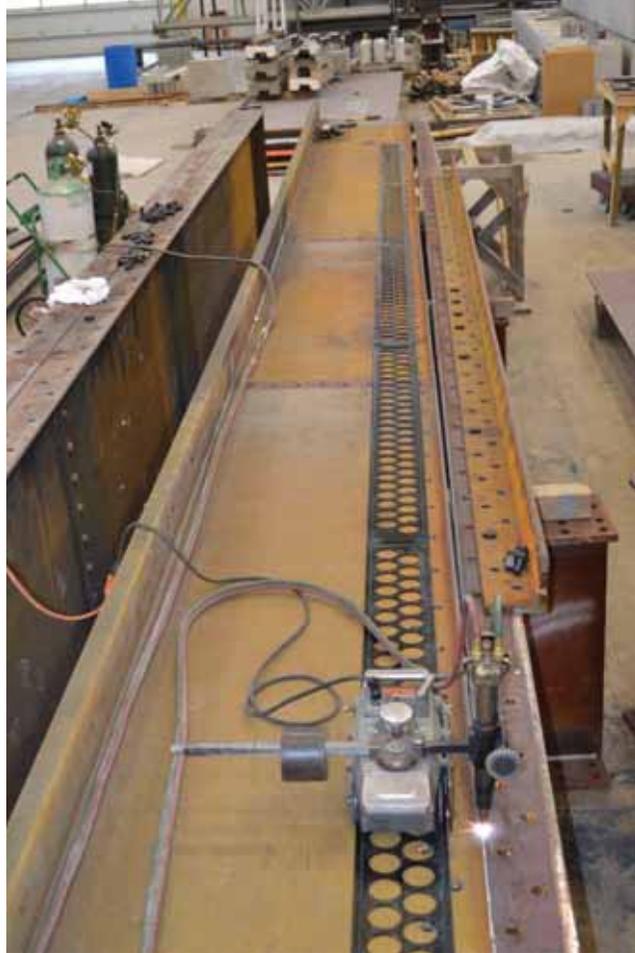
Figure 3-66 Specimen 30-1 web plate fabrication

Specimen 30-1 was fabricated from the web plate and top flange that was originally used for Specimen 36-1. Due to the yielding of the web plate during the fracture test of Specimen 36-1, the specimen was left with a deflected shape of approximately $1\frac{3}{4}$ " at the beam mid-span. The web plate was cut with a track torch (as shown in Figure 3-66) to have a straight profile and new holes were drilled to meet the spacing requirements of the flange angles. The flange angles and cover plate were drilled by staff at the laboratory. A 14"x1" cover plate was used to determine whether the fracture of a component with a larger area could potentially have enough energy to initiate and propagate a fracture in adjacent components. The components within the constant moment region were hot riveted
