Purdue University

Steel Bridge Research, Inspection, Training, and Engineering (S-BRITE) Center

Member-level Redundancy of Built-up Steel Girders Subjected to Flexure

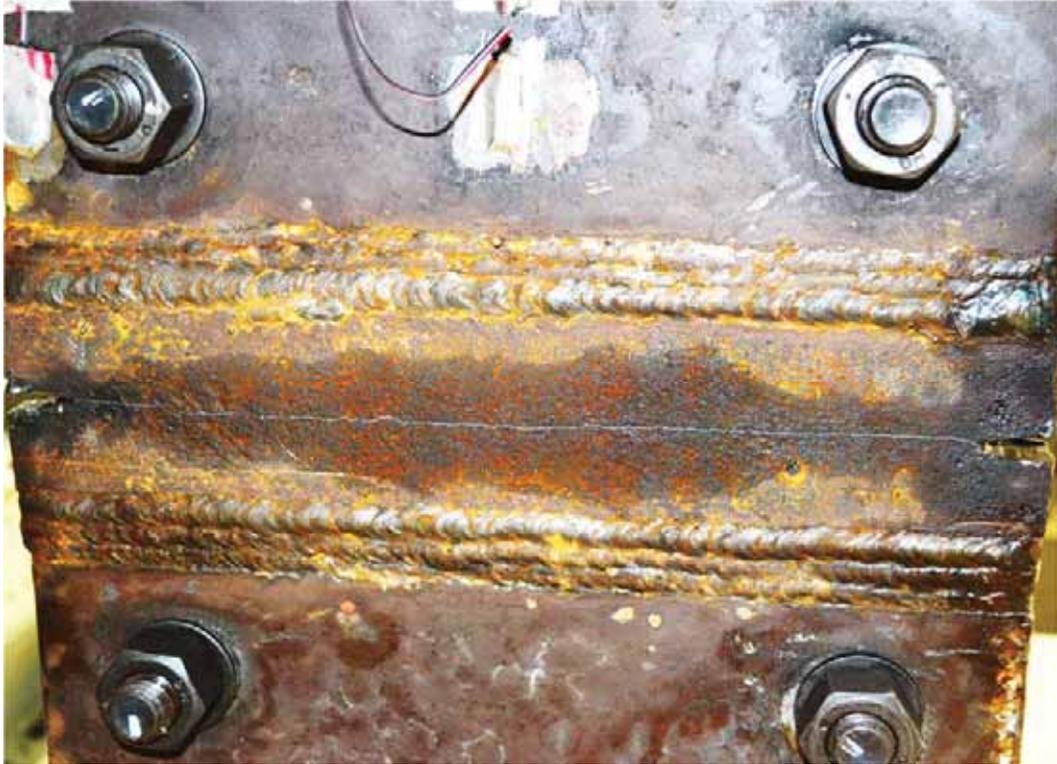
Figure 3-67 Specimen 30-1 fractured cover plate

Eight rivets were removed from the cover plate-to-flange angle connection directly adjacent to the notches so that constraint would not prevent the fracture from occurring. Due to the plastic deformation at the notch edges (which resulted from the driven wedges during the first failed fracture attempt), welds were used to fill the notch prior to the notch being ground back out to create a new seat for the wedges. The specimen was then placed back in the temperature chamber and cooled to -44°F . The actuators were loaded to 130 kips and the wedges loaded to 40 kips. The cover plate of the specimen then fractured (see Figure 3-67). No other components were found to have cracks.

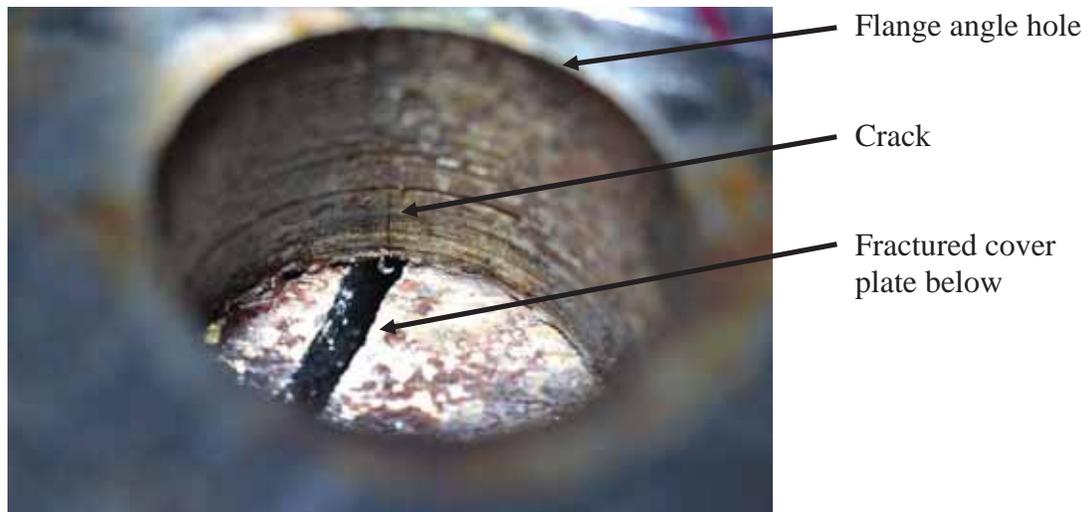
Figure 3-68 Specimen 30-1 flange angle crack in hole

The specimen was cyclically loaded from 80 kips to 110 kips. This was equal to a calculated net section stress range of 8.3 ksi of the original section and 12.6 ksi of the partially failed section. After 820,000 cycles, a crack (with length of 0.125") was detected at the bottom of the hole of the horizontal flange of the west flange angle directly above the fractured cover plate. Figure 3-68 shows the crack after some small growth while still inside the hole. After another 430,000 cycles the crack had grown across the interior region of the flange angle and had started up the vertical leg. At a total of 1.3 million cycles a crack was detected in the opposite side of the same hole of the horizontal flange of the west flange angle. When the specimen had reached 1.4 million cycles the remaining portion of

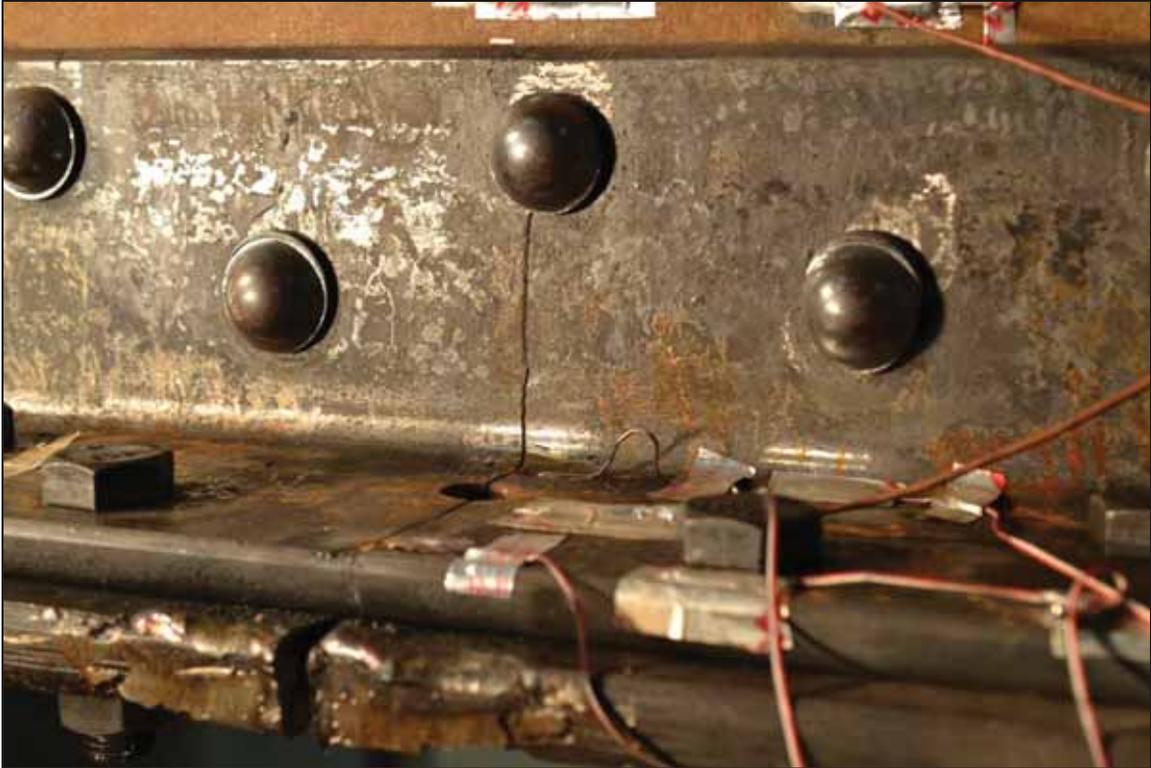
Figure 3-69 Specimen 30-1 fractured west flange angle

the west flange angle fractured. At this point, the crack on the east side of the hole had grown through the entire horizontal portion and an additional 1.0" into the vertical leg of the flange angle (measured from the top face of the horizontal leg), and the crack on the west side of the hole had grown 0.875". Figure 3-69 shows the west flange angle after the fracture had occurred.

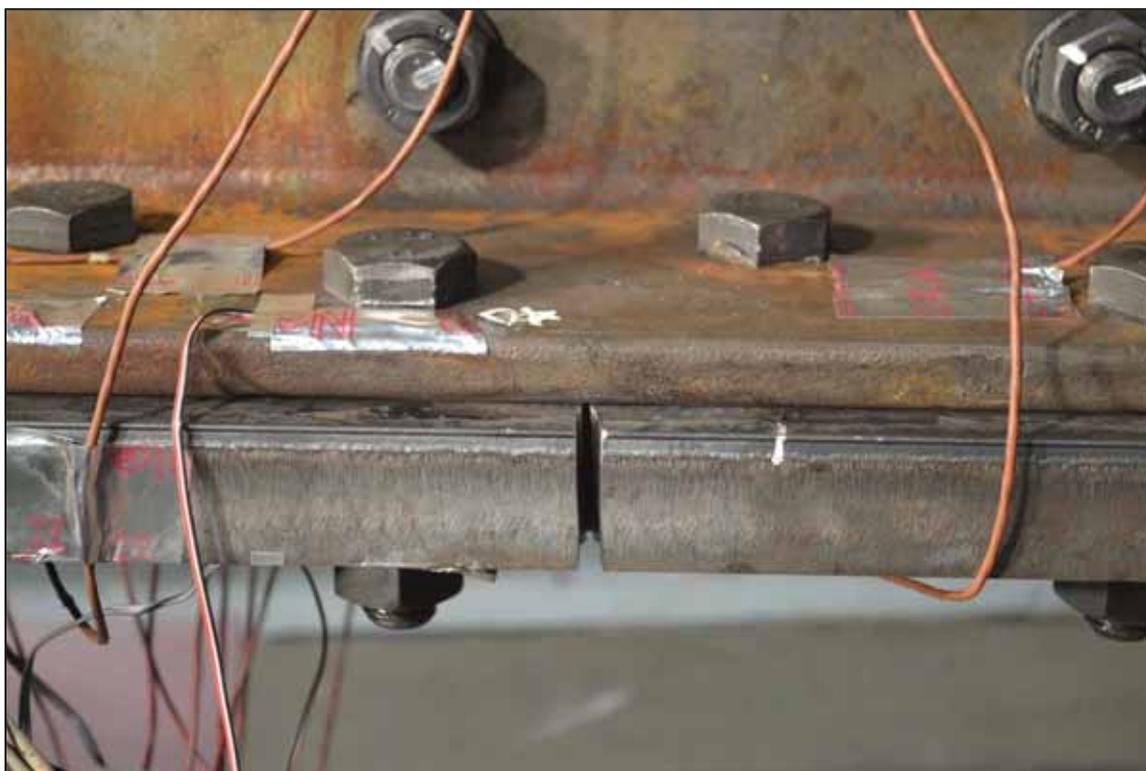
Figure 3-70 Specimen 36-5 notched cover plate

the cover plate near the mid-span (see Figure 3-70). No hardfacing welds were placed at the notch tip.

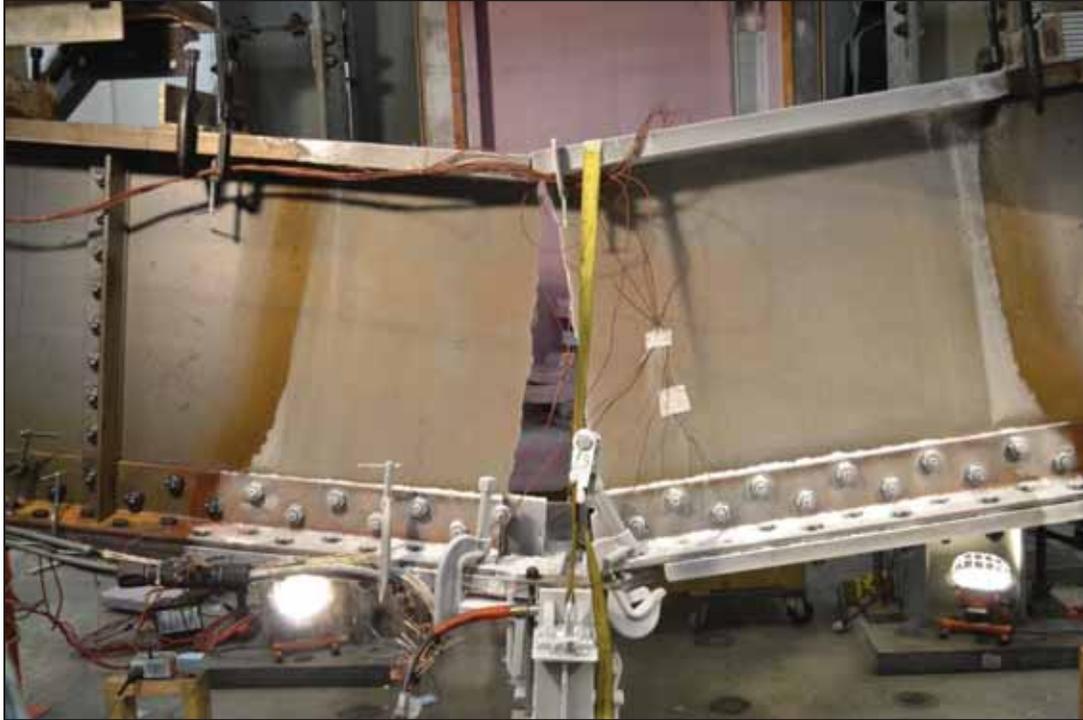
Figure 3-71 Fractured Specimen 36-5

Based on previous fractures of other specimens, two bolts on either side of the notch were removed to minimize constraint near the notches. Specimen 36-5 was cooled to a temperature of -74° F in the temperature chamber. A load of 150 kips from each actuator was applied to the specimen. No fracture occurred at this load. At this point the wedges were driven into the notches with a 20 ton hydraulic ram. This resulted in a fracture of the cover plate. Subsequent fracture of the remaining components occurred almost simultaneously, as expected. Both of the flange angles as well as the web plate and the top flange plate were all fractured (see Figure 3-71). The cover plate fractured at the location of the notches. The west flange angle fractured at the nearest hole to the south of the notches. The east flange angle as well as the web plate and the top flange plate all fractured

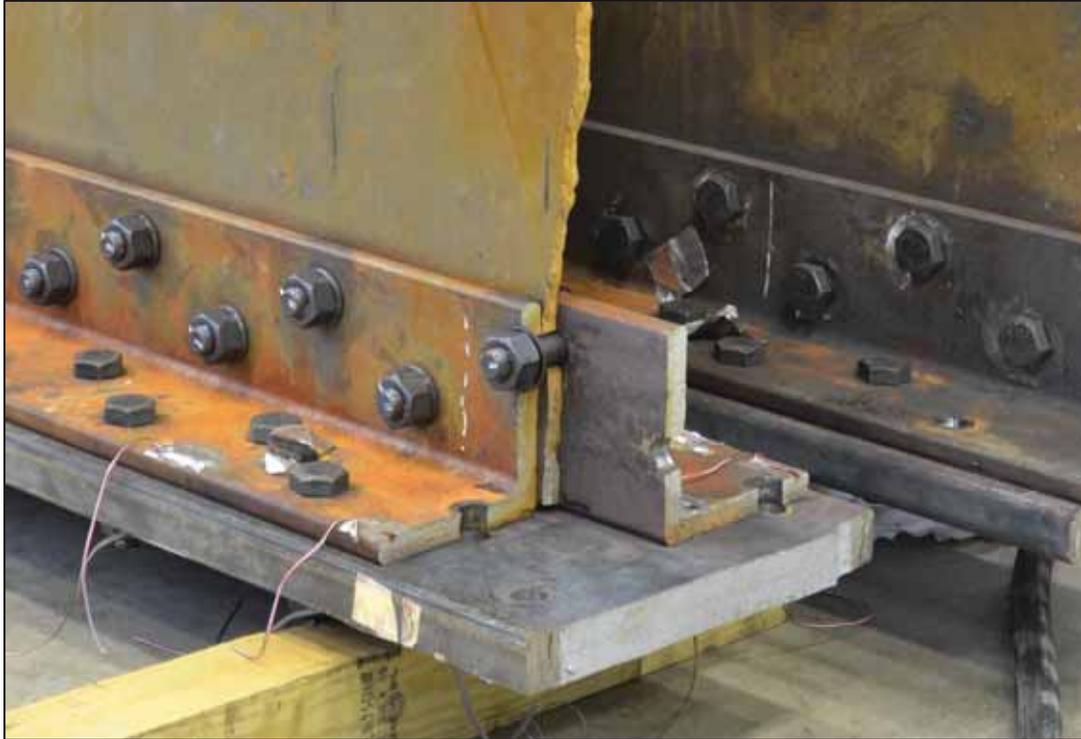
Figure 3-72 Specimen 36-5 south fracture surfaces

in the same plane which correlated to the fastener hole which was one hole south of the fracture which occurred in the west flange angle (see Figure 3-72).

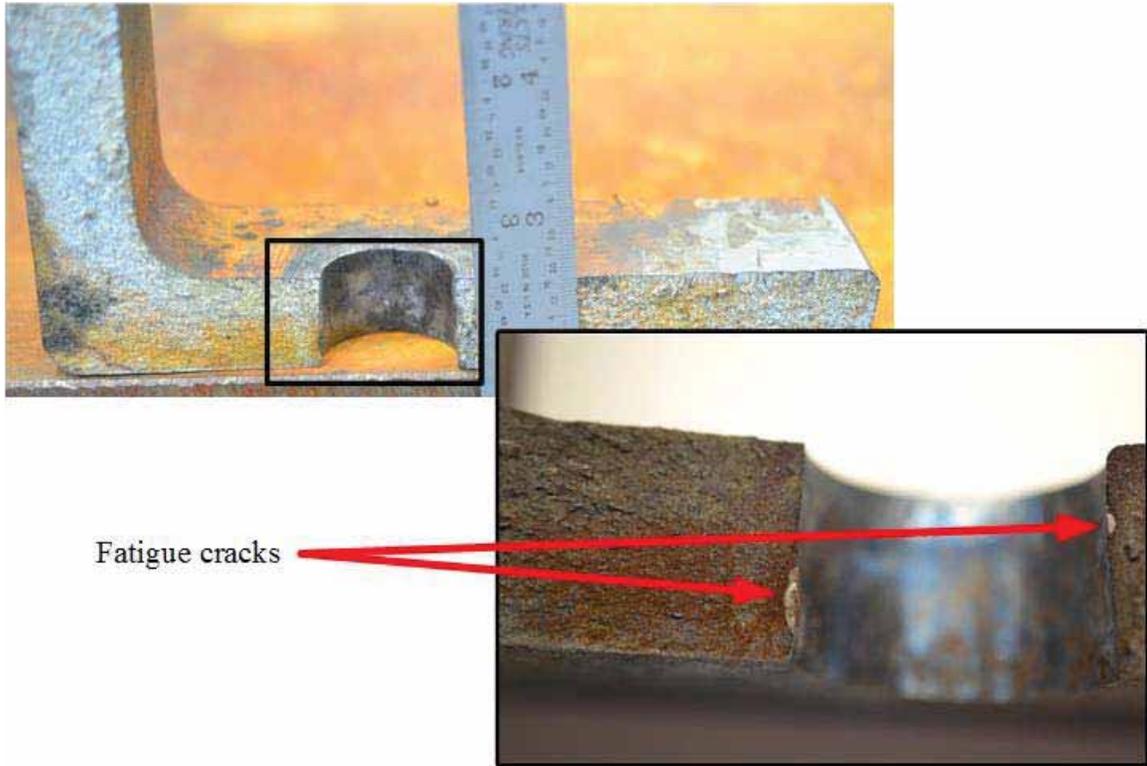
Figure 3-73 Specimen 36-5 Rivet hole fatigue cracks

Upon removal of the specimen, a detailed inspection was performed to determine the cause of the fracture in the flange angles and in the web. A small fatigue crack was located at a rivet hole in the horizontal leg of the west flange angle (see Figure 3-73). The cracks were very small and contained within the hole and were visually hidden by the head of the fastener. It is very unlikely that they would have been detected with any NDE techniques, such as UT. However they served as initiation points for a fracture which resulted in the fracture of all of the remaining specimen components as there was simply not enough of the flange remaining to carry the load once the angle failed.

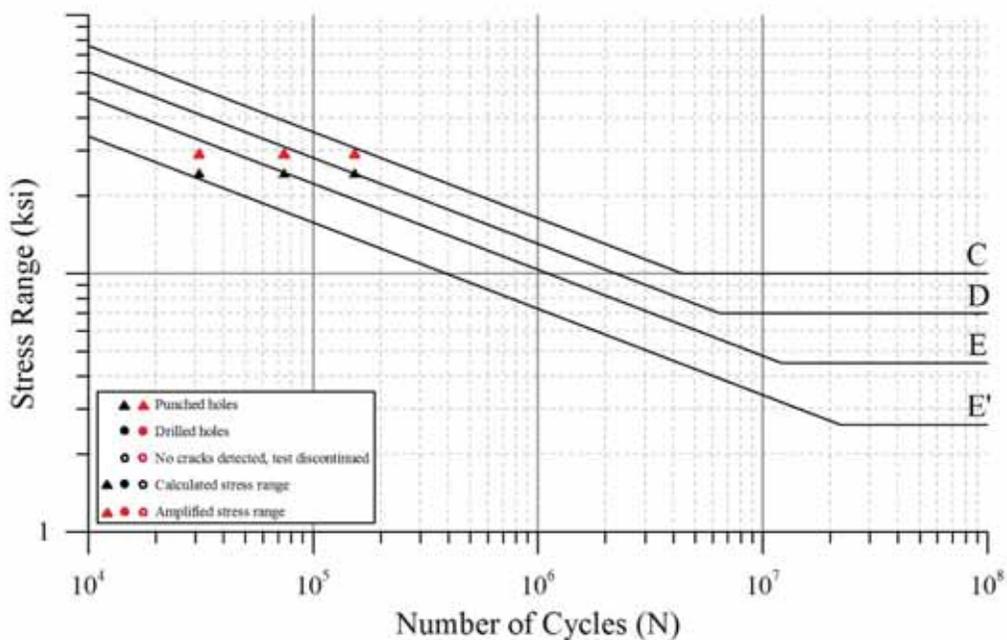
Figure 3-75 Fatigue data for specimens with punched holes

Figure 3-75 and Figure 3-76 show the number of cycles until the end of test on the x-axis and the calculated net-section stress range (of the partially failed cross-section) on the y-axis for each of the hole preparation types. As illustrated in Figure 3-75 the specimens with punched holes exceeded the Category E' fatigue resistance curve at the time of a second component failure. Each of the three specimens tested, however, had experienced a large number of cycles at an initial stress range (of the unfailed net section) of 16.8 ksi. This is a much higher stress range than has typically been found in built-up member bridges (Fisher et al., 1987). Because the total number of cycles reported for this research is only counted *after* the failure of the first component, it is likely that a substantial portion of the fatigue life of the second components occurred during the phase of the test attempting to fracture the first component. As shown in Figure 3-76, the fatigue life, using the amplified net-section stress as a result of the localized stress increase, of specimens with drilled holes exceeds the Category C fatigue resistance curve at the time of failure of the second component or at the time the test was stopped. As a comparison, the fatigue life, using the calculated net-section stress, indicates that the Category D fatigue resistance curve is a reasonable lower bound.

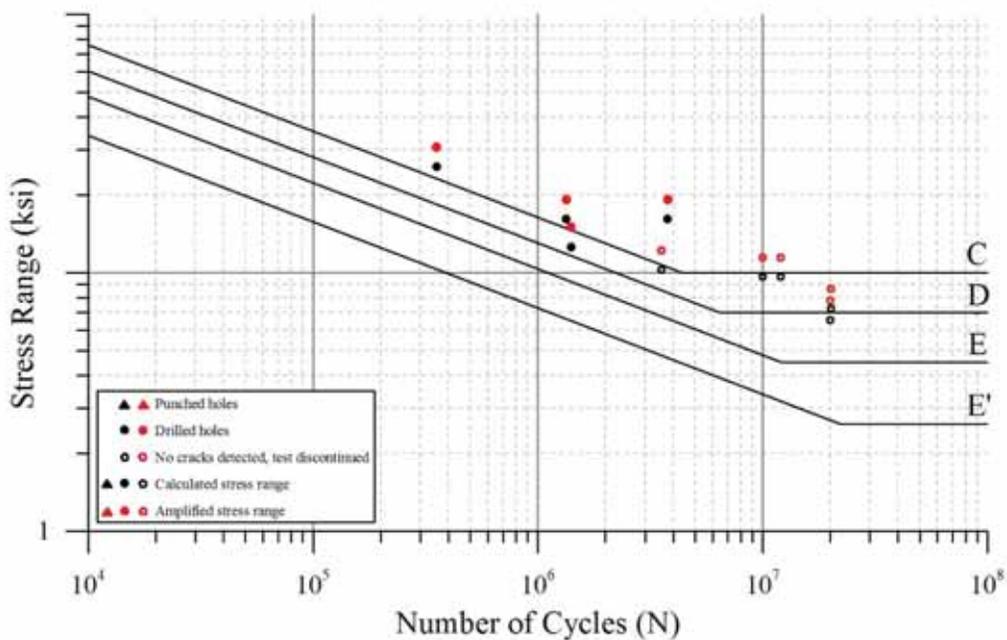
Figure 3-76 Fatigue data for specimens with drilled holes

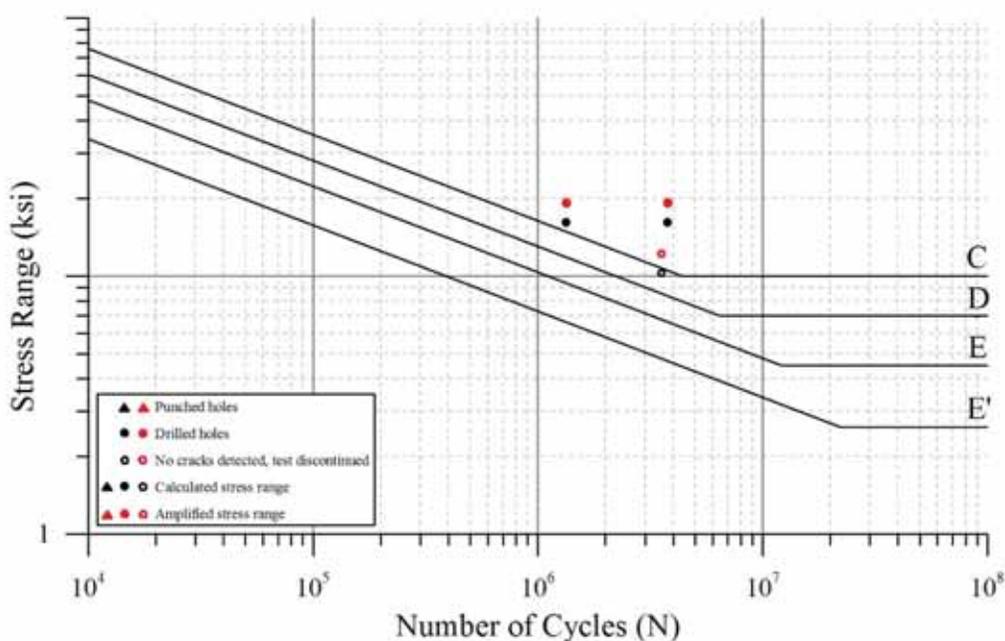
Figure 3-77 Fatigue data for specimens with non-symmetric cross sections

Three specimens were tested in fatigue with non-symmetric cross sections (Specimens 23-2, 23-3, 46-5) resulting from the initial failure of a flange angle. All other specimens had a symmetric cross section at the initiation of the fatigue testing (due to the failure of a cover plate). The fatigue data for non-symmetric cross sections is presented in Figure 3-77, and the fatigue data for symmetric cross sections is shown in Figure 3-78. The specimens with non-symmetrical cross sections performed similarly to those with symmetrical cross sections. There was no evident decrease in fatigue life due to out-of-plane stresses resulting from a failed flange angle.

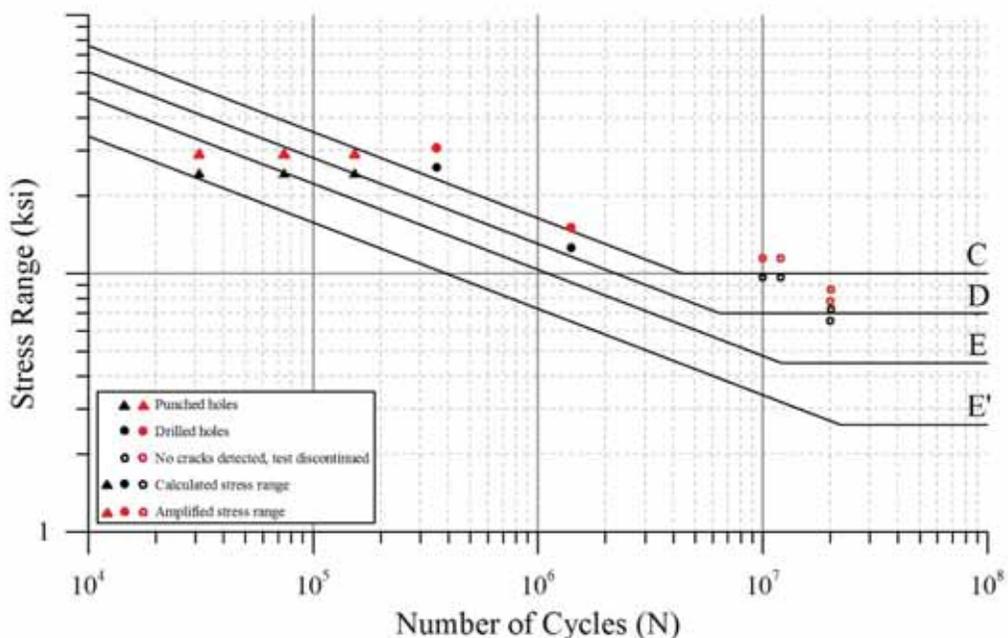
Figure 3-78 Fatigue data for specimens with symmetric cross sections

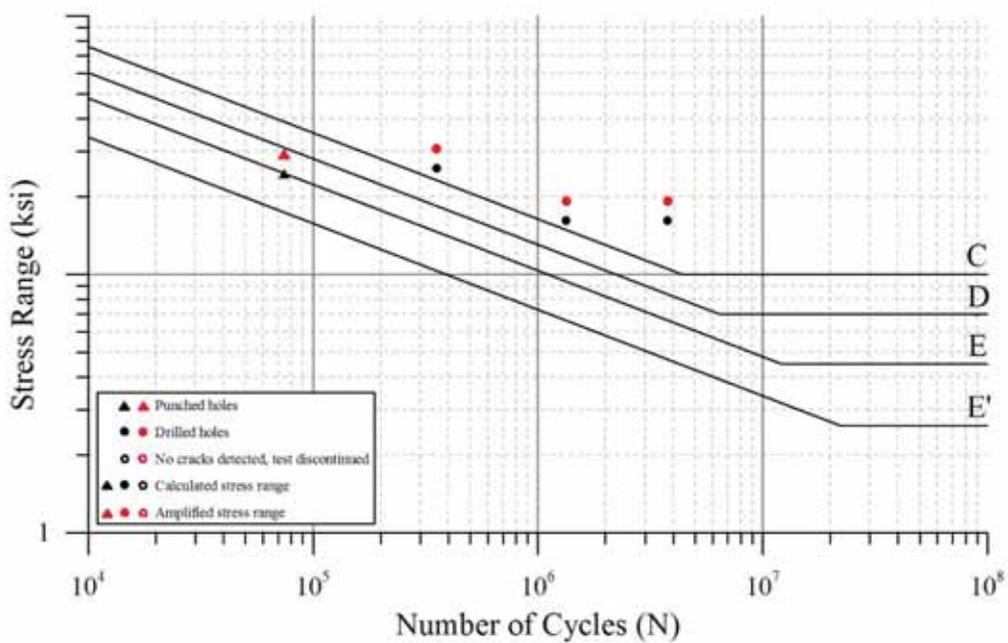
Figure 3-79 Fatigue data for specimens with low-friction between components

Four specimens (Specimens 23-1, 23-2, 23-3, and 46-1) were fabricated with a thin layer of packing grease between the cover plate and the flange angles to simulate a low friction (worse case) condition where the fasteners were relied upon to transmit the majority of the stresses between components. Each of these specimens consisted of only one cover plate attached to the bottom flange angles. The fatigue data for specimens with low friction is shown in Figure 3-79 and that of specimens with unprepared surfaces (expected to represent typical fabrication) is shown in Figure 3-80. No clear trend was noted between the two types of specimens. However, this may have been the result of the hot riveting process. During the fabrication of the specimens, as each rivet was being driven, a flame was observed at the hole. It was a result of the grease igniting when coming

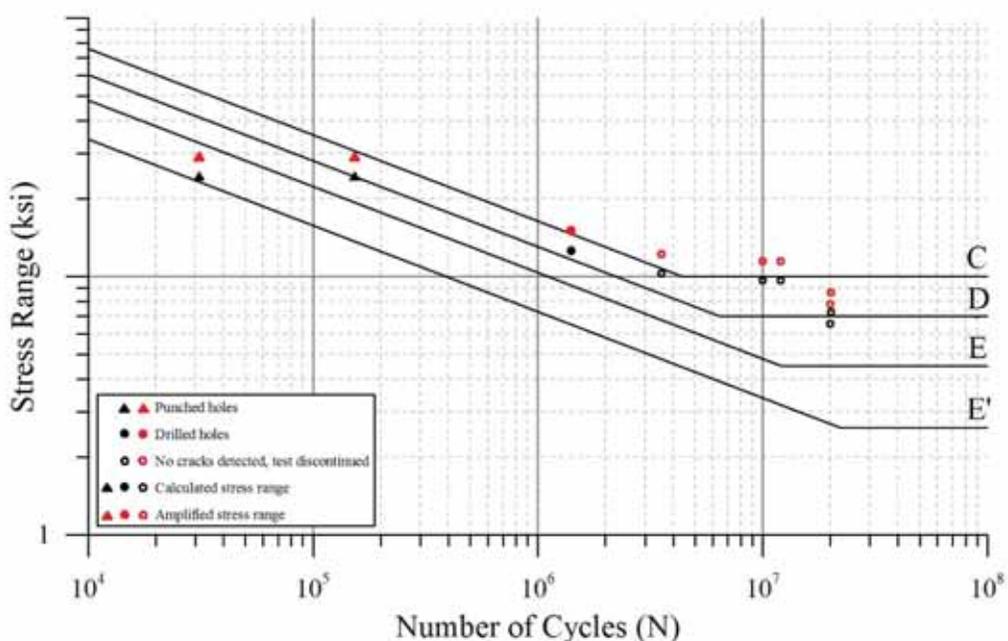
Figure 3-80 Fatigue data for specimens with typical friction between components

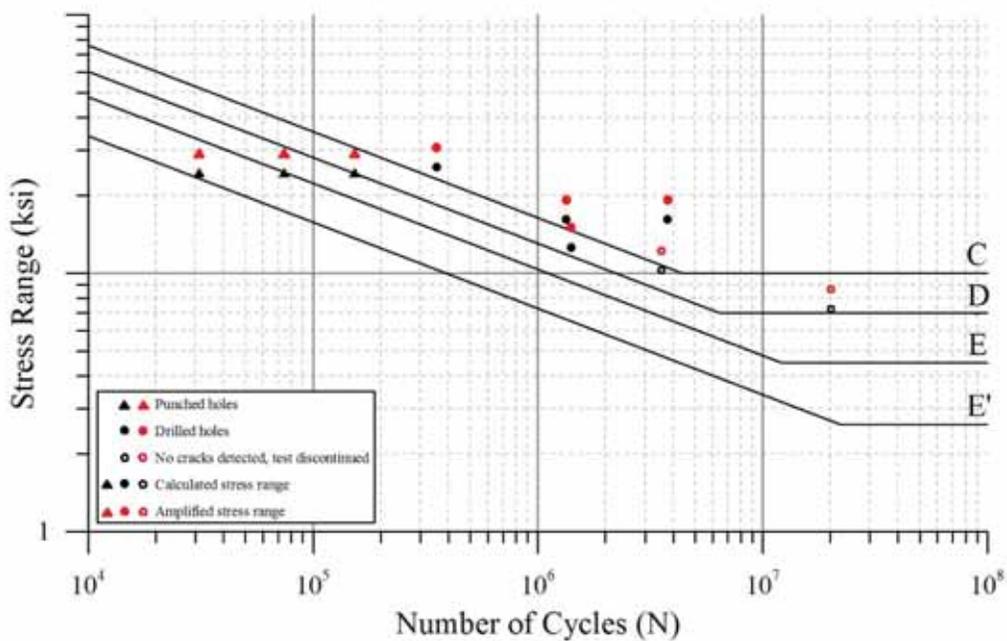
Figure 3-81 Fatigue data for specimens with 1 cover plate

Three specimens were tested which had two cover plates (Specimens 36-2, 36-3, and 36-4) connected to the bottom flange angles. All other specimens consisted of one cover plate connected to the bottom flange angles. The intent of this parameter was to determine whether the number of components affected the fatigue life of the specimen. The number of cycles were still counted from the time of failure of the first specimen until the failure of the second specimen. Figure 3-81 shows the fatigue data for specimens having one cover plate and Figure 3-82 shows the fatigue data for specimens having two cover plates. The specimens containing two cover plates were all stopped due to a large number of accumulated fatigue cycles with no detection of cracks. Each of these specimens was tested at a net section stress range (both amplified and calculated) of the partially failed

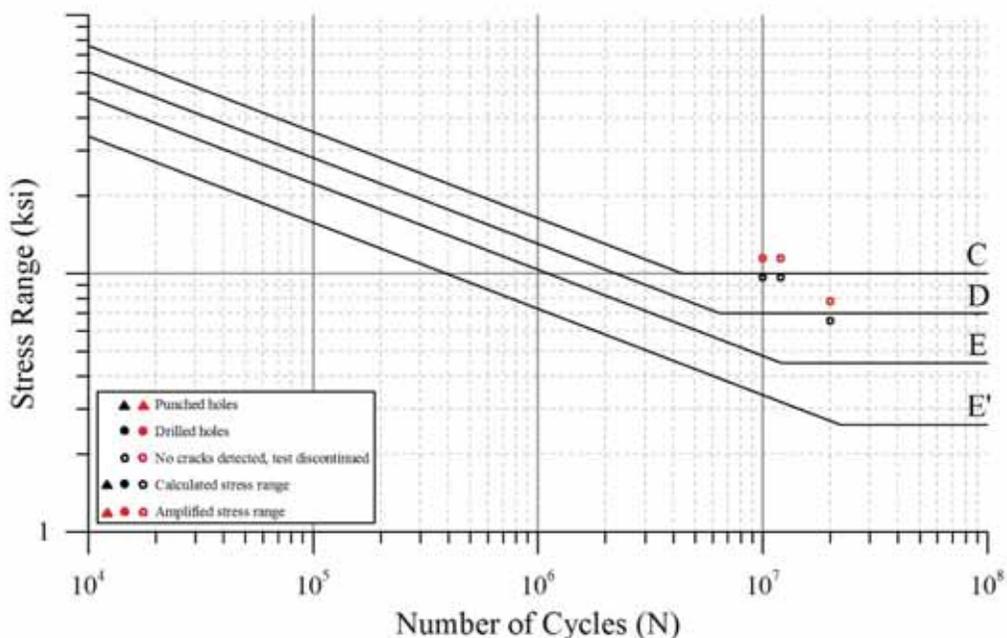
Figure 3-82 Fatigue data for specimens with 2 cover plates

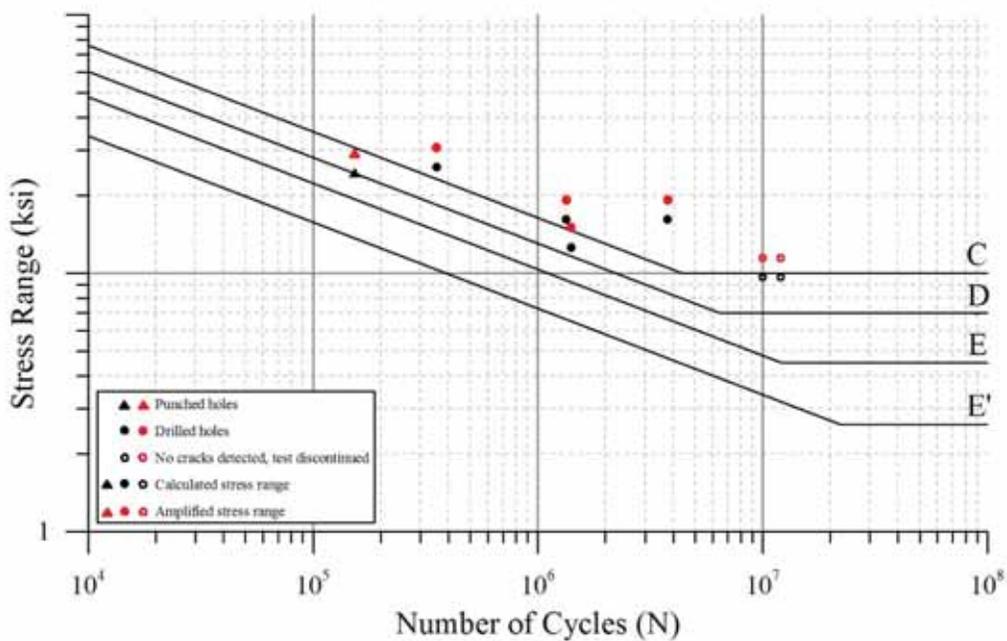
Figure 3-83 Fatigue data for specimens with rivets

Five specimens were tested in fatigue with high-strength A325 bolts (fully pretensioned) connecting the bottom flange components (Specimens 36-2, 46-1, 46-2, 46-4, and 46-5). All other specimens used rivets to connect the bottom flange components. Some specimens connected with rivets used snug tightened A325 bolts to simulate the tension force applied by a rivet. The fatigue data for specimens with rivets is presented in Figure 3-83 and the fatigue data for specimens connected with high-strength tensioned bolts is shown in Figure 3-84. No noticeable difference in fatigue life was observed between specimens constructed with fully pretensioned high-strength bolts and those constructed with rivets. This behavior resulted because of the similarities of the resulting detail after a component failure. It was observed that when a component of a specimen

with high-strength bolts was failed, the pretension was minimized due to fretting, or the fatigue of the washer and/or the nut. After the pretension of the bolt was lost, the fatigue detail was essentially that of a plate with a hole (having a loose fastener in it).

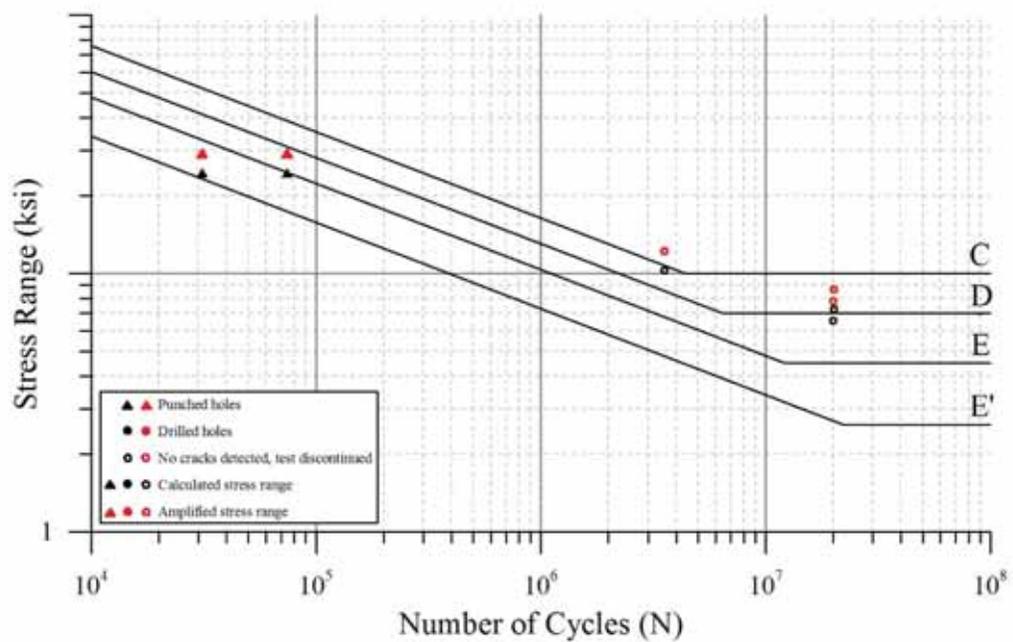
Figure 3-84 Fatigue data for specimens with bolts

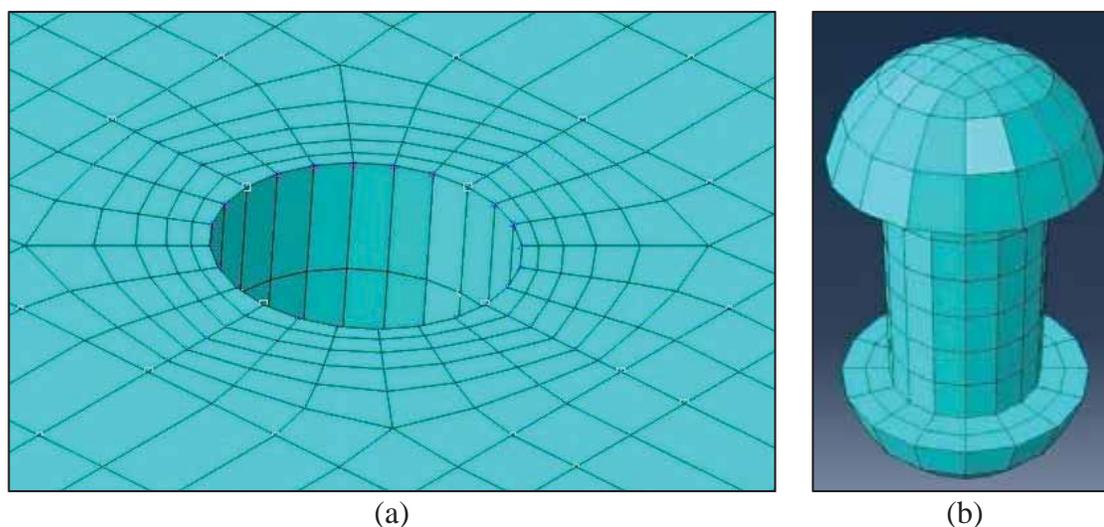
Figure 4-1 (a) Mesh at fastener hole; (b) Rivet mesh

Each of the built-up components was created as an individual part composed of three dimensional deformable solid elements. The cross section of each longitudinal component was created and then extruded to the required length. Rivets were created by drawing half of a cross section and extruding the profile along a radial sweep. 8-noded linear brick elements with reduced integration and hourglass control (C3D8R) were used with a structured hex mesh. The global seed size was set to 0.5 inches for all longitudinal components except the top flange which was set to 2.0 inches due to its distance from the area of interest (the bottom flange). Local seeds were created at the holes to refine the mesh near the interaction with the fasteners (see Figure 4-1a). The global seed size of the rivets was set to 0.25 inches (see Figure 4-1b).

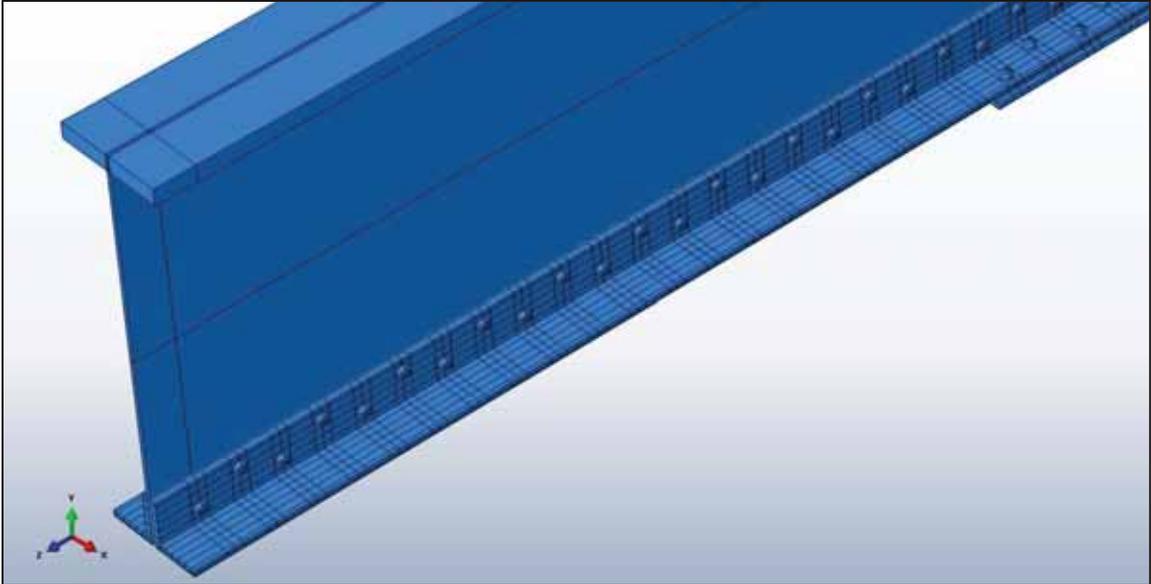
Figure 4-2 FE model assembly

Based on the work of Bonachera Martin (2014), the parts were assembled with “Hard Contact” Normal Behavior and Penalty Tangential Behavior having a friction coefficient of 0.5 to simulate the friction between the riveted components (web plate, flange angles, and cover plate). Figure 4-2 shows a typical assembled model with top flange, web plate, flange angles, cover plate, and rivets. The connection between the top flange and the web plate was simulated by using a mesh tie constraint. A pin bearing was modeled 6” from one end of the model by using a boundary condition displacement in the vertical and longitudinal direction. A roller was modeled 6” from the opposite end using a boundary condition preventing displacement in the vertical direction only. Lateral torsional buckling bracing was simulated by applying a boundary condition restricting movement in the transverse direction at nodes on either face of the top flange where the centerline of the actuator was located.

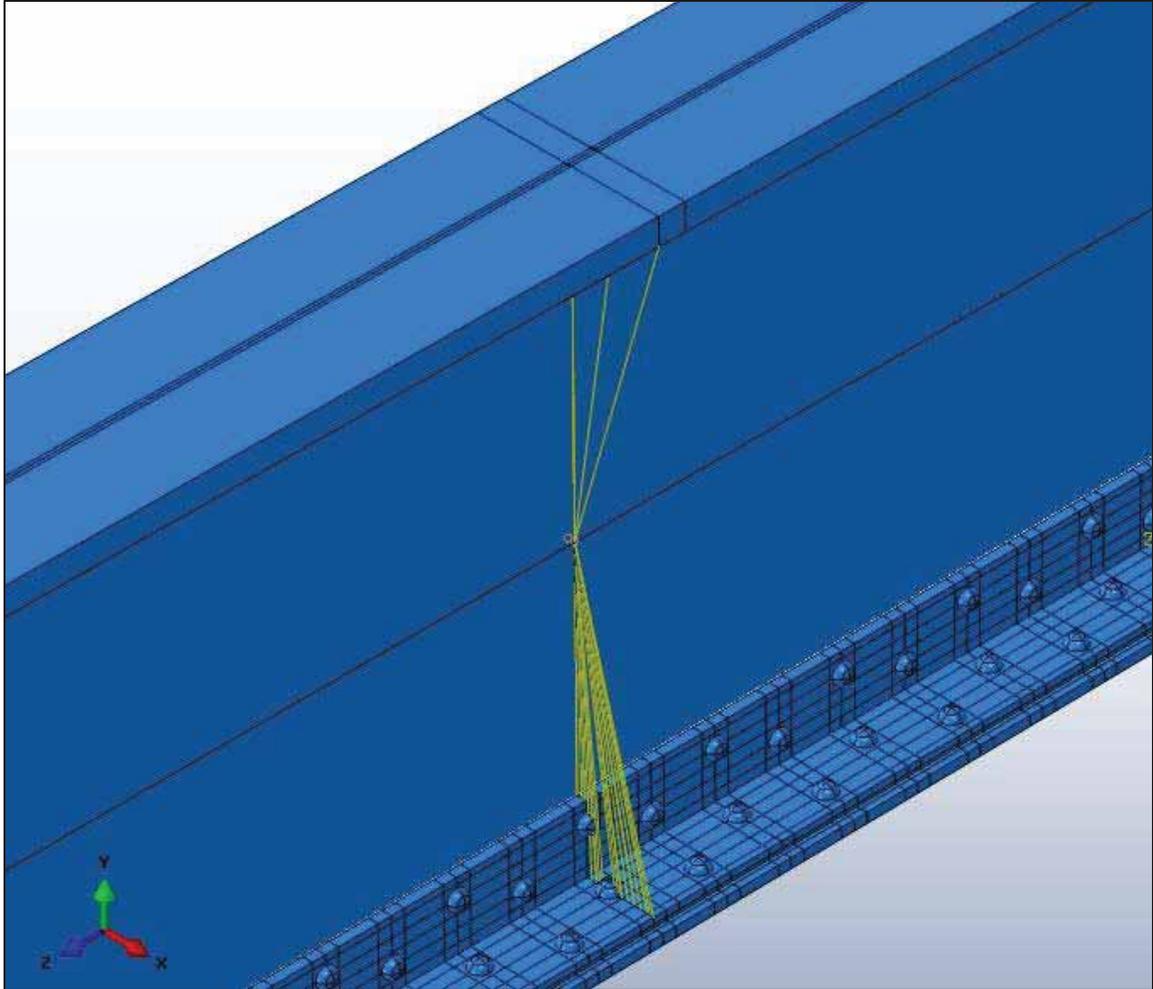
Figure 4-3 FE model stiffener

Stiffeners were modeled by using a rigid kinematic coupling (see Figure 4-3). The master node was selected at mid-height of the web plate. Linear nodal regions along the top flange, web plate, and bottom flange (in the vertical plane) were selected as the slave regions. The U1, U2, and U3 degrees of freedom were all constrained.

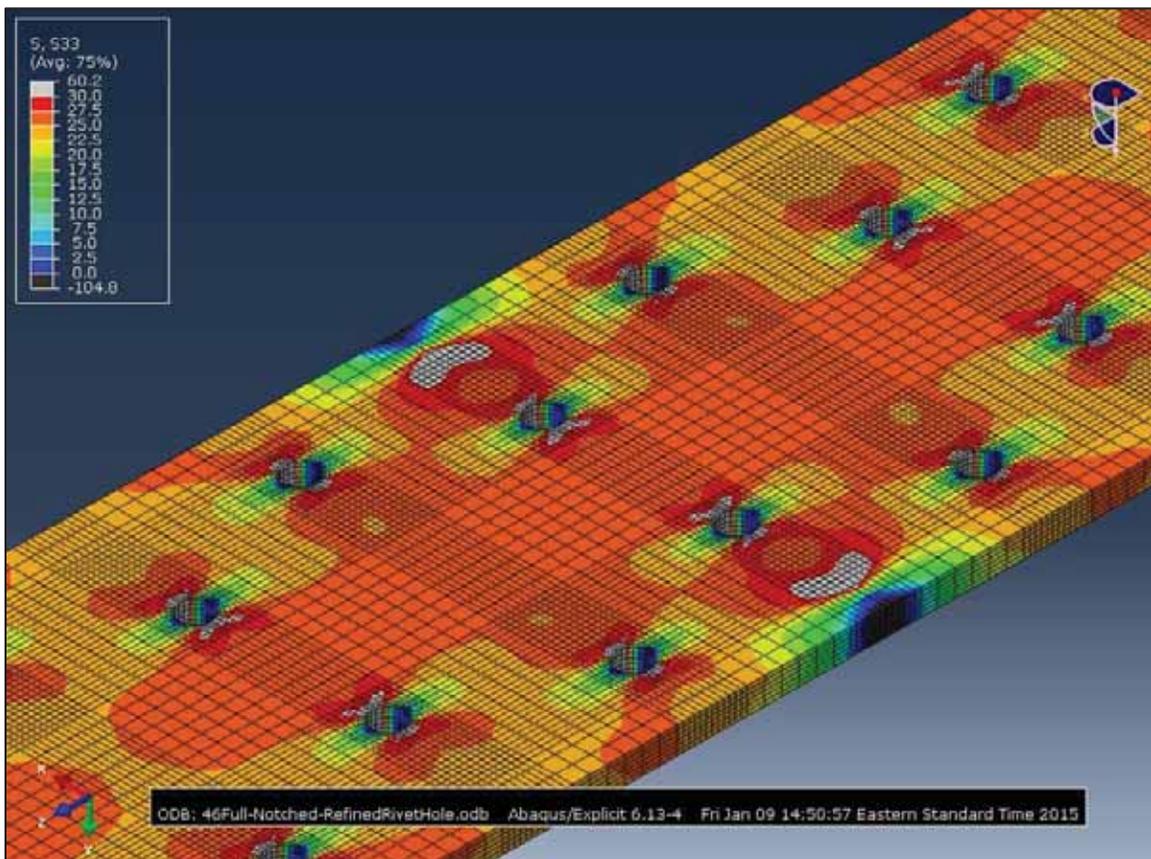
Figure 4-4 Full model: stress in cover plate at mid-span

created for the loading – the first was to apply the dead load, and the second to apply the live load. A smooth step (with NLGEOM set to on) was created for the loading to reduce vibration in the model. Figure 4-4 shows the longitudinal stress of the cover plate in the constant moment region resulting from the full edge-notched model. The cover plate shown has notches at the center of the image, in line with the fastener holes. The stress range in the plot is between 0ksi - 30ksi in order to illustrate the stress distribution in the component and concentrations around fastener holes (maximum stresses tensile and compressive stresses are shown beyond the range of the plot). Other components (flange angles and web plate) have similar stress distributions around the fastener holes.

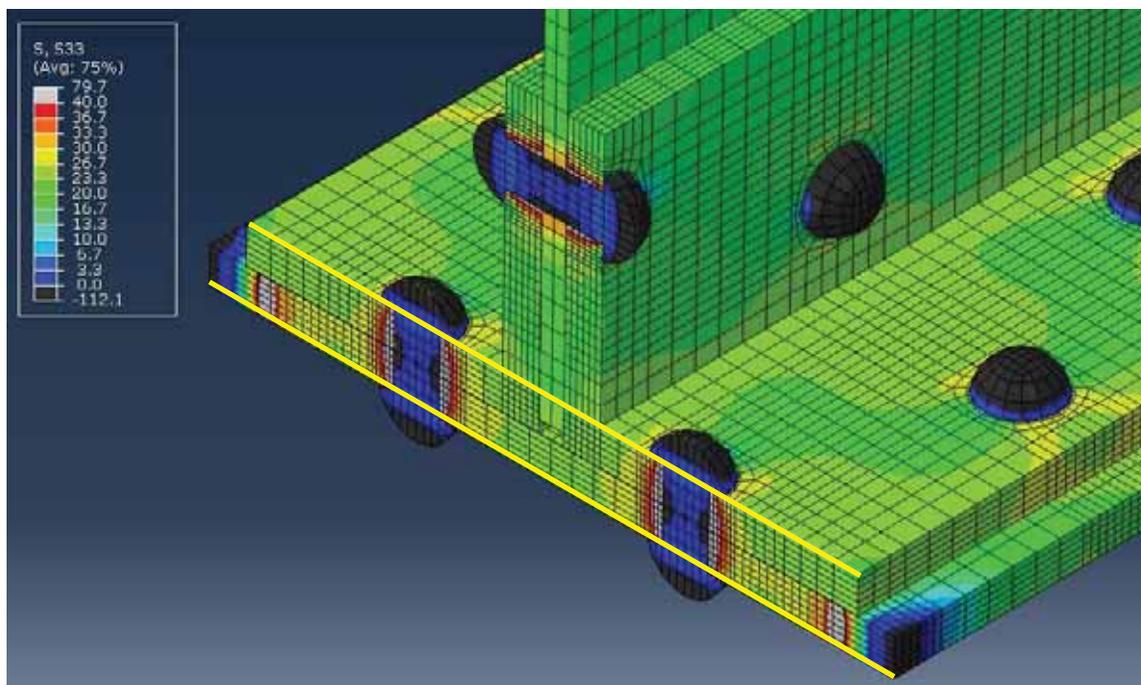
Figure 4-5 Full model – stress paths at cover plate and flange angle

After the model was run, the resulting longitudinal stresses were plotted in both the longitudinal and transverse directions of the bottom flange angles and cover plate. Discrete paths were selected which correlated with the grid line locations of the strain gages used on the experimental specimens. It was determined that the best representation of the effects of stress concentrations were found through a comparison of stresses at a given transverse cross-section. Additionally, in order to benchmark the model, the stress values were obtained at each gage location (i.e. the top face of the flange angle, and the bottom face of the cover plate). An illustration of the paths (yellow lines) along which the stresses were measured for the purposes of benchmarking the models is shown in Figure 4-5. Figure 4-6 shows the longitudinal stresses obtained from the full model compared with the experimental data recorded from Specimen 46-4 prior to cover plate degradation. The stress is plotted as a function of the transverse distance along the top of the flange angle to represent the overall stress distribution at the cross section. The stress from both the model and the experimental results for all strain gages on the bottom flange are shown in Table 4-1. The model showed good correlation with the behavior of the experimental specimen as illustrated by an average of 1.11 ksi difference between longitudinal stress values at the location of the strain gages.

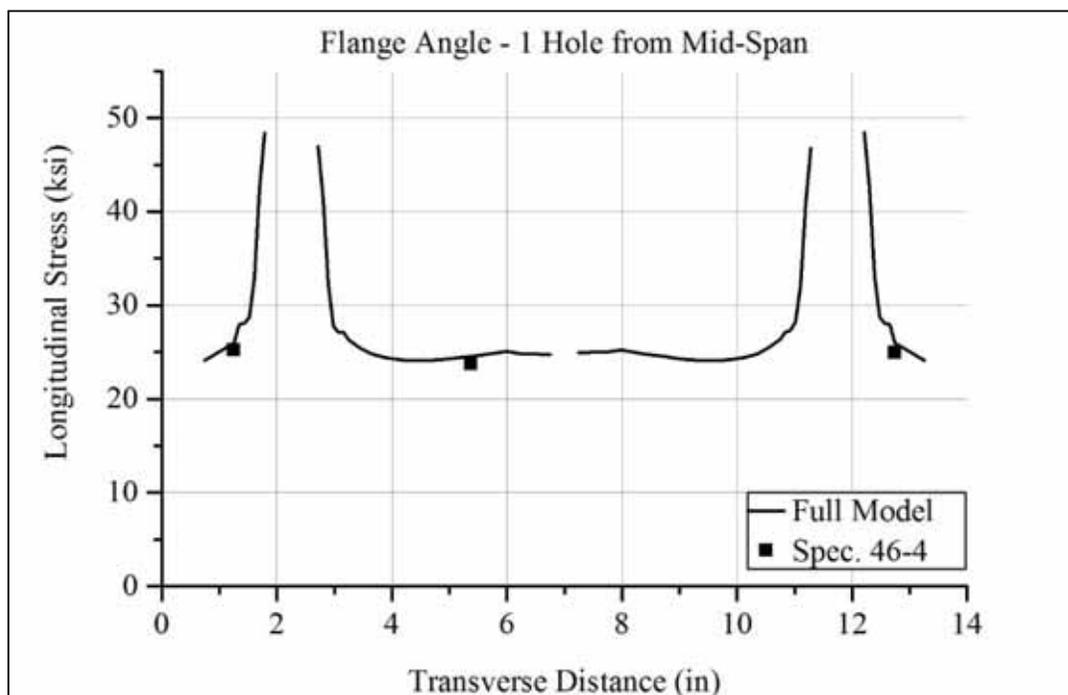
Figure 4-6 Stress comparison (FE full model vs. experimental data)

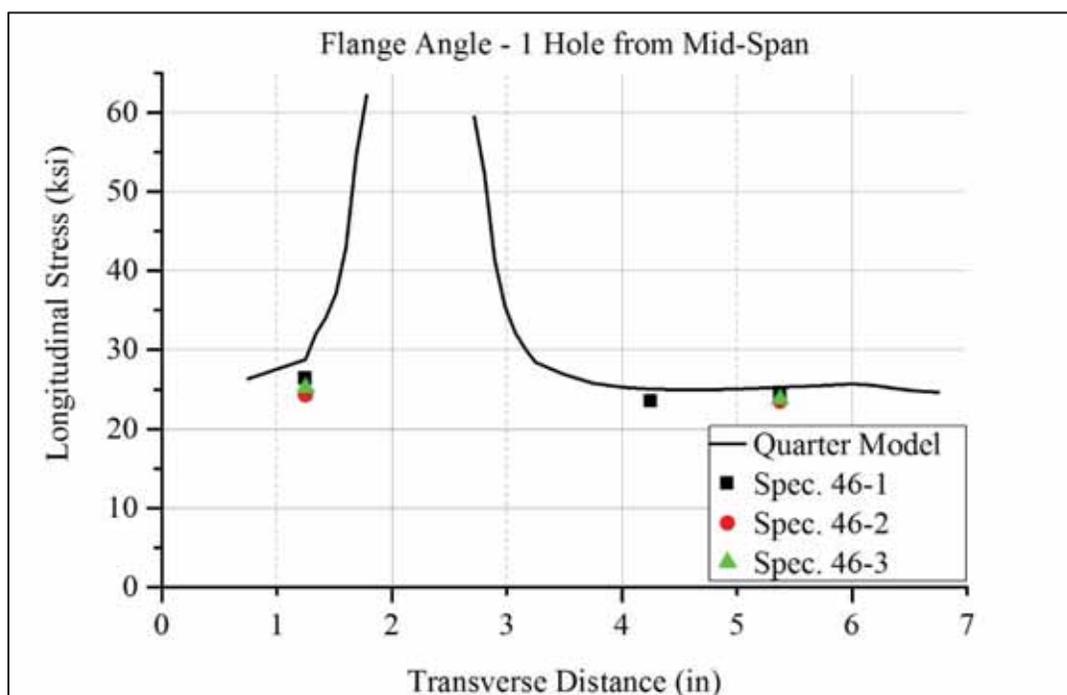
Figure 4-7 Stress comparison (FE quarter model vs. experimental data)

Another model was created to validate the data obtained from specimens with hole notches (Specimens 46-1, 46-2, and 46-3). In order to simplify the finite element model, and reduce the computational time (from 252 hours to 112 hours), a quarter symmetry model was constructed. Figure 4-7 shows the experimental data plotted with the results from the FE quarter model, one hole away from mid-span (the location of the notches). Table 3-2 compares the stress from each of the gages on the bottom flange components with that obtained from the FE model at the same coordinates. The model showed good agreement with an average stress difference of 1.33 ksi from the experimental data. In general, the model was more conservative than the experimental results with slightly higher stress values.

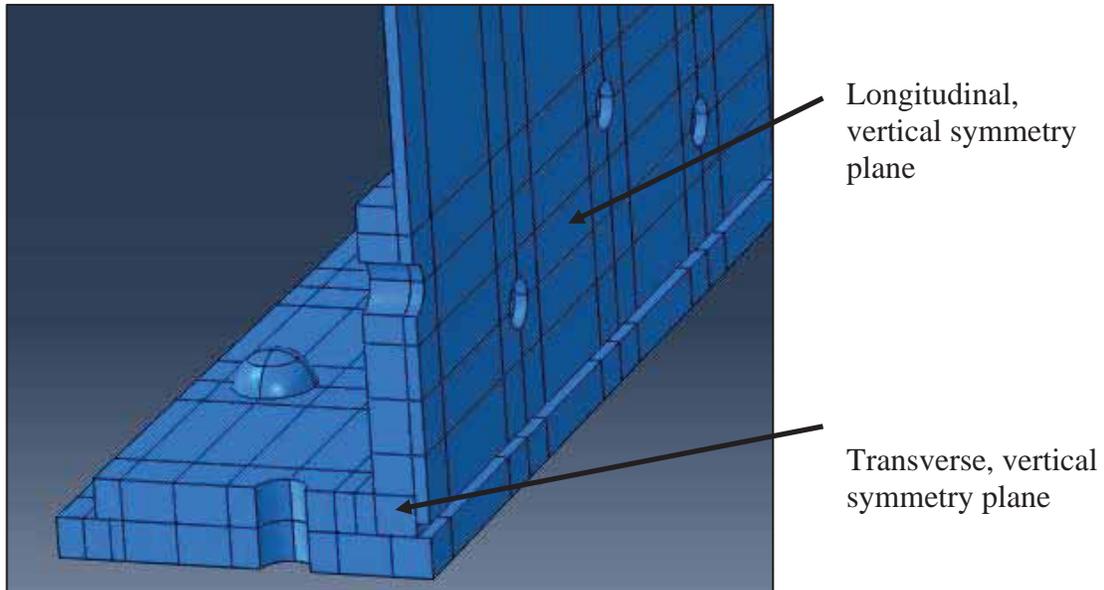
Figure 4-8 Axial model symmetry planes

The model was created as a quarter symmetry model to decrease the computational requirements. Two planes of symmetry were created, one plane along the longitudinal vertical centerline axis, and the other as a vertical transverse axis at the failure location (see Figure 4-8). Non-linear geometry was not used due to the observed minimal impact, as well as the decrease in time required to run each model. Implicit (standard) models were used. Each longitudinal component (top flange, web plate, flange angle, and cover plate) was extruded to a length of 8'-0" (the length of approximately two beam heights) to allow adequate distance from the location of a mid-span failure to accurately describe the stress redistribution.
