Purdue University

Steel Bridge Research, Inspection, Training, and Engineering (S-BRITE) Center

Member-level Redundancy of Built-up Steel Girders Subjected to Flexure

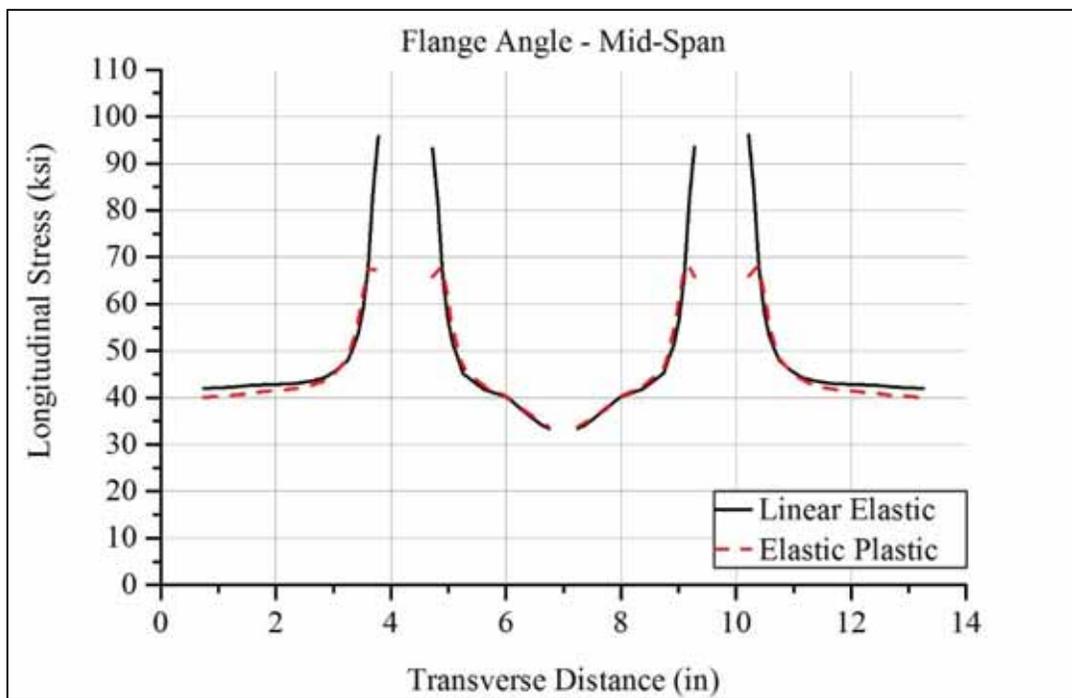
Figure 4-9 Full model – linear elastic vs. elastic plastic

A linear elastic steel material was used for all components. This was the result of comparing the results from full models having linear elastic materials, with those having plasticity in the form of the Ramberg-Osgood equation as described in Section 4.1.1. The longitudinal stress of the flange angle at the mid-span of two models were plotted to compare the behavior and are shown in Figure 4-9. The stresses matched very well between the two models except at the edge of the hole where the stress concentration results in significantly higher stresses. Due to the overall good correlation (within 6.6% overall, and 2.6% for the stresses below yield), further models were constructed with linear elastic material properties. This approach is also conservative in terms of estimating the amplification effects after component fracture occurs since local stresses are over predicted.

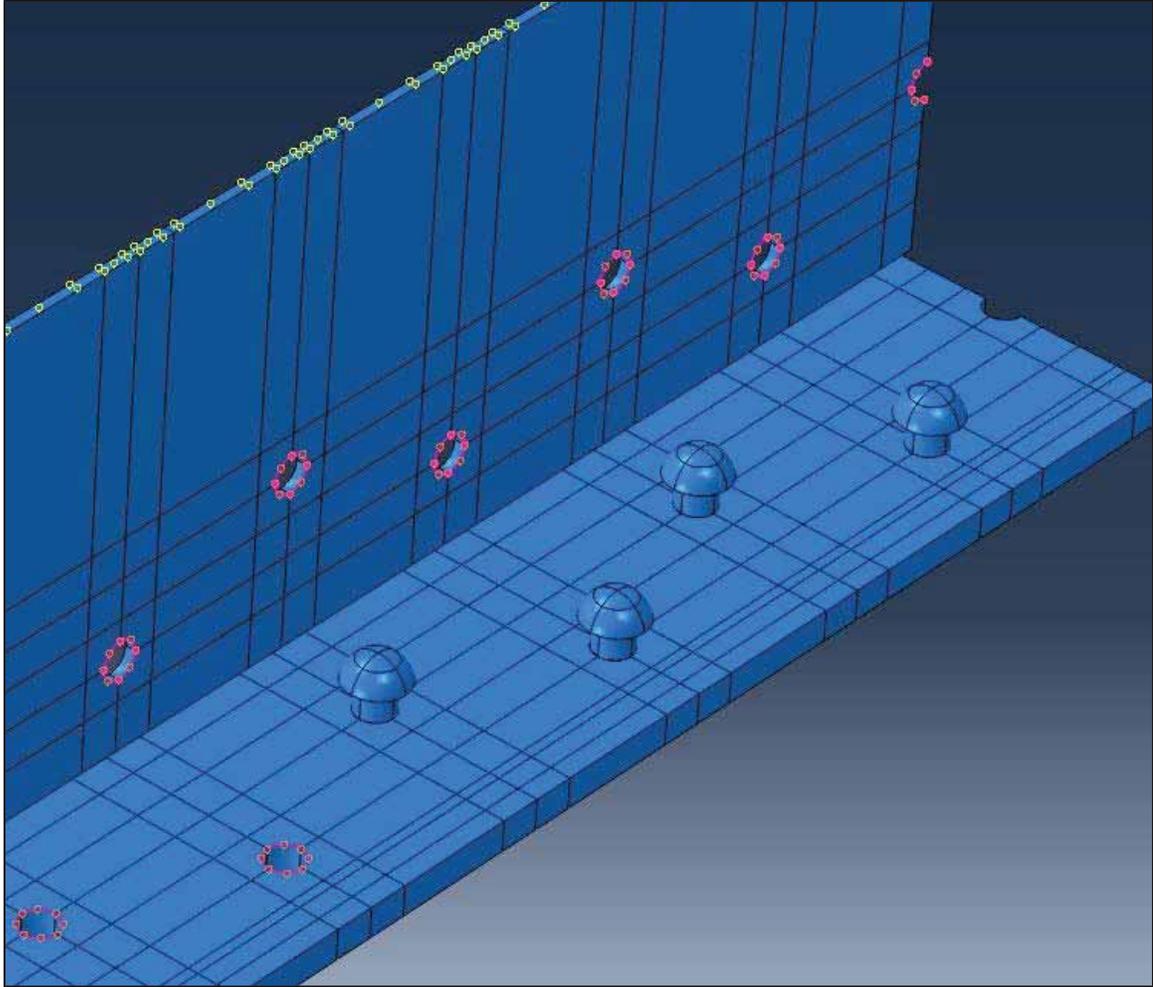
Figure 4-10 Axial model – modeled and simulated rivets

It was found that the fastener pretension had minimal impact on the longitudinal stresses in the components near the area of interest. Consequently, no pretension was applied to the rivets. Rivets were modeled in the first four holes (connecting the horizontal flange of the flange angle to the cover plate) adjacent to the failure plane. This correlates with the work performed by Bonachera Martin 2014, in which four rivets were found to be the transfer length required for riveted plates with a discontinuity. All other rivets were simulated by using a nodal tie constraint around the hole at the intersection of adjoining components. Figure 4-10 shows the bottom flange cover plate with the web (the flange angle is hidden) and both the modeled rivets as well as the simulated rivets with nodal tie constraints. A global seed size of 0.125” was used for the rivet mesh.

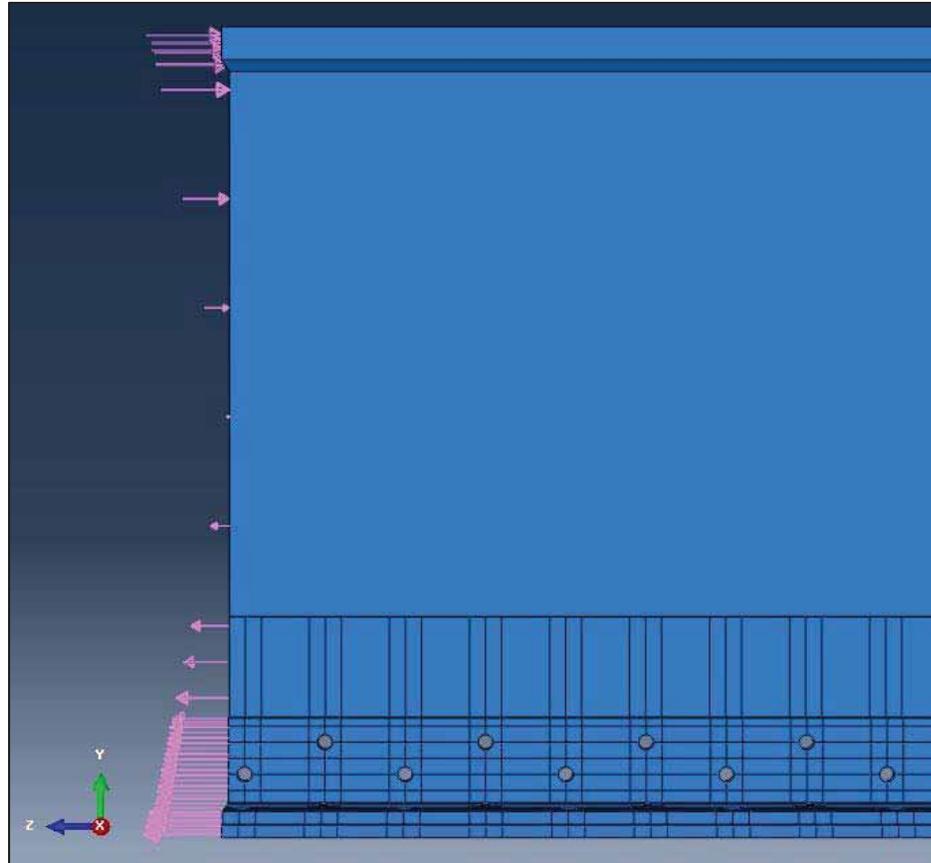
Figure 4-11 Axial model – trapezoidal load distribution

'Hard Contact' normal behavior was used for the contact method. Hard contact prevents the penetration of the two surfaces modeled, but allows separation. No friction was included in this simplified model because it was found that its inclusion had little influence on the resulting longitudinal stress results. An axial stress was applied to the cross section of the beam (see Figure 4-11). The axial load had a trapezoidal shape in order to simulate a beam in bending. The magnitude of the stress was equal to 27.5 ksi (0.55 F_y of the test specimens).

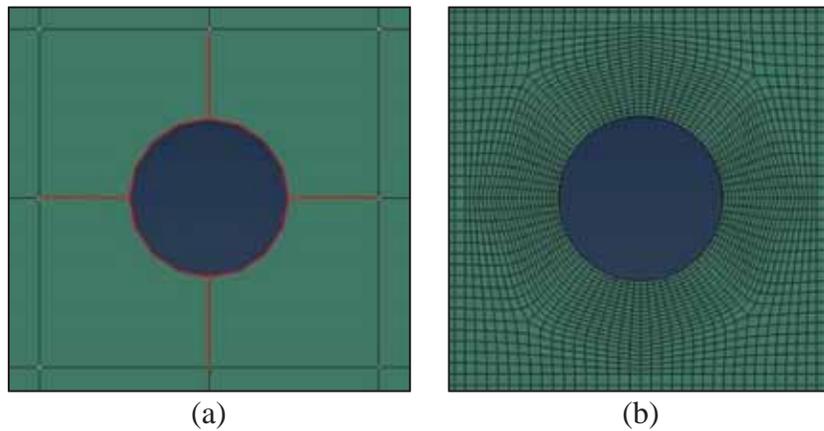
Figure 4-12 (a) Hole mesh seeding location, (b) Hole mesh

After the axial model was successfully created, the resulting longitudinal stresses were compared with the full model. The stress values were very nearly the same with an average of 2.0% difference. A mesh refinement study was performed with 4 additional models with increasing levels of refinement. Because the model constructed was of a beam with a failed cover plate, the most affected stress distributions (and therefore the point of interest) were in the flange angle near the failure. A 24” portion of the flange angle adjacent to the failed cover plate was refined to the levels shown in Table 4-3. The number of hole seeds describe the number of seeds at each quarter of the edge of the hole along a line

extending from each quadrant of the hole to a 2''x2'' square centered around the hole (as shown in Figure 4-12a).

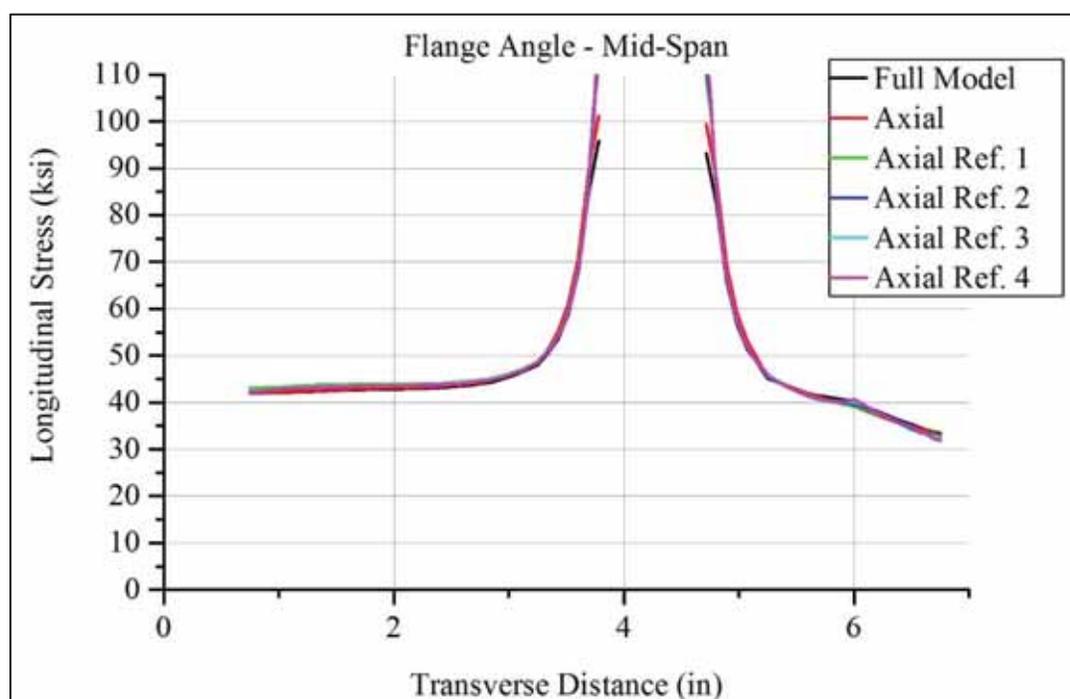
Figure 4-13 Axial model (with refined versions) vs. full model

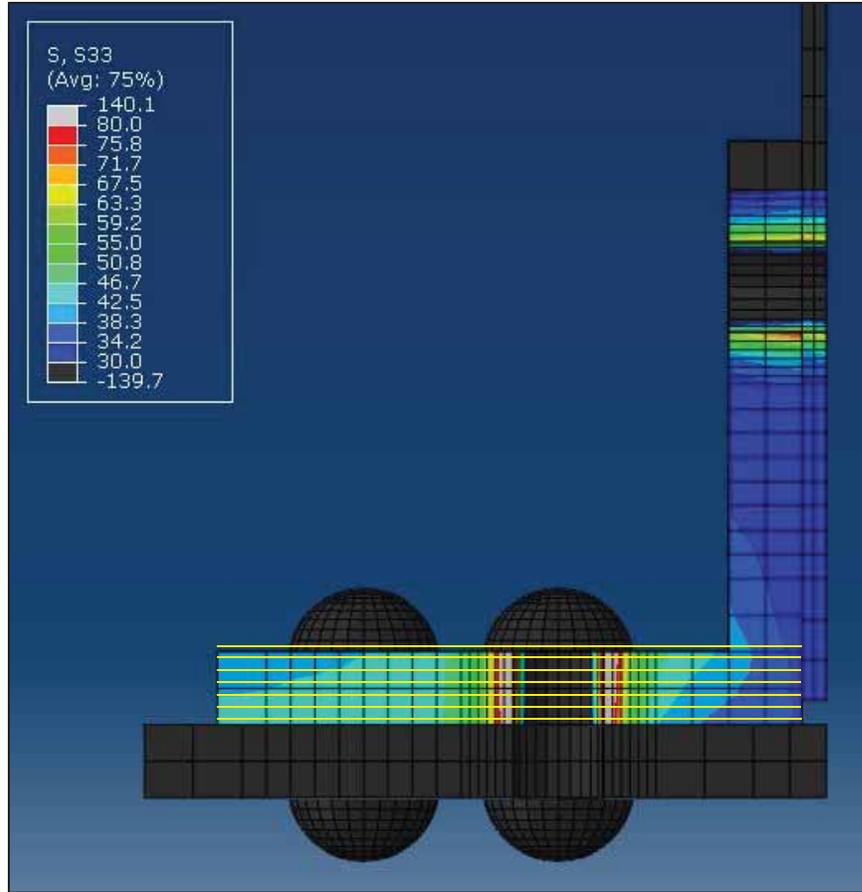
Figure 4-14 Axial model – Stress paths through horizontal leg of flange angle

In order to compare the results of the different models, a single equivalent net-section stress value of the partially failed cross-section was desired for each component at a cross-section. The trapezoidal rule was used to obtain the force in the component, and subsequently, the force was divided by the net area to obtain an equivalent net-section stress. A large stress gradient was observed through the thickness of a component in the FE model when a component in the same cross-section was partially or fully failed. In order to take into account the variation in stresses throughout the thickness, horizontal paths were created at evenly spaced increments at the point of interest and were compared. Figure 4-14 shows the flange angle of an axial model, with the plotted longitudinal stress (note the stress gradient). In addition, the horizontal paths used to determine stress profiles through the thickness of the component are shown (drawn as yellow lines in the image).

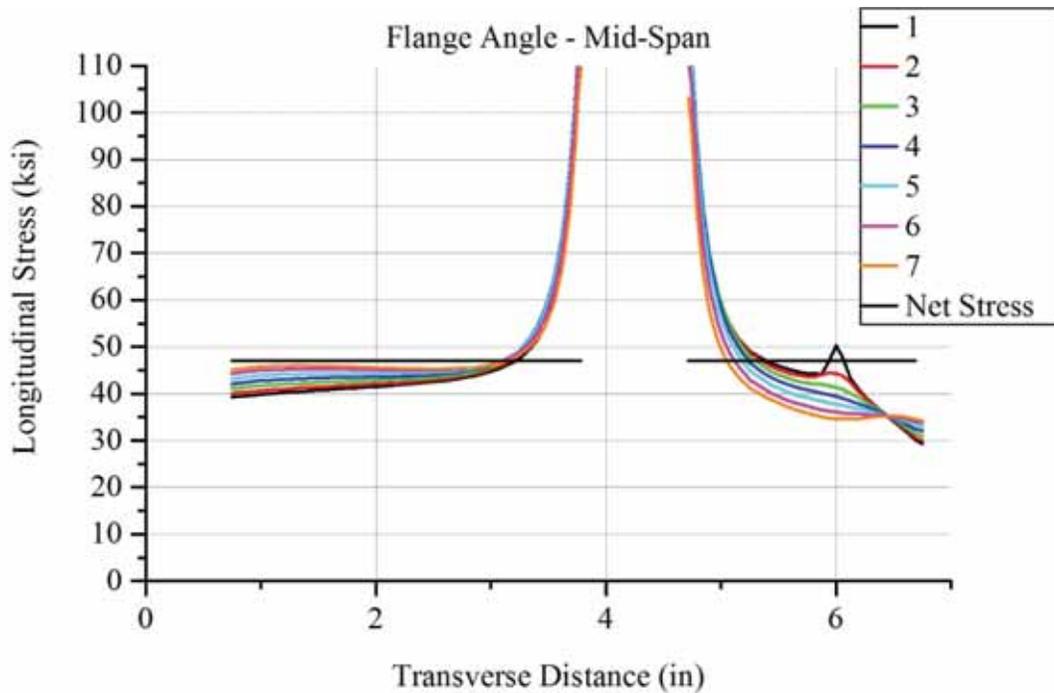
Figure 4-15 Axial model – stress gradient through flange angle thickness

Lastly, the force in the component was divided by the net-area at the cross-section to determine an equivalent net-section stress. Figure 4-15 shows the stress profile at each of the paths through the thickness of the flange angle as well as the equivalent net-section stress calculated from the trapezoidal rule.

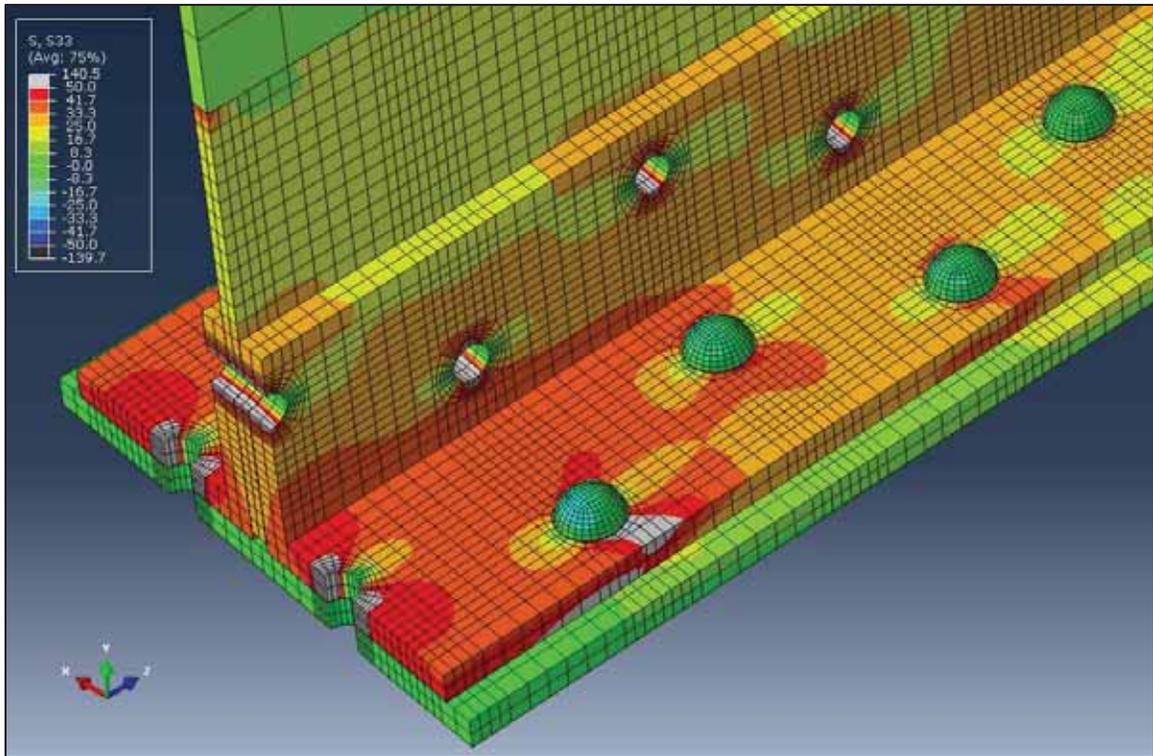
Figure 4-16 Typical axial model (failed cover plate)

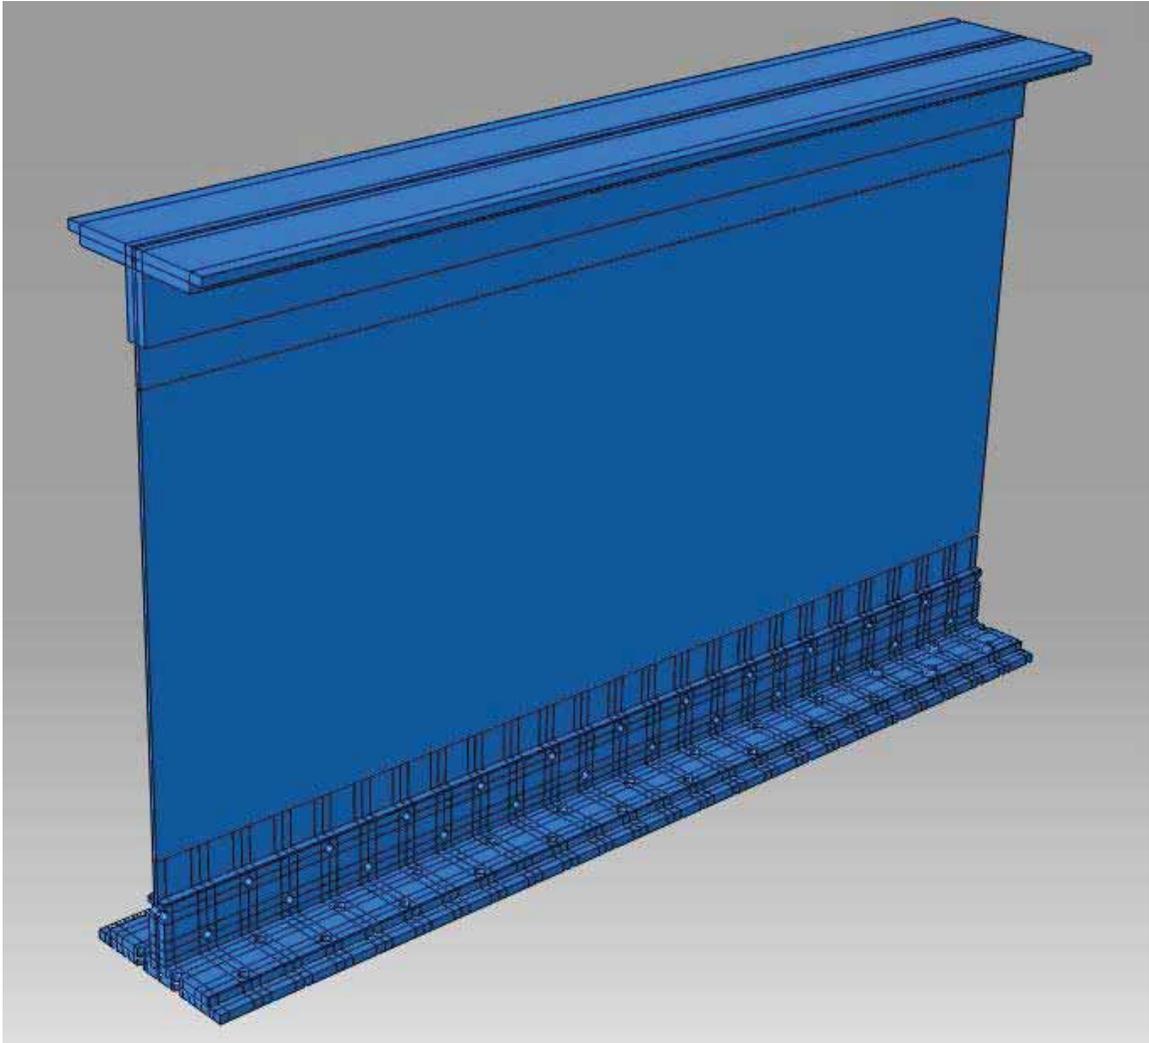
Figure 4-17 Parametric model

The finite element model used in the parametric studies was based on the axial model developed in Section 4.1.3. An implicit (standard) model was used with beam components having a length of 120". The web plate was 0.5"x72", the flange angles were 8x8x1", and the top and bottom cover plates were 20"x1". Rivets were 1" diameter nominal, with a modeled diameter of 1-1/16" (due to the hole size and the tendency for rivets to expand and fill a hole during the driving process). The top flange, components (cover plate, flange angles, and upper 12" of the web plate) were modeled as a single shape and then extruded. Partitions were used in the top flange part to create boundaries at simulated component faces. No rivets were used for the upper cover plate because of the distance from the point of interest. The remaining 60" of the web plate was divided into two sections, a 12" strip at the bottom which had fastener holes and was connected to the bottom flange angles, and a 48" middle portion which was tied to the upper and lower portion with a surface tie constraint. Following the findings from the development of the axial model (in Section 4.1.3), the first four rivets (on each side of the flange angle-to-

cover plate connection) were modeled, and the remaining rivets were simulated with nodal tie constraints between each of the elements at the rivet holes.

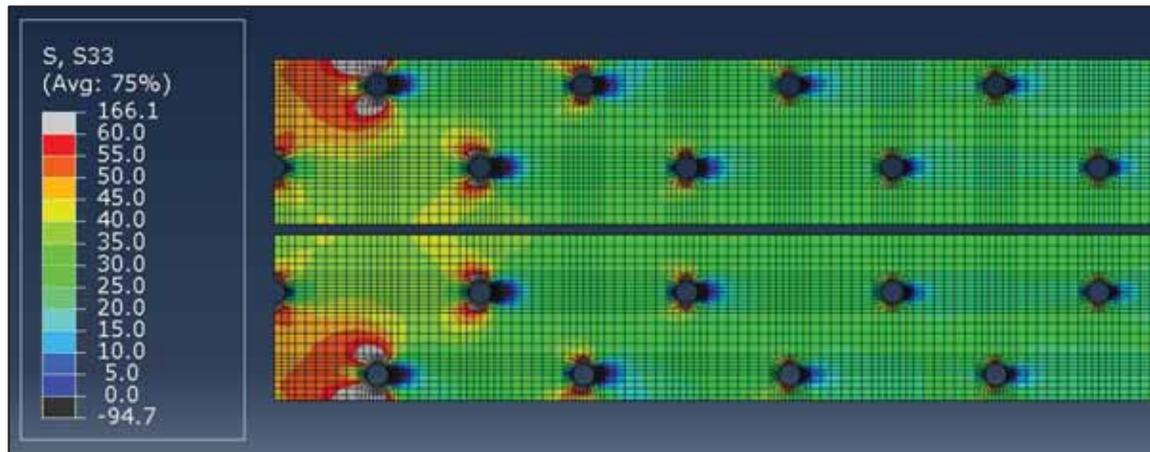
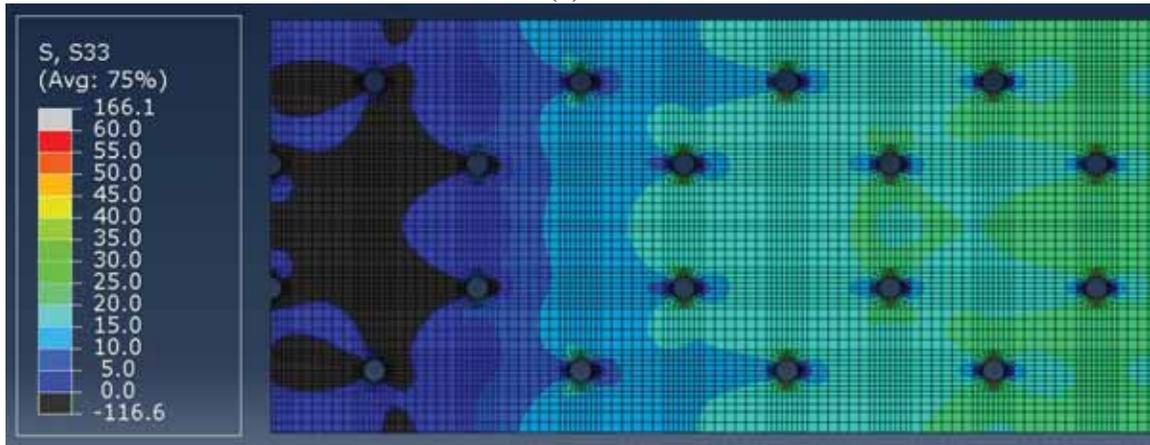
(a)

(b)

Figure 4-18 Stress transfer in (a) Flange angles, (b) Cover plate

The longitudinal stresses in the unfailed components were very similar at both the cross-section of the failure (mid-span for these models) and the first hole adjacent to the failure. This was expected because of the required stress transfer and the net-section at this location. Figure 4-18 shows the stress transfer in both the flange angles (a) and the cover plate (b) of a model with a fully failed cover plate (at the left side of the components

shown). The longitudinal stresses are plotted from a range of 0 ksi to 60 ksi in order to illustrate the stress distribution between components. As is shown in the figure, the largest stresses in the flange angle are from the failure plane (left side) to the first row of rivets to the right of the failure.

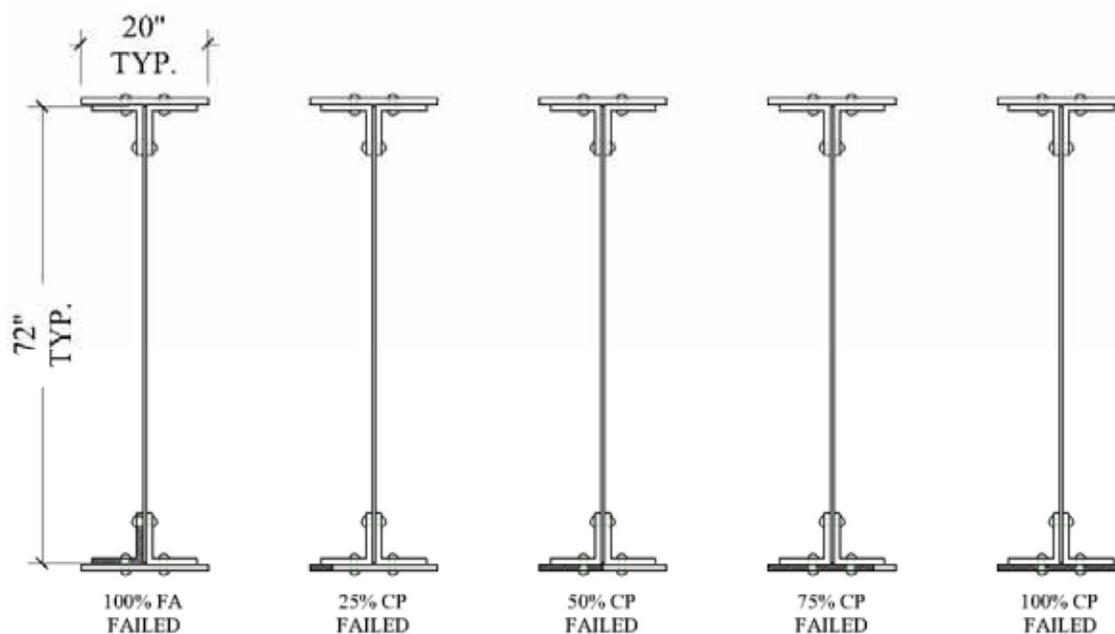
Figure 4-19 Non-symmetric cross-section models

To determine the influence of a non-symmetric cross-section on the longitudinal stress in a component adjacent to a failed, or partially failed, component (i.e., a cover plate), a series of models were constructed and analyzed with increasing percentages of a failure in the single cover plate. Additionally a model with a failed flange angle was compared (see Figure 4-19 for the model geometries). The built-up member size and geometry described in Section 4.1.3 was used for each of the models. It was expected that a larger non-symmetric influence would result when a portion of a cover plate was failed than when a flange angle was completely failed due to the proportional bottom flange area.

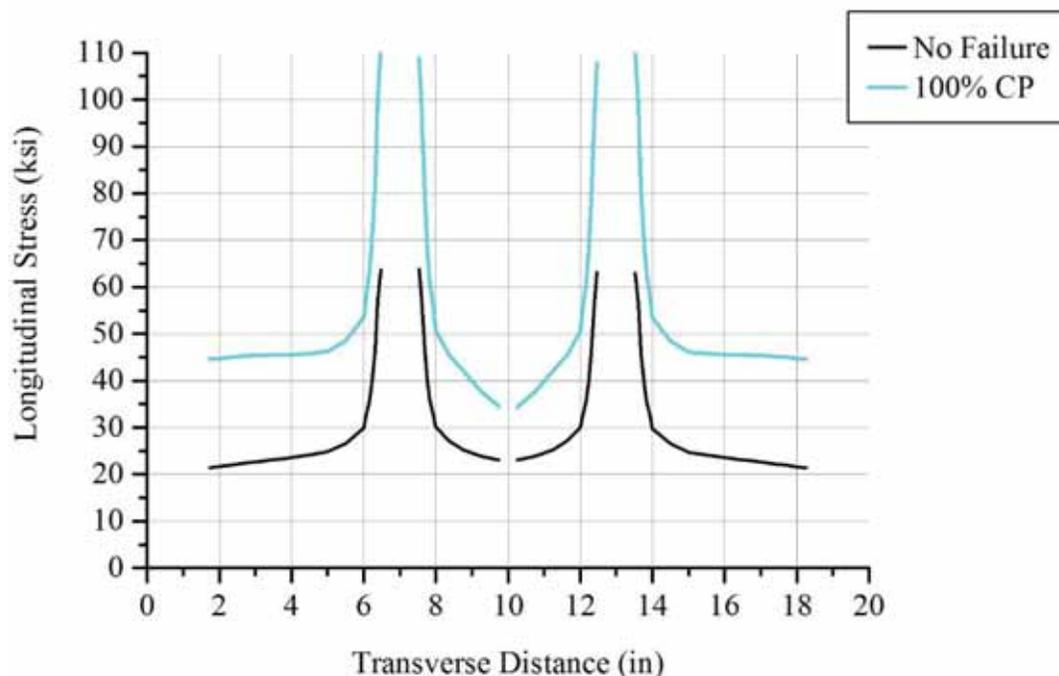
Plots were made to compare the distribution of longitudinal stresses in each flange angle with the original stresses. Figure 4-20 shows the stresses in the original model (with no failure) compared to those in a model with the entire cover plate failed. The increase in the net-section stress (obtained through the trapezoidal rule as described in Section 4.1.3) was from 26.9 ksi (approximately $0.55F_y$) to 48.9 ksi, an increase of 81.7%. Due to the symmetry of the failed cross-section, the stresses have a similar distribution to the original stresses along the horizontal leg of the flange angle.

Figure 4-20 Stress comparison – No failure vs. 100% cover plate failure

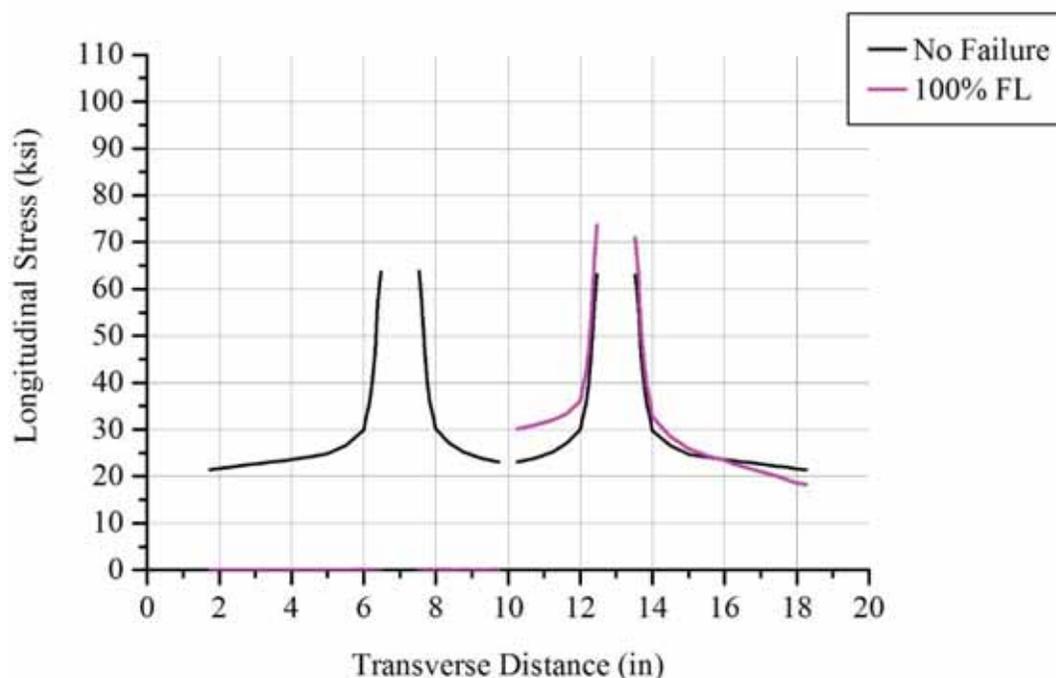
A model was then analyzed for stress increases in a flange angle due to a non-symmetric condition resulting from a complete failure of an adjacent flange angle. A modest stress increase of 8.6% (of the after failure net-section) resulted from this situation. The distribution of the stress can be seen in Figure 4-21. However, as will be discussed, the stresses for this condition were much lower than those produced by a partially failed cover plate.

Figure 4-21 Stress comparison – No failure vs. 100% flange angle failure

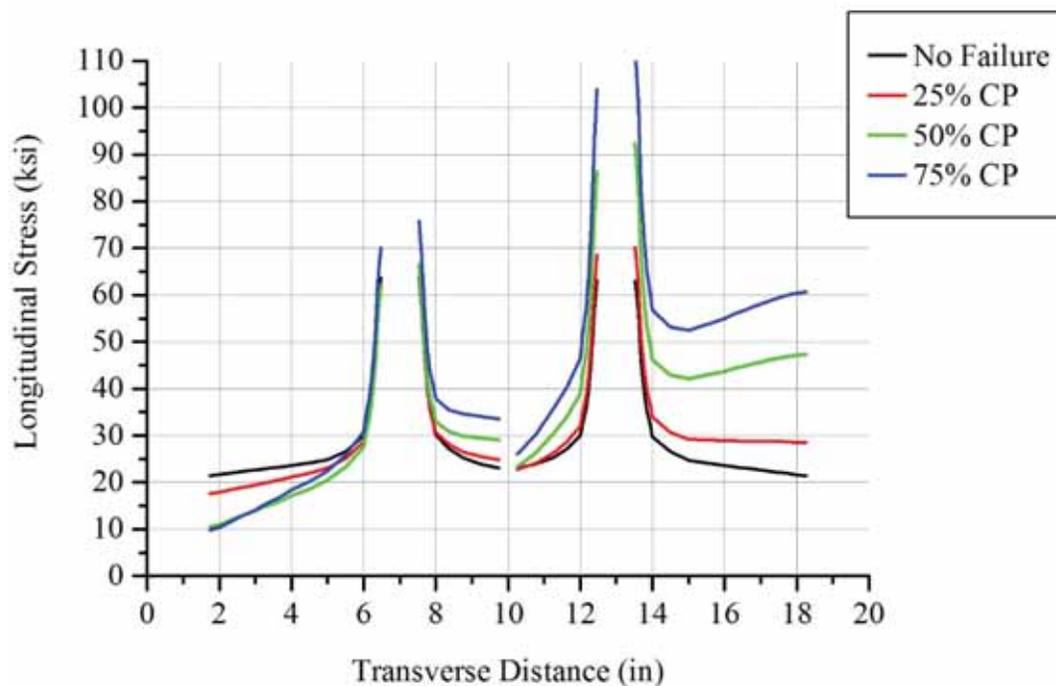
The resulting stresses in the horizontal leg of the flange angle from models having three different amounts of cover plate degradation (25%, 50%, and 75%) are shown in Figure 4-22. As can be seen in the figure, the stress distribution results in an increase in longitudinal stresses in the flange angle above the cracked portion of the cover plate. Additional models (with partial flange failures of 60%, 85%, and 95%) were analyzed to characterize the increase in stress as influenced by the percentage of partial failure. Table 4-5 gives compares the resulting net-section stress (from the FE models) for each portion of cover plate failure. Figure 4-23 shows this information graphically.

Figure 4-22 Stress comparison – No failure vs. 25%, 50%, 75% cover plate failure

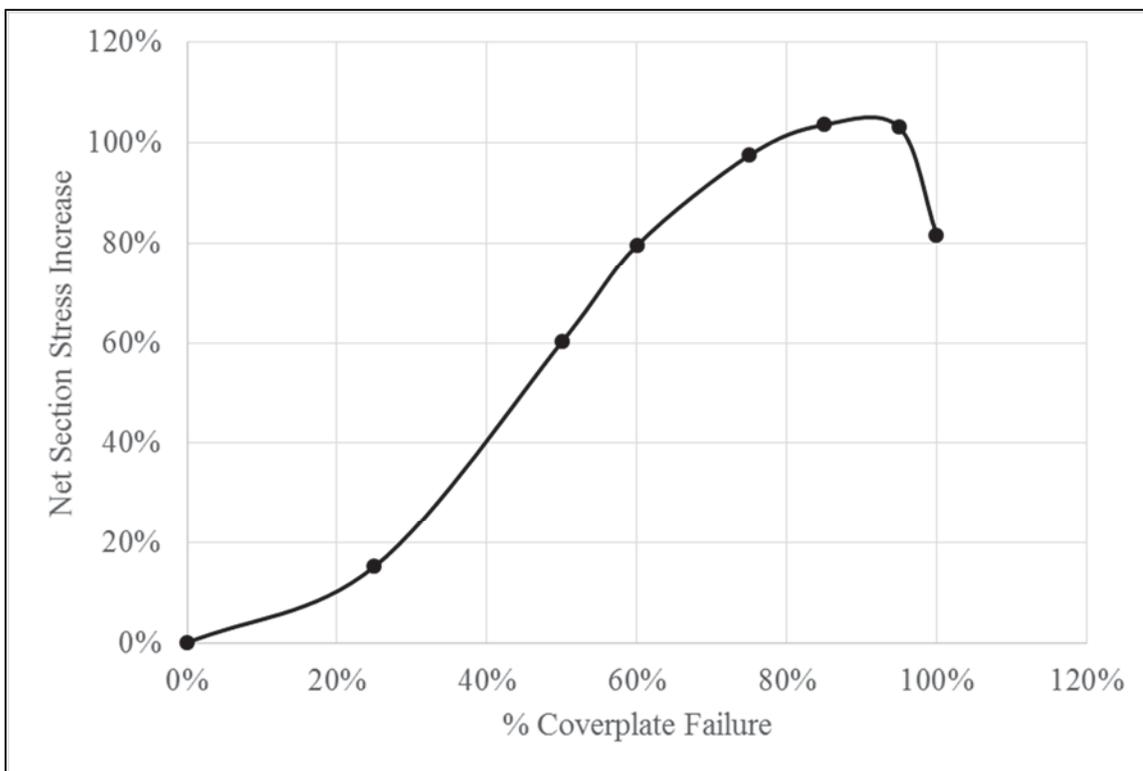
Figure 4-23 Out-of-plane stress redistribution (20" CP - partial cover plate failure)

The data indicates that with a fully failed cover plate, the stress increases 81.7% in the flange angles (at the plane of failure). With a partially failed cover plate, the out-of-plane effects reach approximately the same level (79.6%) when the cover plate is 60% failed. Eight additional models with a significantly larger top and bottom cover plate (26"x1") were also constructed and analyzed. All other aspects of these models (including the remaining components) were identical to the previously analyzed models with 20"x1" cover plates. The tabulated stress increases due to out-of-plane behavior are shown in Table 4-6 and the graphical representation of the data is shown in Figure 4-24. The data illustrates that, similarly to the 20" cover plate specimens, the stress increase in a single

resulted in a stress increase in the remaining flange angles. It was found that a failed flange angle increased the stresses in the adjacent flange angle by 8.6%, while a fully failed cover plate increased the stresses in the flange angles by 81.7%. A partially failed cover plate was found to have the largest impact on the resulting stresses in a single flange angle (located directly above the failure plane). The resulting stresses in the flange angle when a cover plate was 60% failed was approximately equal to those of the flange angle when the cover plate was fully failed. Cover plate failure greater than 60% resulted in higher stresses in the flange angle until the cover plate was completely failed at which time, due to the symmetry of the cross-section, the stresses decreased in the flange angle (as shown in Figure 4-23 and Figure 4-24).

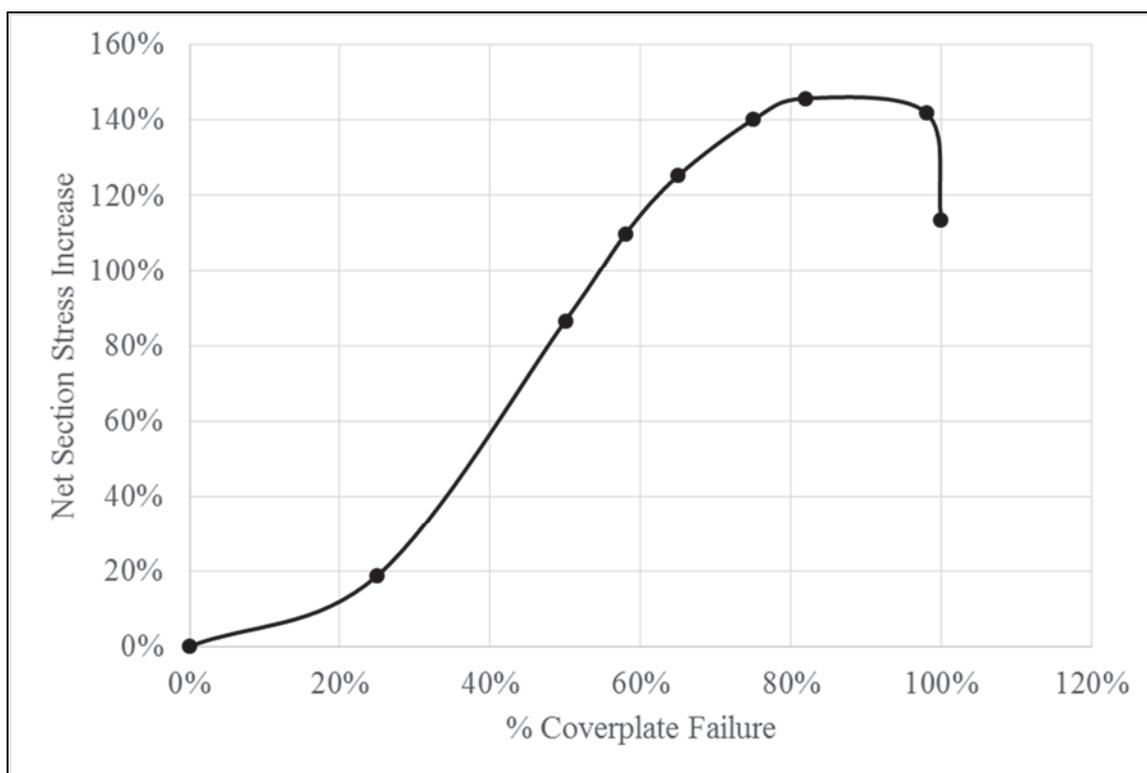
flange angle is equivalent to a fully failed cover plate model when about 60% of the cover plate has failed. The value increases until the crack is about 95% across the cover plate.

Figure 4-24 Out-of-plane stress redistribution (26" CP - partial cover plate failure)

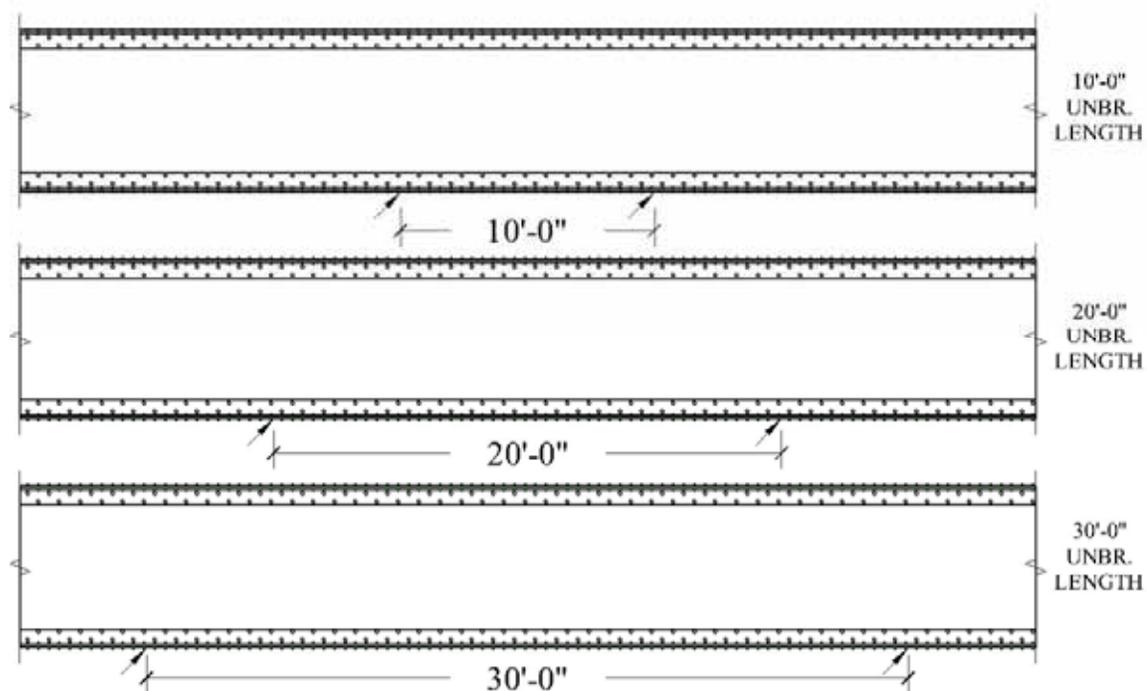
In order to isolate the behavior of the unbraced length, a single built-up member size was used while only varying the bracing points for this sensitivity analysis study. The member geometry was very similar to that used in previous portions of this parametric study. The top and bottom flange were composed of 8x8x1" flange angles, with a single 20"x1" cover plate. A 72"x1/2" web plate was used with a 75% failure at the mid-span (plane of symmetry). Each component had a length of 15'-0" (from the plane of symmetry). Figure 4-25 shows a drawing of each of the simulated beams. The bracing was simulated by restraining the transverse displacement of the vertical leg of the bottom flange angle at 1/2 of each of the three unbraced lengths (5', 10', and 15') due to the symmetry of the model.

Figure 4-25 Unbraced length parameter model geometries

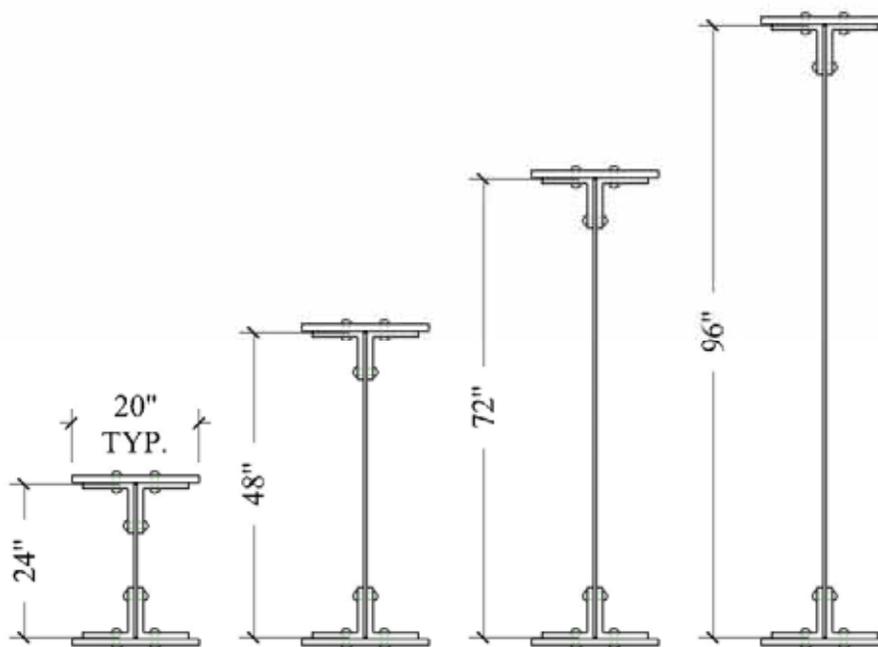
96"). All other geometric dimensions and material properties of the models were held constant to isolate the specimen height parameter. Similar to previous models in the parametric study, 8"x8"x1" flange angles were constructed with 20"x1" cover plates and an unbraced bottom flange length of 20'-0". Figure 4-26 shows each of the four model types.

Figure 4-26 Web height parameter model geometries

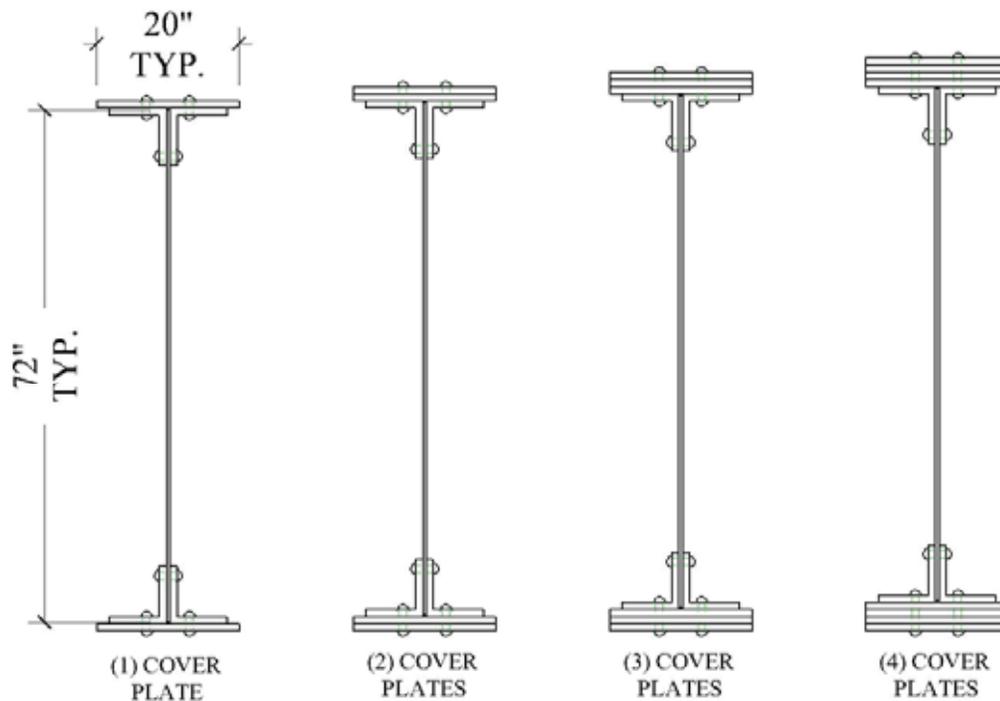
Due to the existence of girders with multiple cover plates (to meet bending stress demands), the effect of partial and complete failure of a single component was investigated. Models with varying quantities of cover plates were constructed. Similar to previous models, the geometry of each model consisted of 8x8x1" flange angles with a 72"x1/2" web plate and an unbraced bottom flange length of 20'-0". The number of 20"x1" cover plates was varied from 1 to 4 (see Figure 4-27). Fasteners in adjacent cover plates were simulated the same way as previously described for other models – the first four rivets were modeled physically modeled, and the remaining rivets were simulated using nodal tie constraints.

Figure 4-27 Cover plate quantity parameter model geometries

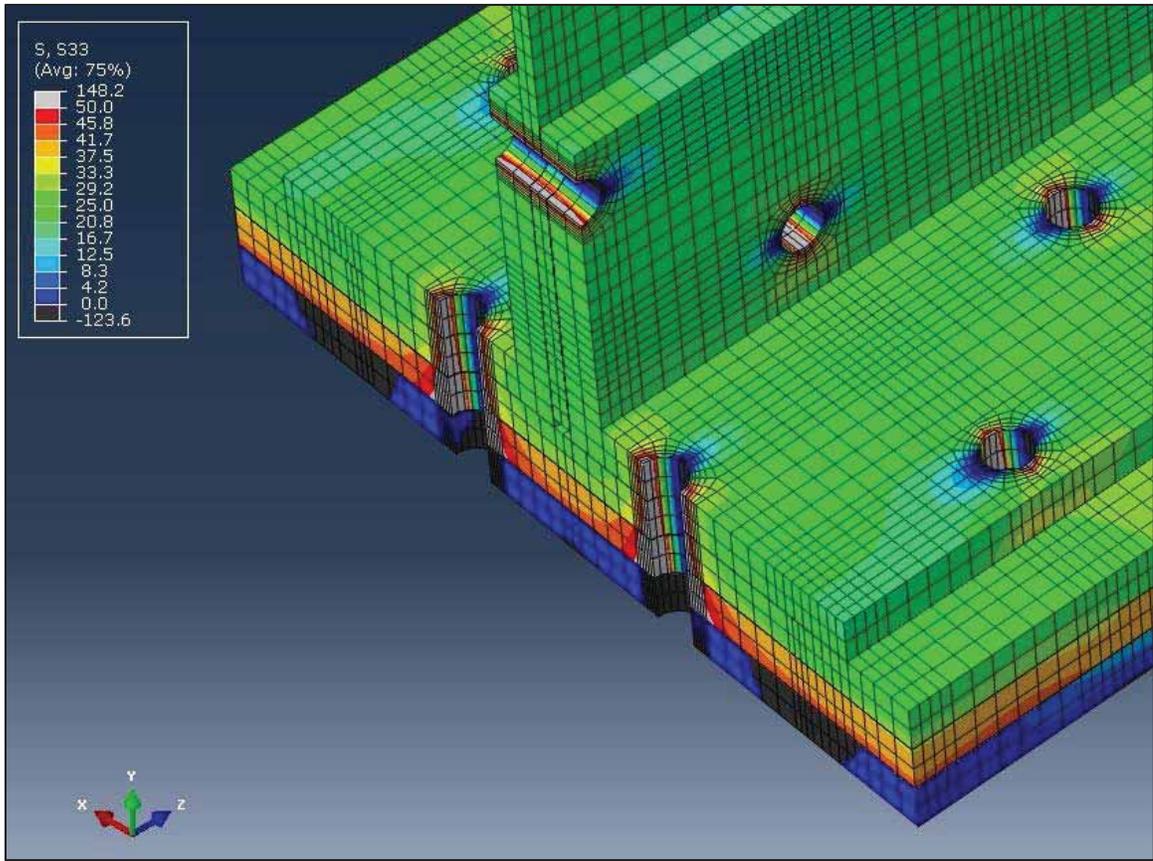
The four different geometries were modeled first with no failed components in order to obtain baseline stresses to compare stress distribution. Next, all four models were analyzed with a fully failed bottom cover plate and then with a 75% fully failed bottom cover plate. Longitudinal stresses were measured in each of the bottom flange components and then converted to an equivalent net-section stress using the trapezoidal rule as discussed in Section 4.1.3. Figure 4-28 shows the longitudinal stresses in a model with three cover plates (fully failed lower cover plate).

Figure 4-28 Model with 3 cover plates – lower cover plate failed

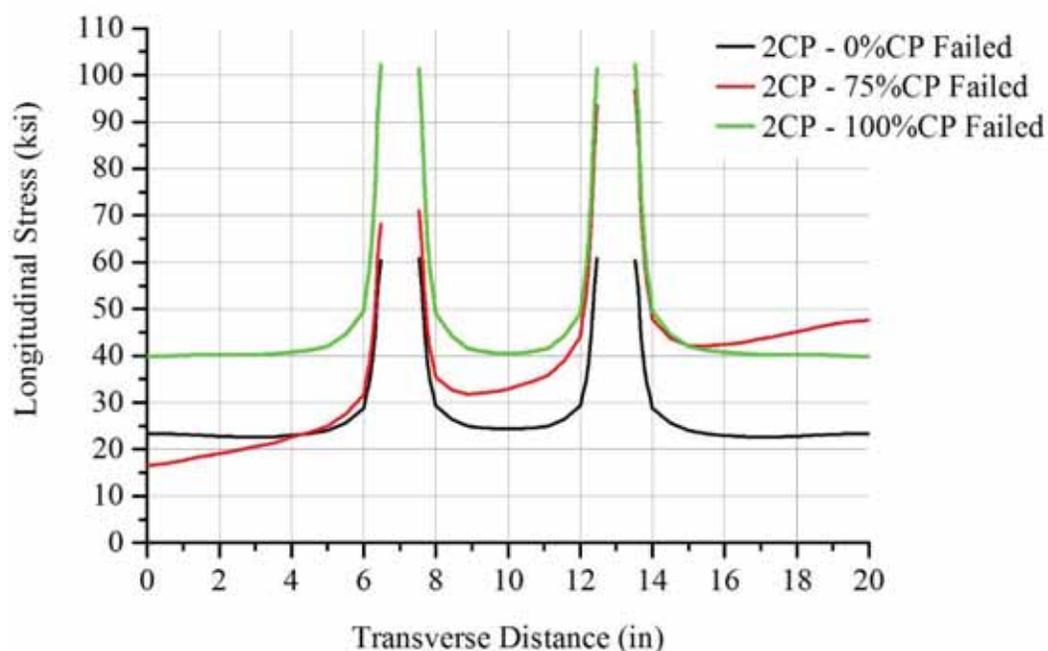
result in significant stress increases in the stress redistribution when more than one cover plate was used. This is further illustrated in Figure 4-29 which shows the longitudinal stresses in the cover plate adjacent to the failed bottom cover plate for each of the three simulated cover plate conditions (0%, 75%, and 100% cover plate failure).

Figure 4-29 Model w/ two cover plates – stresses at 3 stages of cover plate failure

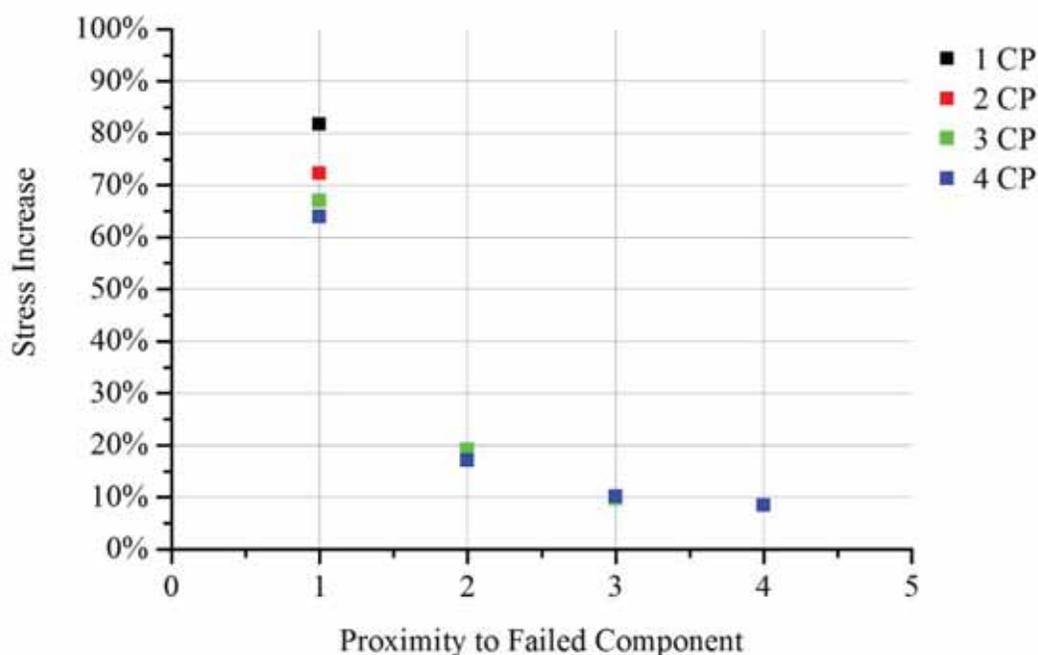
In order to quantify the stress increase in adjacent components, the longitudinal stresses were measured in each of the bottom flange components of each of the models. The resulting component net-section stress increase of the partially failed cross-section was then plotted to determine the relationship between the proximity of each component to the amount of stress redistribution (see Figure 4-30). As shown in the graph, the majority of the stress (64%-84%) of a failed component was distributed to the next closest component. Additionally, girders with a single cover plate experienced a significantly higher stress in the component adjacent to the failure than girders with more cover plates. Girders with more than one cover plate saw an increase of approximately 20% in the 2nd closest component, and approximately 10% in the 3rd and 4th closest components.

Figure 4-30 Stress Increase in girders with multiple cover plates

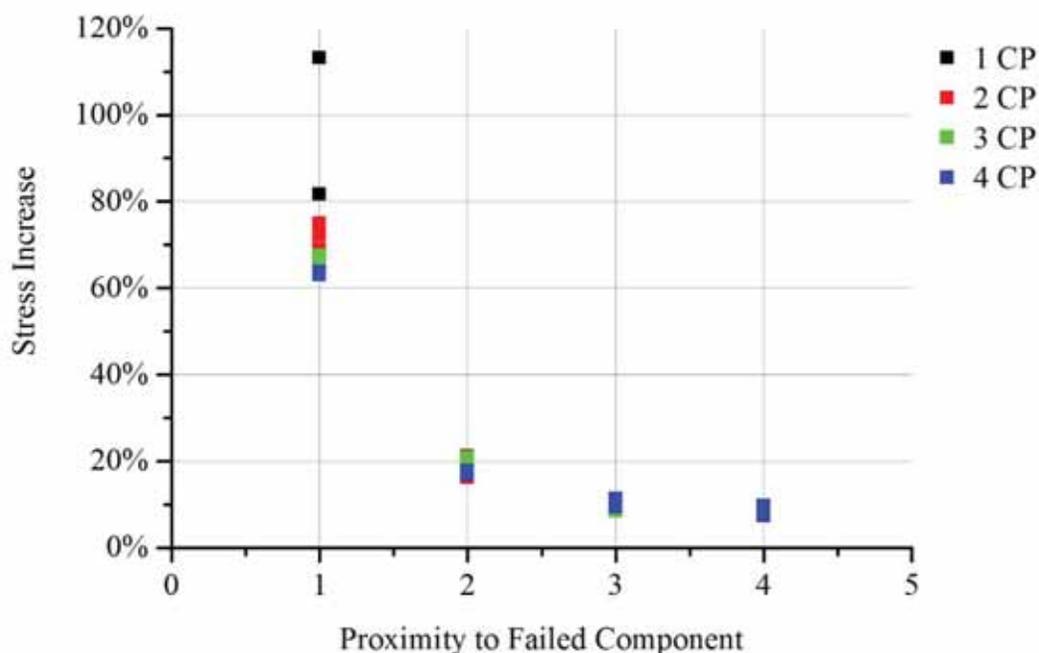
models with 1, 2, 3, and 4 cover plates. The trends were then plotted along with those of the 20" cover plates (see Figure 4-31)

Figure 4-31 Stress increase in components of girders with multiple cover plates (16", 20", 26" cover plates)
